# IndianOil

## JOURNEY RISK MANAGEMENT (JRM) STUDY

### Salem Terminal TO PARIYUR CORPORATION

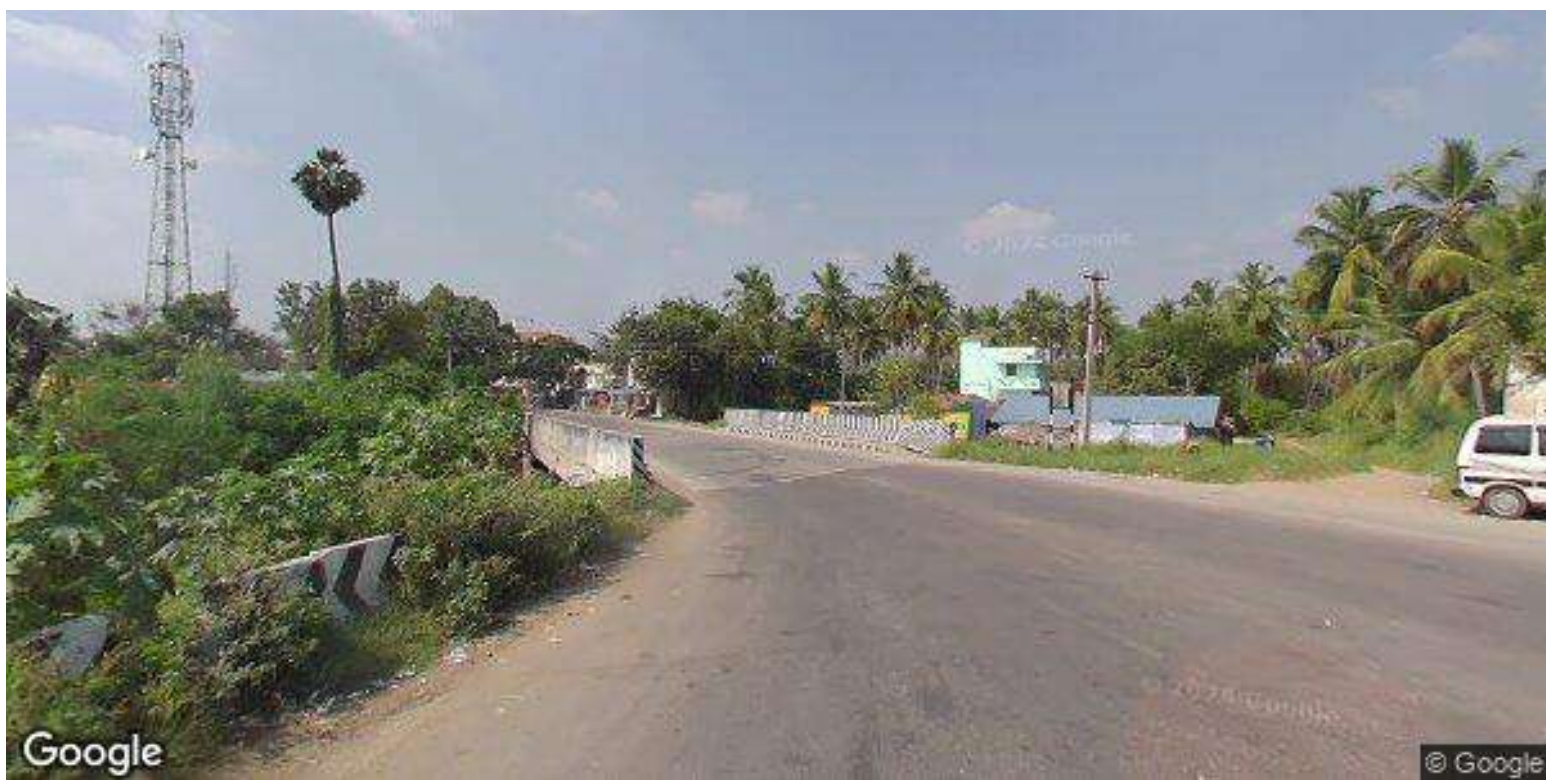
**Coordinates:** 11.44893, 77.87413

**Risk Type:** Turn

**Speed Limit:** 15 KM/Hr

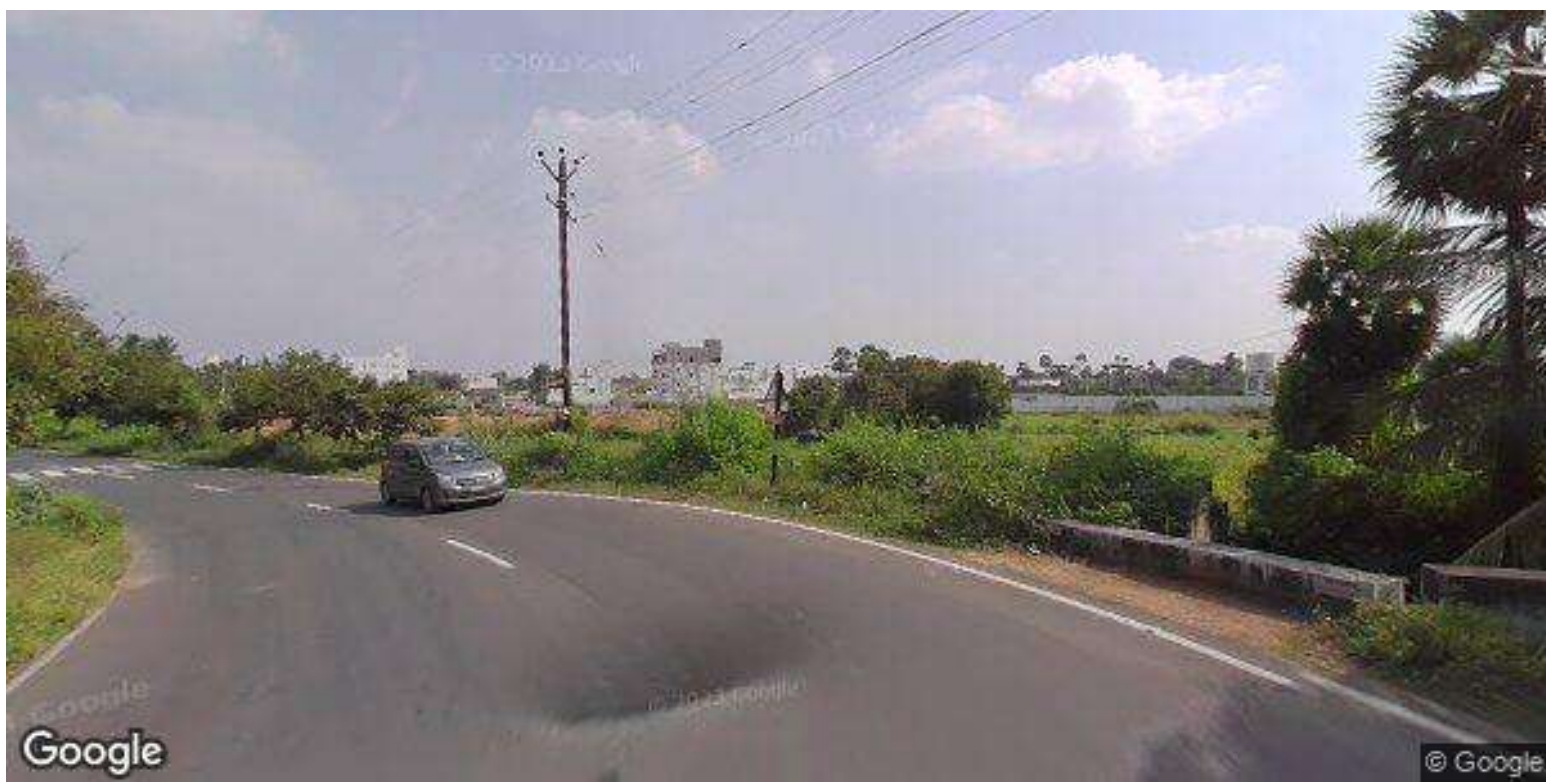
**Coordinates:** 11.45350, 77.85700

**Risk Type:** Turn

**Speed Limit:** 15 KM/Hr

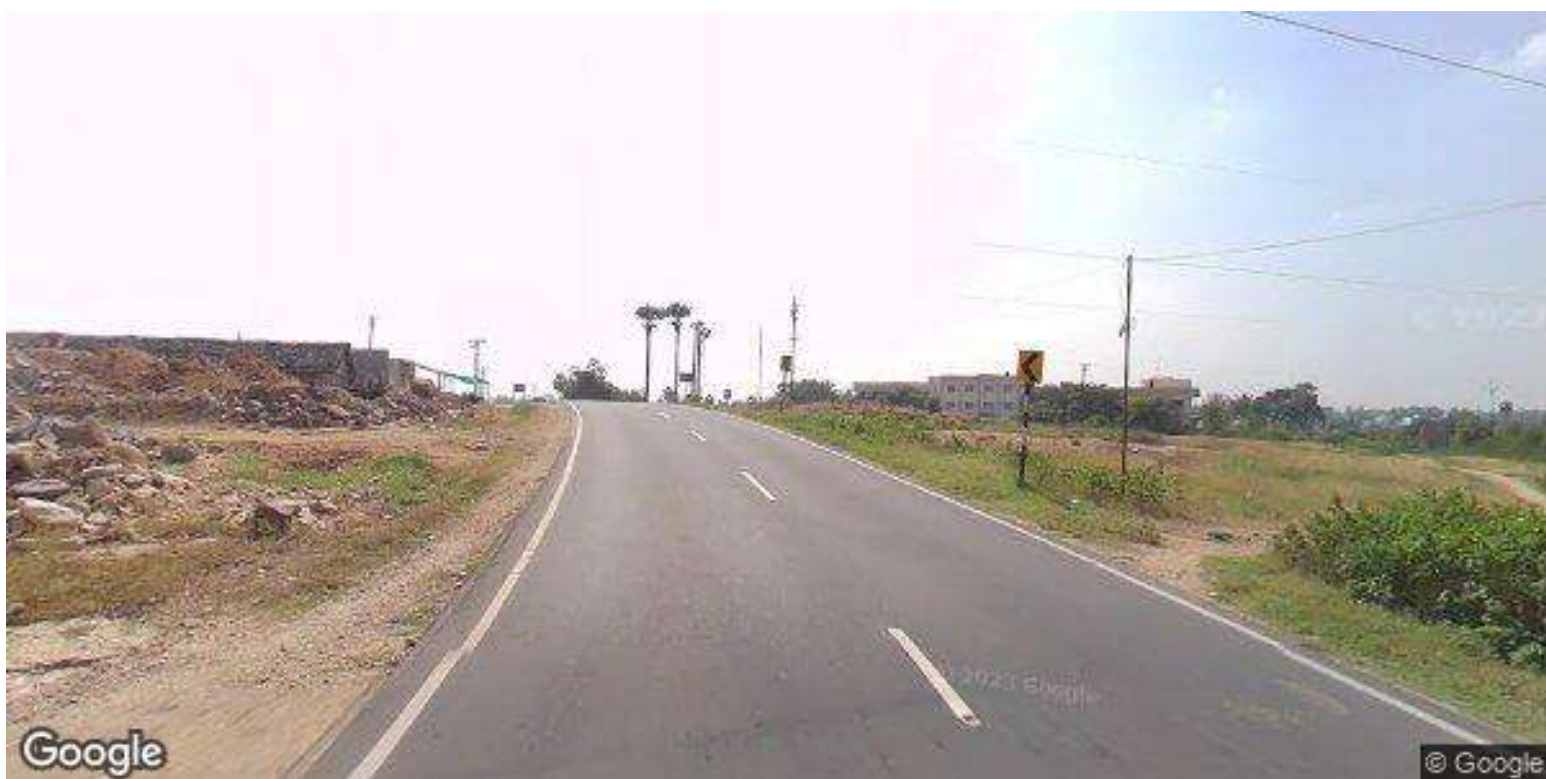
**Coordinates: 11.46046, 77.85037**

**Risk Type: Turn**

**Speed Limit: 15 KM/Hr**

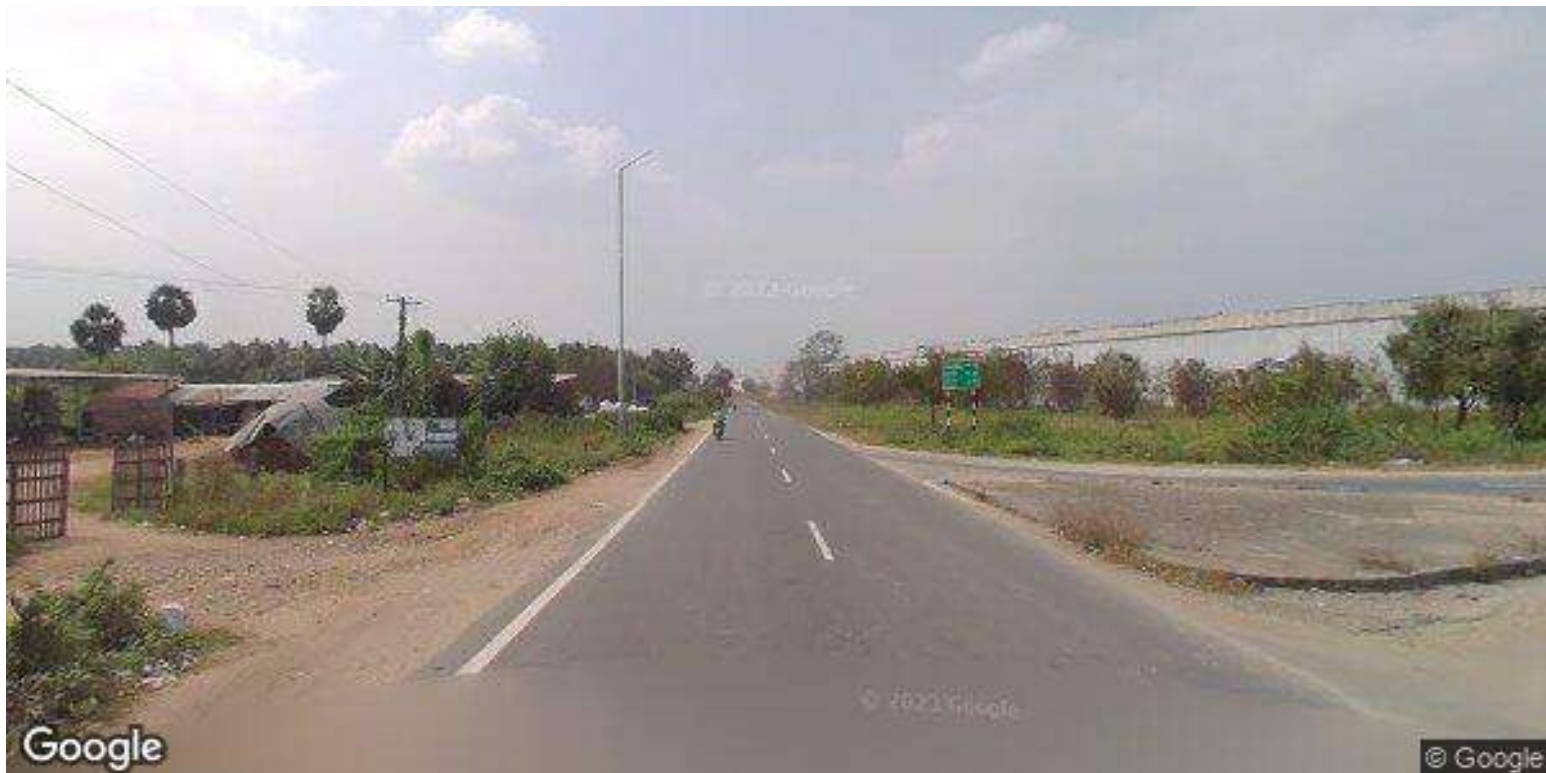
**Coordinates: 11.45542, 77.81725**

**Risk Type: Turn**

**Speed Limit: 15 KM/Hr**

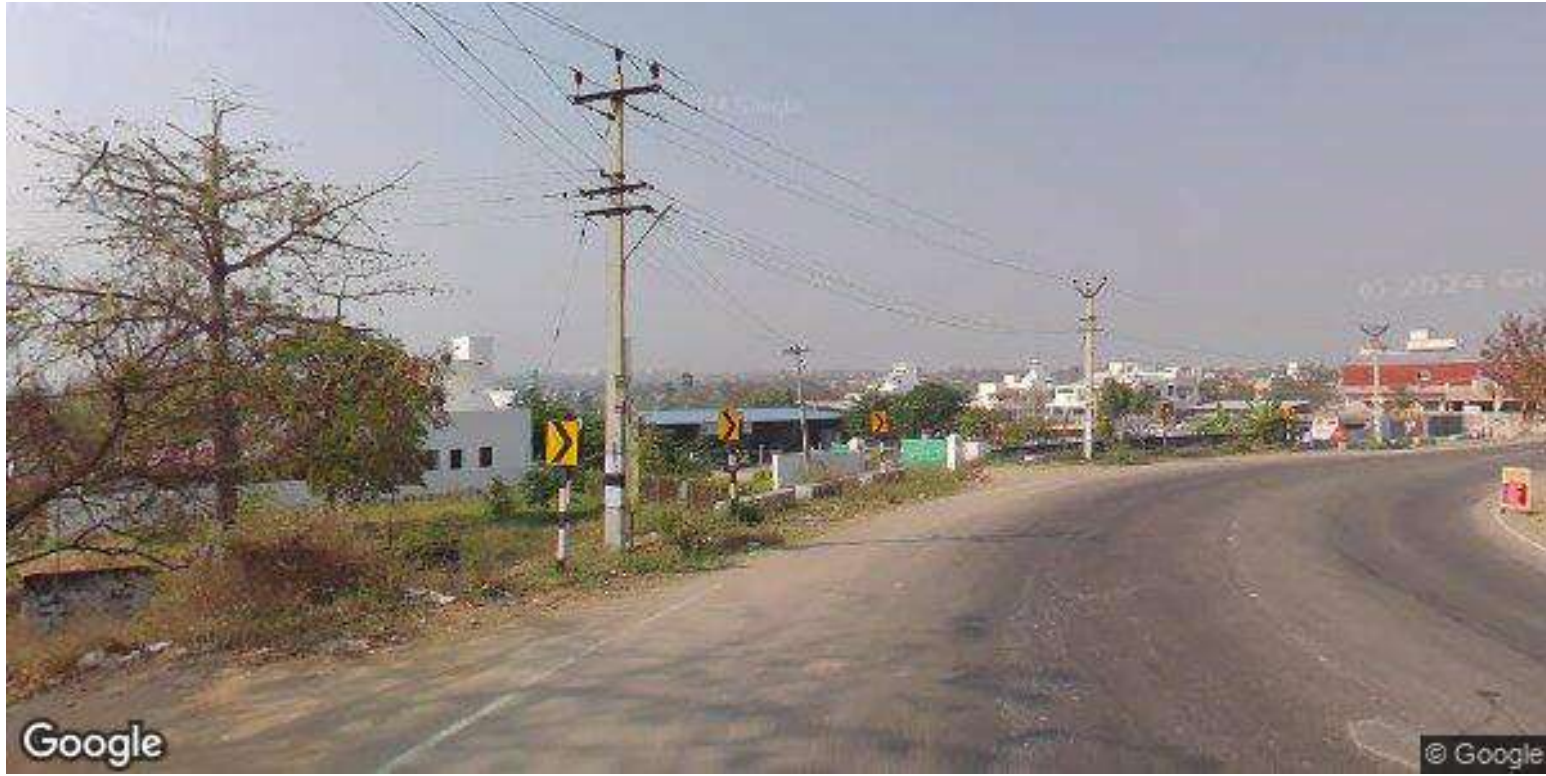
**Risk Type:** Turn  
**Speed Limit:** 15 KM/Hr  
**Distance from Start:** 25.60 km  
**Coordinates:** 11.43273, 77.67018

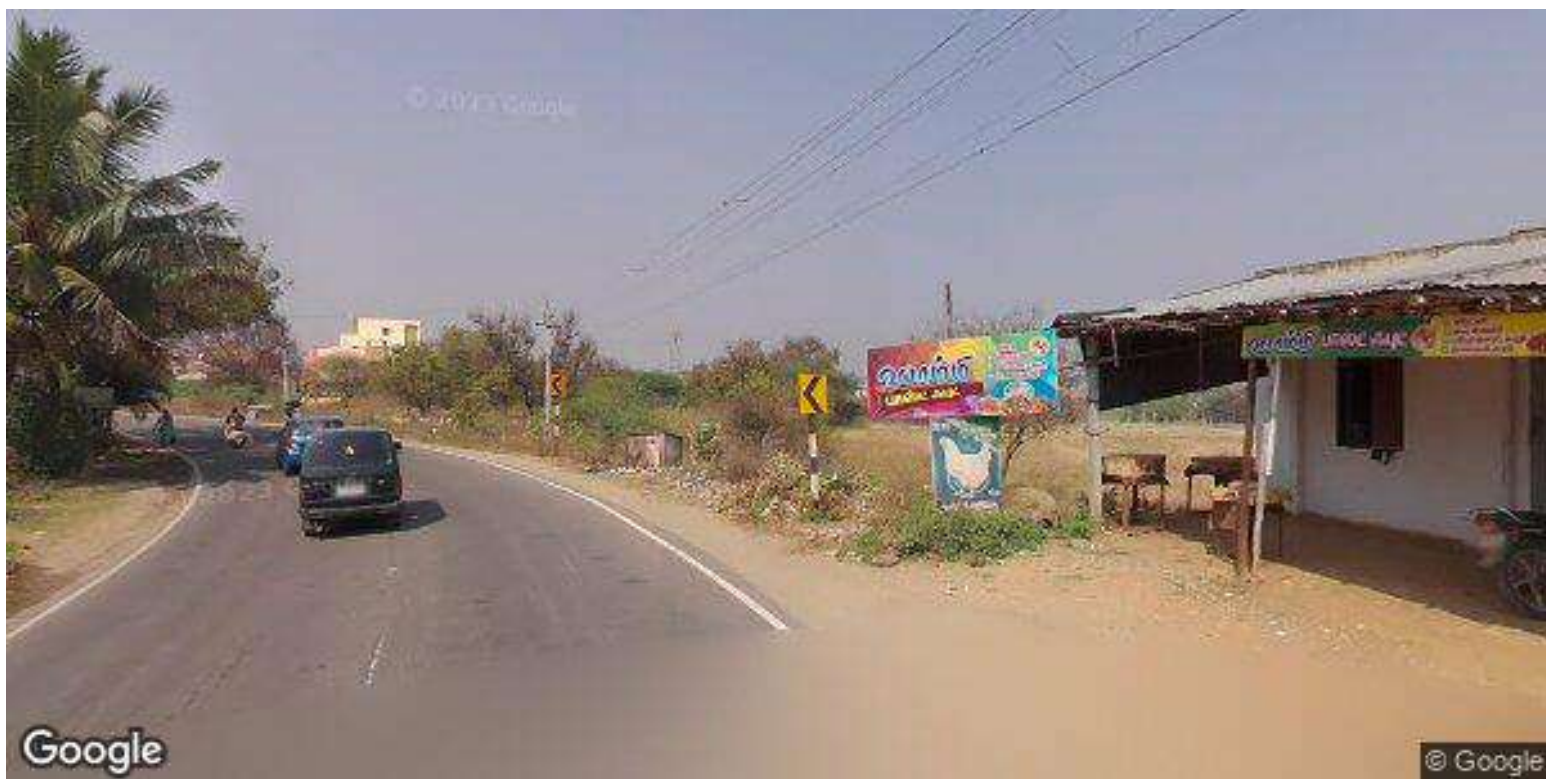
**Risk Type:** Turn  
**Speed Limit:** 15 KM/Hr  
**Distance from Start:** 25.98 km  
**Coordinates:** 11.43346, 77.66700

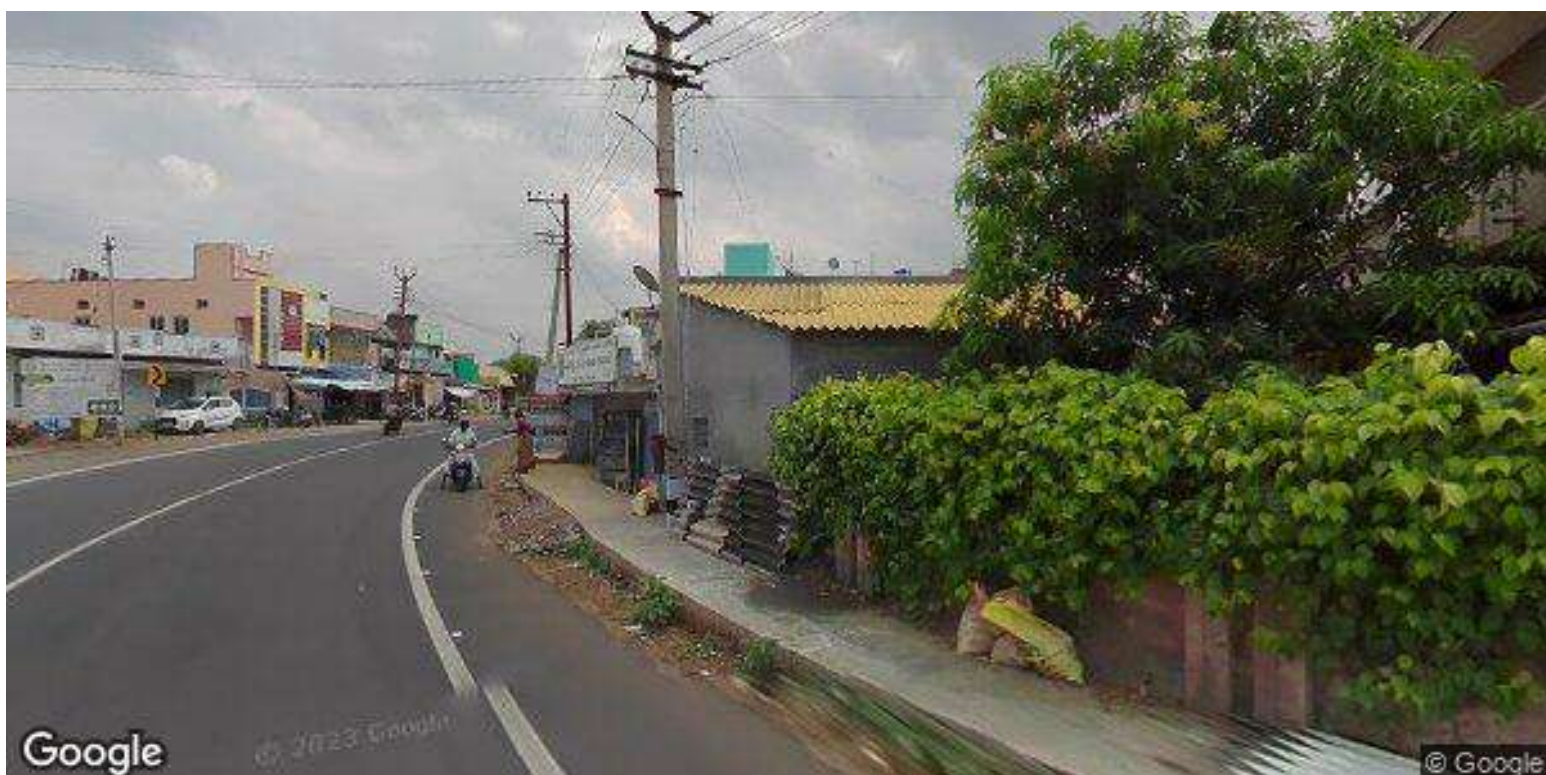
**Coordinates: 11.42821, 77.56543**

**Risk Type: Turn**

**Speed Limit: 15 KM/Hr**

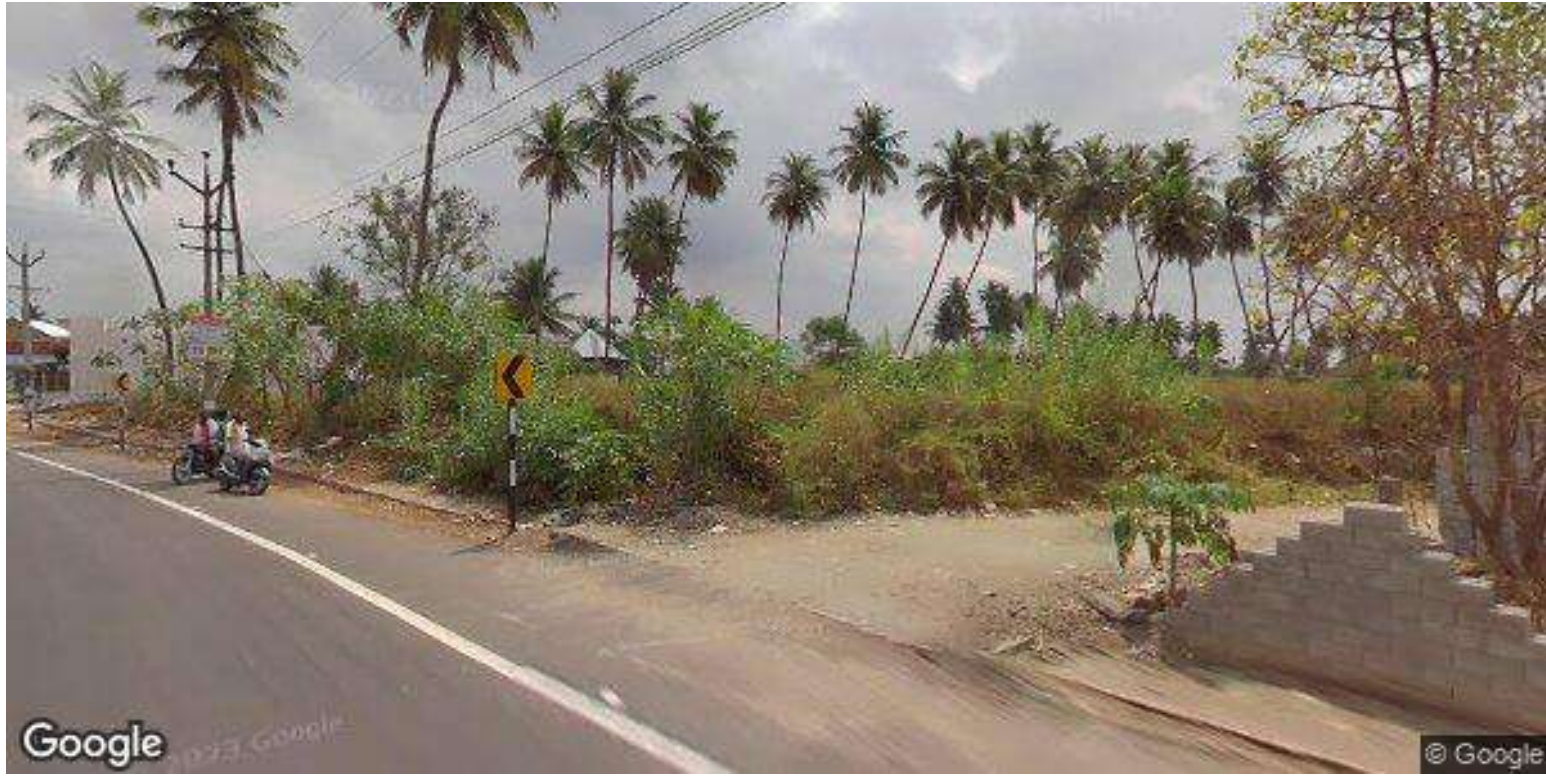
**Coordinates: 11.42707, 77.56407**

**Risk Type: Turn**

**Speed Limit: 15 KM/Hr**

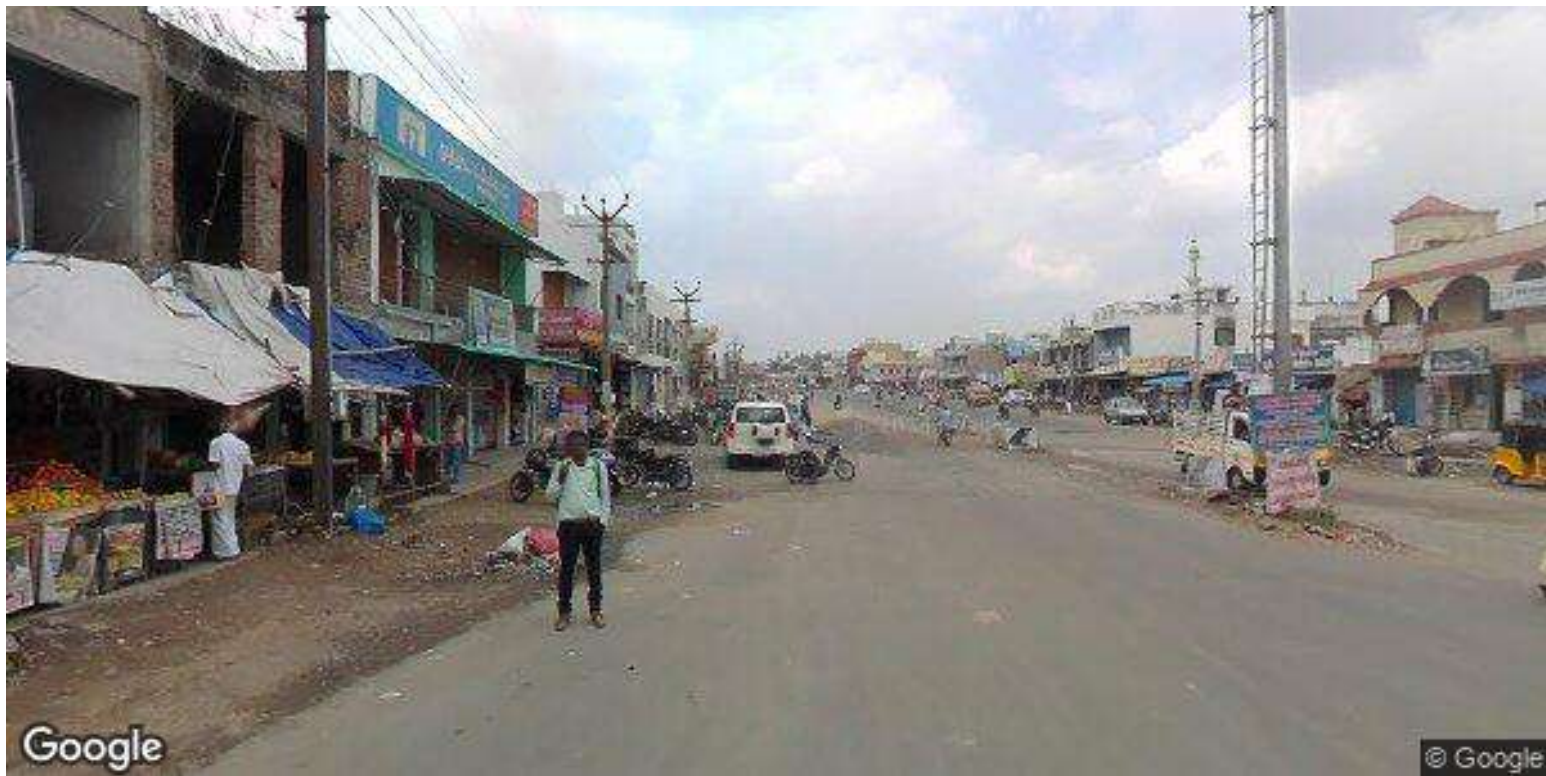
**Coordinates: 11.42329, 77.55798**

**Risk Type: Turn**

**Speed Limit: 15 KM/Hr**

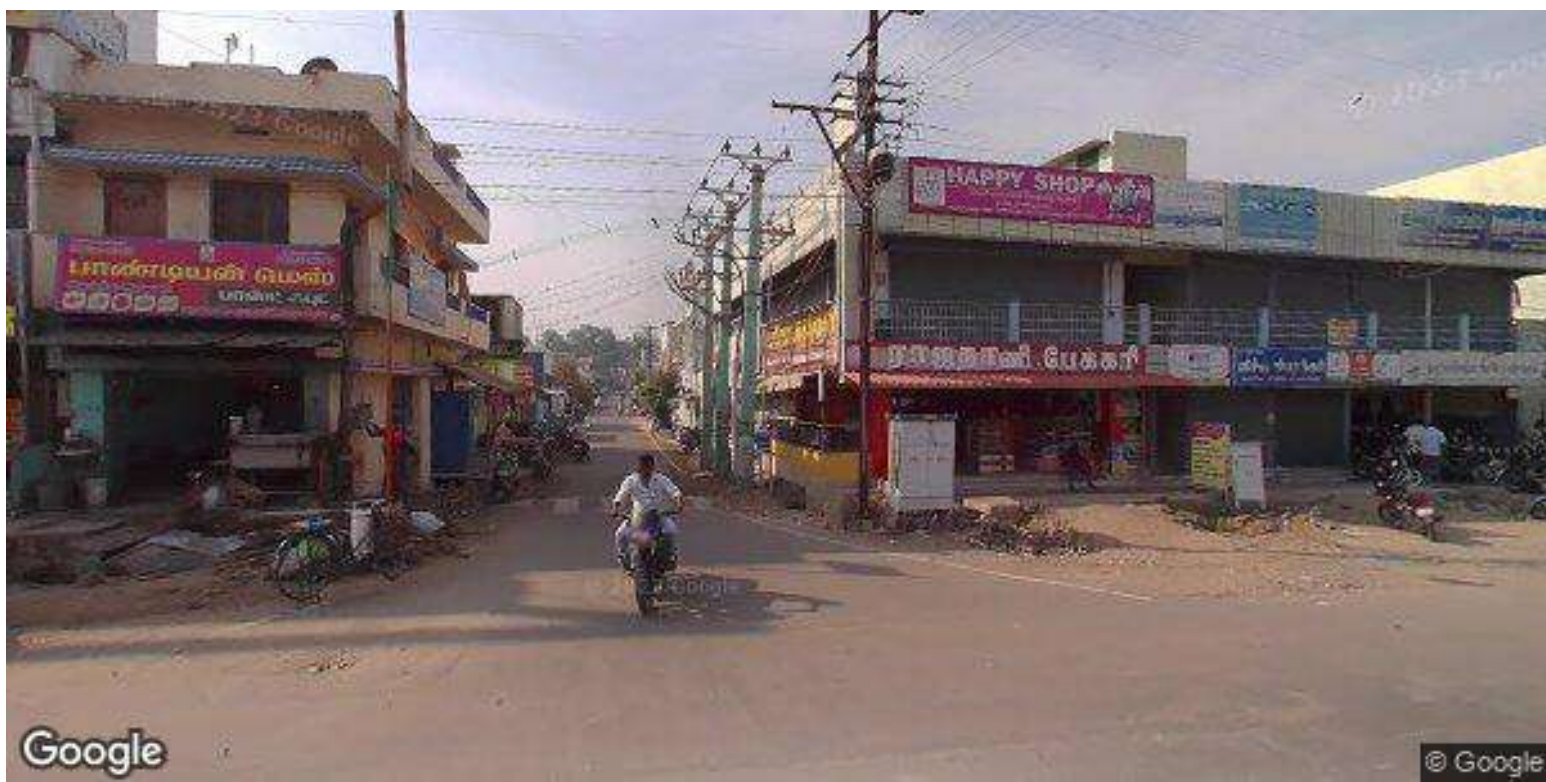
**Coordinates:** 11.45462, 77.44375

**Risk Type:** Blind Spot

**Speed Limit:** 10 KM/Hr

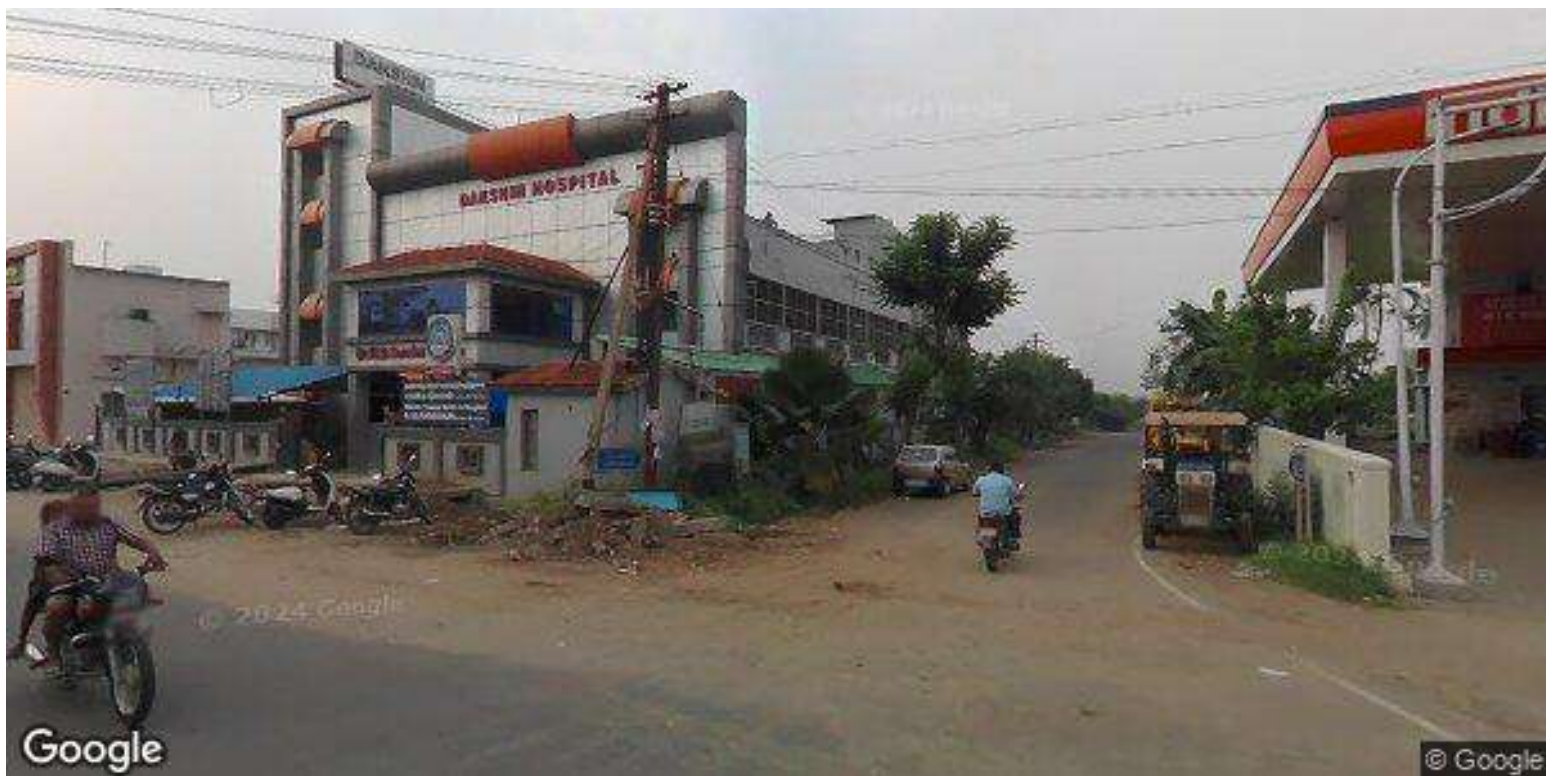
**Coordinates:** 11.45420, 77.44634

**Risk Type:** Blind Spot

**Speed Limit:** 10 KM/Hr
