## JOURNEY RISK MANAGEMENT (JRM) STUDY

### Salem Terminal to SUBRAMANYAA FUELS

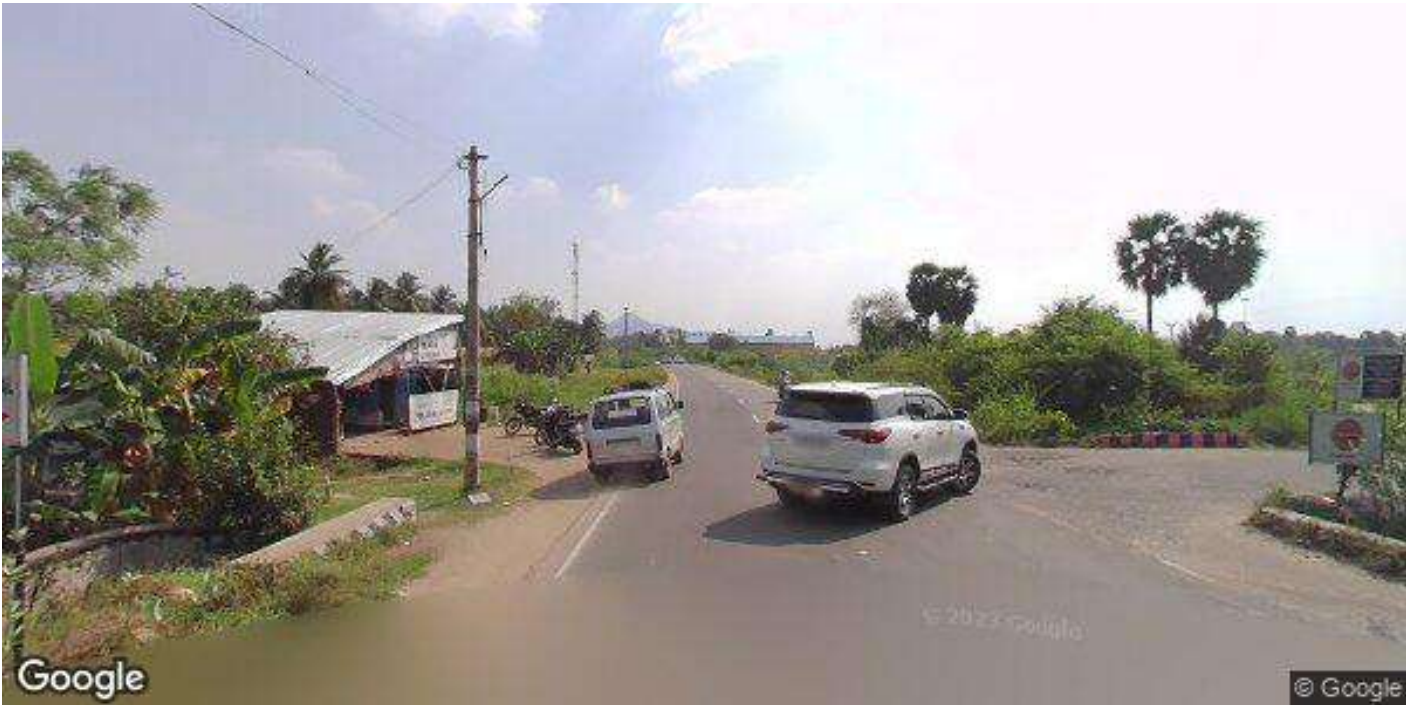
Risk Type: Turn

Risk Level: High

**Speed Limit: 15 KM/Hr**  
**Coordinates: 11.44029, 77.87544**

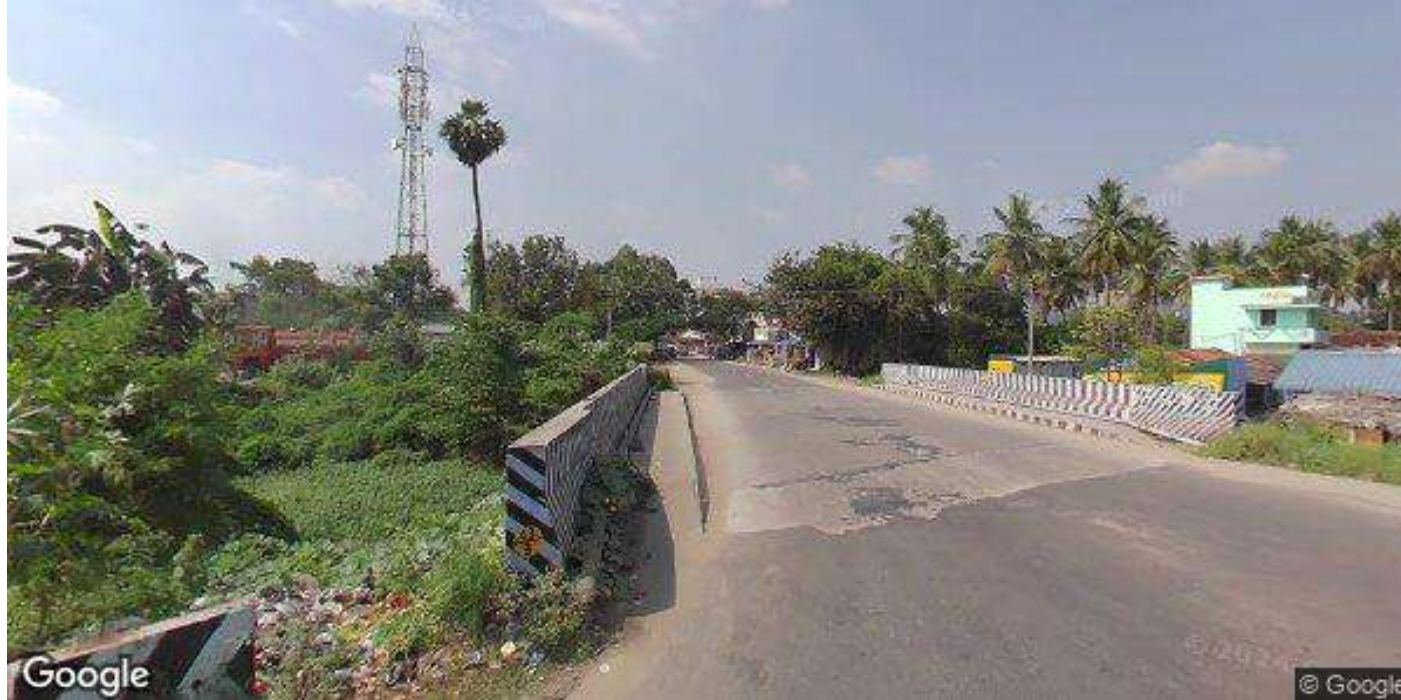
**Risk Type: Turn**  
**Risk Level: High**  
**Speed Limit: 15 KM/Hr**  
**Coordinates: 11.44900, 77.87406**

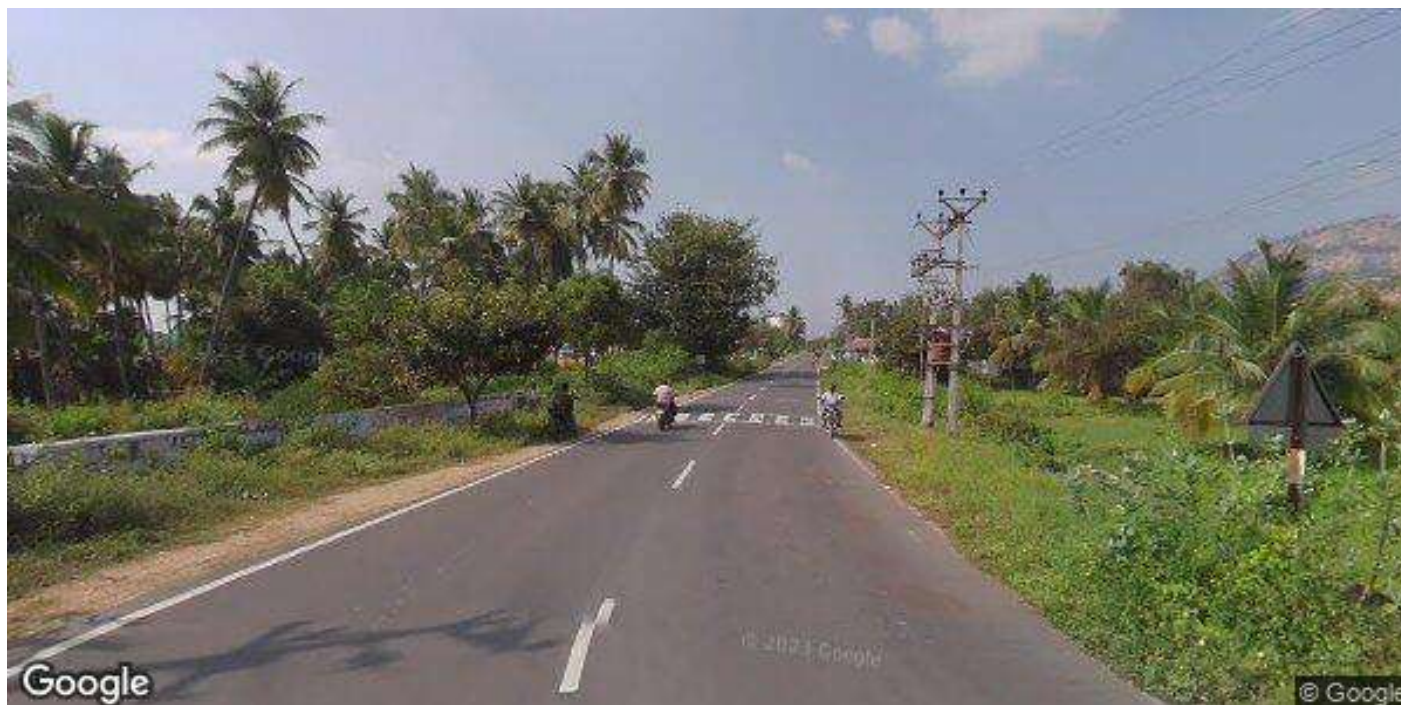
**Risk Type: Turn**  
**Risk Level: High**  
**Speed Limit: 15 KM/Hr**  
**Coordinates: 11.45353, 77.85697**

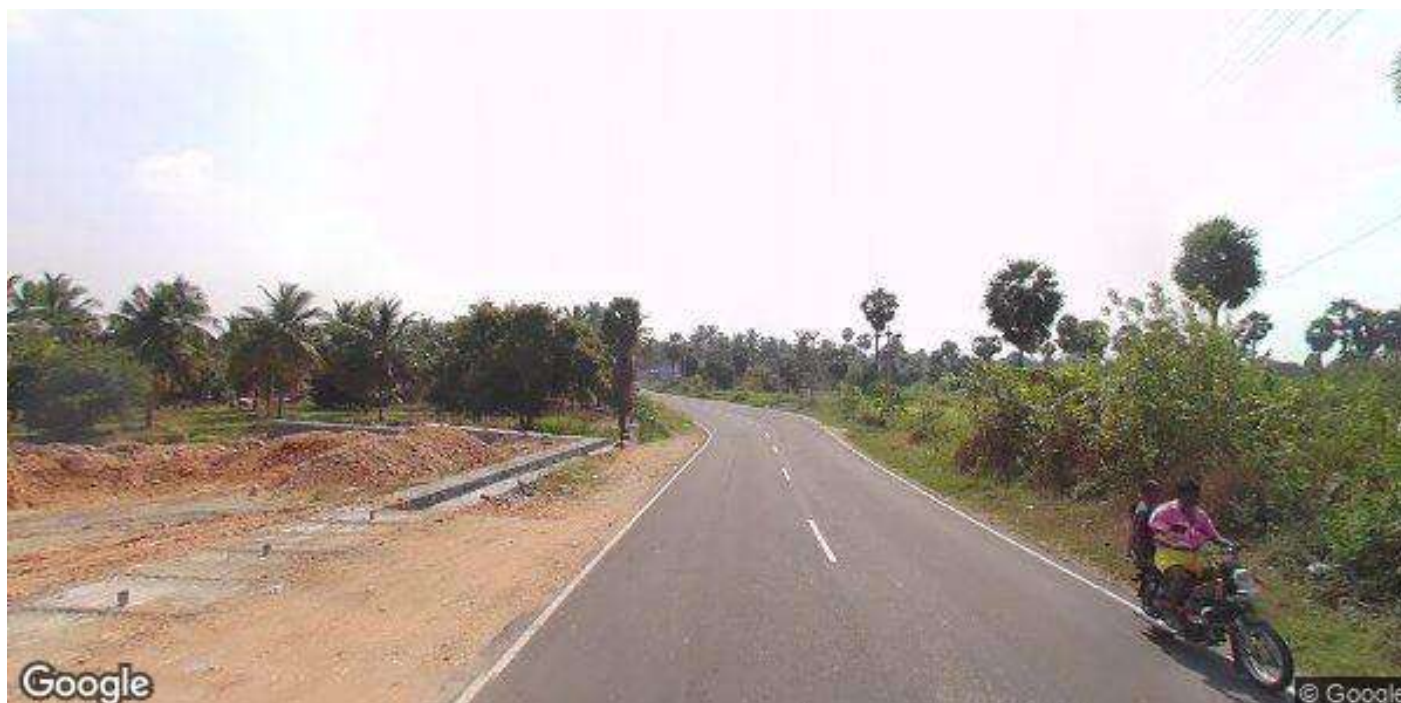
**Risk Type:** Turn  
**Risk Level:** Medium  
**Speed Limit:** 30 KM/Hr  
**Coordinates:** 11.45781, 77.85203

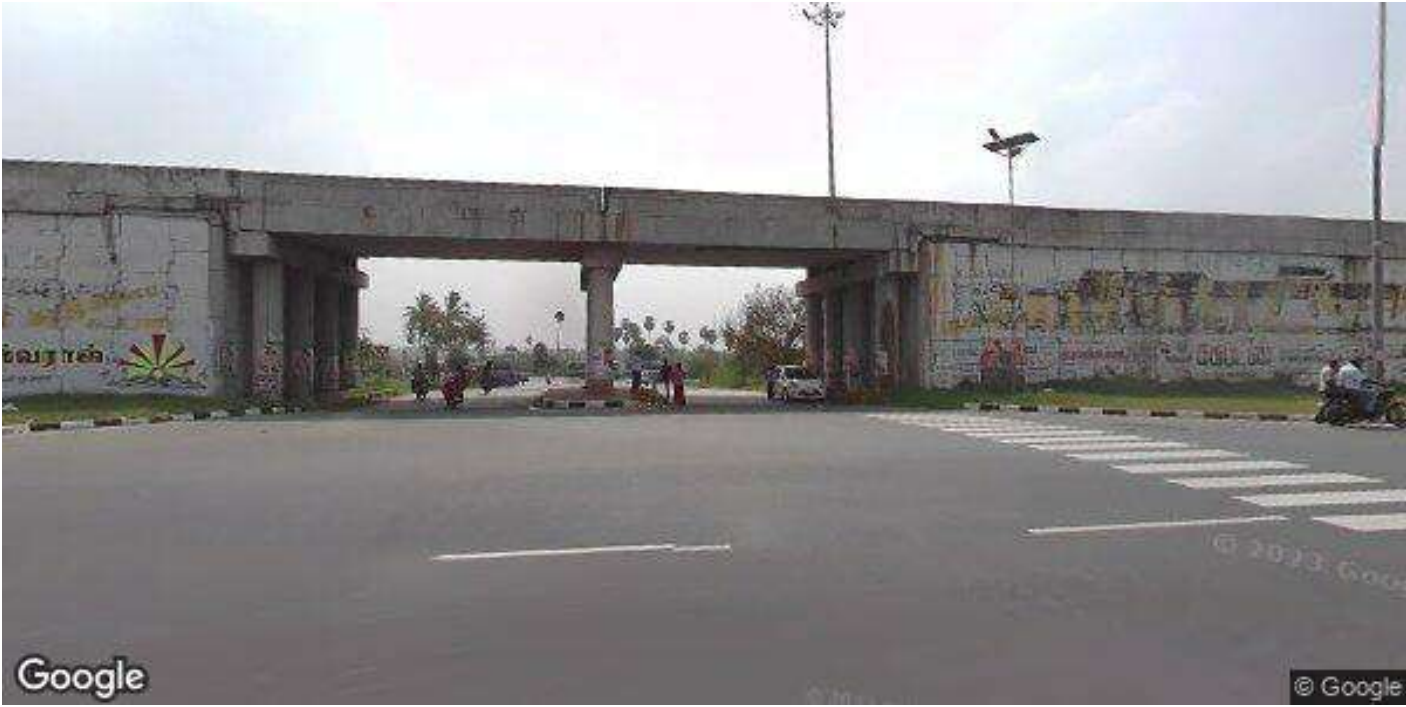
**Risk Type:** Turn  
**Risk Level:** High  
**Speed Limit:** 15 KM/Hr  
**Coordinates:** 11.45636, 77.81678

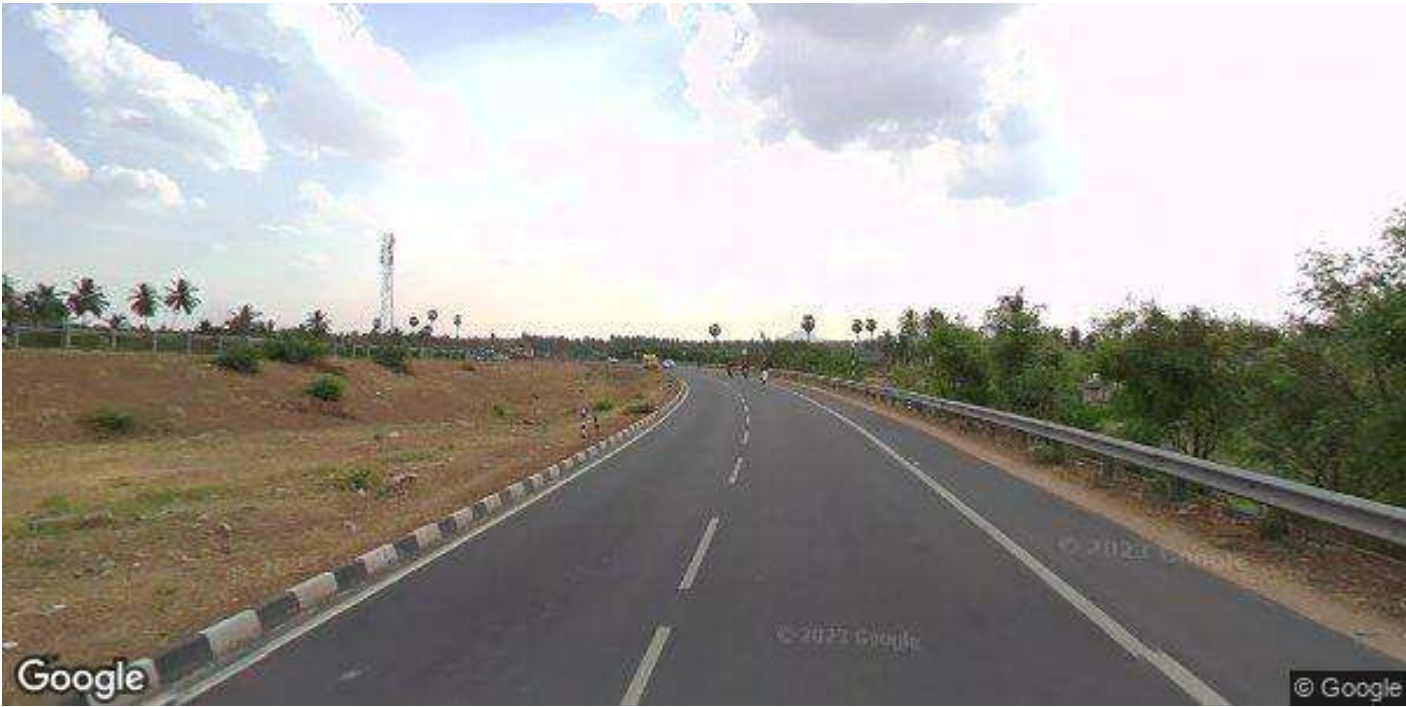
**Risk Type:** Turn  
**Risk Level:** Medium  
**Speed Limit:** 30 KM/Hr  
**Coordinates:** 11.53573, 77.95794

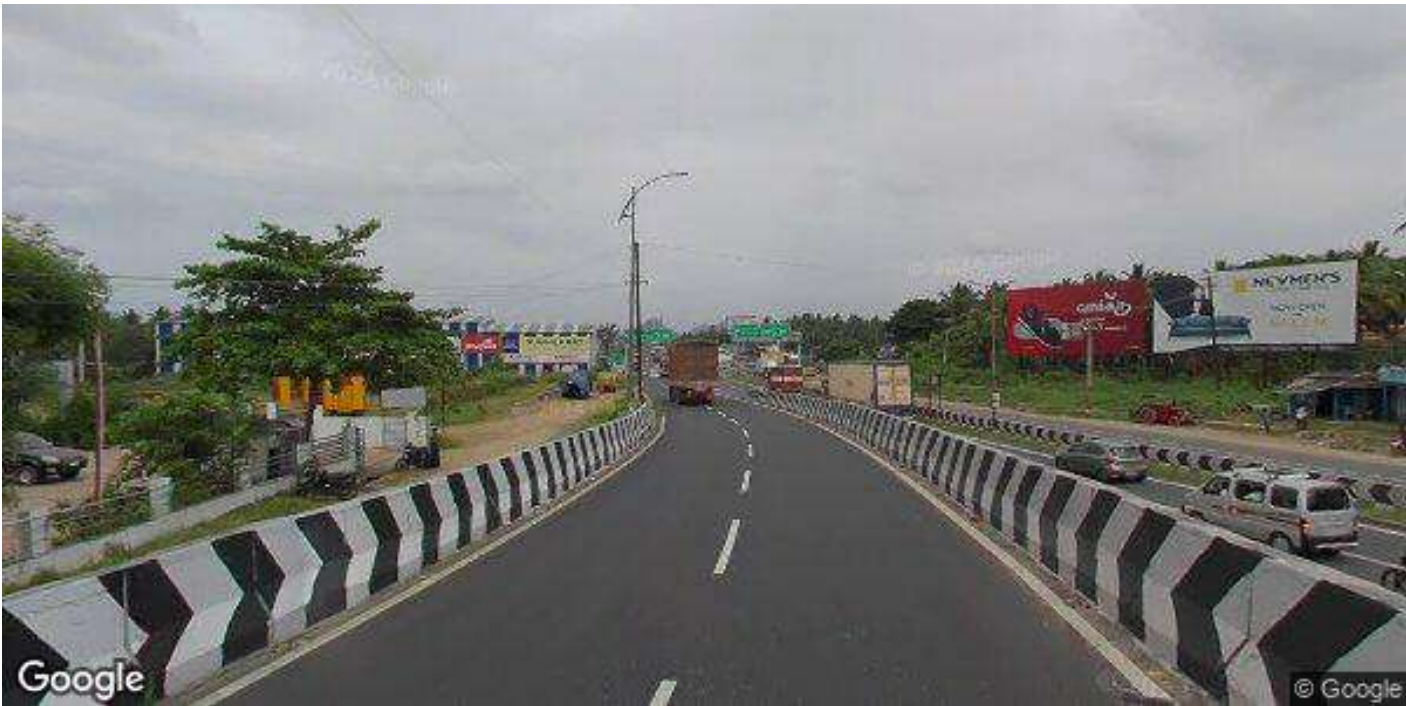
**Risk Type:** Turn  
**Risk Level:** Medium  
**Speed Limit:** 30 KM/Hr  
**Coordinates:** 11.64338, 78.11998

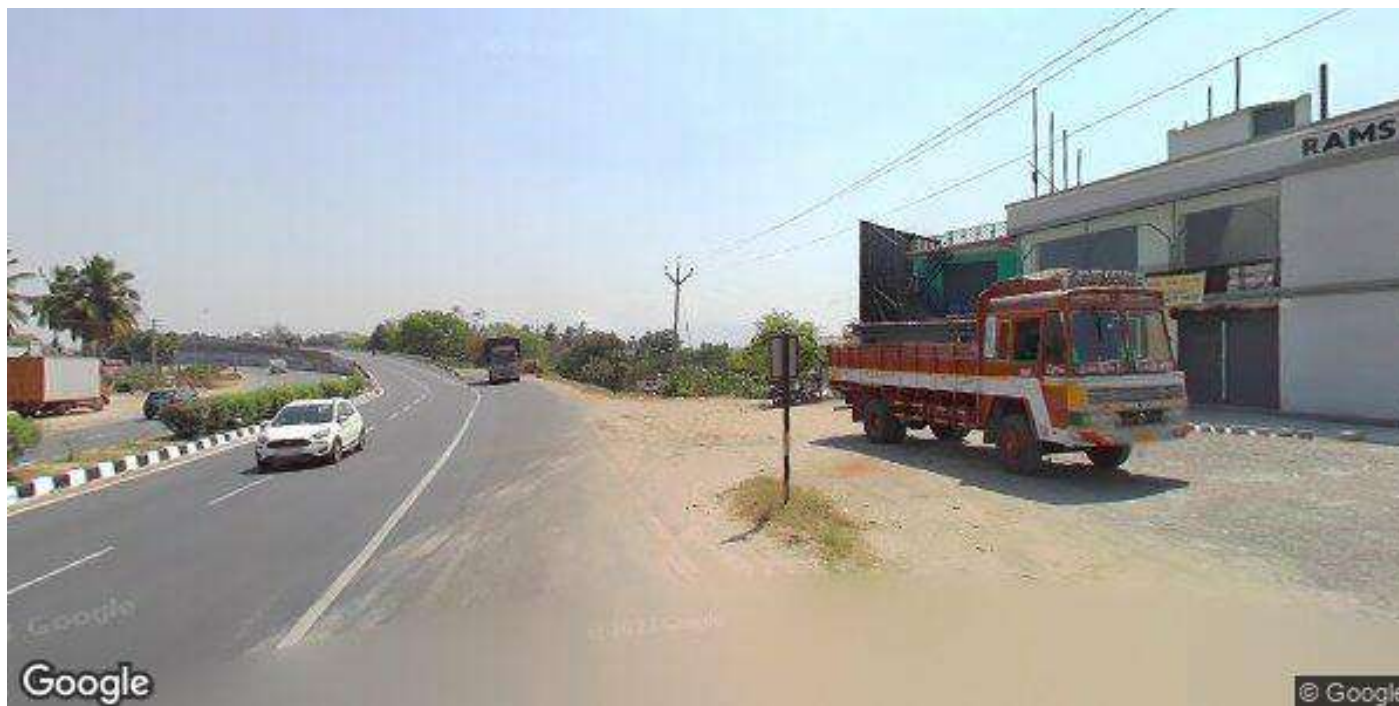
**Risk Type:** Turn  
**Risk Level:** Medium  
**Speed Limit:** 30 KM/Hr  
**Coordinates:** 11.74068, 78.05047

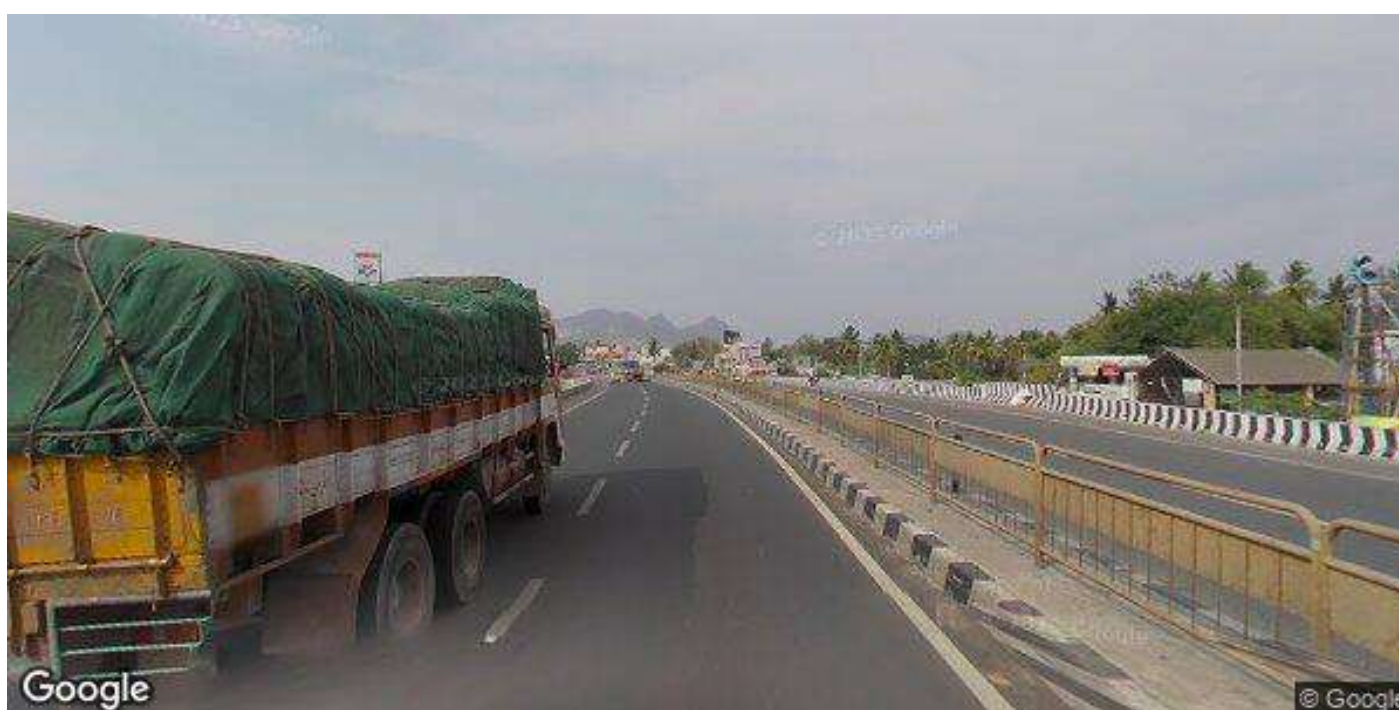
**Risk Type:** Turn  
**Risk Level:** Medium  
**Speed Limit:** 30 KM/Hr  
**Coordinates:** 11.86753, 78.08331

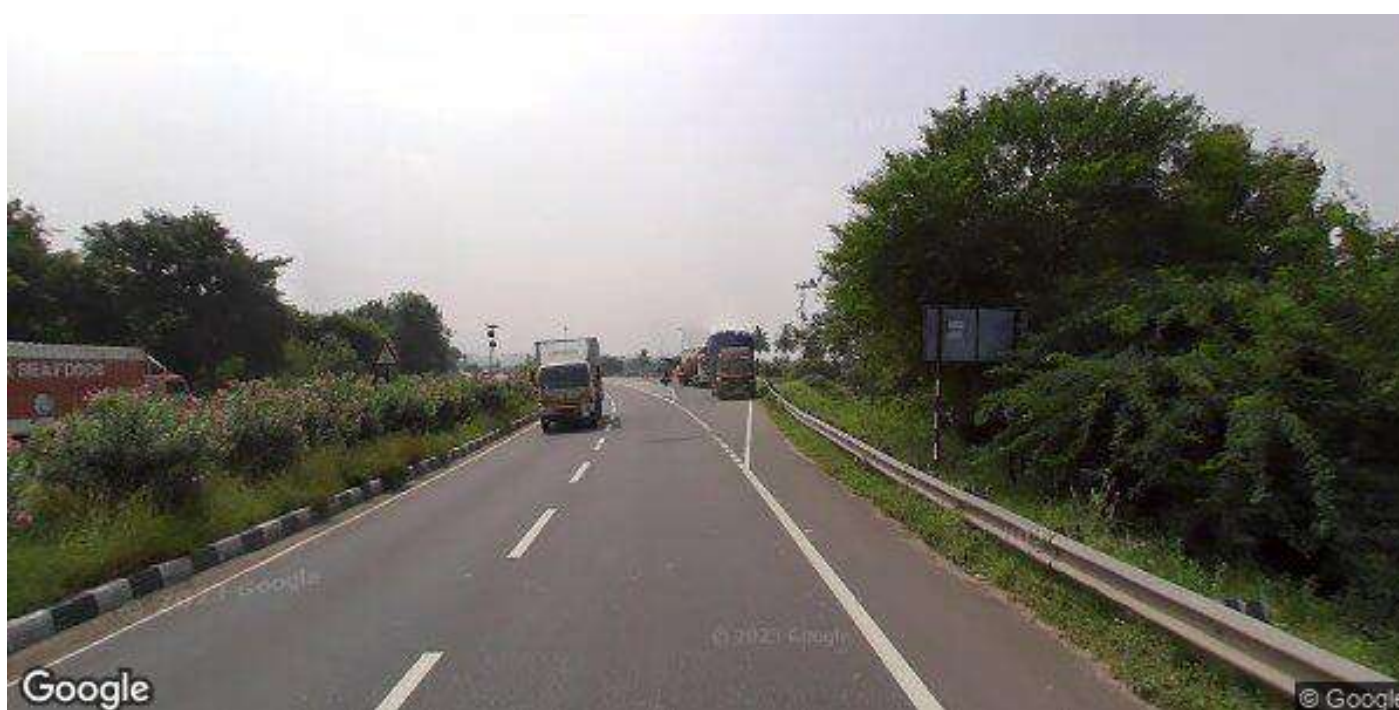
**Risk Type:** Turn  
**Risk Level:** Medium  
**Speed Limit:** 30 KM/Hr  
**Coordinates:** 11.91302, 78.05856

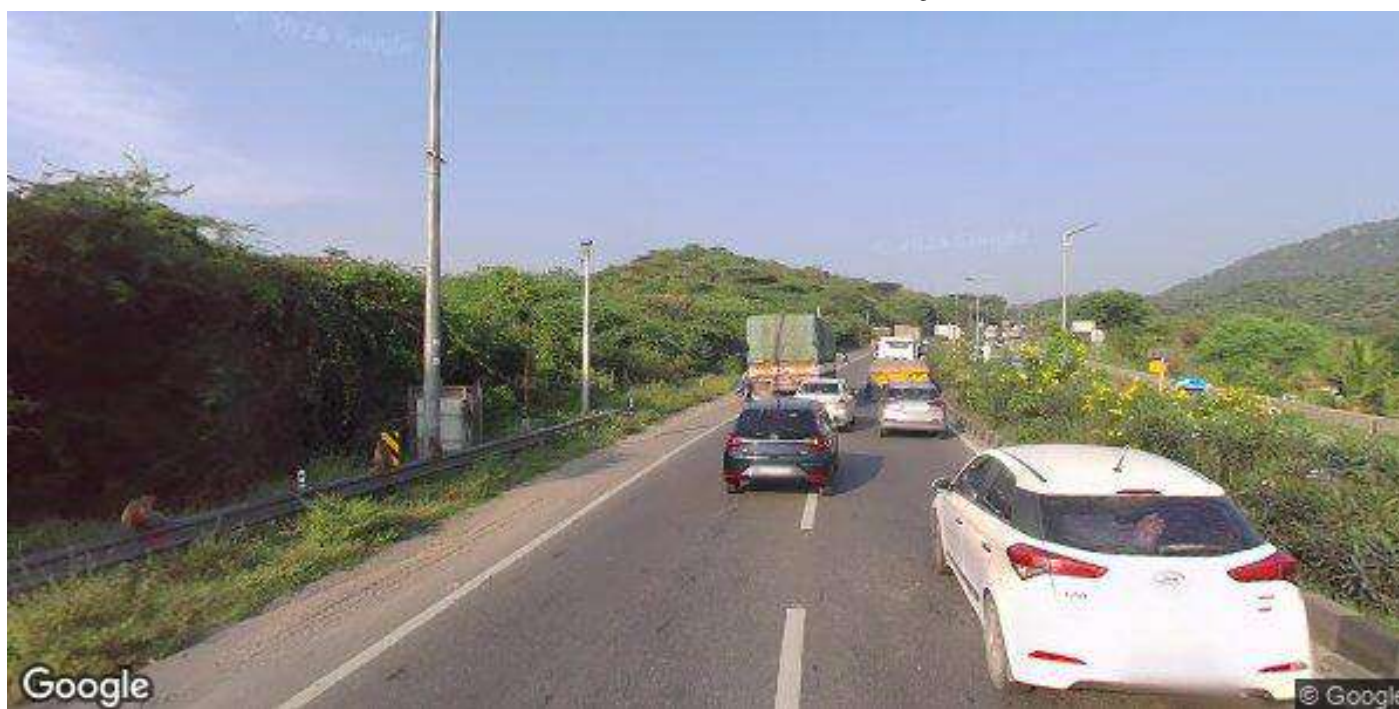
**Risk Type:** Turn  
**Risk Level:** Medium  
**Speed Limit:** 30 KM/Hr  
**Coordinates:** 11.95625, 78.04748

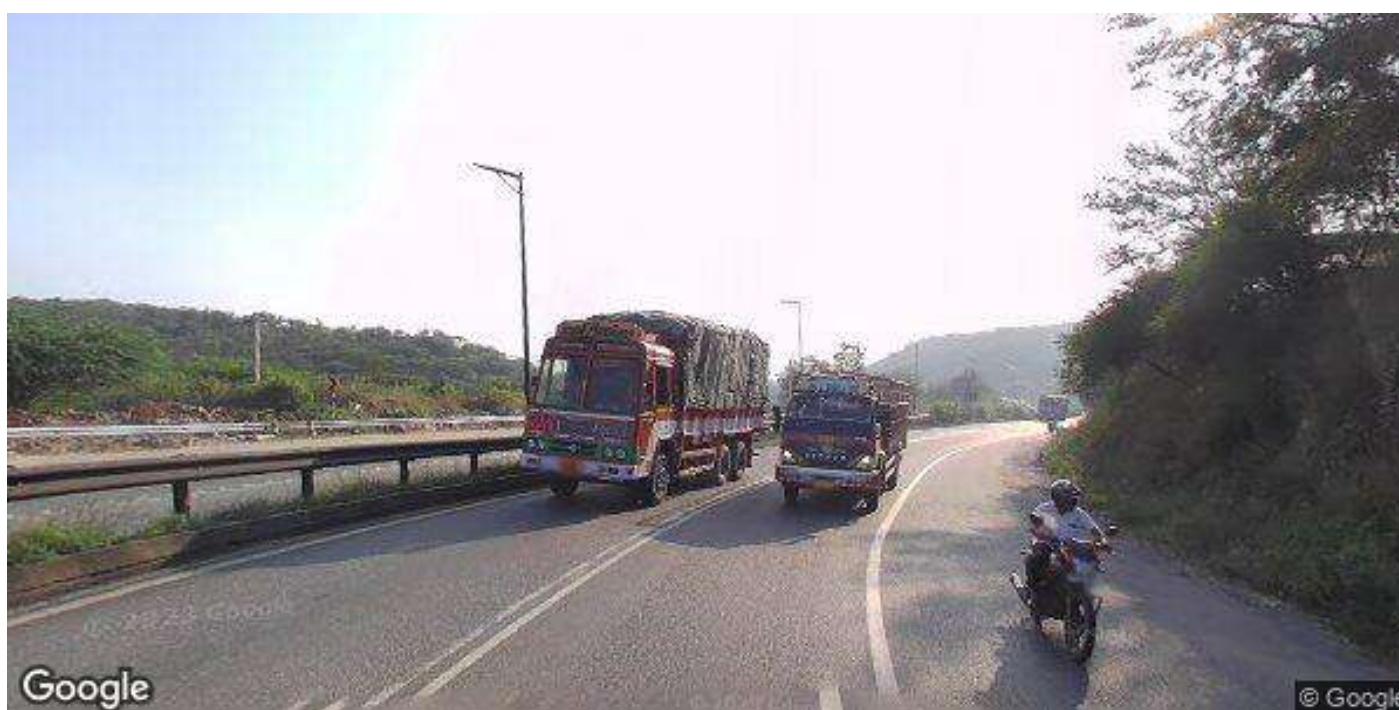
**Risk Type:** Turn  
**Risk Level:** High  
**Speed Limit:** 15 KM/Hr  
**Coordinates:** 11.95824, 78.04981

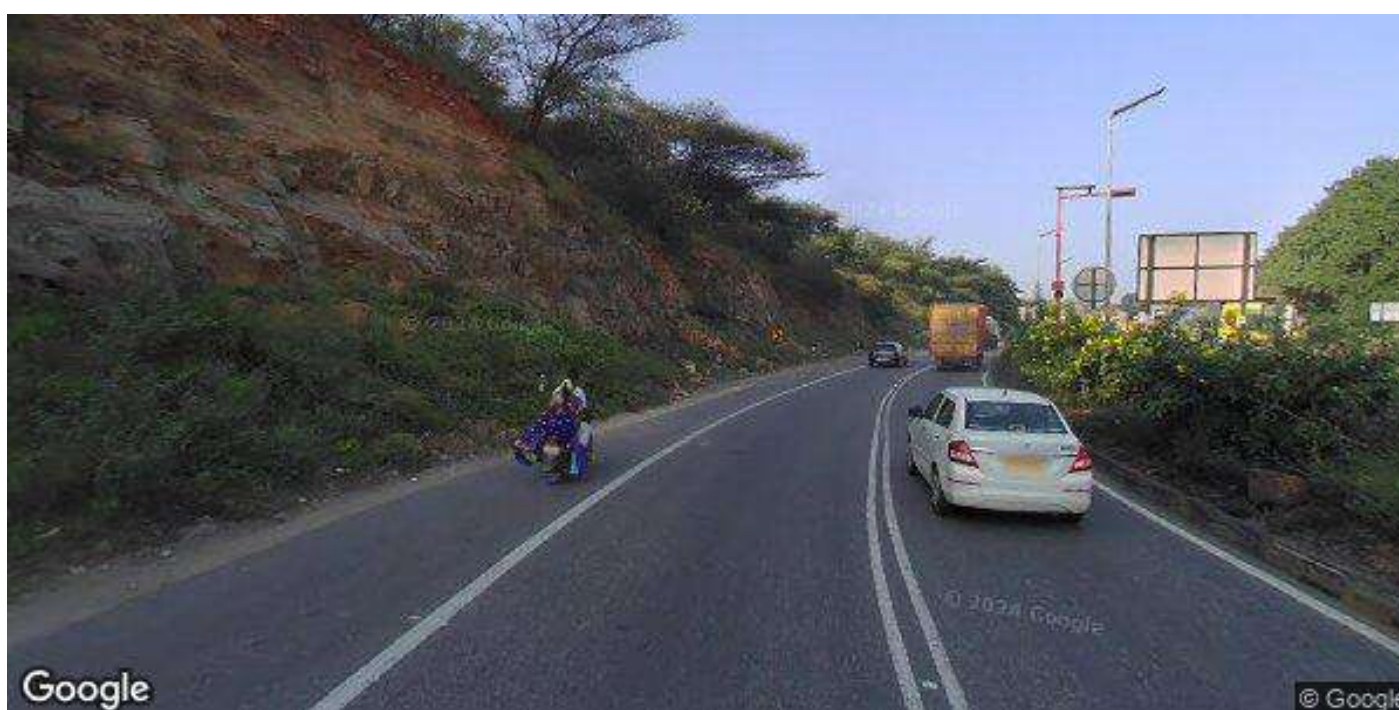
**Risk Type:** Turn  
**Risk Level:** High  
**Speed Limit:** 15 KM/Hr  
**Coordinates:** 11.96040, 78.04947

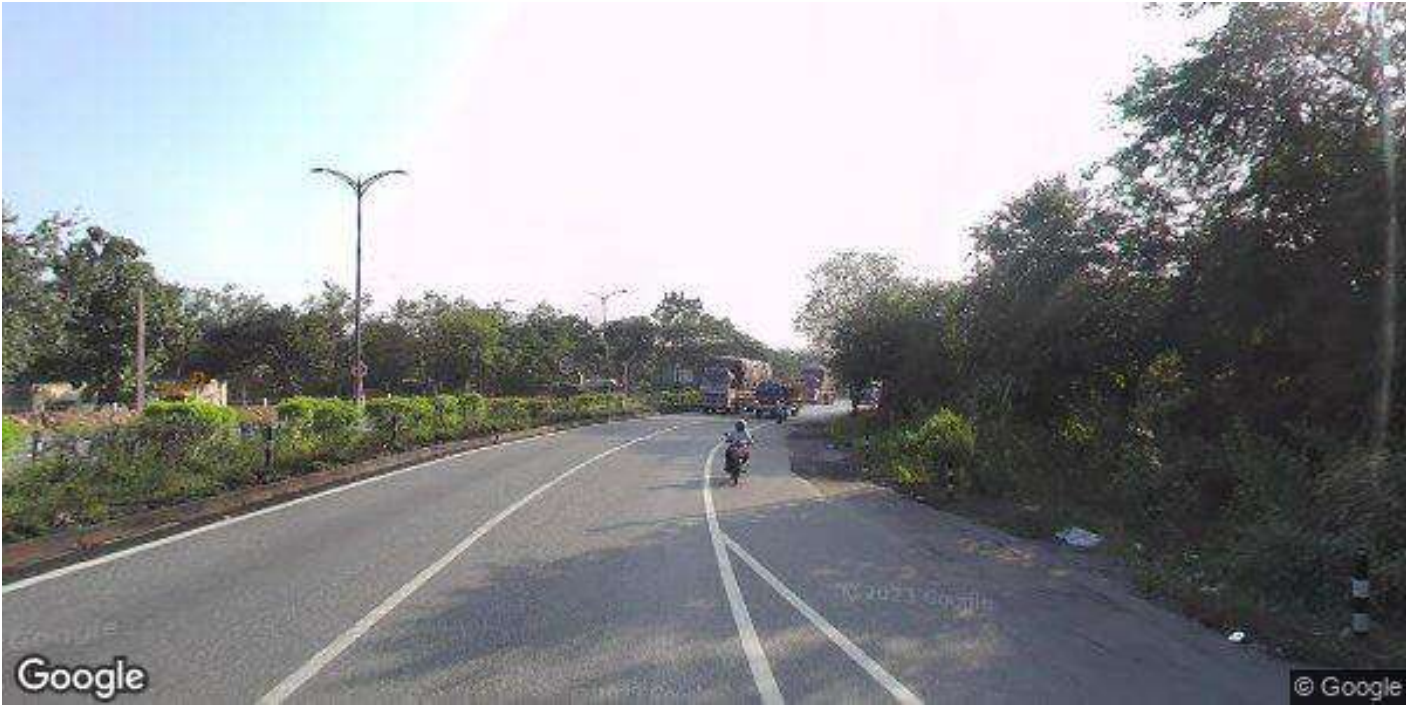
**Risk Type:** Turn  
**Risk Level:** Medium  
**Speed Limit:** 30 KM/Hr  
**Coordinates:** 11.96320, 78.05139

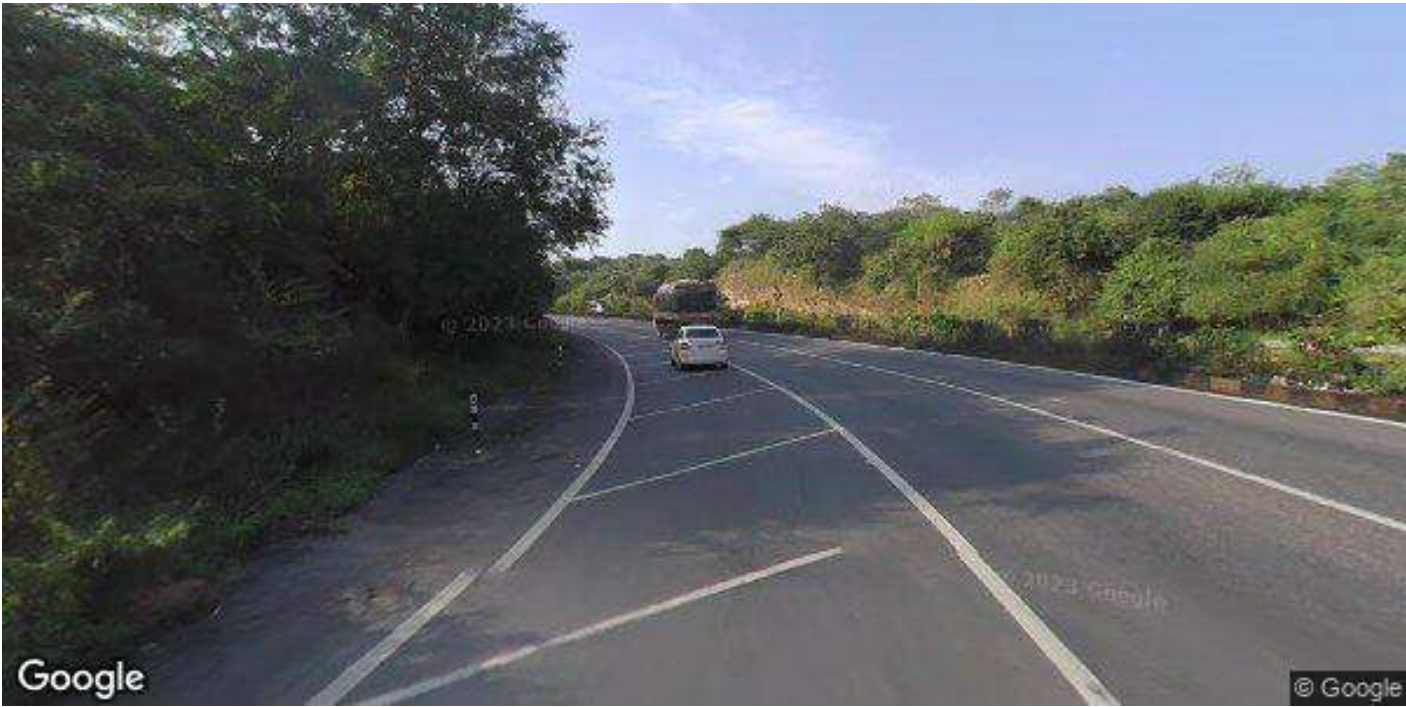
**Risk Type:** Turn  
**Risk Level:** Medium  
**Speed Limit:** 30 KM/Hr  
**Coordinates:** 11.96401, 78.05134

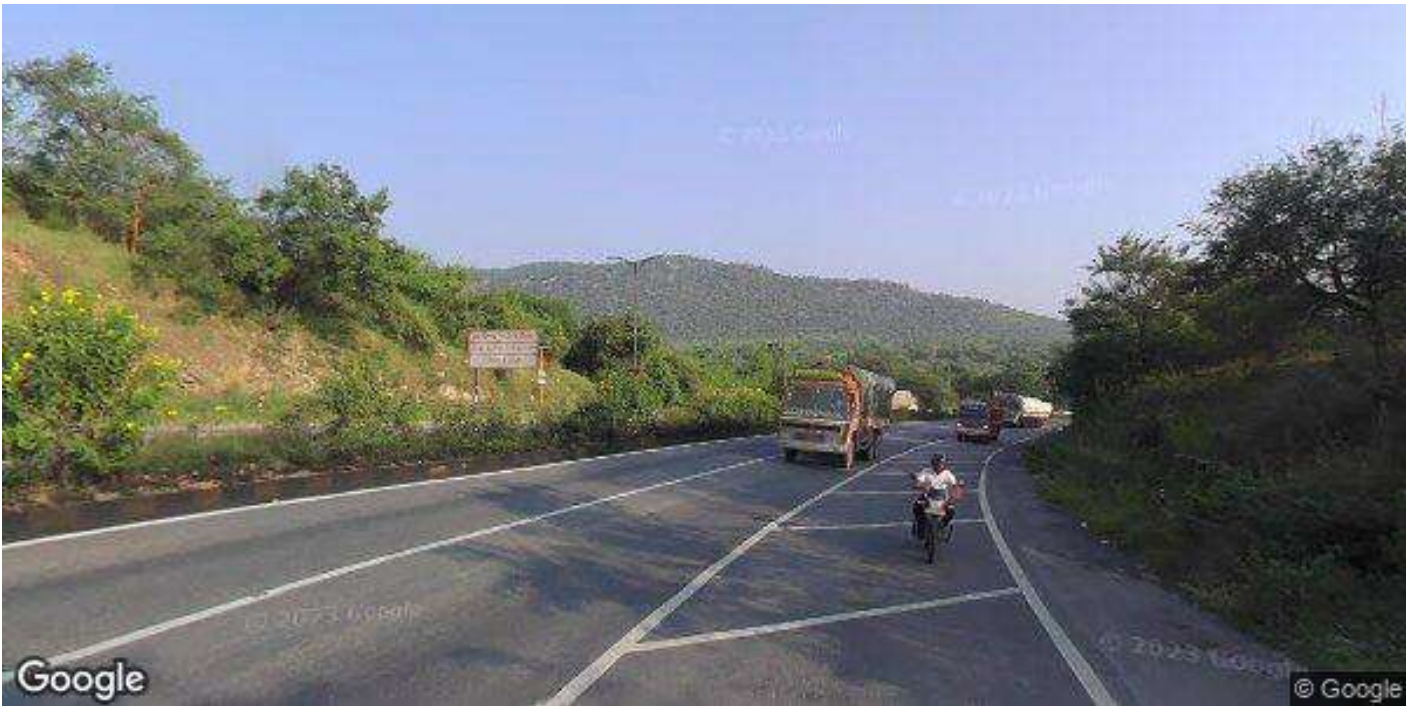
**Risk Type:** Turn  
**Risk Level:** Medium  
**Speed Limit:** 30 KM/Hr  
**Coordinates:** 11.96463, 78.05077

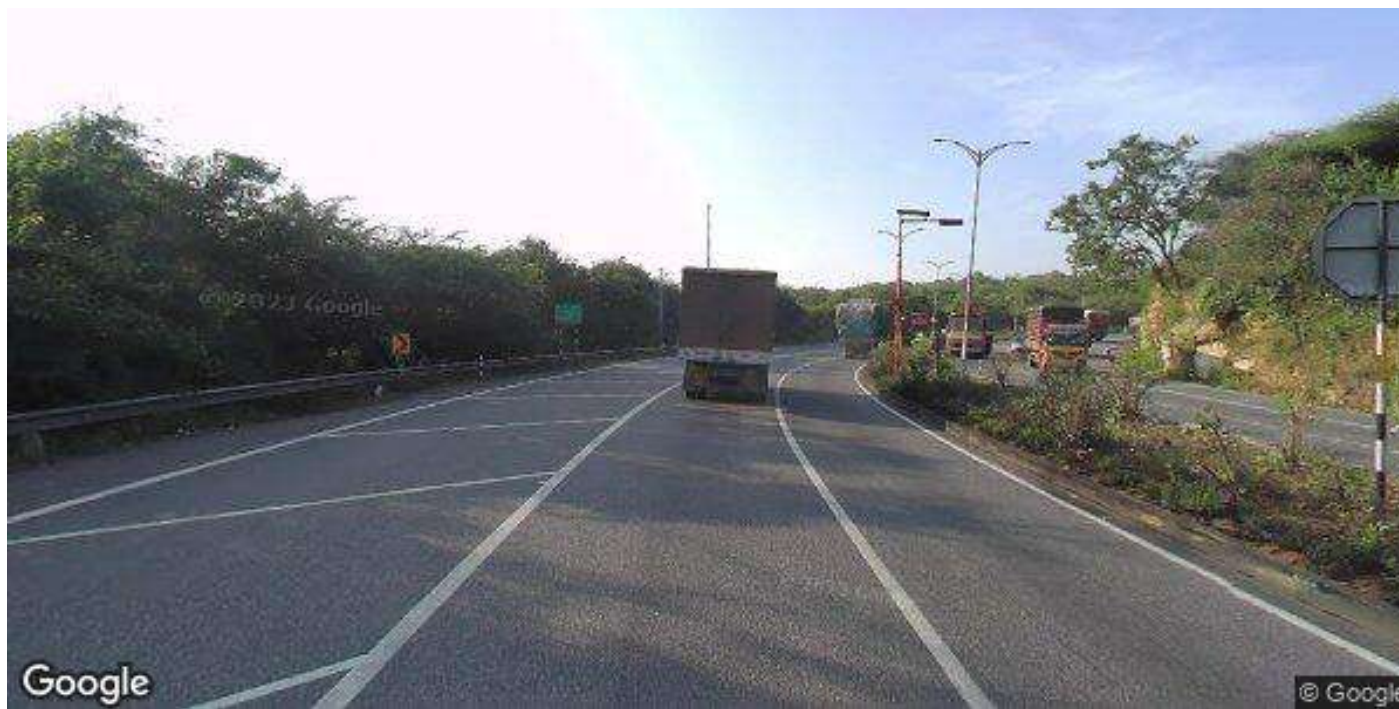
**Risk Type:** Turn  
**Risk Level:** Medium  
**Speed Limit:** 30 KM/Hr  
**Coordinates:** 11.96504, 78.04975

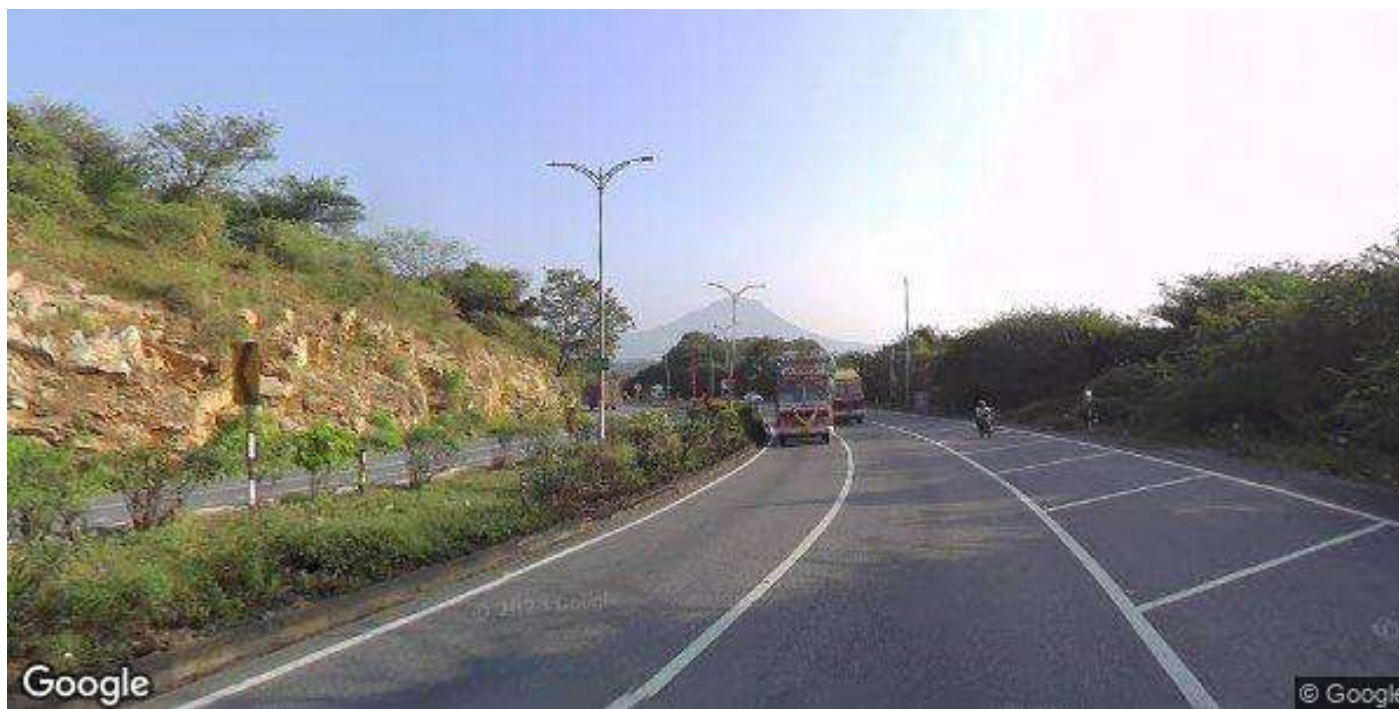
**Risk Type:** Turn  
**Risk Level:** High  
**Speed Limit:** 15 KM/Hr  
**Coordinates:** 11.96597, 78.04920

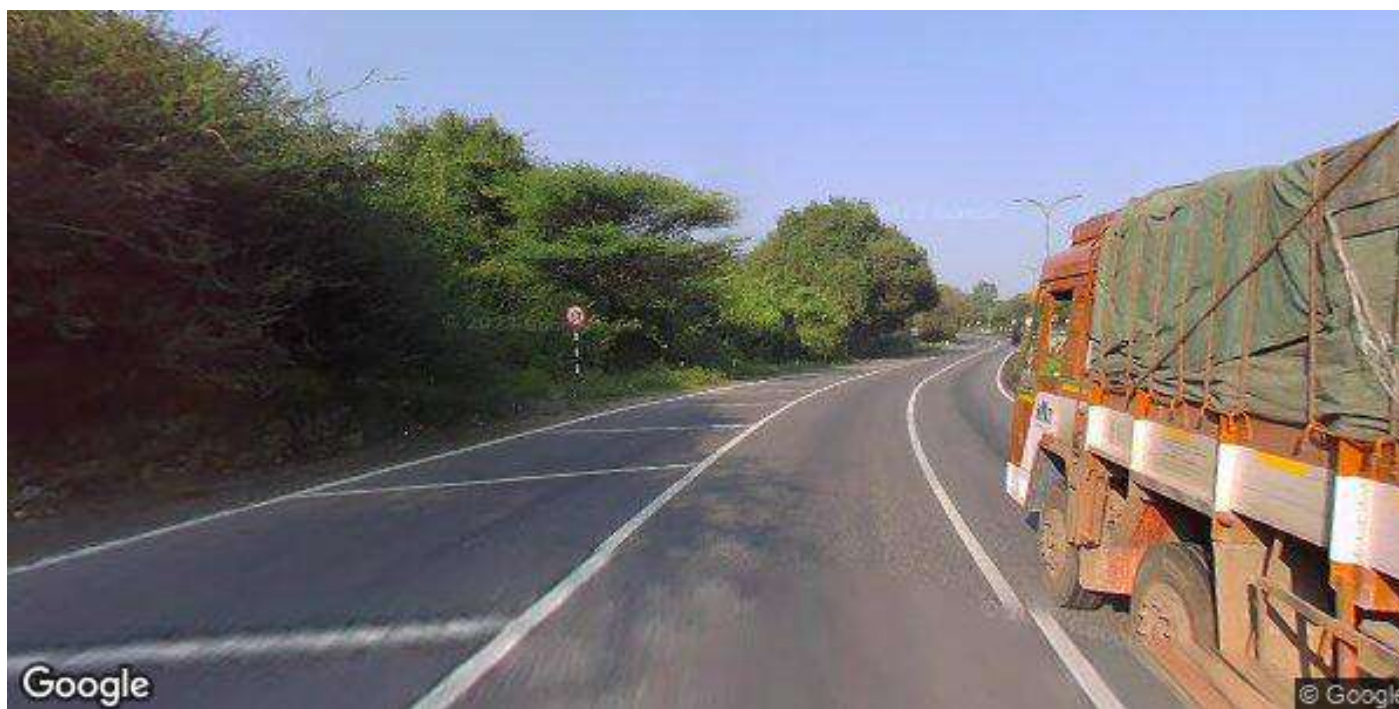
**Risk Type:** Turn  
**Risk Level:** Medium  
**Speed Limit:** 30 KM/Hr  
**Coordinates:** 11.96679, 78.04942

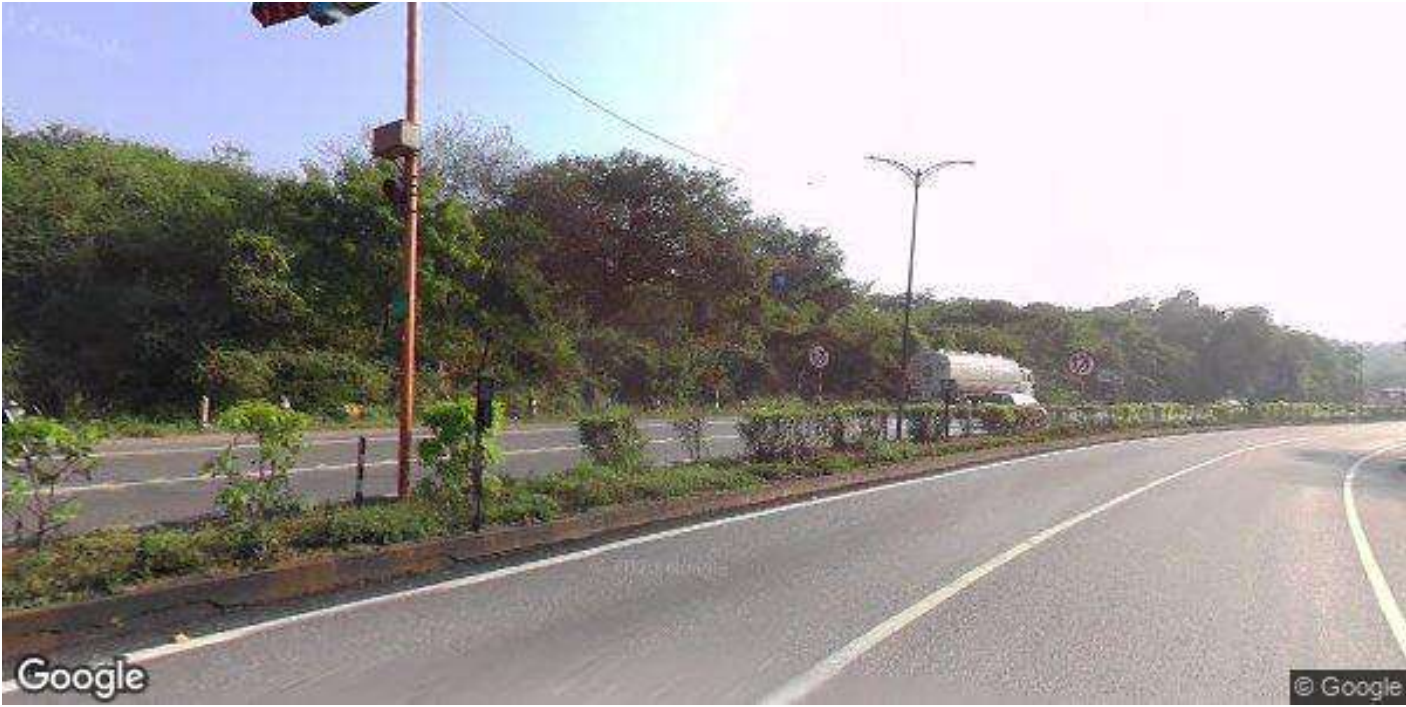
**Risk Type:** Turn  
**Risk Level:** Medium  
**Speed Limit:** 30 KM/Hr  
**Coordinates:** 11.96804, 78.05080

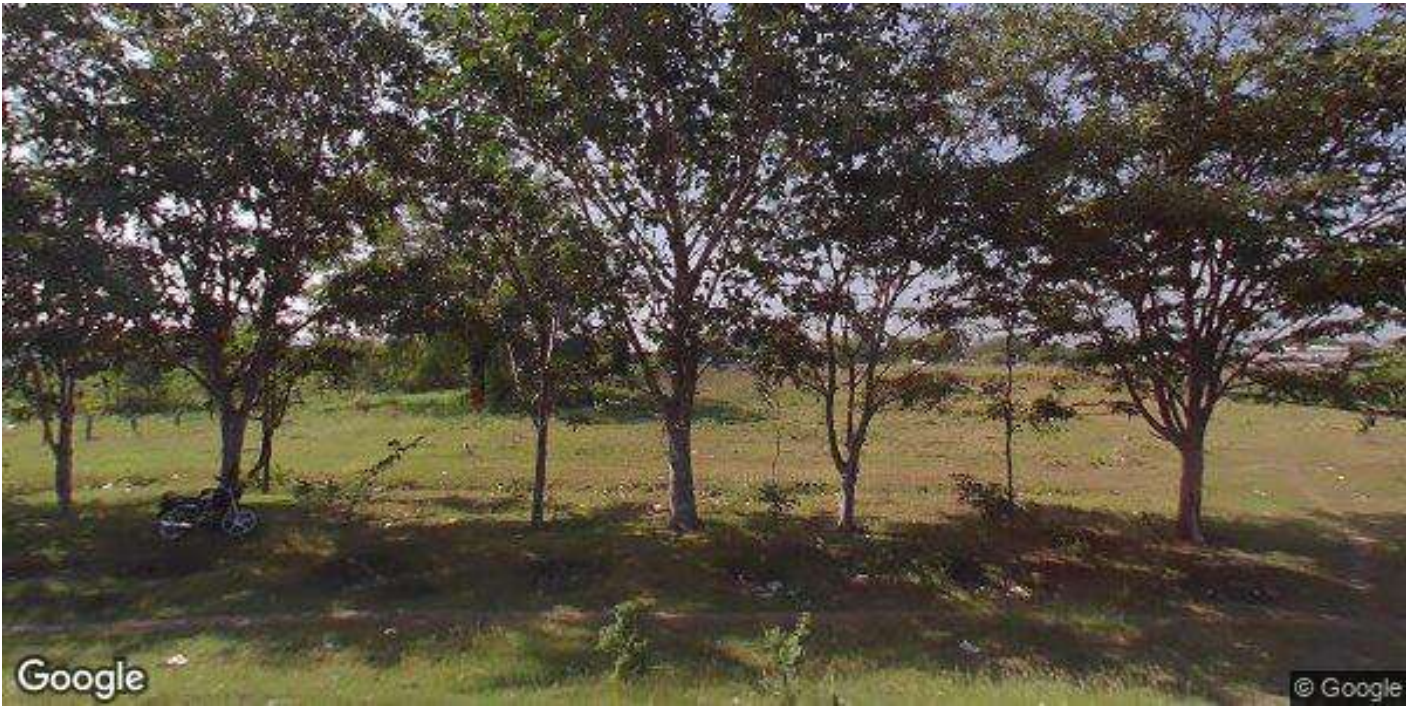
**Risk Type:** Turn  
**Risk Level:** Medium  
**Speed Limit:** 30 KM/Hr  
**Coordinates:** 12.12067, 78.13281

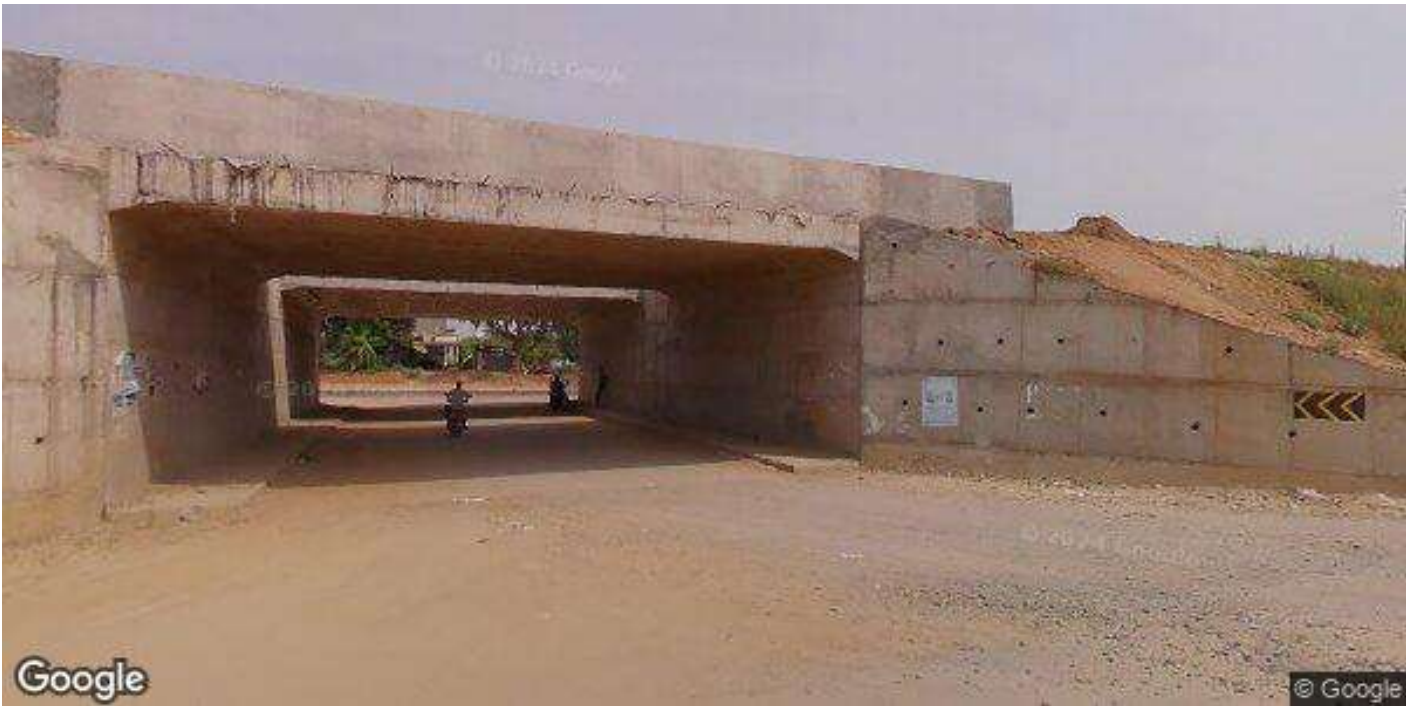
**Risk Type:** Turn  
**Risk Level:** High  
**Speed Limit:** 15 KM/Hr  
**Coordinates:** 12.26532, 78.08427
