## JOURNEY RISK MANAGEMENT (JRM) STUDY

### Salem Terminal to SUBRAMANYAA FUELS

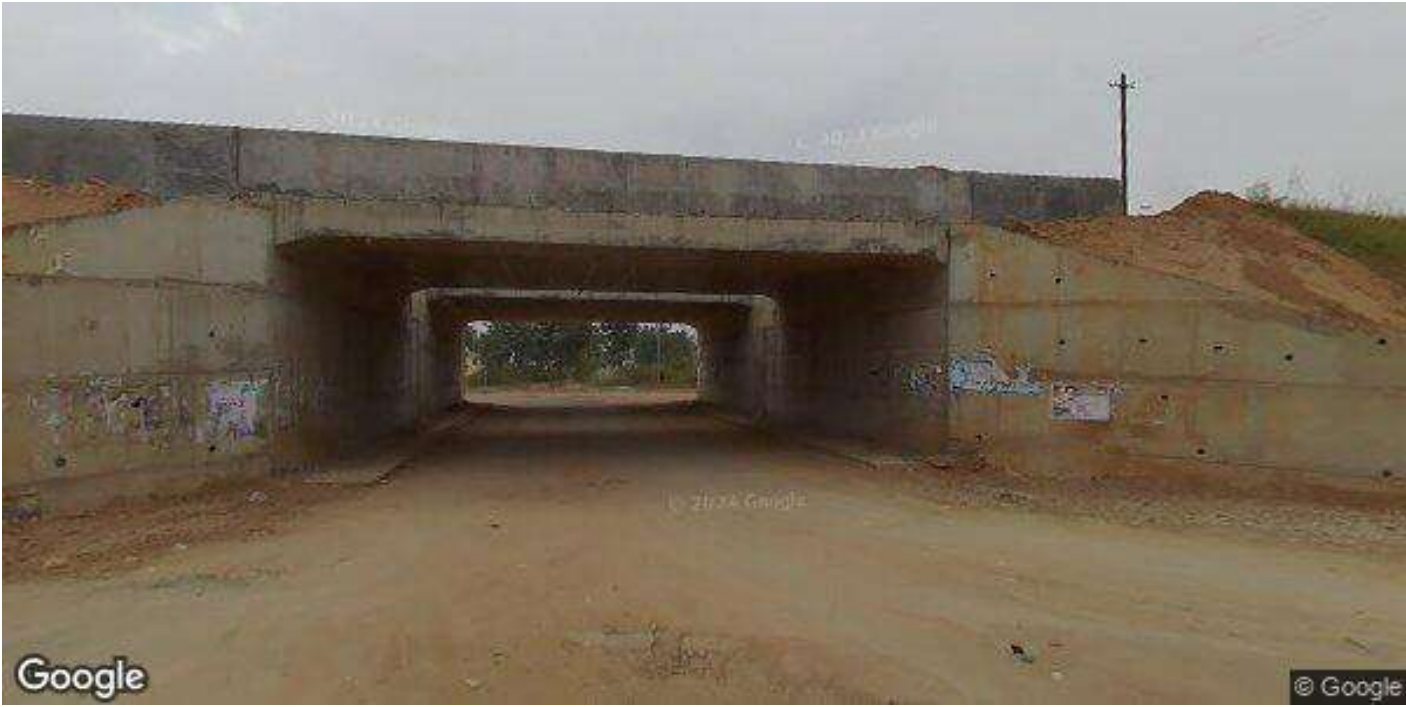
**Risk Type:** Turn  
**Risk Level:** High  
**Speed Limit:** 15 KM/Hr  
**Coordinates:** 12.26548, 78.08438

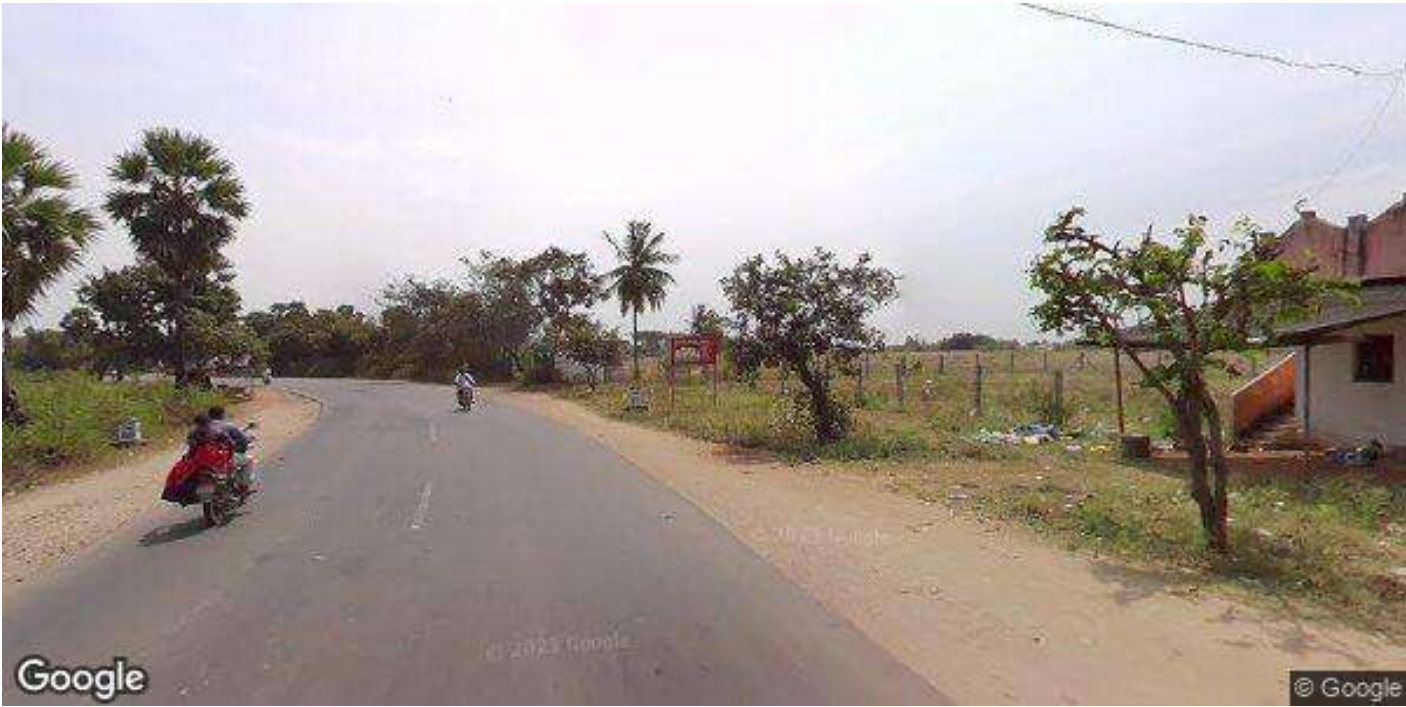
**Risk Type:** Turn  
**Risk Level:** Medium  
**Speed Limit:** 30 KM/Hr  
**Coordinates:** 12.27200, 78.08089

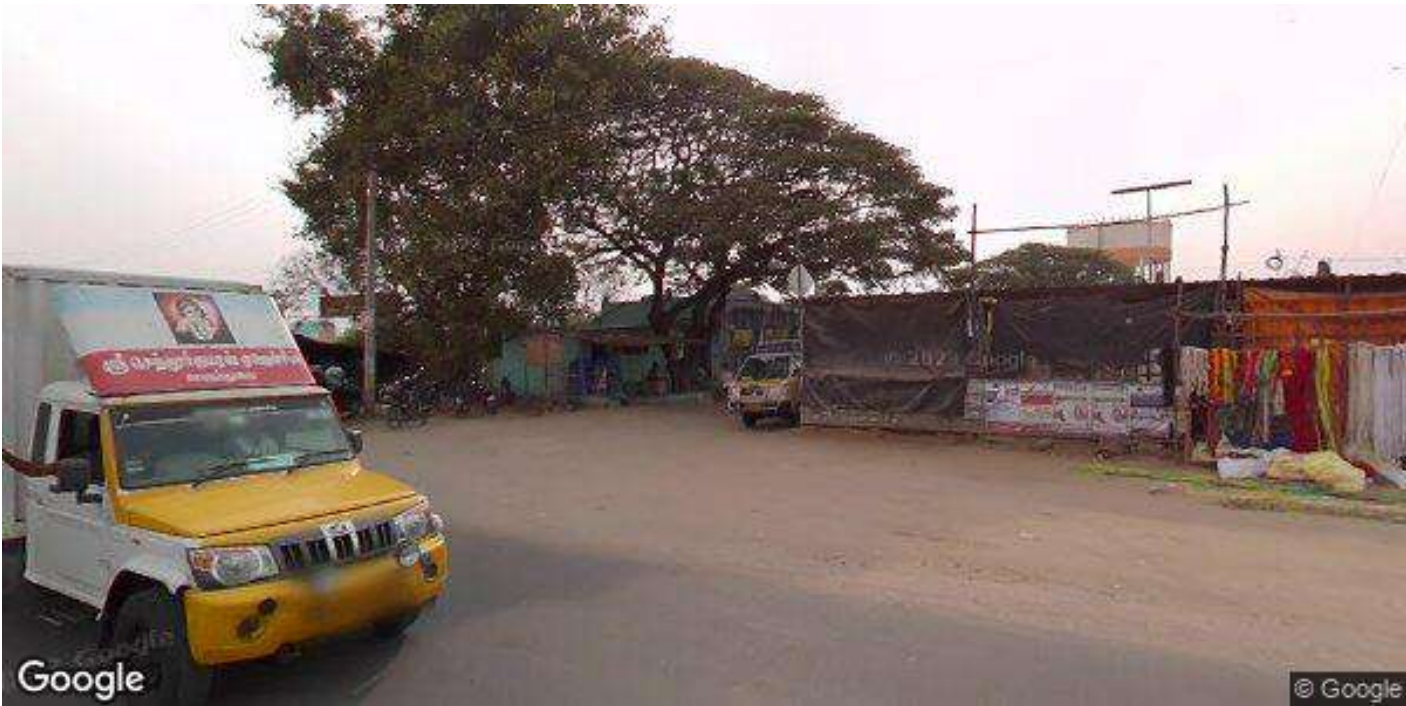
**Risk Type:** Turn  
**Risk Level:** High  
**Speed Limit:** 15 KM/Hr  
**Coordinates:** 12.29579, 78.07370

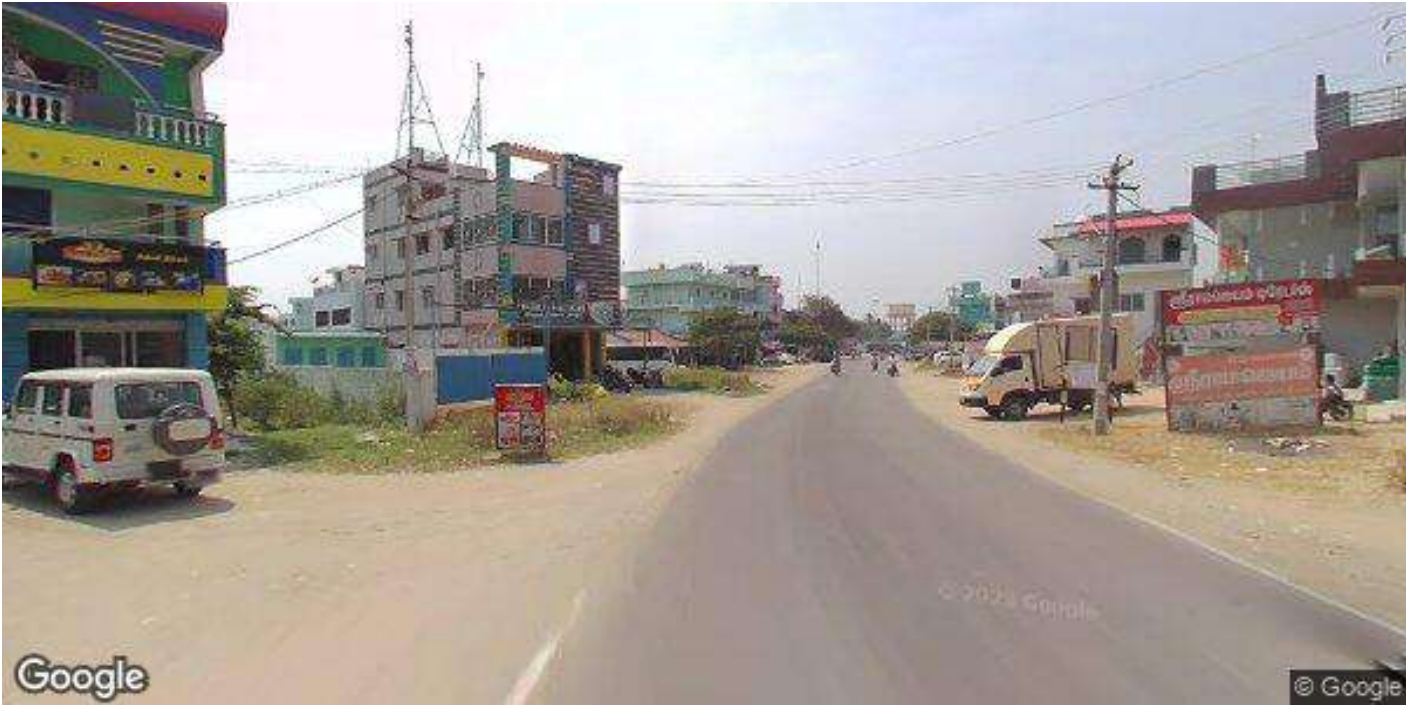
**Risk Type:** Turn  
**Risk Level:** High  
**Speed Limit:** 15 KM/Hr  
**Coordinates:** 12.29649, 78.07542
