# IndianOil

## JOURNEY RISK MANAGEMENT (JRM) STUDY

### Salem Terminal to KSG AGENCIES

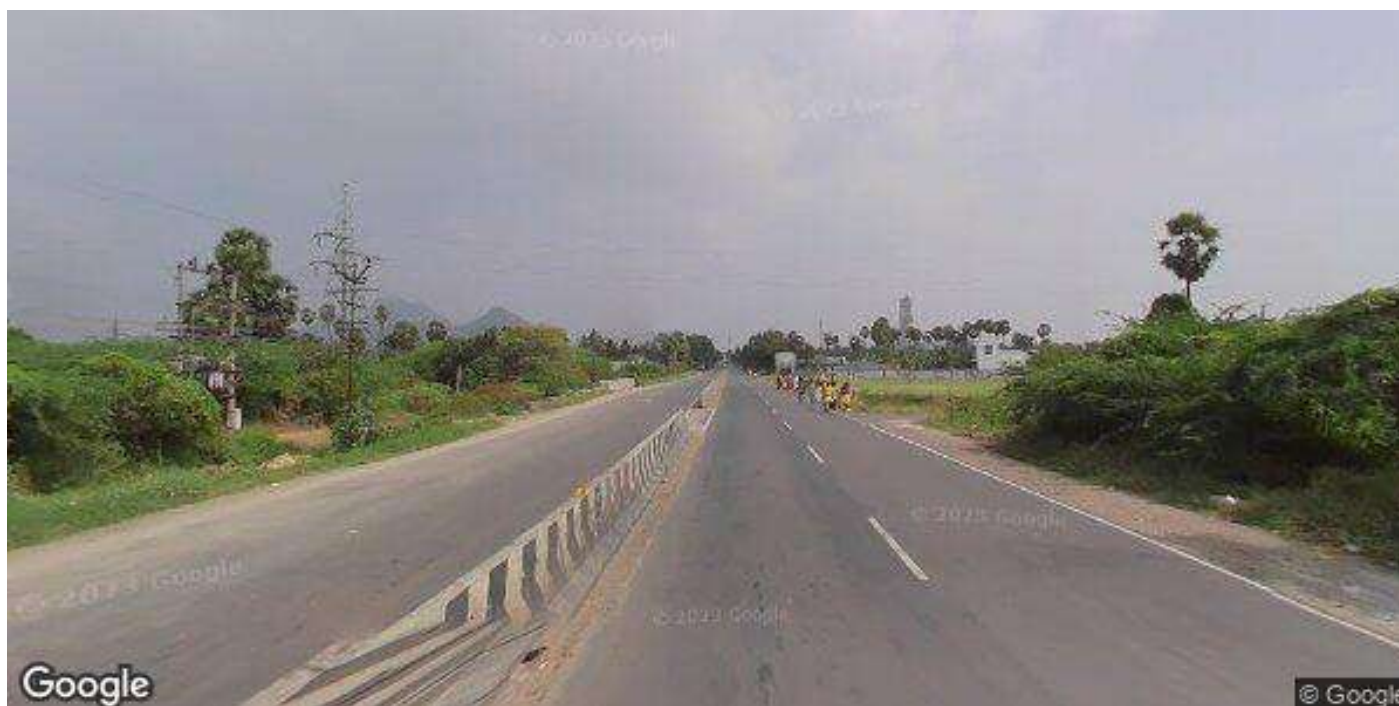
**Risk Type:** Turn  
**Risk Level:** Medium  
**Speed Limit:** 30 KM/Hr  
**Coordinates:** 11.45546, 77.81800

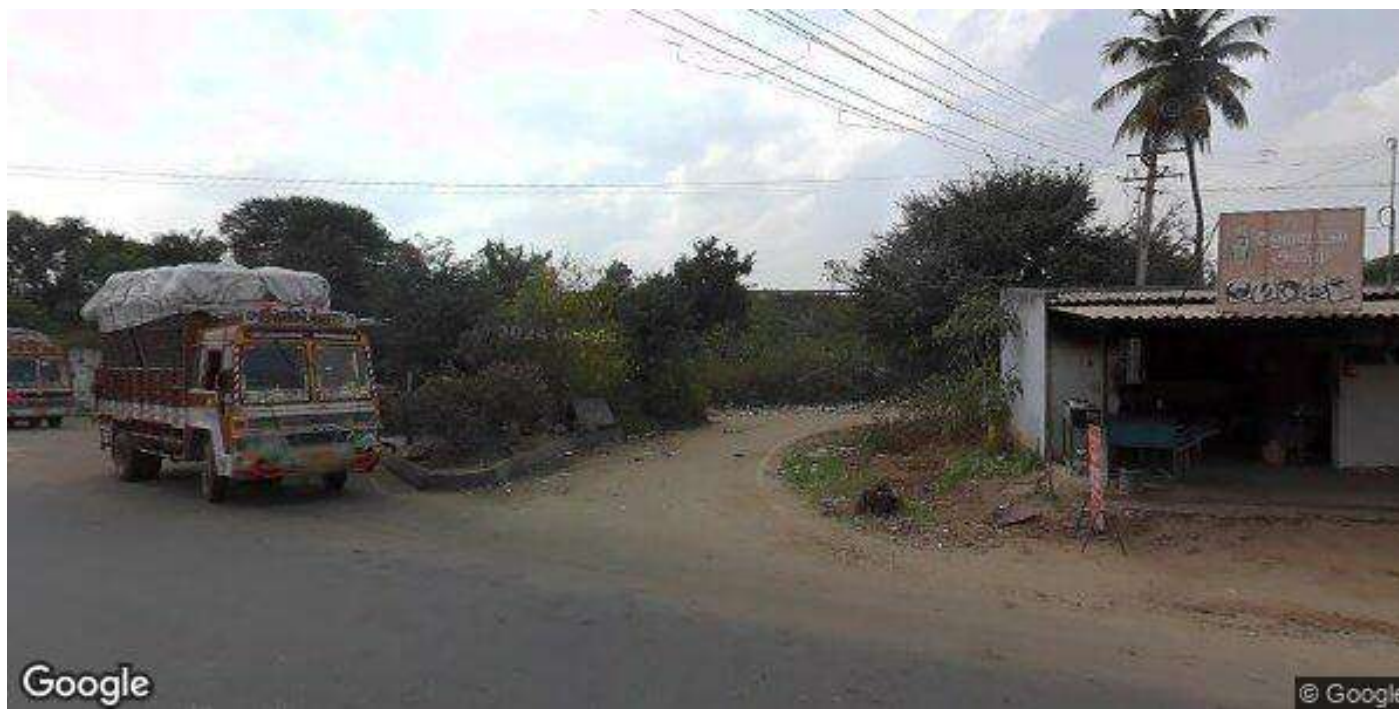
**Risk Type:** Blind Spot  
**Risk Level:** Blind Spot  
**Speed Limit:** 10 KM/Hr  
**Coordinates:** 11.49400, 77.88538

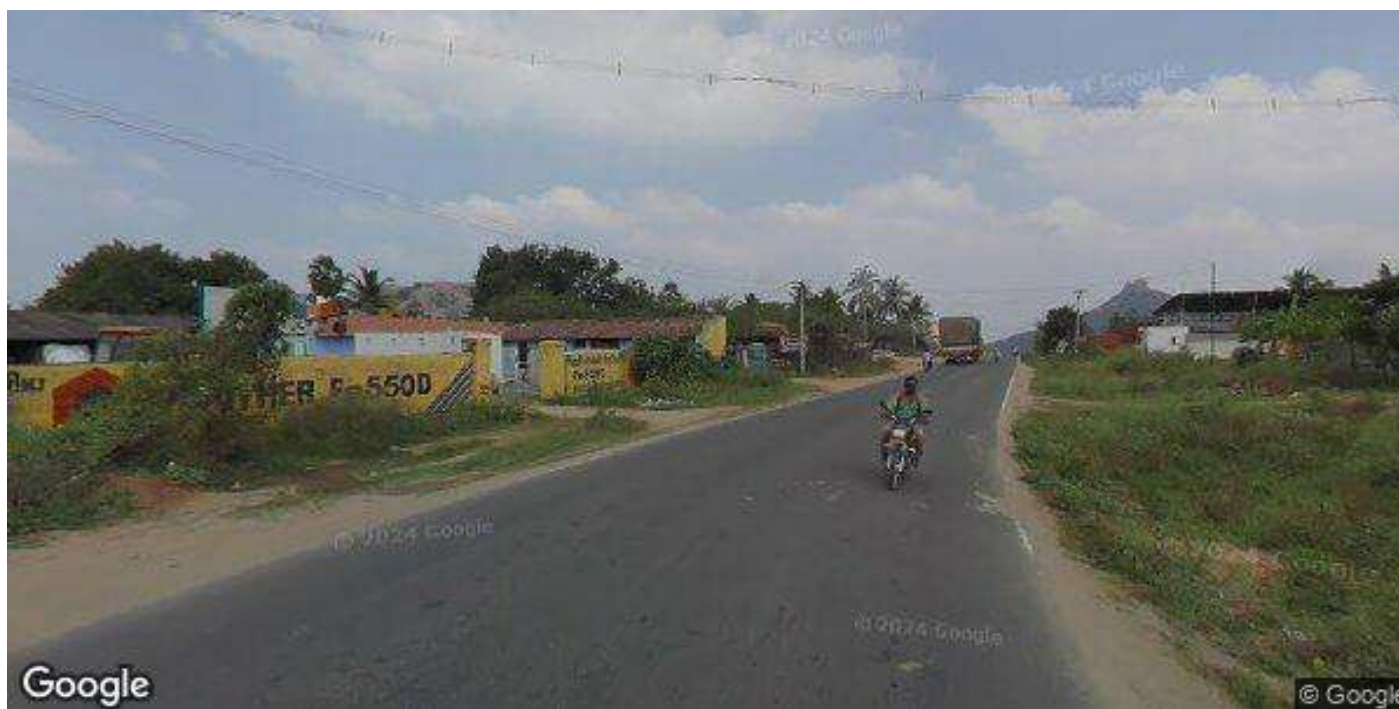
**Risk Type:** Turn  
**Risk Level:** High  
**Speed Limit:** 15 KM/Hr  
**Coordinates:** 11.49469, 77.88488

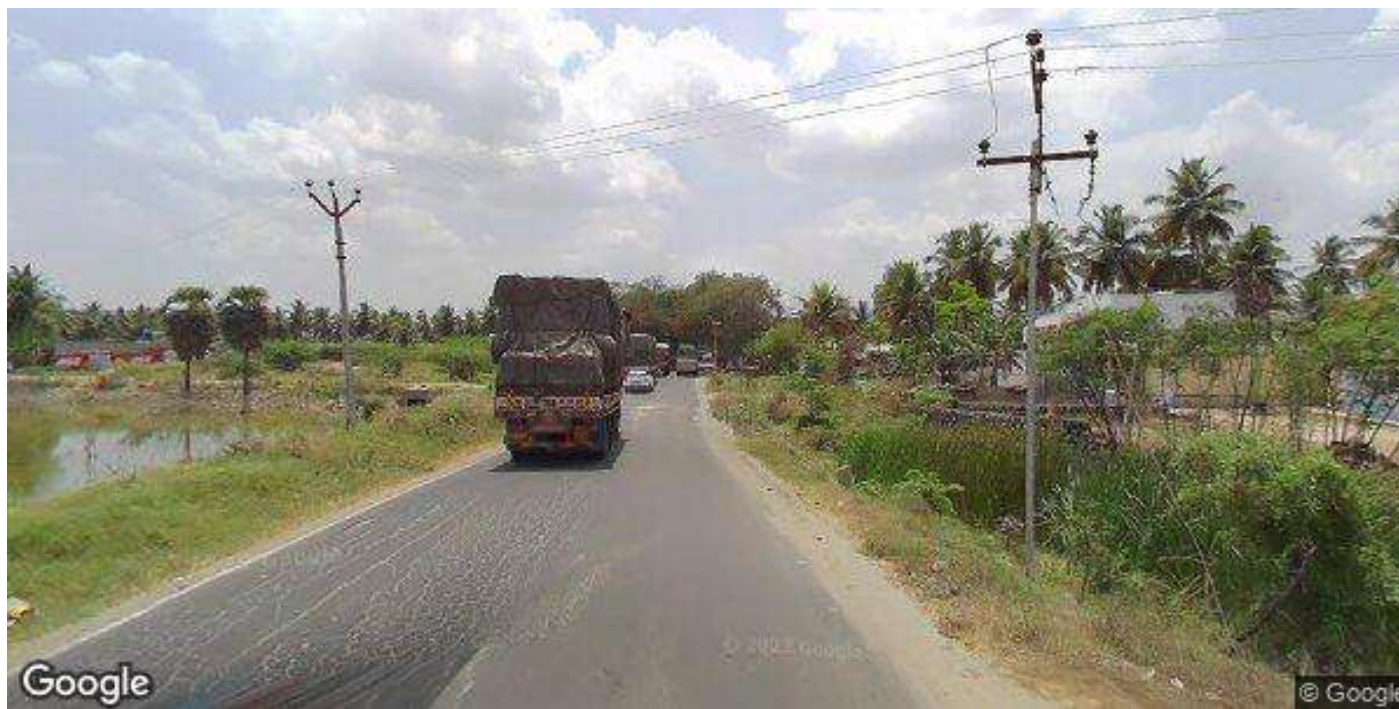
**Risk Type:** Turn  
**Risk Level:** Medium  
**Speed Limit:** 30 KM/Hr  
**Coordinates:** 11.56072, 77.89919

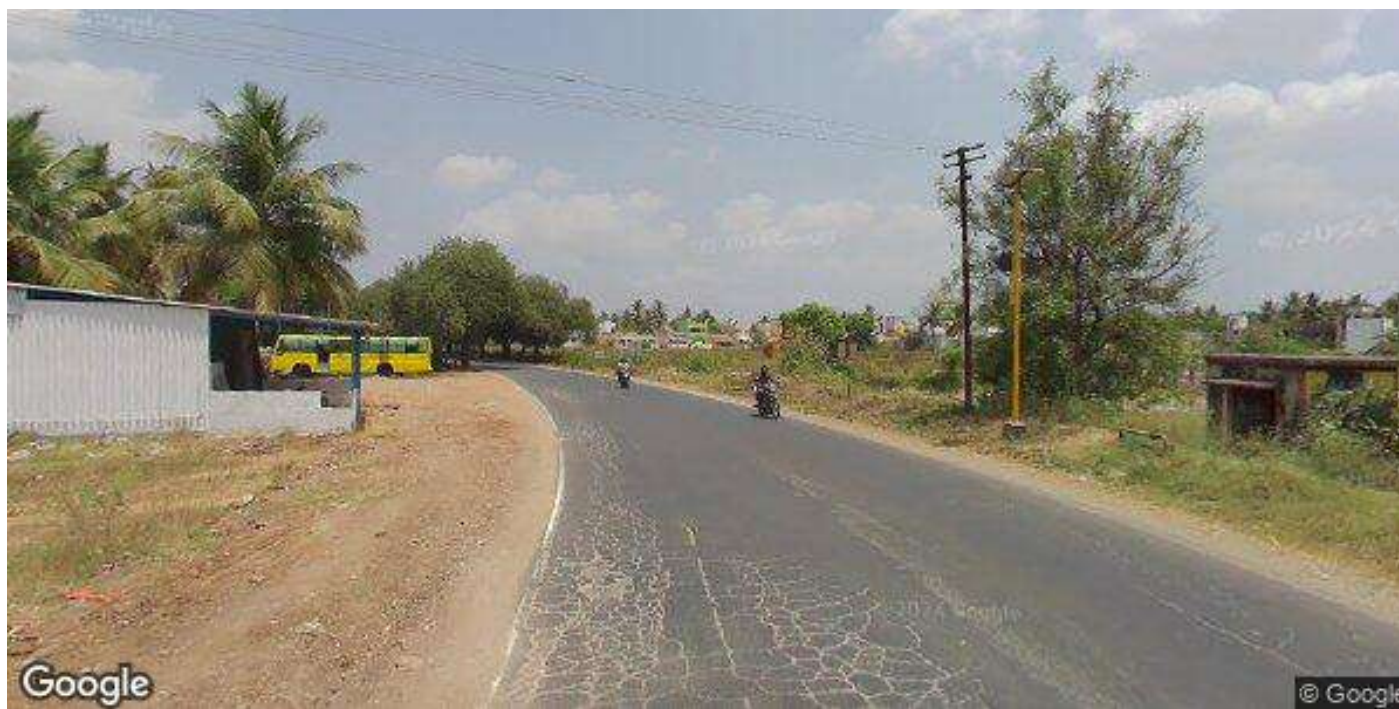
**Risk Type:** Turn  
**Risk Level:** Medium  
**Speed Limit:** 30 KM/Hr  
**Coordinates:** 11.56140, 77.89991

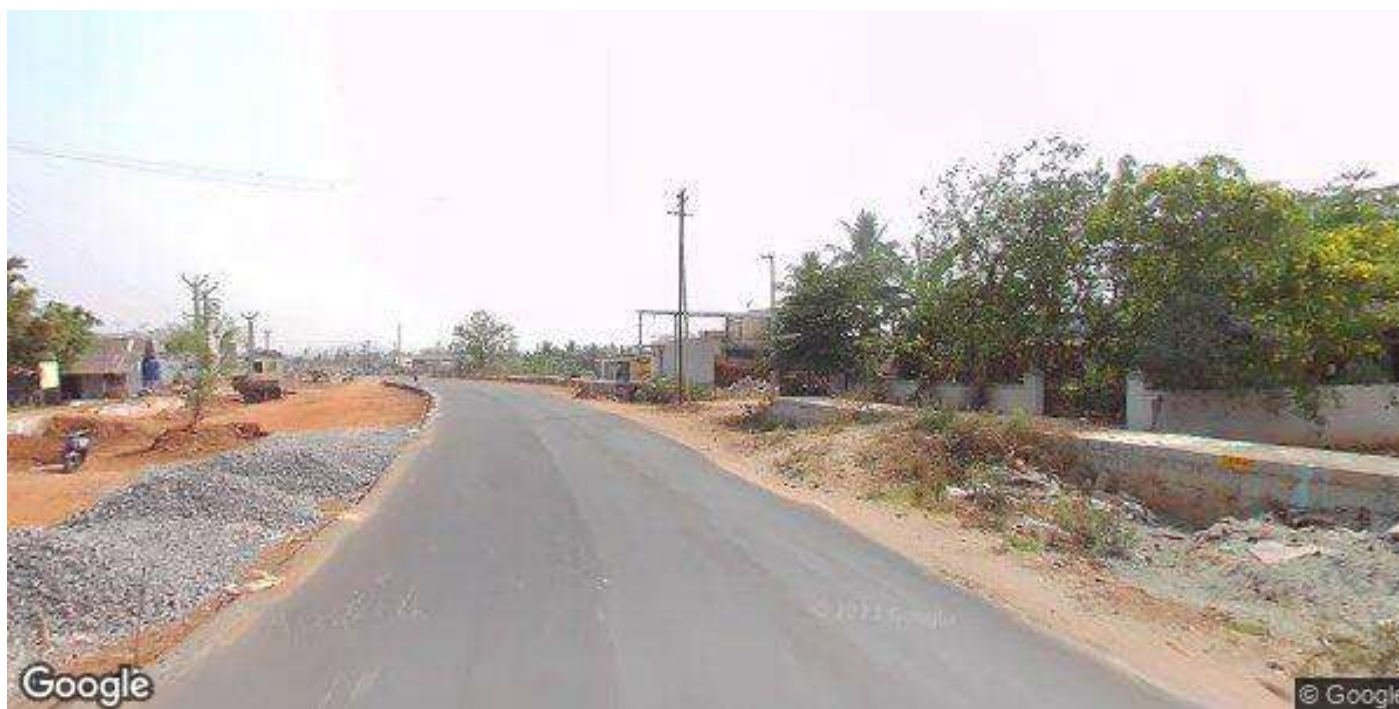
**Risk Type:** Turn  
**Risk Level:** Medium  
**Speed Limit:** 30 KM/Hr  
**Coordinates:** 11.59085, 77.90592

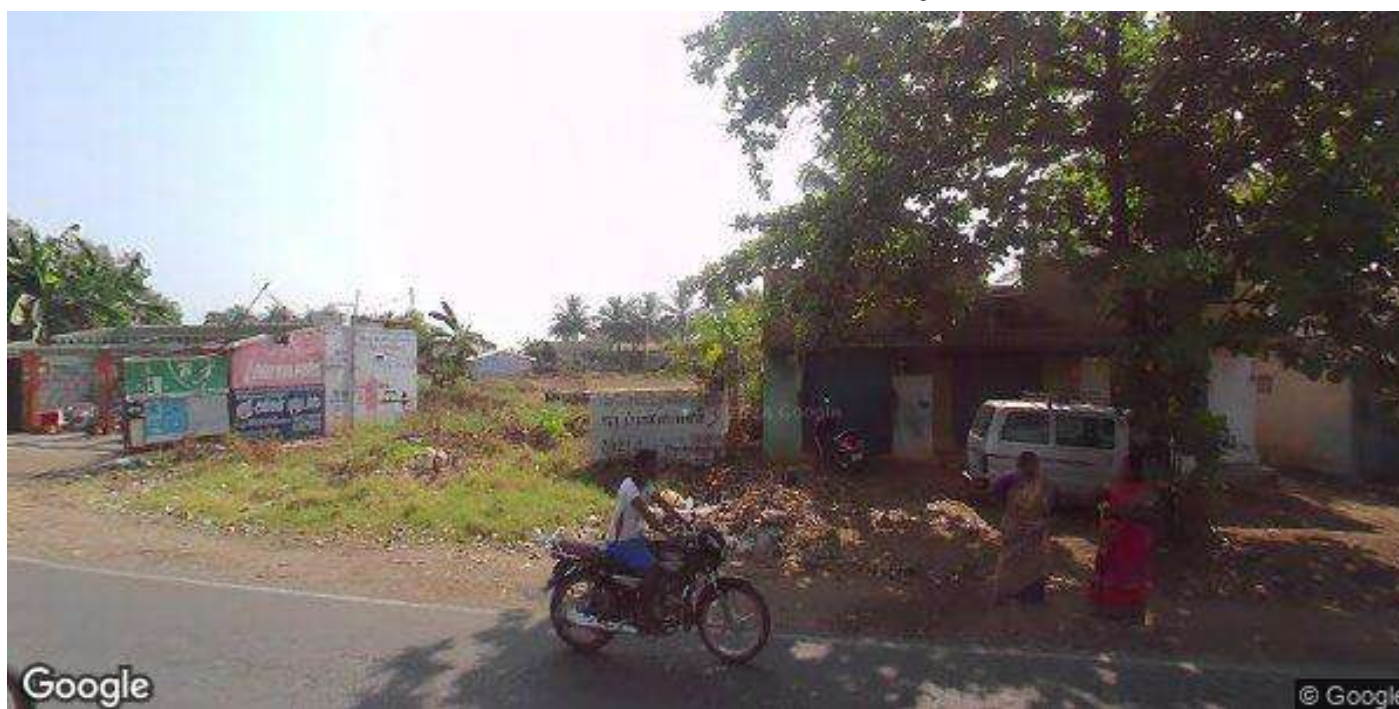
**Risk Type:** Turn  
**Risk Level:** Medium  
**Speed Limit:** 30 KM/Hr  
**Coordinates:** 11.59253, 77.90690

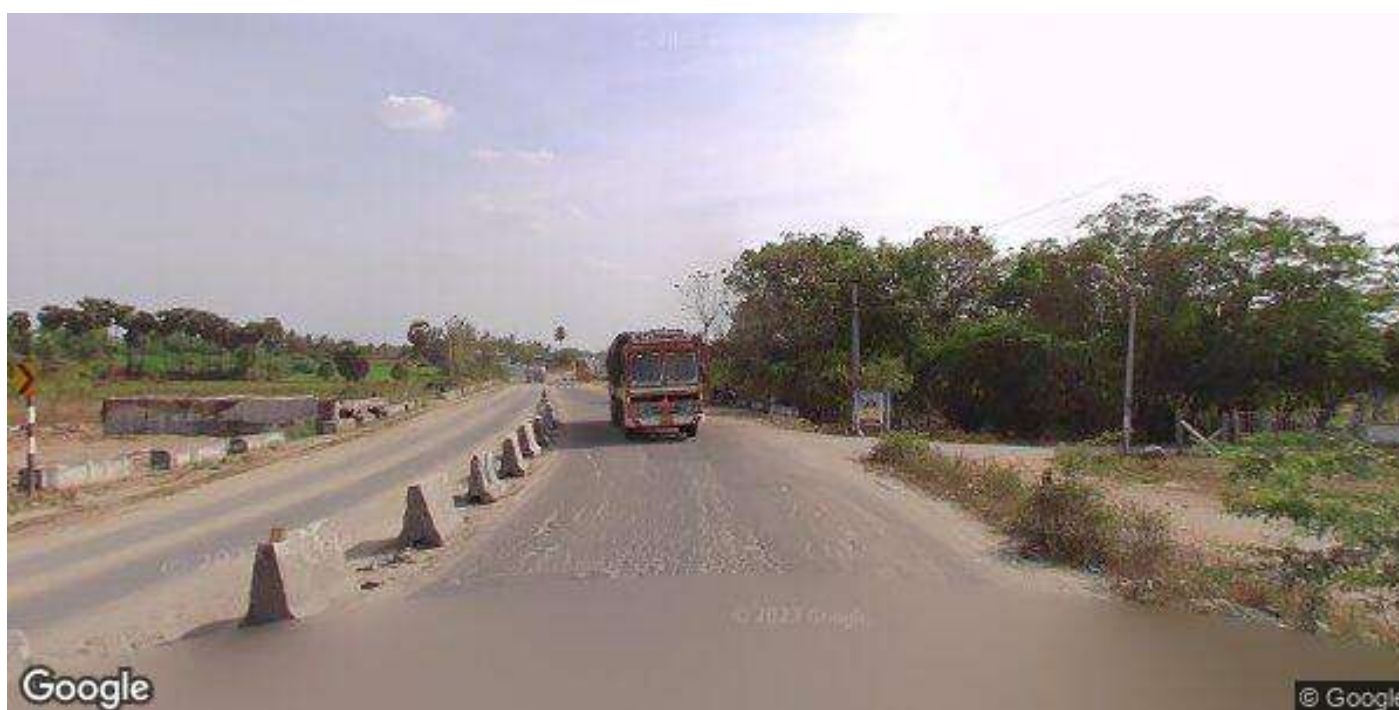
**Risk Type:** Turn  
**Risk Level:** Medium  
**Speed Limit:** 30 KM/Hr  
**Coordinates:** 11.63848, 77.94825

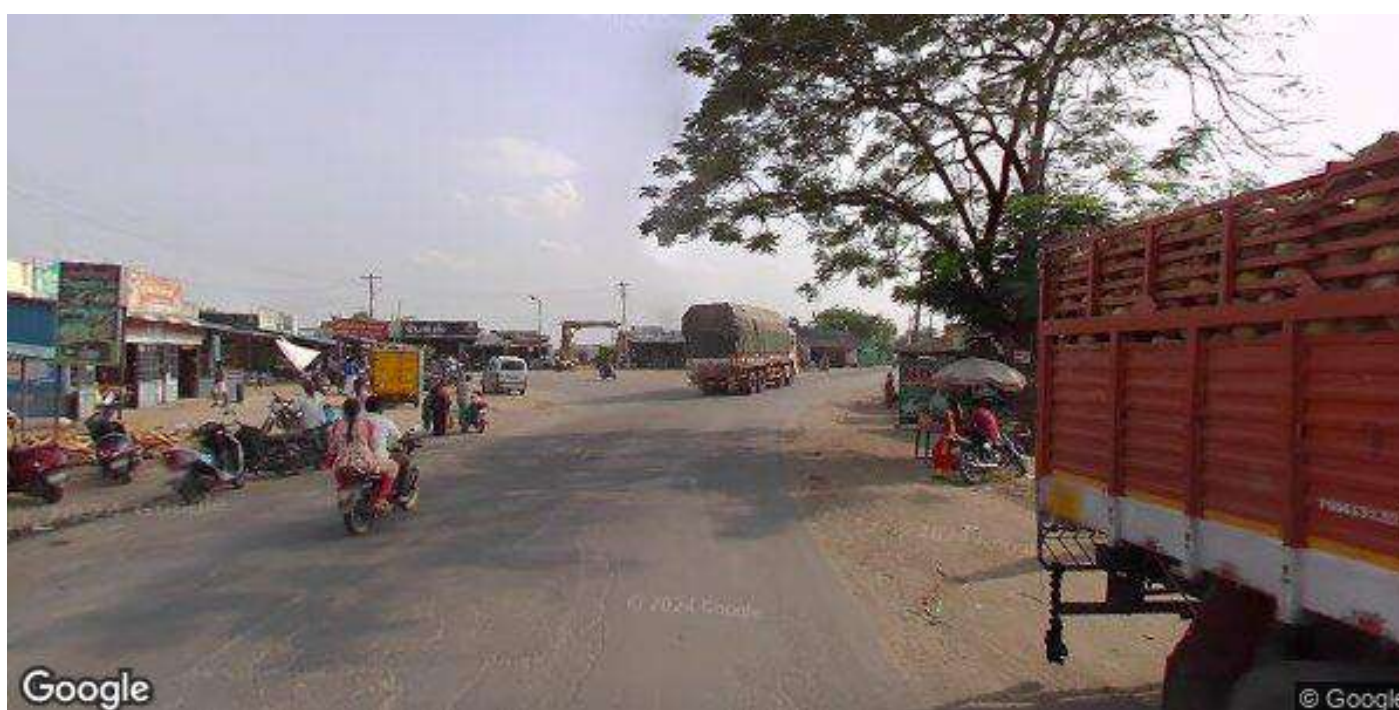
**Risk Type:** Turn  
**Risk Level:** High  
**Speed Limit:** 15 KM/Hr  
**Coordinates:** 11.64197, 77.95197

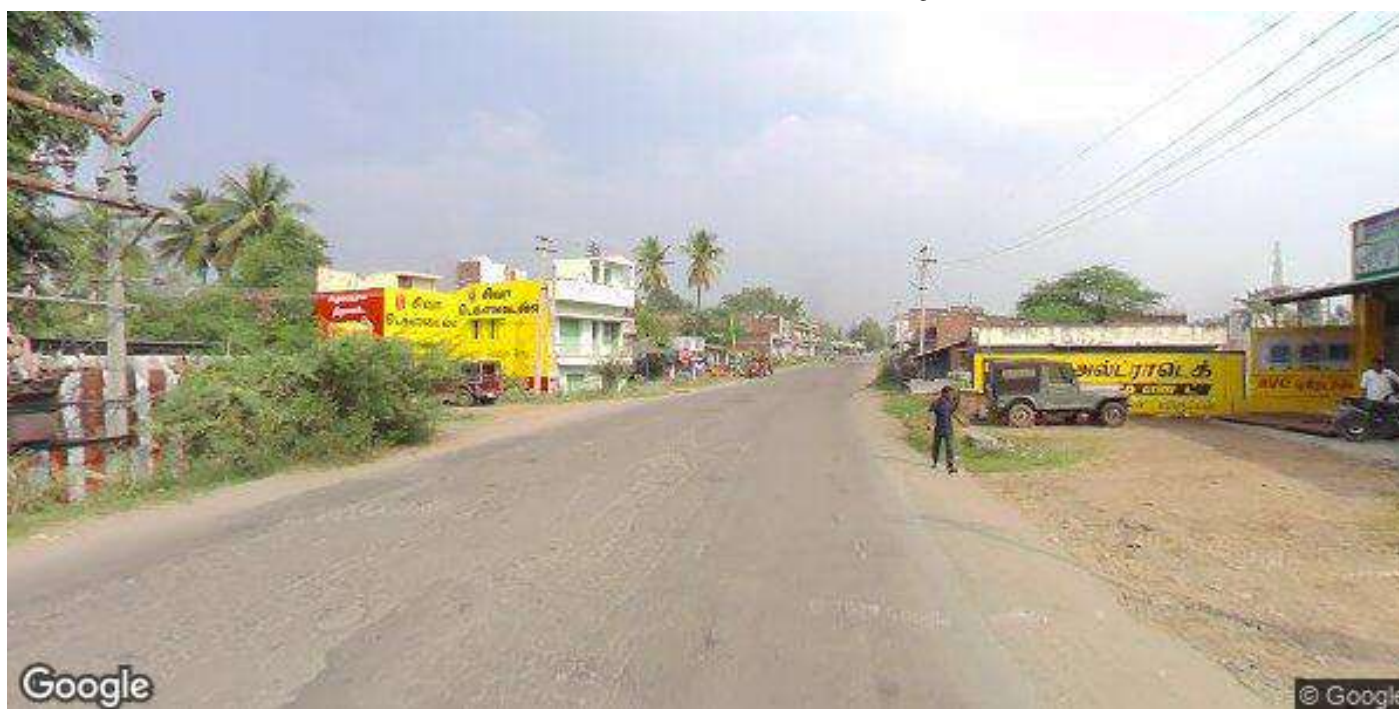
**Risk Type:** Turn  
**Risk Level:** Medium  
**Speed Limit:** 30 KM/Hr  
**Coordinates:** 11.64558, 77.95108

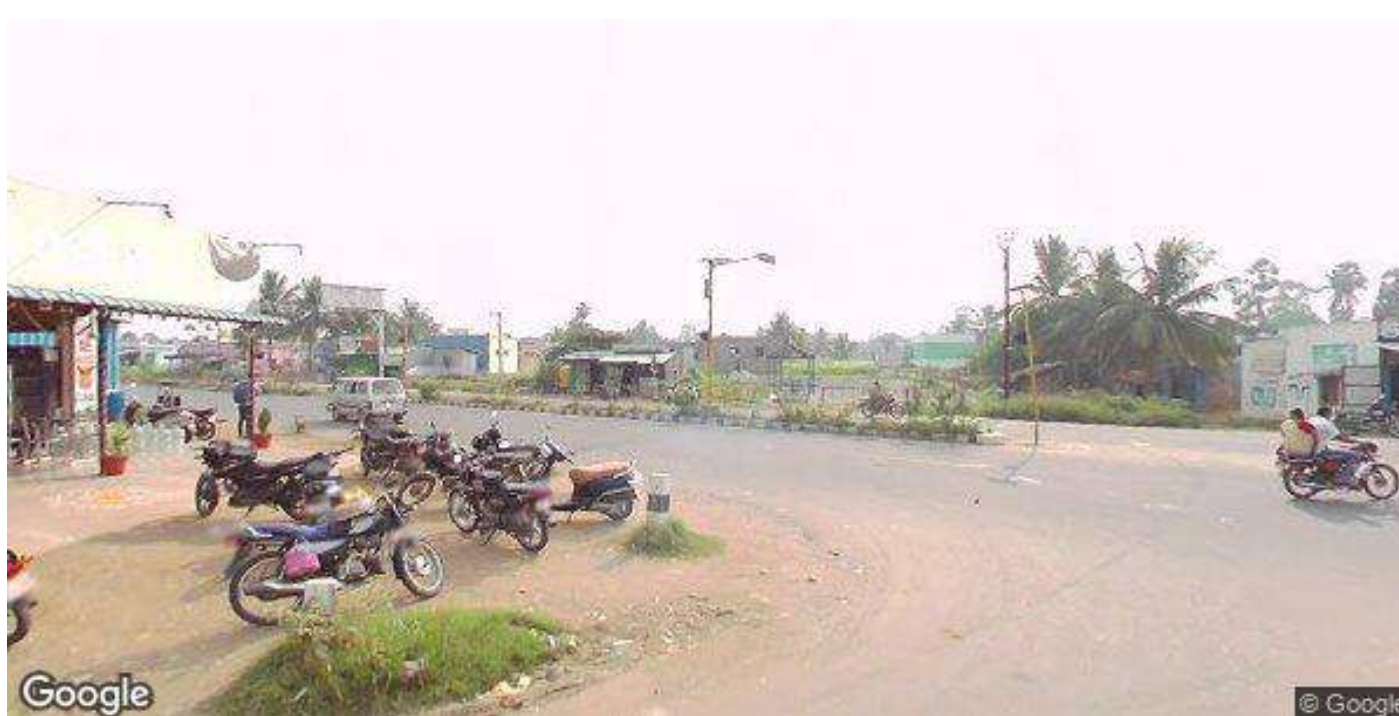
**Risk Type:** Turn  
**Risk Level:** Medium  
**Speed Limit:** 30 KM/Hr  
**Coordinates:** 11.67883, 77.96865

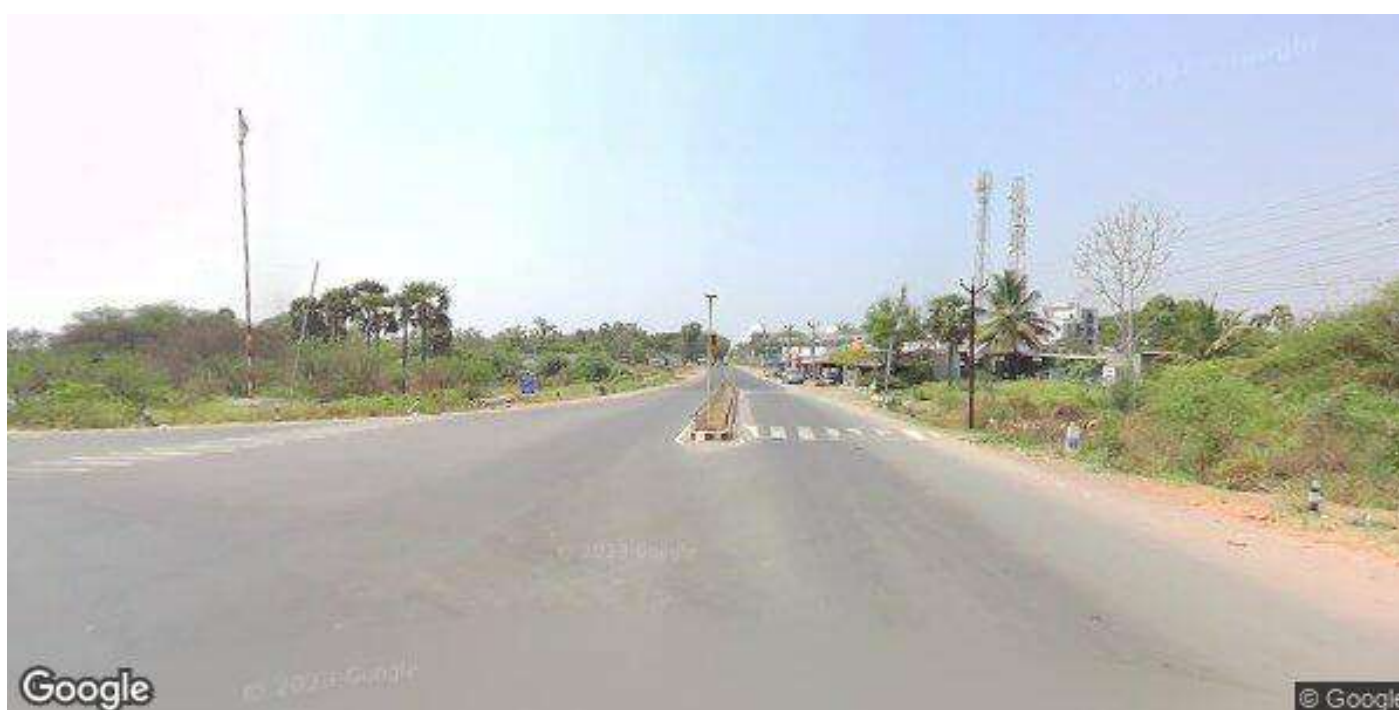
**Risk Type:** Turn  
**Risk Level:** High  
**Speed Limit:** 15 KM/Hr  
**Coordinates:** 11.70227, 77.97864

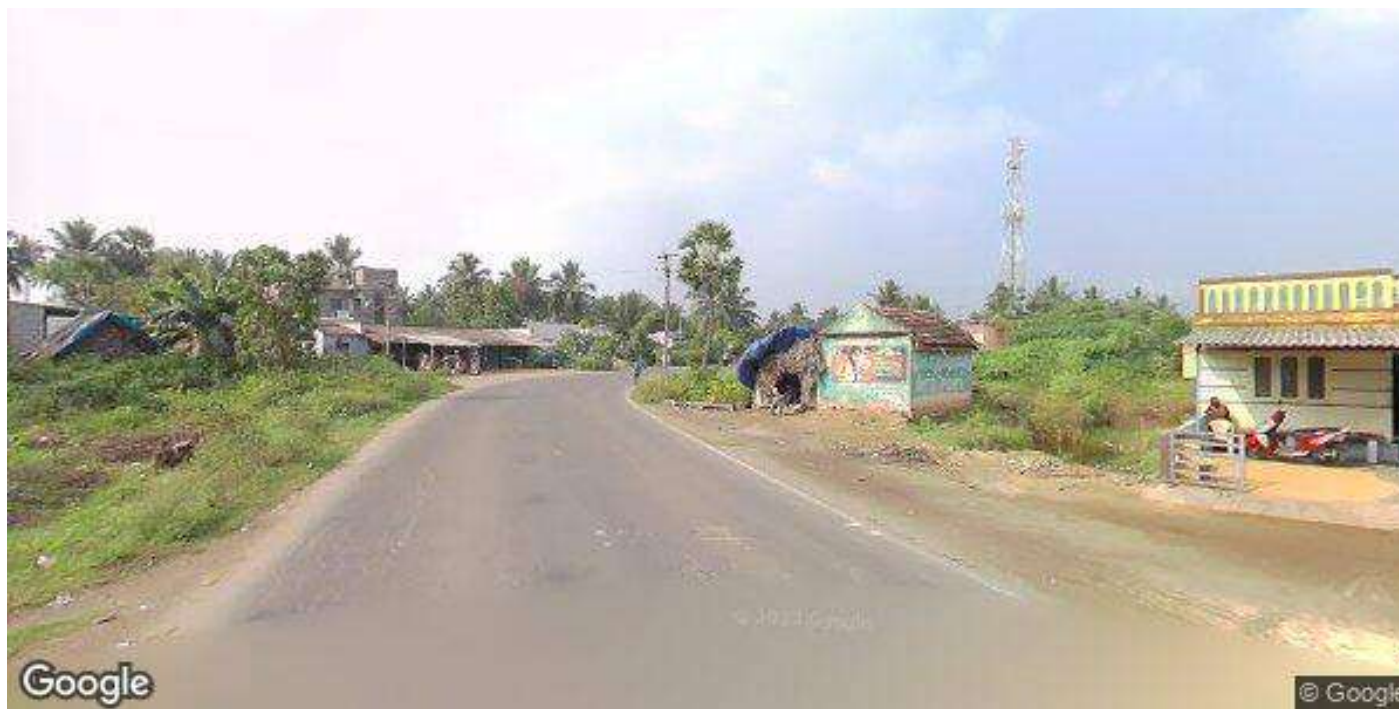
**Risk Type:** Turn  
**Risk Level:** Medium  
**Speed Limit:** 30 KM/Hr  
**Coordinates:** 11.71386, 77.99552

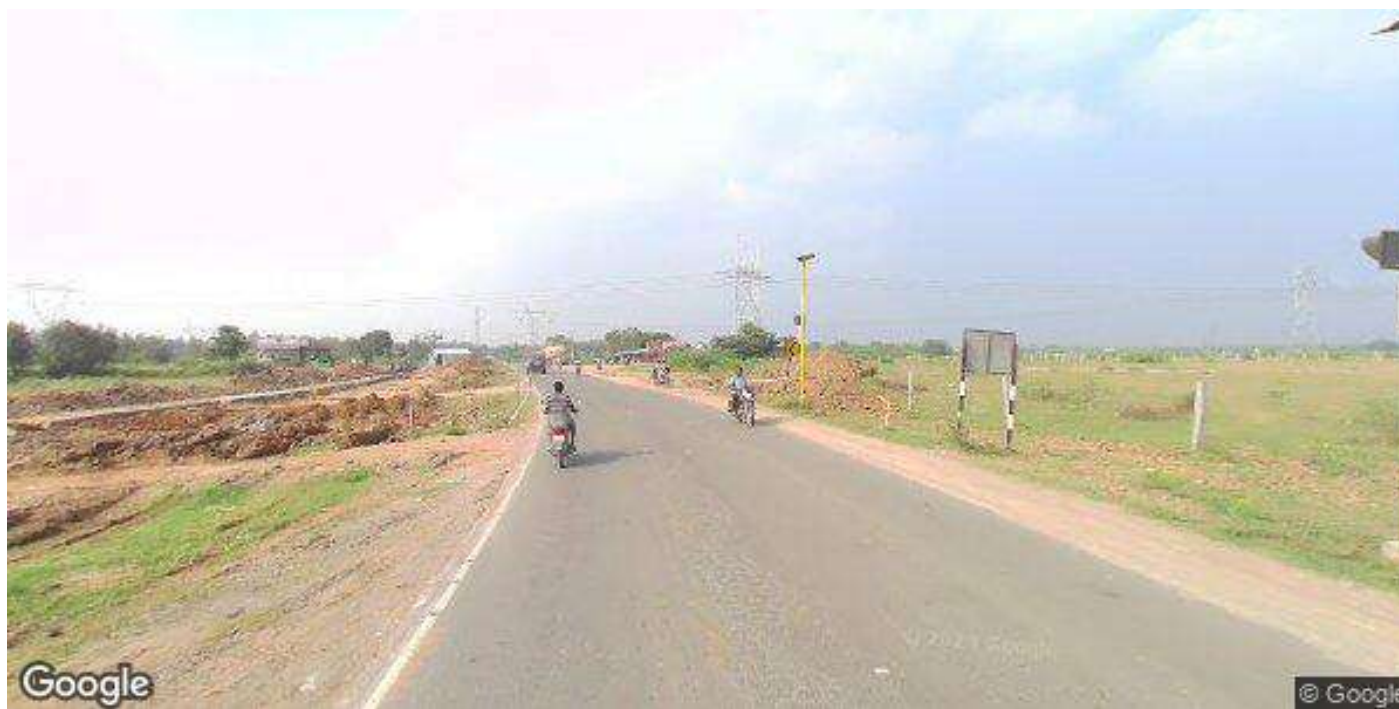
**Risk Type:** Turn  
**Risk Level:** Medium  
**Speed Limit:** 30 KM/Hr  
**Coordinates:** 11.71735, 78.00019

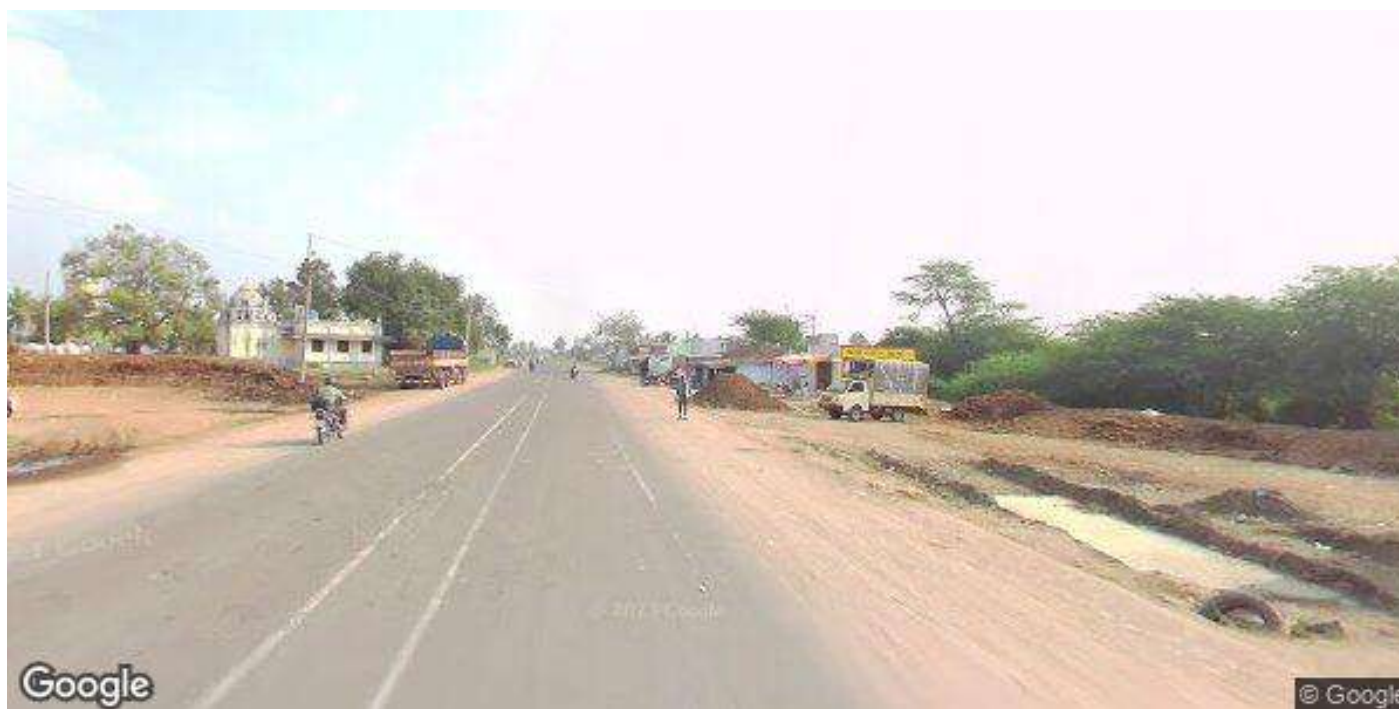
**Risk Type:** Turn  
**Risk Level:** Medium  
**Speed Limit:** 30 KM/Hr  
**Coordinates:** 11.71972, 78.01202

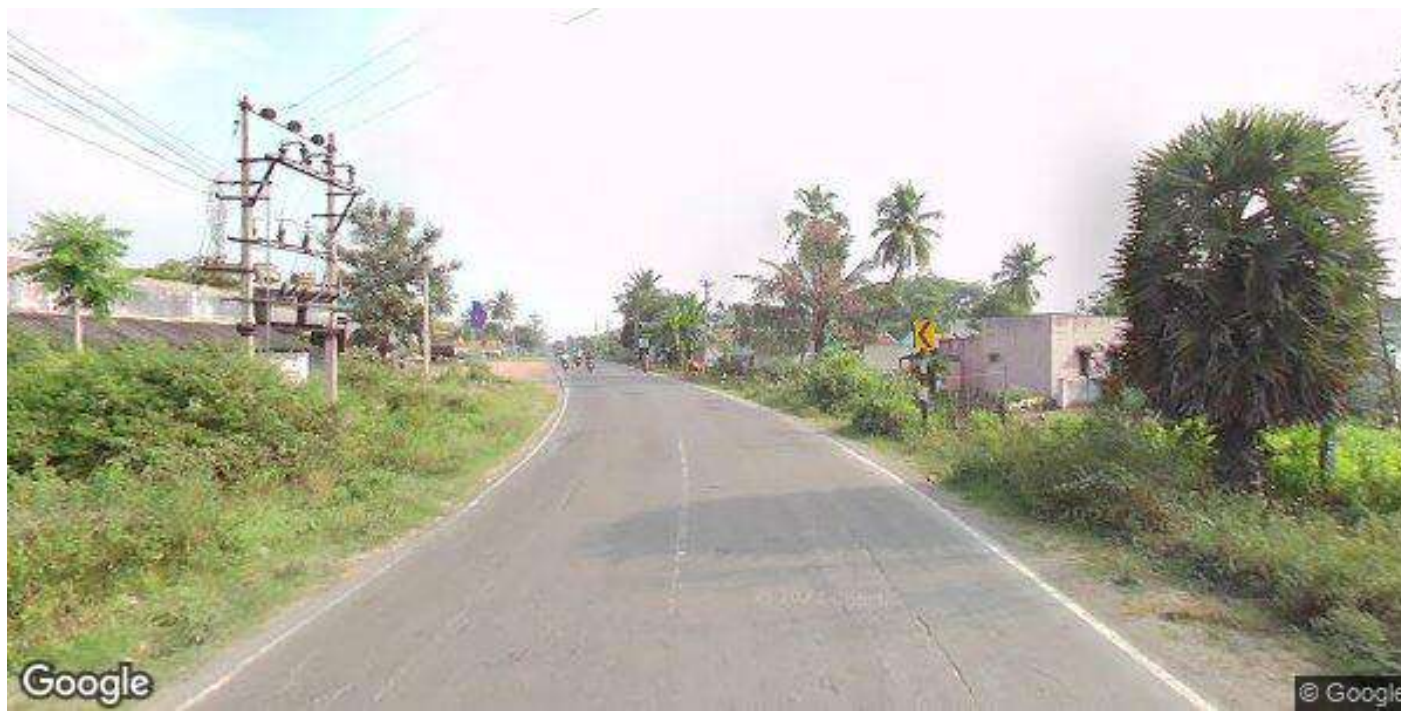
**Risk Type:** Turn  
**Risk Level:** Medium  
**Speed Limit:** 30 KM/Hr  
**Coordinates:** 11.72765, 78.02291

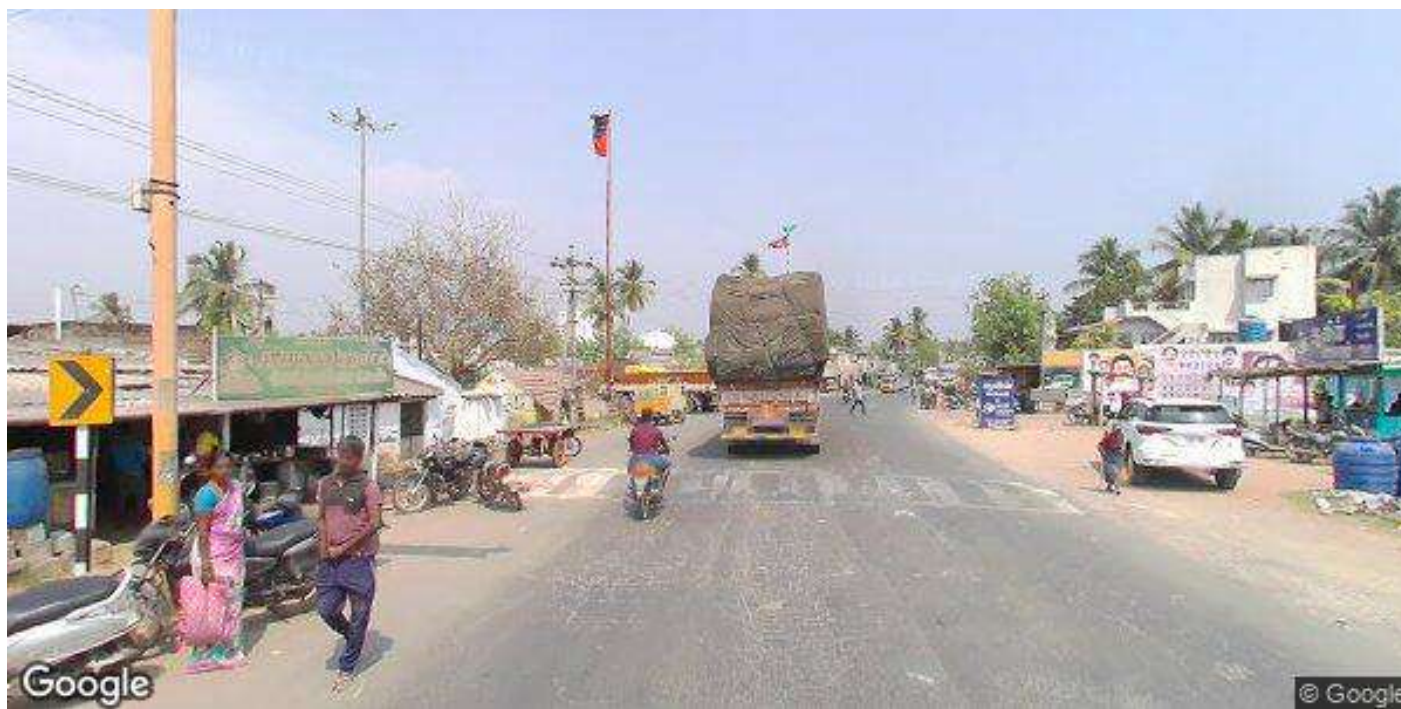
**Risk Type:** Turn  
**Risk Level:** High  
**Speed Limit:** 15 KM/Hr  
**Coordinates:** 11.73785, 78.03496

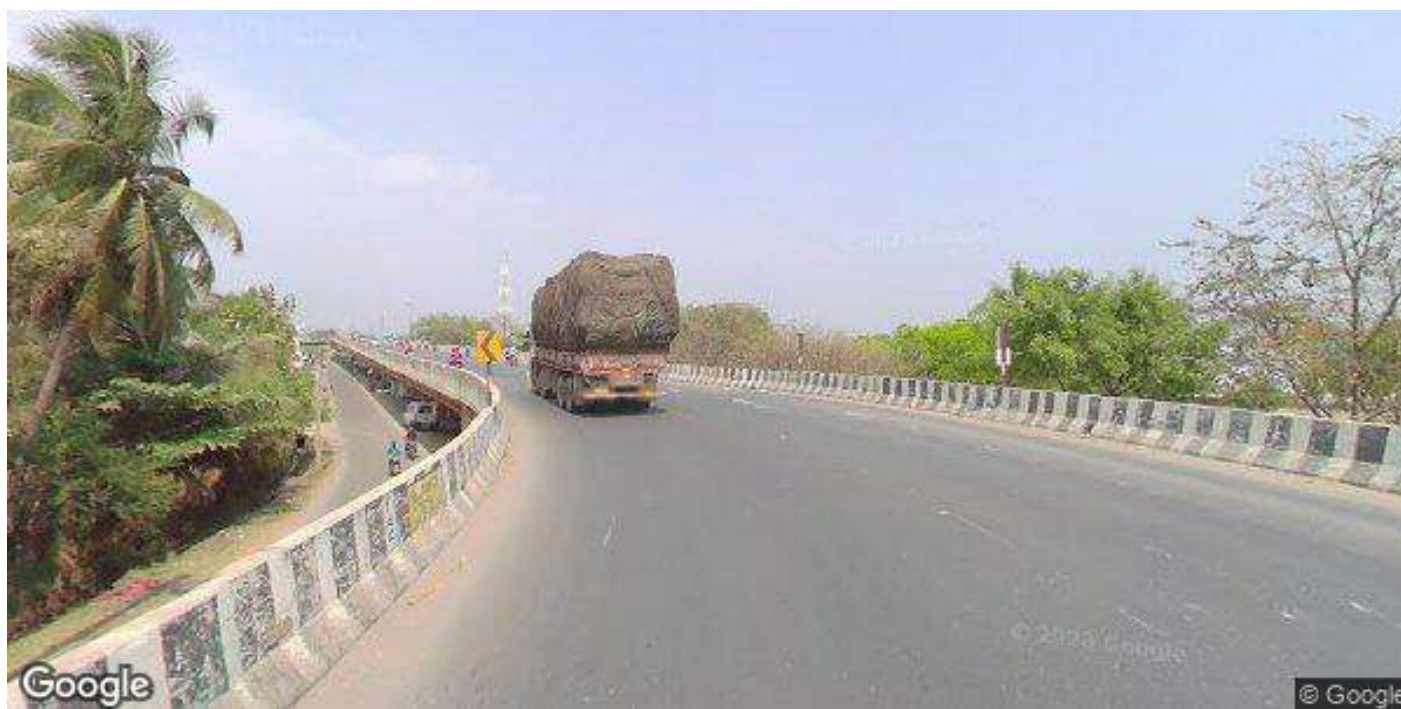
**Risk Type:** Turn  
**Risk Level:** High  
**Speed Limit:** 15 KM/Hr  
**Coordinates:** 11.73653, 78.03886

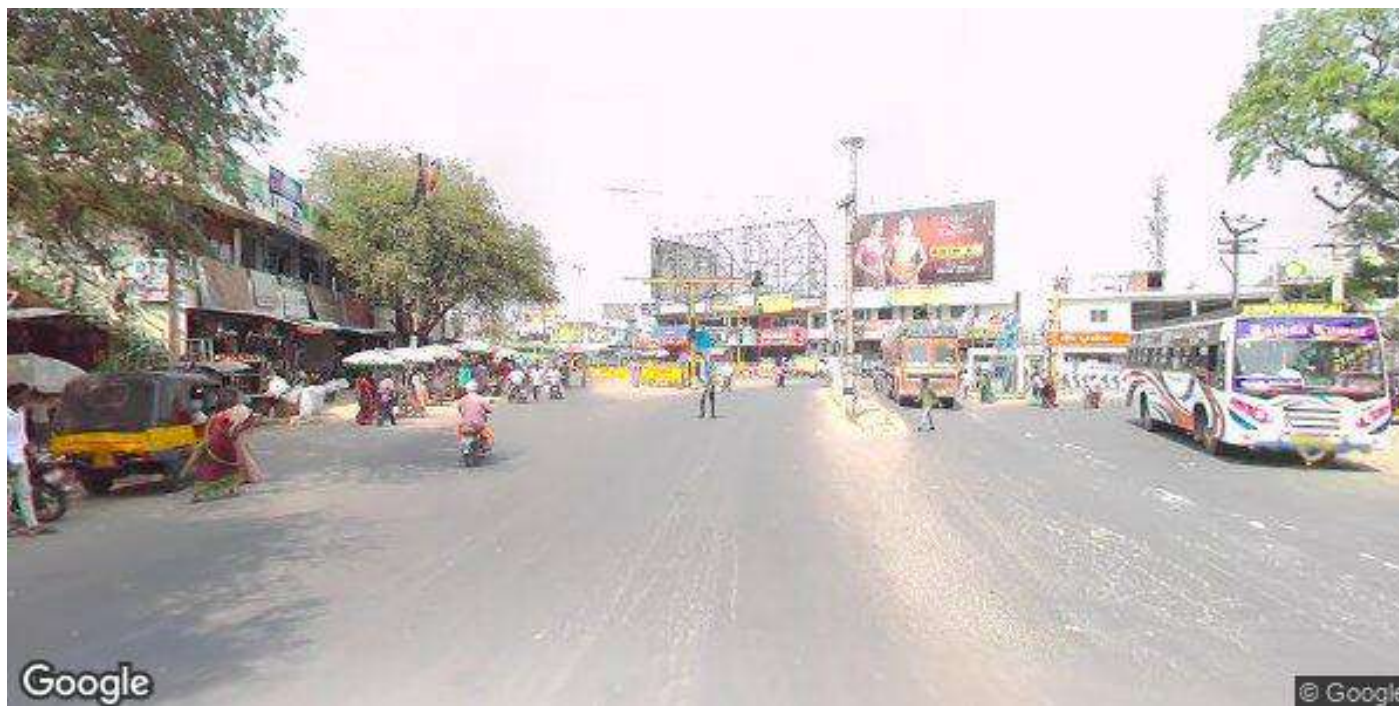
**Risk Type:** Turn  
**Risk Level:** Medium  
**Speed Limit:** 30 KM/Hr  
**Coordinates:** 11.74252, 78.04705

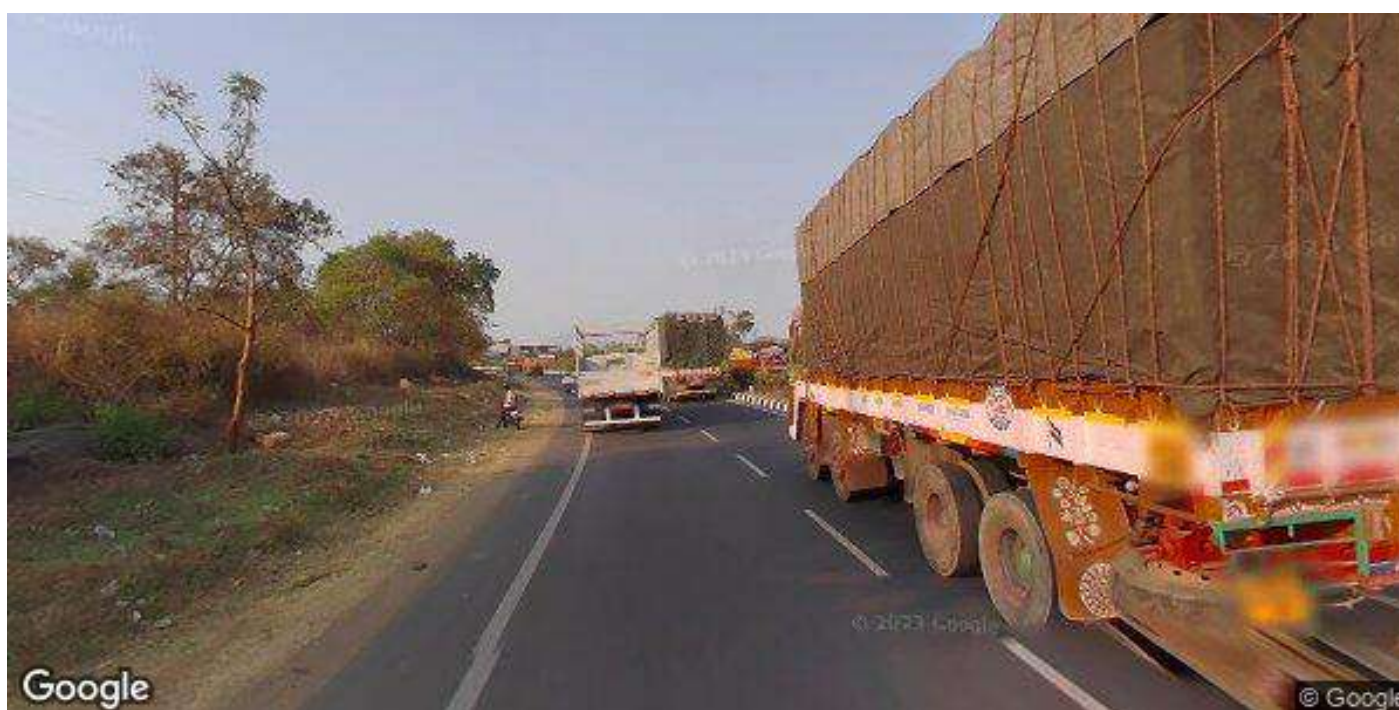
**Risk Type:** Turn  
**Risk Level:** Medium  
**Speed Limit:** 30 KM/Hr  
**Coordinates:** 11.77998, 78.05786

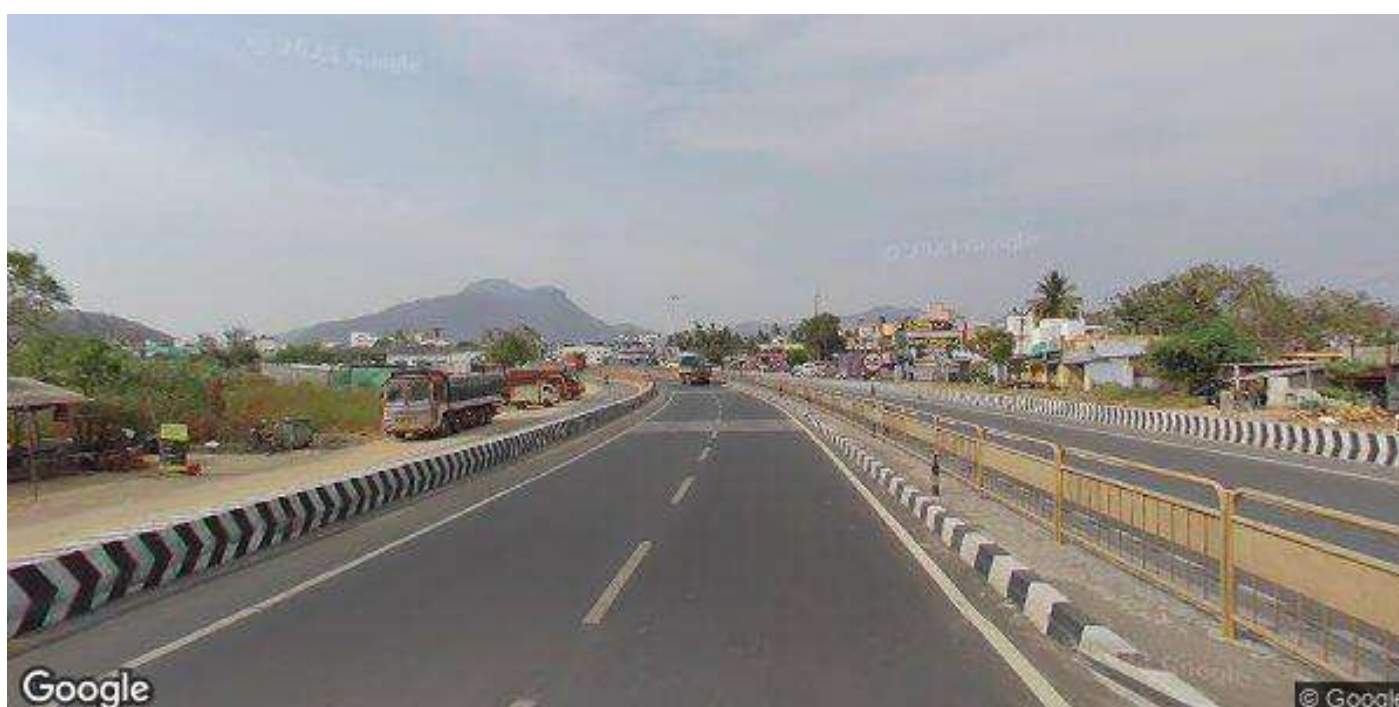
**Risk Type:** Turn  
**Risk Level:** Medium  
**Speed Limit:** 30 KM/Hr  
**Coordinates:** 11.86915, 78.08382

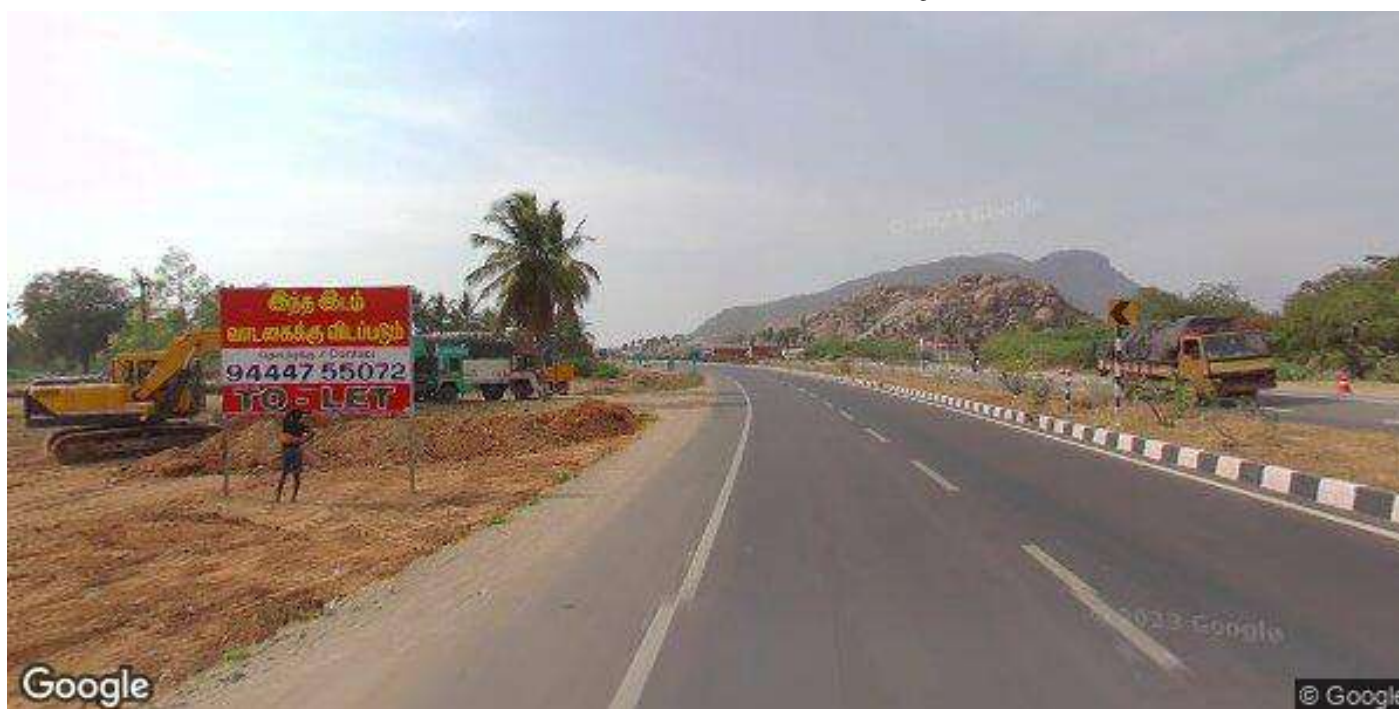
**Risk Type:** Turn  
**Risk Level:** Medium  
**Speed Limit:** 30 KM/Hr  
**Coordinates:** 11.87998, 78.08170
