# IndianOil

## JOURNEY RISK MANAGEMENT (JRM) STUDY

### Salem Terminal to KSG AGENCIES

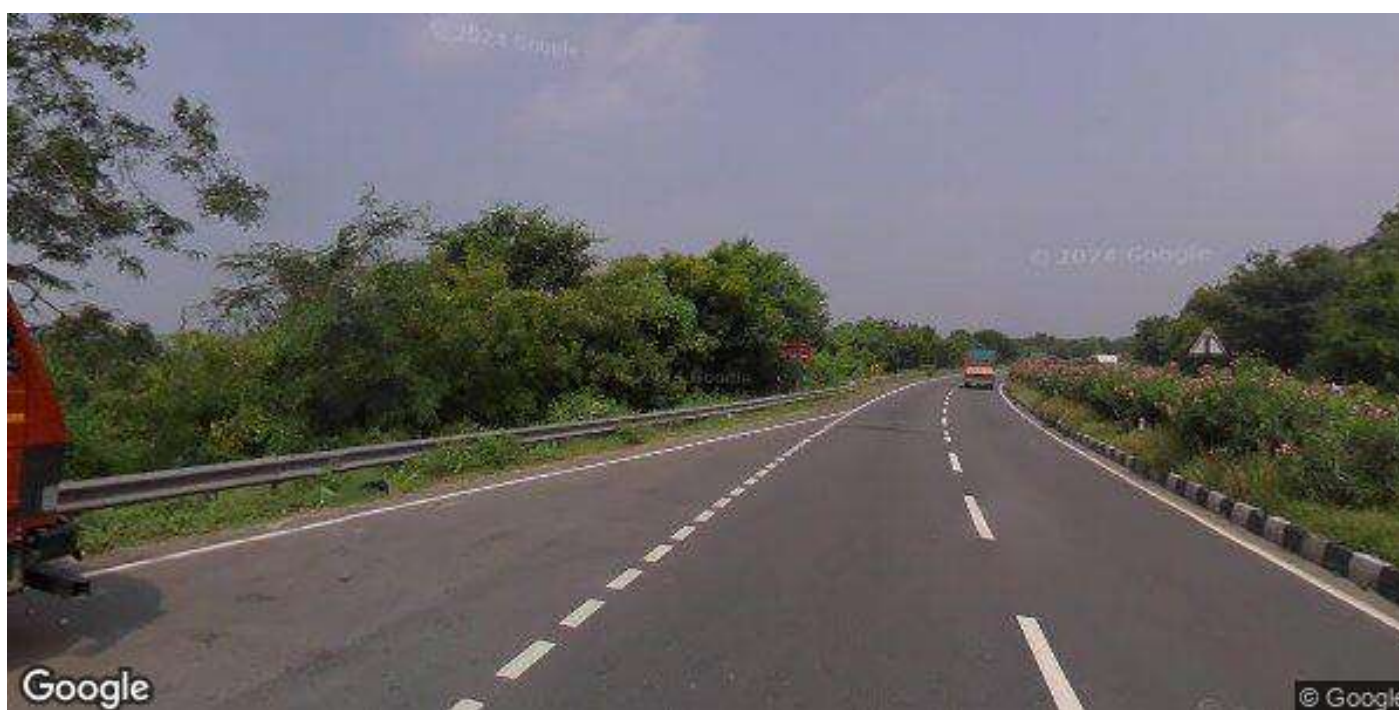
**Risk Type:** Turn  
**Risk Level:** Medium  
**Speed Limit:** 30 KM/Hr  
**Coordinates:** 11.91266, 78.05852

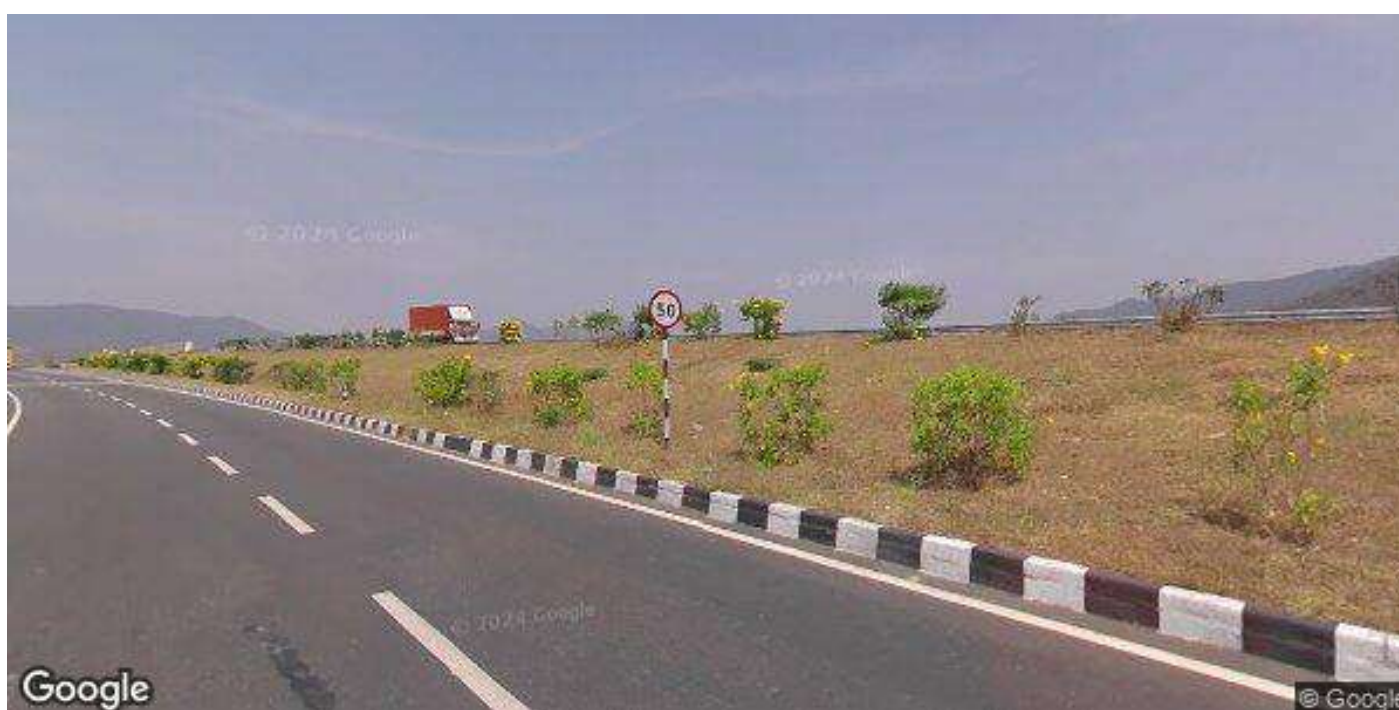
**Risk Type:** Turn  
**Risk Level:** Medium  
**Speed Limit:** 30 KM/Hr  
**Coordinates:** 11.92653, 78.06517

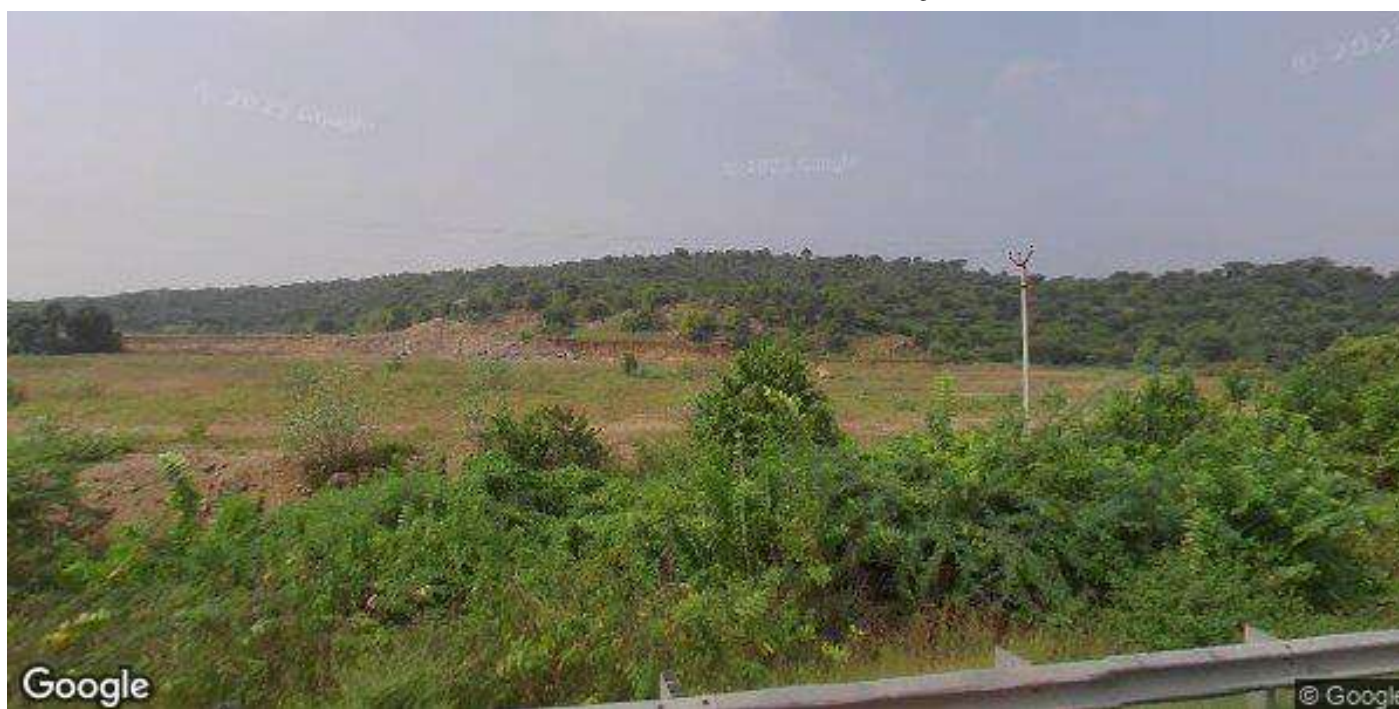
**Risk Type:** Turn  
**Risk Level:** Medium  
**Speed Limit:** 30 KM/Hr  
**Coordinates:** 11.93196, 78.06473

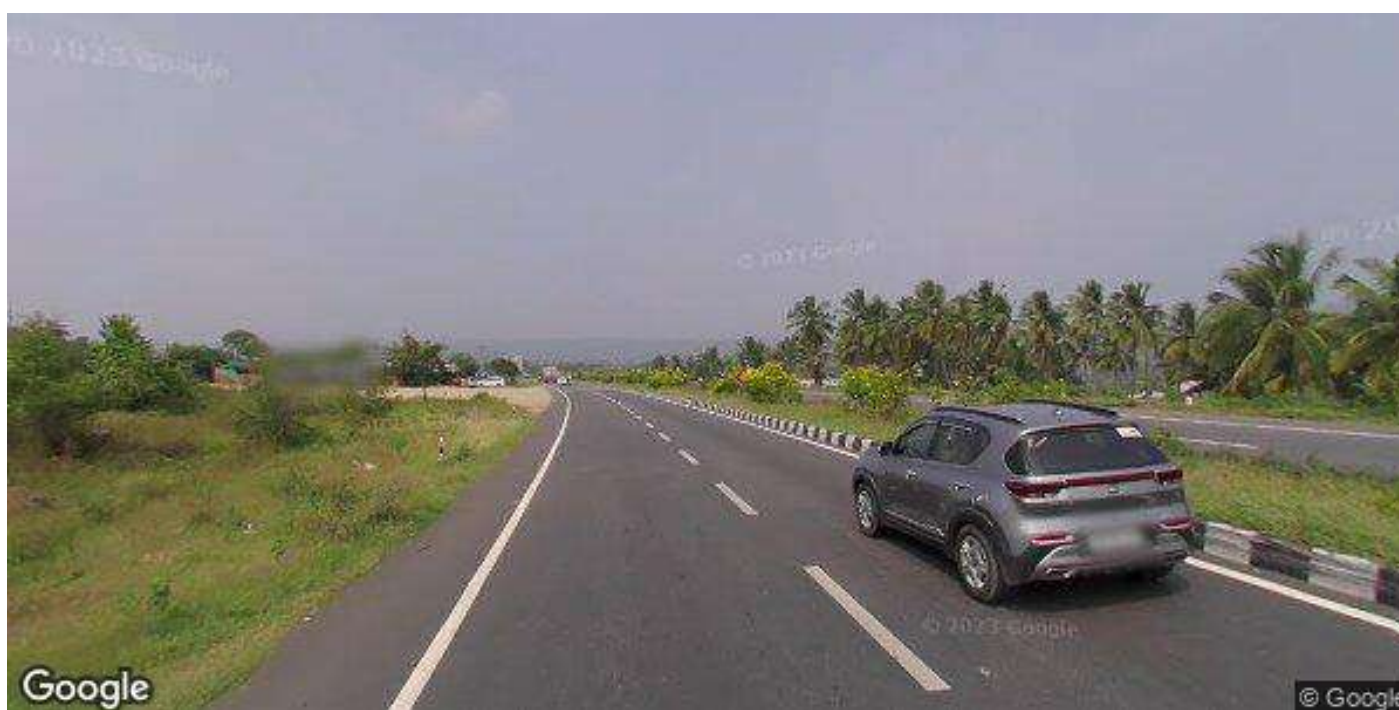
**Risk Type:** Turn  
**Risk Level:** Medium  
**Speed Limit:** 30 KM/Hr  
**Coordinates:** 11.93473, 78.06268

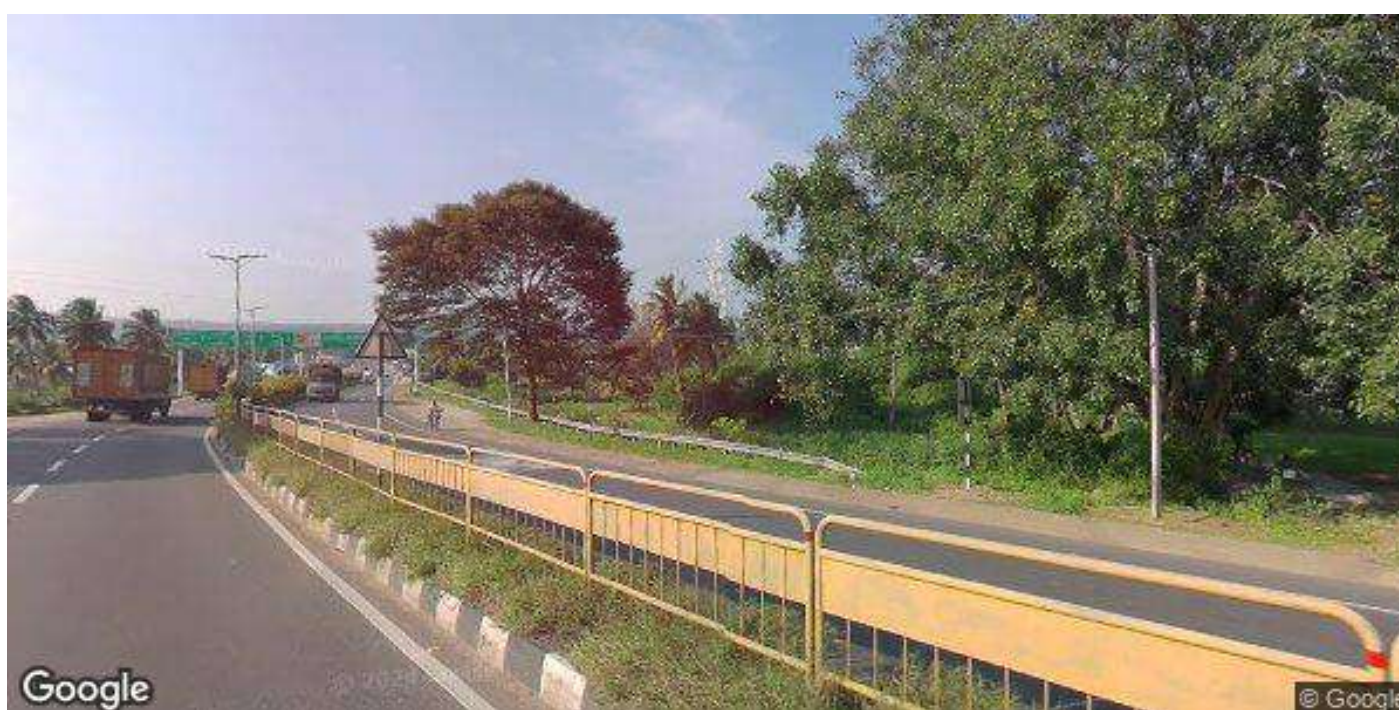
**Risk Type:** Turn  
**Risk Level:** Medium  
**Speed Limit:** 30 KM/Hr  
**Coordinates:** 11.93746, 78.05331

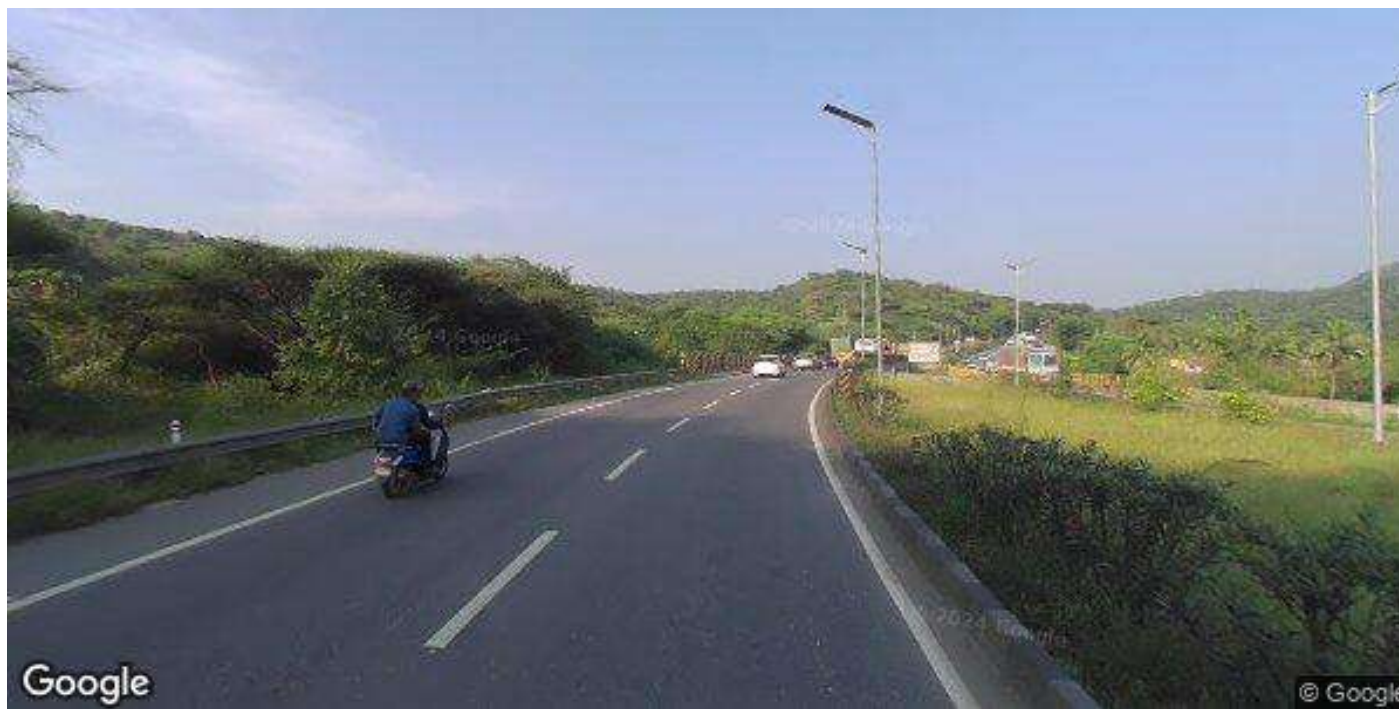
**Risk Type:** Turn  
**Risk Level:** Medium  
**Speed Limit:** 30 KM/Hr  
**Coordinates:** 11.95531, 78.04698

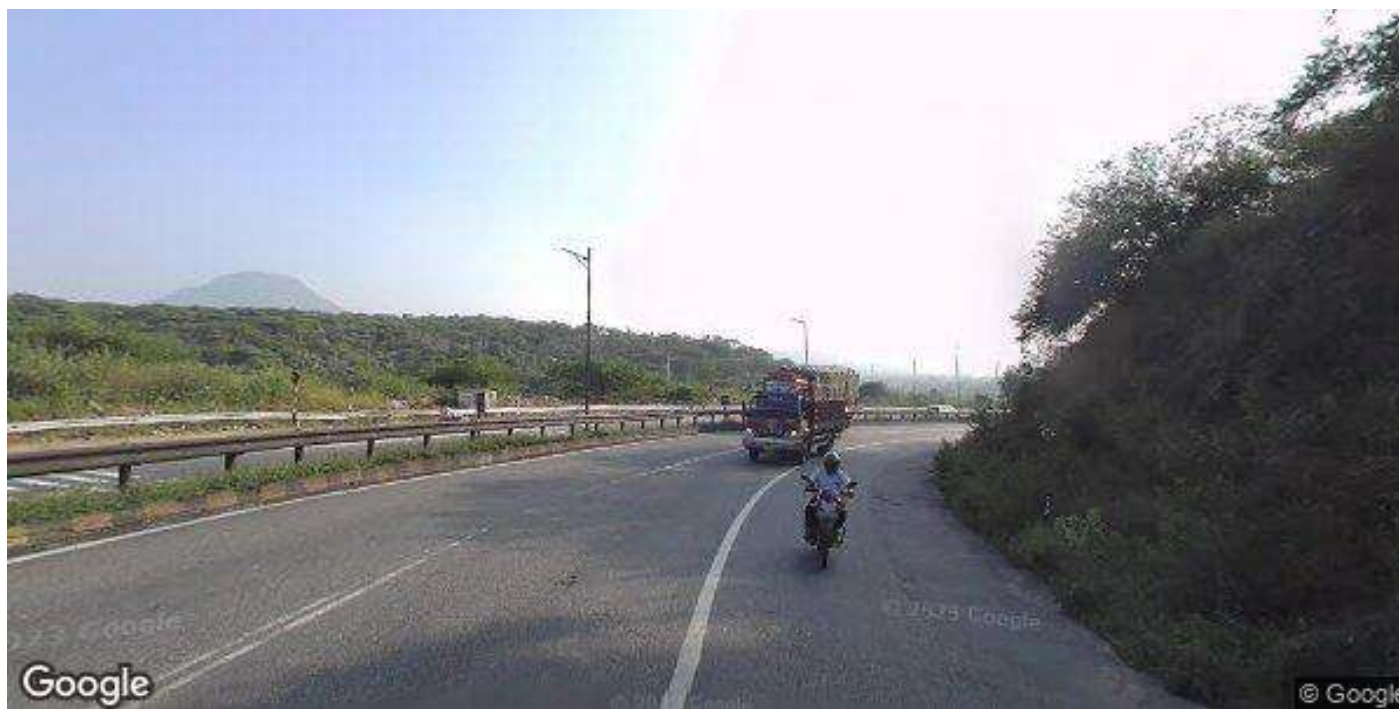
**Risk Type:** Turn  
**Risk Level:** High  
**Speed Limit:** 15 KM/Hr  
**Coordinates:** 11.95854, 78.04990

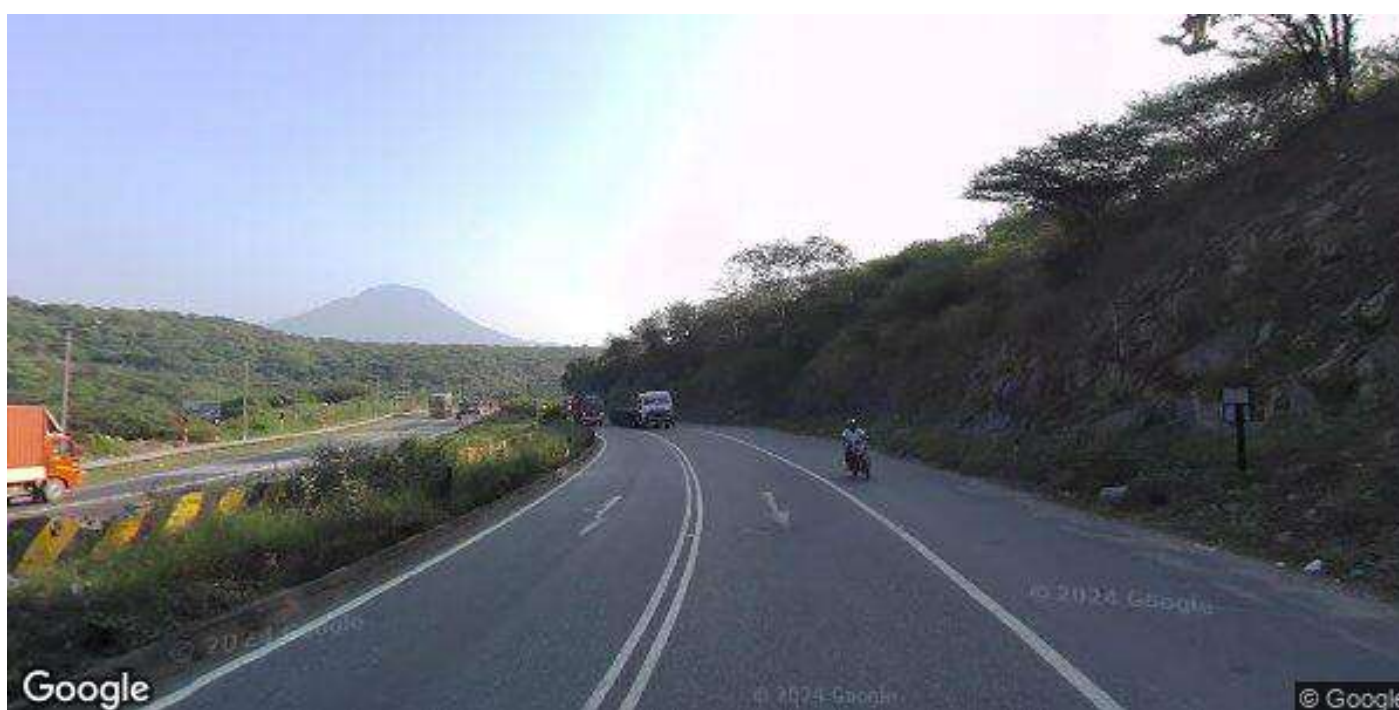
**Risk Type:** Turn  
**Risk Level:** High  
**Speed Limit:** 15 KM/Hr  
**Coordinates:** 11.96015, 78.04945

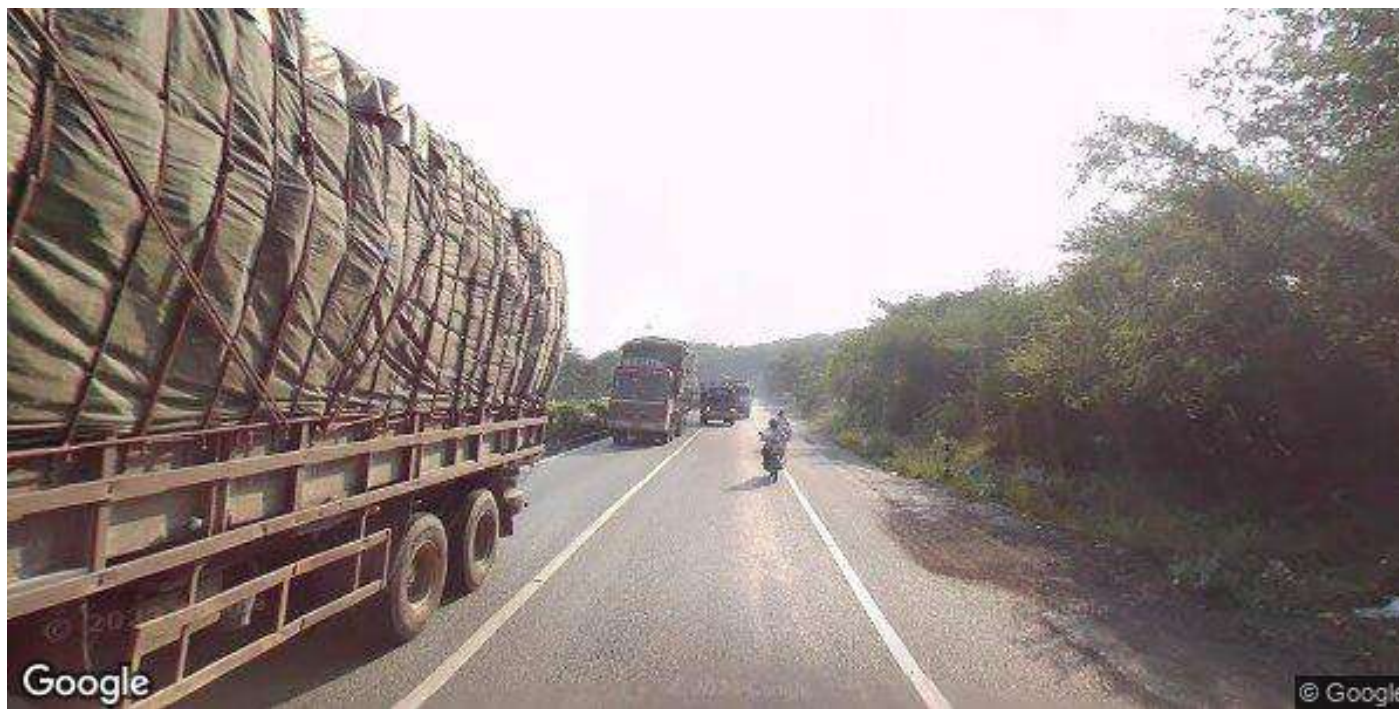
**Risk Type:** Turn  
**Risk Level:** Medium  
**Speed Limit:** 30 KM/Hr  
**Coordinates:** 11.96266, 78.05115

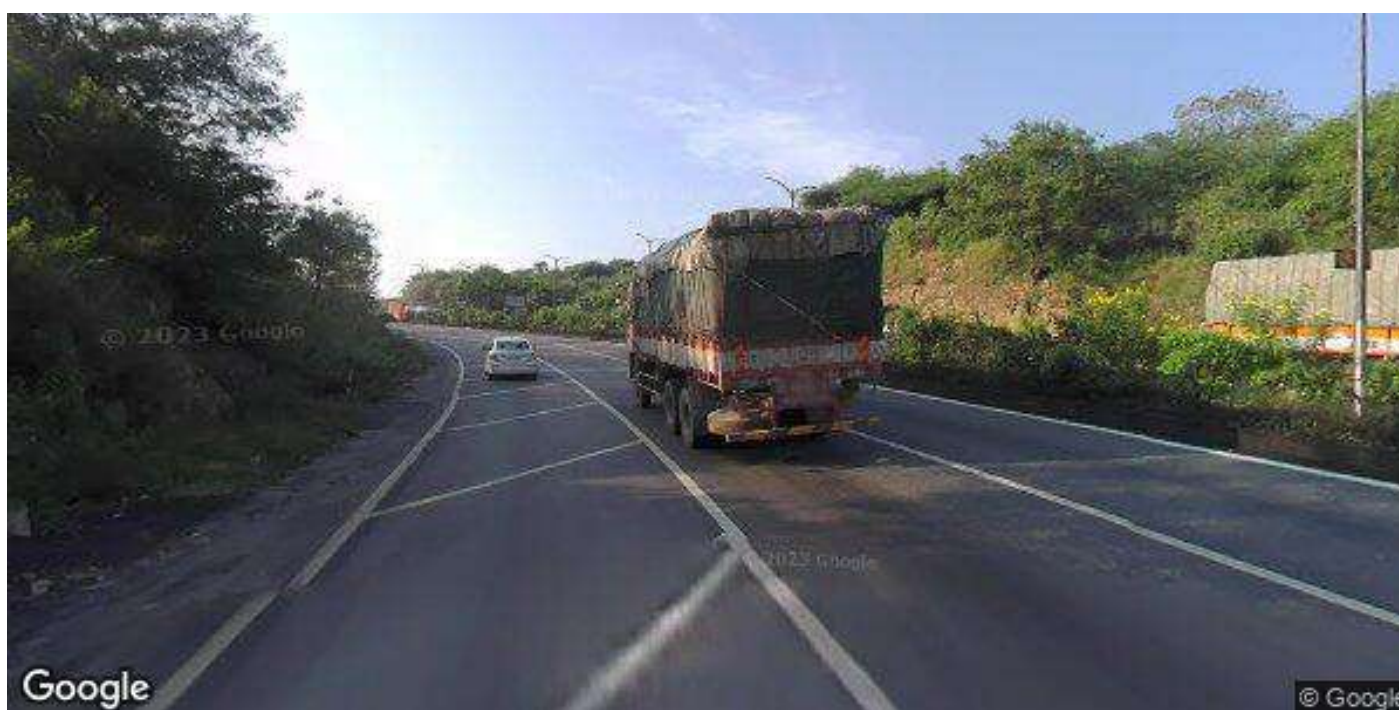
**Risk Type:** Turn  
**Risk Level:** High  
**Speed Limit:** 15 KM/Hr  
**Coordinates:** 11.96433, 78.05113

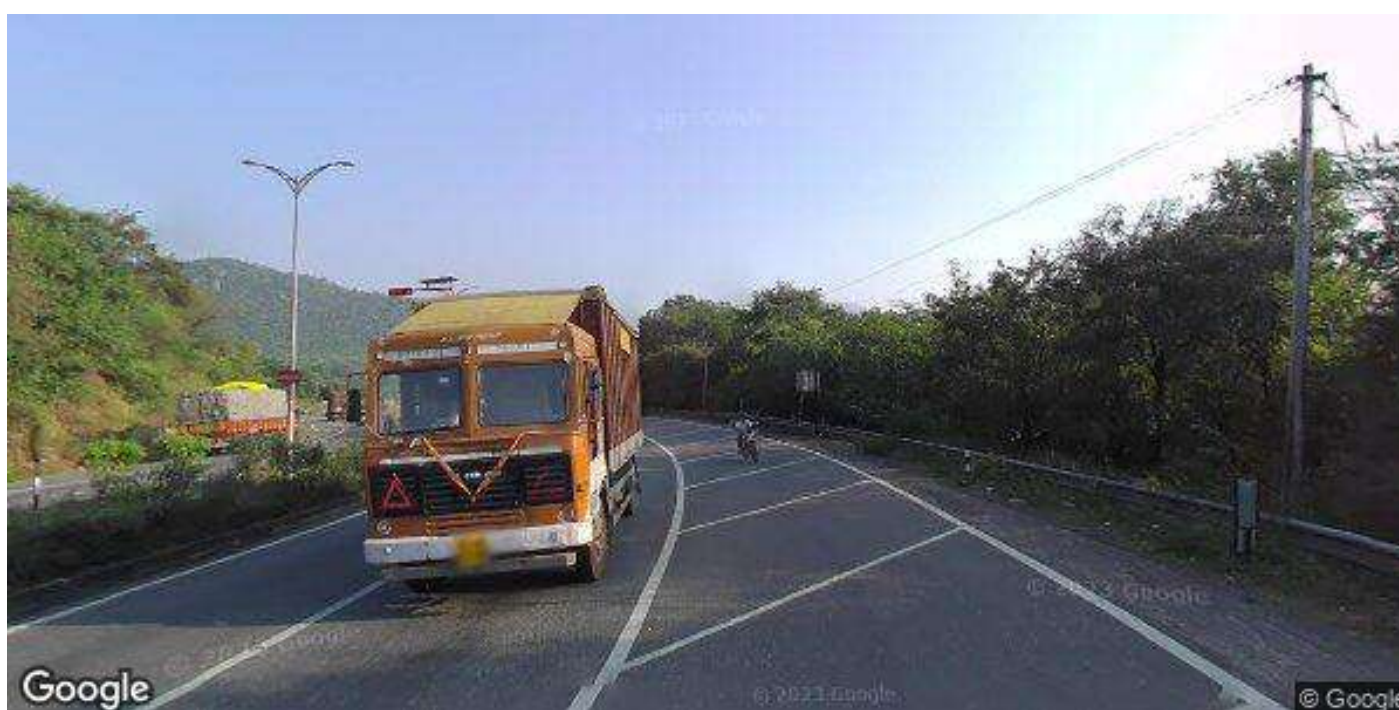
**Risk Type:** Turn  
**Risk Level:** High  
**Speed Limit:** 15 KM/Hr  
**Coordinates:** 11.96542, 78.04938

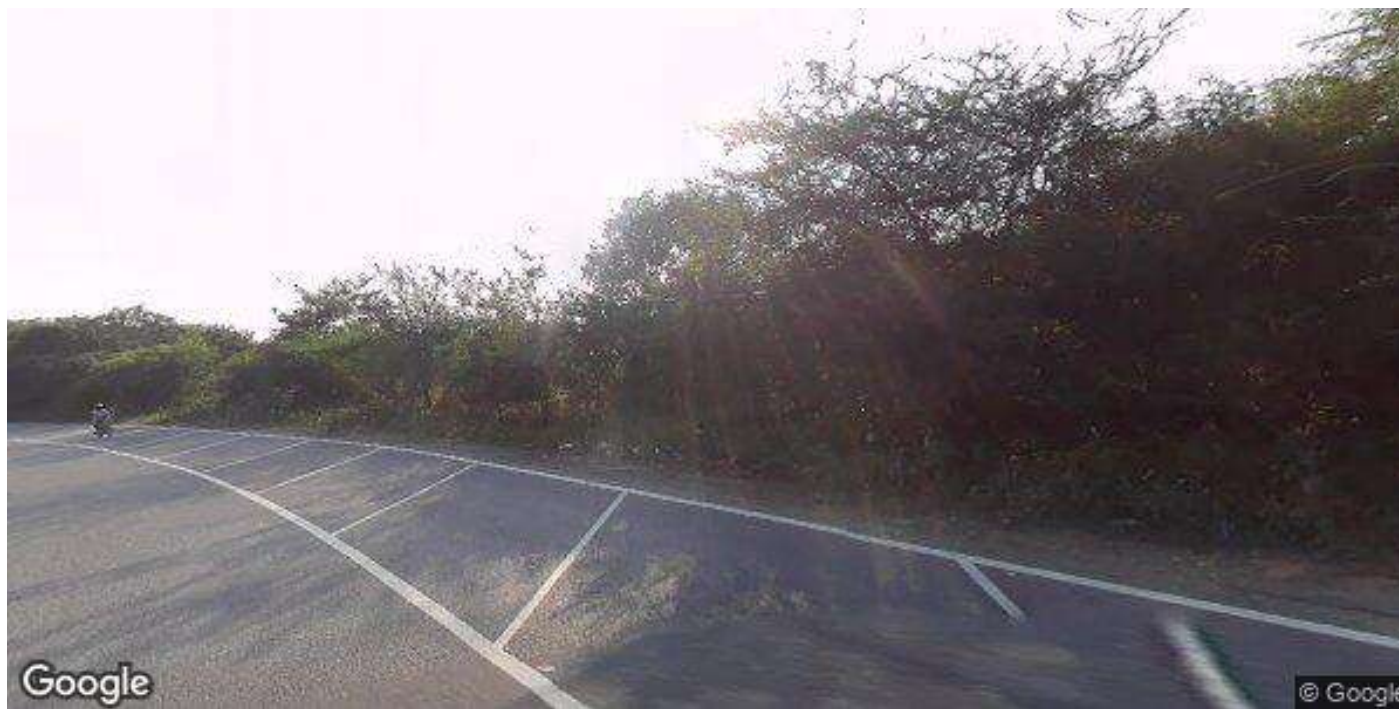
**Risk Type:** Turn  
**Risk Level:** High  
**Speed Limit:** 15 KM/Hr  
**Coordinates:** 11.96650, 78.04927

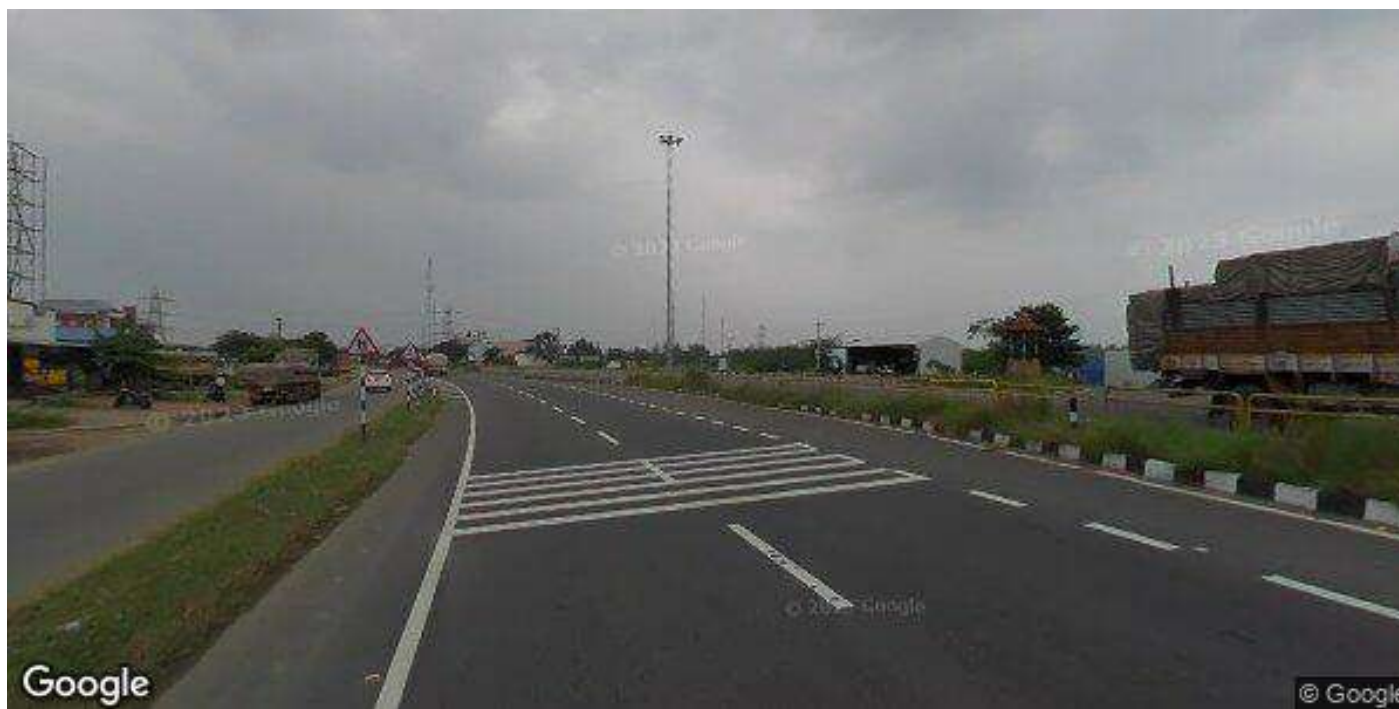
**Risk Type:** Turn  
**Risk Level:** Medium  
**Speed Limit:** 30 KM/Hr  
**Coordinates:** 12.17041, 78.16823

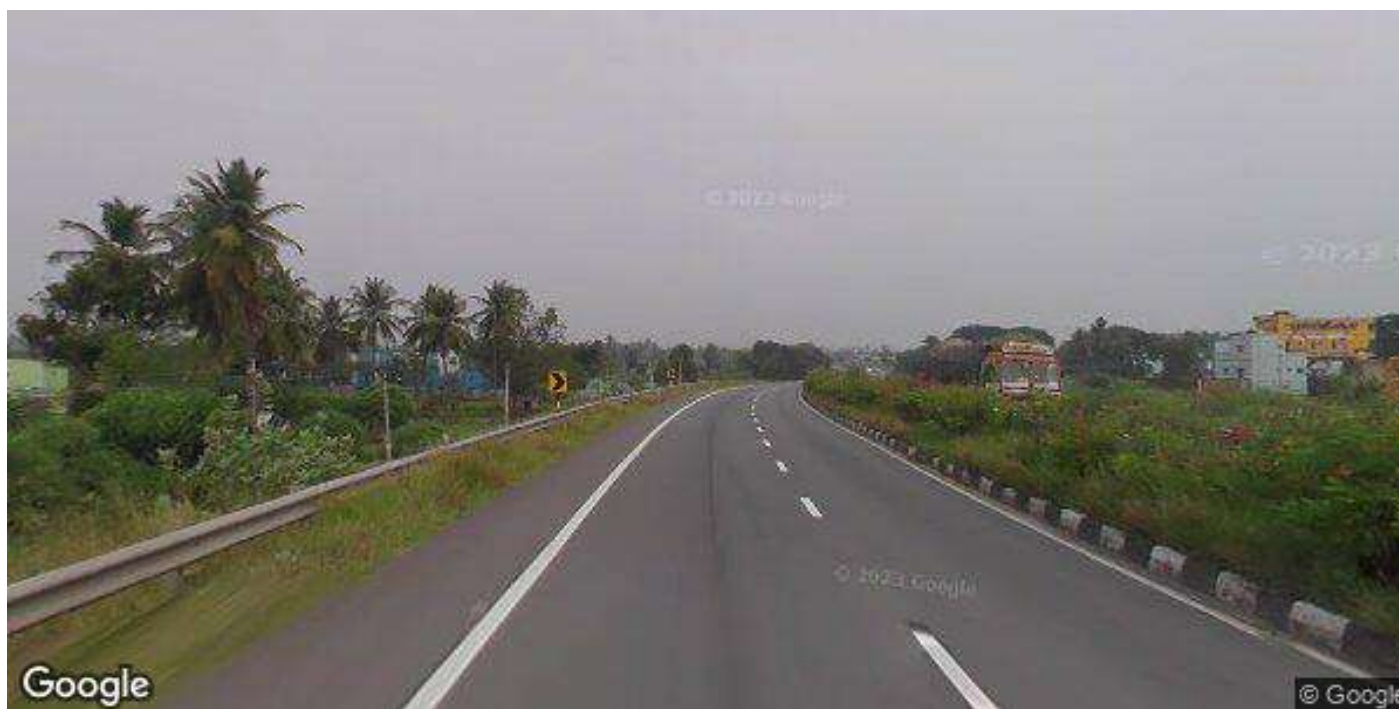
**Risk Type:** Turn  
**Risk Level:** Medium  
**Speed Limit:** 30 KM/Hr  
**Coordinates:** 12.22515, 78.19158

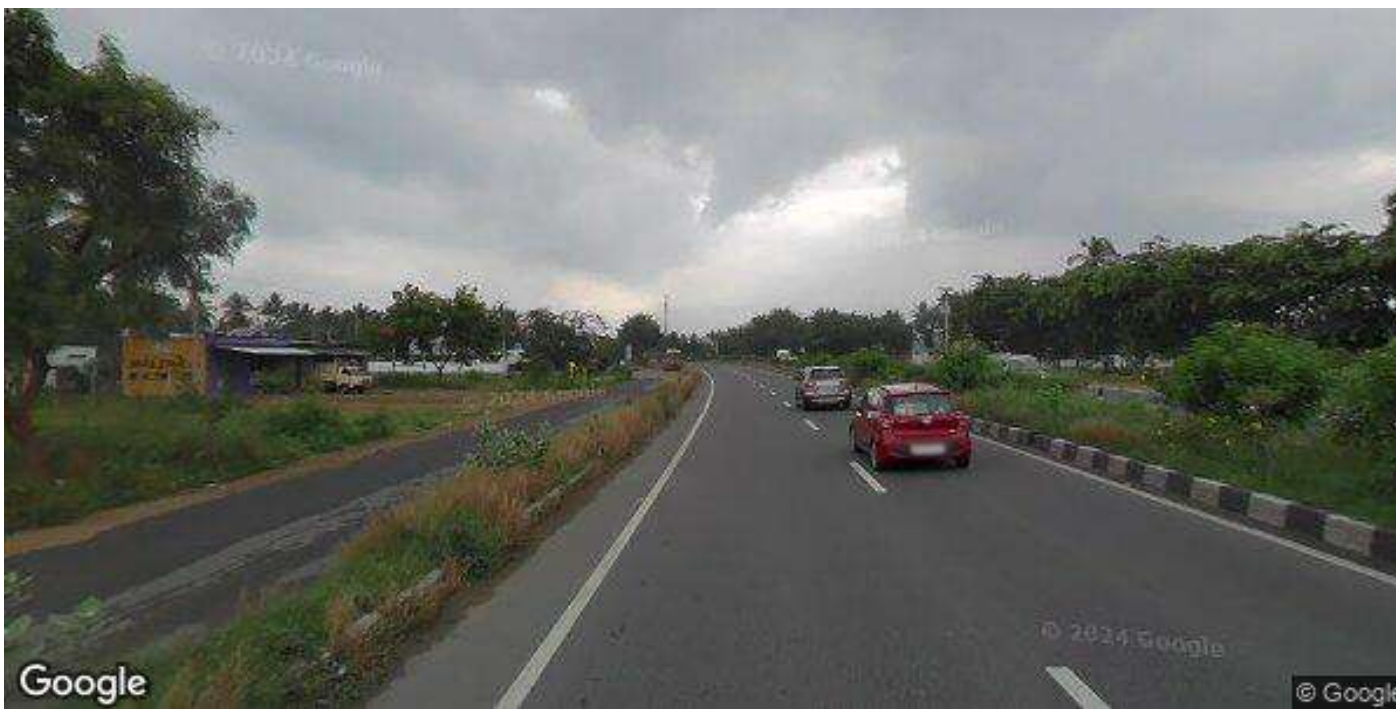
**Risk Type:** Turn  
**Risk Level:** Medium  
**Speed Limit:** 30 KM/Hr  
**Coordinates:** 12.22995, 78.19466

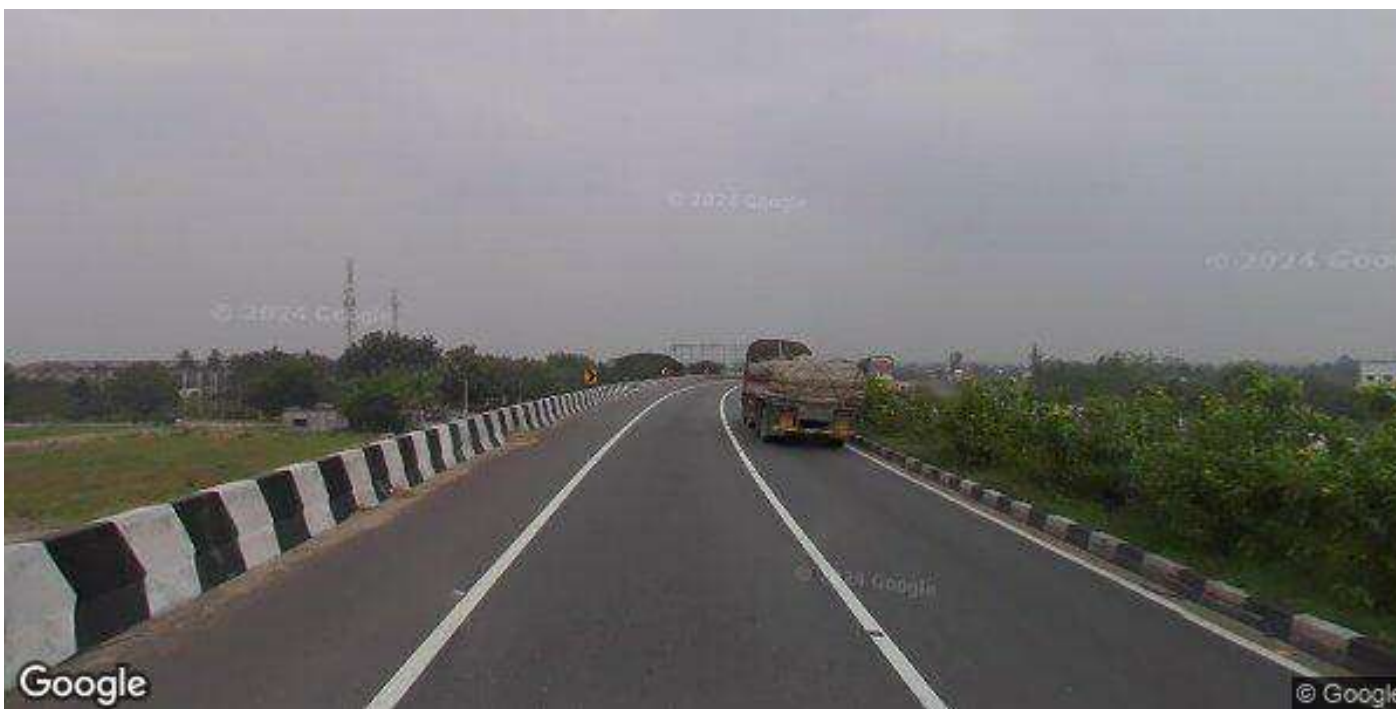
**Risk Type:** Turn  
**Risk Level:** Medium  
**Speed Limit:** 30 KM/Hr  
**Coordinates:** 12.24547, 78.19501

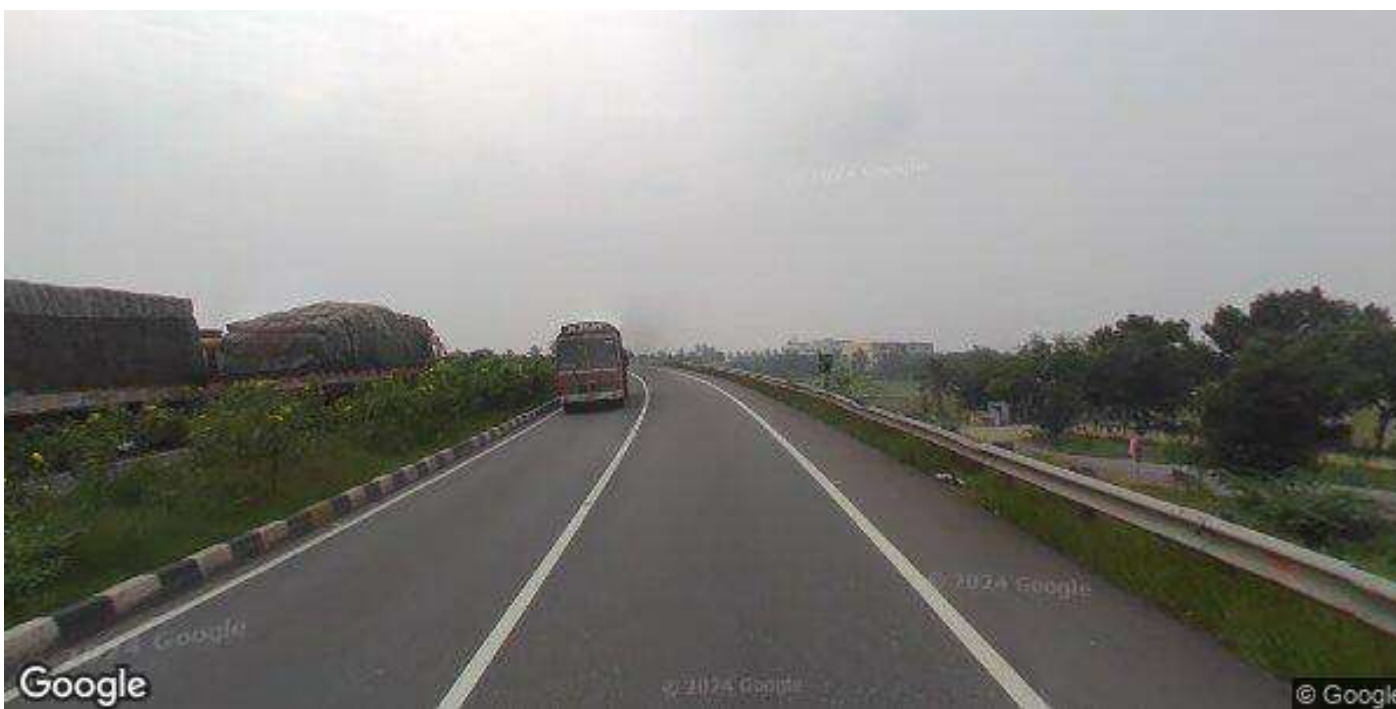
**Risk Type:** Turn  
**Risk Level:** Medium  
**Speed Limit:** 30 KM/Hr  
**Coordinates:** 12.24685, 78.19561

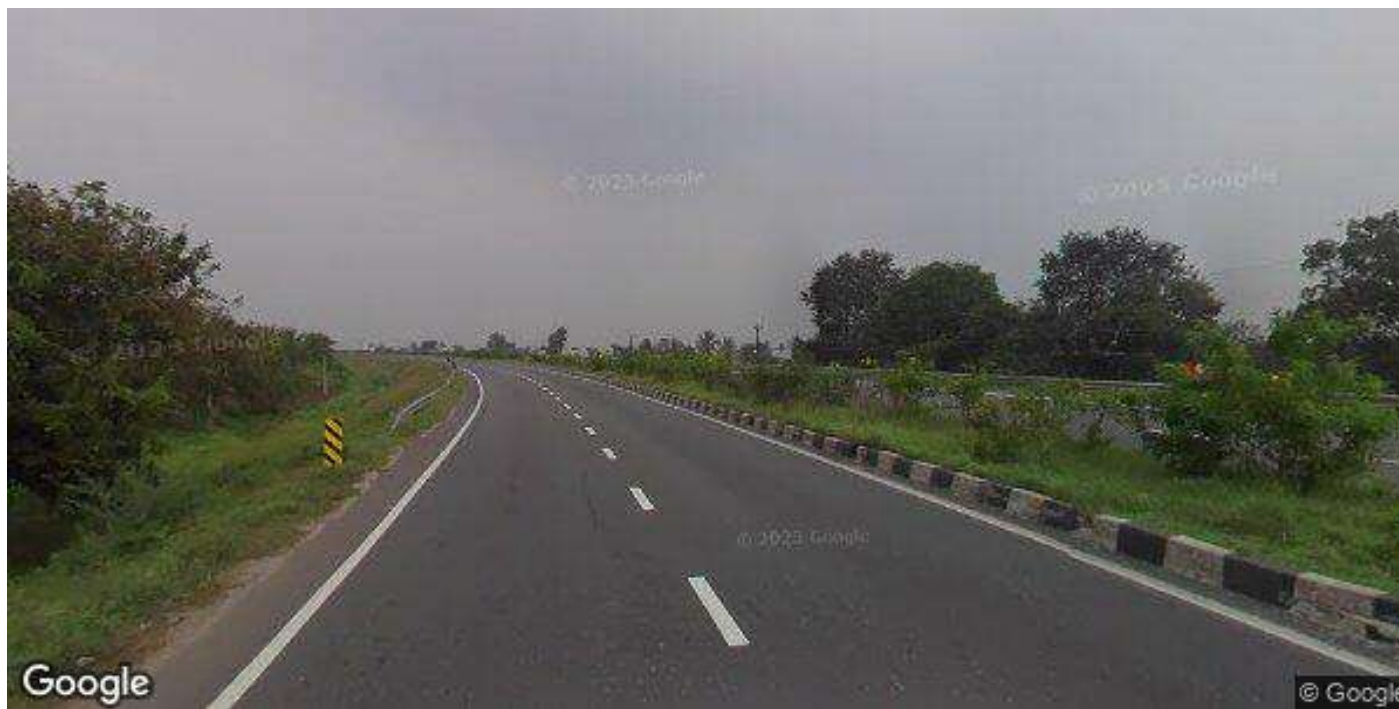
**Risk Type:** Turn  
**Risk Level:** Medium  
**Speed Limit:** 30 KM/Hr  
**Coordinates:** 12.25120, 78.20010

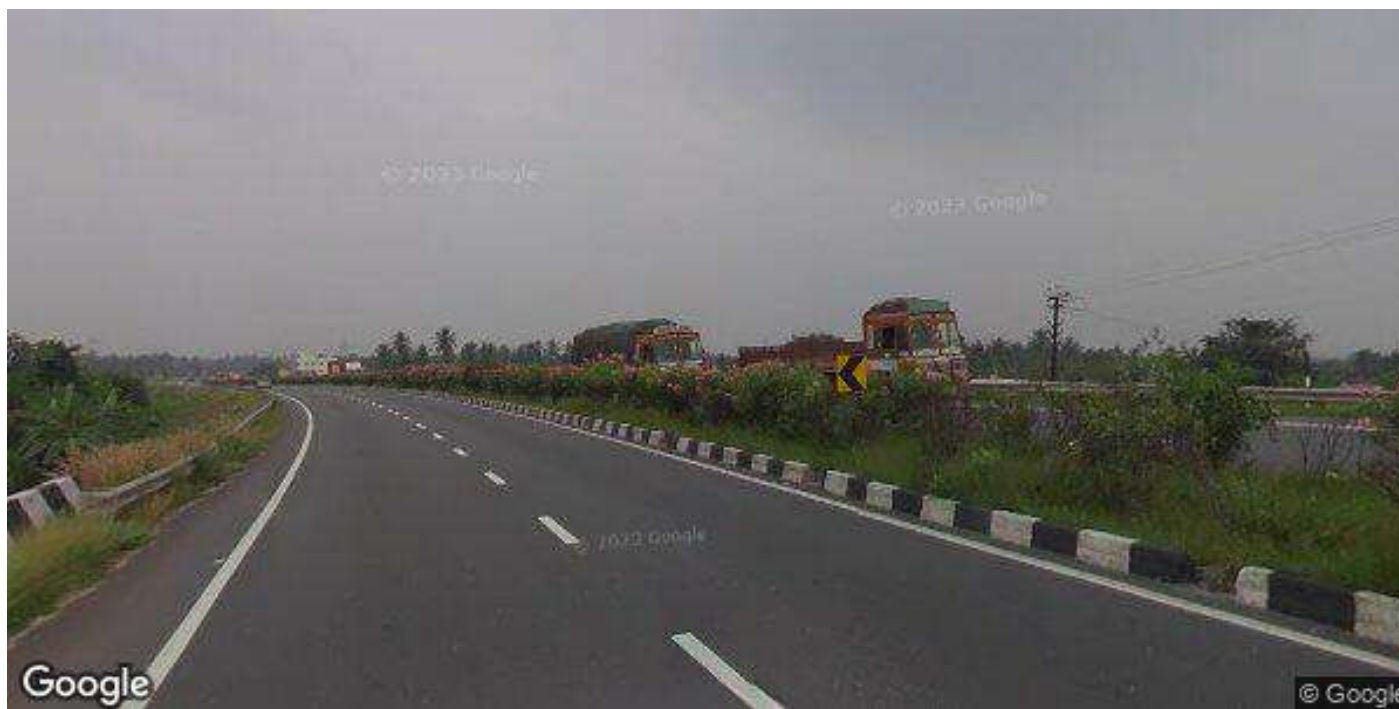
**Risk Type:** Turn  
**Risk Level:** Medium  
**Speed Limit:** 30 KM/Hr  
**Coordinates:** 12.25442, 78.20015

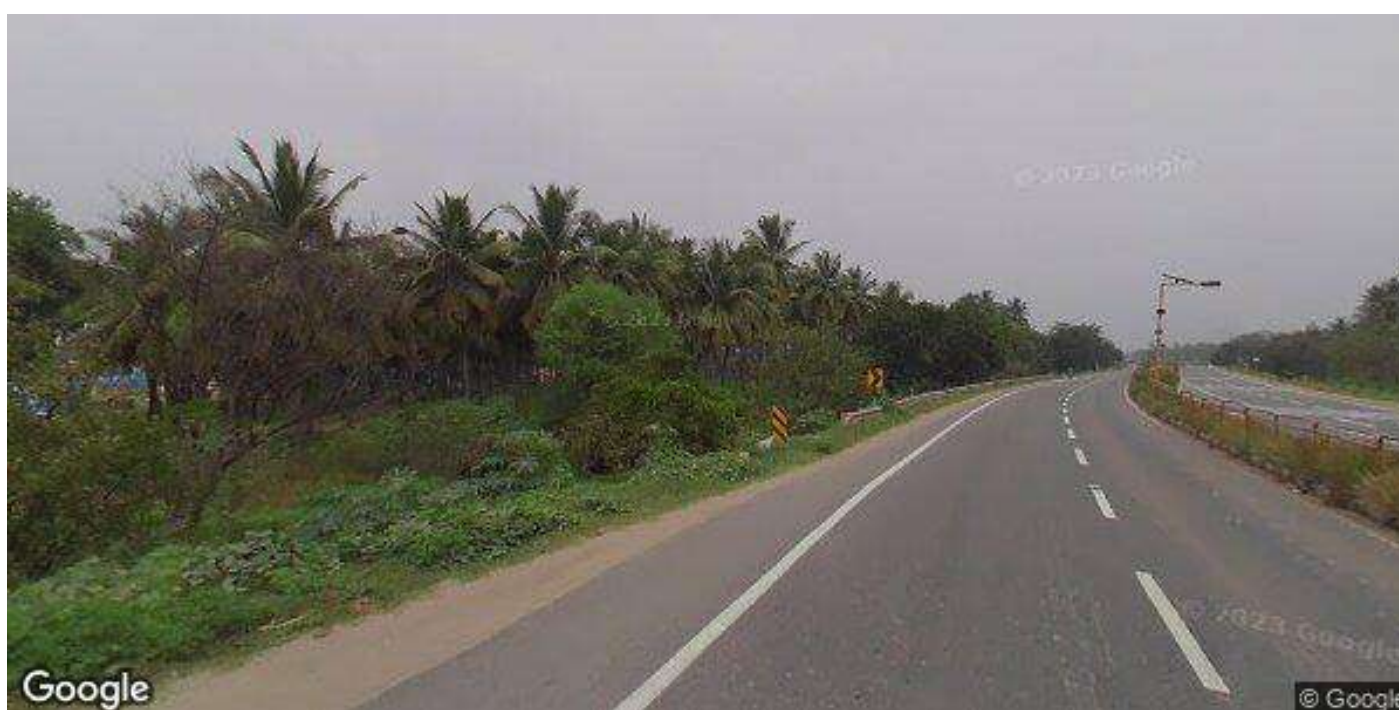
**Risk Type:** Turn  
**Risk Level:** Medium  
**Speed Limit:** 30 KM/Hr  
**Coordinates:** 12.29194, 78.19961

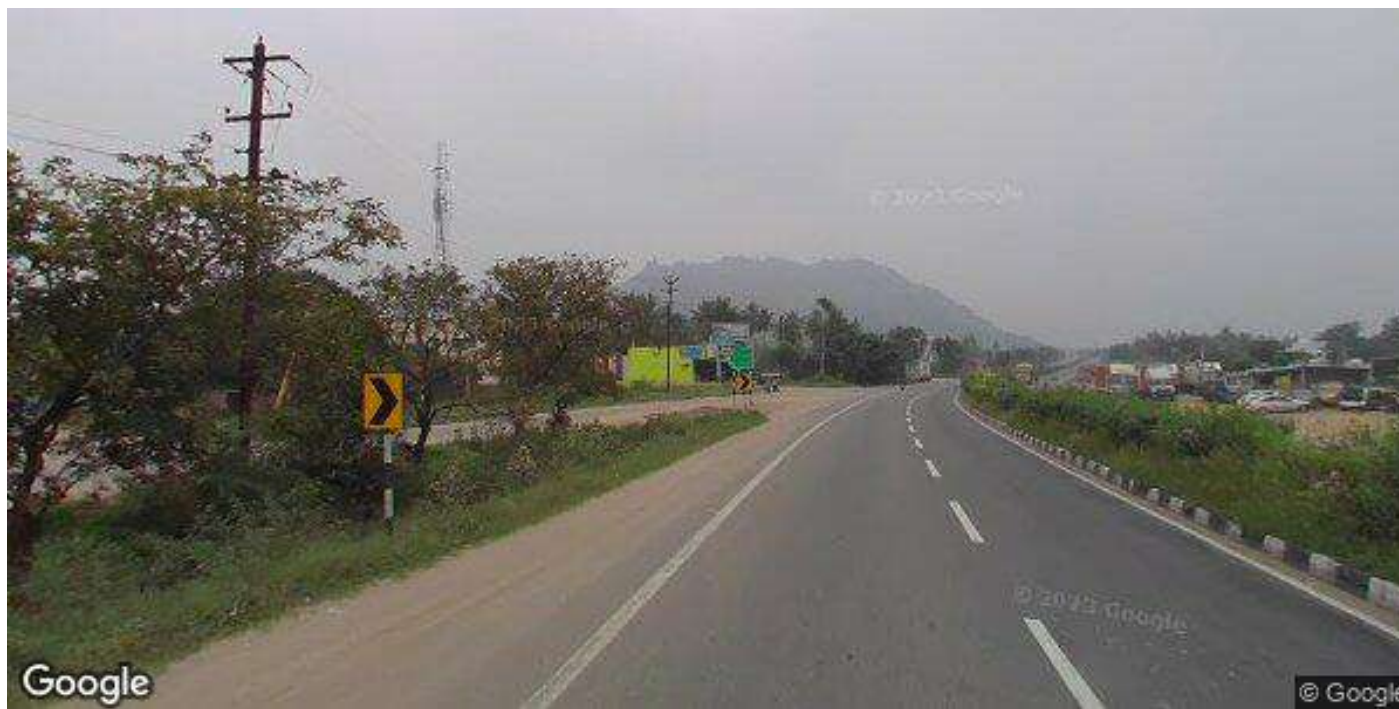
**Risk Type:** Turn  
**Risk Level:** Medium  
**Speed Limit:** 30 KM/Hr  
**Coordinates:** 12.32012, 78.20734

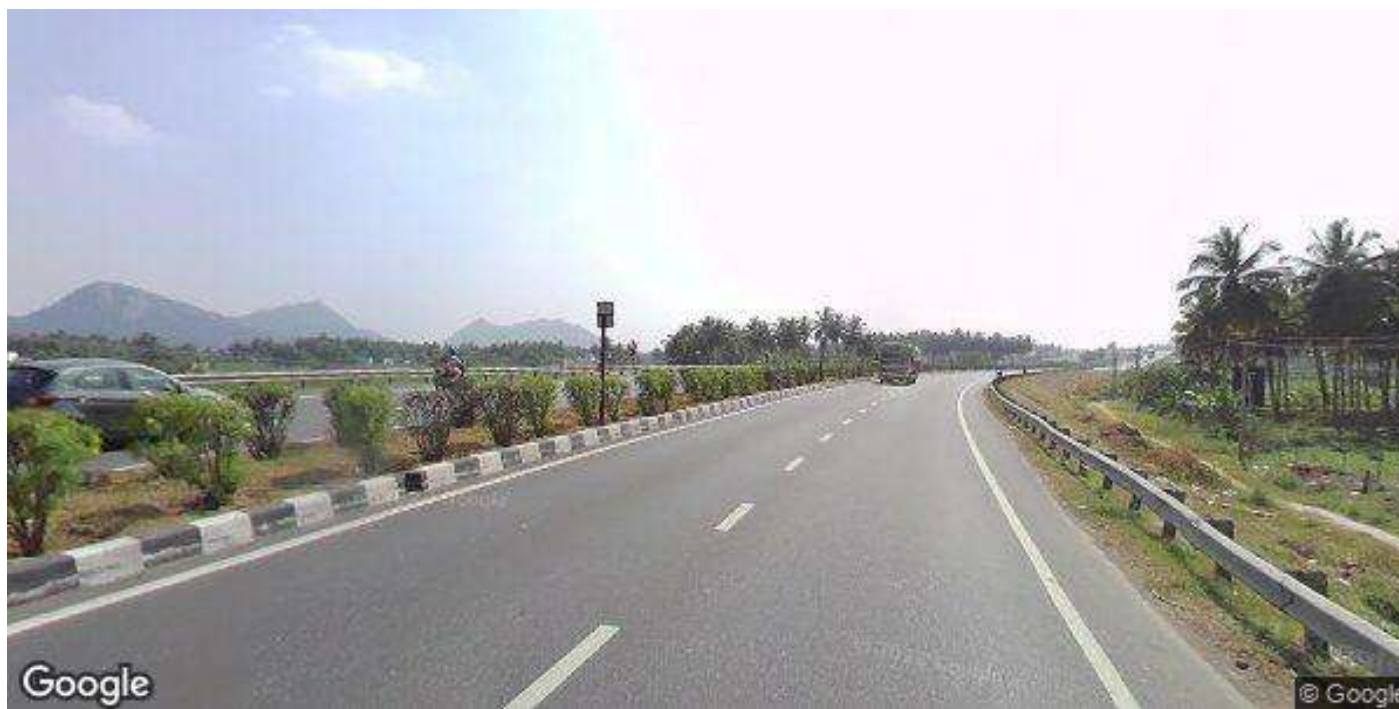
**Risk Type:** Turn  
**Risk Level:** Medium  
**Speed Limit:** 30 KM/Hr  
**Coordinates:** 12.40661, 78.22318
