# IndianOil

## JOURNEY RISK MANAGEMENT (JRM) STUDY

### Salem Terminal to KSG AGENCIES

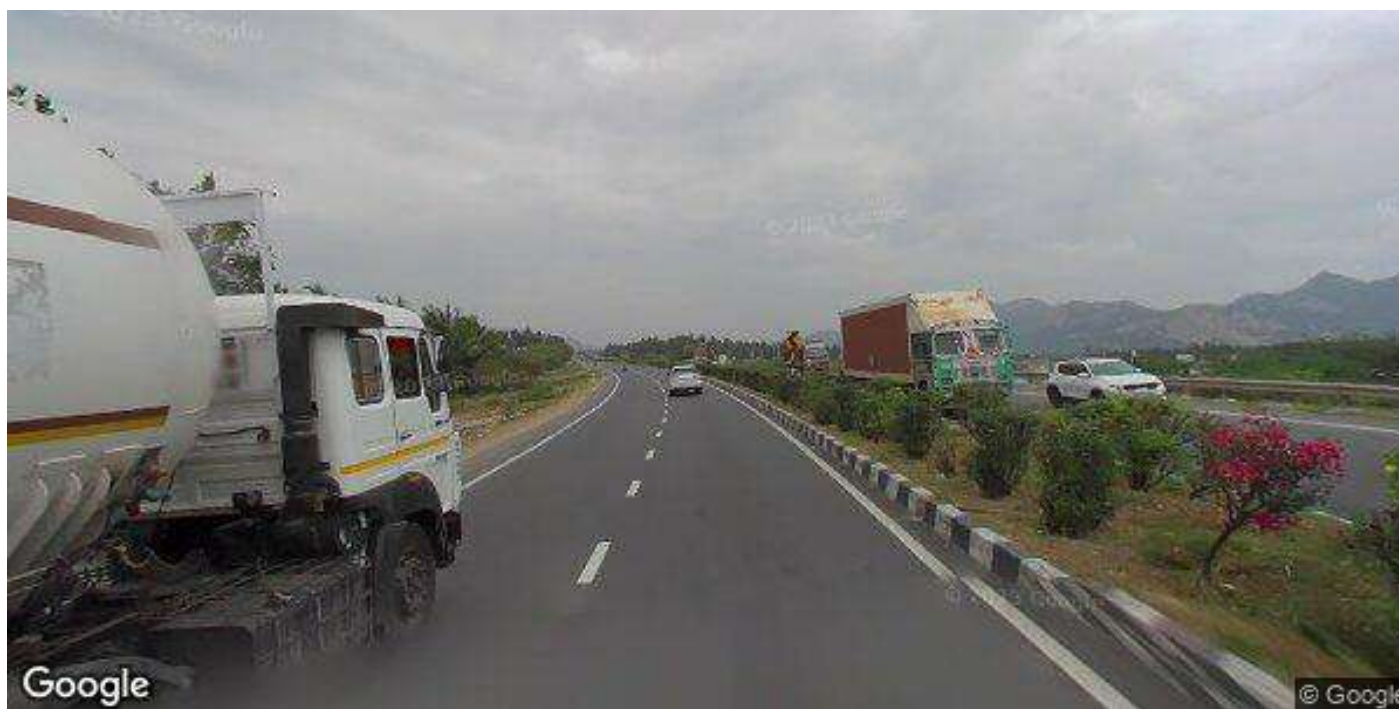
**Risk Type:** Turn  
**Risk Level:** Medium  
**Speed Limit:** 30 KM/Hr  
**Coordinates:** 12.42548, 78.22666

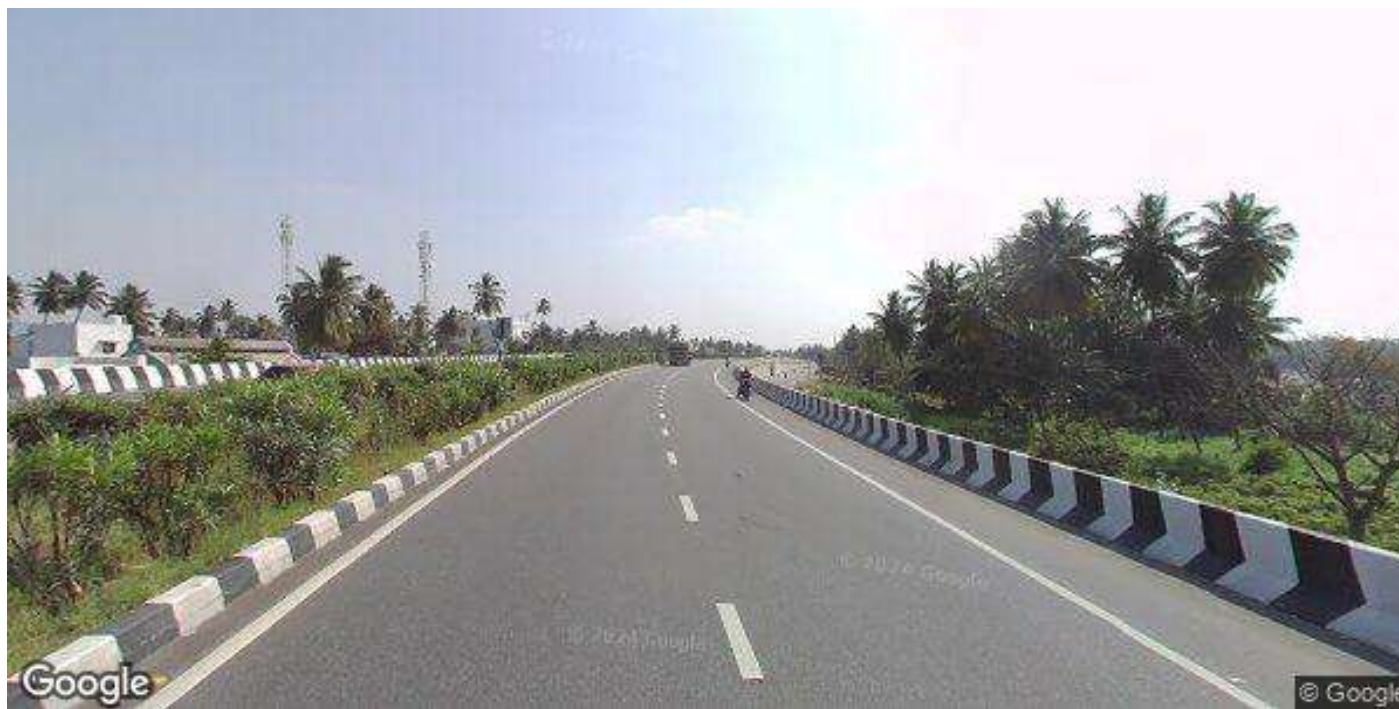
**Risk Type:** Turn  
**Risk Level:** Medium  
**Speed Limit:** 30 KM/Hr  
**Coordinates:** 12.45066, 78.21821

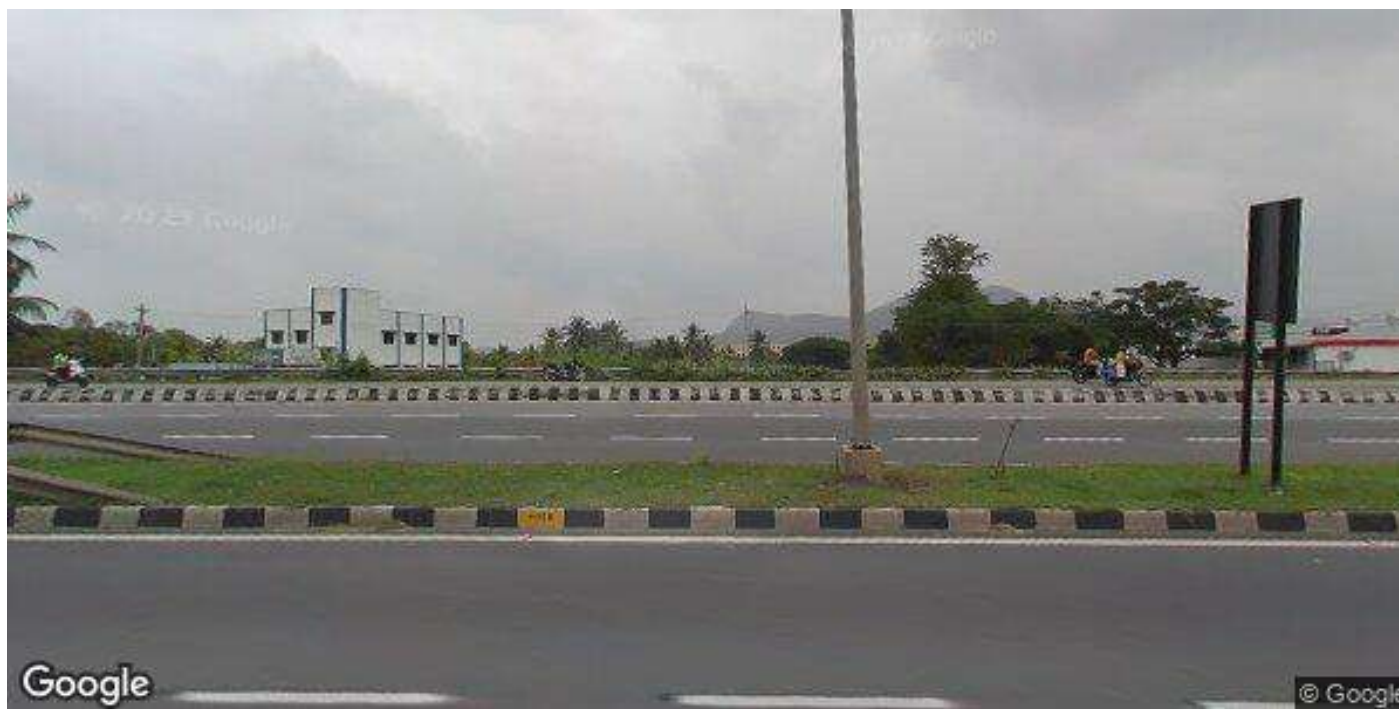
**Risk Type:** Turn  
**Risk Level:** Medium  
**Speed Limit:** 30 KM/Hr  
**Coordinates:** 12.50265, 78.22345

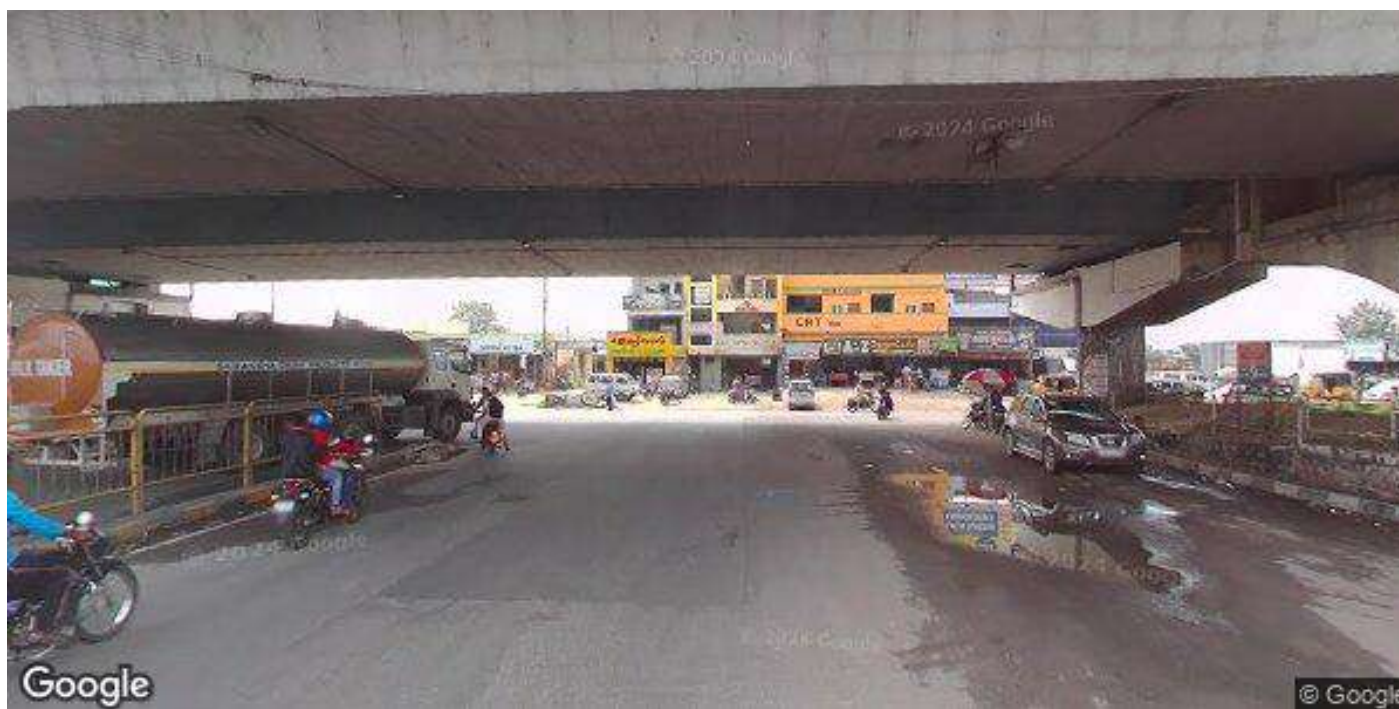
**Risk Type:** Turn  
**Risk Level:** High  
**Speed Limit:** 15 KM/Hr  
**Coordinates:** 12.50736, 78.22244

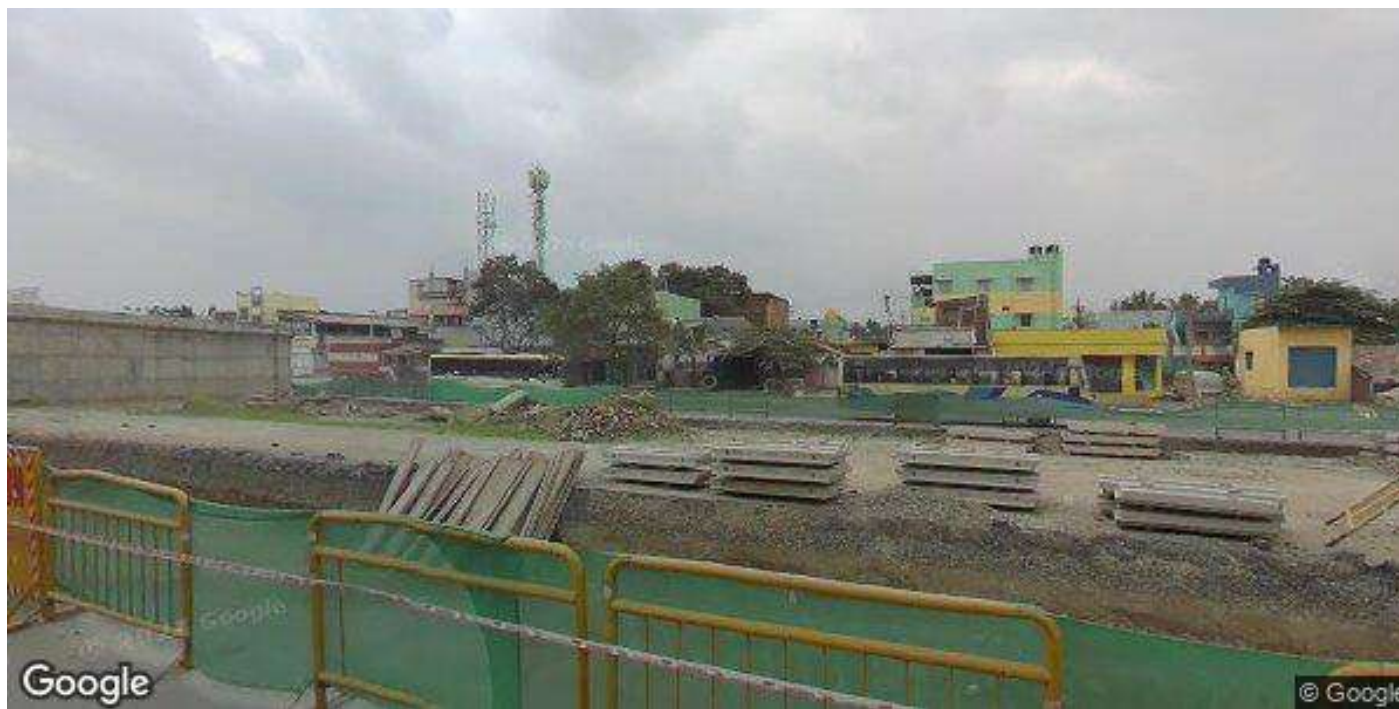
**Risk Type:** Turn  
**Risk Level:** Medium  
**Speed Limit:** 30 KM/Hr  
**Coordinates:** 12.52332, 78.23159

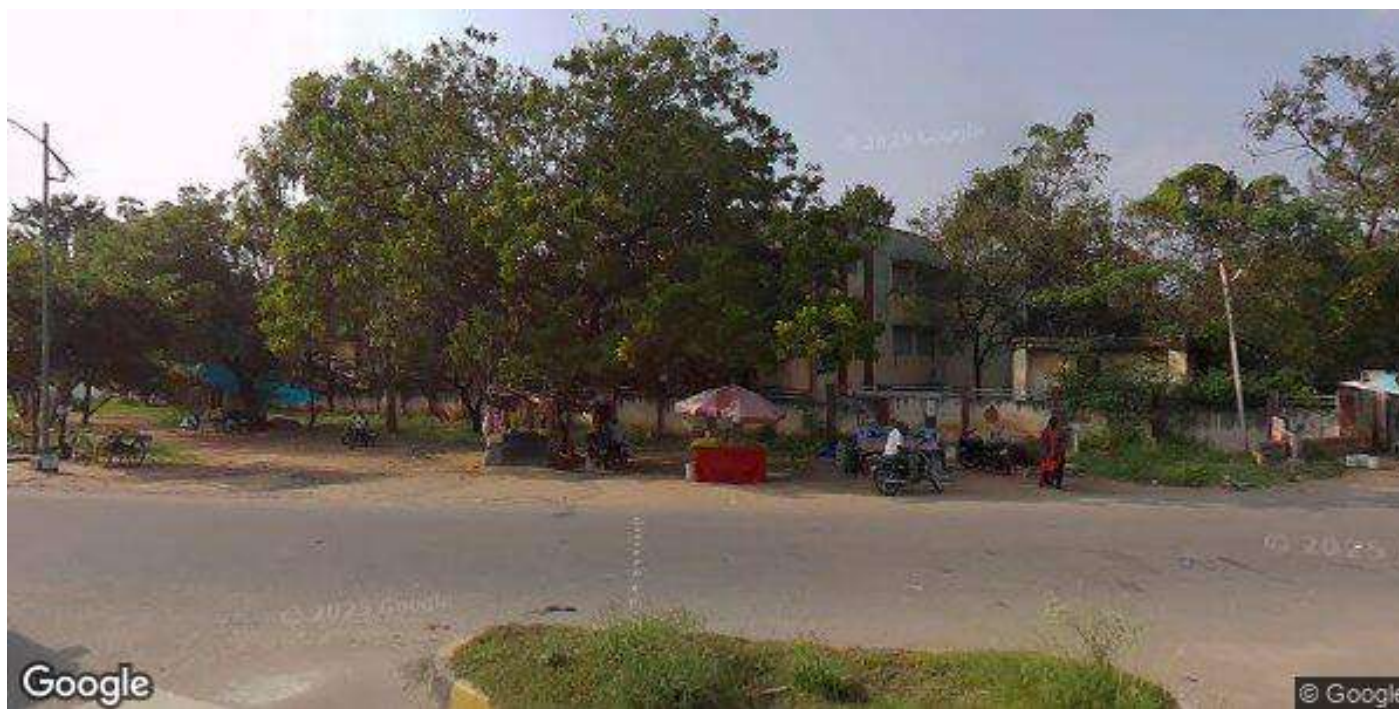
**Risk Type:** Turn  
**Risk Level:** High  
**Speed Limit:** 15 KM/Hr  
**Coordinates:** 12.53439, 78.24841

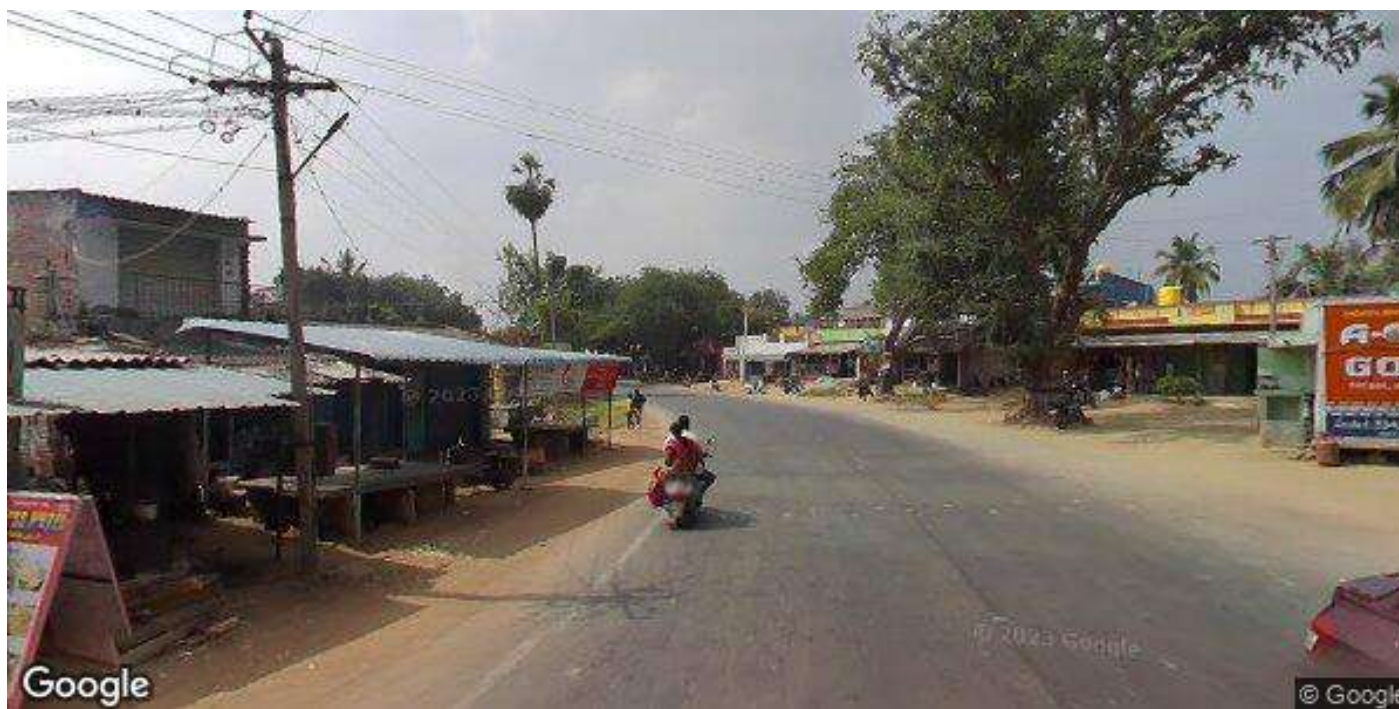
**Risk Type:** Turn  
**Risk Level:** Medium  
**Speed Limit:** 30 KM/Hr  
**Coordinates:** 12.55996, 78.26849

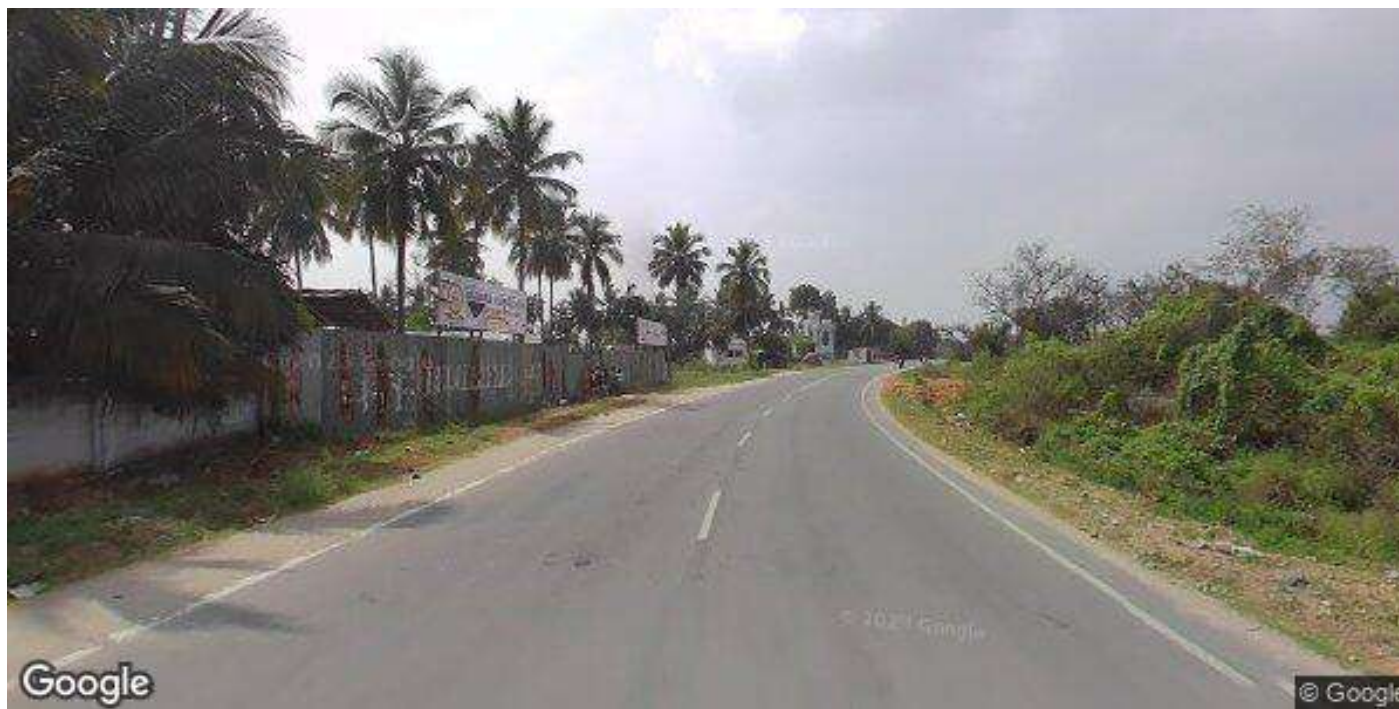
**Risk Type:** Turn  
**Risk Level:** Medium  
**Speed Limit:** 30 KM/Hr  
**Coordinates:** 12.56656, 78.28341

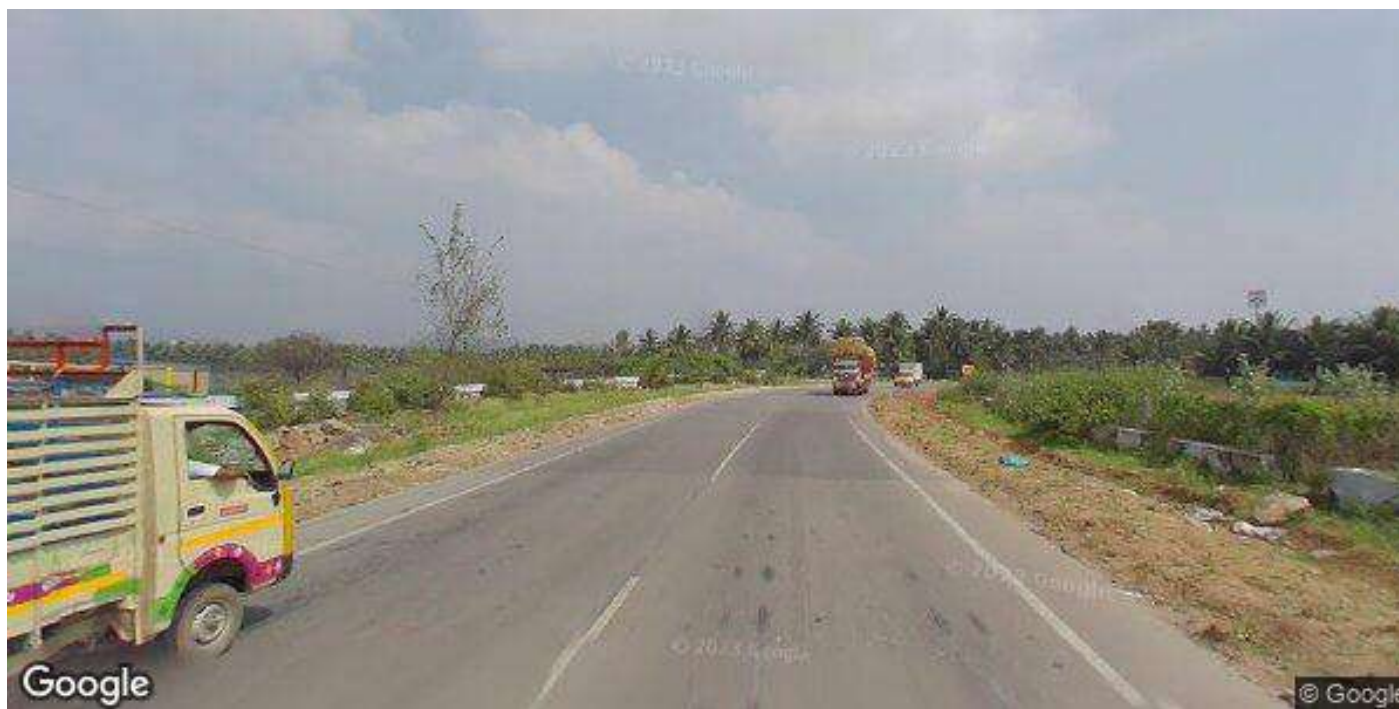
**Risk Type:** Turn  
**Risk Level:** Medium  
**Speed Limit:** 30 KM/Hr  
**Coordinates:** 12.56892, 78.28474

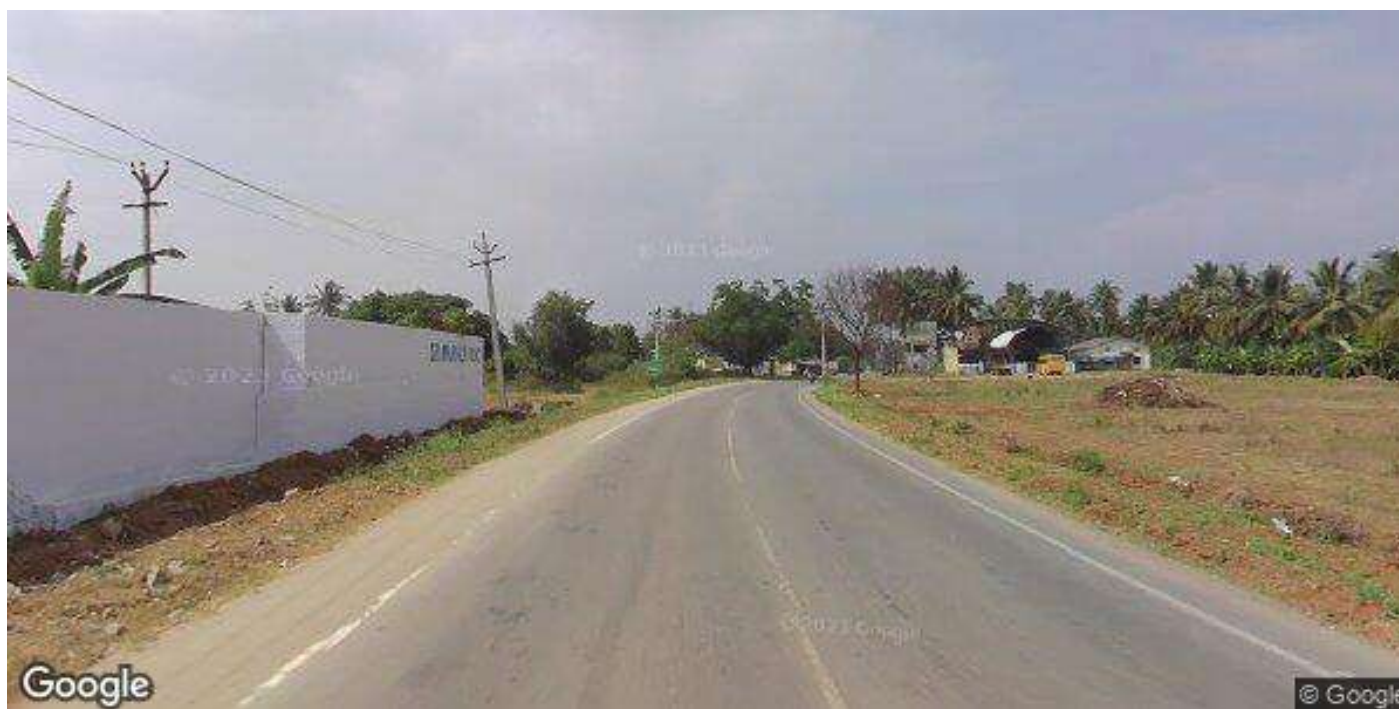
**Risk Type:** Turn  
**Risk Level:** Medium  
**Speed Limit:** 30 KM/Hr  
**Coordinates:** 12.56948, 78.28970
