# IndianOil

## **JOURNEY RISK MANAGEMENT (JRM) STUDY**

**Salem Terminal to ADITYA TRADERS IOC DEALERS  
NH-7**

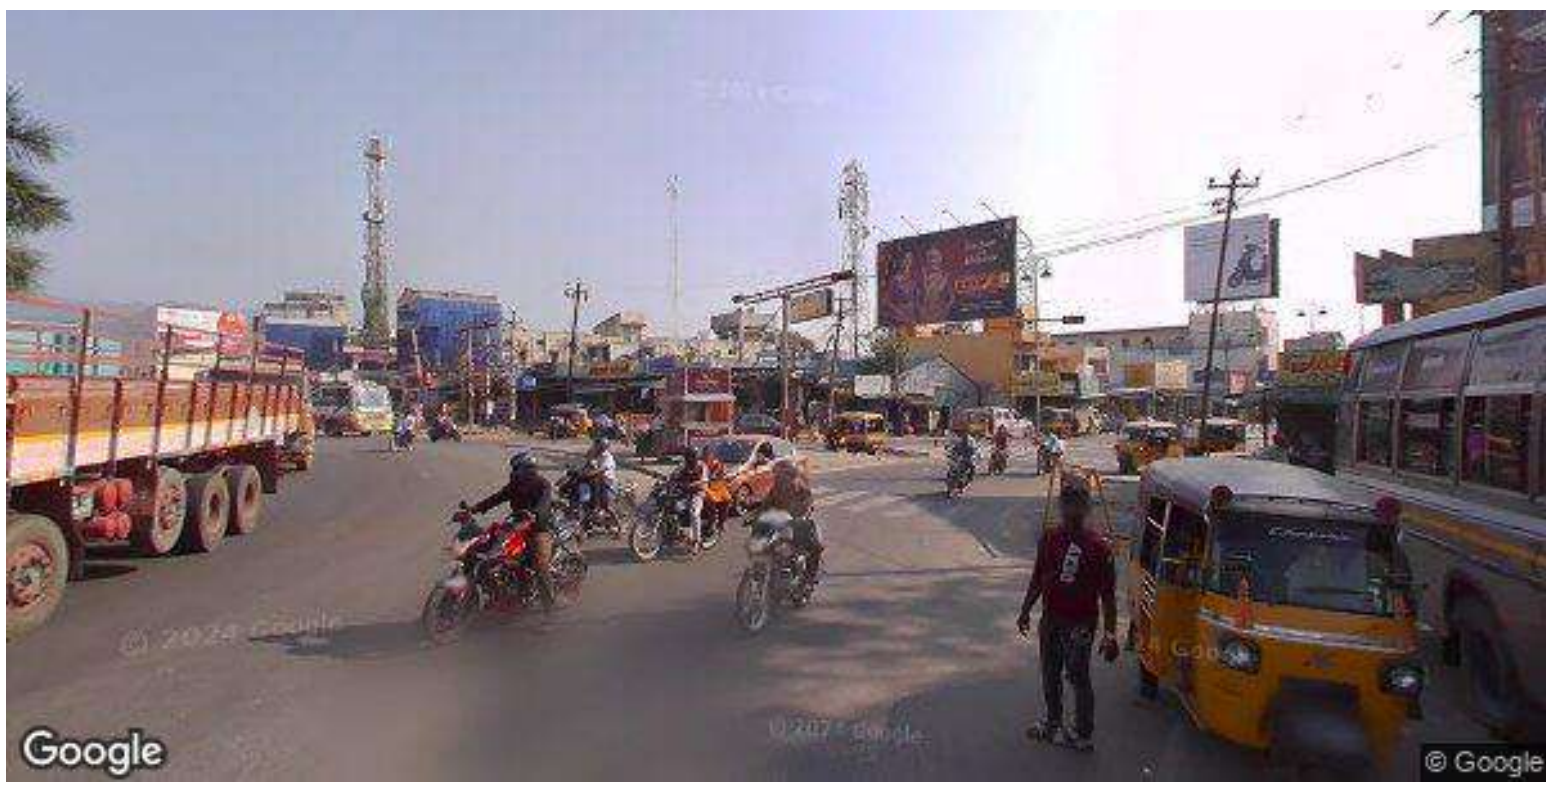
**Coordinates:** 11.63266, 78.12699

**Risk Type:** Roundabout

**Risk Level:** High

**Speed Limit:** 15 KM/Hr

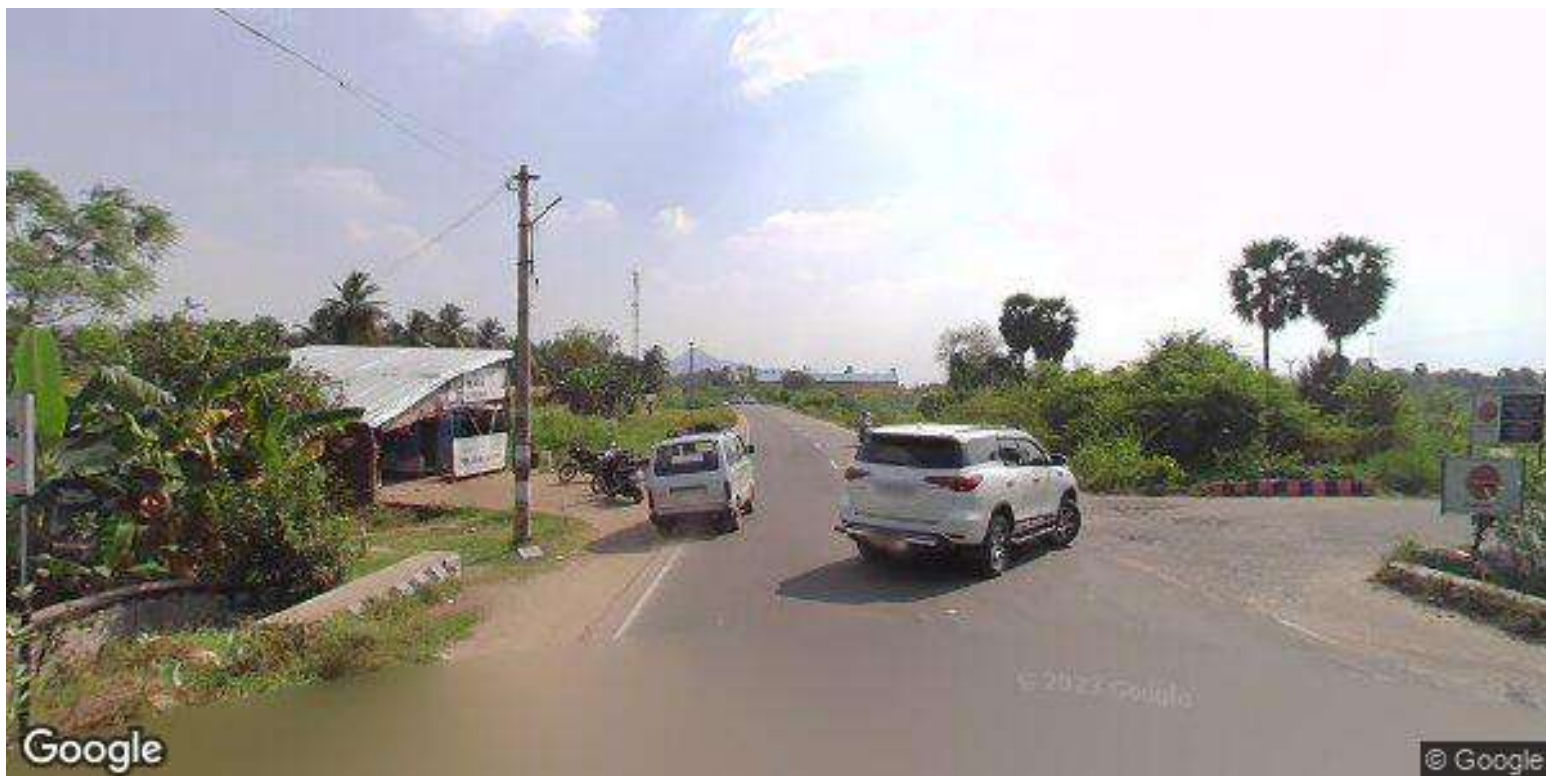
**Coordinates:** 11.44029, 77.87544

**Risk Type:** Turn

**Risk Level:** High

**Speed Limit:** 15 KM/Hr

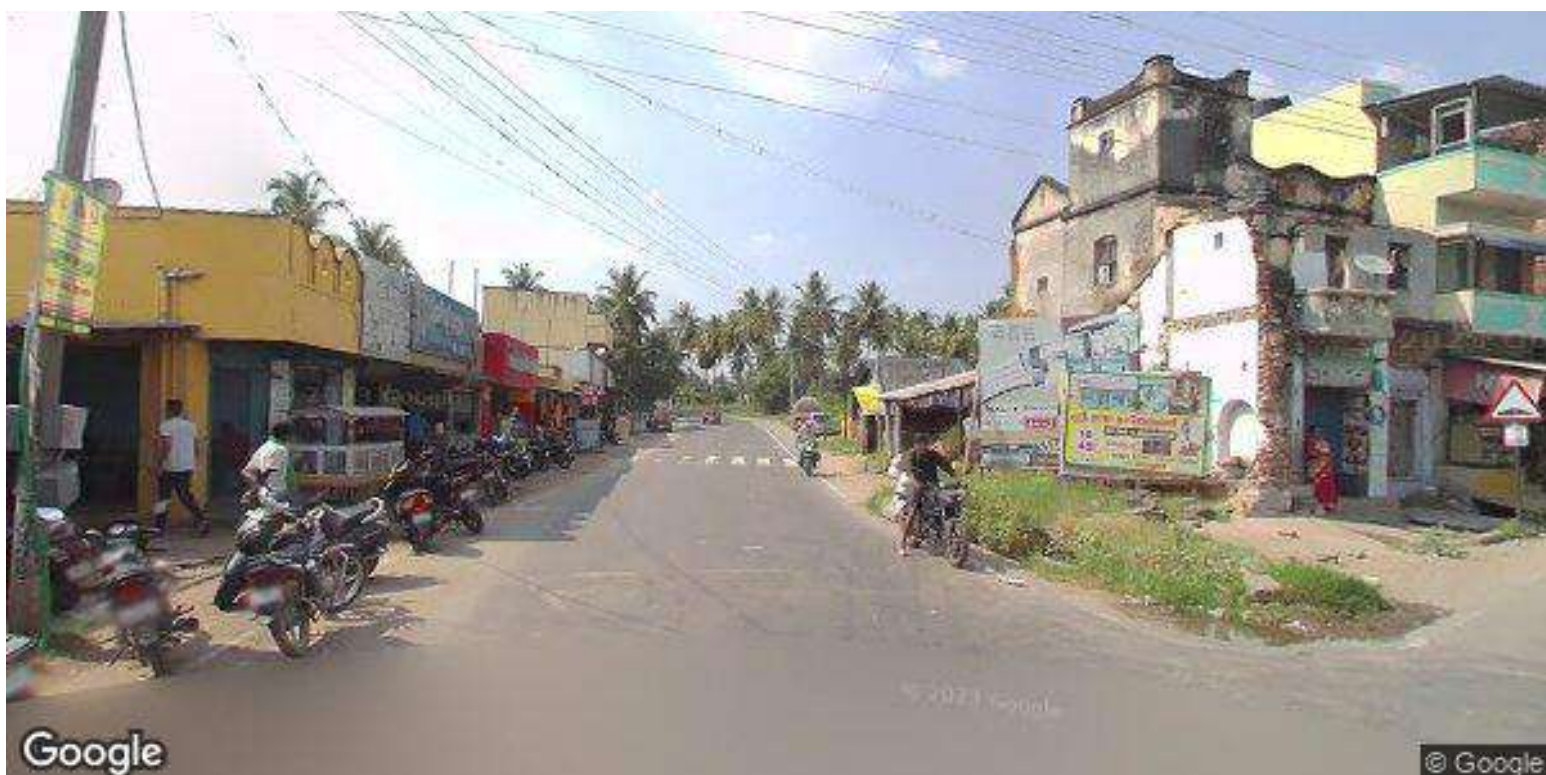
**Coordinates: 11.45007, 77.87201**

**Risk Type: Turn**

**Risk Level: High**

**Speed Limit: 15 KM/Hr**

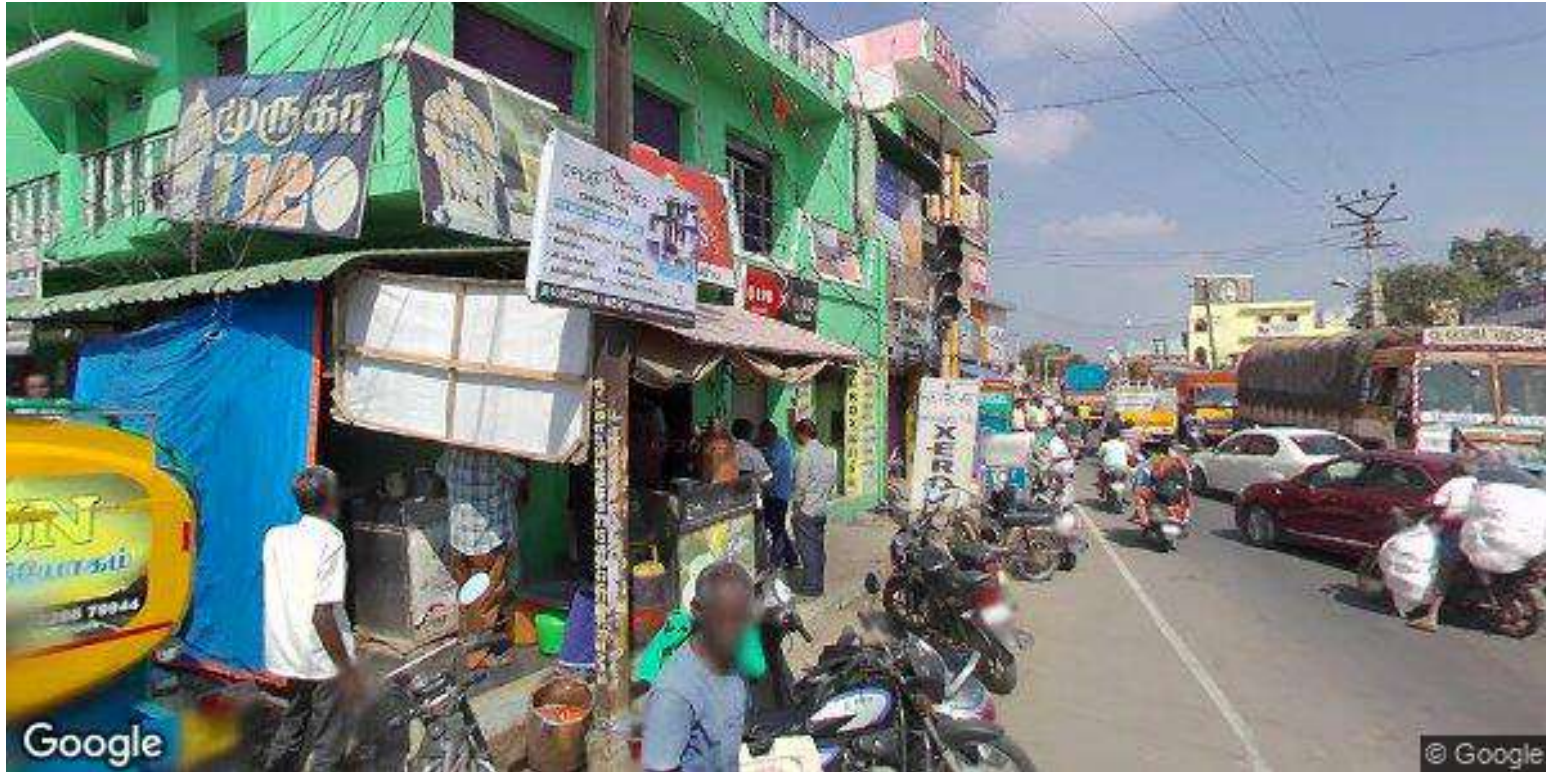
**Coordinates: 11.47407, 77.86839**

**Risk Type: Turn**

**Risk Level: High**

**Speed Limit: 15 KM/Hr**

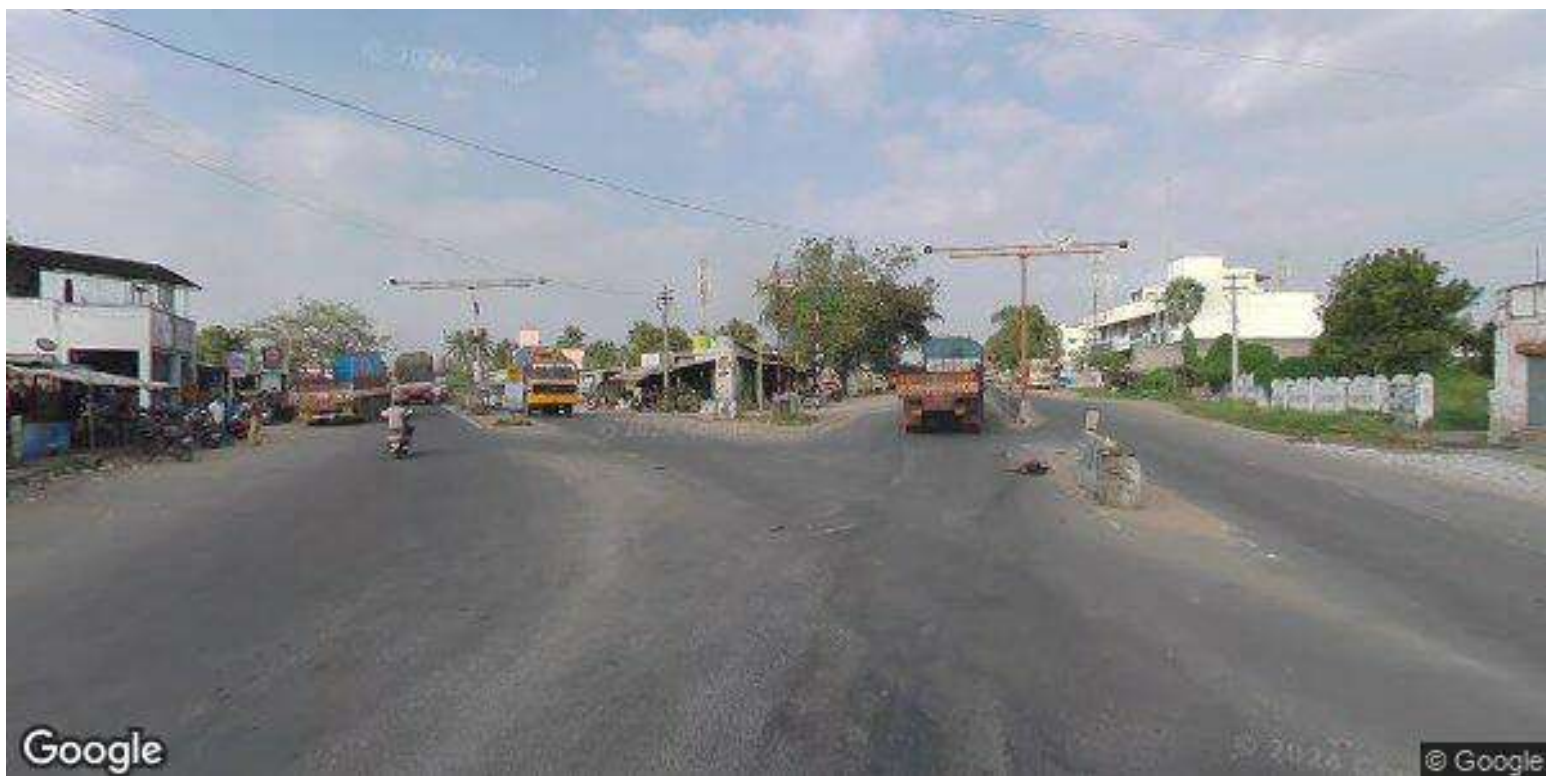
**Coordinates: 11.48366, 77.88781**

**Risk Type: Turn**

**Risk Level: Medium**

**Speed Limit: 30 KM/Hr**

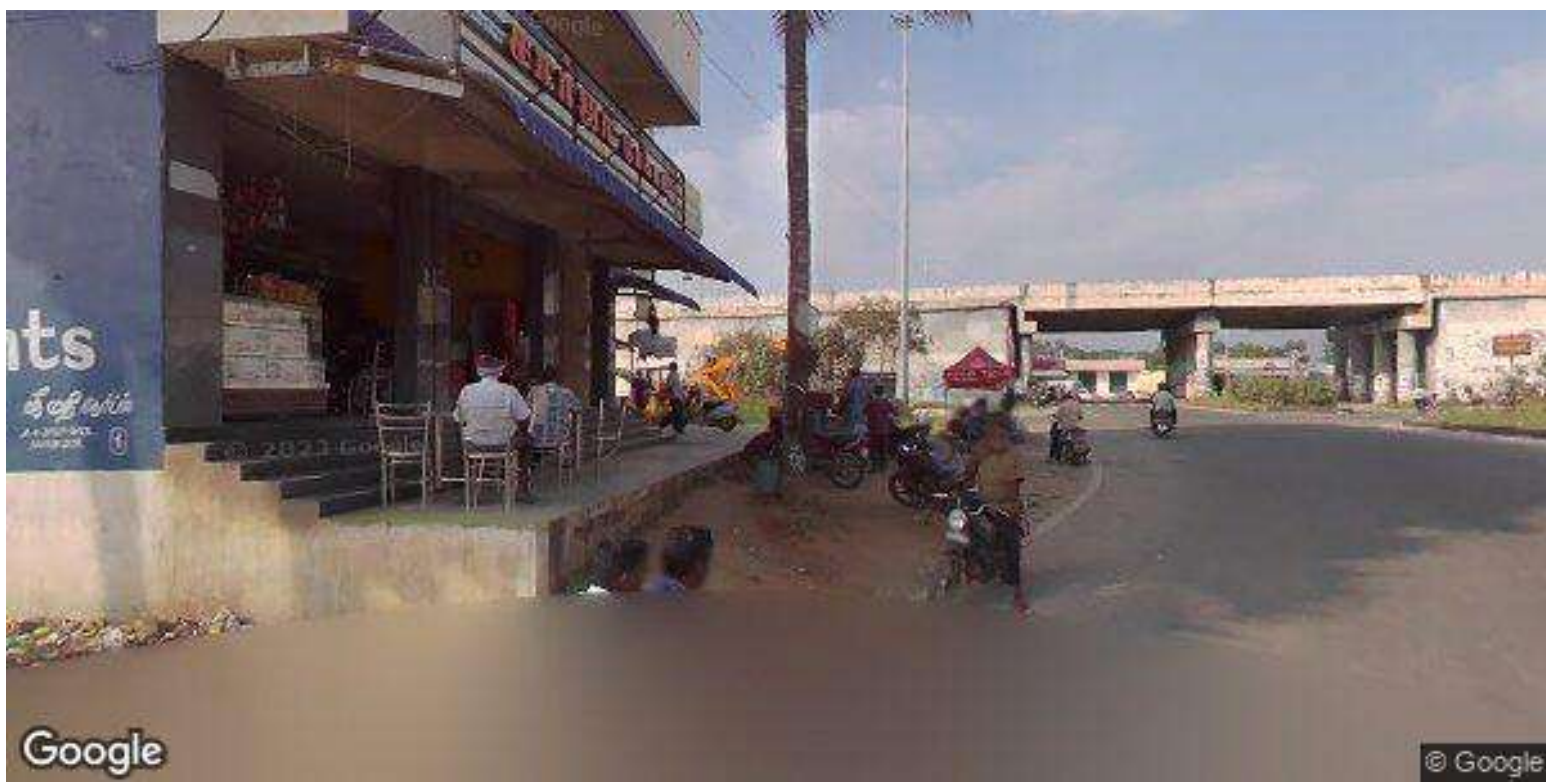
Coordinates: 11.49149, 77.89601

Risk Type: Turn

Risk Level: High

Speed Limit: 15 KM/Hr

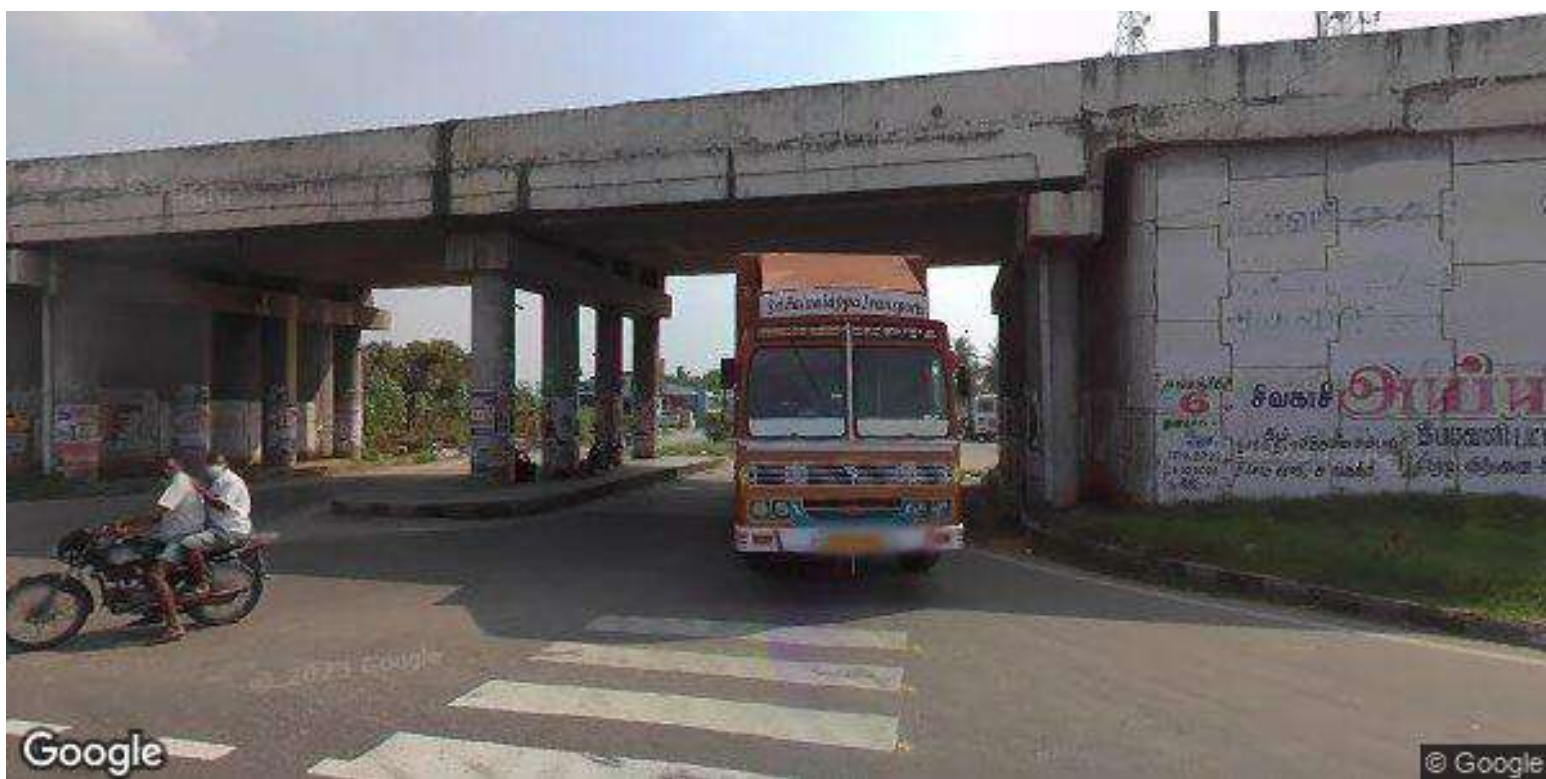
Coordinates: 11.49224, 77.89601

Risk Type: Turn

Risk Level: High

Speed Limit: 15 KM/Hr

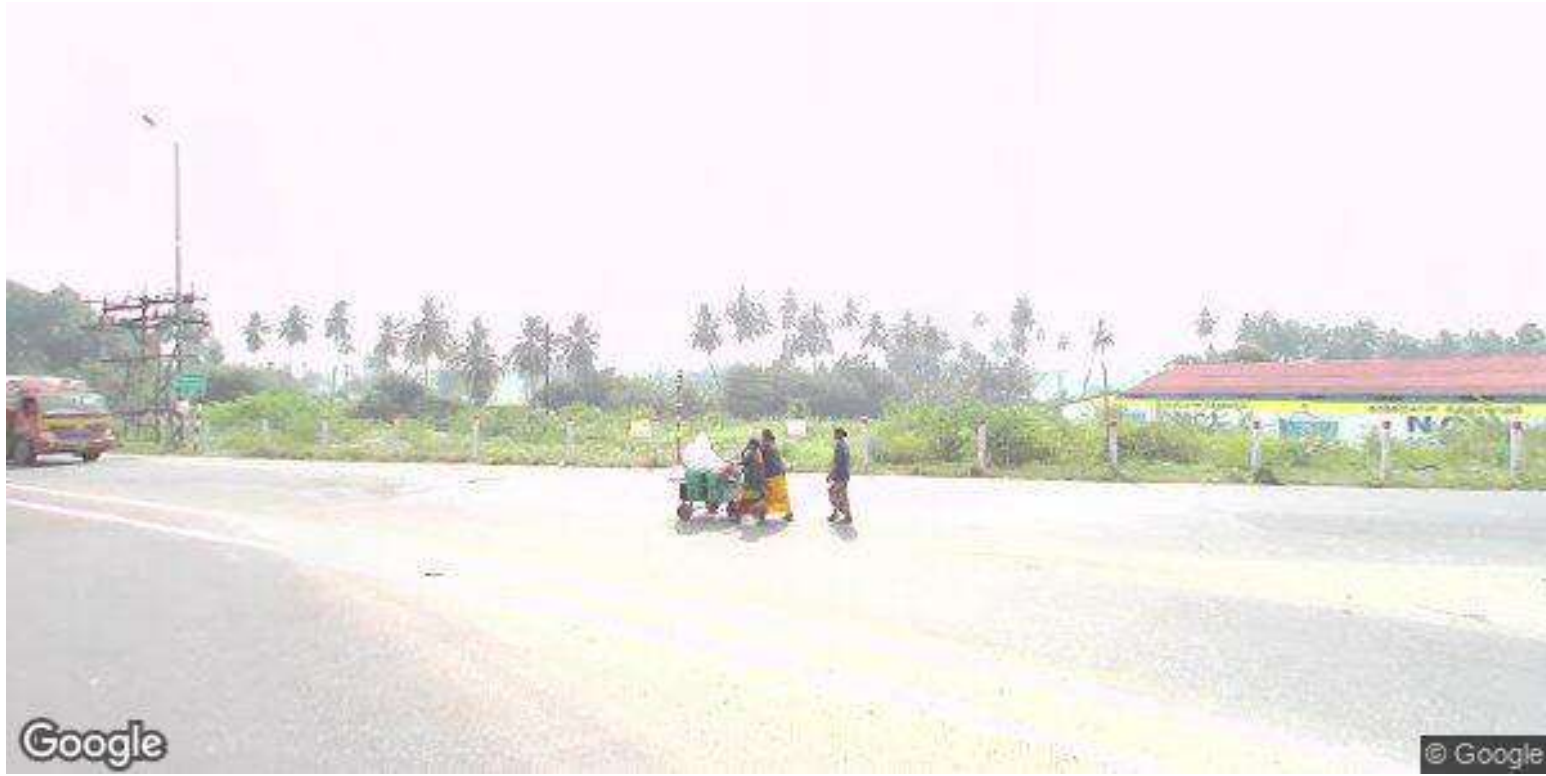
**Risk Type:** Turn  
**Risk Level:** High  
**Speed Limit:** 15 KM/Hr  
**Coordinates:** 11.61216, 78.10423

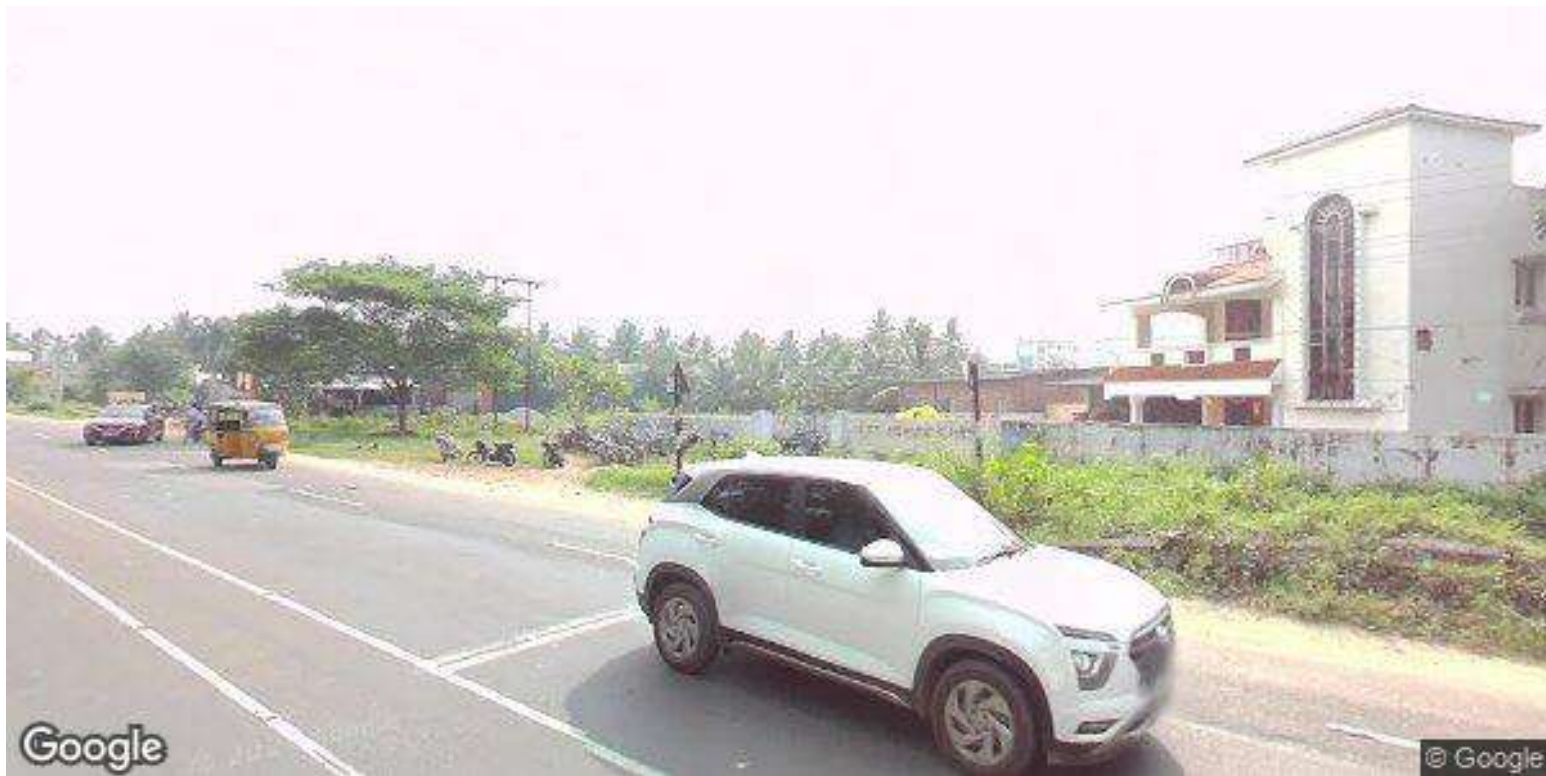
**Risk Type:** Turn  
**Risk Level:** Medium  
**Speed Limit:** 30 KM/Hr  
**Coordinates:** 11.61284, 78.10600

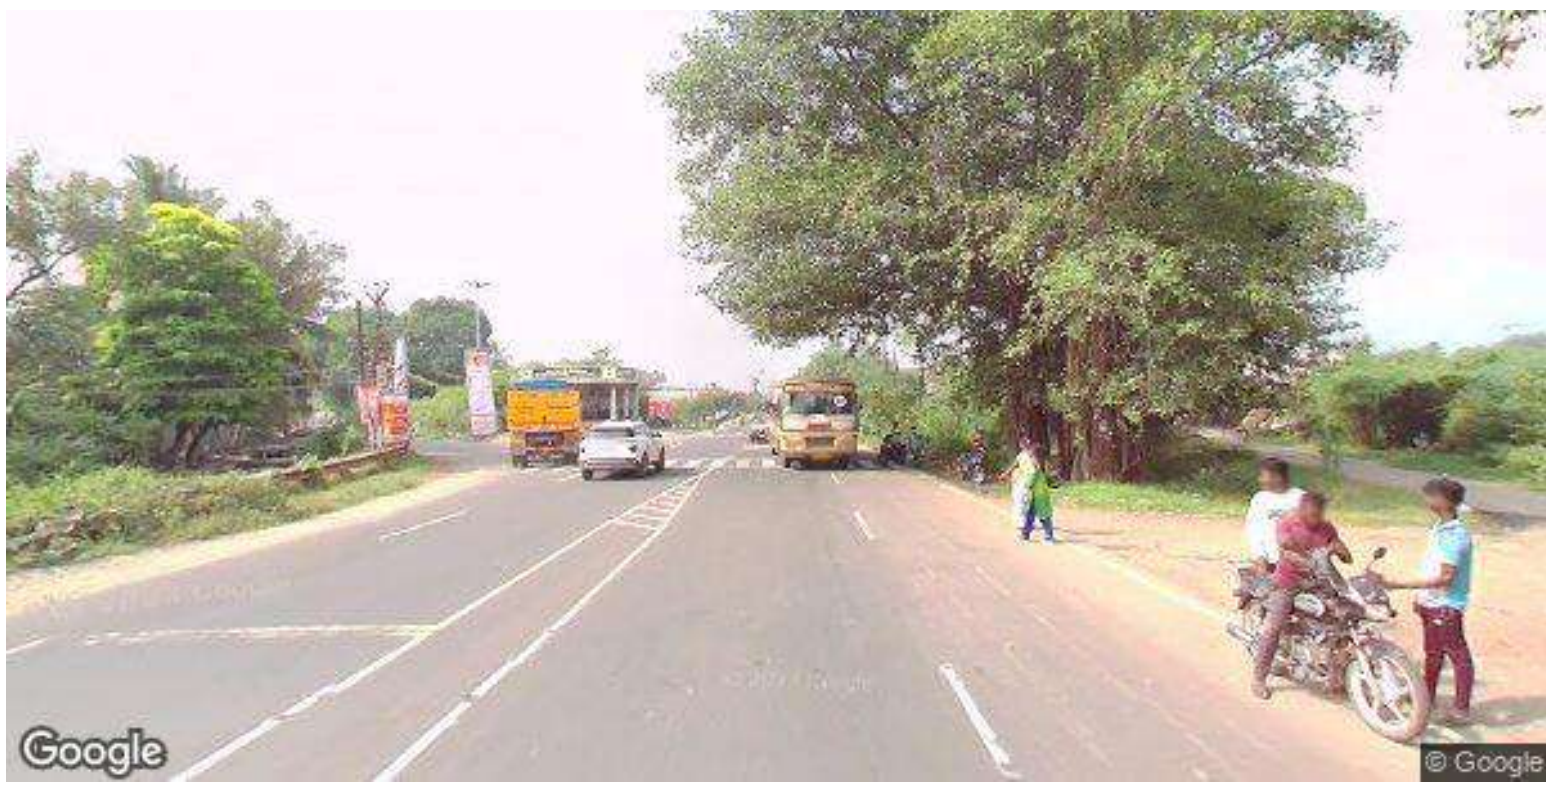
**Coordinates:** 11.61292, 78.10606

**Risk Type:** Turn

**Risk Level:** Medium

**Speed Limit:** 30 KM/Hr

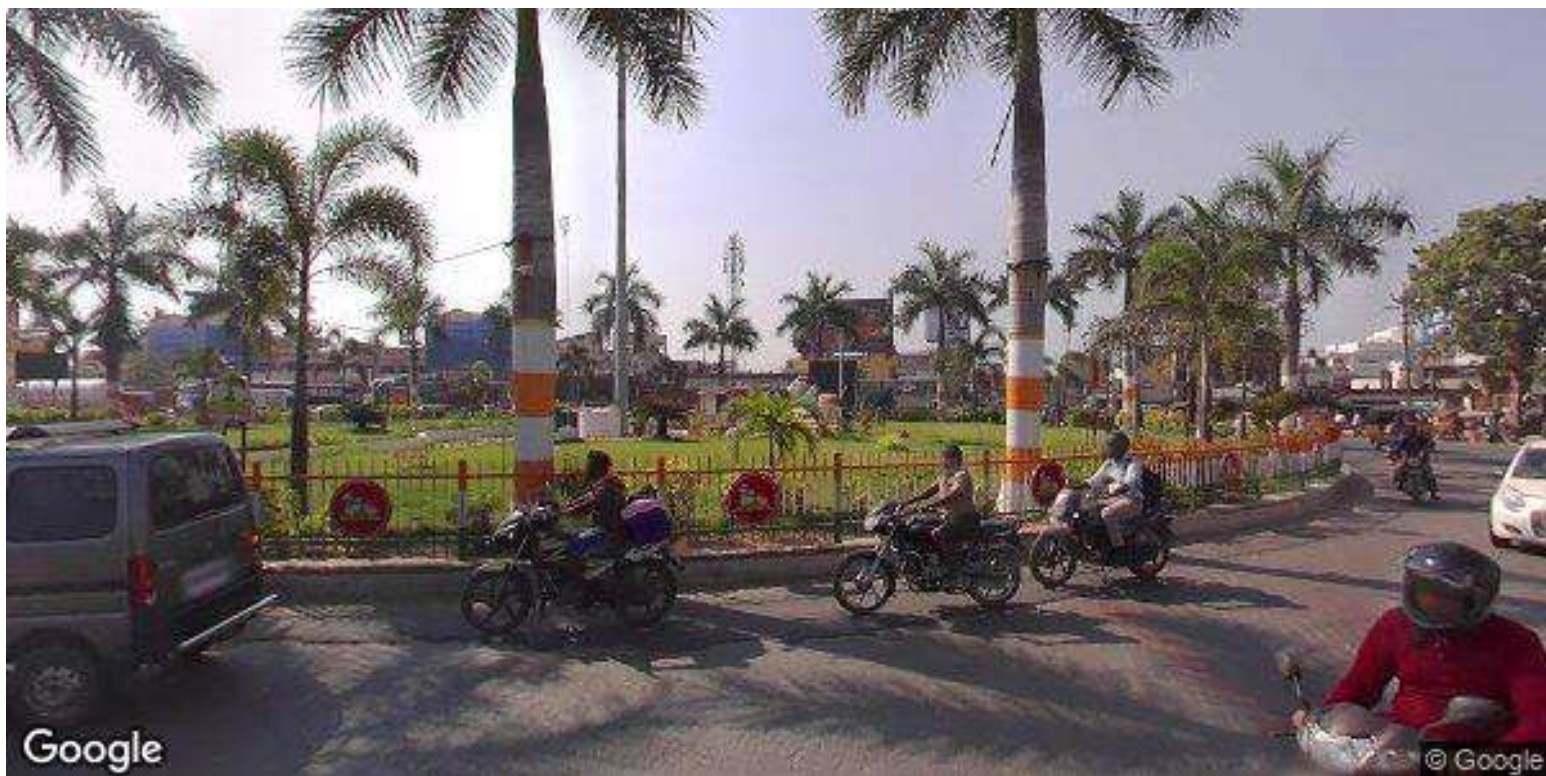
**Coordinates:** 11.63306, 78.12728

**Risk Type:** Turn

**Risk Level:** Medium

**Speed Limit:** 30 KM/Hr

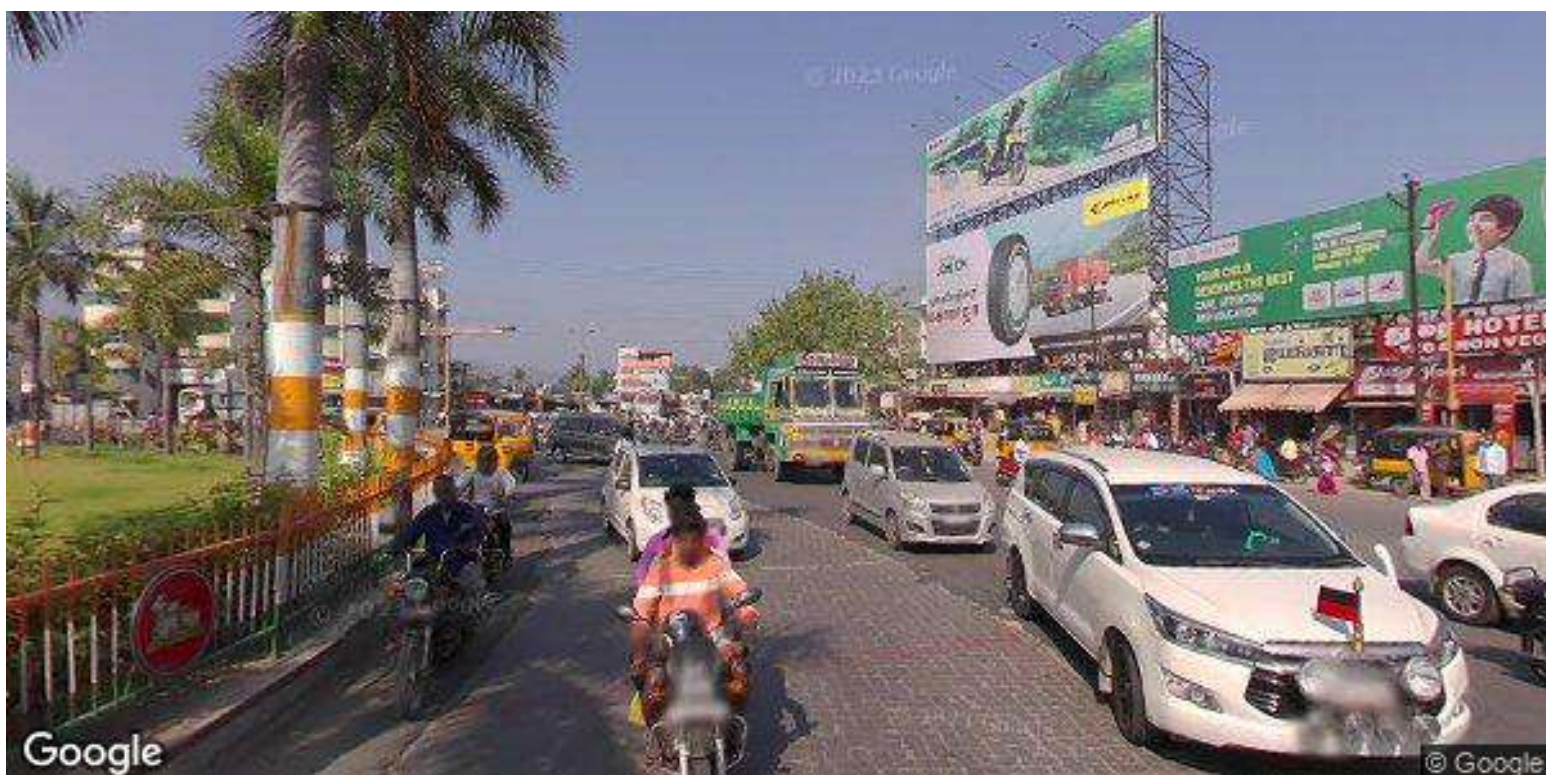
**Coordinates:** 11.63302, 78.12742

**Risk Type:** Turn

**Risk Level:** Medium

**Speed Limit:** 30 KM/Hr

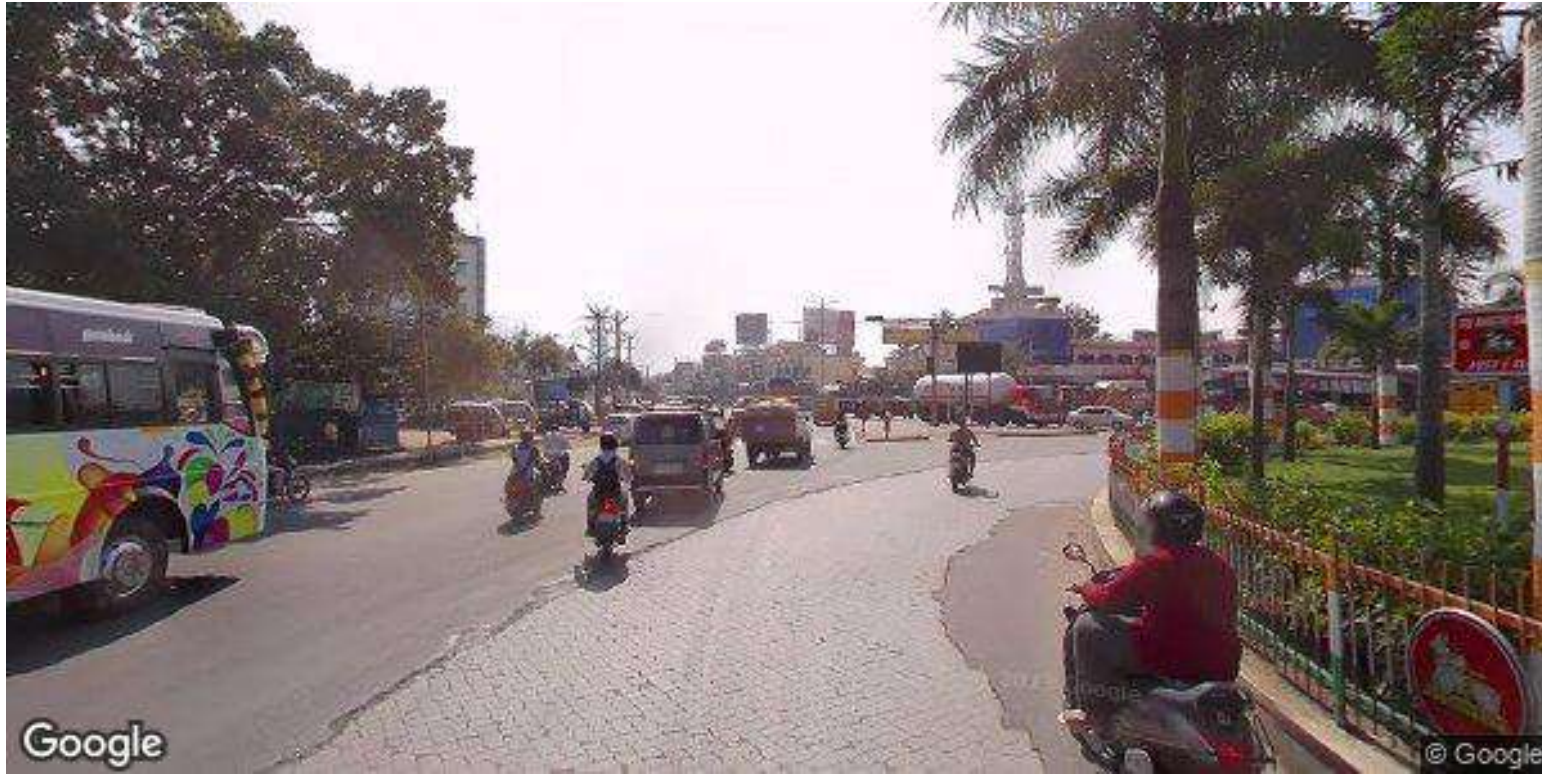
**Coordinates:** 11.63292, 78.12753

**Risk Type:** Turn

**Risk Level:** Medium

**Speed Limit:** 30 KM/Hr
