# IndianOil

## JOURNEY RISK MANAGEMENT (JRM) STUDY

### Salem Terminal to SELVAM FUELS IOC DEALERS

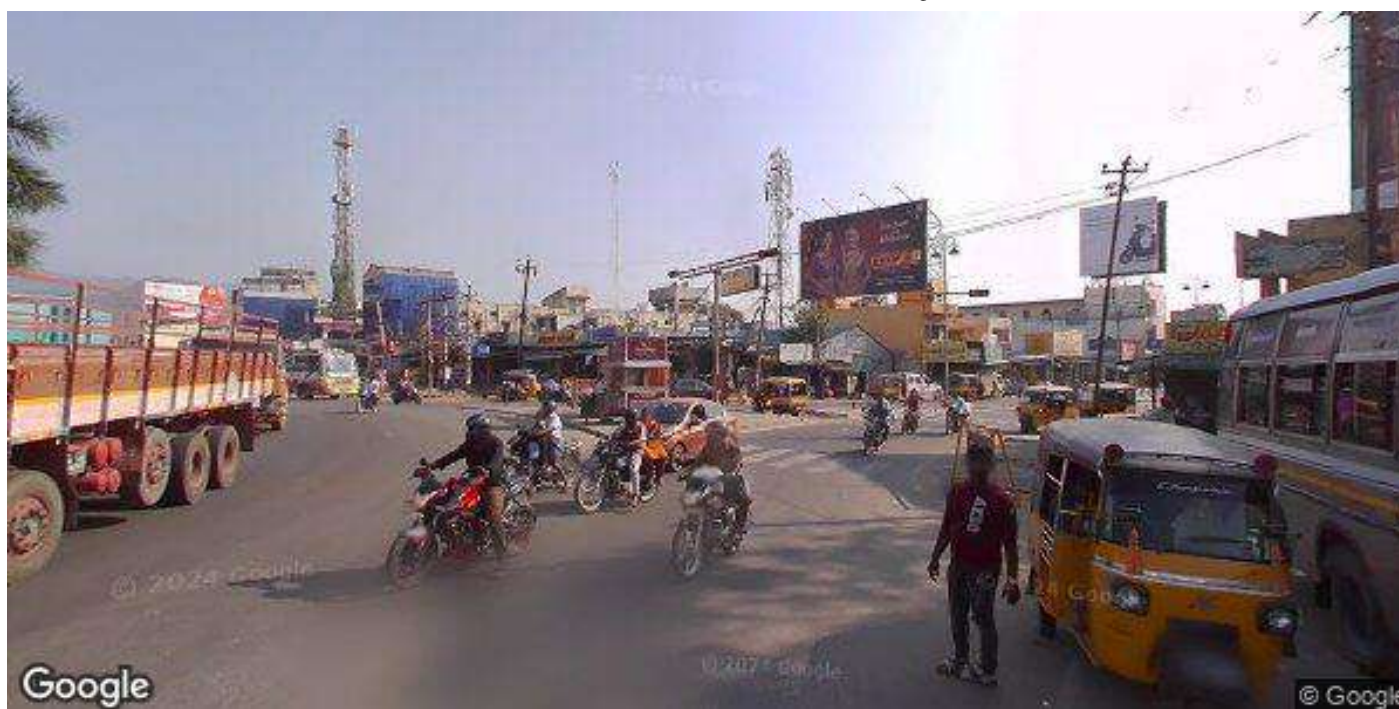
**Coordinates:** 11.63266, 78.12699

**Risk Type:** Roundabout

**Risk Level:** High

**Speed Limit:** 15 KM/Hr

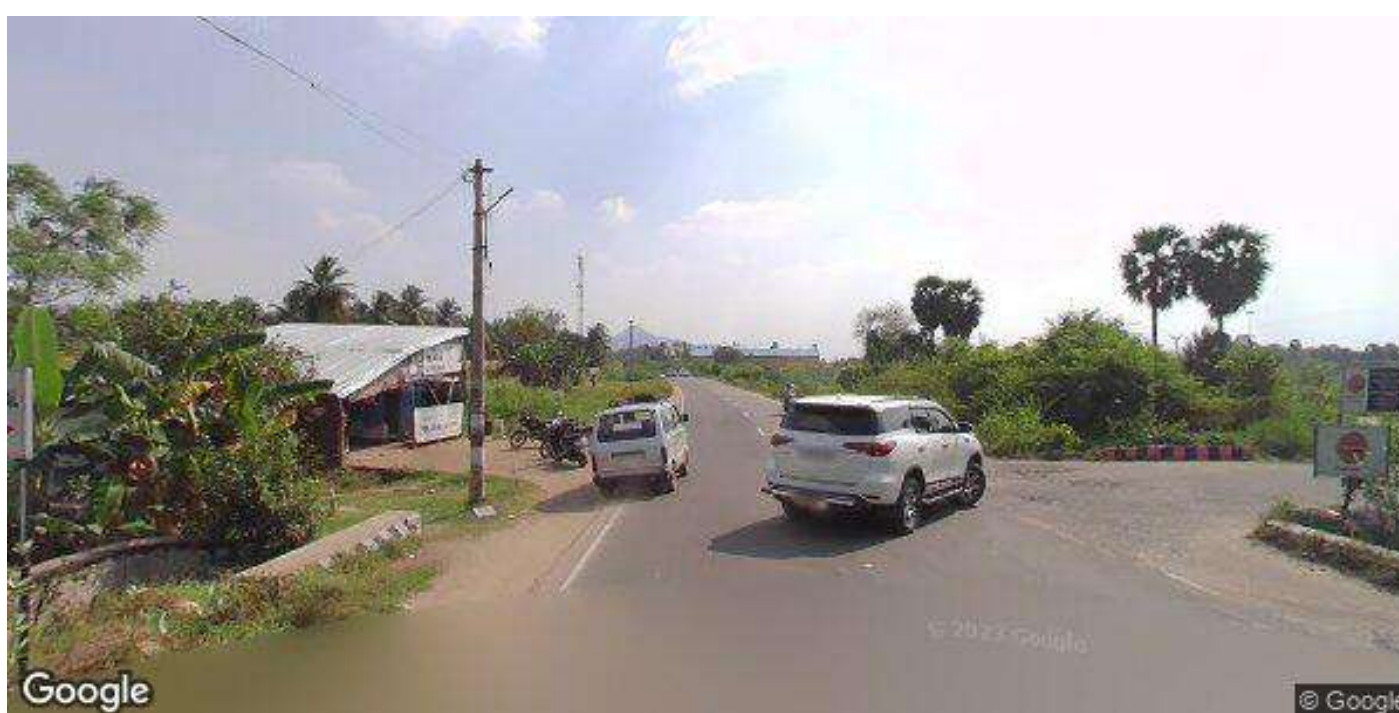
**Coordinates:** 11.44029, 77.87544

**Risk Type:** Turn

**Risk Level:** High

**Speed Limit:** 15 KM/Hr

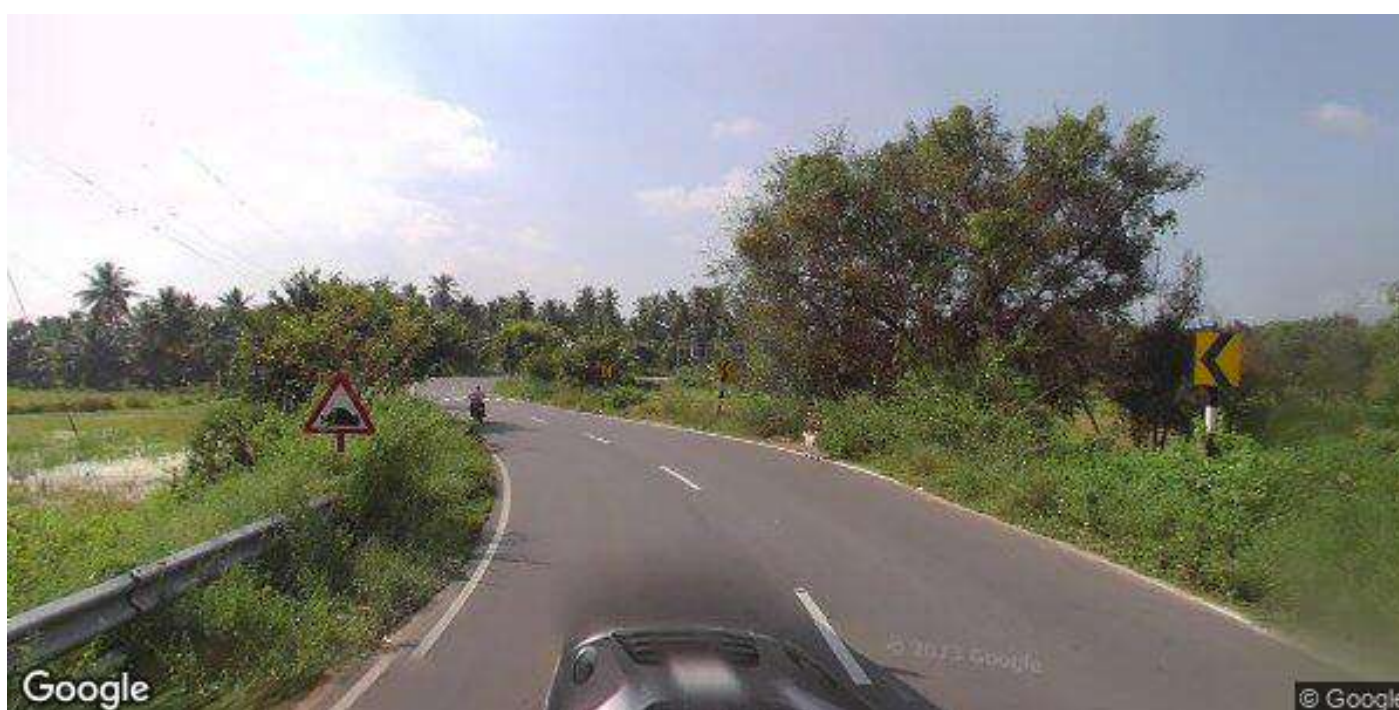
**Coordinates:** 11.45358, 77.85781

**Risk Type:** Turn

**Risk Level:** Medium

**Speed Limit:** 30 KM/Hr

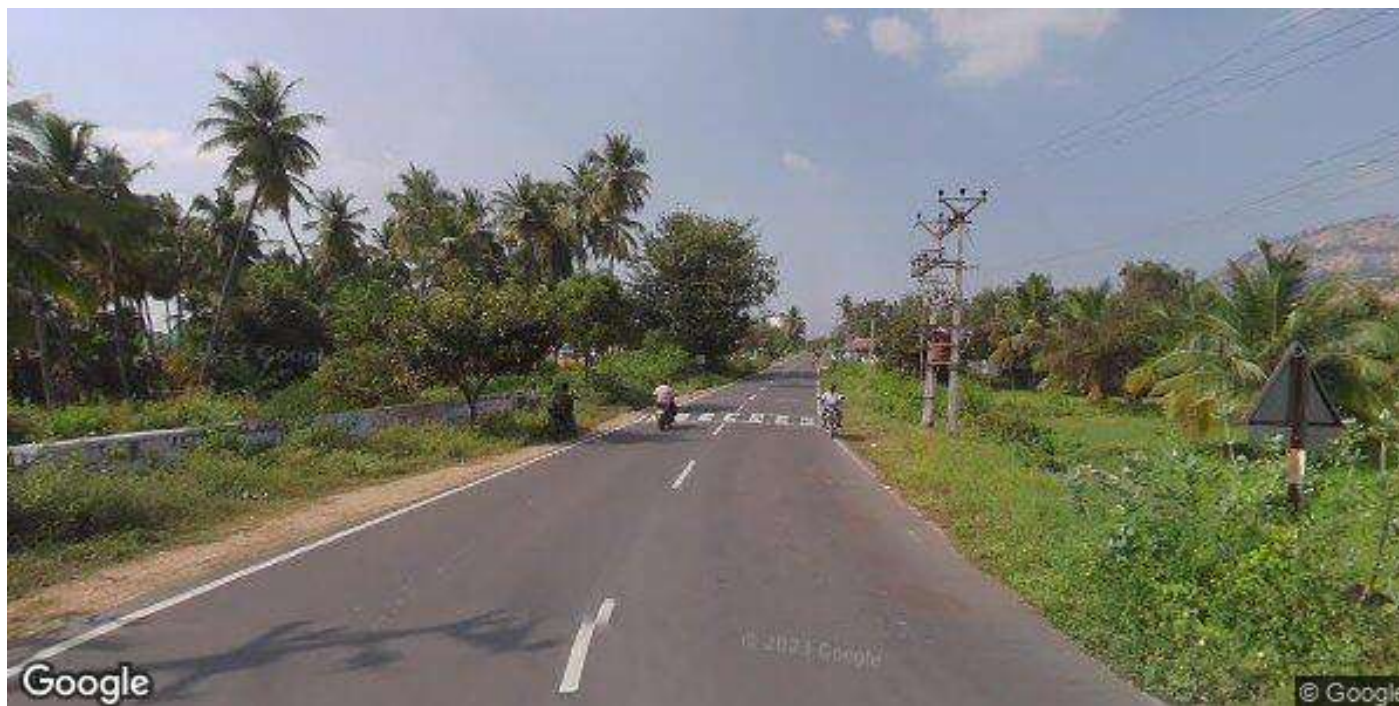
**Risk Type:** Turn  
**Risk Level:** Medium  
**Speed Limit:** 30 KM/Hr  
**Coordinates:** 11.45353, 77.85697

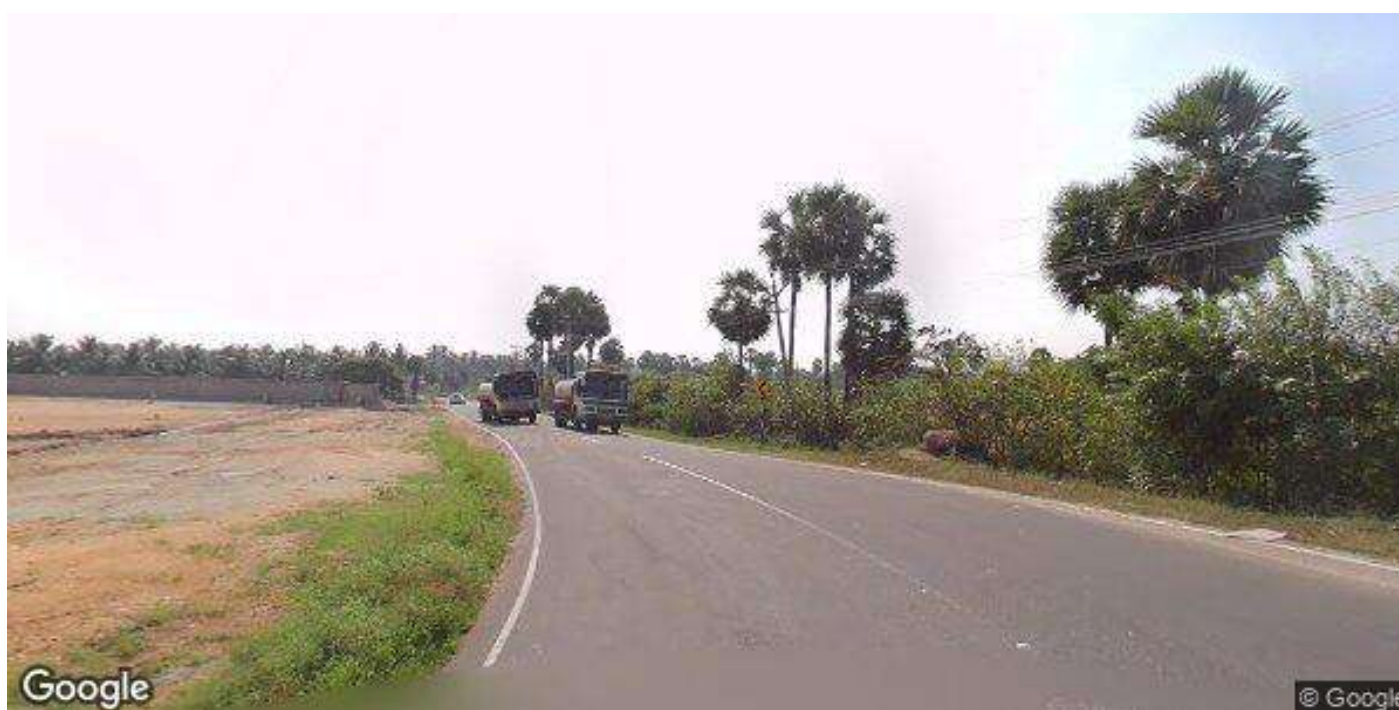
**Risk Type:** Turn  
**Risk Level:** Medium  
**Speed Limit:** 30 KM/Hr  
**Coordinates:** 11.45839, 77.85143

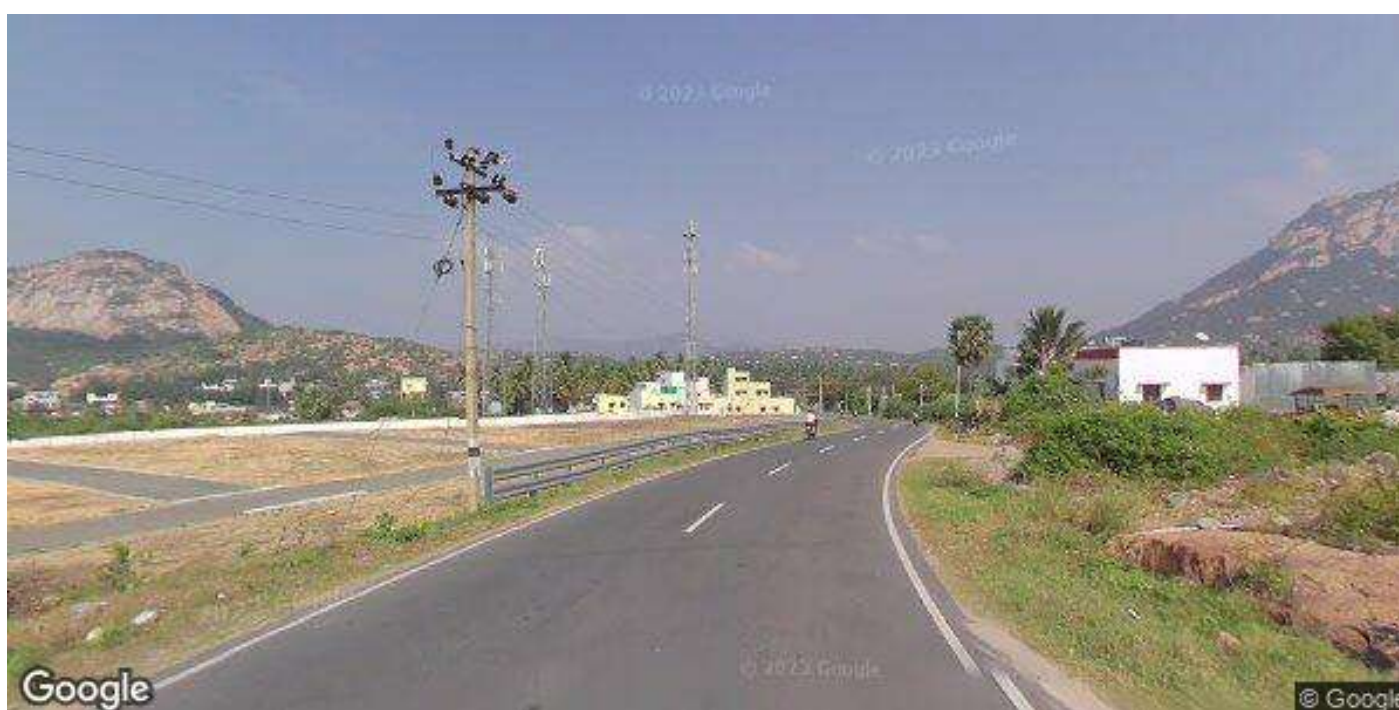
**Risk Type:** Turn  
**Risk Level:** Medium  
**Speed Limit:** 30 KM/Hr  
**Coordinates:** 11.46053, 77.85034

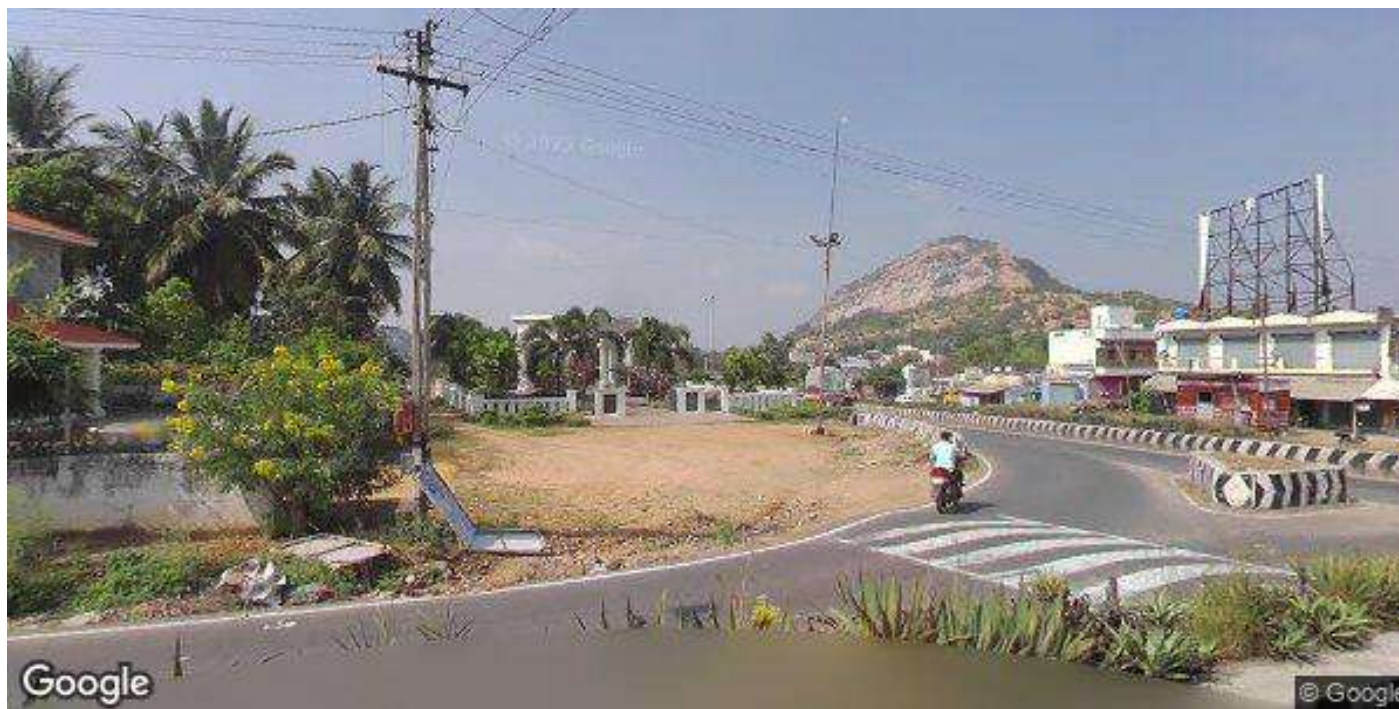
**Risk Type:** Turn  
**Risk Level:** Medium  
**Speed Limit:** 30 KM/Hr  
**Coordinates:** 11.46307, 77.84941

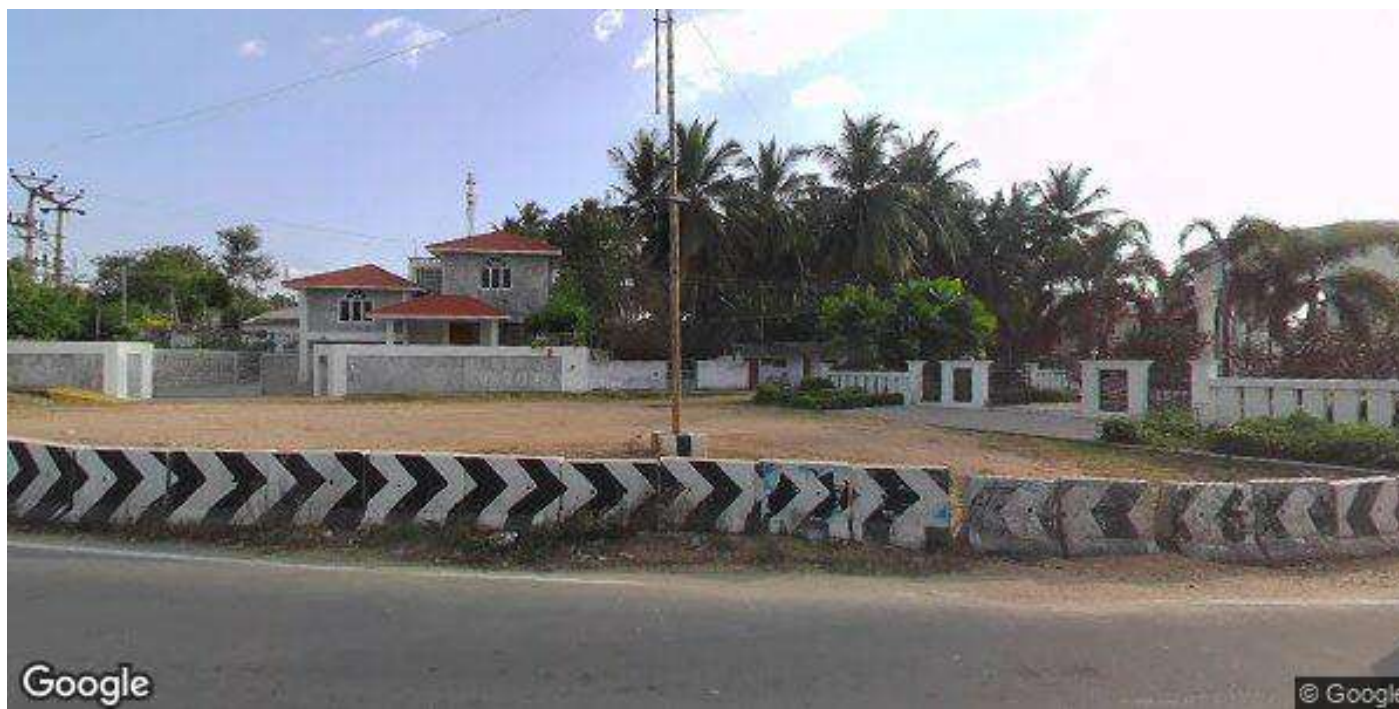
**Risk Type:** Turn  
**Risk Level:** Medium  
**Speed Limit:** 30 KM/Hr  
**Coordinates:** 11.46316, 77.84921

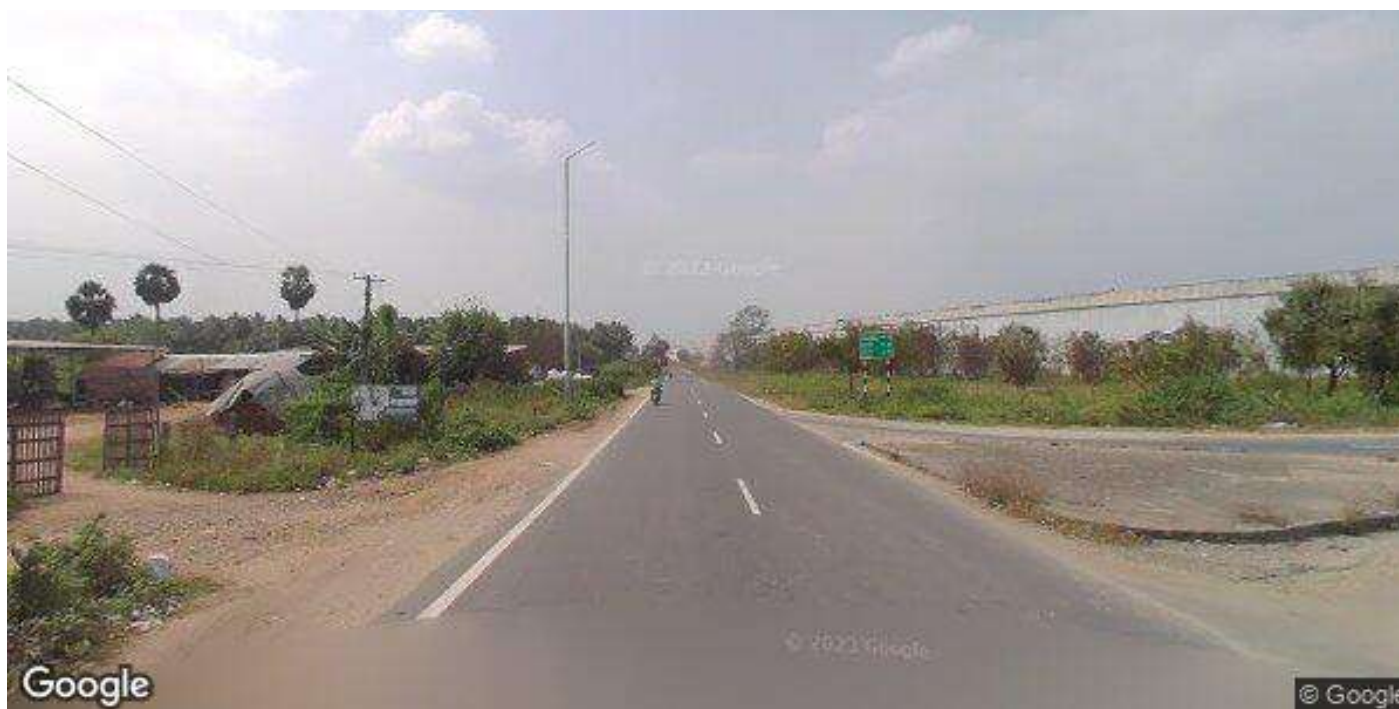
**Risk Type:** Turn  
**Risk Level:** High  
**Speed Limit:** 15 KM/Hr  
**Coordinates:** 11.45542, 77.81725

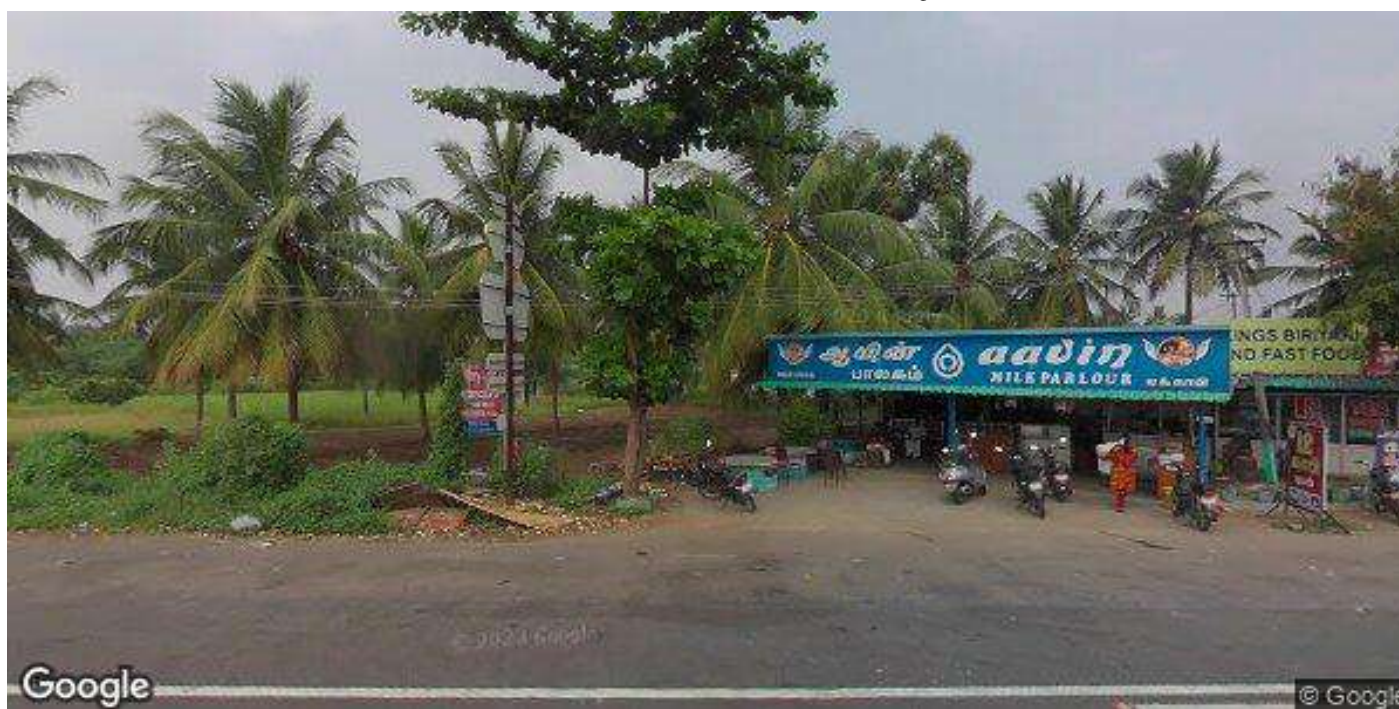
**Risk Type:** Blind Spot  
**Risk Level:** Blind Spot  
**Speed Limit:** 10 KM/Hr  
**Coordinates:** 11.45631, 77.81668

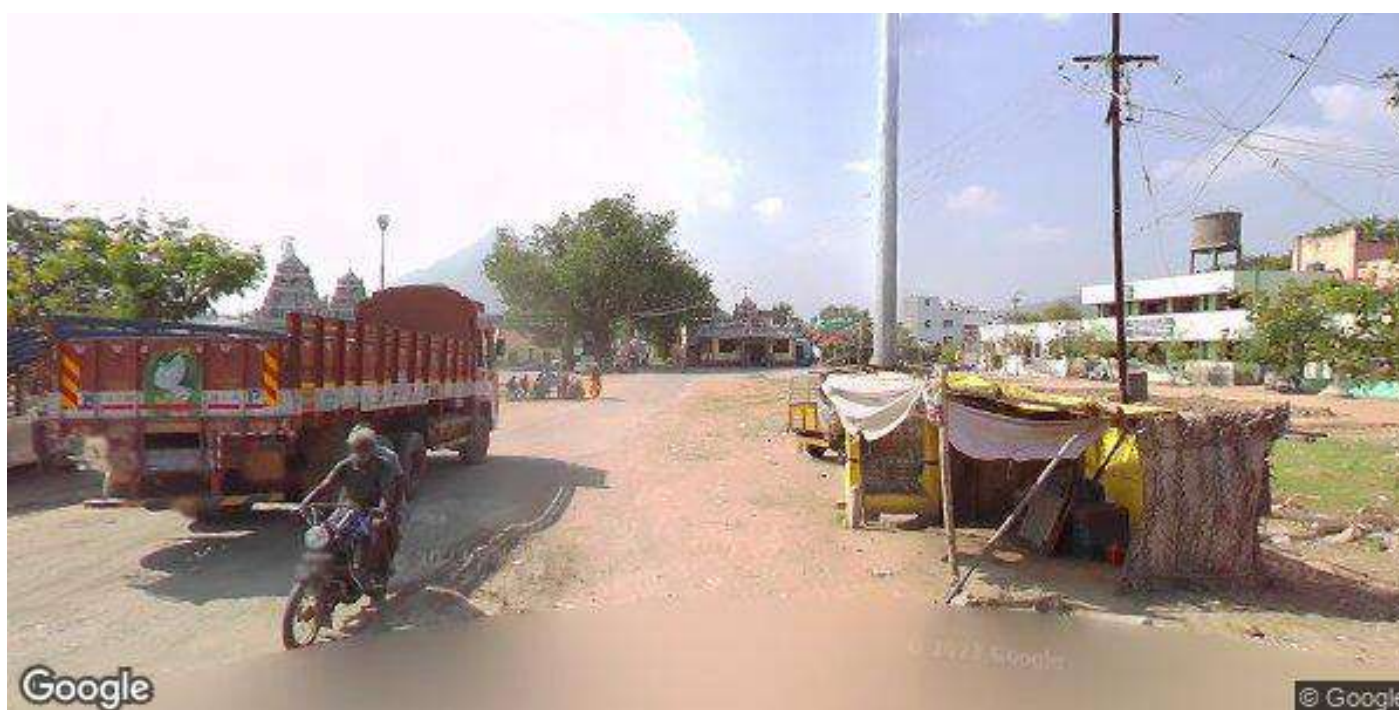
**Risk Type:** Blind Spot  
**Risk Level:** Blind Spot  
**Speed Limit:** 10 KM/Hr  
**Coordinates:** 11.62145, 78.10740

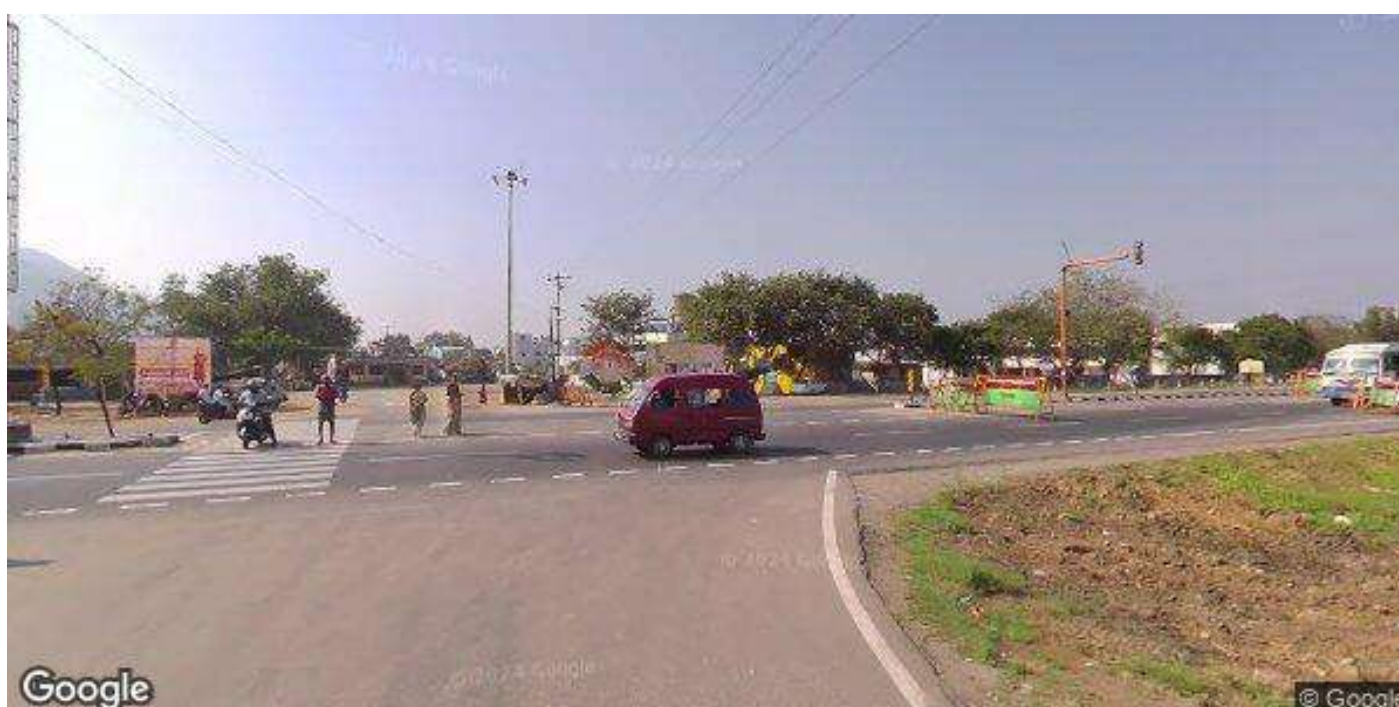
**Risk Type:** Turn  
**Risk Level:** High  
**Speed Limit:** 15 KM/Hr  
**Coordinates:** 11.62130, 78.10776

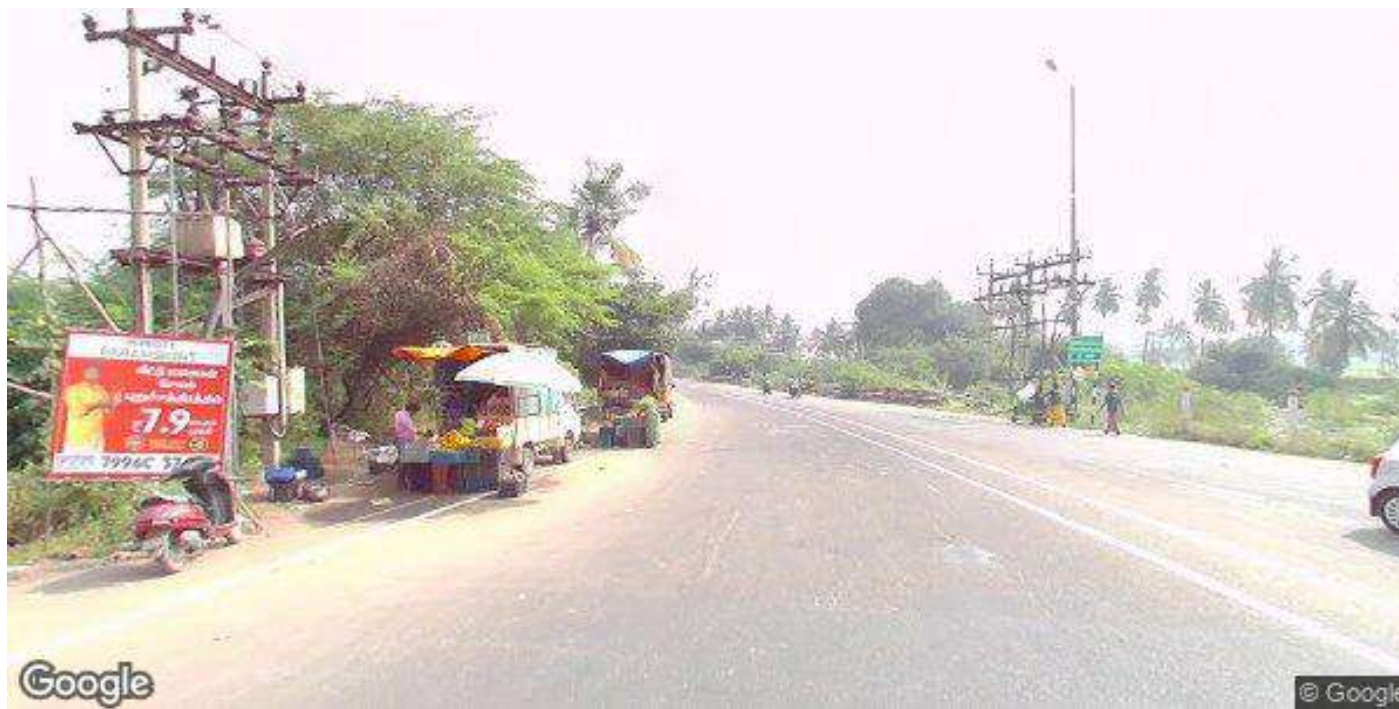
**Risk Type:** Blind Spot  
**Risk Level:** Blind Spot  
**Speed Limit:** 10 KM/Hr  
**Coordinates:** 11.61217, 78.10439

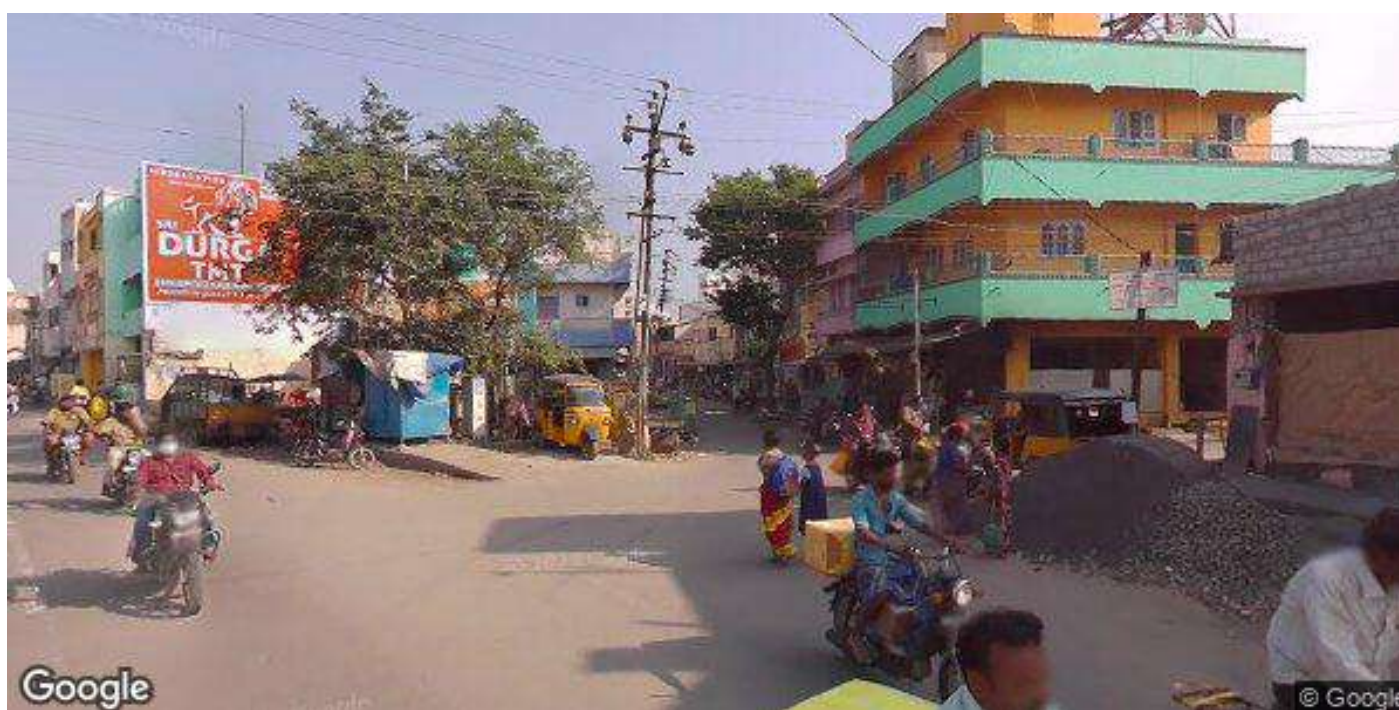
**Risk Type:** Turn  
**Risk Level:** Medium  
**Speed Limit:** 30 KM/Hr  
**Coordinates:** 11.64844, 78.14338

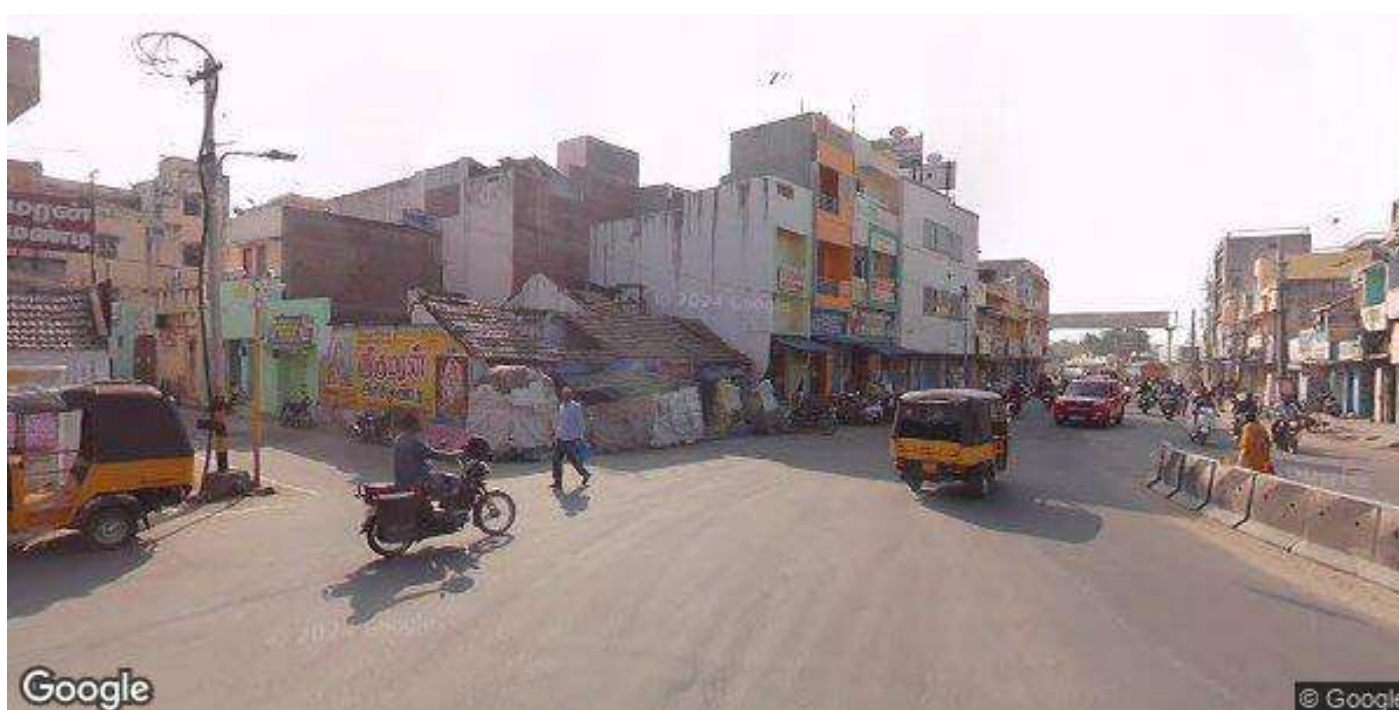
**Risk Type:** Turn  
**Risk Level:** Medium  
**Speed Limit:** 30 KM/Hr  
**Coordinates:** 11.65152, 78.14229

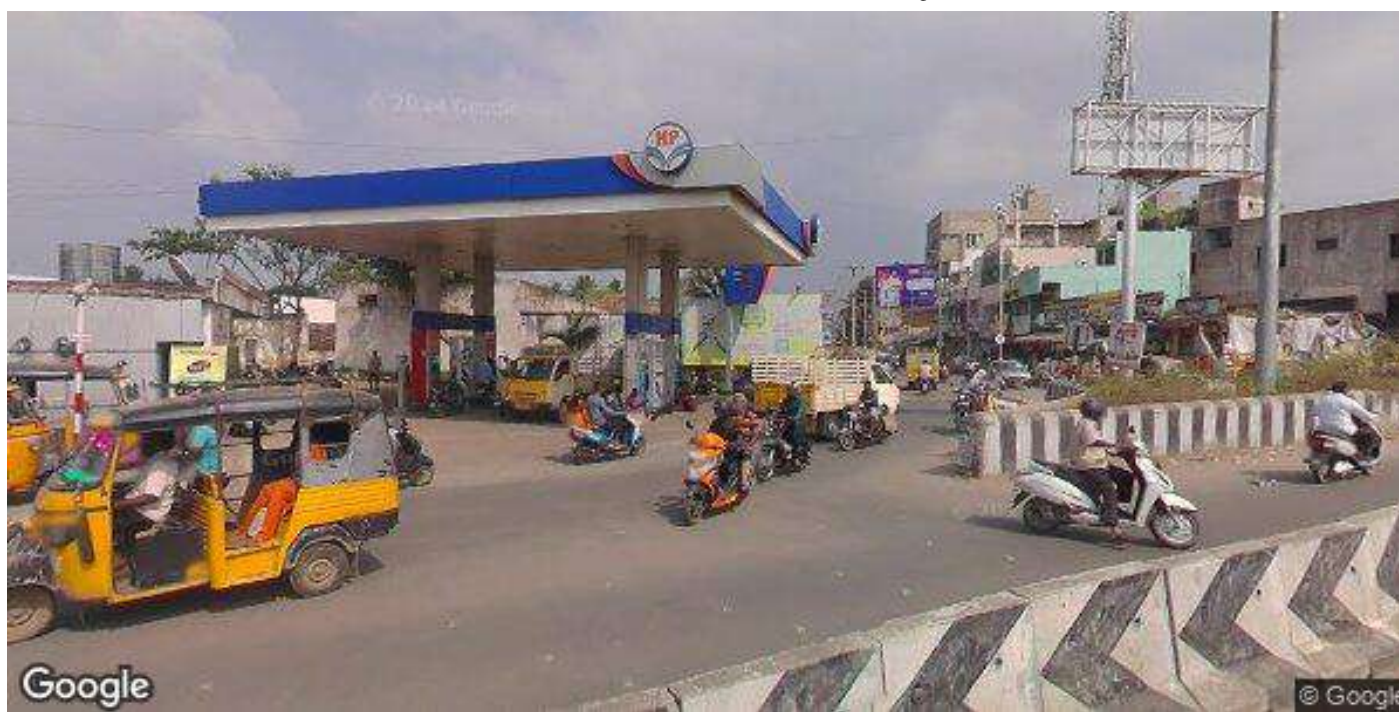
**Risk Type:** Blind Spot  
**Risk Level:** Blind Spot  
**Speed Limit:** 10 KM/Hr  
**Coordinates:** 11.65573, 78.13972

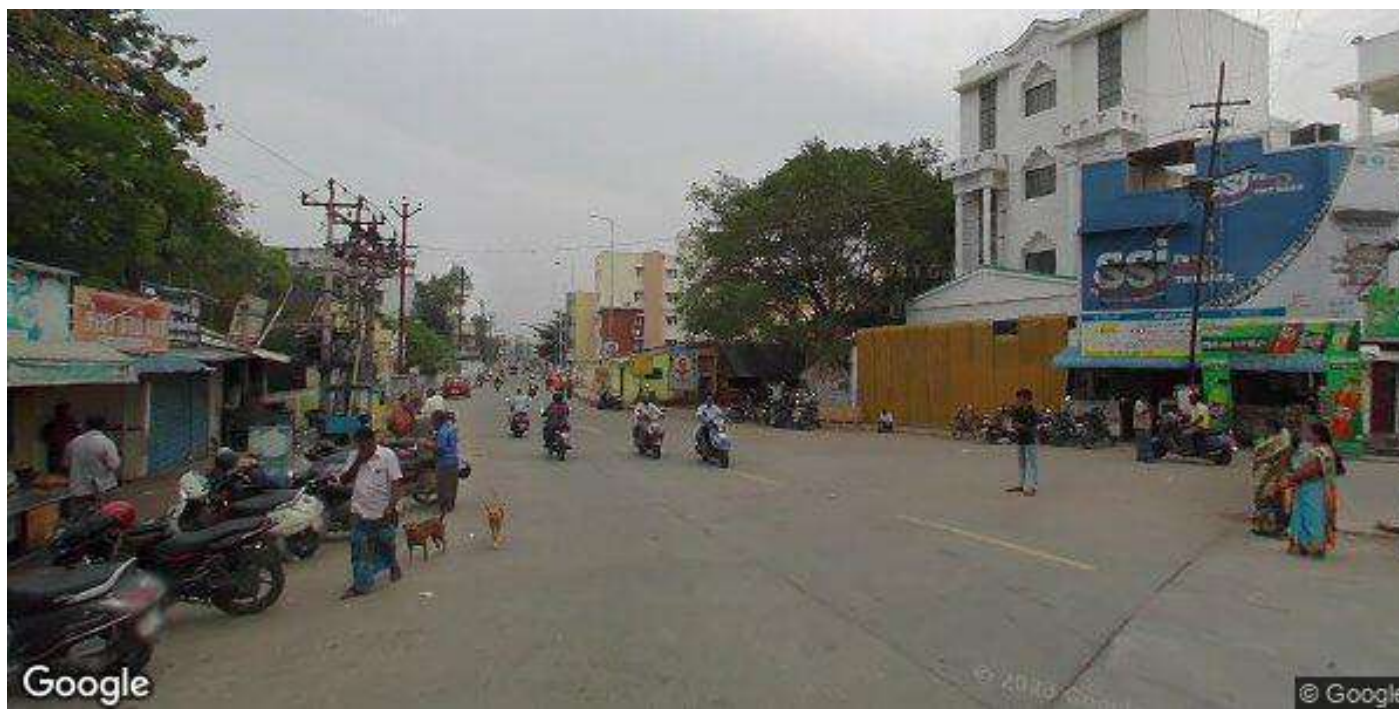
**Risk Type:** Turn  
**Risk Level:** Medium  
**Speed Limit:** 30 KM/Hr  
**Coordinates:** 11.65678, 78.14605

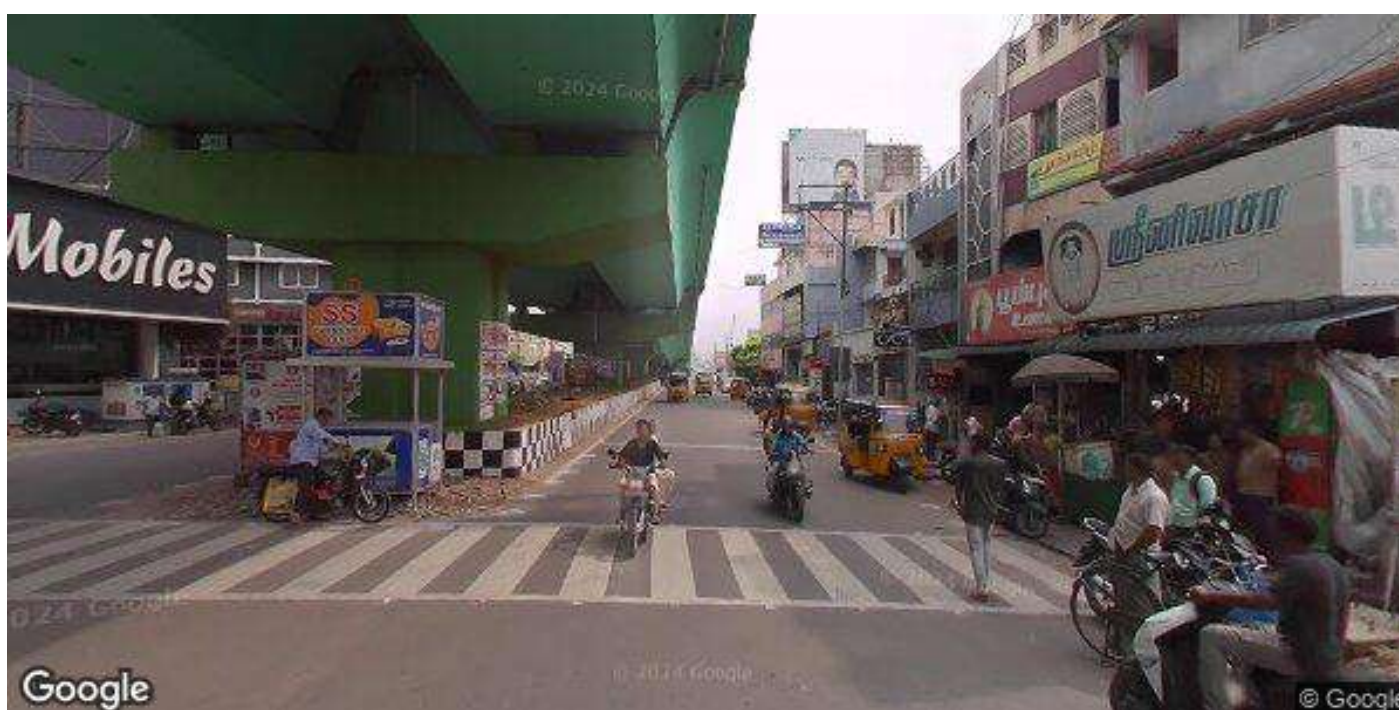
**Risk Type:** Turn  
**Risk Level:** High  
**Speed Limit:** 15 KM/Hr  
**Coordinates:** 11.66305, 78.14758
