# IndianOil

## JOURNEY RISK MANAGEMENT (JRM) STUDY

### Salem Terminal TO GUBER AGENCY IOC DEALERS

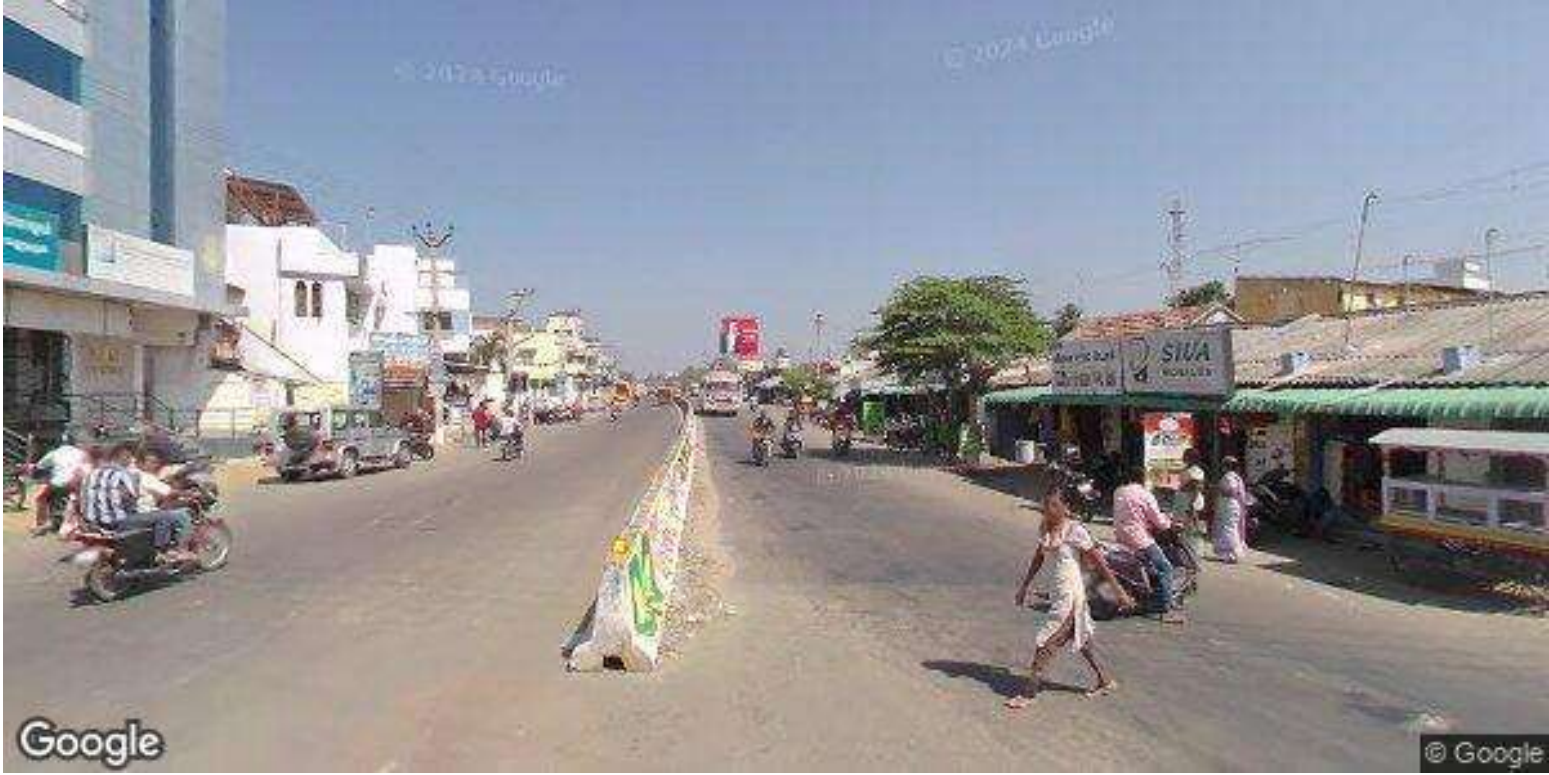
Coordinates: 11.37086, 77.74828

Risk Type: Roundabout

Risk Level: High

Speed Limit: 15 KM/Hr

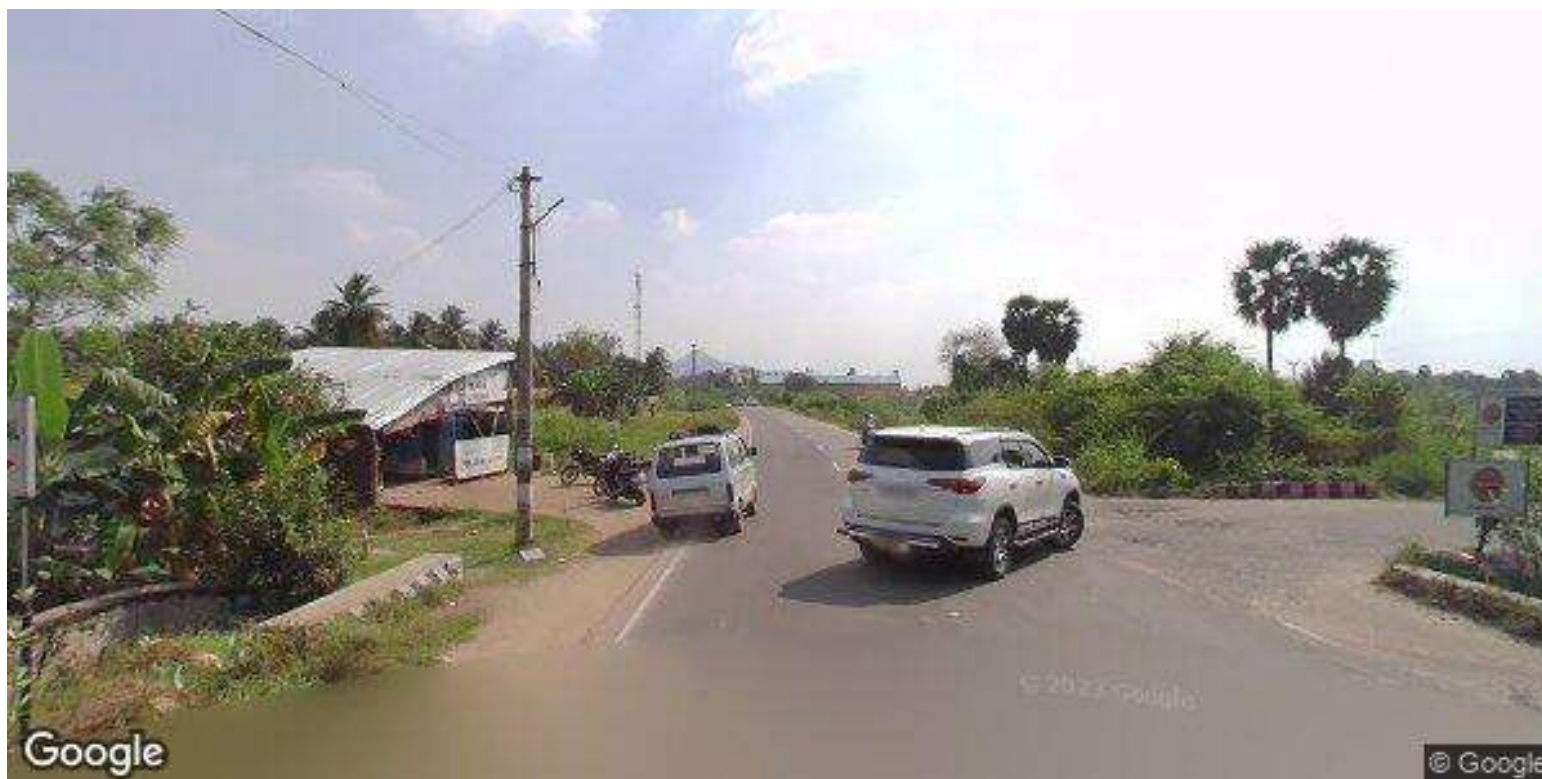
**Coordinates:** 11.44029, 77.87544

**Risk Type:** Turn

**Risk Level:** High

**Speed Limit:** 15 KM/Hr

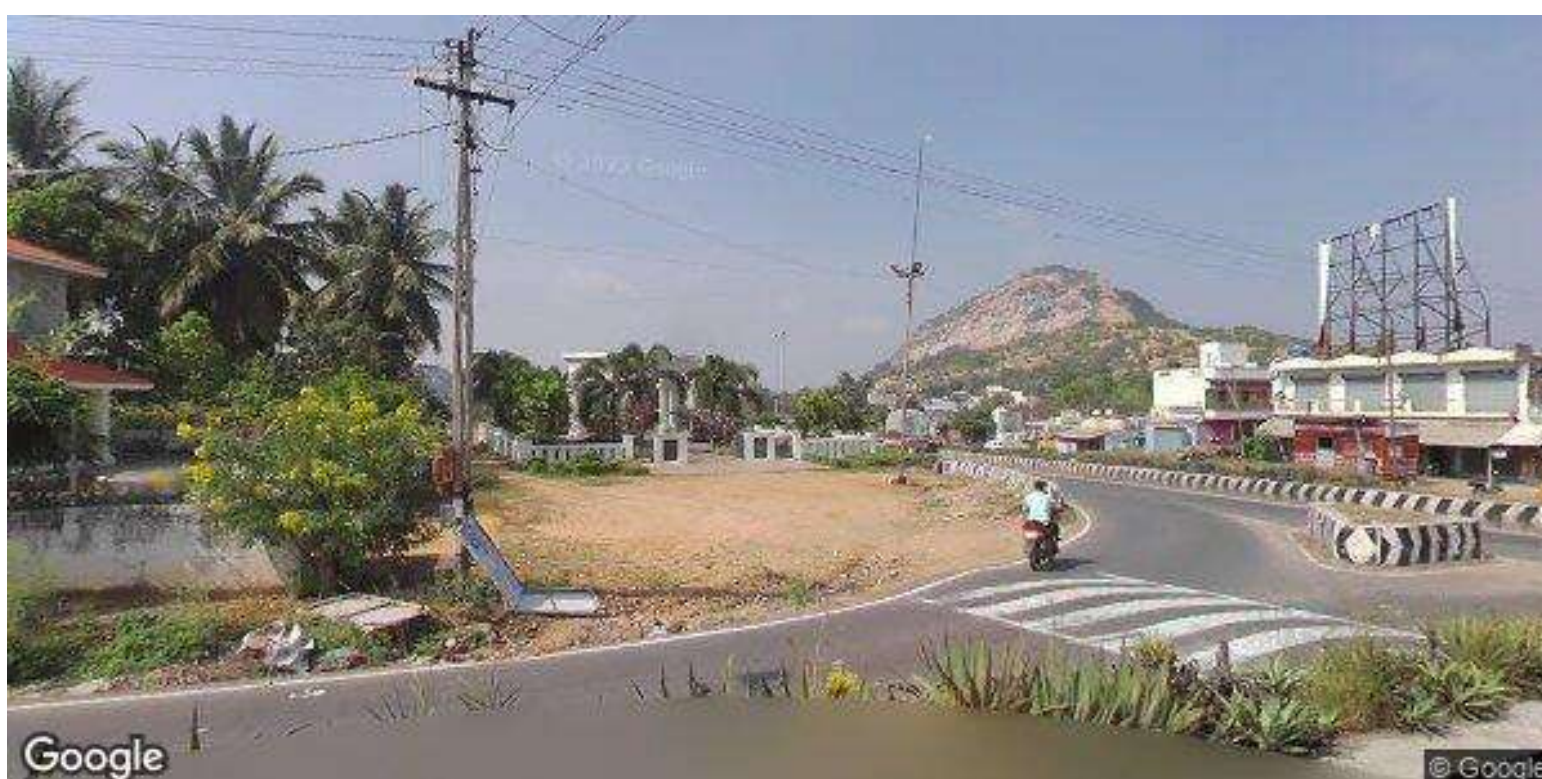
**Coordinates:** 11.46307, 77.84941

**Risk Type:** Turn

**Risk Level:** Medium

**Speed Limit:** 30 KM/Hr

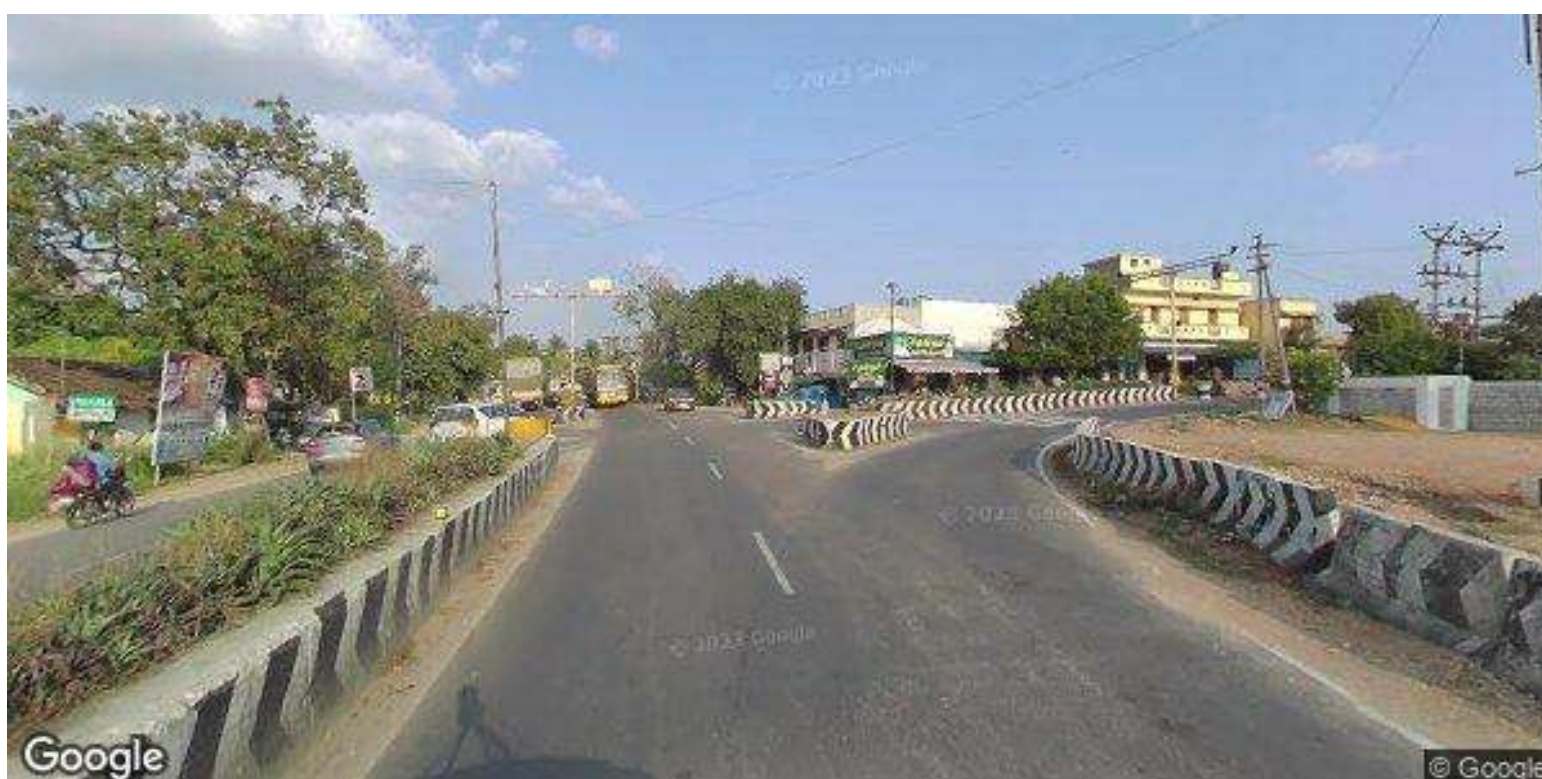
**Coordinates: 11.46318, 77.84913**

**Risk Type: Turn**

**Risk Level: Medium**

**Speed Limit: 30 KM/Hr**

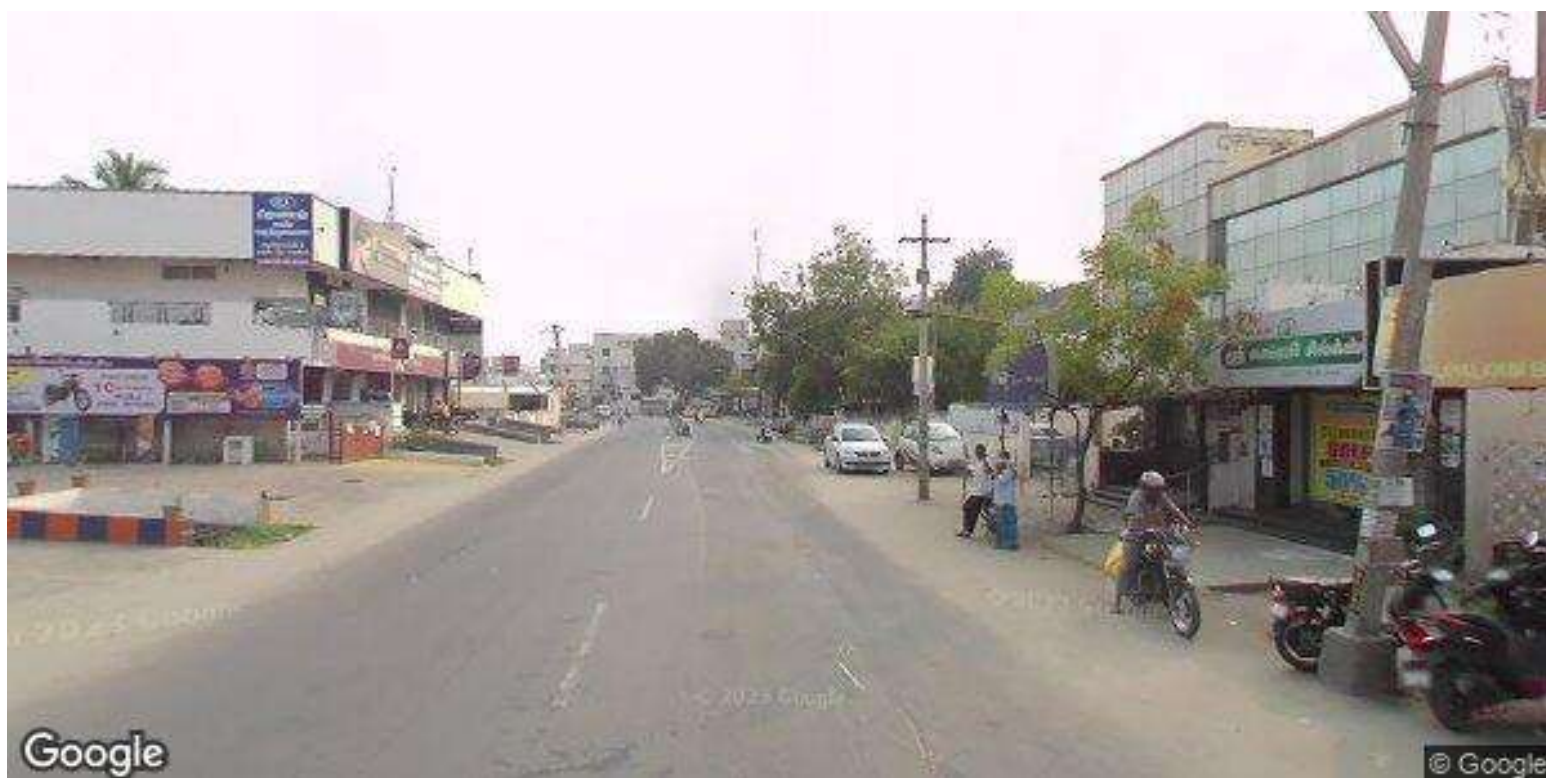
**Coordinates: 11.36696, 77.74794**

**Risk Type: Turn**

**Risk Level: High**

**Speed Limit: 15 KM/Hr**

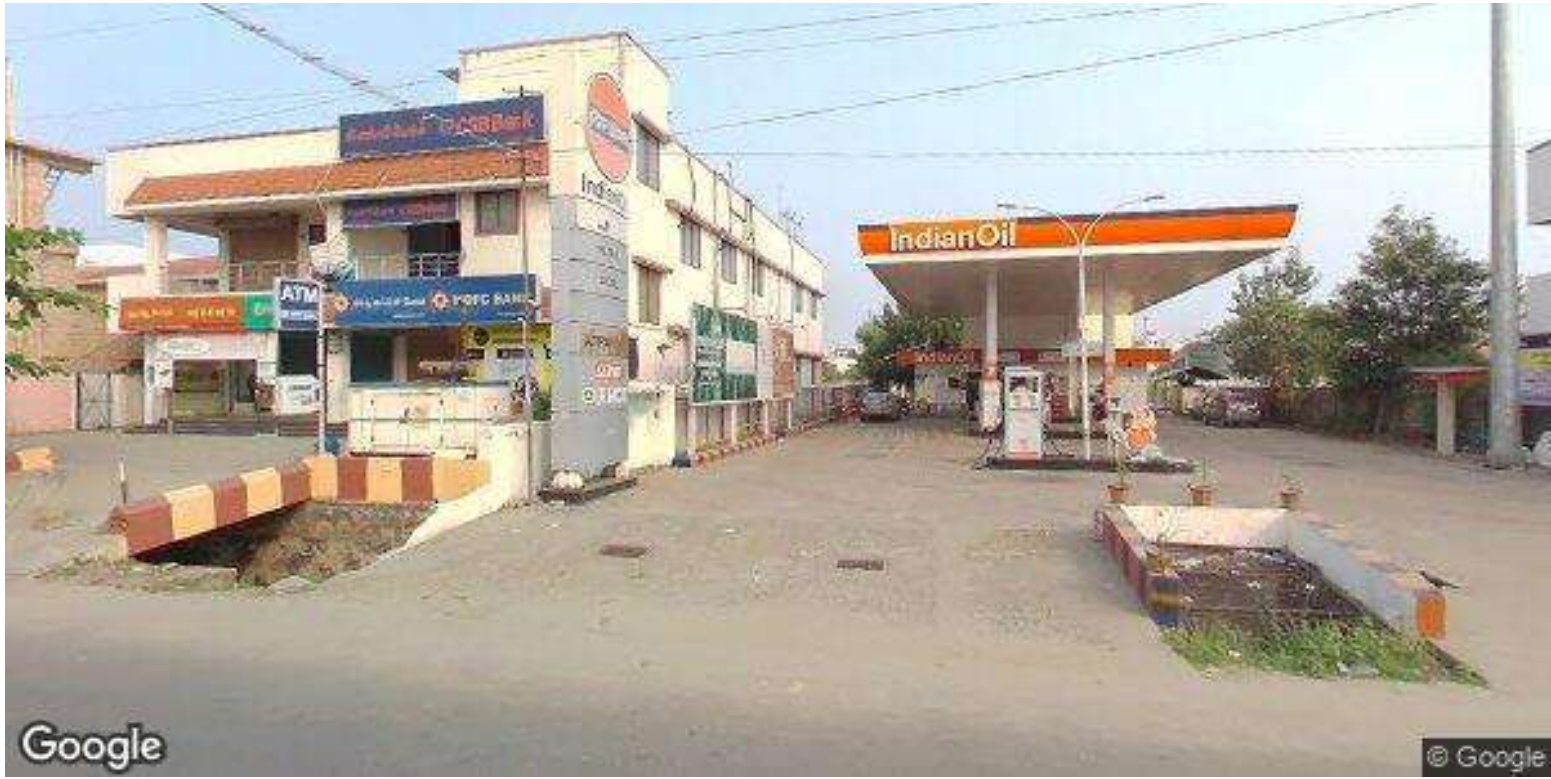
**Risk Type:** Turn  
**Risk Level:** Medium  
**Speed Limit:** 30 KM/Hr  
**Coordinates:** 11.36692, 77.74807

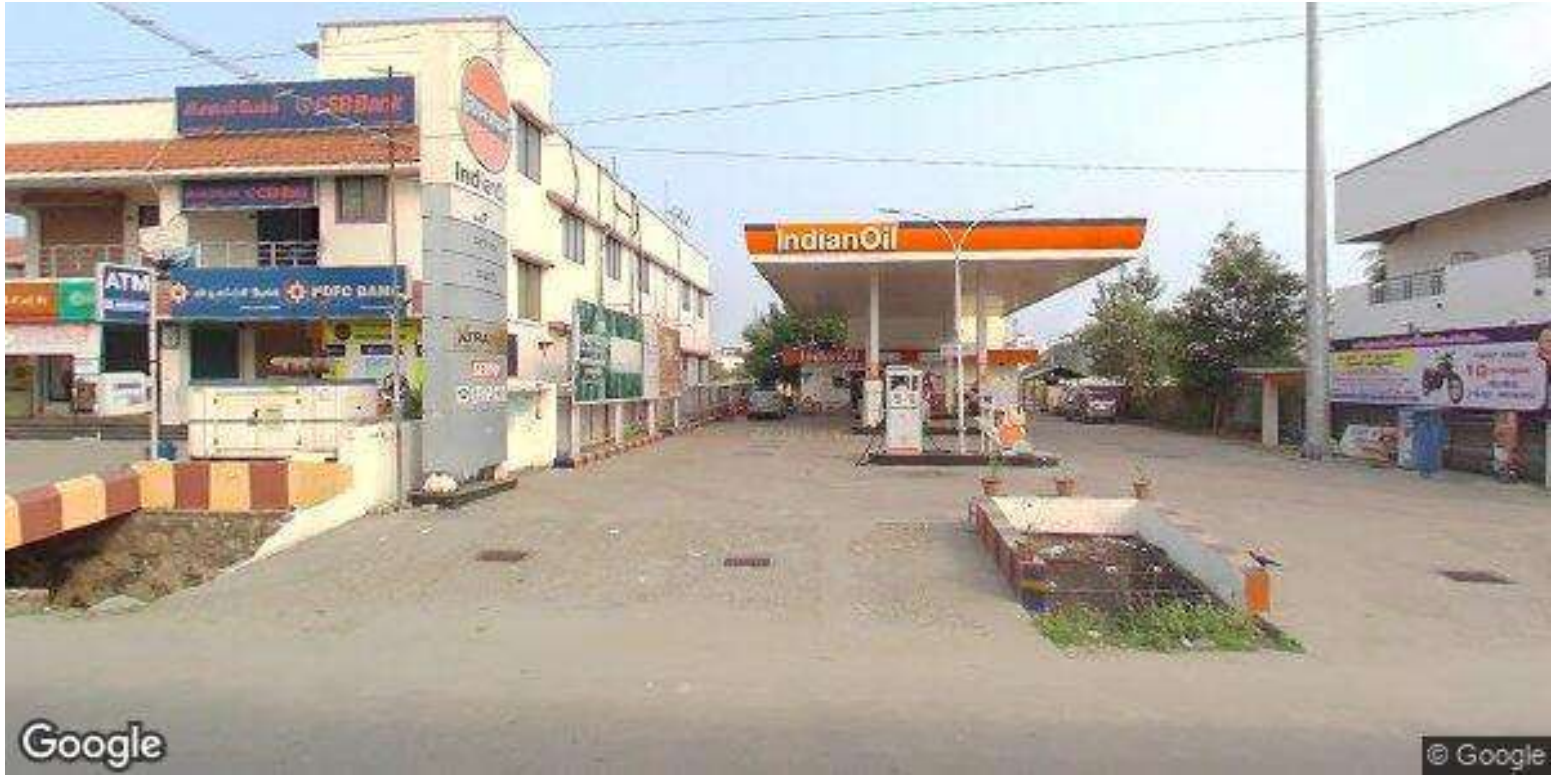
**Risk Type:** Turn  
**Risk Level:** High  
**Speed Limit:** 15 KM/Hr  
**Coordinates:** 11.36690, 77.74809
