# IndianOil

## JOURNEY RISK MANAGEMENT (JRM) STUDY

### Salem Terminal to SRIVENI ENTERPRISES

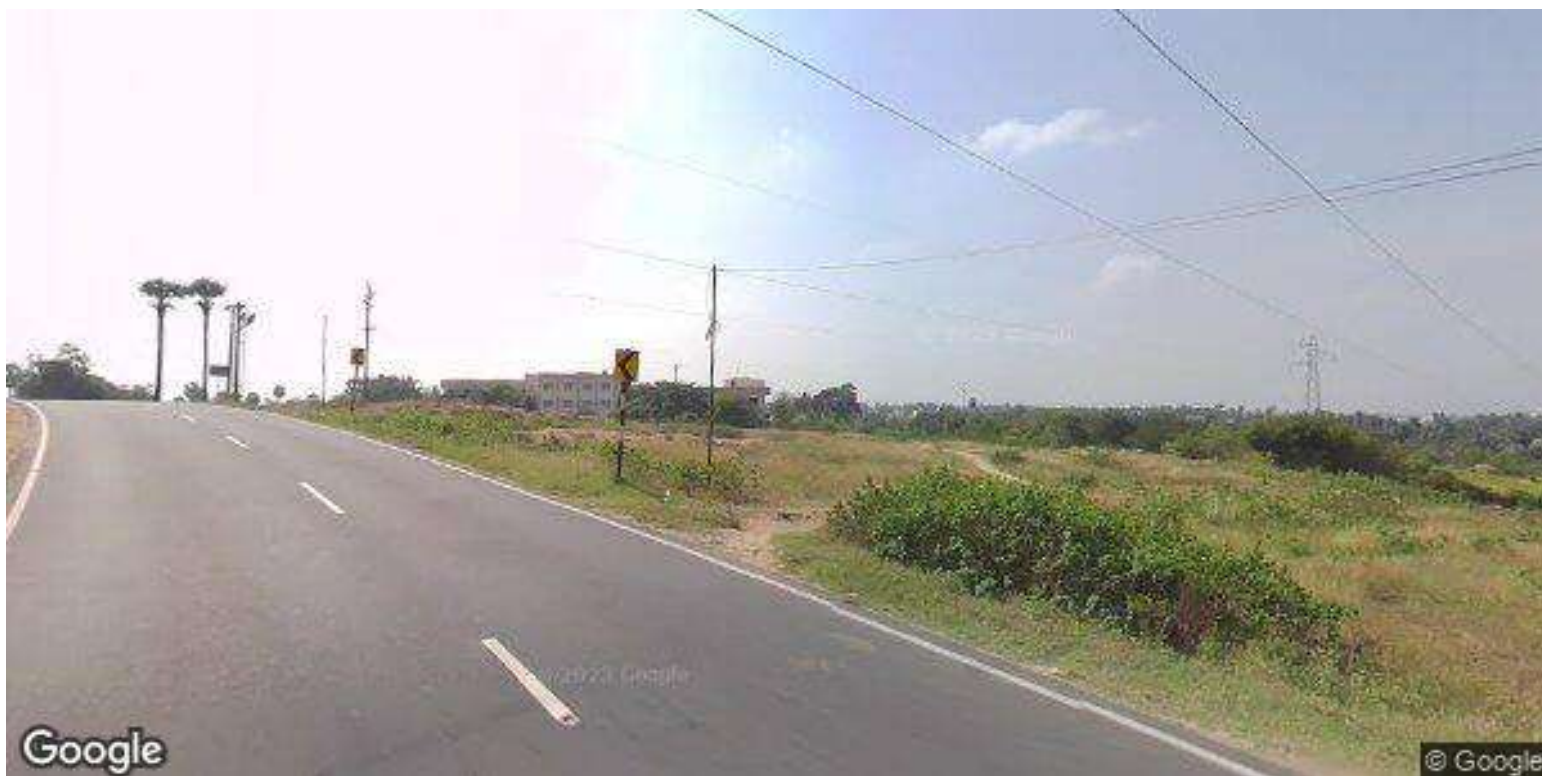
**Risk Type:** Turn  
**Risk Level:** Medium  
**Speed Limit:** 30 KM/Hr  
**Coordinates:** 11.46048, 77.85036

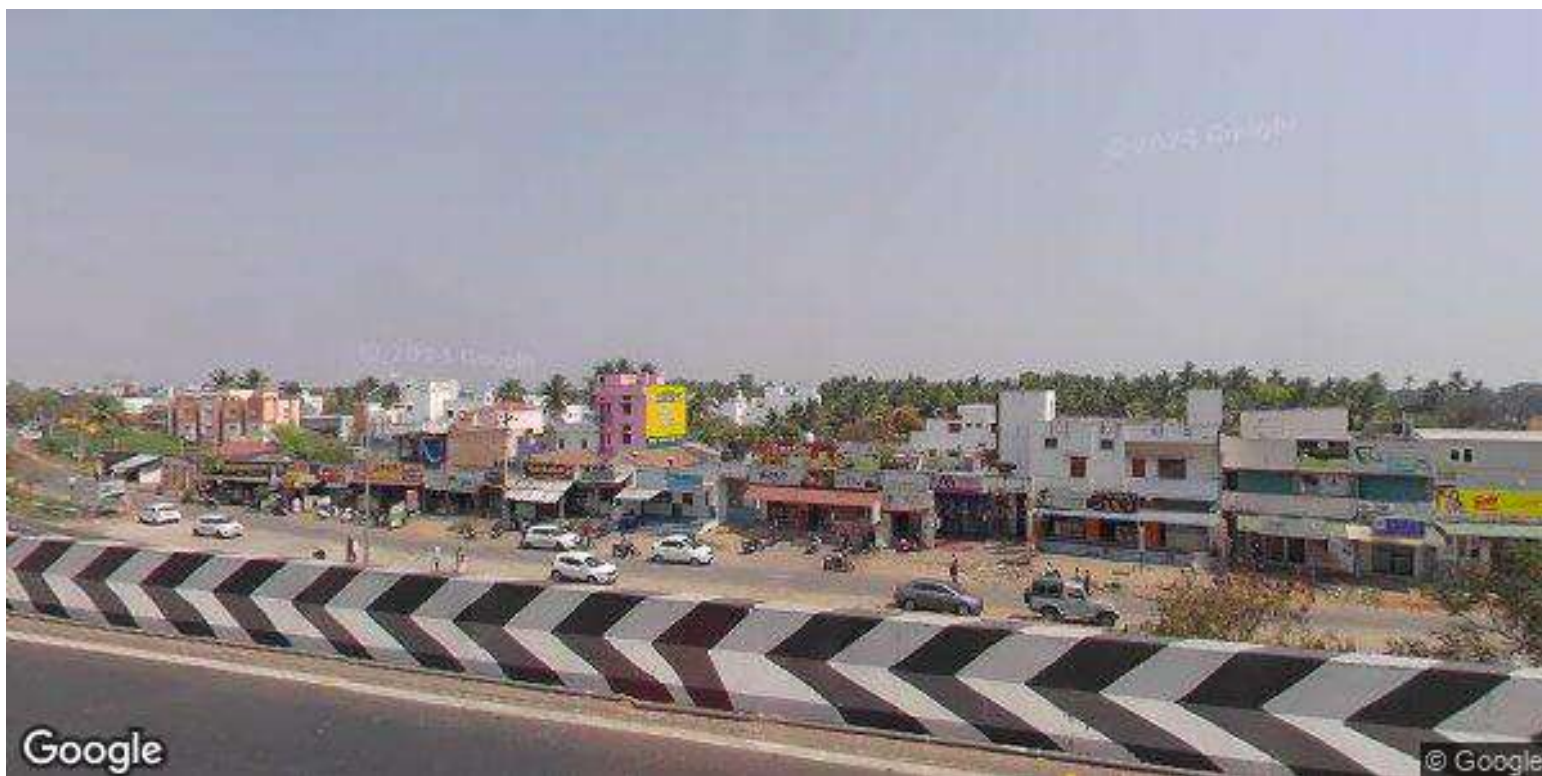
**Risk Type:** Turn  
**Risk Level:** Medium  
**Speed Limit:** 30 KM/Hr  
**Coordinates:** 11.43003, 77.67551

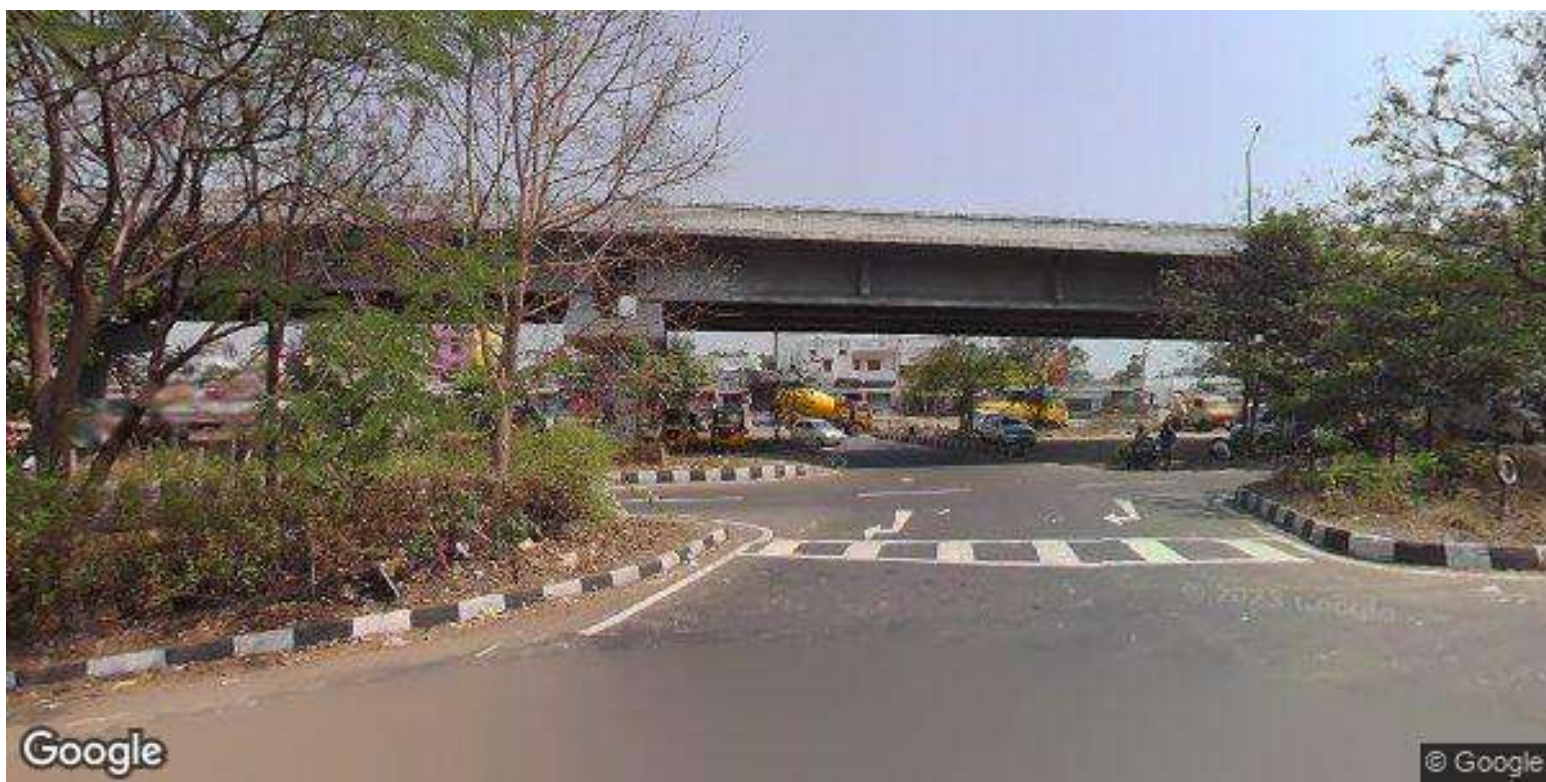
**Coordinates:** 11.43026, 77.67525

**Risk Type:** Turn

**Risk Level:** High

**Speed Limit:** 15 KM/Hr

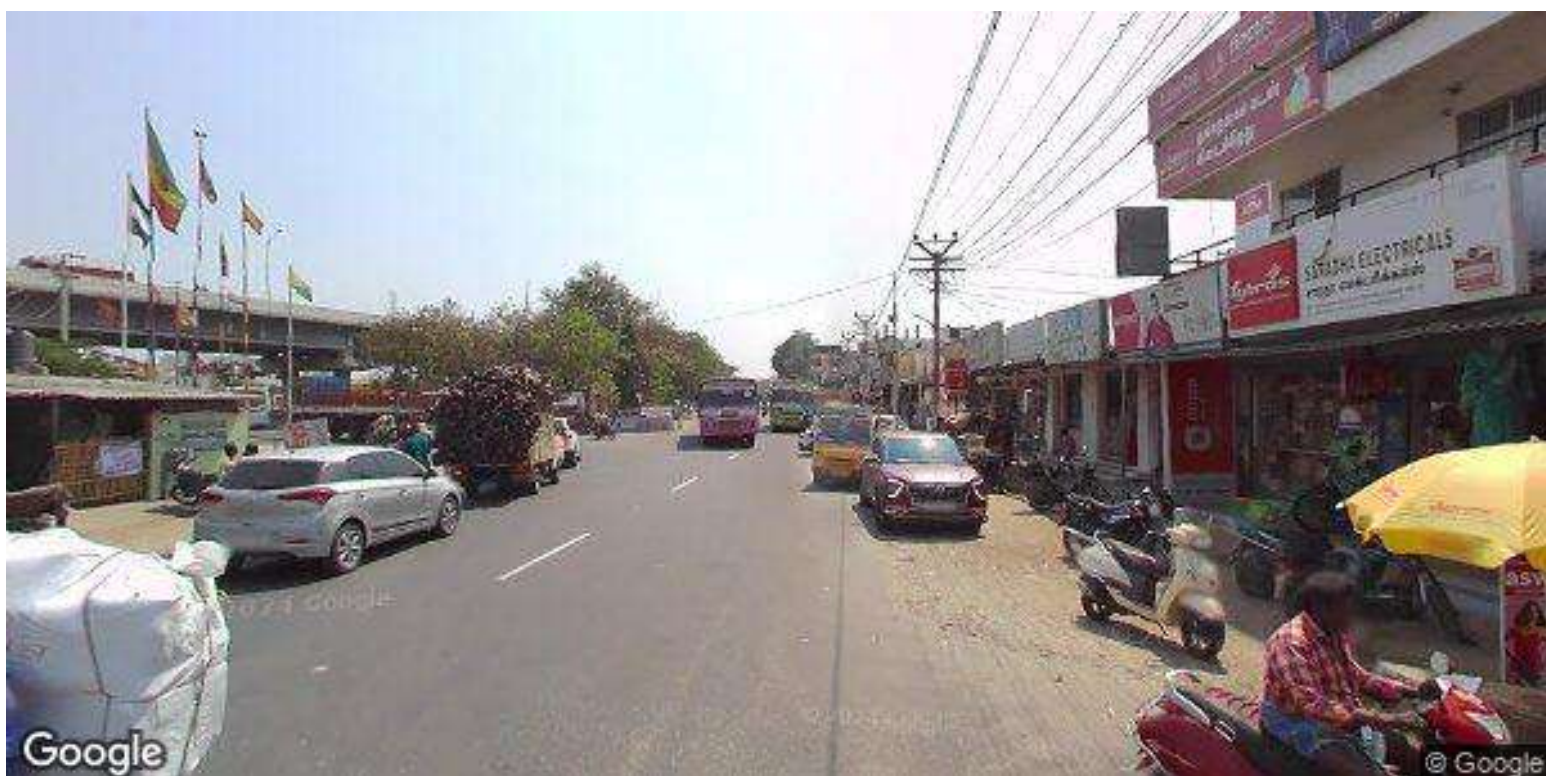
**Coordinates:** 11.43099, 77.67543

**Risk Type:** Turn

**Risk Level:** High

**Speed Limit:** 15 KM/Hr

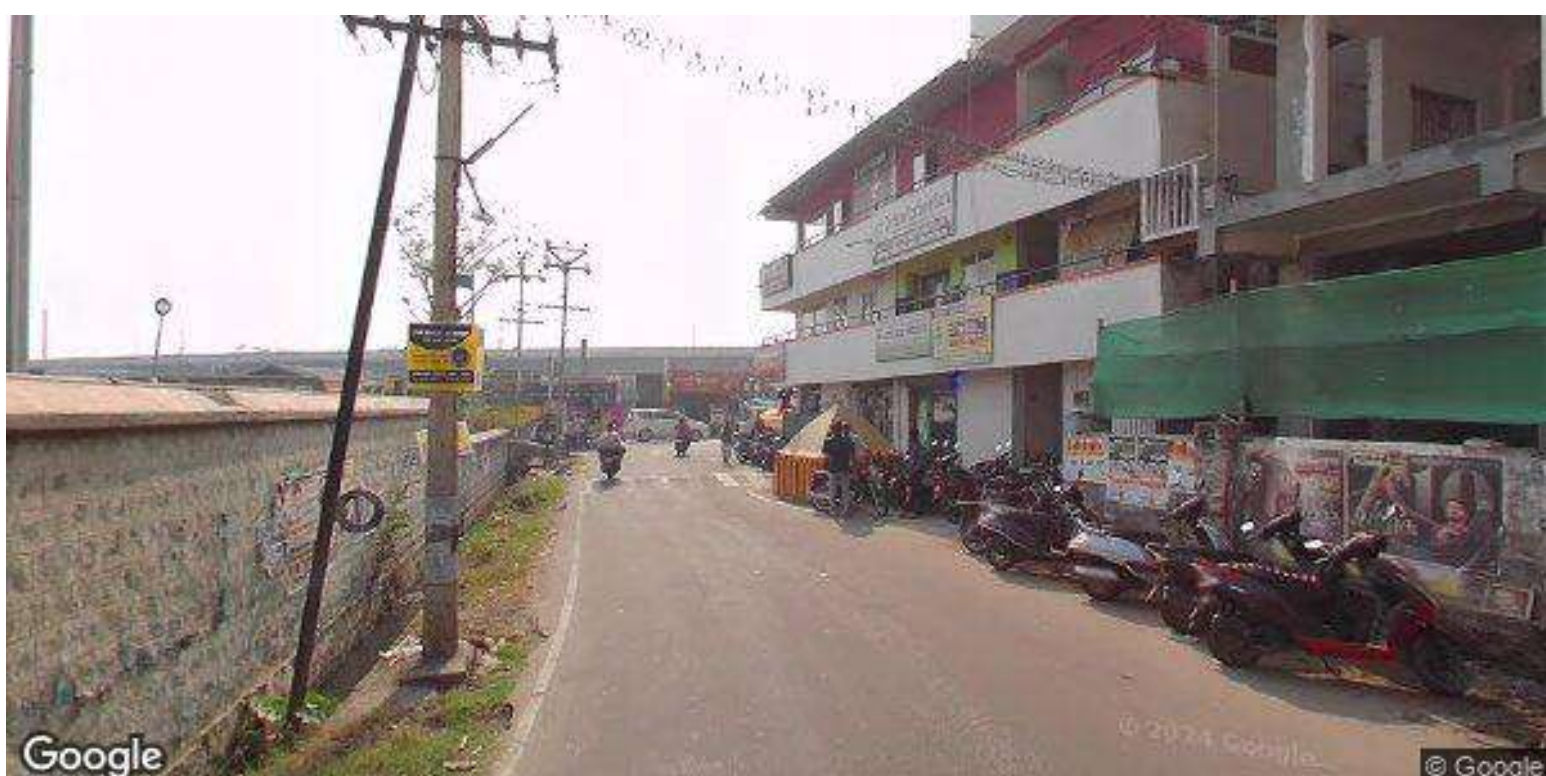
**Risk Type:** Turn  
**Risk Level:** Medium  
**Speed Limit:** 30 KM/Hr  
**Coordinates:** 11.43113, 77.67507

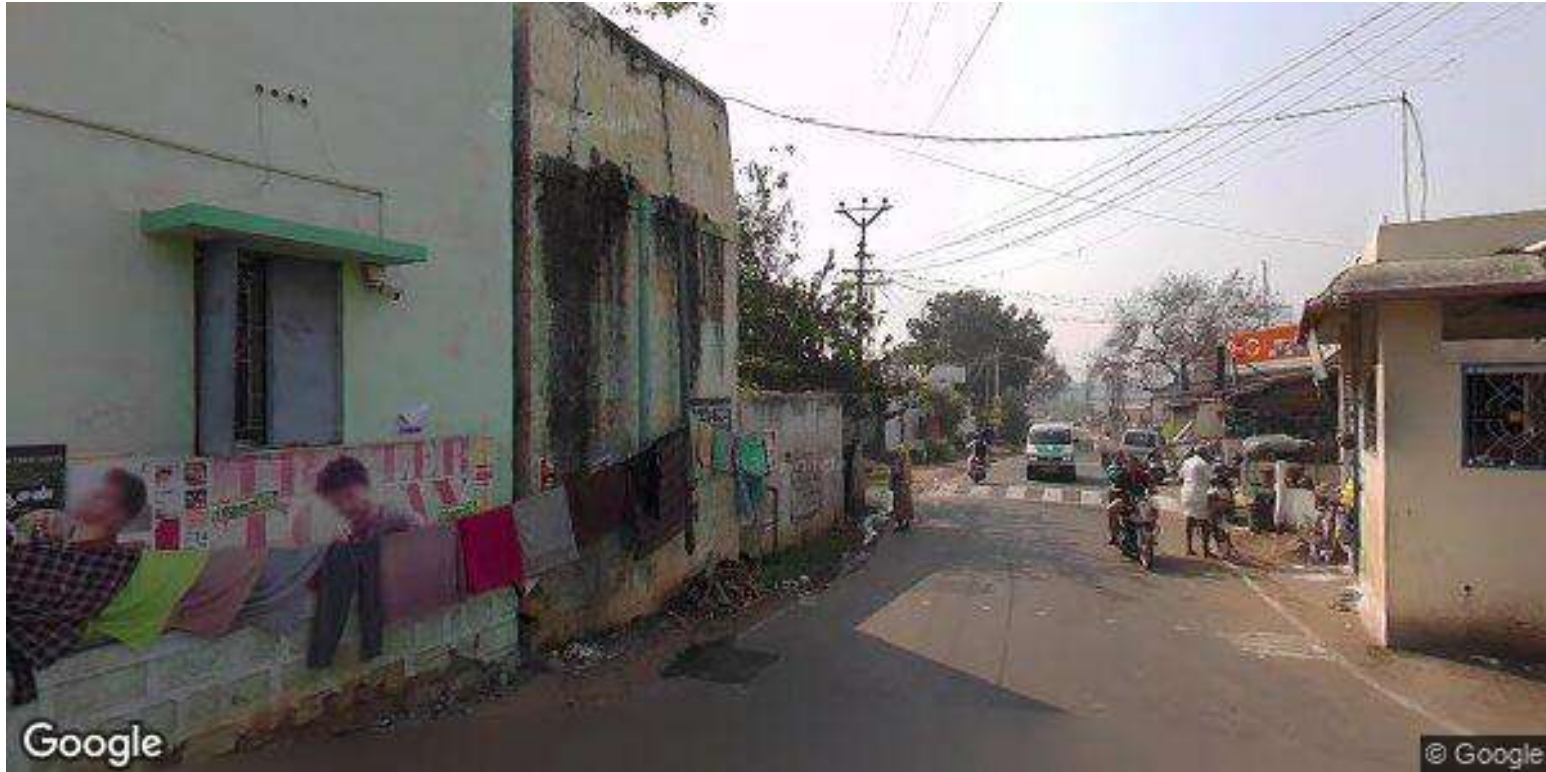
**Risk Type:** Turn  
**Risk Level:** High  
**Speed Limit:** 15 KM/Hr  
**Coordinates:** 11.43596, 77.67365

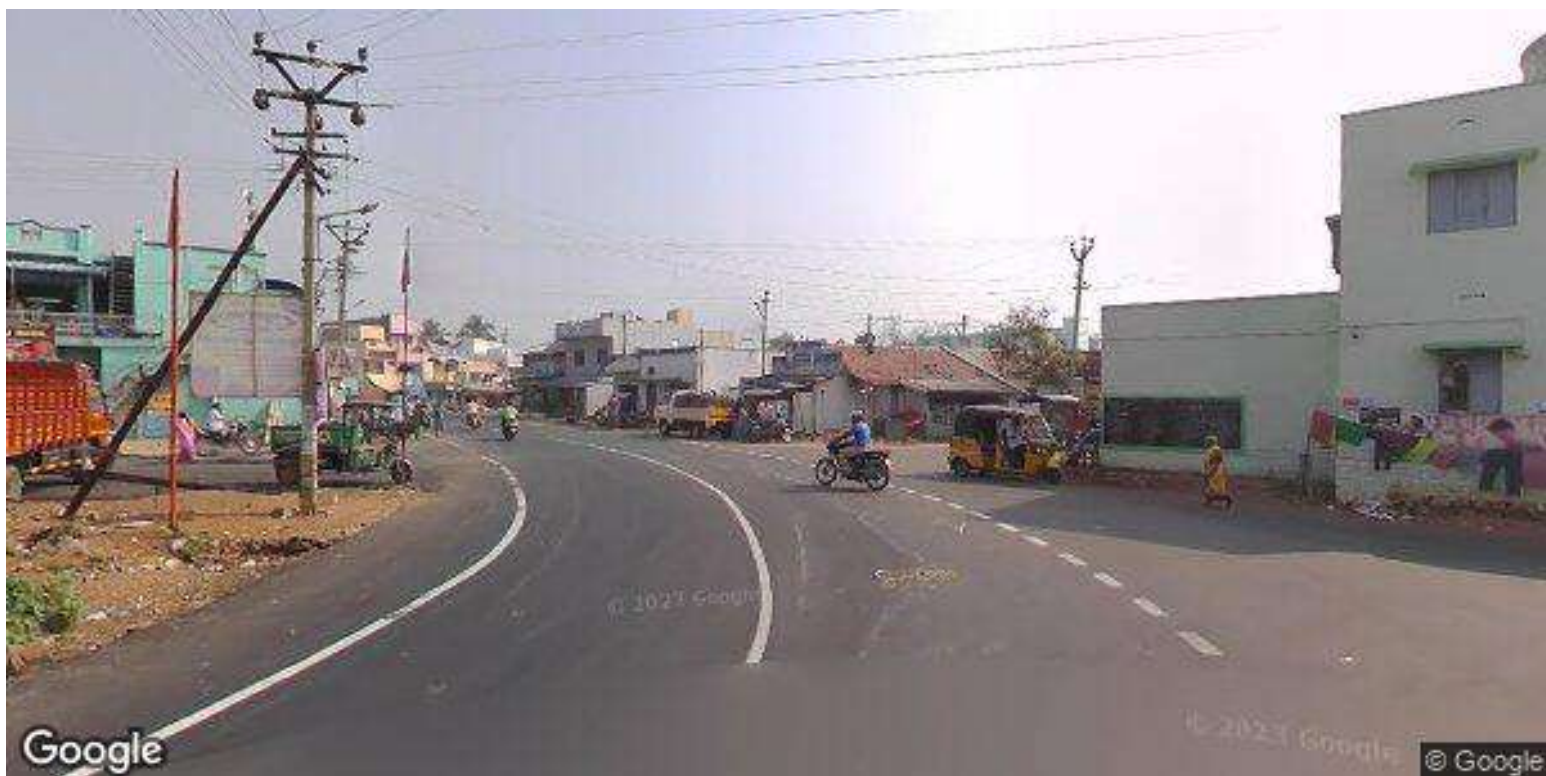
**Risk Type:** Turn  
**Risk Level:** Medium  
**Speed Limit:** 30 KM/Hr  
**Coordinates:** 11.43600, 77.67354

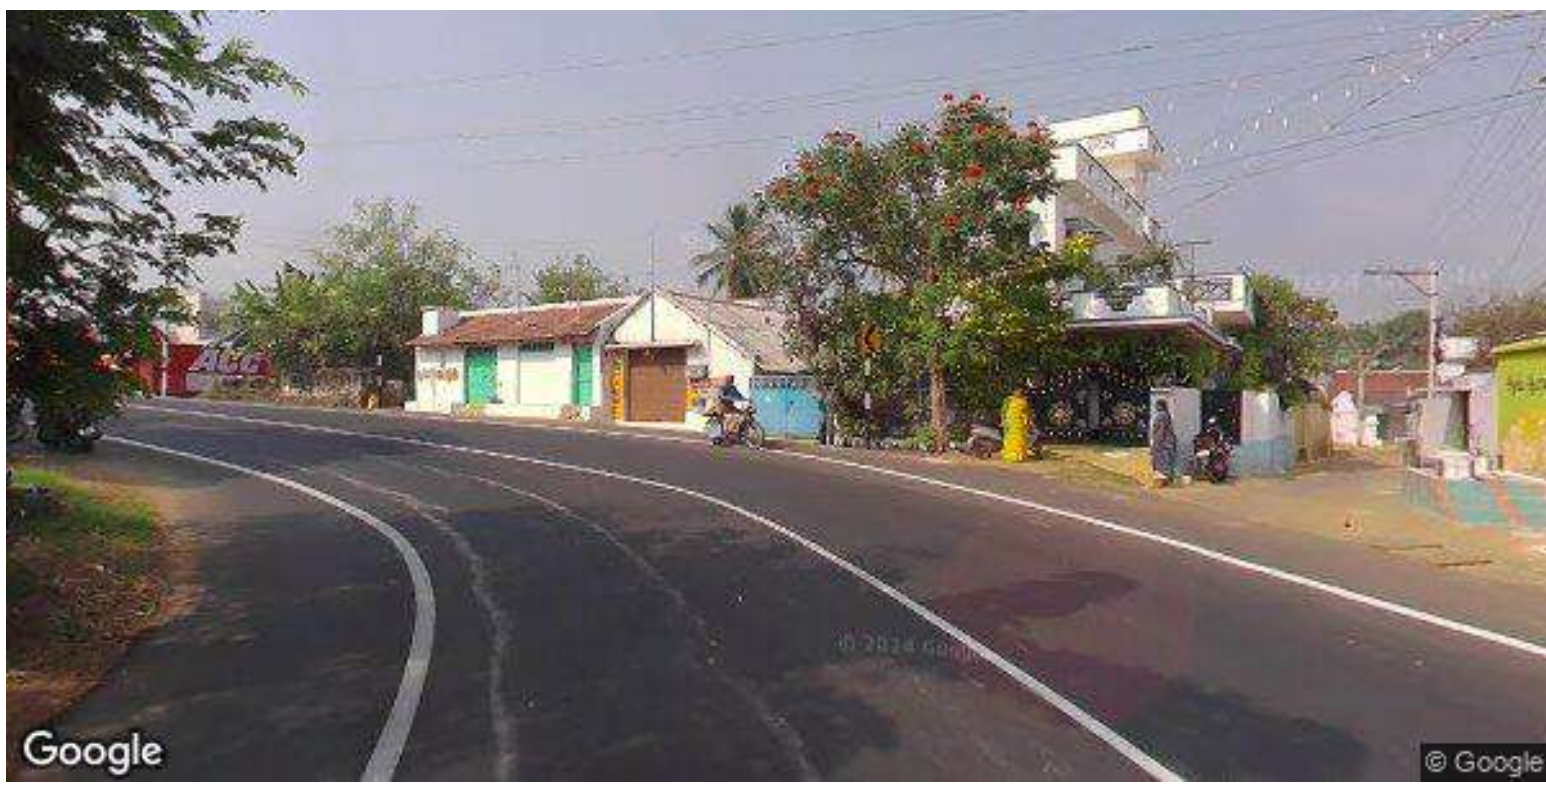
**Coordinates:** 11.43441, 77.67066

**Risk Type:** Turn

**Risk Level:** Medium

**Speed Limit:** 30 KM/Hr

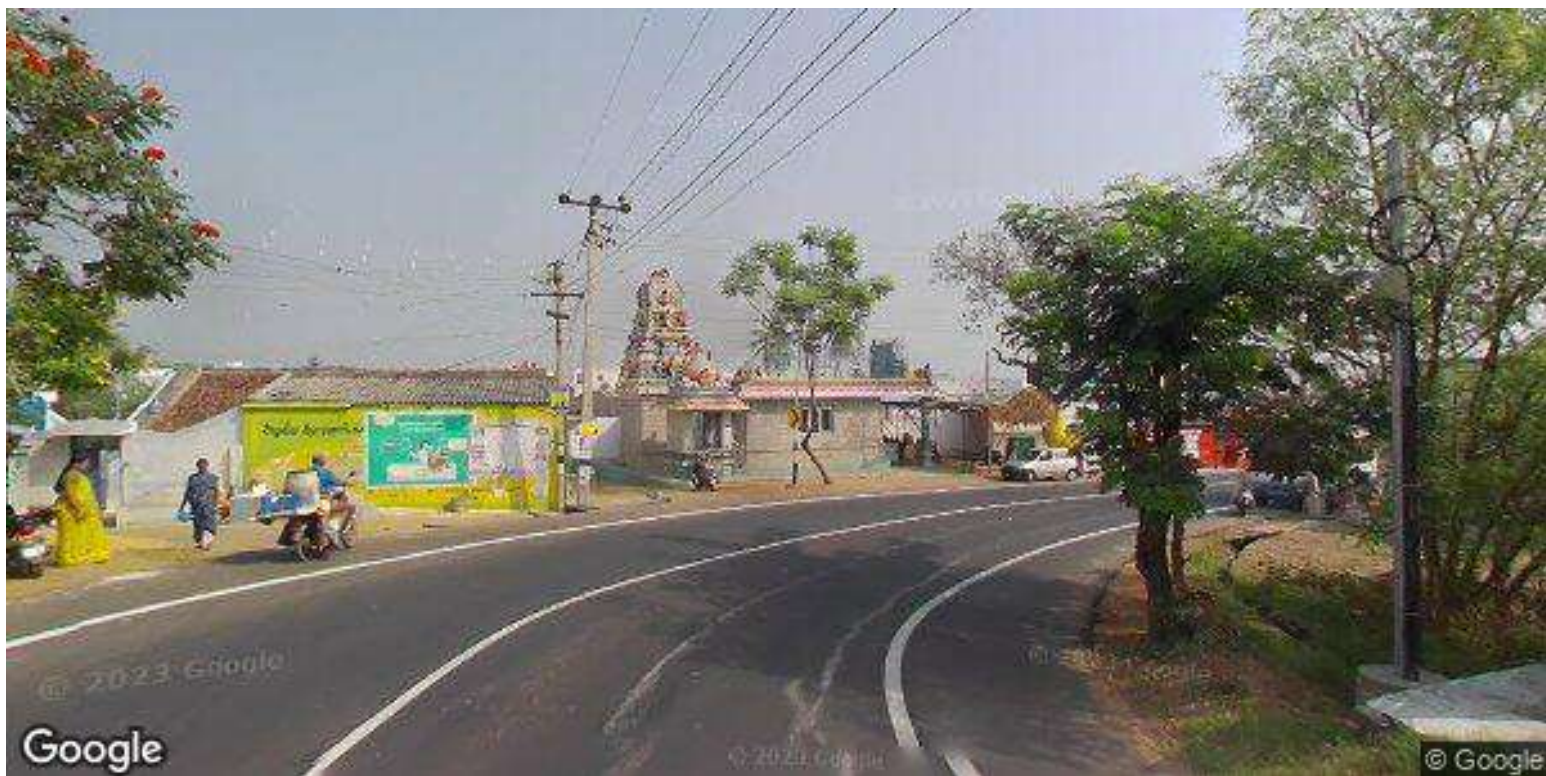
**Coordinates:** 11.43430, 77.67060

**Risk Type:** Turn

**Risk Level:** Medium

**Speed Limit:** 30 KM/Hr

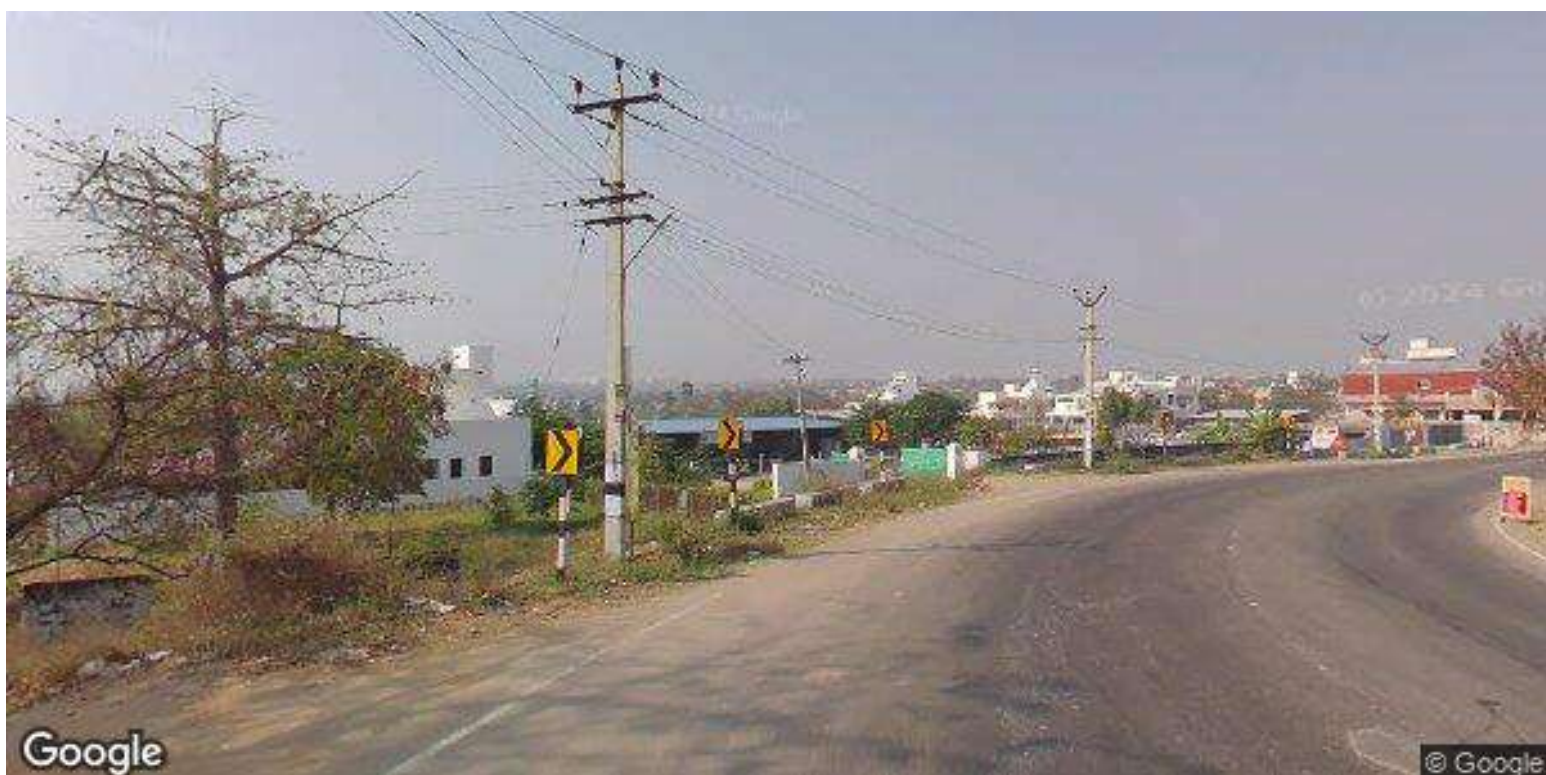
**Risk Type:** Turn  
**Risk Level:** High  
**Speed Limit:** 15 KM/Hr  
**Coordinates:** 11.43273, 77.67018

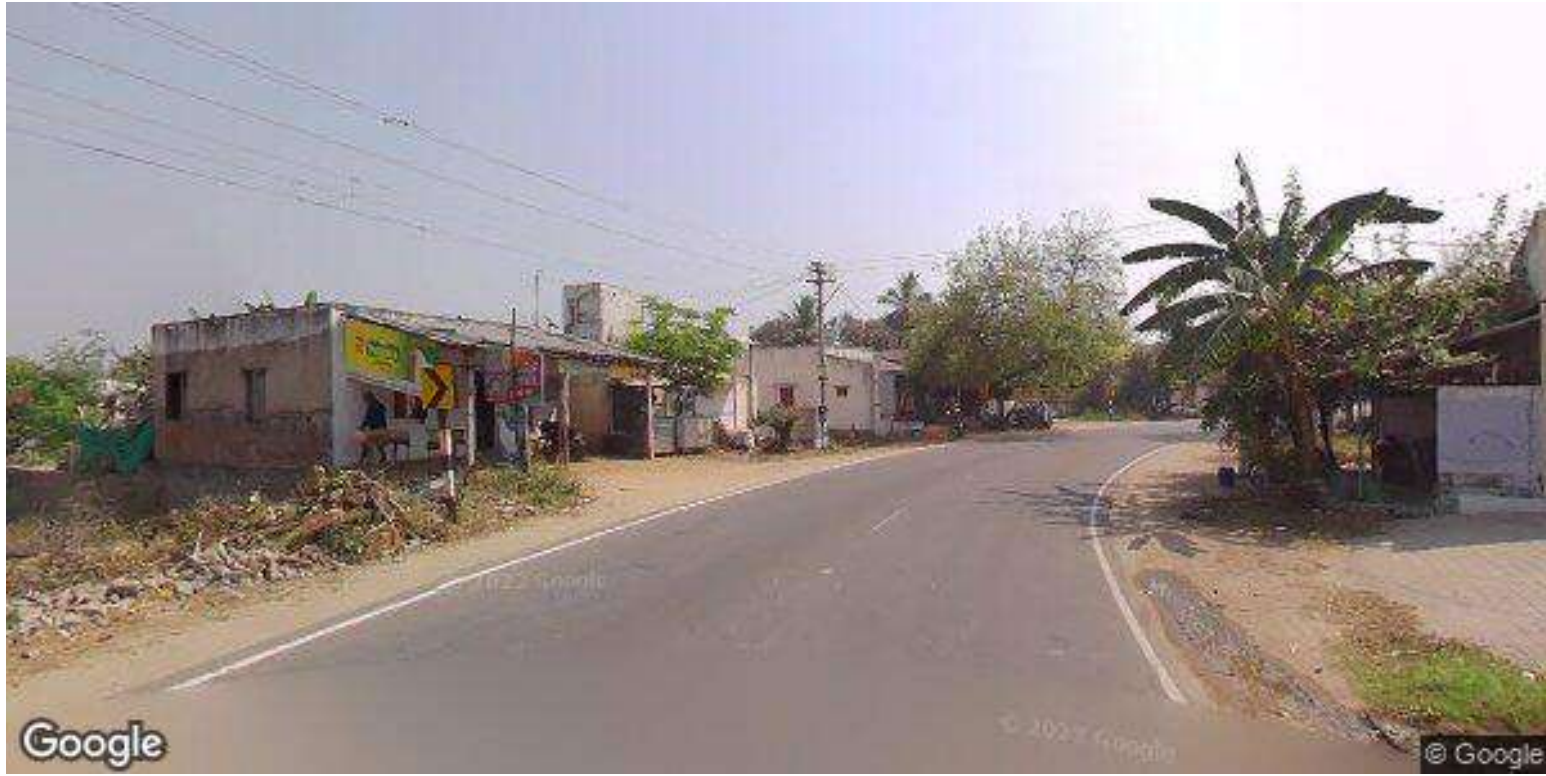
**Risk Type:** Turn  
**Risk Level:** Medium  
**Speed Limit:** 30 KM/Hr  
**Coordinates:** 11.43342, 77.66685

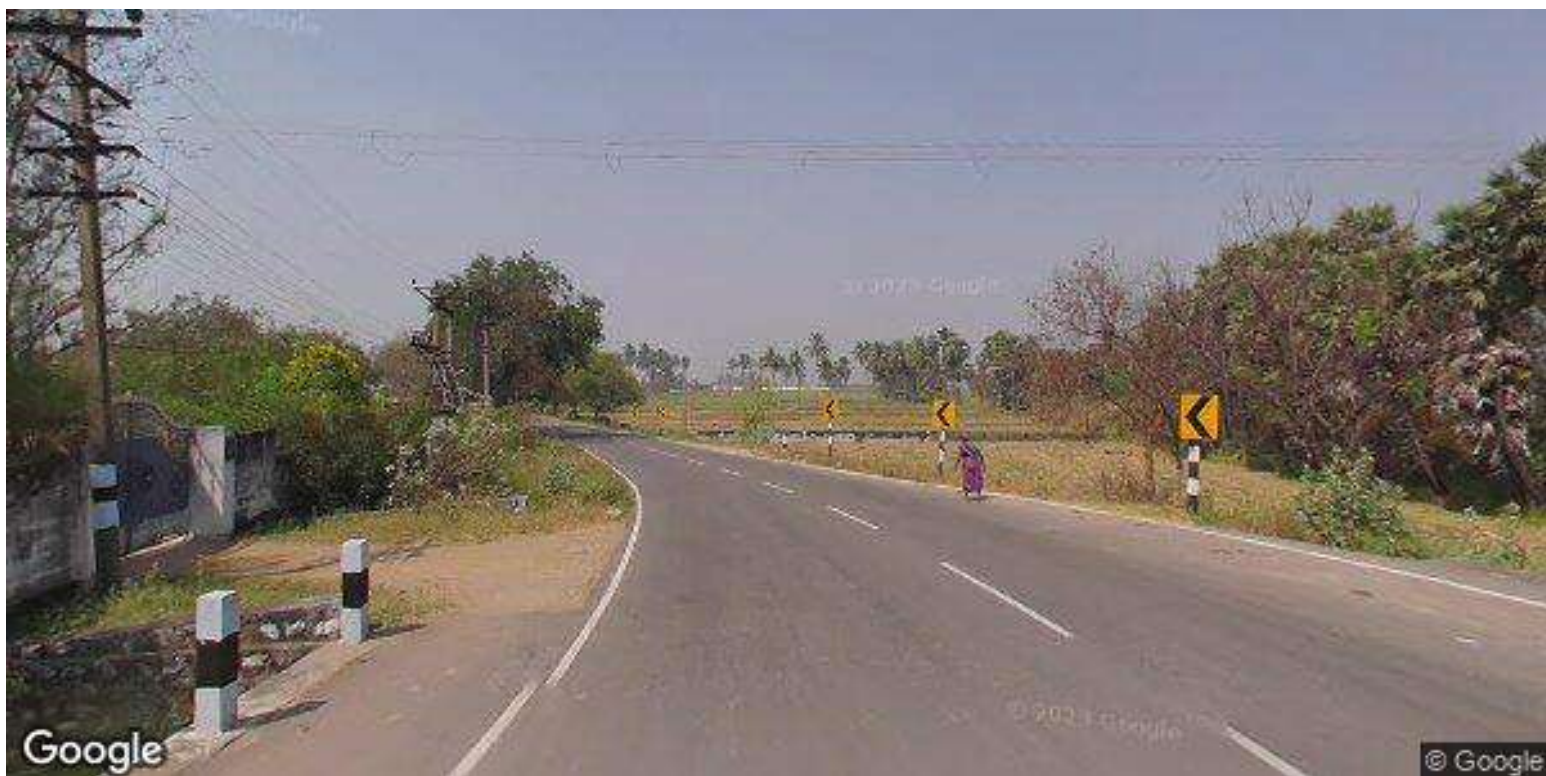
**Risk Type:** Turn  
**Risk Level:** Medium  
**Speed Limit:** 30 KM/Hr  
**Coordinates:** 11.43223, 77.65338

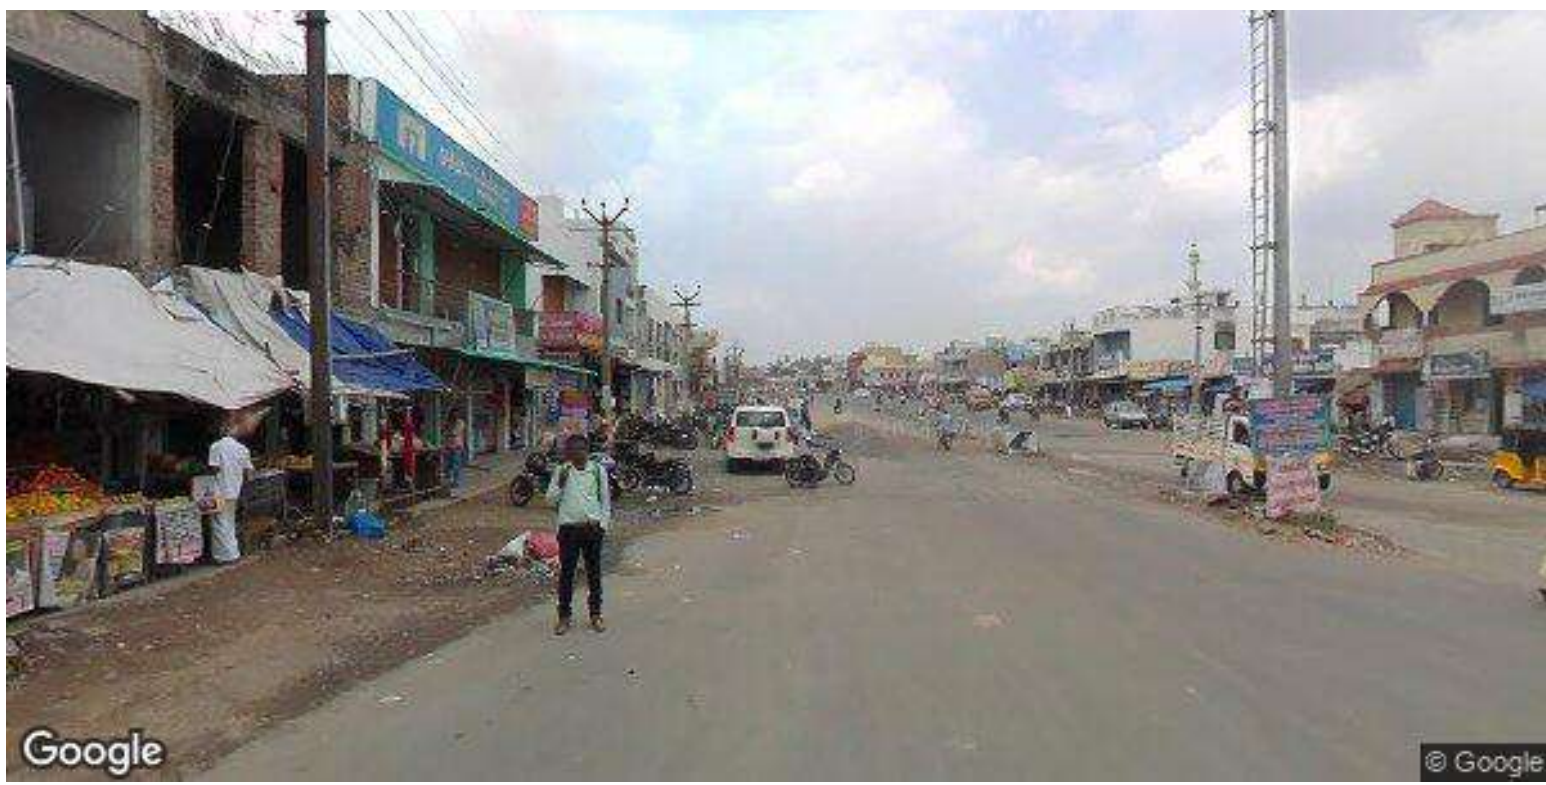
**Coordinates:** 11.42329, 77.55798

**Risk Type:** Turn

**Risk Level:** High

**Speed Limit:** 15 KM/Hr

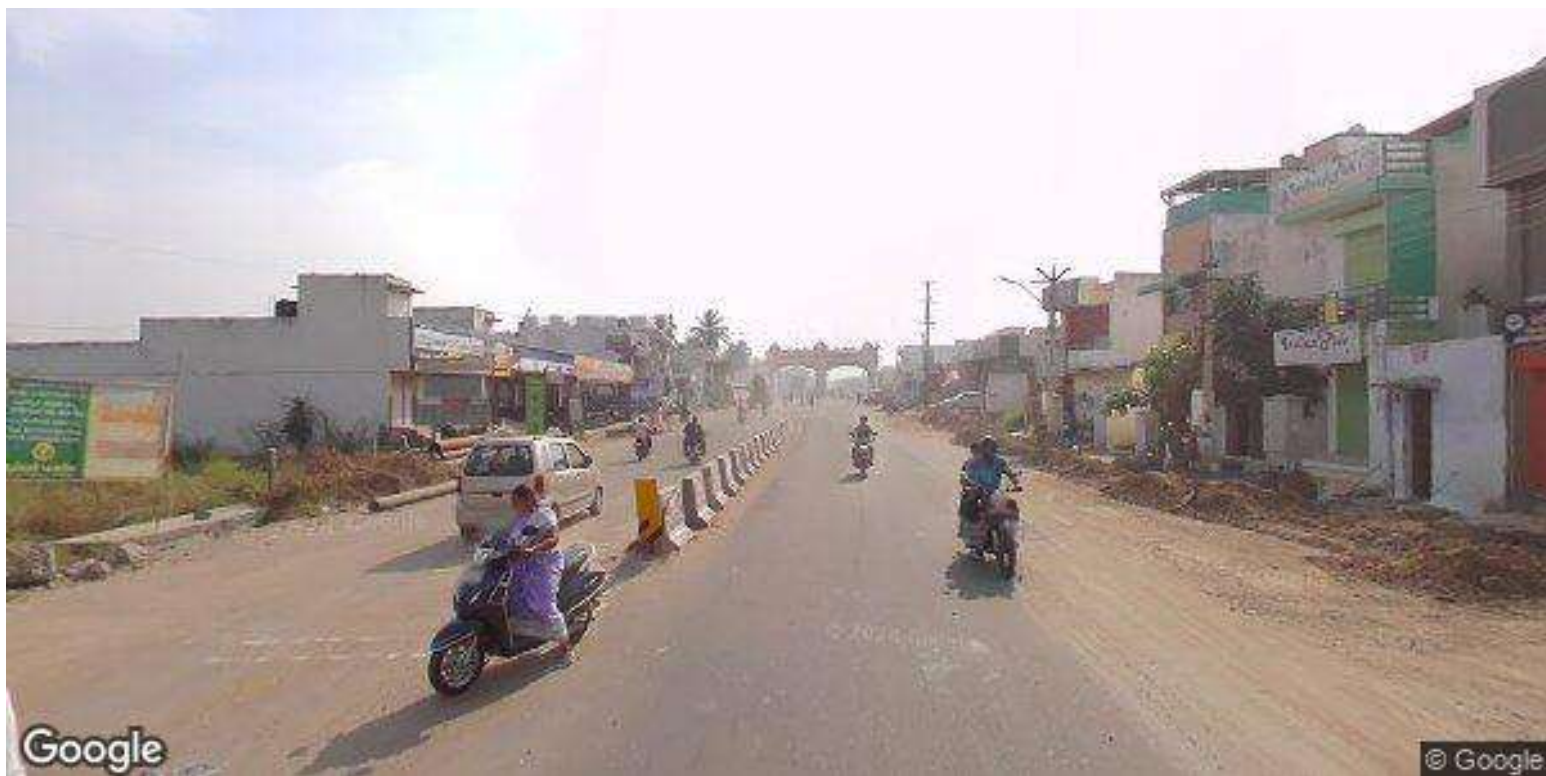
**Coordinates:** 11.45352, 77.44862

**Risk Type:** Blind Spot

**Risk Level:** Blind Spot

**Speed Limit:** 10 KM/Hr
