# IndianOil

## **JOURNEY RISK MANAGEMENT (JRM) STUDY**

### **Salem Terminal to SRI SIVASAKTHI AGENCY**

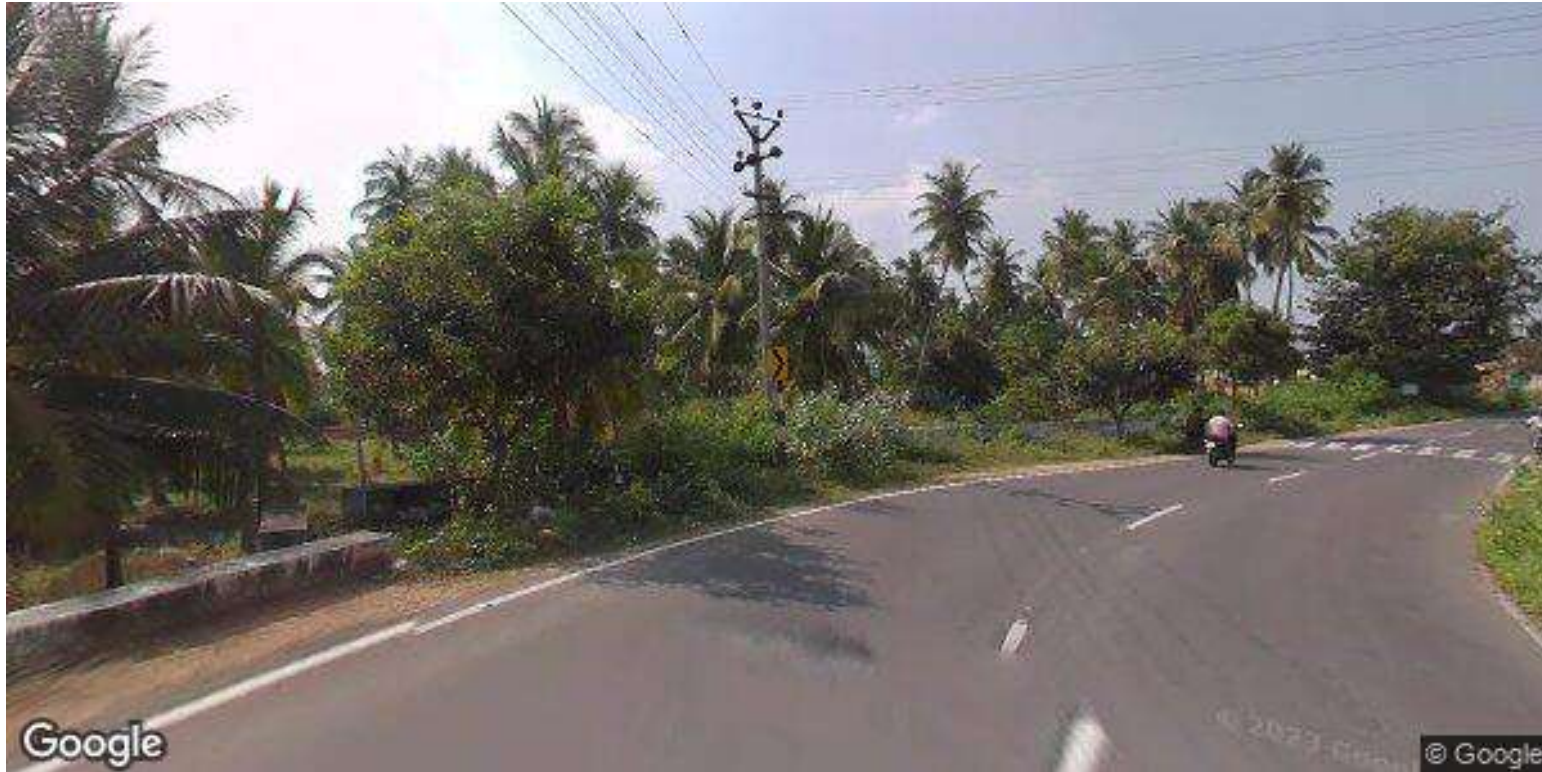
**Risk Type:** Turn  
**Risk Level:** Medium  
**Speed Limit:** 30 KM/Hr  
**Coordinates:** 11.45348, 77.85706

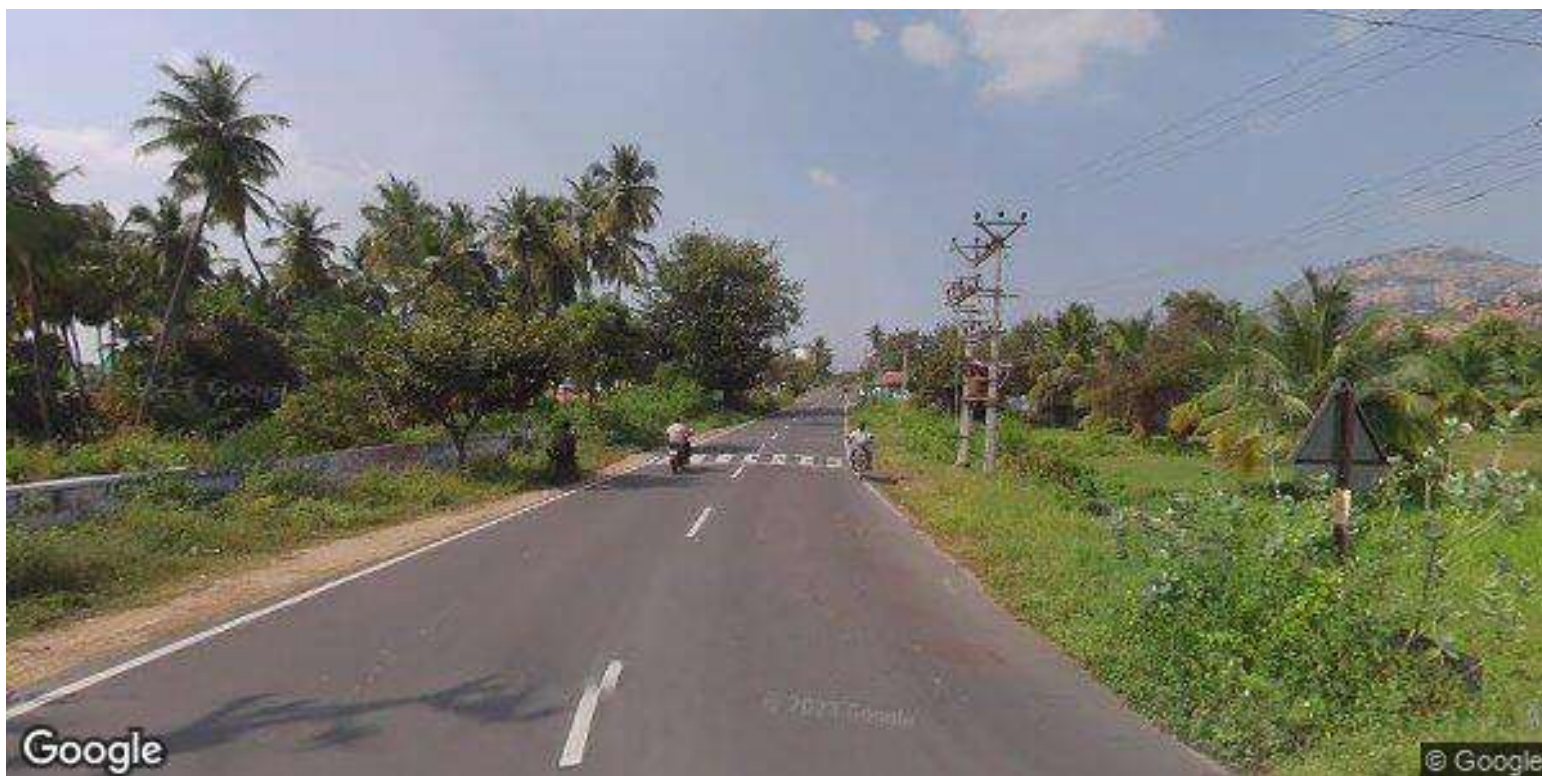
**Risk Type:** Turn  
**Risk Level:** Medium  
**Speed Limit:** 30 KM/Hr  
**Coordinates:** 11.45352, 77.85698

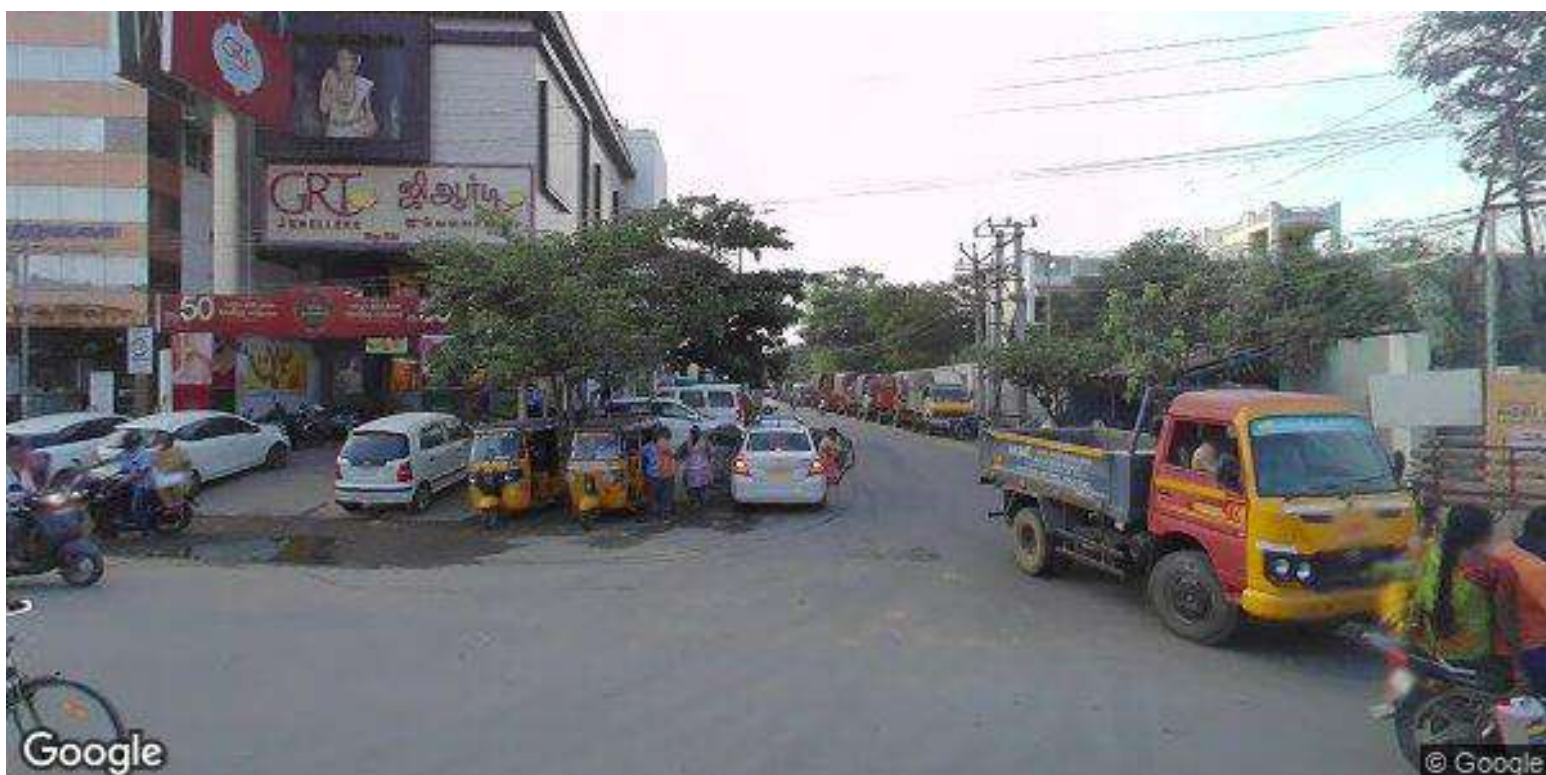
**Coordinates: 11.34678, 77.73104**

**Risk Type: Turn**

**Risk Level: High**

**Speed Limit: 15 KM/Hr**

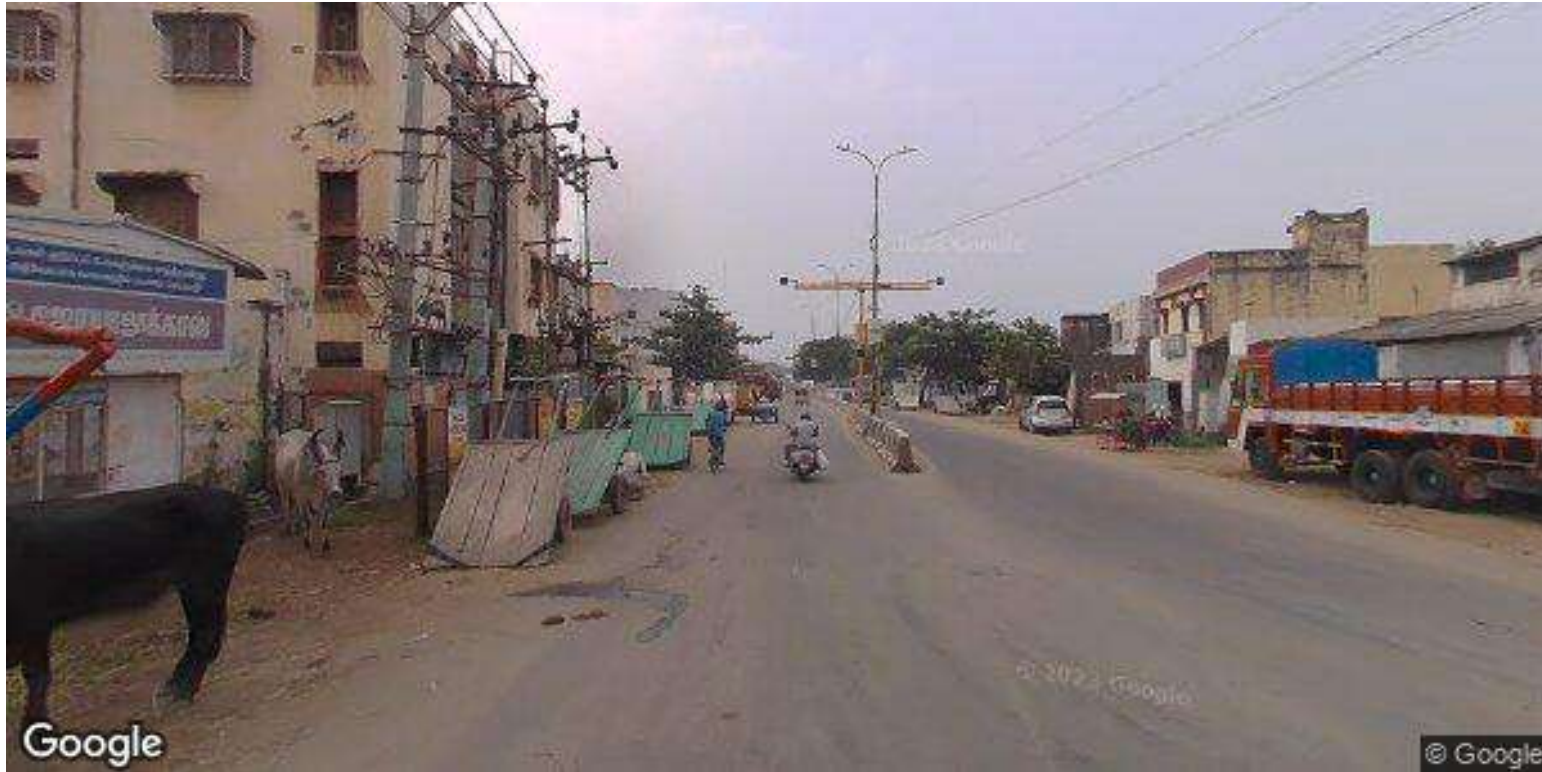
**Coordinates: 11.34680, 77.72584**

**Risk Type: Blind Spot**

**Risk Level: Blind Spot**

**Speed Limit: 10 KM/Hr**

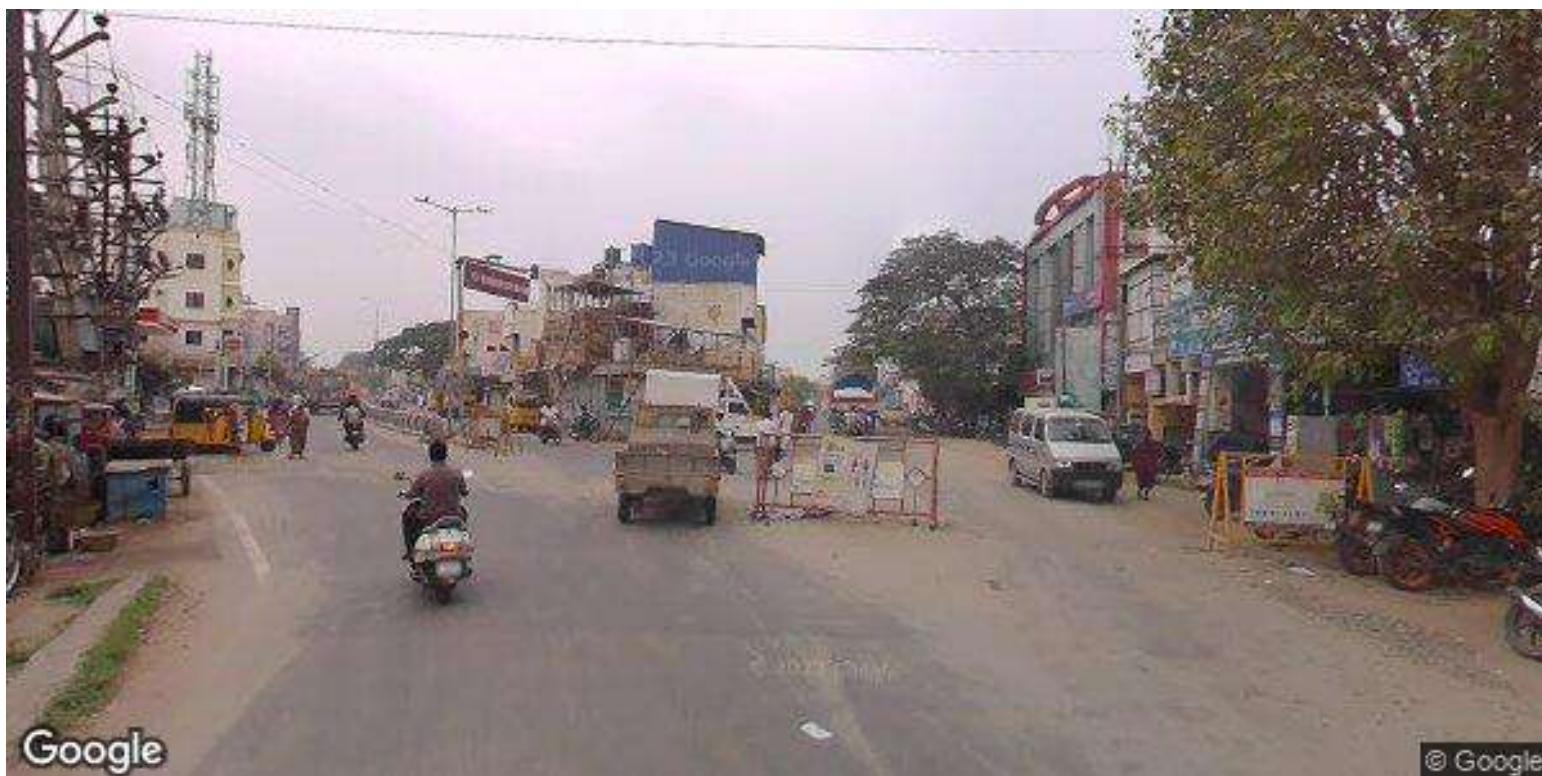
**Coordinates: 11.34492, 77.72706**

**Risk Type: Blind Spot**

**Risk Level: Blind Spot**

**Speed Limit: 10 KM/Hr**

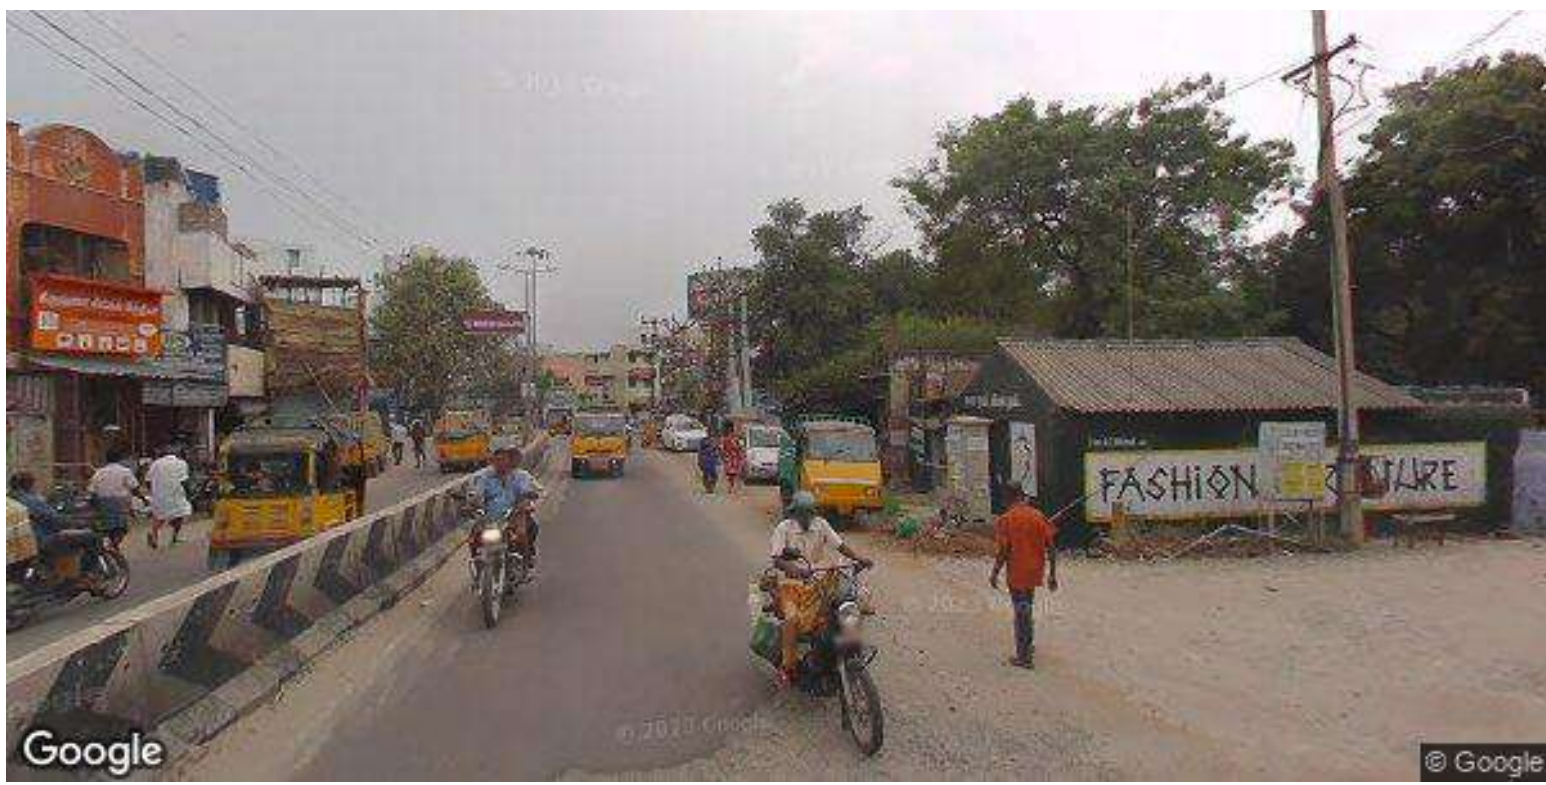
**Coordinates:** 11.34508, 77.72653

**Risk Type:** Turn

**Risk Level:** High

**Speed Limit:** 15 KM/Hr
