# IndianOil

## JOURNEY RISK MANAGEMENT (JRM) STUDY

### Salem Terminal to KPK THILLAI AGENCIESS IOC DEALERS

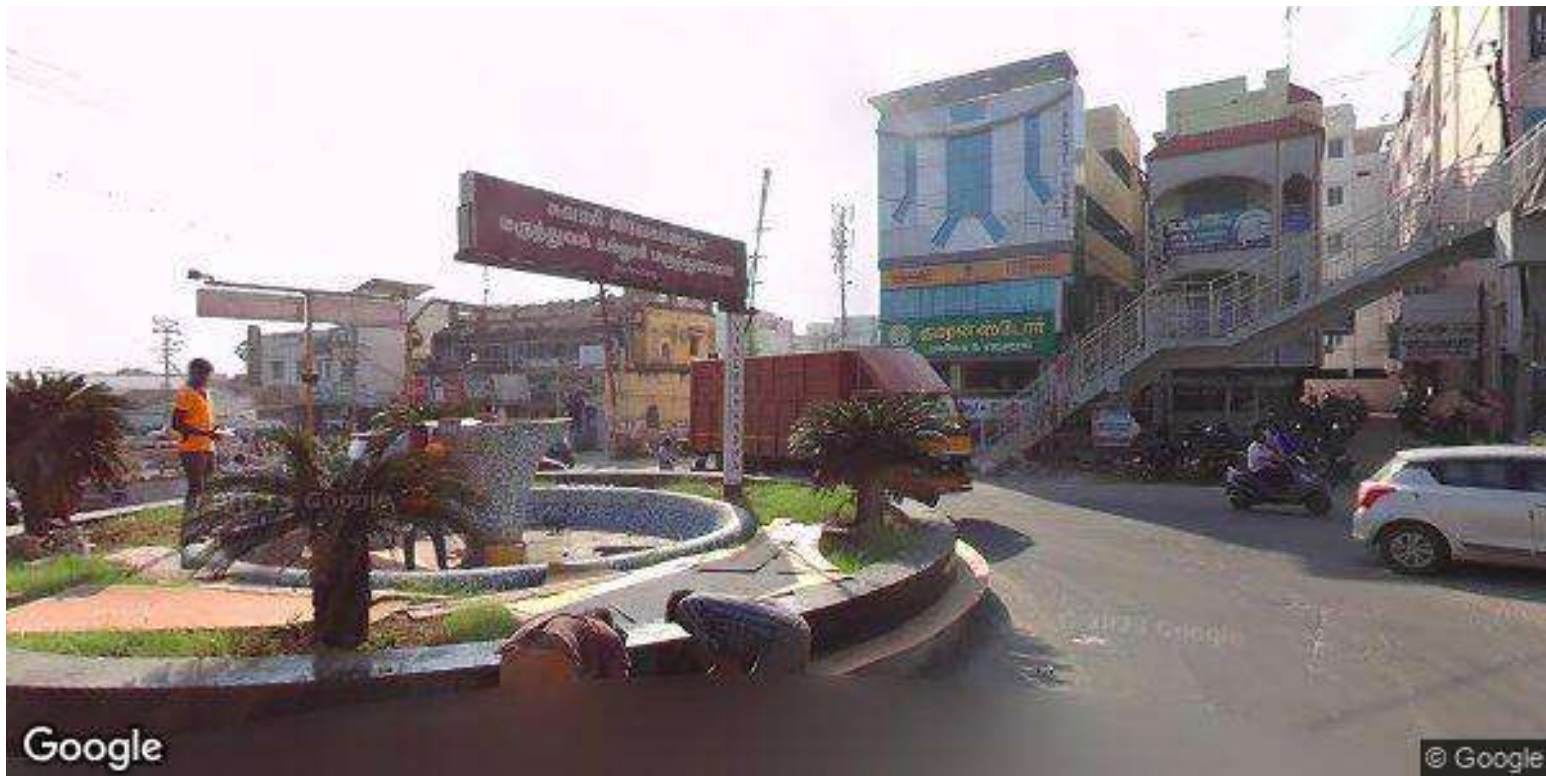
**Coordinates:** 11.38395, 77.89480

**Risk Type:** Roundabout

**Risk Level:** High

**Speed Limit:** 15 KM/Hr

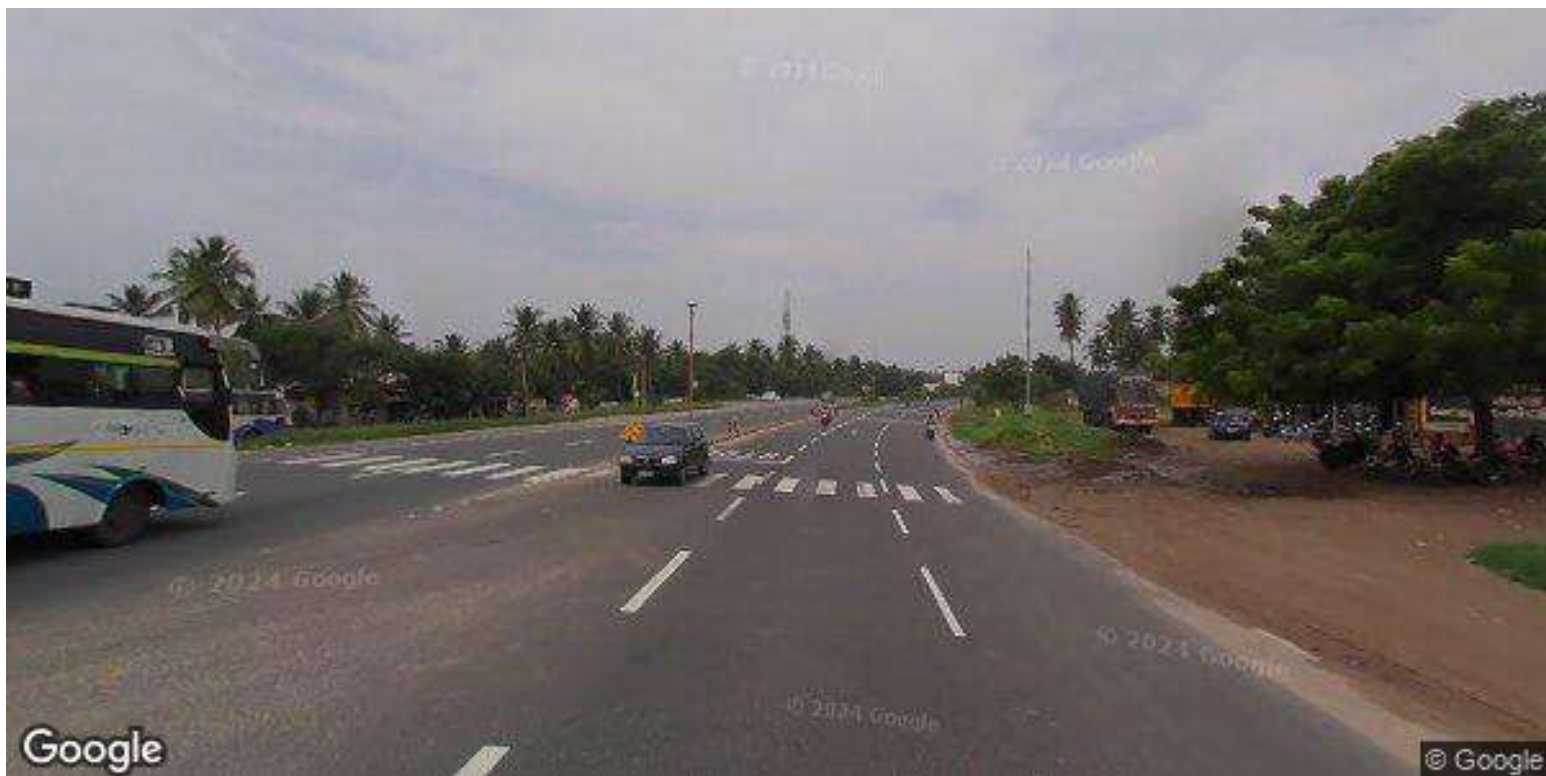
**Coordinates:** 11.12555, 78.01664

**Risk Type:** Turn

**Risk Level:** High

**Speed Limit:** 15 KM/Hr

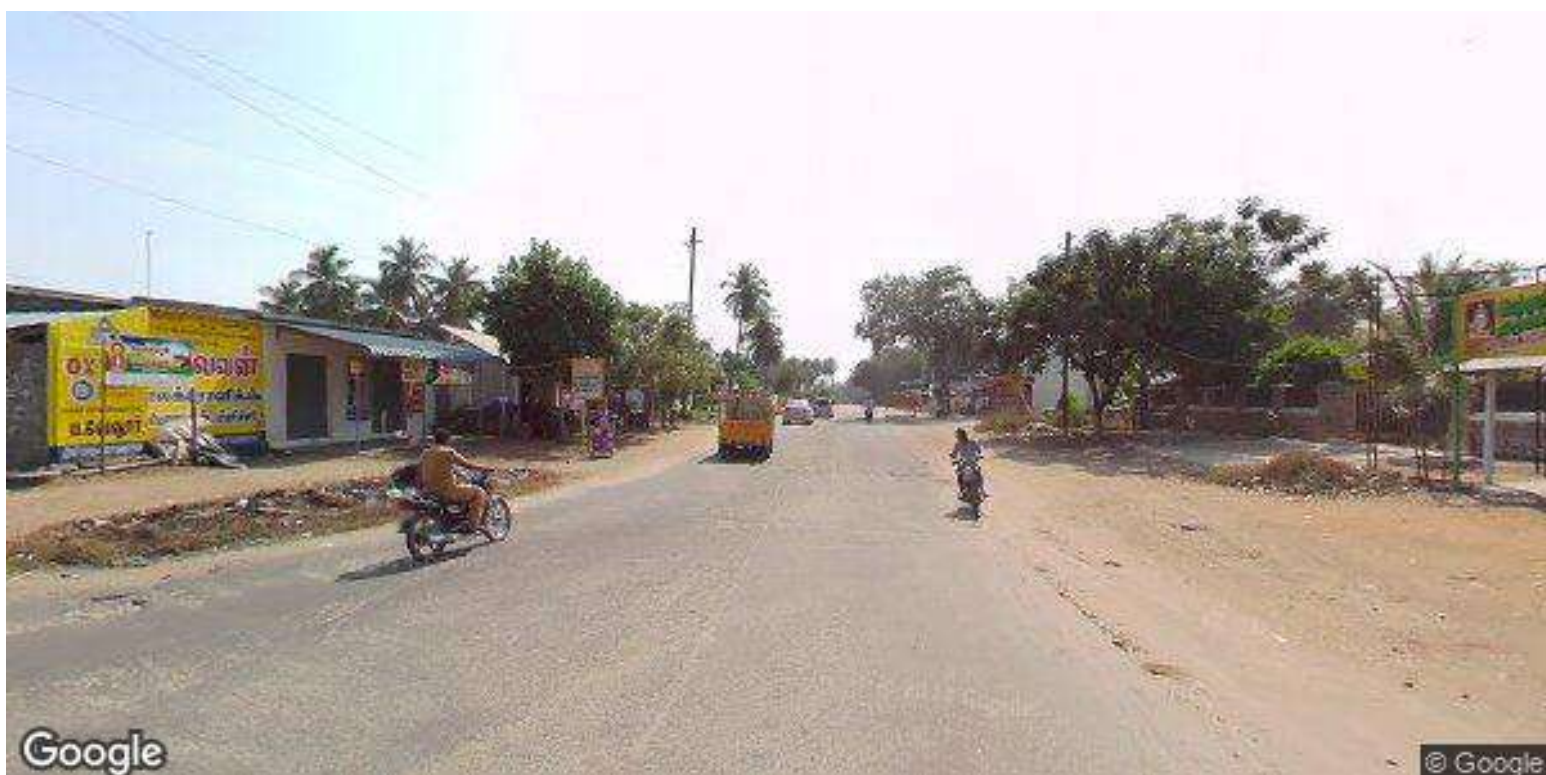
**Coordinates:** 11.12540, 78.01613

**Risk Type:** Turn

**Risk Level:** High

**Speed Limit:** 15 KM/Hr
