## JOURNEY RISK MANAGEMENT (JRM) STUDY

### Salem Terminal TO P.S.AGENCIES IOC DEALERS

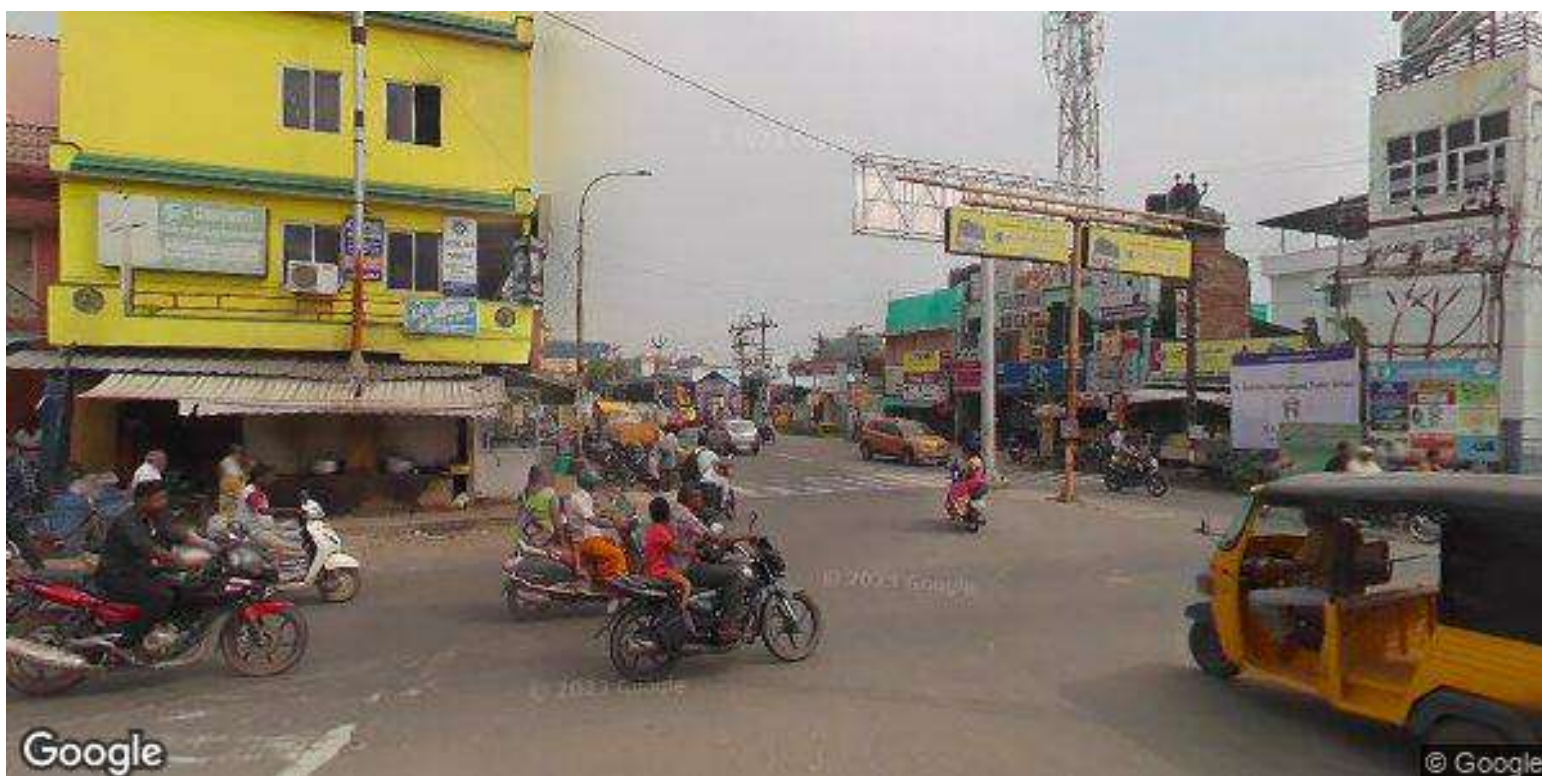
**Risk Type:** Roundabout  
**Risk Level:** High  
**Speed Limit:** 15 KM/Hr  
**Coordinates:** 11.66434, 78.13175

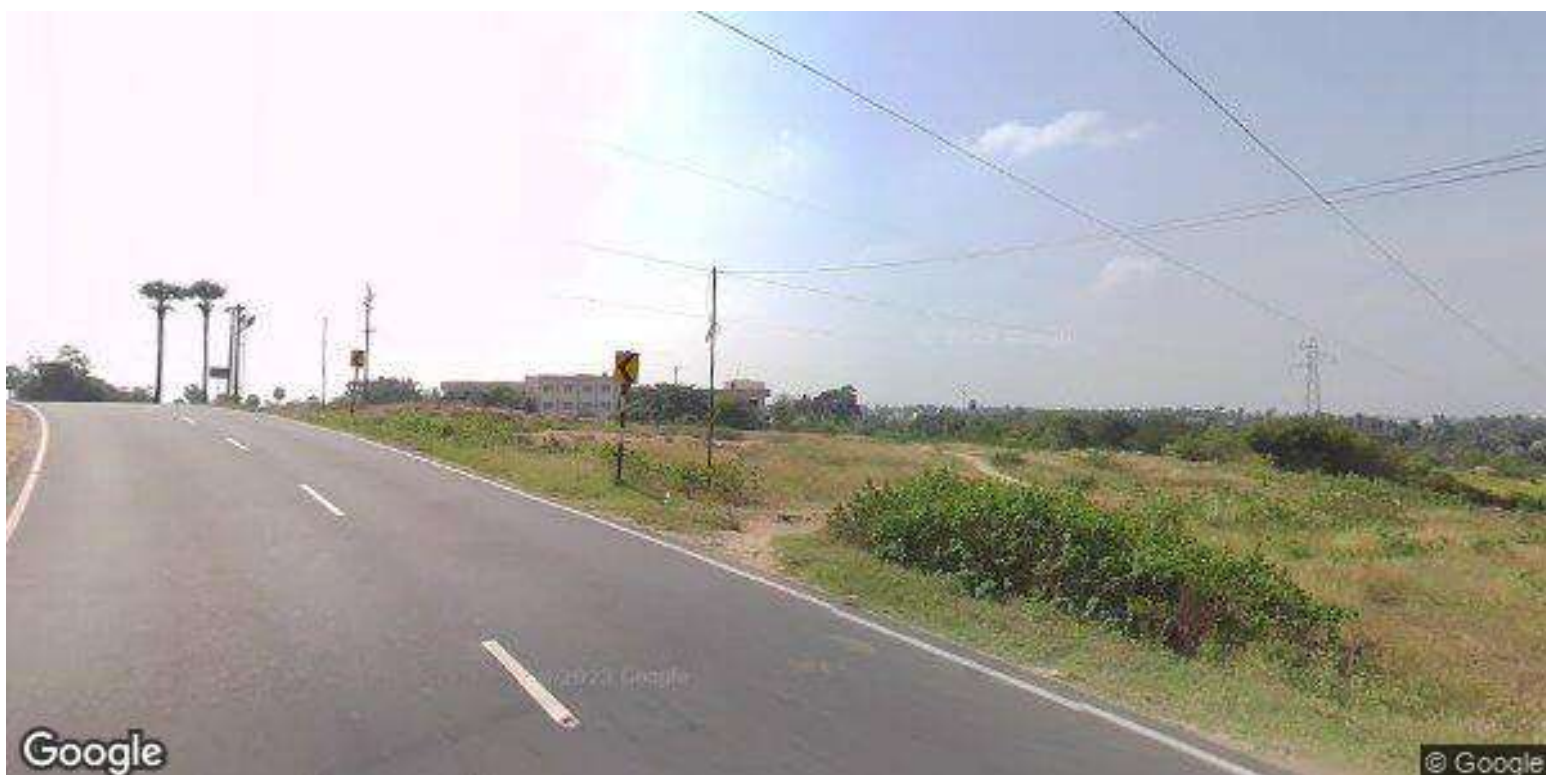
**Coordinates:** 11.46048, 77.85036

**Risk Type:** Turn

**Risk Level:** Medium

**Speed Limit:** 30 KM/Hr

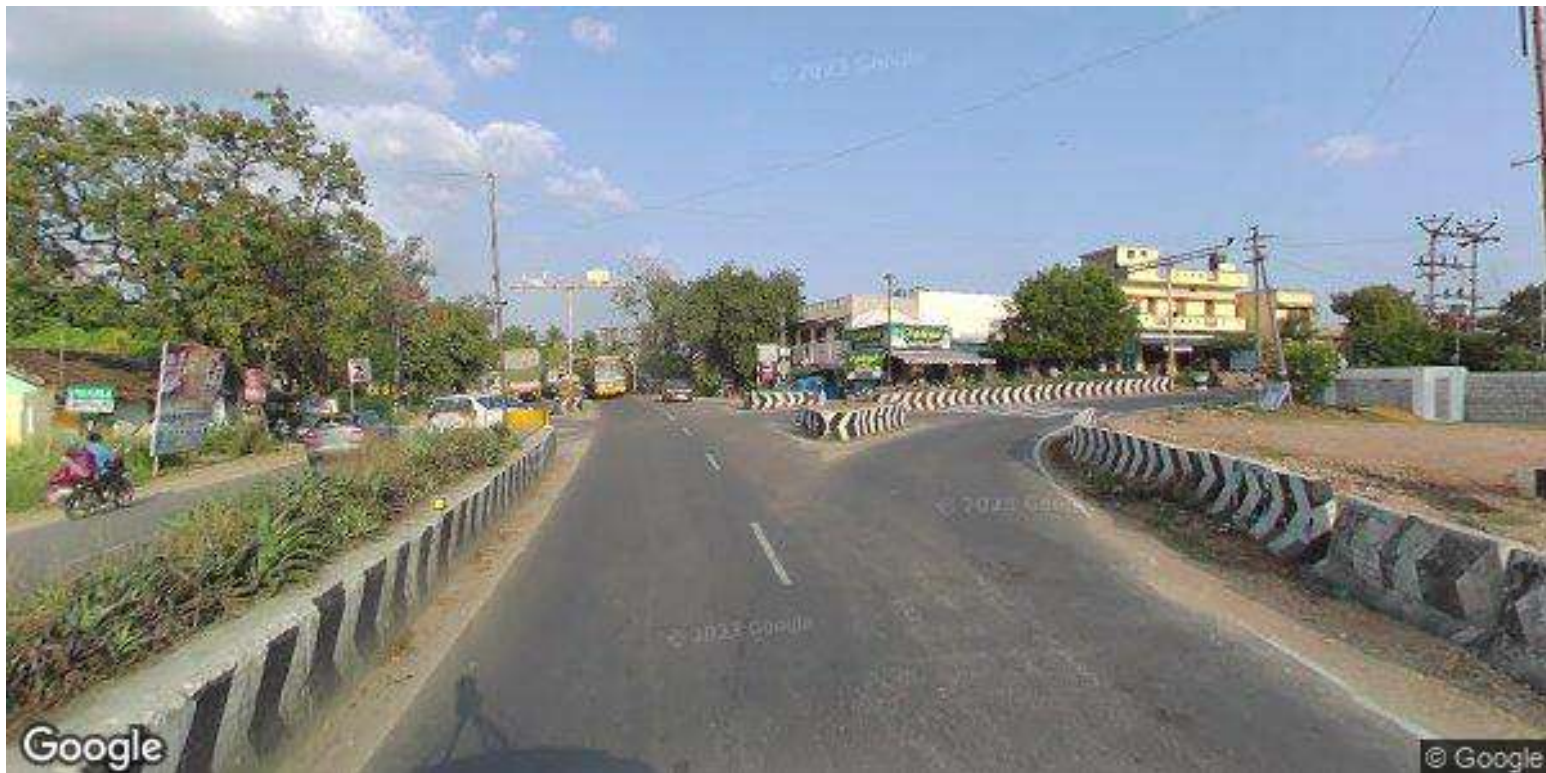
**Coordinates:** 11.46318, 77.84913

**Risk Type:** Turn

**Risk Level:** Medium

**Speed Limit:** 30 KM/Hr

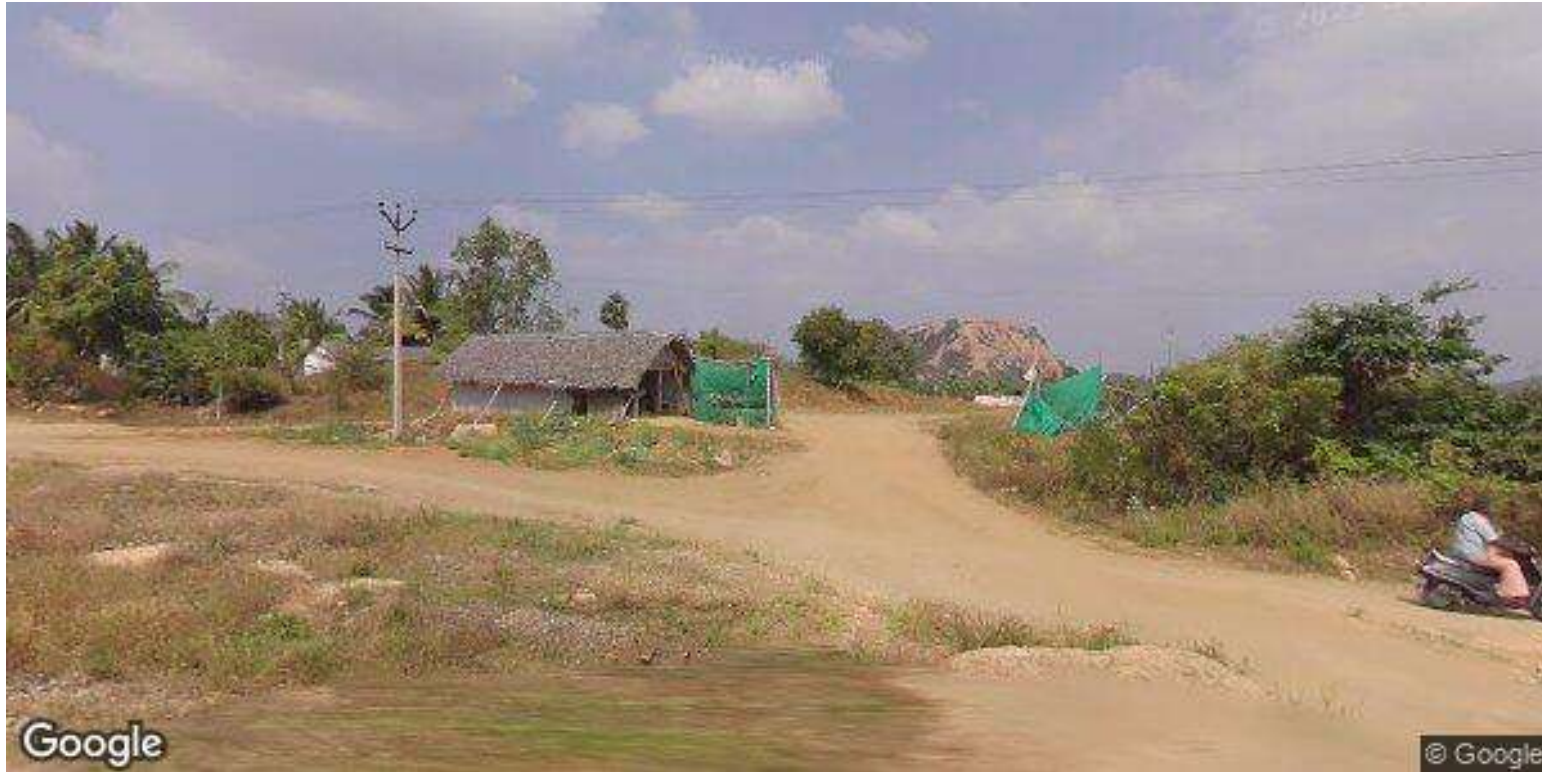
**Risk Type:** Turn  
**Risk Level:** Medium  
**Speed Limit:** 30 KM/Hr  
**Coordinates:** 11.49419, 77.88015

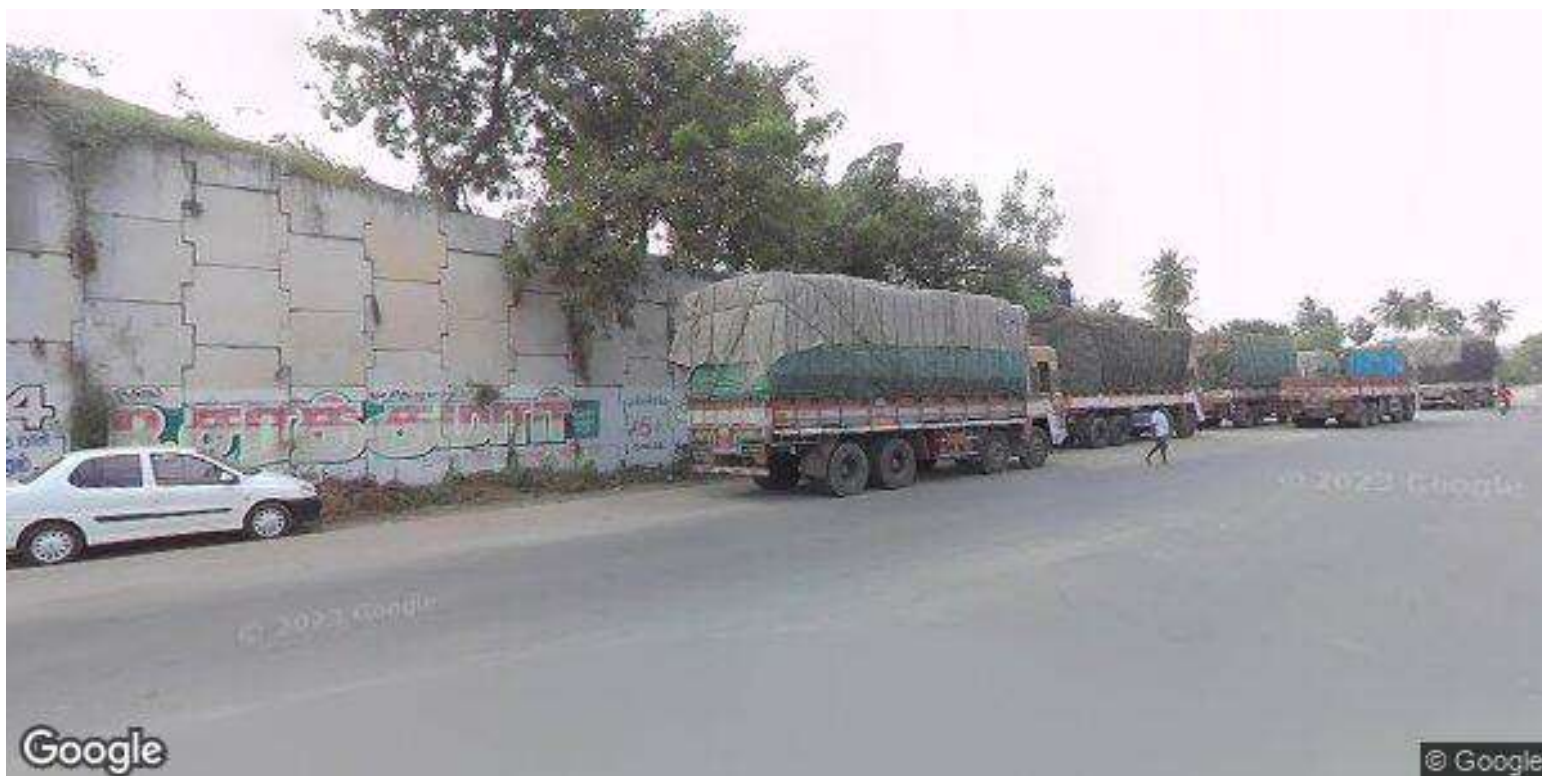
**Risk Type:** Turn  
**Risk Level:** Medium  
**Speed Limit:** 30 KM/Hr  
**Coordinates:** 11.49365, 77.88596

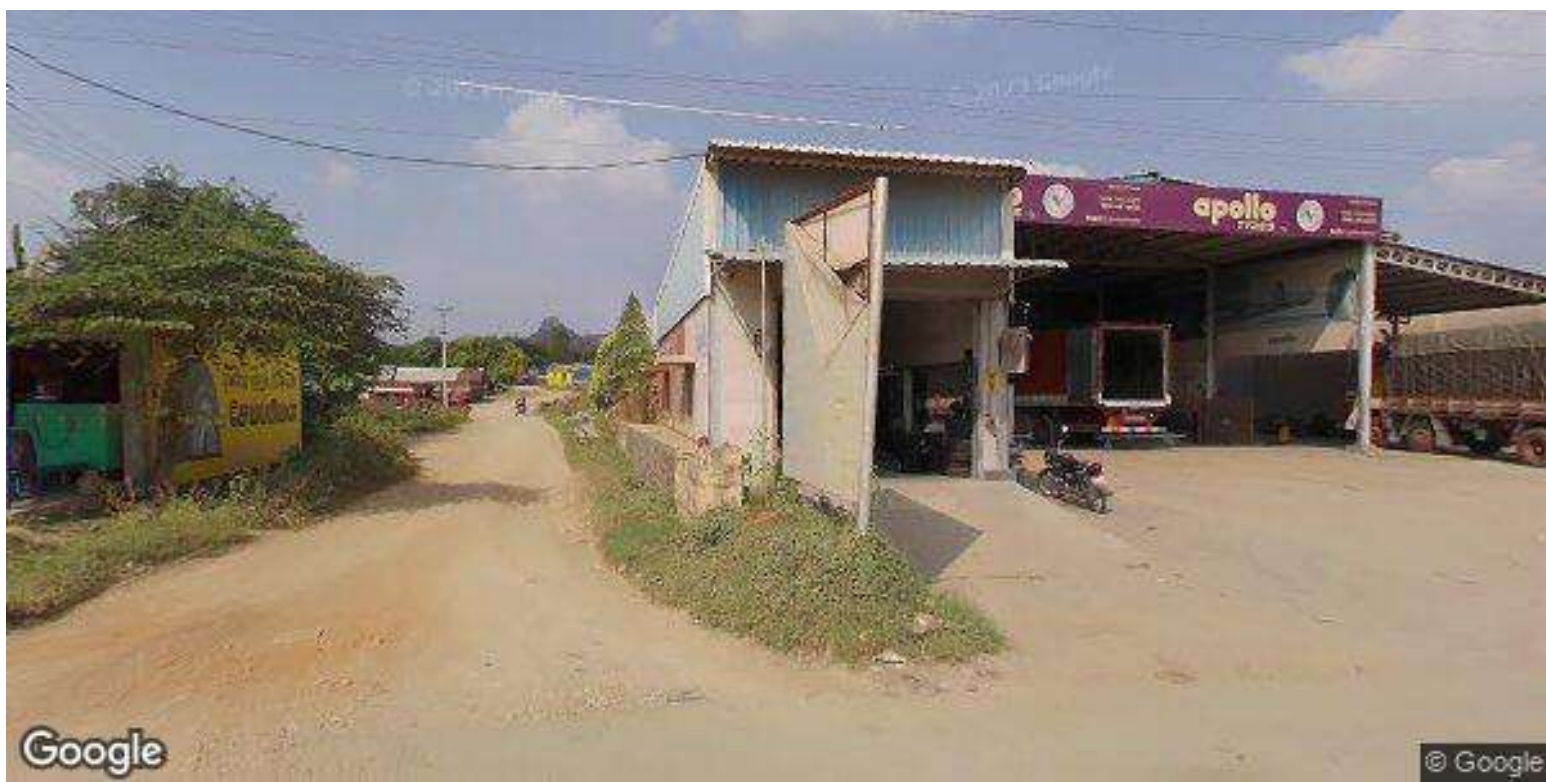
**Coordinates:** 11.49235, 77.89561

**Risk Type:** Turn

**Risk Level:** High

**Speed Limit:** 15 KM/Hr

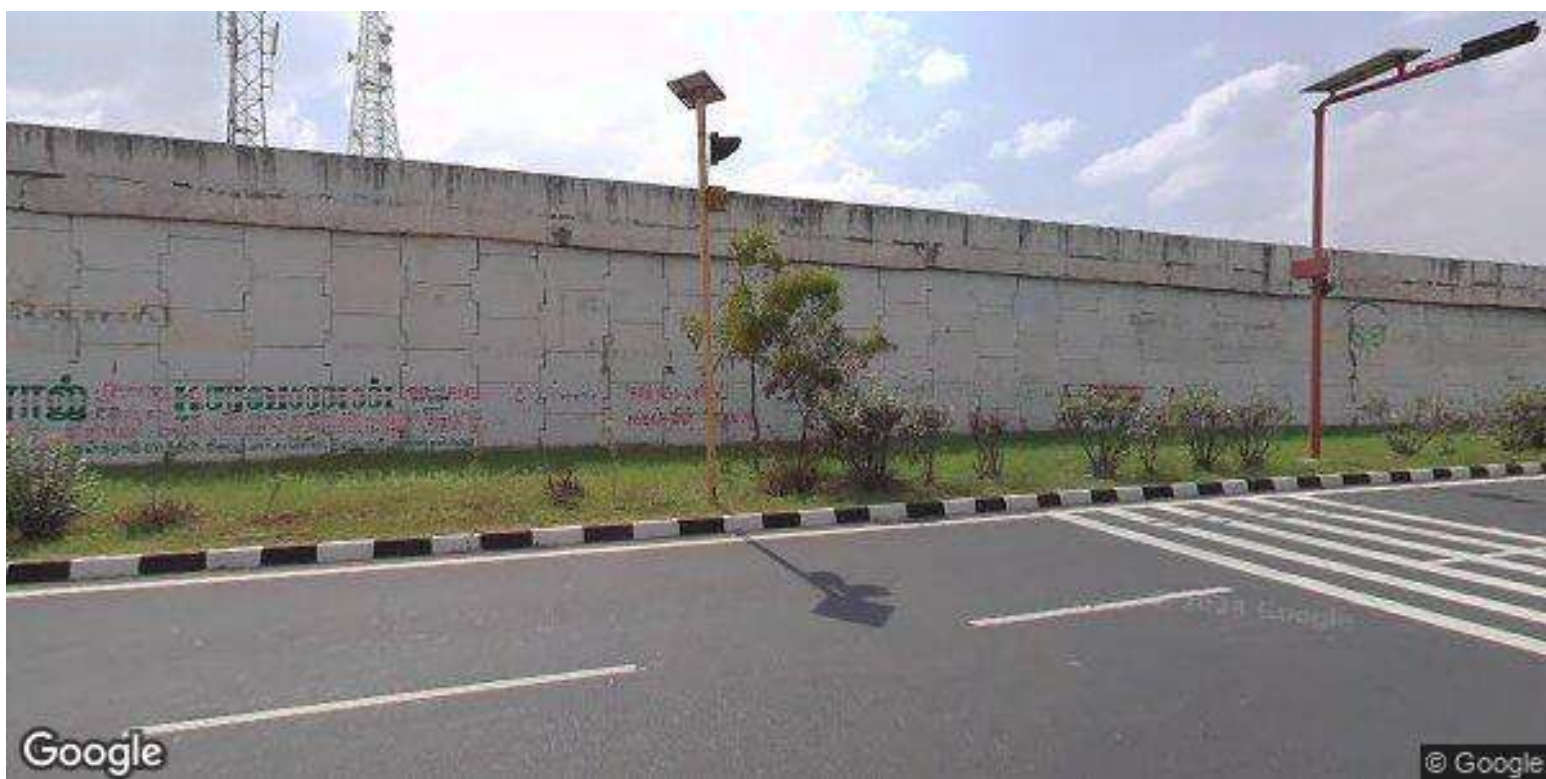
**Coordinates:** 11.49225, 77.89560

**Risk Type:** Blind Spot

**Risk Level:** Blind Spot

**Speed Limit:** 10 KM/Hr

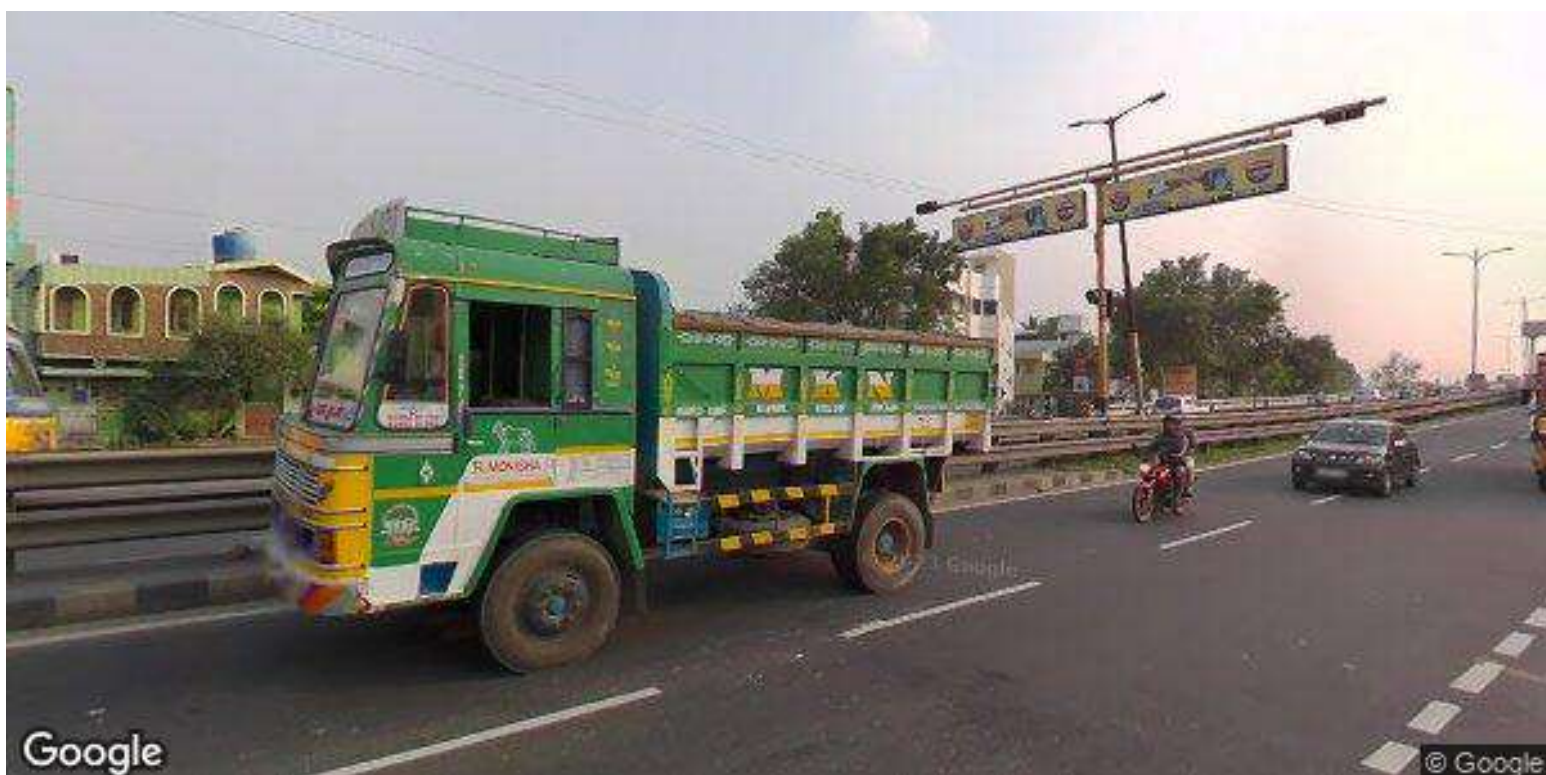
**Risk Type:** Turn  
**Risk Level:** High  
**Speed Limit:** 15 KM/Hr  
**Coordinates:** 11.66458, 78.12303

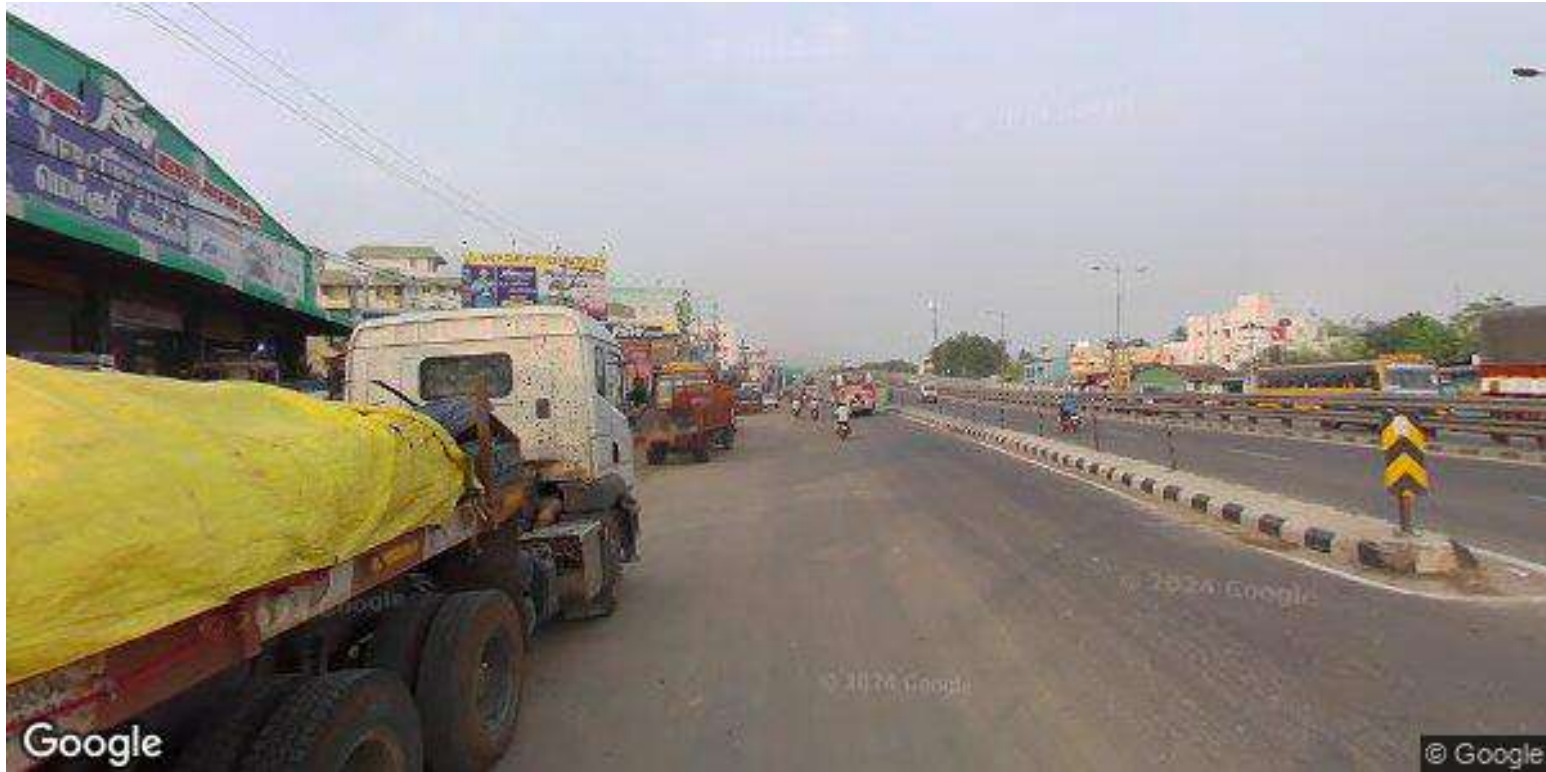
**Risk Type:** Turn  
**Risk Level:** High  
**Speed Limit:** 15 KM/Hr  
**Coordinates:** 11.66477, 78.12298

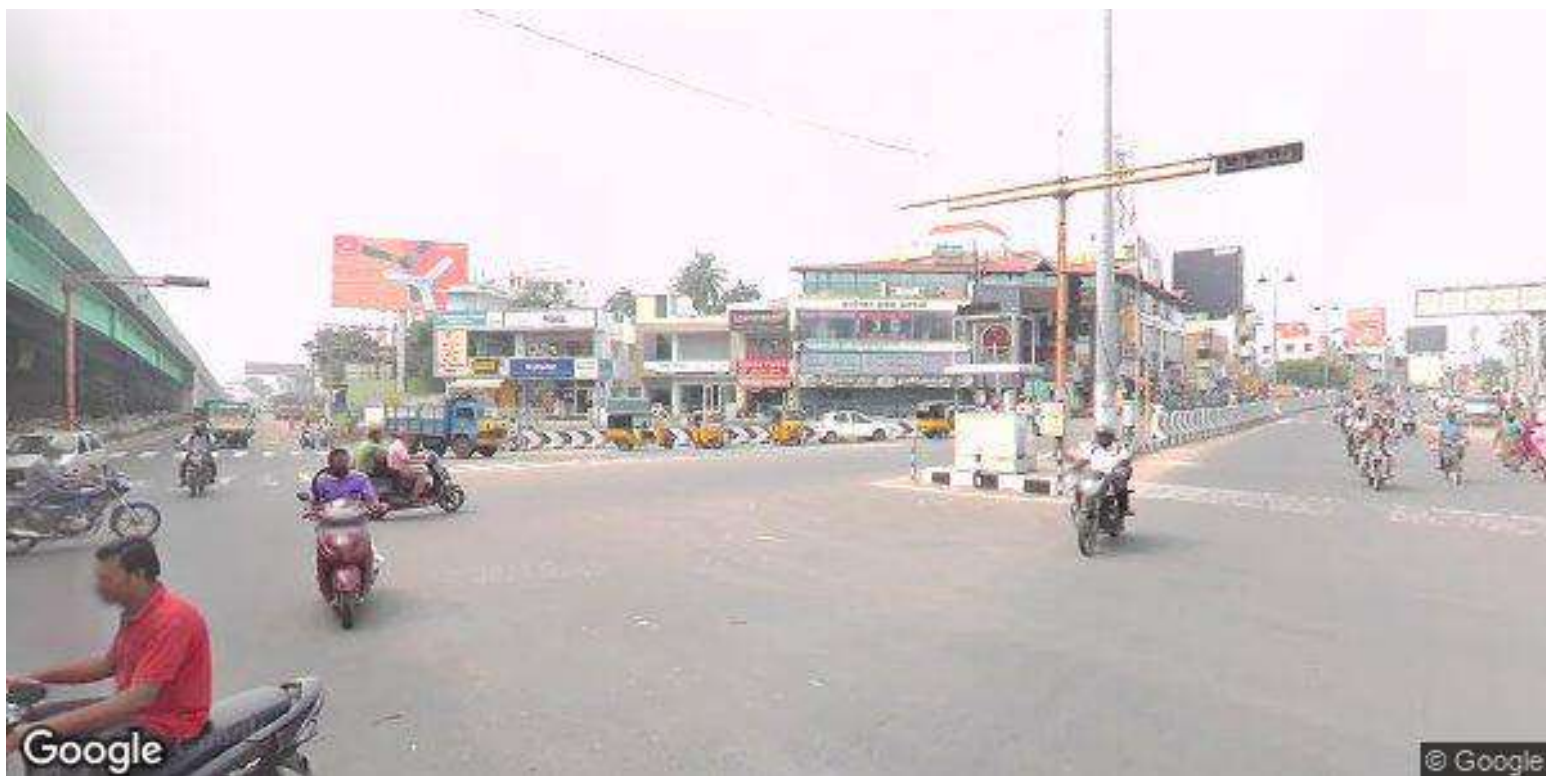
**Risk Type:** Turn  
**Risk Level:** High  
**Speed Limit:** 15 KM/Hr  
**Coordinates:** 11.66763, 78.12466

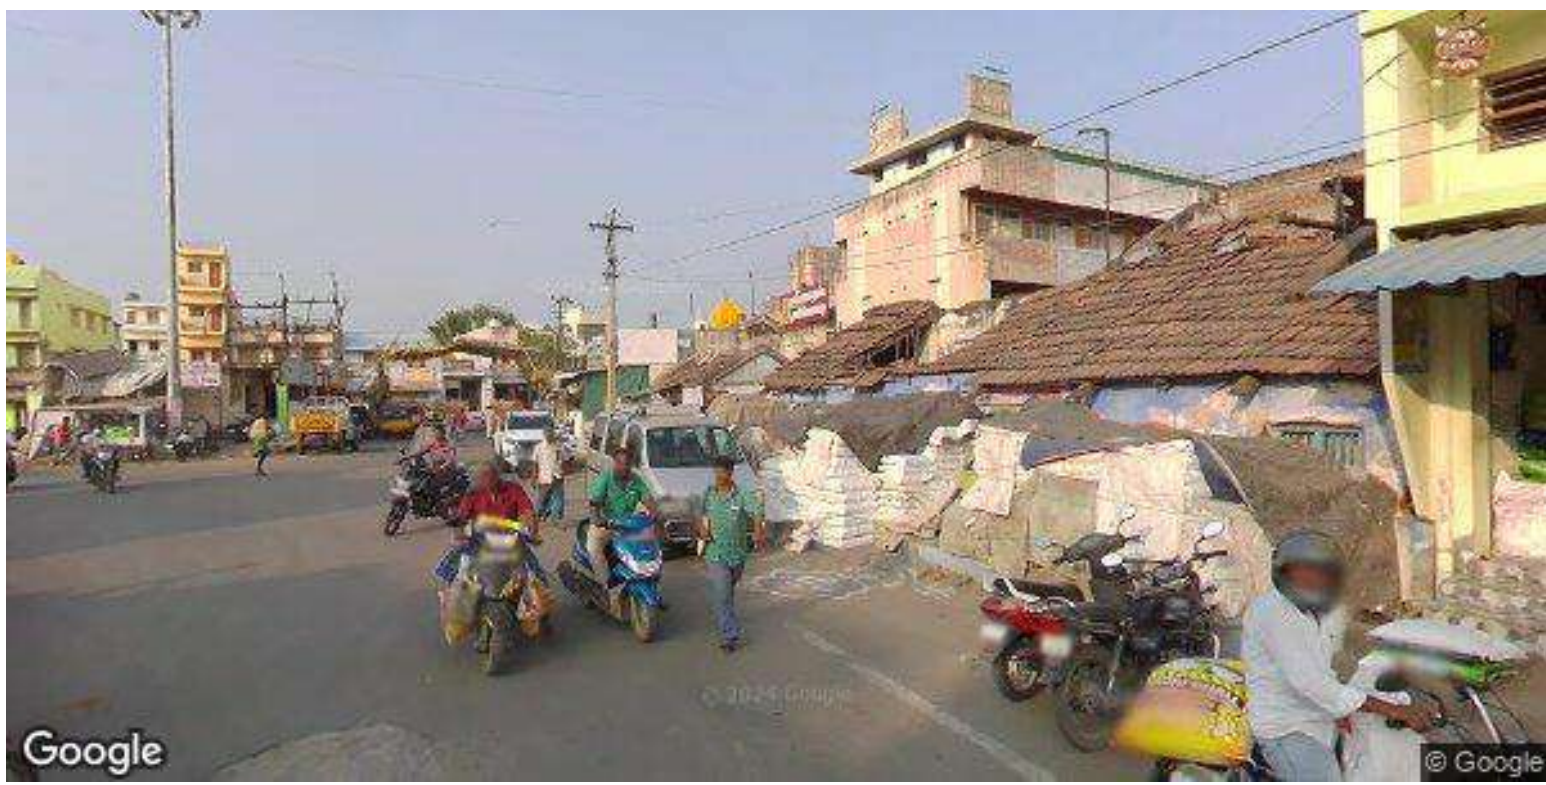
**Coordinates:** 11.65141, 78.14234

**Risk Type:** Blind Spot

**Risk Level:** Blind Spot

**Speed Limit:** 10 KM/Hr

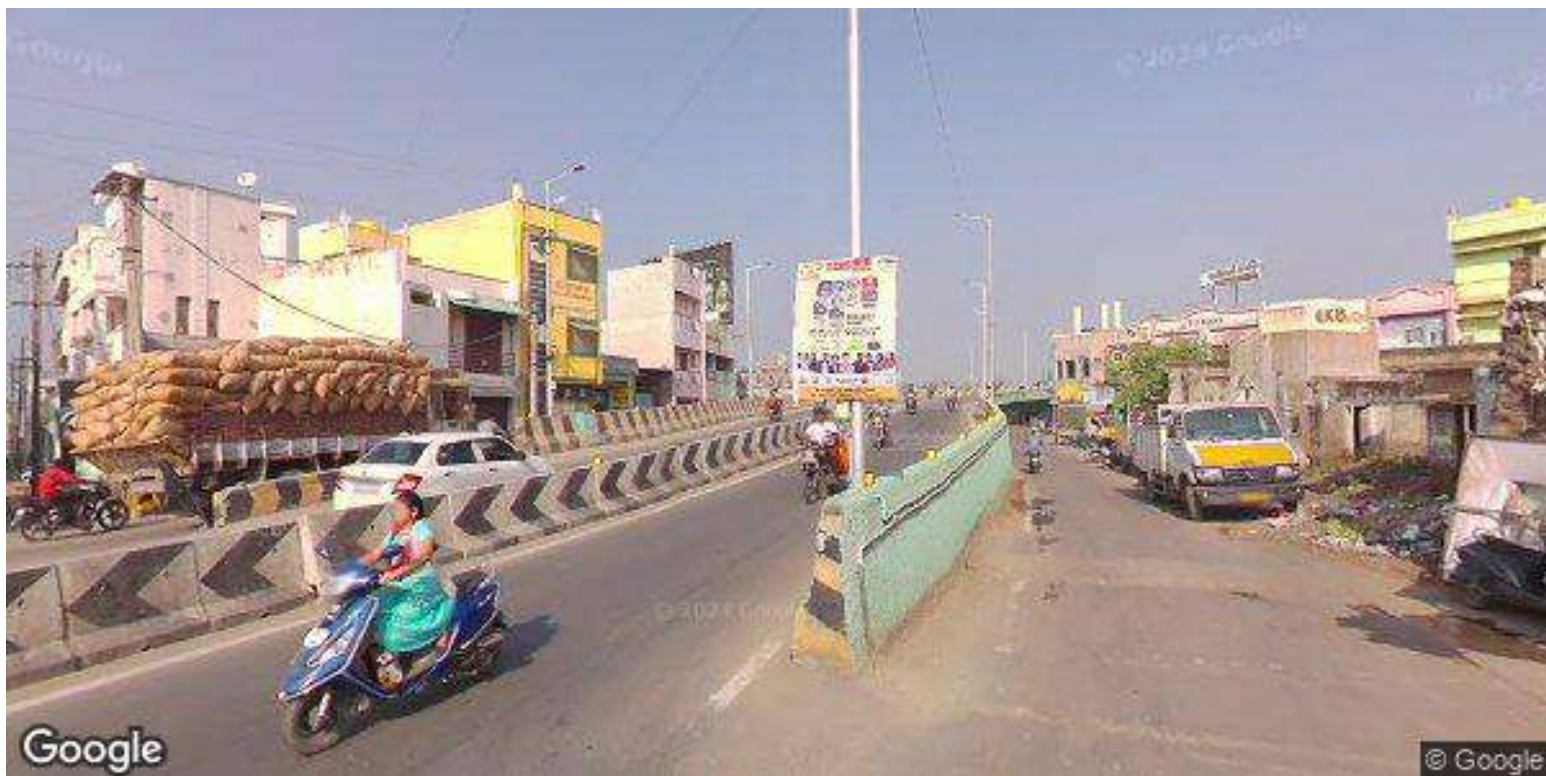
**Coordinates:** 11.65161, 78.14230

**Risk Type:** Turn

**Risk Level:** Medium

**Speed Limit:** 30 KM/Hr

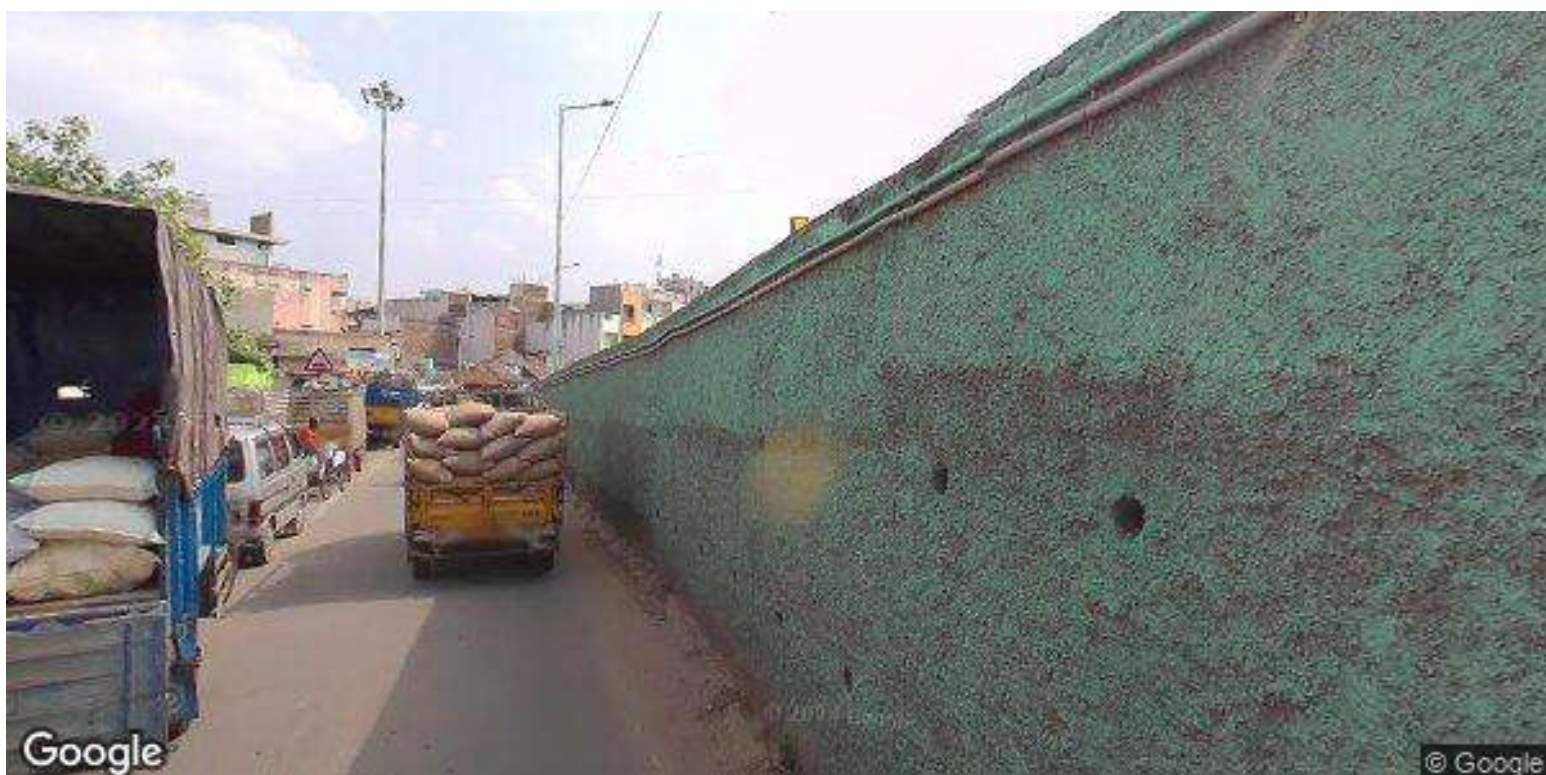
**Risk Type:** Blind Spot  
**Risk Level:** Blind Spot  
**Speed Limit:** 10 KM/Hr  
**Coordinates:** 11.65191, 78.14199

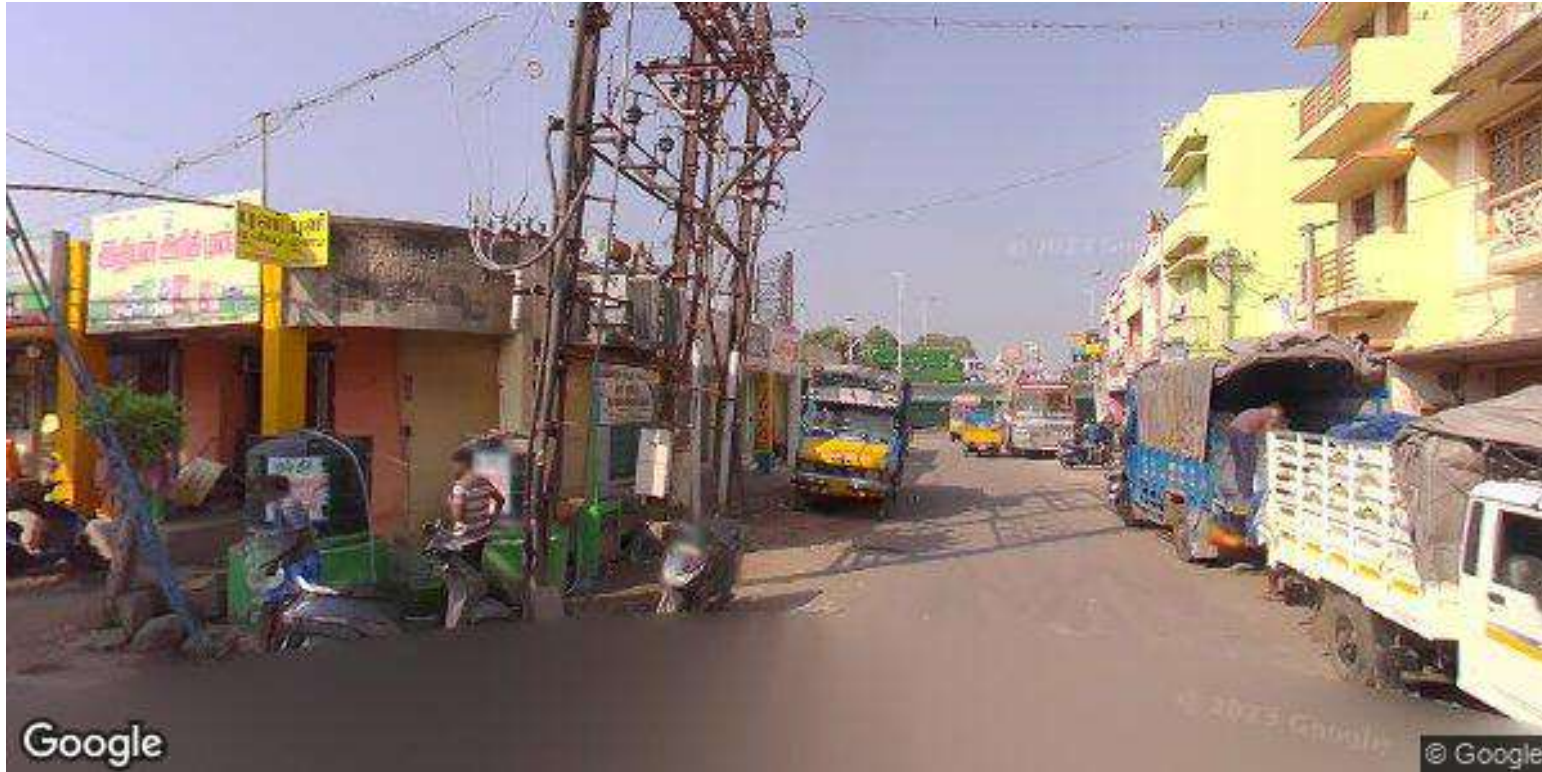
**Risk Type:** Blind Spot  
**Risk Level:** Blind Spot  
**Speed Limit:** 10 KM/Hr  
**Coordinates:** 11.65197, 78.14241

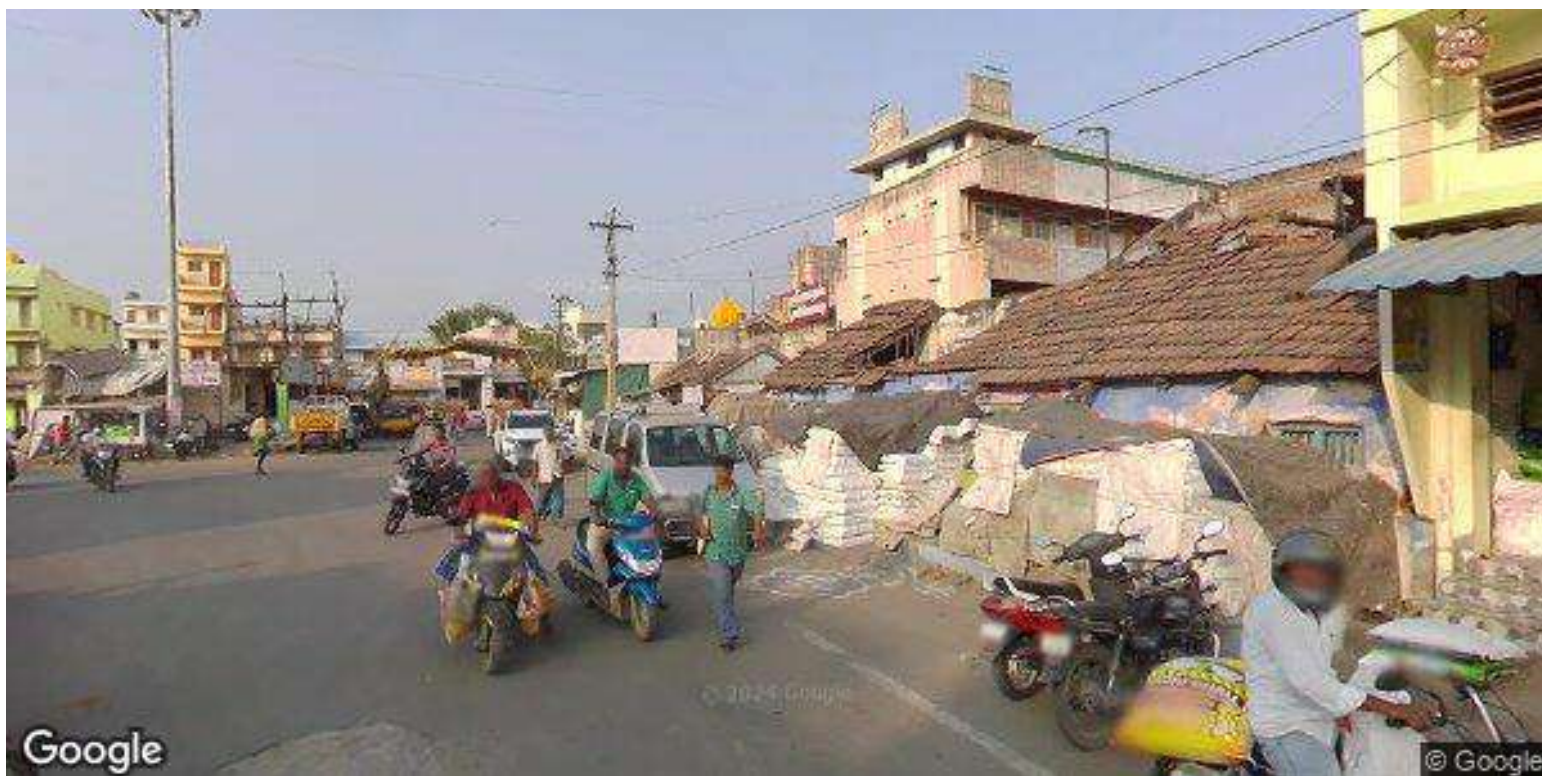
**Risk Type:** Blind Spot  
**Risk Level:** Blind Spot  
**Speed Limit:** 10 KM/Hr  
**Coordinates:** 11.65141, 78.14234

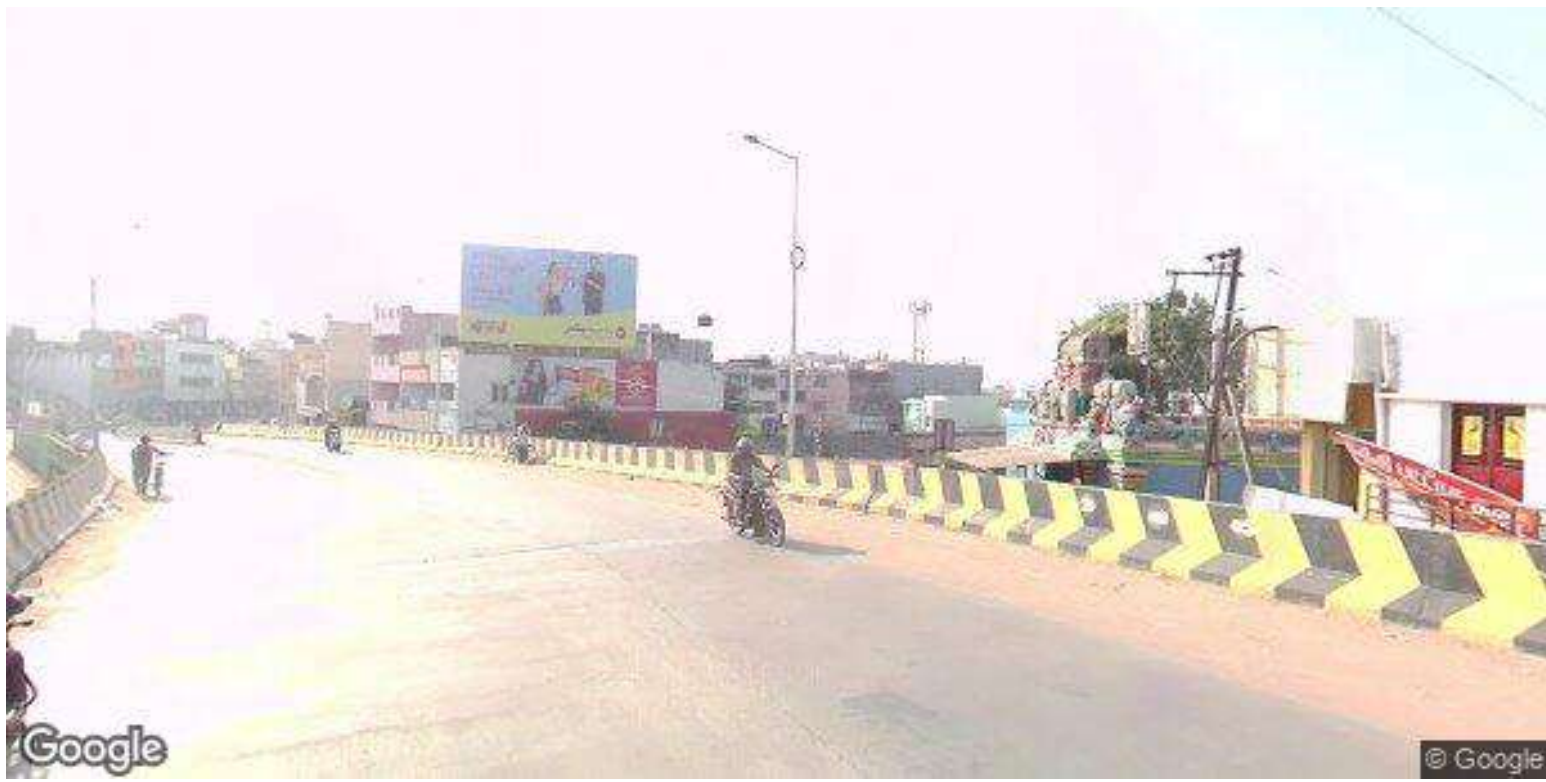
**Coordinates:** 11.65221, 78.14162

**Risk Type:** Turn

**Risk Level:** Medium

**Speed Limit:** 30 KM/Hr
