# IndianOil

## JOURNEY RISK MANAGEMENT (JRM) STUDY

### Salem Terminal to SRI VEERAKUMAR AUTO SERVICE

### Route Safety Analysis: Sangagiri to Chinnaputhur, Tamil Nadu

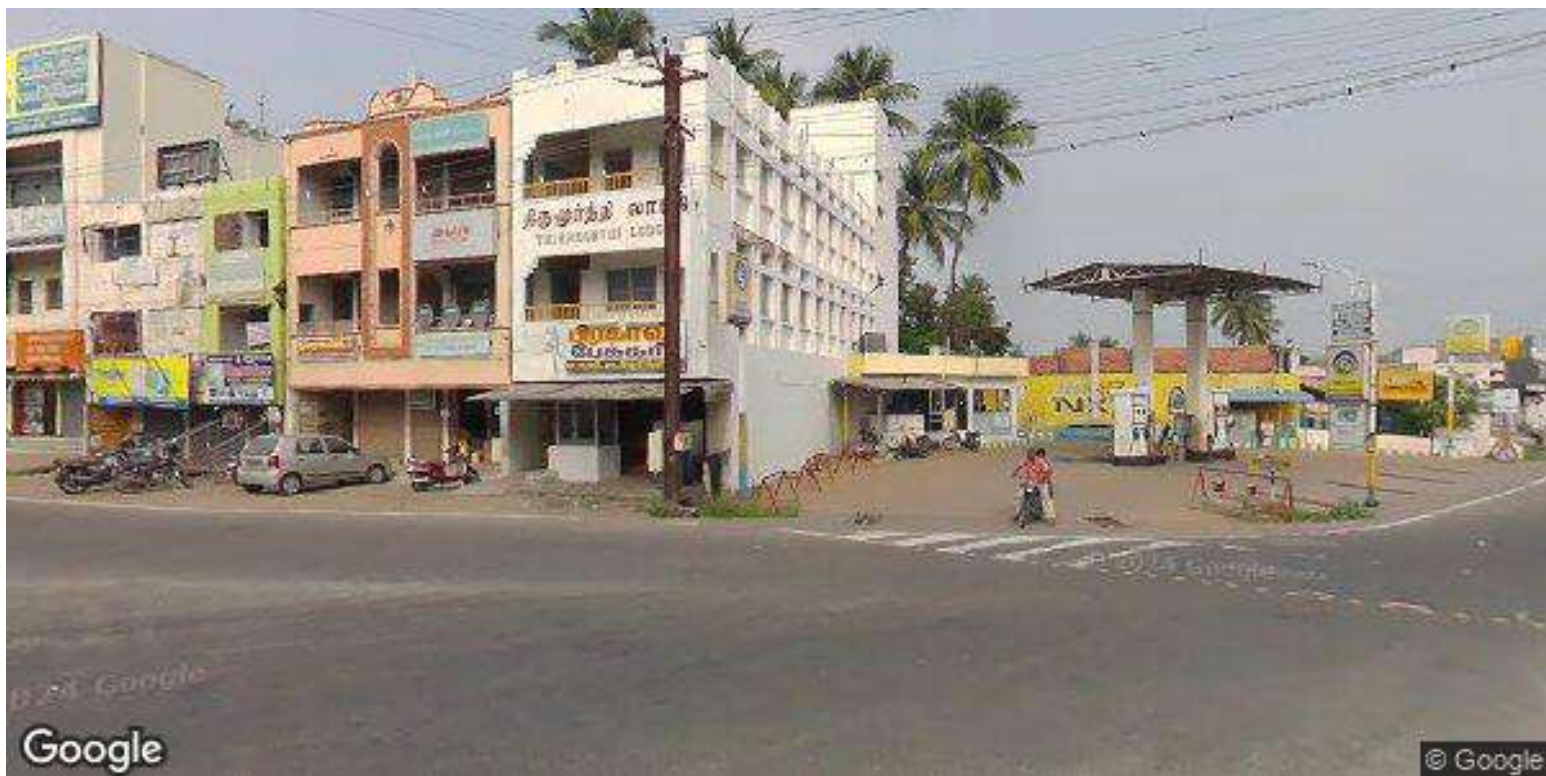
**Coordinates:** 11.00172, 77.56268

**Risk Type:** Roundabout

**Risk Level:** High

**Speed Limit:** 15 KM/Hr

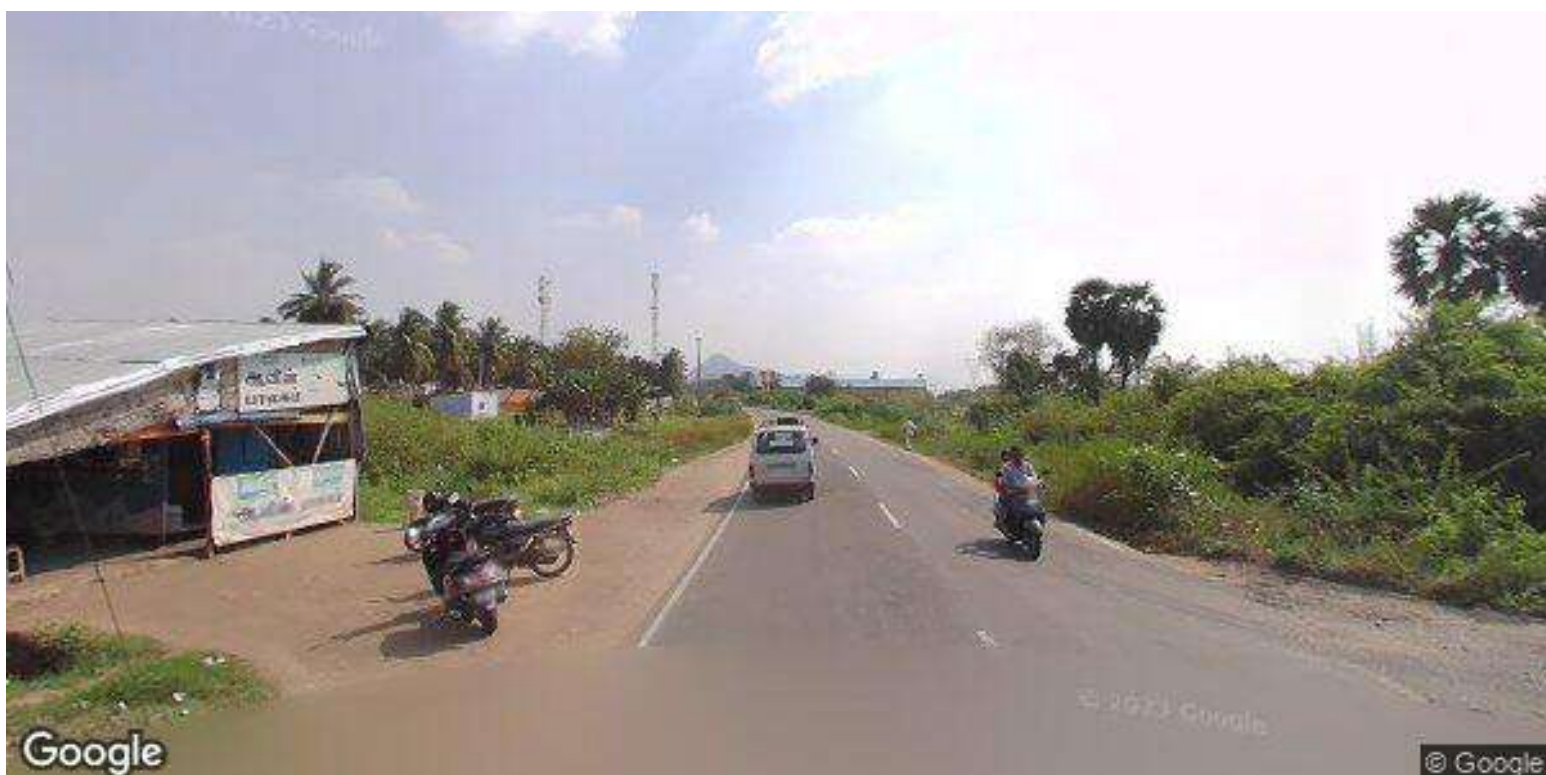
**Risk Type:** Turn  
**Risk Level:** High  
**Speed Limit:** 15 KM/Hr  
**Coordinates:** 11.44022, 77.87546

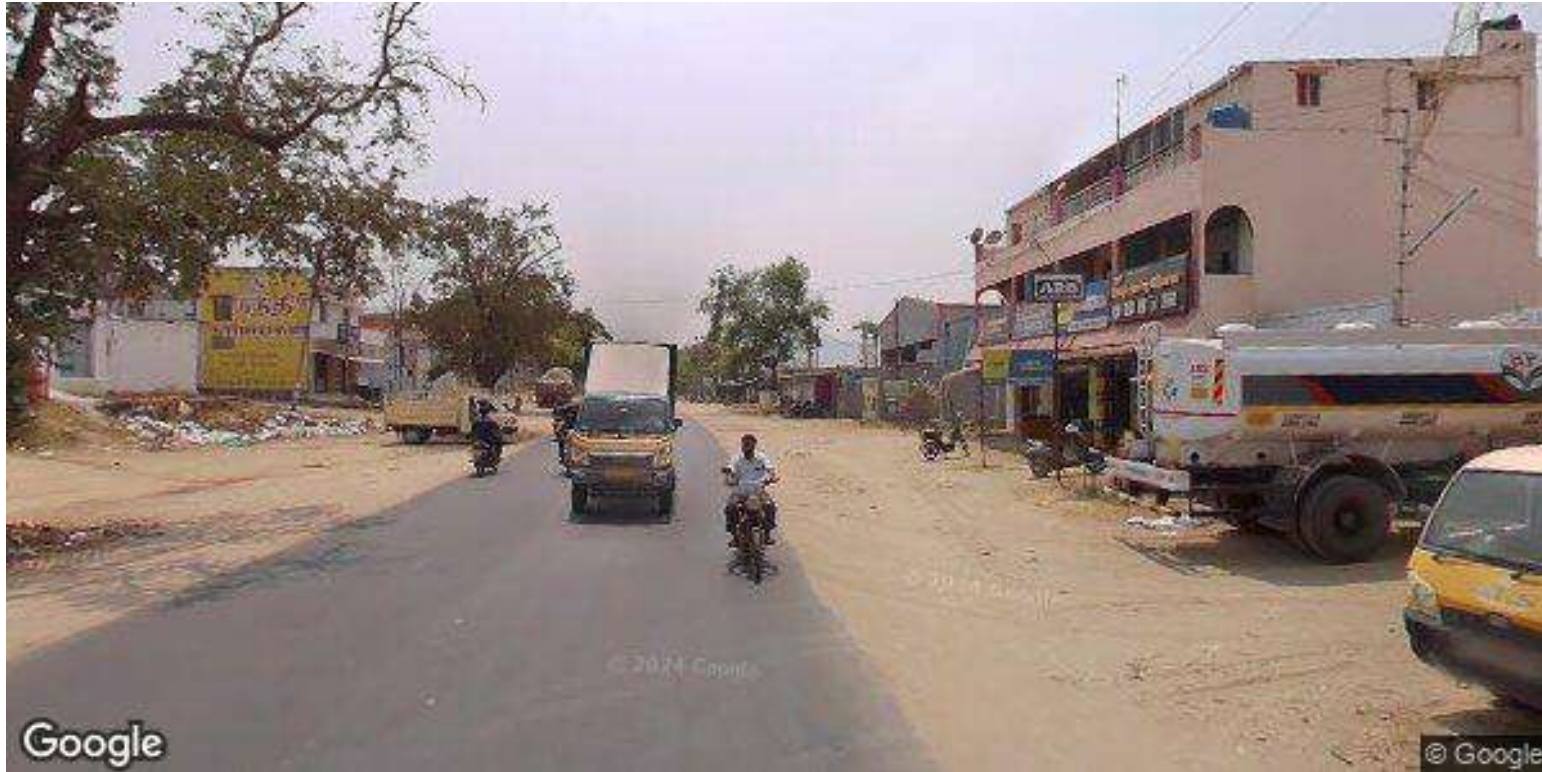
**Risk Type:** Turn  
**Risk Level:** Medium  
**Speed Limit:** 30 KM/Hr  
**Coordinates:** 11.39976, 77.88382

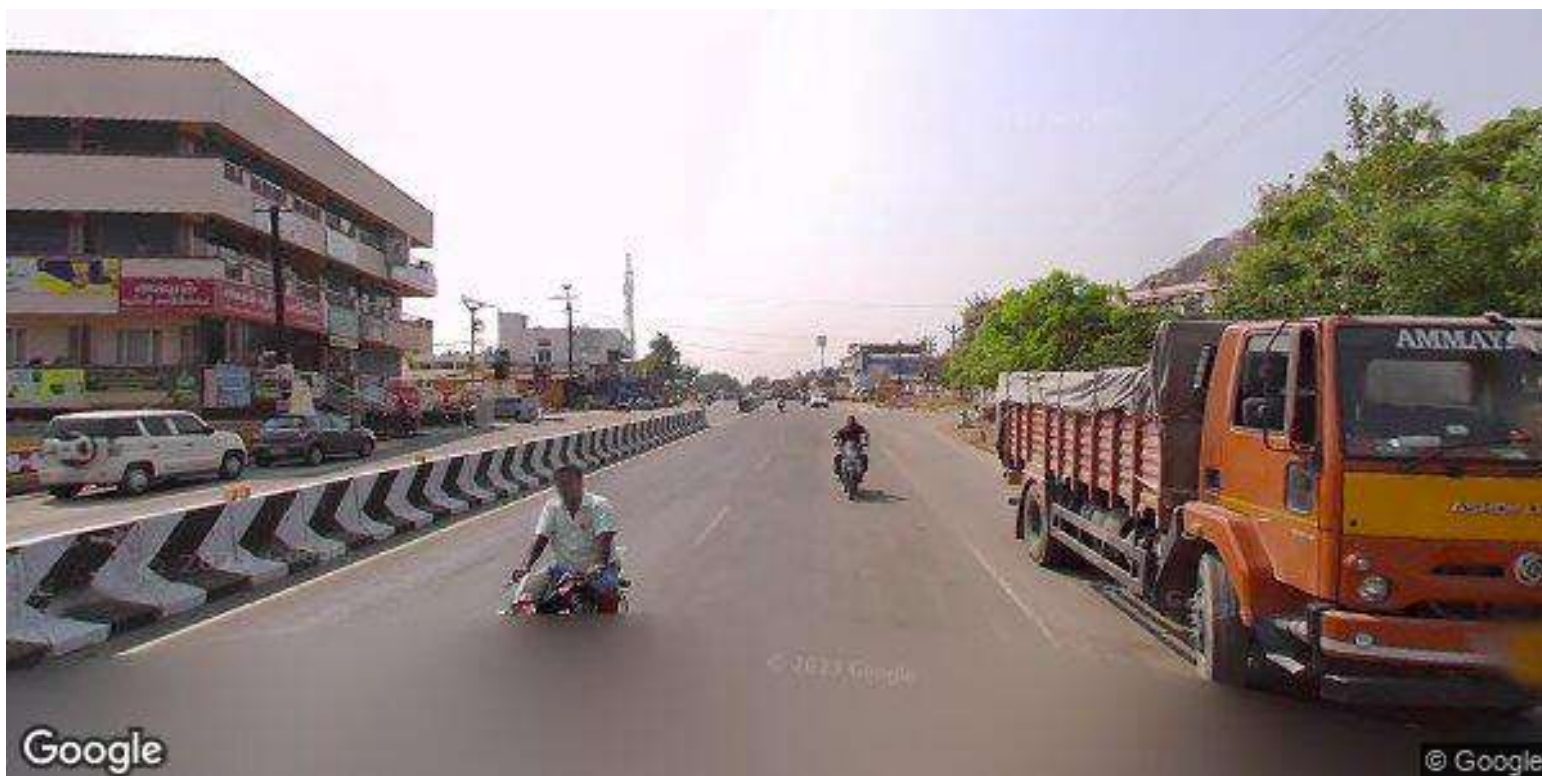
**Risk Type:** Turn  
**Risk Level:** Medium  
**Speed Limit:** 30 KM/Hr  
**Coordinates:** 11.39690, 77.88852

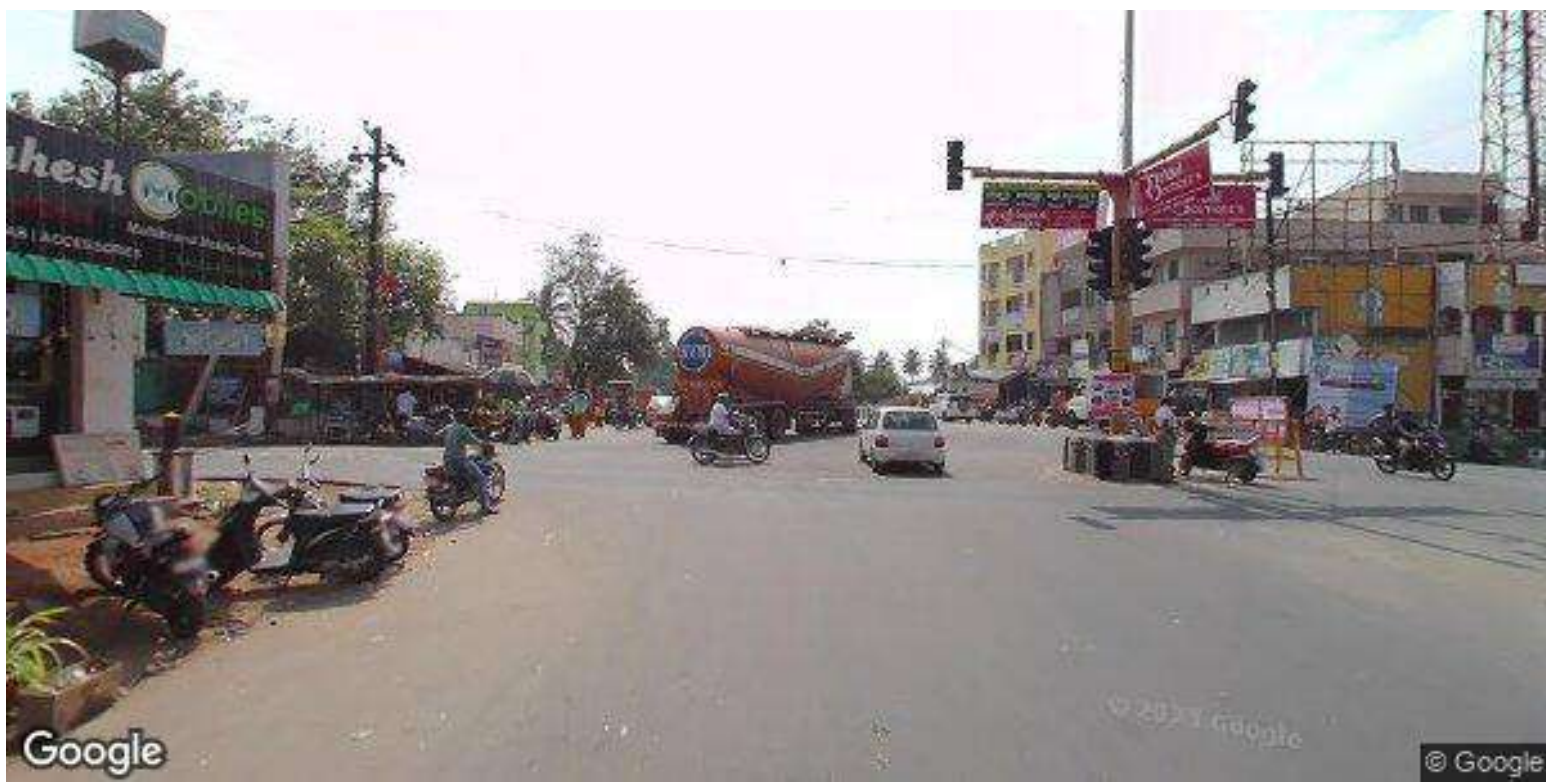
**Coordinates:** 11.36616, 77.88885

**Risk Type:** Turn

**Risk Level:** High

**Speed Limit:** 15 KM/Hr

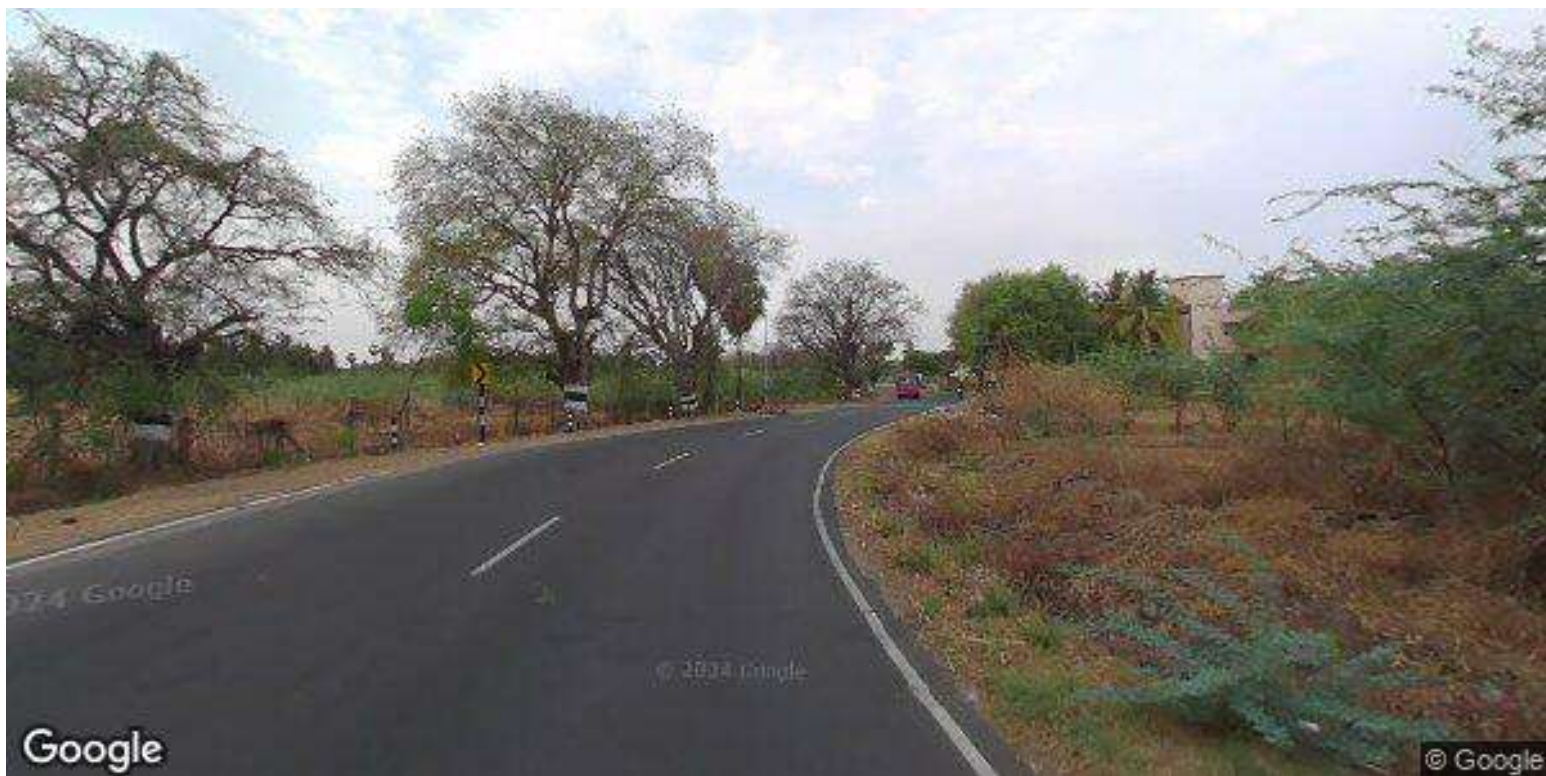
**Coordinates:** 11.34067, 77.86347

**Risk Type:** Turn

**Risk Level:** Medium

**Speed Limit:** 30 KM/Hr

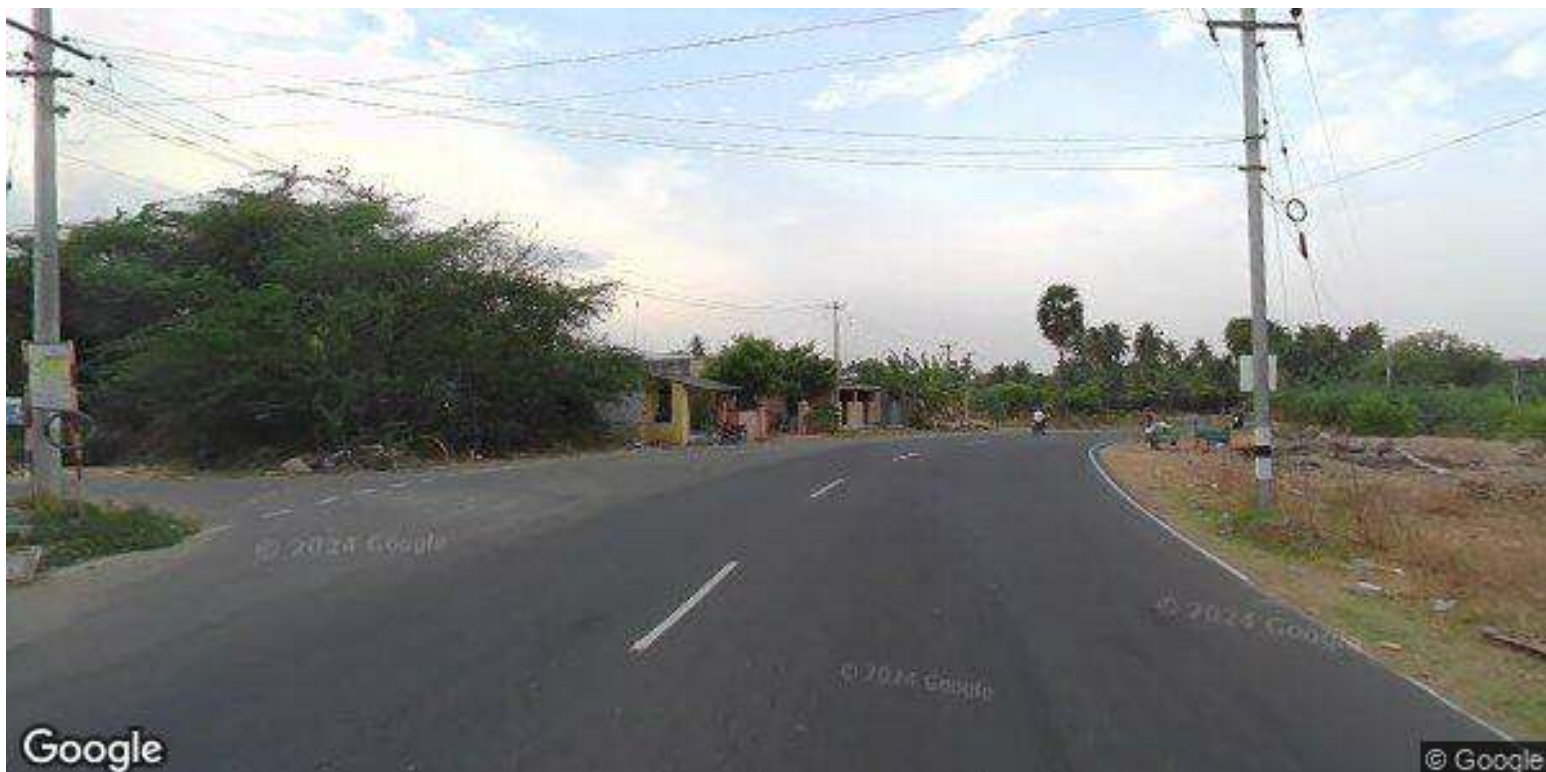
**Risk Type:** Turn  
**Risk Level:** High  
**Speed Limit:** 15 KM/Hr  
**Coordinates:** 11.33854, 77.86216

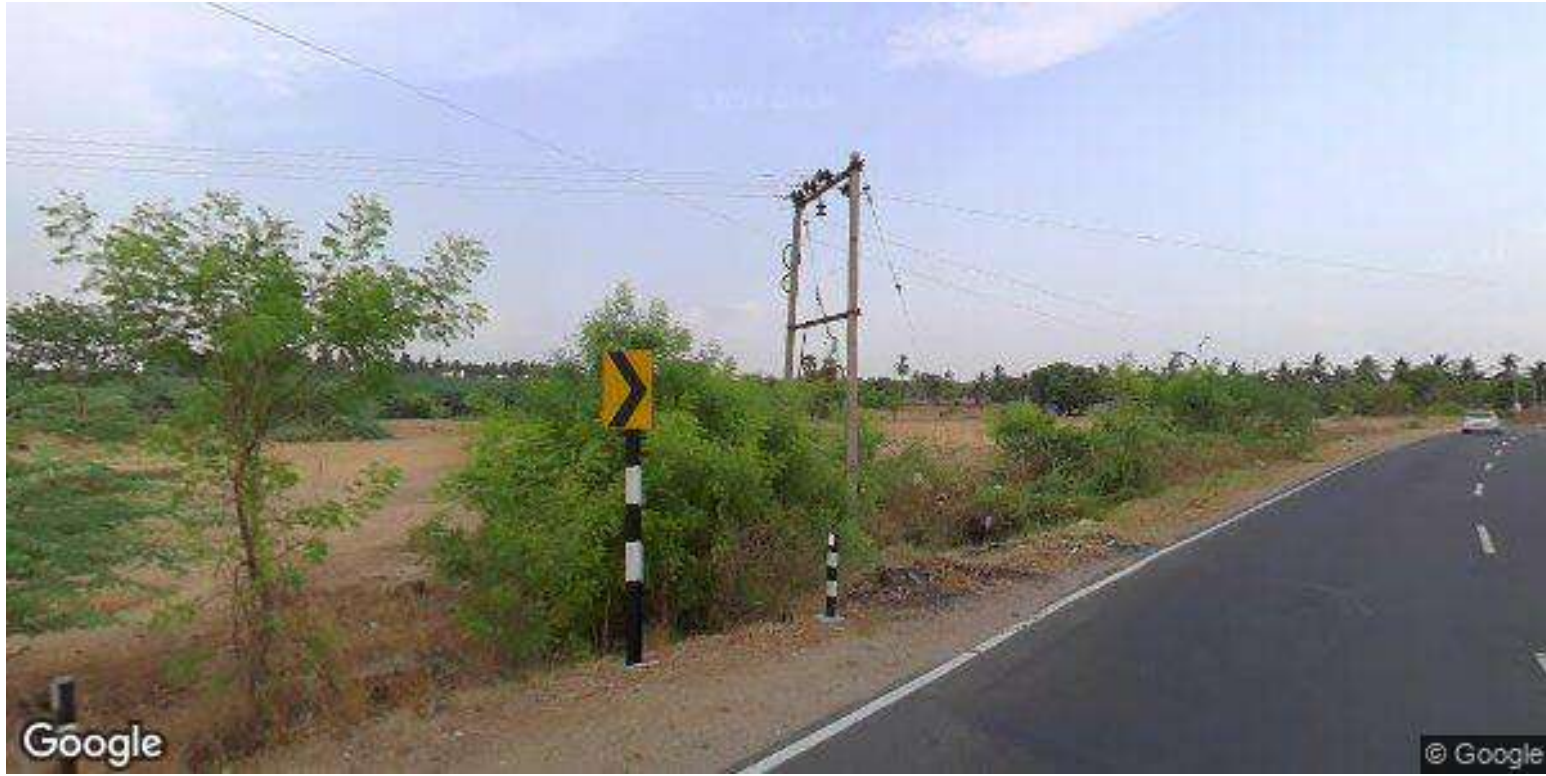
**Risk Type:** Turn  
**Risk Level:** Medium  
**Speed Limit:** 30 KM/Hr  
**Coordinates:** 11.33778, 77.86236

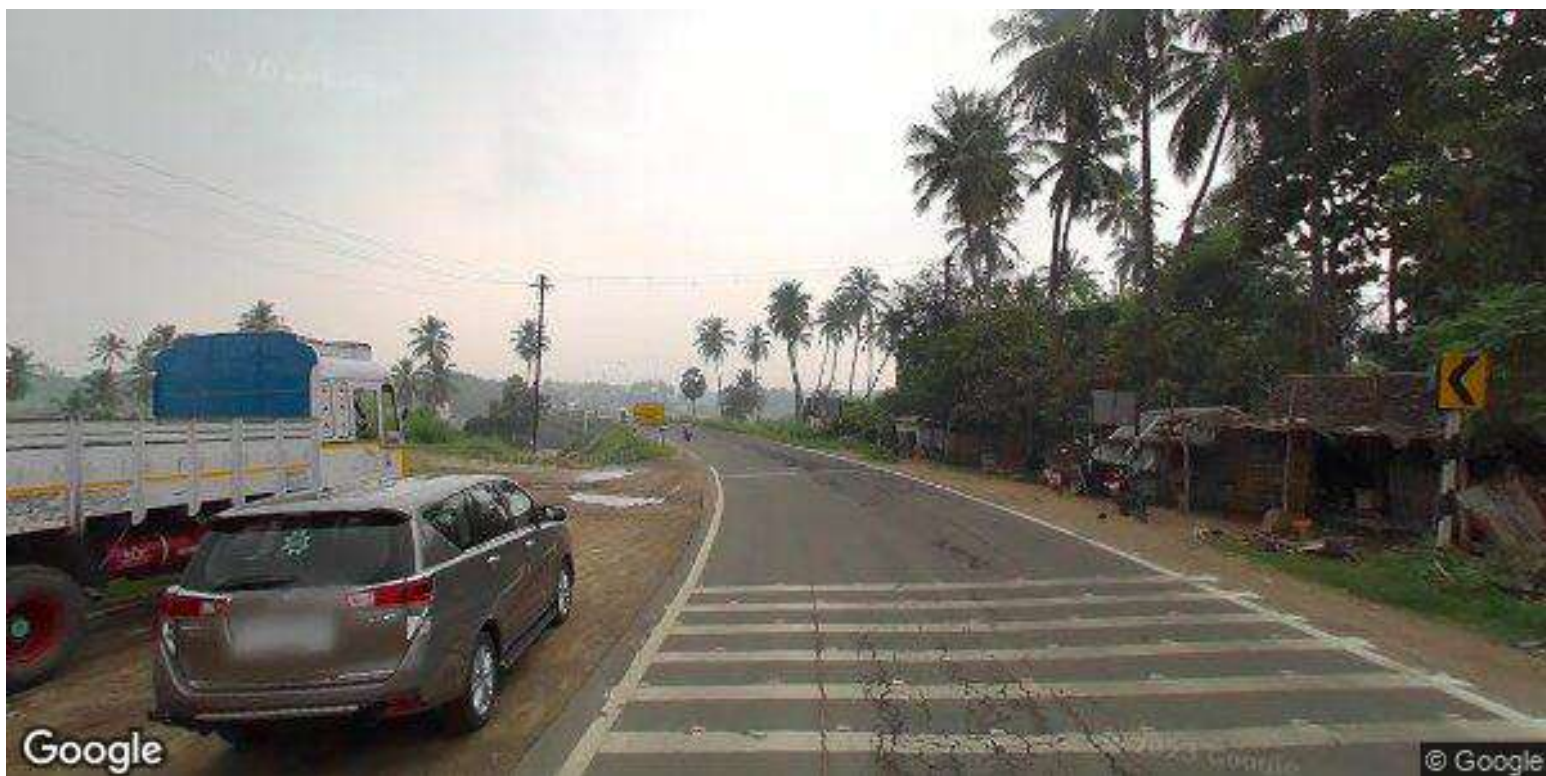
**Risk Type:** Turn  
**Risk Level:** Medium  
**Speed Limit:** 30 KM/Hr  
**Coordinates:** 11.30952, 77.77587

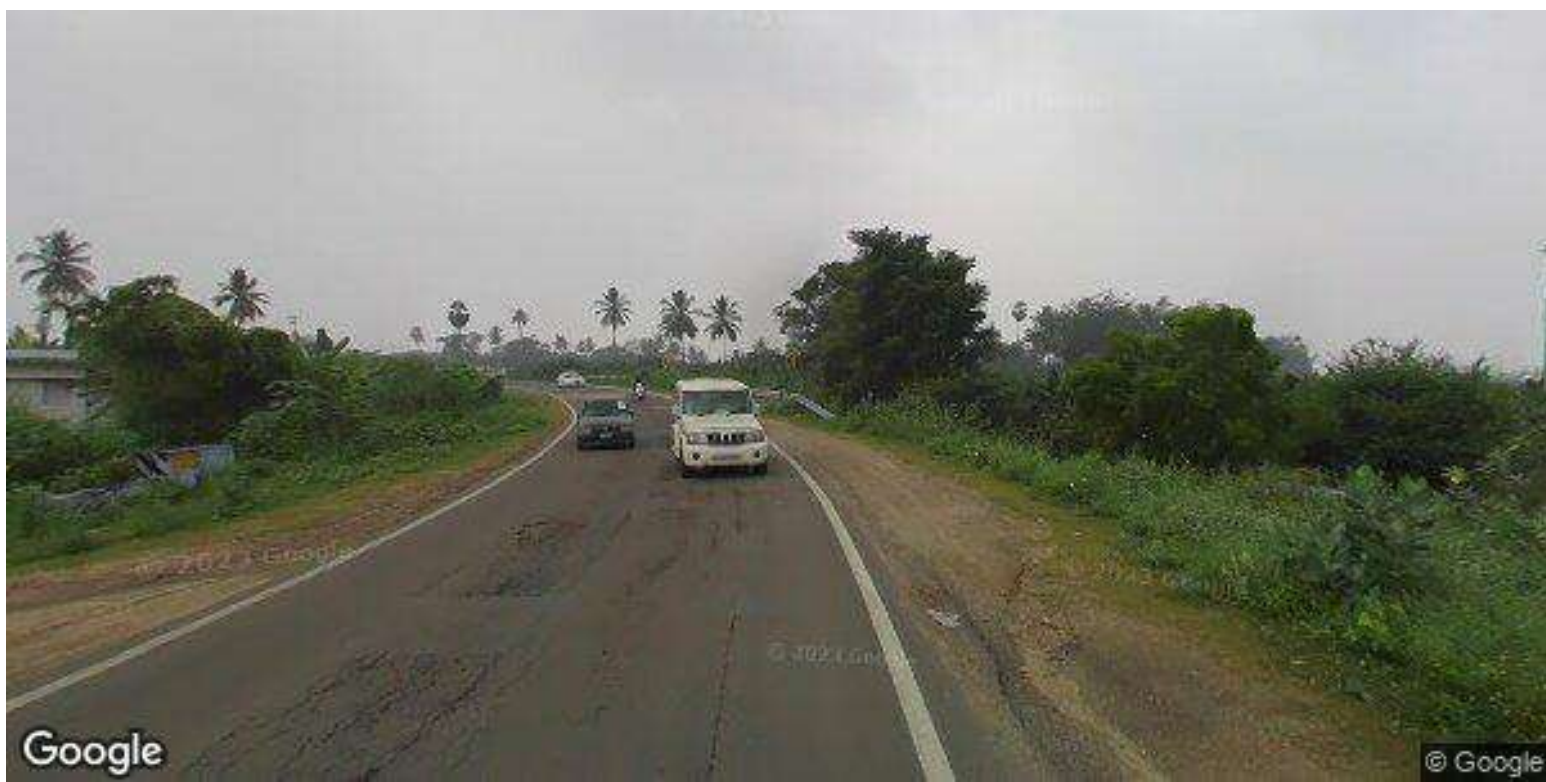
**Coordinates:** 11.31111, 77.77178

**Risk Type:** Turn

**Risk Level:** Medium

**Speed Limit:** 30 KM/Hr

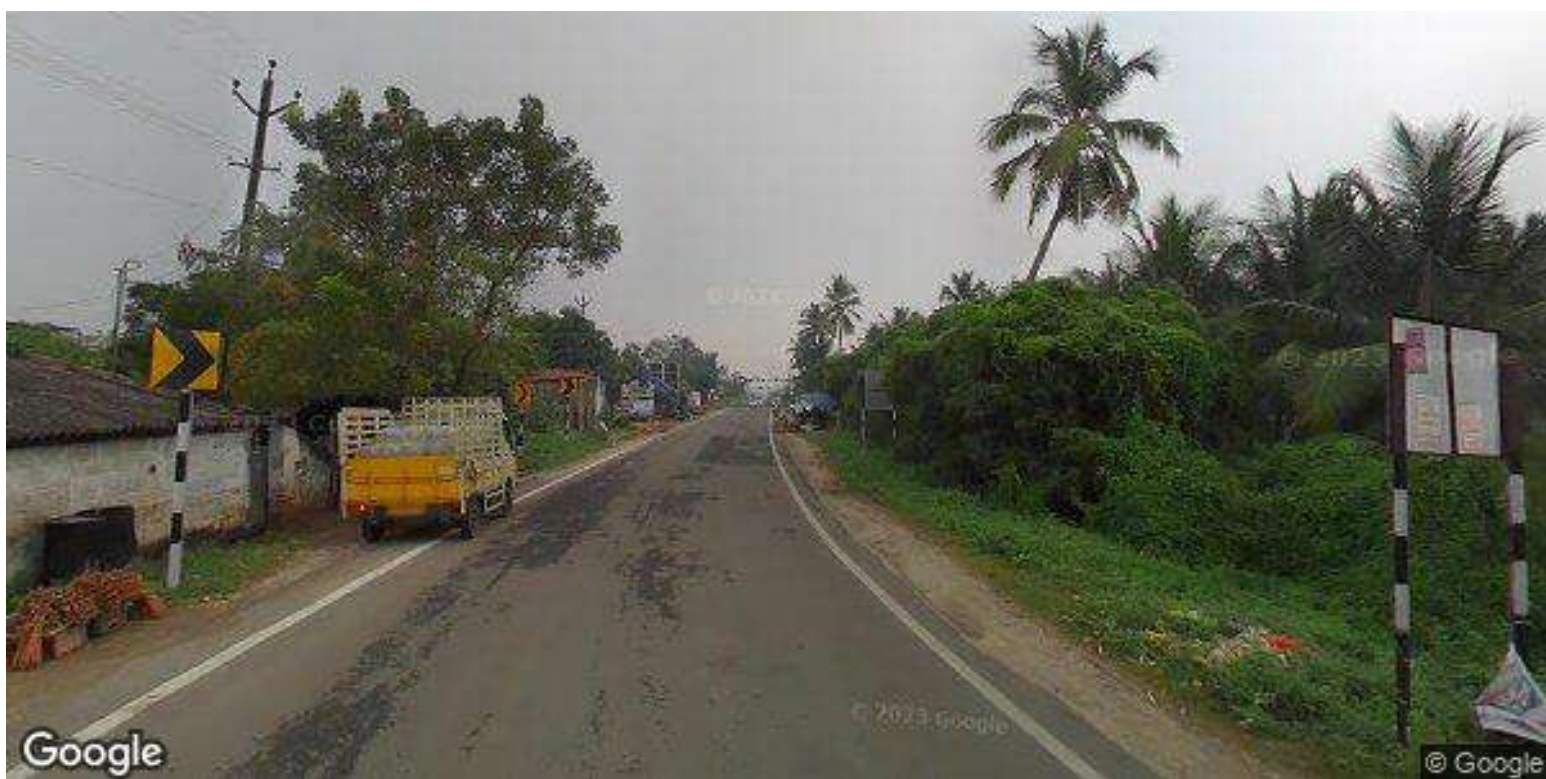
**Coordinates:** 11.30973, 77.76712

**Risk Type:** Turn

**Risk Level:** Medium

**Speed Limit:** 30 KM/Hr

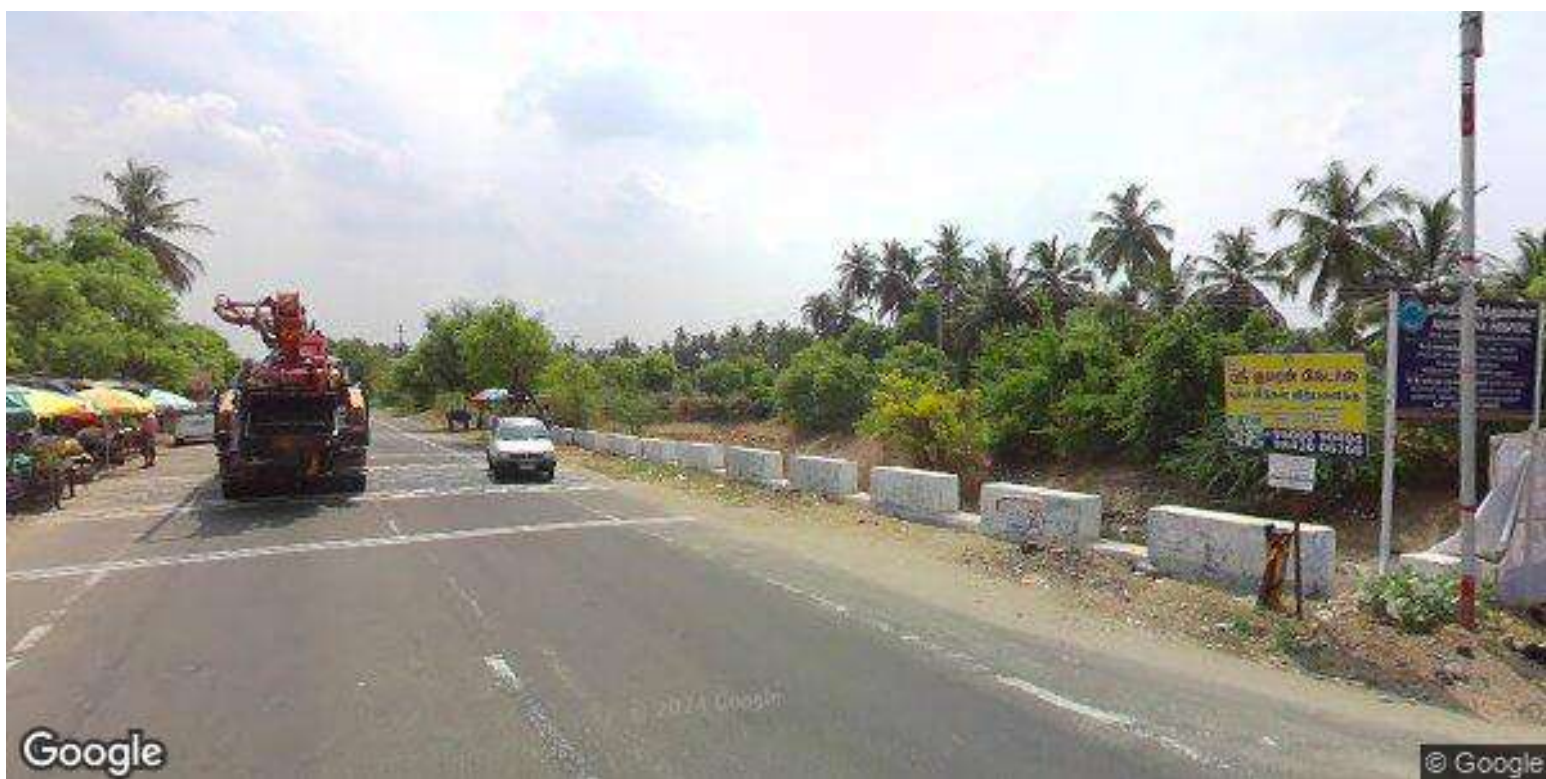
**Risk Type:** Turn  
**Risk Level:** High  
**Speed Limit:** 15 KM/Hr  
**Coordinates:** 11.29490, 77.74685

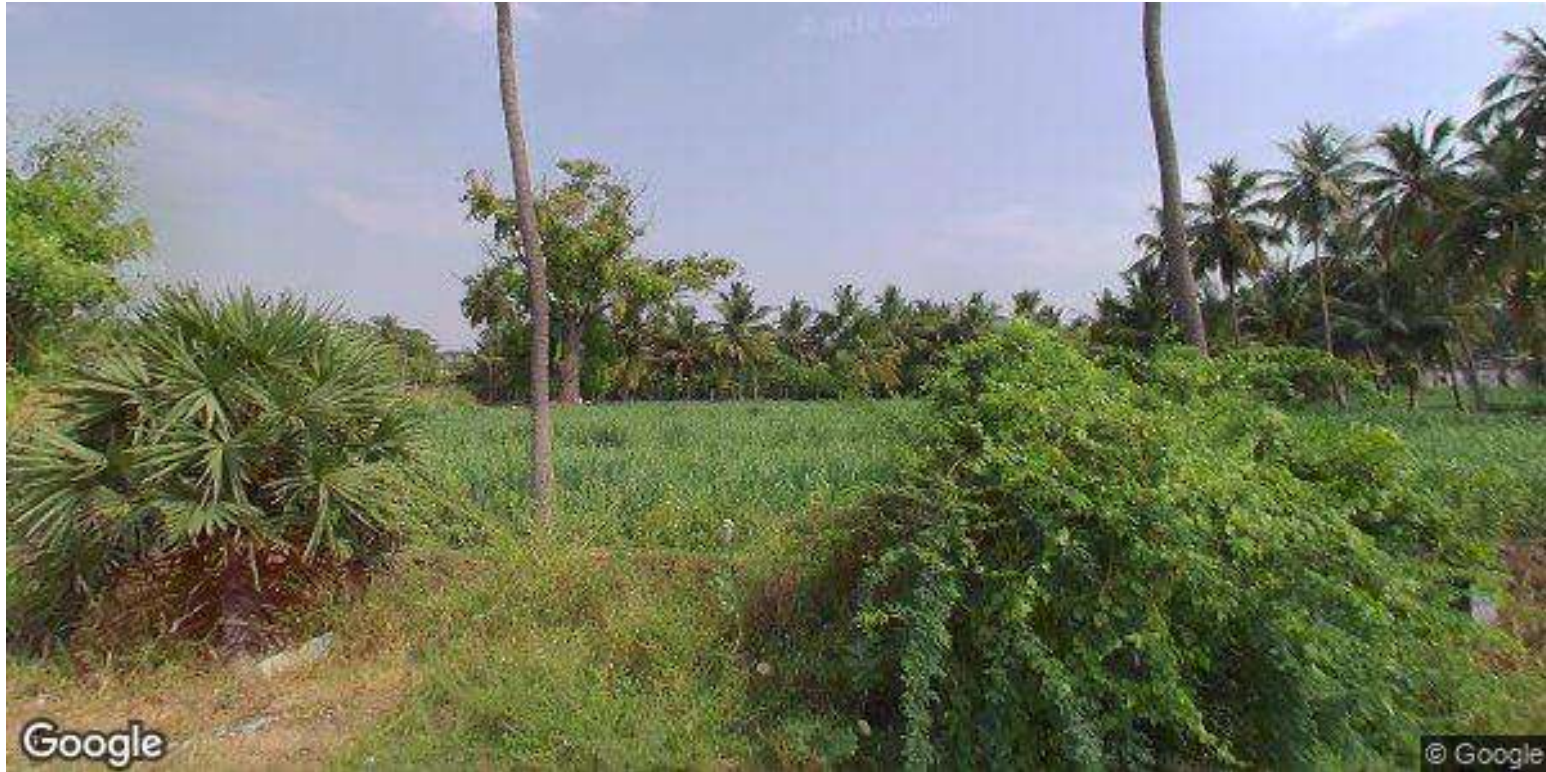
**Risk Type:** Turn  
**Risk Level:** High  
**Speed Limit:** 15 KM/Hr  
**Coordinates:** 11.29125, 77.74646

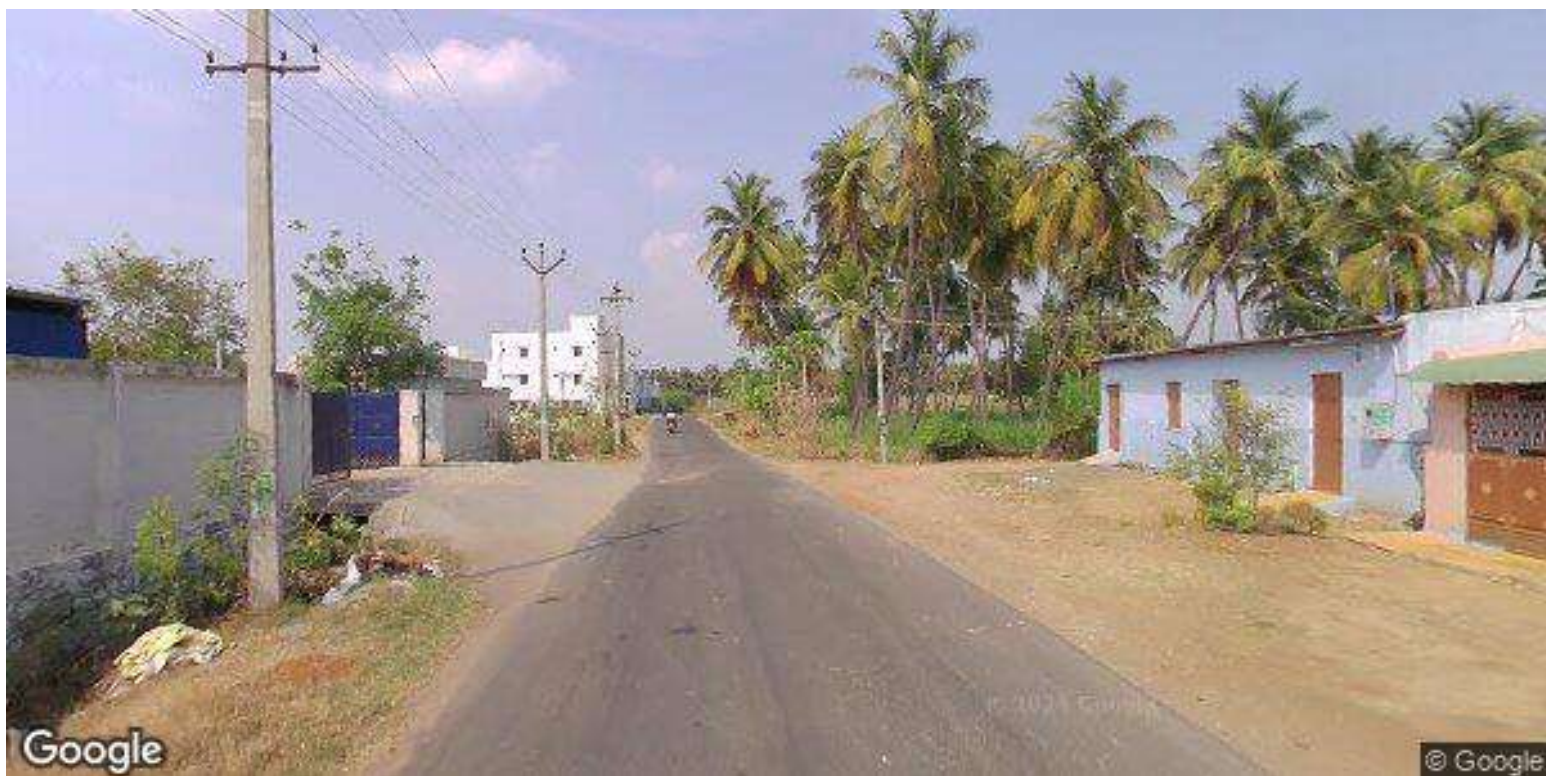
**Risk Type:** Turn  
**Risk Level:** Medium  
**Speed Limit:** 30 KM/Hr  
**Coordinates:** 11.29076, 77.74528

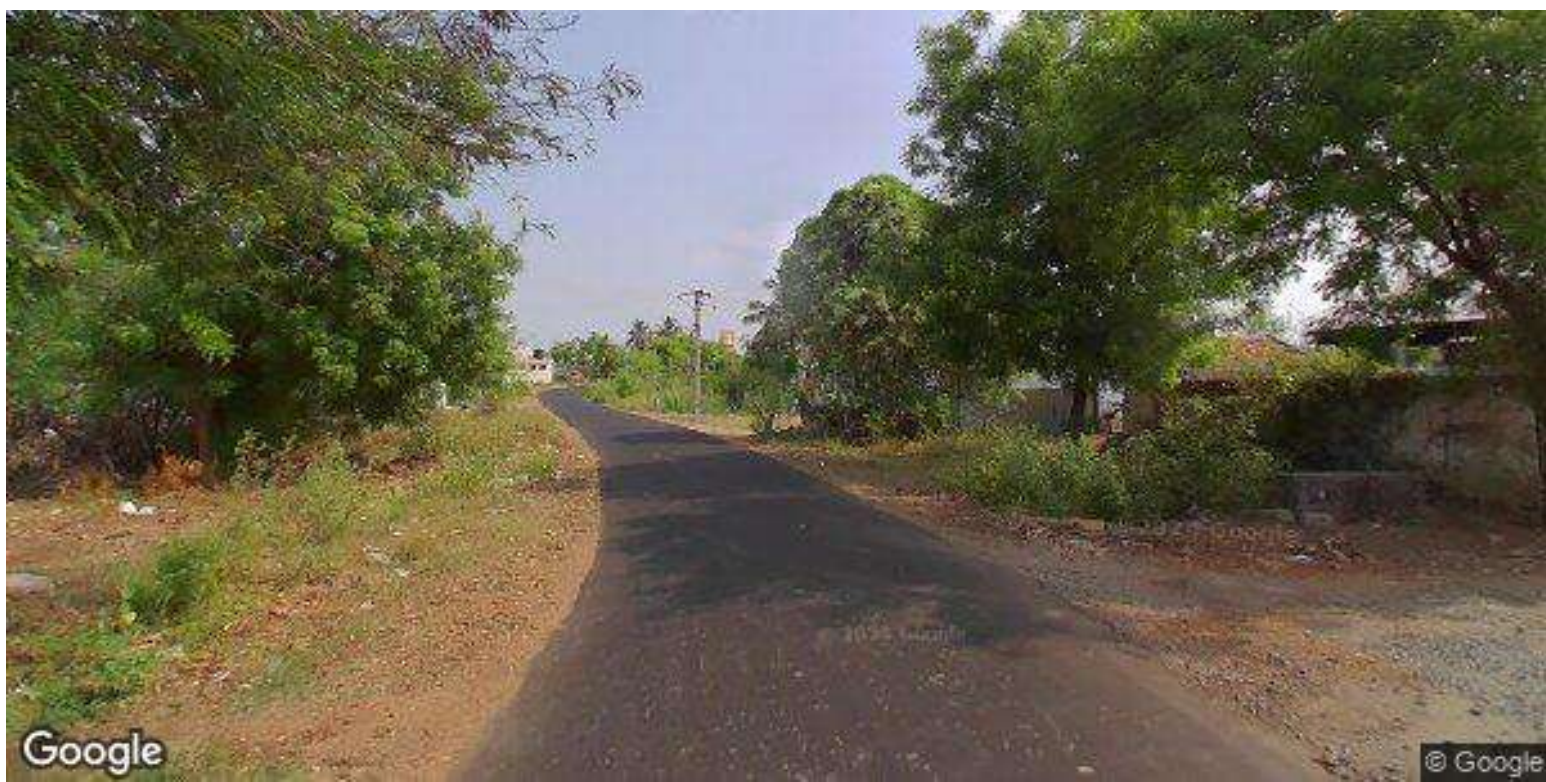
**Coordinates:** 11.28844, 77.74319

**Risk Type:** Turn

**Risk Level:** Medium

**Speed Limit:** 30 KM/Hr

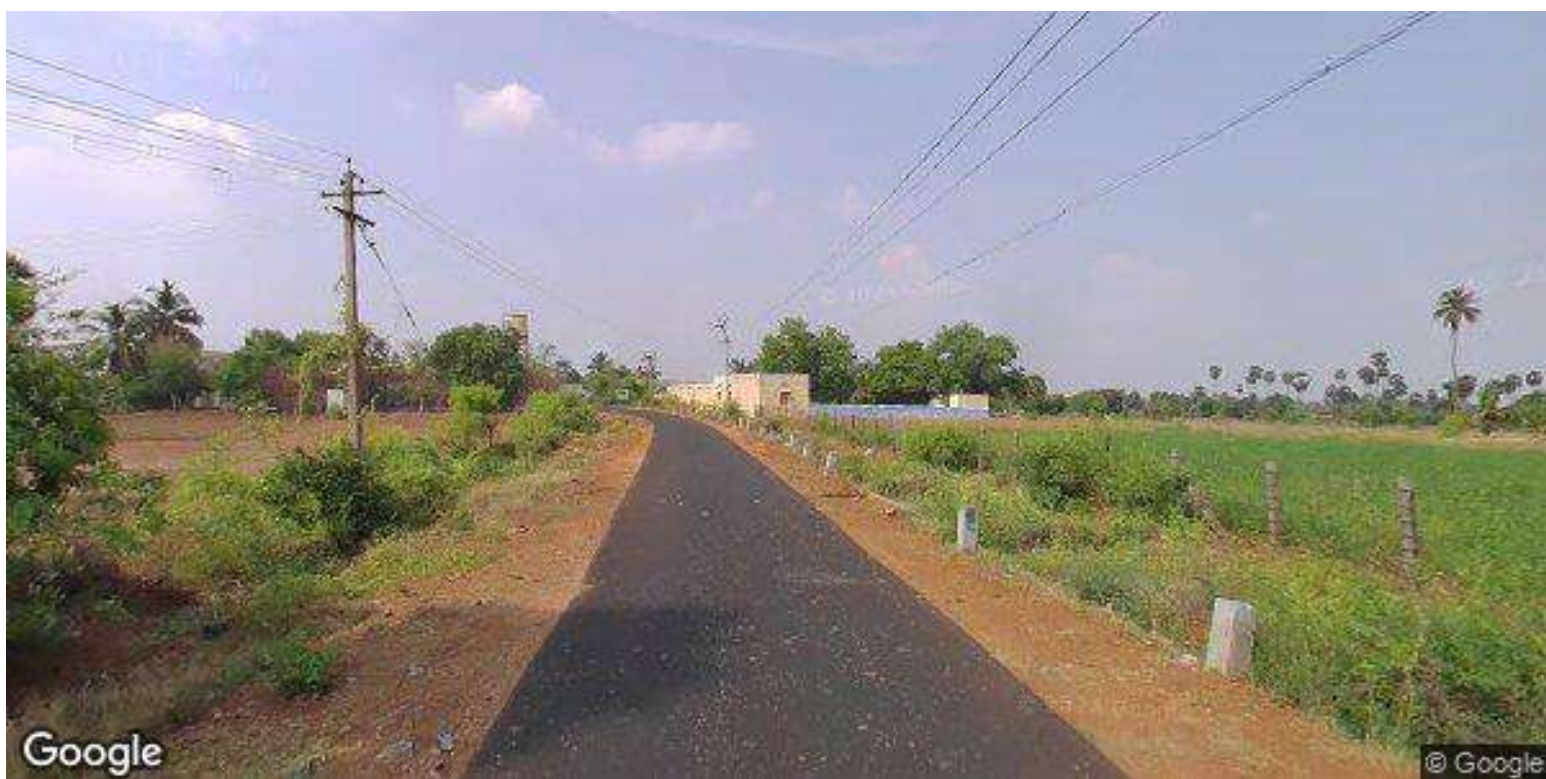
**Coordinates:** 11.28518, 77.74231

**Risk Type:** Turn

**Risk Level:** Medium

**Speed Limit:** 30 KM/Hr

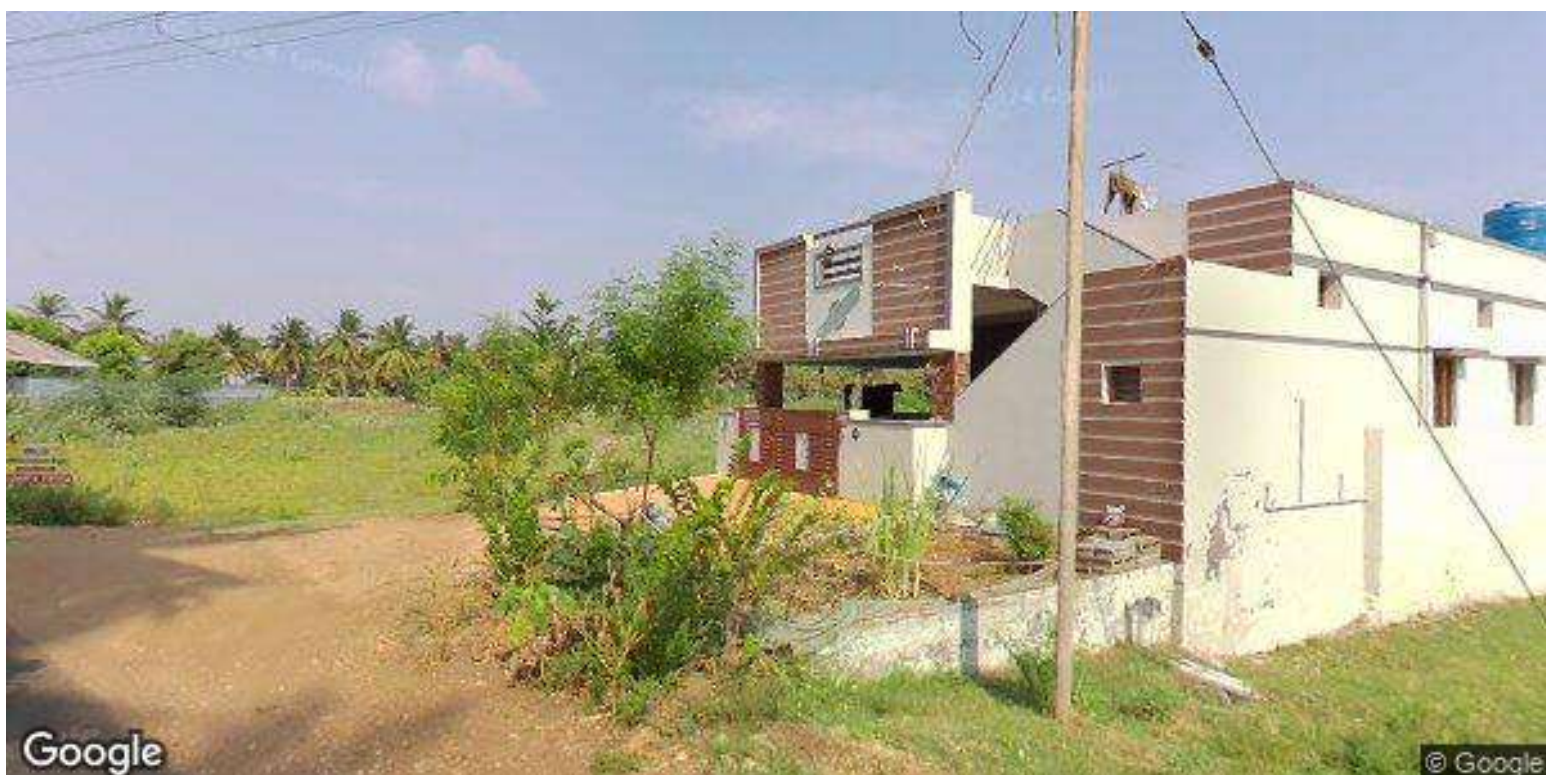
**Coordinates:** 11.27319, 77.72981

**Risk Type:** Turn

**Risk Level:** High

**Speed Limit:** 15 KM/Hr

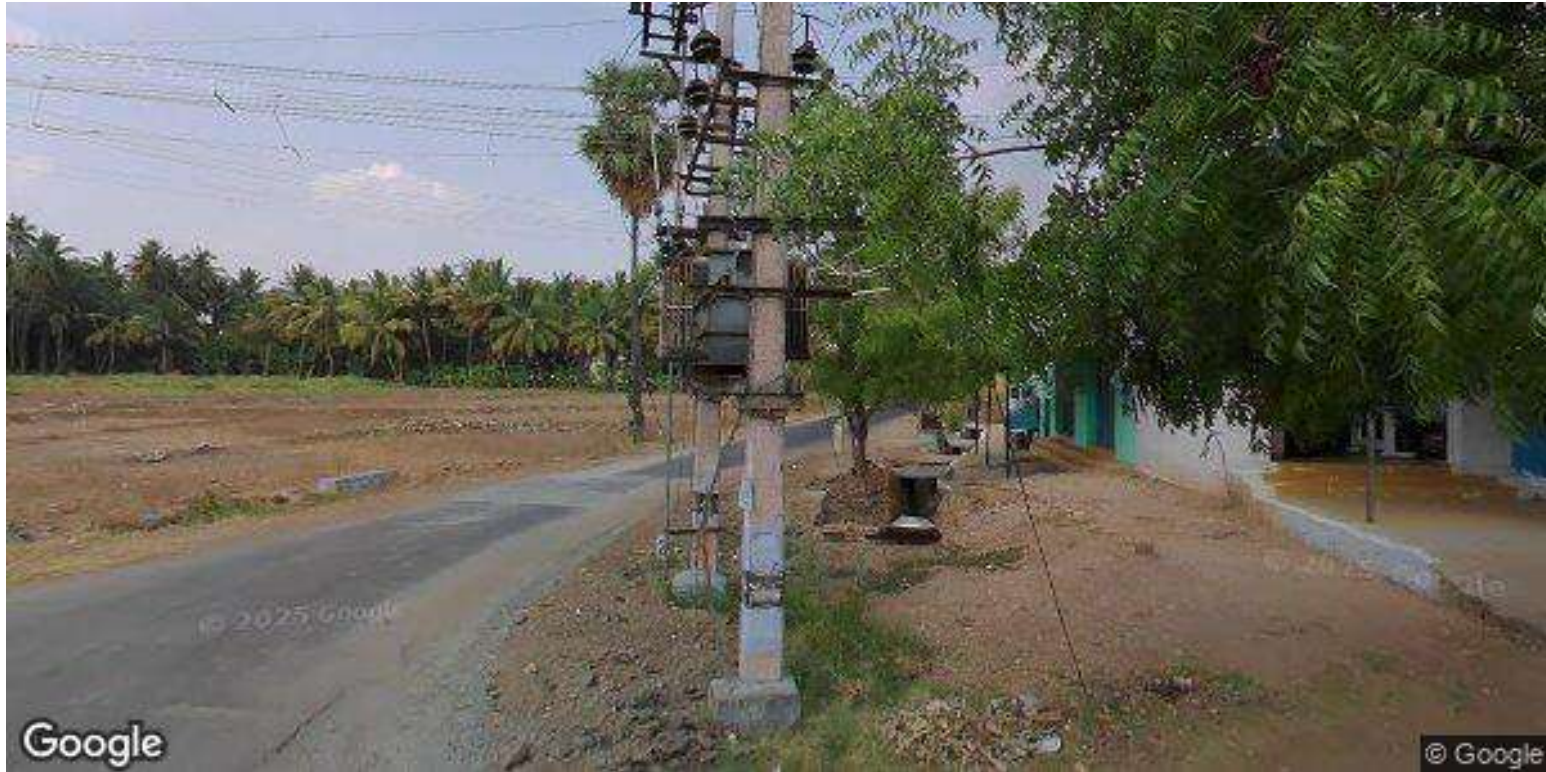
**Coordinates:** 11.27330, 77.72715

**Risk Type:** Blind Spot

**Risk Level:** Blind Spot

**Speed Limit:** 10 KM/Hr

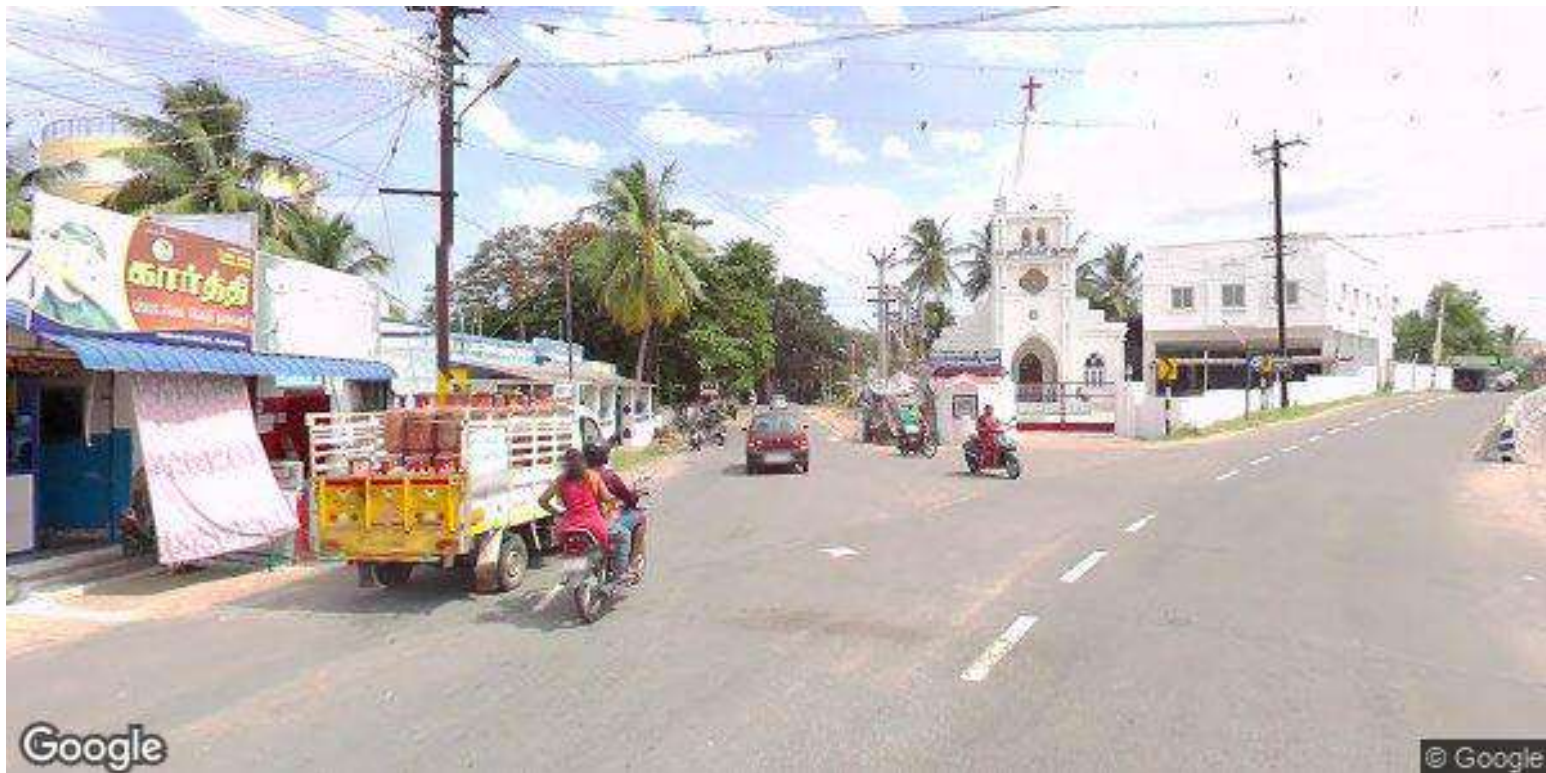
**Coordinates:** 11.23054, 77.71796

**Risk Type:** Turn

**Risk Level:** Medium

**Speed Limit:** 30 KM/Hr
