# IndianOil

## JOURNEY RISK MANAGEMENT (JRM) STUDY

### Salem Terminal to SRI VEERAKUMAR AUTO SERVICE

### Route Safety Analysis: Sangagiri to Chinnaputhur, Tamil Nadu

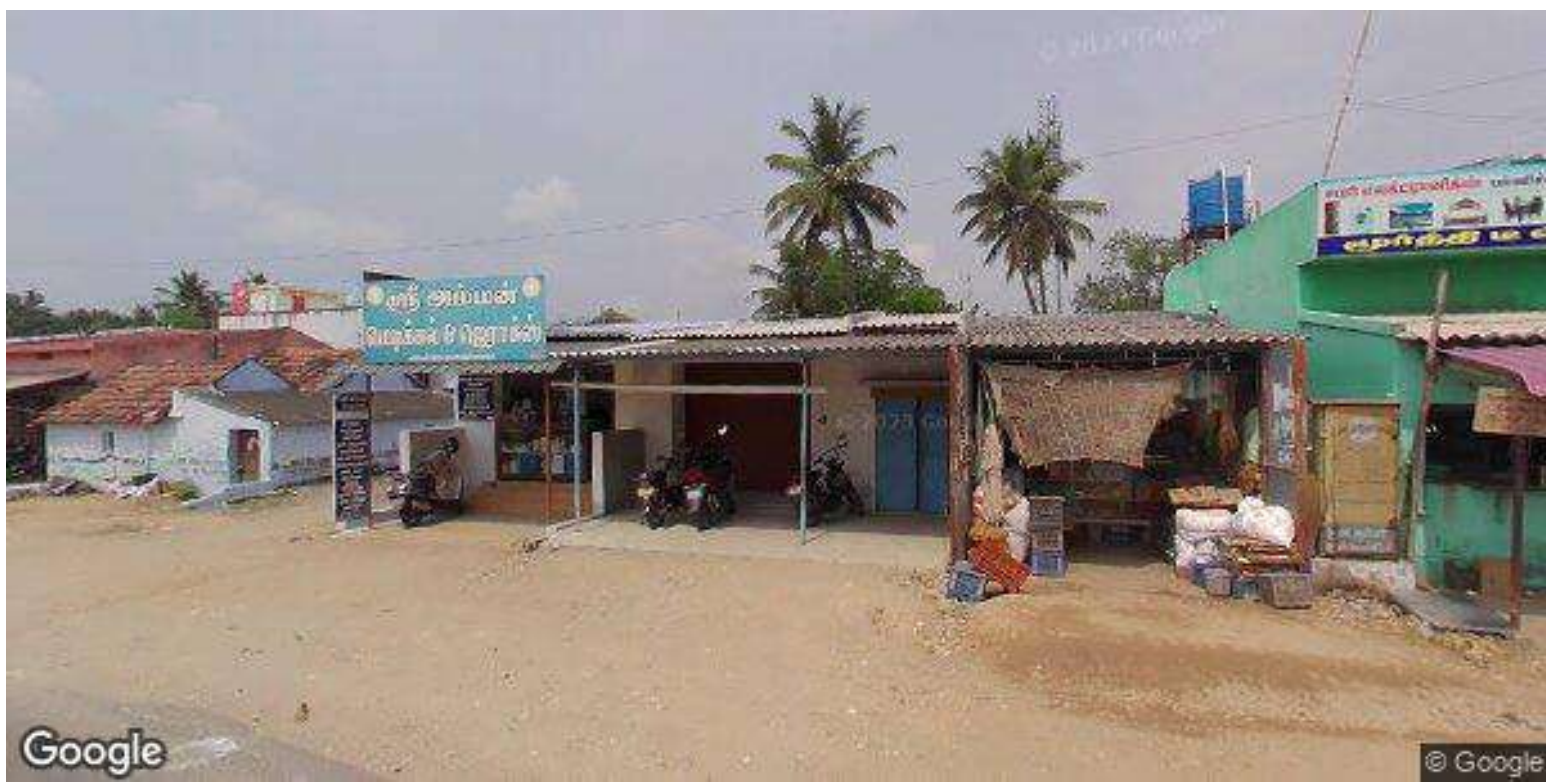
**Coordinates:** 11.20776, 77.70916

**Risk Type:** Turn

**Risk Level:** Medium

**Speed Limit:** 30 KM/Hr

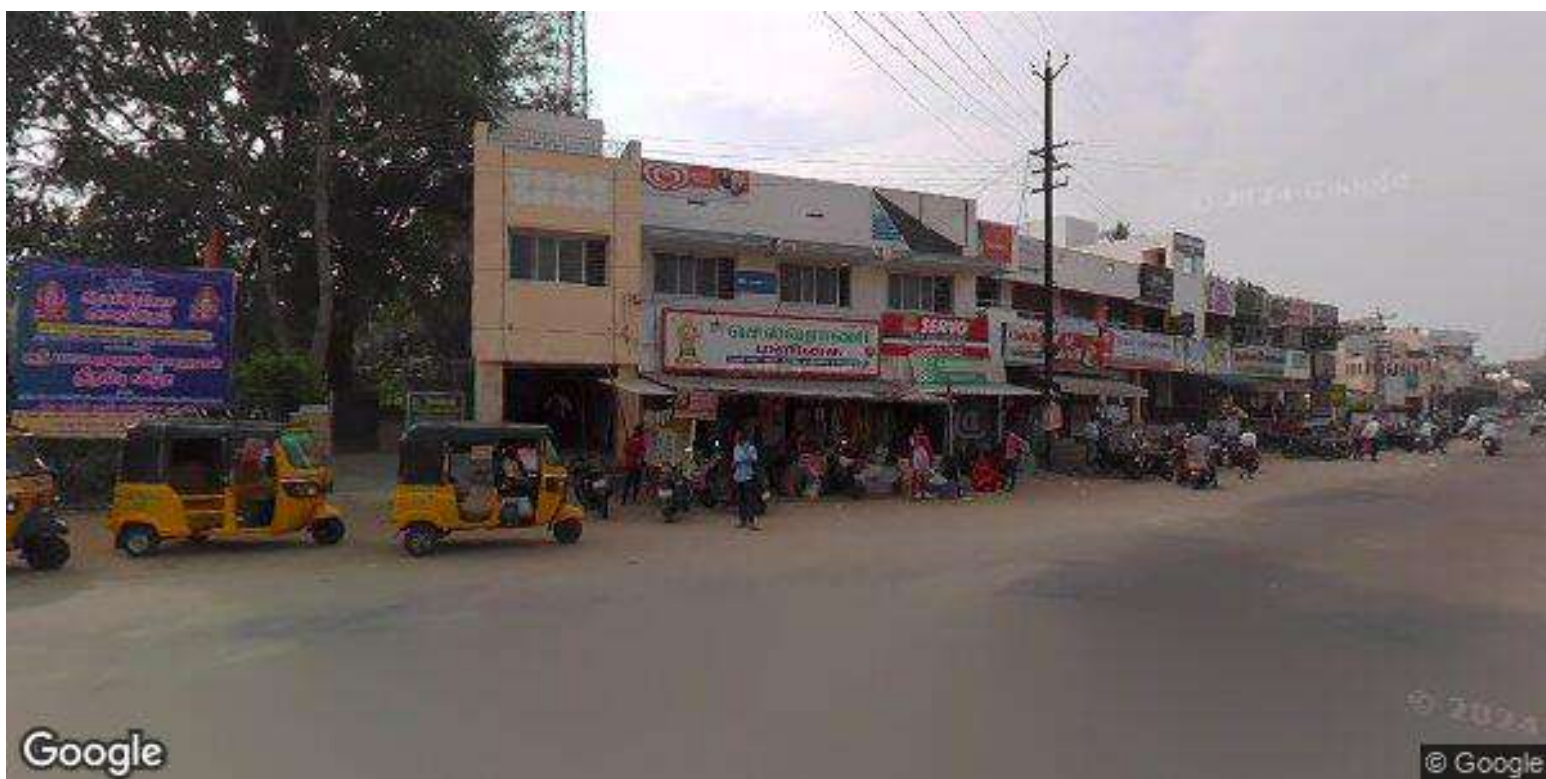
**Coordinates:** 11.15942, 77.70068

**Risk Type:** Turn

**Risk Level:** Medium

**Speed Limit:** 30 KM/Hr

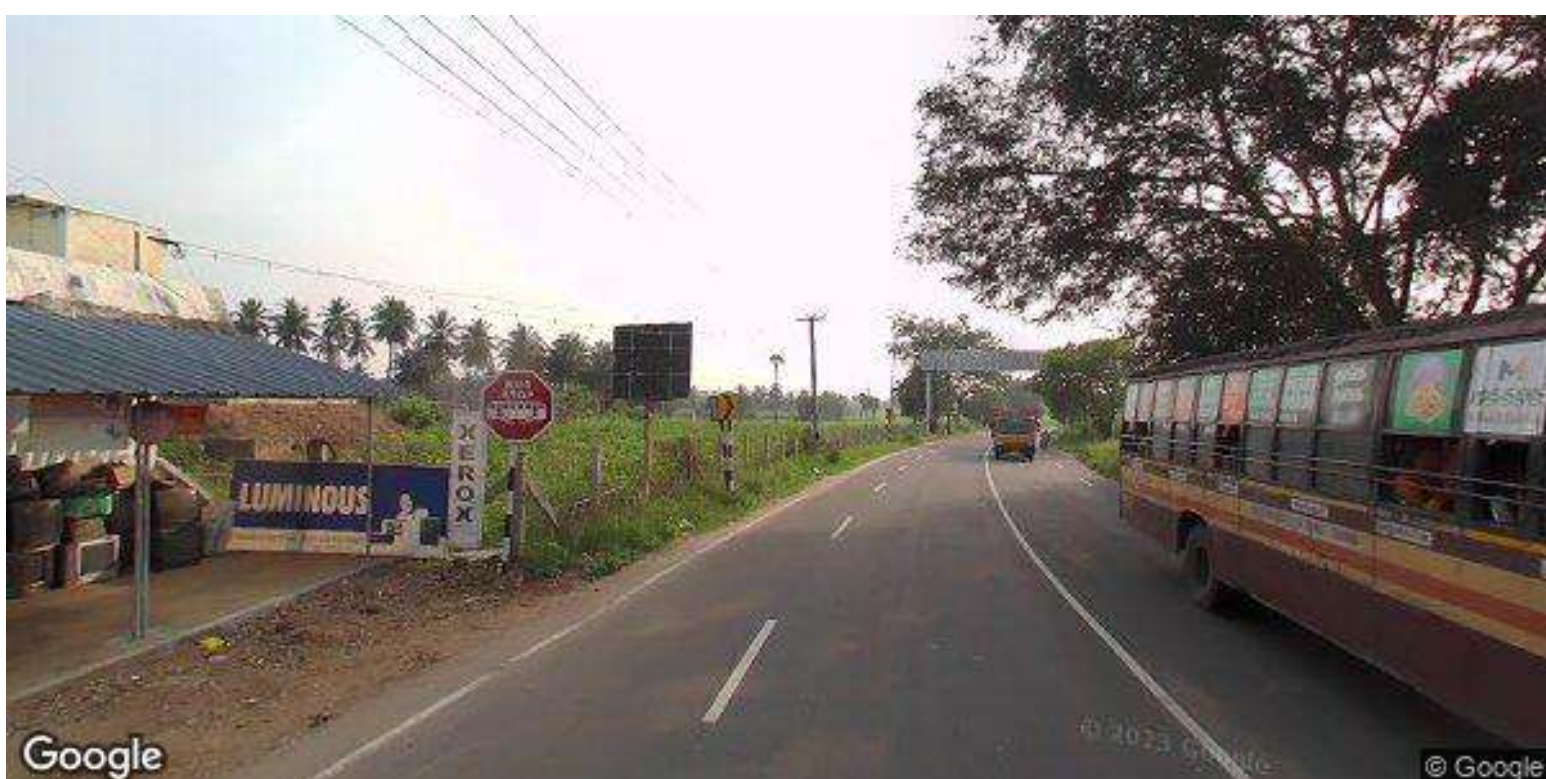
**Risk Type:** Turn  
**Risk Level:** Medium  
**Speed Limit:** 30 KM/Hr  
**Coordinates:** 11.12102, 77.67919

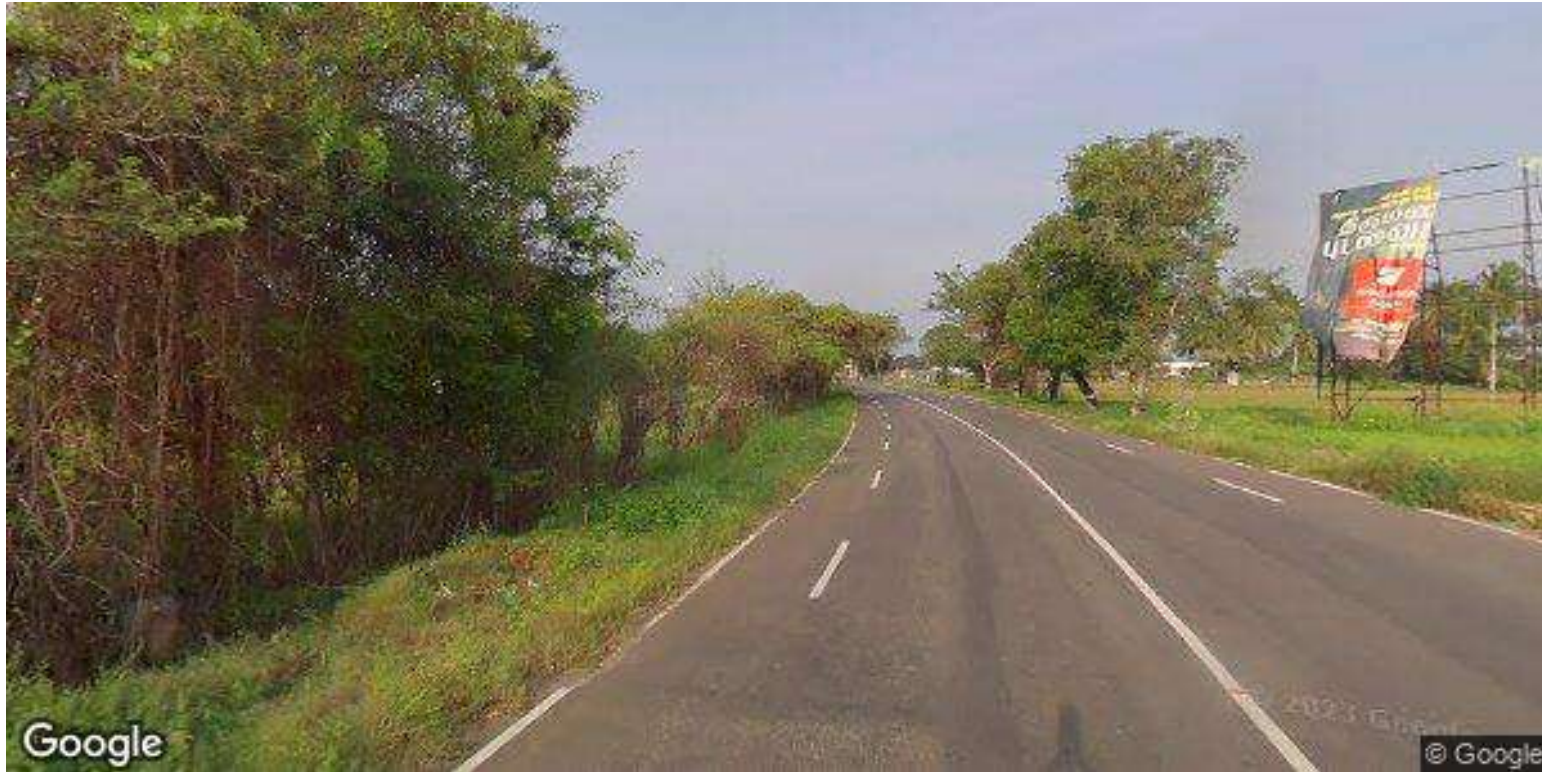
**Risk Type:** Turn  
**Risk Level:** Medium  
**Speed Limit:** 30 KM/Hr  
**Coordinates:** 11.11932, 77.67786

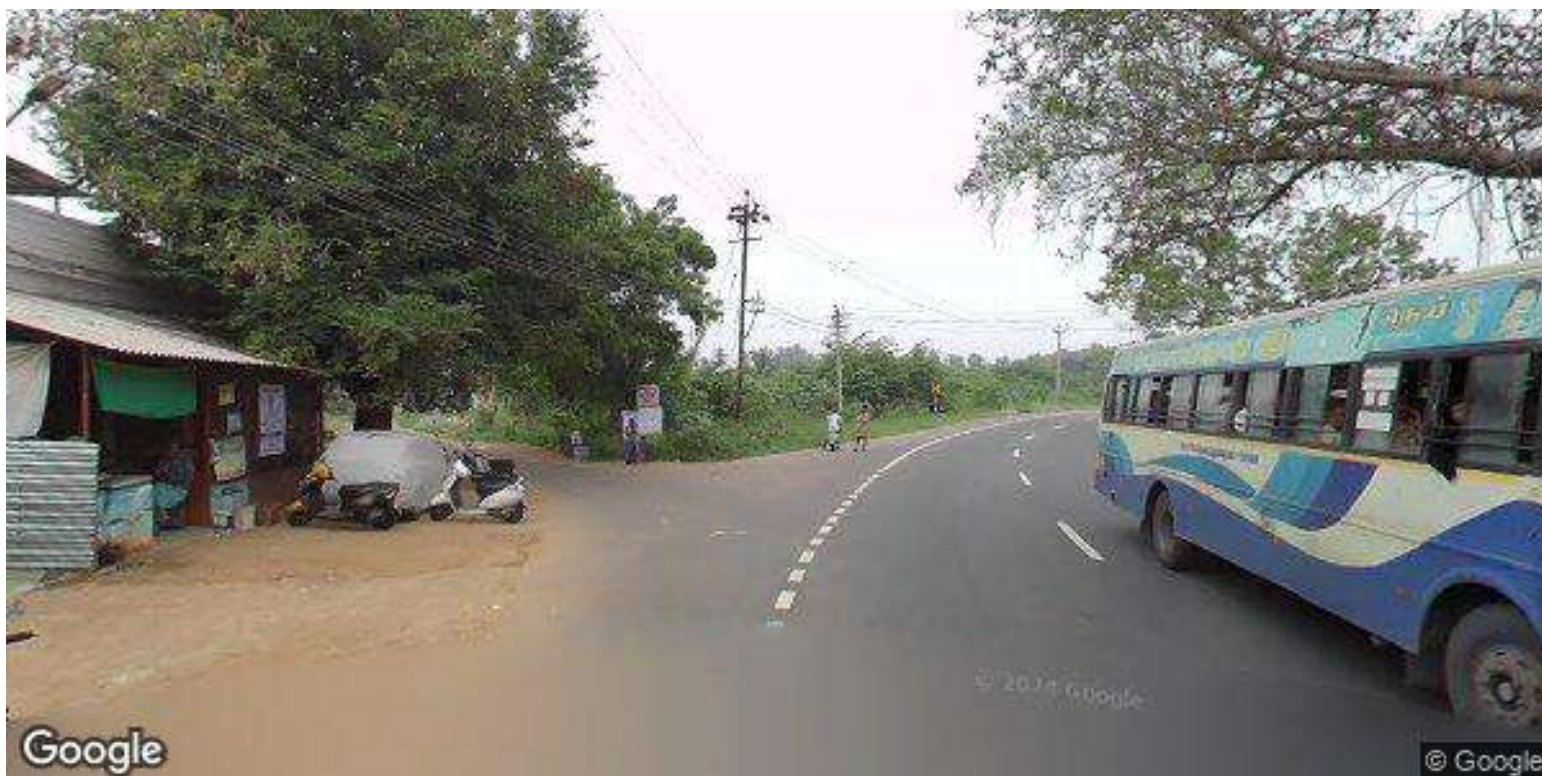
**Risk Type:** Turn  
**Risk Level:** Medium  
**Speed Limit:** 30 KM/Hr  
**Coordinates:** 11.11710, 77.67175

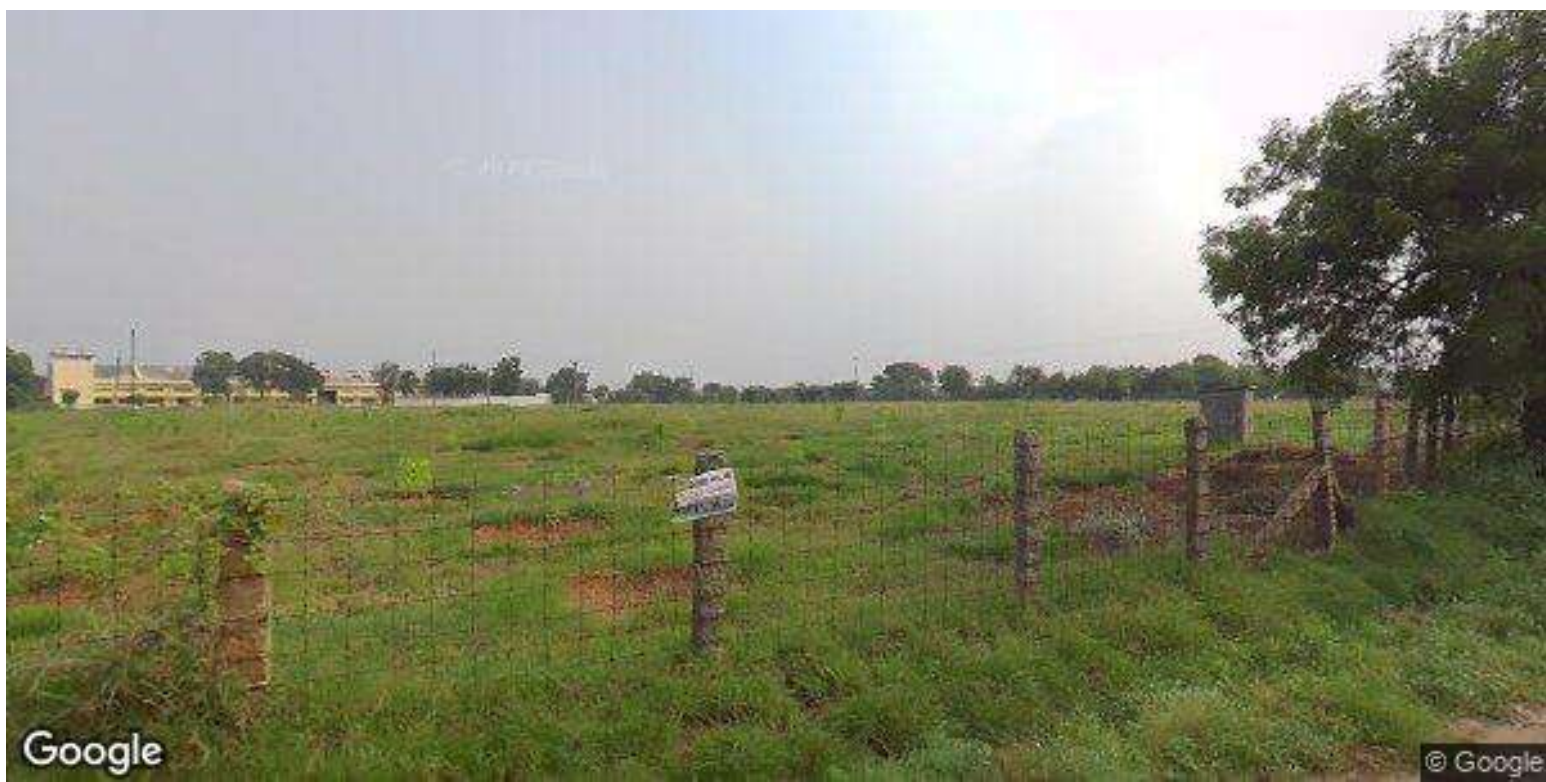
**Coordinates:** 11.09491, 77.66603

**Risk Type:** Turn

**Risk Level:** Medium

**Speed Limit:** 30 KM/Hr

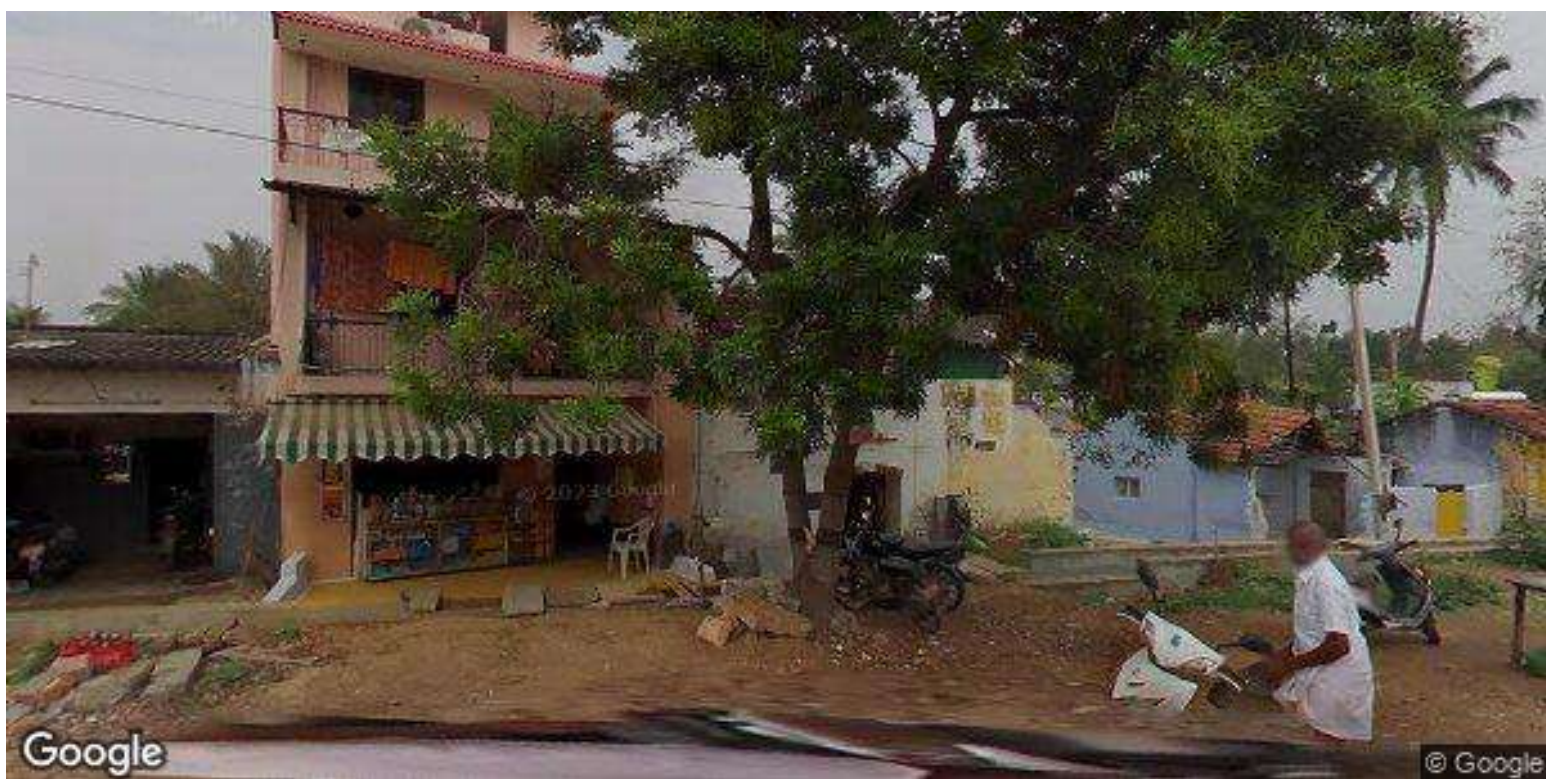
**Coordinates:** 11.08696, 77.66407

**Risk Type:** Turn

**Risk Level:** Medium

**Speed Limit:** 30 KM/Hr

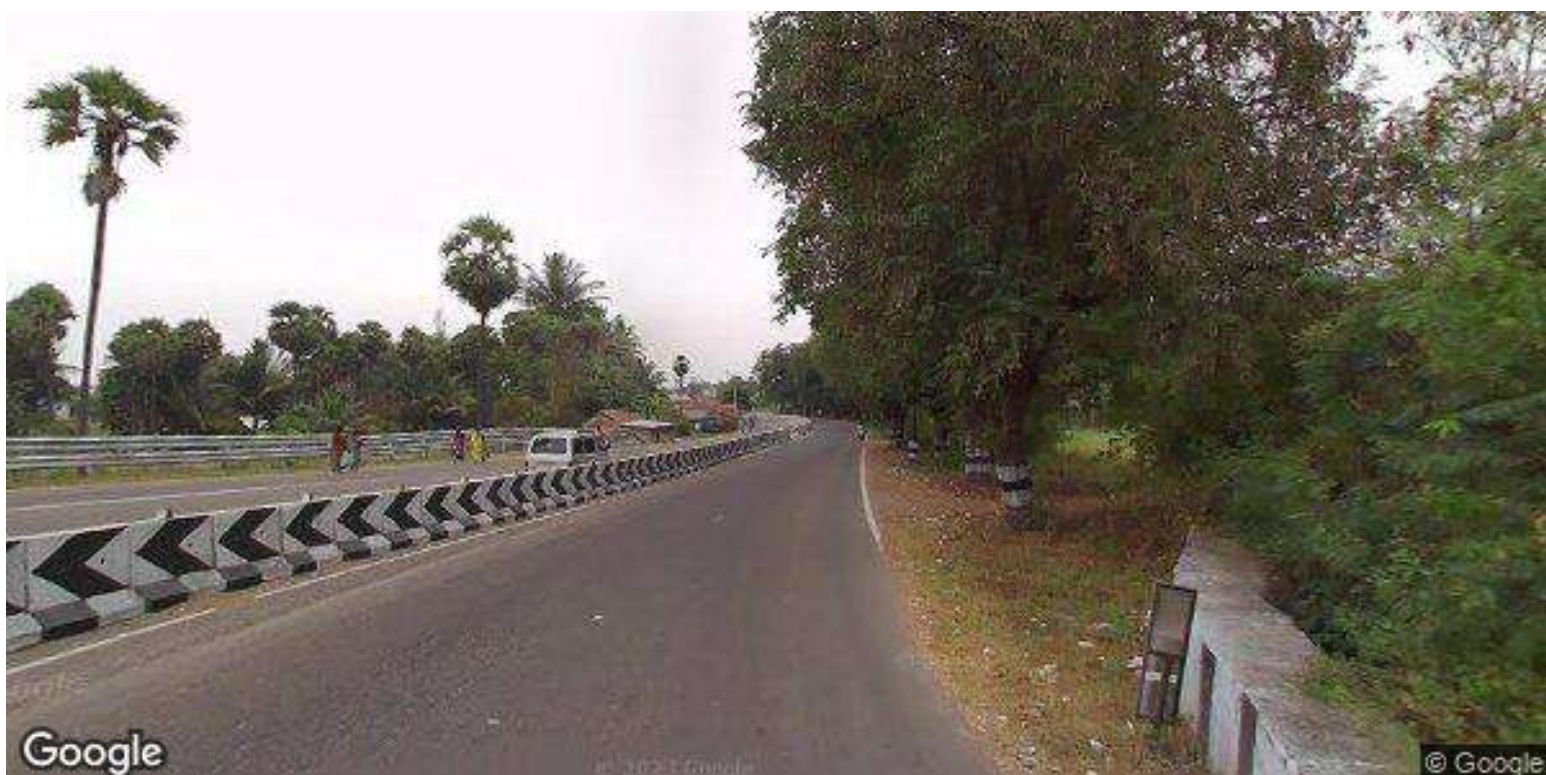
**Risk Type:** Turn  
**Risk Level:** Medium  
**Speed Limit:** 30 KM/Hr  
**Coordinates:** 11.08296, 77.65857

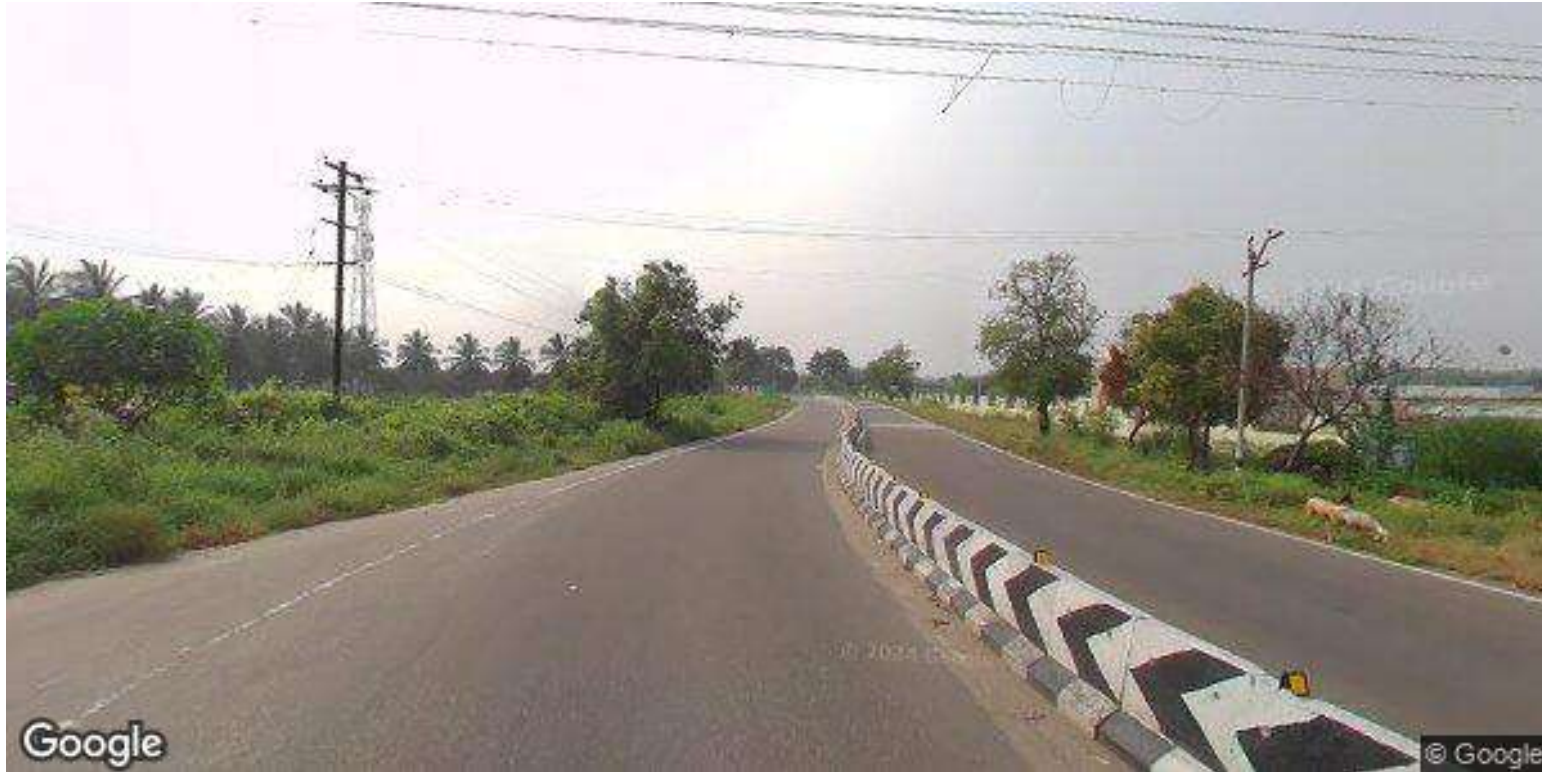
**Risk Type:** Turn  
**Risk Level:** Medium  
**Speed Limit:** 30 KM/Hr  
**Coordinates:** 11.06183, 77.63924

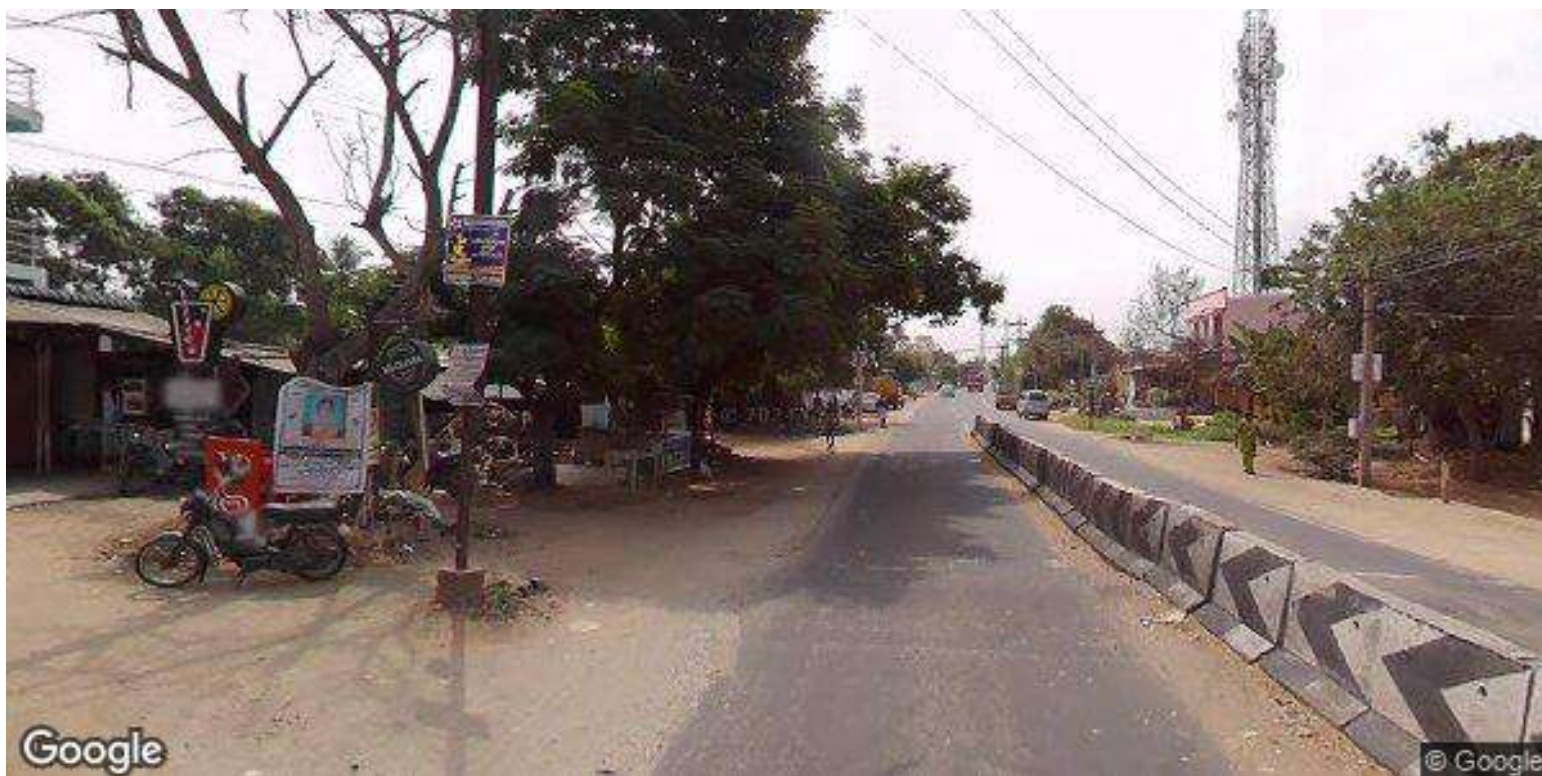
**Risk Type:** Turn  
**Risk Level:** High  
**Speed Limit:** 15 KM/Hr  
**Coordinates:** 11.00826, 77.56962

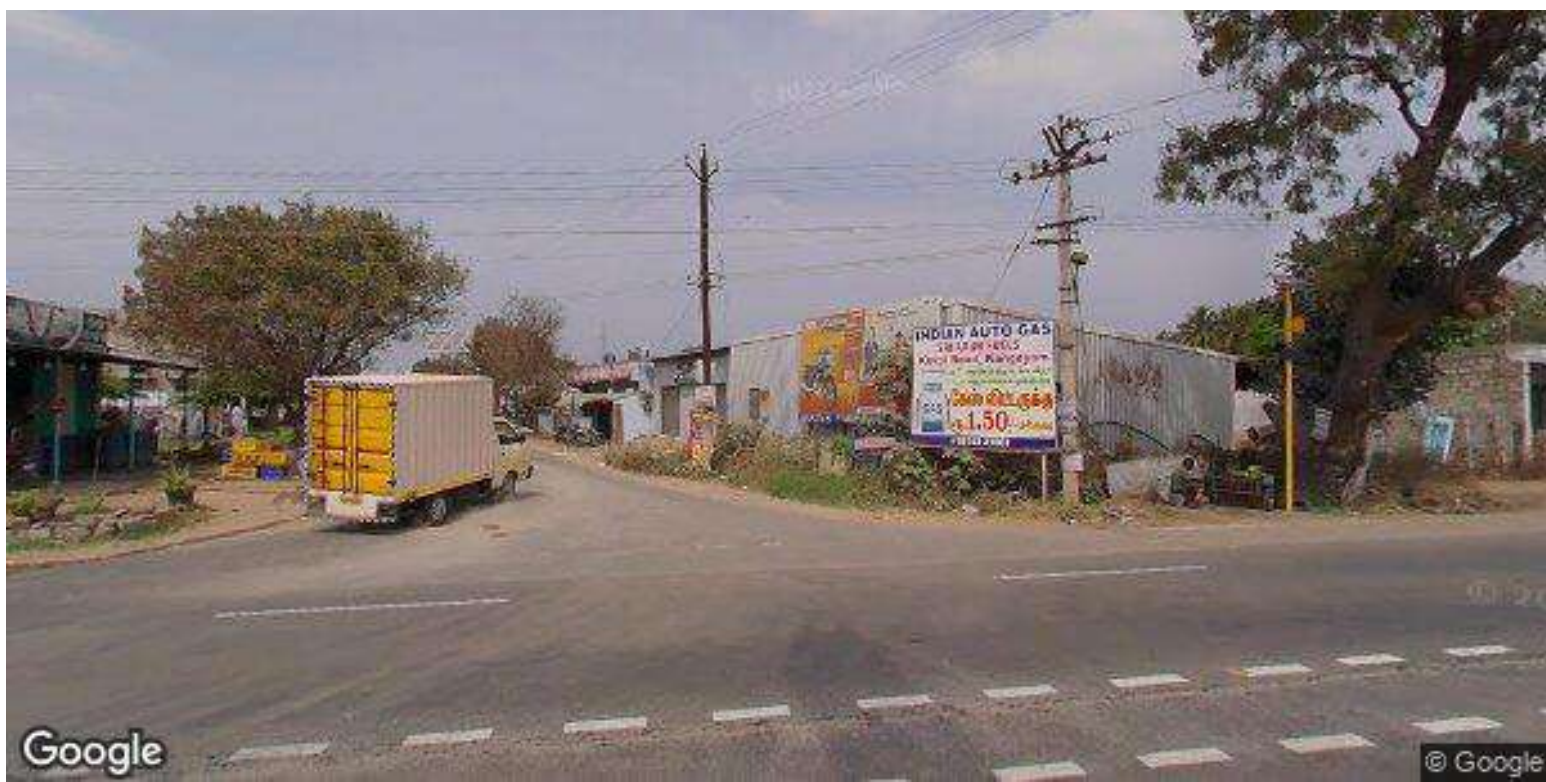
**Coordinates:** 11.00058, 77.56882

**Risk Type:** Blind Spot

**Risk Level:** Blind Spot

**Speed Limit:** 10 KM/Hr

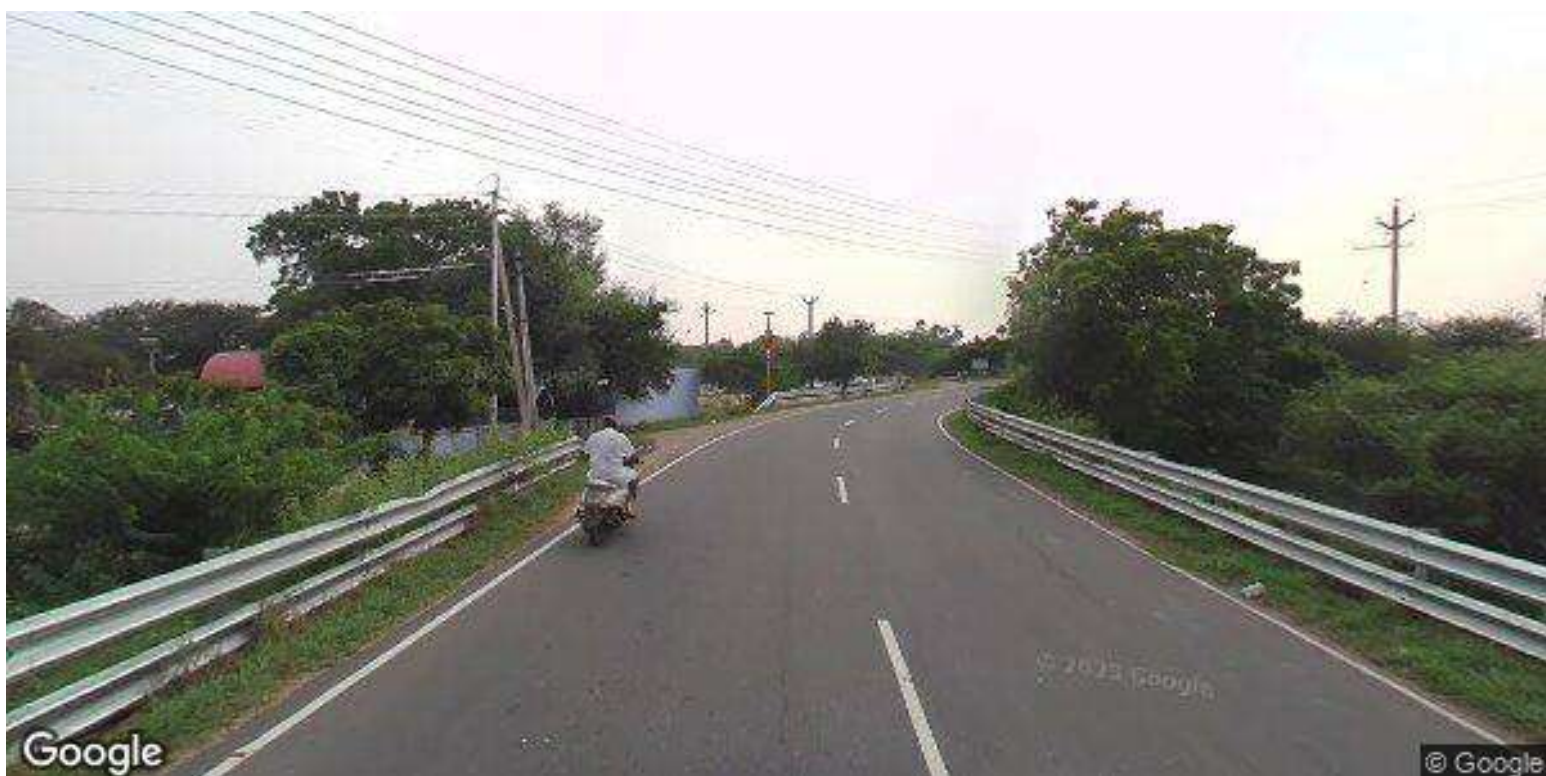
**Coordinates:** 10.94722, 77.54709

**Risk Type:** Turn

**Risk Level:** High

**Speed Limit:** 15 KM/Hr

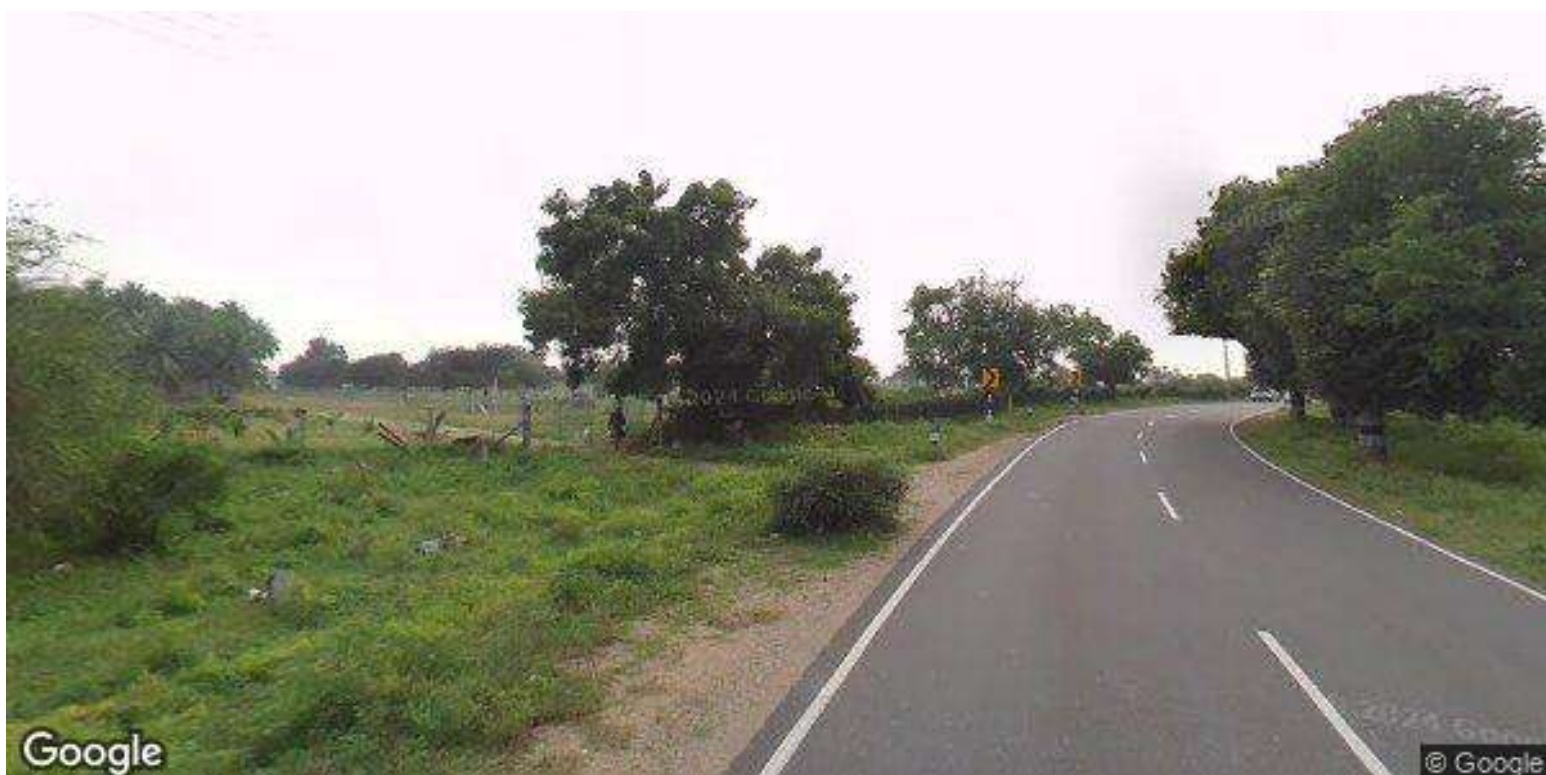
**Risk Type:** Turn  
**Risk Level:** Medium  
**Speed Limit:** 30 KM/Hr  
**Coordinates:** 10.93895, 77.53976

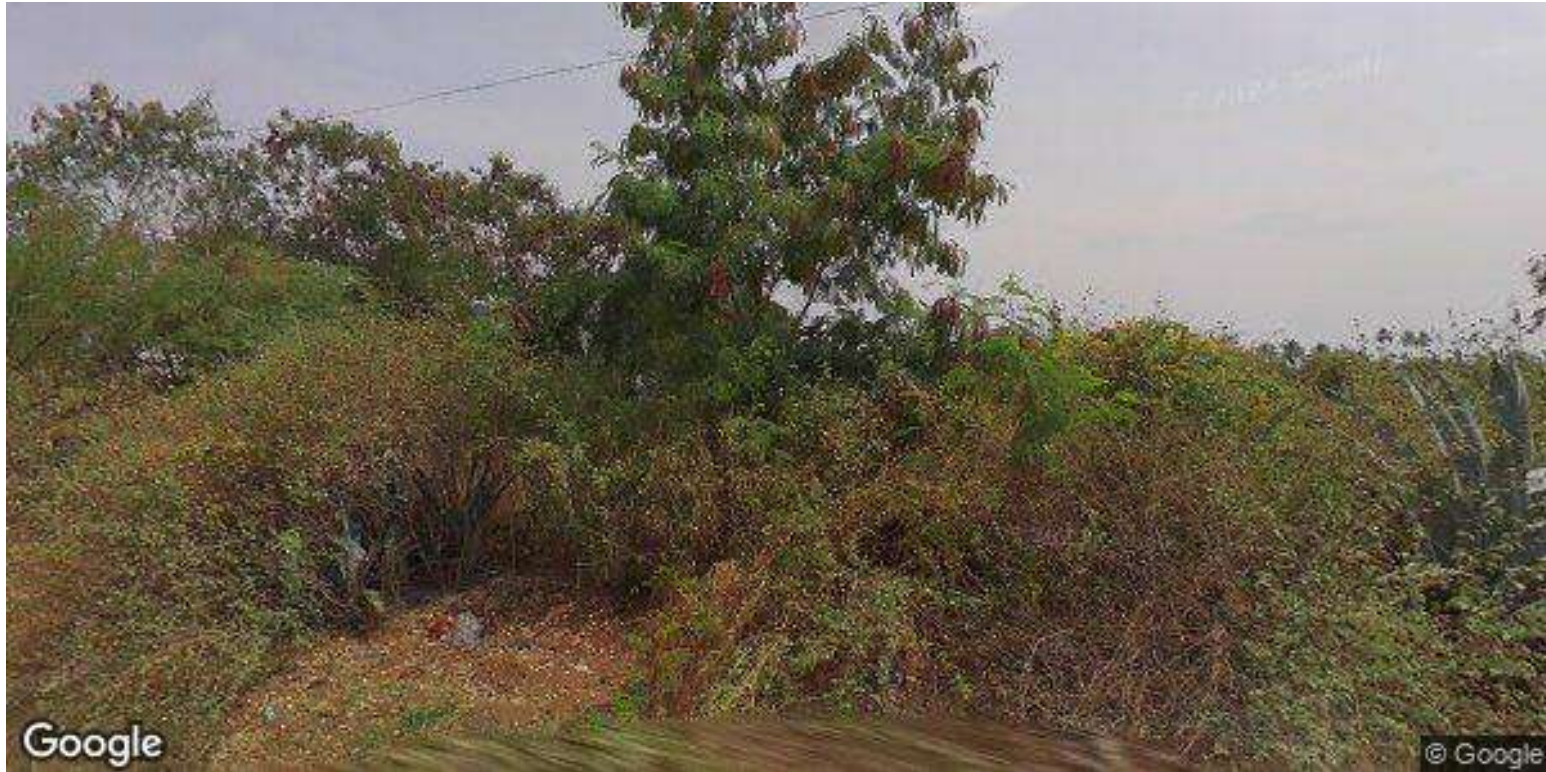
**Risk Type:** Turn  
**Risk Level:** Medium  
**Speed Limit:** 30 KM/Hr  
**Coordinates:** 10.93054, 77.53265

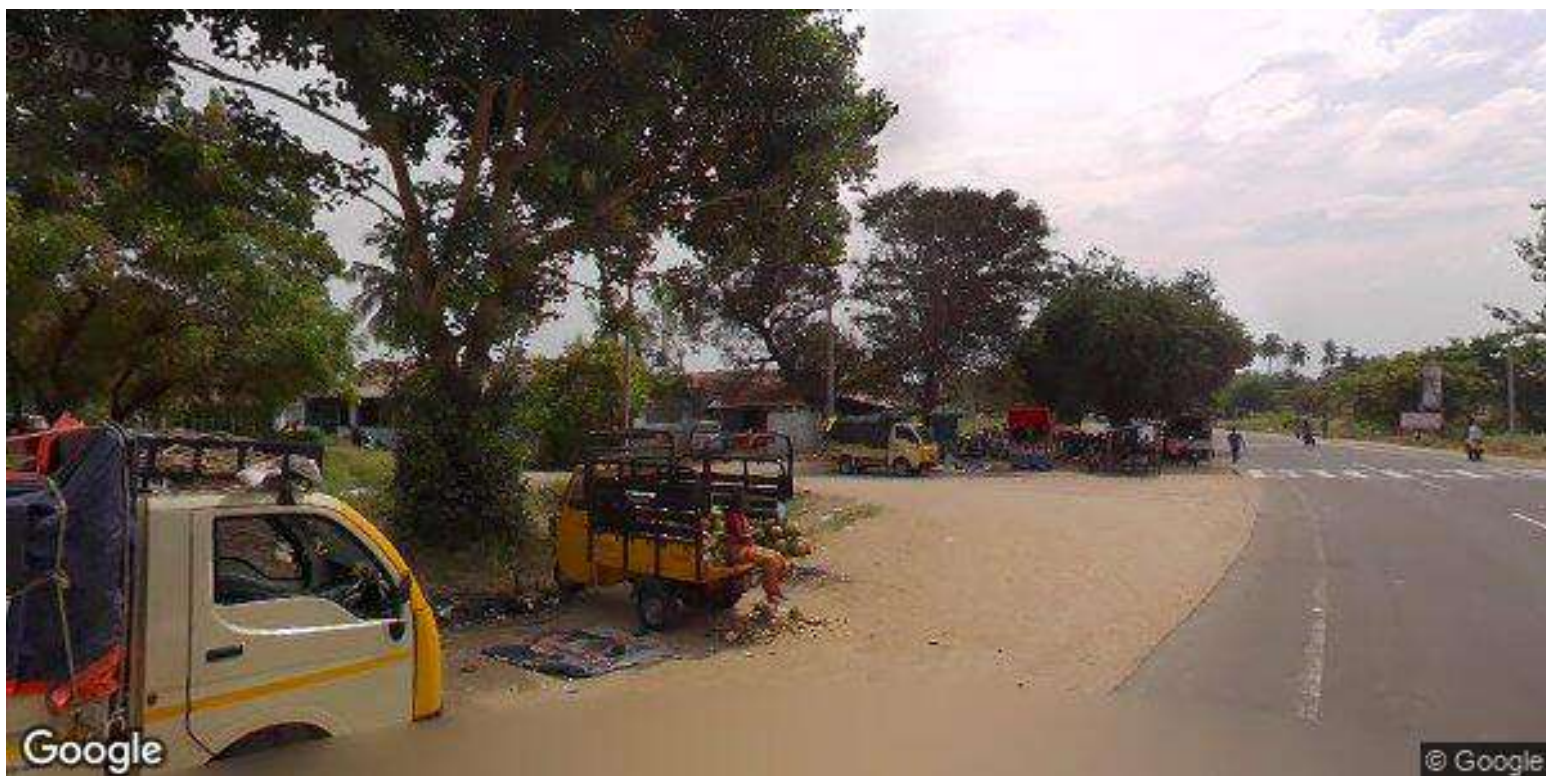
**Risk Type:** Turn  
**Risk Level:** Medium  
**Speed Limit:** 30 KM/Hr  
**Coordinates:** 10.89213, 77.52646

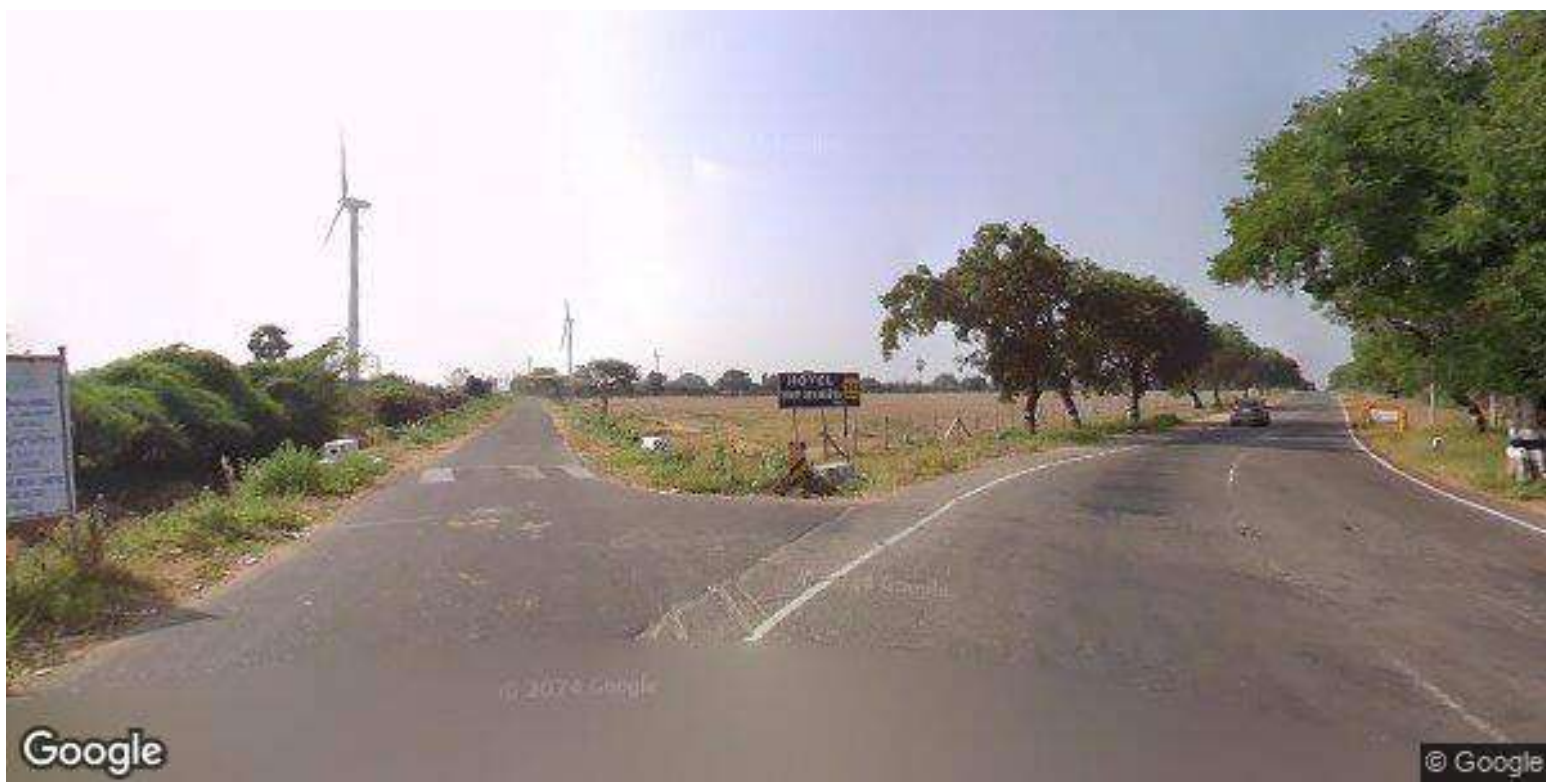
**Coordinates:** 10.83409, 77.52932

**Risk Type:** Turn

**Risk Level:** Medium

**Speed Limit:** 30 KM/Hr

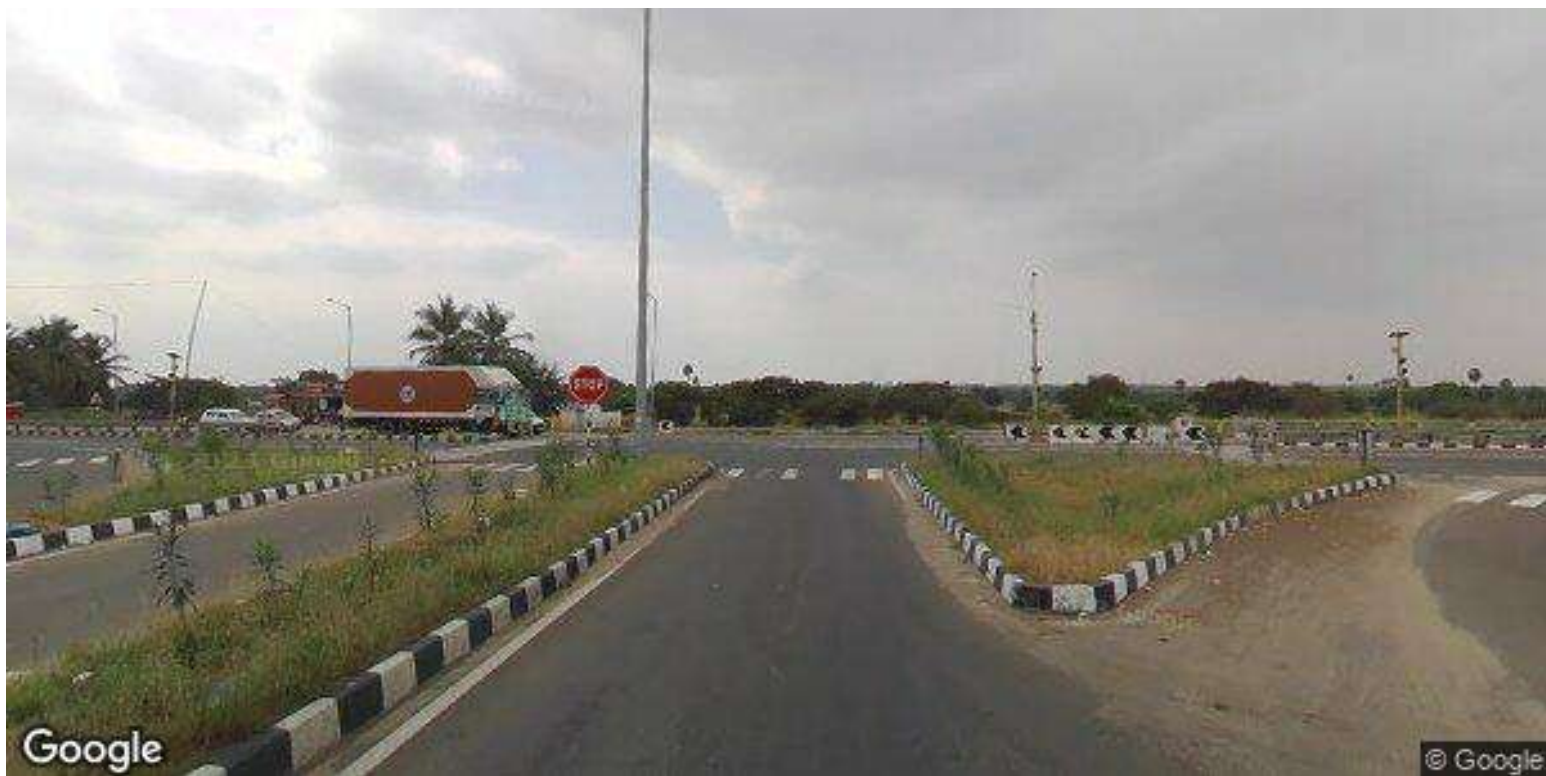
**Coordinates:** 10.77642, 77.50712

**Risk Type:** Turn

**Risk Level:** Medium

**Speed Limit:** 30 KM/Hr

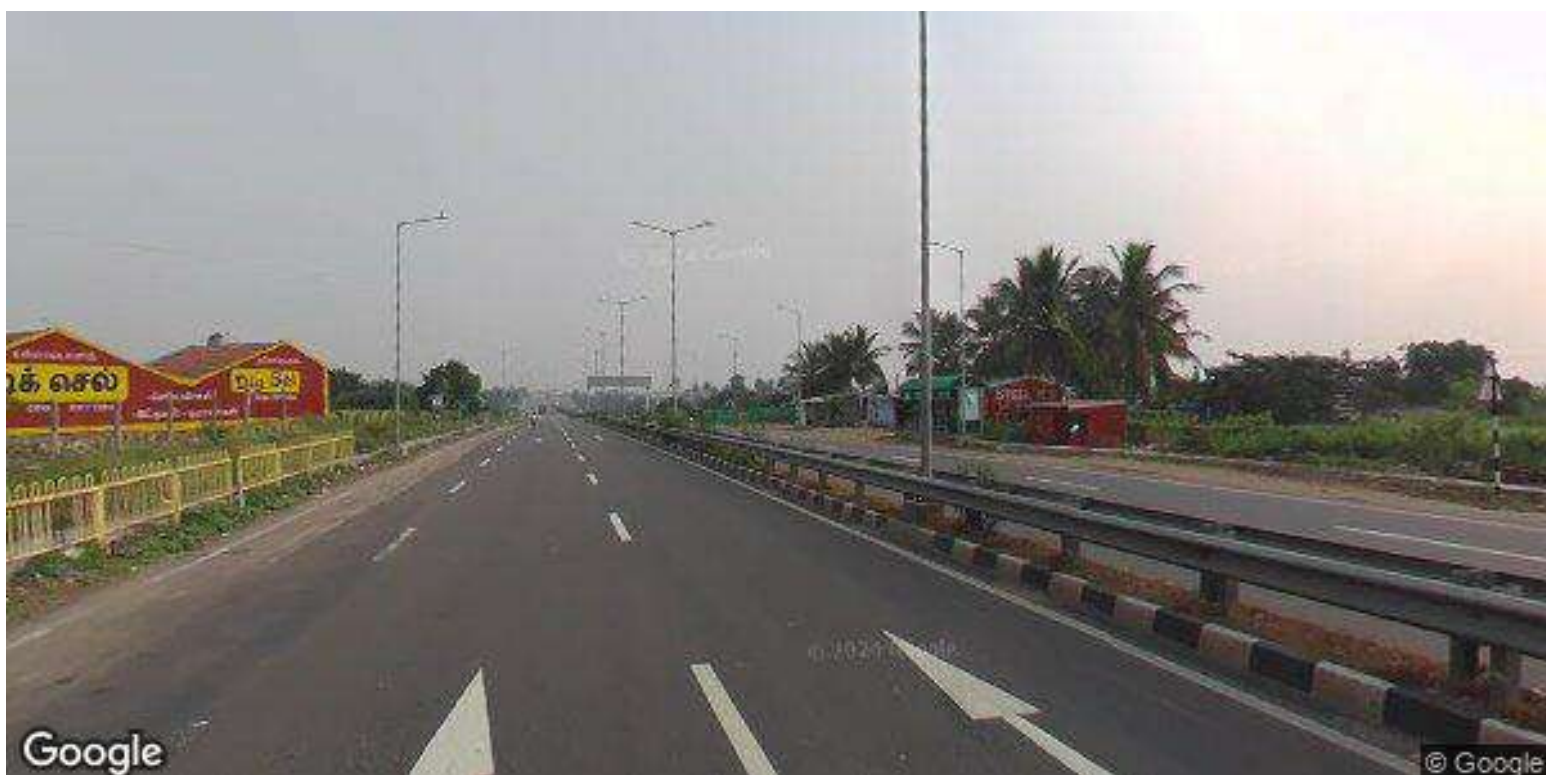
**Risk Type:** Turn  
**Risk Level:** Medium  
**Speed Limit:** 30 KM/Hr  
**Coordinates:** 10.77580, 77.50724
