# IndianOil

## JOURNEY RISK MANAGEMENT (JRM) STUDY

### Salem Terminal to SRI VEERAKUMAR AUTO SERVICE

### Route Safety Analysis: Sangagiri to Chinnaputhur, Tamil Nadu

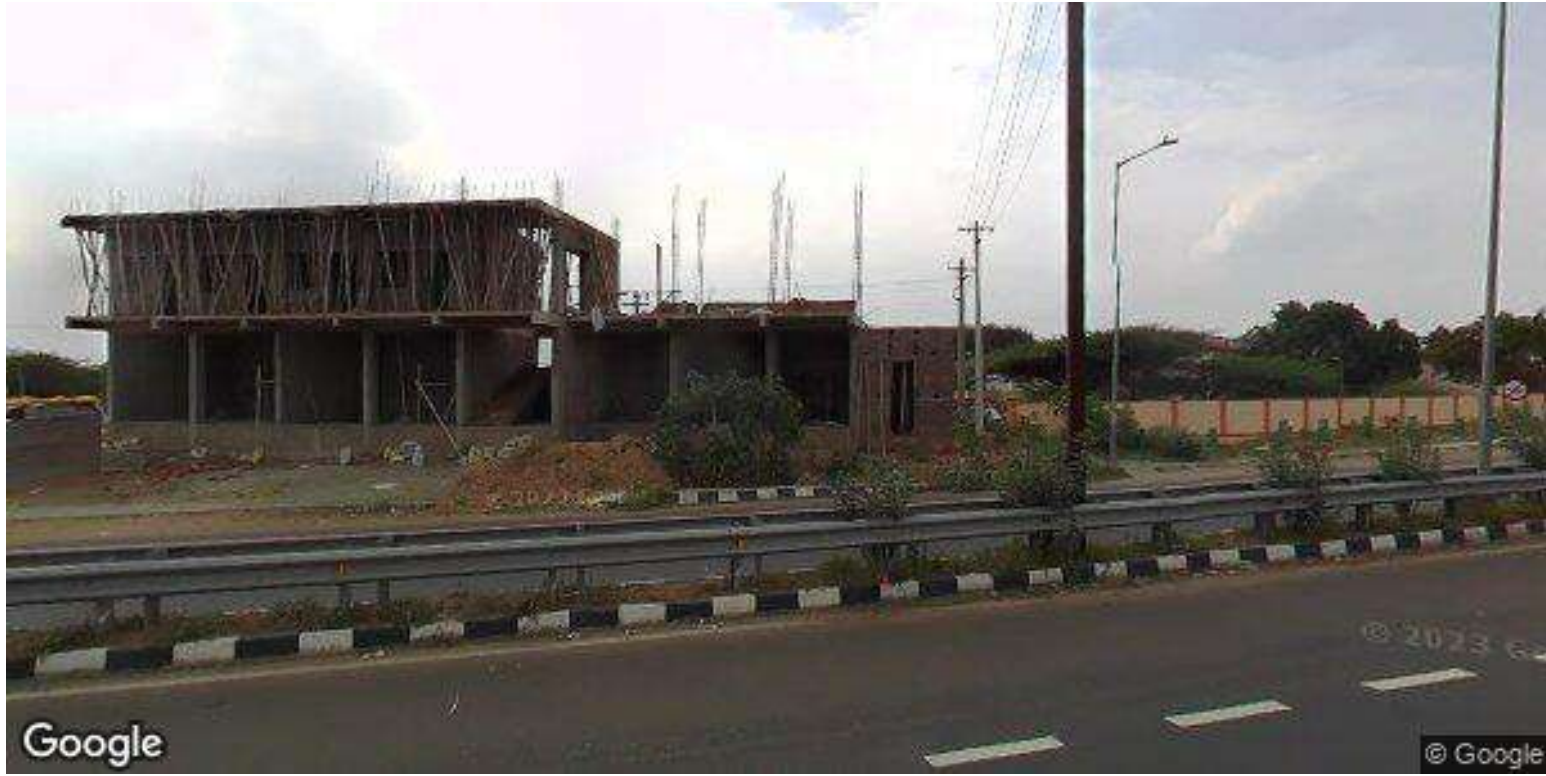
**Risk Type:** Turn  
**Risk Level:** Medium  
**Speed Limit:** 30 KM/Hr  
**Coordinates:** 10.75864, 77.51918

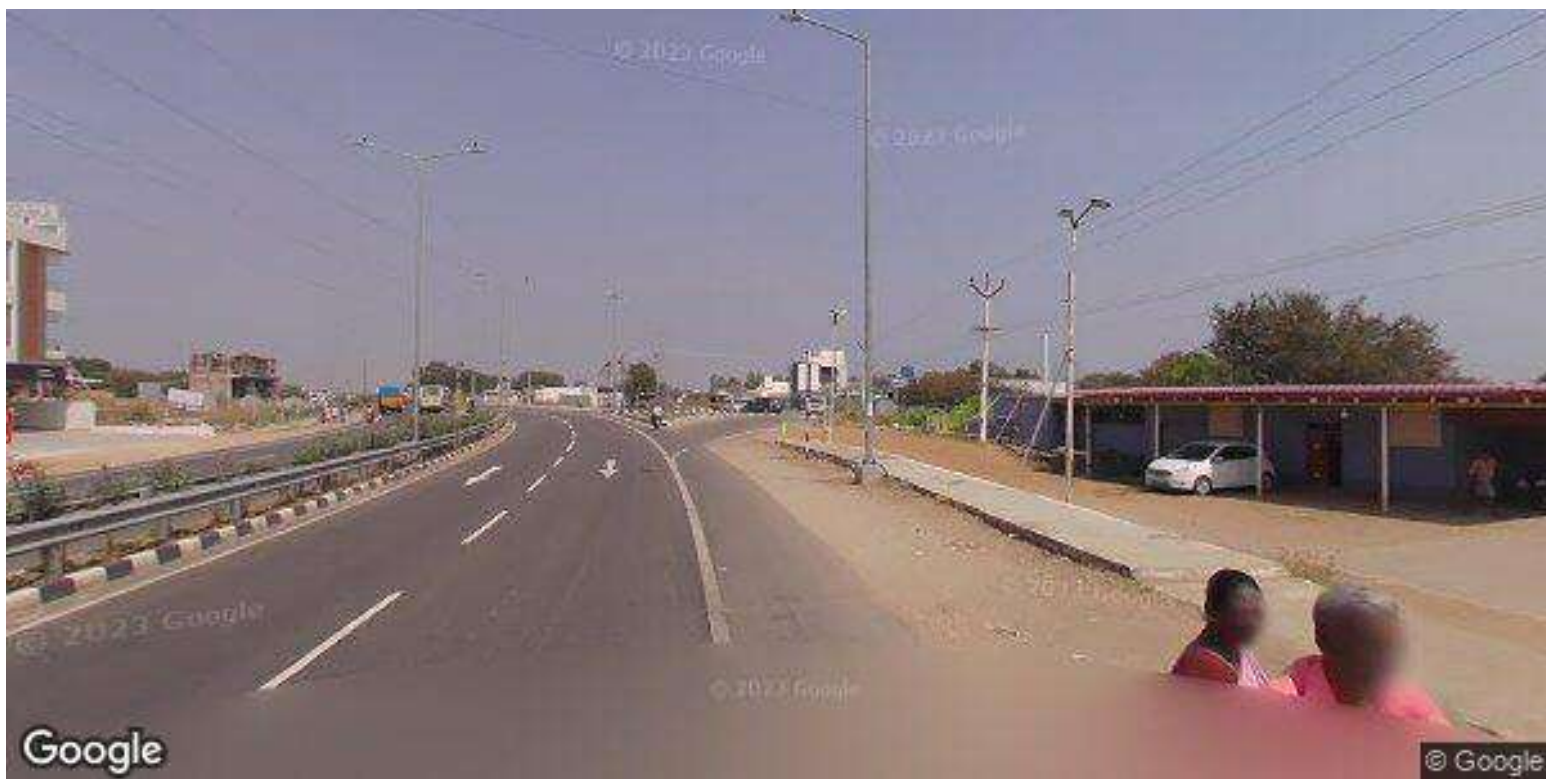
**Risk Type:** Turn  
**Risk Level:** Medium  
**Speed Limit:** 30 KM/Hr  
**Coordinates:** 10.75722, 77.51935

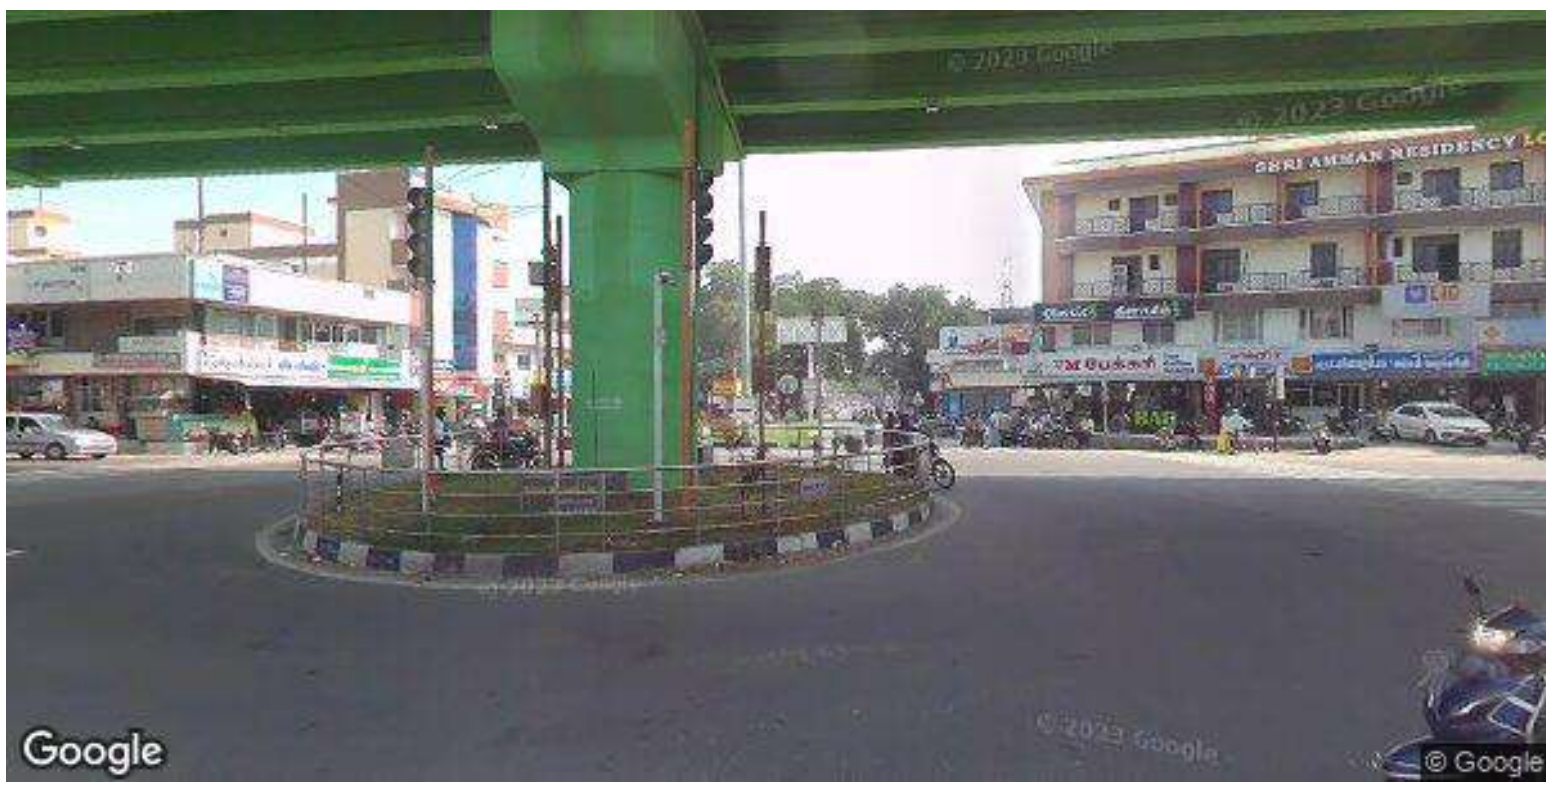
**Coordinates:** 10.73533, 77.51739

**Risk Type:** Turn

**Risk Level:** High

**Speed Limit:** 15 KM/Hr

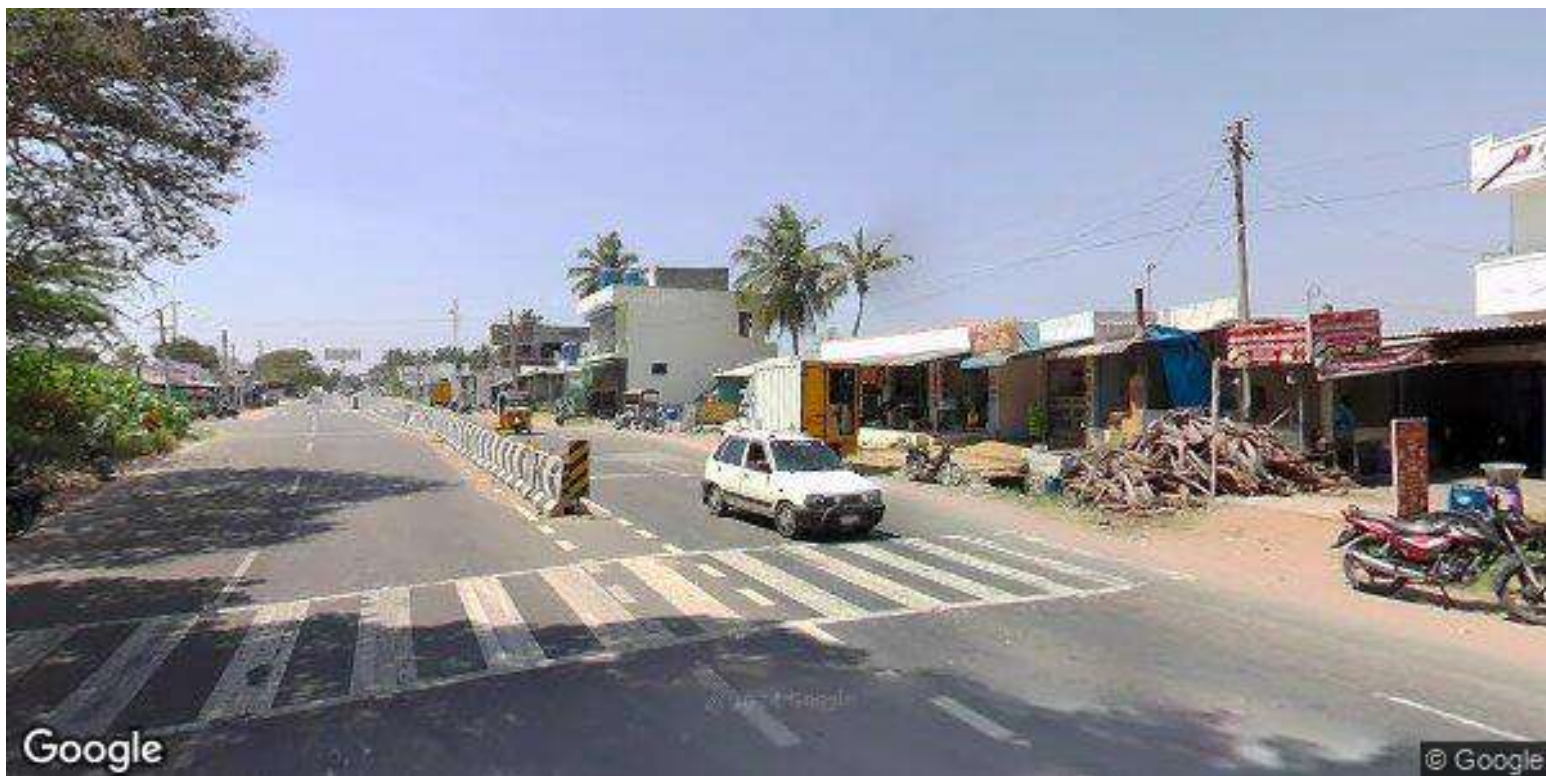
**Coordinates:** 10.70947, 77.43031

**Risk Type:** Blind Spot

**Risk Level:** Blind Spot

**Speed Limit:** 10 KM/Hr
