## JOURNEY RISK MANAGEMENT (JRM) STUDY

### Salem Terminal TO KARUR TALUK LORRY OWNERS ASSOC

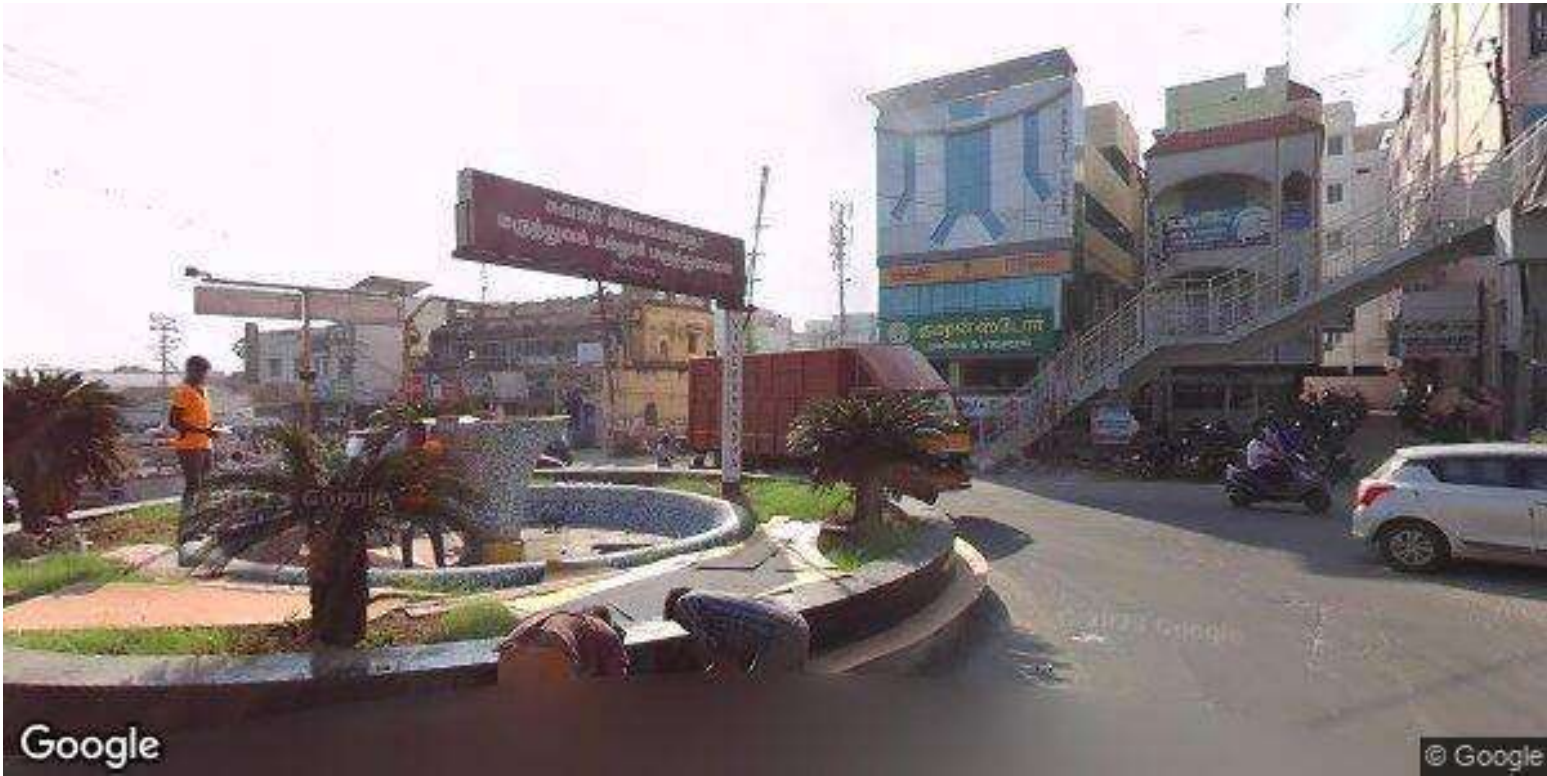
Coordinates: 11.38395, 77.89480

Risk Type: Roundabout

Risk Level: High

Speed Limit: 15 KM/Hr

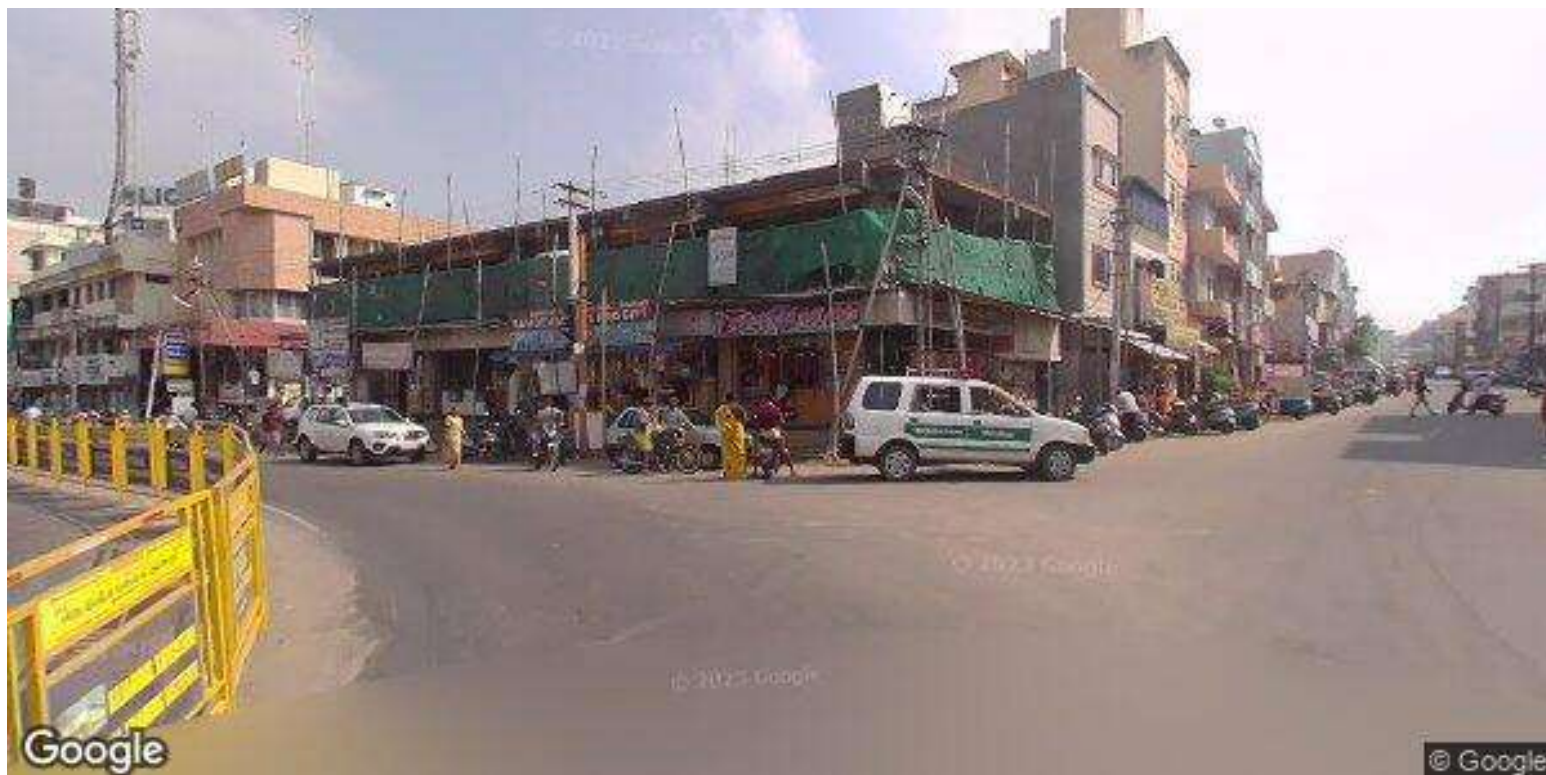
**Coordinates:** 11.37868, 77.89498

**Risk Type:** Turn

**Risk Level:** High

**Speed Limit:** 15 KM/Hr

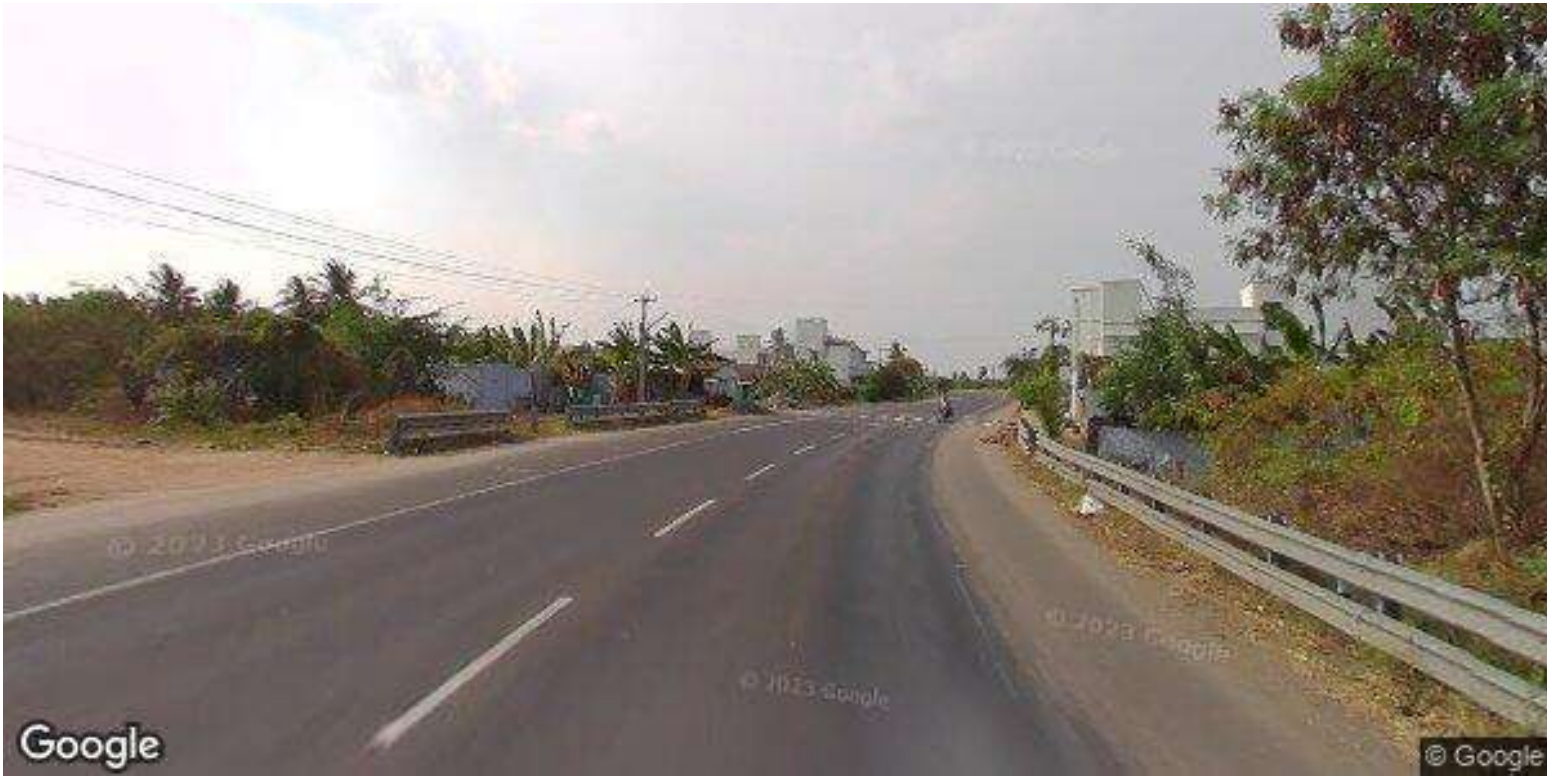
**Risk Type:** Turn  
**Risk Level:** Medium  
**Speed Limit:** 30 KM/Hr  
**Coordinates:** 11.16764, 78.01565

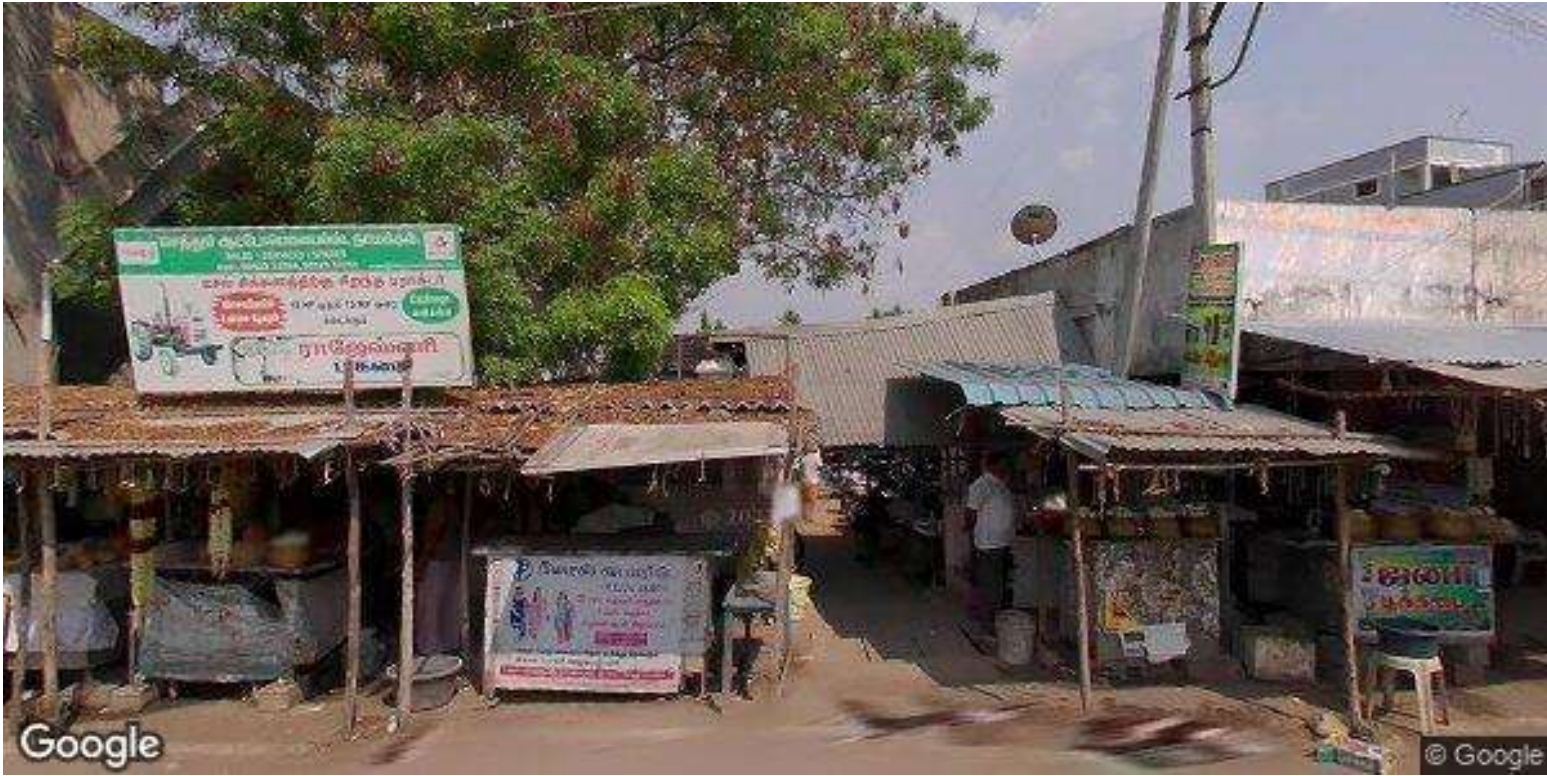
**Risk Type:** Turn  
**Risk Level:** High  
**Speed Limit:** 15 KM/Hr  
**Coordinates:** 11.15573, 78.02176

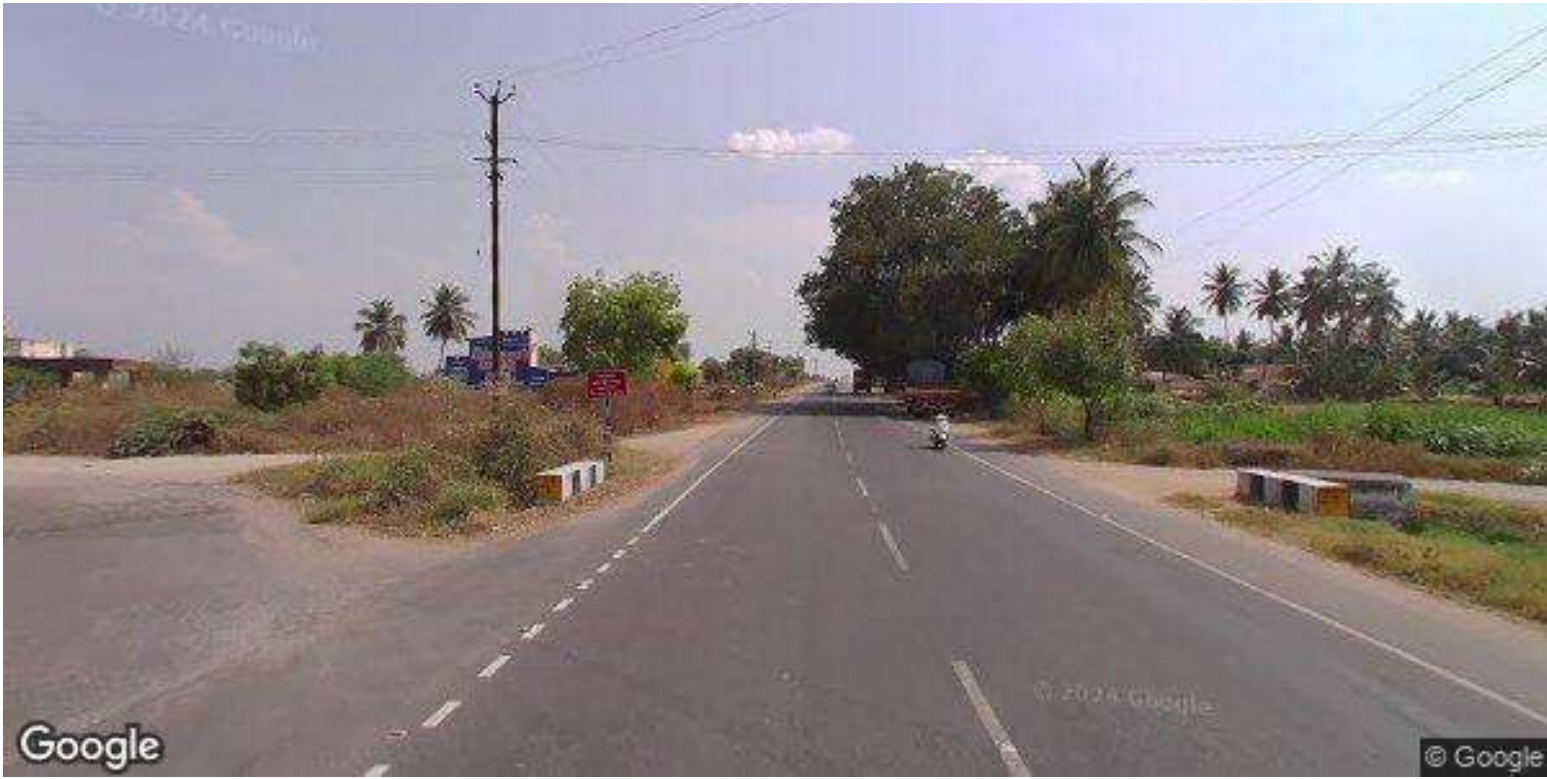
**Risk Type:** Turn  
**Risk Level:** High  
**Speed Limit:** 15 KM/Hr  
**Coordinates:** 11.14545, 78.02208

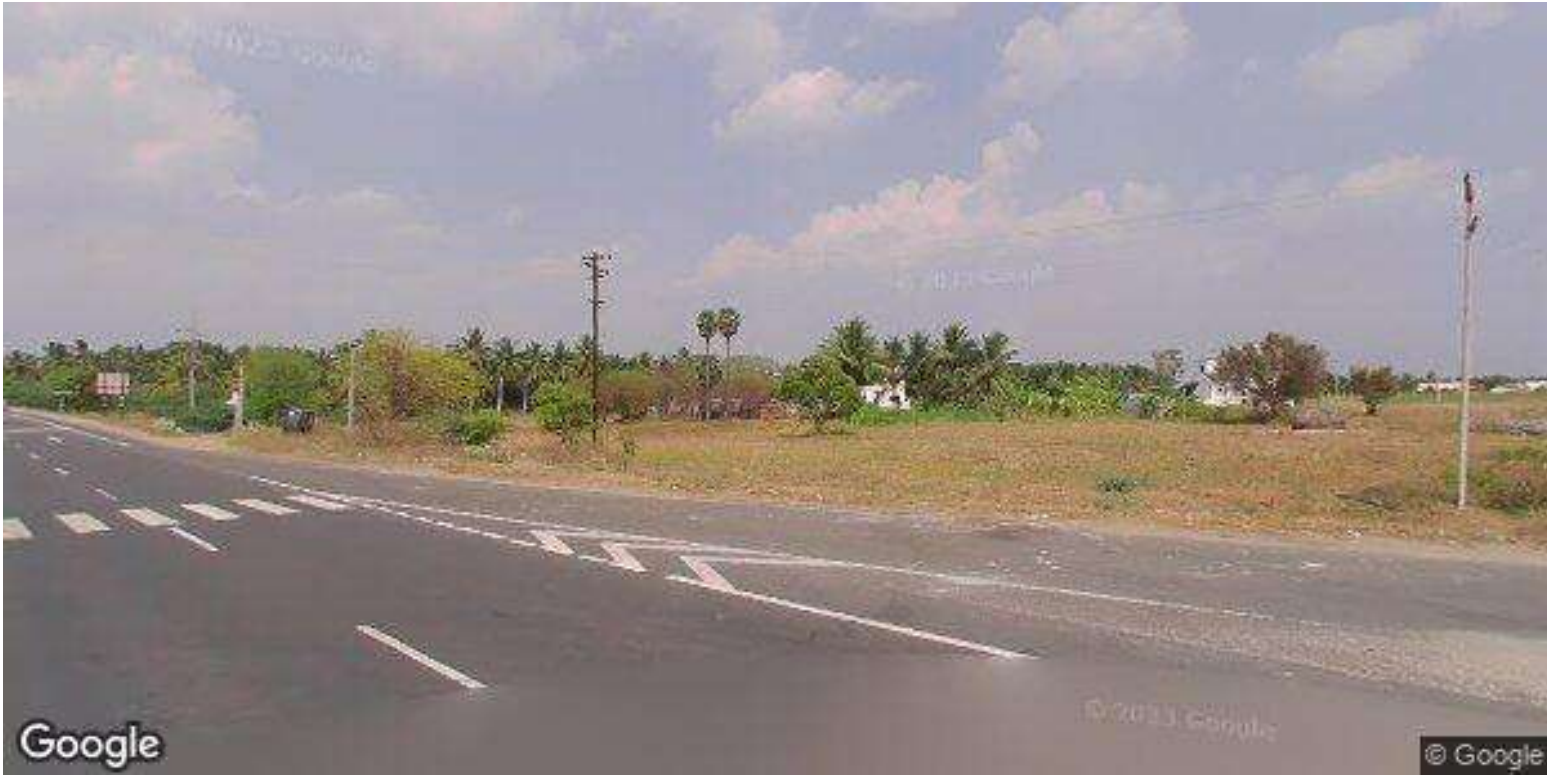
**Risk Type:** Turn  
**Risk Level:** High  
**Speed Limit:** 15 KM/Hr  
**Coordinates:** 11.14480, 78.02291

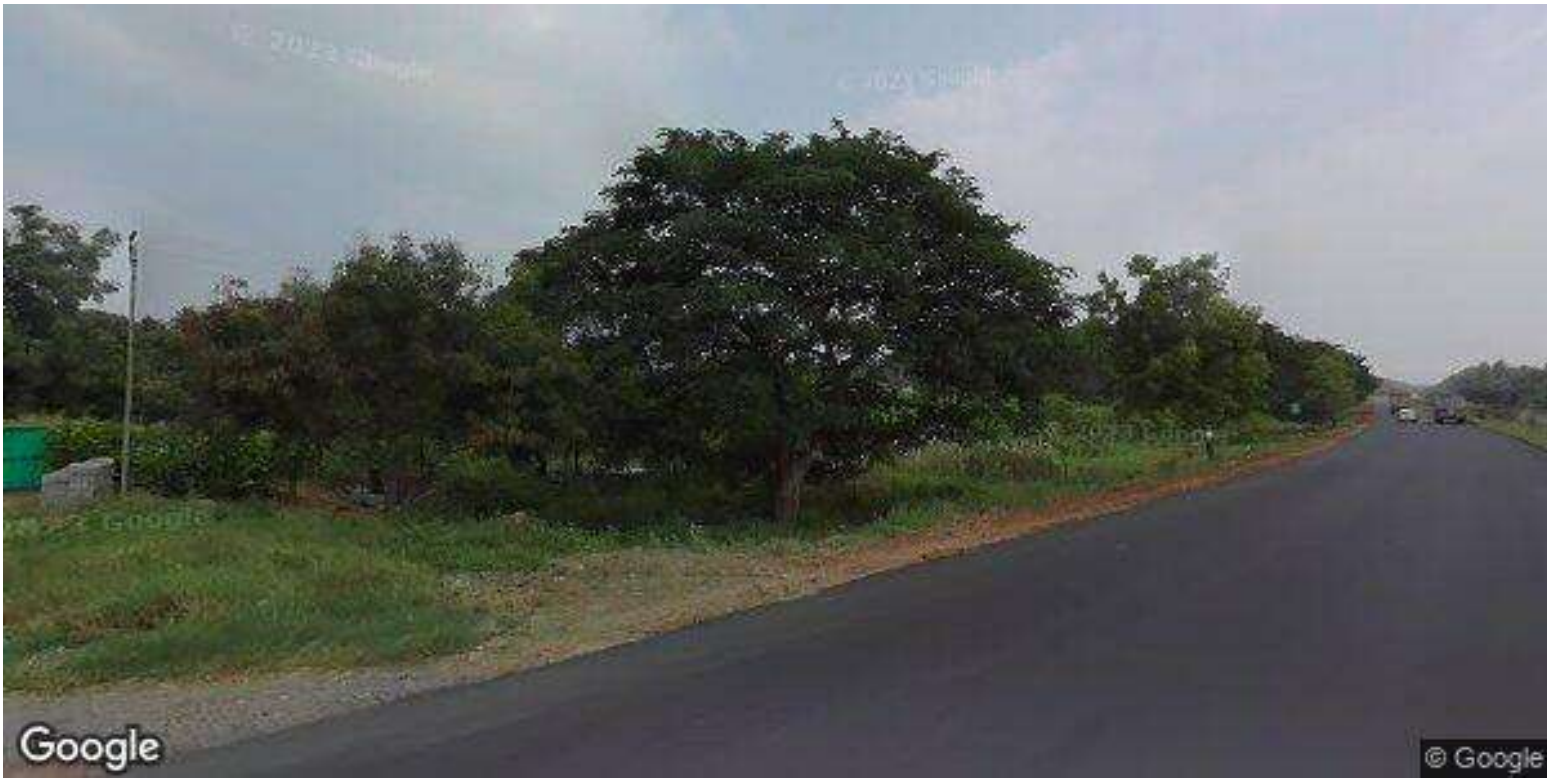
**Risk Type:** Blind Spot  
**Risk Level:** Blind Spot  
**Speed Limit:** 10 KM/Hr  
**Coordinates:** 11.06358, 78.01751

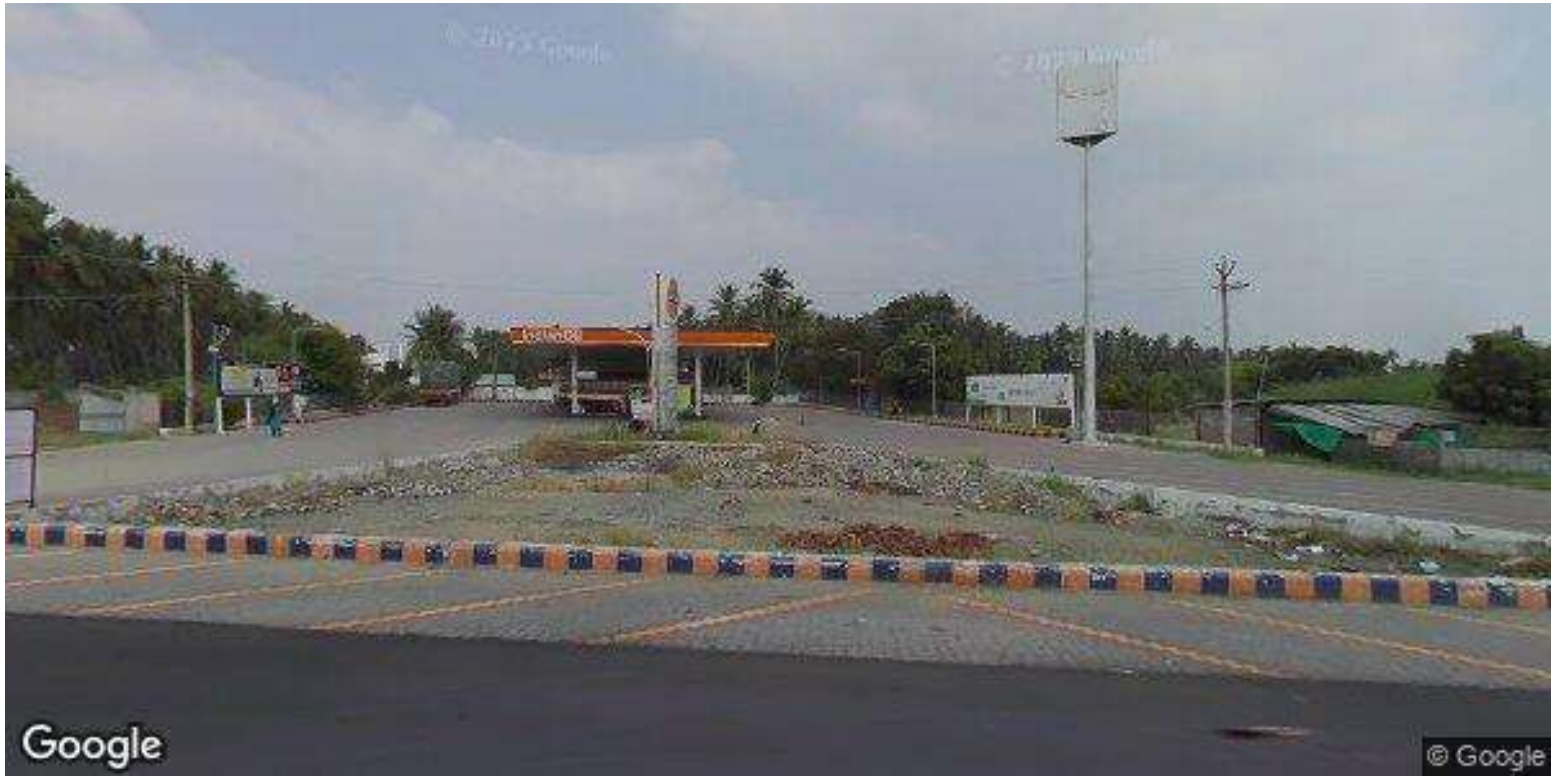
**Risk Type:** Turn  
**Risk Level:** High  
**Speed Limit:** 15 KM/Hr  
**Coordinates:** 11.06408, 78.01744
