## **JOURNEY RISK MANAGEMENT (JRM) STUDY**

### **Salem Terminal to SRI SARAVANA AGENCIES PUDUPAI**

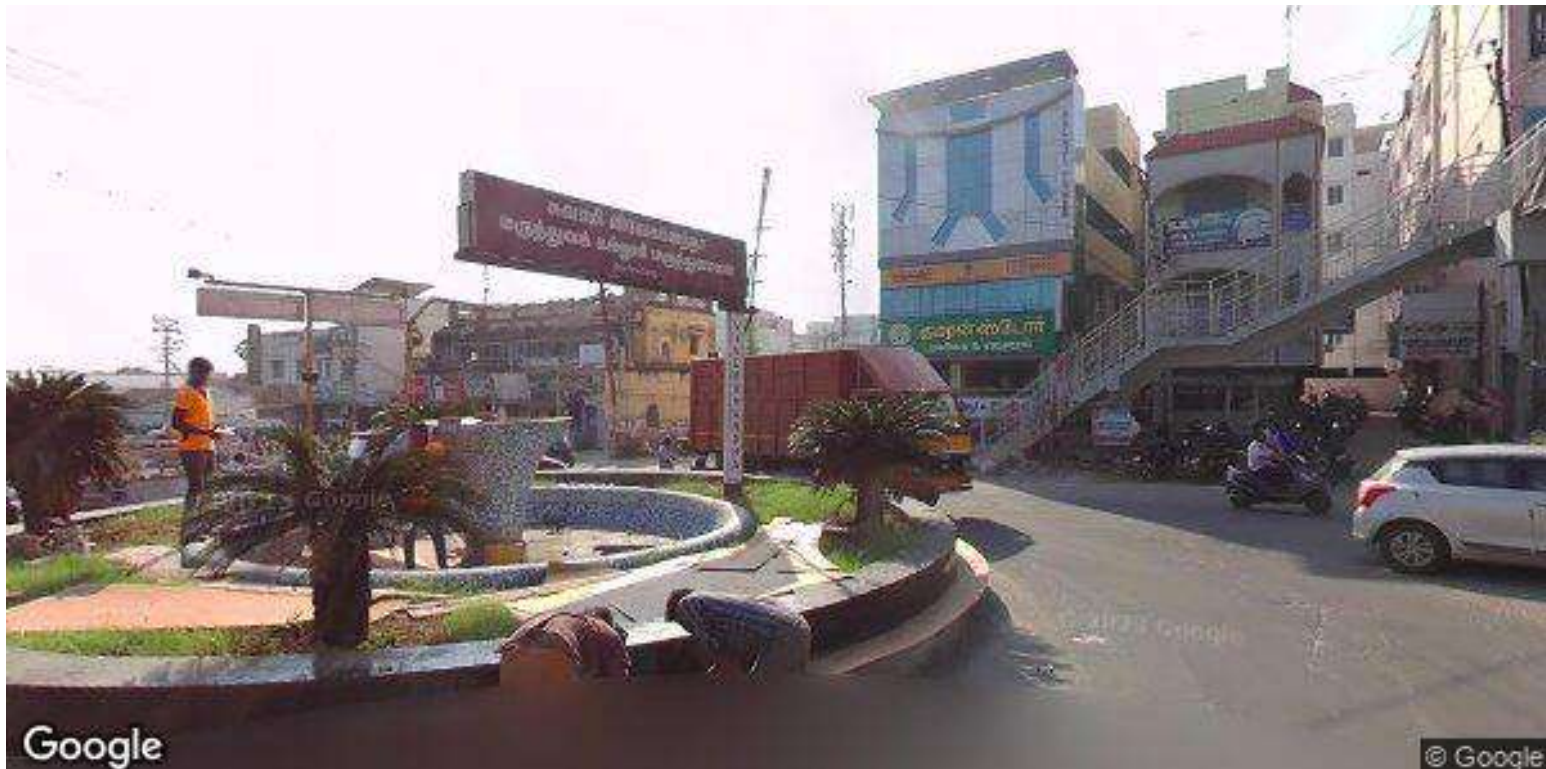
**Risk Type:** Roundabout  
**Risk Level:** High  
**Speed Limit:** 15 KM/Hr  
**Coordinates:** 11.38395, 77.89480

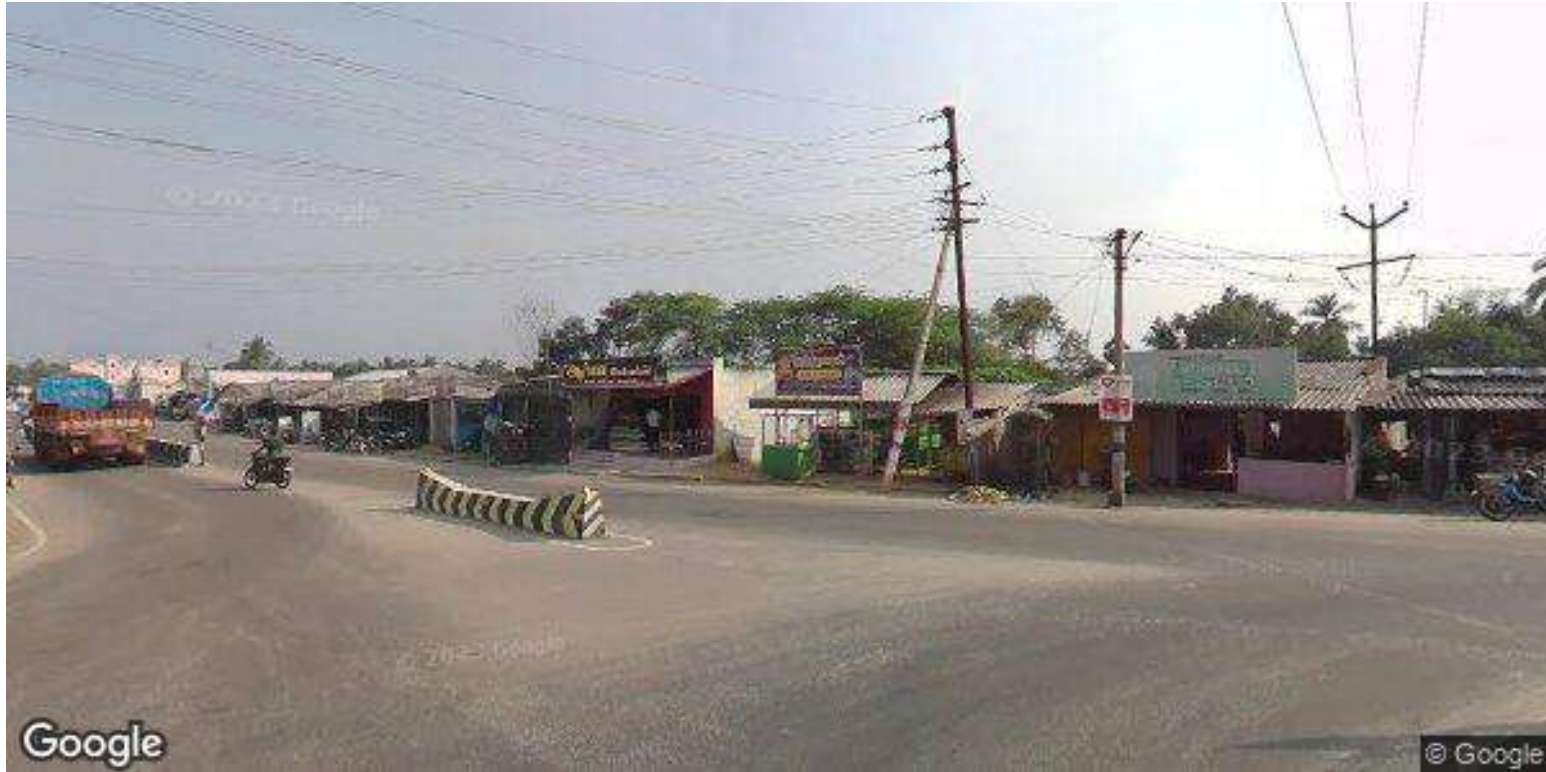
**Risk Type:** Roundabout  
**Risk Level:** High  
**Speed Limit:** 15 KM/Hr  
**Coordinates:** 11.04637, 77.73761

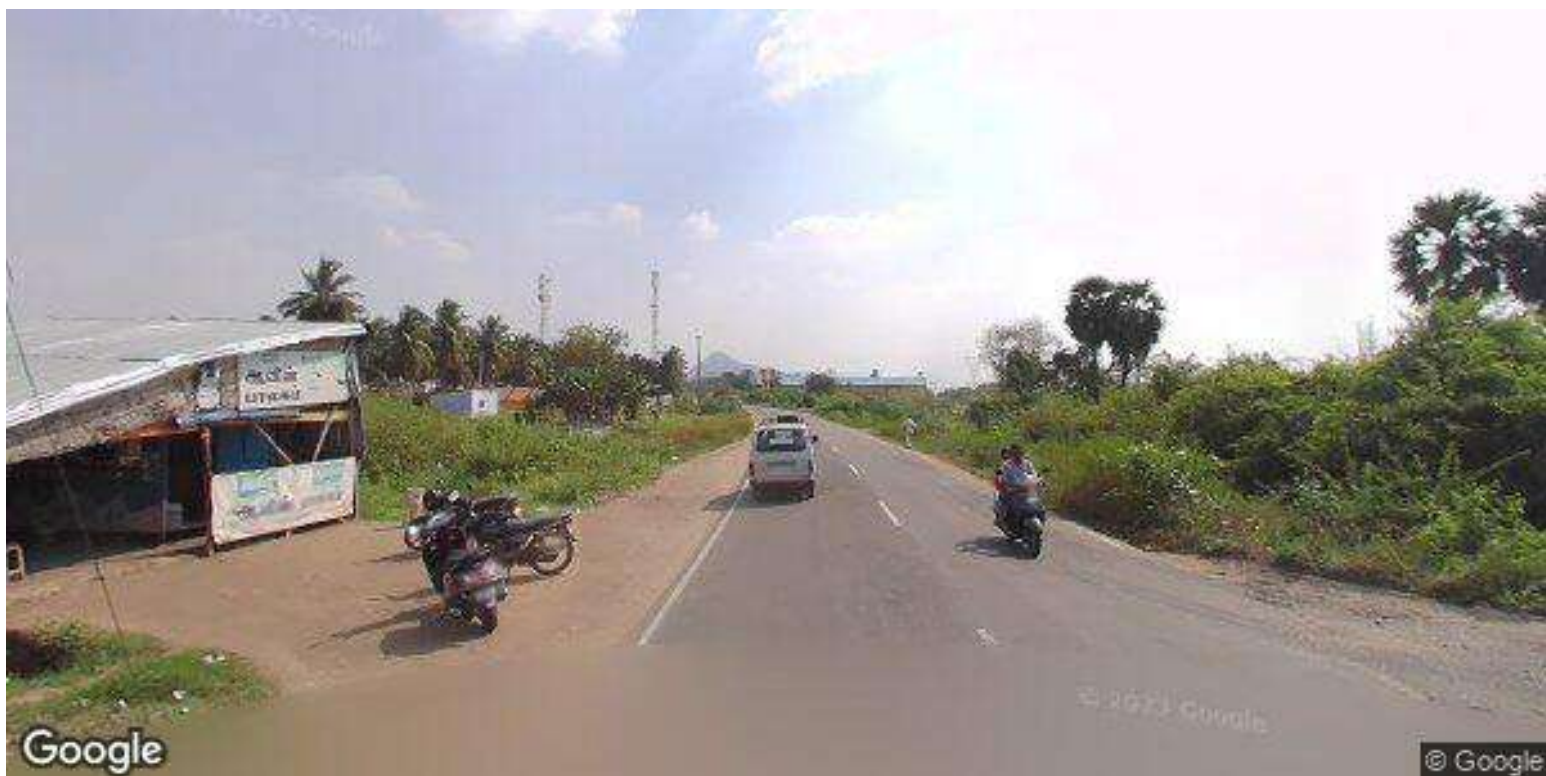
**Risk Type:** Turn  
**Risk Level:** High  
**Speed Limit:** 15 KM/Hr  
**Coordinates:** 11.44022, 77.87546

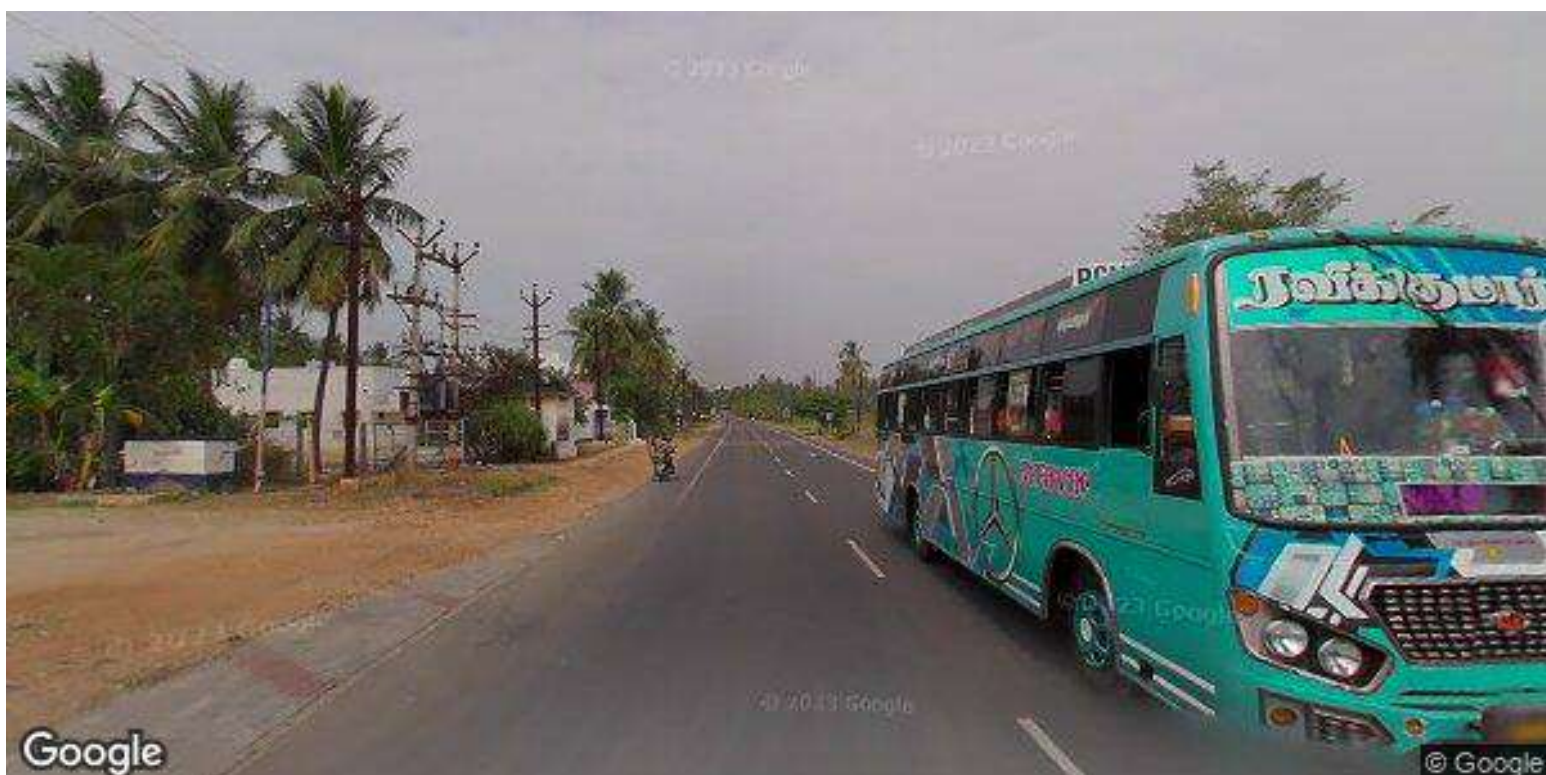
**Coordinates:** 11.30869, 77.92911

**Risk Type:** Turn

**Risk Level:** Medium

**Speed Limit:** 30 KM/Hr

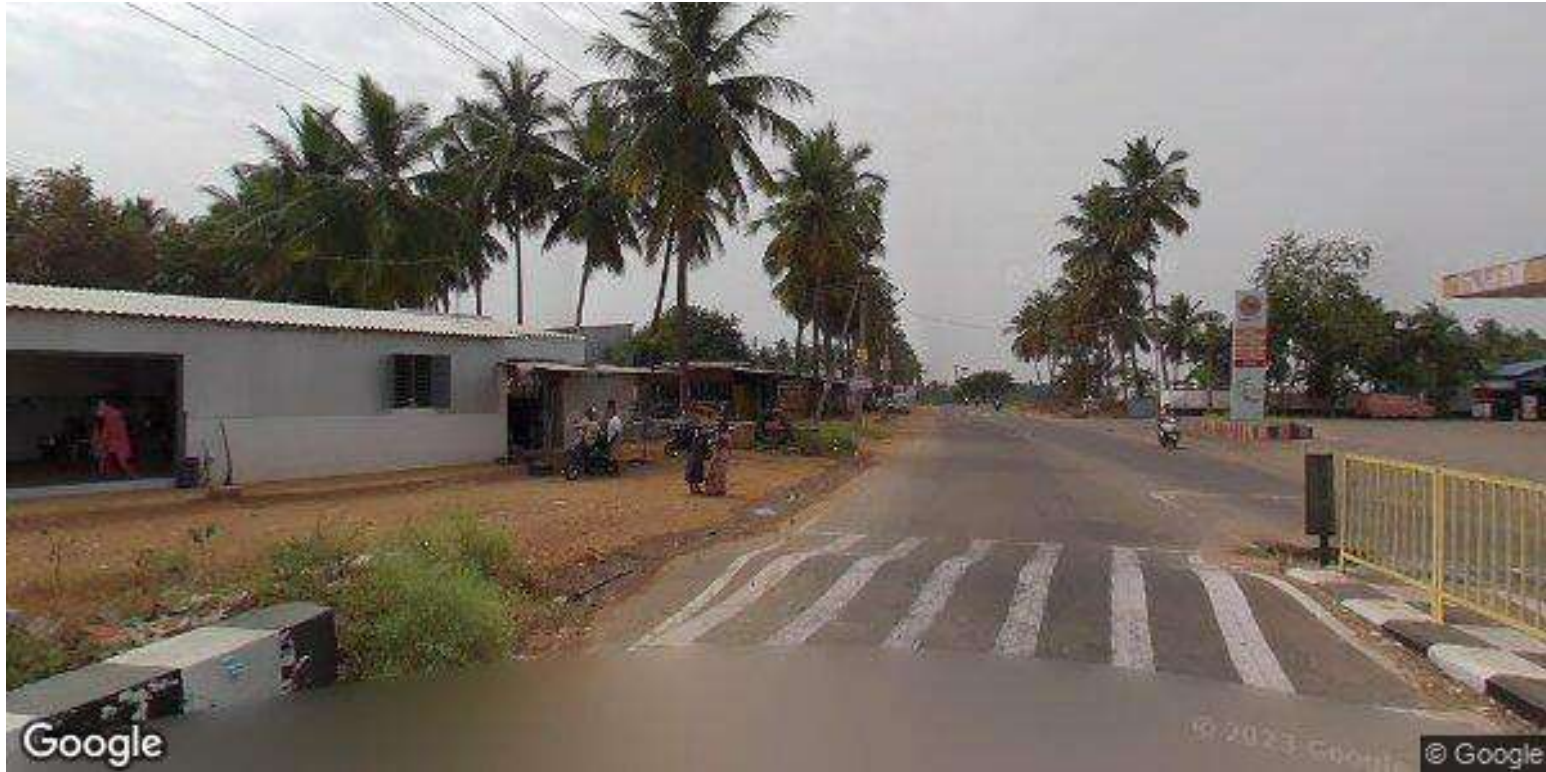
**Coordinates:** 11.30849, 77.92910

**Risk Type:** Turn

**Risk Level:** Medium

**Speed Limit:** 30 KM/Hr

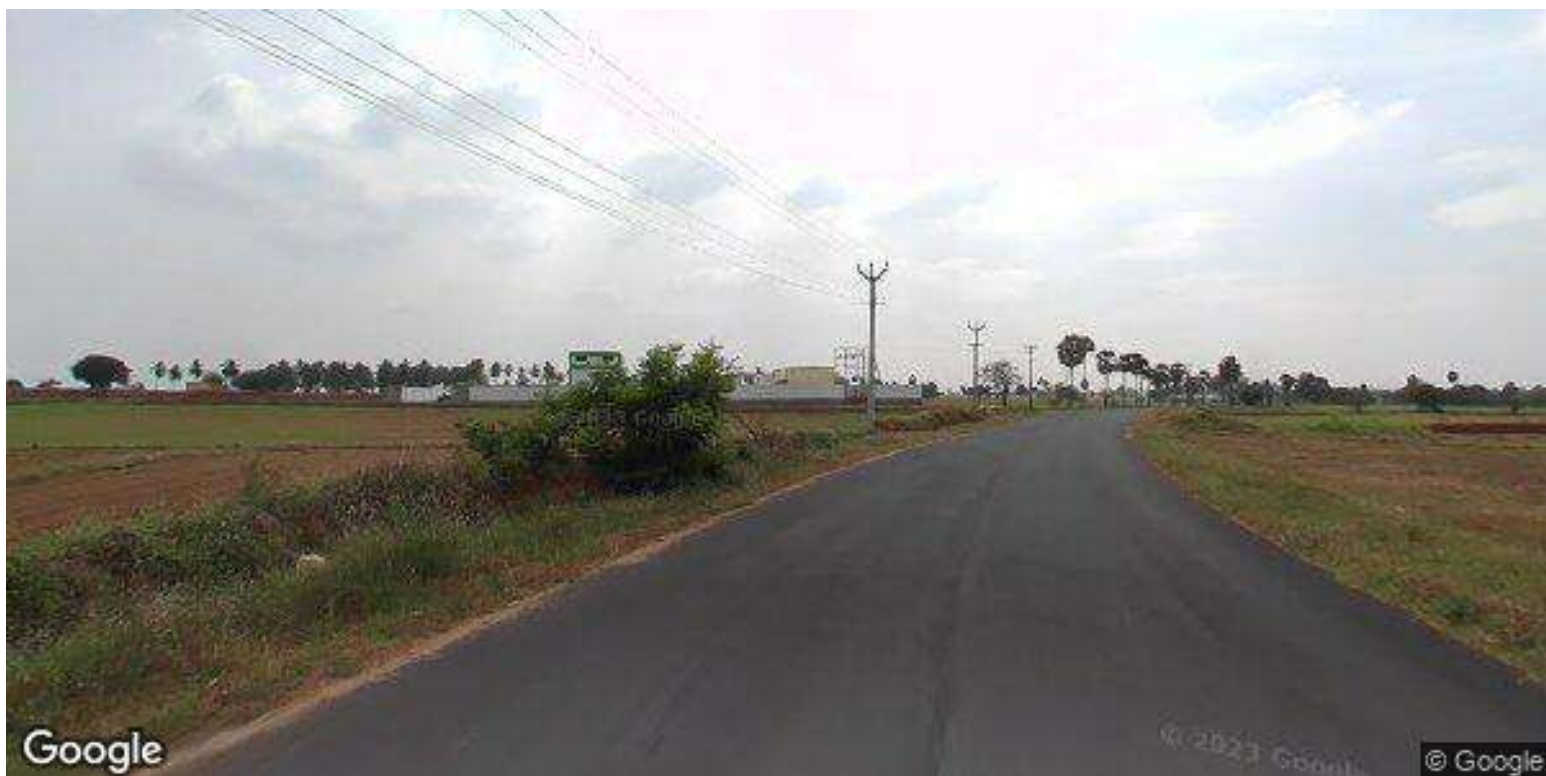
**Coordinates:** 11.27840, 77.91284

**Risk Type:** Turn

**Risk Level:** Medium

**Speed Limit:** 30 KM/Hr

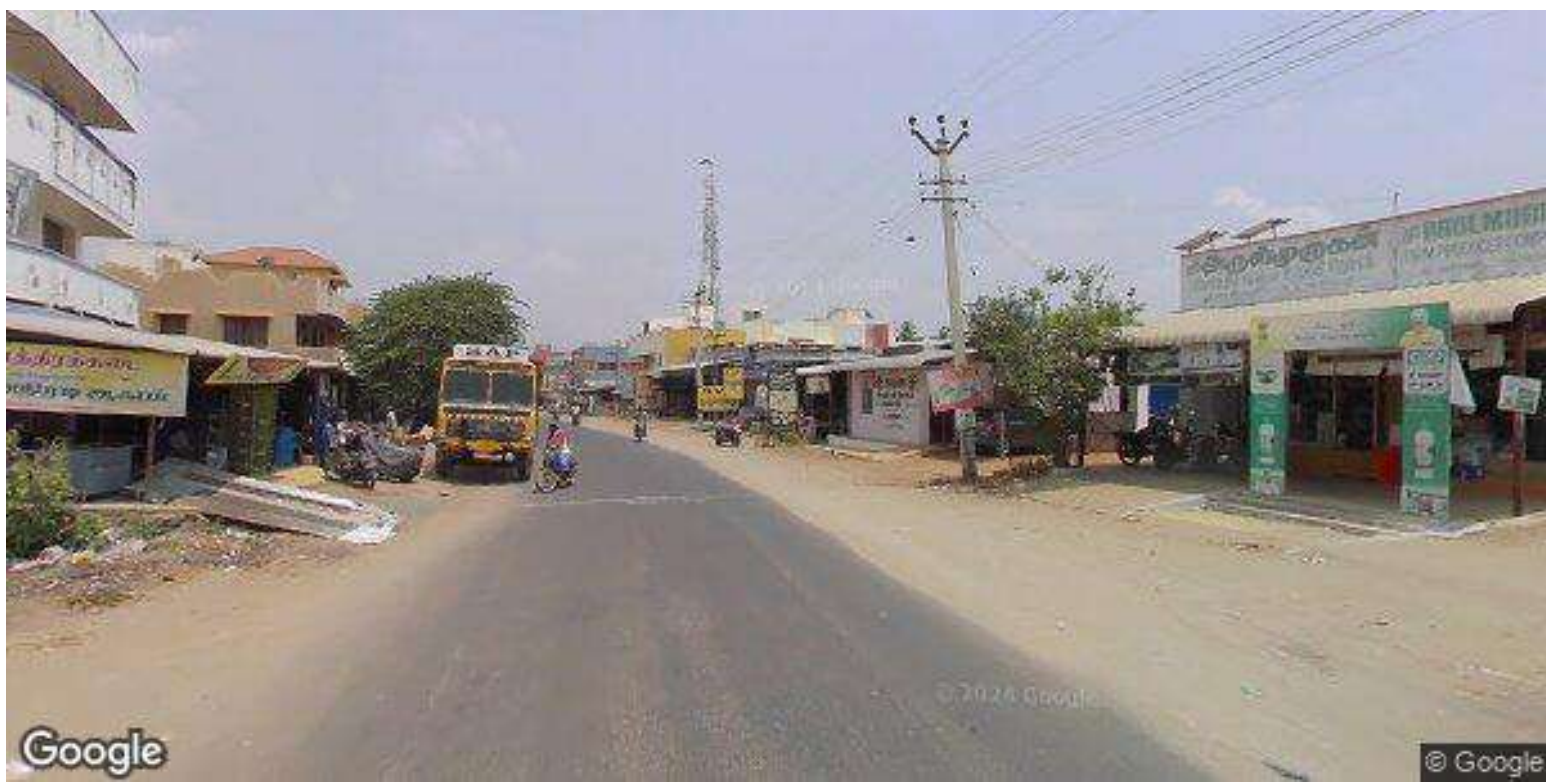
**Coordinates:** 11.24172, 77.87357

**Risk Type:** Turn

**Risk Level:** Medium

**Speed Limit:** 30 KM/Hr

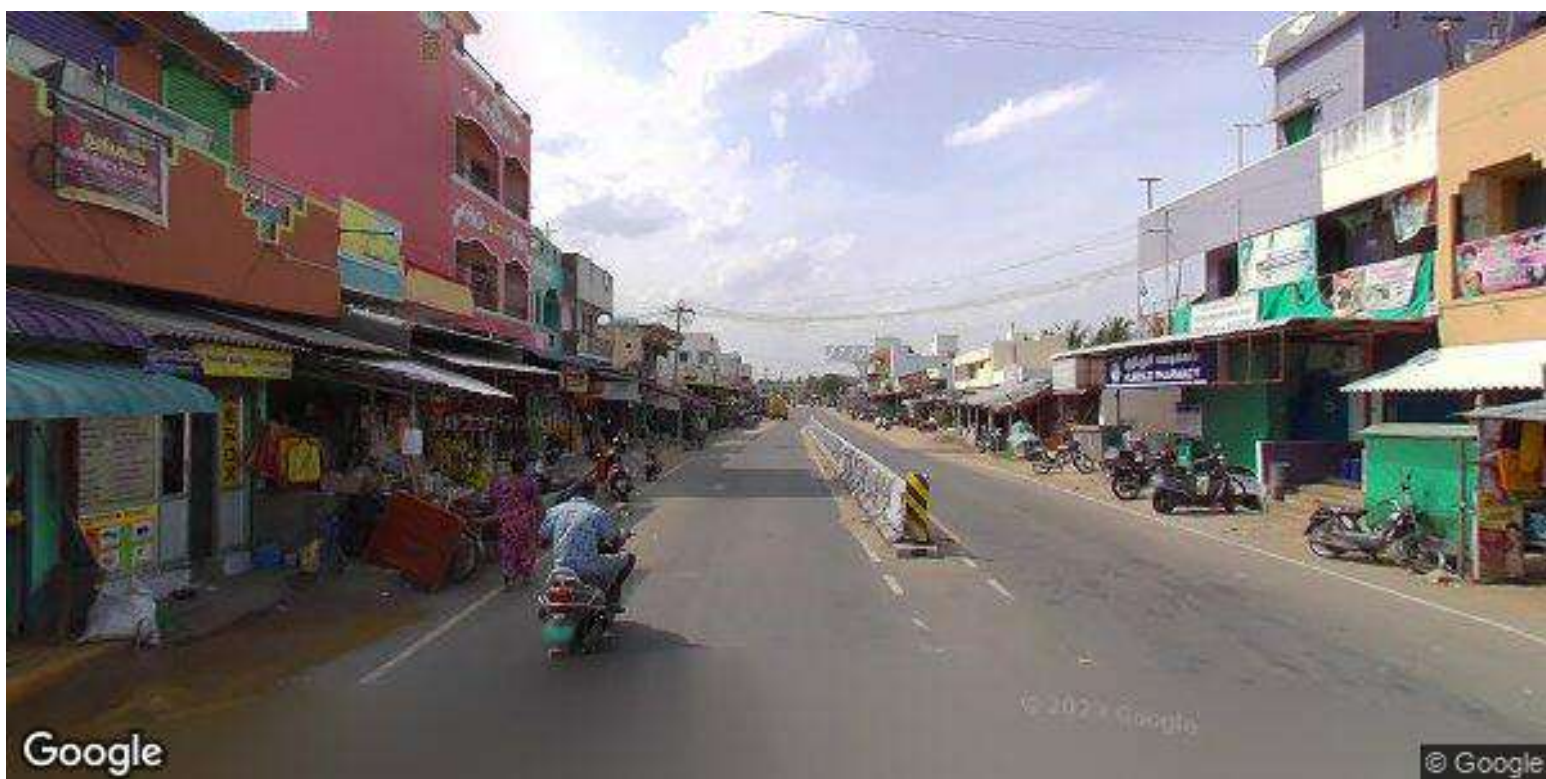
**Coordinates:** 11.24000, 77.87363

**Risk Type:** Turn

**Risk Level:** High

**Speed Limit:** 15 KM/Hr

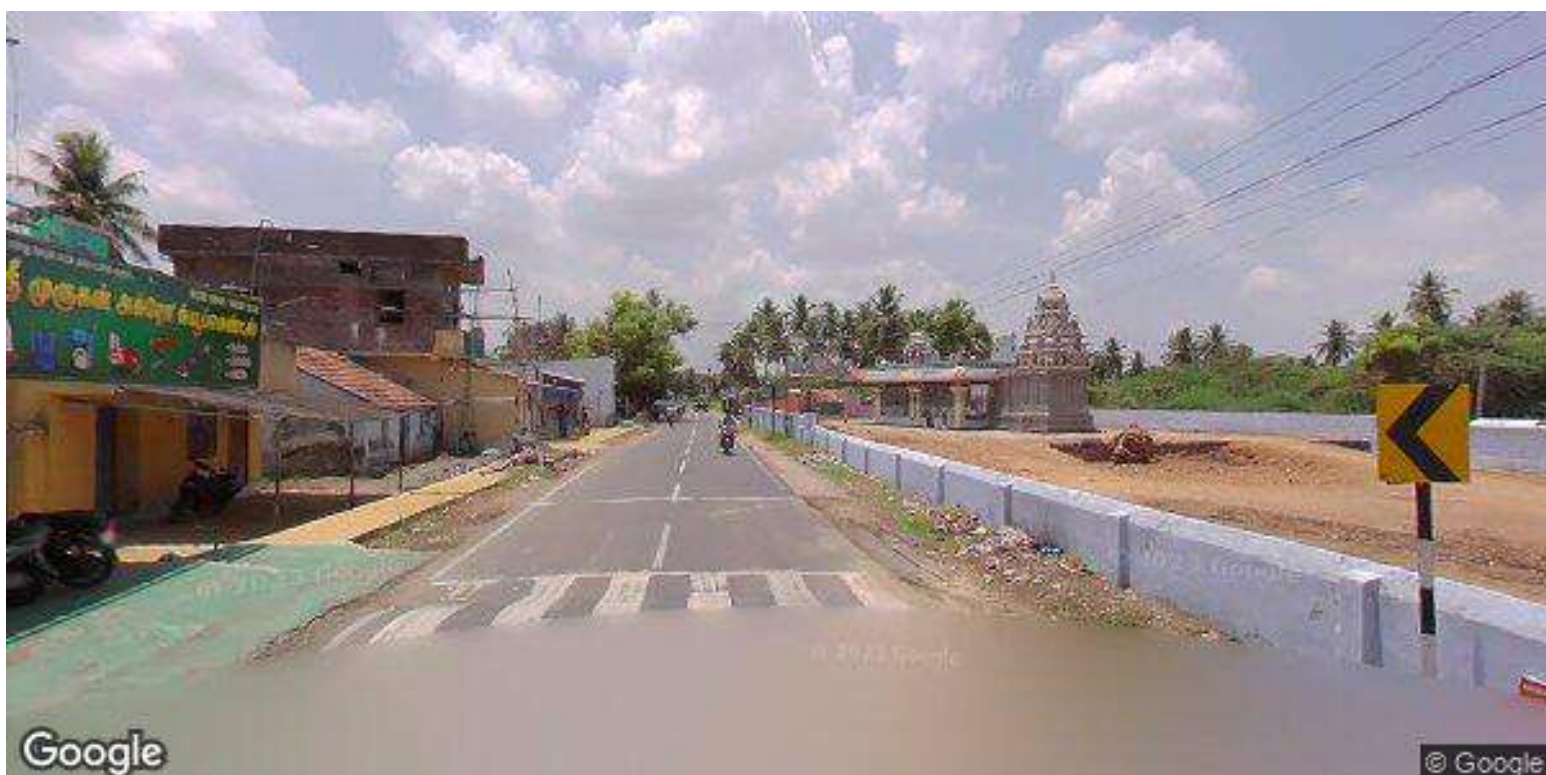
**Coordinates: 11.24041, 77.86919**

**Risk Type: Turn**

**Risk Level: Medium**

**Speed Limit: 30 KM/Hr**

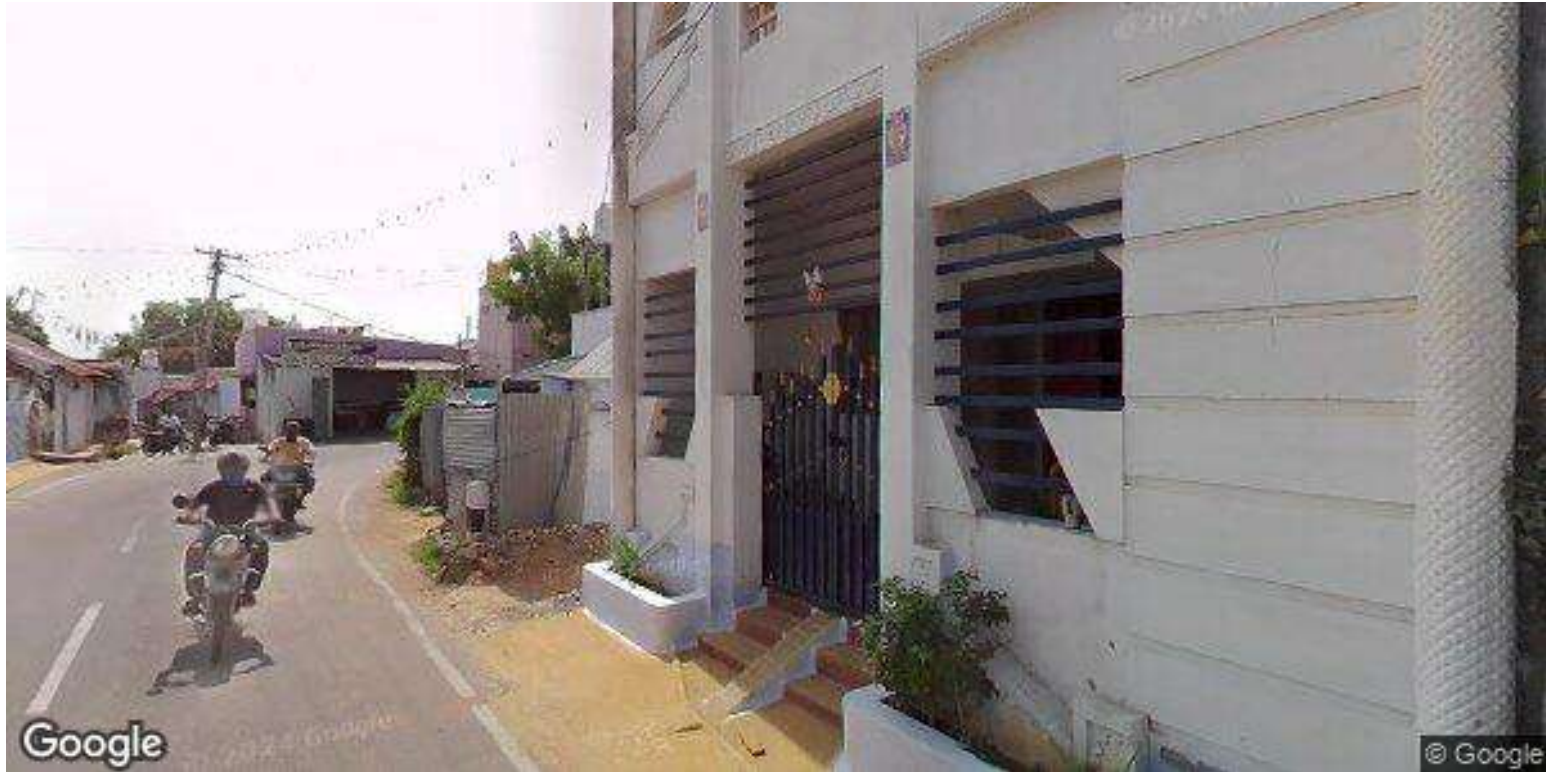
**Coordinates: 11.24159, 77.86874**

**Risk Type: Turn**

**Risk Level: High**

**Speed Limit: 15 KM/Hr**

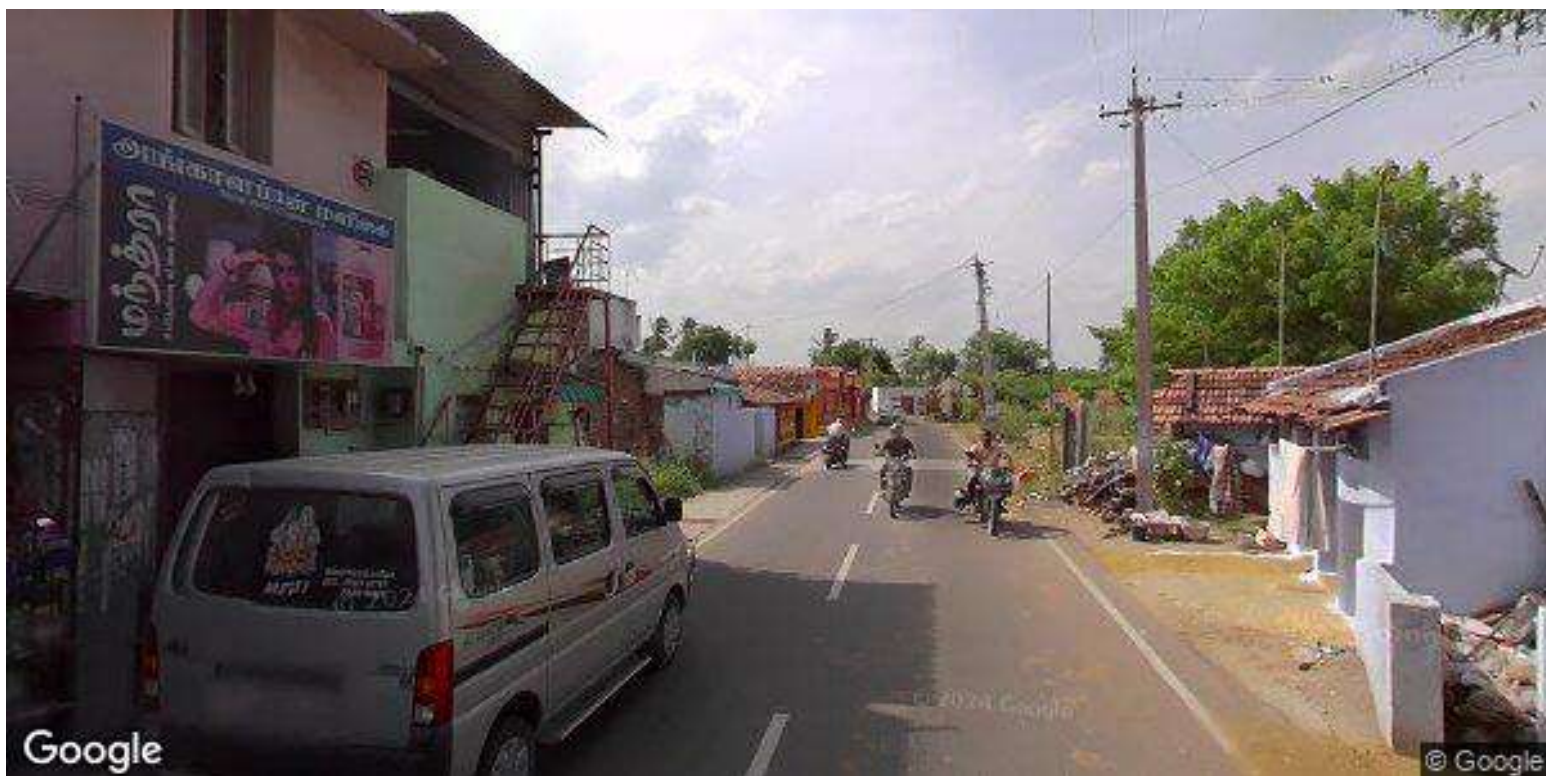
**Coordinates: 11.24170, 77.86842**

**Risk Type: Turn**

**Risk Level: High**

**Speed Limit: 15 KM/Hr**

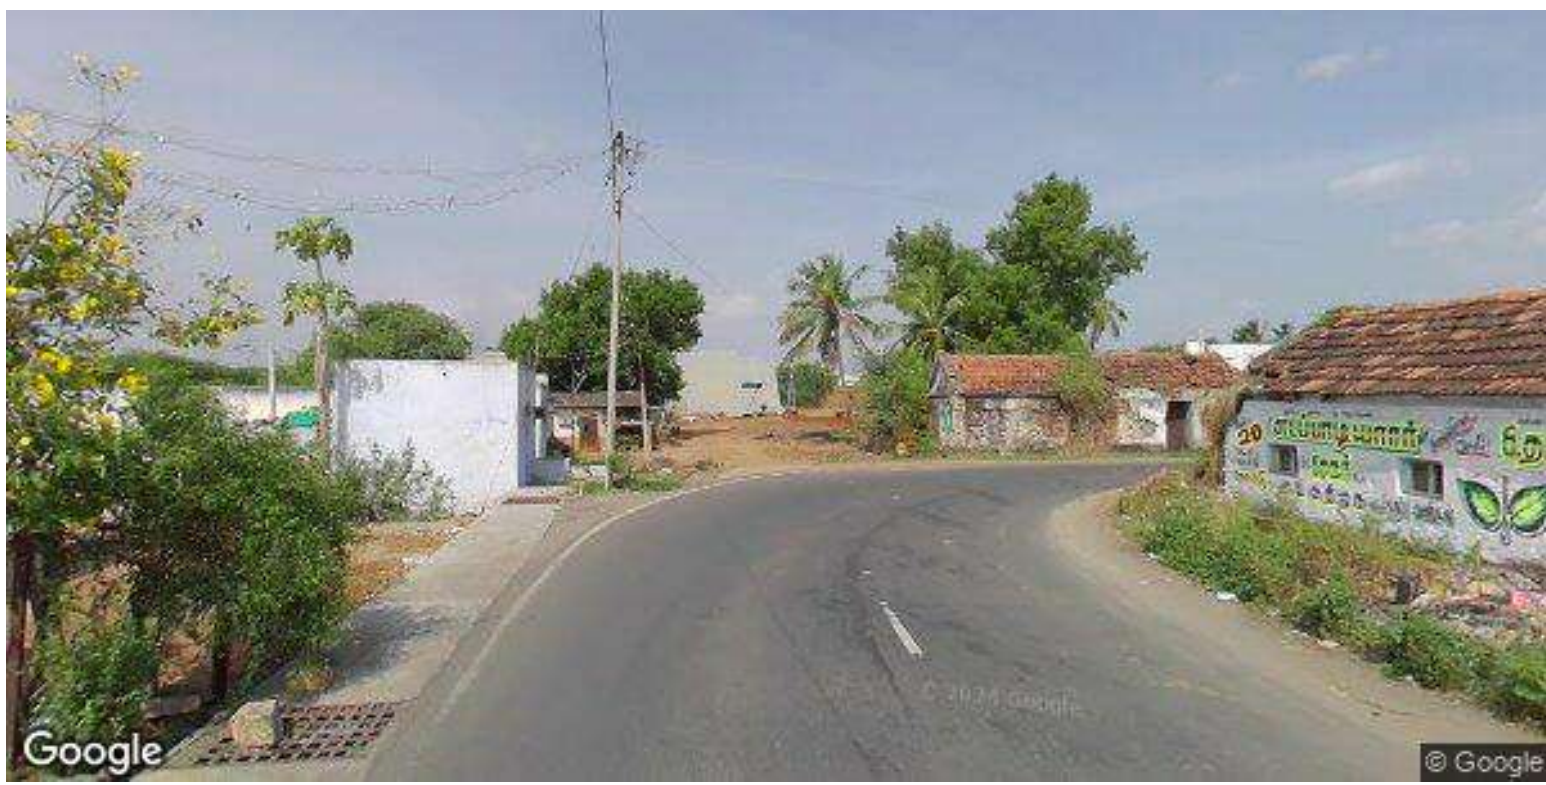
**Coordinates:** 11.24248, 77.86829

**Risk Type:** Turn

**Risk Level:** High

**Speed Limit:** 15 KM/Hr

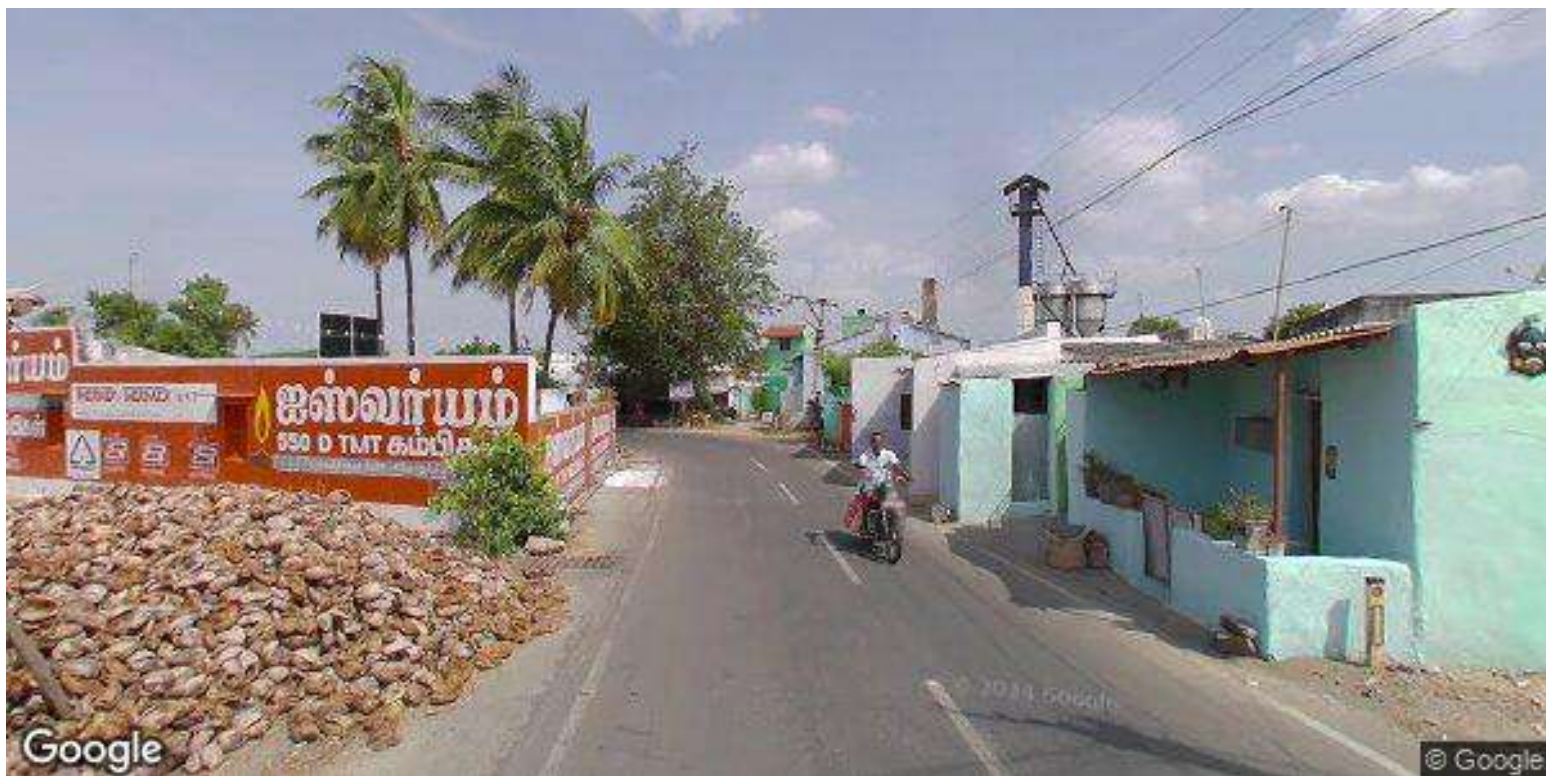
**Coordinates:** 11.24257, 77.86776

**Risk Type:** Turn

**Risk Level:** High

**Speed Limit:** 15 KM/Hr

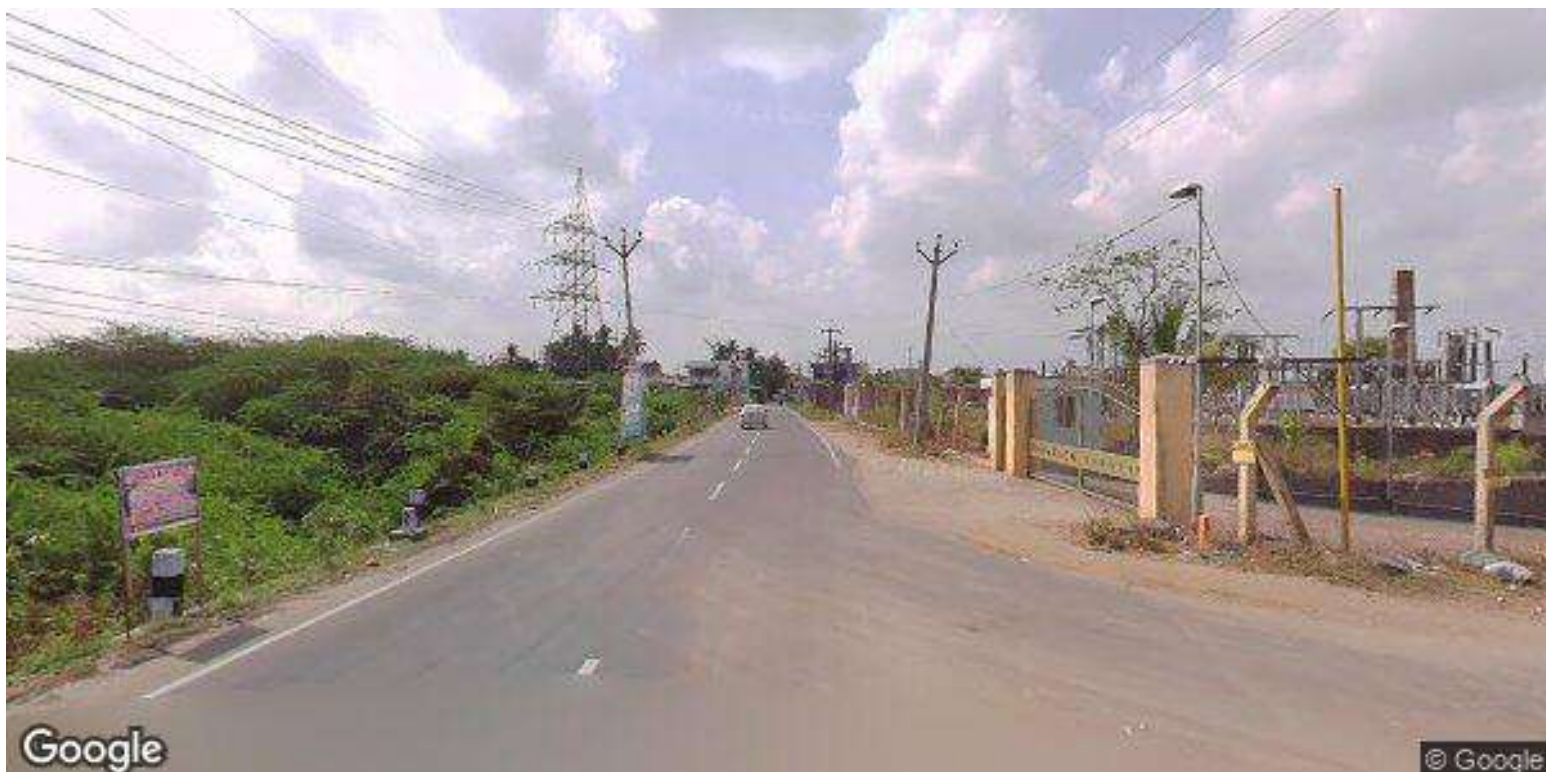
**Risk Type:** Blind Spot  
**Risk Level:** Blind Spot  
**Speed Limit:** 10 KM/Hr  
**Coordinates:** 11.24384, 77.86689

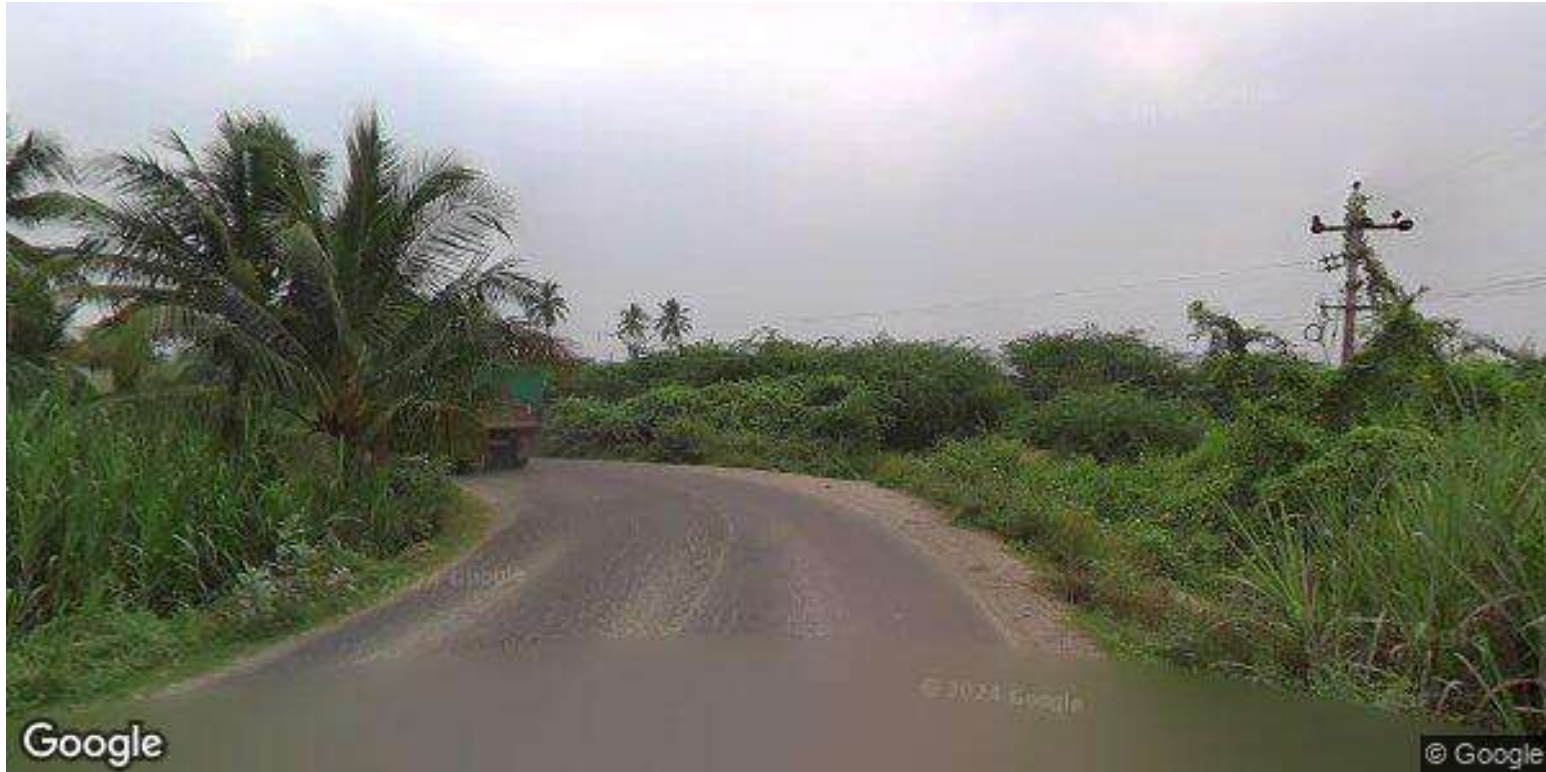
**Risk Type:** Turn  
**Risk Level:** High  
**Speed Limit:** 15 KM/Hr  
**Coordinates:** 11.24103, 77.86020

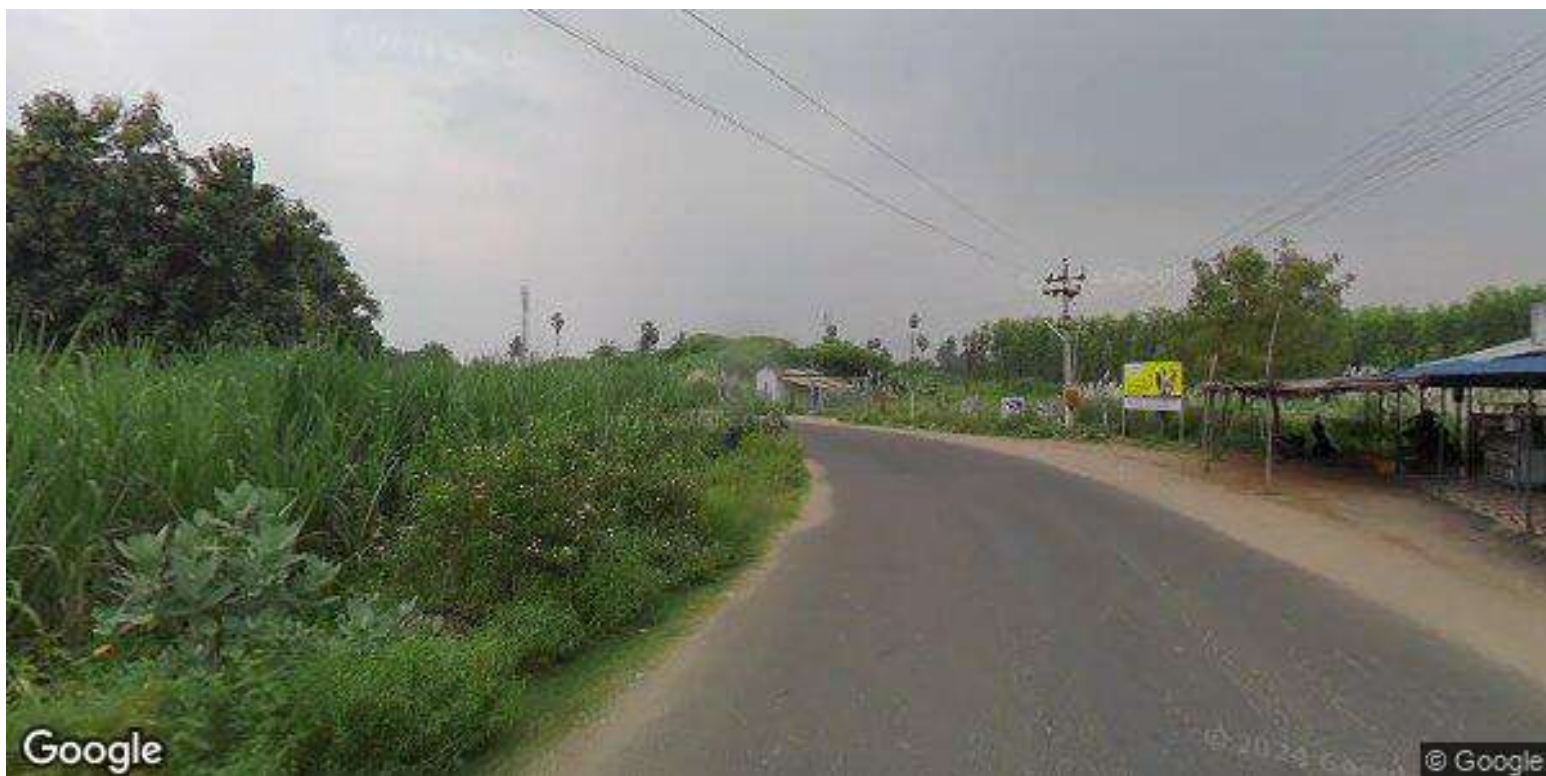
**Risk Type:** Turn  
**Risk Level:** High  
**Speed Limit:** 15 KM/Hr  
**Coordinates:** 11.24200, 77.85882

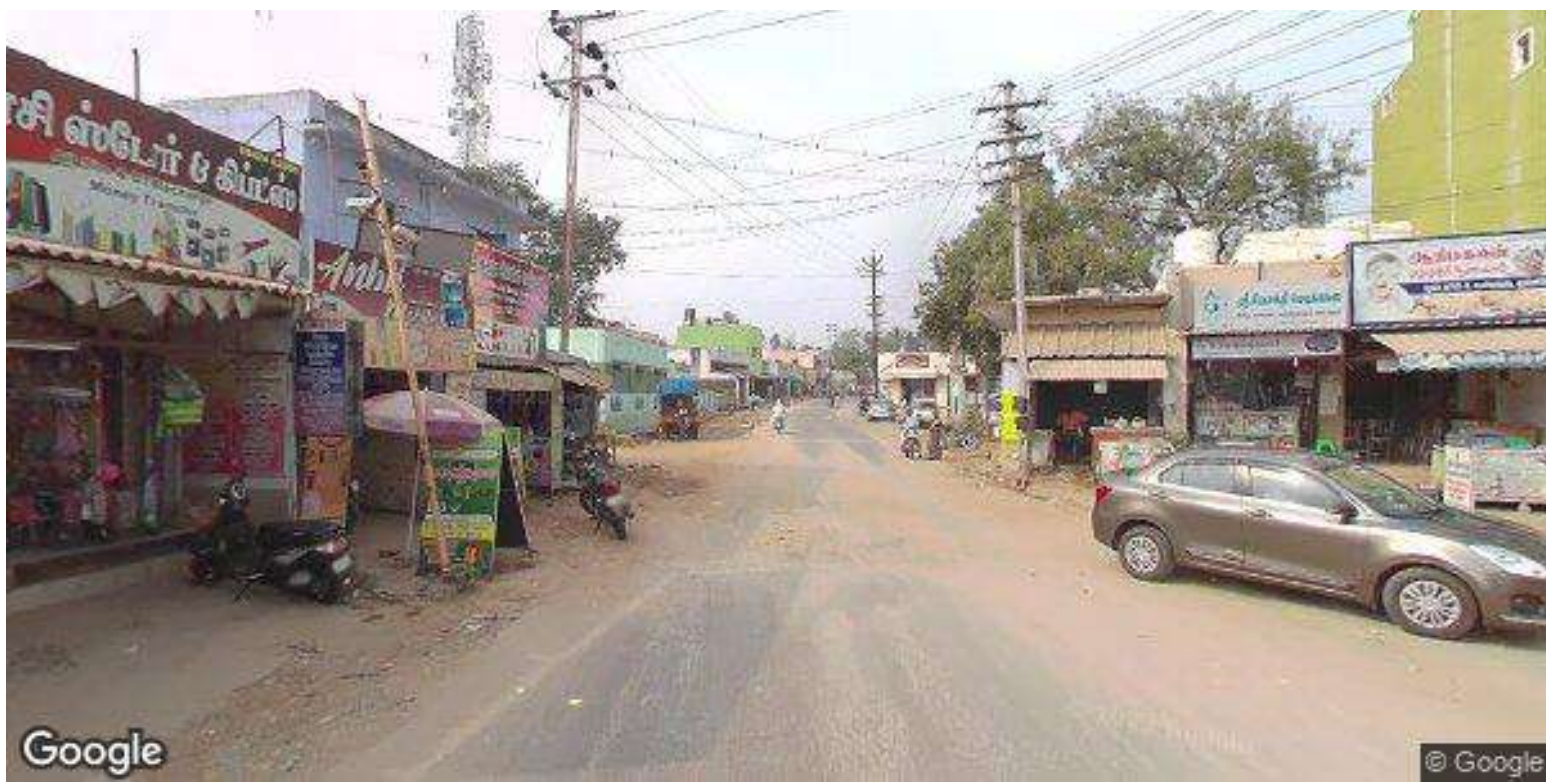
**Coordinates:** 11.18856, 77.77110

**Risk Type:** Turn

**Risk Level:** High

**Speed Limit:** 15 KM/Hr

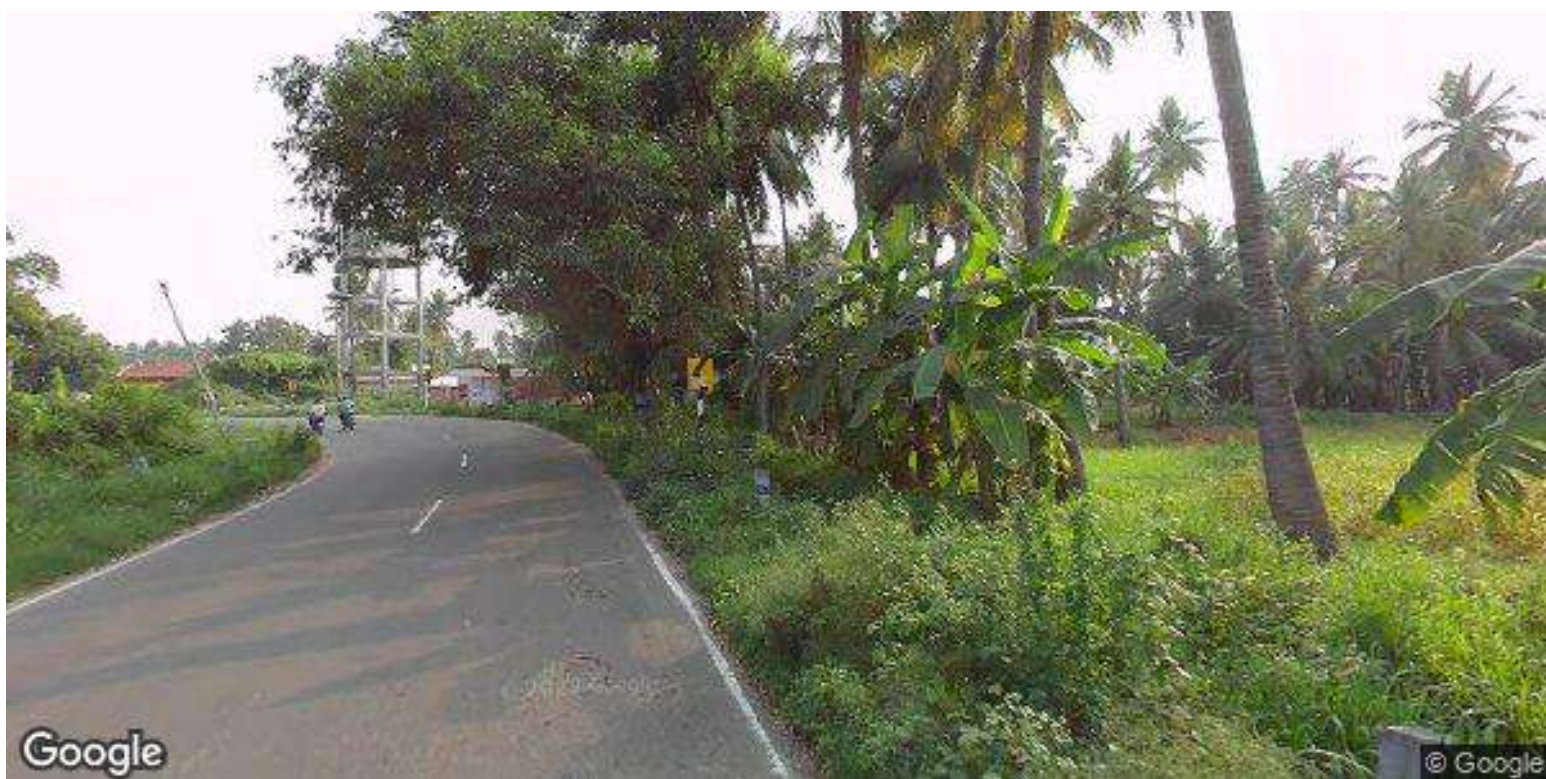
**Coordinates:** 11.16441, 77.77358

**Risk Type:** Turn

**Risk Level:** Medium

**Speed Limit:** 30 KM/Hr

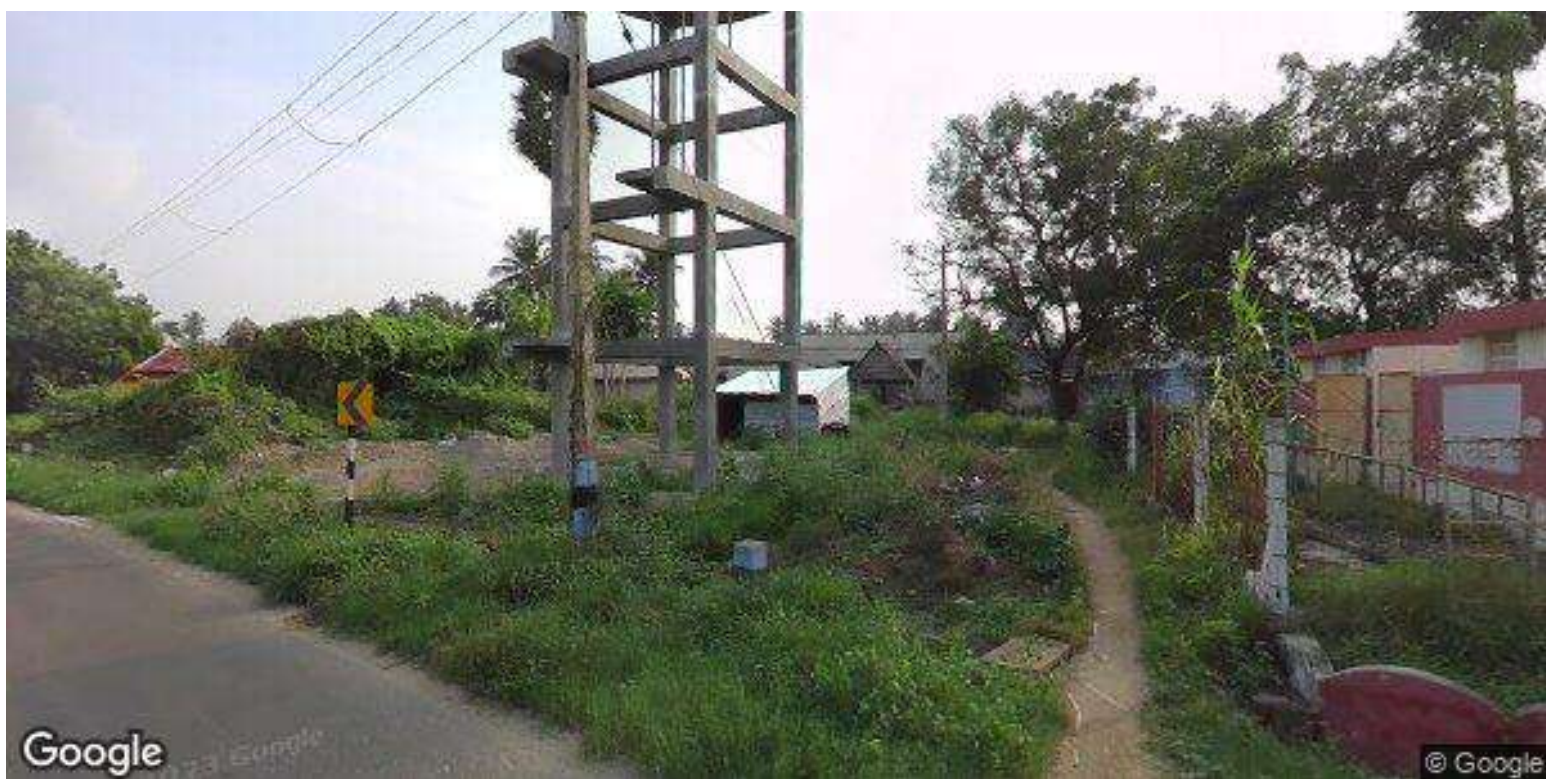
**Risk Type:** Turn  
**Risk Level:** Medium  
**Speed Limit:** 30 KM/Hr  
**Coordinates:** 11.16404, 77.77379
