## **JOURNEY RISK MANAGEMENT (JRM) STUDY**

### **Salem Terminal to SRI SARAVANA AGENCIES PUDUPAI**

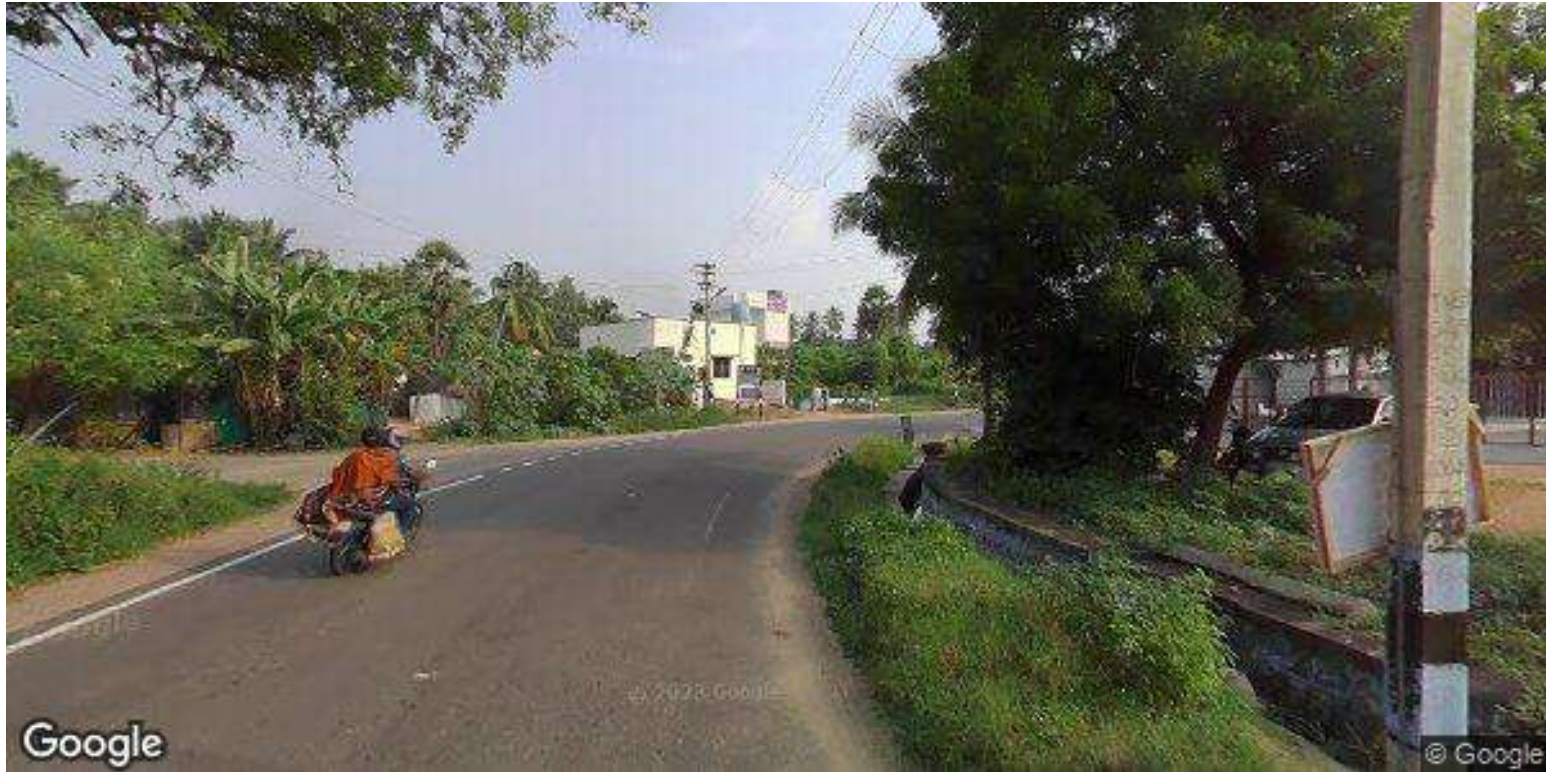
**Risk Type:** Turn  
**Risk Level:** High  
**Speed Limit:** 15 KM/Hr  
**Coordinates:** 11.16377, 77.77421

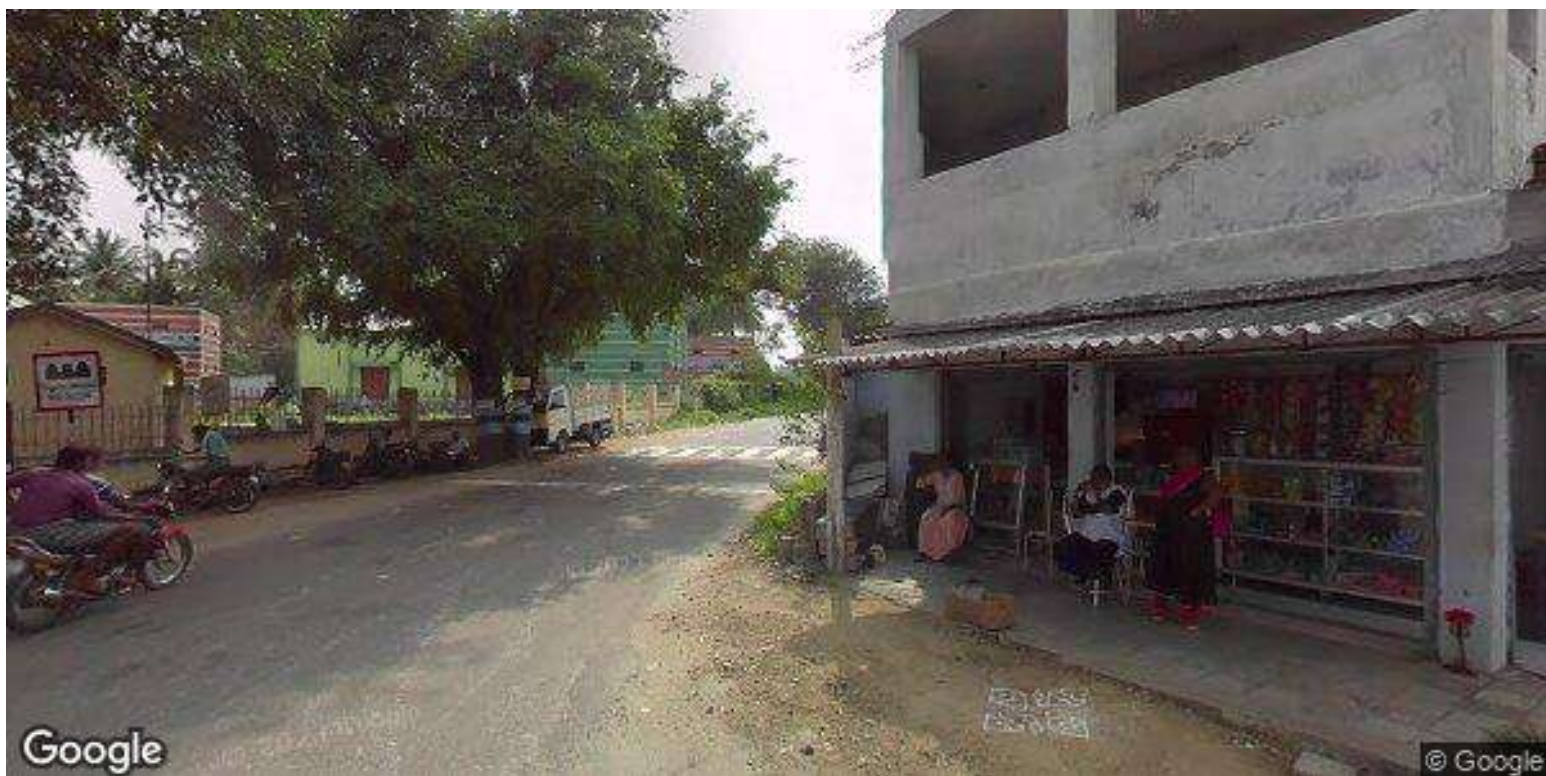
**Risk Type:** Turn  
**Risk Level:** Medium  
**Speed Limit:** 30 KM/Hr  
**Coordinates:** 11.13664, 77.76524

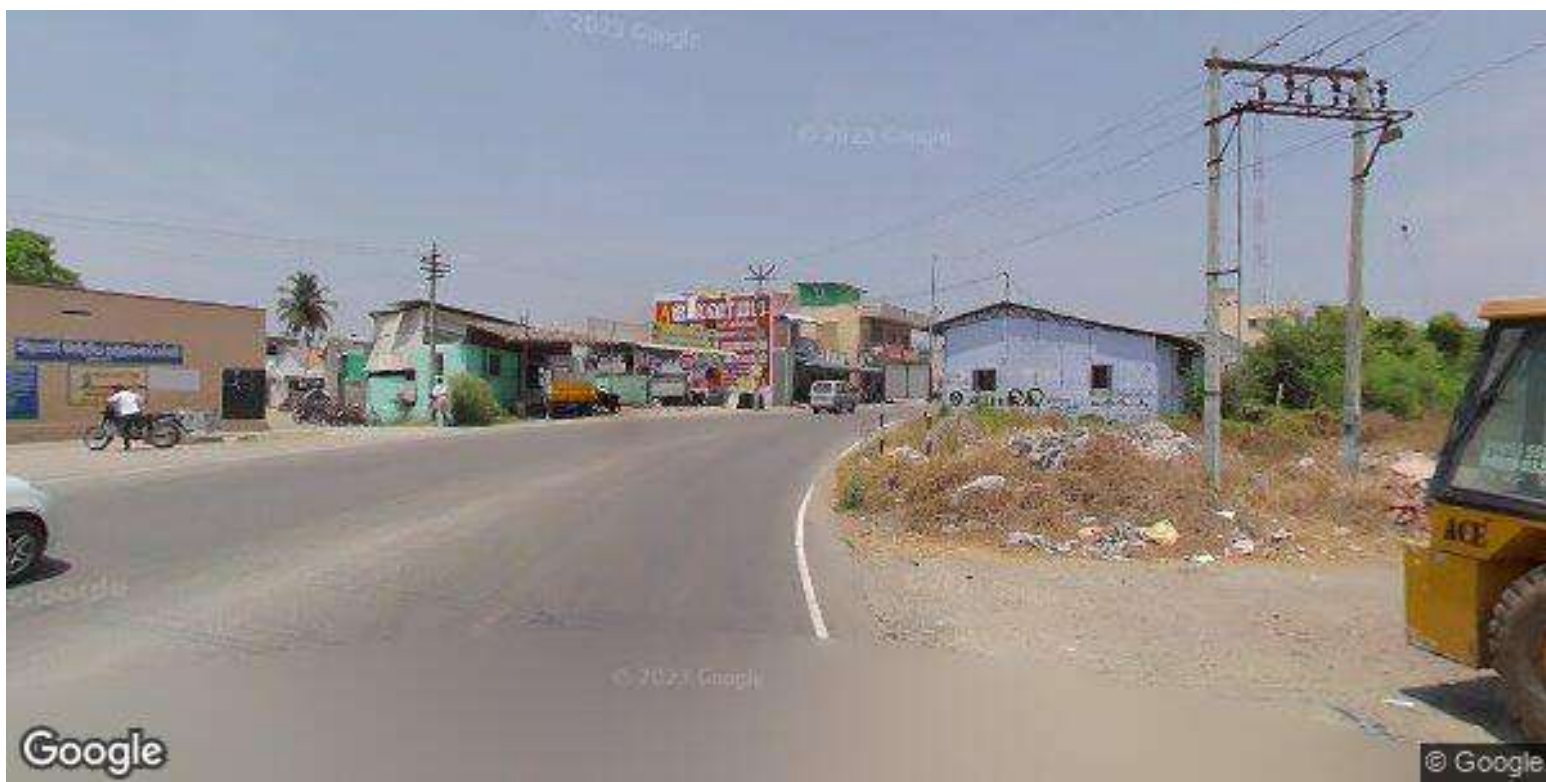
**Coordinates:** 11.04699, 77.73747

**Risk Type:** Turn

**Risk Level:** Medium

**Speed Limit:** 30 KM/Hr

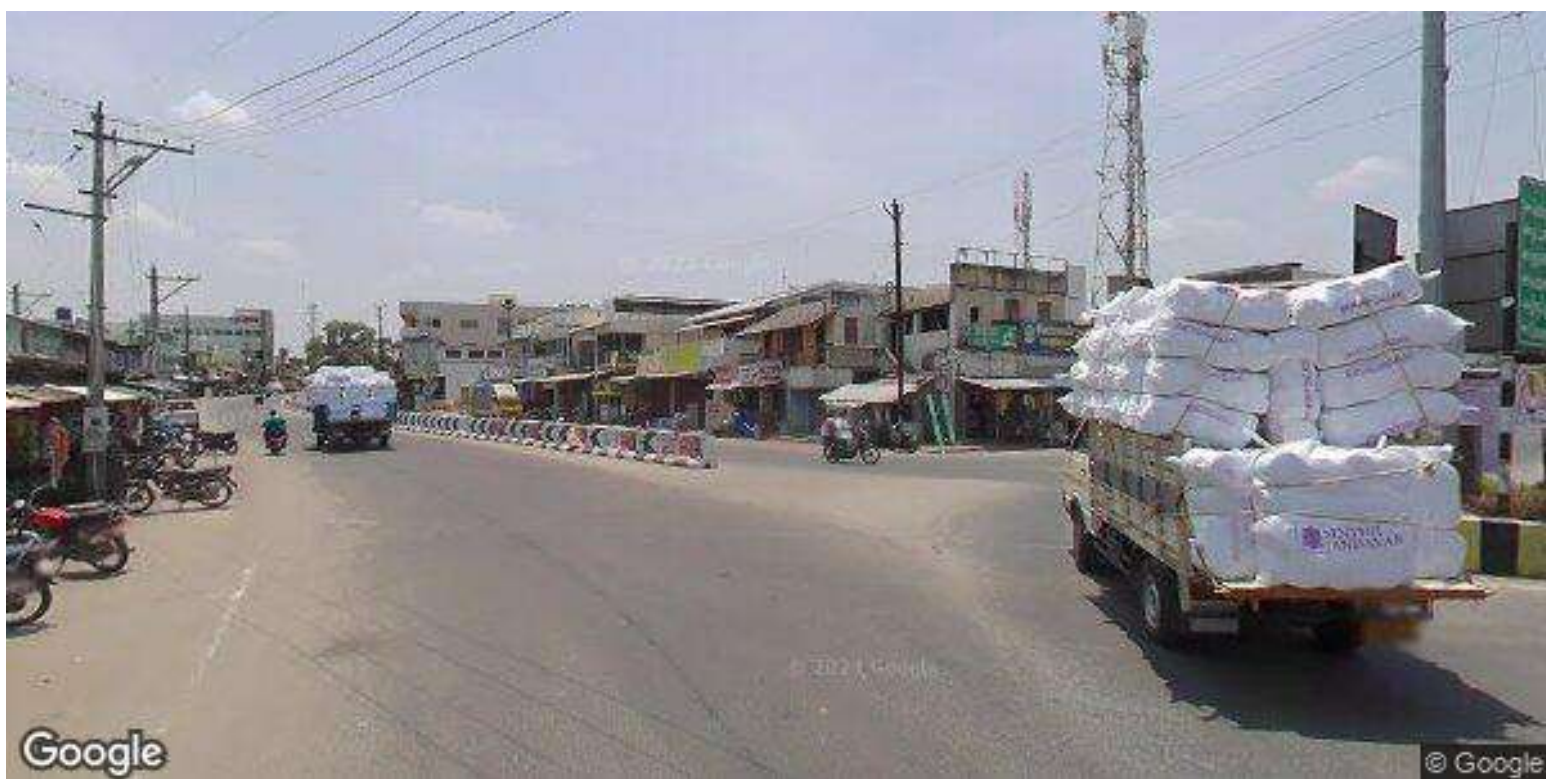
**Coordinates:** 11.04515, 77.73621

**Risk Type:** Turn

**Risk Level:** High

**Speed Limit:** 15 KM/Hr

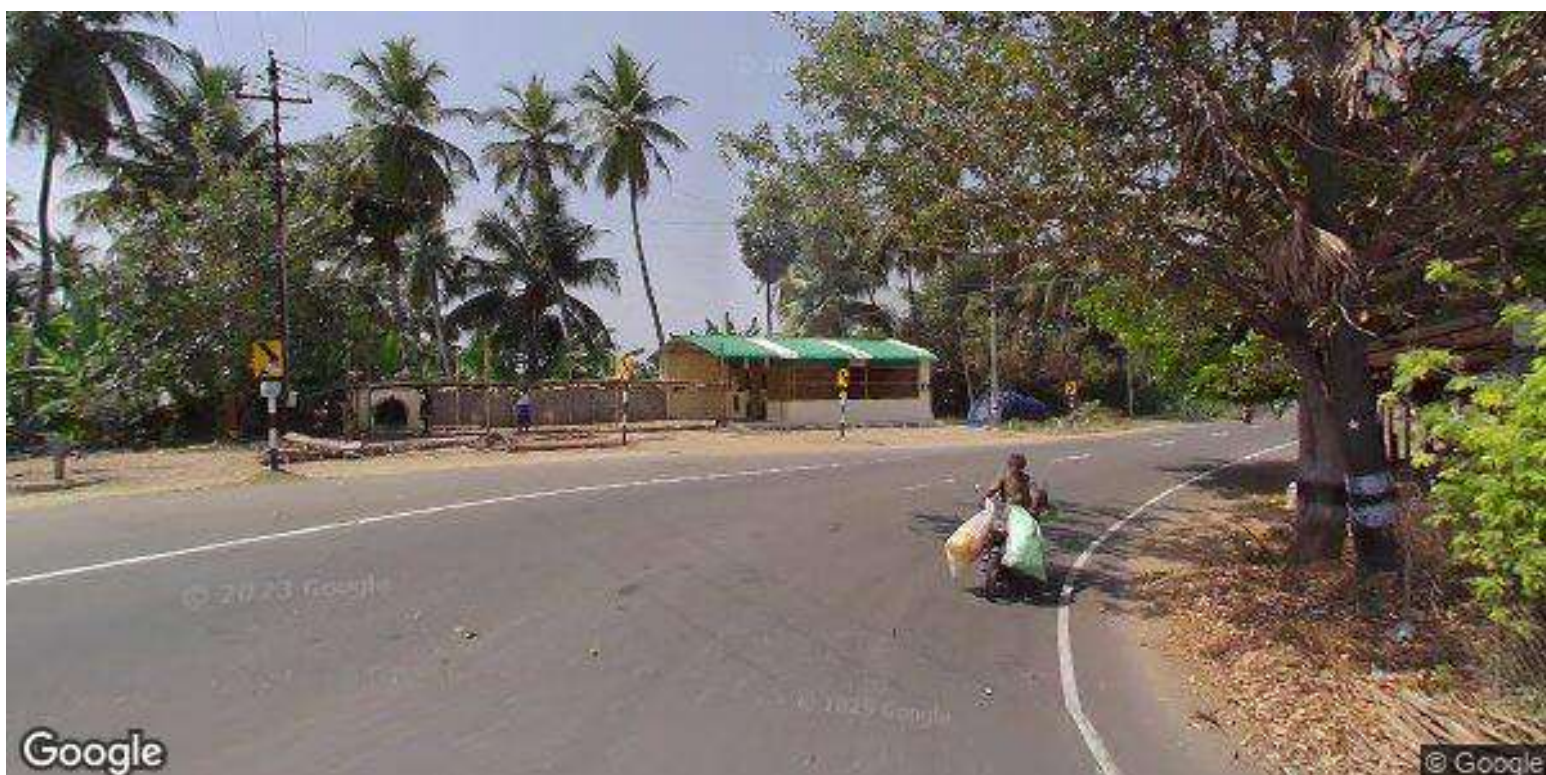
**Risk Type:** Turn  
**Risk Level:** High  
**Speed Limit:** 15 KM/Hr  
**Coordinates:** 10.99026, 77.72511

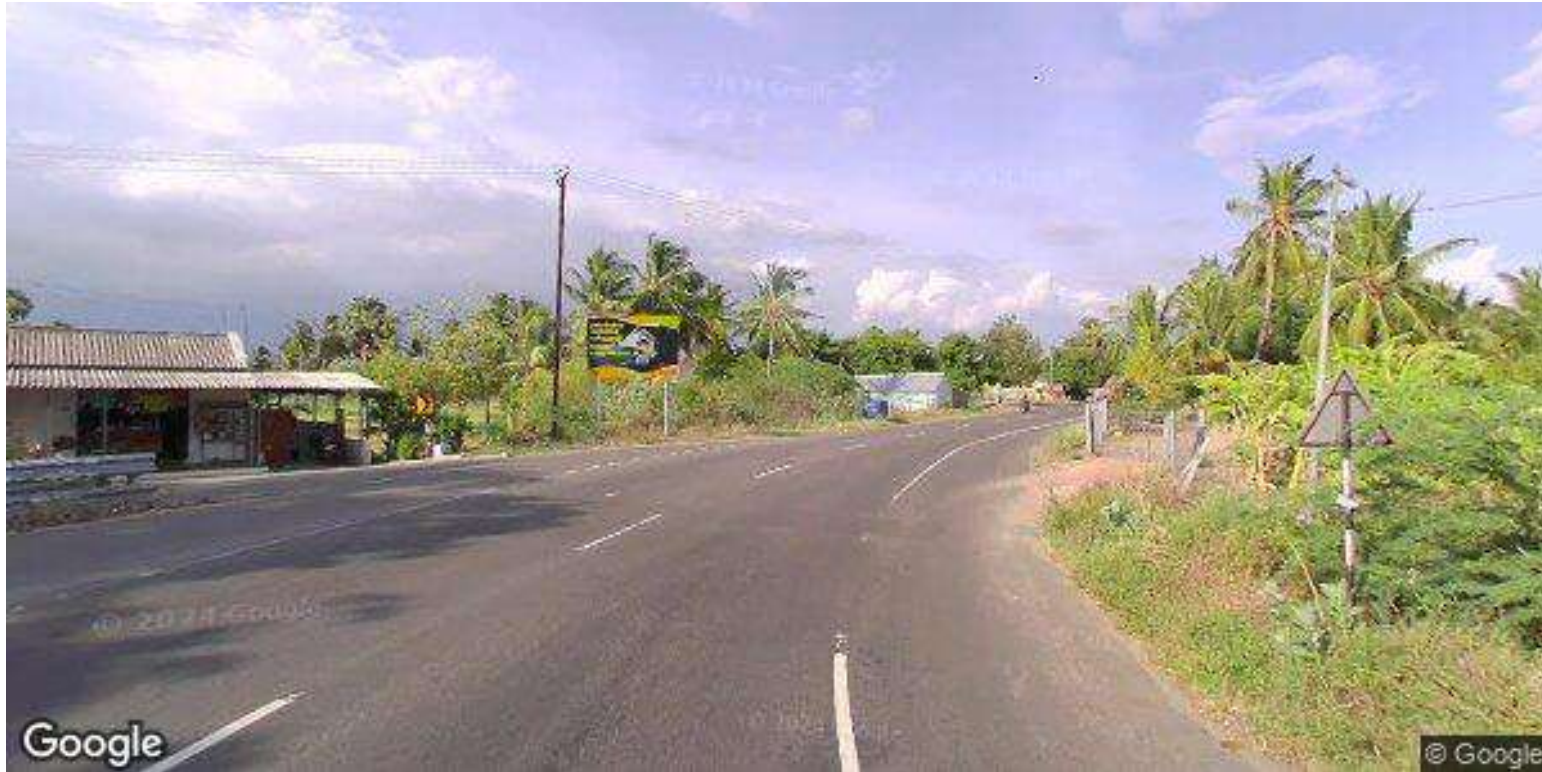
**Risk Type:** Turn  
**Risk Level:** High  
**Speed Limit:** 15 KM/Hr  
**Coordinates:** 10.98974, 77.72388

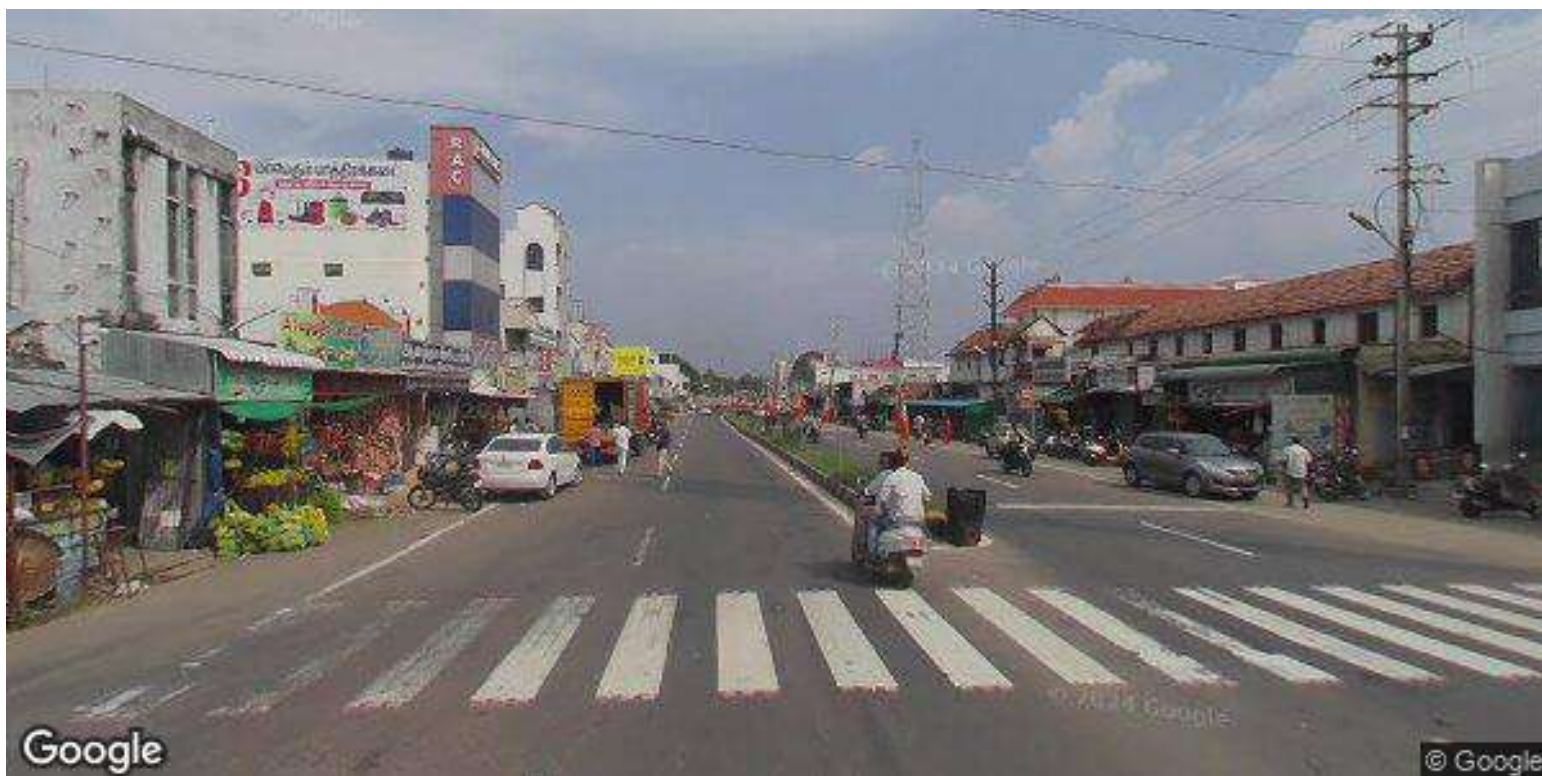
**Risk Type:** Blind Spot  
**Risk Level:** Blind Spot  
**Speed Limit:** 10 KM/Hr  
**Coordinates:** 10.94597, 77.71319

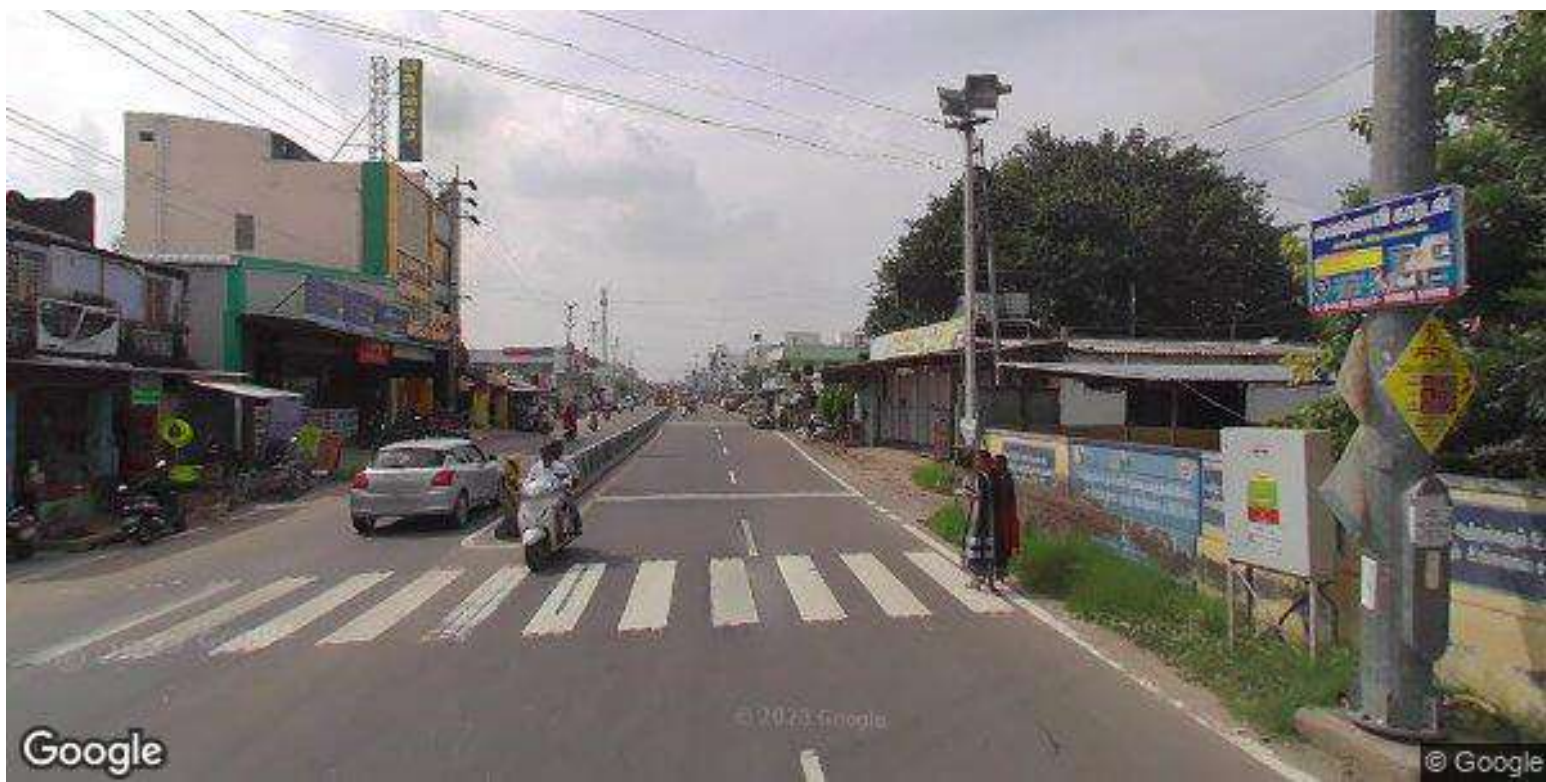
**Coordinates:** 10.94571, 77.71574

**Risk Type:** Turn

**Risk Level:** High

**Speed Limit:** 15 KM/Hr

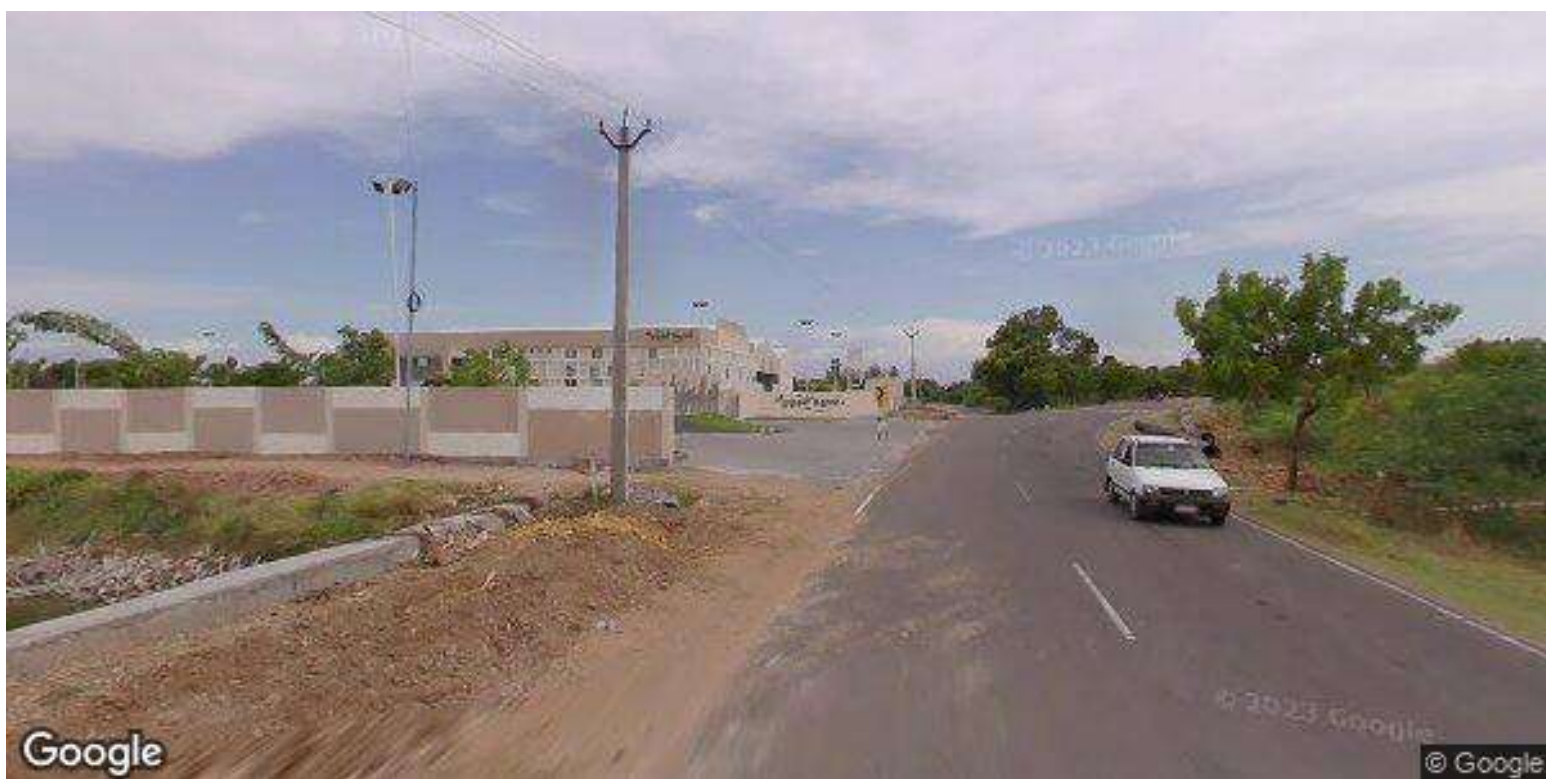
**Coordinates:** 10.92251, 77.72391

**Risk Type:** Turn

**Risk Level:** Medium

**Speed Limit:** 30 KM/Hr

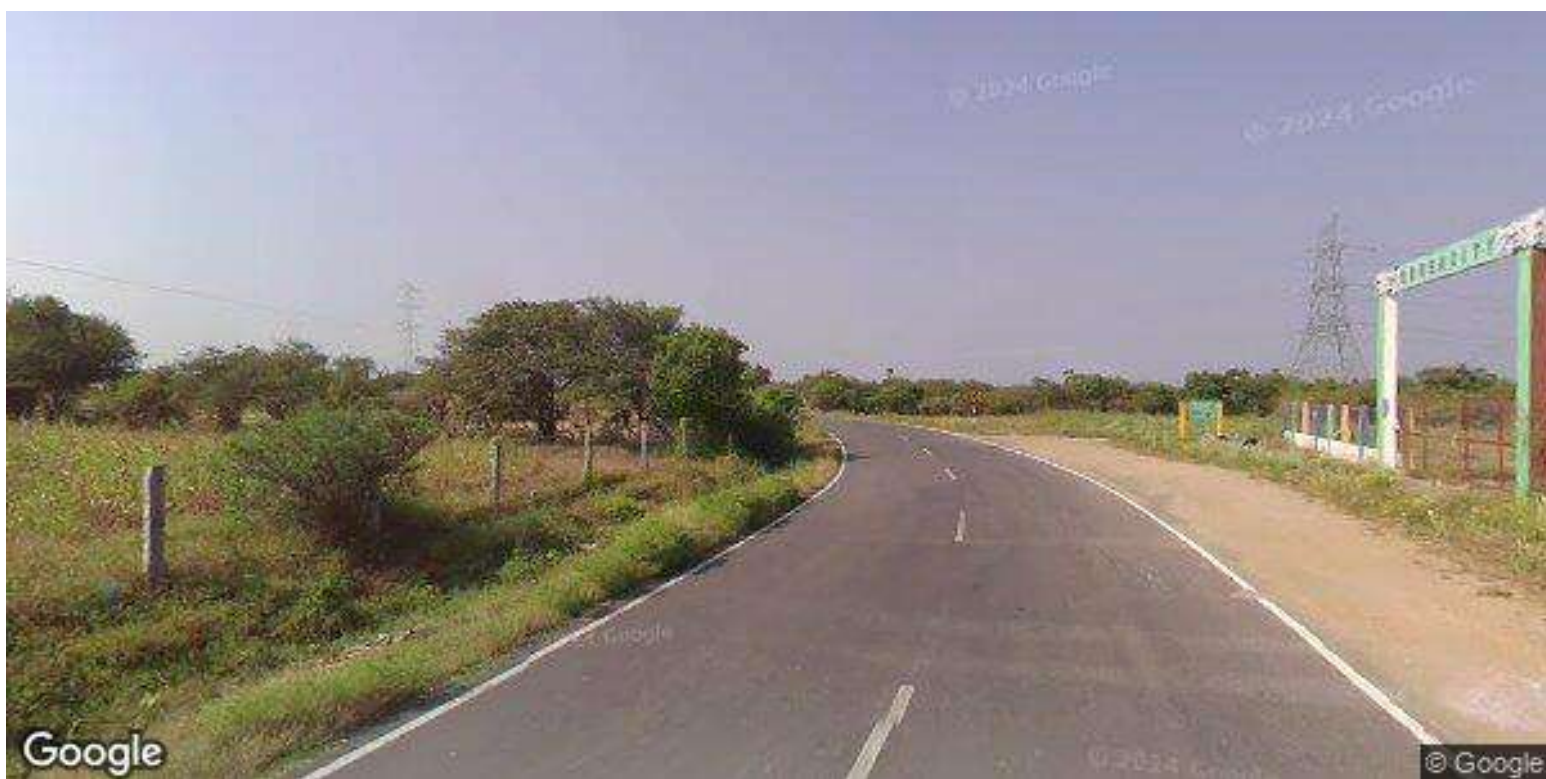
**Coordinates:** 10.87191, 77.72259

**Risk Type:** Turn

**Risk Level:** Medium

**Speed Limit:** 30 KM/Hr
