# IndianOil

## JOURNEY RISK MANAGEMENT (JRM) STUDY

### Salem Terminal TO VENKATESWARA AUTO SERVICE

Route Safety Analysis Report

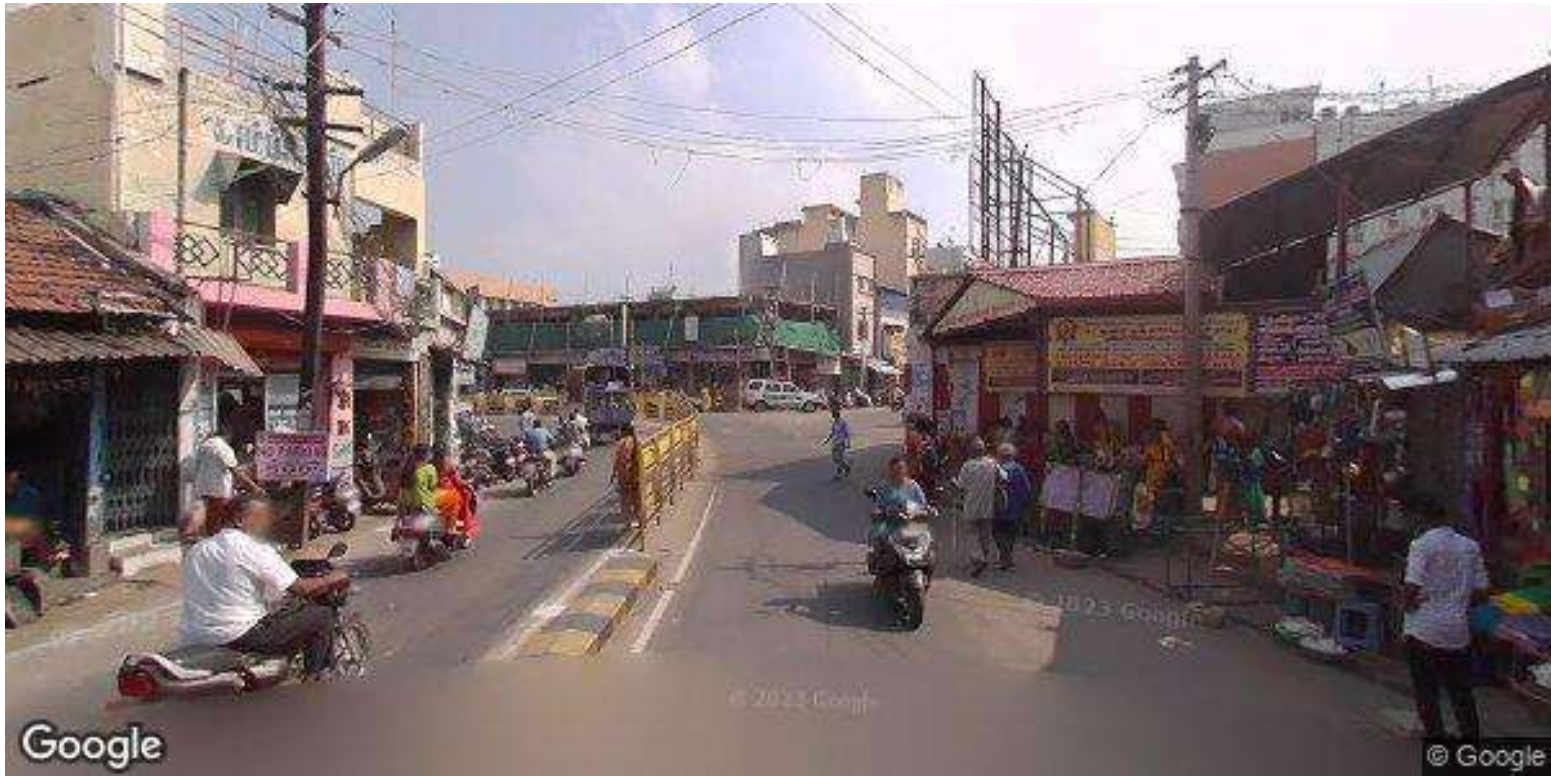
**Risk Type:** Turn  
**Risk Level:** Medium  
**Speed Limit:** 30 KM/Hr  
**Coordinates:** 11.37857, 77.89473

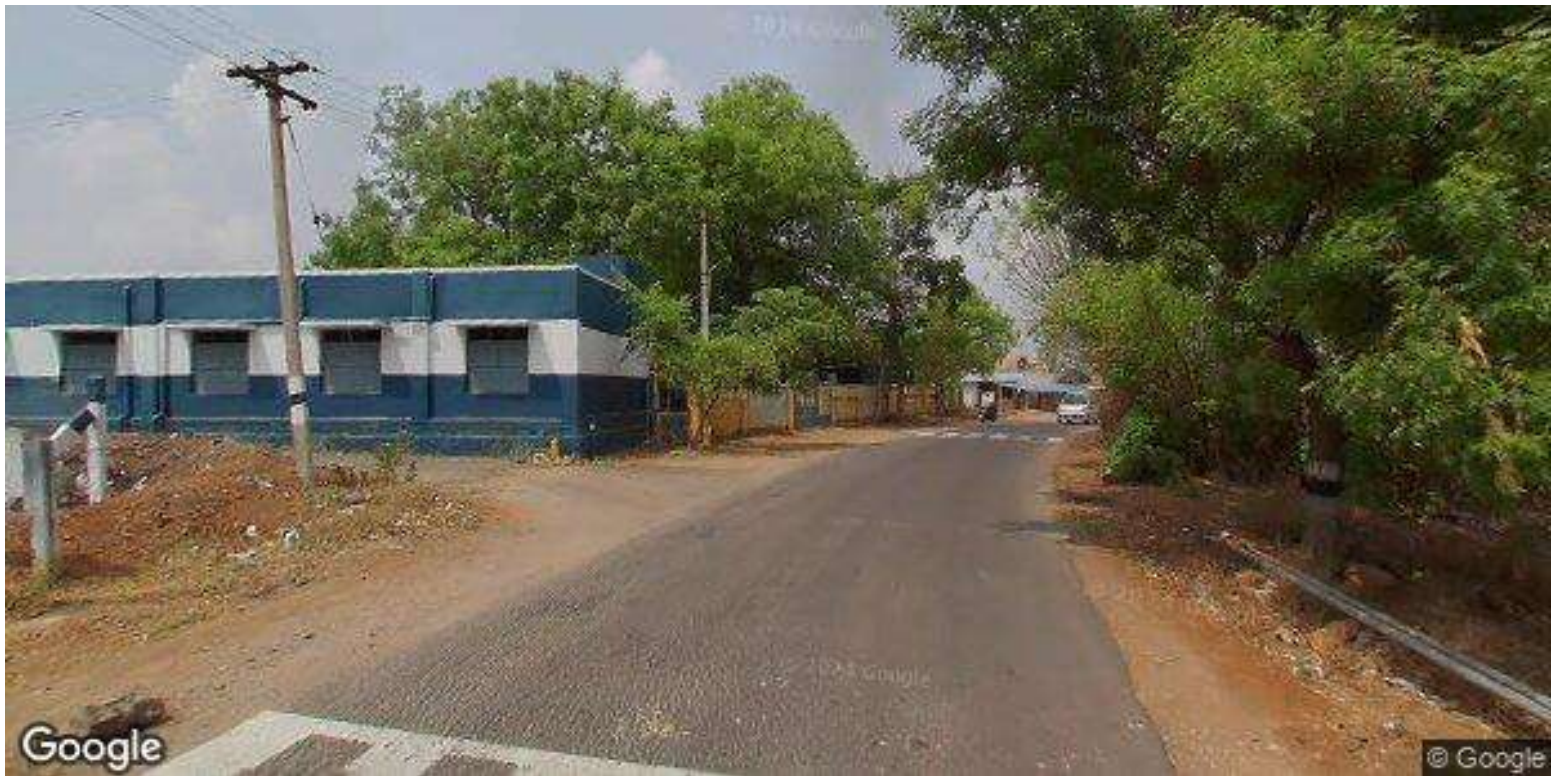
**Risk Type:** Turn  
**Risk Level:** High  
**Speed Limit:** 15 KM/Hr  
**Coordinates:** 11.33268, 77.88827

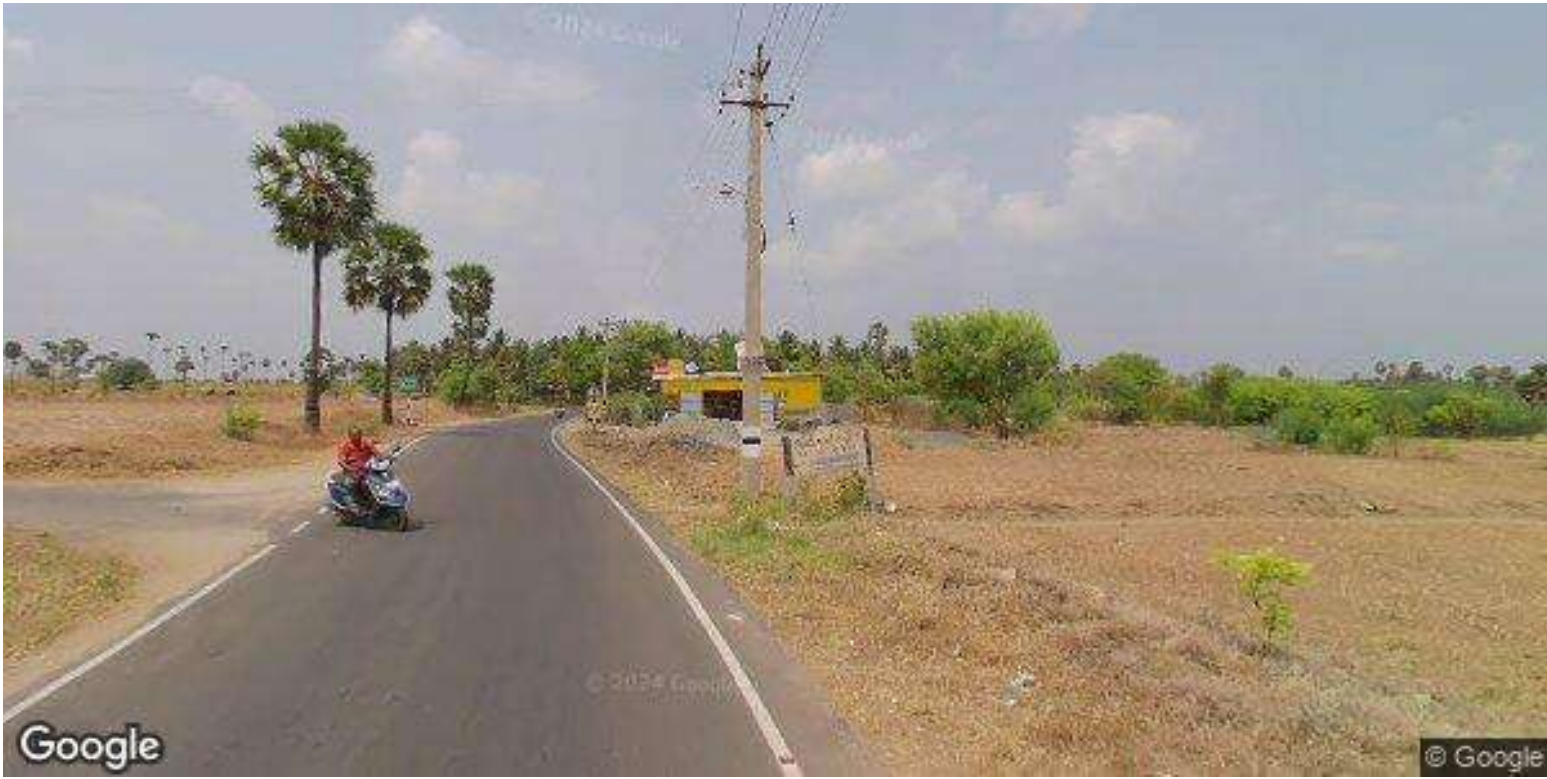
**Risk Type:** Turn  
**Risk Level:** Medium  
**Speed Limit:** 30 KM/Hr  
**Coordinates:** 11.33165, 77.88697

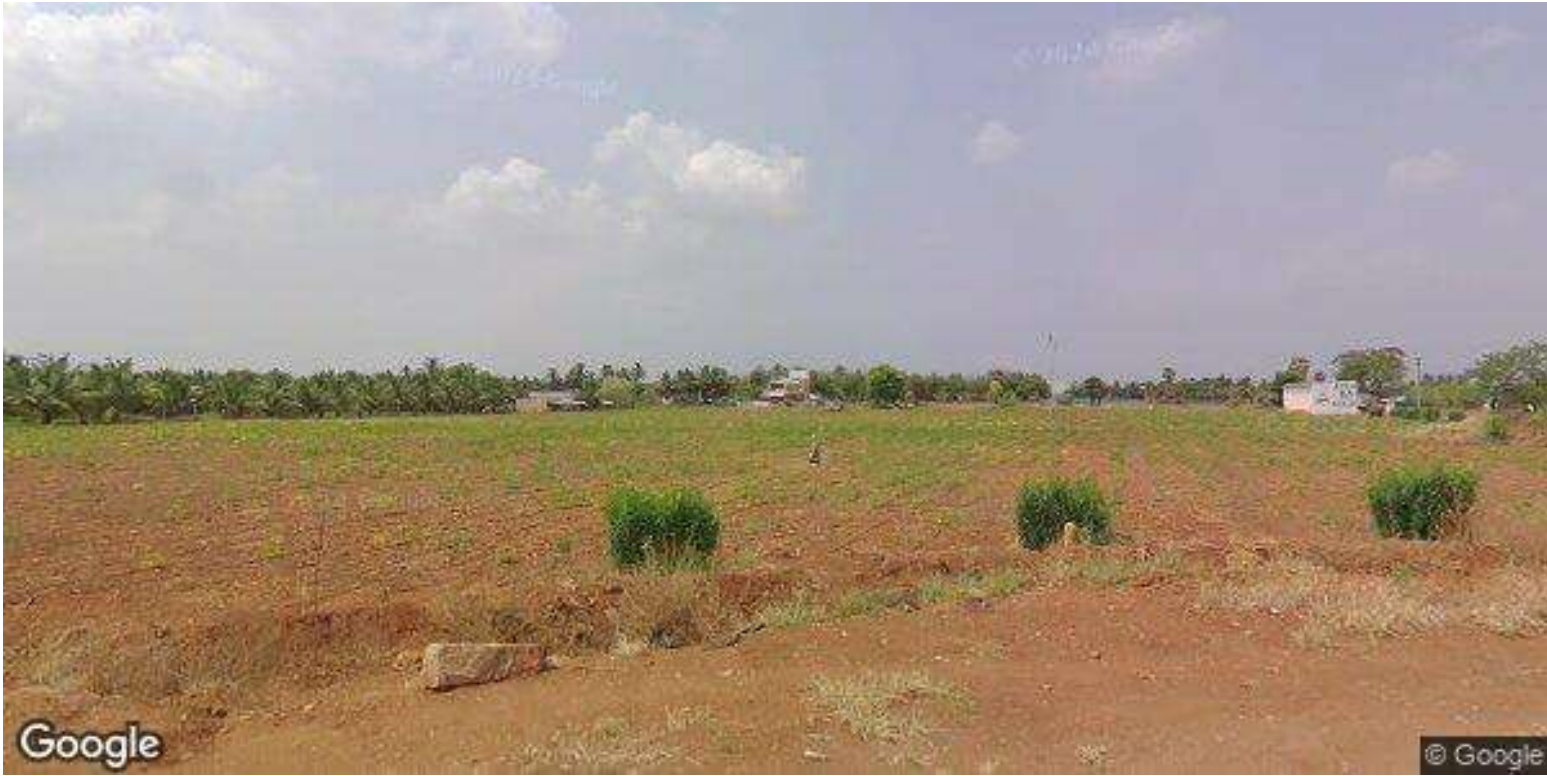
**Risk Type:** Turn  
**Risk Level:** High  
**Speed Limit:** 15 KM/Hr  
**Coordinates:** 11.32130, 77.88484

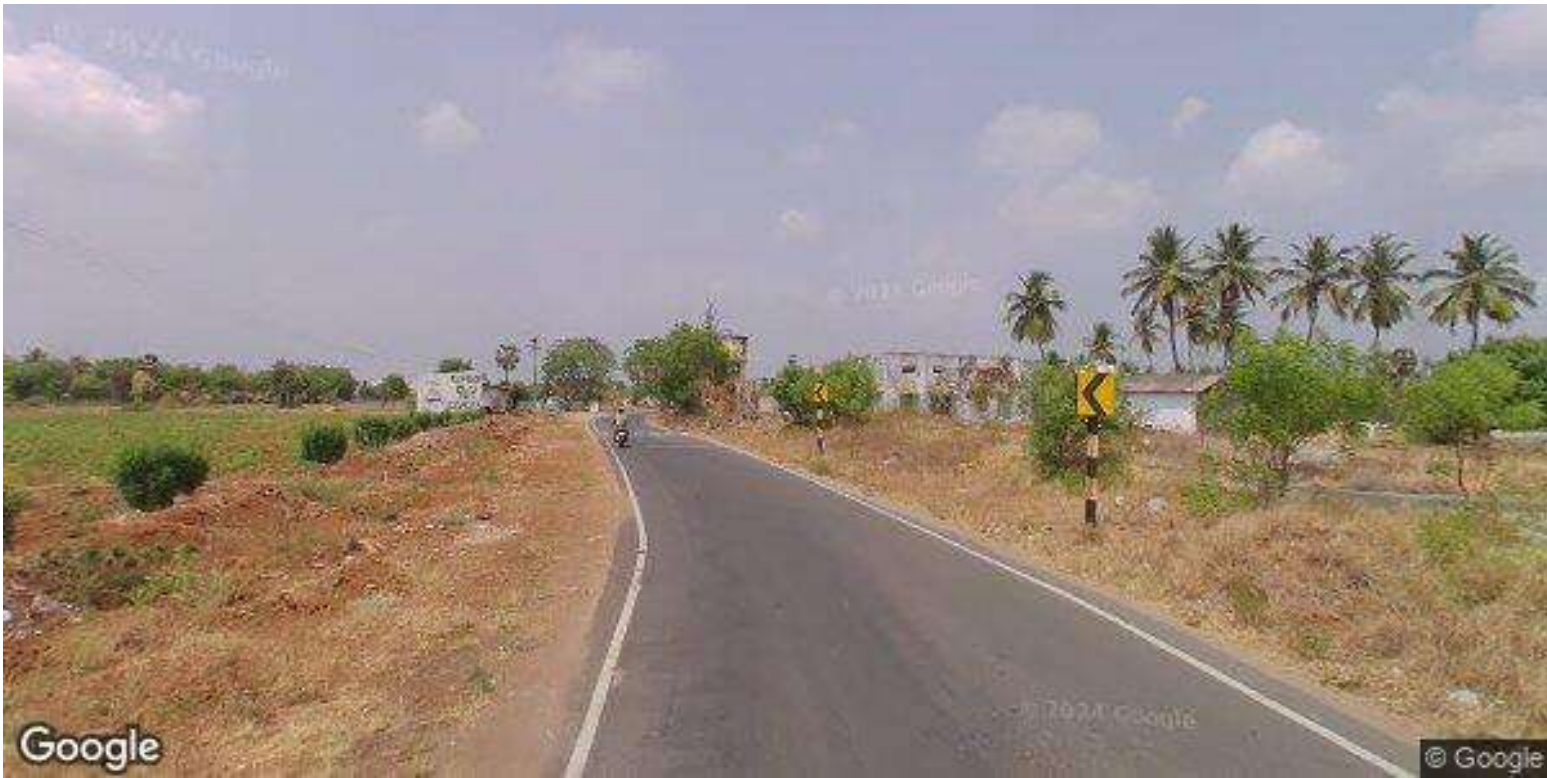
**Risk Type:** Turn  
**Risk Level:** Medium  
**Speed Limit:** 30 KM/Hr  
**Coordinates:** 11.32102, 77.88435

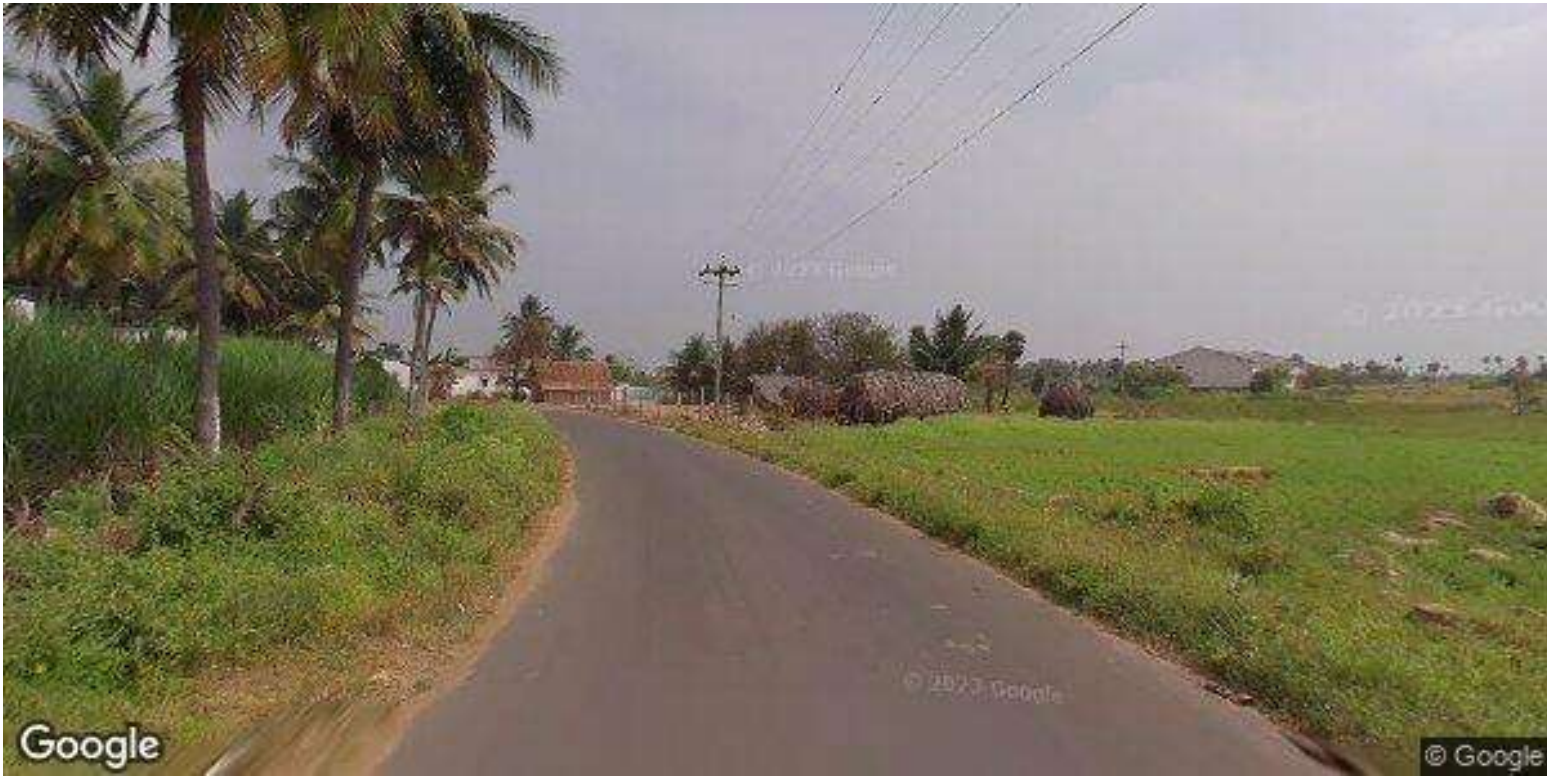
**Risk Type:** Turn  
**Risk Level:** Medium  
**Speed Limit:** 30 KM/Hr  
**Coordinates:** 11.31183, 77.88094

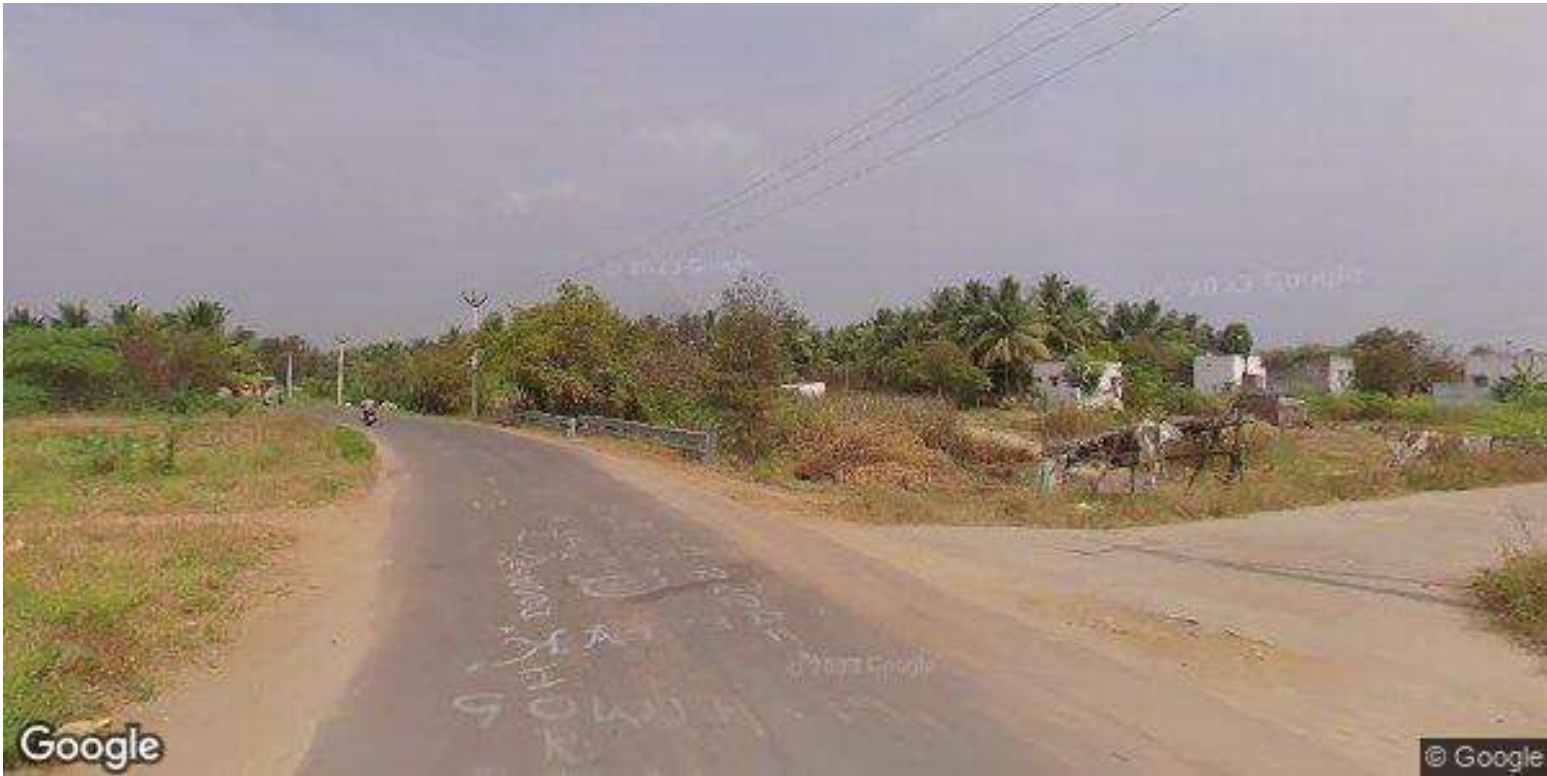
**Risk Type:** Turn  
**Risk Level:** Medium  
**Speed Limit:** 30 KM/Hr  
**Coordinates:** 11.30805, 77.87934

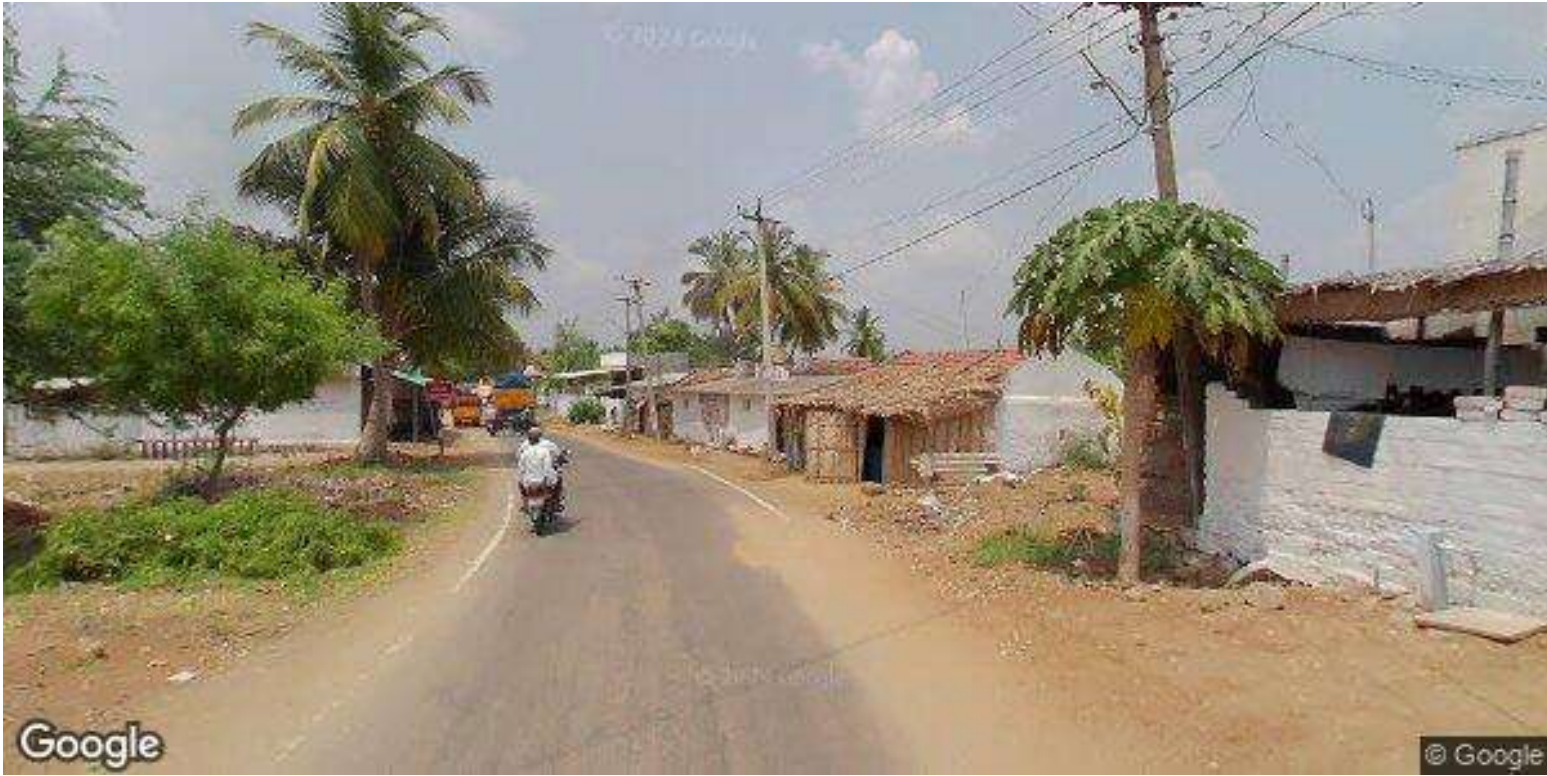
**Risk Type:** Turn  
**Risk Level:** Medium  
**Speed Limit:** 30 KM/Hr  
**Coordinates:** 11.30625, 77.87776

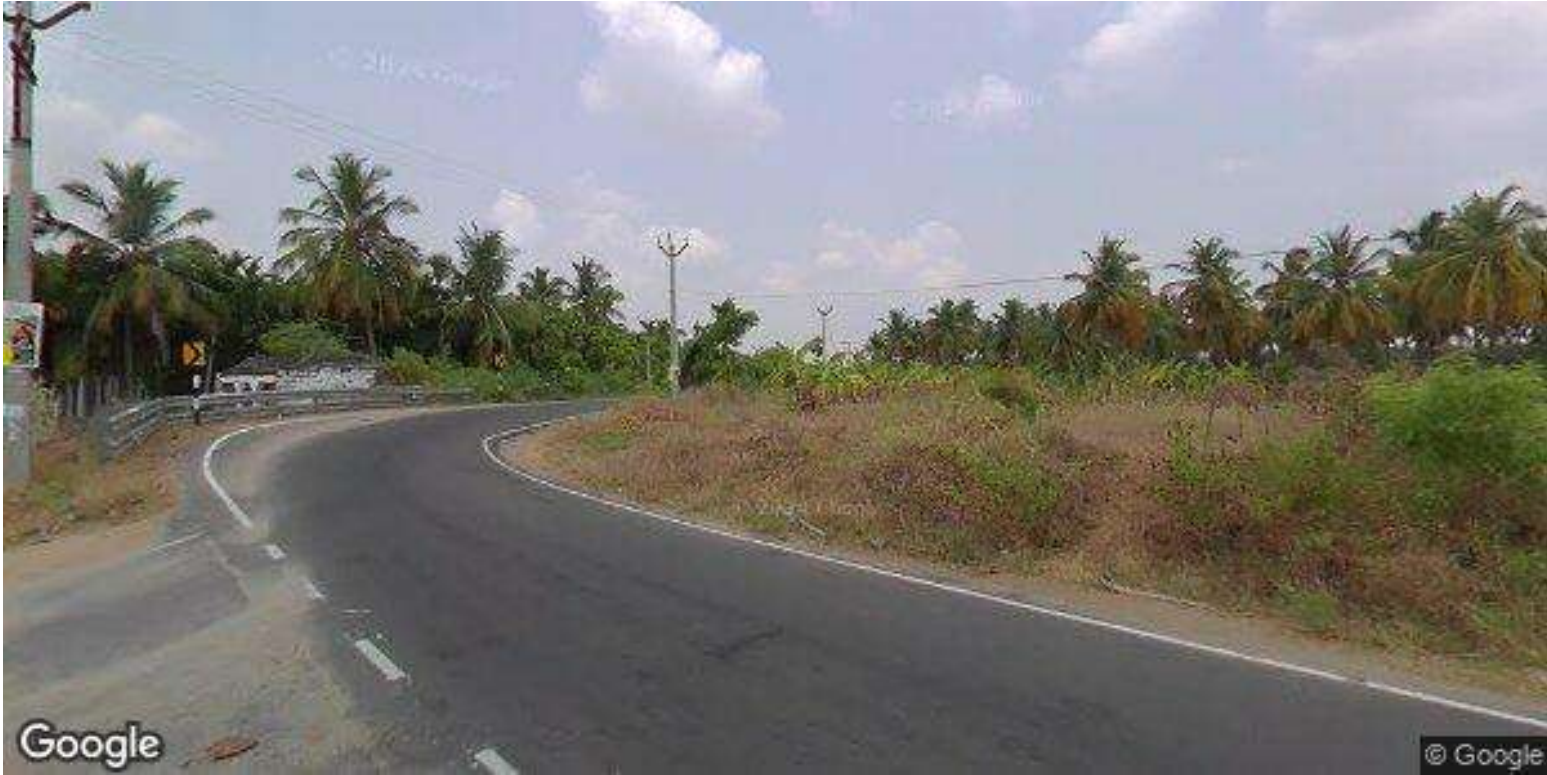
**Risk Type:** Turn  
**Risk Level:** High  
**Speed Limit:** 15 KM/Hr  
**Coordinates:** 11.29763, 77.87710

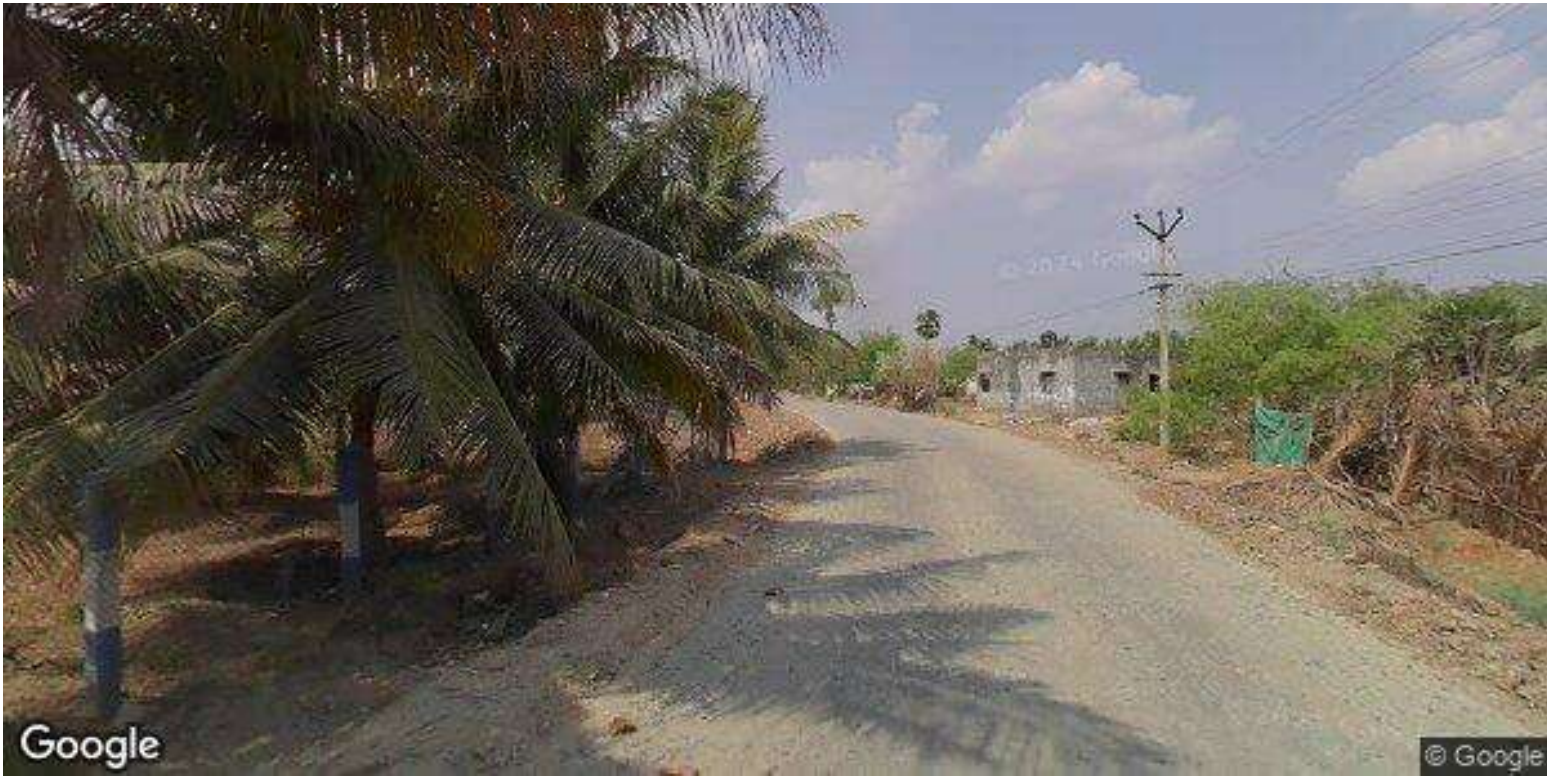
**Risk Type:** Turn  
**Risk Level:** Medium  
**Speed Limit:** 30 KM/Hr  
**Coordinates:** 11.27096, 77.87034

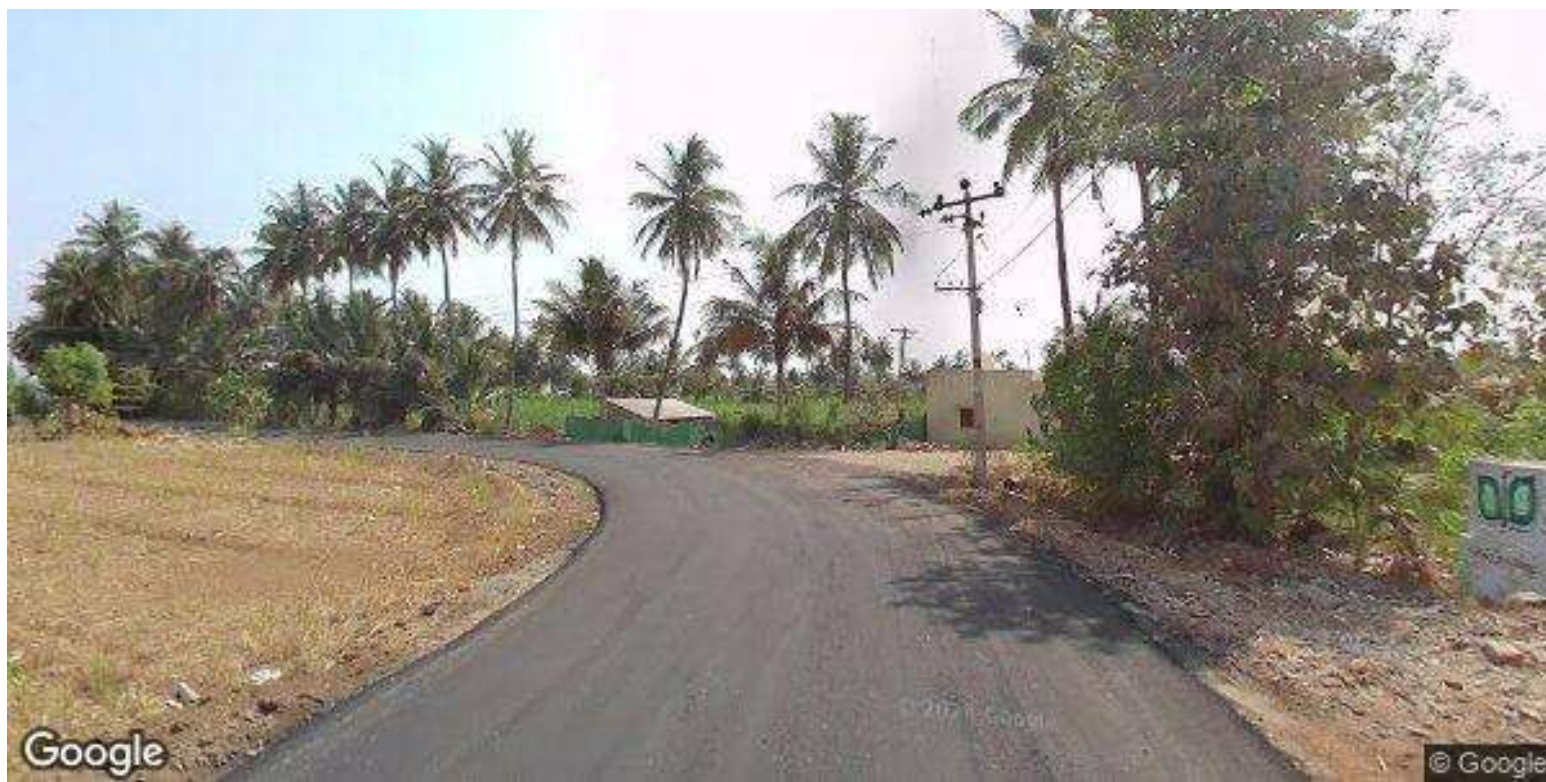
**Risk Type: Turn**

**Risk Level: High**

**Speed Limit: 15 KM/Hr**

**Coordinates: 11.26028, 77.85633**

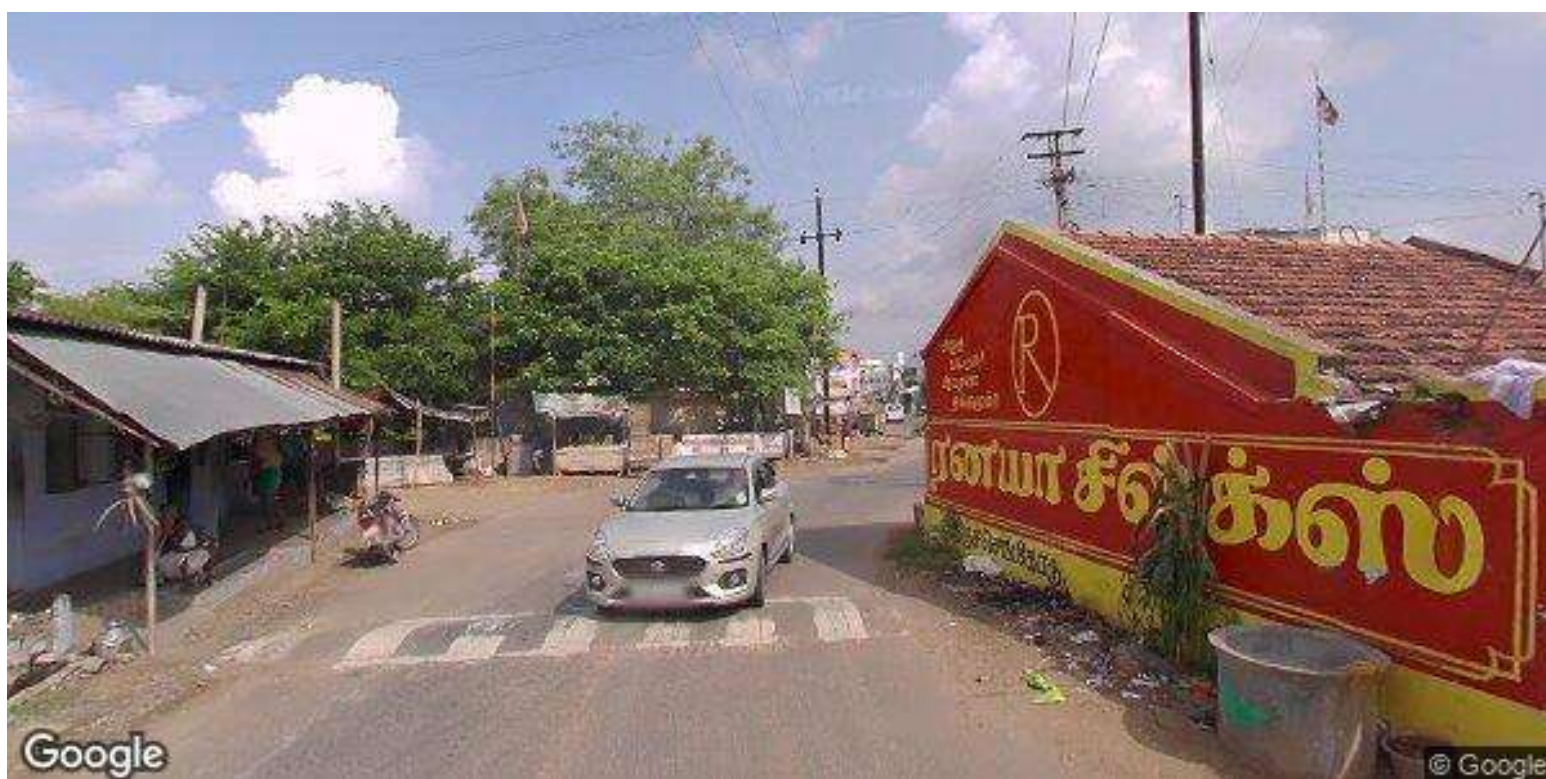
**Risk Type: Turn**

**Risk Level: High**

**Speed Limit: 15 KM/Hr**

**Coordinates: 11.25791, 77.85522**

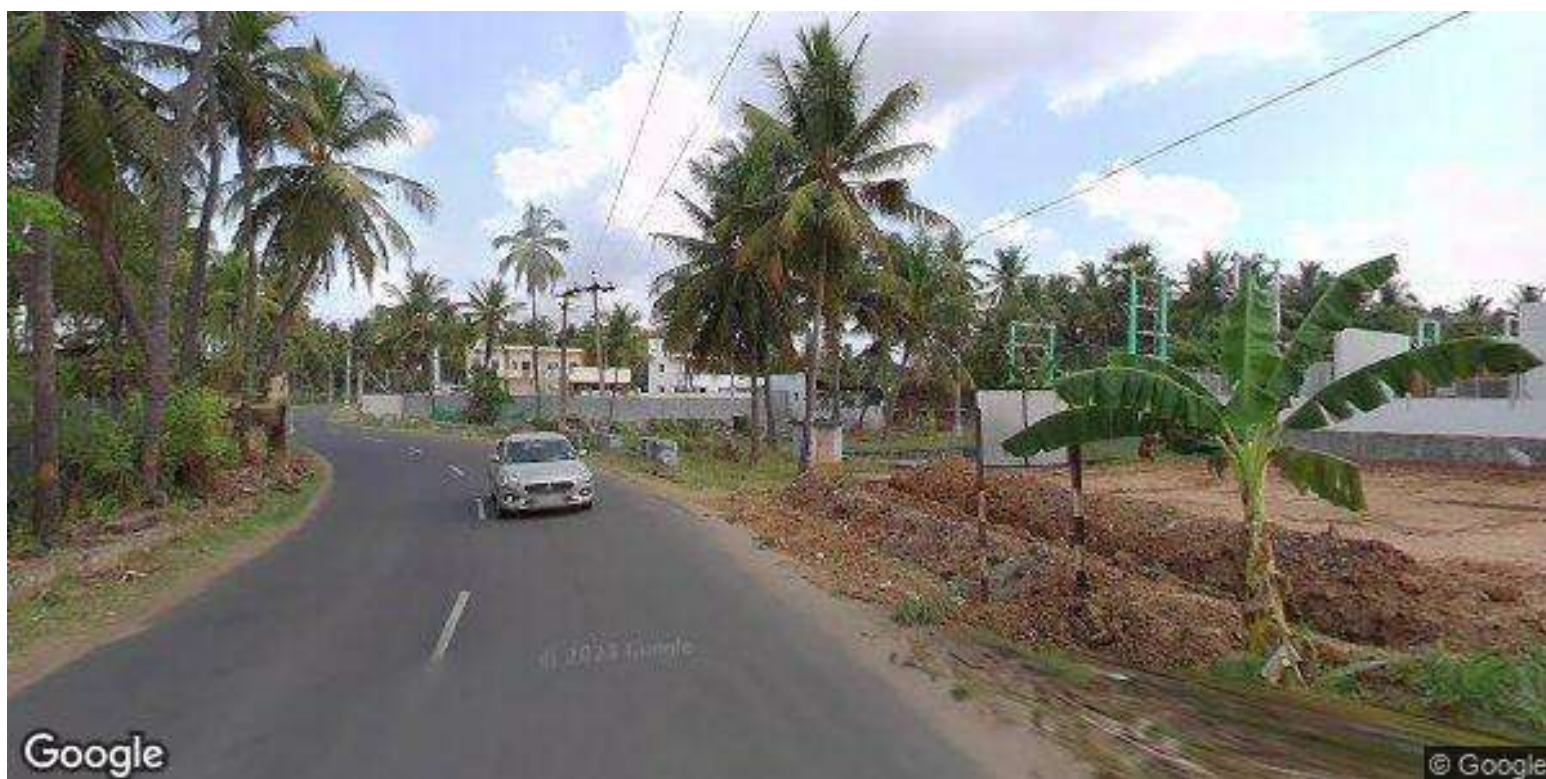
**Risk Type:** Turn  
**Risk Level:** Medium  
**Speed Limit:** 30 KM/Hr  
**Coordinates:** 11.25287, 77.86220

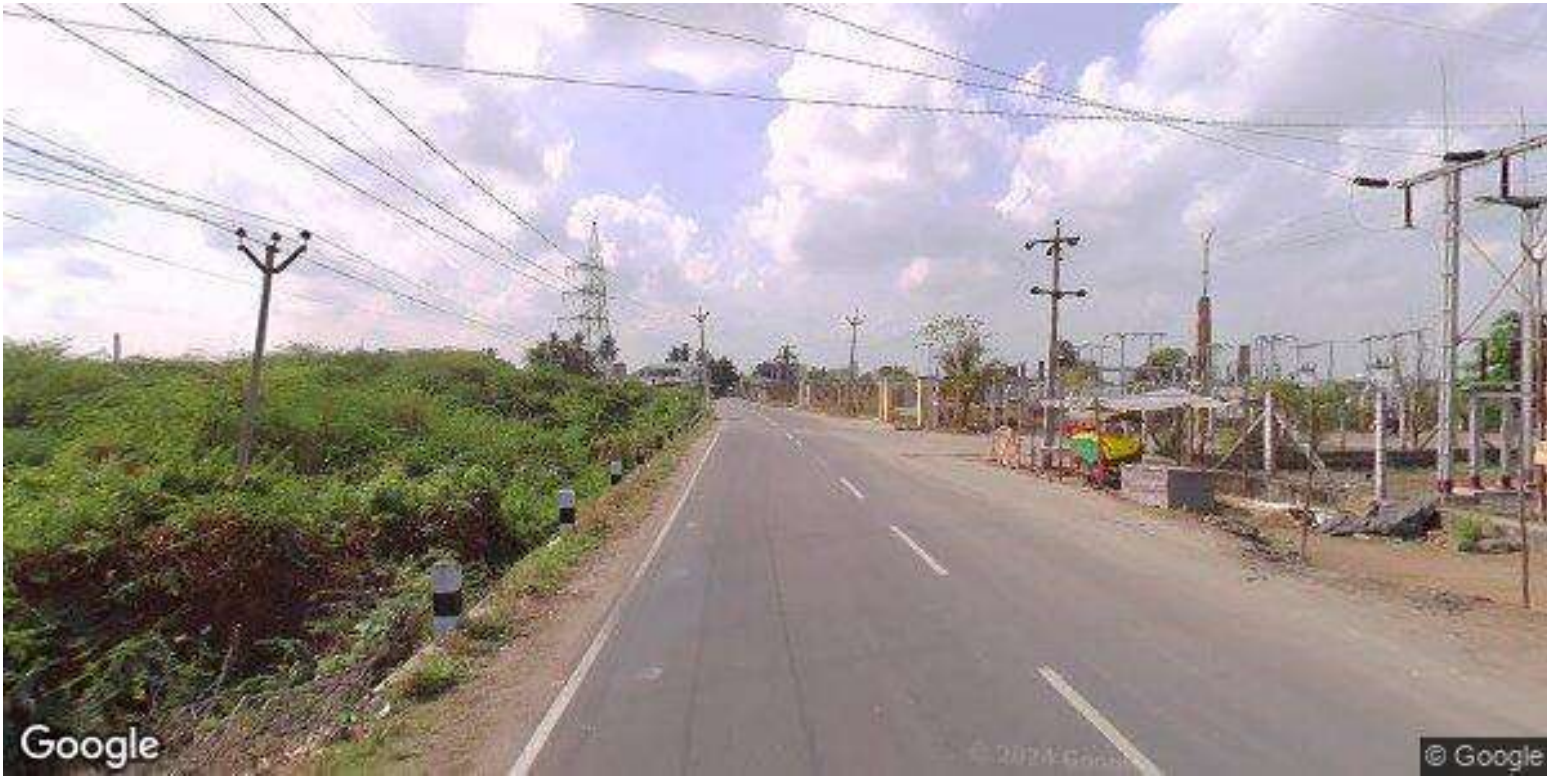
**Risk Type:** Turn  
**Risk Level:** Medium  
**Speed Limit:** 30 KM/Hr  
**Coordinates:** 11.24410, 77.86671

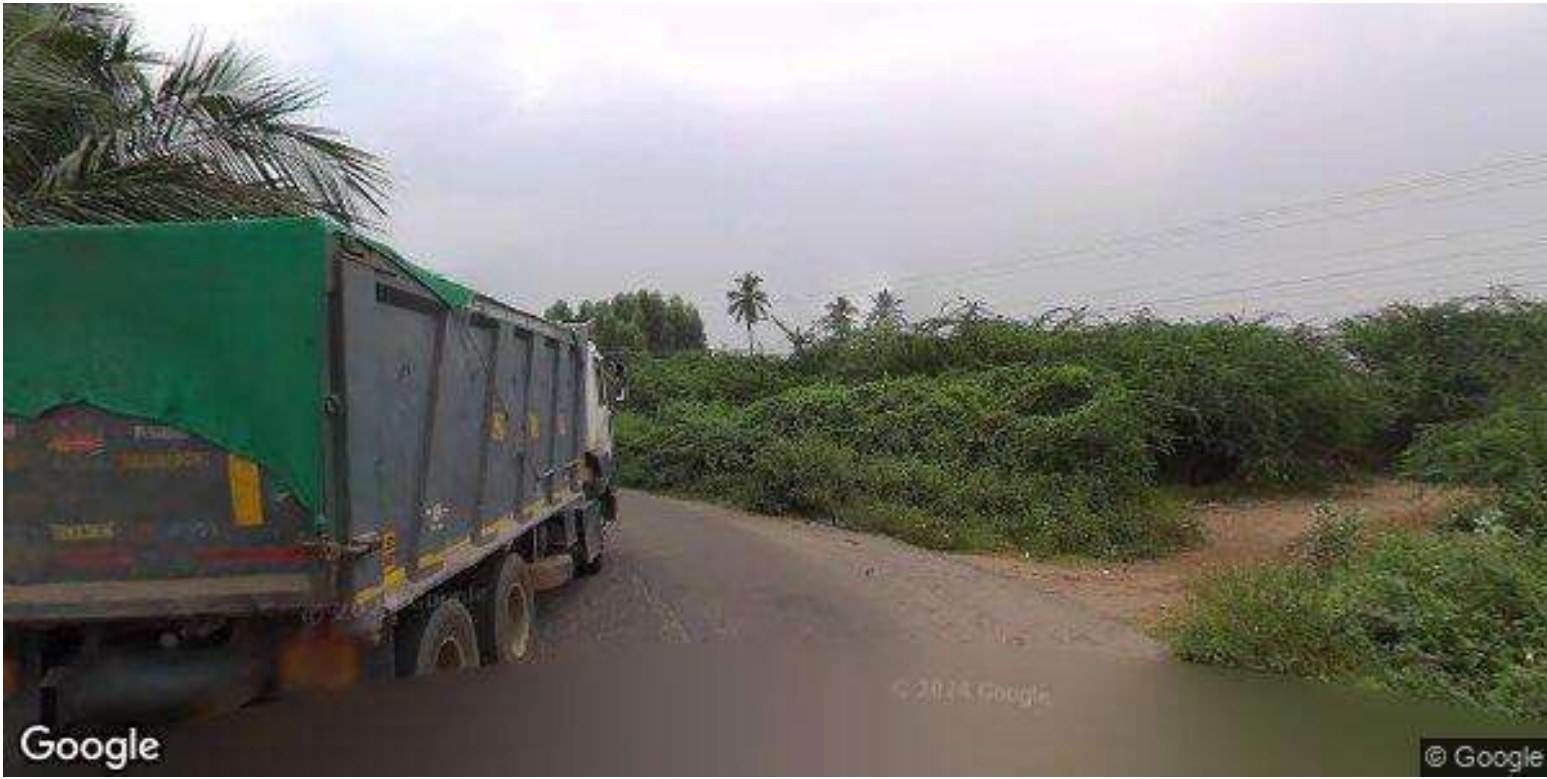
**Risk Type:** Turn  
**Risk Level:** High  
**Speed Limit:** 15 KM/Hr  
**Coordinates:** 11.24100, 77.86030

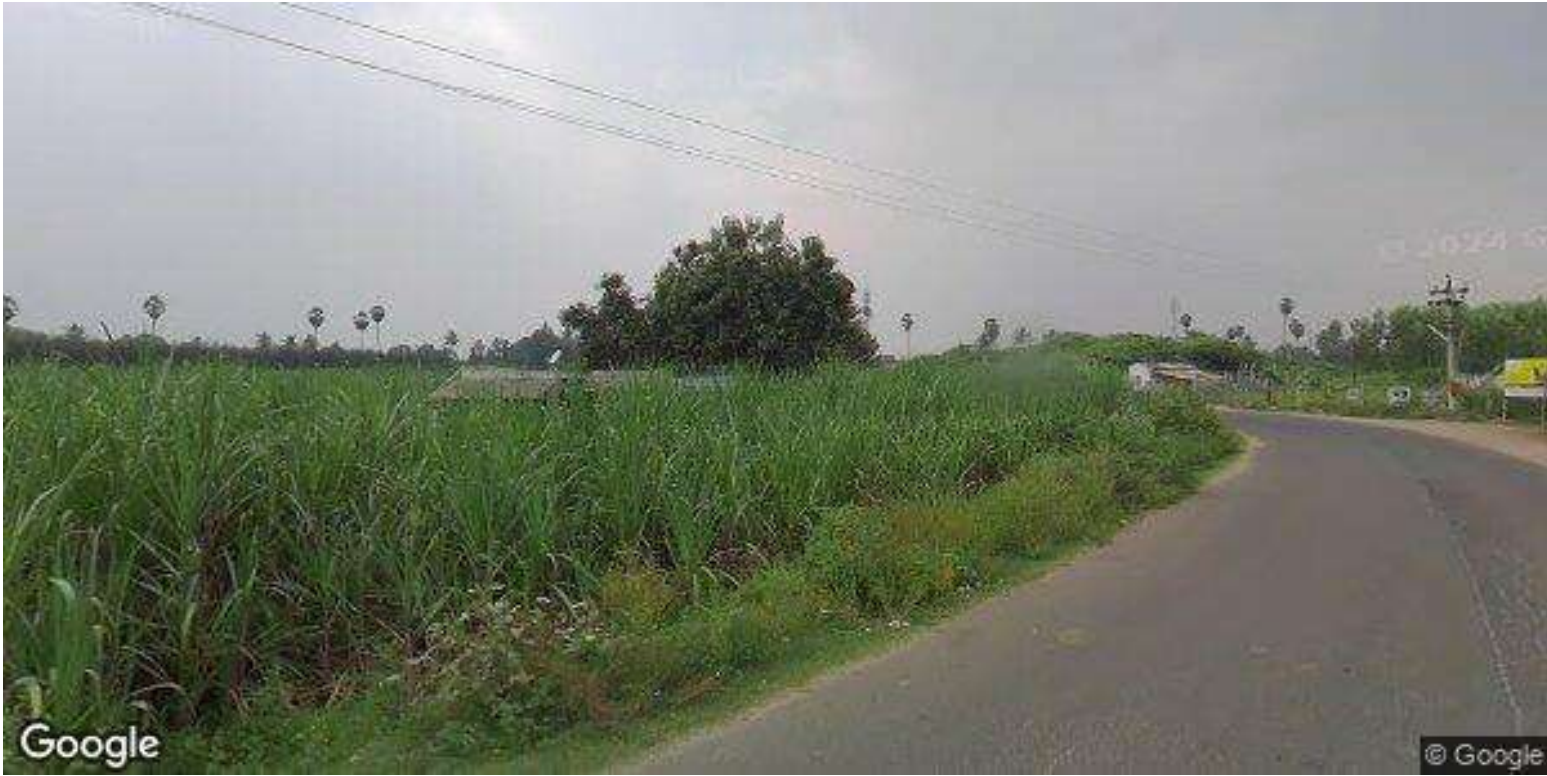
**Risk Type:** Turn  
**Risk Level:** Medium  
**Speed Limit:** 30 KM/Hr  
**Coordinates:** 11.24196, 77.85902

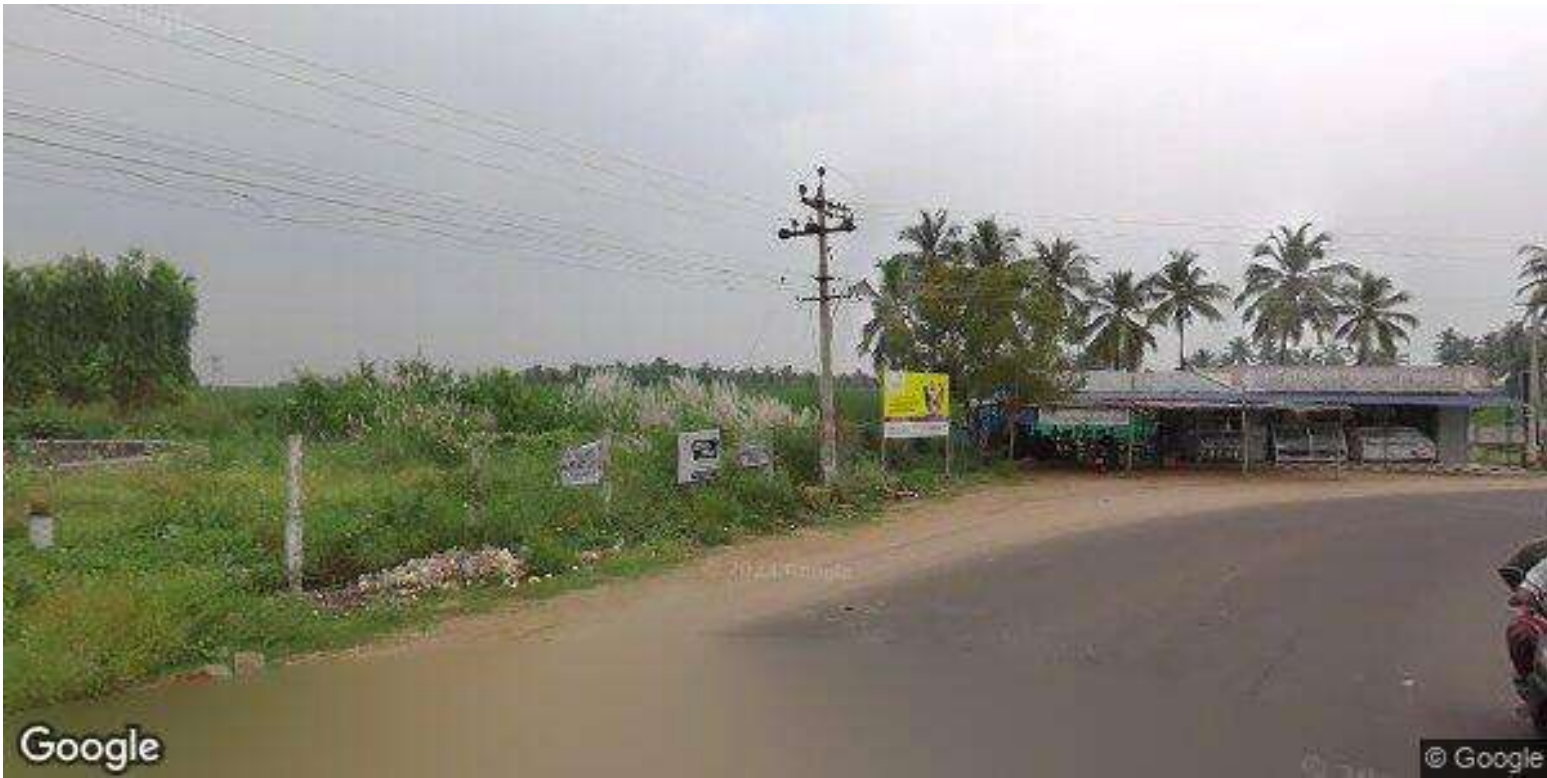
**Risk Type:** Turn  
**Risk Level:** Medium  
**Speed Limit:** 30 KM/Hr  
**Coordinates:** 11.24193, 77.85850

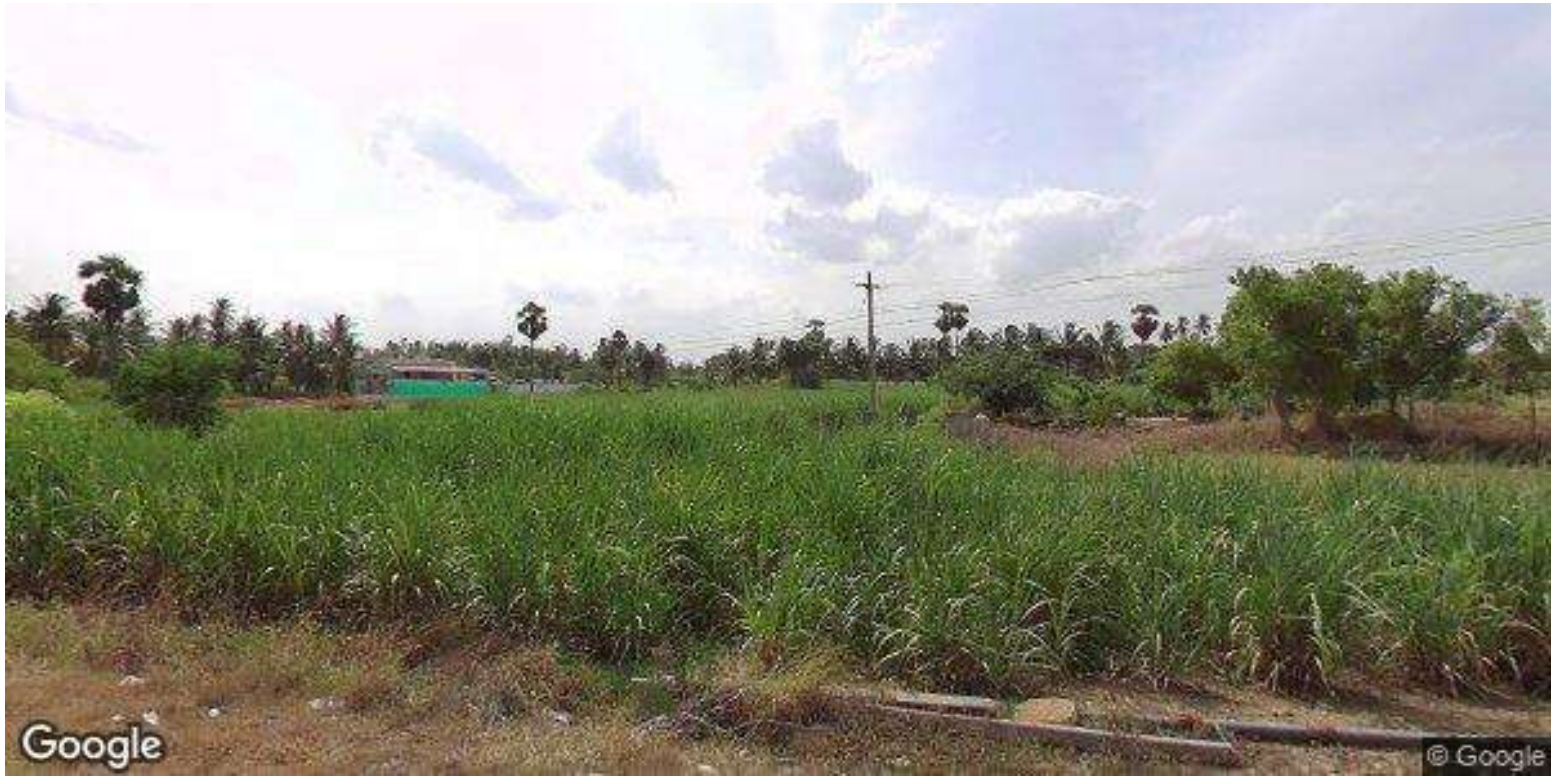
**Risk Type:** Turn  
**Risk Level:** Medium  
**Speed Limit:** 30 KM/Hr  
**Coordinates:** 11.22478, 77.84241
