# IndianOil

## JOURNEY RISK MANAGEMENT (JRM) STUDY

### Salem Terminal TO VENKATESWARA AUTO SERVICE

Route Safety Analysis Report

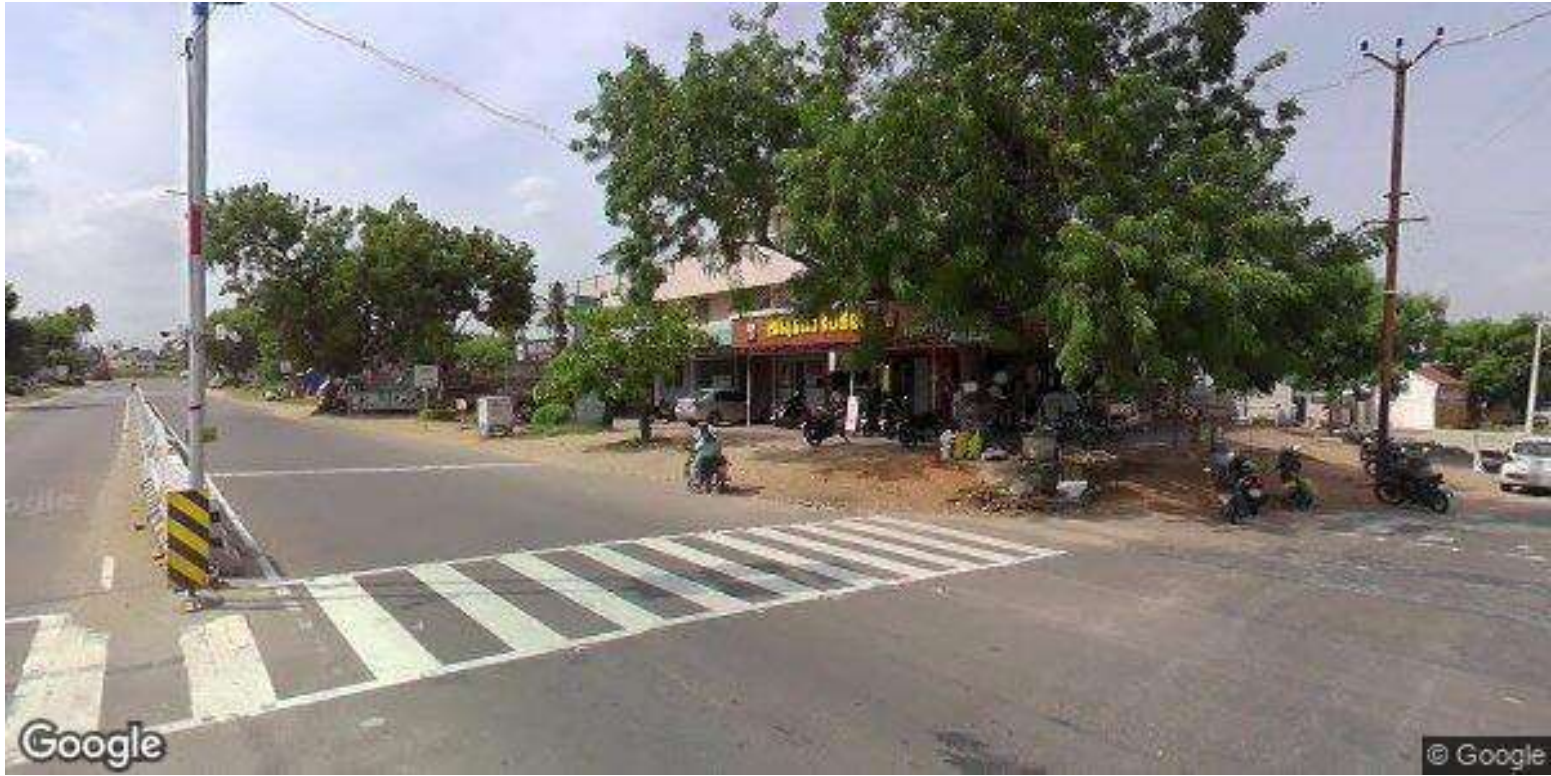
**Risk Type:** Turn  
**Risk Level:** High  
**Speed Limit:** 15 KM/Hr  
**Coordinates:** 11.22377, 77.83980

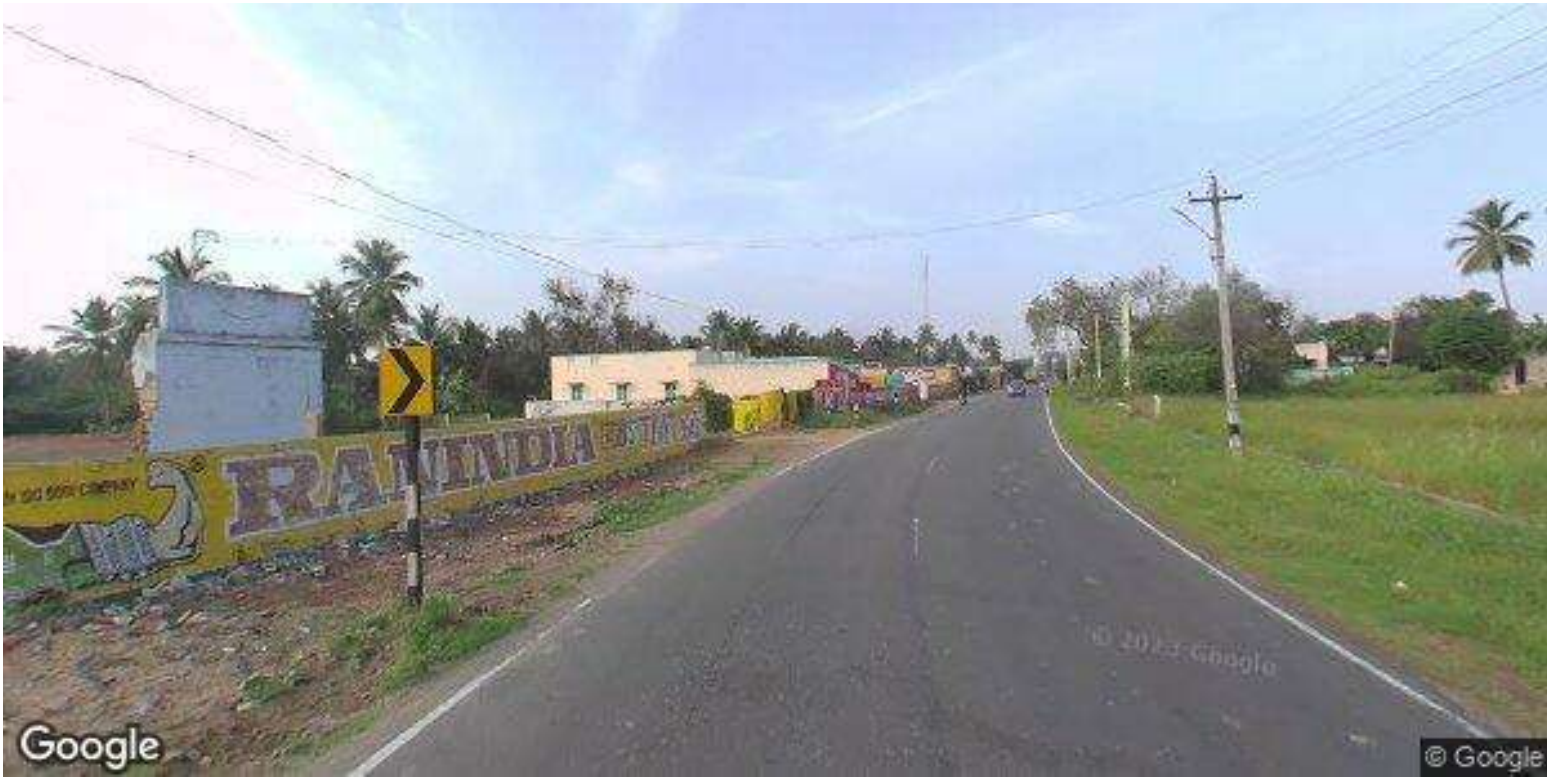
**Risk Type:** Turn  
**Risk Level:** Medium  
**Speed Limit:** 30 KM/Hr  
**Coordinates:** 11.14595, 77.84958

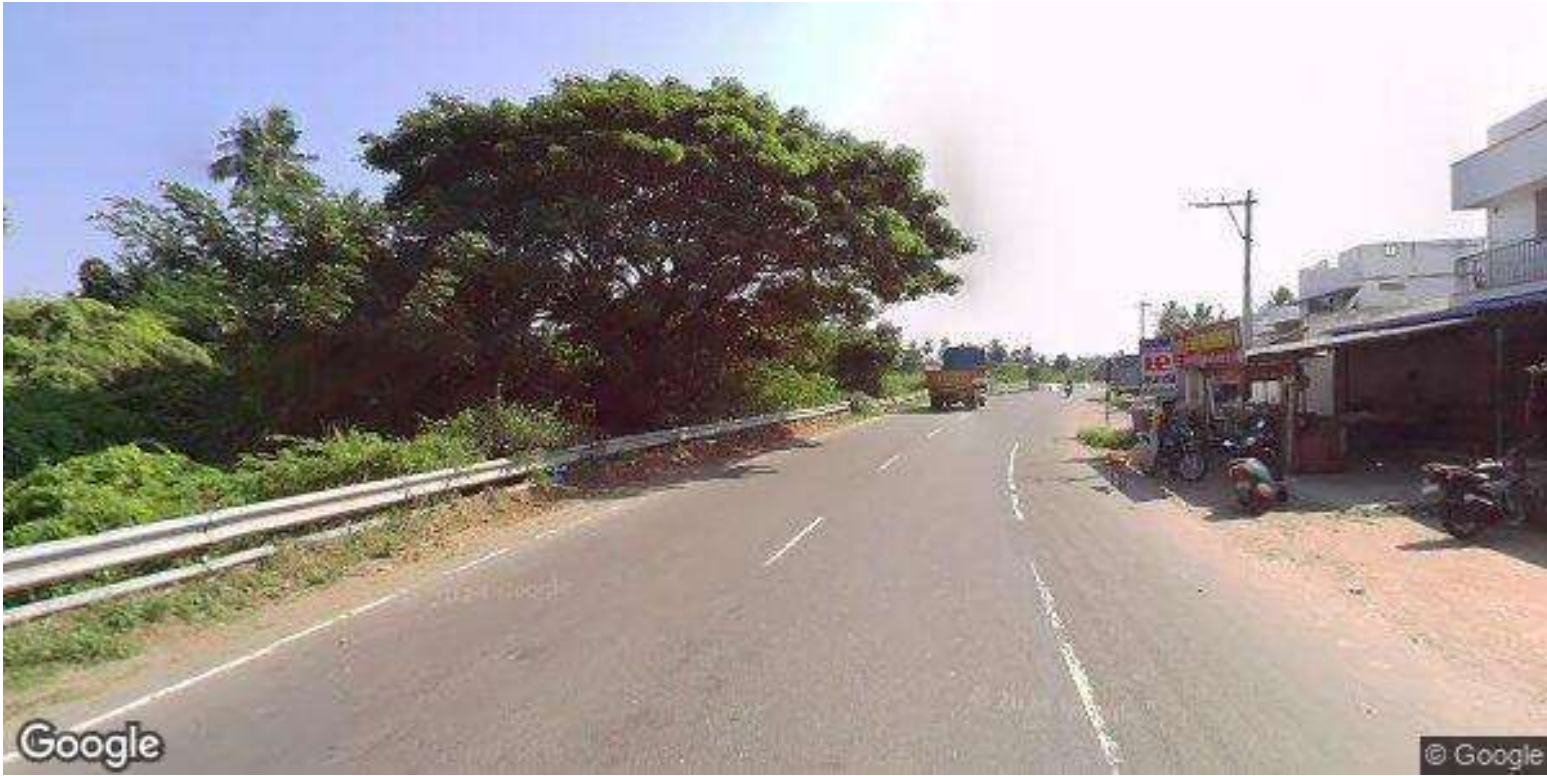
**Risk Type:** Turn  
**Risk Level:** Medium  
**Speed Limit:** 30 KM/Hr  
**Coordinates:** 11.12977, 77.85502

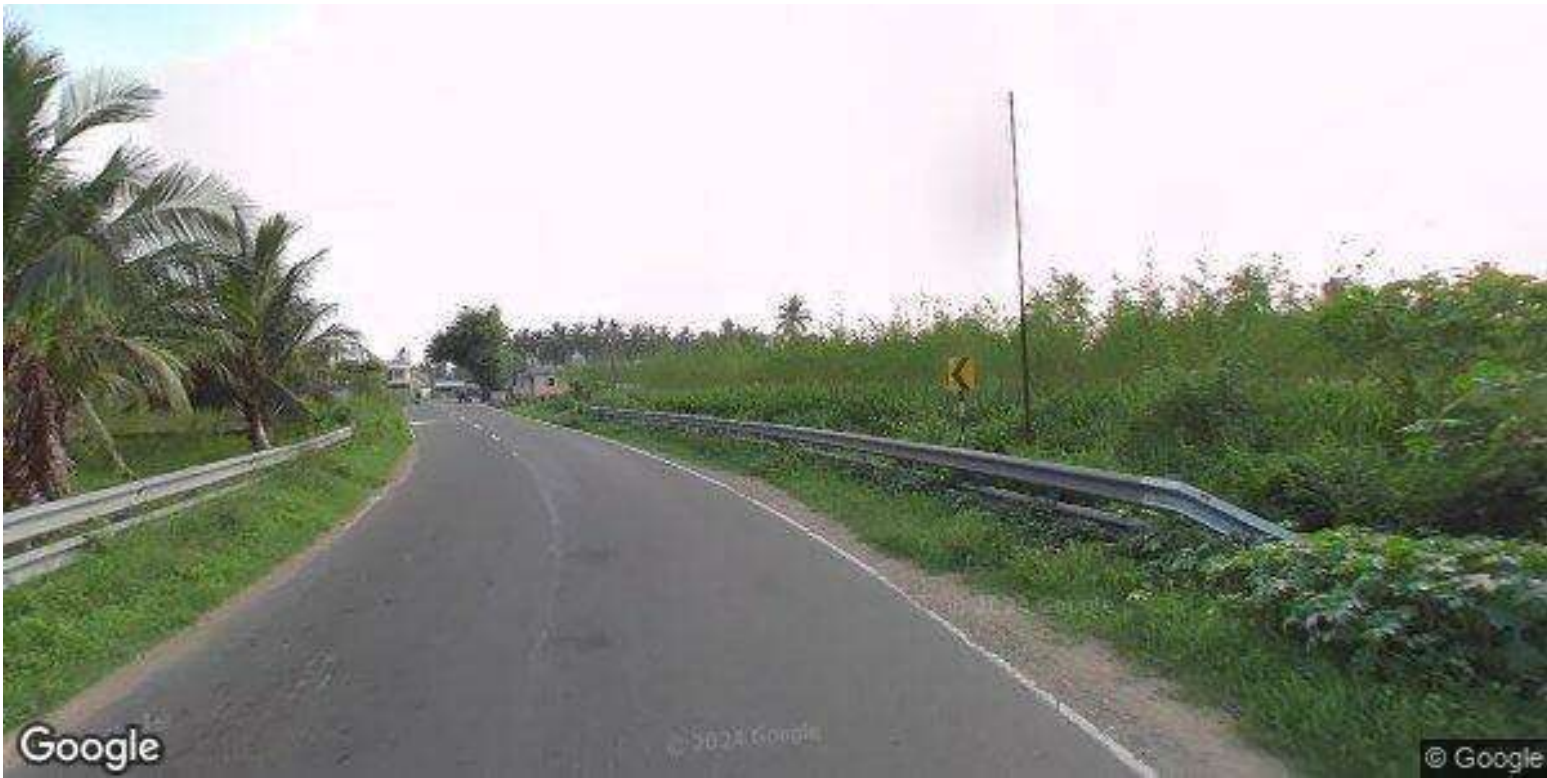
**Risk Type:** Turn  
**Risk Level:** Medium  
**Speed Limit:** 30 KM/Hr  
**Coordinates:** 11.12714, 77.85403

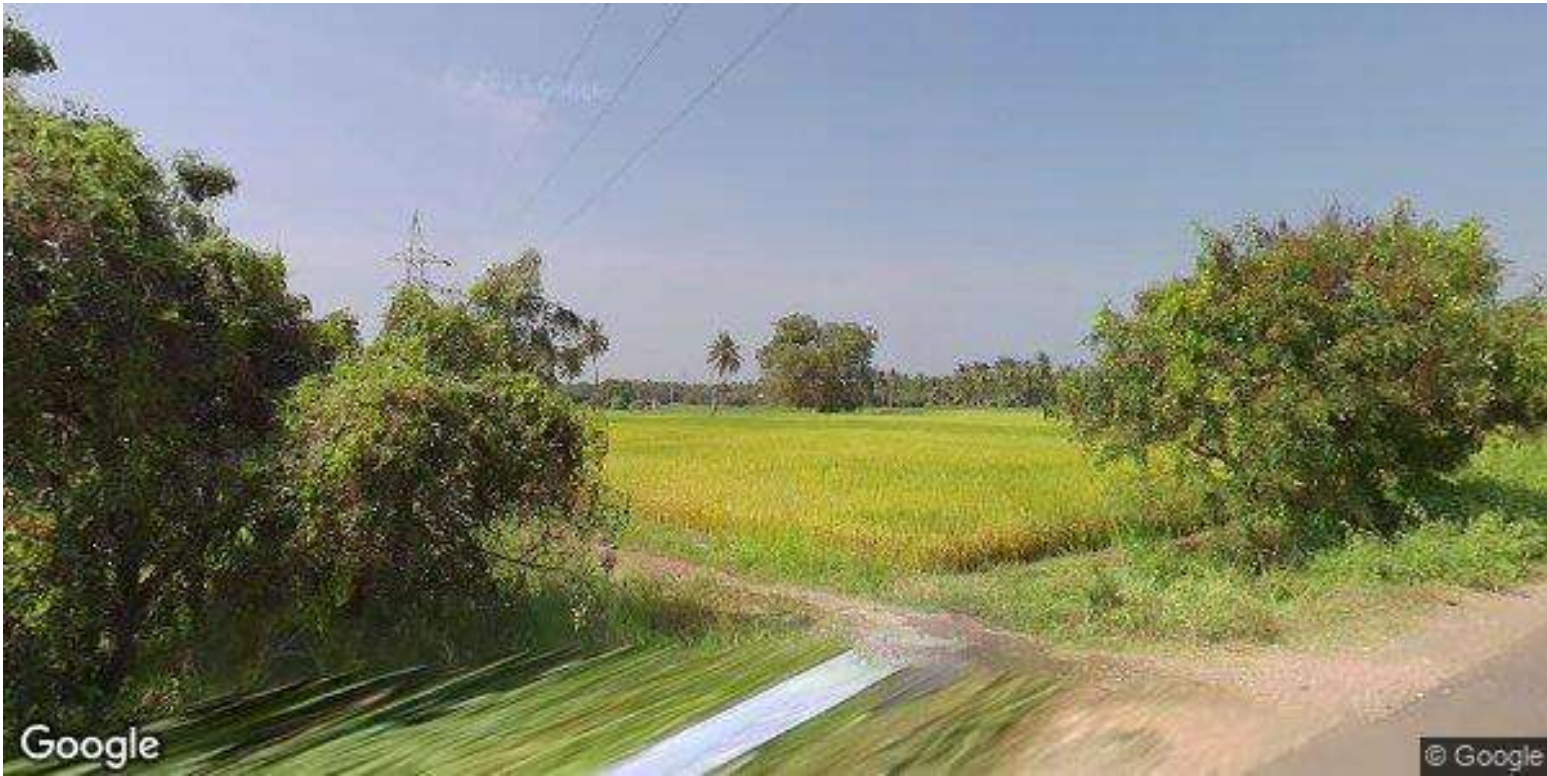
**Risk Type:** Turn  
**Risk Level:** Medium  
**Speed Limit:** 30 KM/Hr  
**Coordinates:** 11.05412, 77.87969

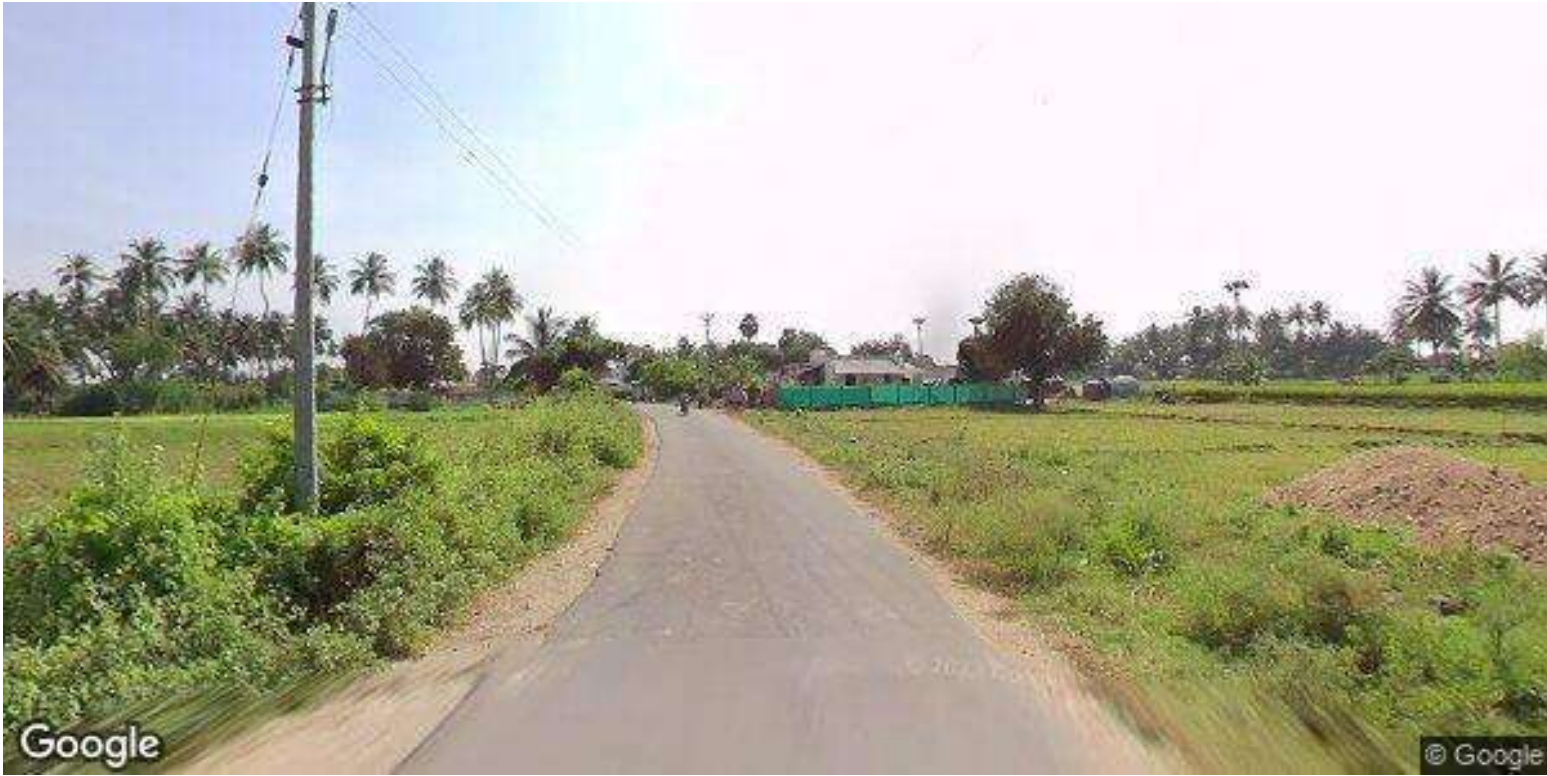
**Risk Type:** Turn  
**Risk Level:** Medium  
**Speed Limit:** 30 KM/Hr  
**Coordinates:** 11.04059, 77.87686

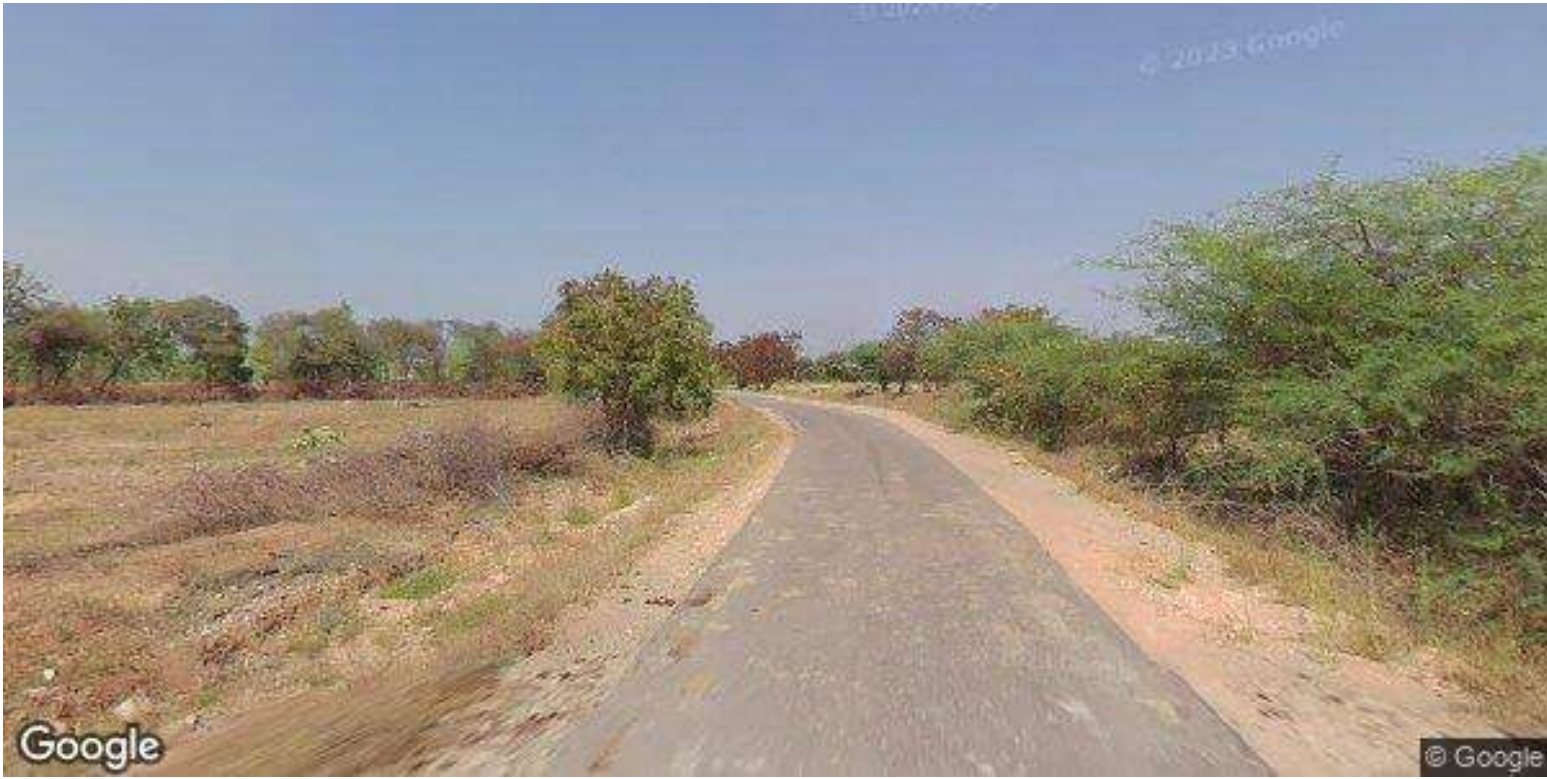
**Risk Type:** Turn  
**Risk Level:** Medium  
**Speed Limit:** 30 KM/Hr  
**Coordinates:** 11.02806, 77.87663

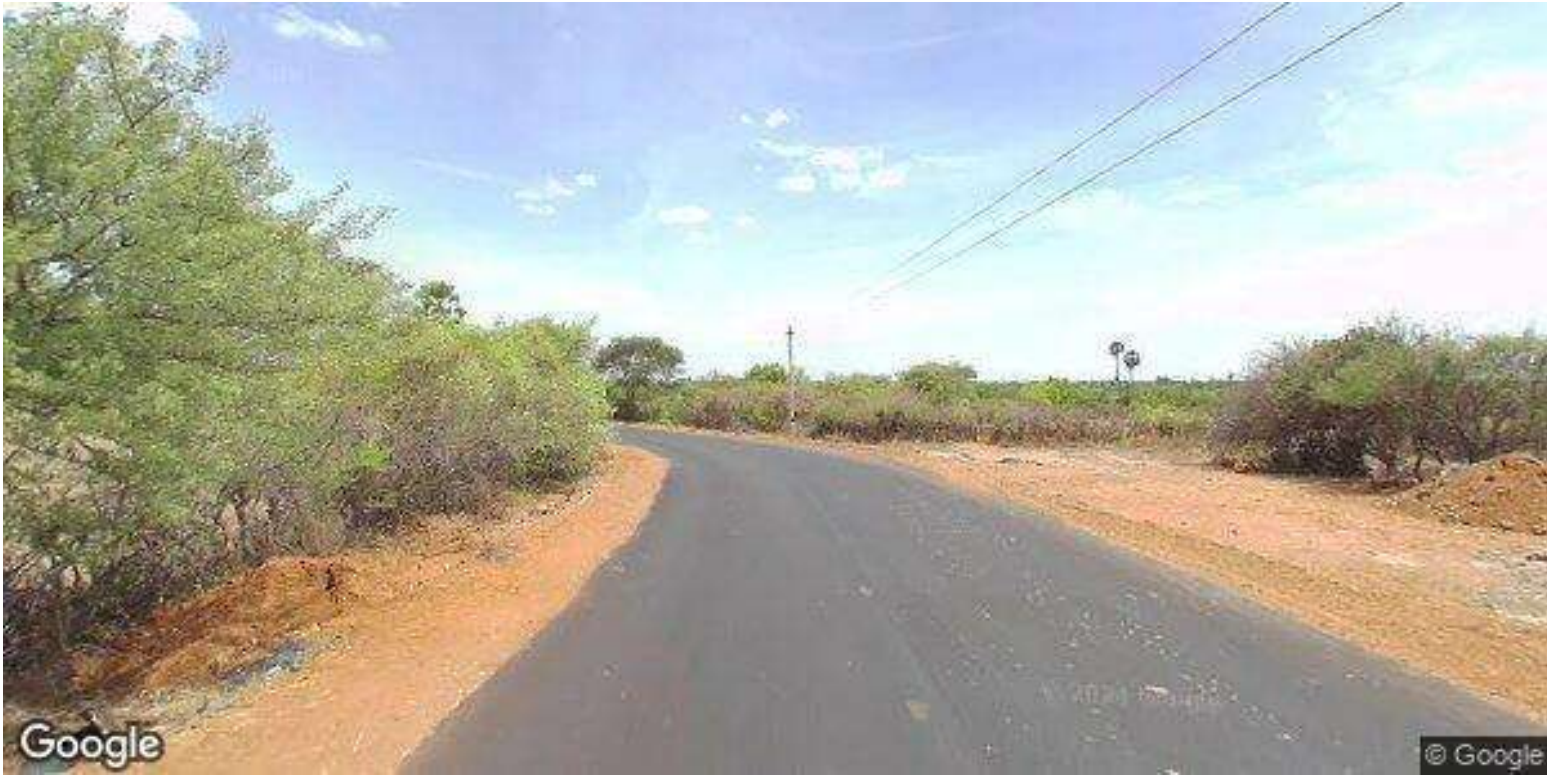
**Risk Type:** Turn  
**Risk Level:** Medium  
**Speed Limit:** 30 KM/Hr  
**Coordinates:** 11.00834, 77.85882

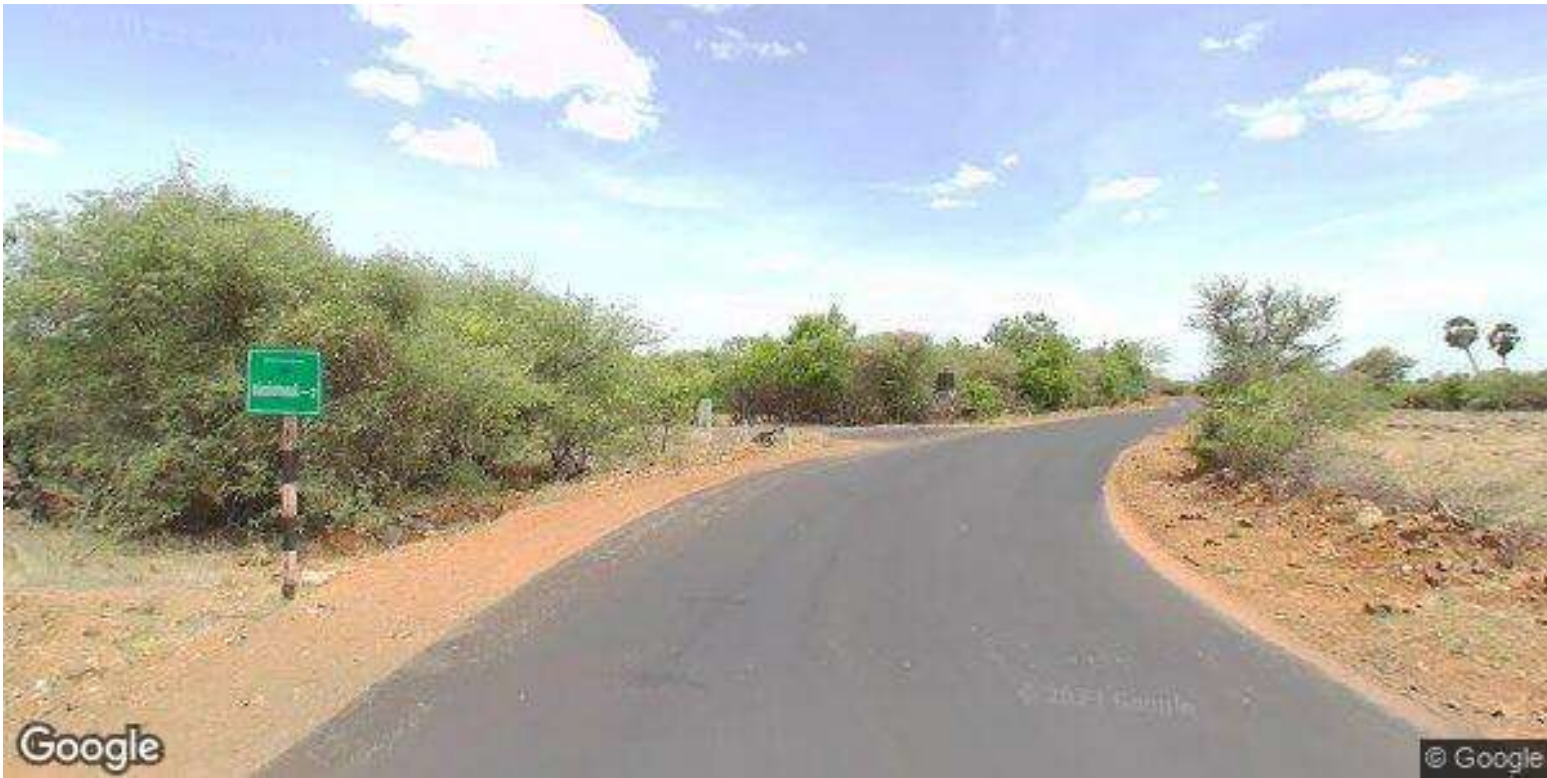
**Risk Type:** Turn  
**Risk Level:** Medium  
**Speed Limit:** 30 KM/Hr  
**Coordinates:** 11.00475, 77.85797

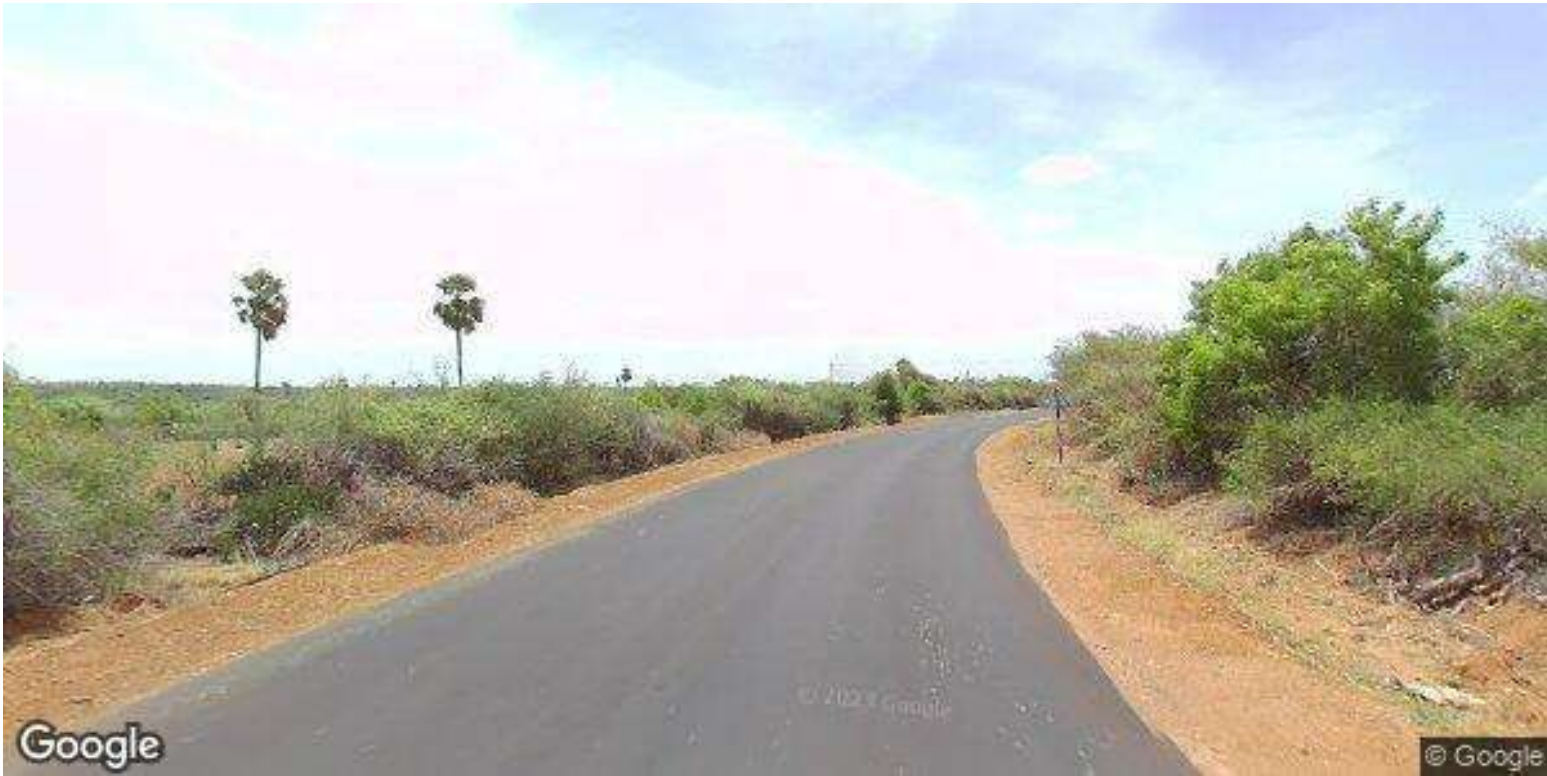
**Risk Type:** Turn  
**Risk Level:** Medium  
**Speed Limit:** 30 KM/Hr  
**Coordinates:** 11.00360, 77.85683

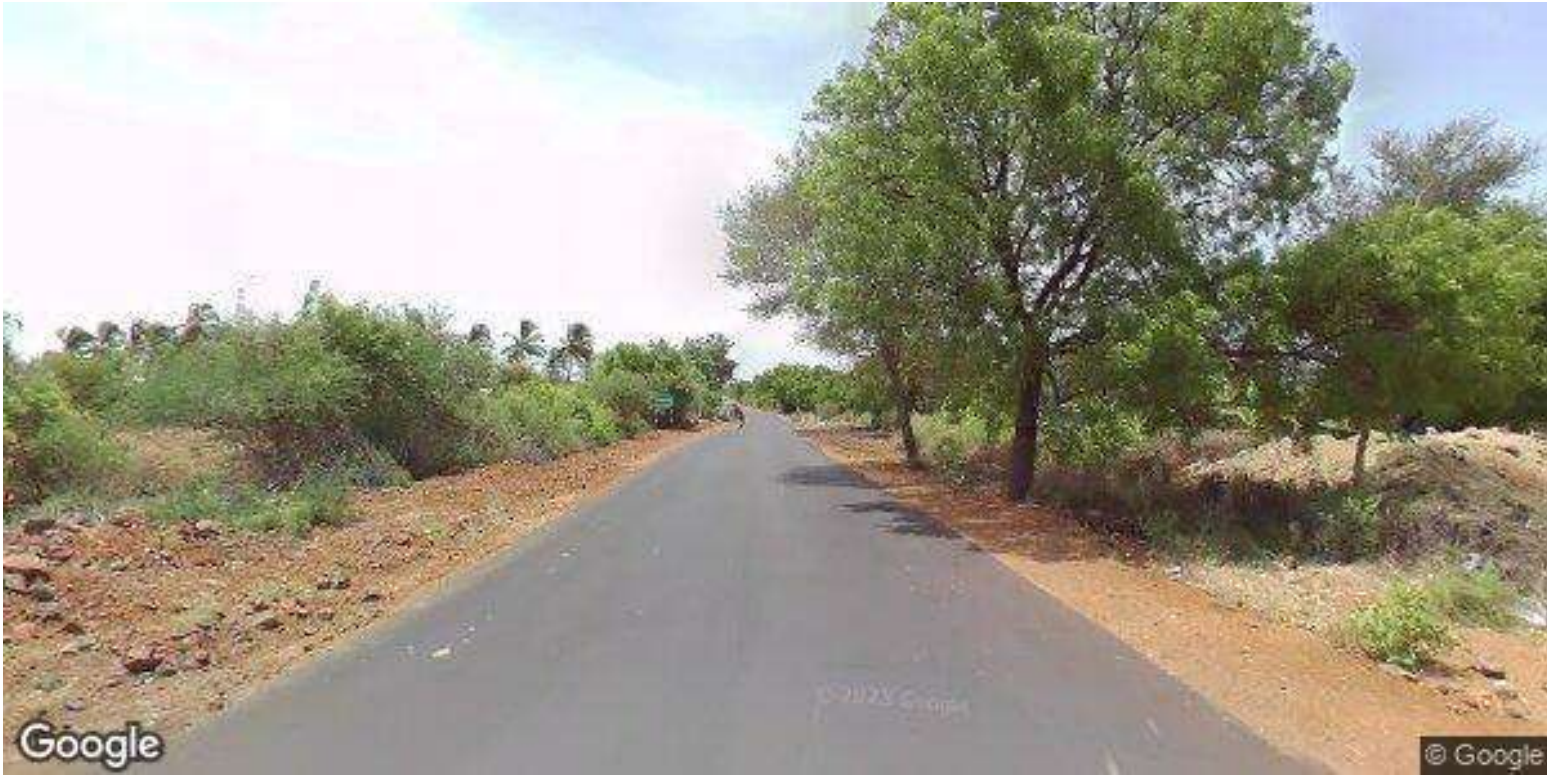
**Risk Type:** Turn  
**Risk Level:** Medium  
**Speed Limit:** 30 KM/Hr  
**Coordinates:** 10.99820, 77.85581

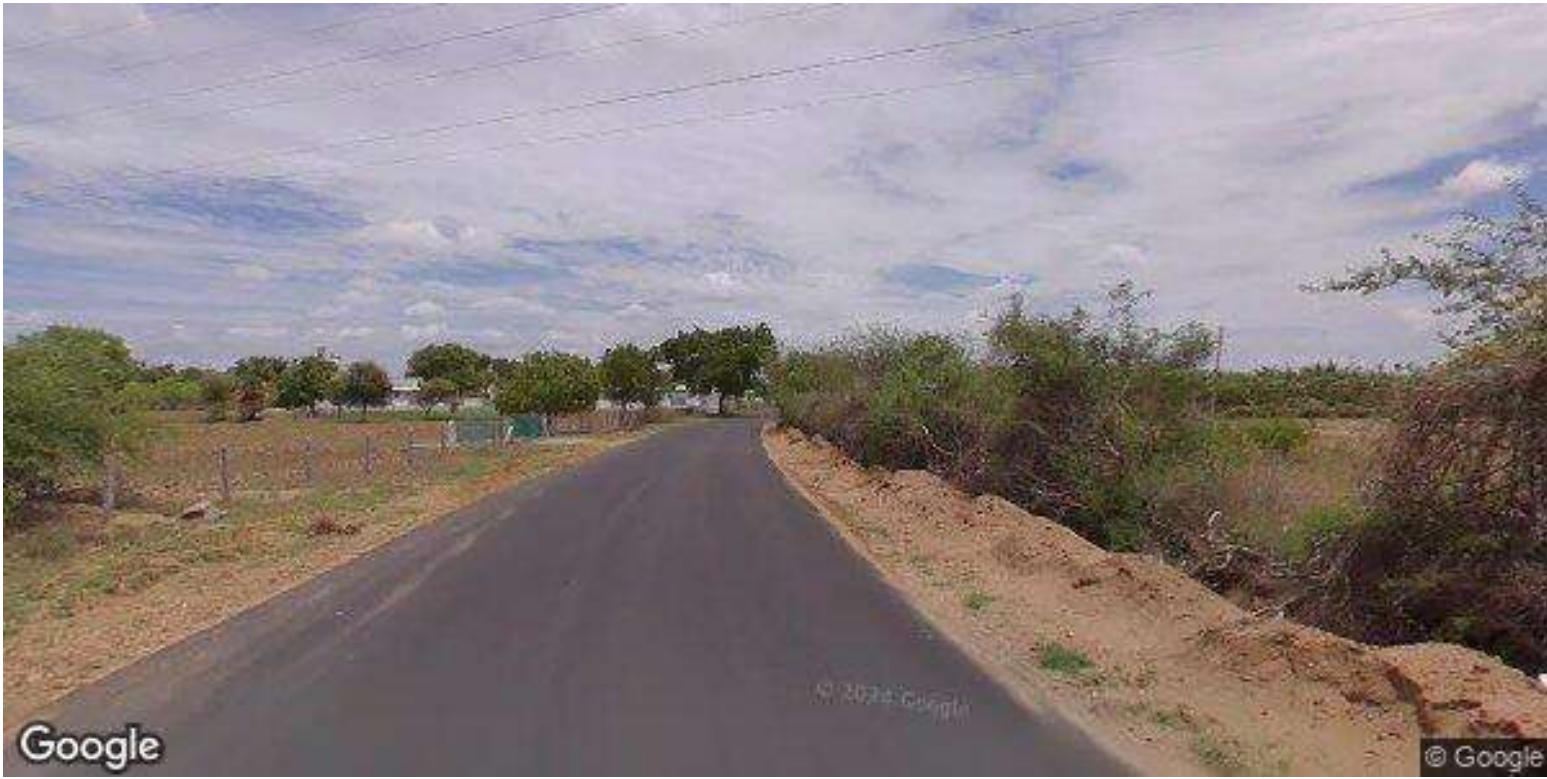
**Risk Type:** Turn  
**Risk Level:** Medium  
**Speed Limit:** 30 KM/Hr  
**Coordinates:** 10.96483, 77.83744

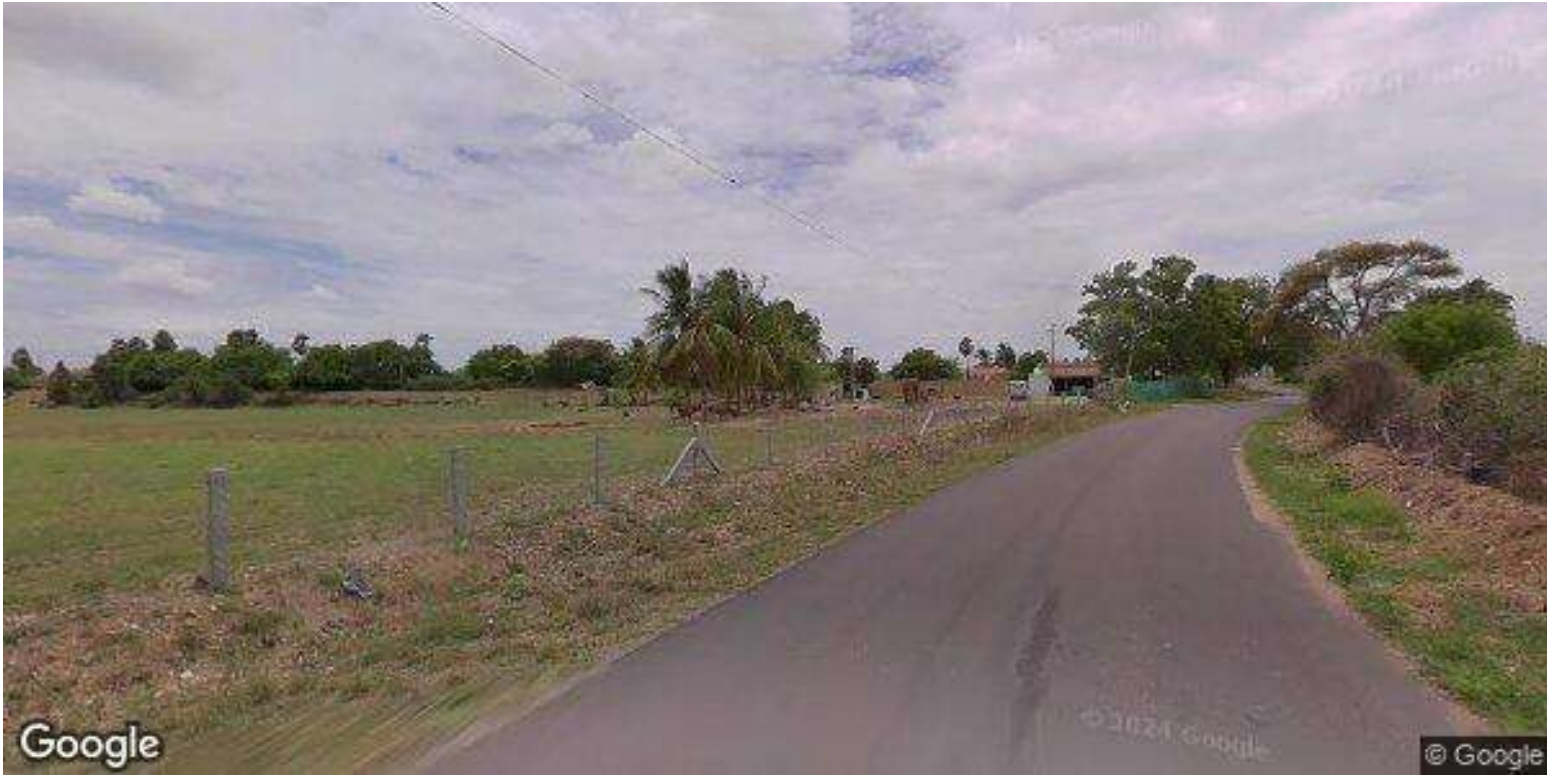
**Risk Type:** Turn  
**Risk Level:** Medium  
**Speed Limit:** 30 KM/Hr  
**Coordinates:** 10.95683, 77.83813

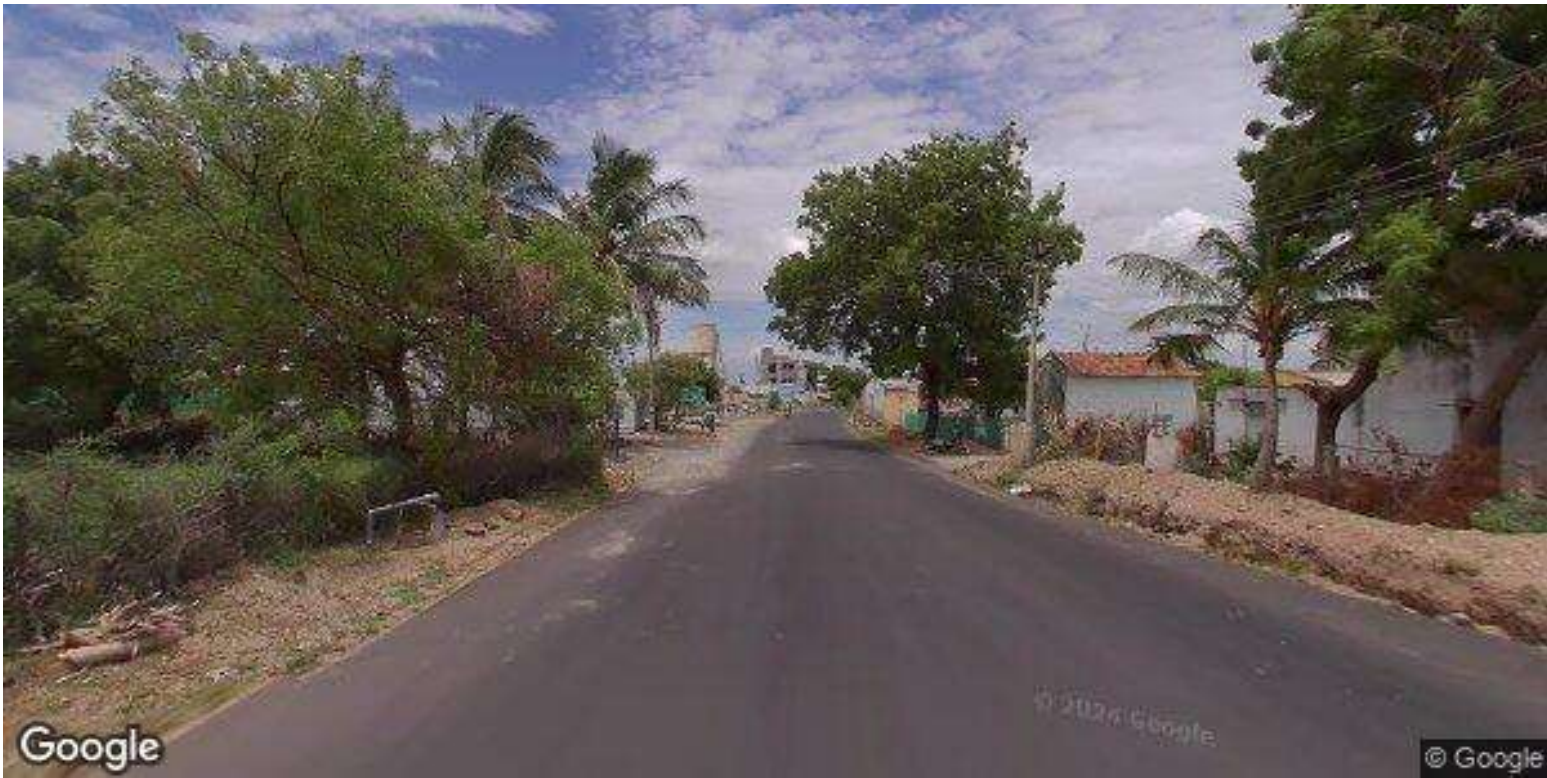
**Risk Type:** Turn  
**Risk Level:** Medium  
**Speed Limit:** 30 KM/Hr  
**Coordinates:** 10.95401, 77.83691

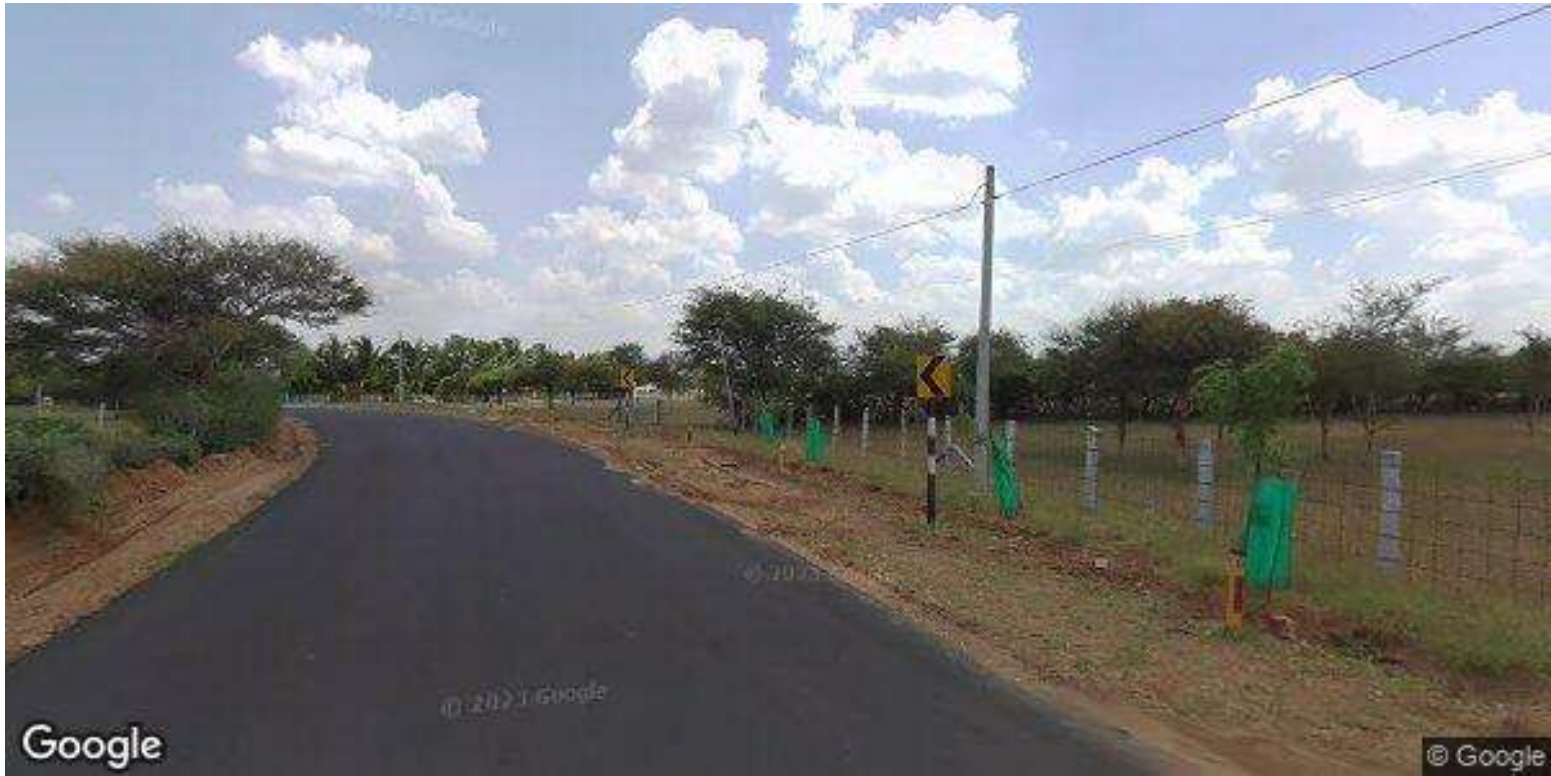
**Risk Type:** Turn  
**Risk Level:** Medium  
**Speed Limit:** 30 KM/Hr  
**Coordinates:** 10.89518, 77.83562

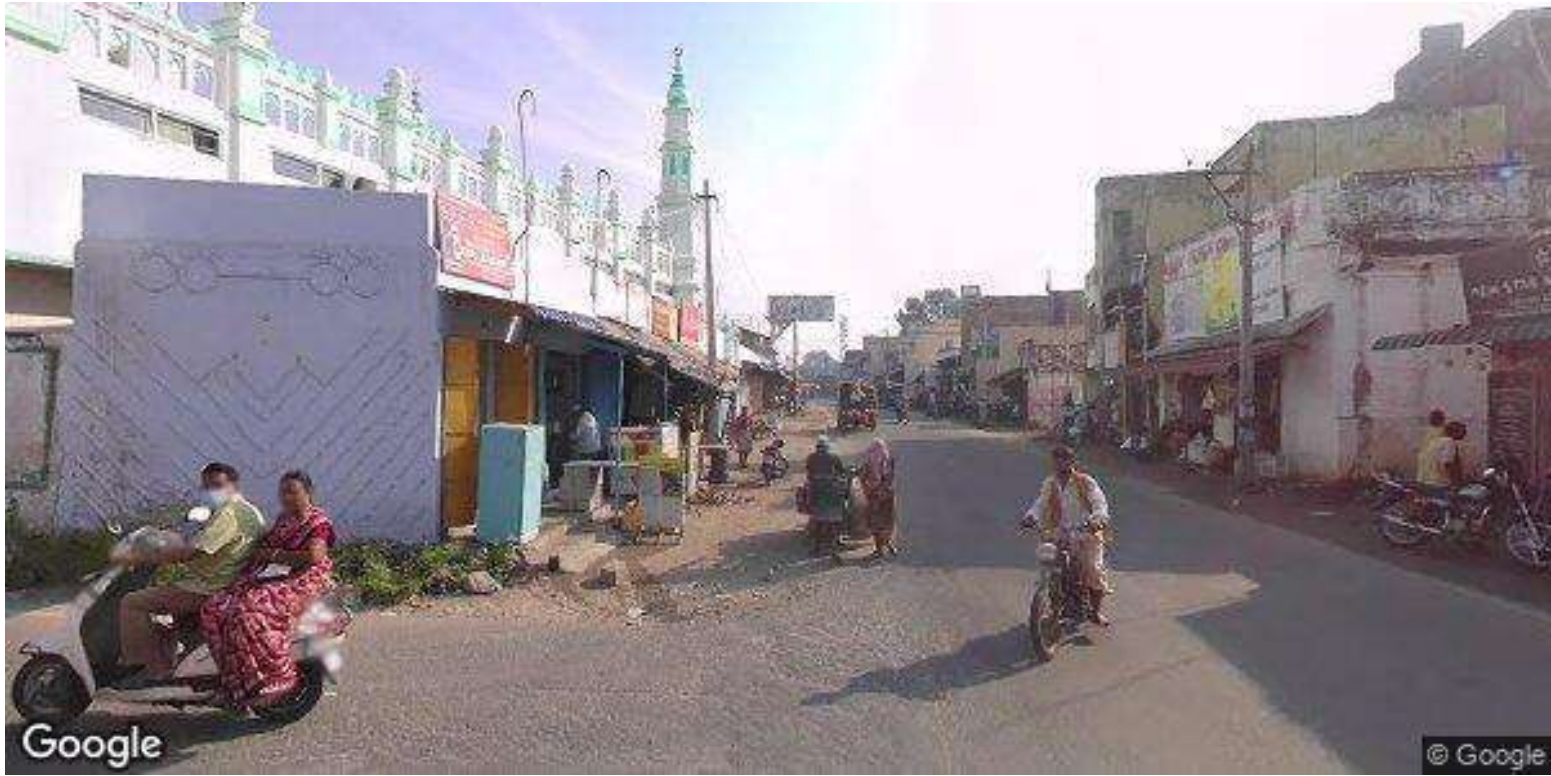
**Risk Type:** Blind Spot  
**Risk Level:** Blind Spot  
**Speed Limit:** 10 KM/Hr  
**Coordinates:** 10.85240, 77.85000

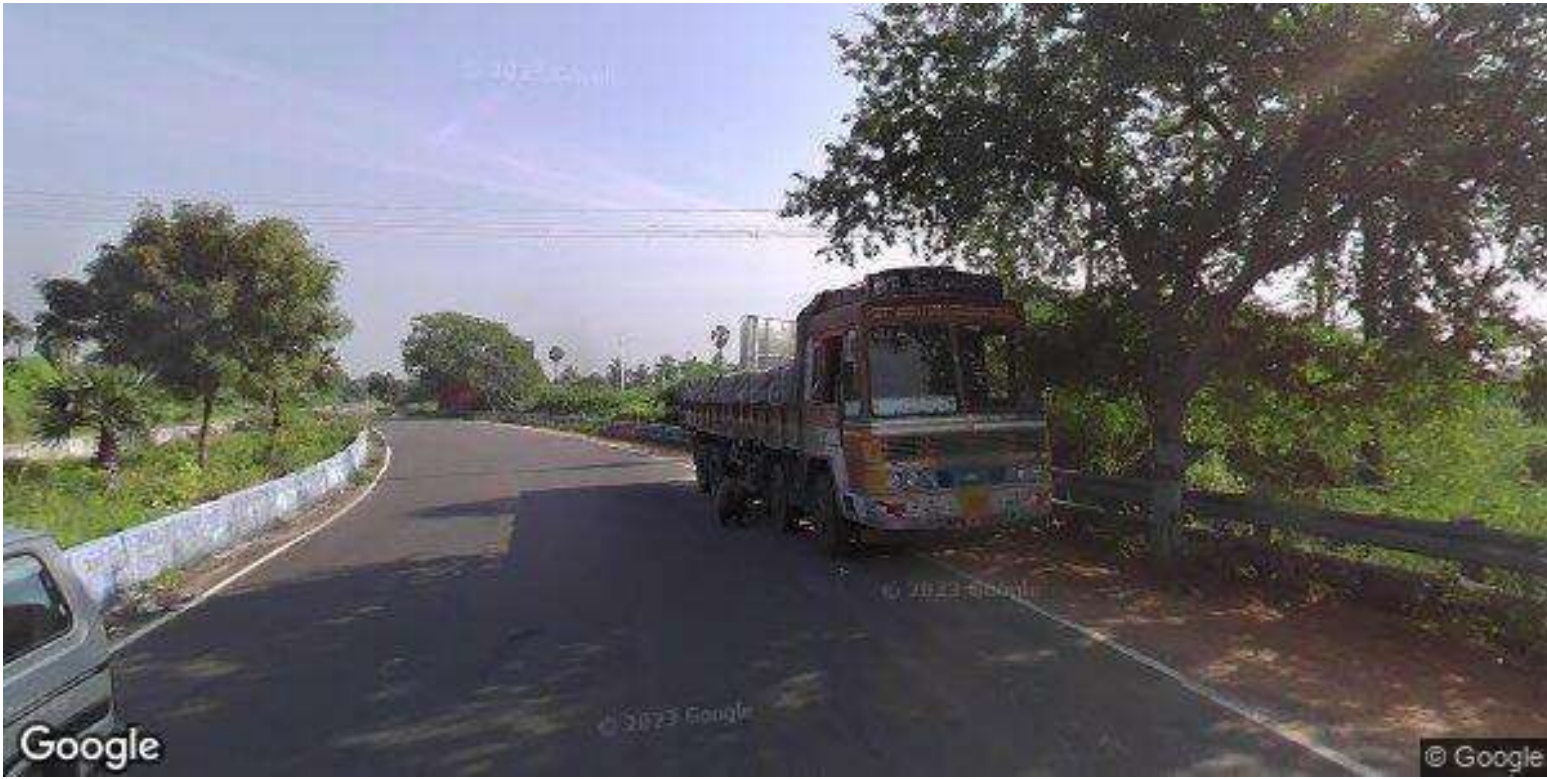
**Risk Type:** Turn  
**Risk Level:** High  
**Speed Limit:** 15 KM/Hr  
**Coordinates:** 10.81414, 77.79125

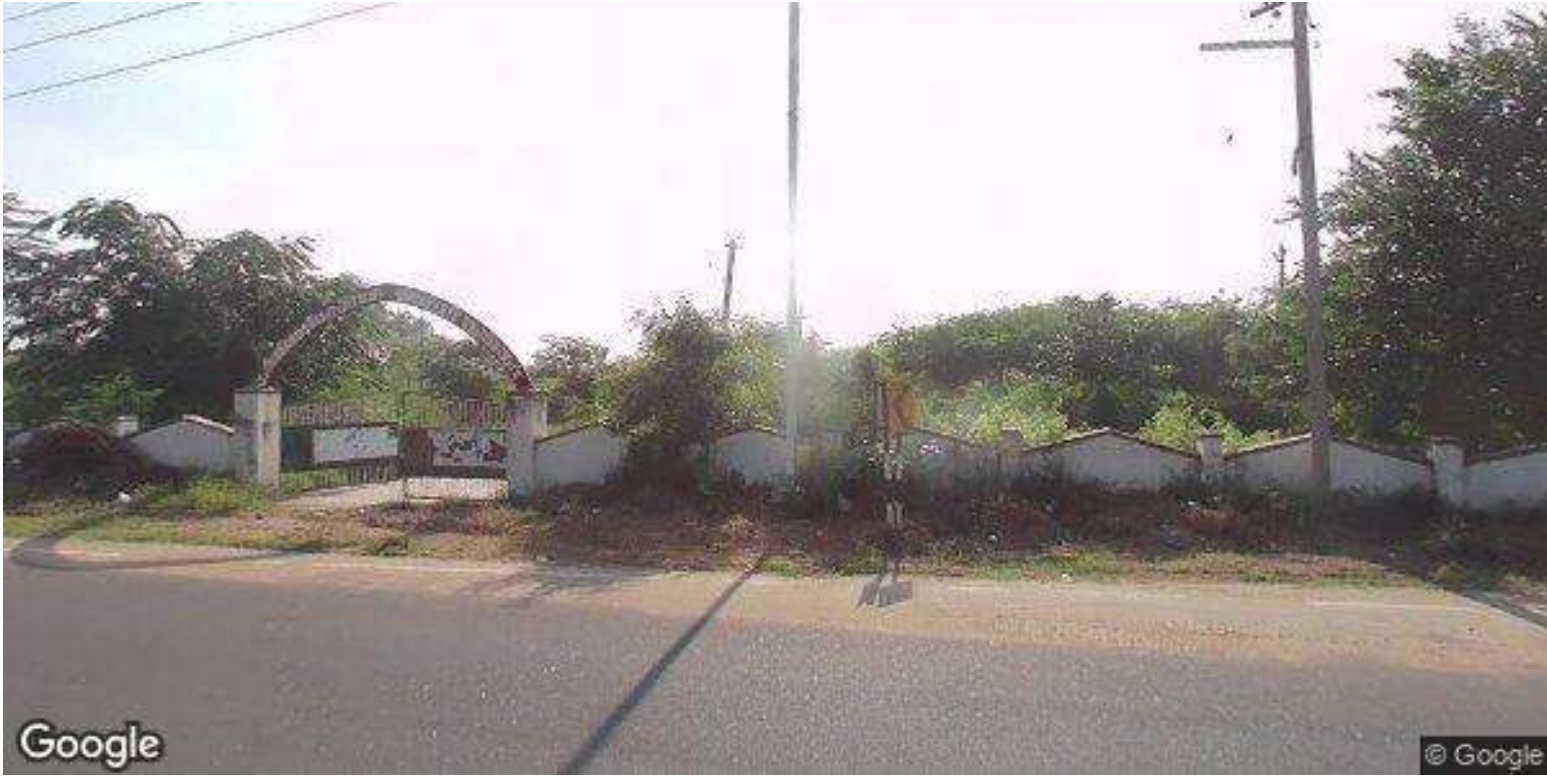
**Risk Type:** Turn  
**Risk Level:** Medium  
**Speed Limit:** 30 KM/Hr  
**Coordinates:** 10.81215, 77.78718
