# IndianOil

## JOURNEY RISK MANAGEMENT (JRM) STUDY

### Salem Terminal TO VENKATESWARA AUTO SERVICE

Route Safety Analysis Report

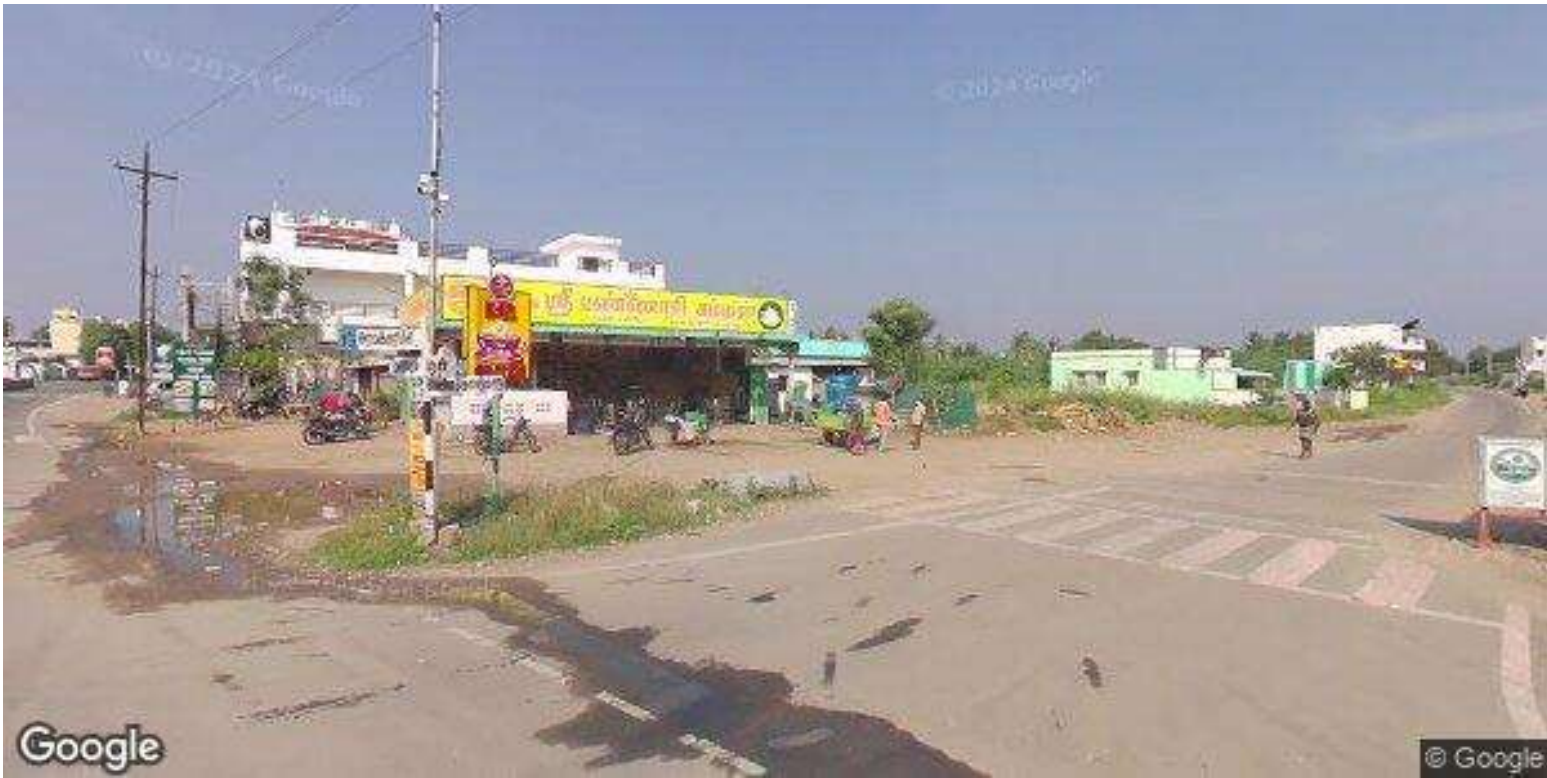
**Risk Type:** Turn

**Risk Level:** High

**Speed Limit:** 15 KM/Hr

**Coordinates:** 10.81177, 77.78603
