## **JOURNEY RISK MANAGEMENT (JRM) STUDY**

### **Salem Terminal To SIVA SAKTHI AGENCY**

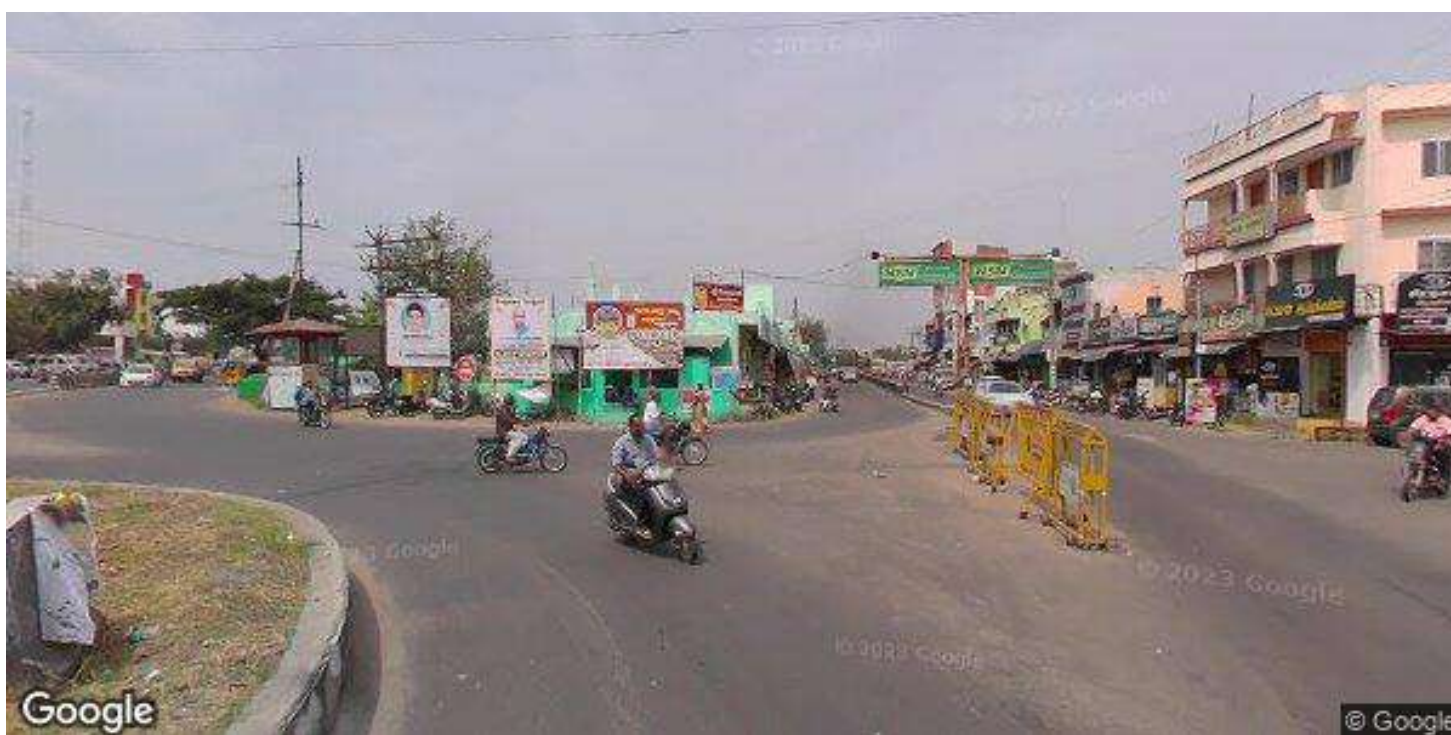
**Risk Type:** Roundabout  
**Risk Level:** High  
**Speed Limit:** 15 KM/Hr  
**Coordinates:** 11.00535, 77.56114

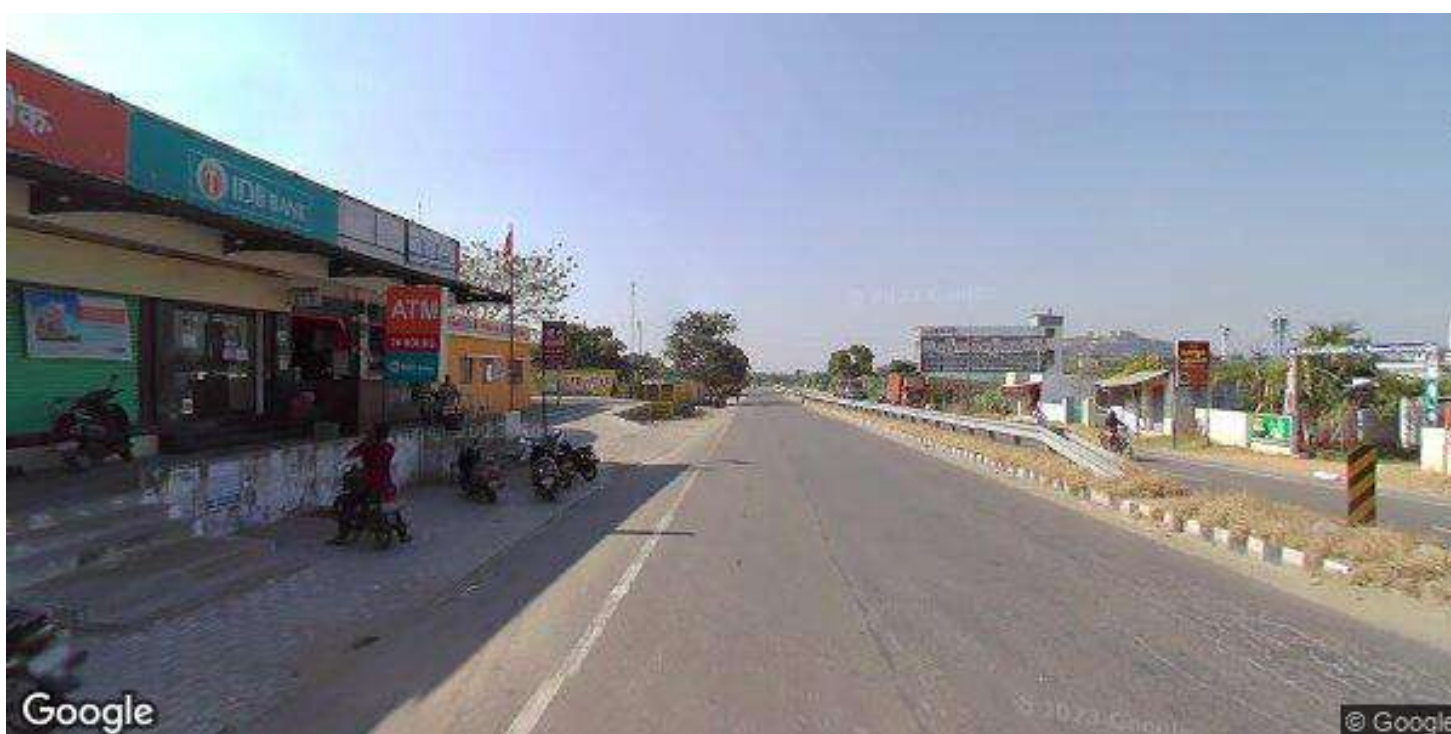
**Risk Type:** U-Turn  
**Risk Level:** High

**Speed Limit: 10 KM/Hr**

**Coordinates: 11.0185643, 77.5453777**

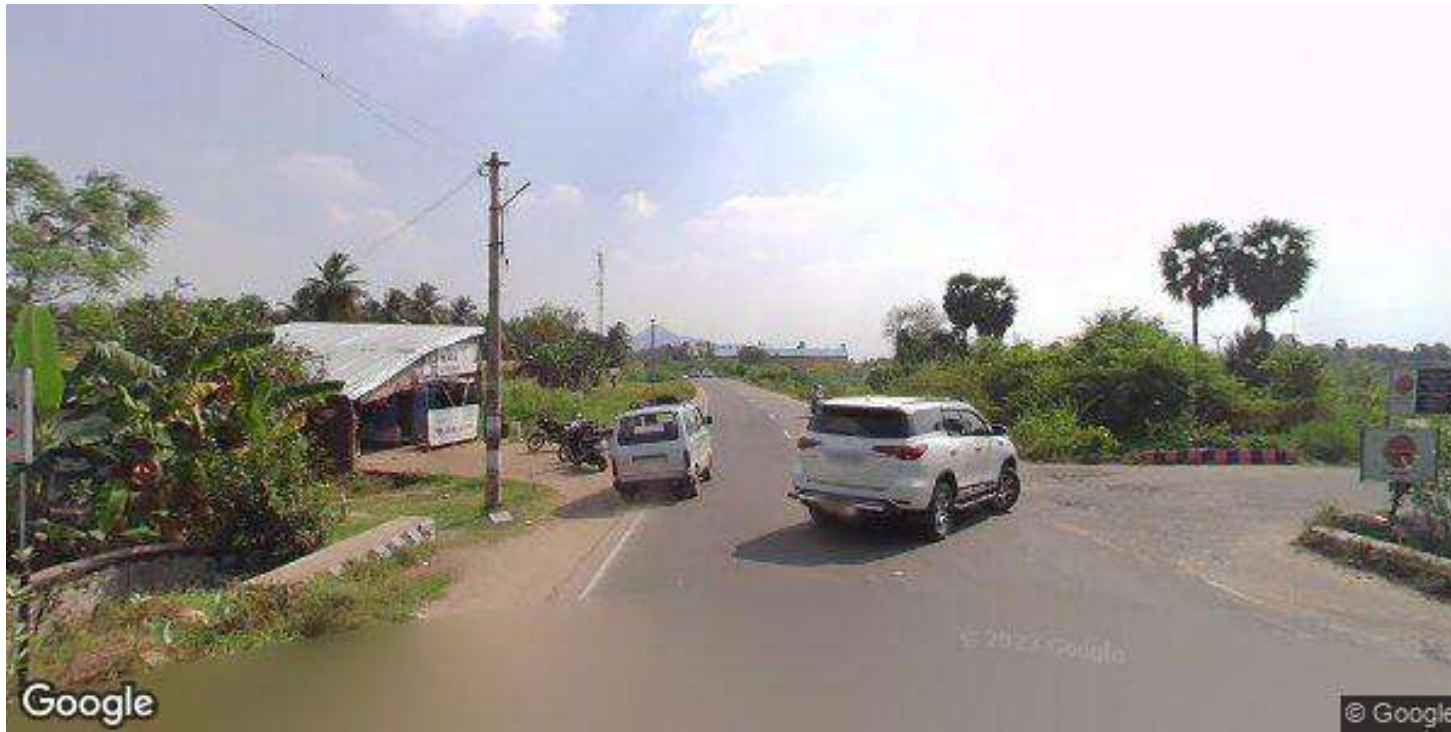
**Risk Type: Turn**

**Risk Level: High**

**Speed Limit: 15 KM/Hr**

**Coordinates: 11.44029, 77.87544**

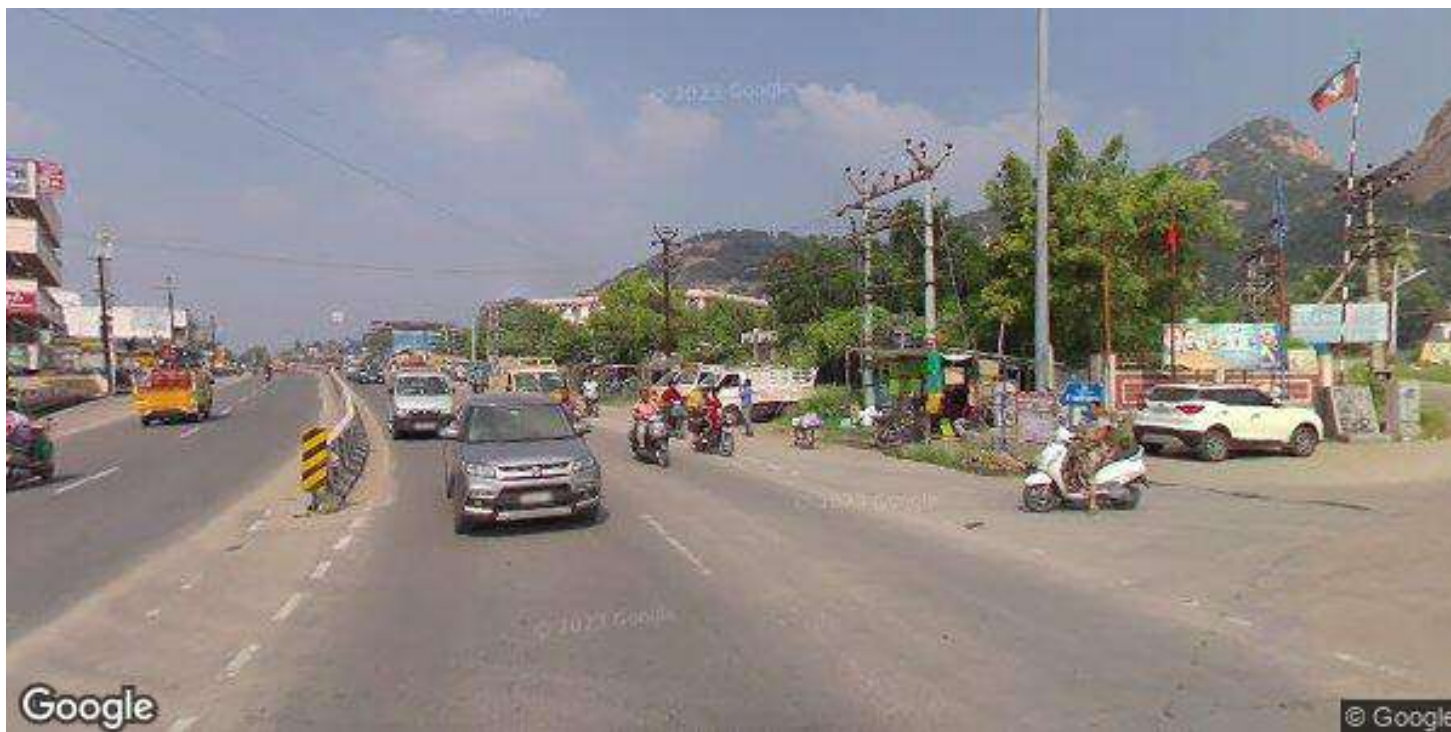
**Risk Type: Turn**

**Risk Level: Medium**

**Speed Limit: 30 KM/Hr**

**Coordinates: 11.39671, 77.88878**

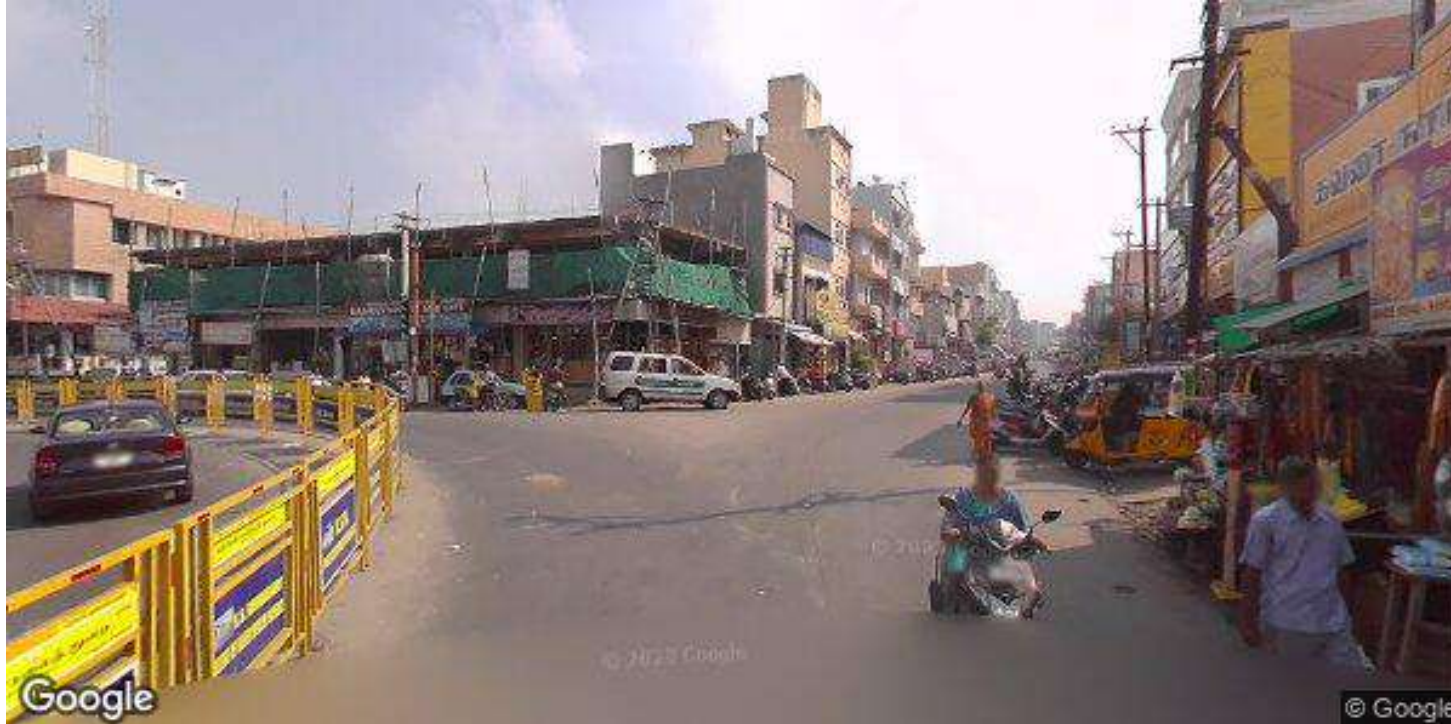
**Risk Type:** Turn

**Risk Level:** Medium

**Speed Limit:** 30 KM/Hr

**Coordinates:** 11.37862, 77.89488

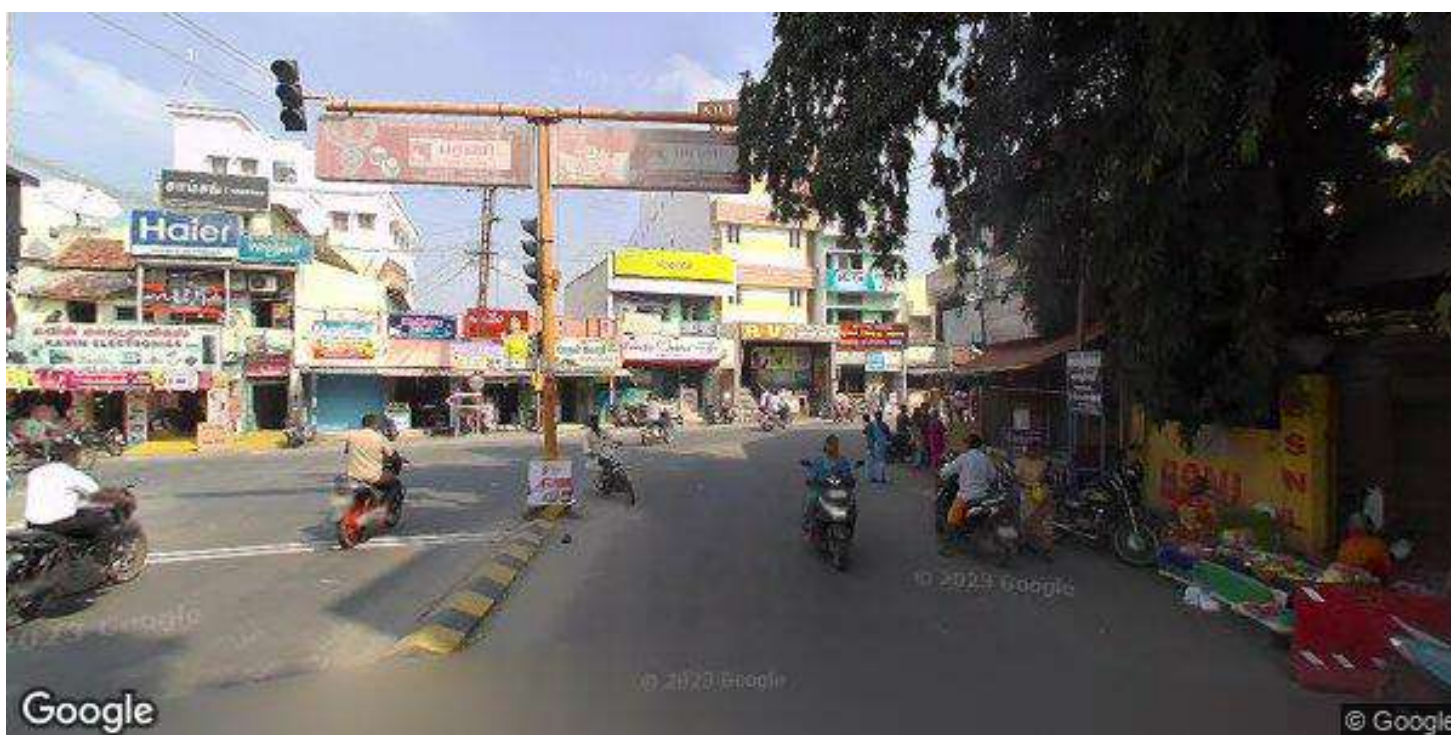
**Risk Type:** Turn

**Risk Level:** Medium

**Speed Limit:** 30 KM/Hr

**Coordinates:** 11.37831, 77.89450

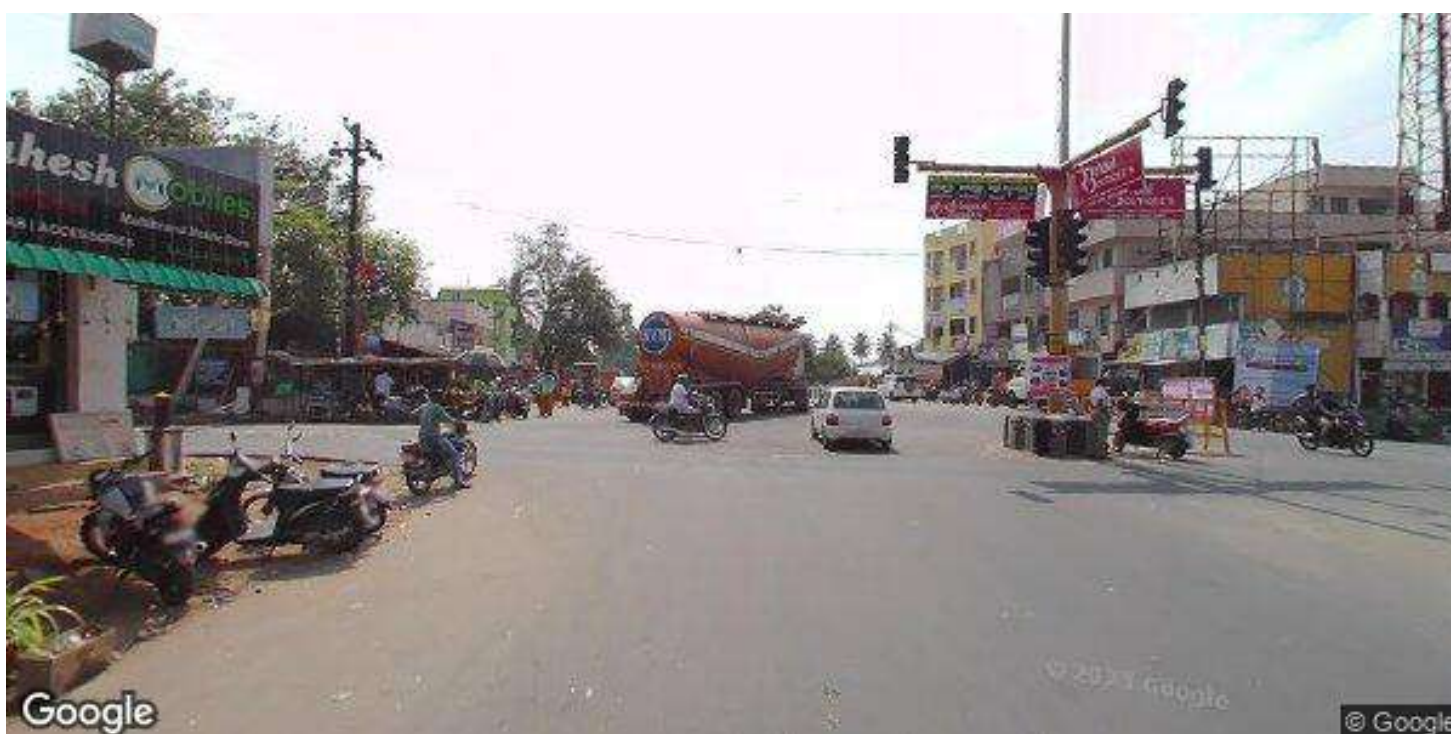
**Risk Type:** Turn

**Risk Level:** Medium

**Speed Limit: 30 KM/Hr**

**Coordinates: 11.36616, 77.88885**

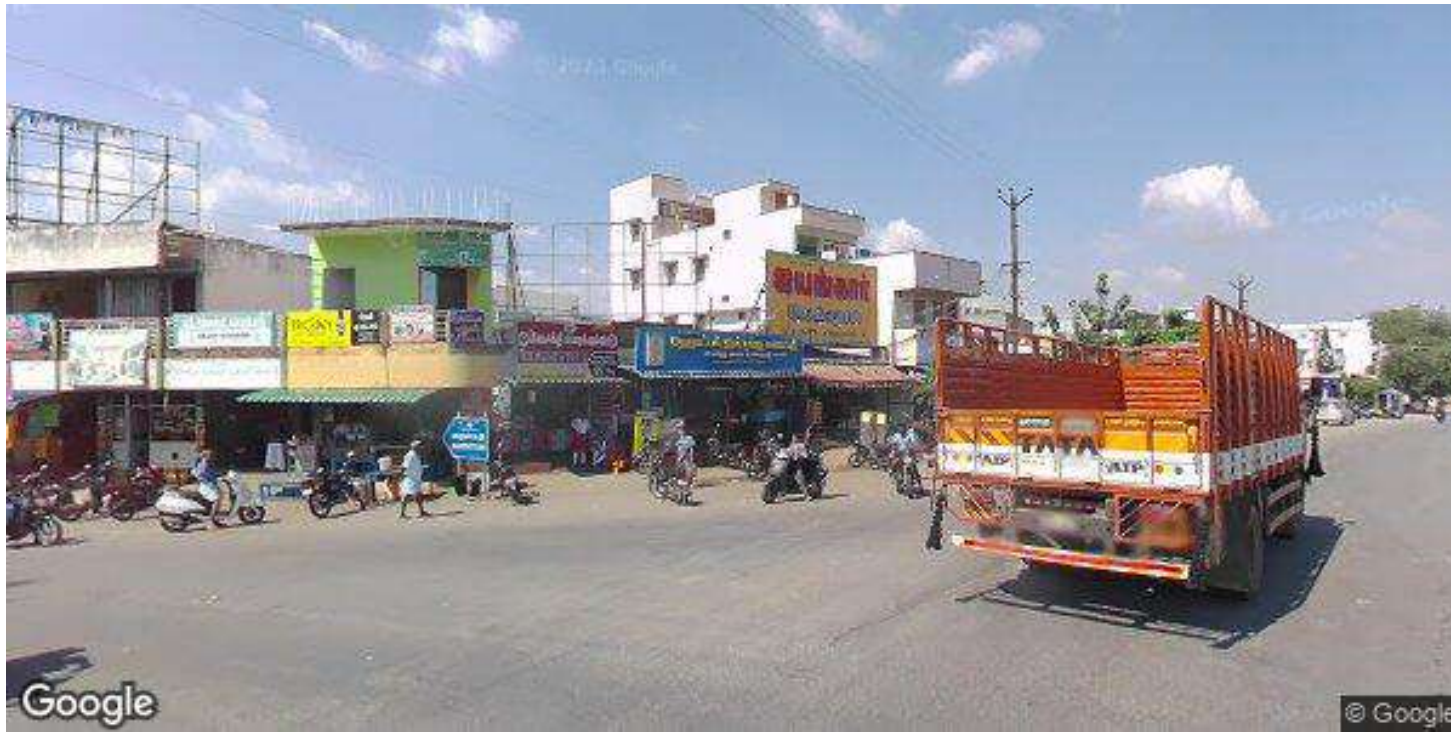
**Risk Type: Turn**

**Risk Level: Medium**

**Speed Limit: 30 KM/Hr**

**Coordinates: 11.36602, 77.88875**

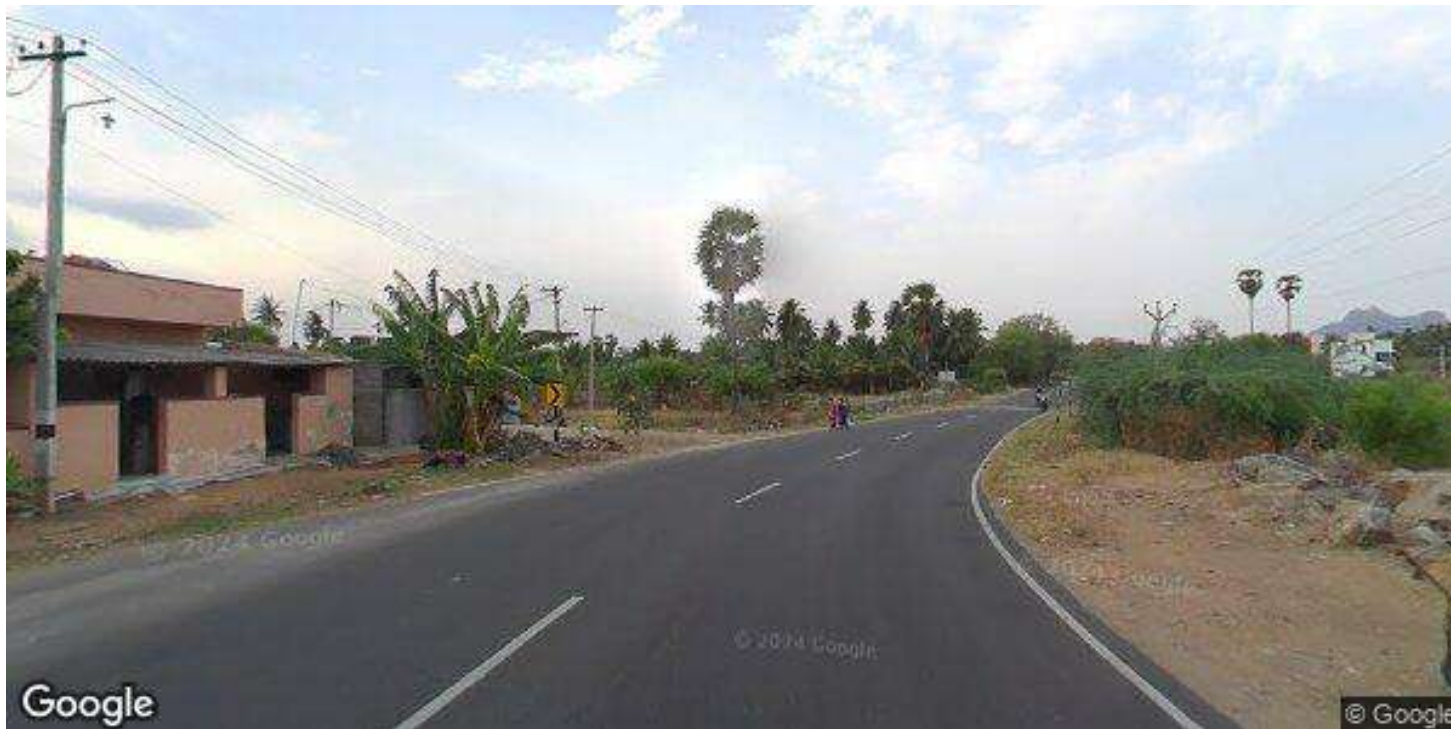
**Risk Type: Turn**

**Risk Level: Medium**

**Speed Limit: 30 KM/Hr**

**Coordinates: 11.33882, 77.86218**

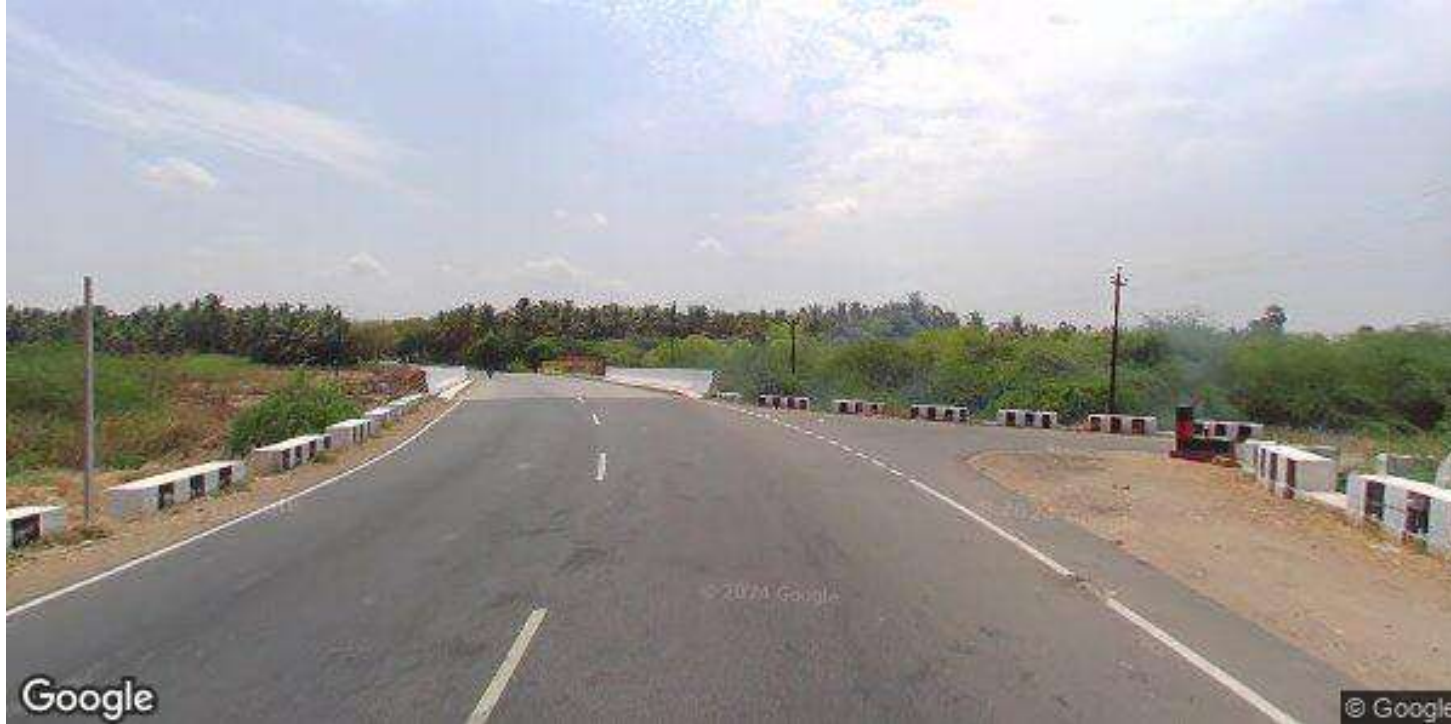
**Risk Type:** Turn

**Risk Level:** Medium

**Speed Limit:** 30 KM/Hr

**Coordinates:** 11.31747, 77.84240

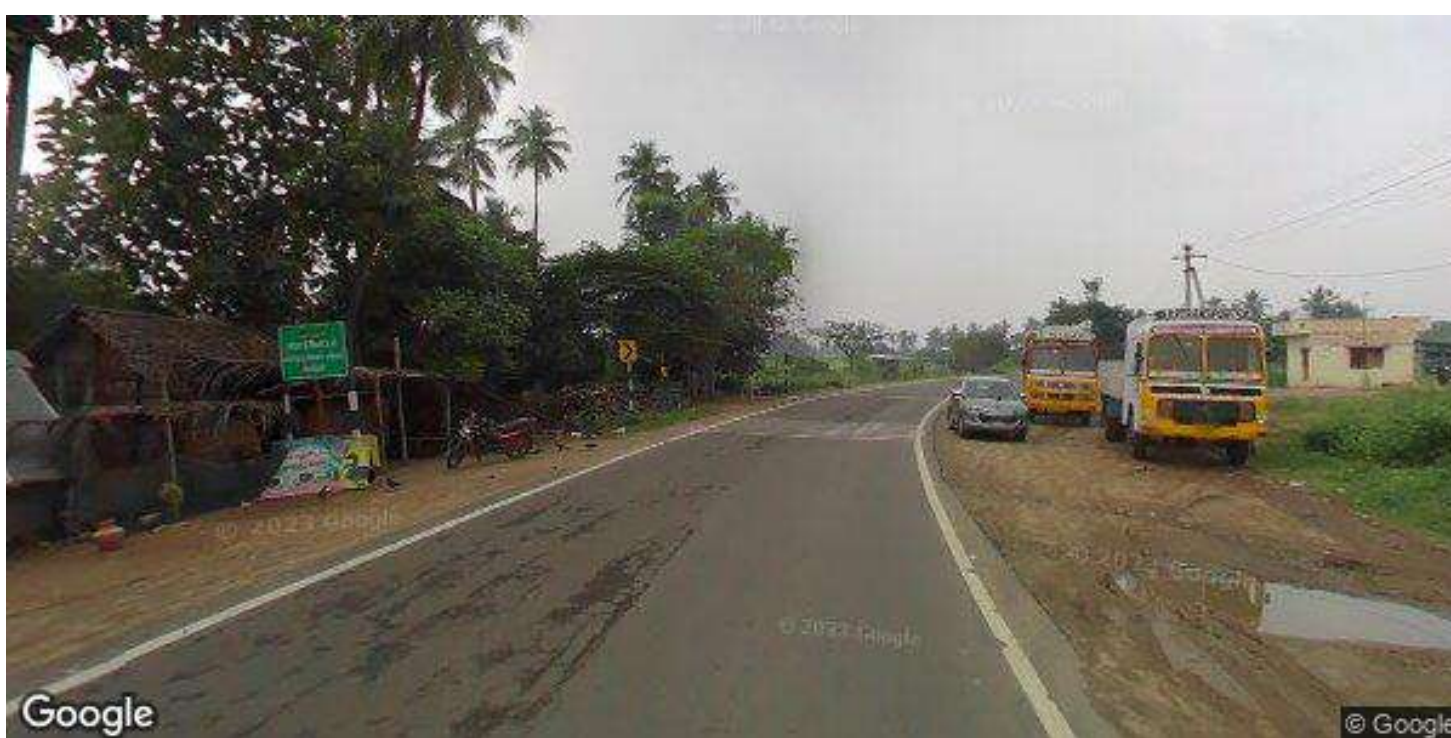
**Risk Type:** Turn

**Risk Level:** Medium

**Speed Limit:** 30 KM/Hr

**Coordinates:** 11.30951, 77.77608

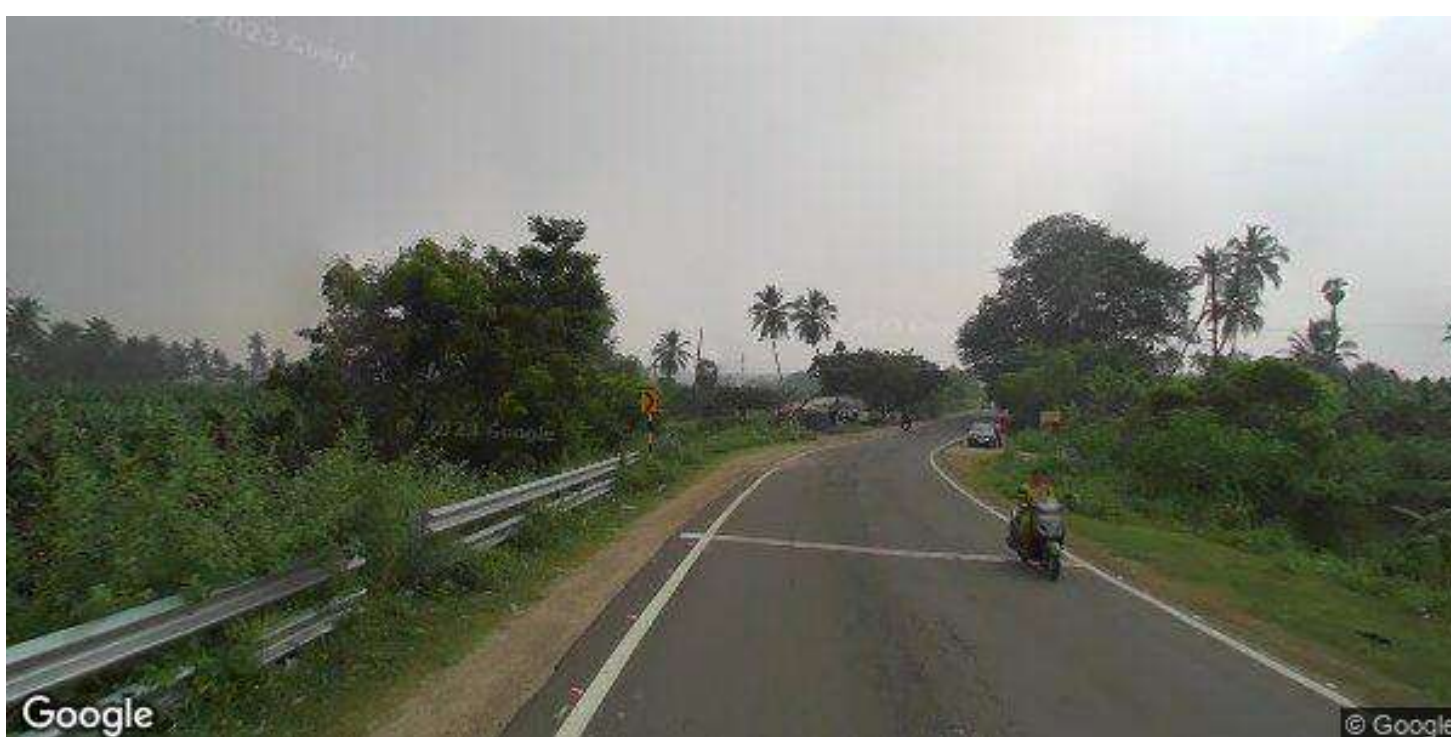
**Risk Type:** Turn

**Risk Level:** Medium

**Speed Limit: 30 KM/Hr**

**Coordinates: 11.31118, 77.77139**

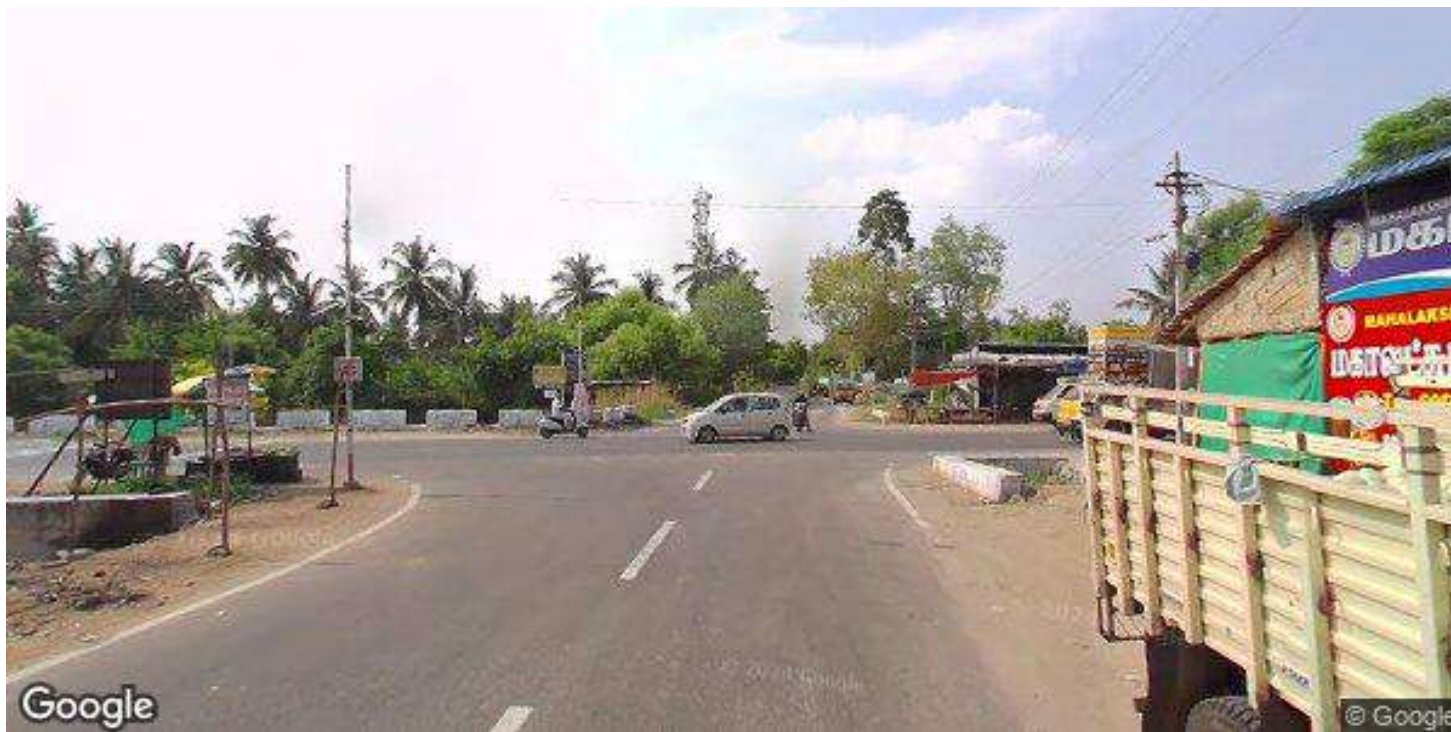
**Risk Type: Turn**

**Risk Level: High**

**Speed Limit: 15 KM/Hr**

**Coordinates: 11.29473, 77.74685**

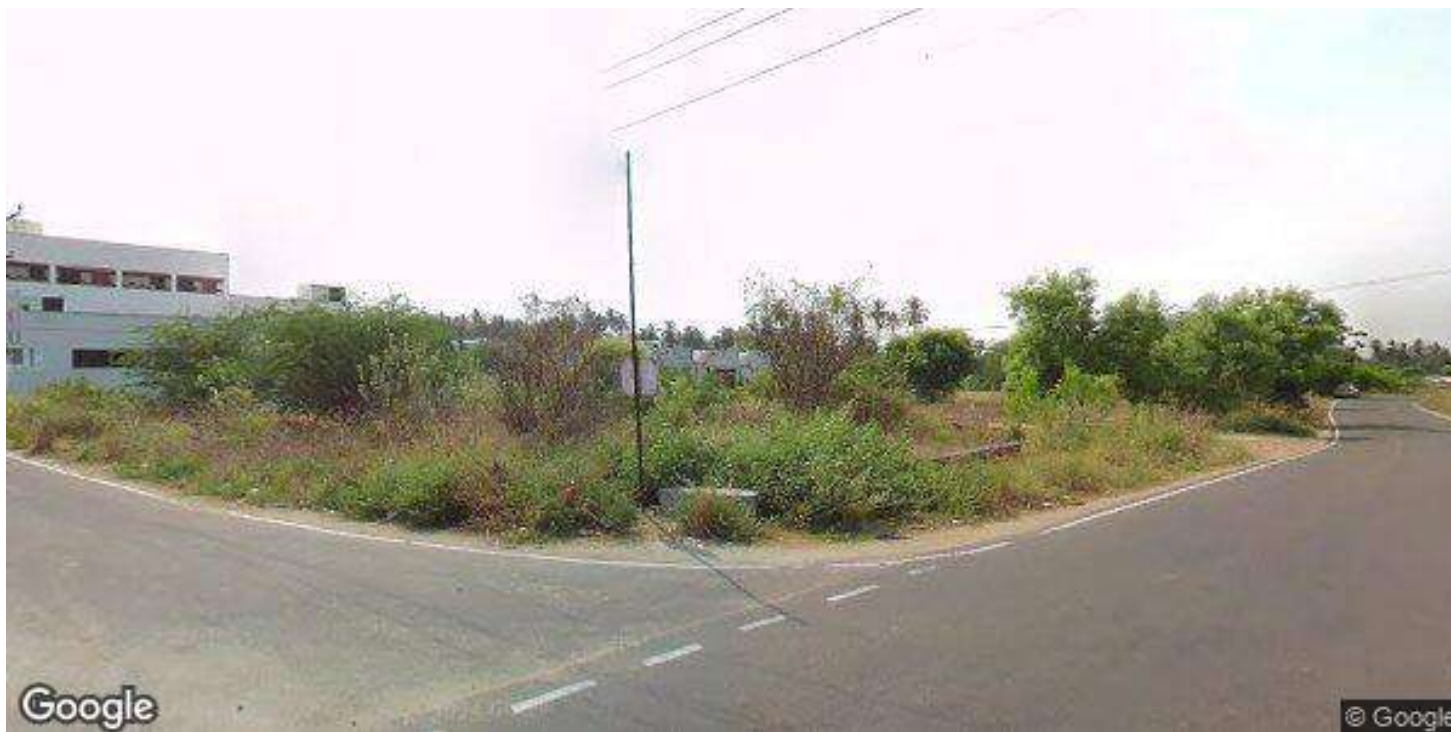
**Risk Type: Turn**

**Risk Level: High**

**Speed Limit: 15 KM/Hr**

**Coordinates: 11.29133, 77.74660**

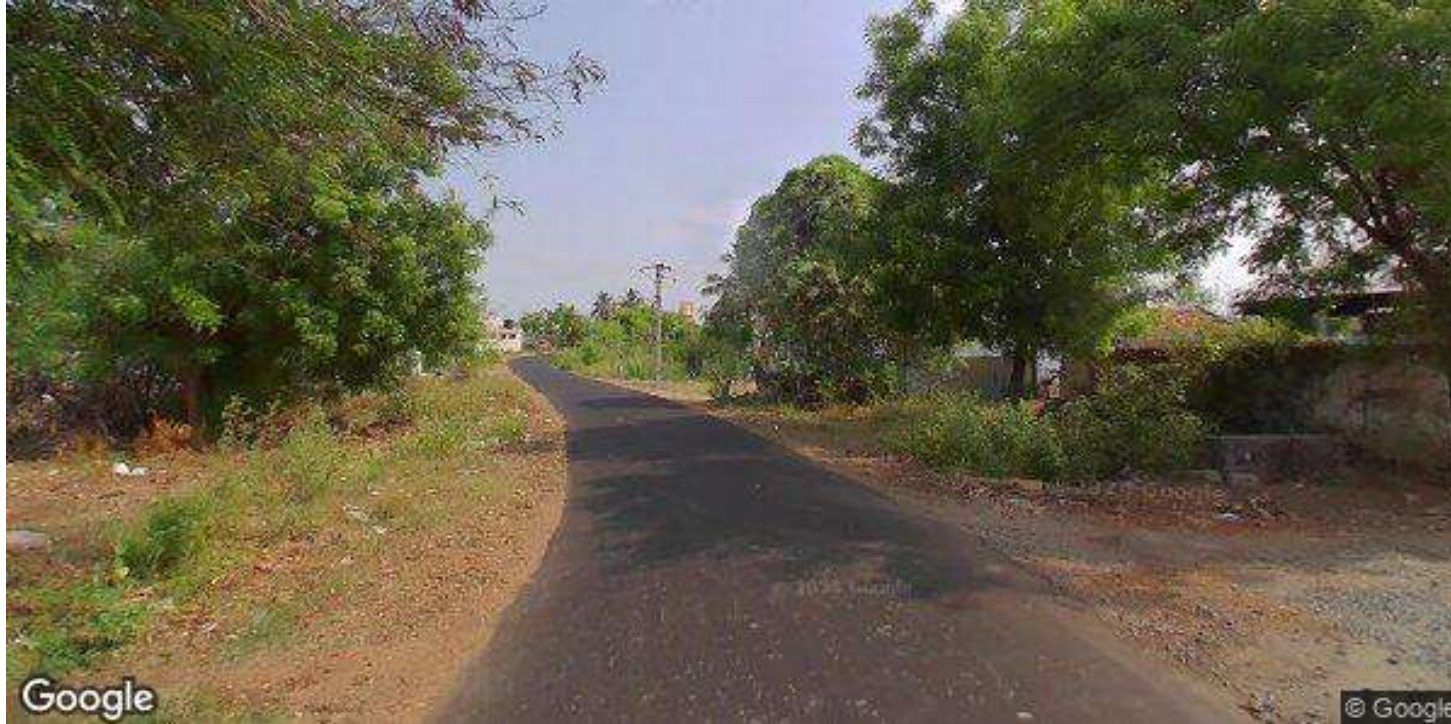
**Risk Type:** Turn

**Risk Level:** Medium

**Speed Limit:** 30 KM/Hr

**Coordinates:** 11.28844, 77.74319

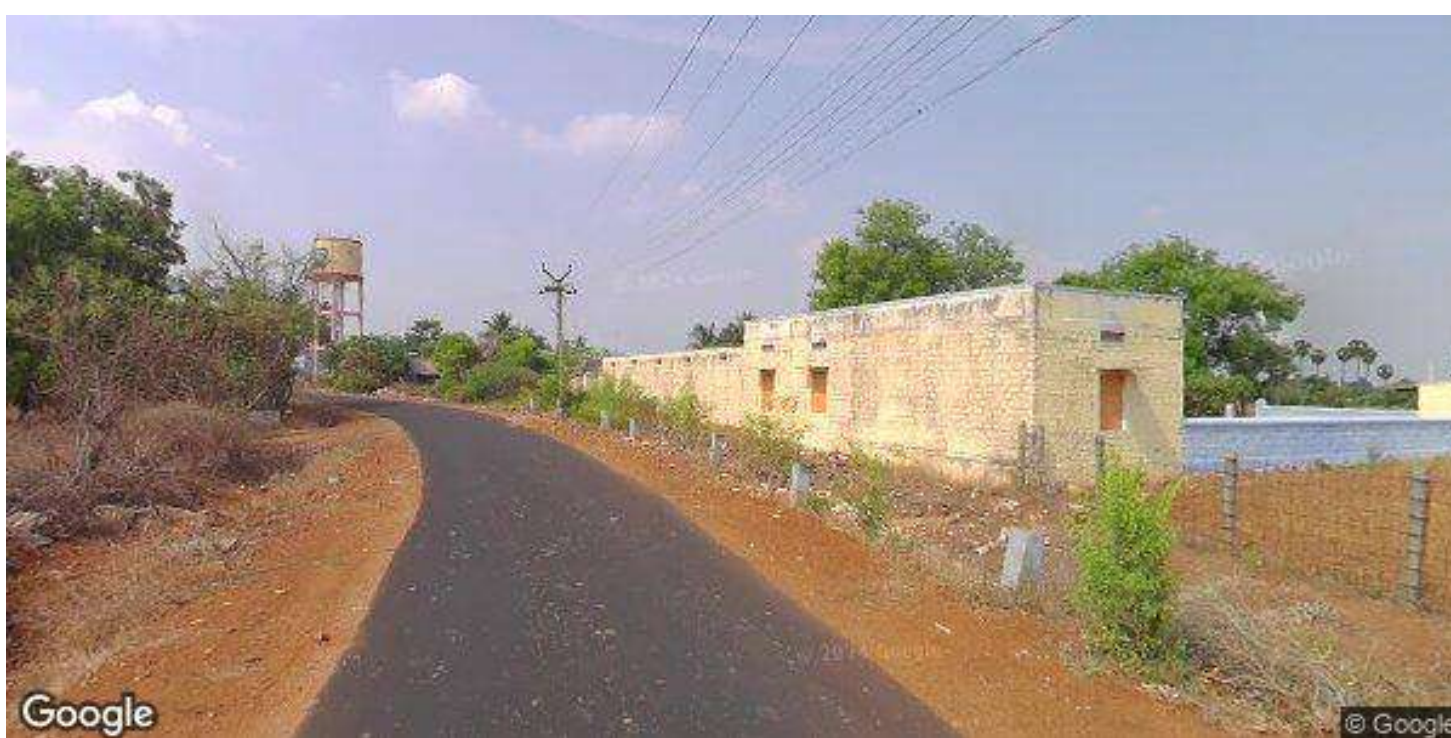
**Risk Type:** Turn

**Risk Level:** Medium

**Speed Limit:** 30 KM/Hr

**Coordinates:** 11.28558, 77.74271

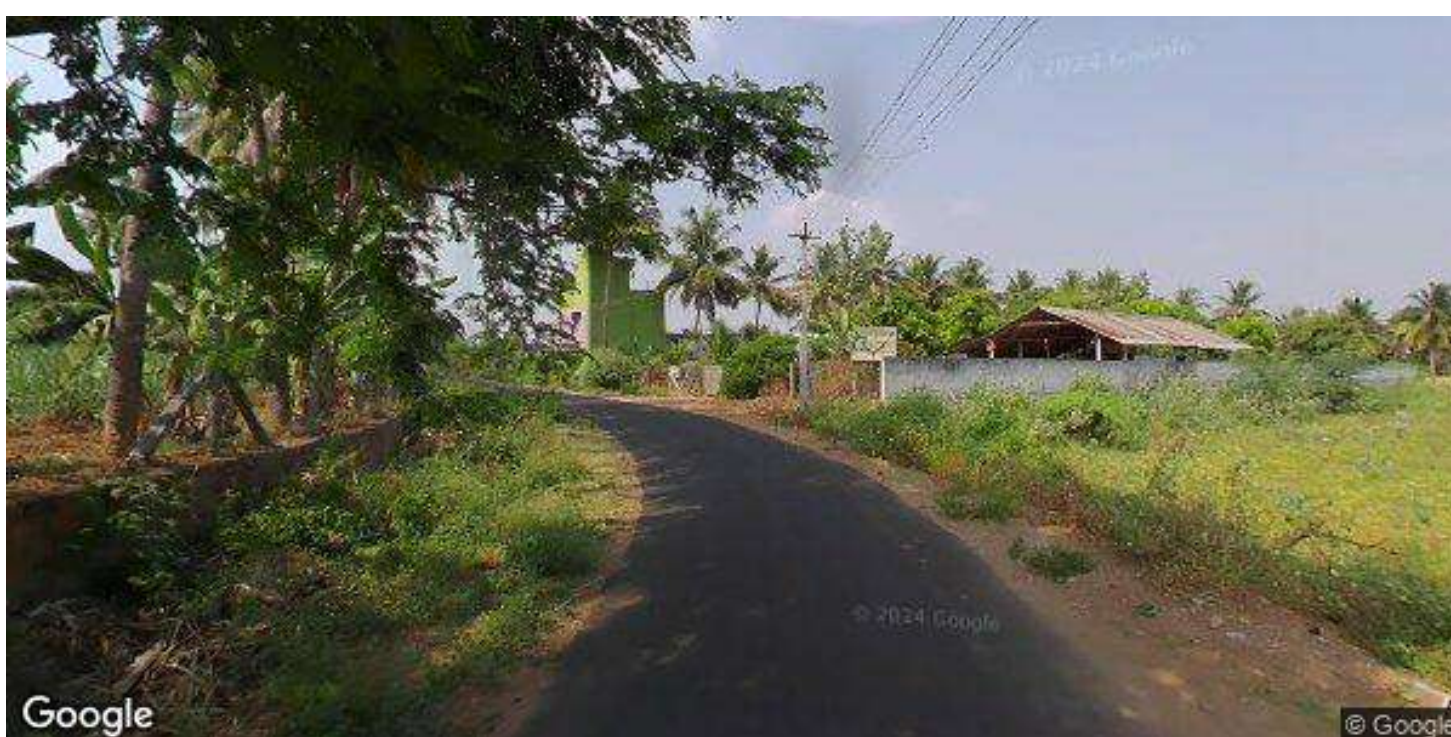
**Risk Type:** Turn

**Risk Level:** Medium

**Speed Limit: 30 KM/Hr**

**Coordinates: 11.27326, 77.72991**

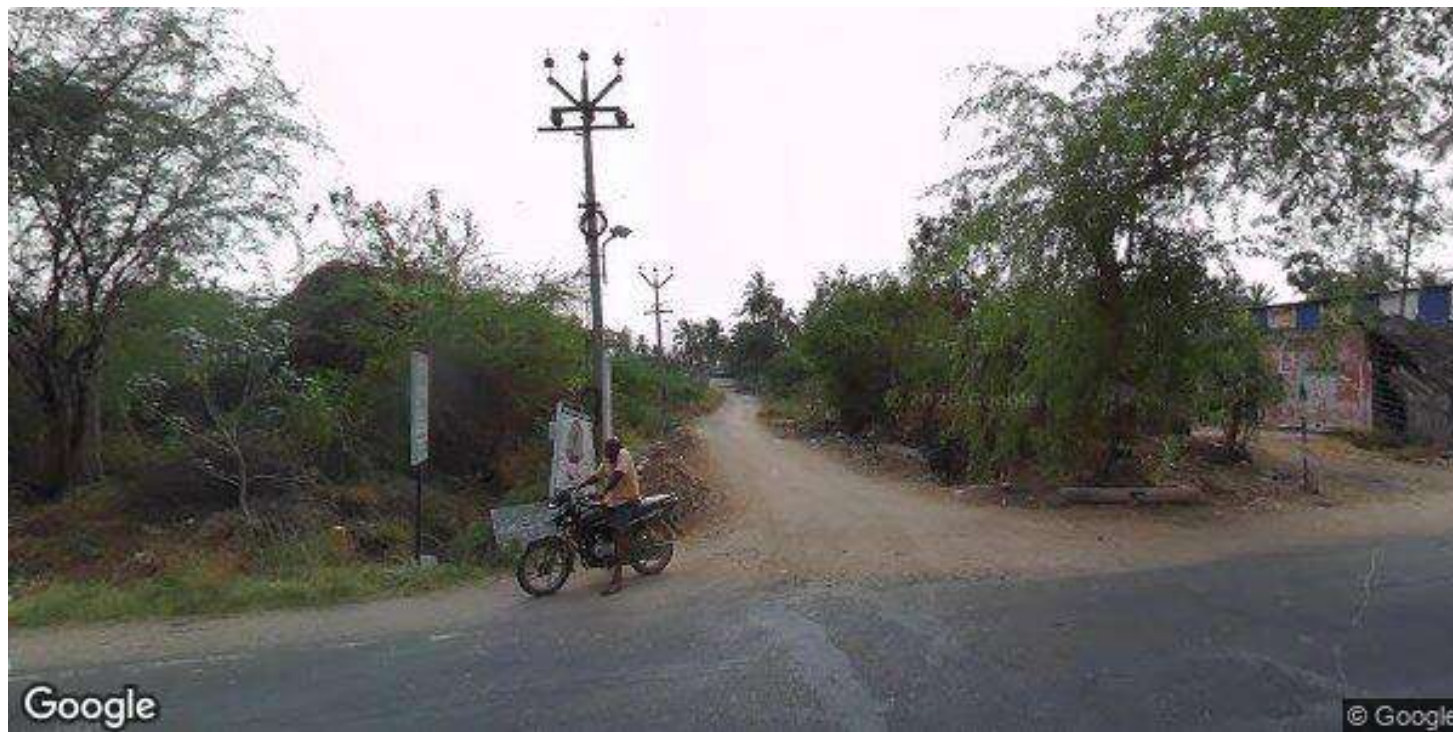
**Risk Type: Blind Spot**

**Risk Level: Blind Spot**

**Speed Limit: 10 KM/Hr**

**Coordinates: 11.27330, 77.72711**

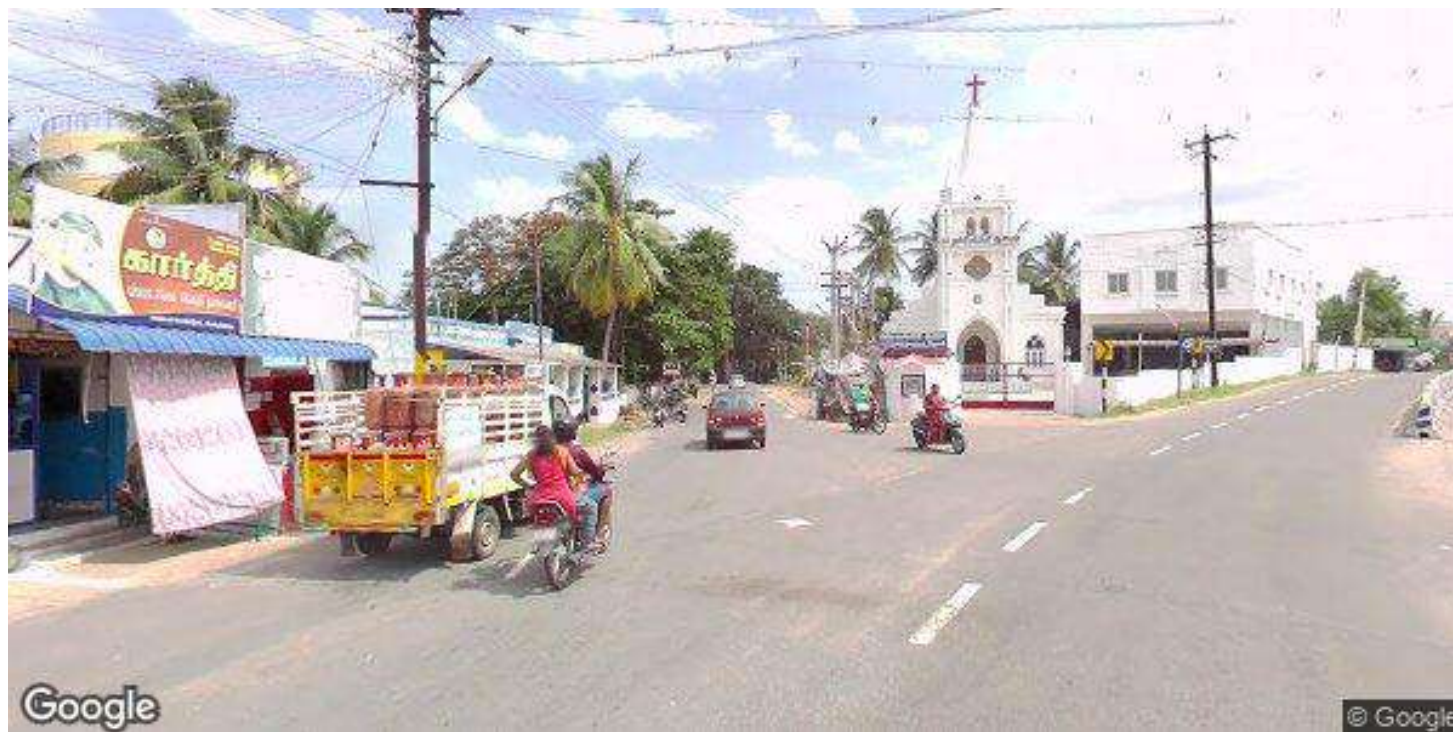
**Risk Type: Turn**

**Risk Level: Medium**

**Speed Limit: 30 KM/Hr**

**Coordinates: 11.23054, 77.71796**

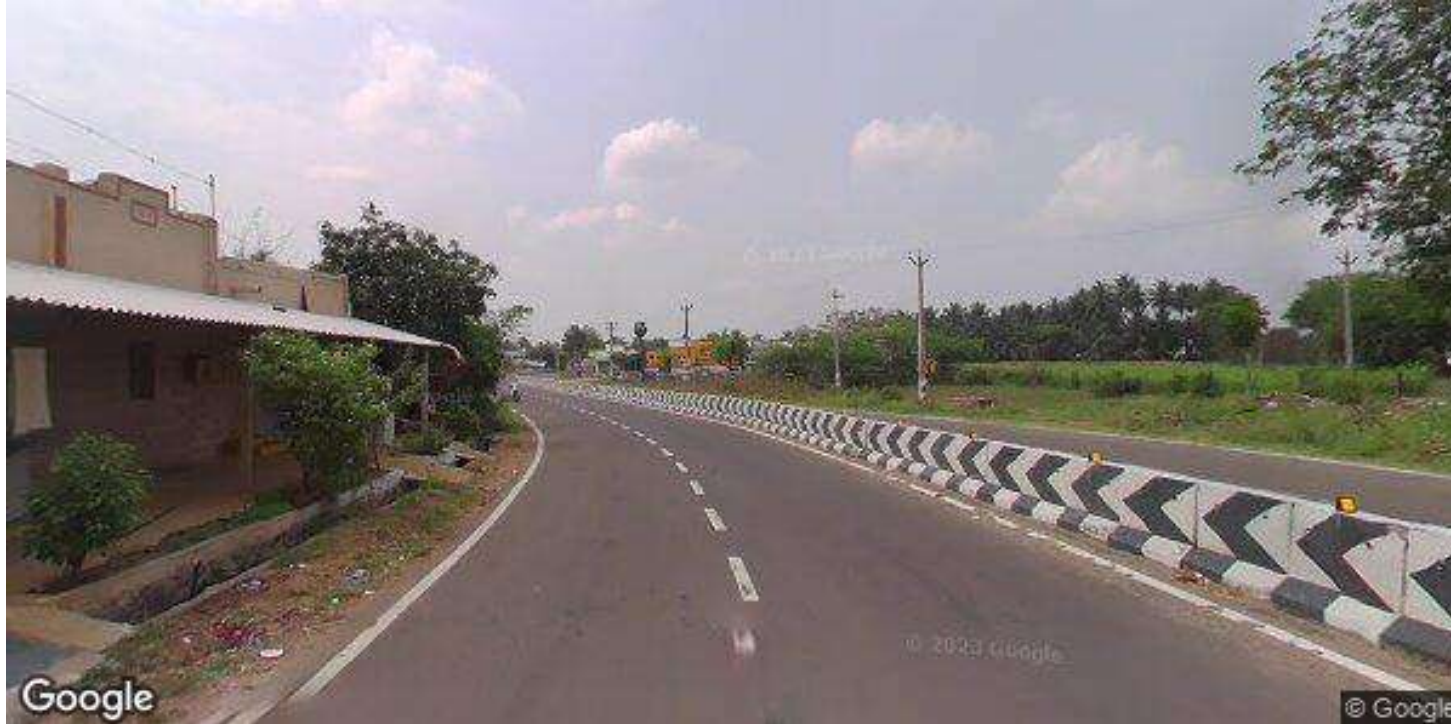
**Risk Type:** Turn  
**Risk Level:** Medium  
**Speed Limit:** 30 KM/Hr  
**Coordinates:** 11.22387, 77.71385

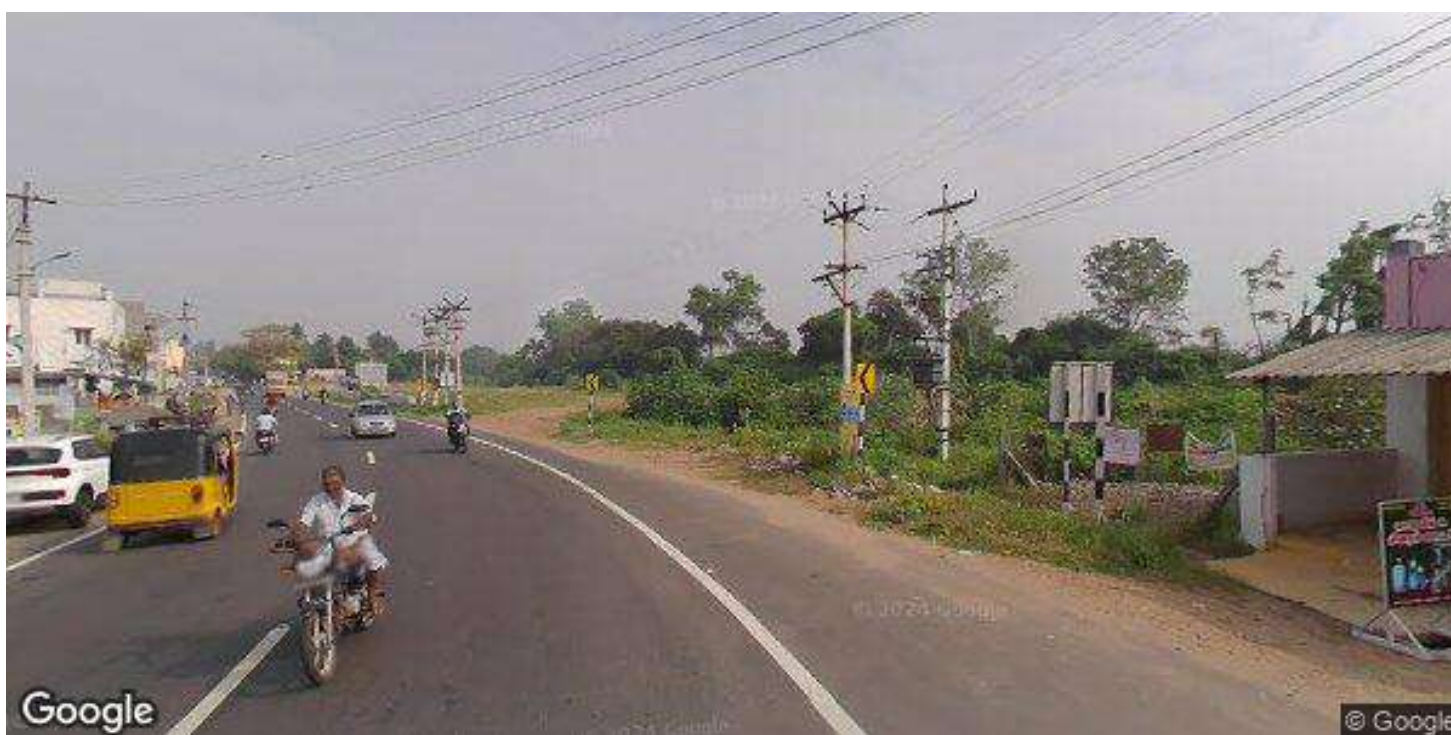
**Risk Type:** Turn  
**Risk Level:** Medium  
**Speed Limit:** 30 KM/Hr  
**Coordinates:** 11.16078, 77.70122
