## **JOURNEY RISK MANAGEMENT (JRM) STUDY**

### **Salem Terminal To SIVA SAKTHI AGENCY**

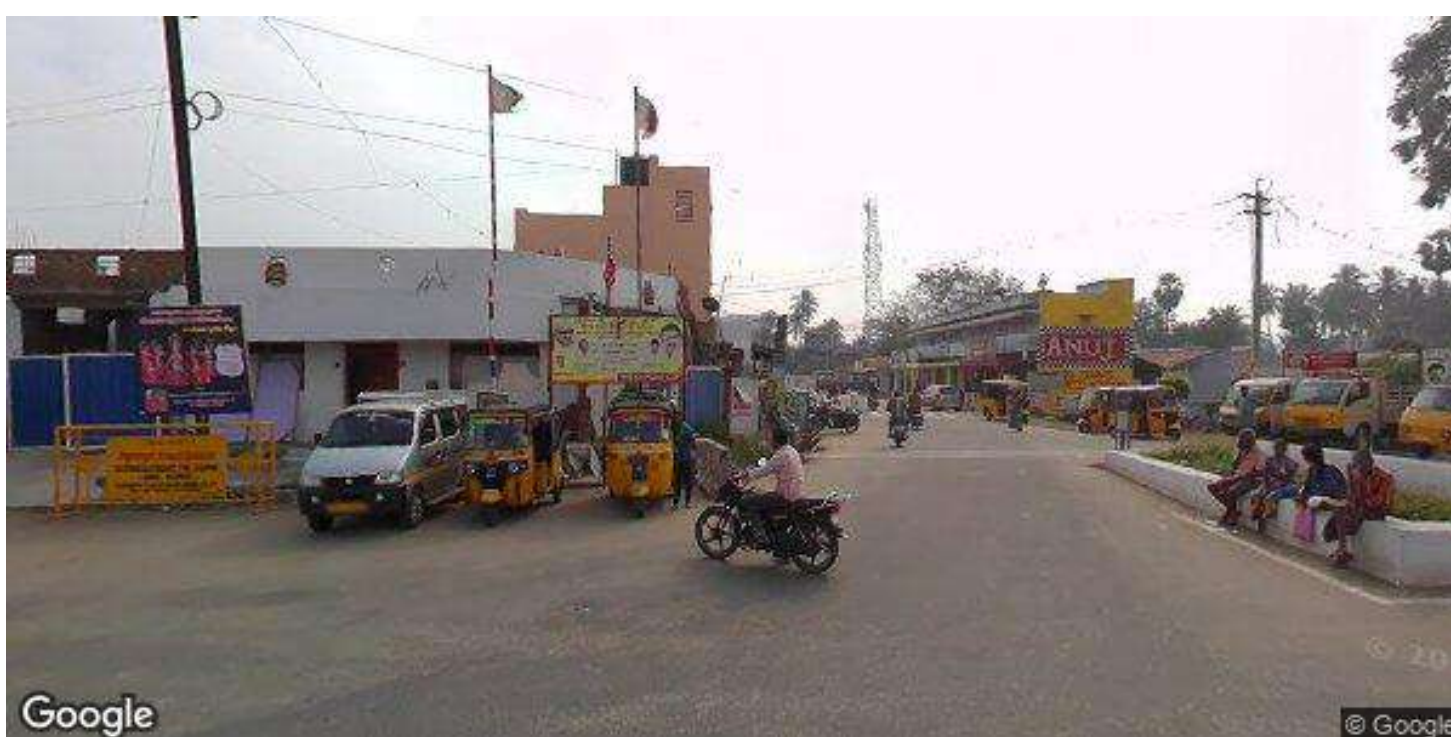
**Risk Type:** Turn  
**Risk Level:** Medium

Speed Limit: 30 KM/Hr

Coordinates: 11.15953, 77.70067

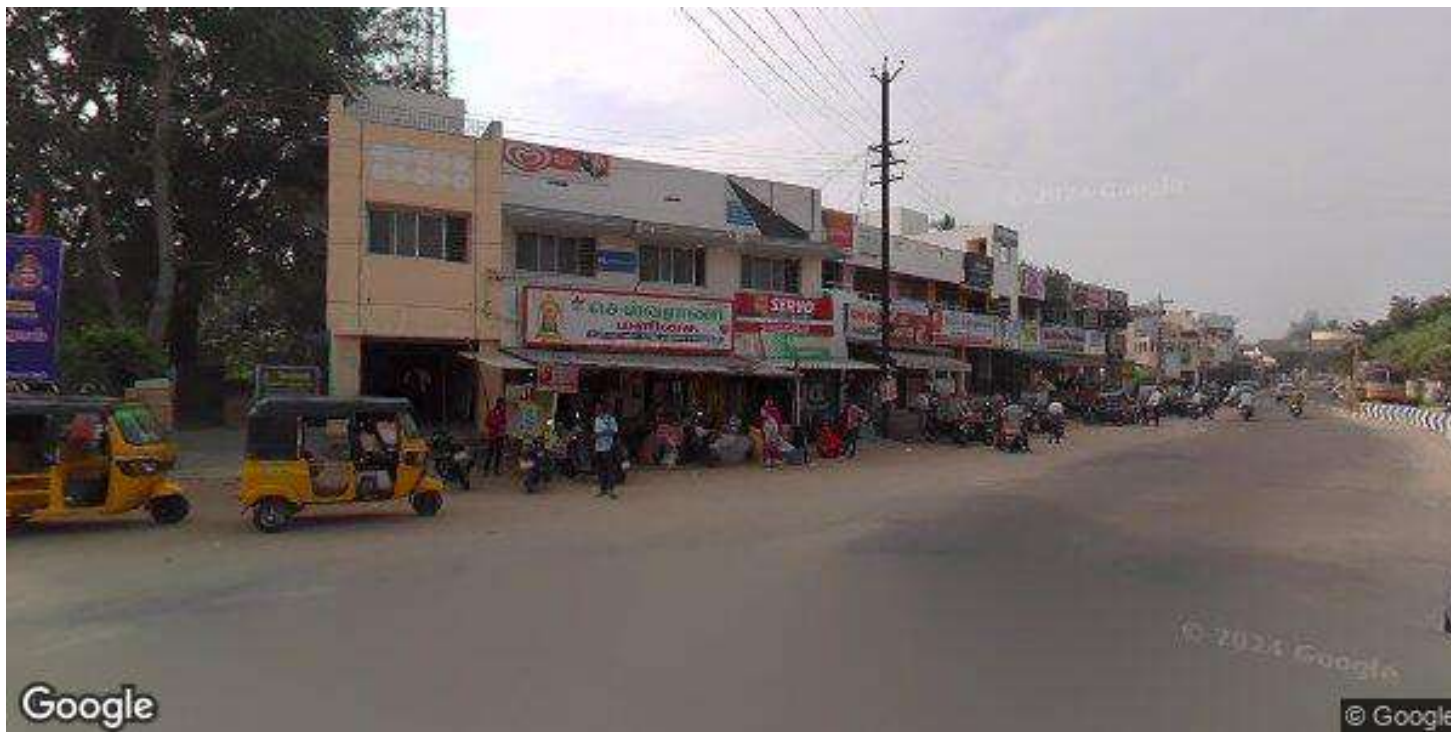
Risk Type: Turn

Risk Level: High

Speed Limit: 15 KM/Hr

Coordinates: 11.15944, 77.70068

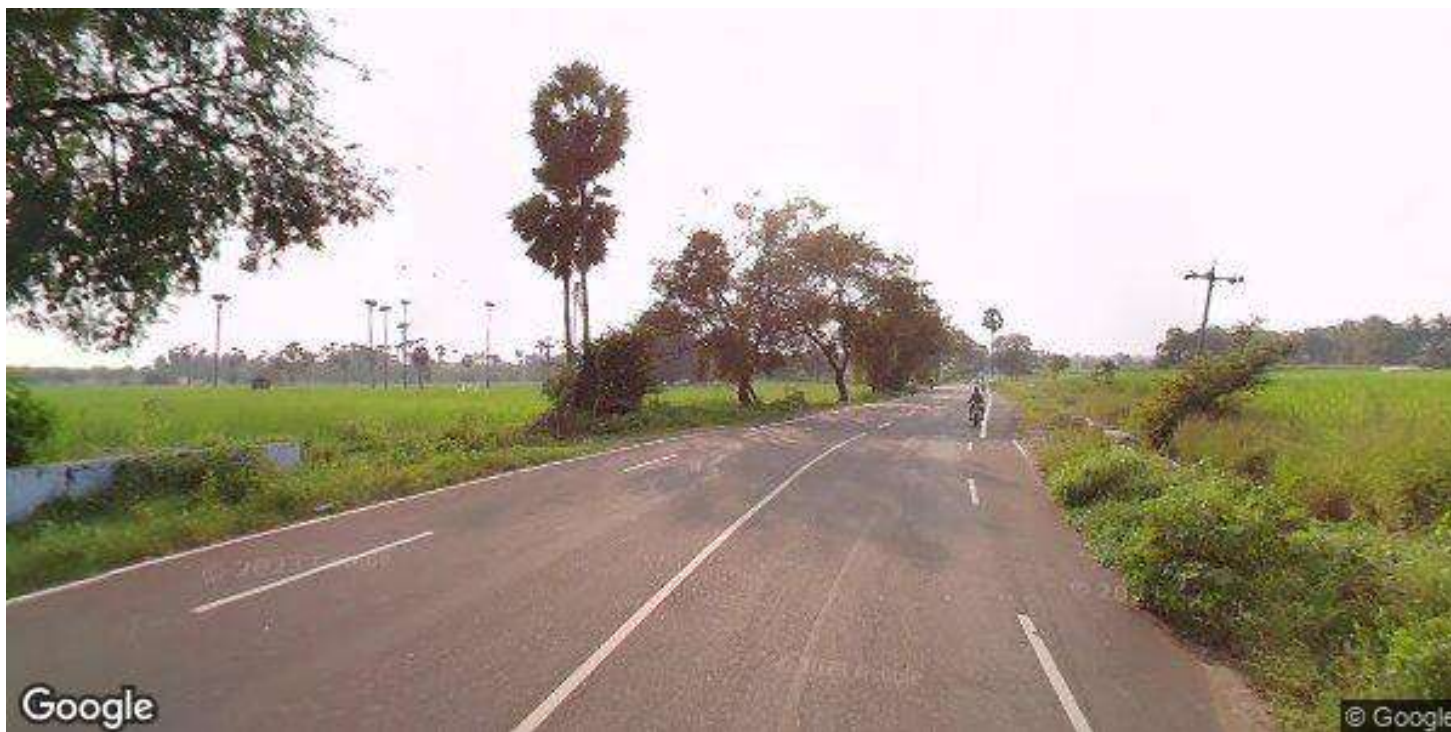
Risk Type: Turn

Risk Level: Medium

Speed Limit: 30 KM/Hr

Coordinates: 11.11918, 77.67766

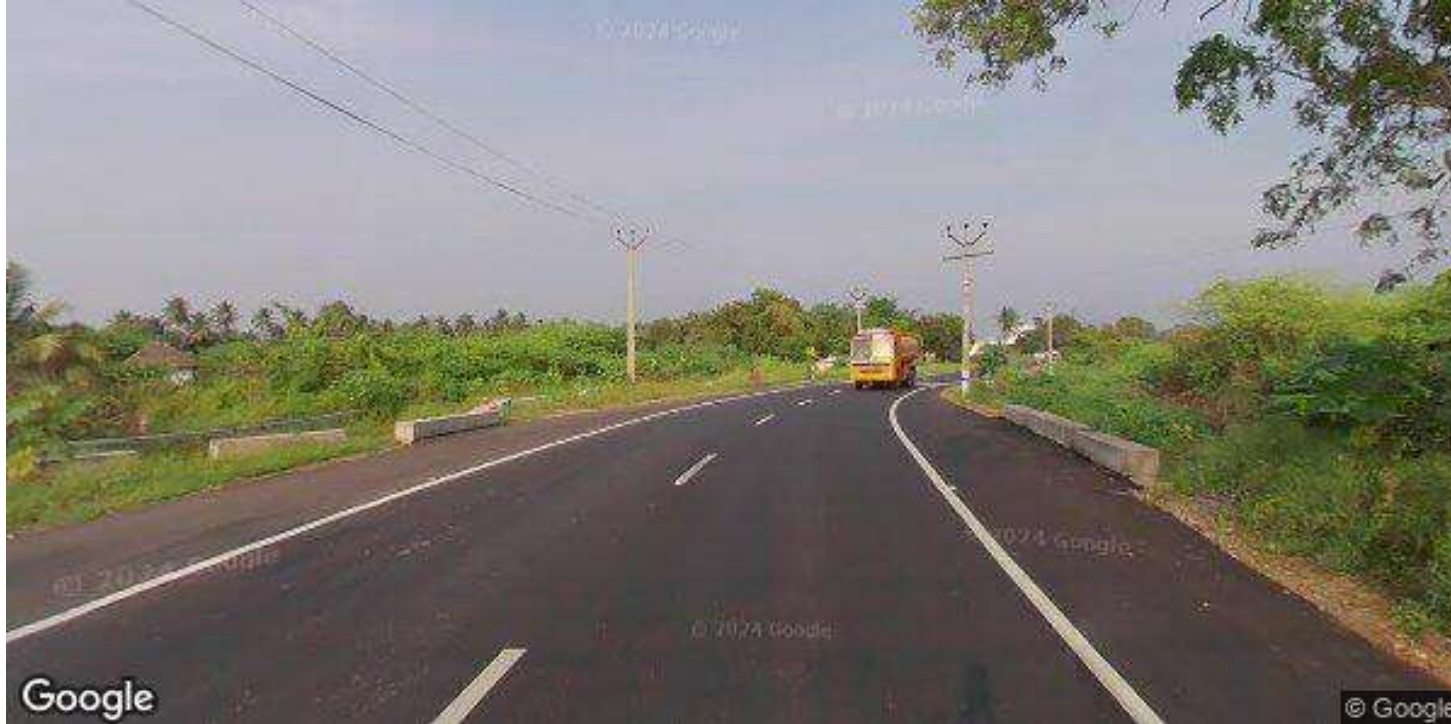
**Risk Type:** Turn

**Risk Level:** Medium

**Speed Limit:** 30 KM/Hr

**Coordinates:** 11.11740, 77.67198

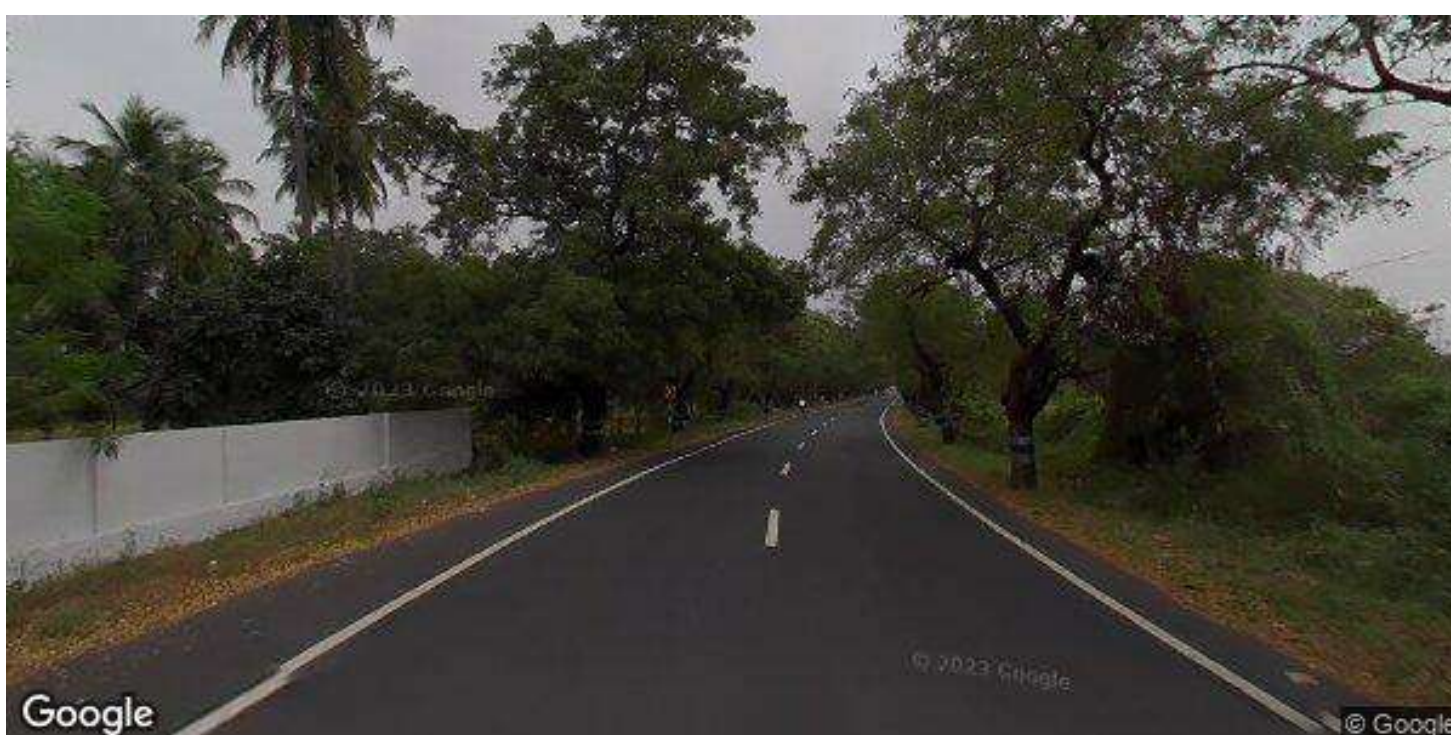
**Risk Type:** Turn

**Risk Level:** Medium

**Speed Limit:** 30 KM/Hr

**Coordinates:** 11.10481, 77.67060

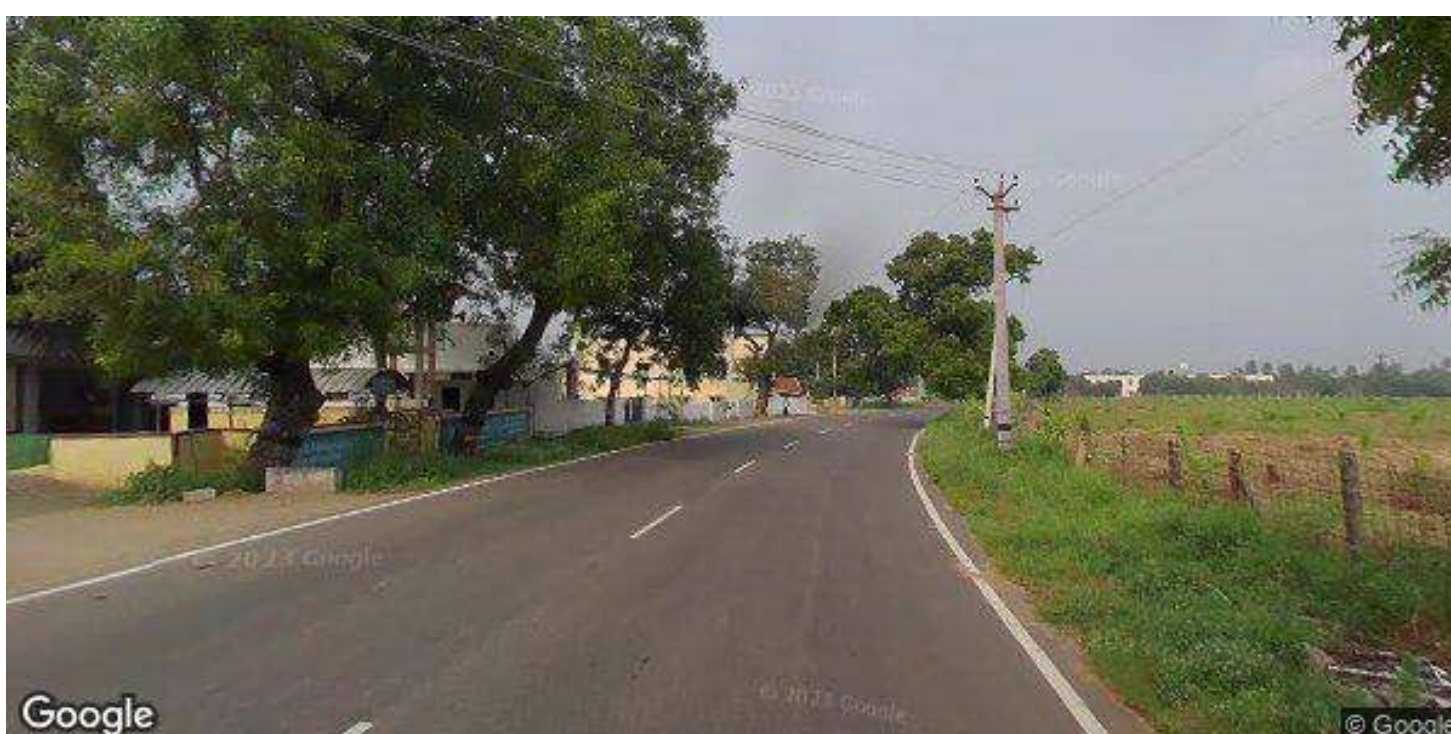
**Risk Type:** Turn

**Risk Level:** Medium

**Speed Limit: 30 KM/Hr**

**Coordinates: 11.09509, 77.66612**

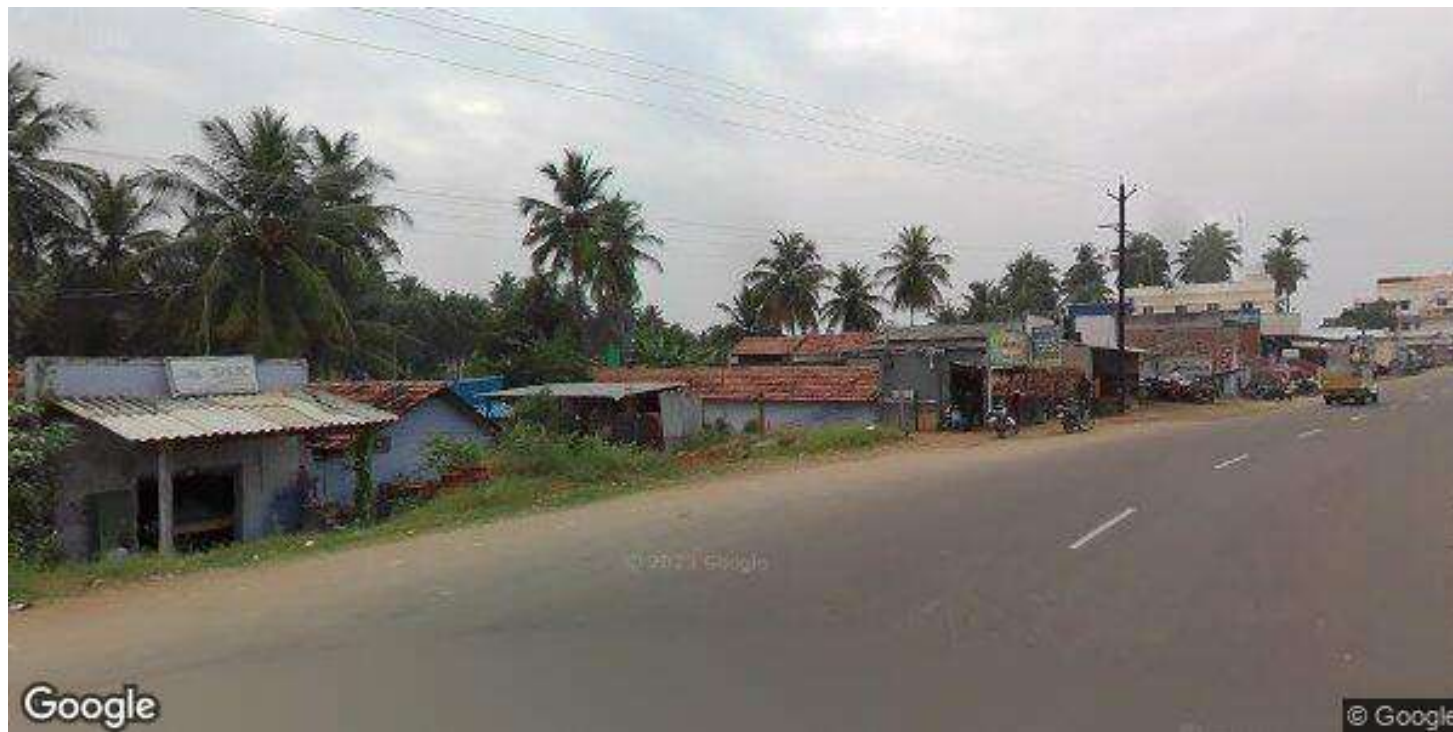
**Risk Type: Turn**

**Risk Level: Medium**

**Speed Limit: 30 KM/Hr**

**Coordinates: 11.08730, 77.66436**

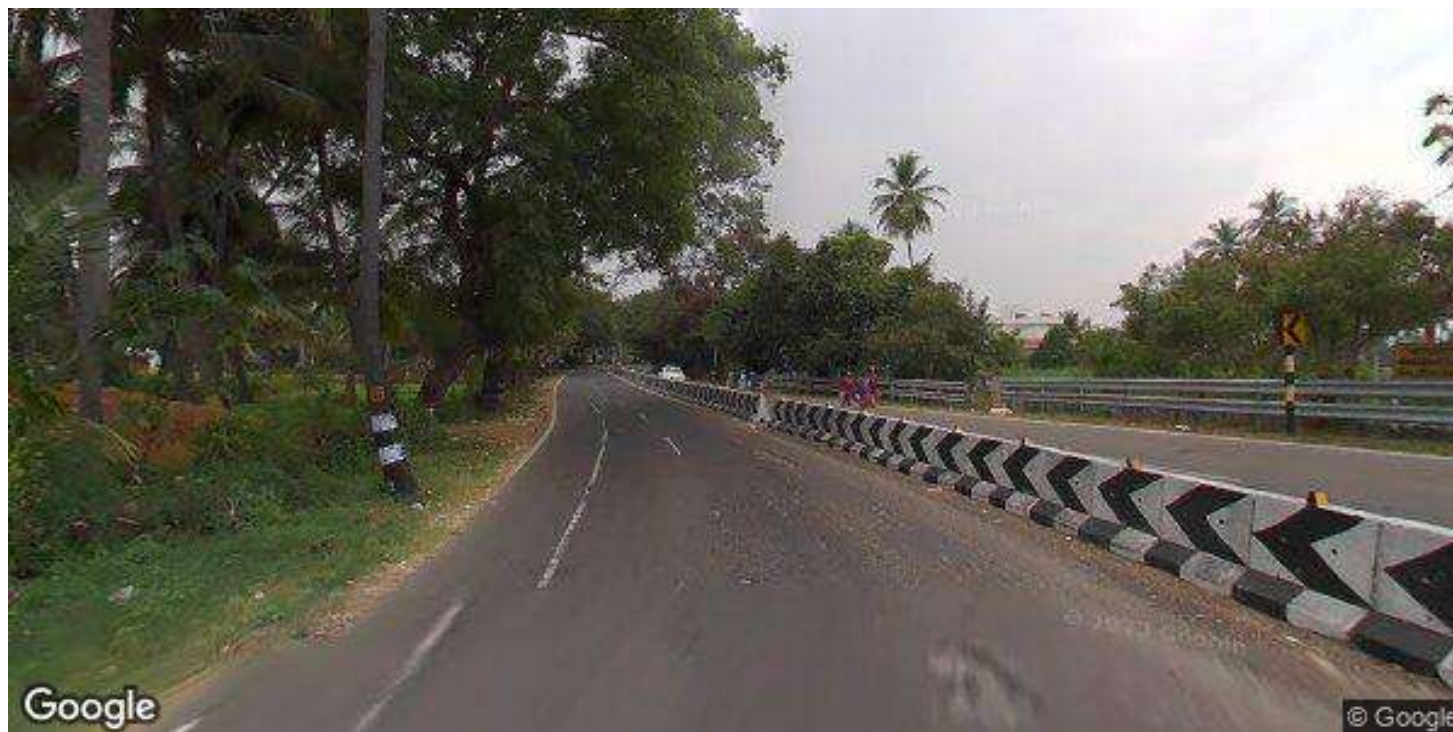
**Risk Type: Turn**

**Risk Level: Medium**

**Speed Limit: 30 KM/Hr**

**Coordinates: 11.08282, 77.65837**

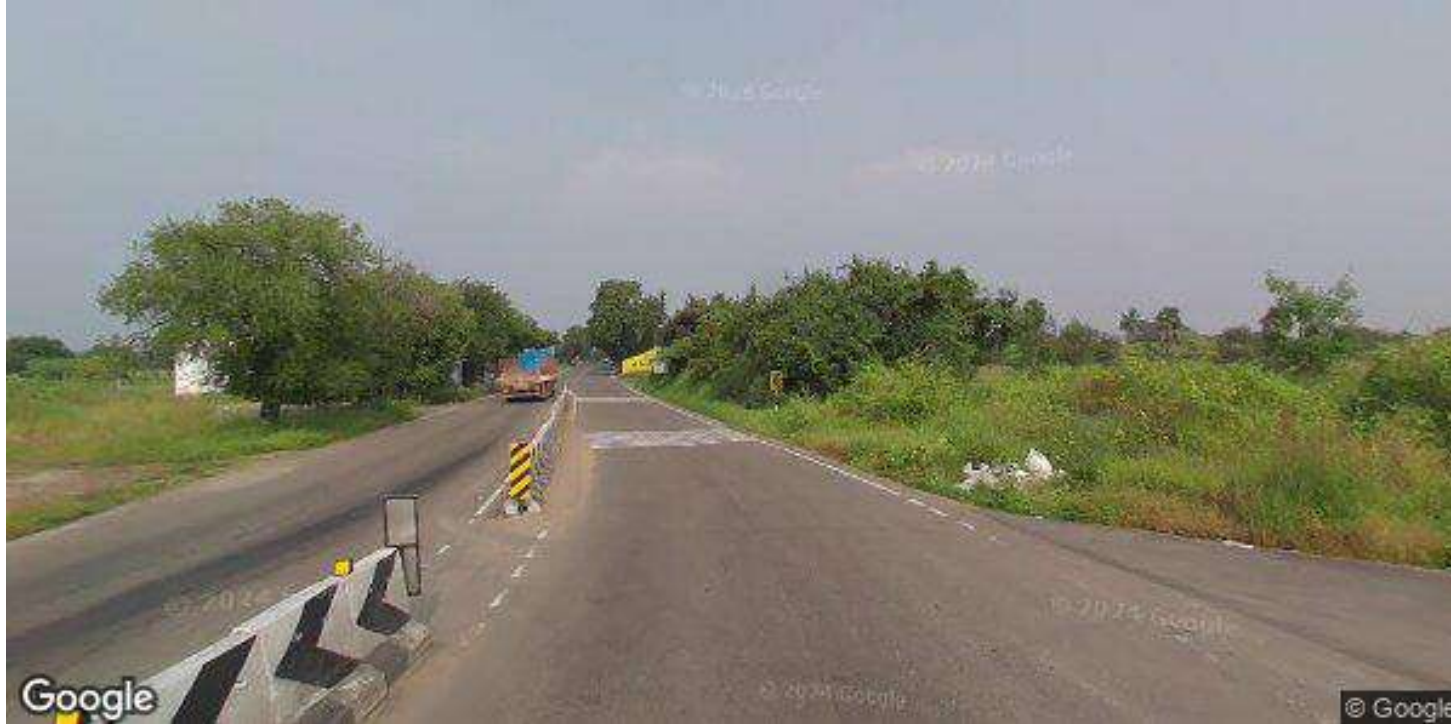
**Risk Type:** Turn

**Risk Level:** High

**Speed Limit:** 15 KM/Hr

**Coordinates:** 11.06189, 77.63943

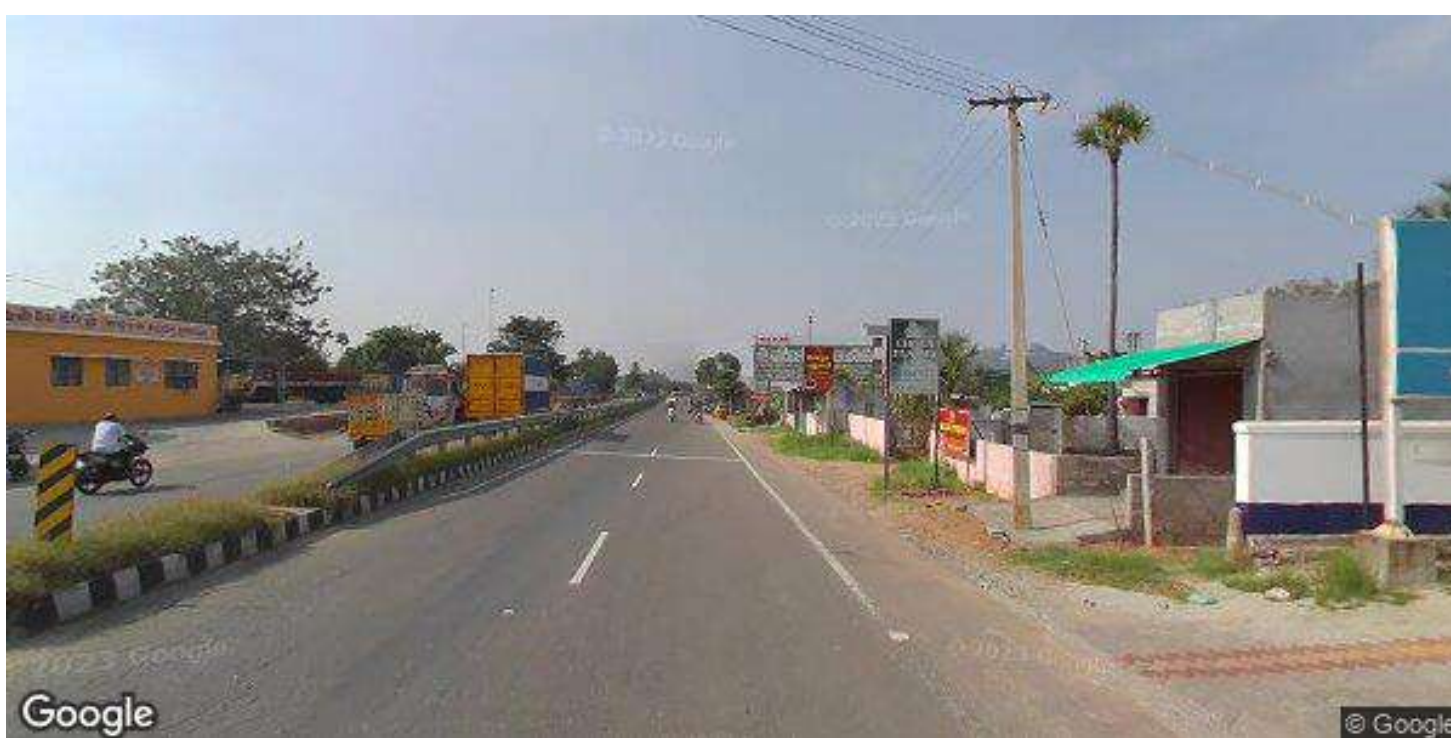
**Risk Type:** Blind Spot

**Risk Level:** Blind Spot

**Speed Limit:** 10 KM/Hr

**Coordinates:** 11.01864, 77.54544
