# IndianOil

## JOURNEY RISK MANAGEMENT (JRM) STUDY

### Salem Terminal to SRIKRISHNA ENERGY

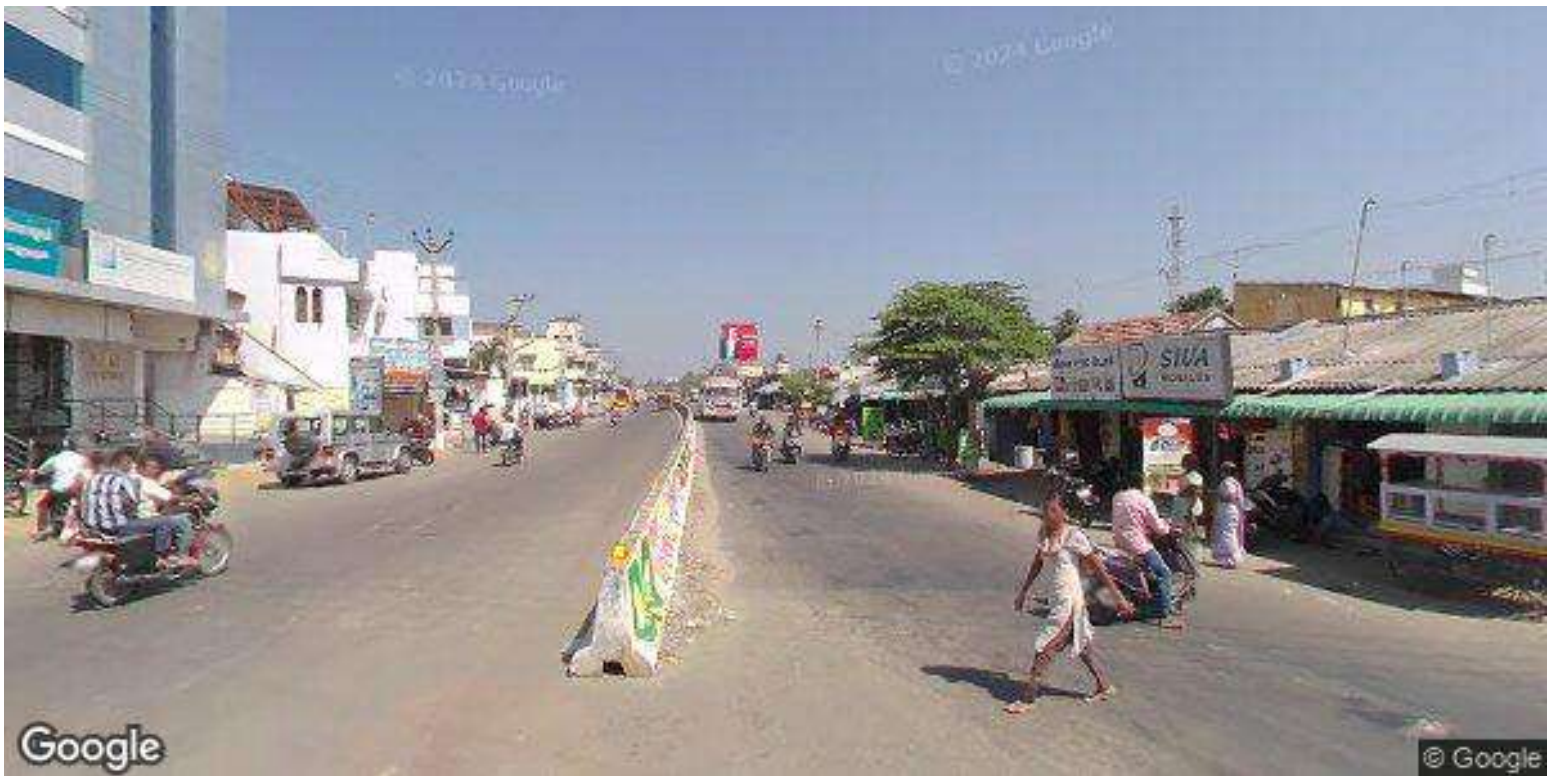
**Coordinates: 11.37086, 77.74828**

**Risk Type: Roundabout**

**Risk Level: High**

**Speed Limit: 15 KM/Hr**

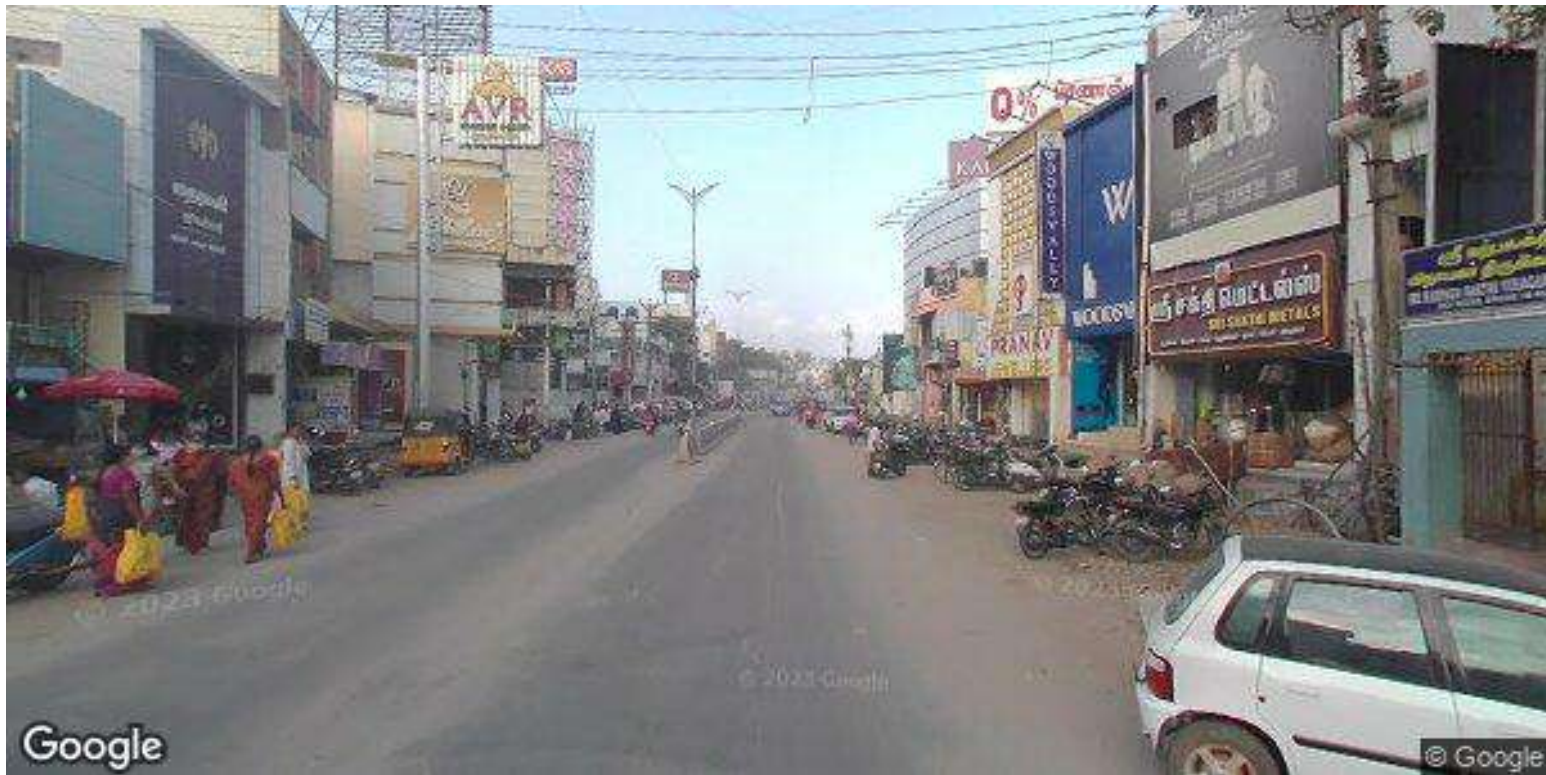
**Coordinates: 11.3453211, 77.7304652**

**Risk Type: U-Turn**

**Risk Level: High**

**Speed Limit: 10 KM/Hr**

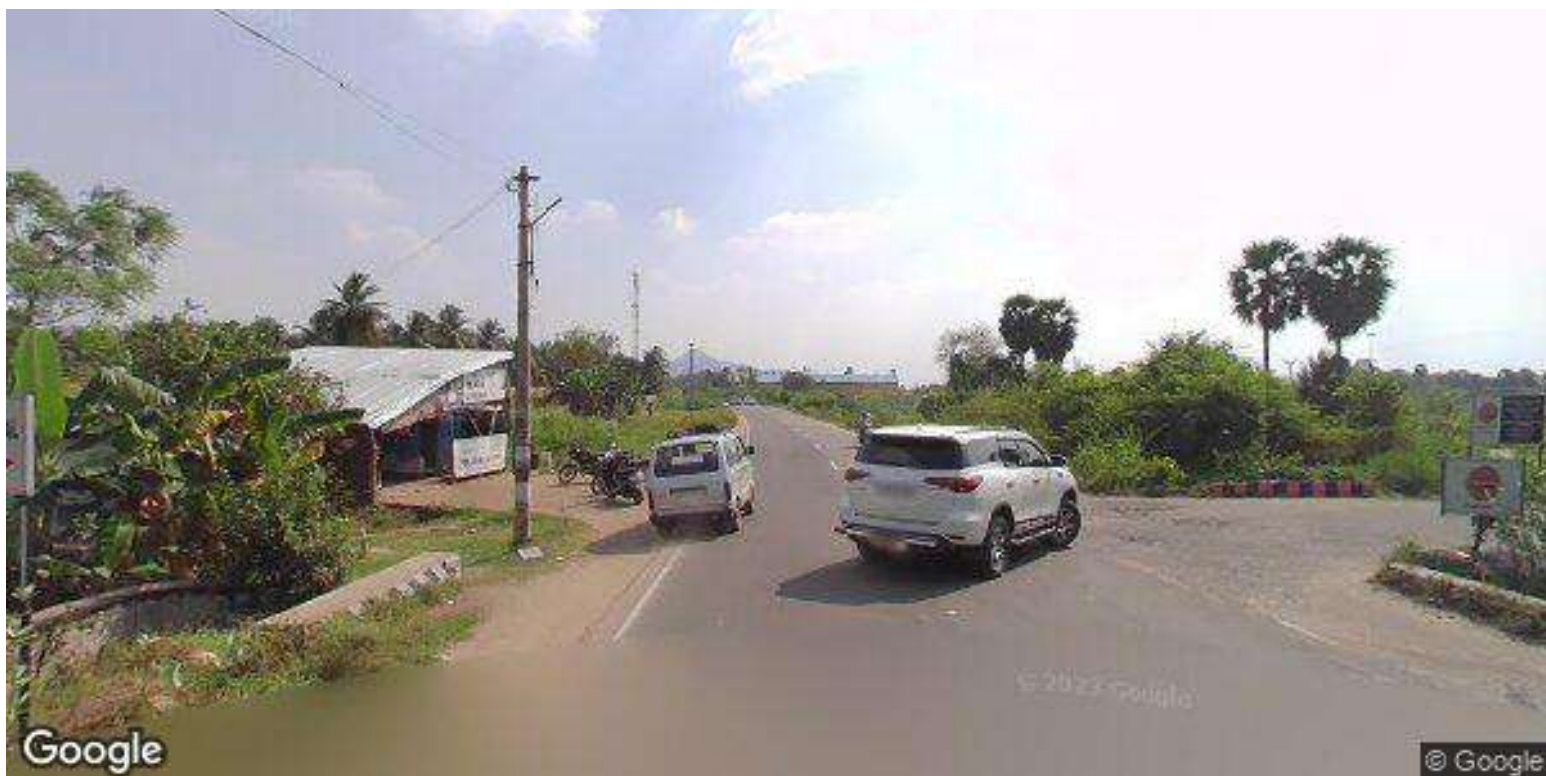
**Coordinates: 11.44029, 77.87544**

**Risk Type: Turn**

**Risk Level: High**

**Speed Limit: 15 KM/Hr**

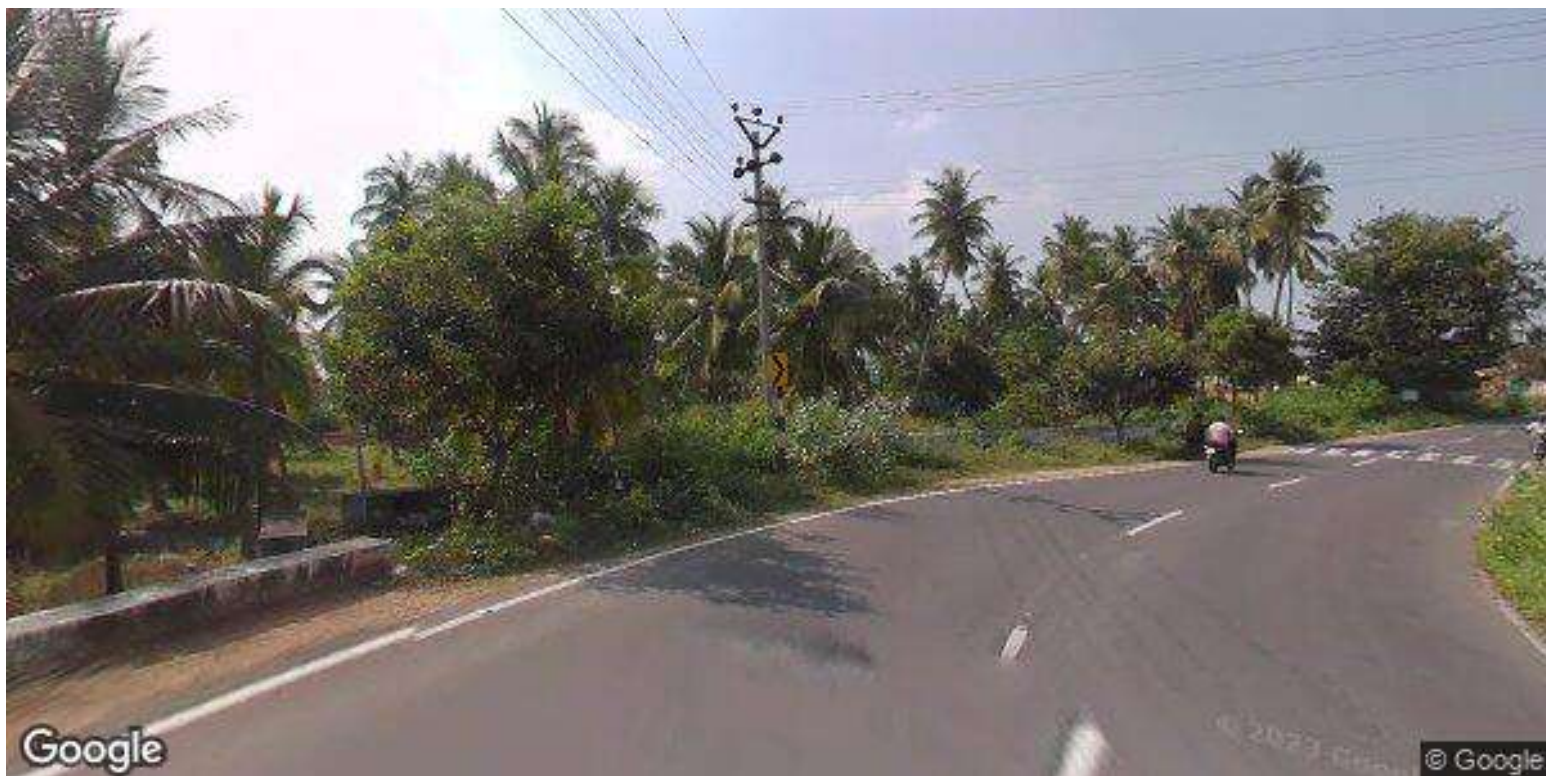
**Coordinates:** 11.45348, 77.85706

**Risk Type:** Turn

**Risk Level:** Medium

**Speed Limit:** 30 KM/Hr

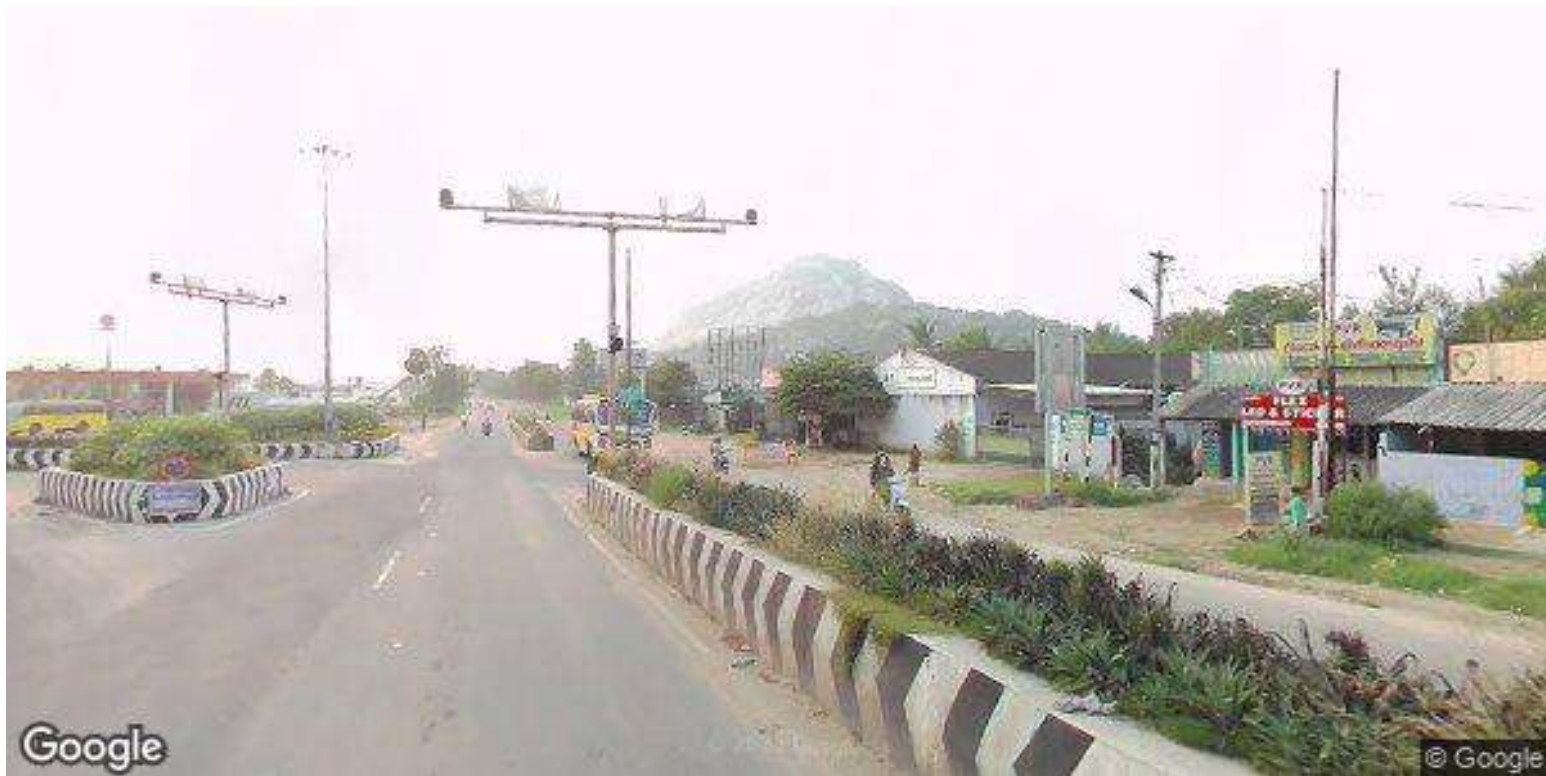
**Risk Type:** Turn  
**Risk Level:** Medium  
**Speed Limit:** 30 KM/Hr  
**Coordinates:** 11.46312, 77.84886

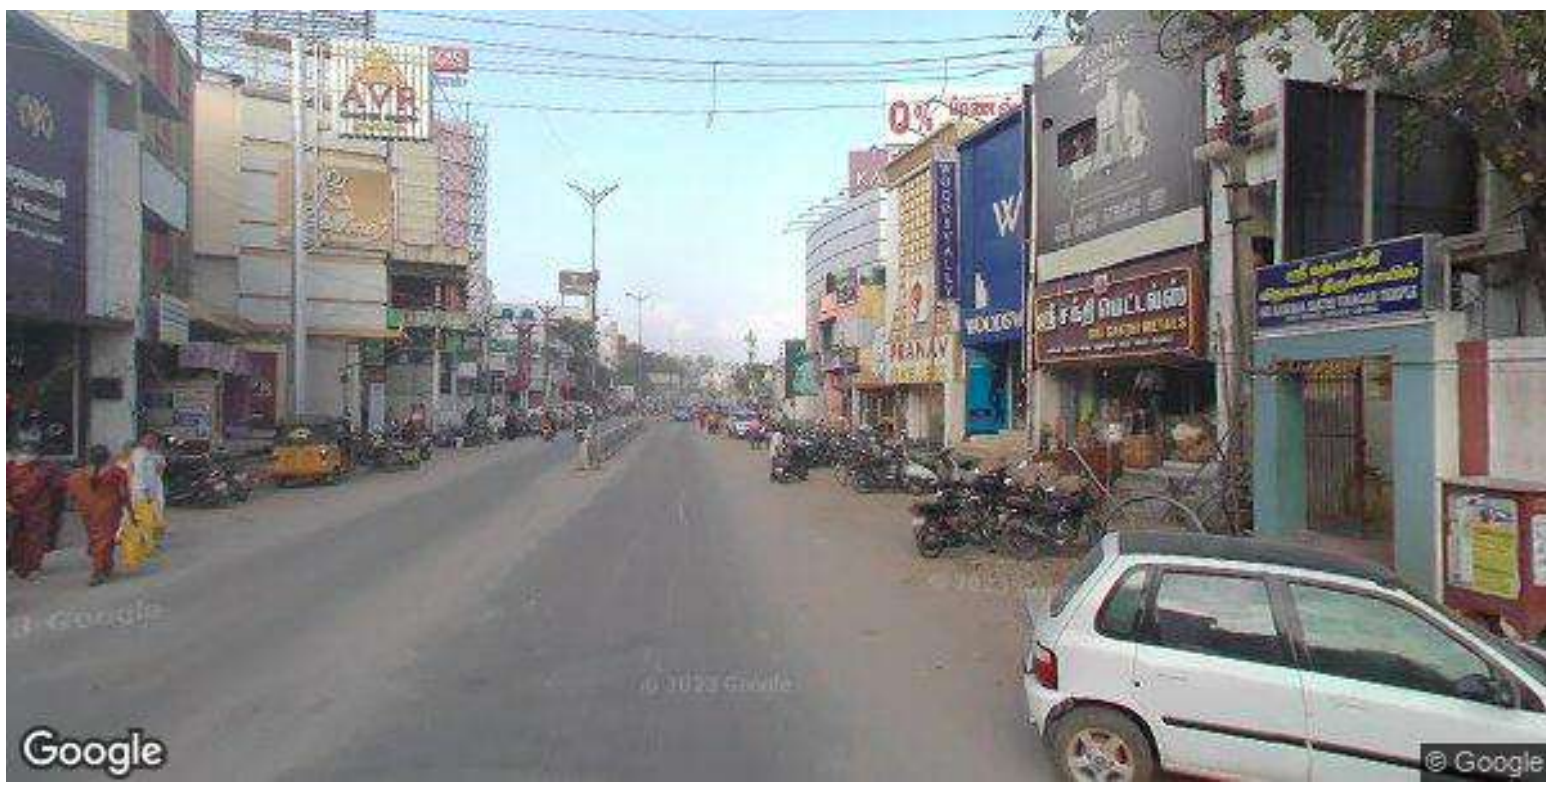
**Coordinates:** 11.34532, 77.73047

**Risk Type:** Turn

**Risk Level:** High

**Speed Limit:** 15 KM/Hr

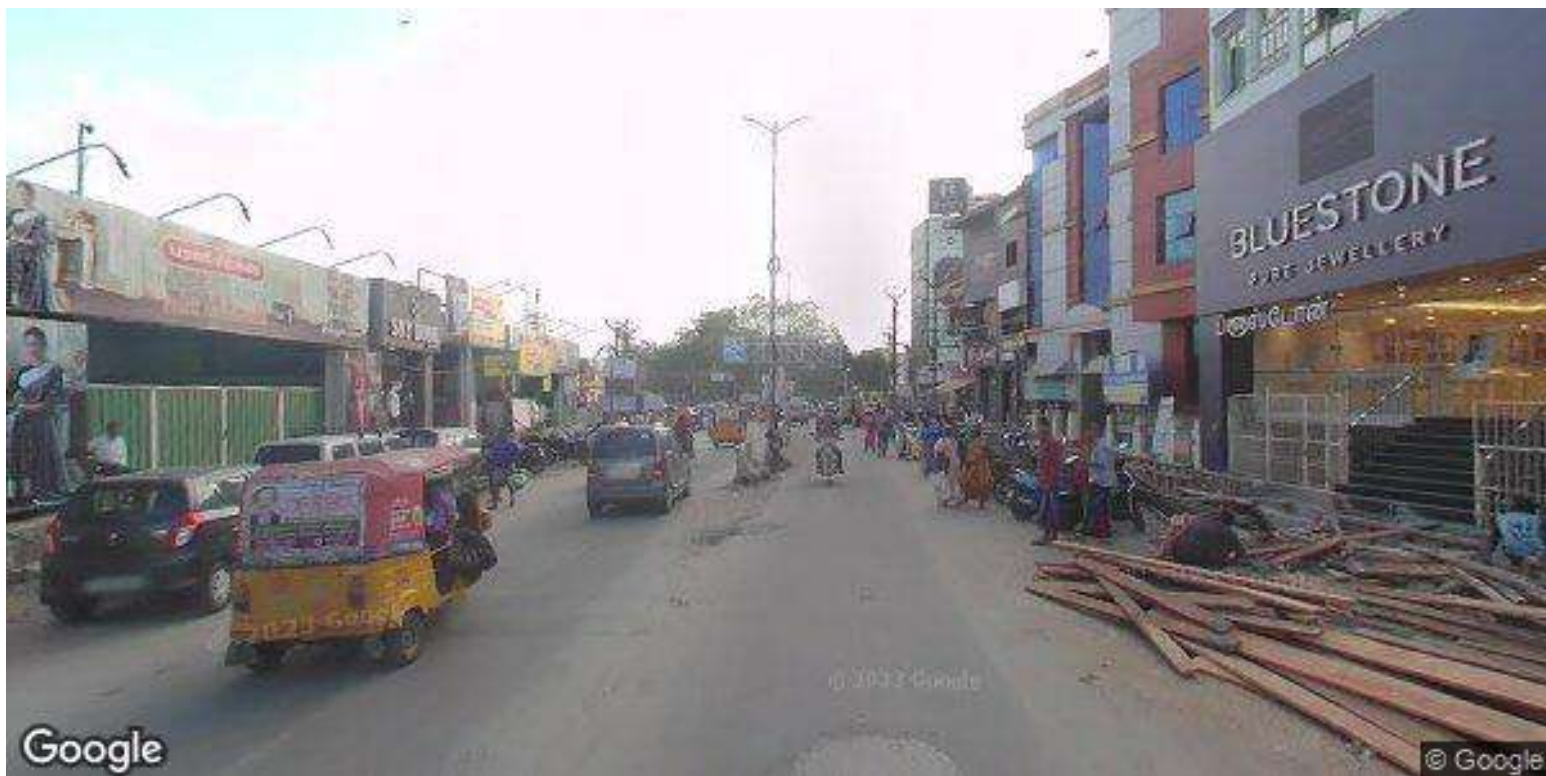
**Coordinates:** 11.34535, 77.73036

**Risk Type:** Blind Spot

**Risk Level:** Blind Spot

**Speed Limit:** 10 KM/Hr
