## **JOURNEY RISK MANAGEMENT (JRM) STUDY**

**Salem Terminal to S.S.M.FUEL SERVICE IOC  
DEALERS-KSK**

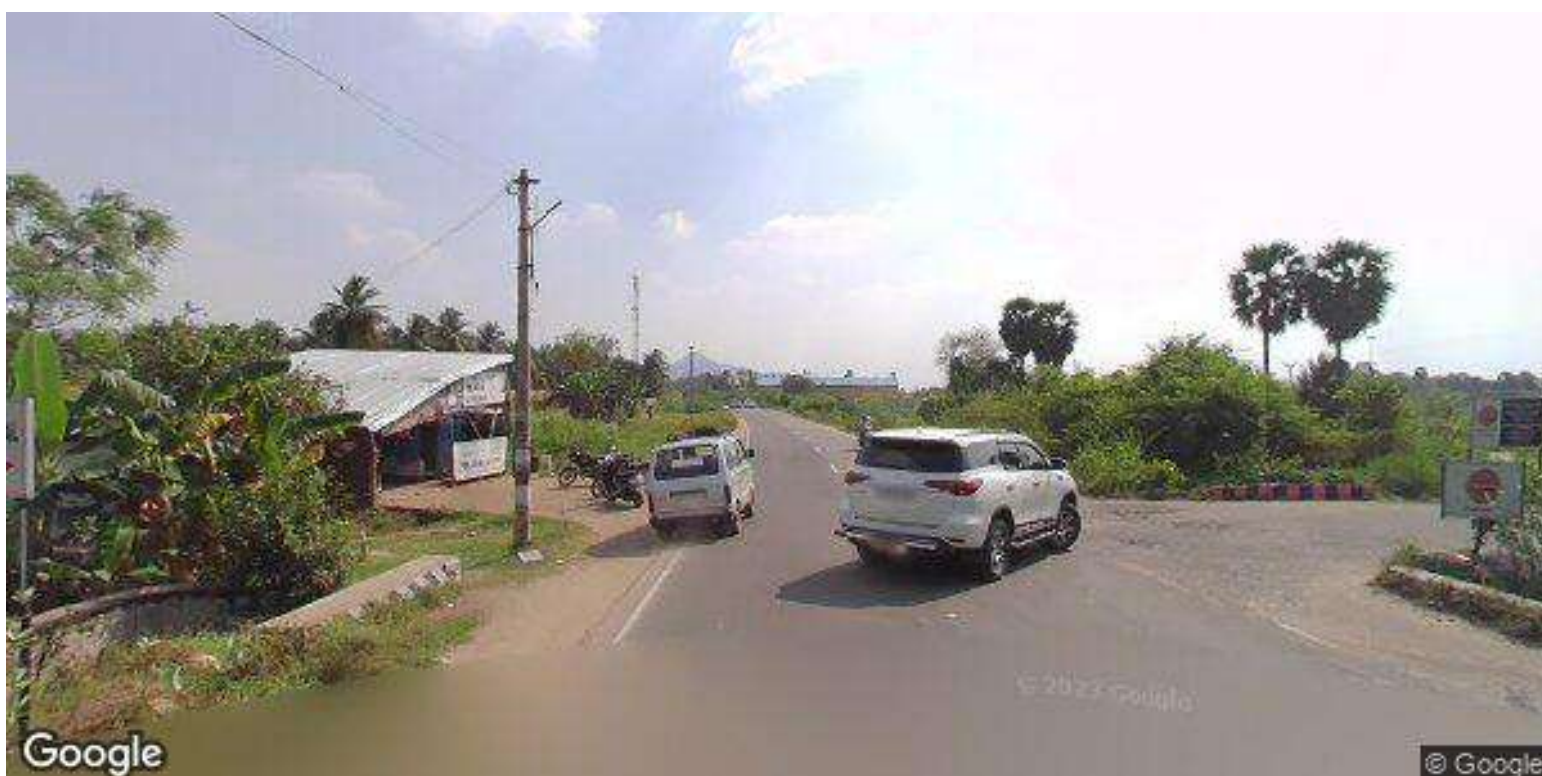
**Coordinates: 11.44029, 77.87544**

**Risk Type:** Blind Spot

**Risk Level:** Blind Spot

**Speed Limit: 10 KM/Hr**

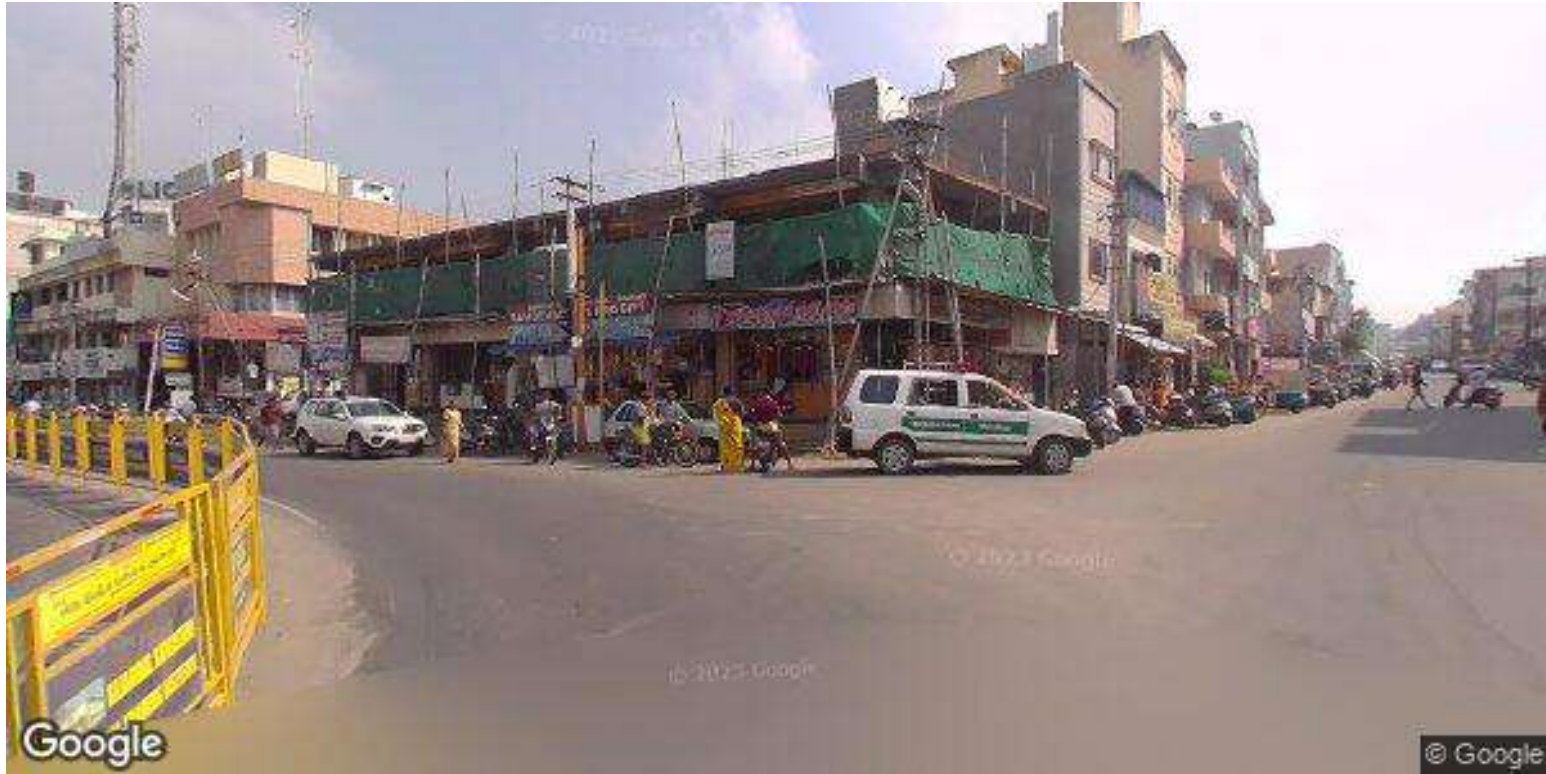
**Coordinates: 11.37868, 77.89498**

**Risk Type: Turn**

**Risk Level: High**

**Speed Limit: 15 KM/Hr**

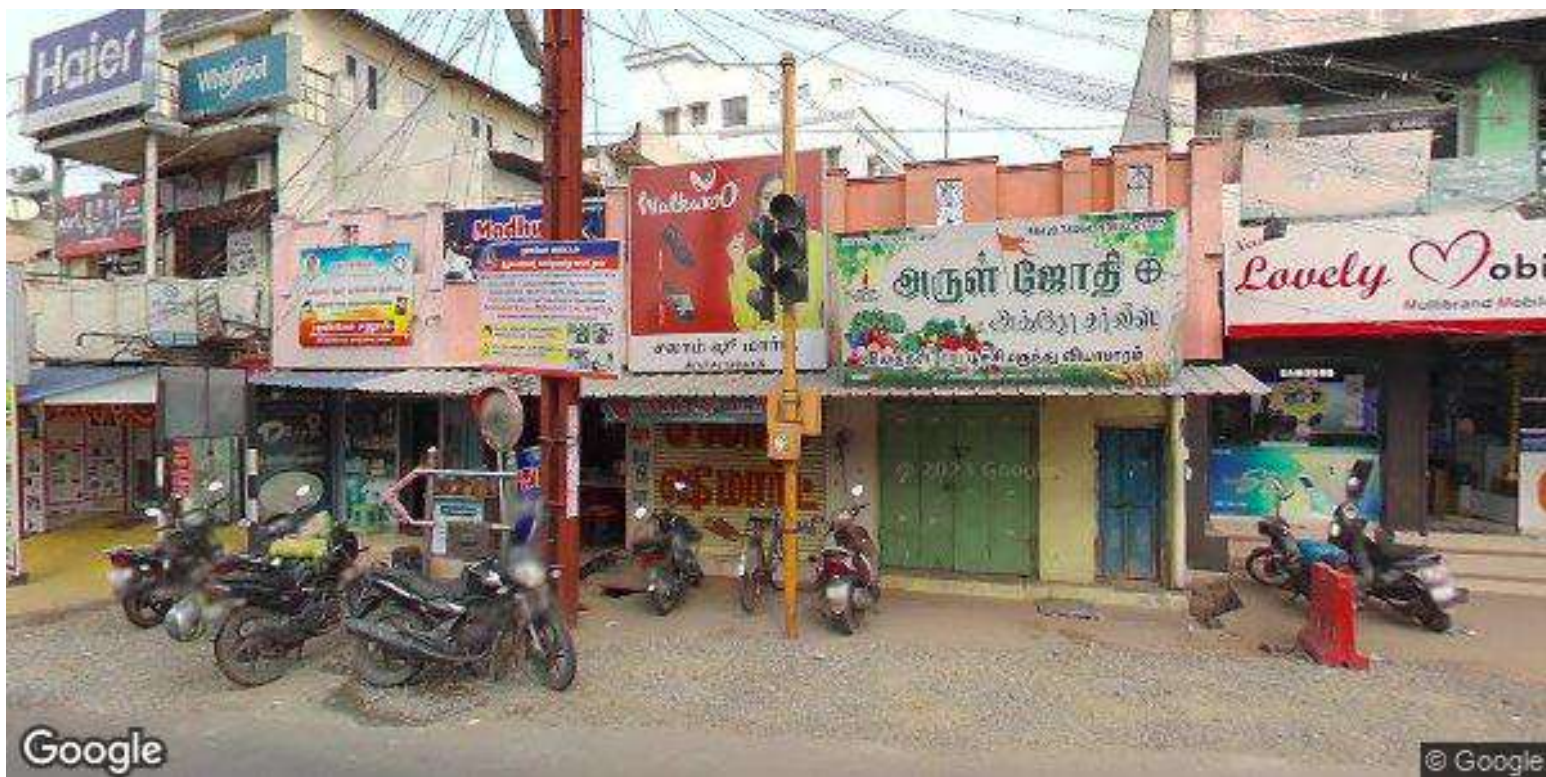
**Coordinates: 11.37850, 77.89453**

**Risk Type: Turn**

**Risk Level: High**

**Speed Limit: 15 KM/Hr**

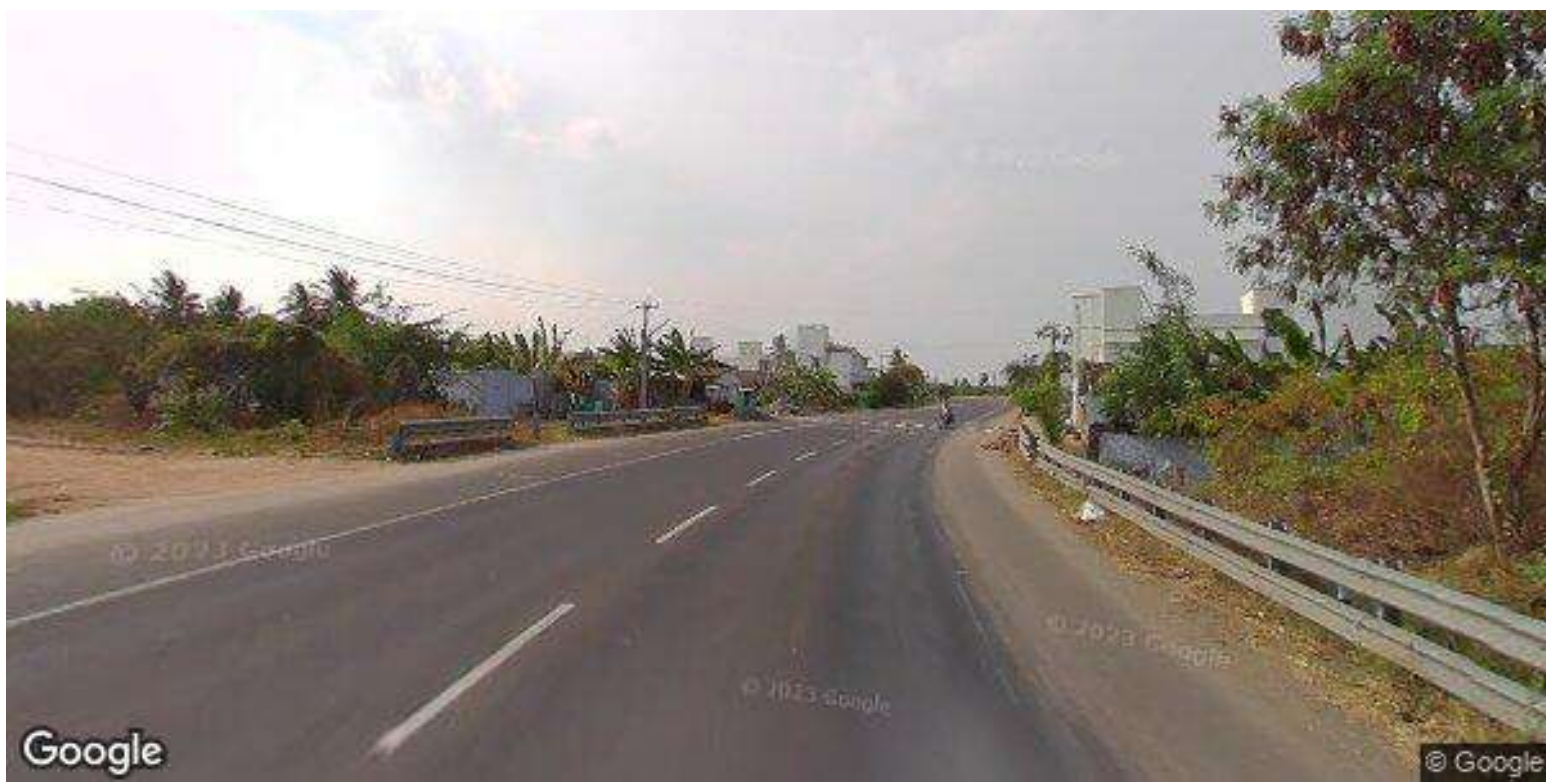
**Coordinates:** 11.16764, 78.01565

**Risk Type:** Turn

**Risk Level:** Medium

**Speed Limit:** 30 KM/Hr

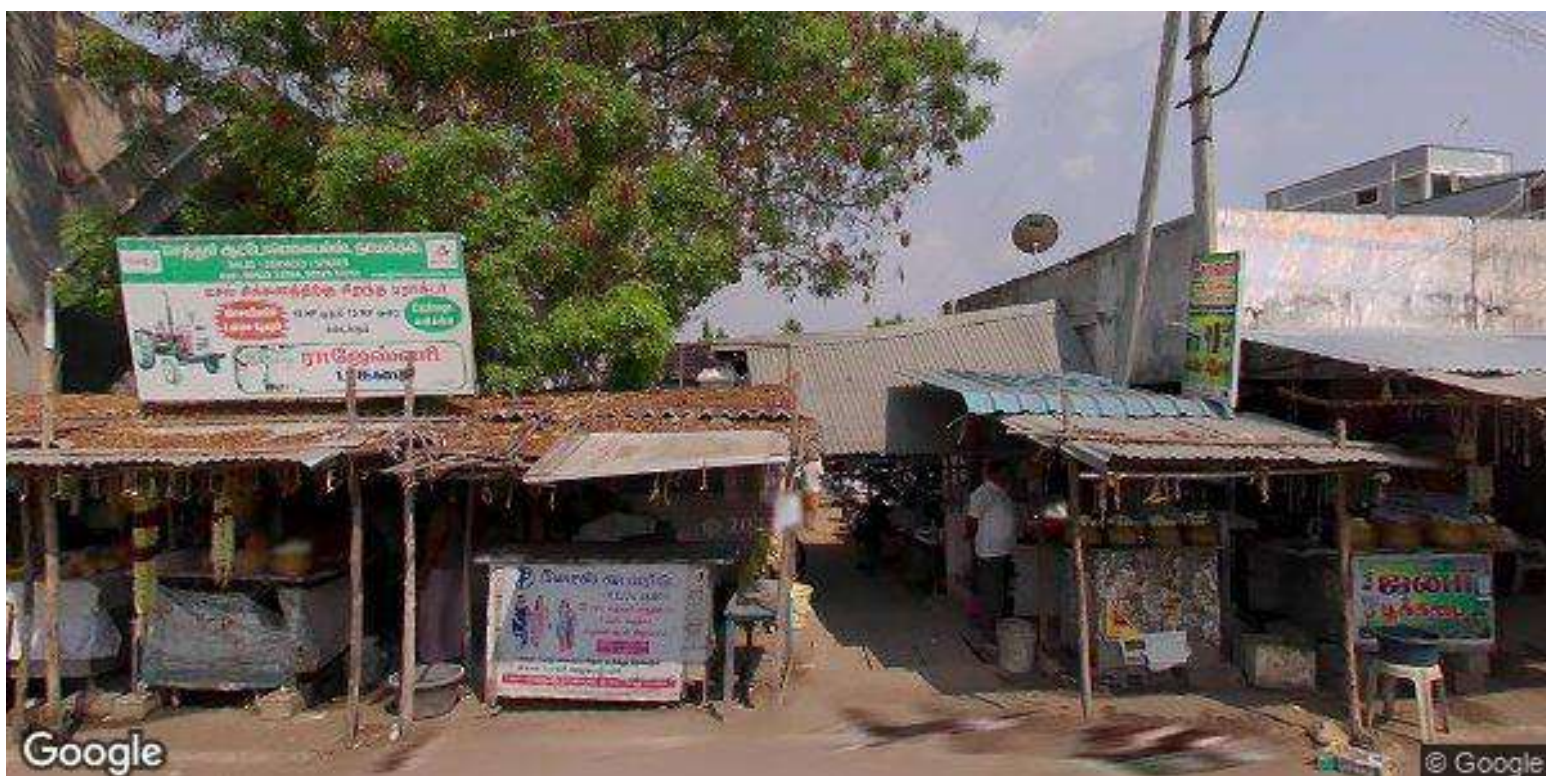
**Coordinates:** 11.15573, 78.02176

**Risk Type:** Turn

**Risk Level:** High

**Speed Limit:** 15 KM/Hr

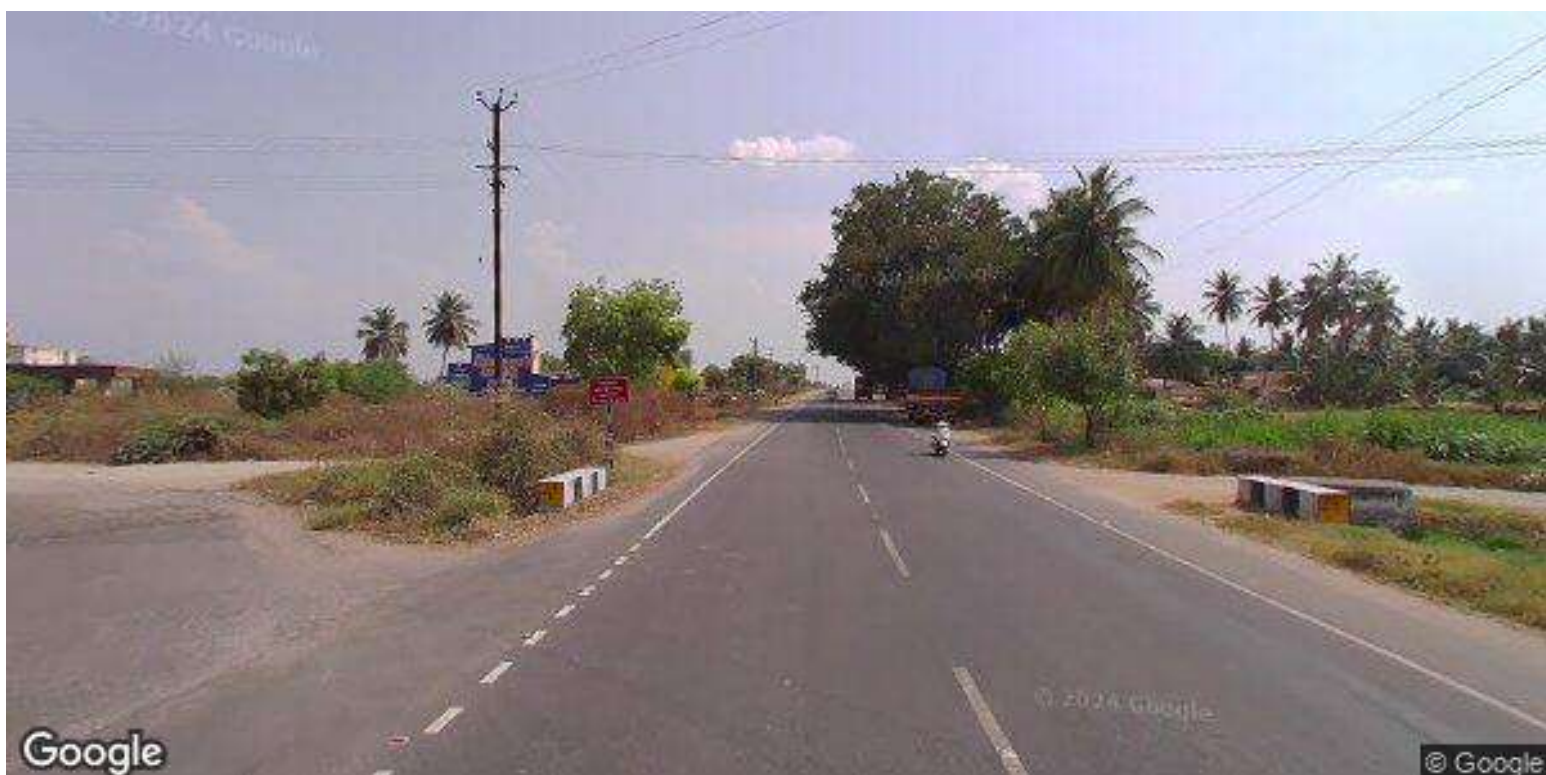
**Risk Type:** Turn  
**Risk Level:** High  
**Speed Limit:** 15 KM/Hr  
**Coordinates:** 11.14545, 78.02208

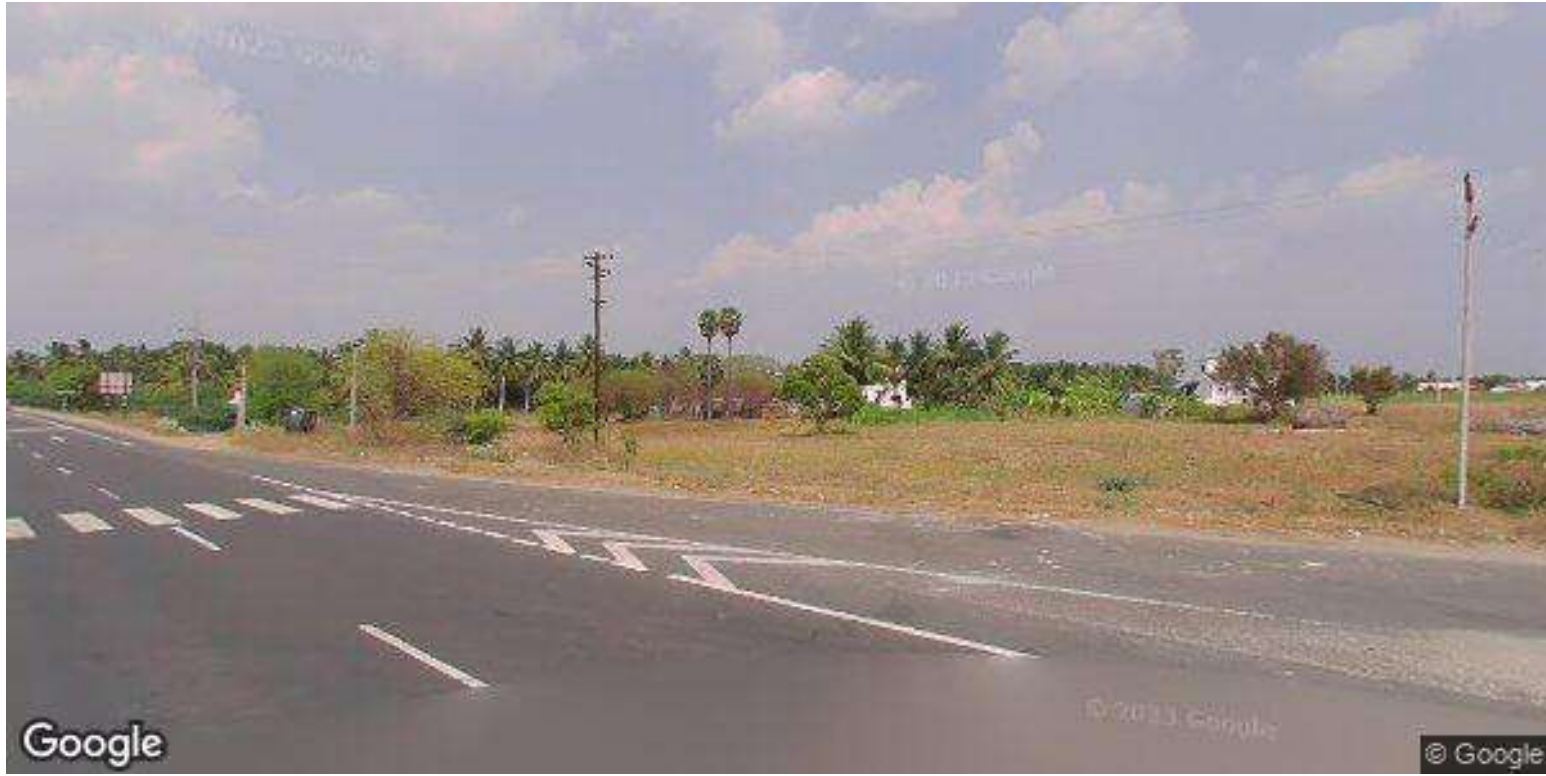
**Risk Type:** Turn  
**Risk Level:** High  
**Speed Limit:** 15 KM/Hr  
**Coordinates:** 11.14480, 78.02291

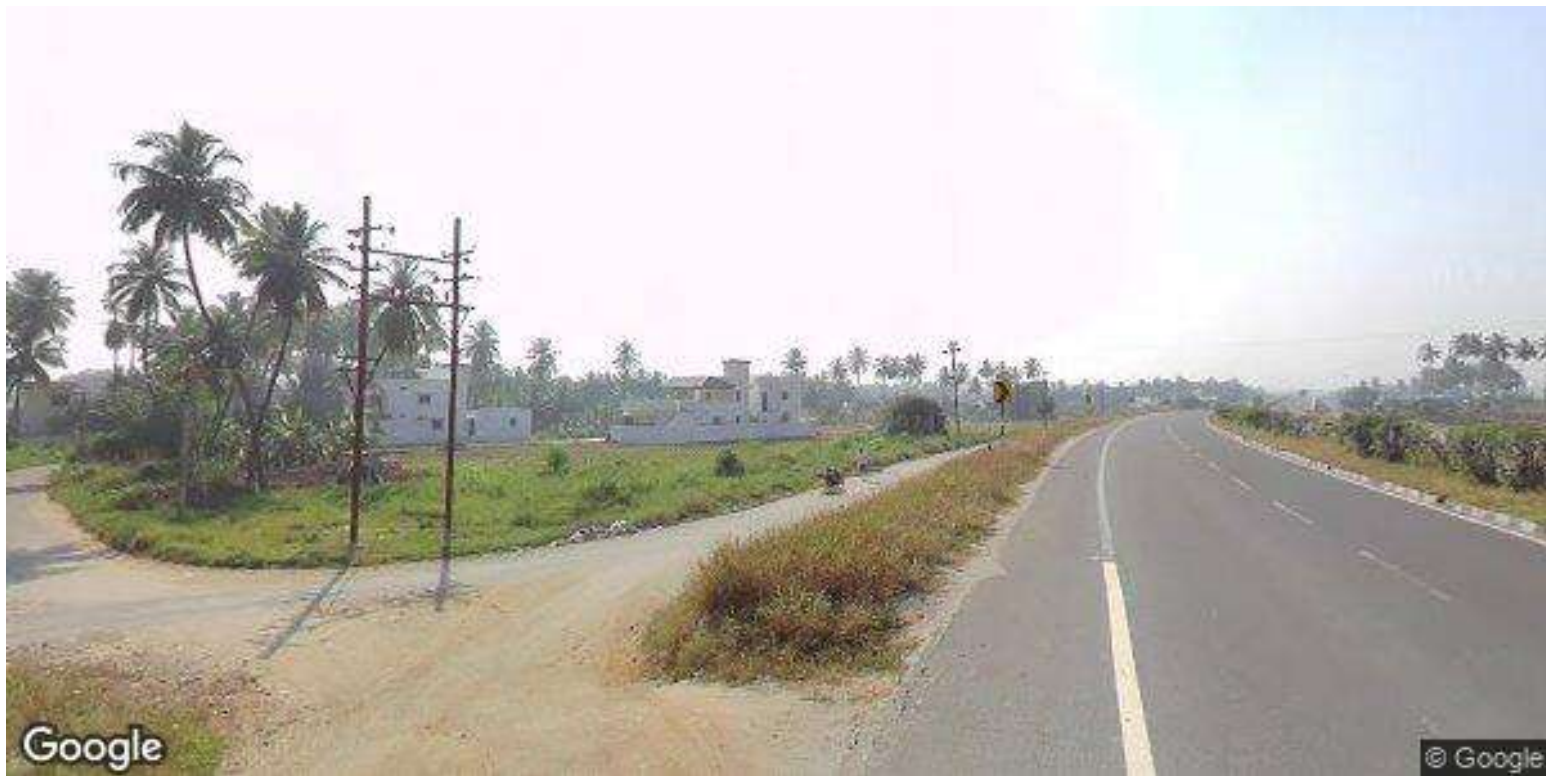
**Risk Type:** Turn  
**Risk Level:** High  
**Speed Limit:** 15 KM/Hr  
**Coordinates:** 11.11887, 78.01758

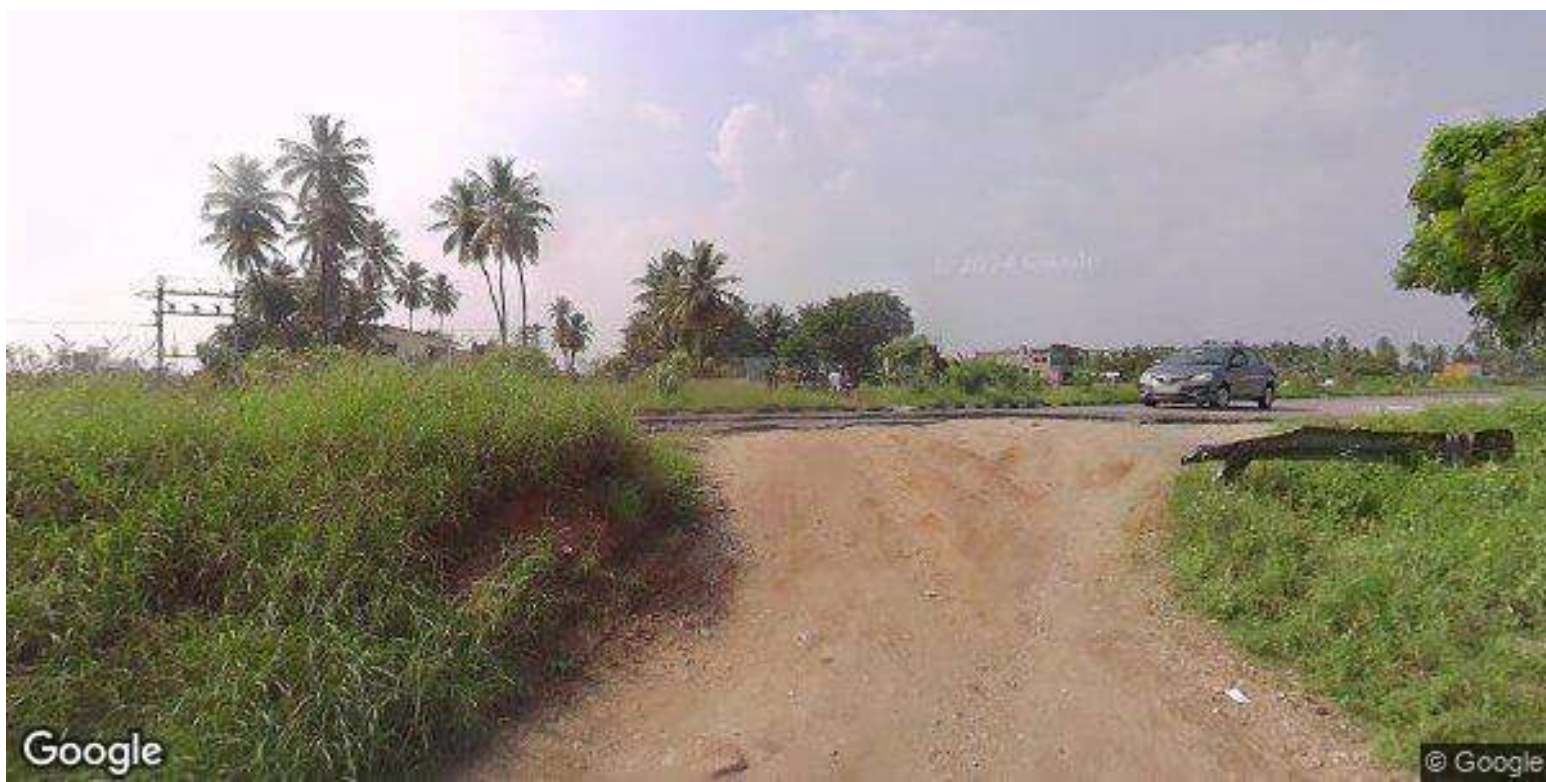
**Coordinates:** 11.11883, 78.01771

**Risk Type:** Turn

**Risk Level:** High

**Speed Limit:** 15 KM/Hr

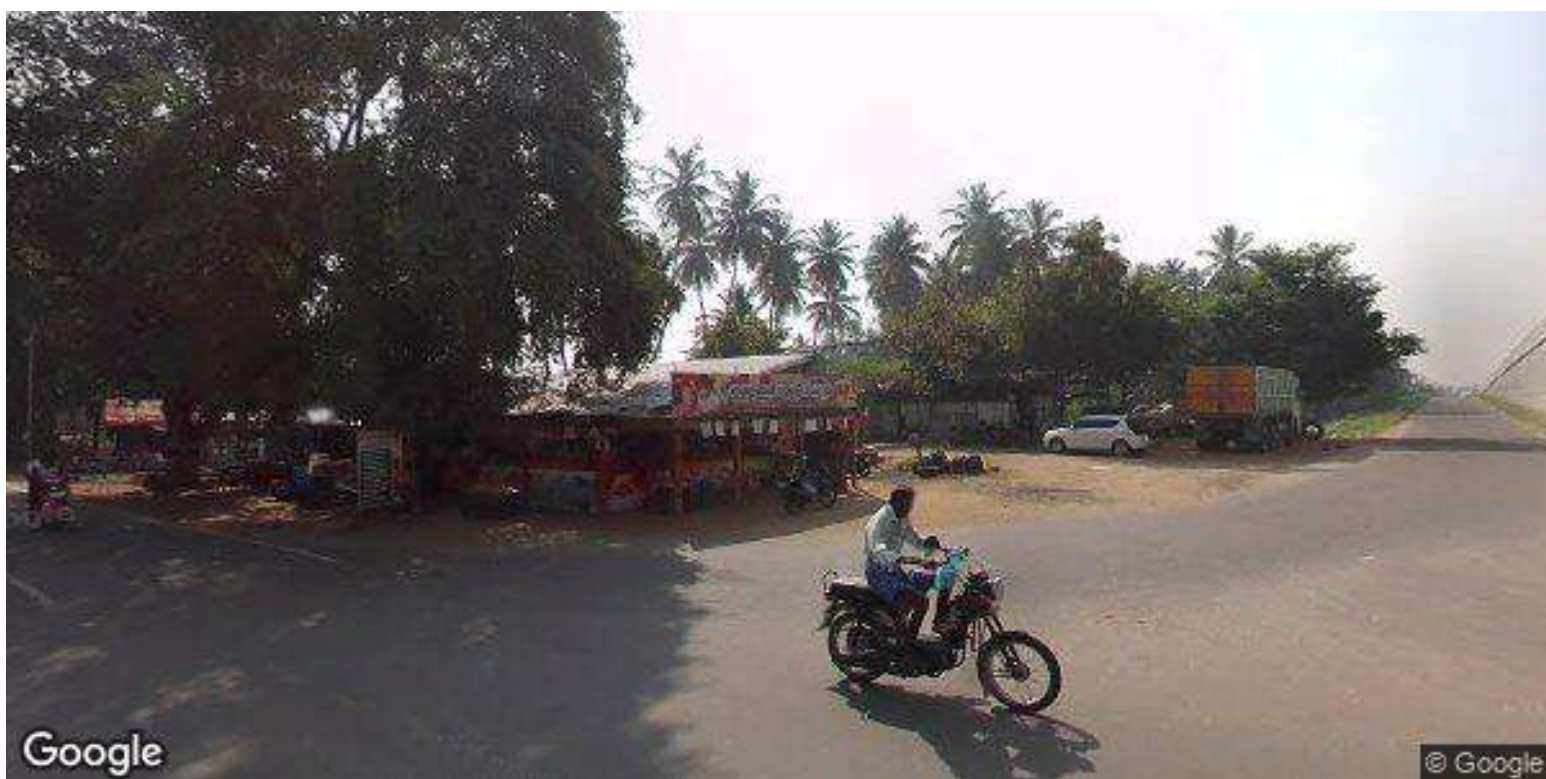
**Coordinates:** 11.11397, 78.01722

**Risk Type:** Blind Spot

**Risk Level:** Blind Spot

**Speed Limit:** 10 KM/Hr

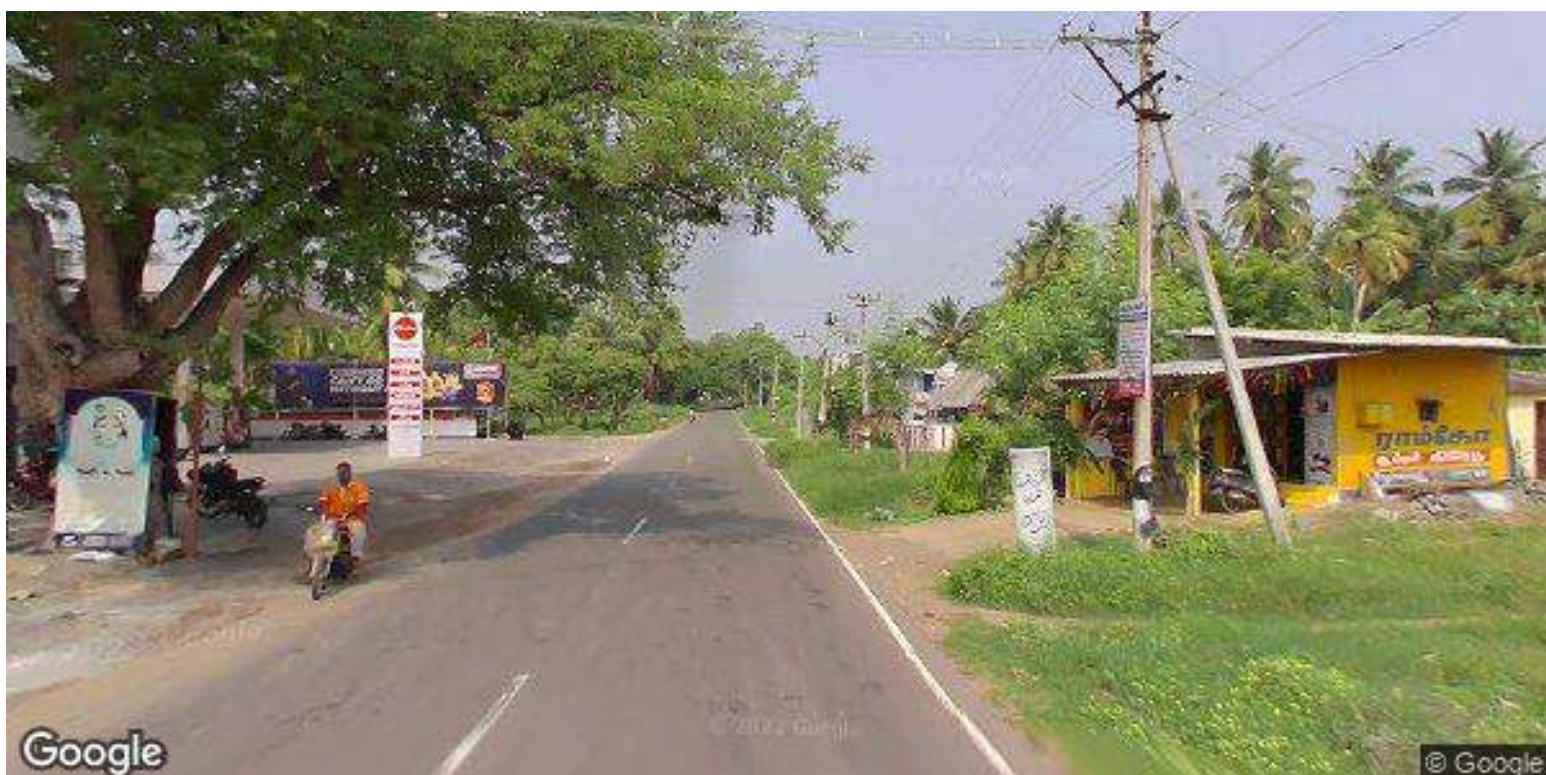
**Coordinates:** 11.09256, 78.06435

**Risk Type:** Turn

**Risk Level:** High

**Speed Limit:** 15 KM/Hr
