## JOURNEY RISK MANAGEMENT (JRM) STUDY

### Salem Terminal TO JAYAA JYOTHI ENTERPRISE

#### Objective of the JRM Report

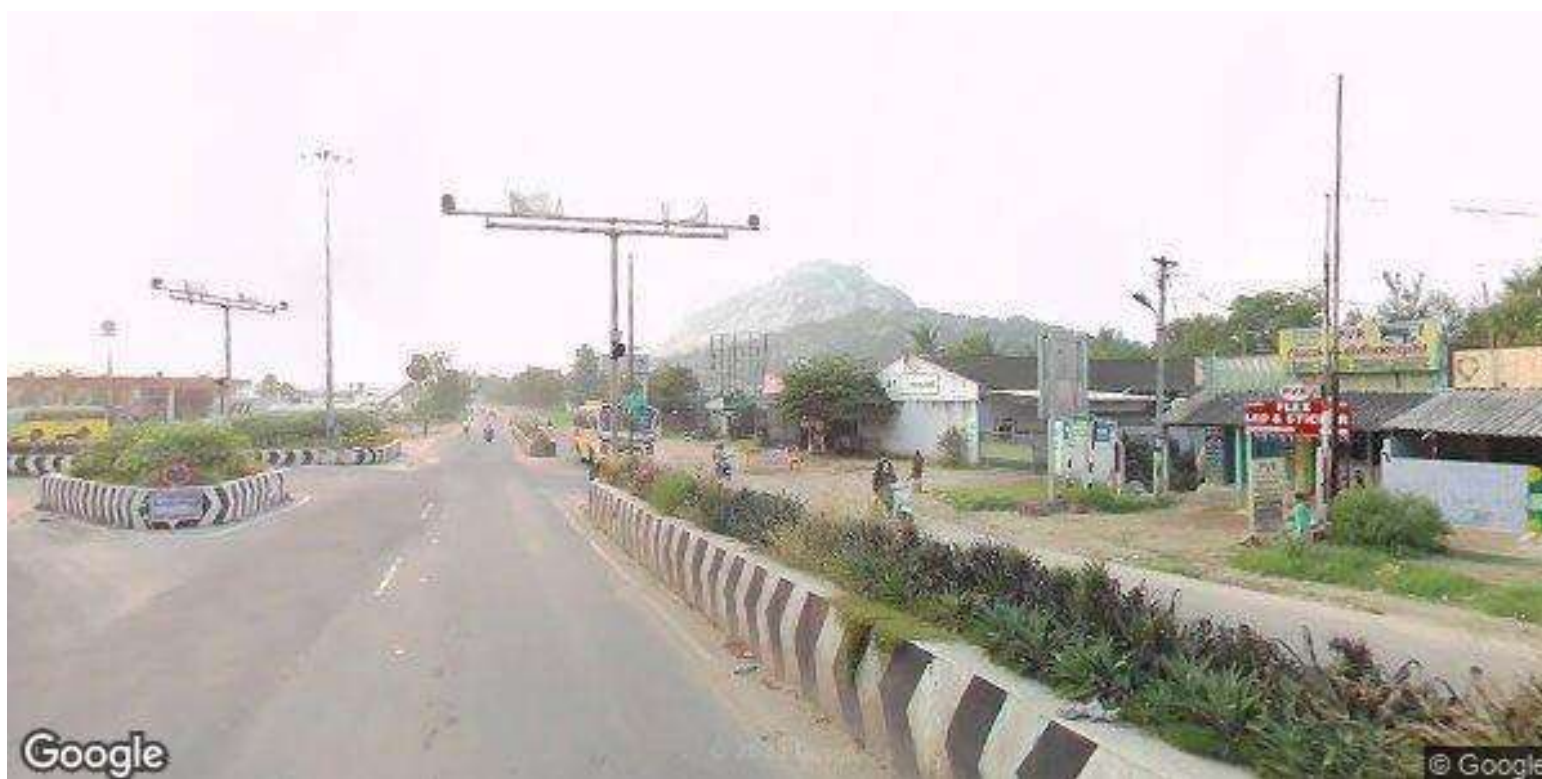
Coordinates: 11.46312, 77.84886

| | Risk Type | Risk Level | Coordinates | Speed Limit |
|---|---|---|---|---|
| 8 | Turn | Medium | 11.46312, 77.84886 | 30 KM/Hr |

Risk Type: Turn

Risk Level: Medium

Speed Limit: 30 KM/Hr

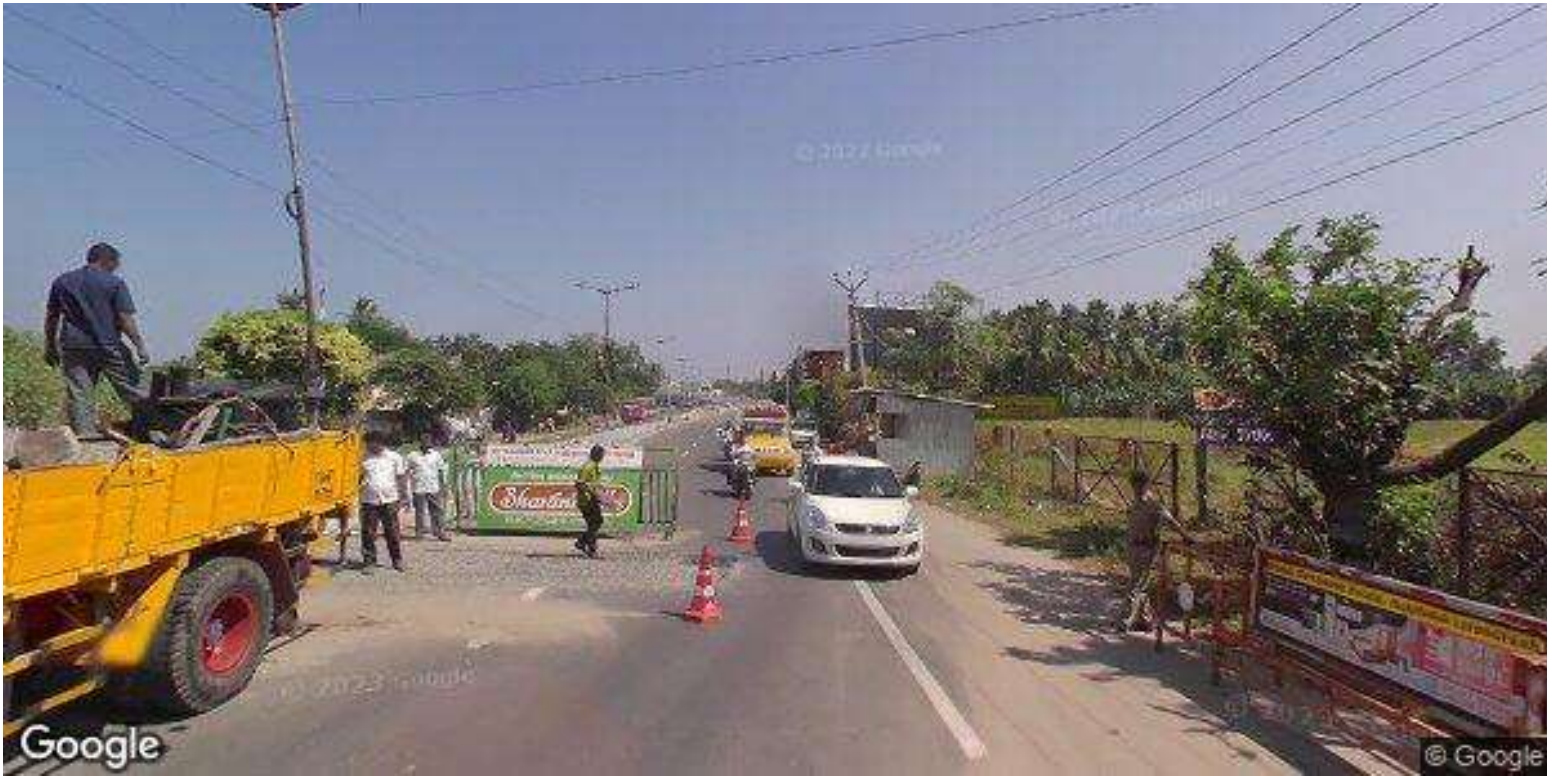
Coordinates: 11.35929, 77.73996

| | Risk Type | Risk Level | Coordinates | Speed Limit |
|---|---|---|---|---|
| 9 | Turn | High | 11.35929, 77.73996 | 15 KM/Hr |

Risk Type: Turn

Risk Level: High

Speed Limit: 15 KM/Hr
