# IndianOil

## JOURNEY RISK MANAGEMENT (JRM) STUDY

### Salem Terminal TO SARAS AGENCIES

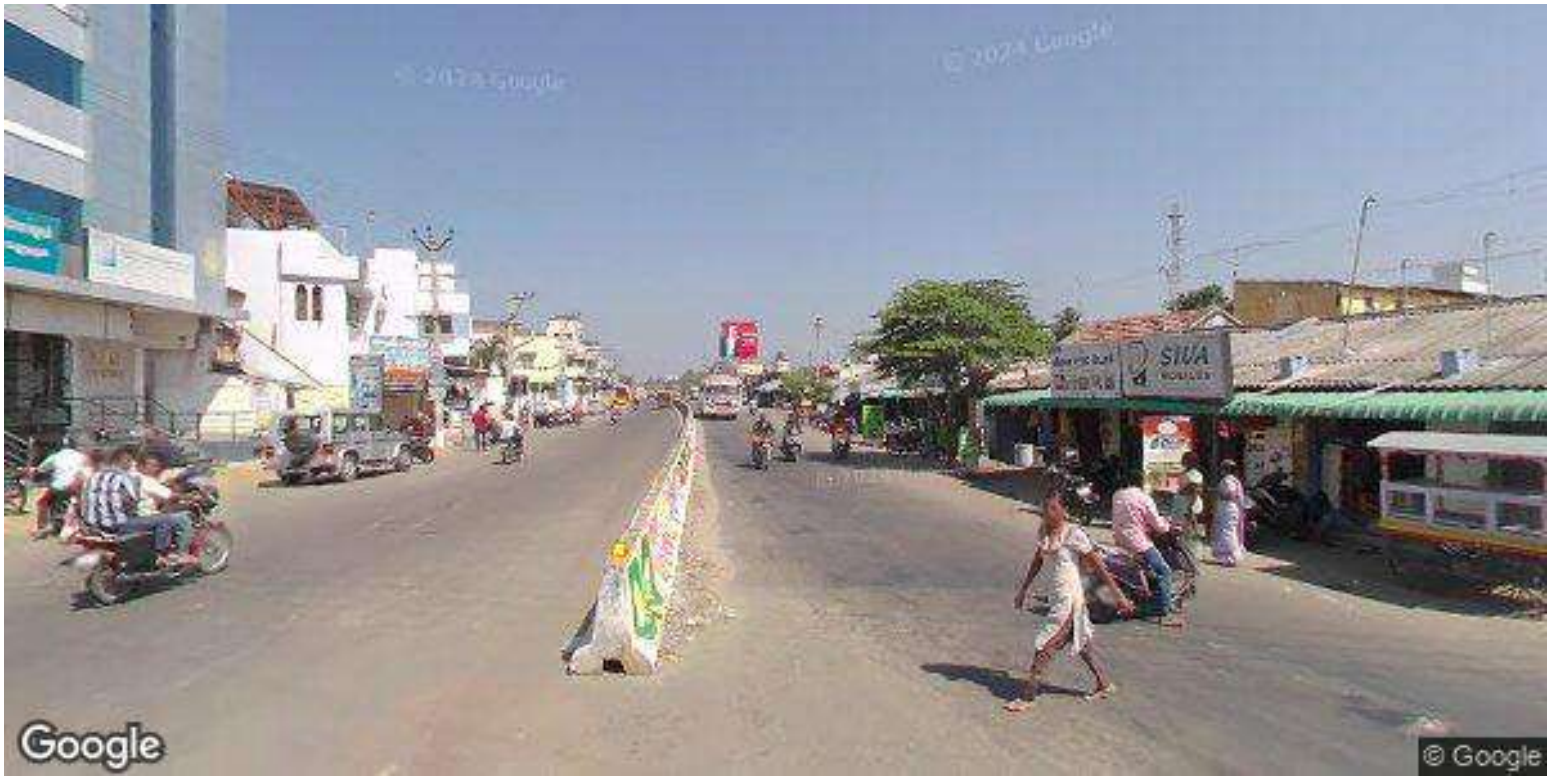
**Coordinates:** 11.37086, 77.74828

**Risk Type:** Roundabout

**Risk Level:** High

**Speed Limit:** 15 KM/Hr

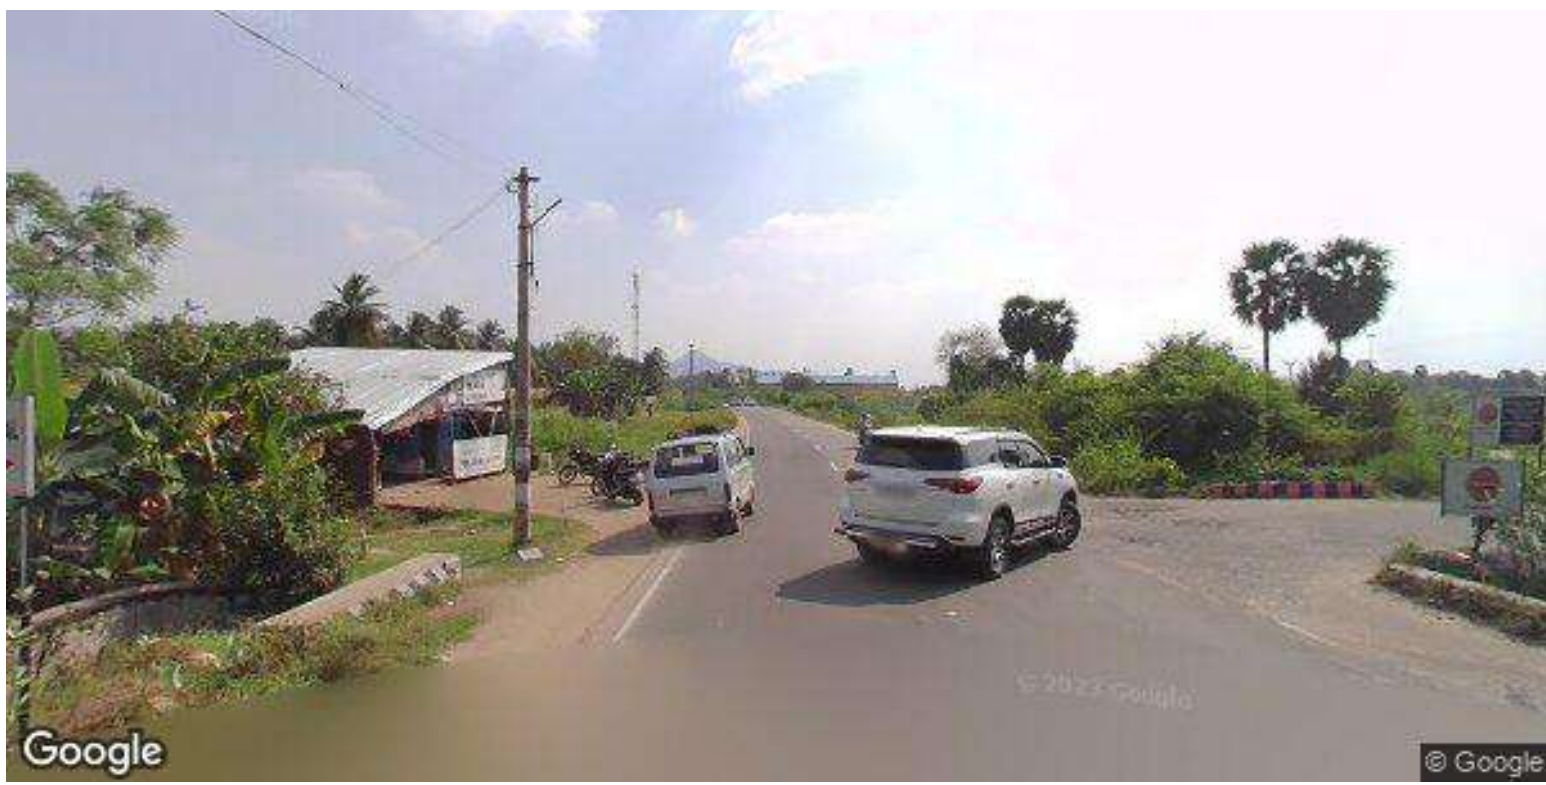
**Coordinates: 11.44029, 77.87544**

**Risk Type: Turn**

**Risk Level: High**

**Speed Limit: 15 KM/Hr**

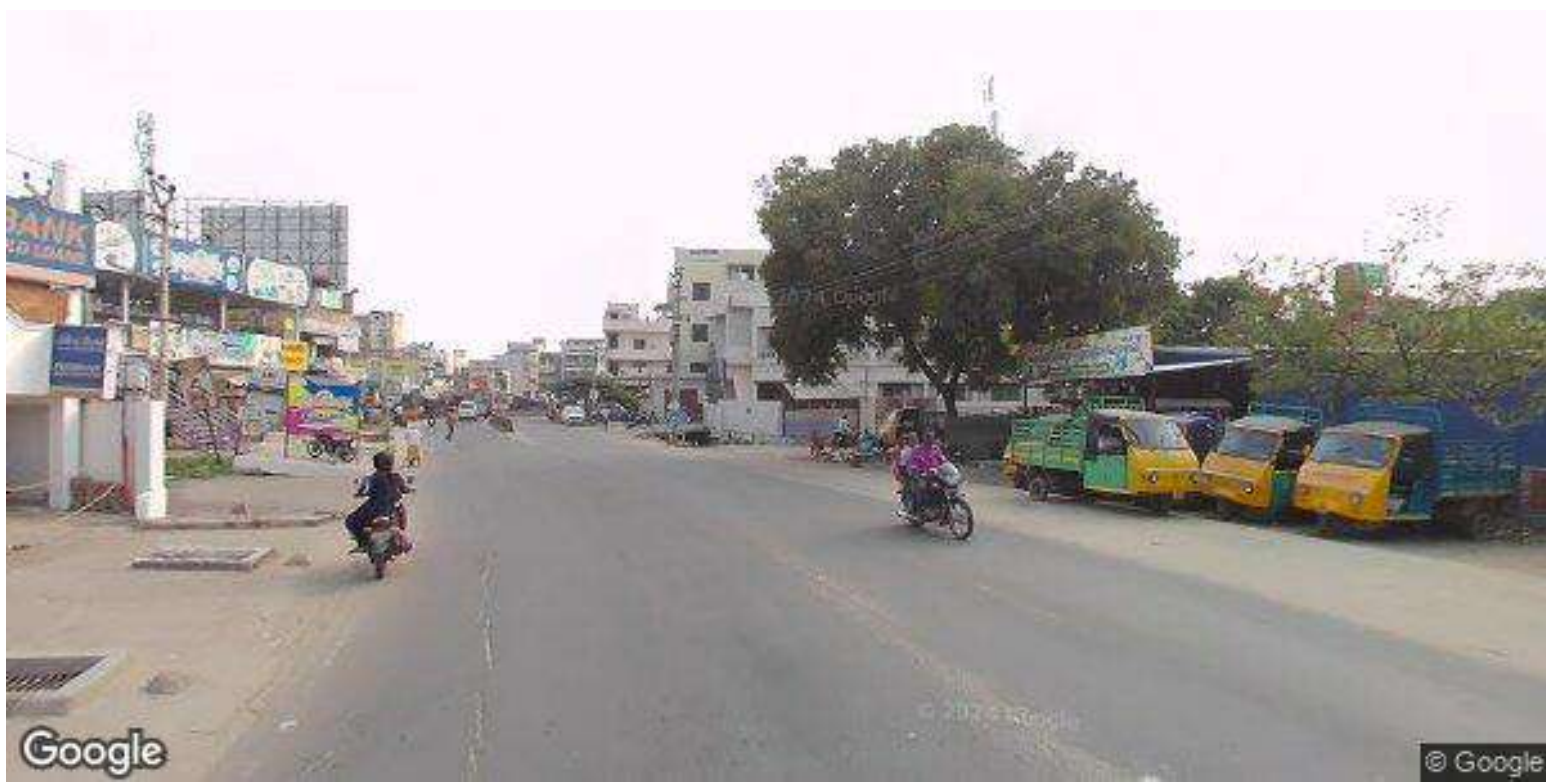
**Coordinates:** 11.36626, 77.74788

**Risk Type:** Turn

**Risk Level:** Medium

**Speed Limit:** 30 KM/Hr

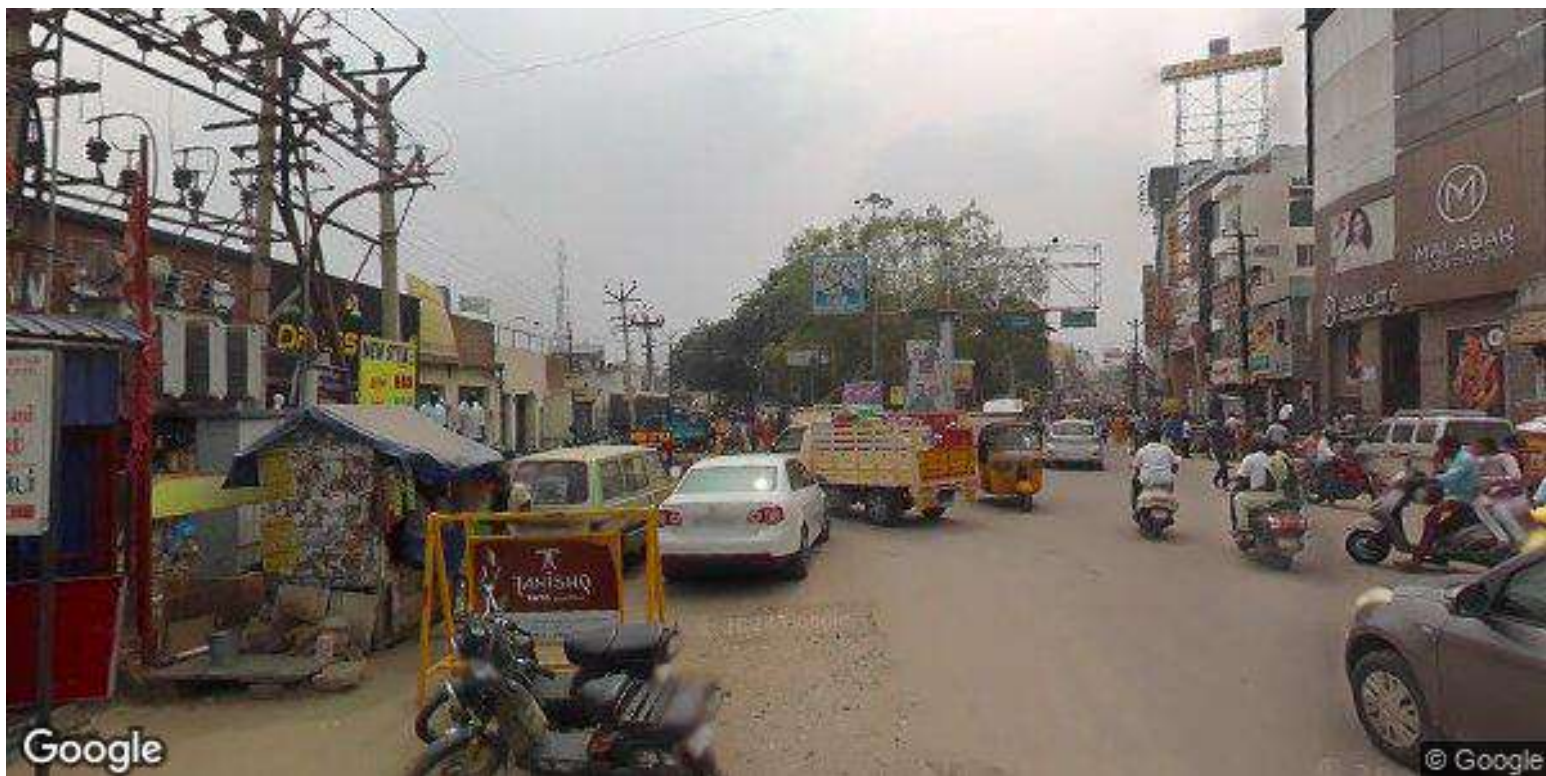
**Coordinates:** 11.34493, 77.73032

**Risk Type:** Turn

**Risk Level:** Medium

**Speed Limit:** 30 KM/Hr

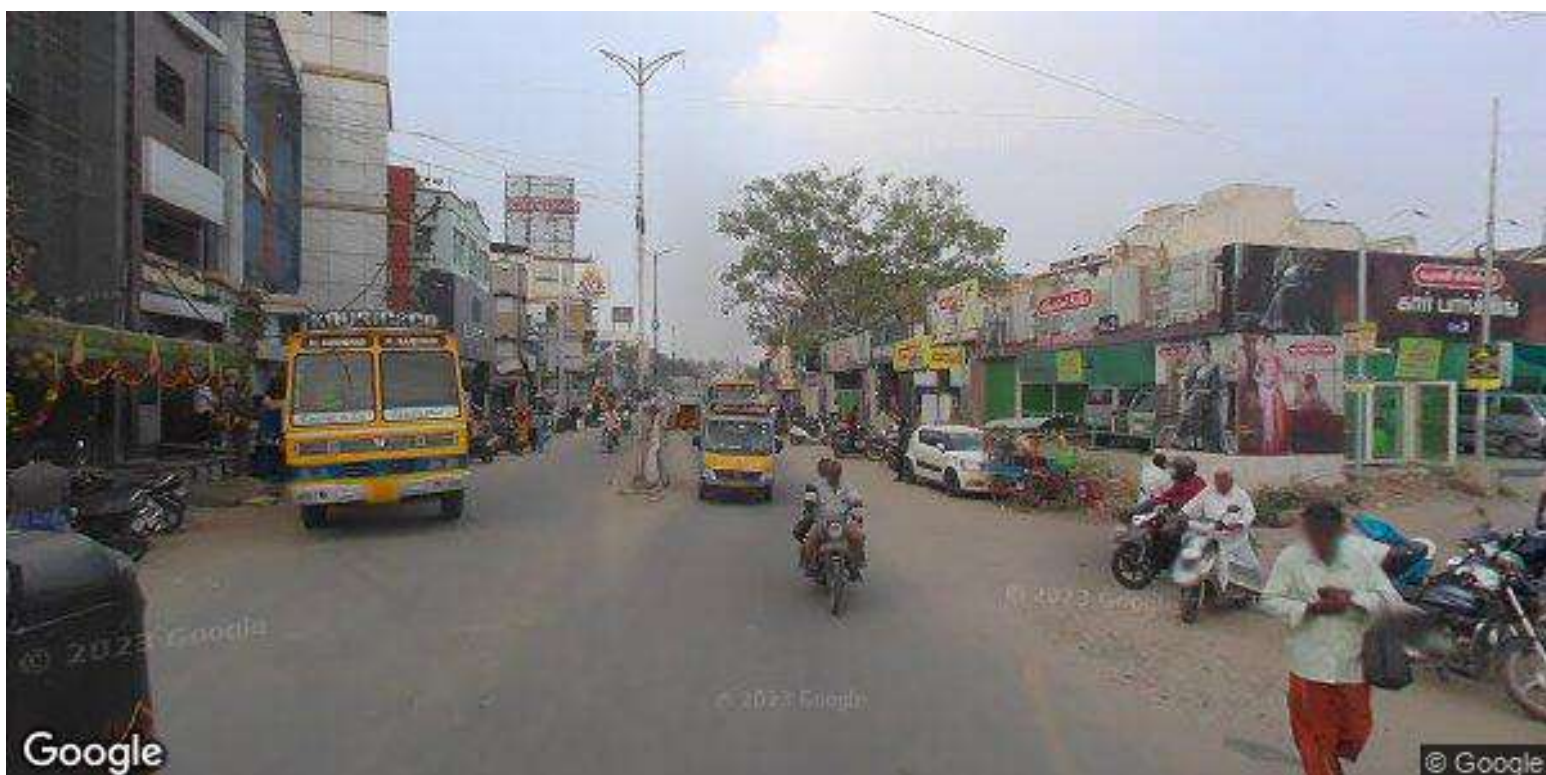
**Coordinates: 11.34487, 77.73024**

**Risk Type: Turn**

**Risk Level: Medium**

**Speed Limit: 30 KM/Hr**

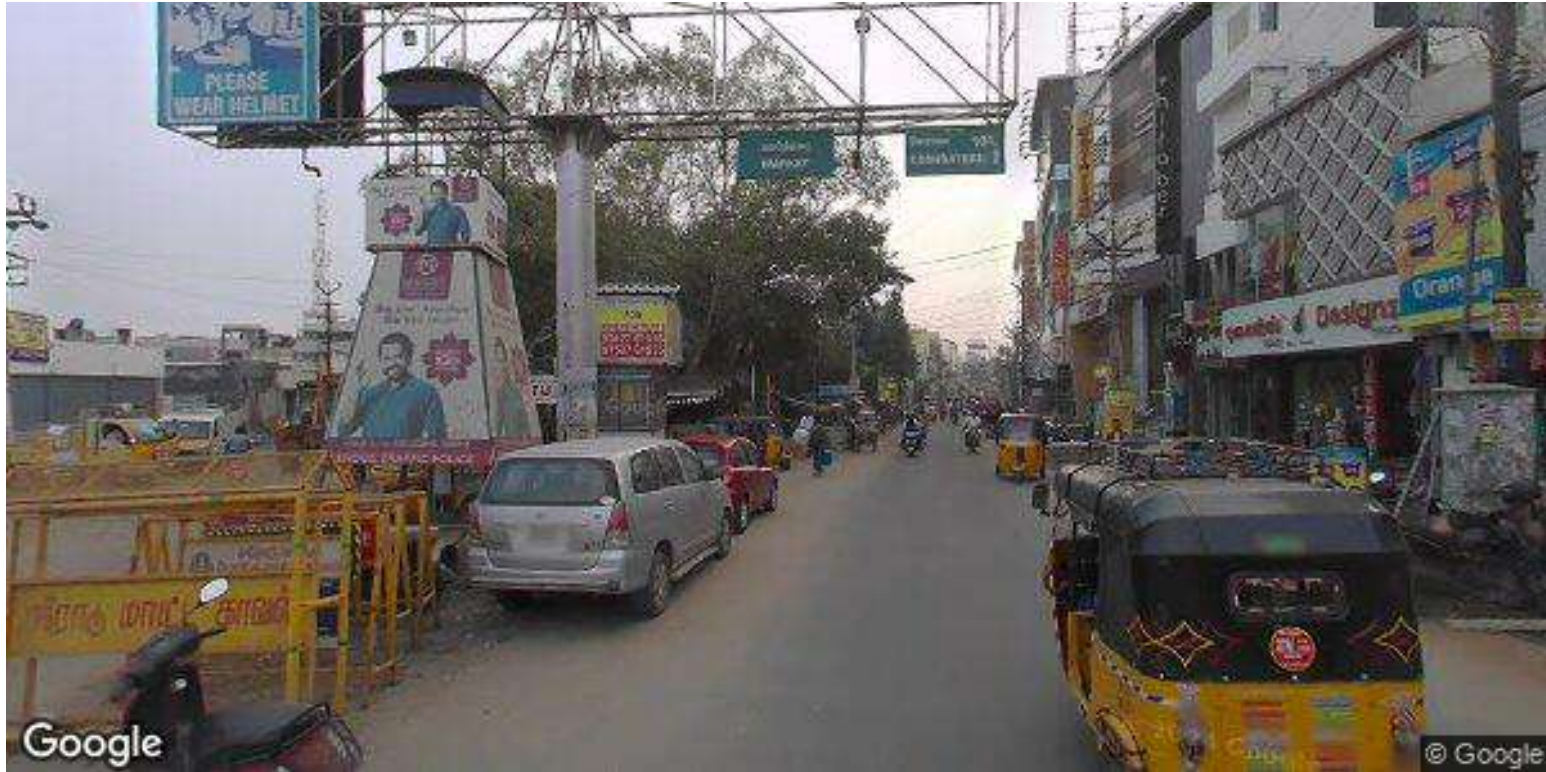
**Coordinates: 11.34470, 77.73018**

**Risk Type: Turn**

**Risk Level: Medium**

**Speed Limit: 30 KM/Hr**

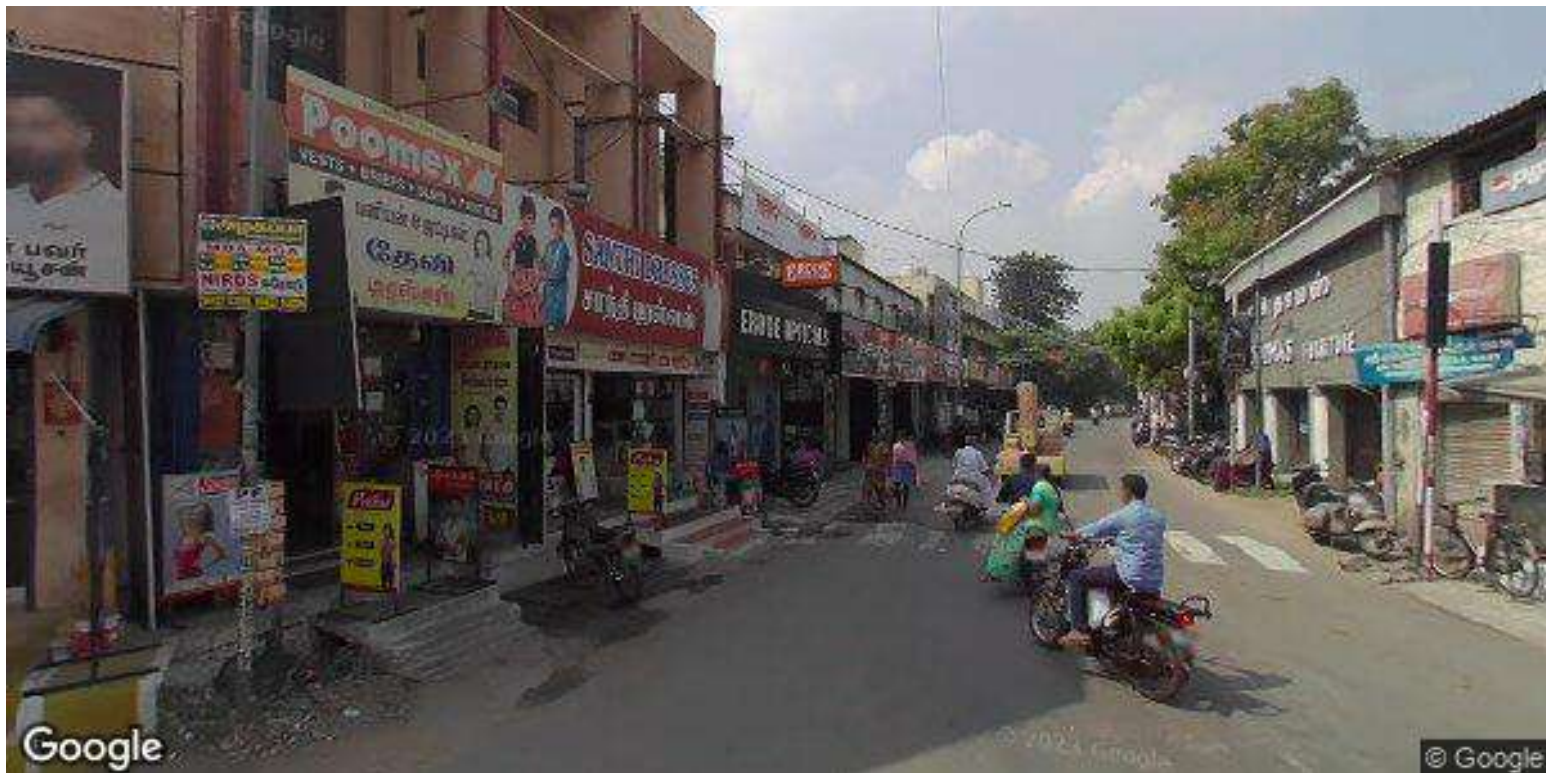
**Coordinates: 11.33920, 77.72902**

**Risk Type: Blind Spot**

**Risk Level: Blind Spot**

**Speed Limit: 10 KM/Hr**

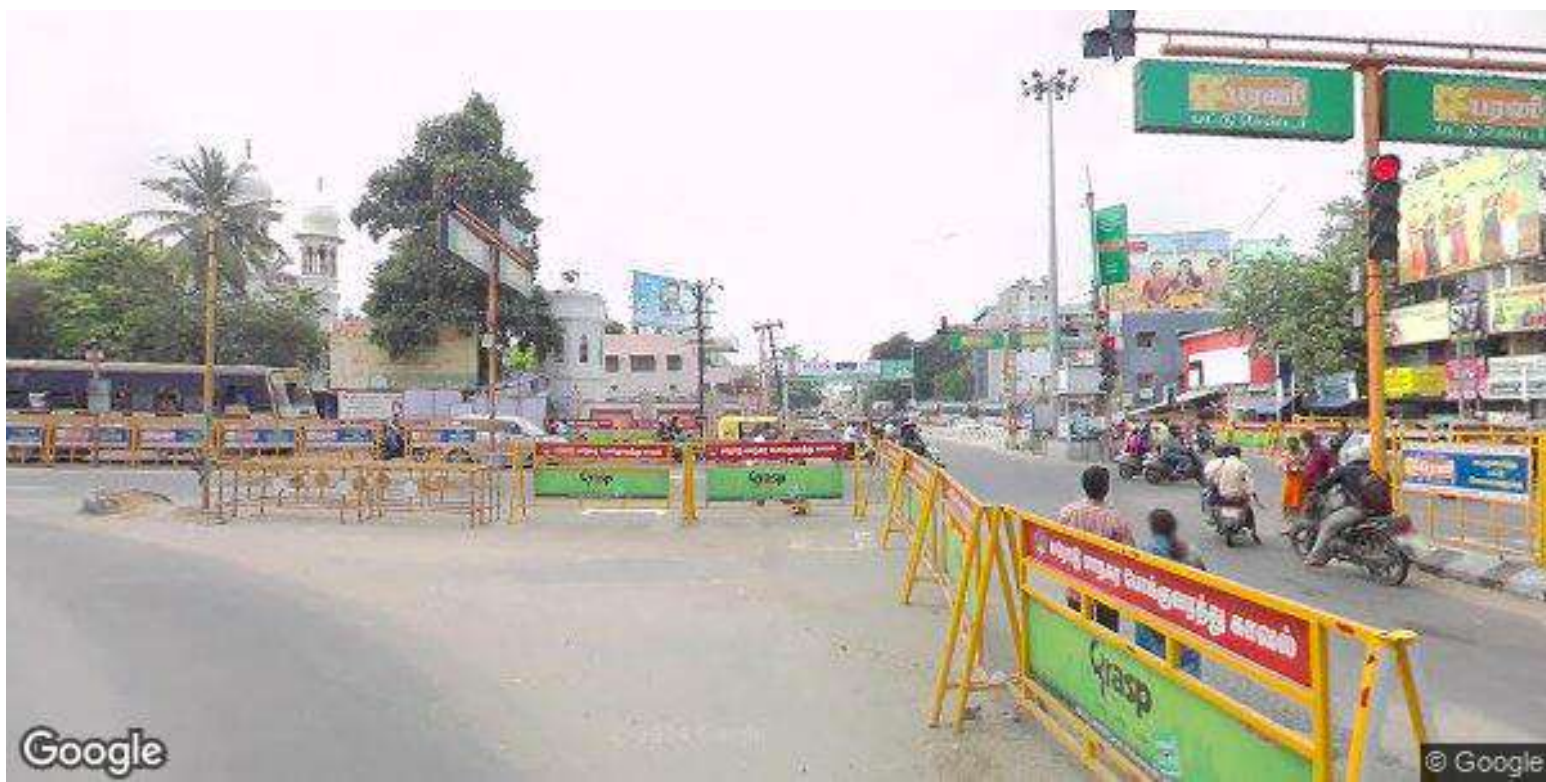
Coordinates: 11.33914, 77.72659

Risk Type: Turn

Risk Level: High

Speed Limit: 15 KM/Hr

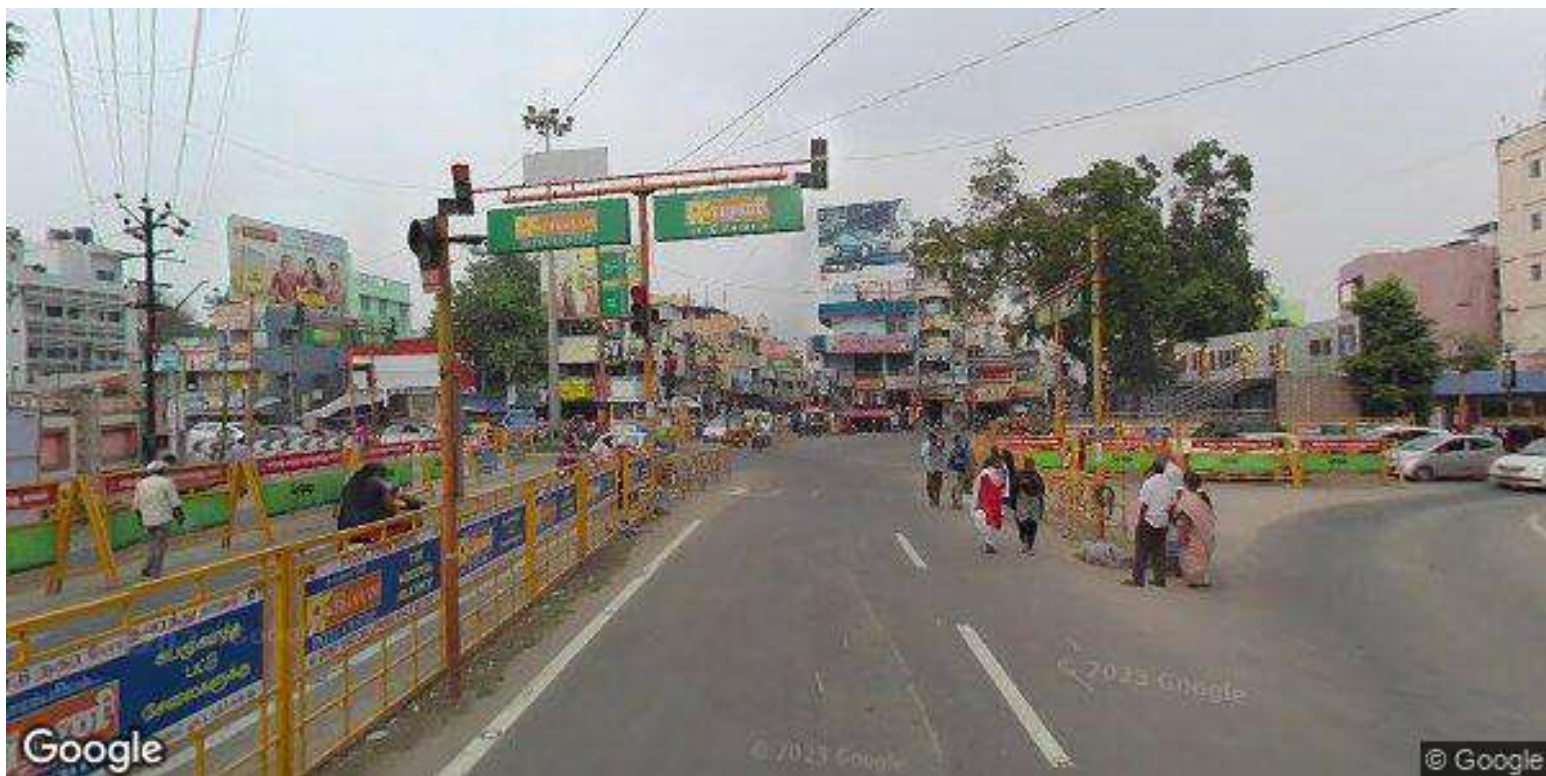
Coordinates: 11.33890, 77.72637

Risk Type: Turn

Risk Level: High

Speed Limit: 15 KM/Hr

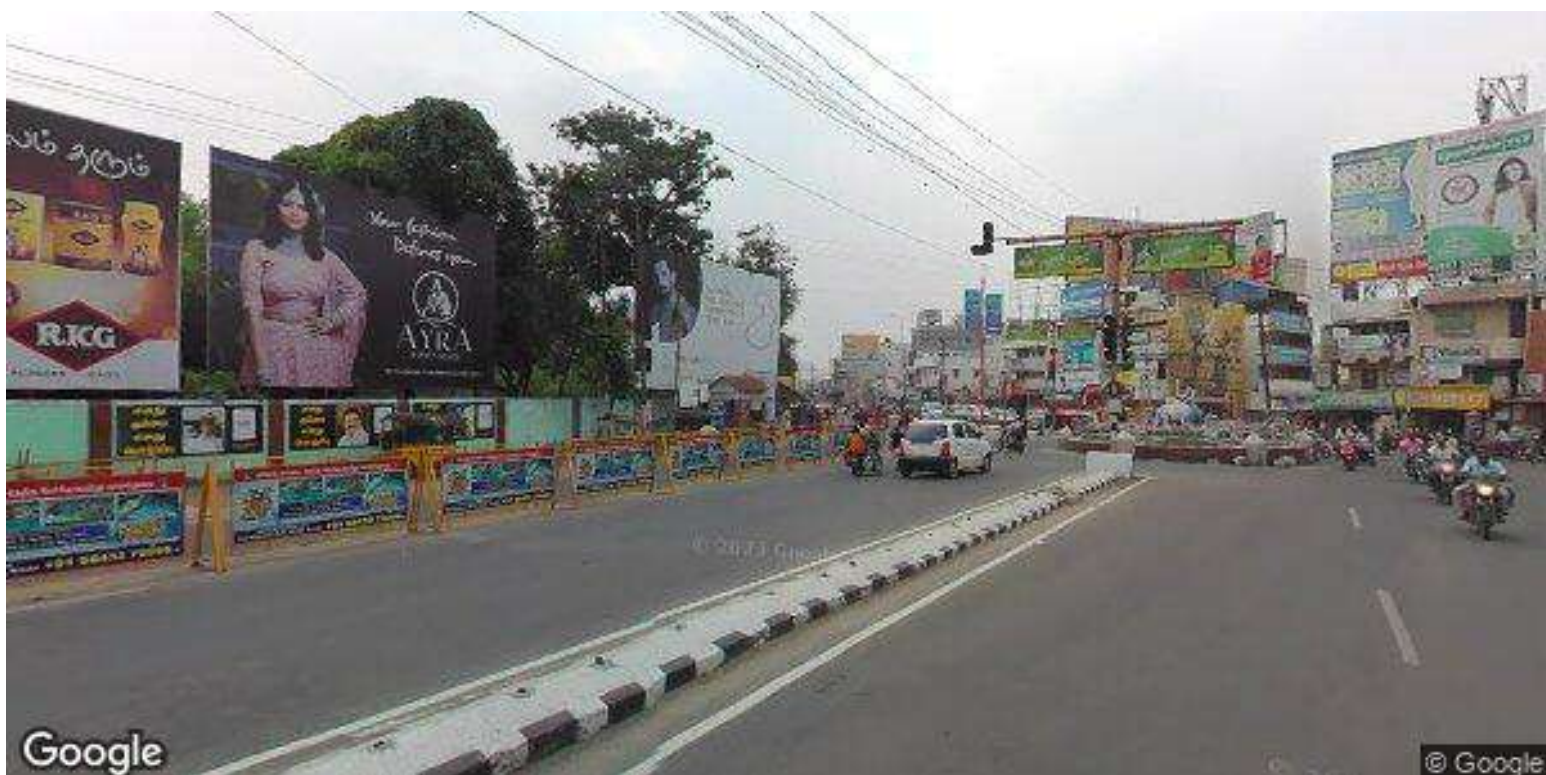
**Risk Type:** Turn  
**Risk Level:** Medium  
**Speed Limit:** 30 KM/Hr  
**Coordinates:** 11.33093, 77.72776

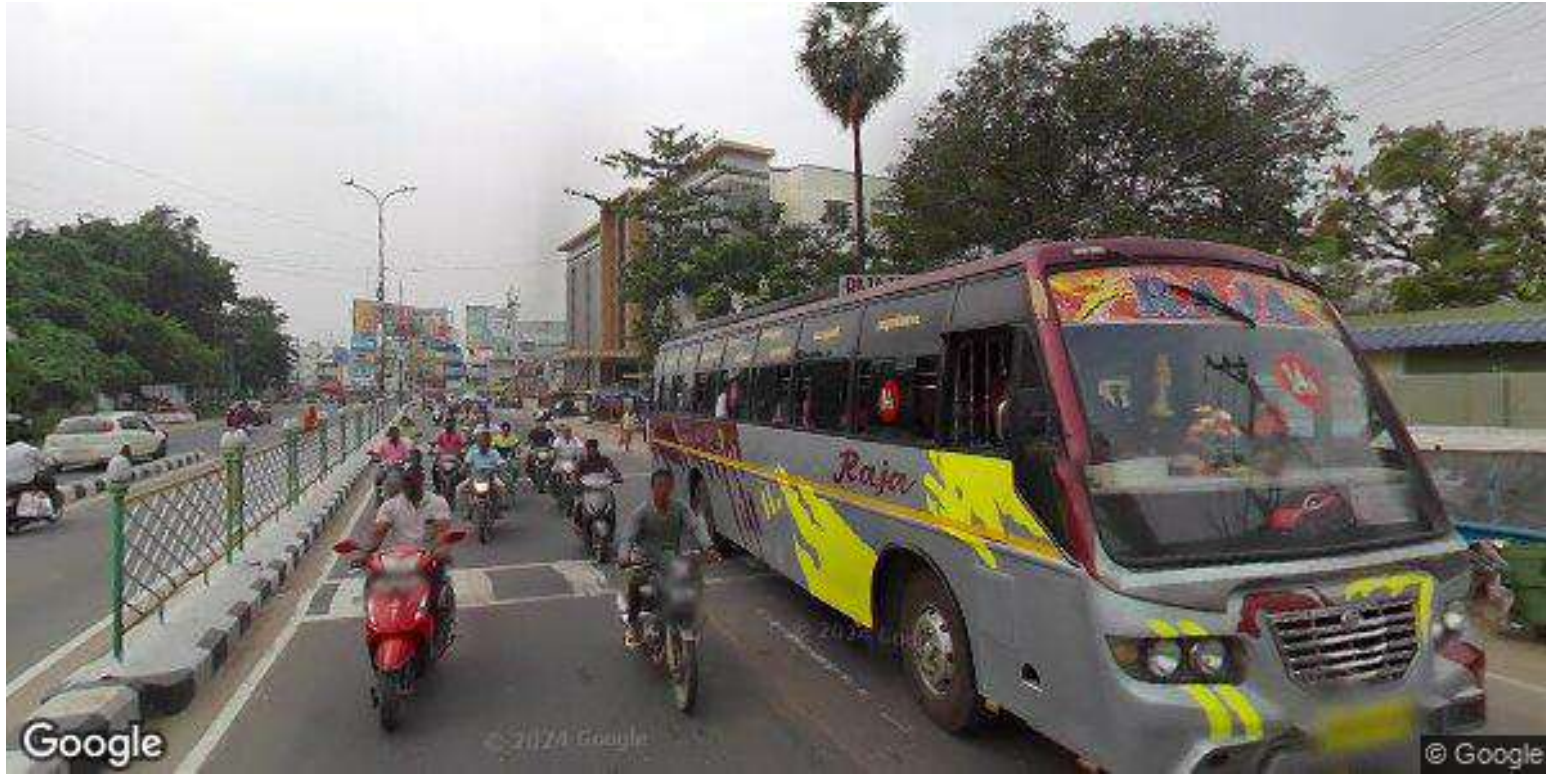
**Risk Type:** Turn  
**Risk Level:** Medium  
**Speed Limit:** 30 KM/Hr  
**Coordinates:** 11.33083, 77.72873

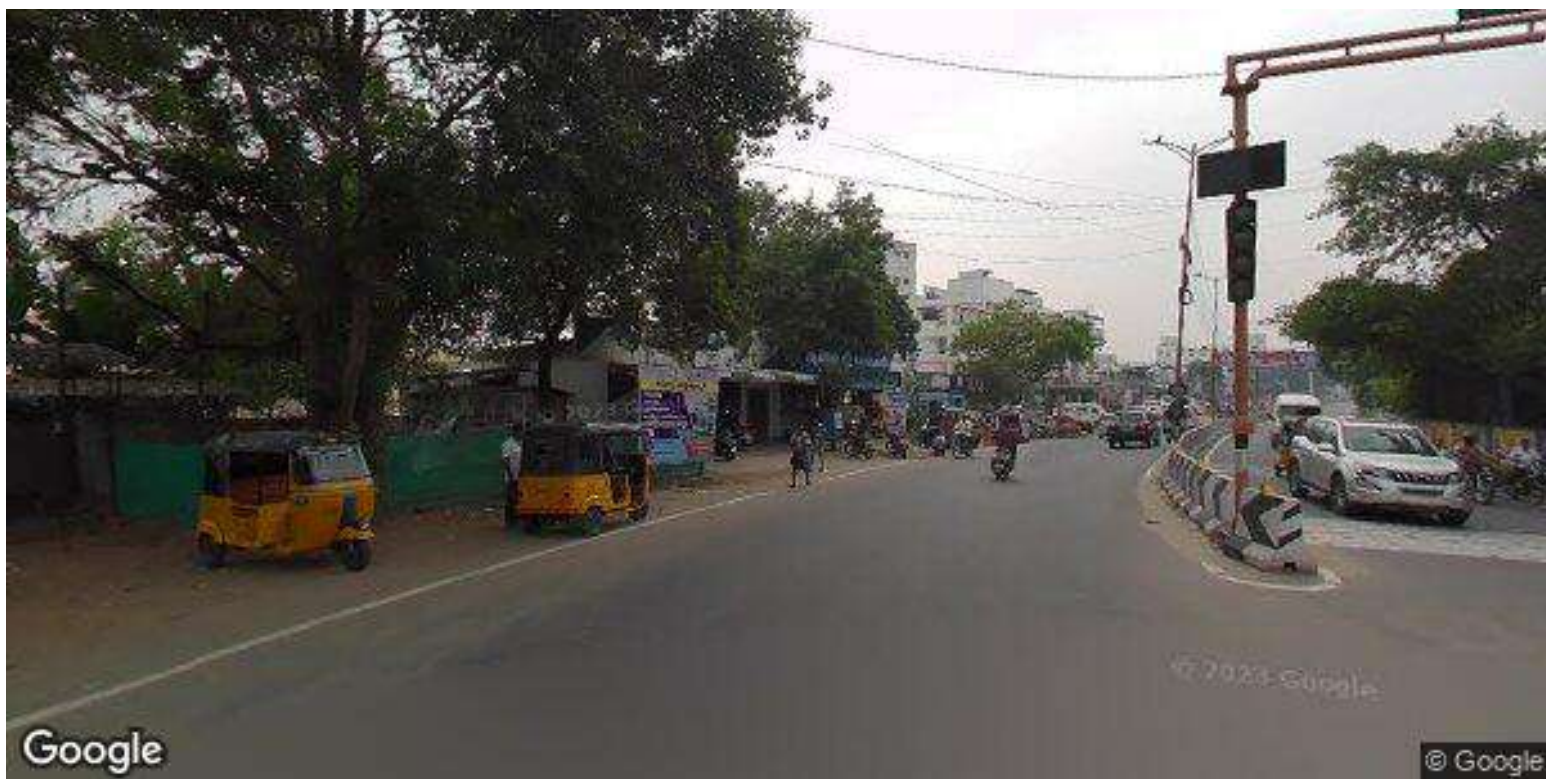
**Risk Type:** Turn  
**Risk Level:** High  
**Speed Limit:** 15 KM/Hr  
**Coordinates:** 11.32694, 77.73073
