# IndianOil

## JOURNEY RISK MANAGEMENT (JRM) STUDY

### Salem Terminal to A.GEE.FUELS

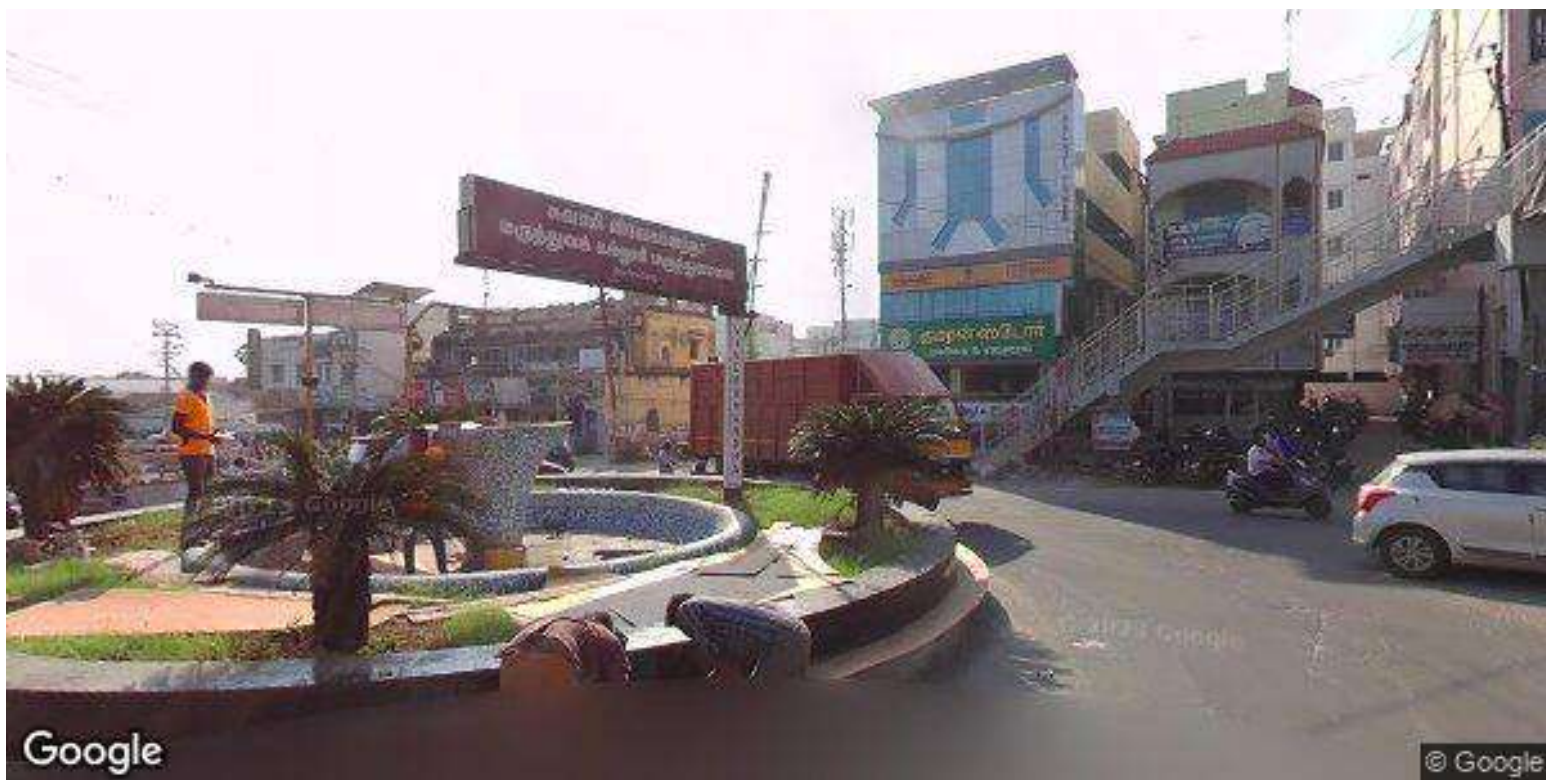
**Coordinates:** 11.38395, 77.89480

**Risk Type:** Roundabout

**Risk Level:** High

**Speed Limit:** 15 KM/Hr

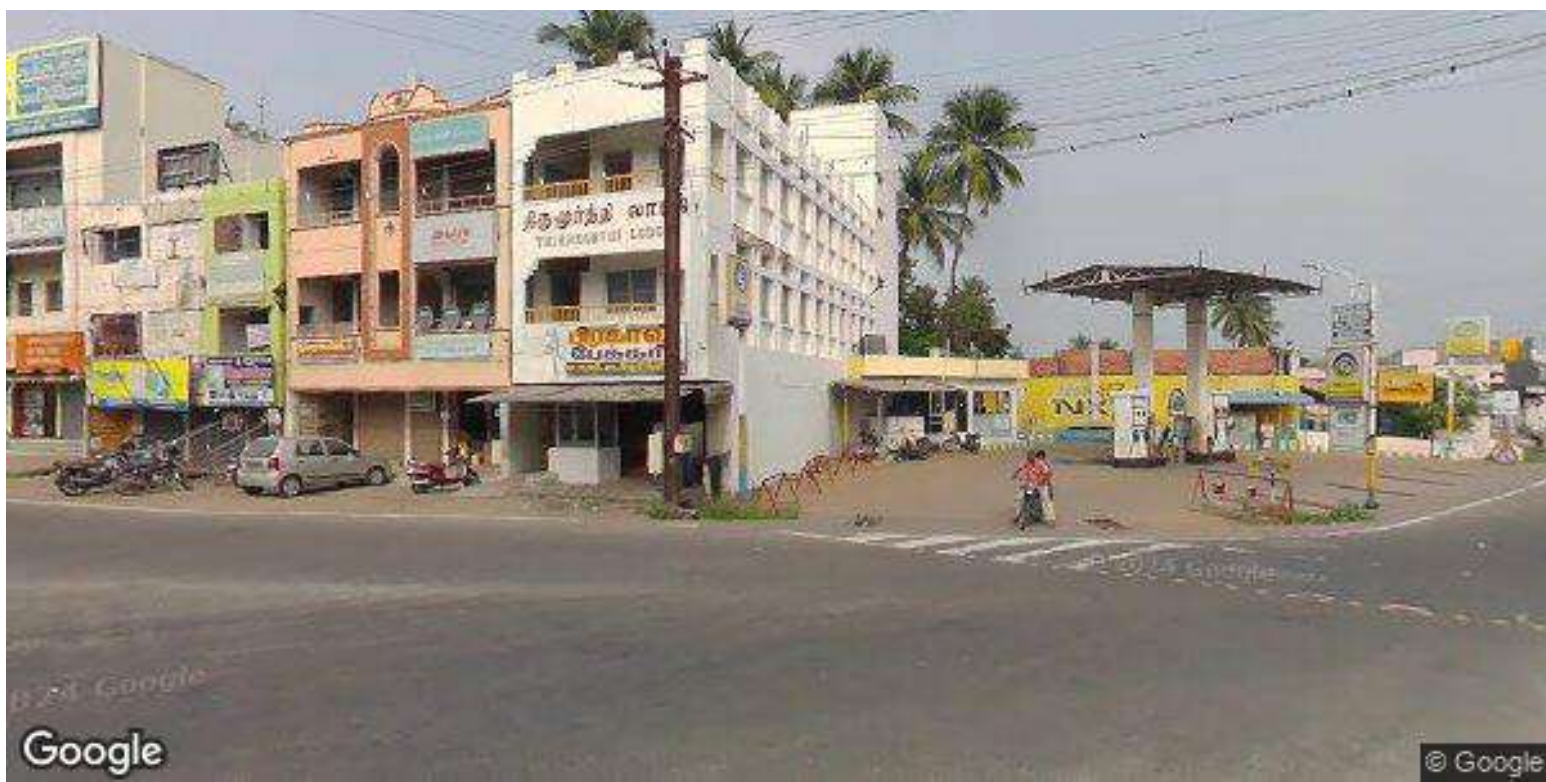
**Coordinates:** 11.00172, 77.56268

**Risk Type:** Roundabout

**Risk Level:** High

**Speed Limit:** 15 KM/Hr

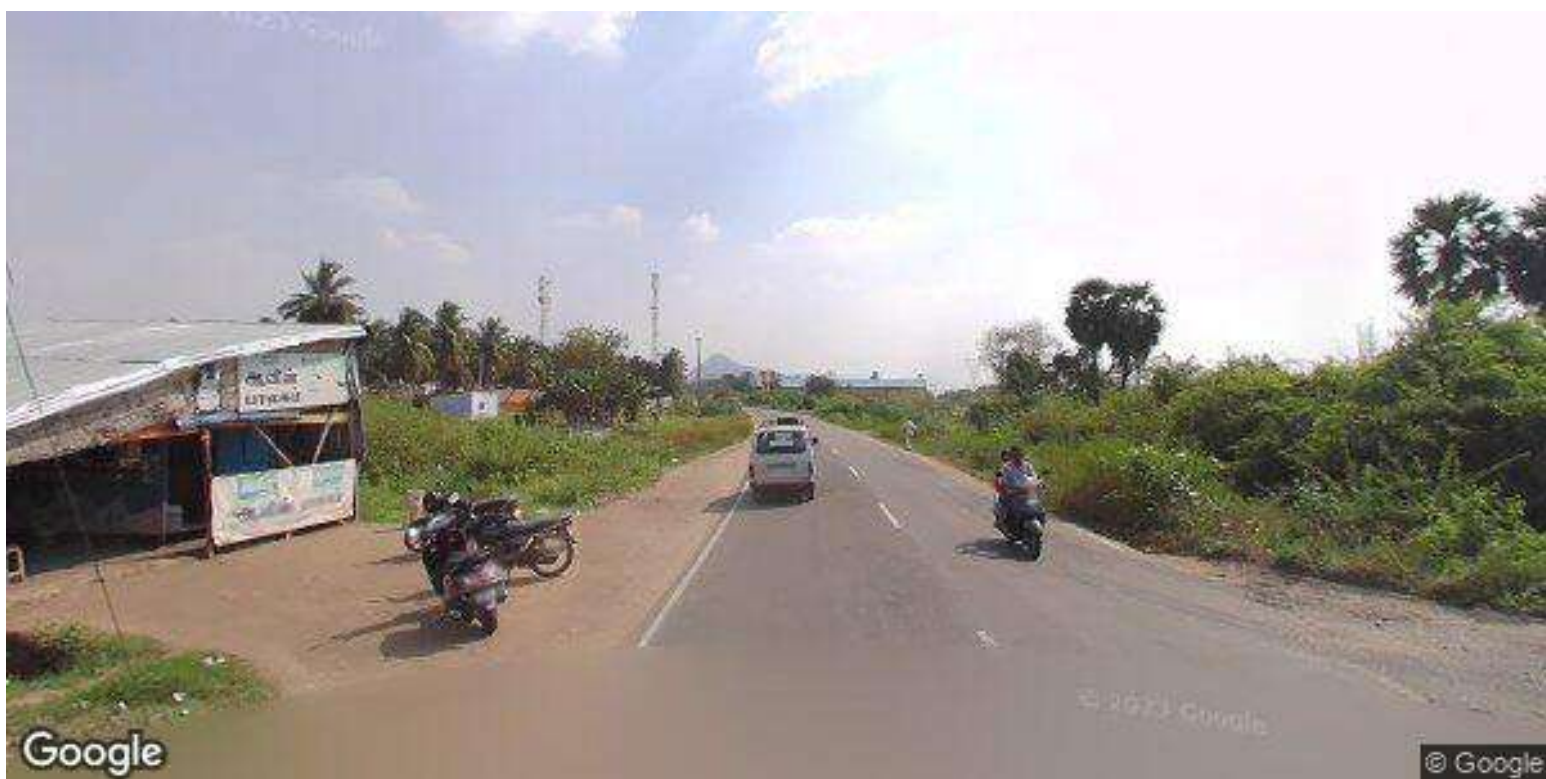
**Coordinates:** 11.44022, 77.87546

**Risk Type:** Turn

**Risk Level:** High

**Speed Limit:** 15 KM/Hr

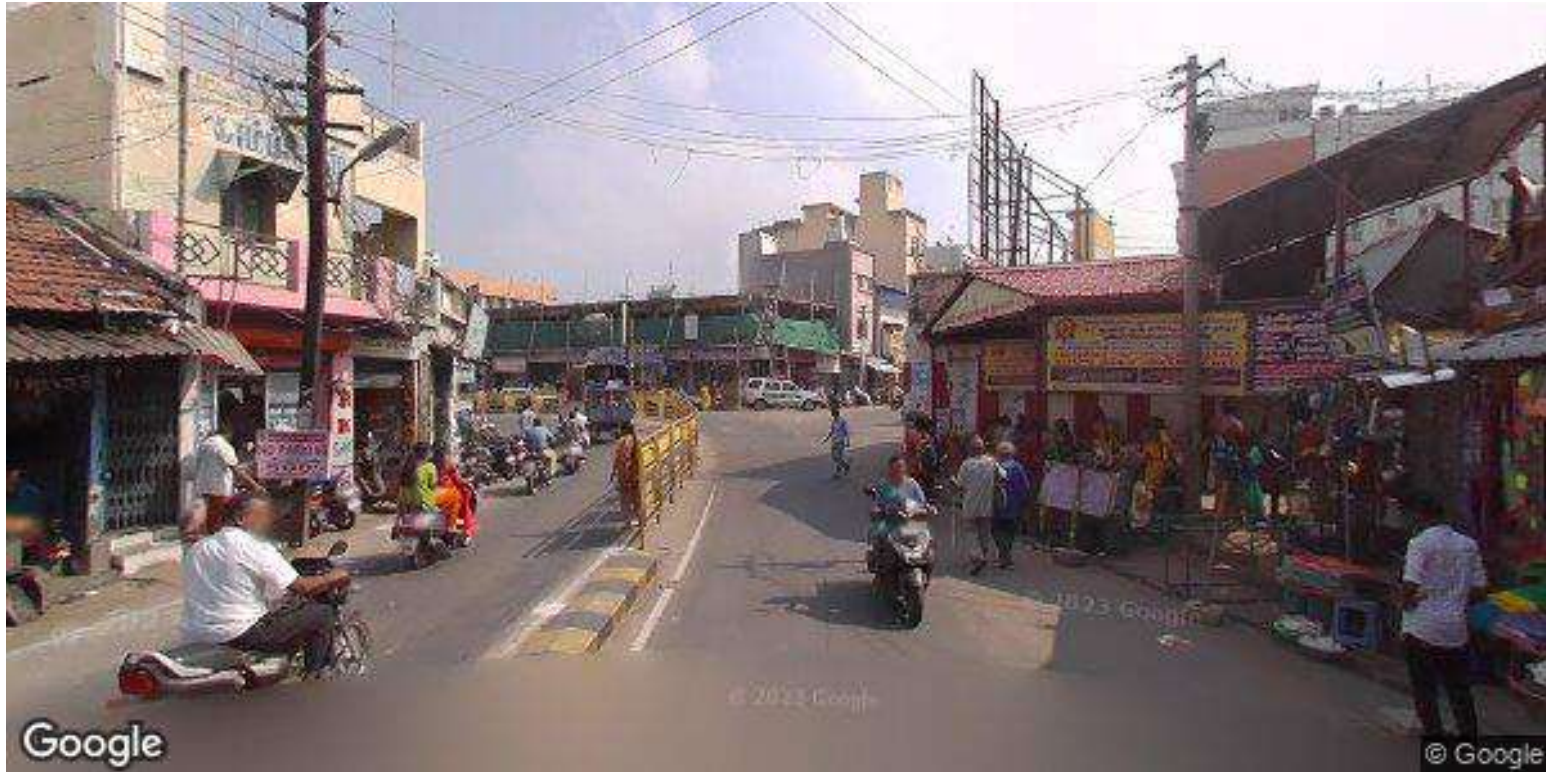
**Risk Type:** Turn  
**Risk Level:** Medium  
**Speed Limit:** 30 KM/Hr  
**Coordinates:** 11.37857, 77.89473

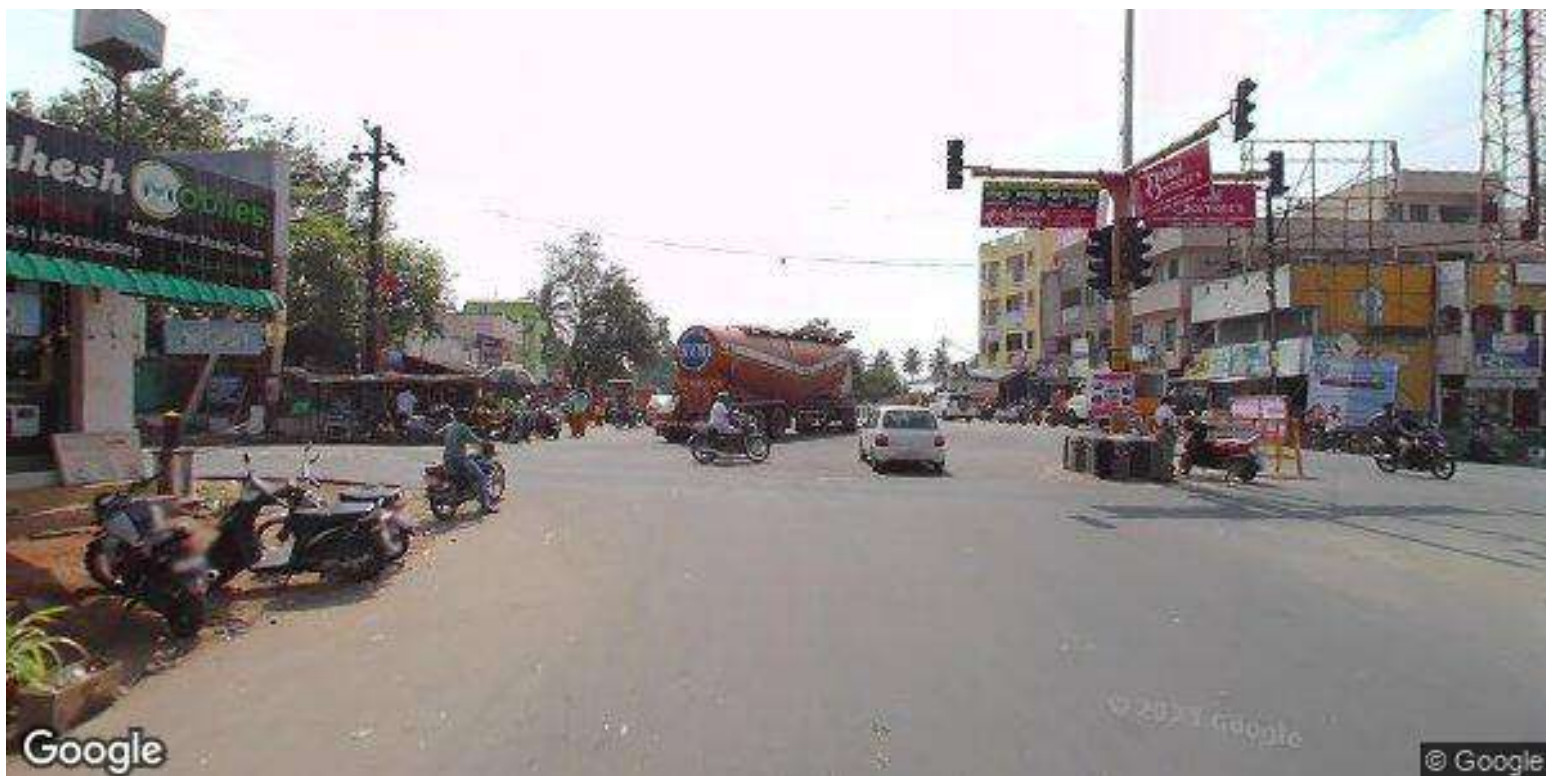
**Risk Type:** Turn  
**Risk Level:** High  
**Speed Limit:** 15 KM/Hr  
**Coordinates:** 11.36616, 77.88885

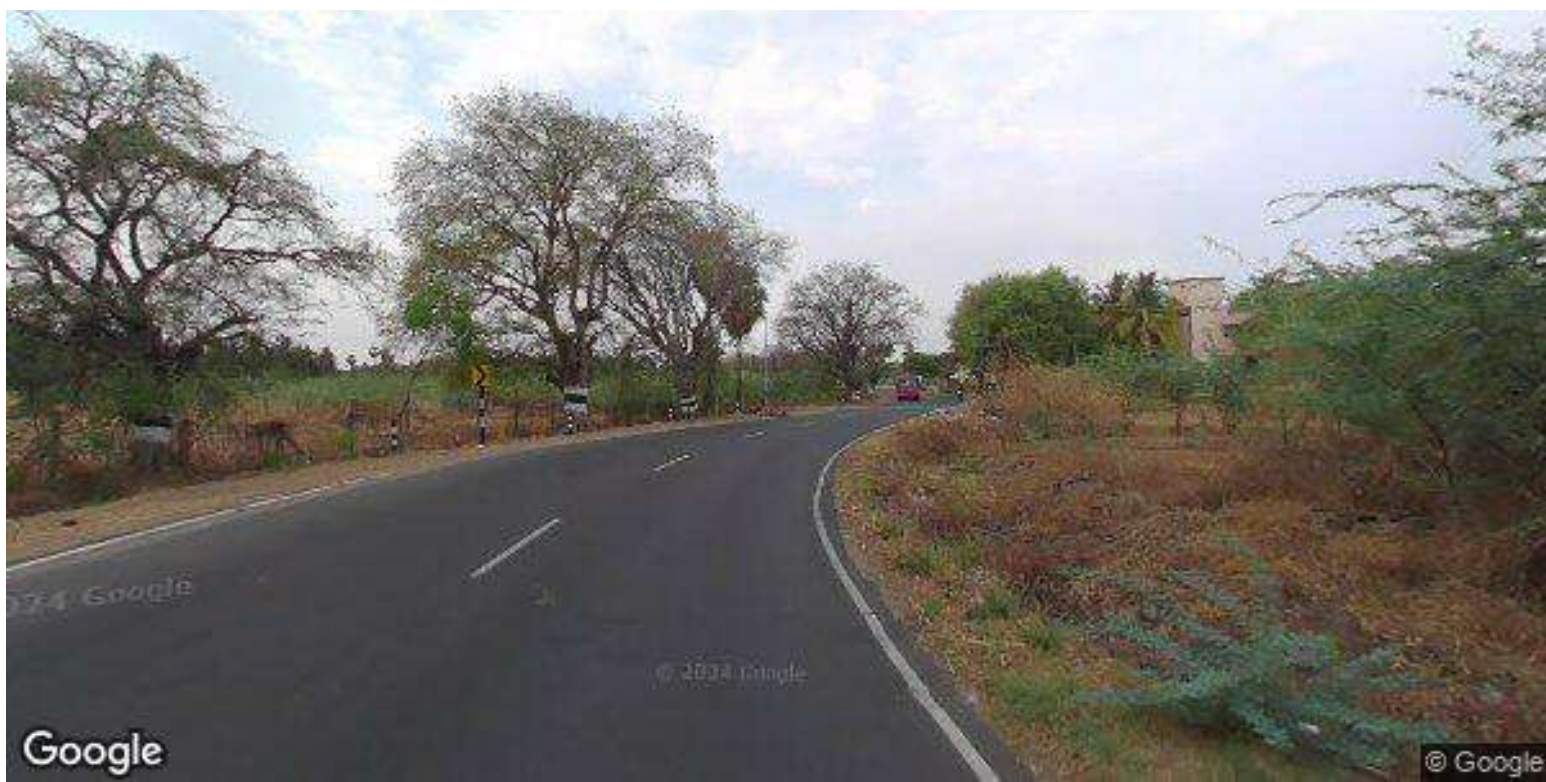
**Coordinates:** 11.34067, 77.86347

**Risk Type:** Turn

**Risk Level:** Medium

**Speed Limit:** 30 KM/Hr

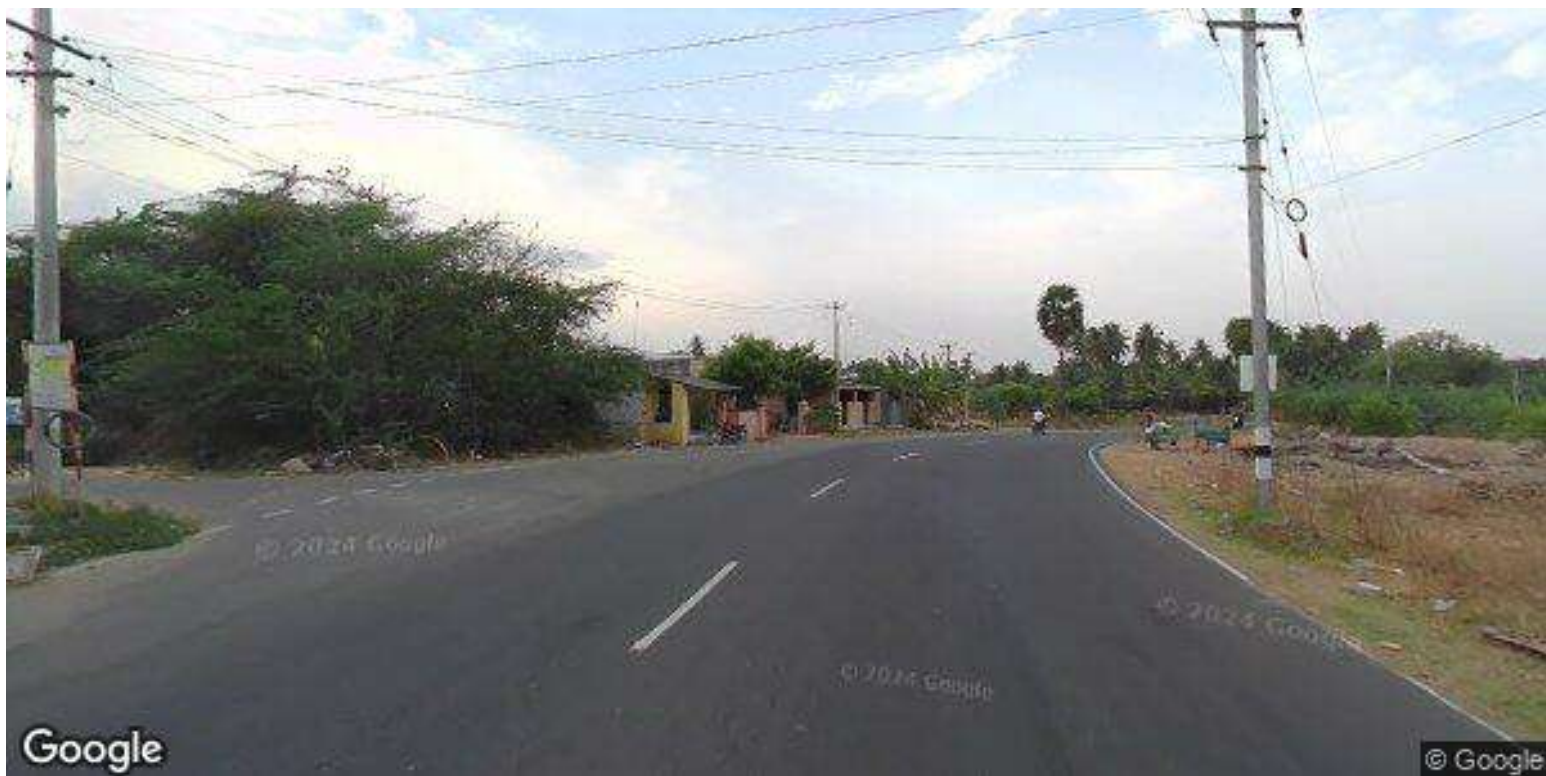
**Coordinates:** 11.33854, 77.86216

**Risk Type:** Turn

**Risk Level:** Medium

**Speed Limit:** 30 KM/Hr

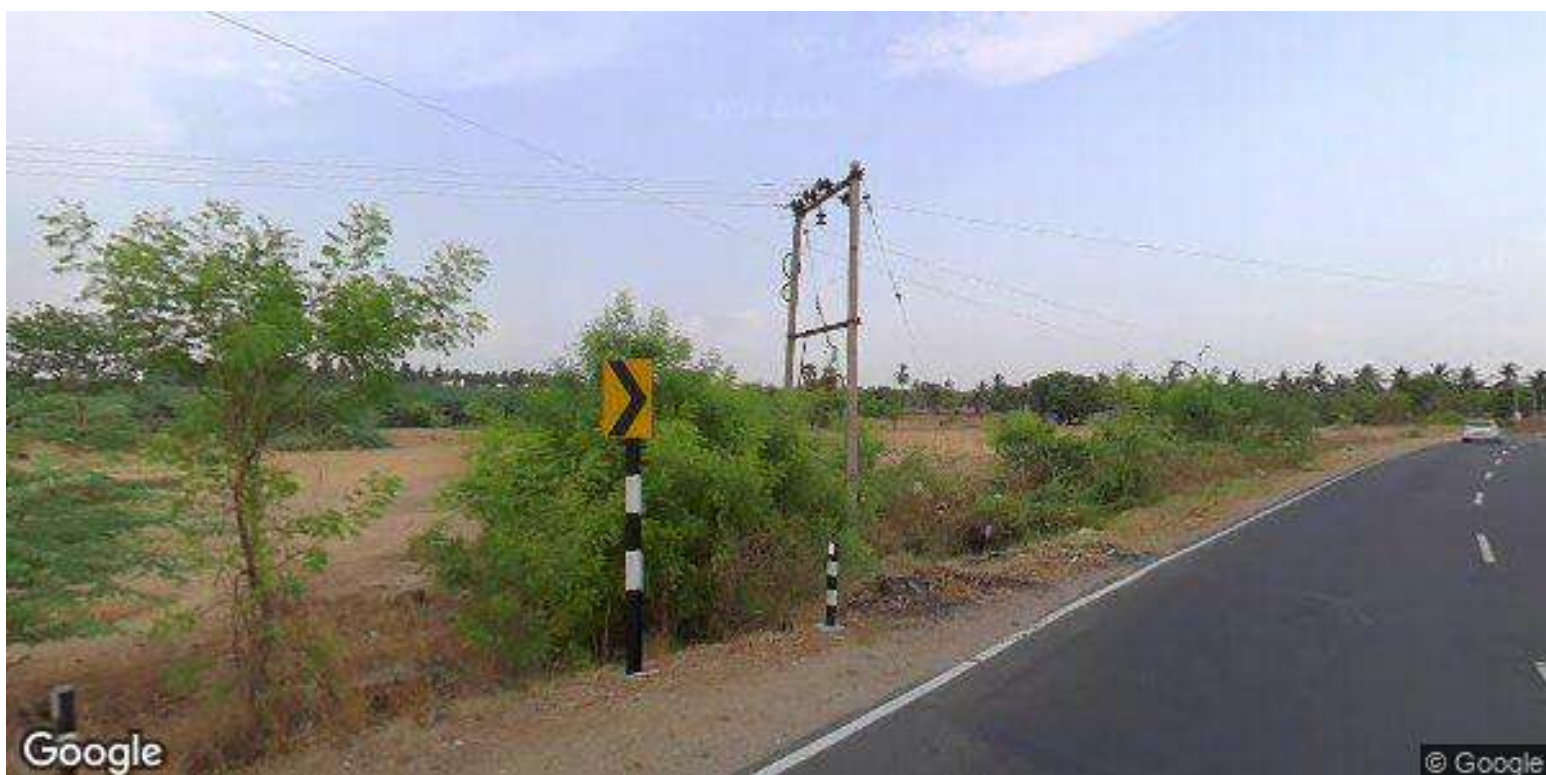
**Coordinates:** 11.33778, 77.86236

**Risk Type:** Turn

**Risk Level:** Medium

**Speed Limit:** 30 KM/Hr

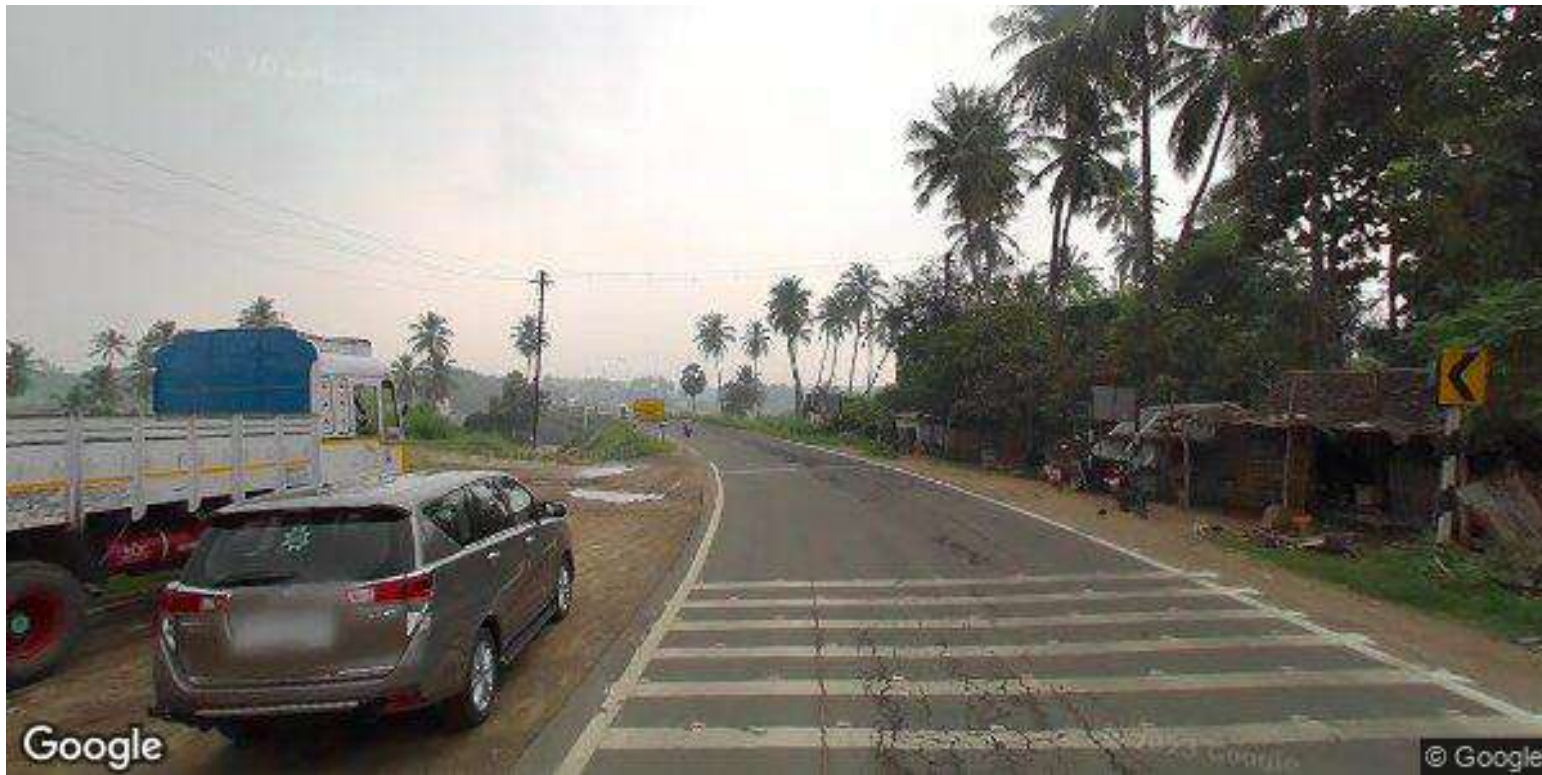
**Coordinates:** 11.30952, 77.77587

**Risk Type:** Turn

**Risk Level:** Medium

**Speed Limit:** 30 KM/Hr

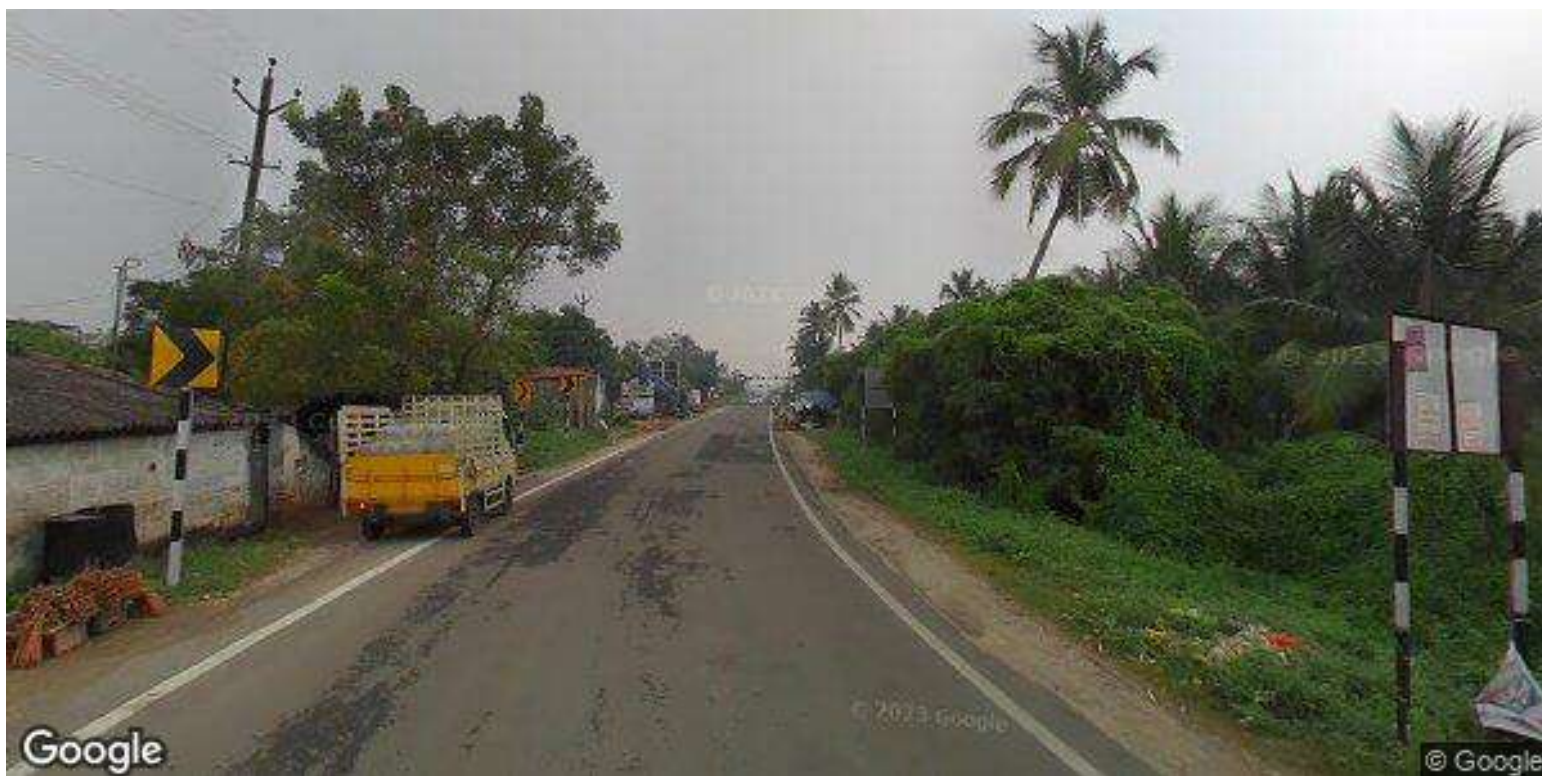
**Coordinates:** 11.30973, 77.76712

**Risk Type:** Turn

**Risk Level:** Medium

**Speed Limit:** 30 KM/Hr

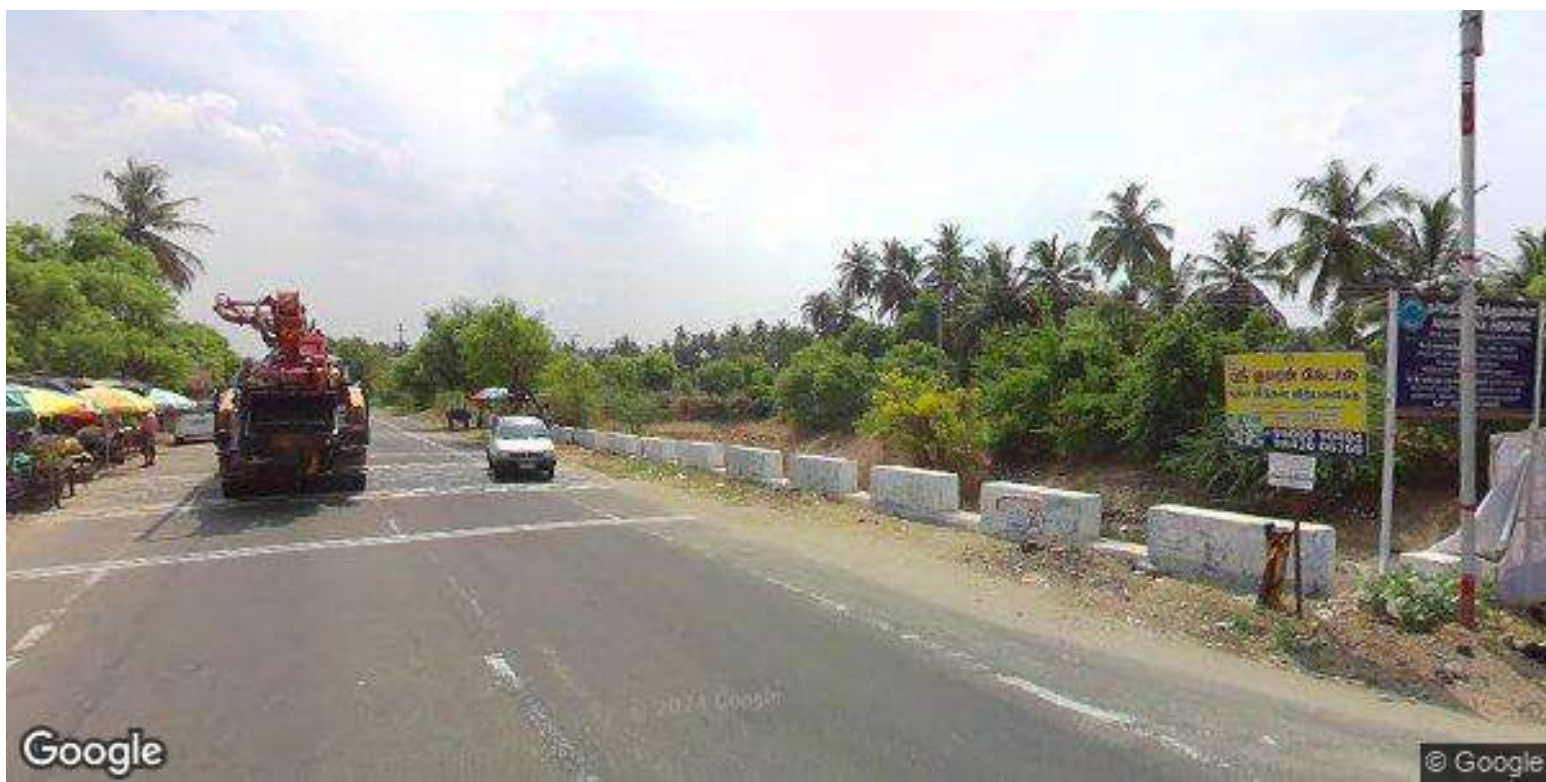
**Coordinates:** 11.29490, 77.74685

**Risk Type:** Turn

**Risk Level:** High

**Speed Limit:** 15 KM/Hr

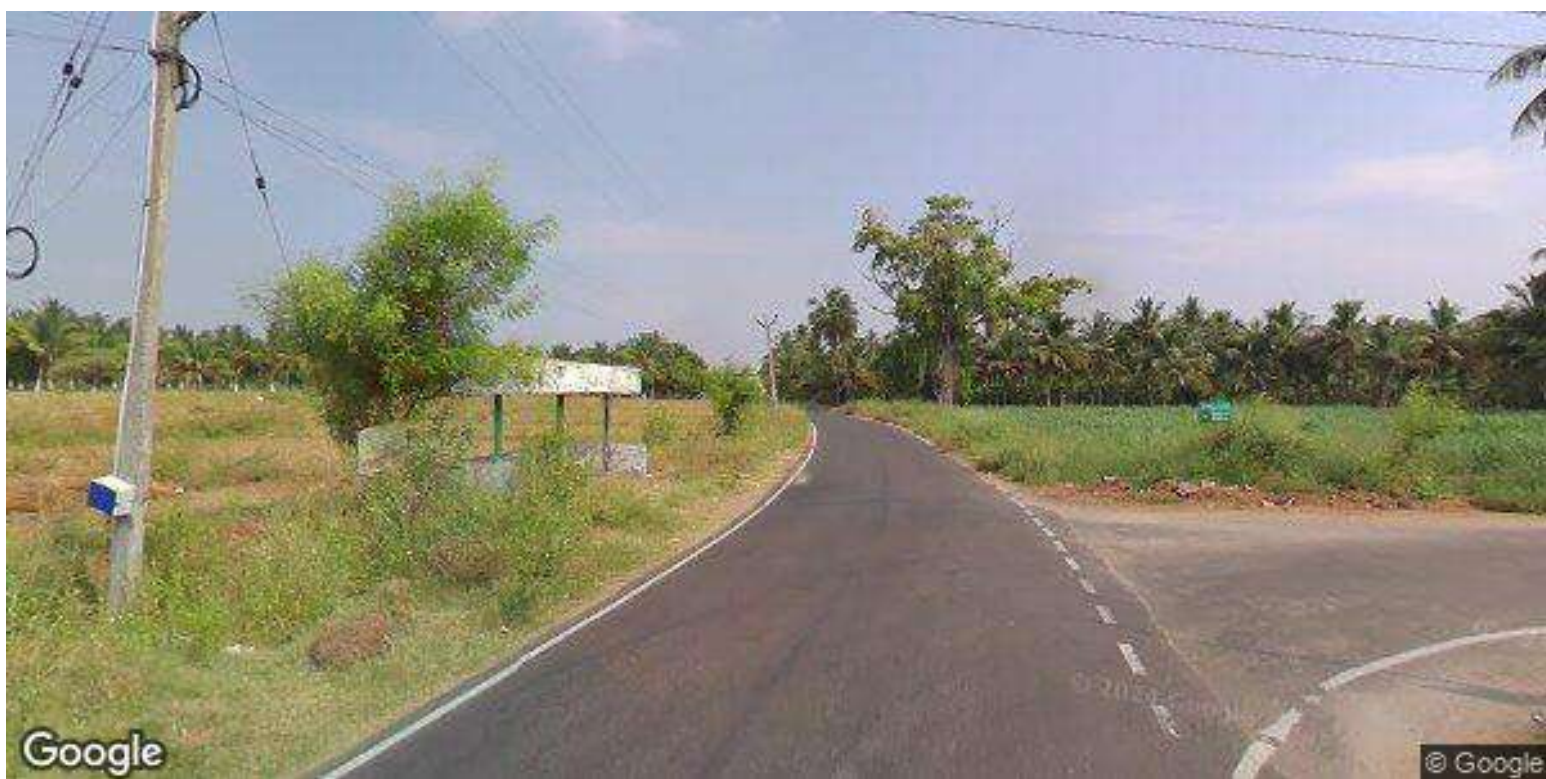
**Coordinates:** 11.29141, 77.74662

**Risk Type:** Turn

**Risk Level:** High

**Speed Limit:** 15 KM/Hr

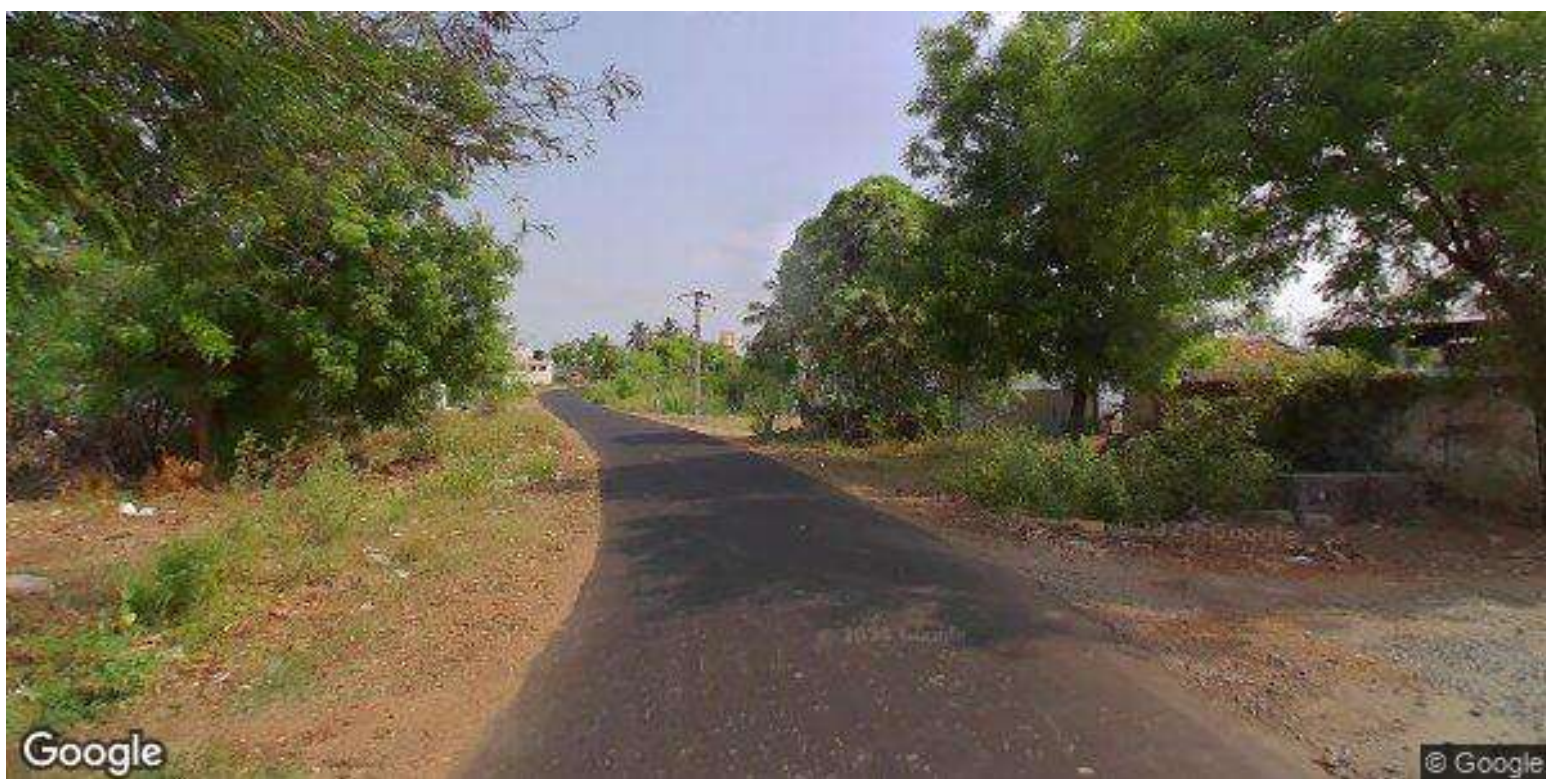
**Risk Type:** Turn  
**Risk Level:** Medium  
**Speed Limit:** 30 KM/Hr  
**Coordinates:** 11.28844, 77.74319

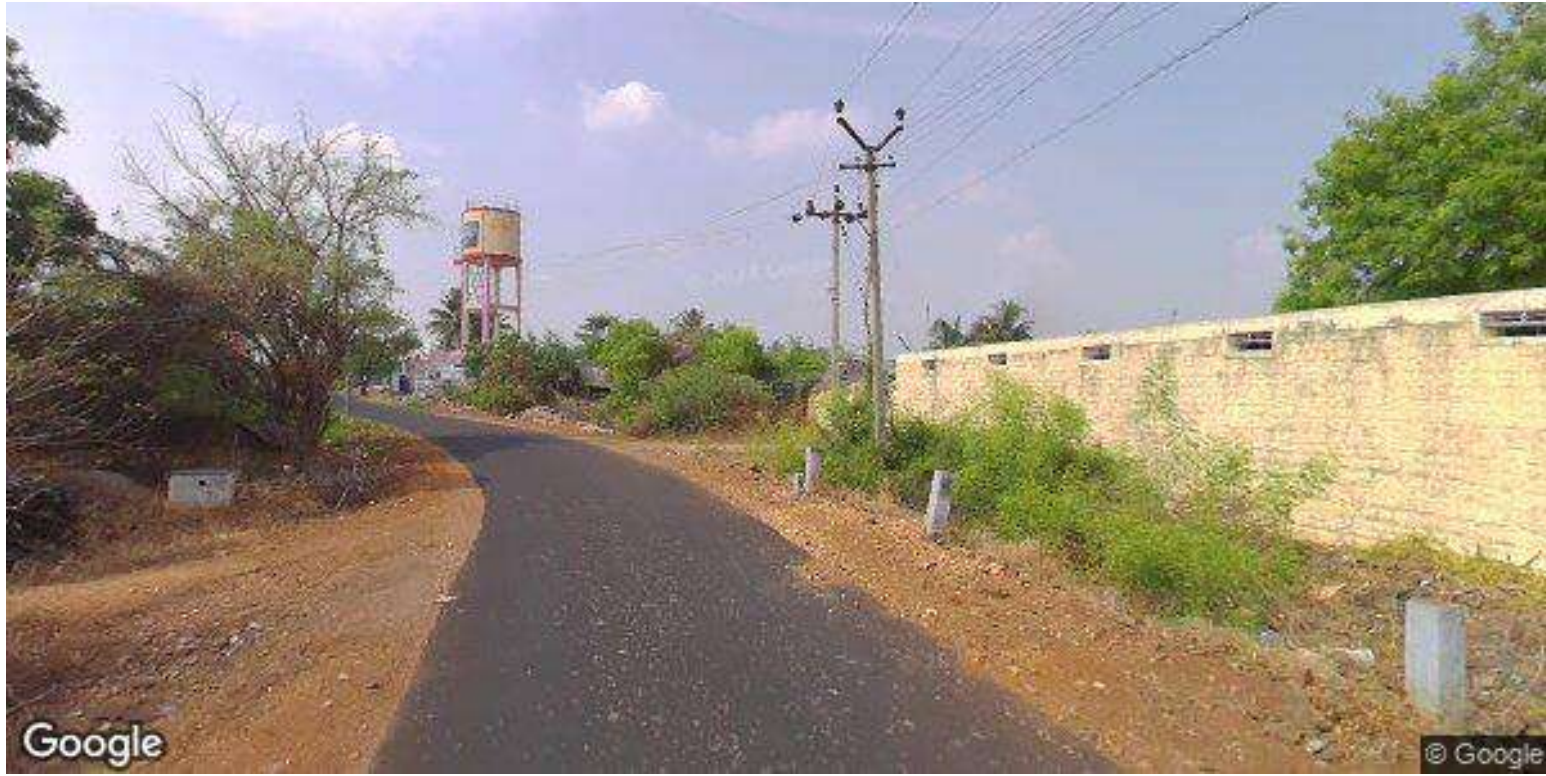
**Risk Type:** Turn  
**Risk Level:** Medium  
**Speed Limit:** 30 KM/Hr  
**Coordinates:** 11.28573, 77.74281

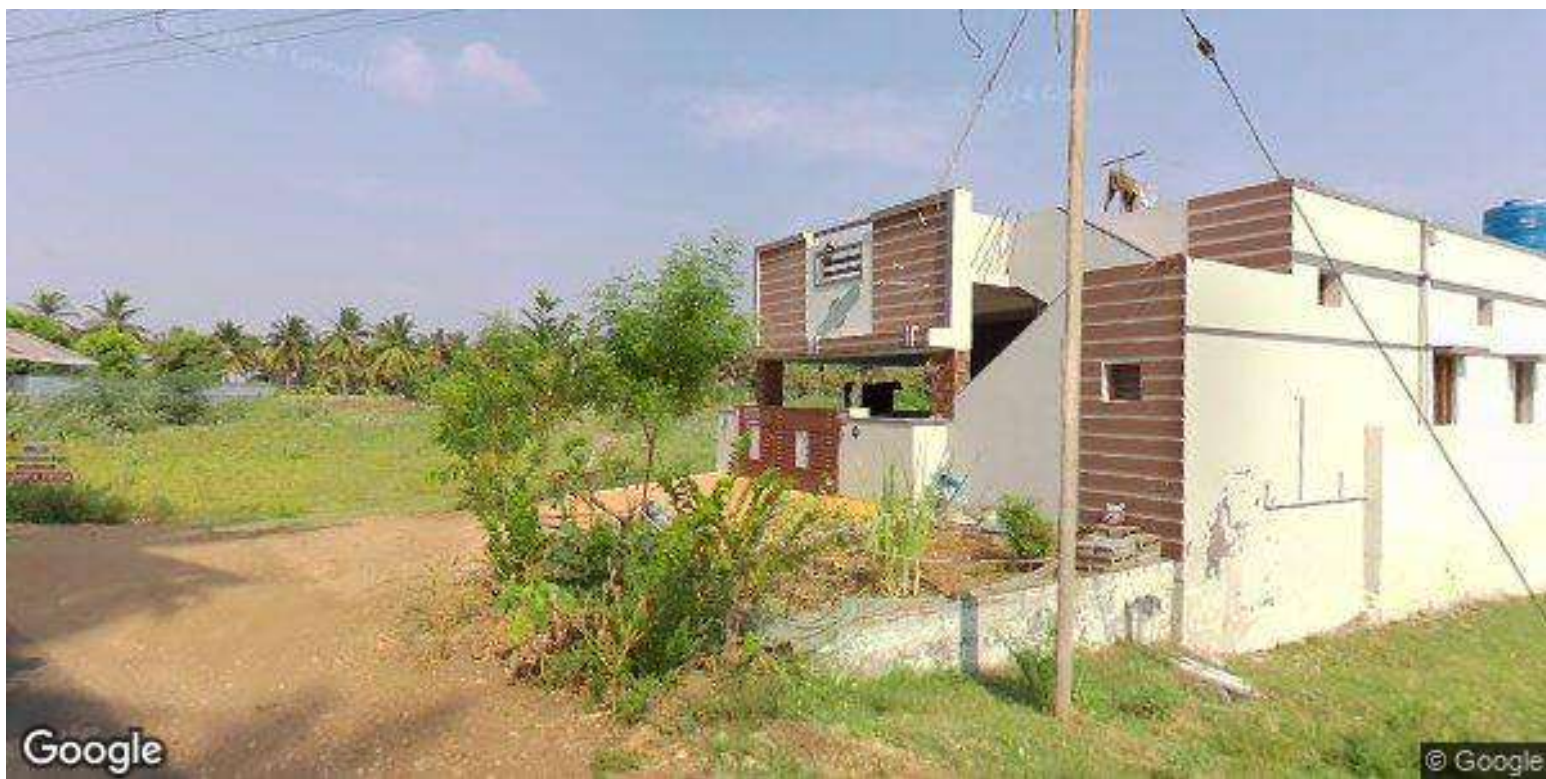
**Risk Type:** Turn  
**Risk Level:** High  
**Speed Limit:** 15 KM/Hr  
**Coordinates:** 11.27319, 77.72981

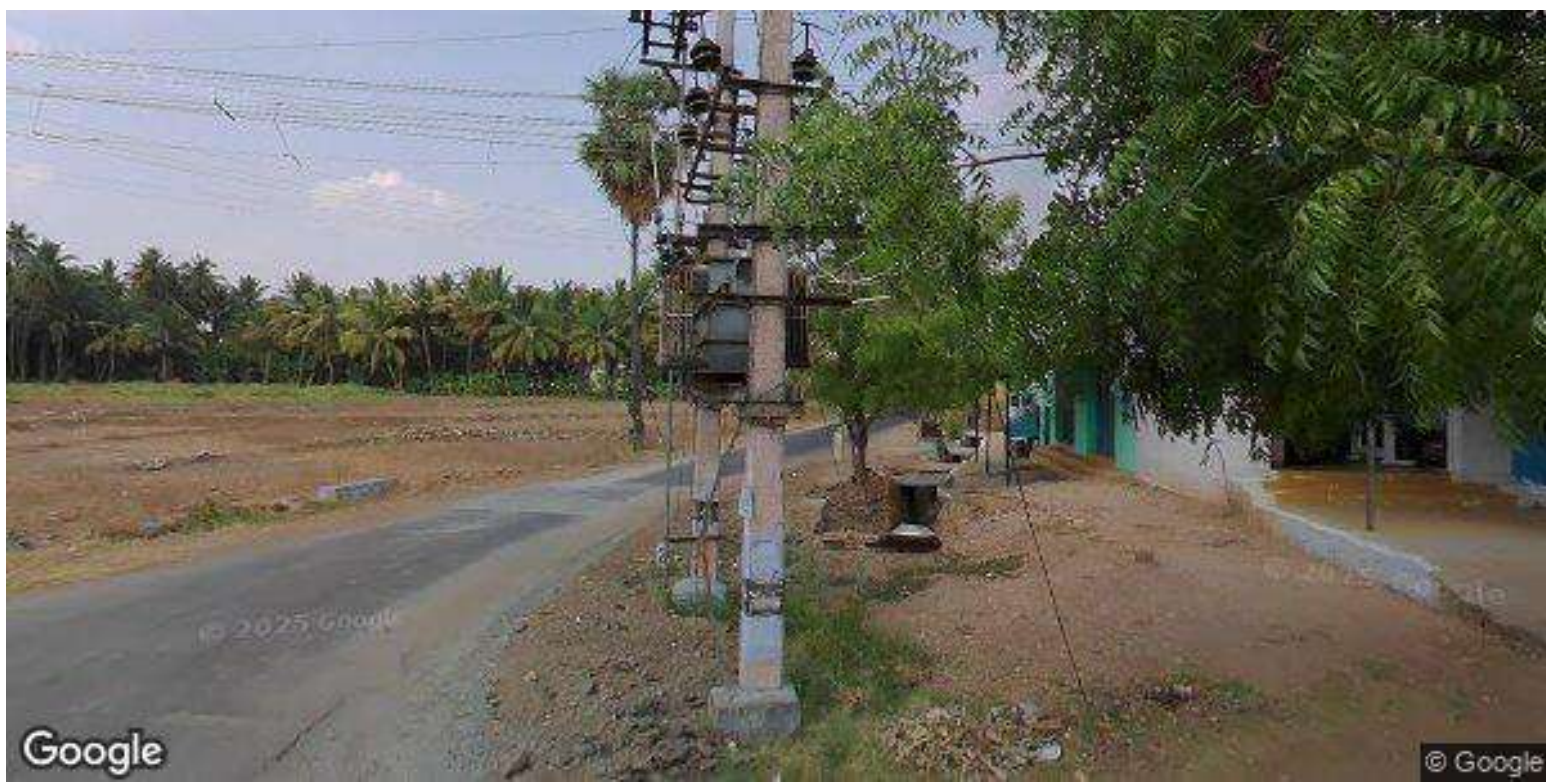
**Coordinates:** 11.27330, 77.72715

**Risk Type:** Blind Spot

**Risk Level:** Blind Spot

**Speed Limit:** 10 KM/Hr

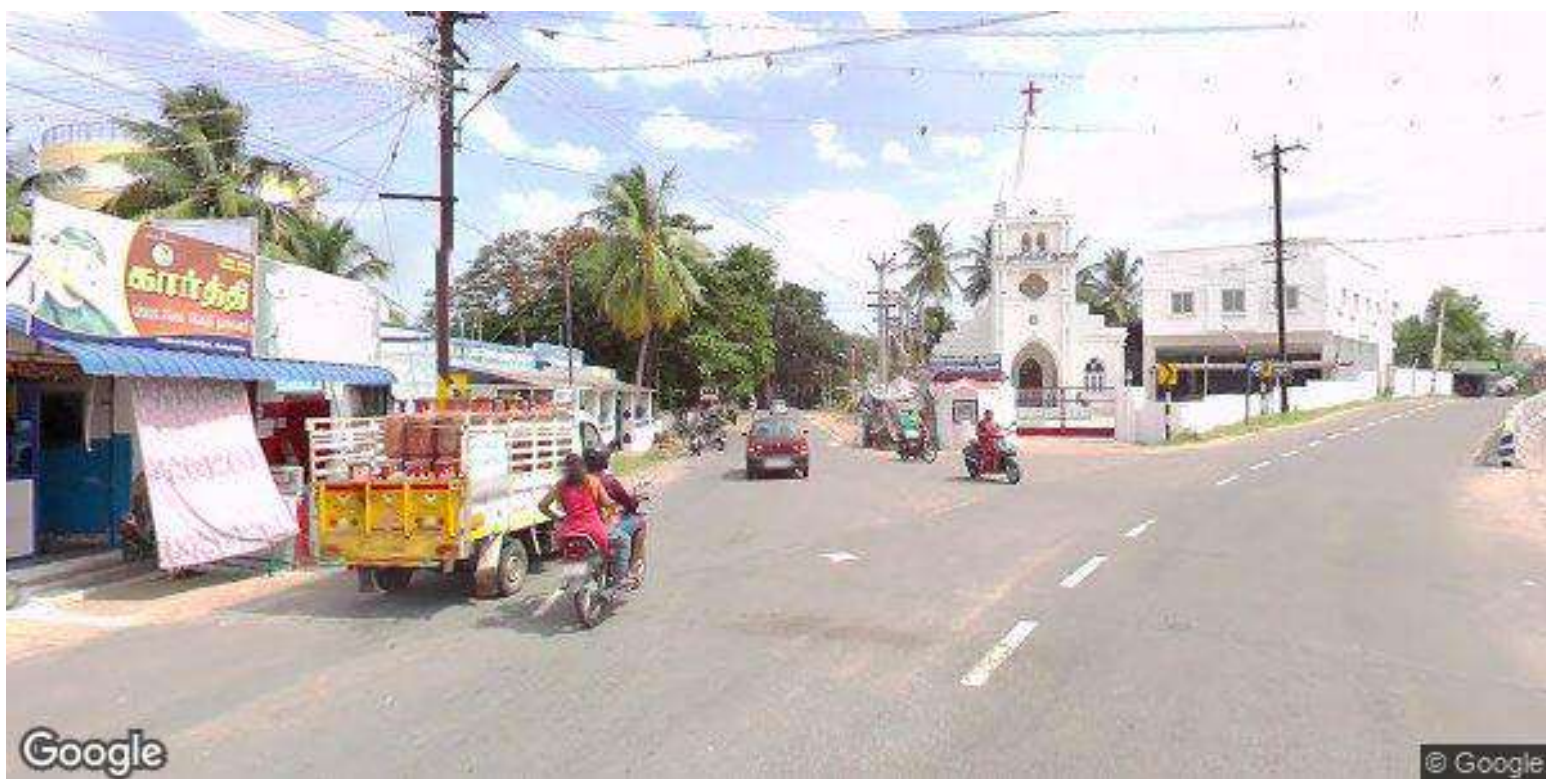
**Coordinates:** 11.23054, 77.71796

**Risk Type:** Turn

**Risk Level:** Medium

**Speed Limit:** 30 KM/Hr

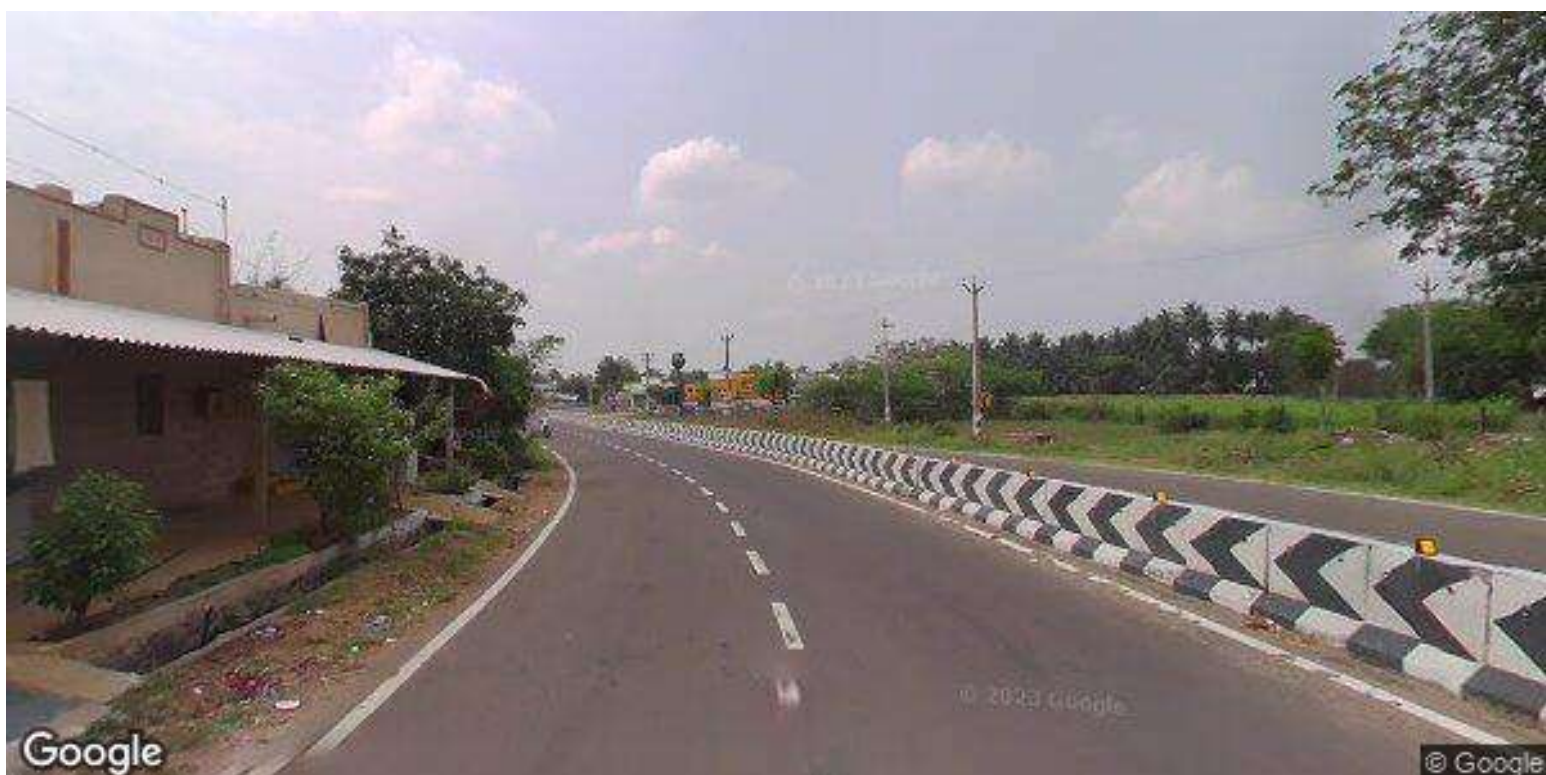
**Coordinates:** 11.22387, 77.71385

**Risk Type:** Turn

**Risk Level:** Medium

**Speed Limit:** 30 KM/Hr

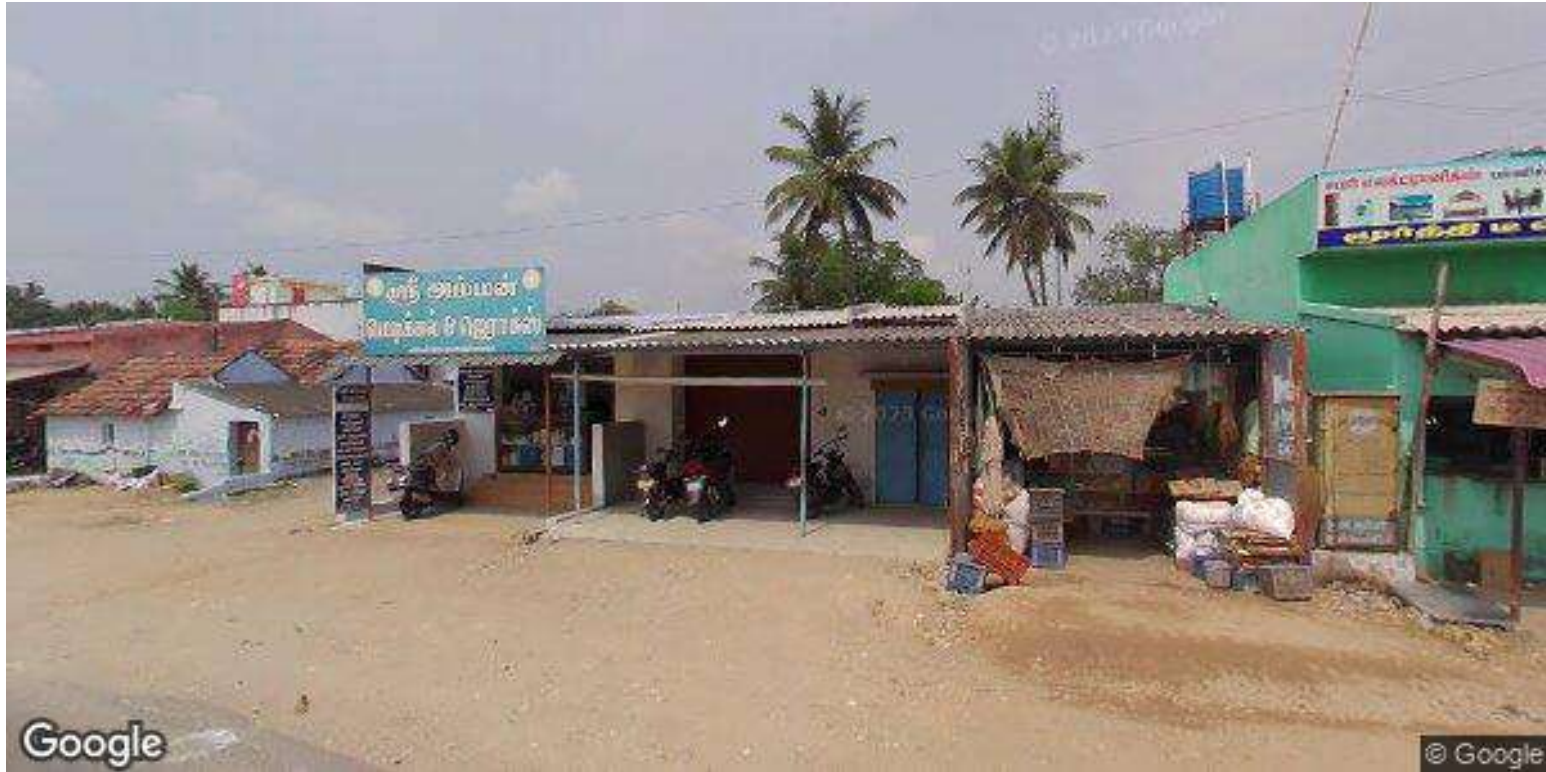
**Coordinates:** 11.20776, 77.70916

**Risk Type:** Turn

**Risk Level:** Medium

**Speed Limit:** 30 KM/Hr
