# IndianOil

## JOURNEY RISK MANAGEMENT (JRM) STUDY

### Salem Terminal to A.GEE.FUELS

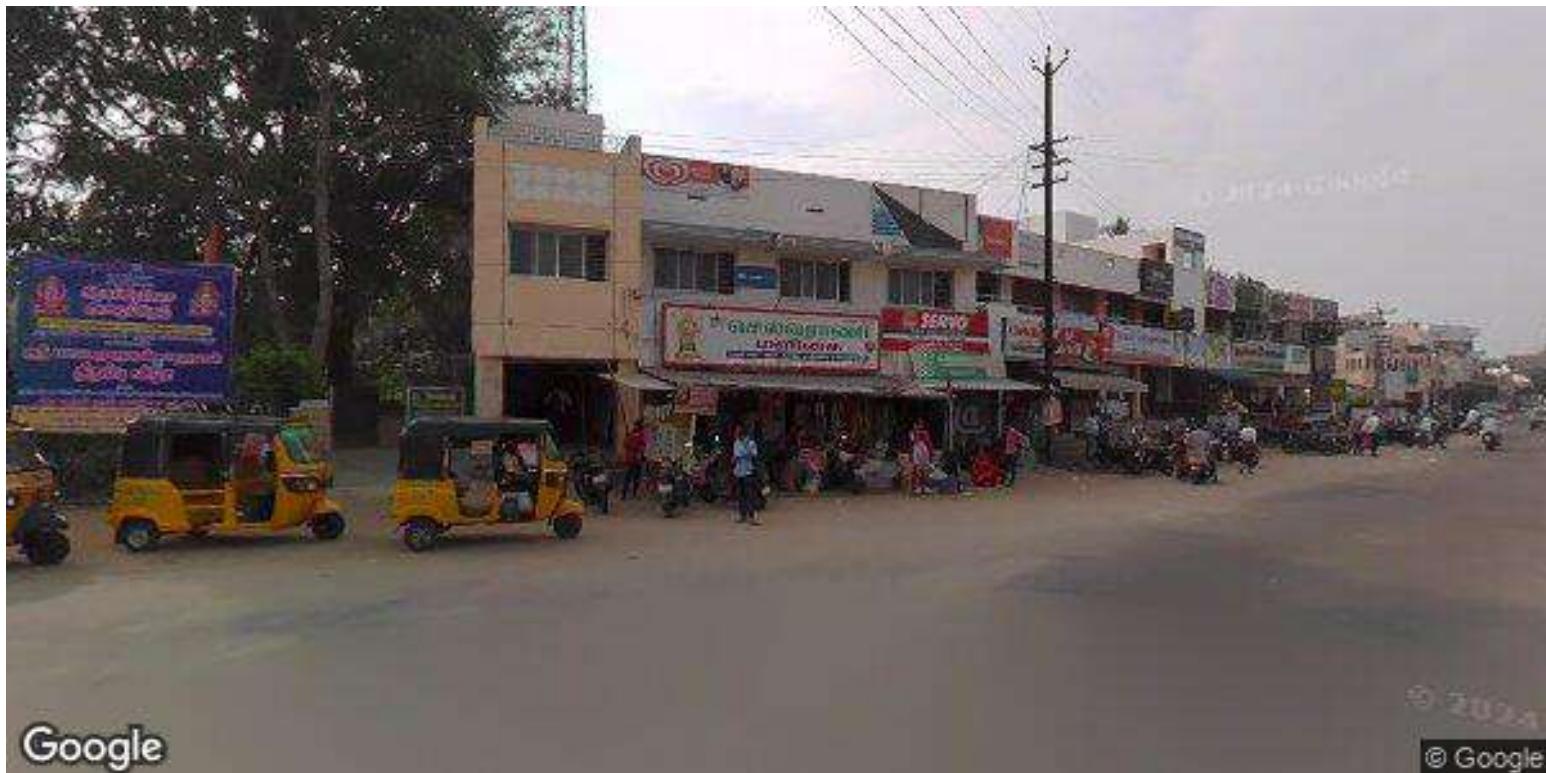
**Coordinates:** 11.15942, 77.70068

**Risk Type:** Turn

**Risk Level:** High

**Speed Limit:** 15 KM/Hr

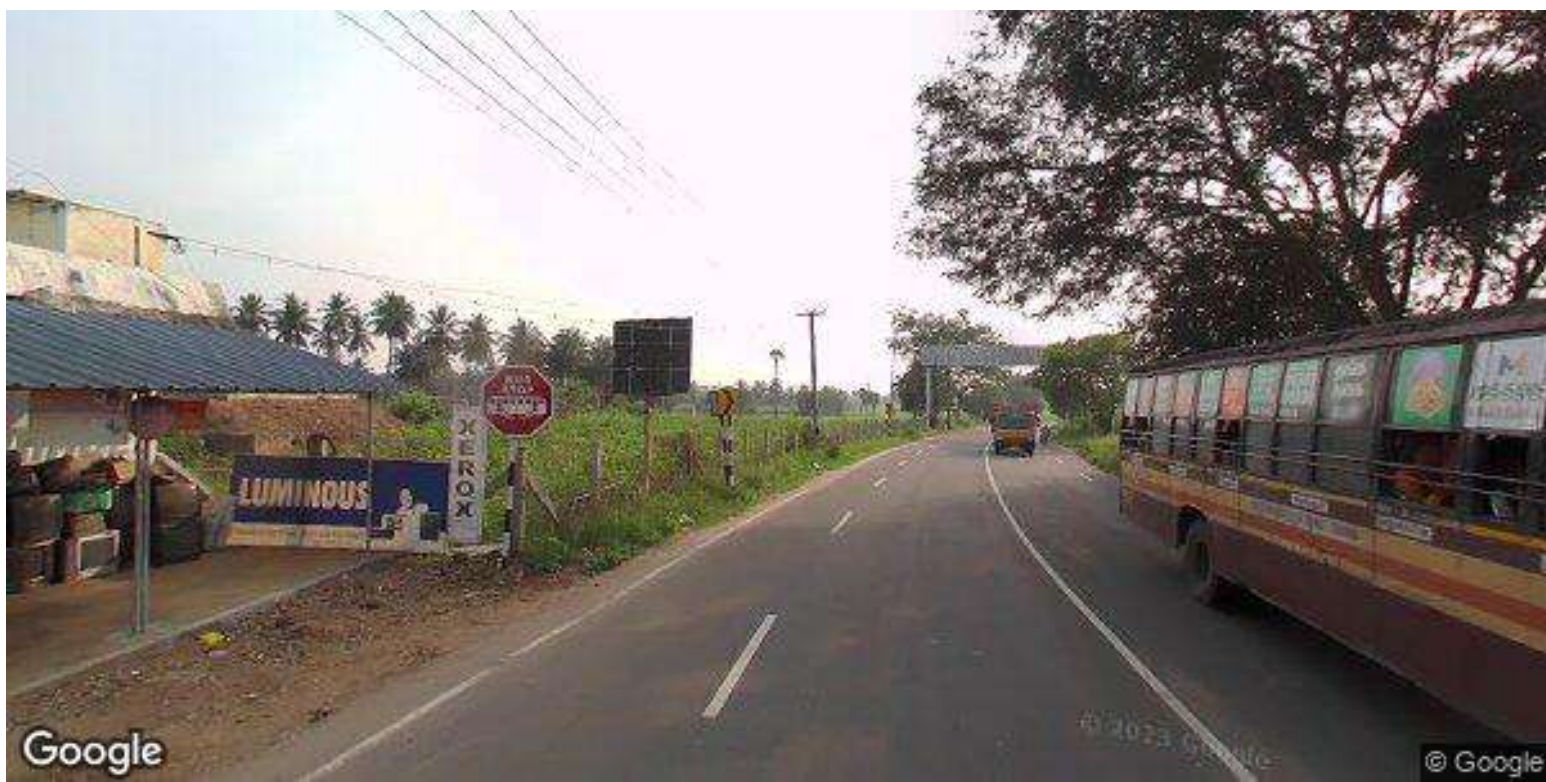
**Coordinates:** 11.12102, 77.67919

**Risk Type:** Turn

**Risk Level:** Medium

**Speed Limit:** 30 KM/Hr

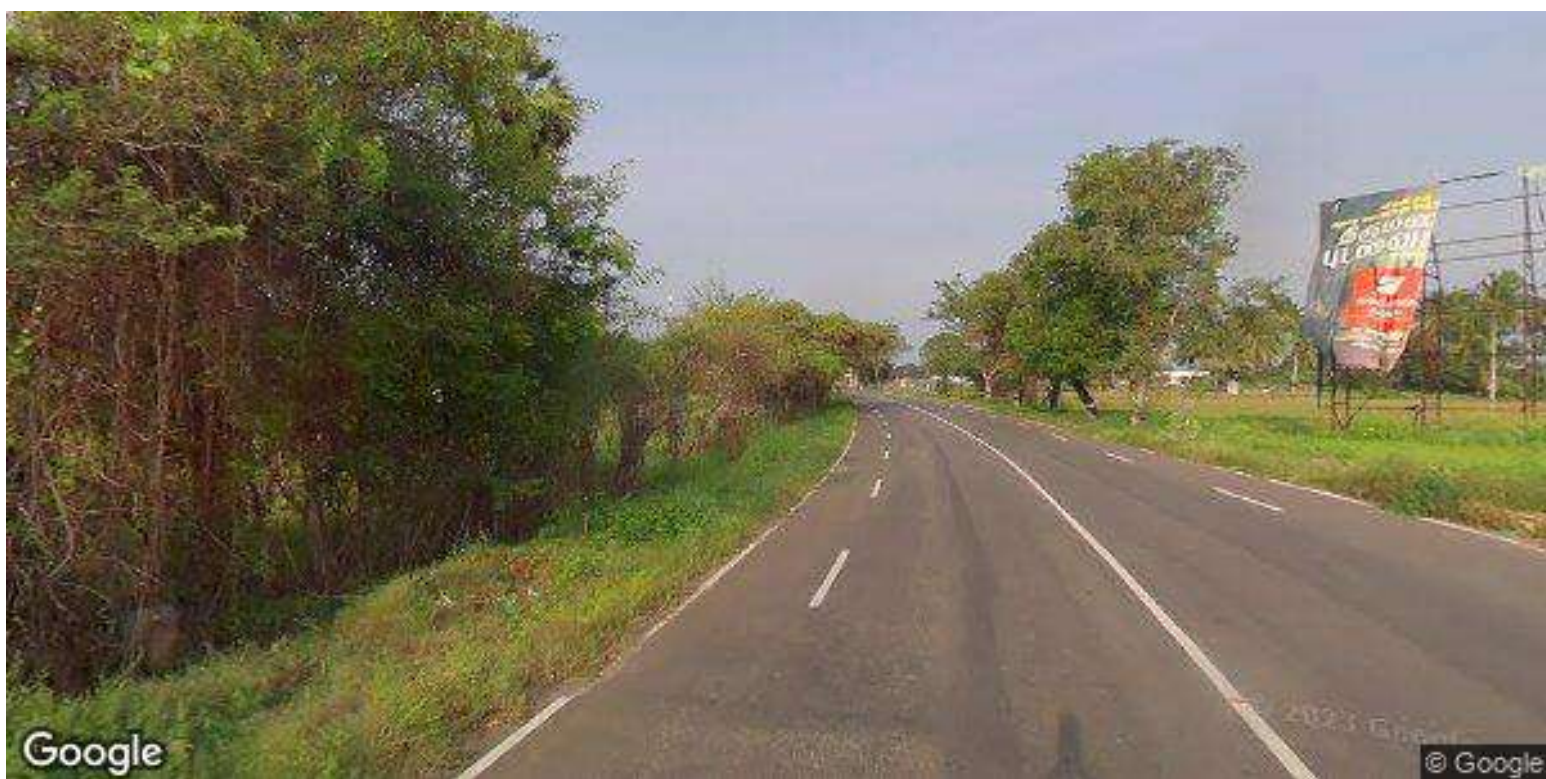
**Coordinates:** 11.11932, 77.67786

**Risk Type:** Turn

**Risk Level:** Medium

**Speed Limit:** 30 KM/Hr

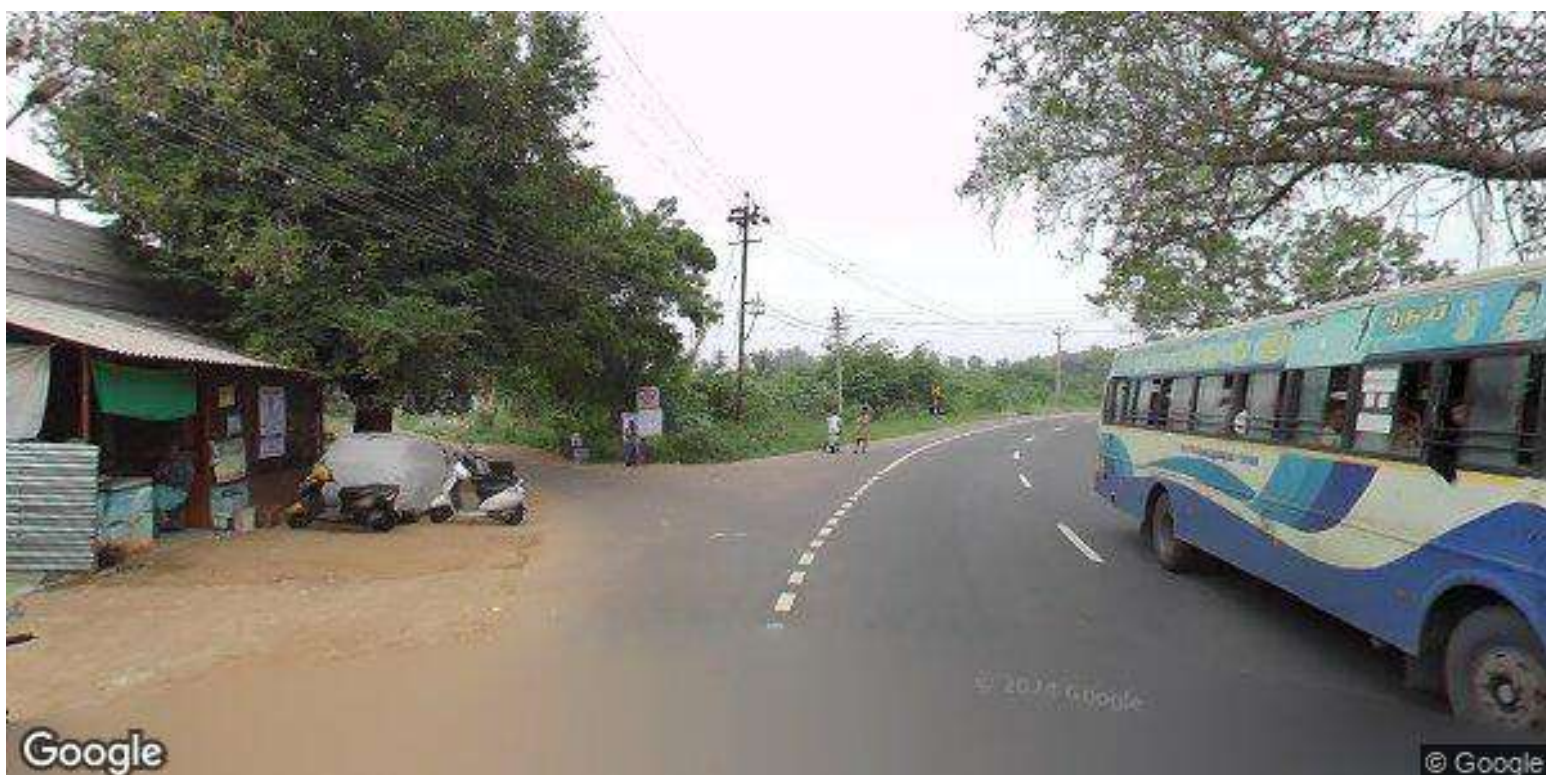
**Risk Type:** Turn  
**Risk Level:** Medium  
**Speed Limit:** 30 KM/Hr  
**Coordinates:** 11.11710, 77.67175

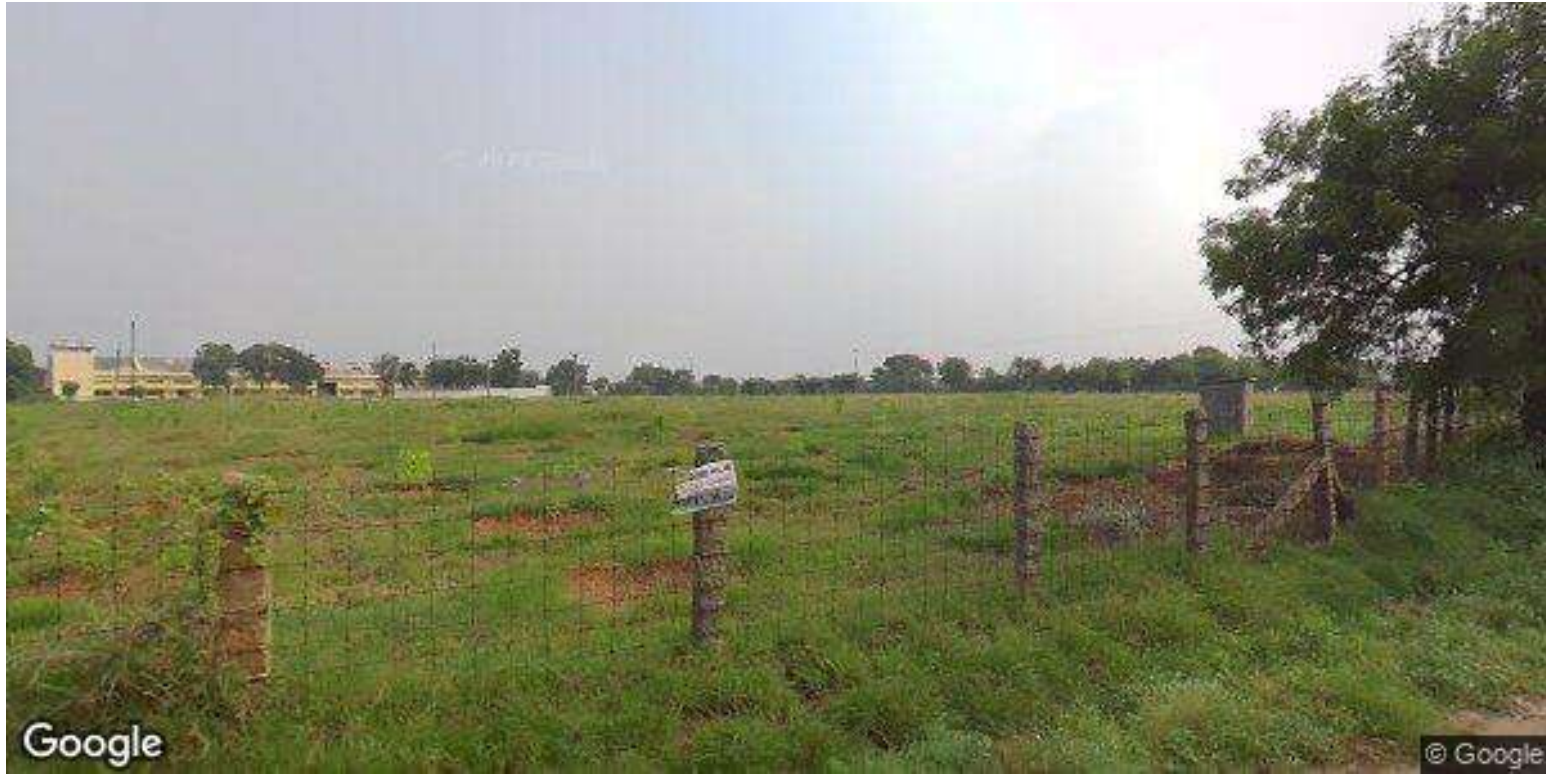
**Risk Type:** Turn  
**Risk Level:** Medium  
**Speed Limit:** 30 KM/Hr  
**Coordinates:** 11.09491, 77.66603

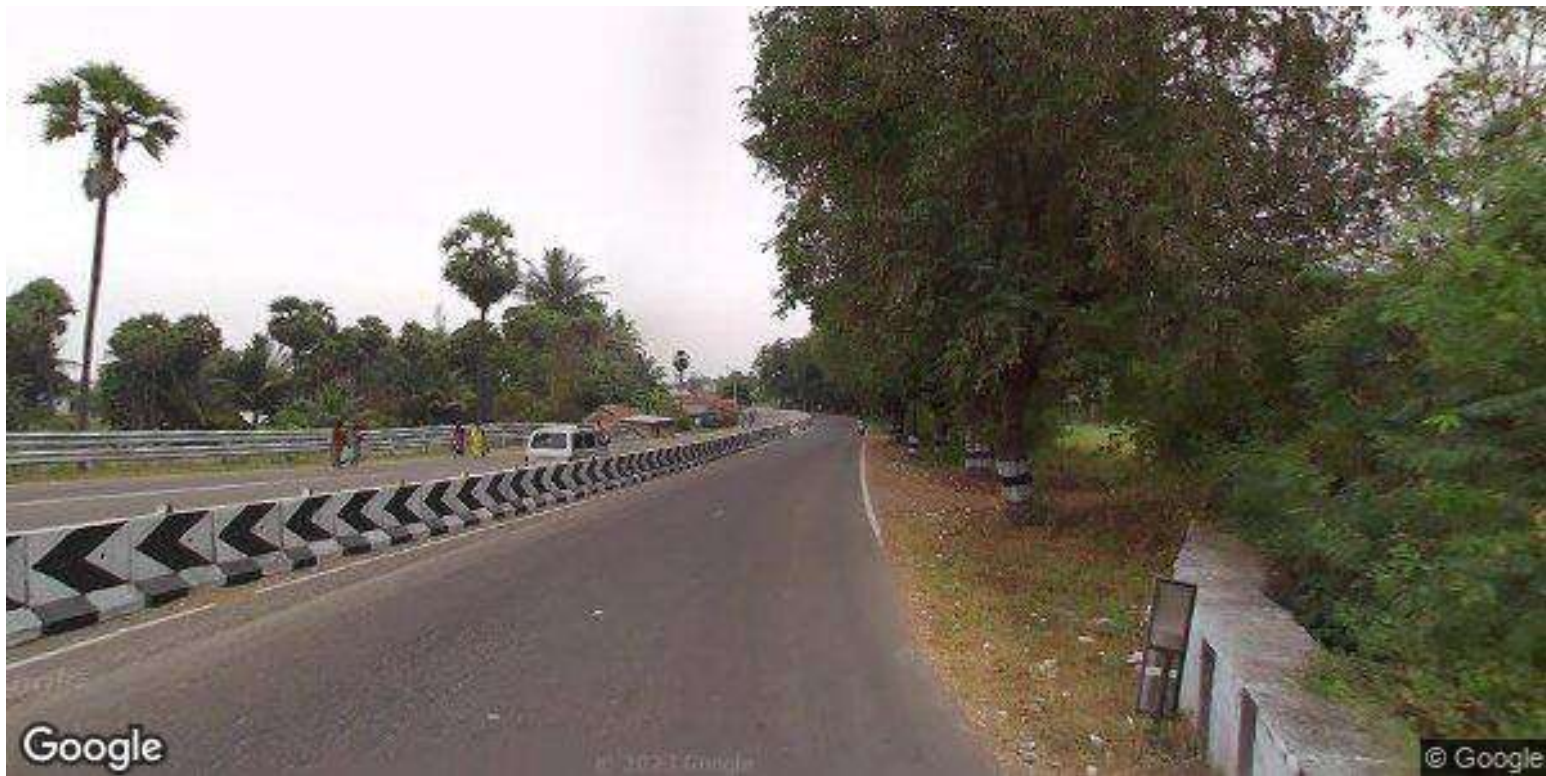
**Risk Type:** Turn  
**Risk Level:** Medium  
**Speed Limit:** 30 KM/Hr  
**Coordinates:** 11.08296, 77.65857

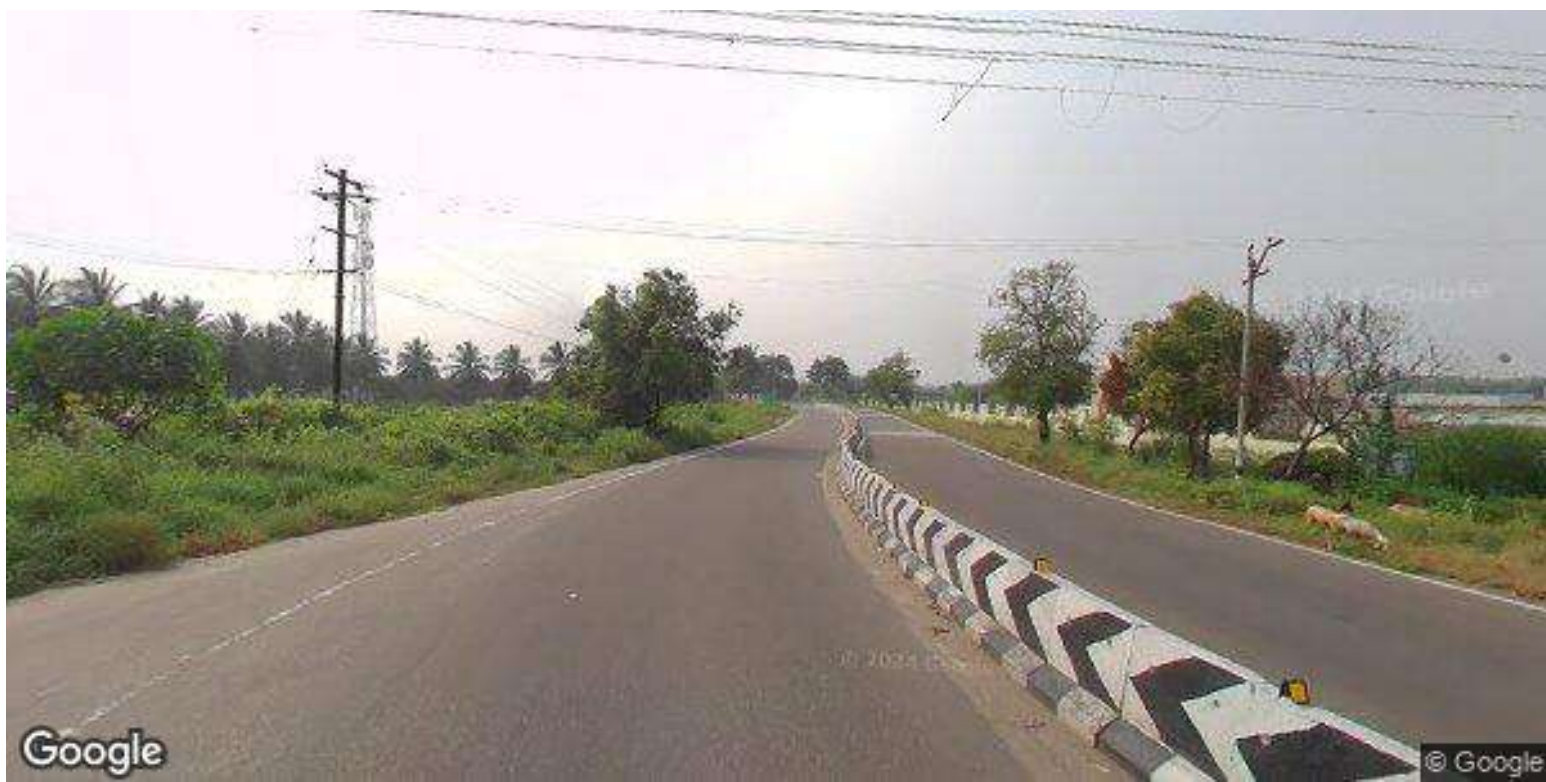
**Coordinates:** 11.06183, 77.63924

**Risk Type:** Turn

**Risk Level:** Medium

**Speed Limit:** 30 KM/Hr

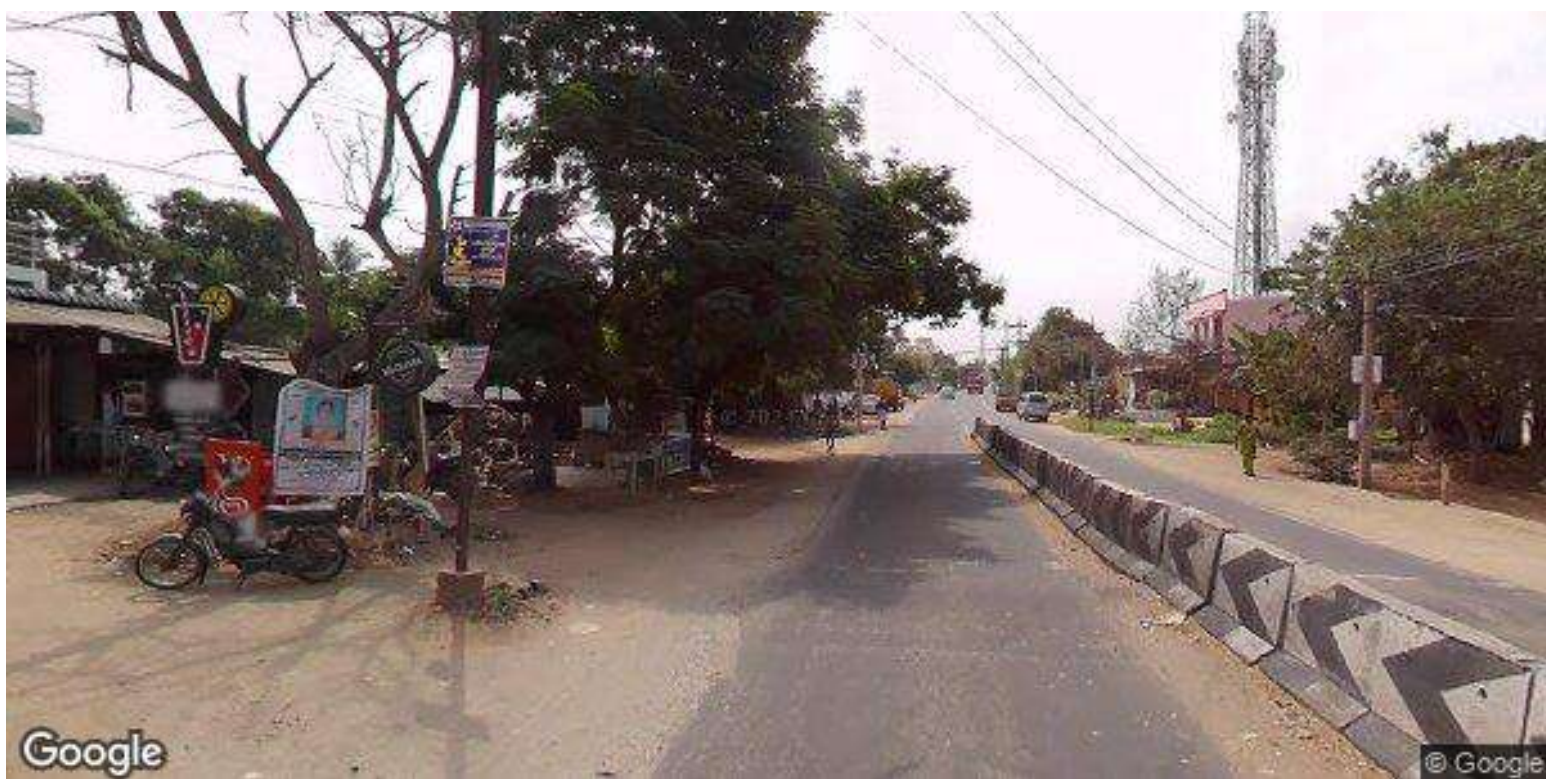
**Coordinates:** 11.00826, 77.56962

**Risk Type:** Turn

**Risk Level:** High

**Speed Limit:** 15 KM/Hr

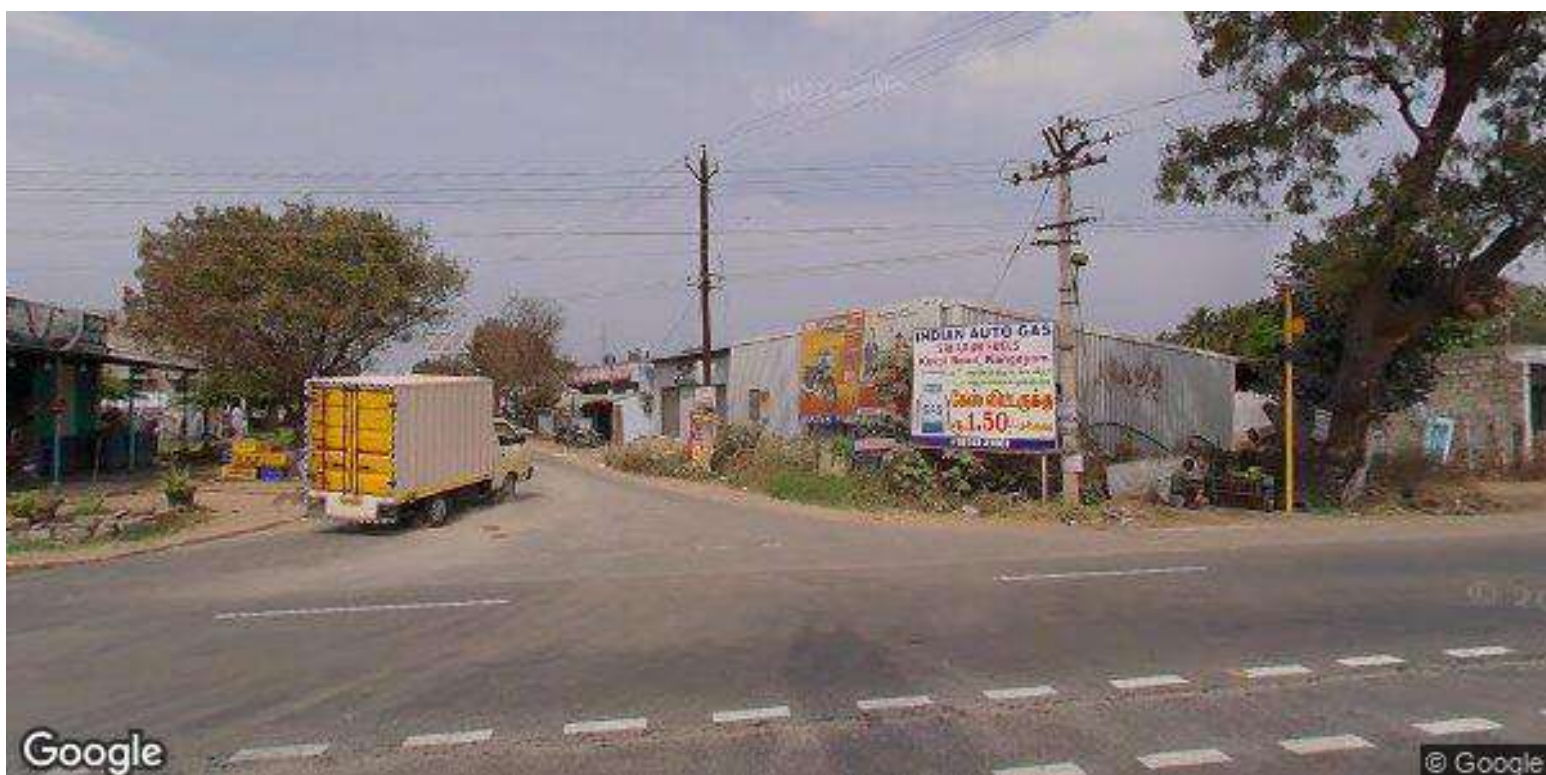
**Risk Type:** Blind Spot  
**Risk Level:** Blind Spot  
**Speed Limit:** 10 KM/Hr  
**Coordinates:** 11.00058, 77.56882

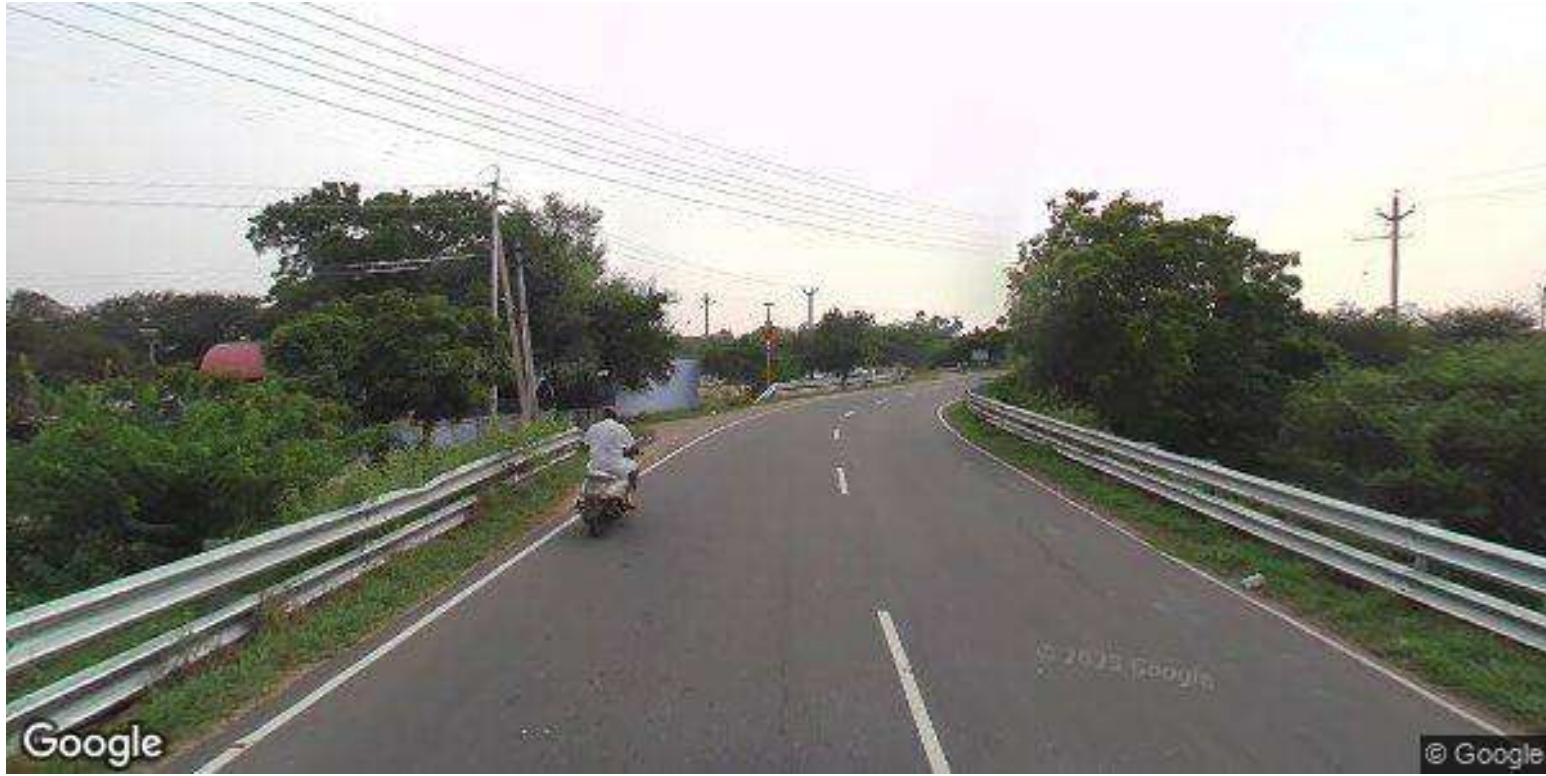
**Risk Type:** Turn  
**Risk Level:** Medium  
**Speed Limit:** 30 KM/Hr  
**Coordinates:** 10.94722, 77.54709

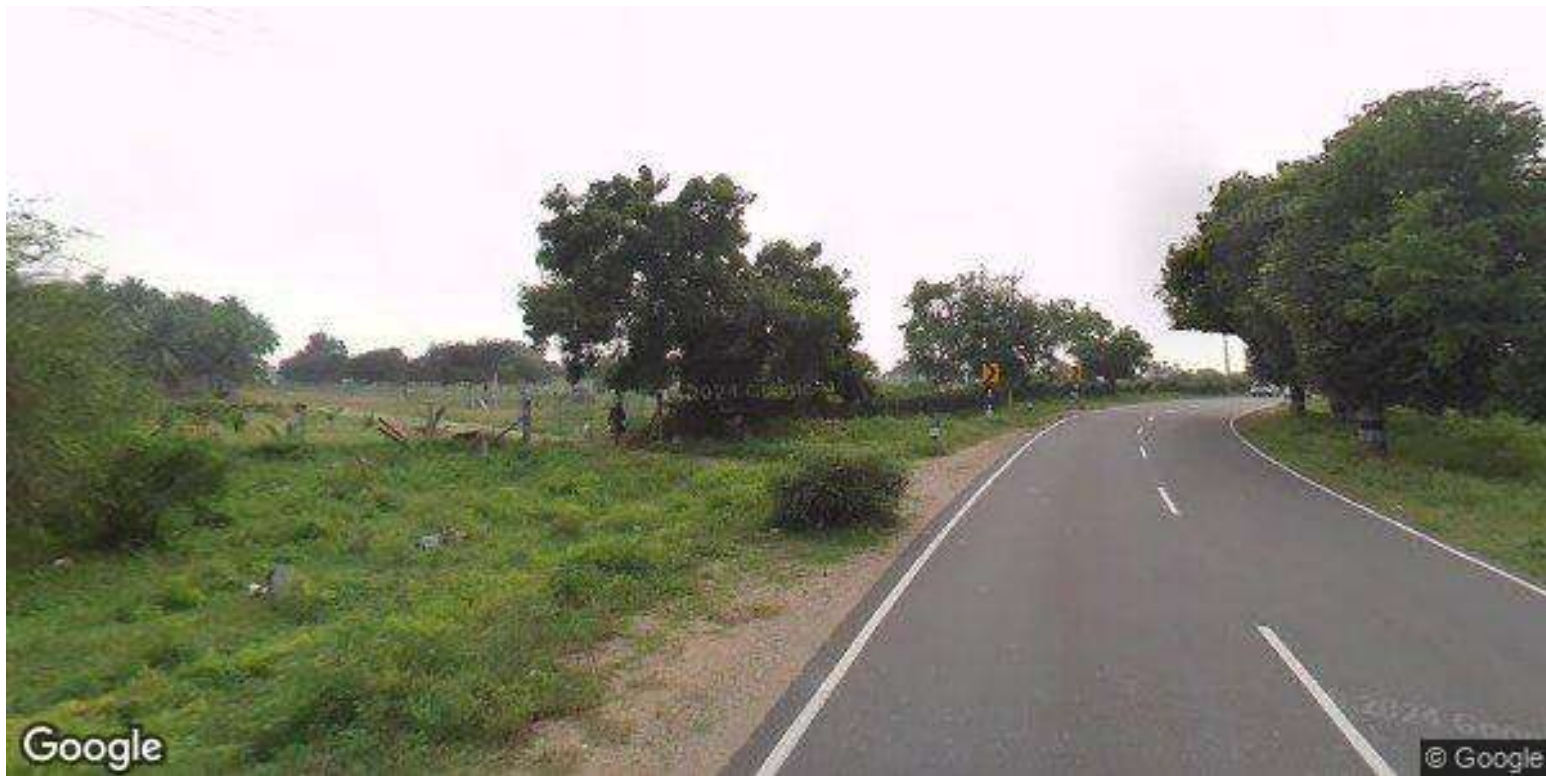
**Risk Type:** Turn  
**Risk Level:** Medium  
**Speed Limit:** 30 KM/Hr  
**Coordinates:** 10.93895, 77.53976

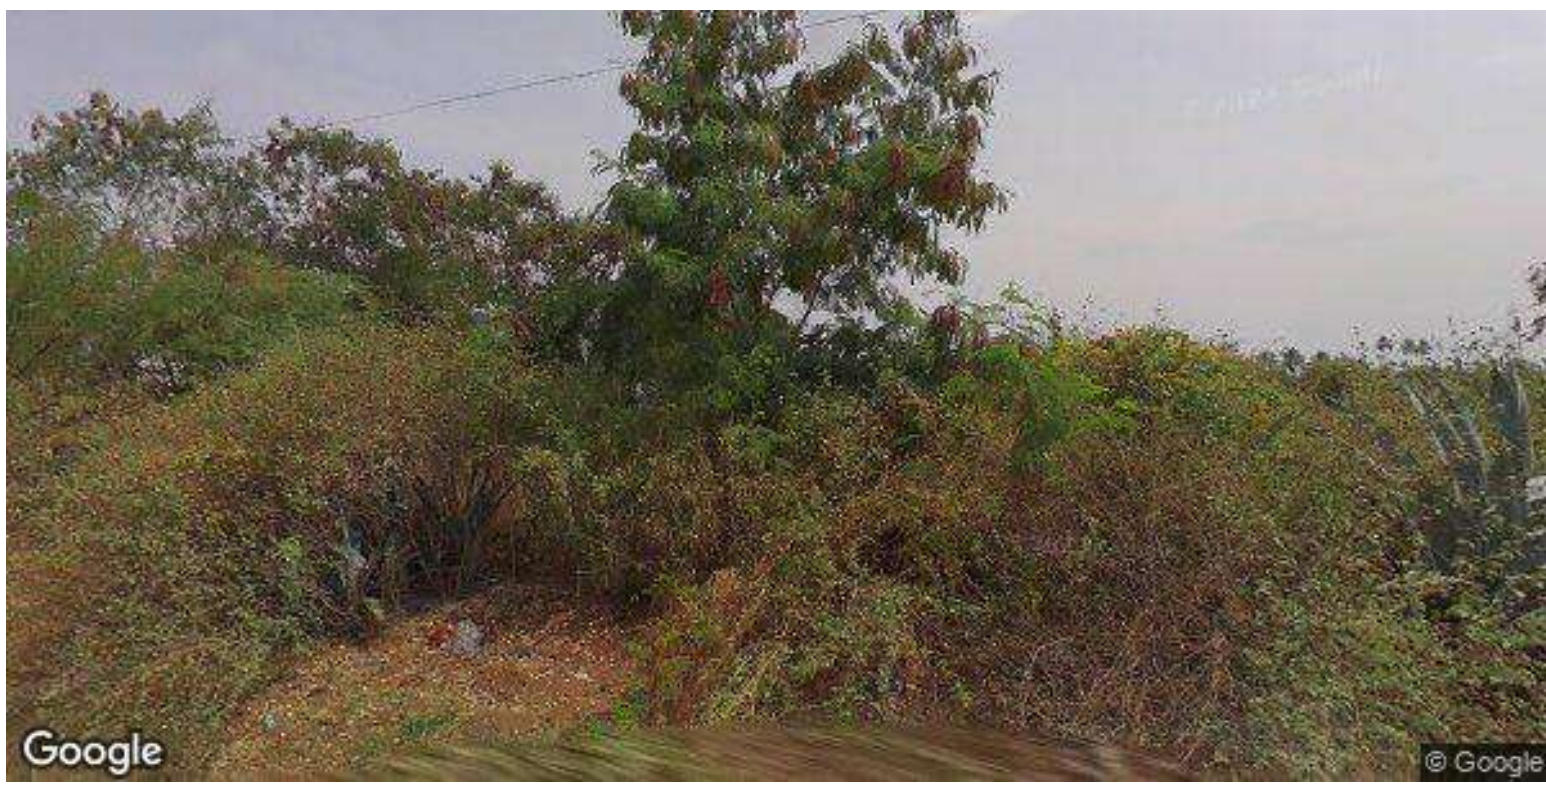
**Coordinates:** 10.93054, 77.53265

**Risk Type:** Turn

**Risk Level:** Medium

**Speed Limit:** 30 KM/Hr

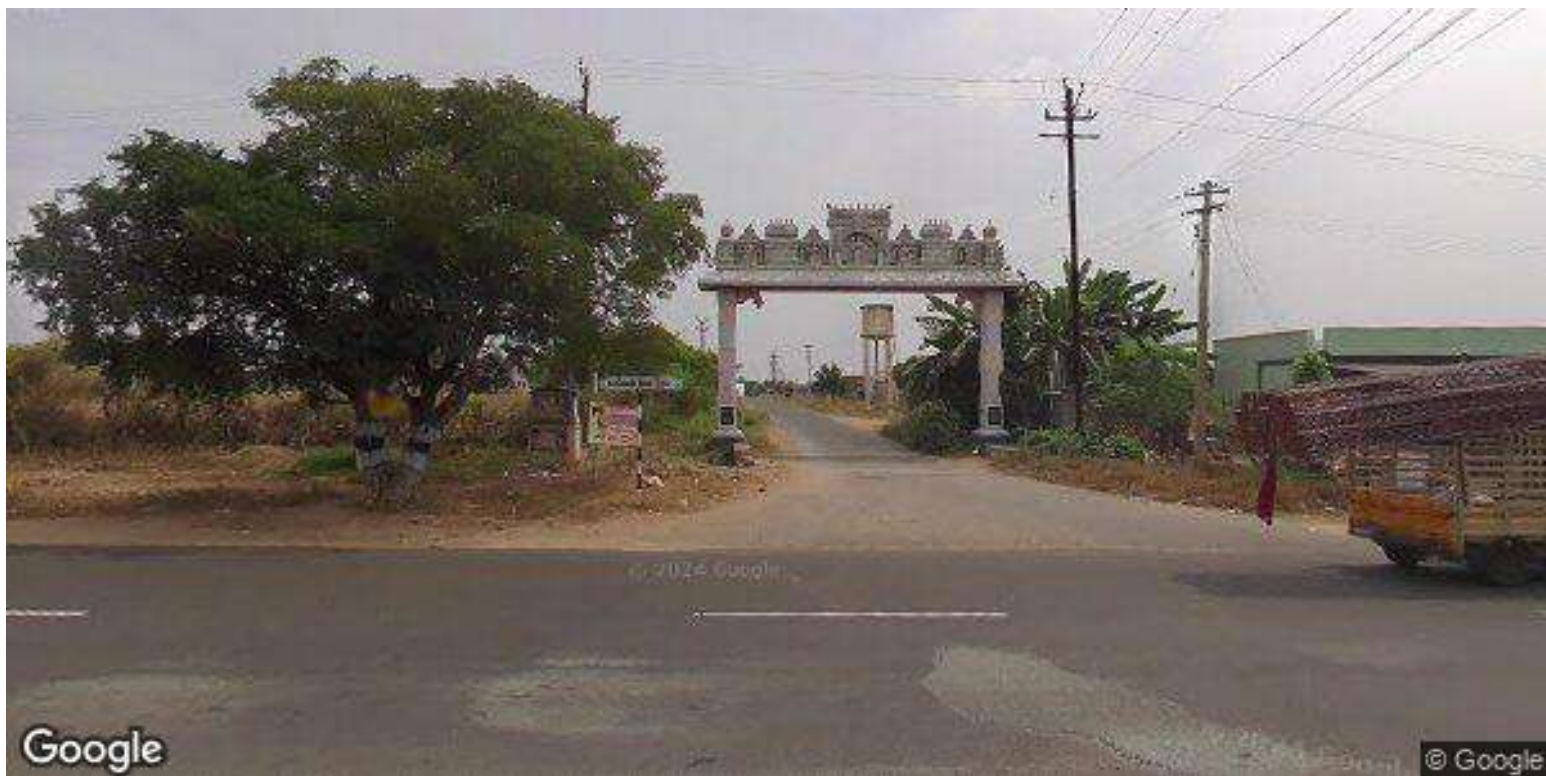
**Coordinates:** 10.89940, 77.52804

**Risk Type:** Turn

**Risk Level:** High

**Speed Limit:** 15 KM/Hr
