## JOURNEY RISK MANAGEMENT (JRM) STUDY

**Salem Terminal to SREE PALANIYAPPAA  
AGENCYIOCDEALERS**

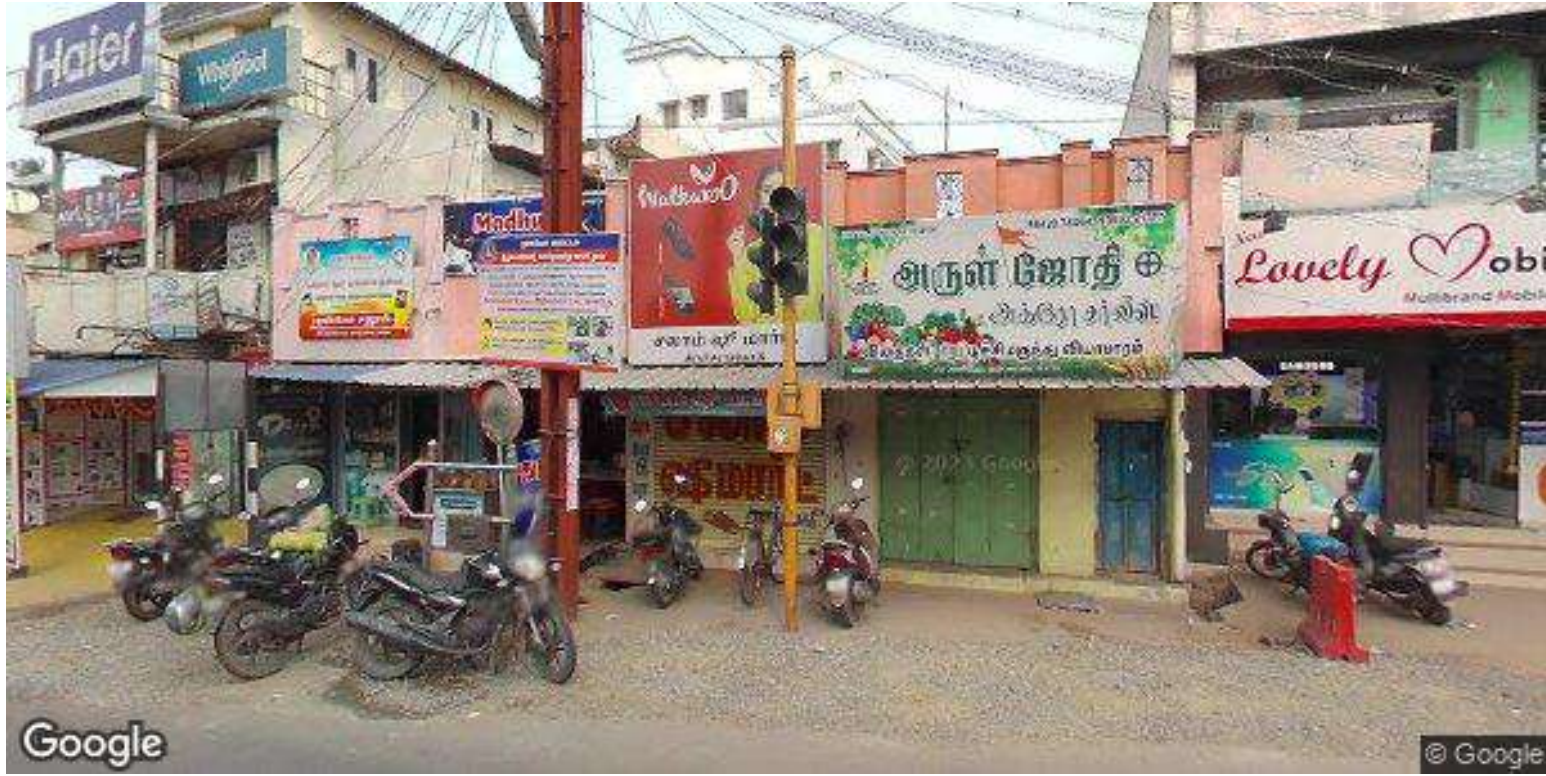
**Coordinates:** 11.37850, 77.89453

**Risk Type:** Turn

**Risk Level:** High

**Speed Limit:** 15 KM/Hr
