## JOURNEY RISK MANAGEMENT (JRM) STUDY

### Salem Terminal to SHIVAM AGENCIES IOC DEALERS- KSK

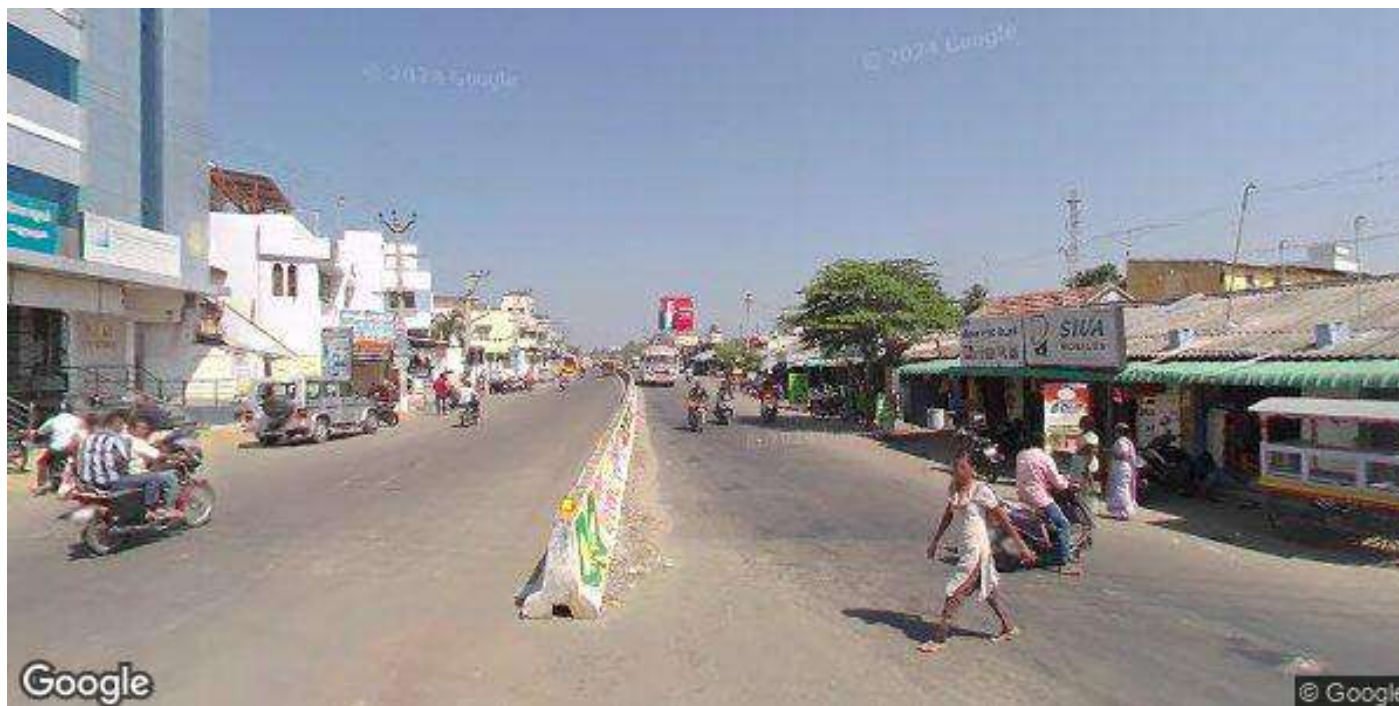
**Risk Type:** Roundabout  
**Risk Level:** High  
**Speed Limit:** 15 KM/Hr  
**Coordinates:** 11.37086, 77.74828

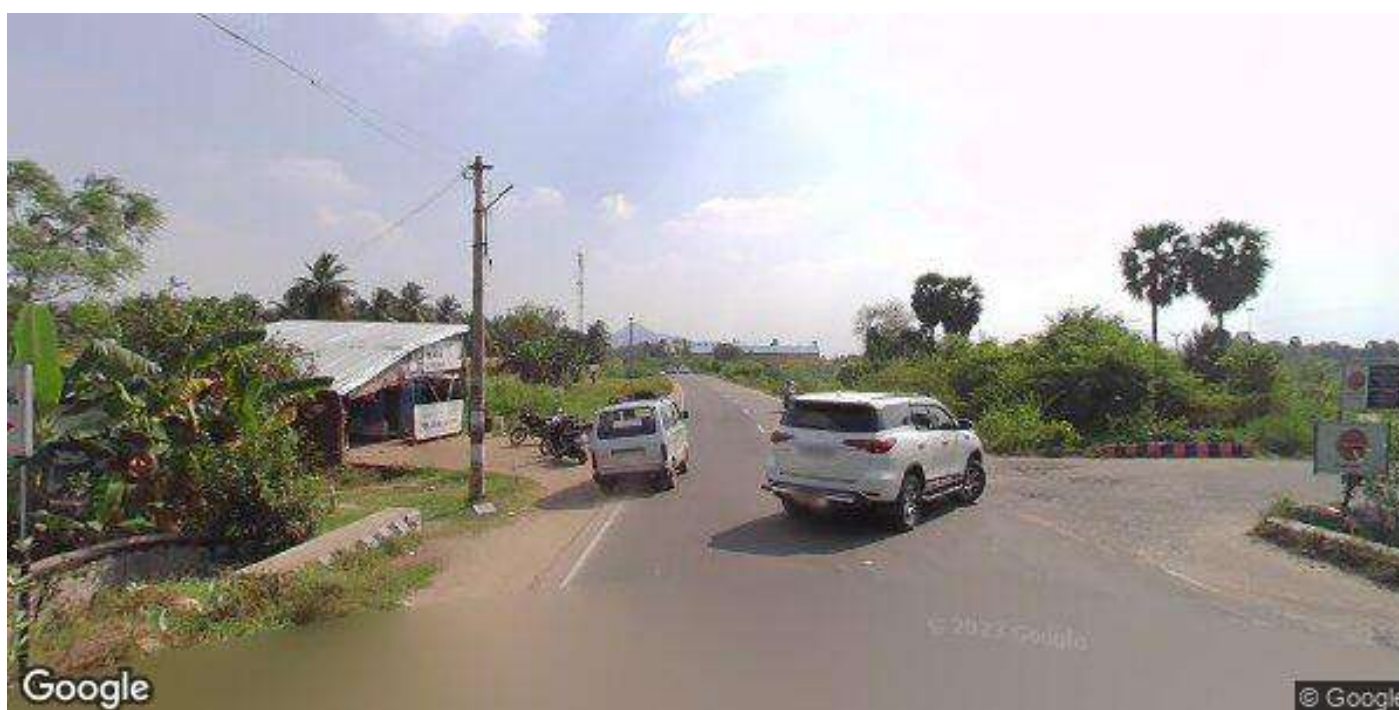
**Risk Type:** Turn  
**Risk Level:** High  
**Speed Limit:** 15 KM/Hr  
**Coordinates:** 11.44029, 77.87544

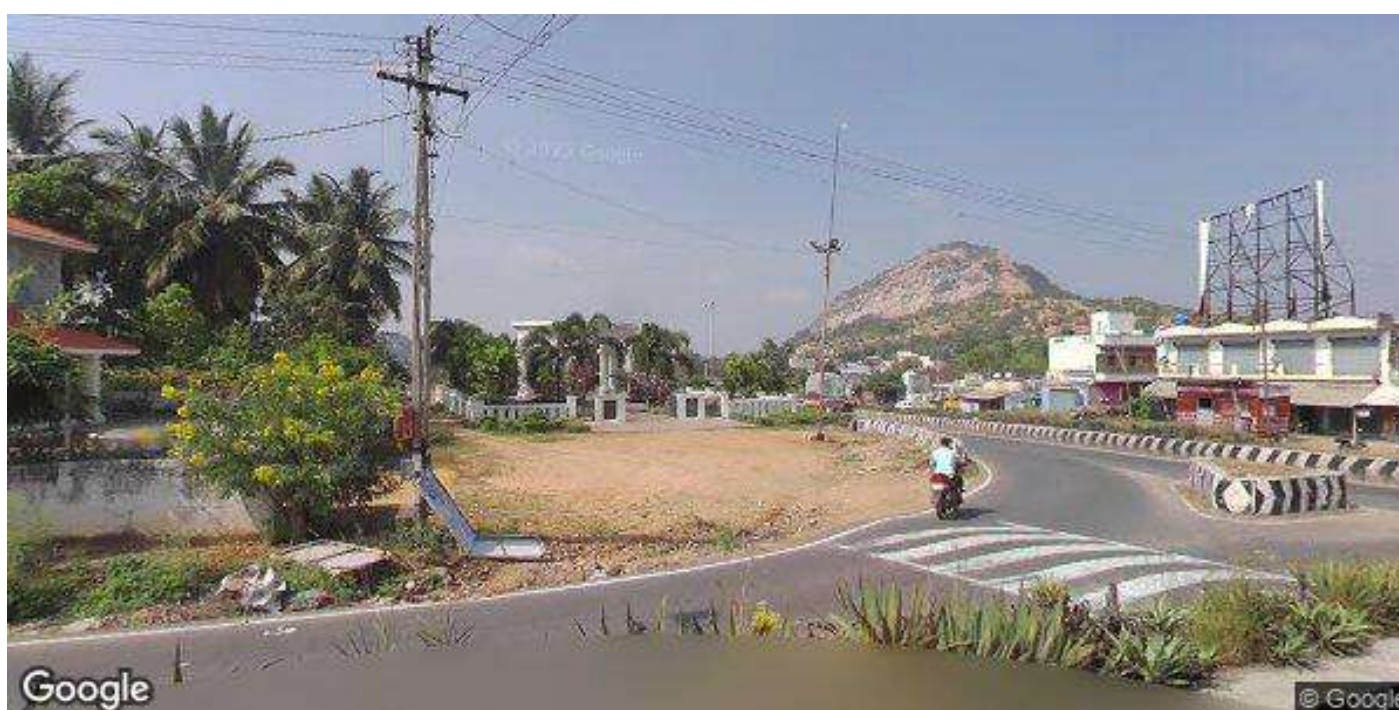
**Risk Type:** Turn  
**Risk Level:** Medium  
**Speed Limit:** 30 KM/Hr  
**Coordinates:** 11.46307, 77.84941

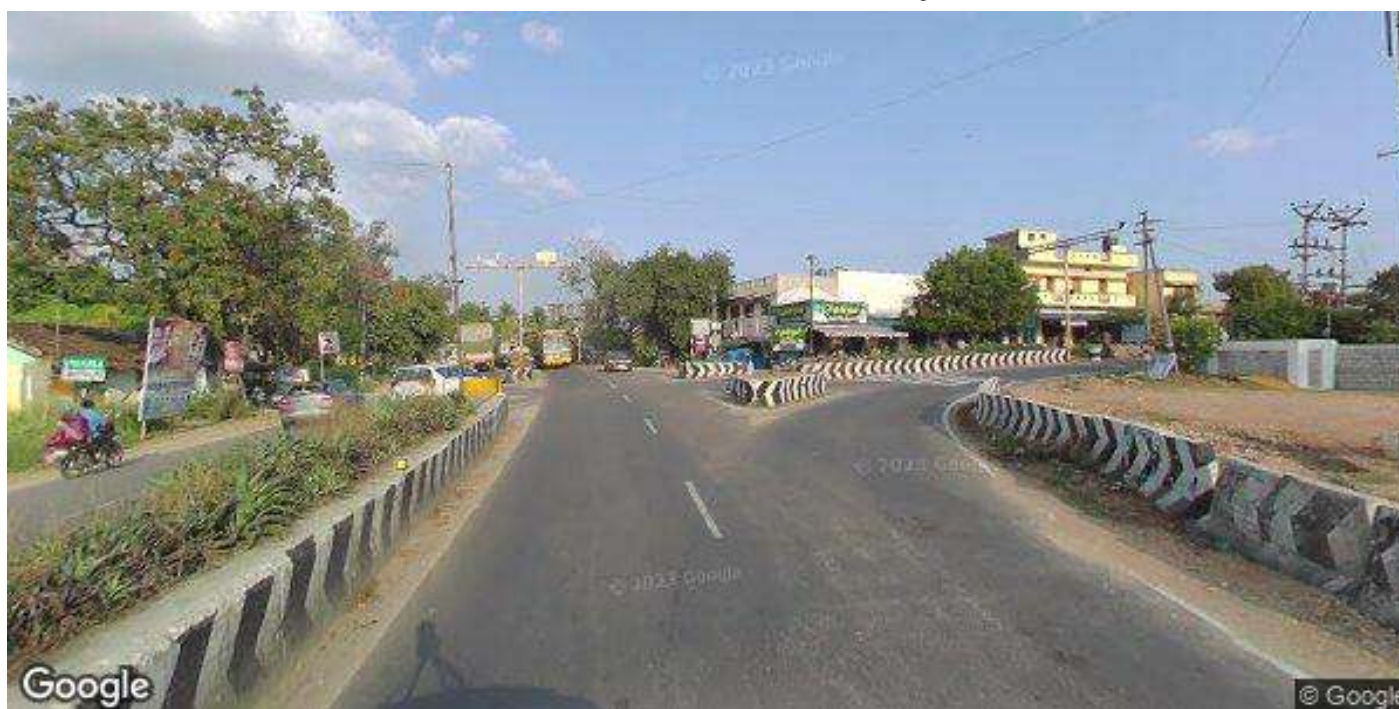
**Risk Type:** Turn  
**Risk Level:** Medium  
**Speed Limit:** 30 KM/Hr  
**Coordinates:** 11.46318, 77.84913

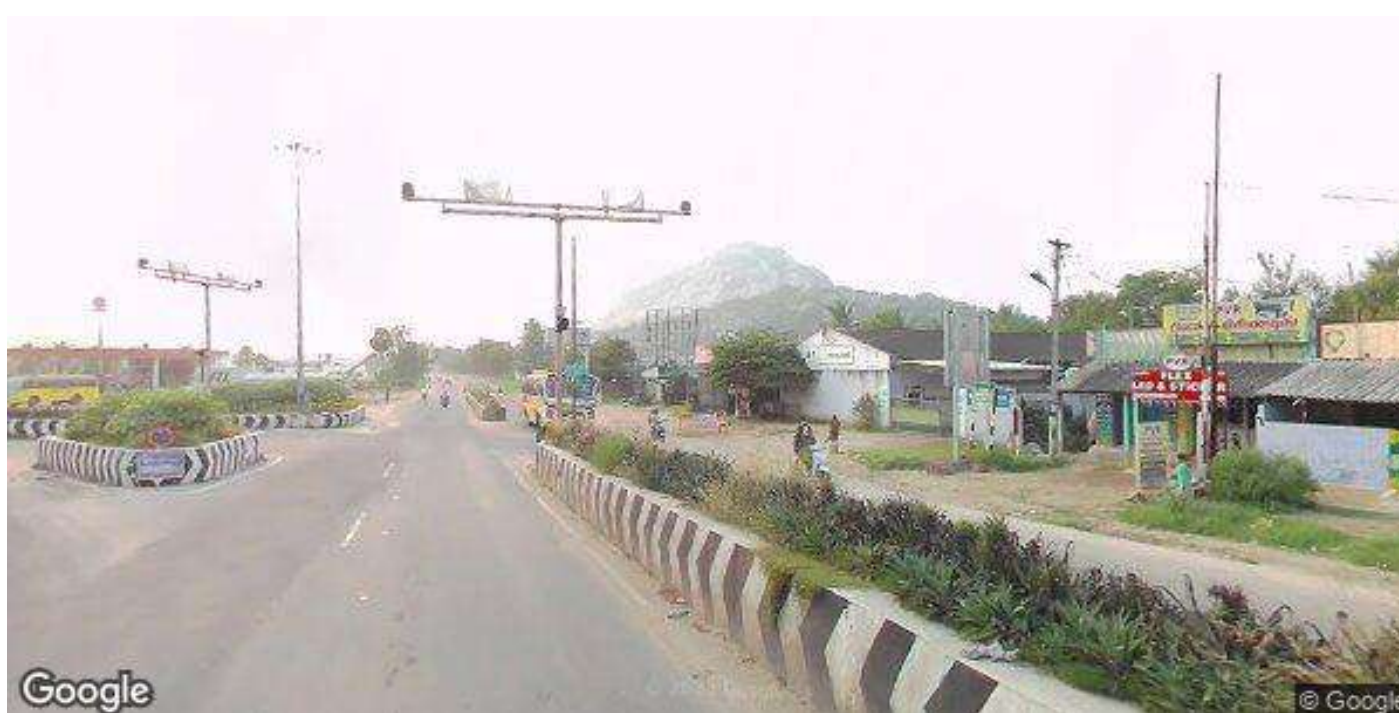
**Risk Type:** Turn  
**Risk Level:** Medium  
**Speed Limit:** 30 KM/Hr  
**Coordinates:** 11.46312, 77.84886

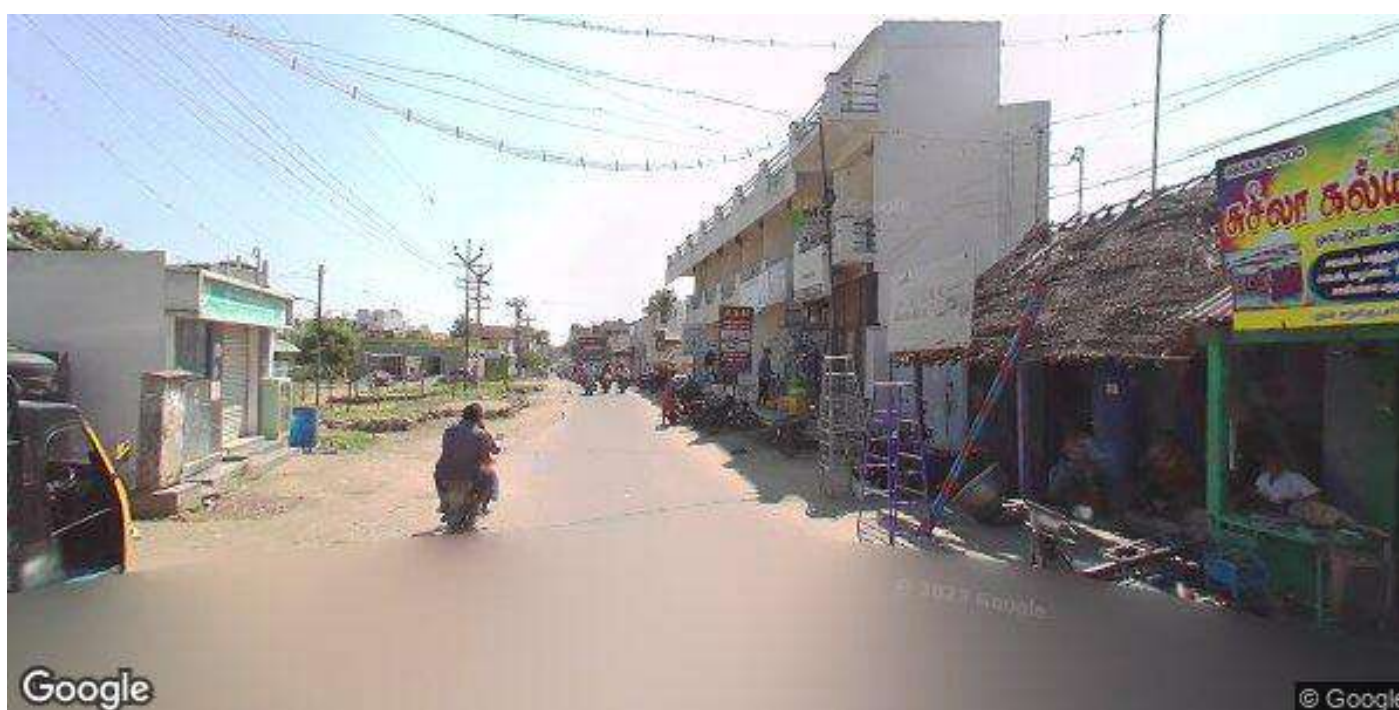
**Risk Type:** Blind Spot  
**Risk Level:** Blind Spot  
**Speed Limit:** 10 KM/Hr  
**Coordinates:** 11.36726, 77.74328
