## JOURNEY RISK MANAGEMENT (JRM) STUDY

### Salem Terminal to A1 FUELS INDIAN OIL DEAL

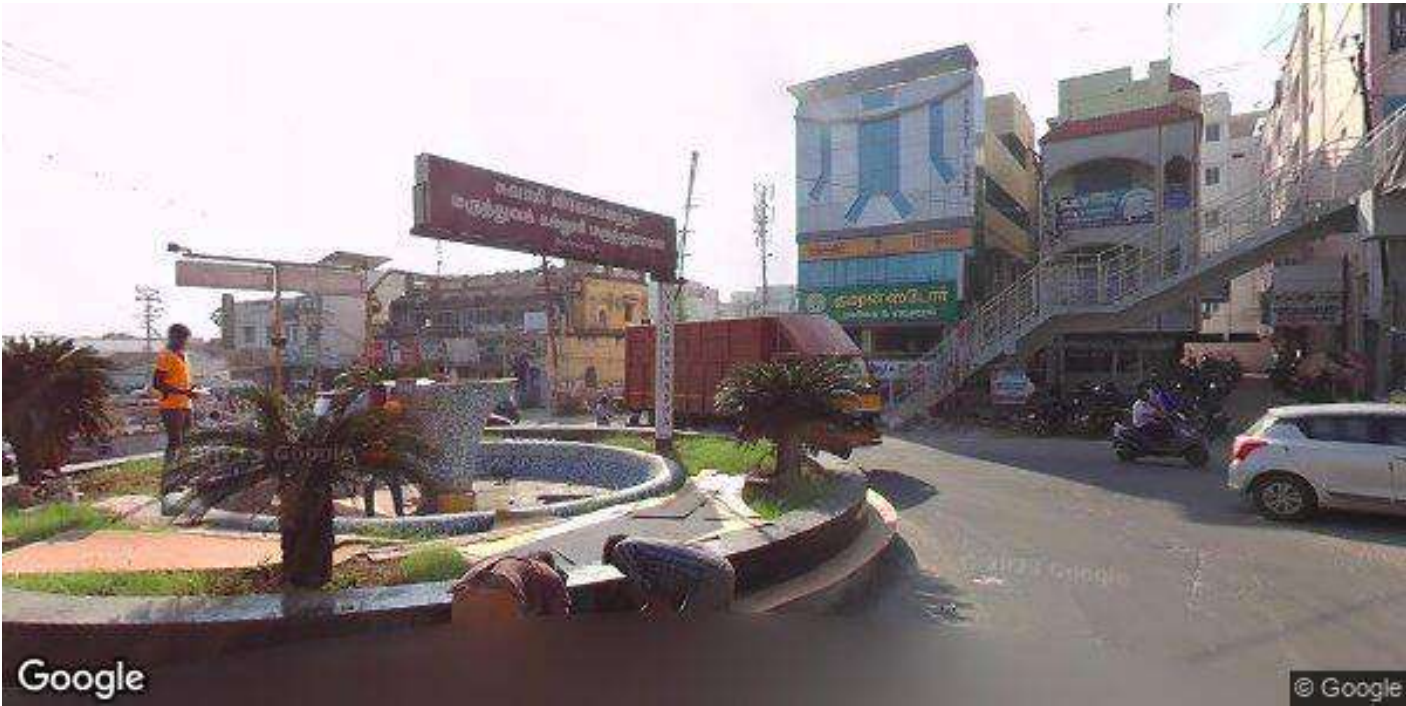
Coordinates: 11.38395, 77.89480

Risk Type: Roundabout

Risk Level: High

Speed Limit: 15 KM/Hr

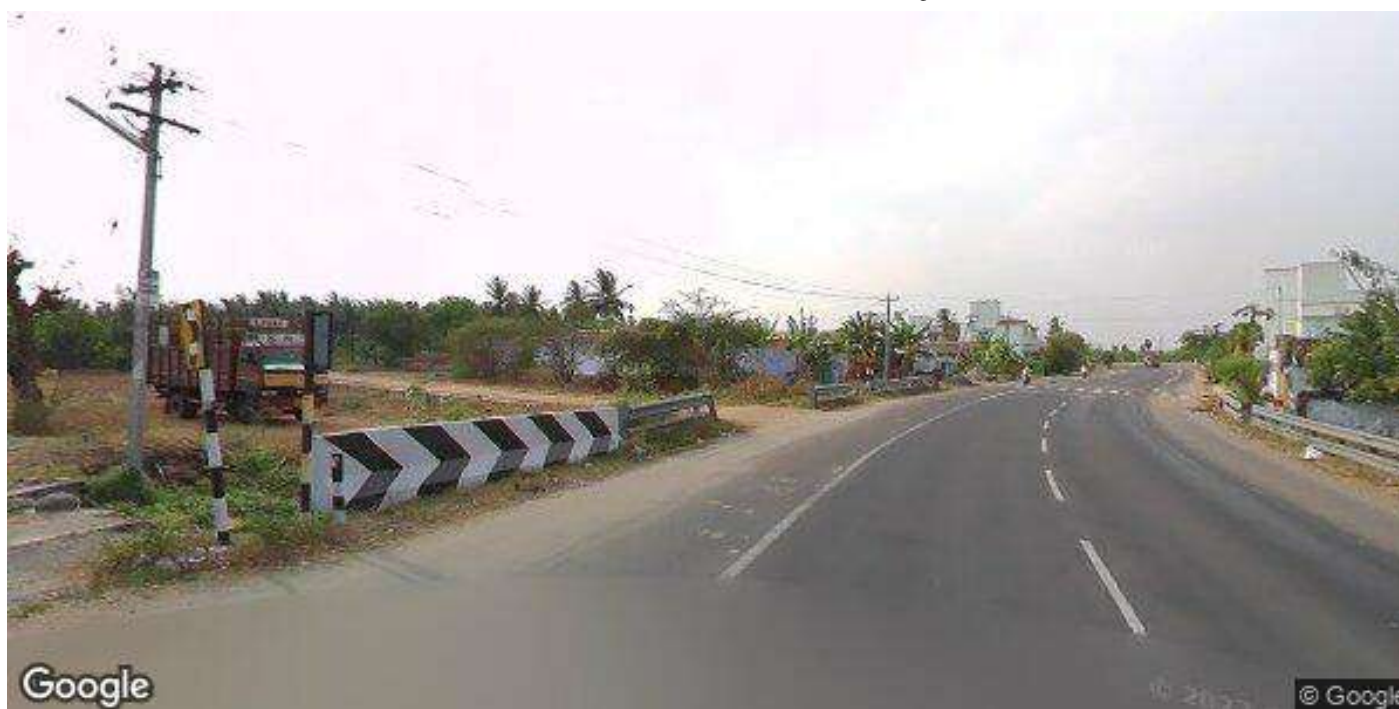
**Risk Type:** Turn  
**Risk Level:** Medium  
**Speed Limit:** 30 KM/Hr  
**Coordinates:** 11.16755, 78.01568

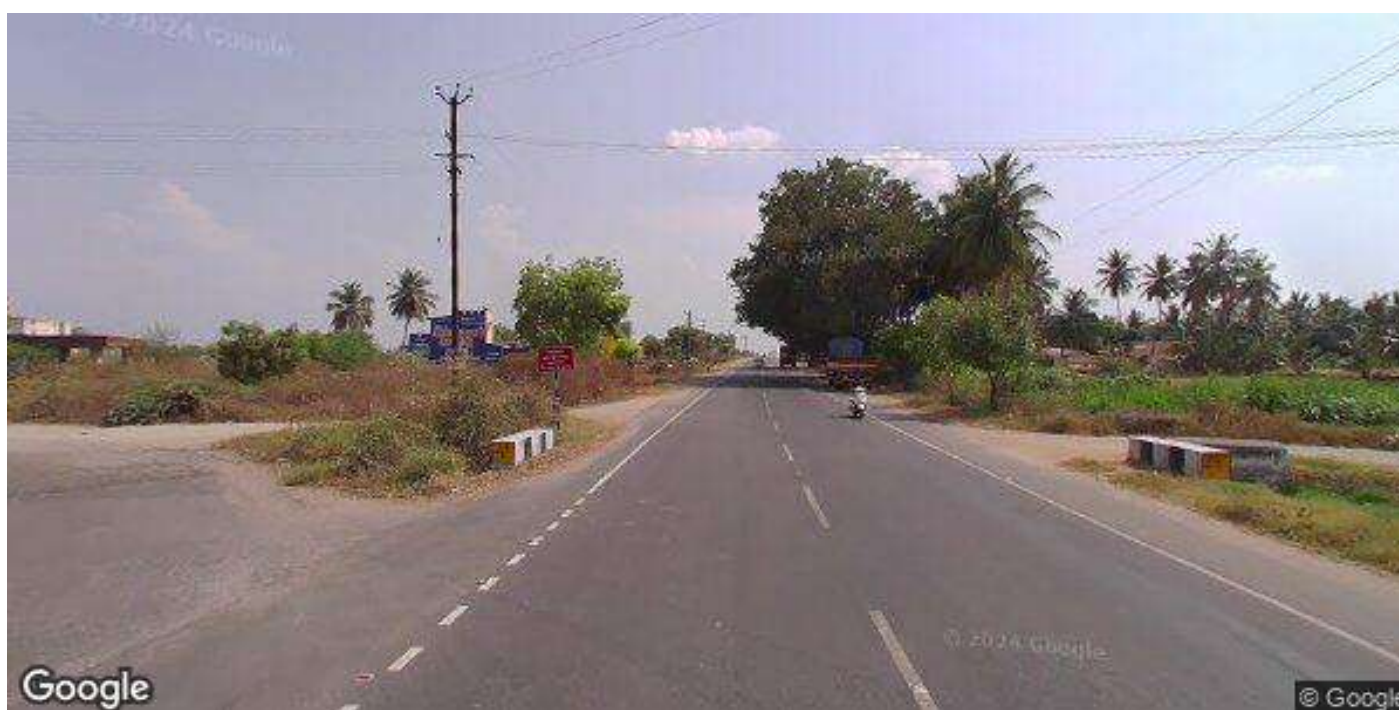
**Risk Type:** Turn  
**Risk Level:** High  
**Speed Limit:** 15 KM/Hr  
**Coordinates:** 11.14545, 78.02208

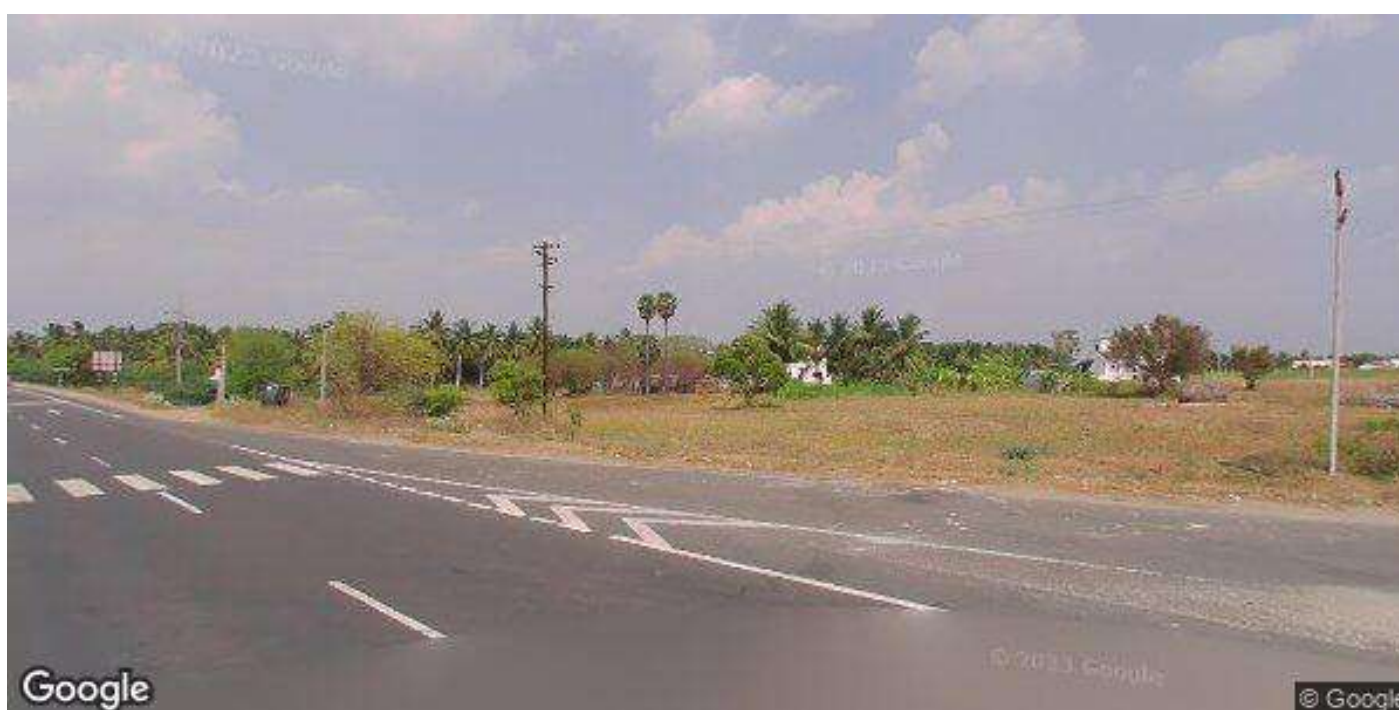
**Risk Type:** Blind Spot  
**Risk Level:** Blind Spot  
**Speed Limit:** 10 KM/Hr  
**Coordinates:** 11.14480, 78.02291
