# IndianOil

## JOURNEY RISK MANAGEMENT (JRM) STUDY

### Salem Terminal to SRI VELAVAN AGENCY

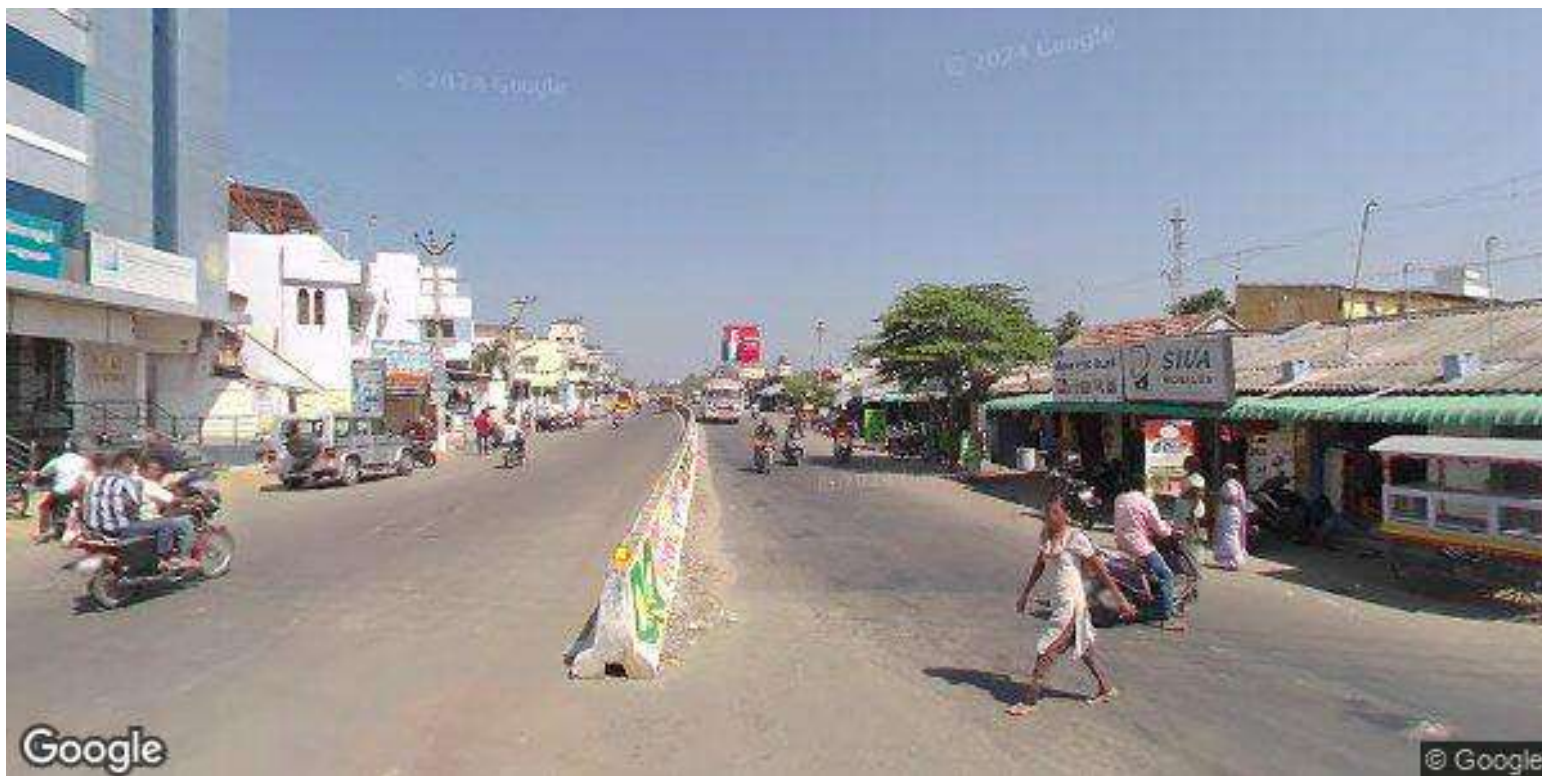
**Coordinates:** 11.37086, 77.74828

**Risk Type:** Roundabout

**Risk Level:** High

**Speed Limit:** 15 KM/Hr

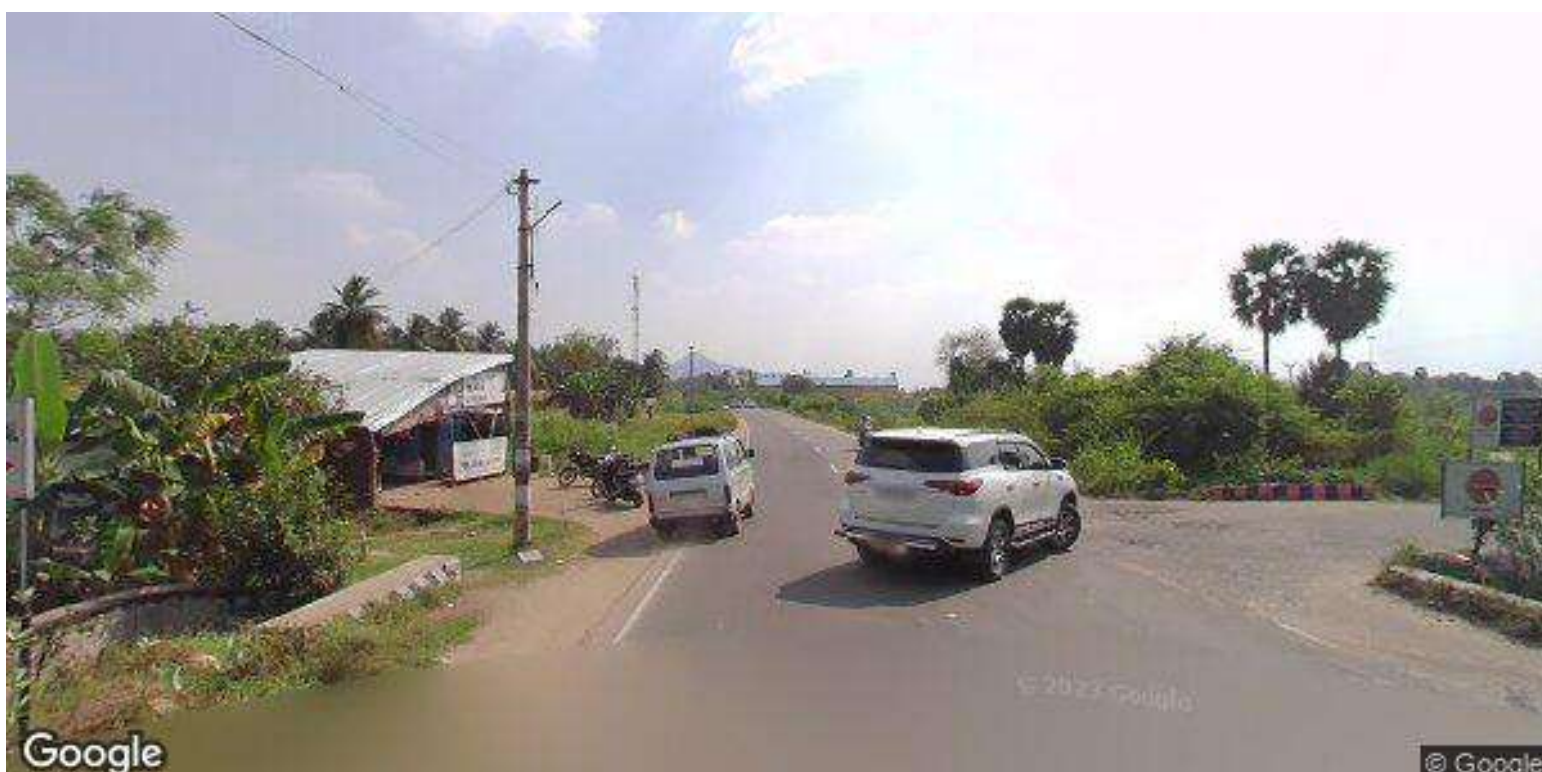
**Risk Type:** Turn  
**Risk Level:** High  
**Speed Limit:** 15 KM/Hr  
**Coordinates:** 11.44029, 77.87544

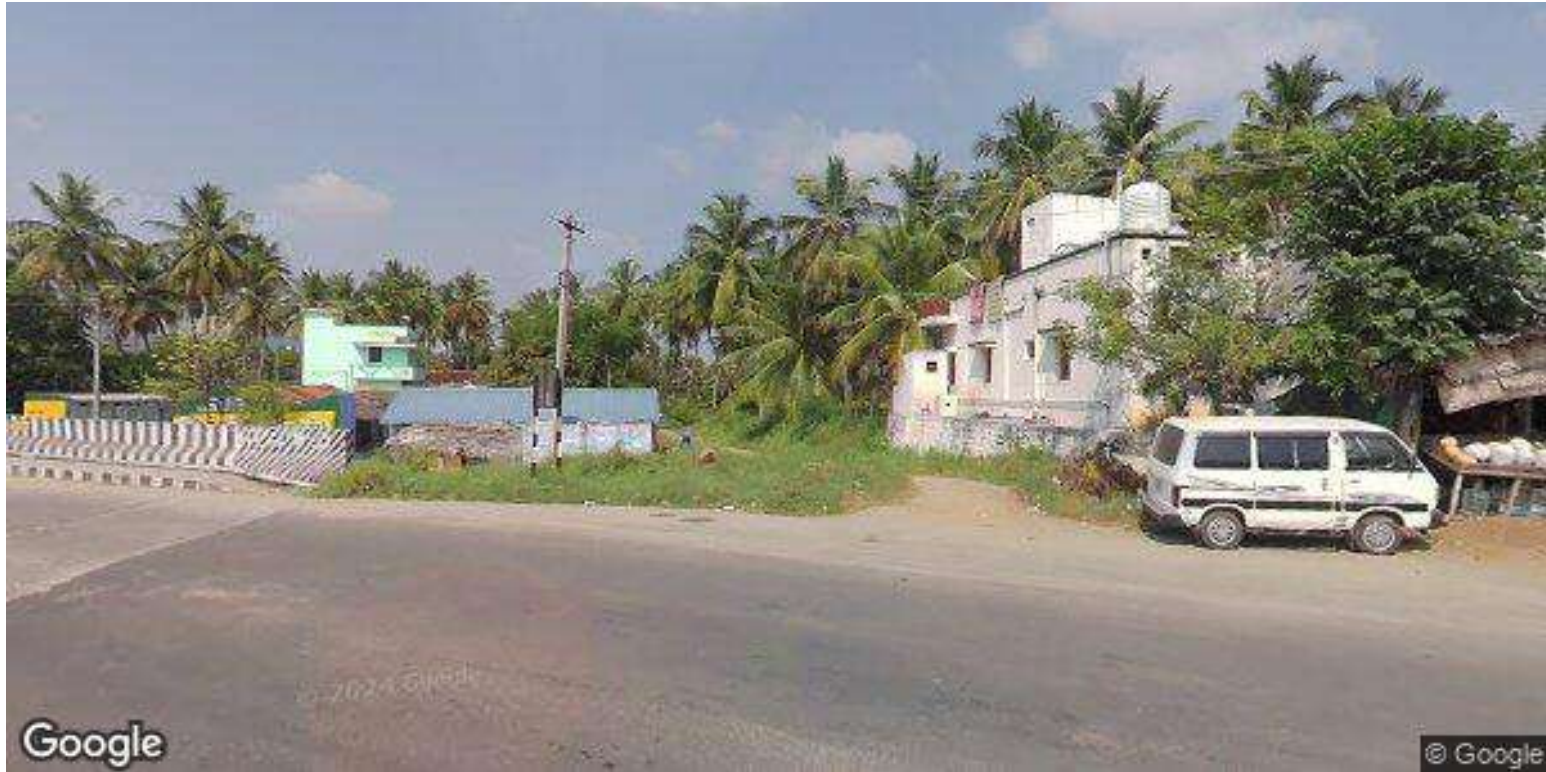
**Risk Type:** Turn  
**Risk Level:** Medium  
**Speed Limit:** 30 KM/Hr  
**Coordinates:** 11.44898, 77.87410

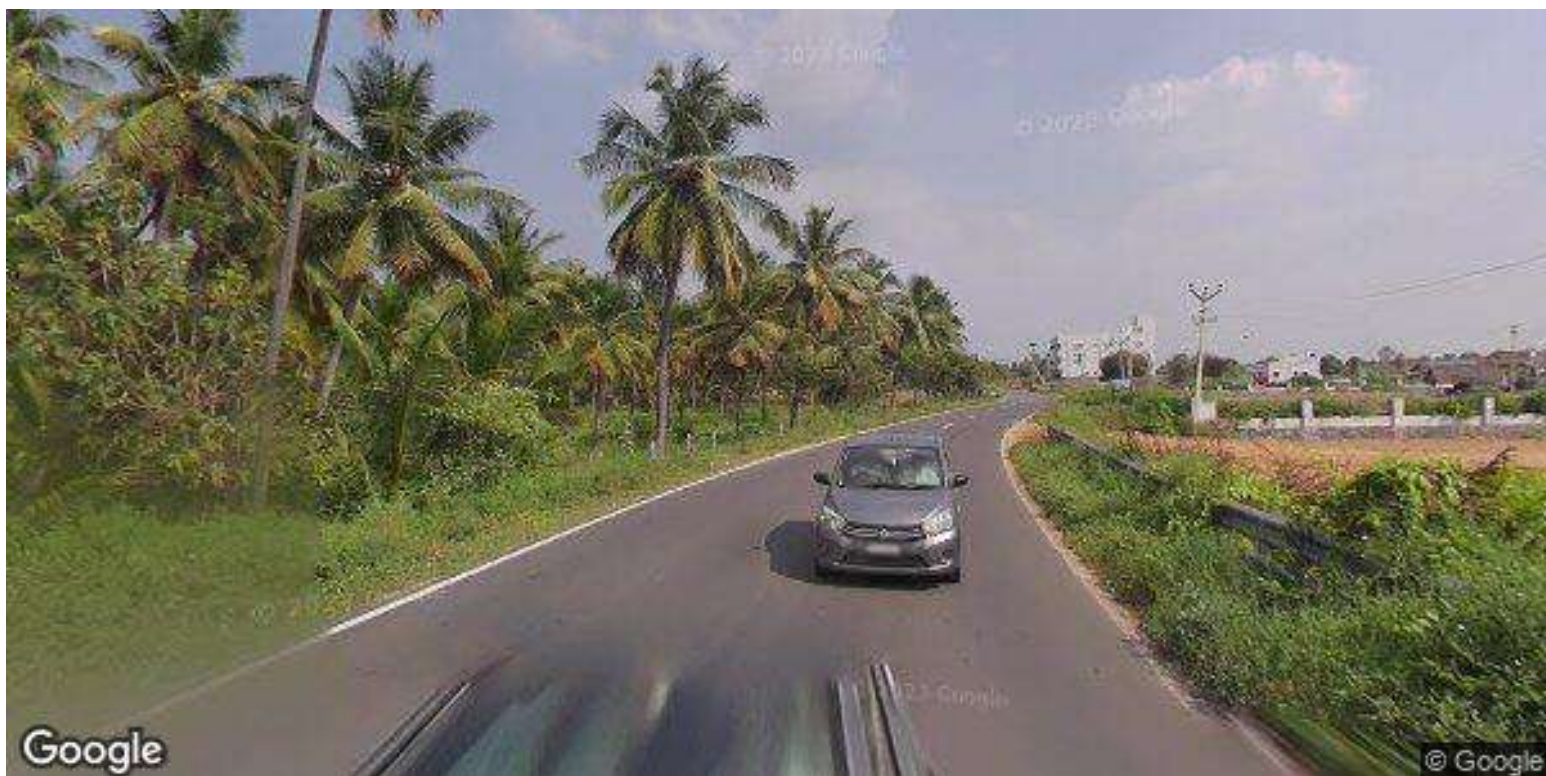
**Risk Type:** Turn  
**Risk Level:** Medium  
**Speed Limit:** 30 KM/Hr  
**Coordinates:** 11.45357, 77.85789

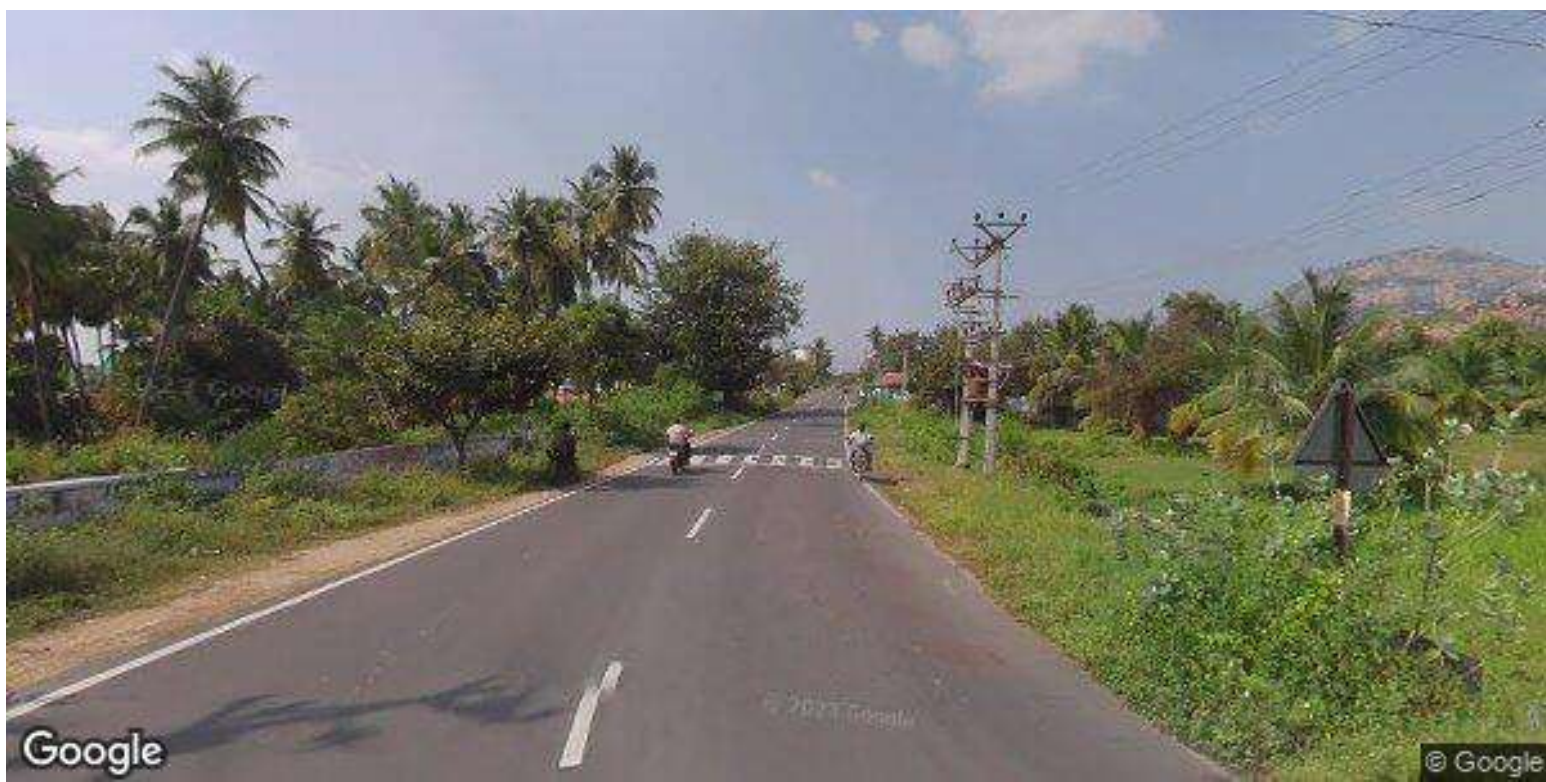
**Coordinates:** 11.45352, 77.85698

**Risk Type:** Turn

**Risk Level:** Medium

**Speed Limit:** 30 KM/Hr

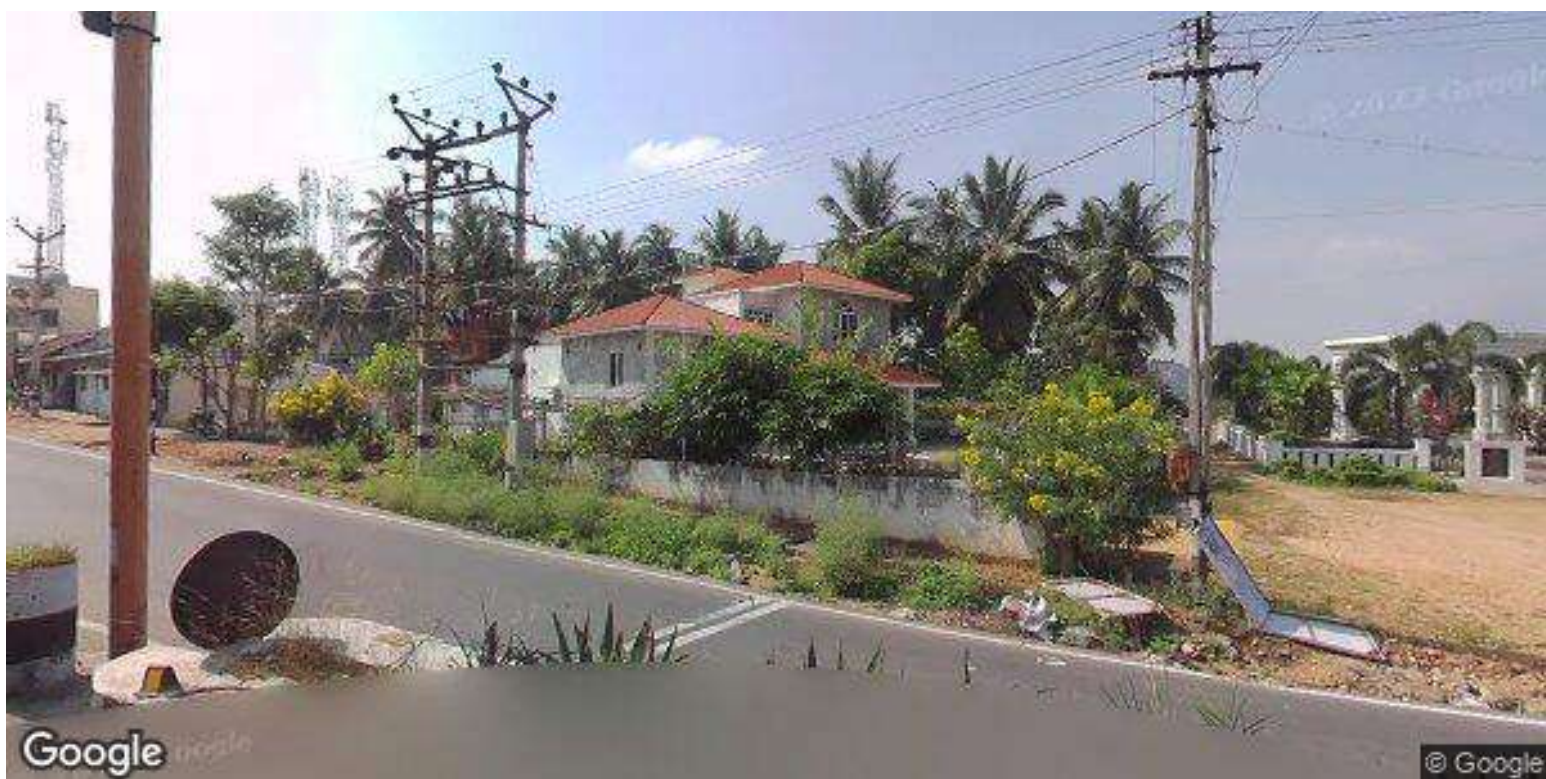
**Coordinates:** 11.46303, 77.84945

**Risk Type:** Turn

**Risk Level:** Medium

**Speed Limit:** 30 KM/Hr

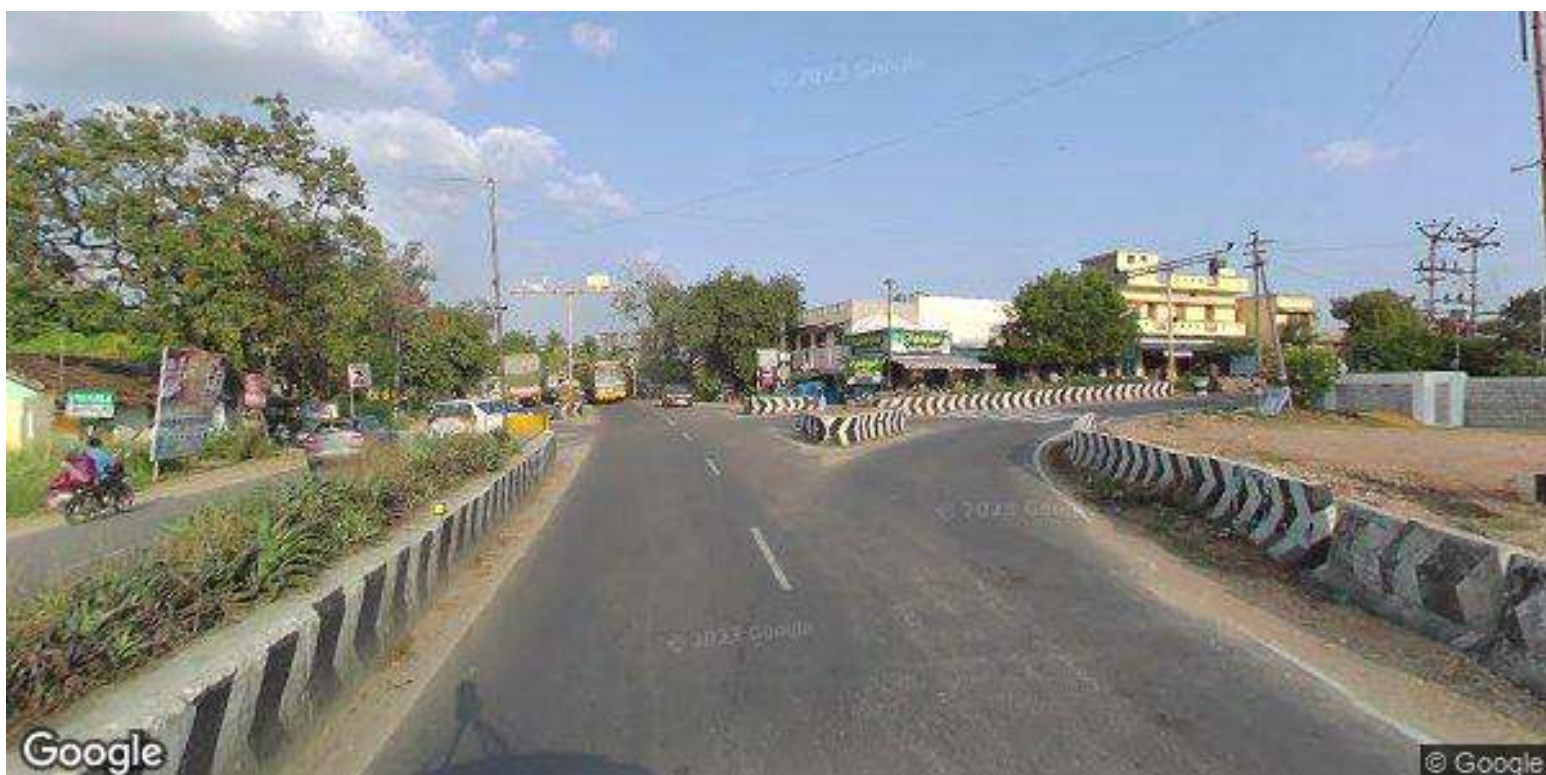
**Risk Type:** Turn  
**Risk Level:** Medium  
**Speed Limit:** 30 KM/Hr  
**Coordinates:** 11.46318, 77.84913

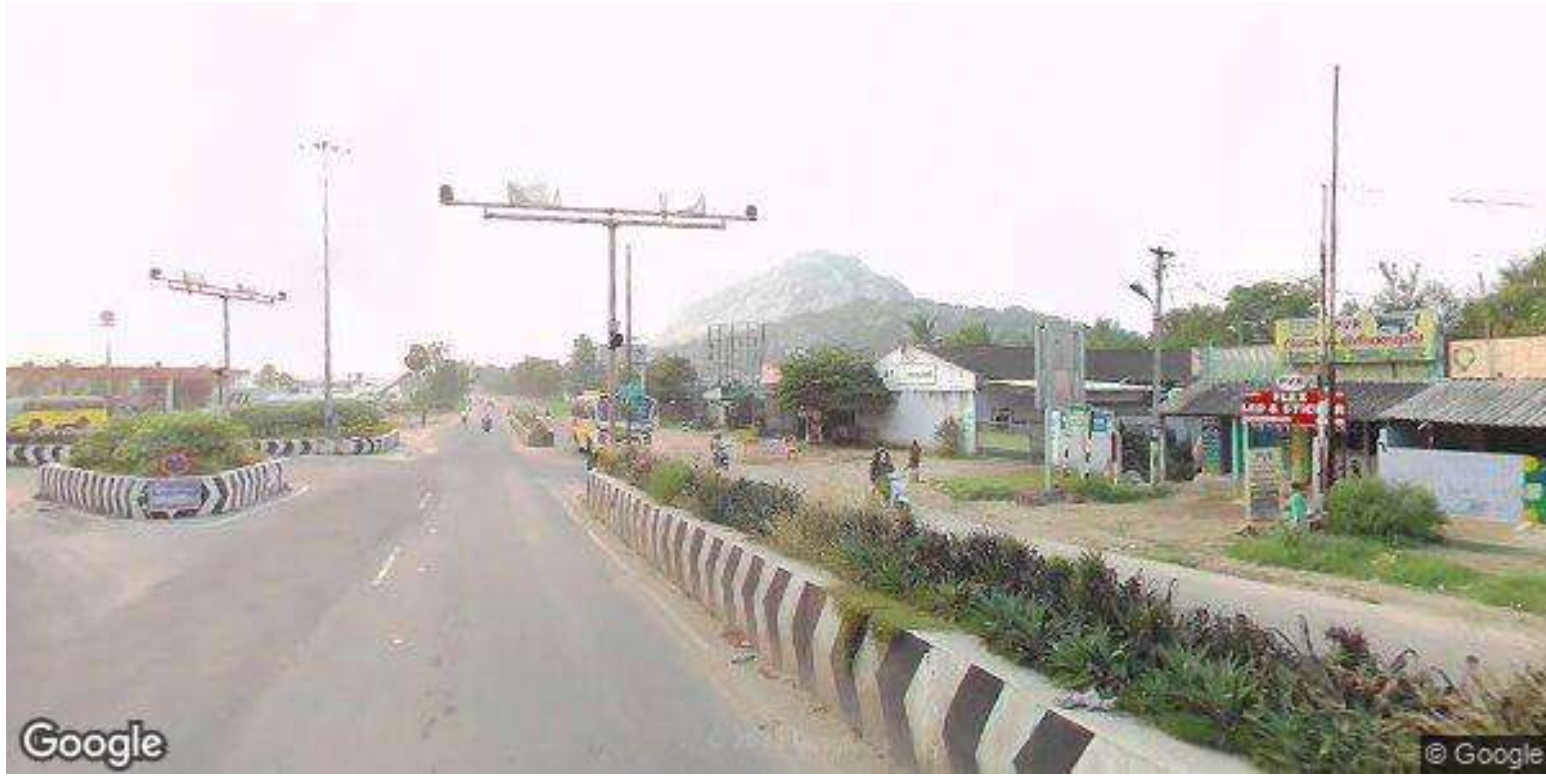
**Risk Type:** Turn  
**Risk Level:** Medium  
**Speed Limit:** 30 KM/Hr  
**Coordinates:** 11.46312, 77.84886

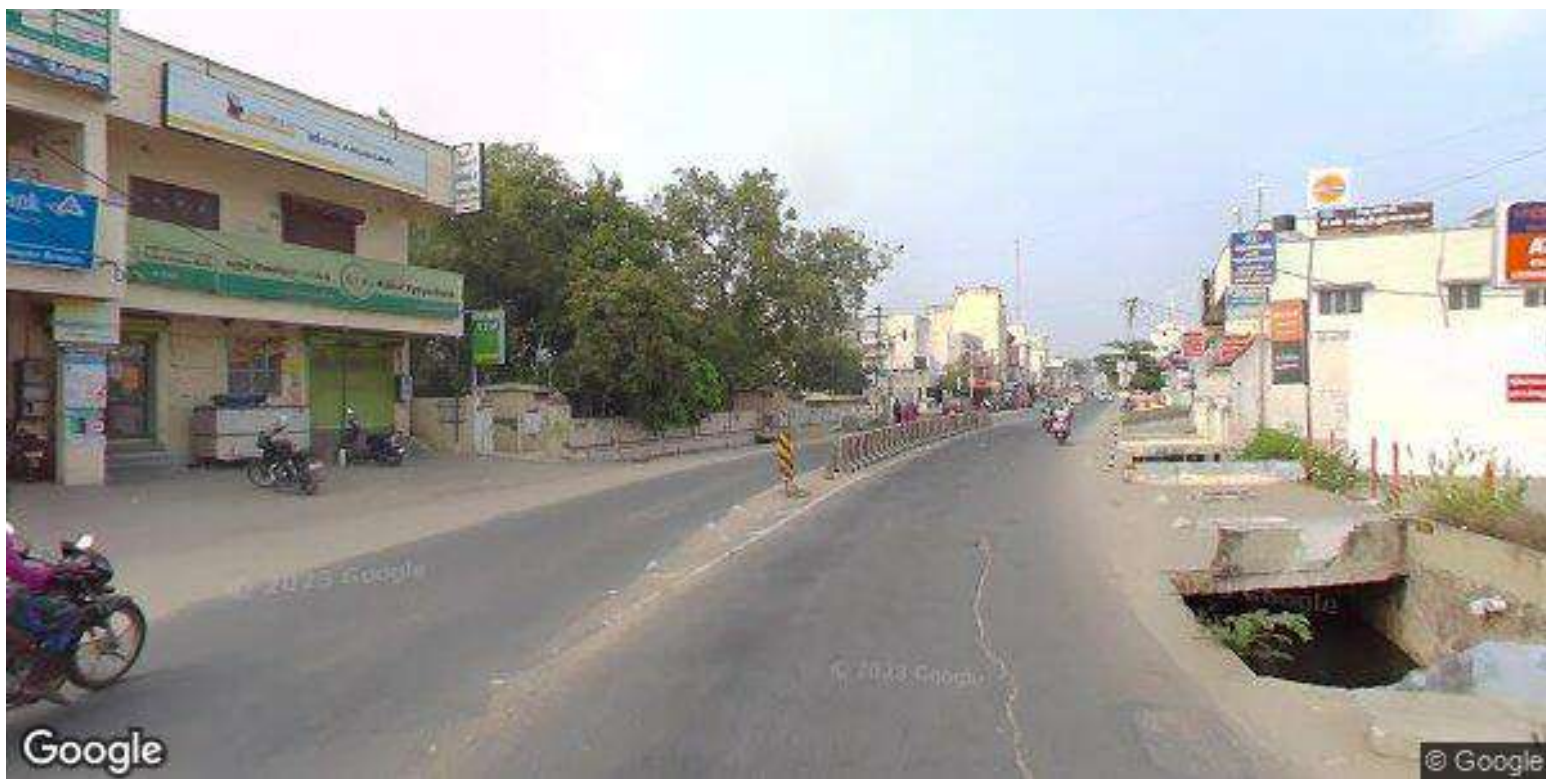
**Risk Type:** Turn  
**Risk Level:** Medium  
**Speed Limit:** 30 KM/Hr  
**Coordinates:** 11.36622, 77.74789

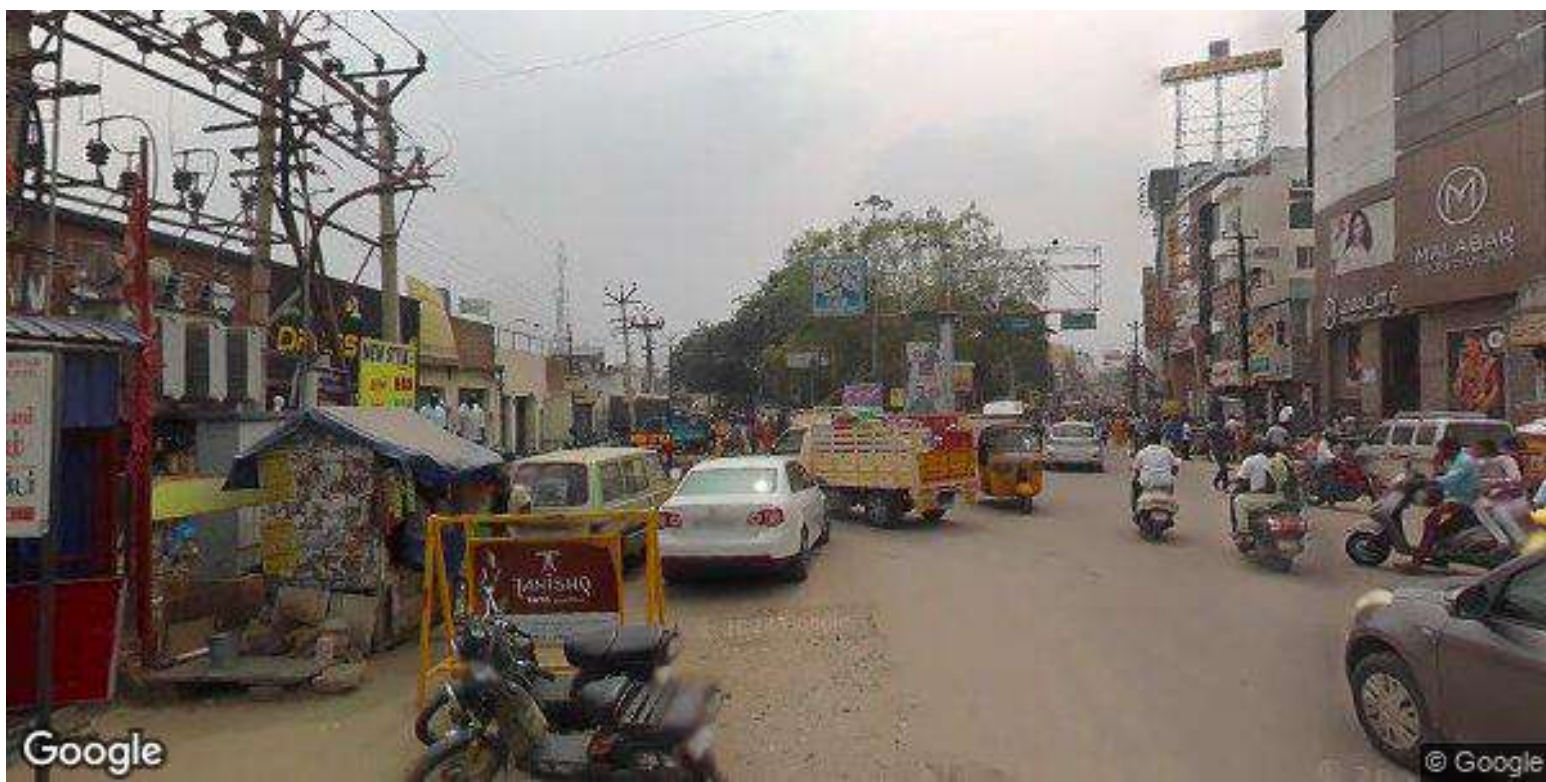
Coordinates: 11.34493, 77.73032

Risk Type: Turn

Risk Level: Medium

Speed Limit: 30 KM/Hr

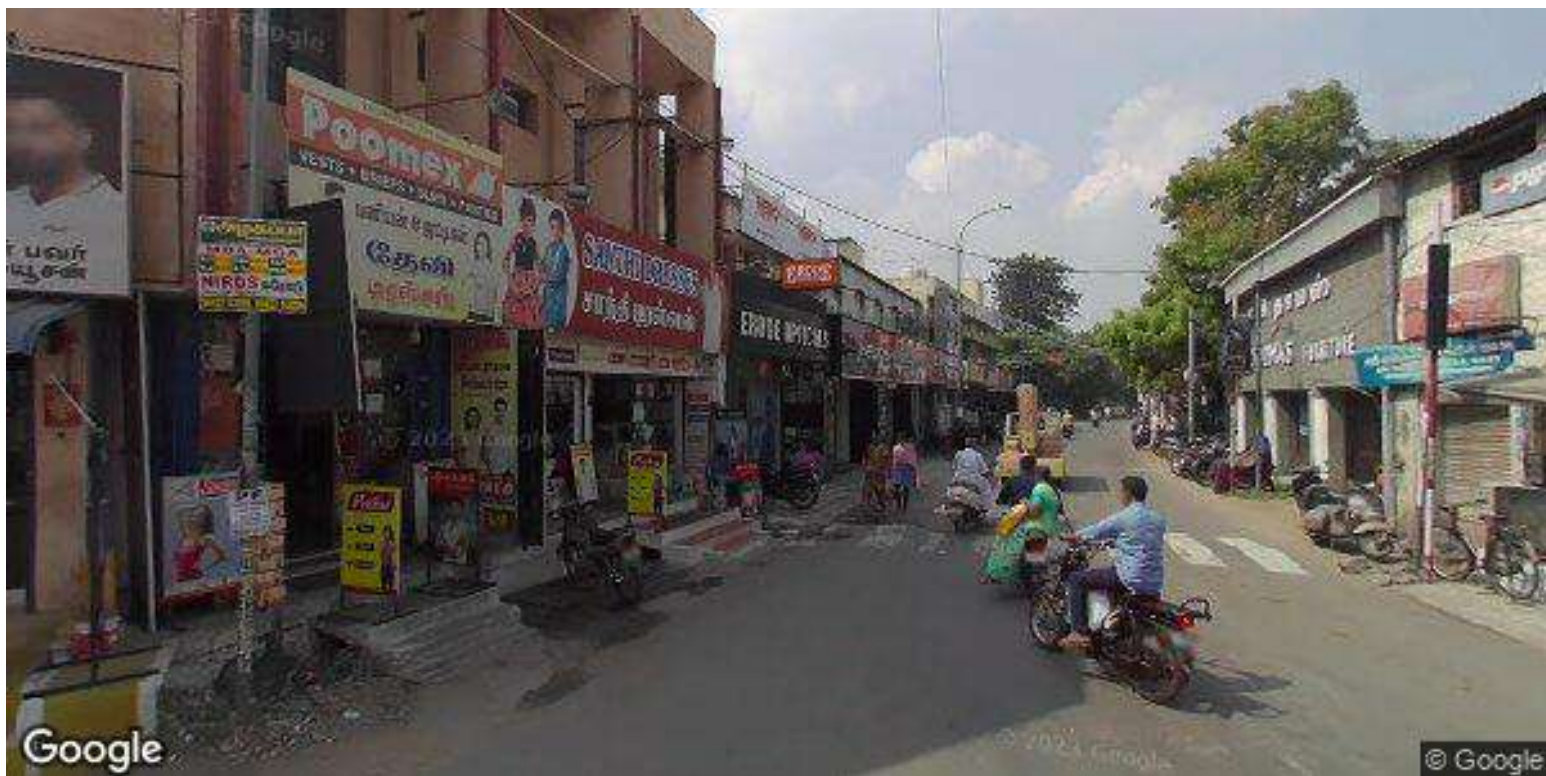
Coordinates: 11.33920, 77.72902

Risk Type: Blind Spot

Risk Level: Blind Spot

Speed Limit: 10 KM/Hr

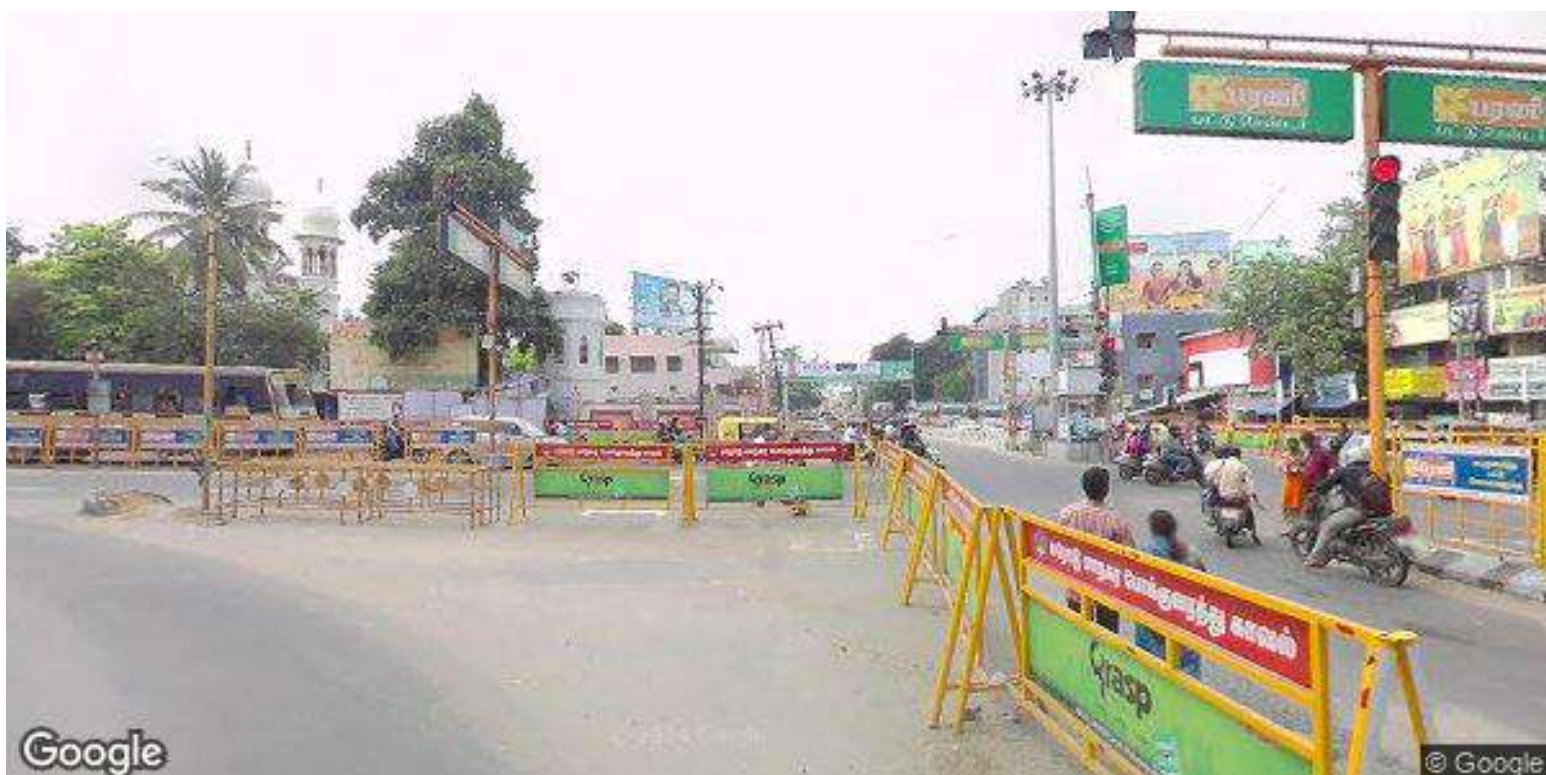
**Coordinates: 11.33914, 77.72659**

**Risk Type: Turn**

**Risk Level: Medium**

**Speed Limit: 30 KM/Hr**

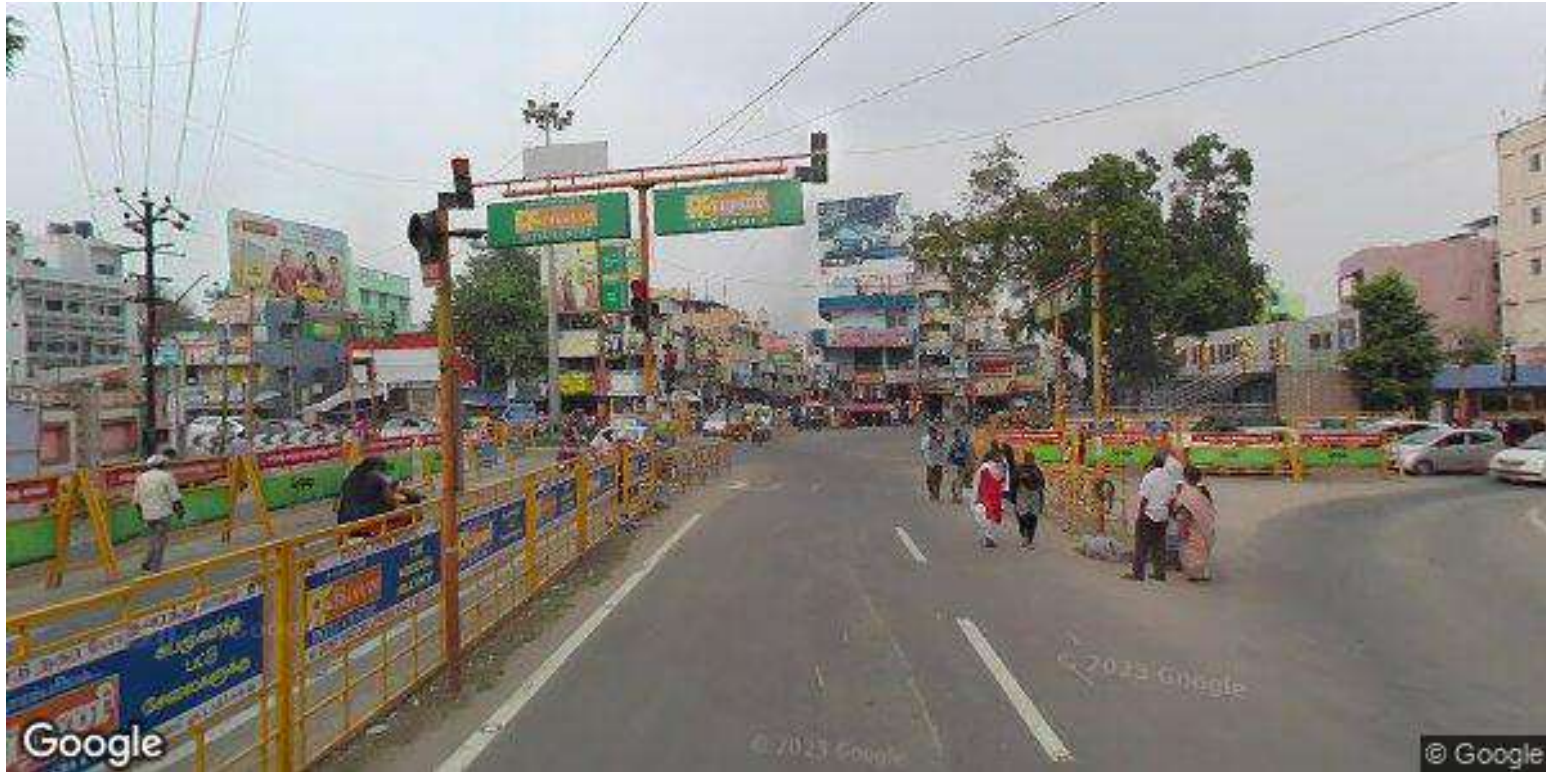
**Coordinates: 11.33890, 77.72637**

**Risk Type: Turn**

**Risk Level: High**

**Speed Limit: 15 KM/Hr**

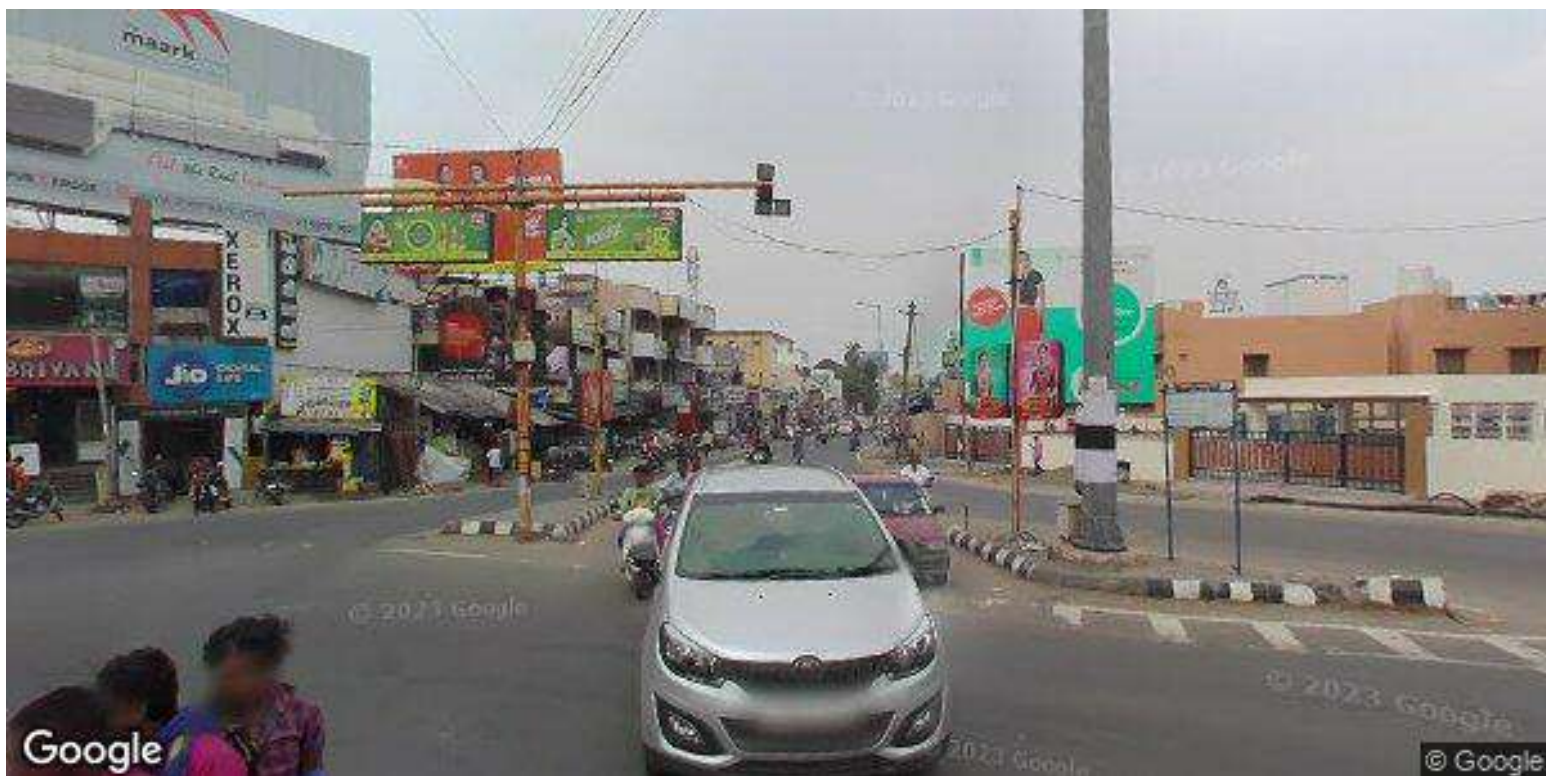
**Coordinates: 11.33095, 77.72748**

**Risk Type: Turn**

**Risk Level: Medium**

**Speed Limit: 30 KM/Hr**

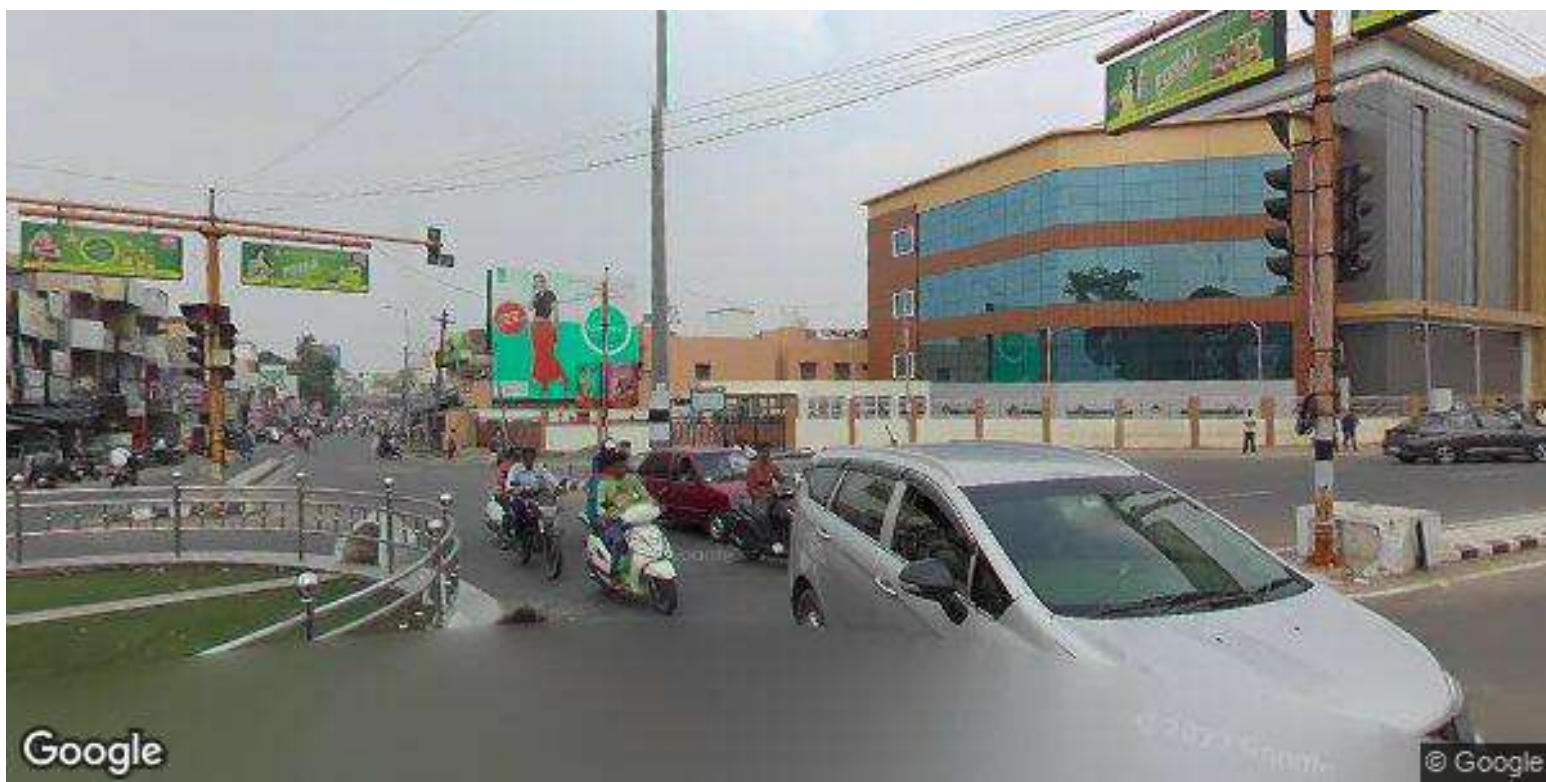
**Coordinates:** 11.33090, 77.72748

**Risk Type:** Turn

**Risk Level:** High

**Speed Limit:** 15 KM/Hr

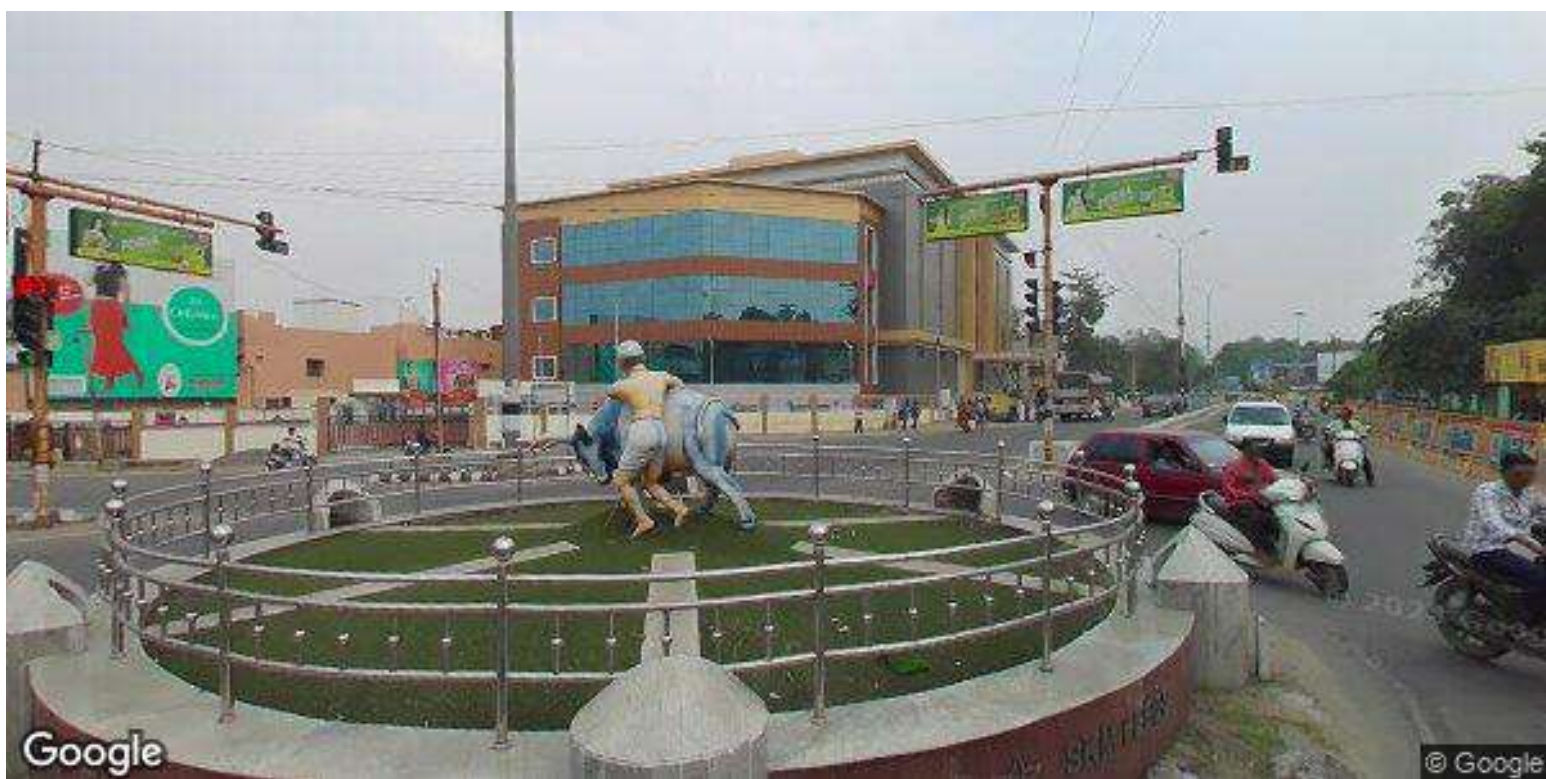
**Coordinates:** 11.33084, 77.72742

**Risk Type:** Turn

**Risk Level:** Medium

**Speed Limit:** 30 KM/Hr

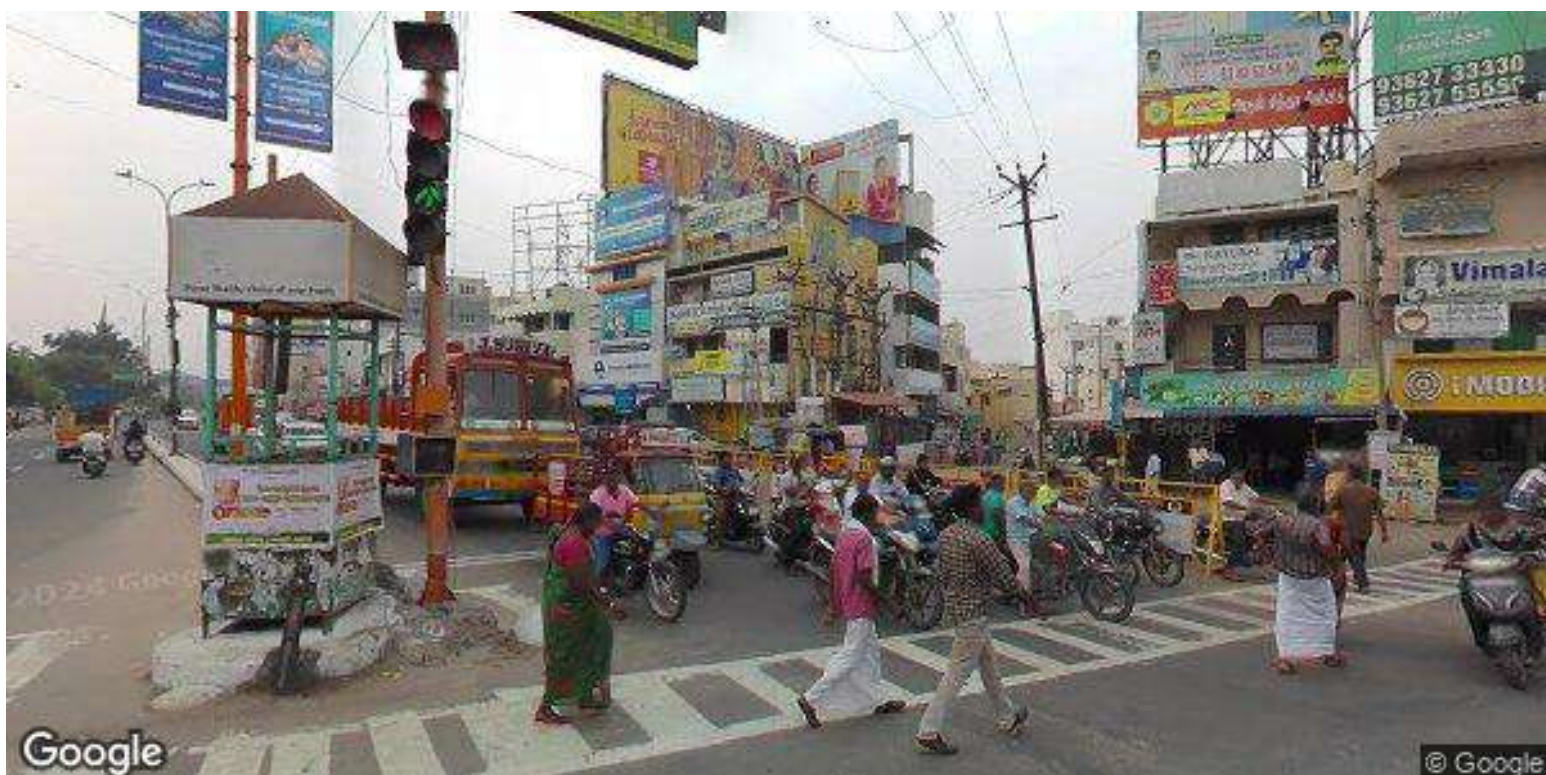
**Coordinates: 11.33083, 77.72734**

**Risk Type: Turn**

**Risk Level: Medium**

**Speed Limit: 30 KM/Hr**

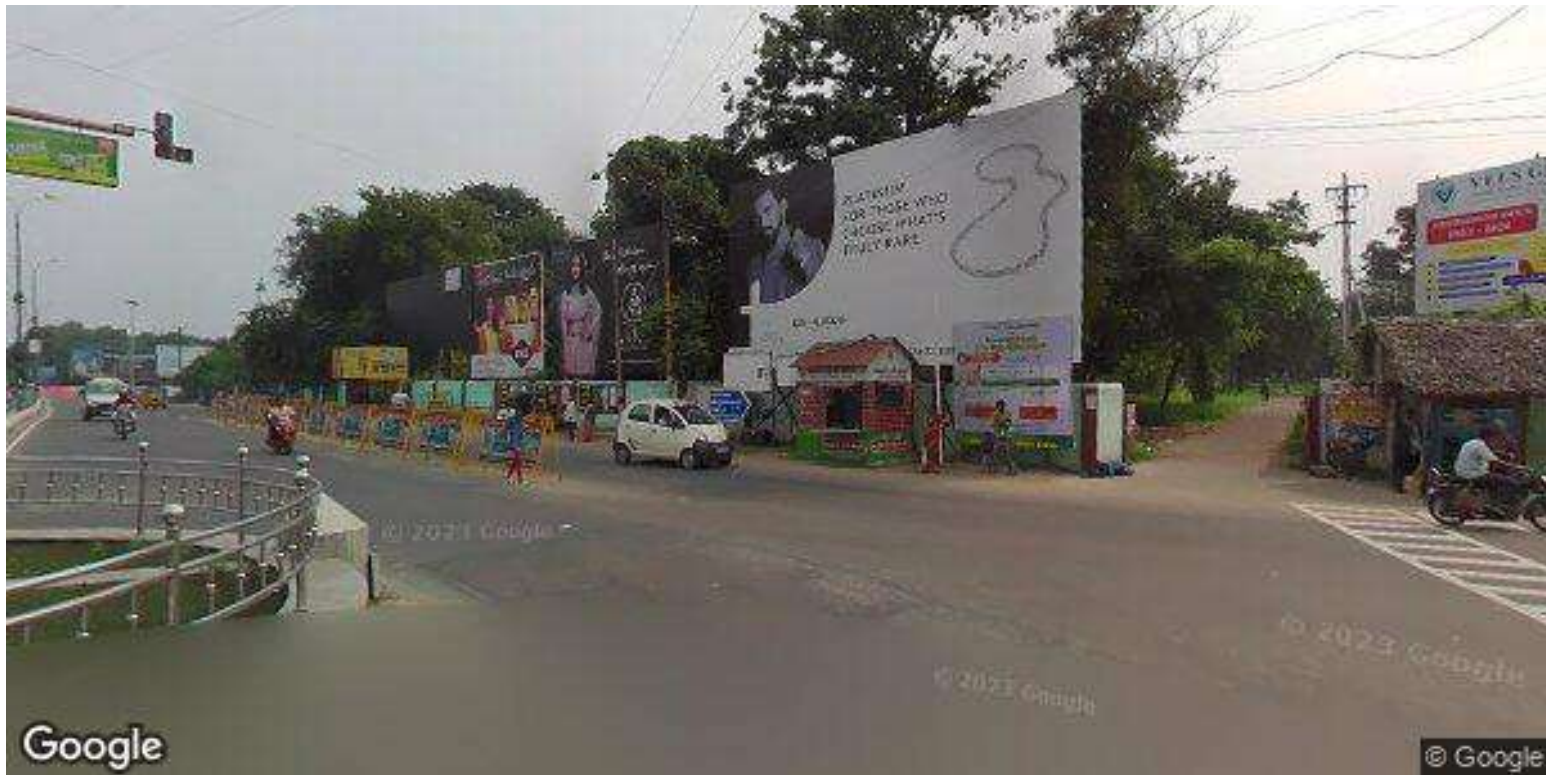
**Coordinates: 11.33084, 77.72731**

**Risk Type: Turn**

**Risk Level: High**

**Speed Limit: 15 KM/Hr**

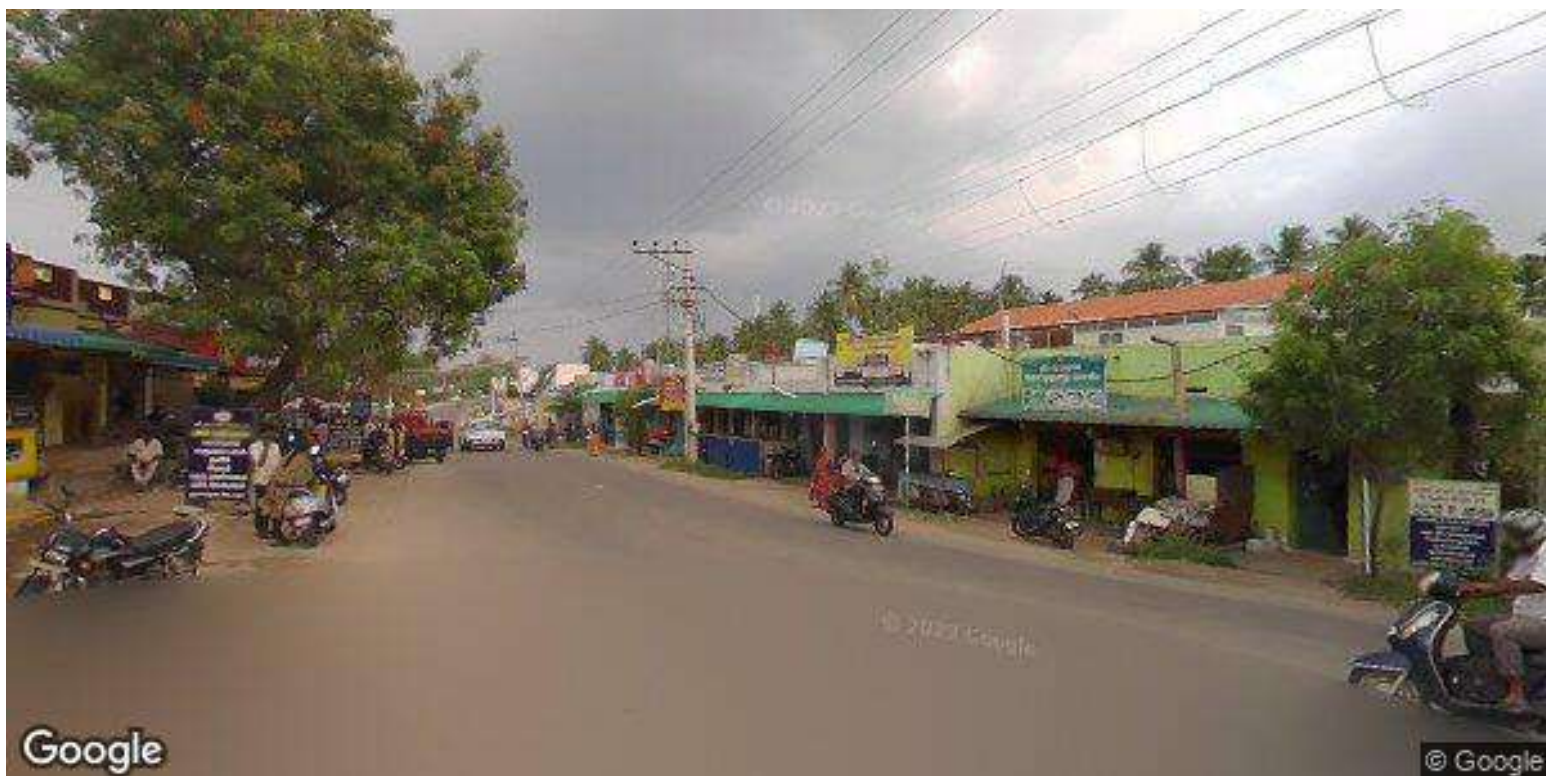
**Coordinates: 11.31172, 77.70715**

**Risk Type: Turn**

**Risk Level: High**

**Speed Limit: 15 KM/Hr**
