# IndianOil

## JOURNEY RISK MANAGEMENT (JRM) STUDY

### Salem Terminal to SRI VELAVAN AGENCY

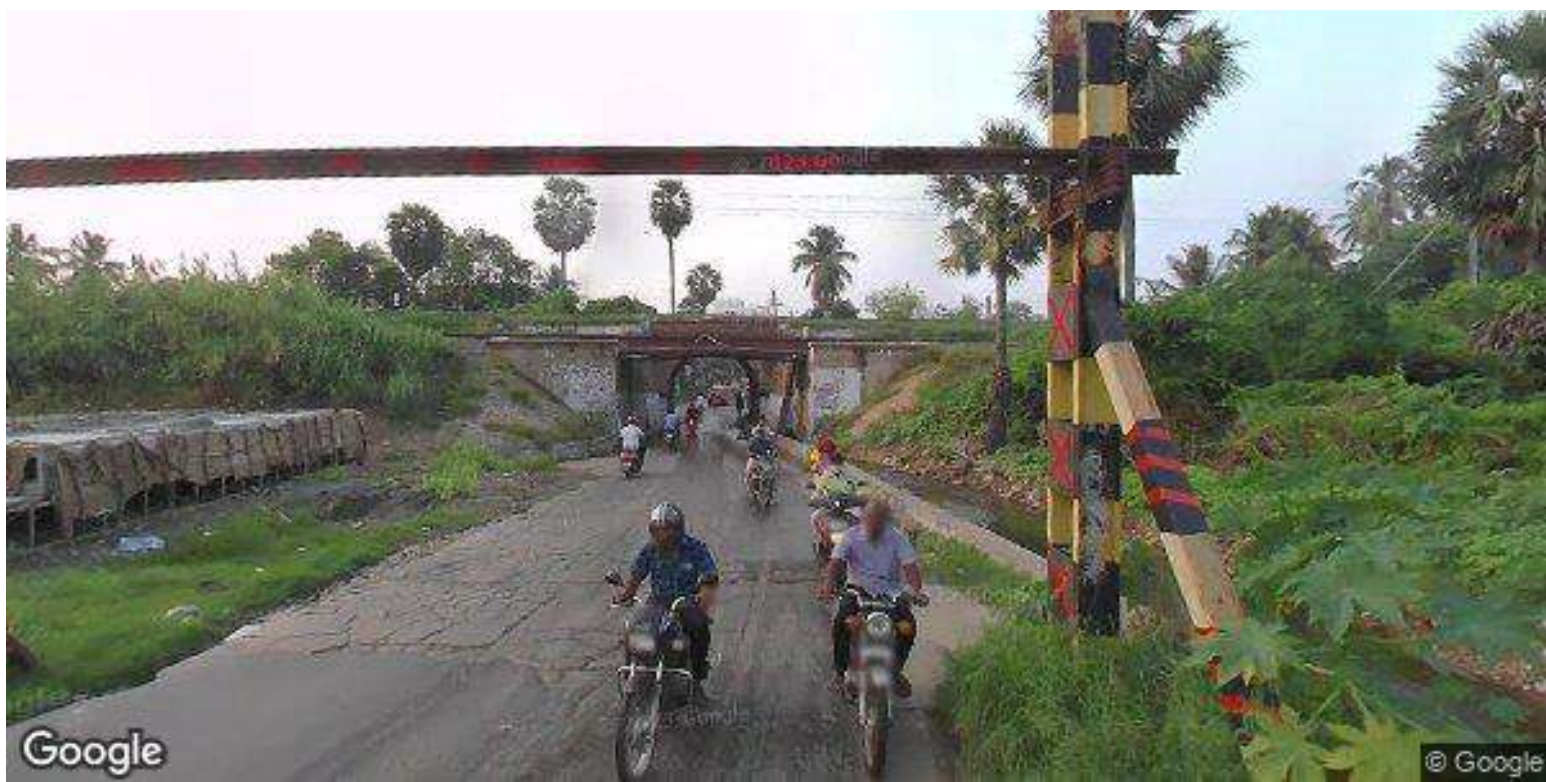
**Coordinates:** 11.31050, 77.70781

**Risk Type:** Turn

**Risk Level:** Medium

**Speed Limit:** 30 KM/Hr

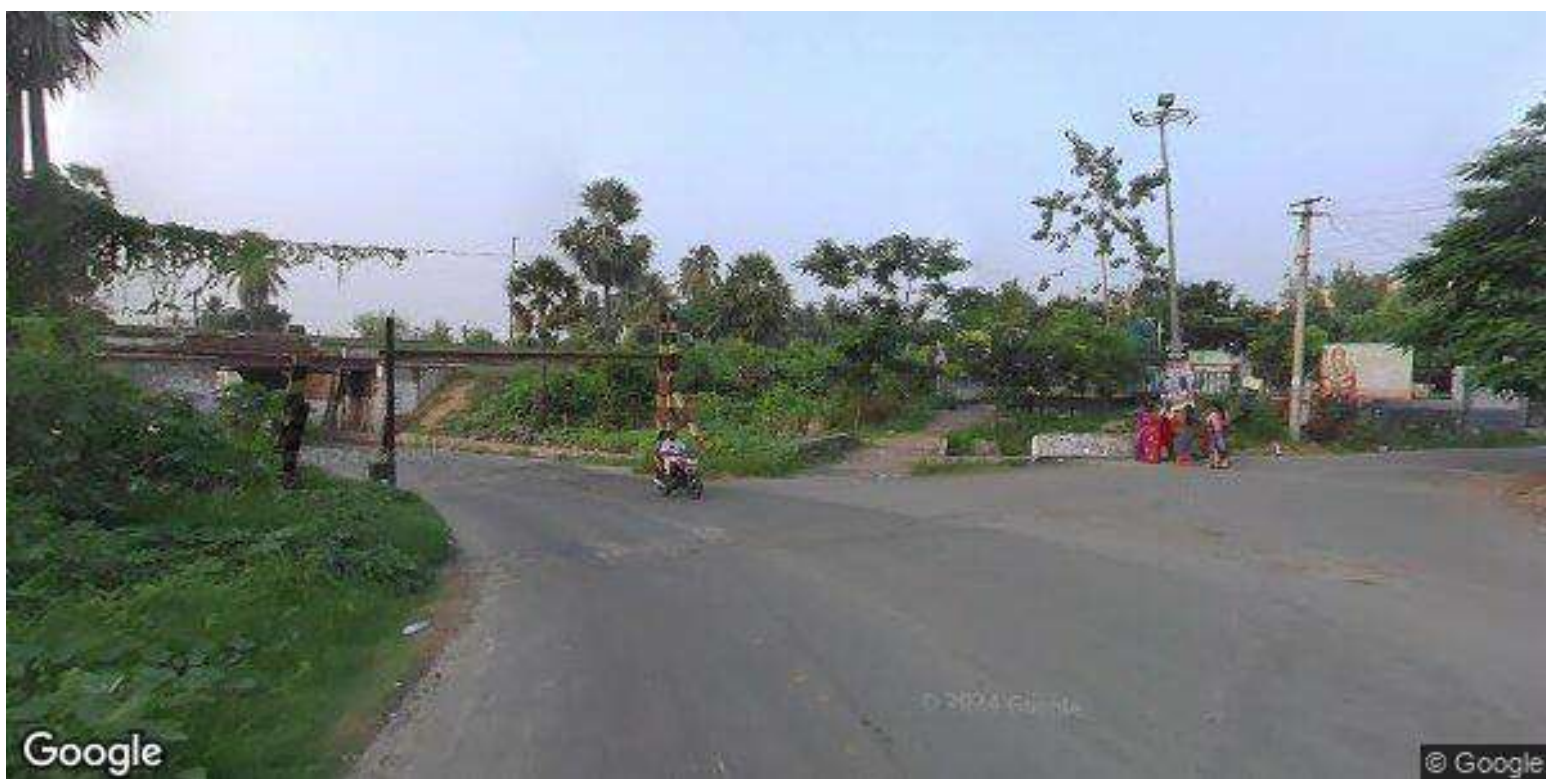
**Coordinates:** 11.31032, 77.70783

**Risk Type:** Turn

**Risk Level:** Medium

**Speed Limit:** 30 KM/Hr

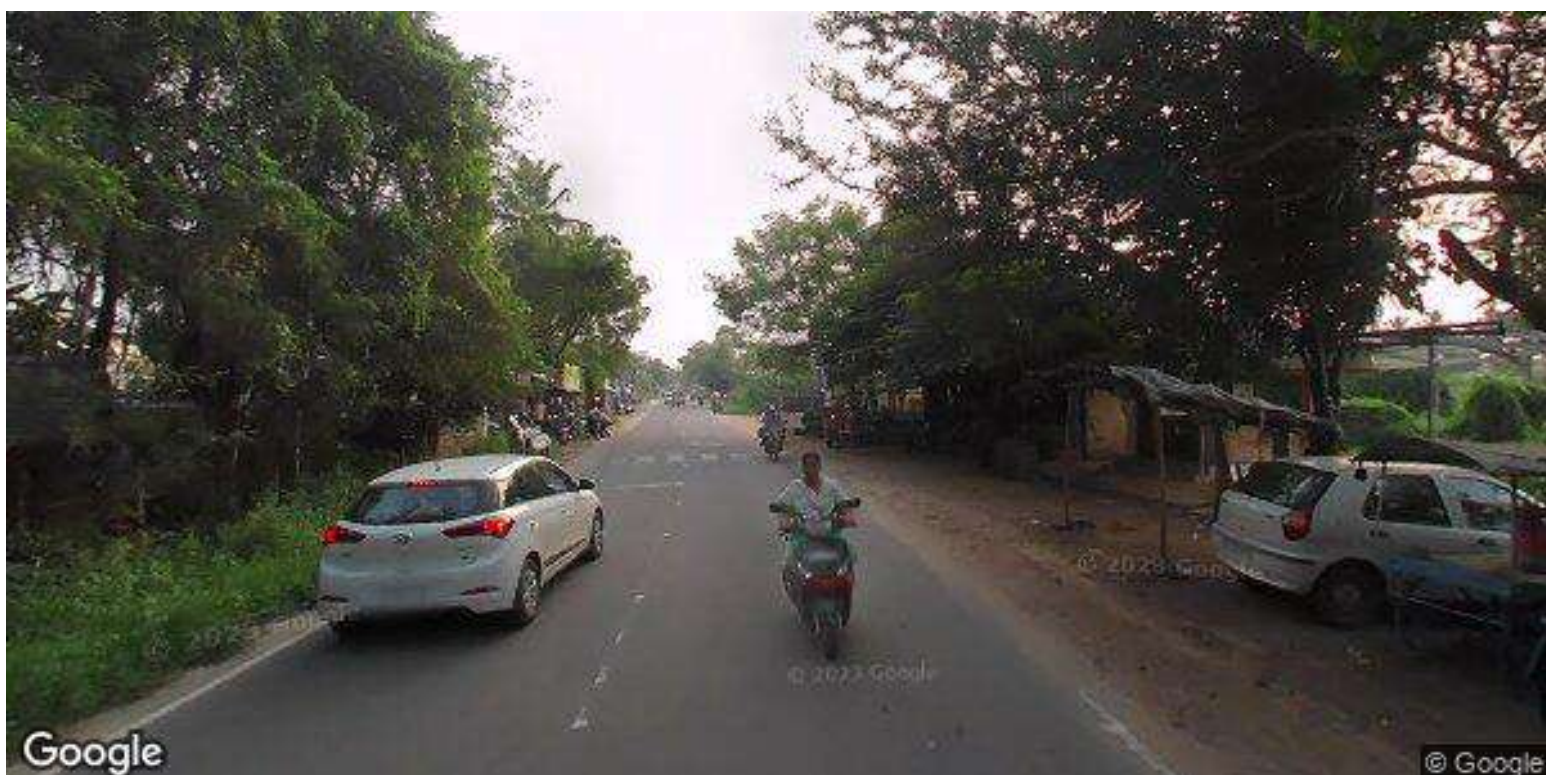
**Coordinates:** 11.30807, 77.70415

**Risk Type:** Turn

**Risk Level:** Medium

**Speed Limit:** 30 KM/Hr
