# IndianOil

## JOURNEY RISK MANAGEMENT (JRM) STUDY

**Salem Terminal TO LAXMI FUELS Indian Oil Dealer**

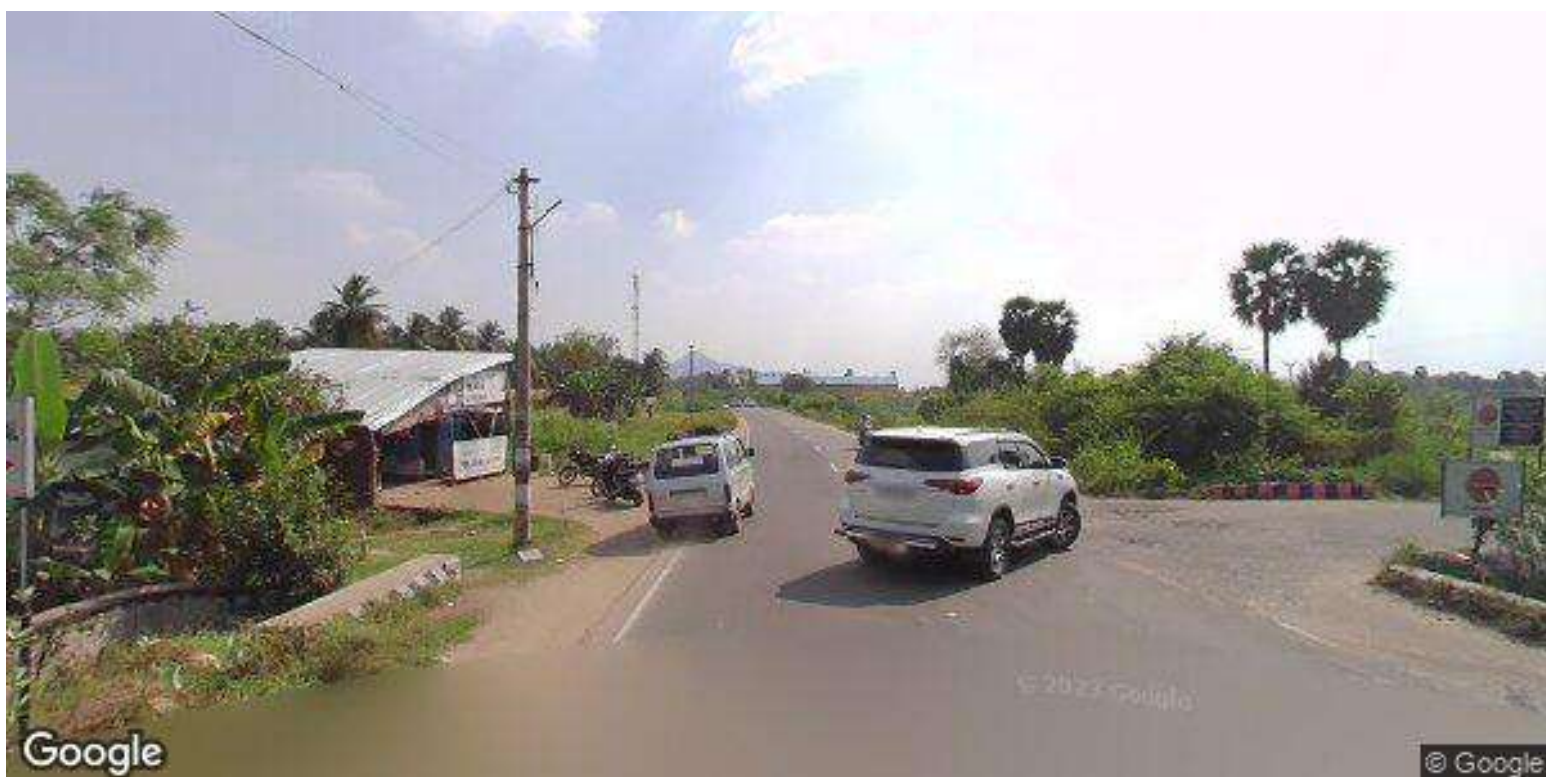
**Coordinates:** 11.44029, 77.87544

**Risk Type:** Turn

**Risk Level:** High

**Speed Limit:** 15 KM/Hr

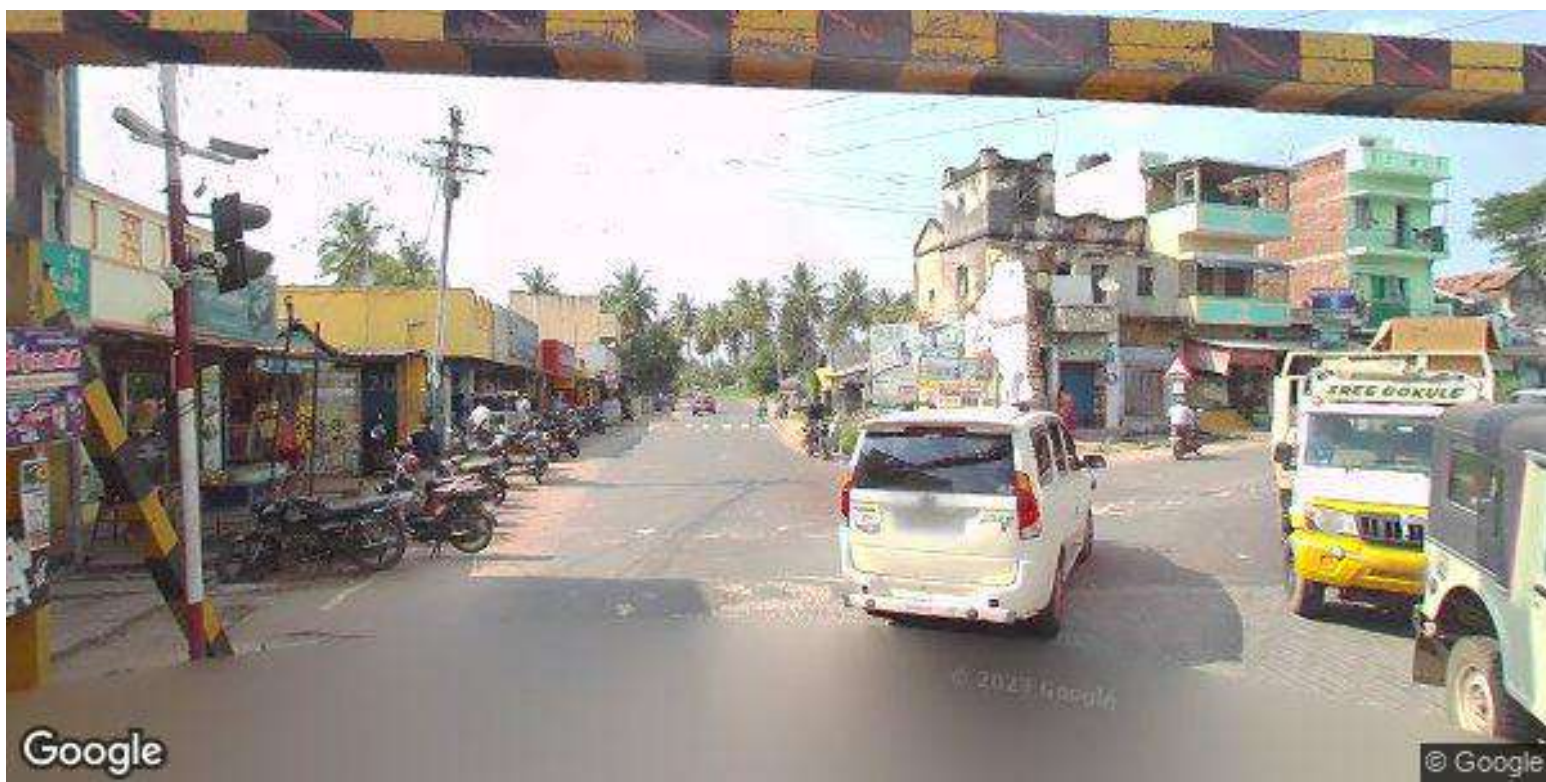
**Coordinates:** 11.45004, 77.87206

**Risk Type:** Turn

**Risk Level:** High

**Speed Limit:** 15 KM/Hr

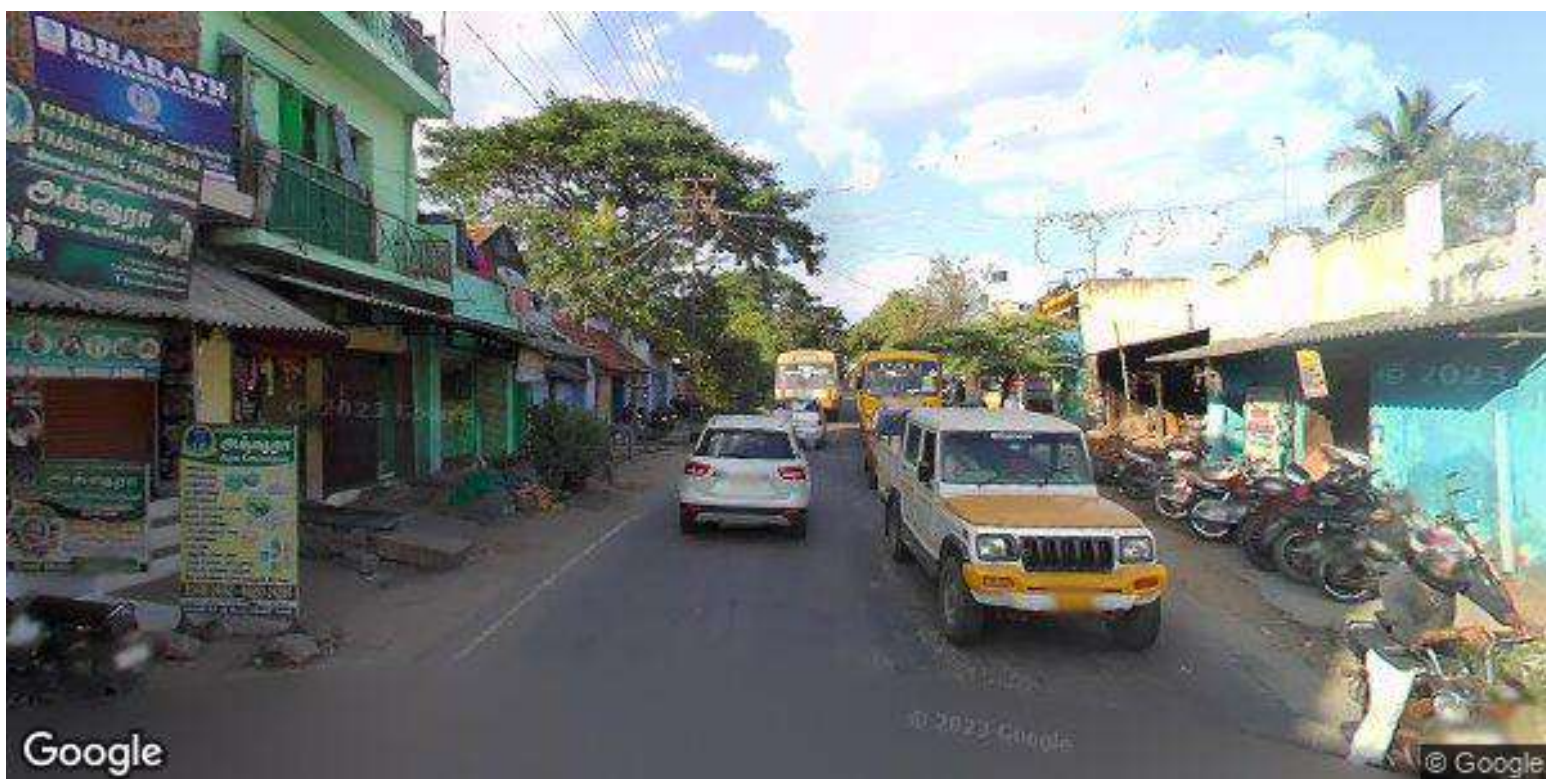
**Coordinates:** 11.45028, 77.87202

**Risk Type:** Turn

**Risk Level:** Medium

**Speed Limit:** 30 KM/Hr

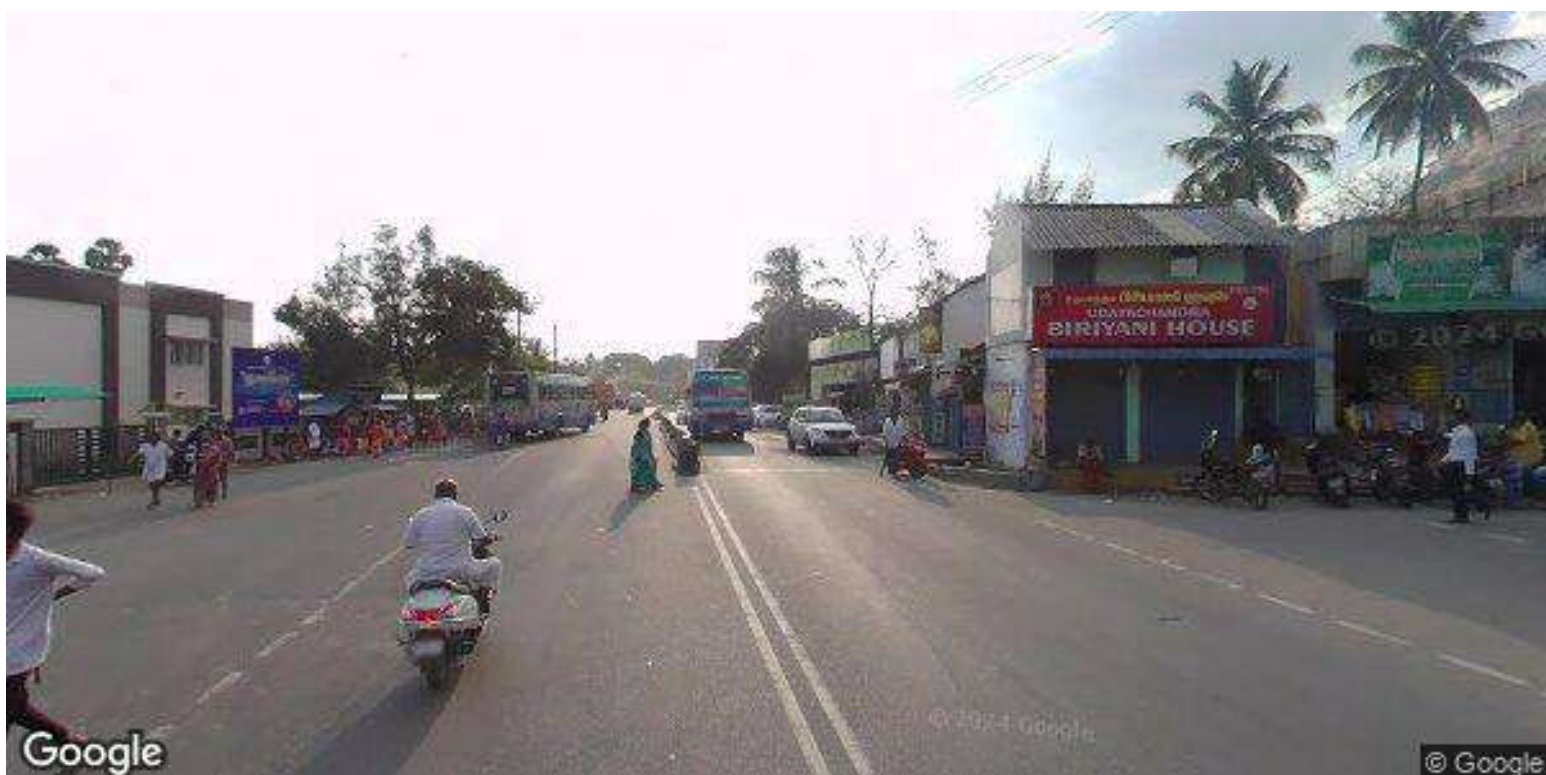
**Coordinates: 11.47403, 77.86841**

**Risk Type: Turn**

**Risk Level: High**

**Speed Limit: 15 KM/Hr**

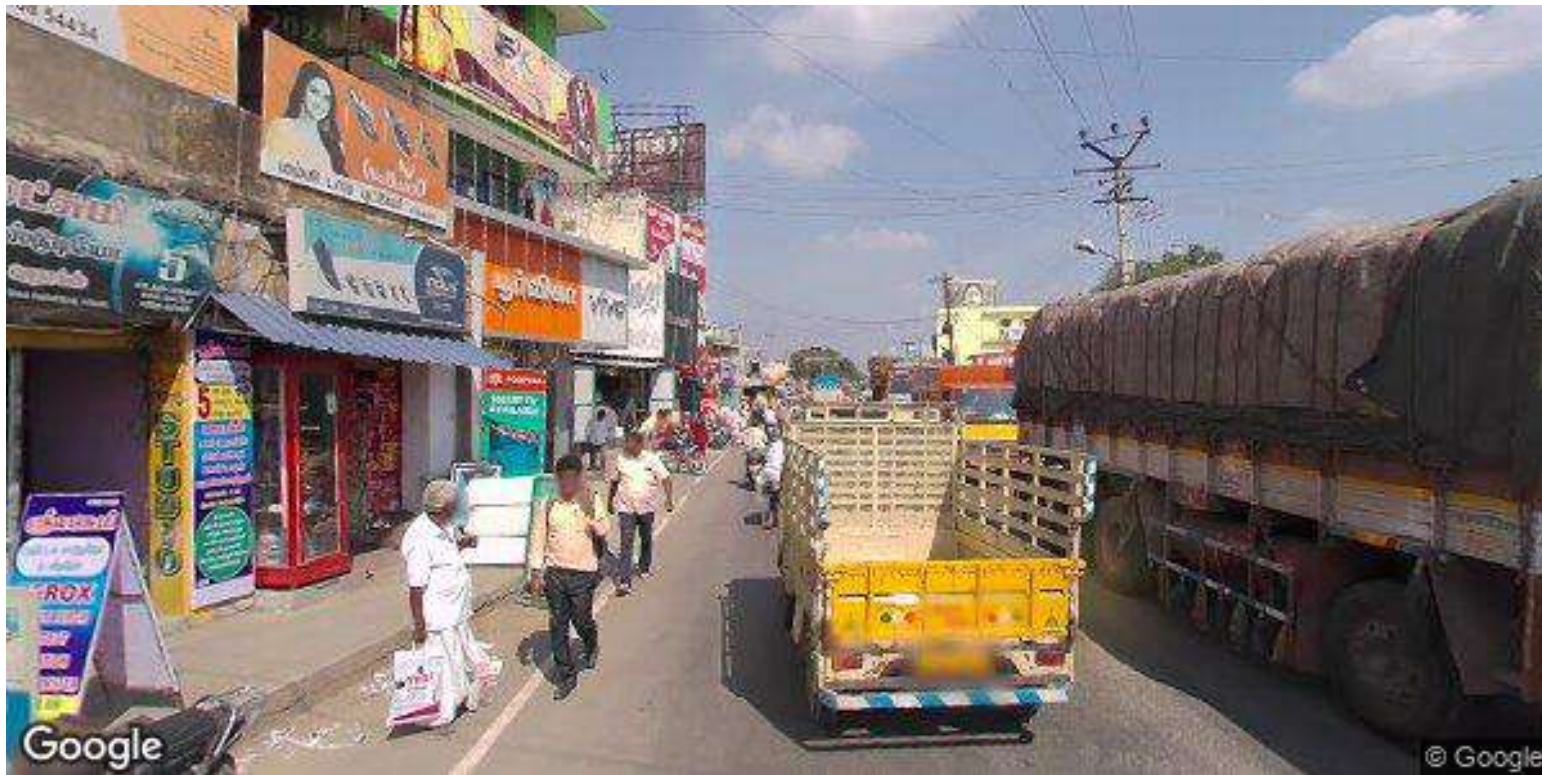
**Coordinates: 11.47410, 77.86845**

**Risk Type: Turn**

**Risk Level: Medium**

**Speed Limit: 30 KM/Hr**

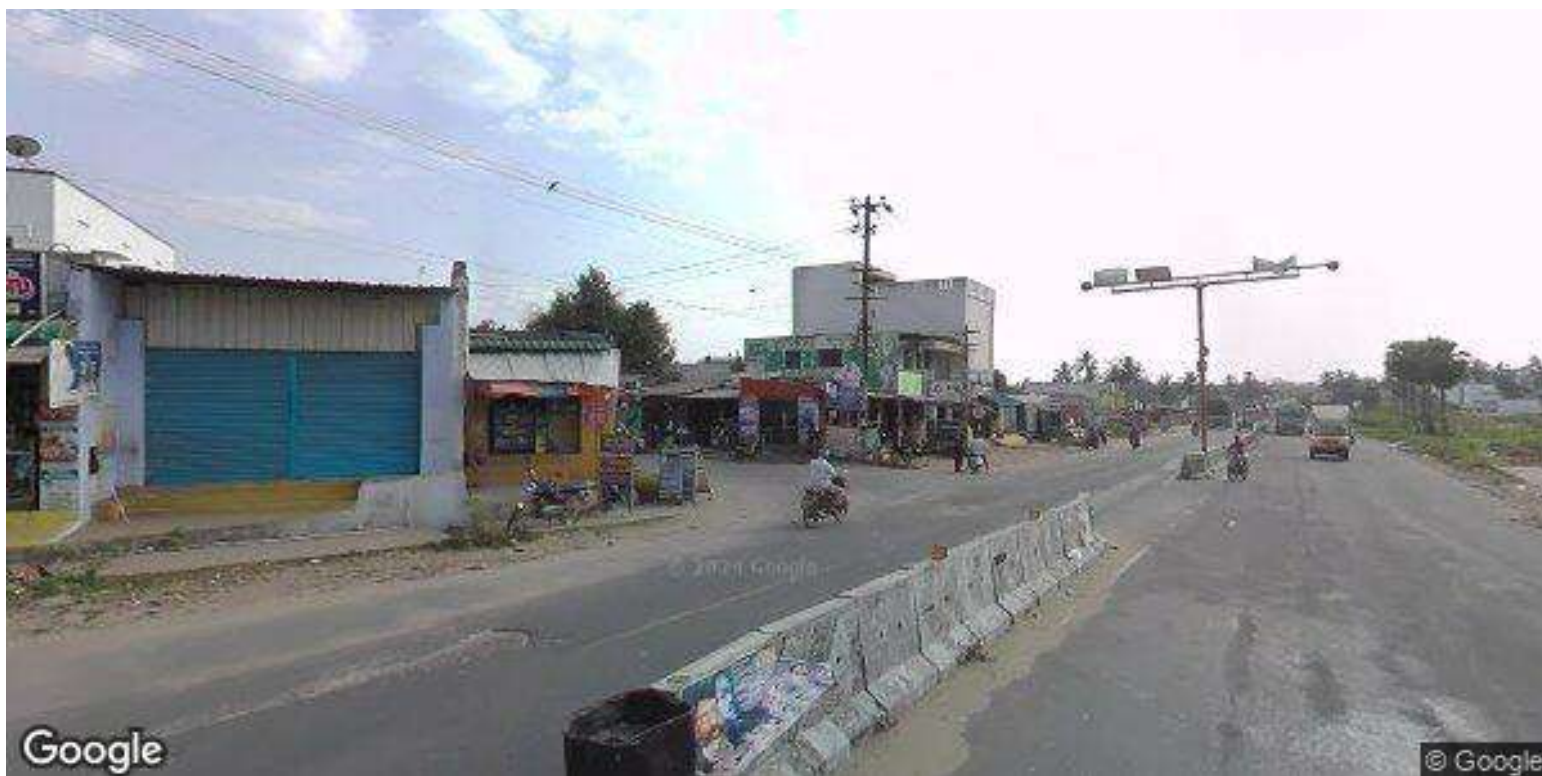
**Coordinates: 11.48363, 77.88780**

**Risk Type: Turn**

**Risk Level: Medium**

**Speed Limit: 30 KM/Hr**

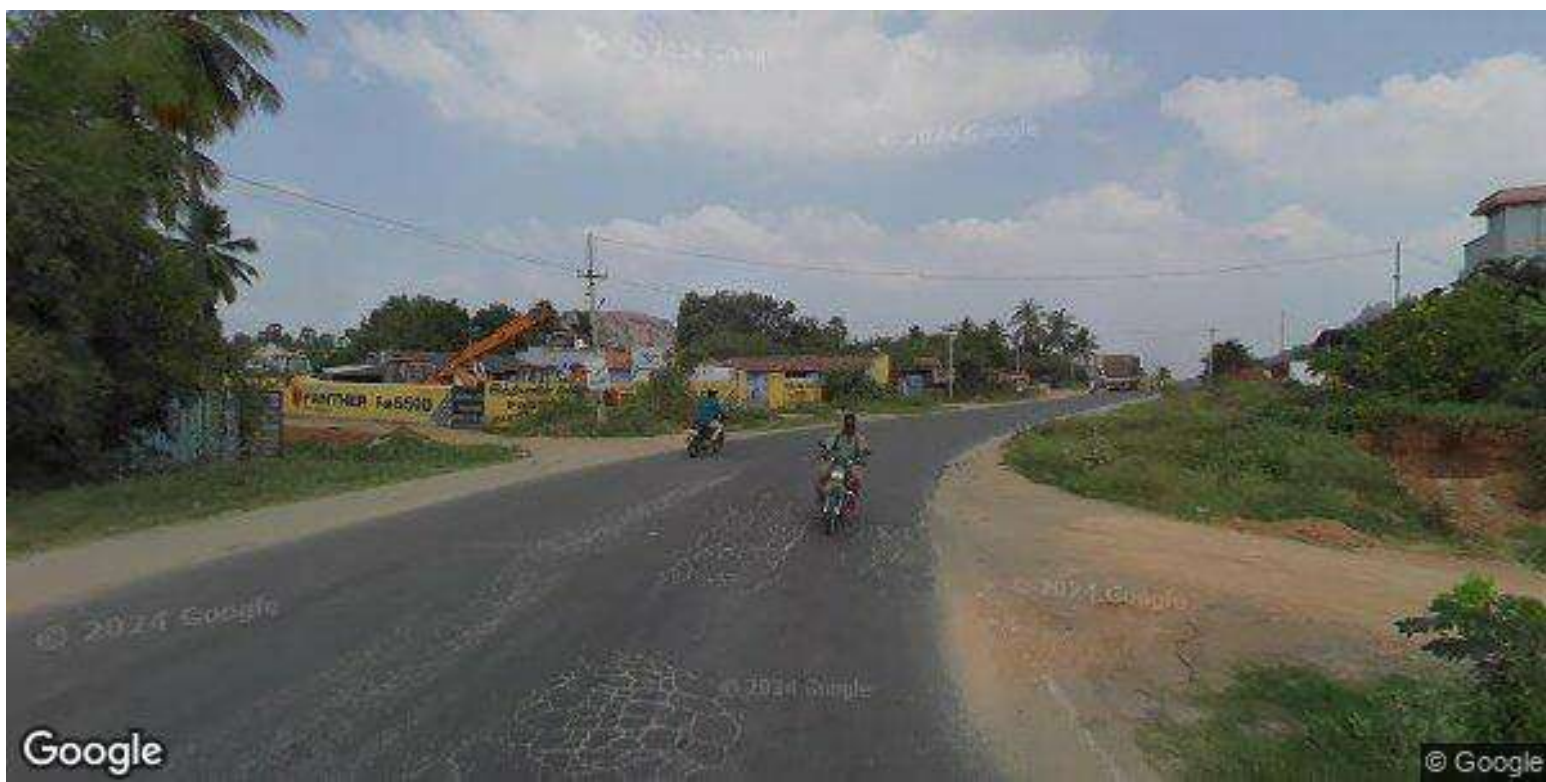
**Coordinates:** 11.49451, 77.88489

**Risk Type:** Turn

**Risk Level:** Medium

**Speed Limit:** 30 KM/Hr

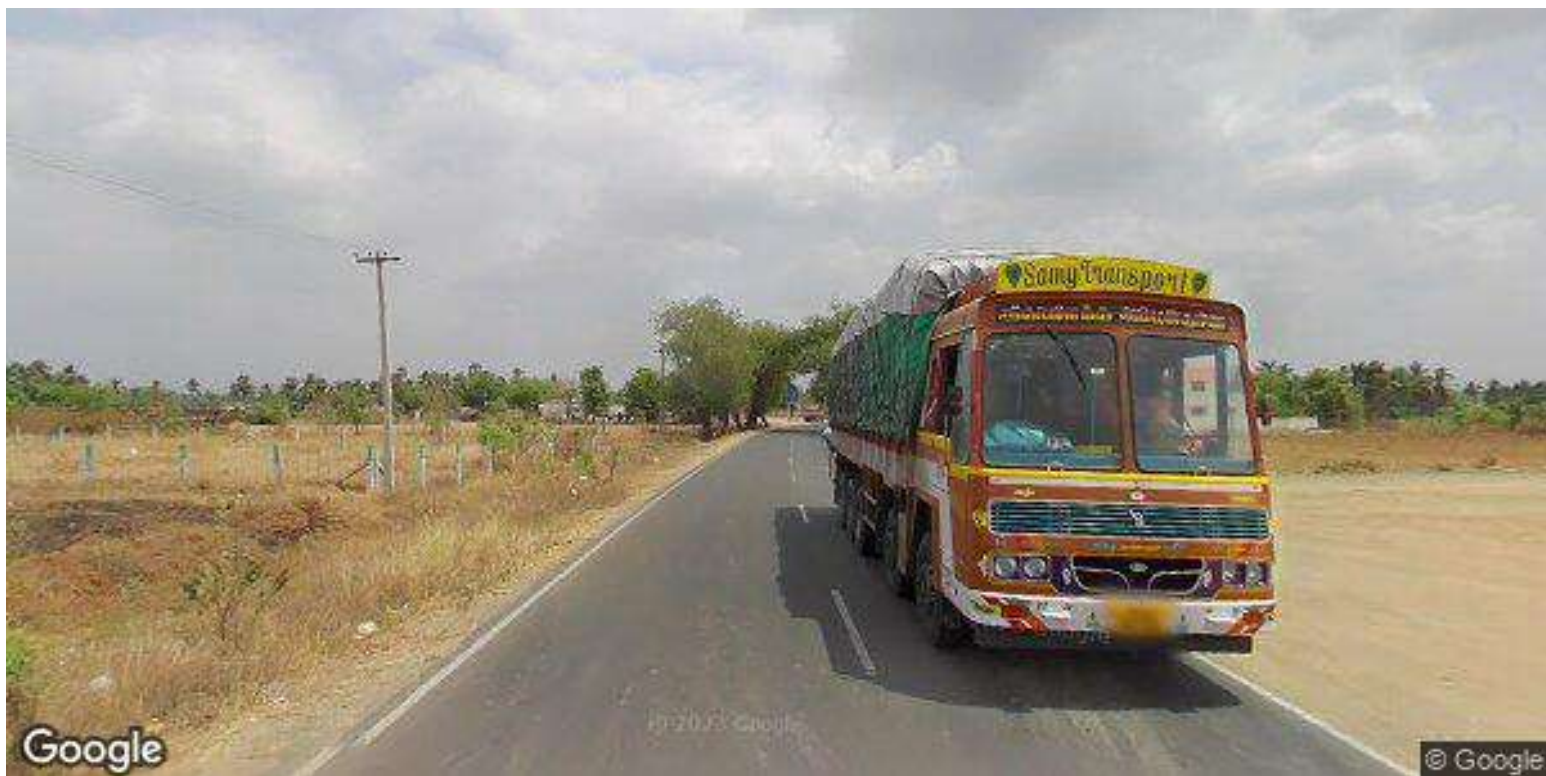
**Coordinates:** 11.55614, 77.89764

**Risk Type:** Turn

**Risk Level:** High

**Speed Limit:** 15 KM/Hr

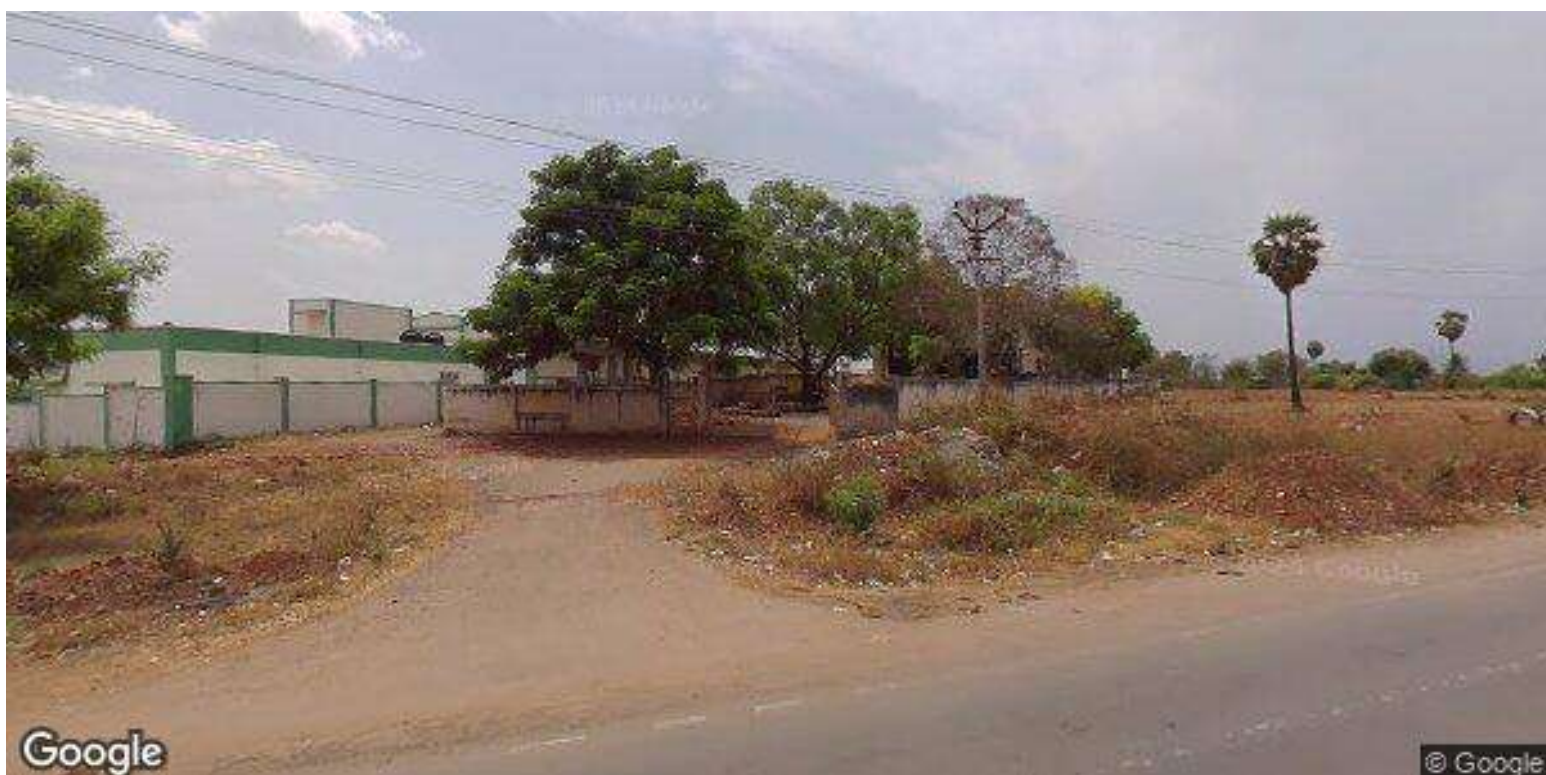
**Risk Type:** Turn  
**Risk Level:** High  
**Speed Limit:** 15 KM/Hr  
**Coordinates:** 11.58317, 77.90647

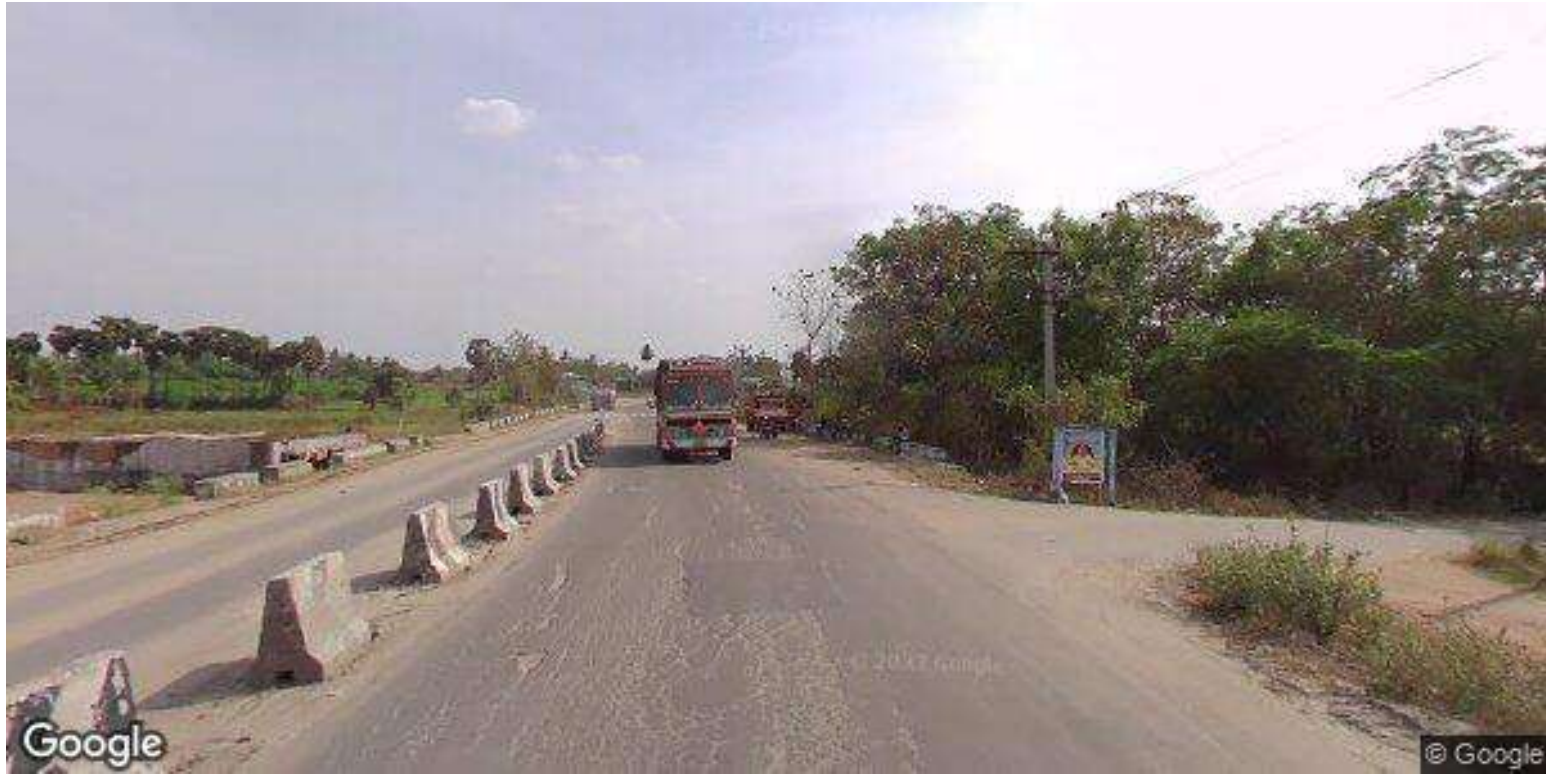
**Risk Type:** Turn  
**Risk Level:** Medium  
**Speed Limit:** 30 KM/Hr  
**Coordinates:** 11.63840, 77.94820

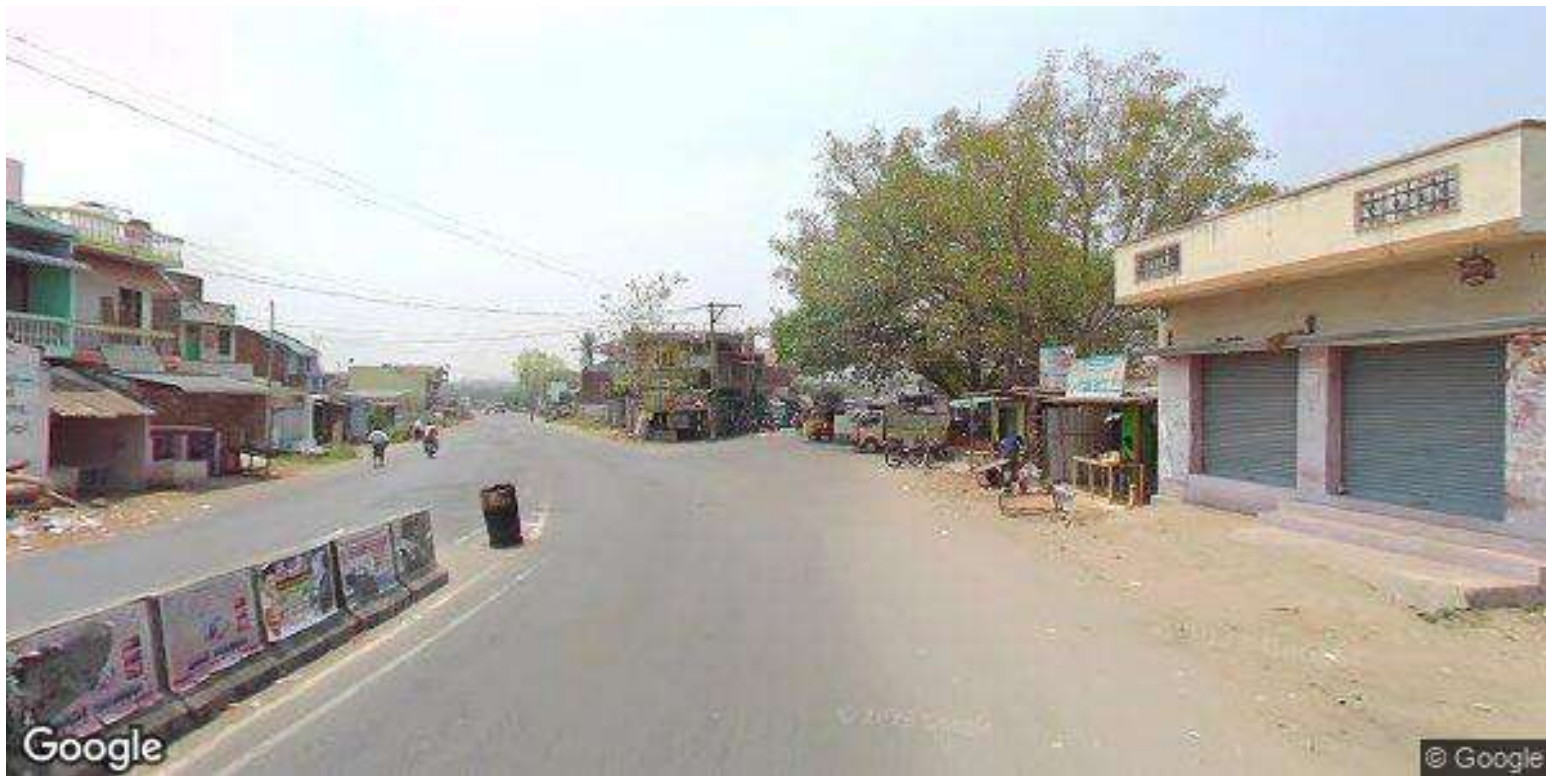
**Risk Type:** Turn  
**Risk Level:** Medium  
**Speed Limit:** 30 KM/Hr  
**Coordinates:** 11.64733, 77.95122

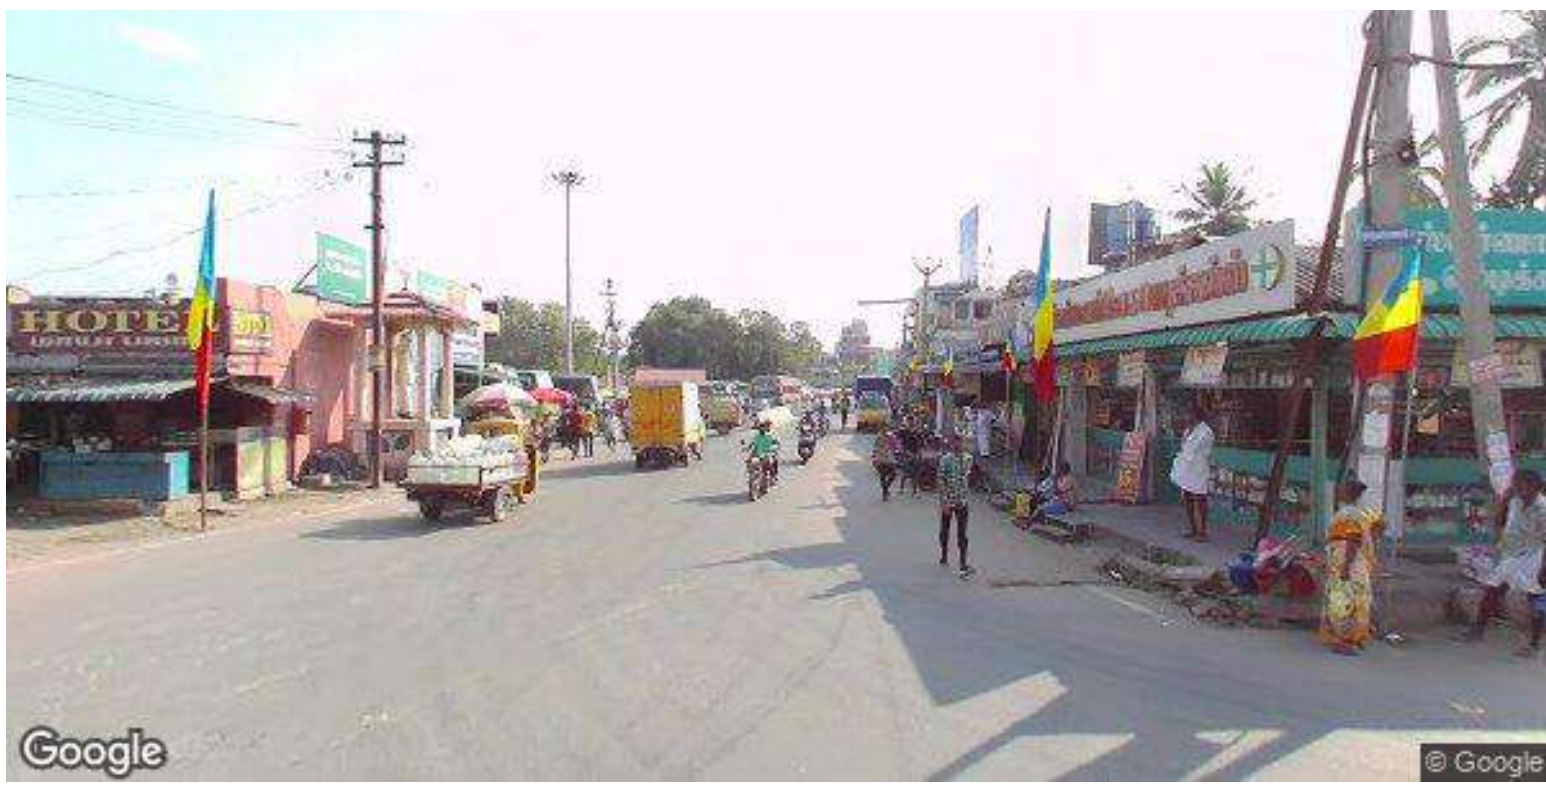
**Coordinates:** 11.69590, 77.97114

**Risk Type:** Blind Spot

**Risk Level:** Blind Spot

**Speed Limit:** 10 KM/Hr

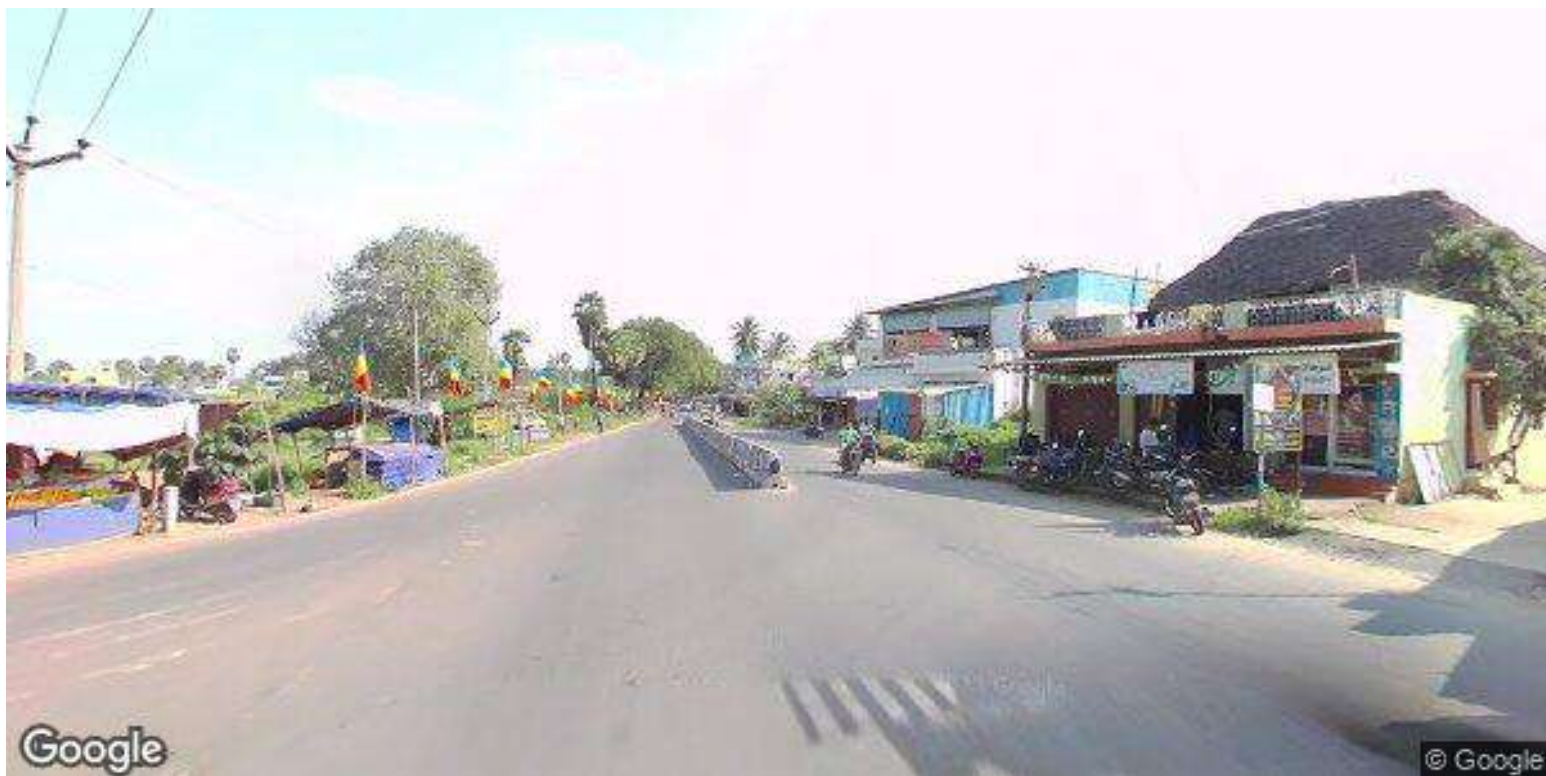
**Coordinates:** 11.70129, 77.96360

**Risk Type:** Turn

**Risk Level:** High

**Speed Limit:** 15 KM/Hr
