# IndianOil

## JOURNEY RISK MANAGEMENT (JRM) STUDY

### Salem Terminal to SRI KRISHNAMOORTHY TRADERS

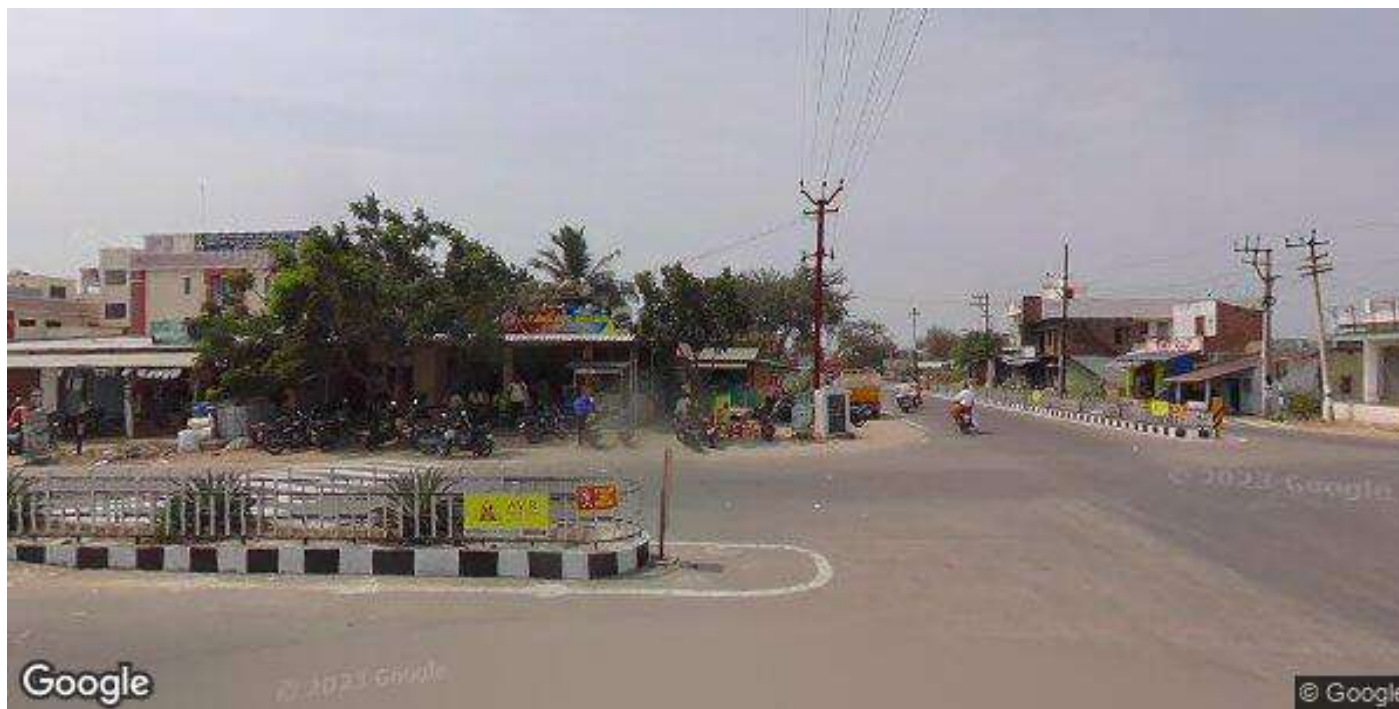
**Risk Type:** Roundabout  
**Risk Level:** High  
**Speed Limit:** 15 KM/Hr  
**Coordinates:** 11.58300, 77.85813

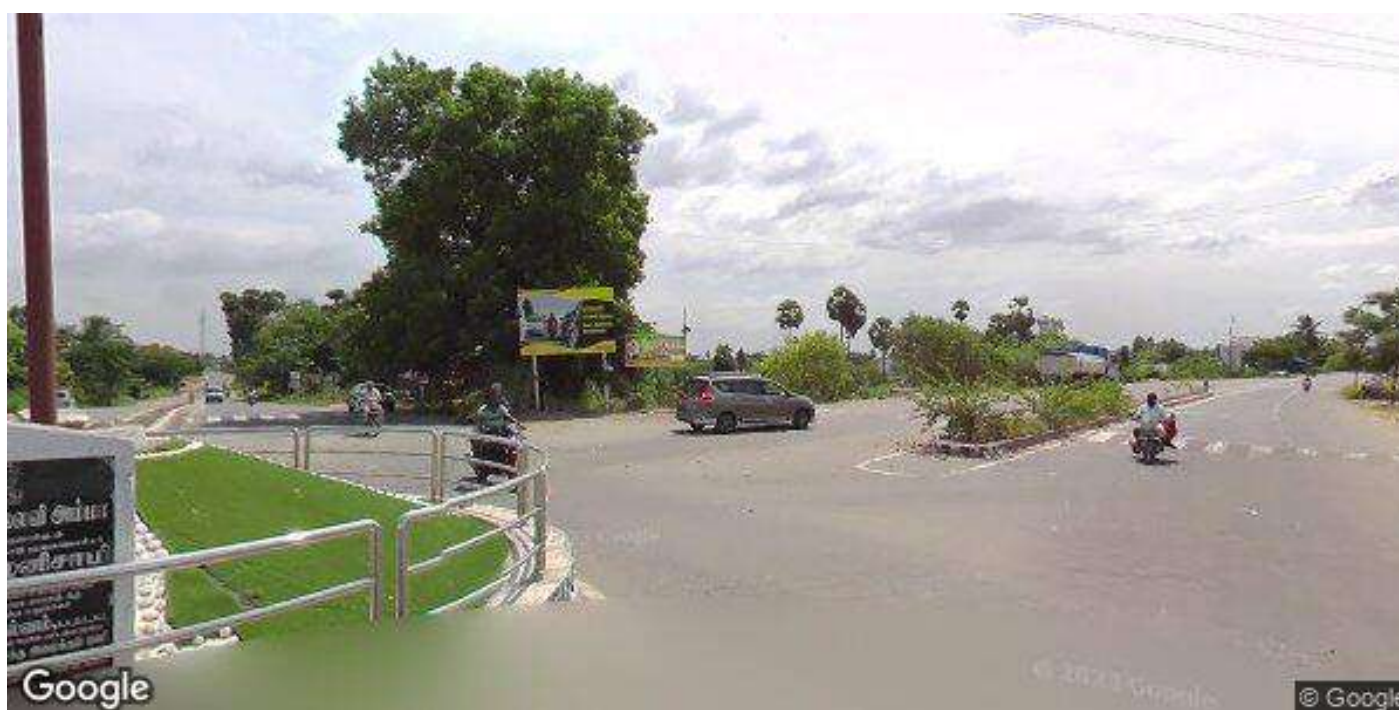
**Risk Type:** Roundabout  
**Risk Level:** High  
**Speed Limit:** 15 KM/Hr  
**Coordinates:** 11.60348, 77.83967

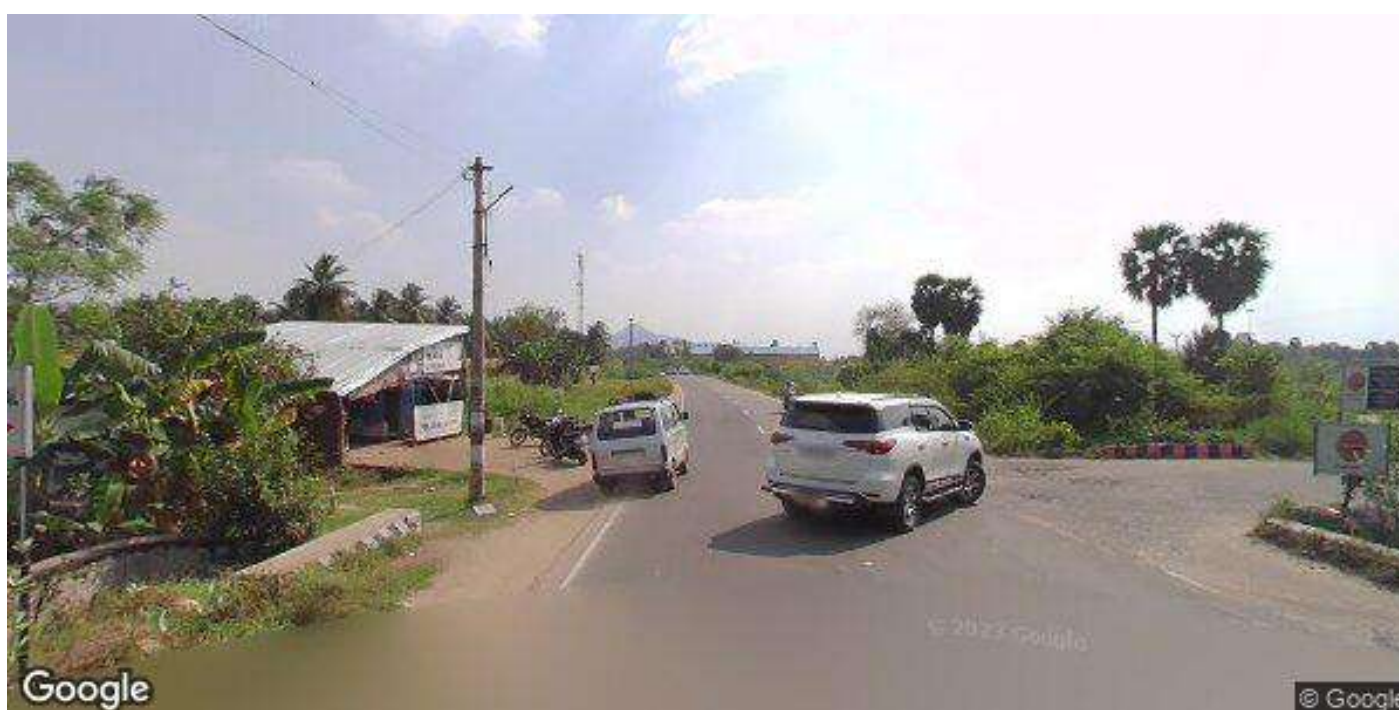
**Risk Type:** Turn  
**Risk Level:** High  
**Speed Limit:** 15 KM/Hr  
**Coordinates:** 11.44029, 77.87544

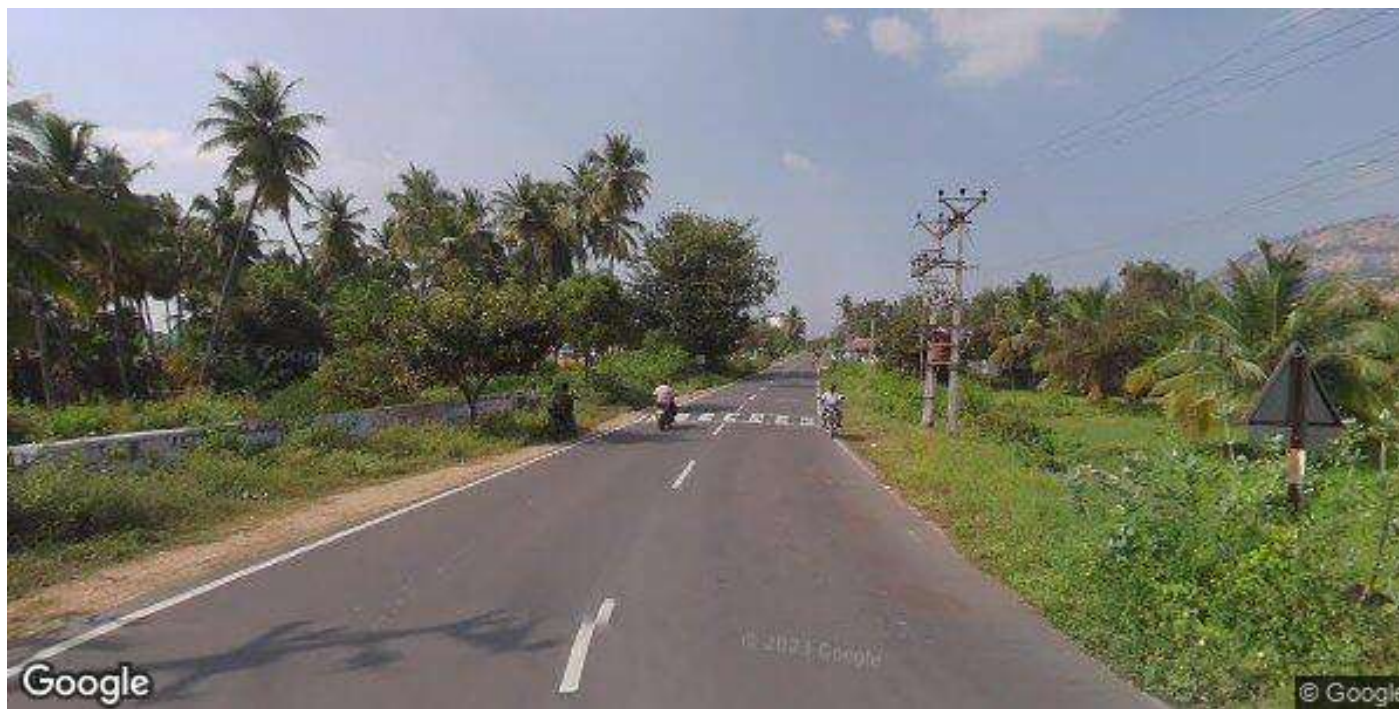
**Risk Type:** Turn  
**Risk Level:** Medium  
**Speed Limit:** 30 KM/Hr  
**Coordinates:** 11.45353, 77.85697

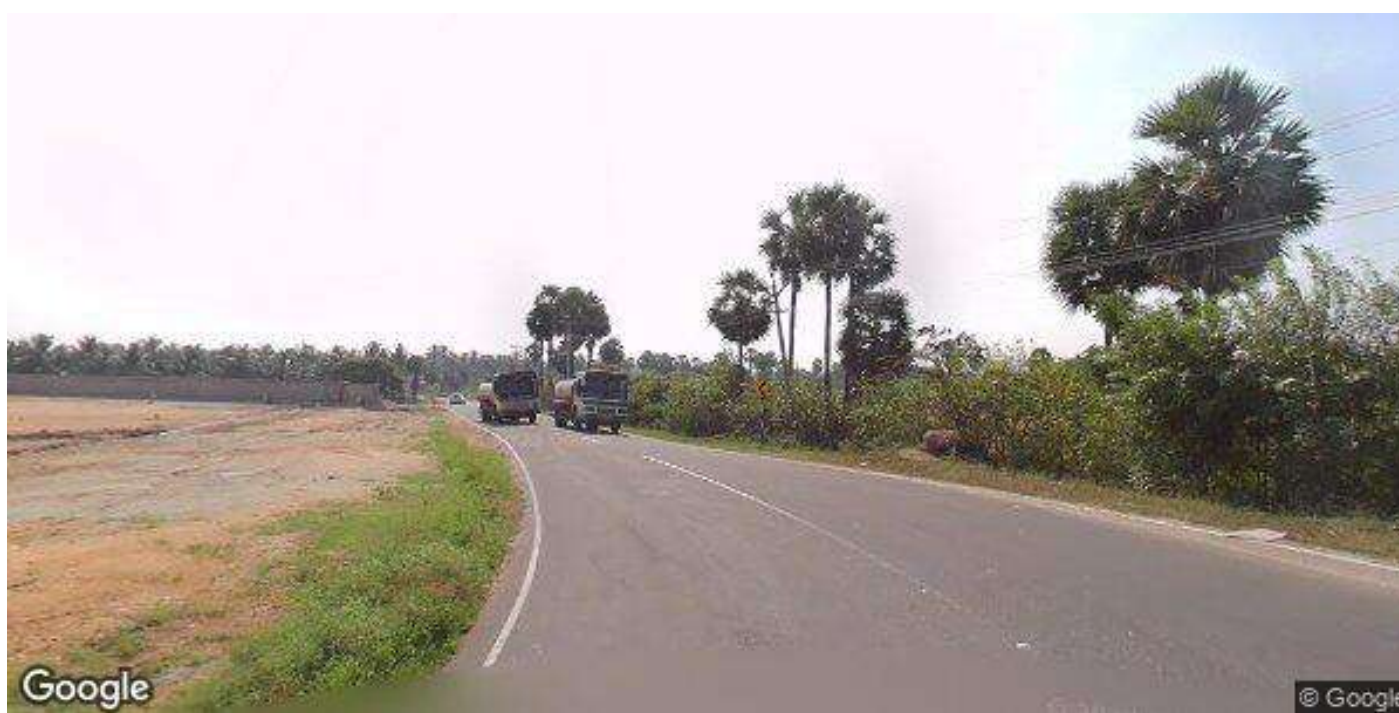
**Risk Type:** Turn  
**Risk Level:** Medium  
**Speed Limit:** 30 KM/Hr  
**Coordinates:** 11.45839, 77.85143

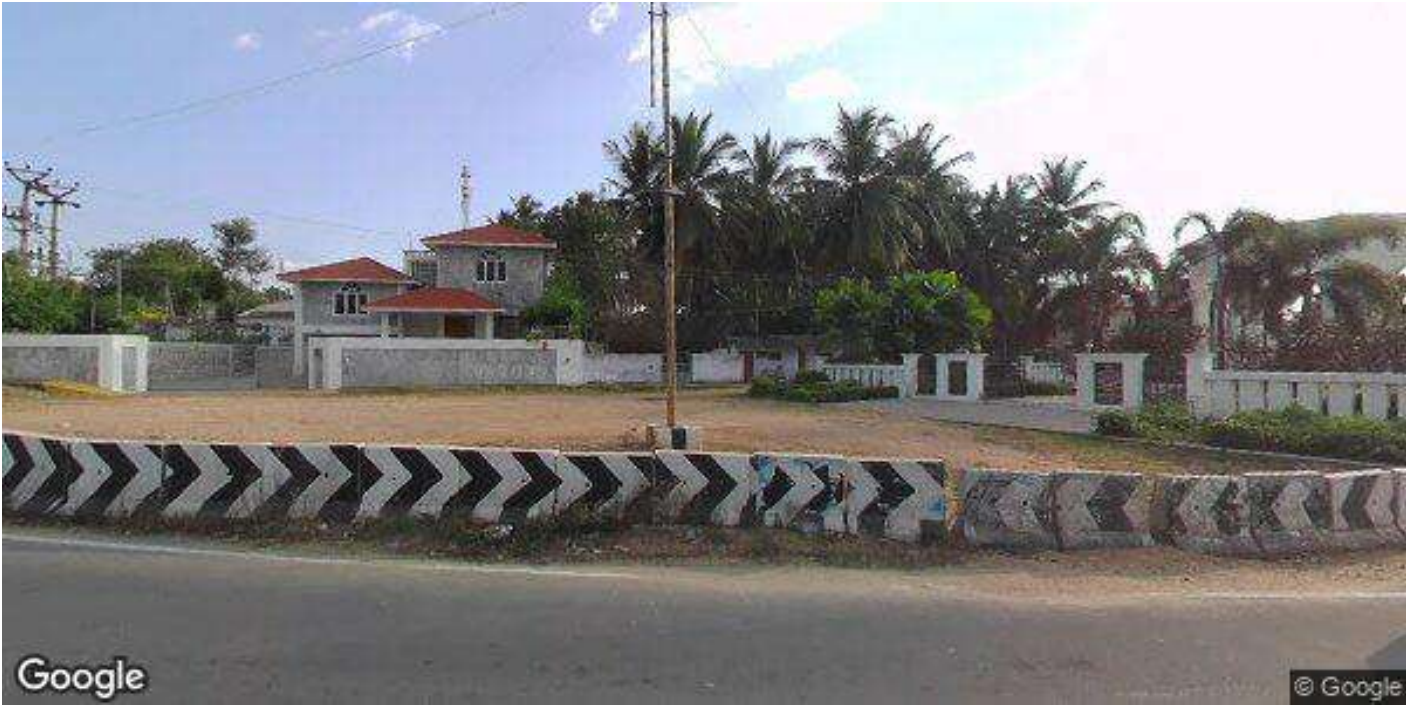
**Risk Type:** Turn  
**Risk Level:** Medium  
**Speed Limit:** 30 KM/Hr  
**Coordinates:** 11.46316, 77.84921

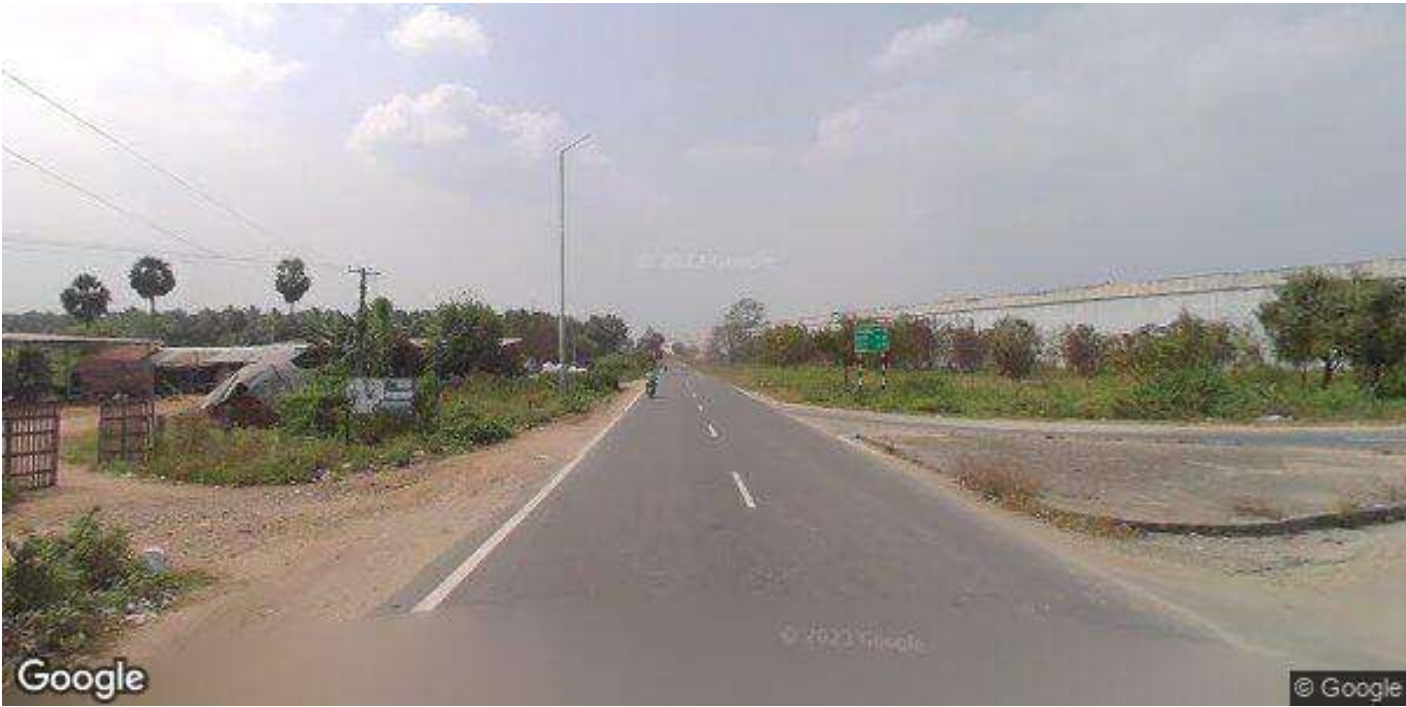
**Risk Type:** Turn  
**Risk Level:** High  
**Speed Limit:** 15 KM/Hr  
**Coordinates:** 11.45542, 77.81725

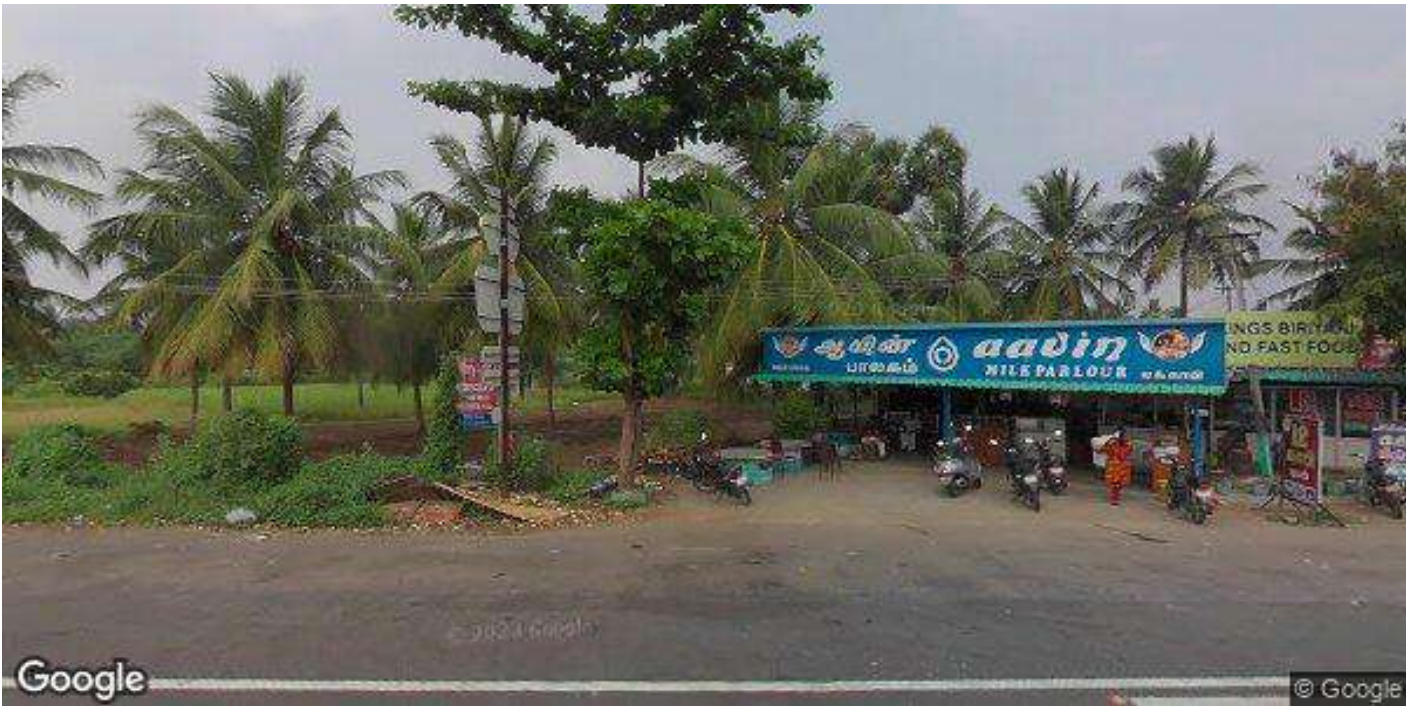
**Risk Type:** Blind Spot  
**Risk Level:** Blind Spot  
**Speed Limit:** 10 KM/Hr  
**Coordinates:** 11.45631, 77.81668

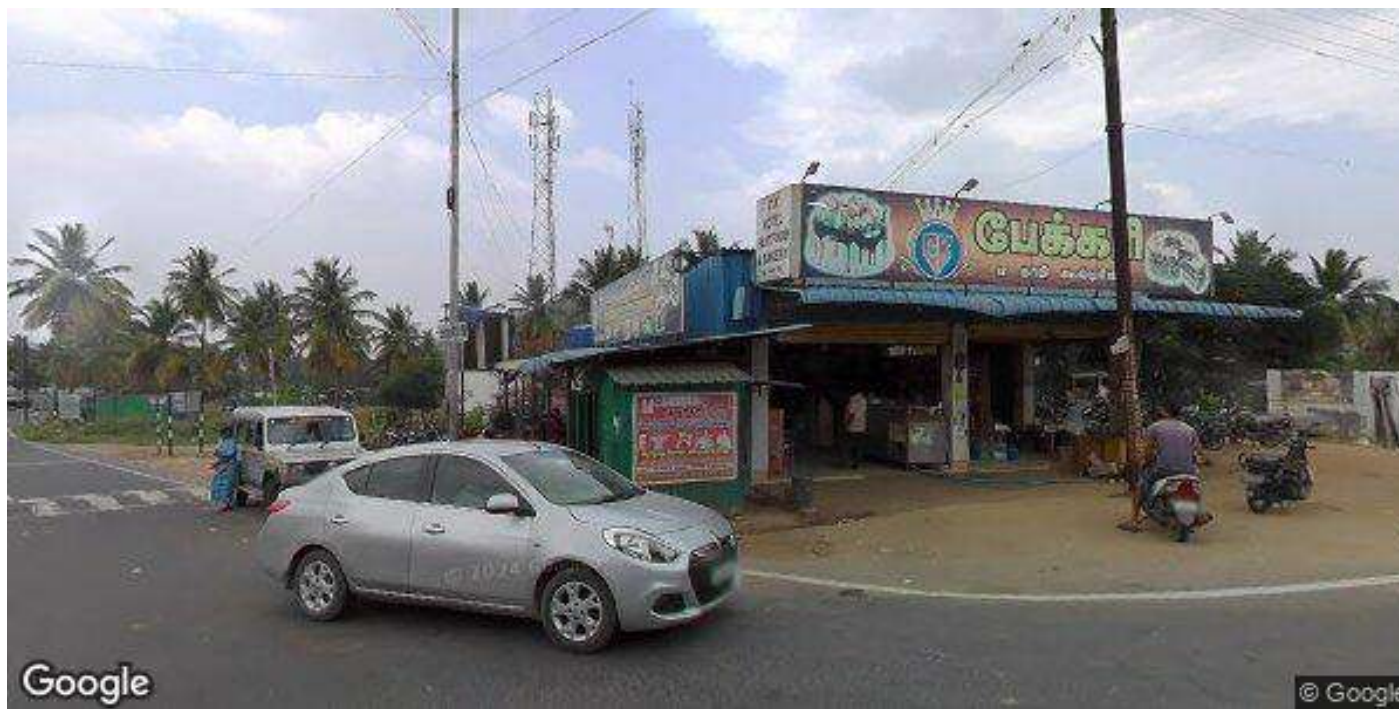
**Risk Type:** Blind Spot  
**Risk Level:** Blind Spot  
**Speed Limit:** 10 KM/Hr  
**Coordinates:** 11.49390, 77.86748

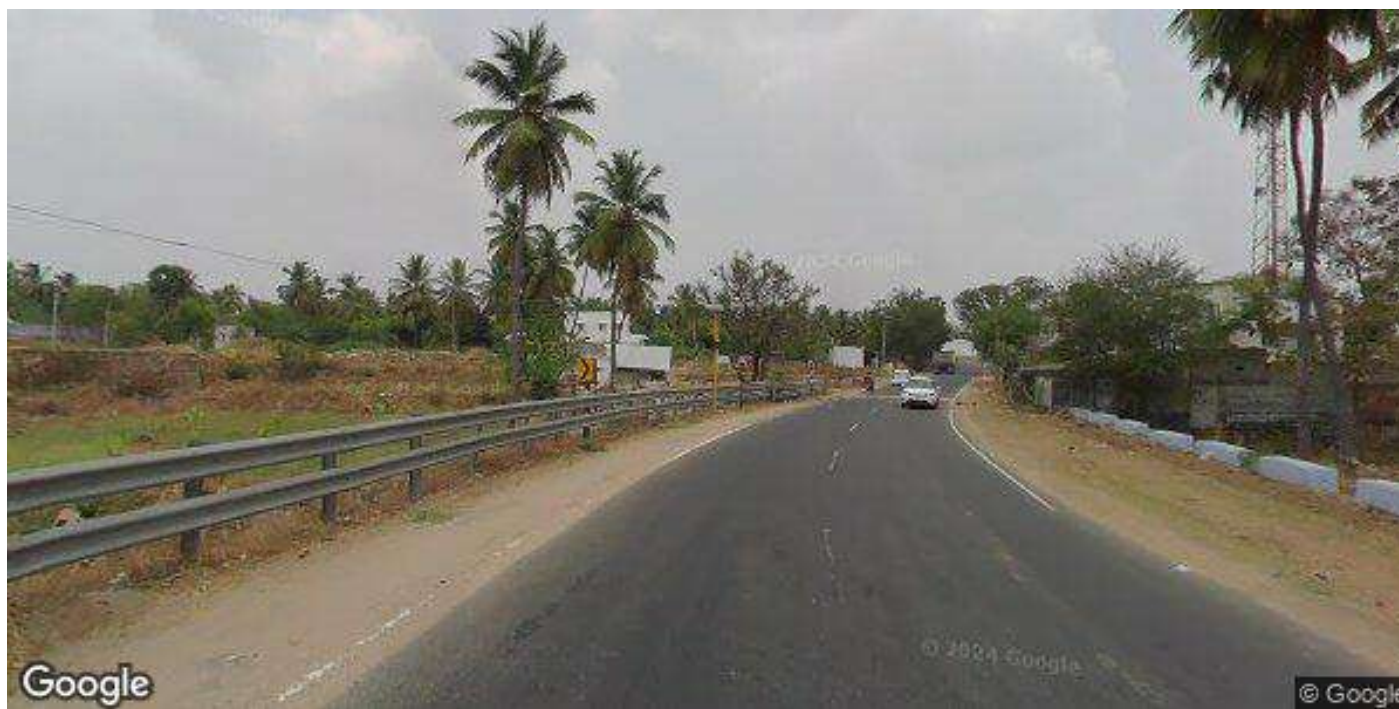
**Risk Type:** Turn  
**Risk Level:** Medium  
**Speed Limit:** 30 KM/Hr  
**Coordinates:** 11.52571, 77.85522

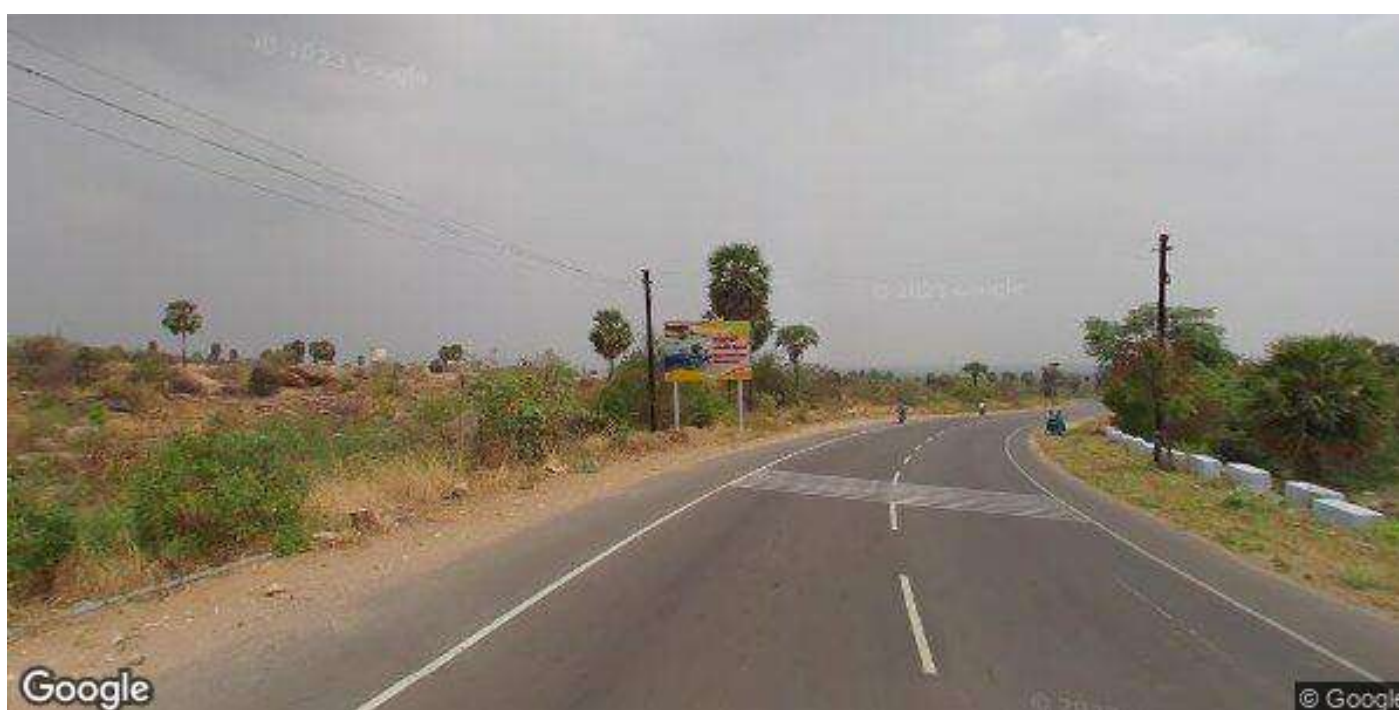
**Risk Type:** Turn  
**Risk Level:** Medium  
**Speed Limit:** 30 KM/Hr  
**Coordinates:** 11.55460, 77.85624

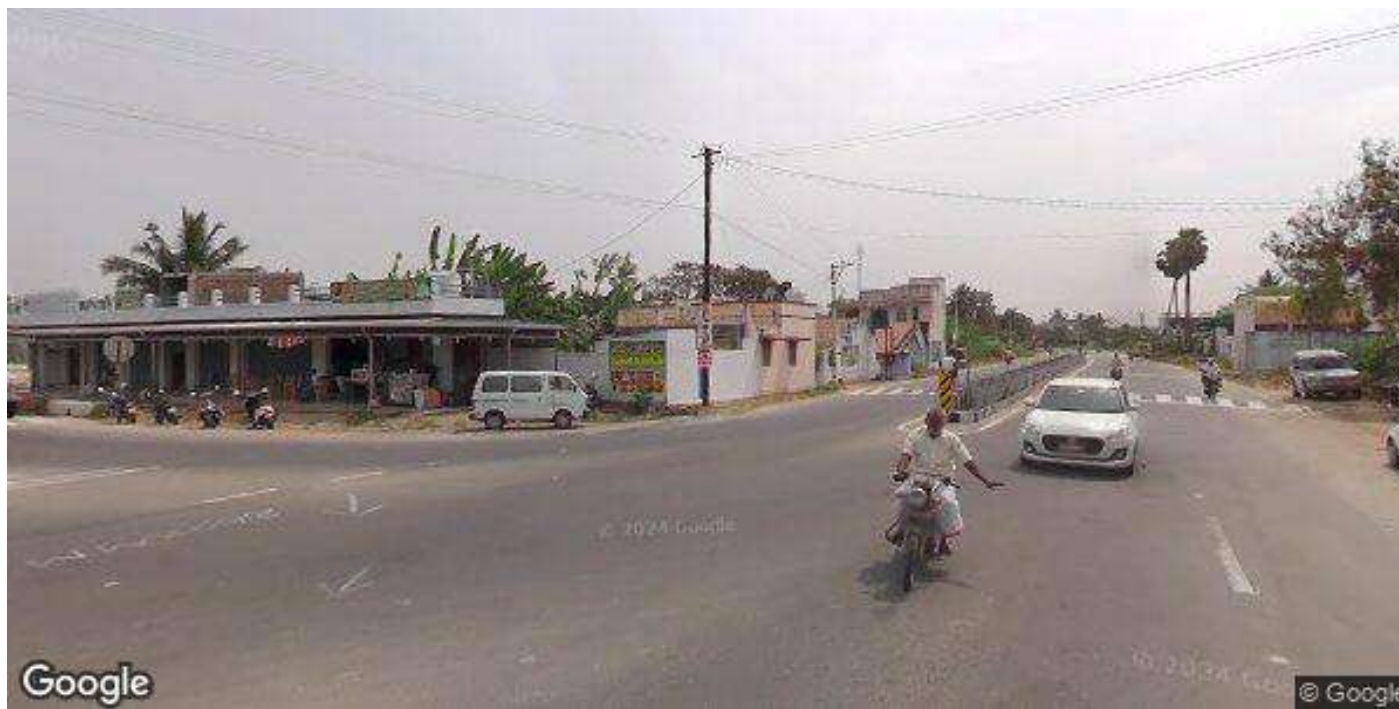
**Risk Type:** Turn  
**Risk Level:** High  
**Speed Limit:** 15 KM/Hr  
**Coordinates:** 11.57903, 77.85432

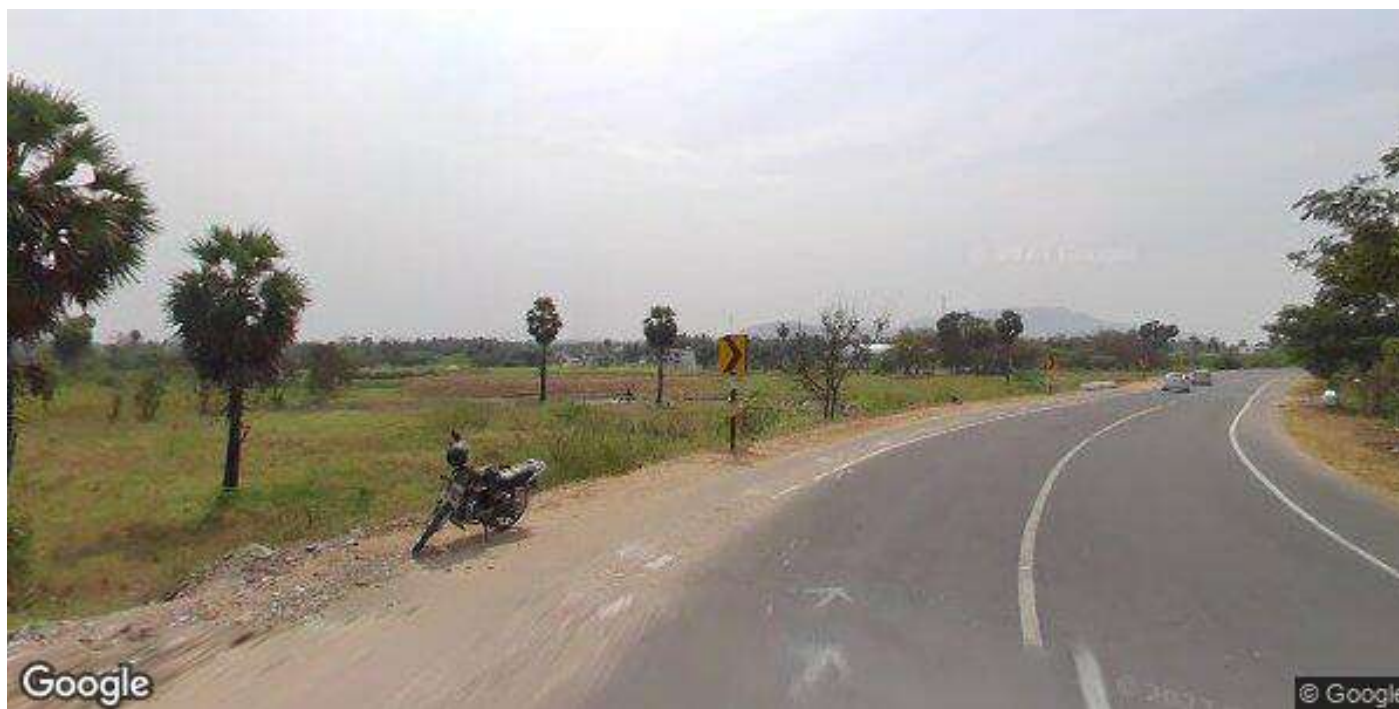
**Risk Type:** Turn  
**Risk Level:** Medium  
**Speed Limit:** 30 KM/Hr  
**Coordinates:** 11.58022, 77.85744

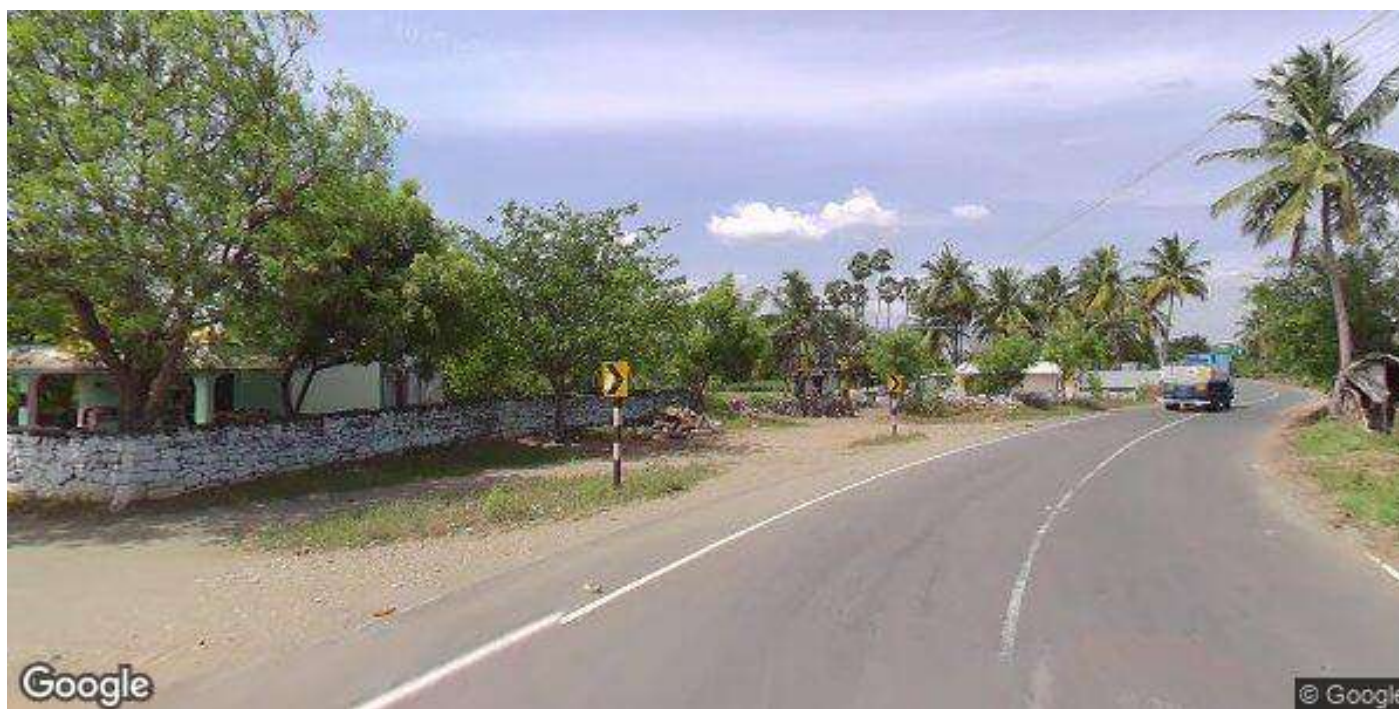
**Risk Type:** Turn  
**Risk Level:** Medium  
**Speed Limit:** 30 KM/Hr  
**Coordinates:** 11.60978, 77.84165

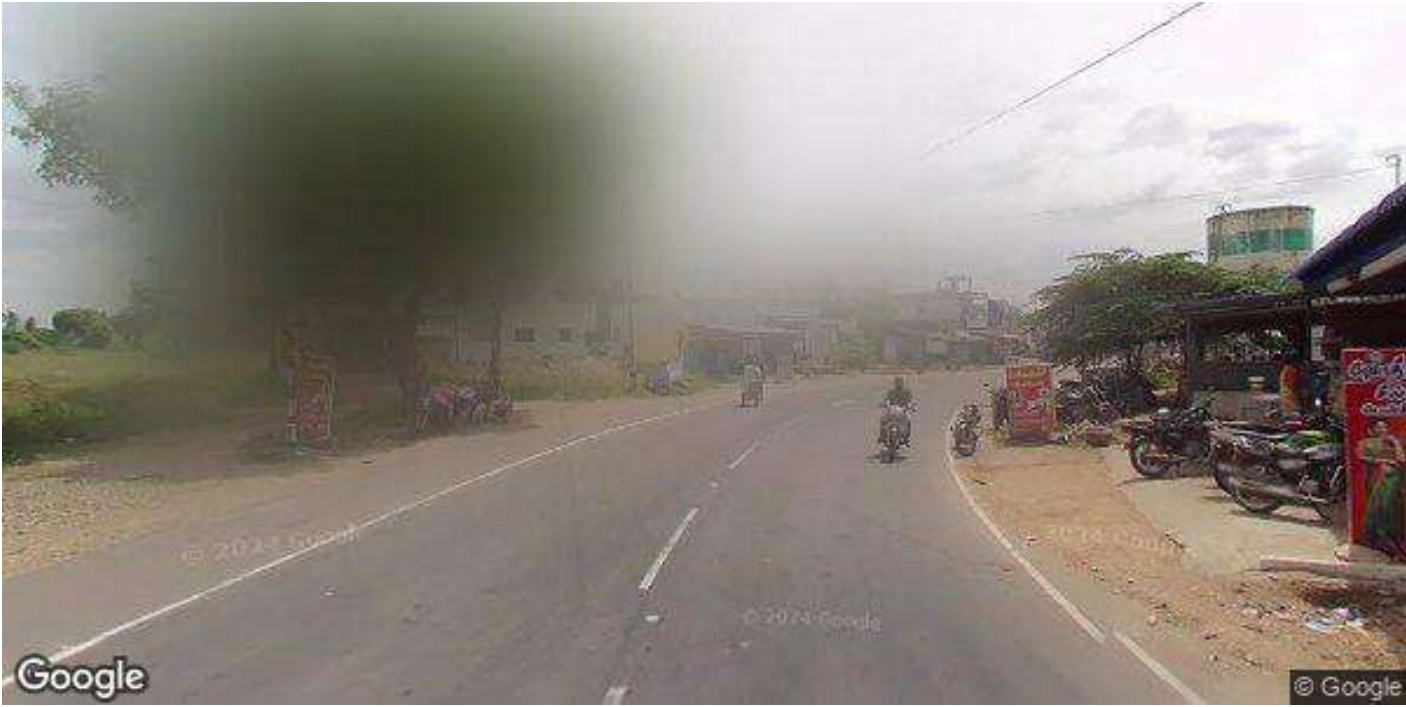
**Risk Type:** Turn  
**Risk Level:** Medium  
**Speed Limit:** 30 KM/Hr  
**Coordinates:** 11.64055, 77.84600
