## JOURNEY RISK MANAGEMENT (JRM) STUDY

### Salem Terminal to LAKSHMI AGENCIES

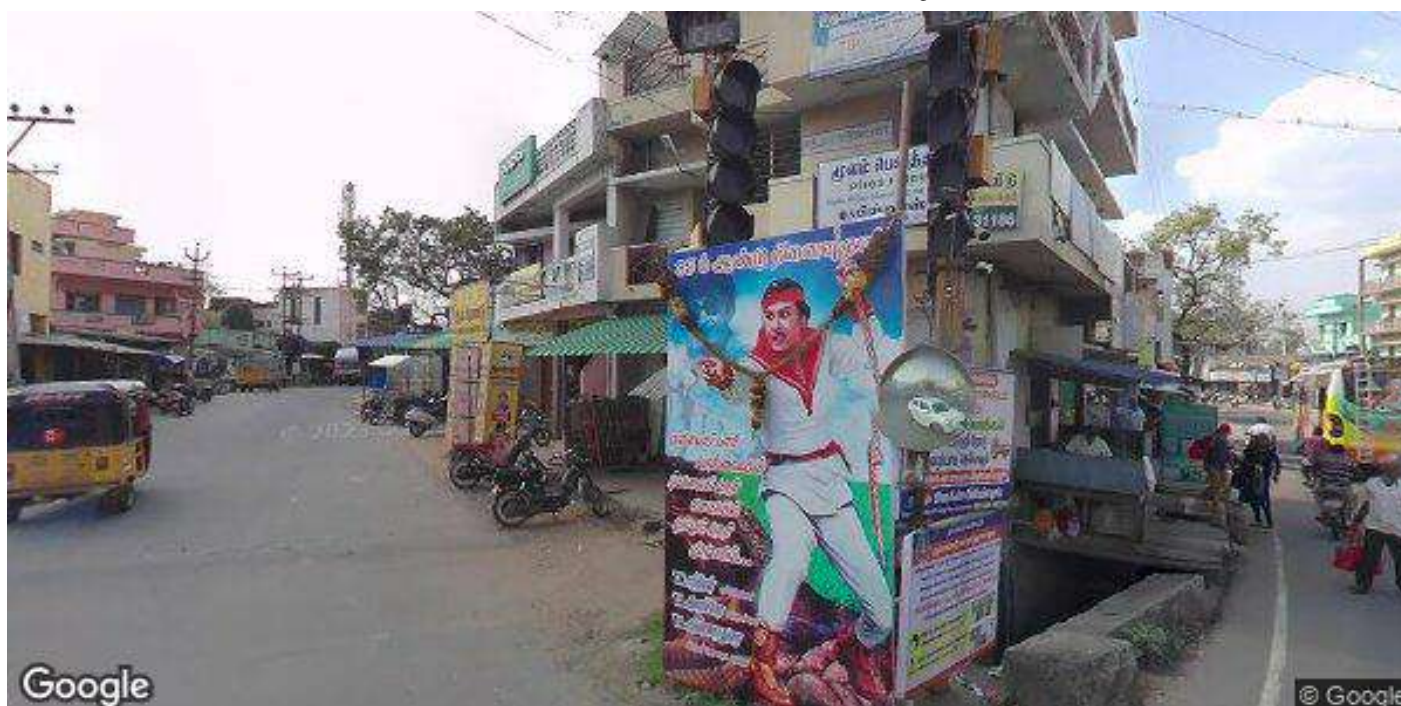
**Risk Type:** Turn  
**Risk Level:** Medium  
**Speed Limit:** 30 KM/Hr  
**Coordinates:** 11.38342, 77.89975

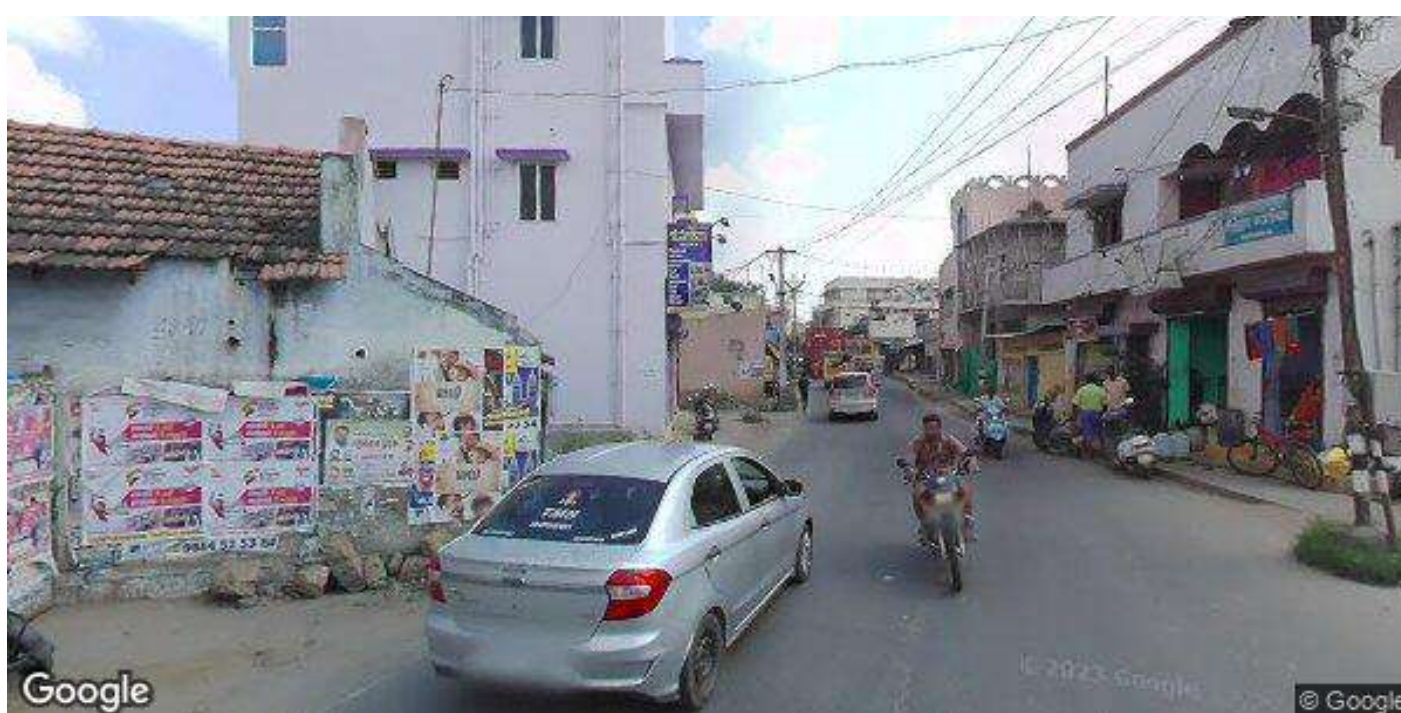
**Risk Type:** Turn  
**Risk Level:** Medium  
**Speed Limit:** 30 KM/Hr  
**Coordinates:** 11.38295, 77.90001

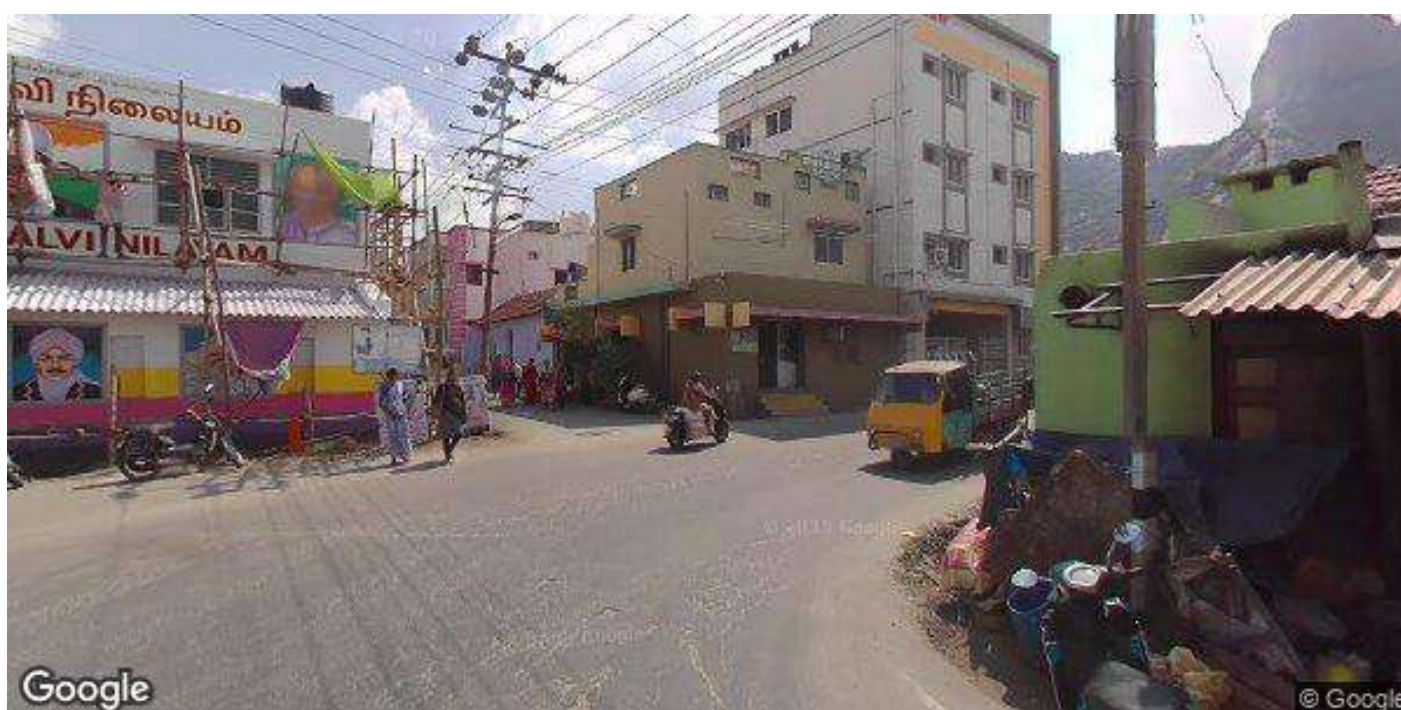
**Risk Type:** Turn  
**Risk Level:** High  
**Speed Limit:** 15 KM/Hr  
**Coordinates:** 11.38186, 77.90258

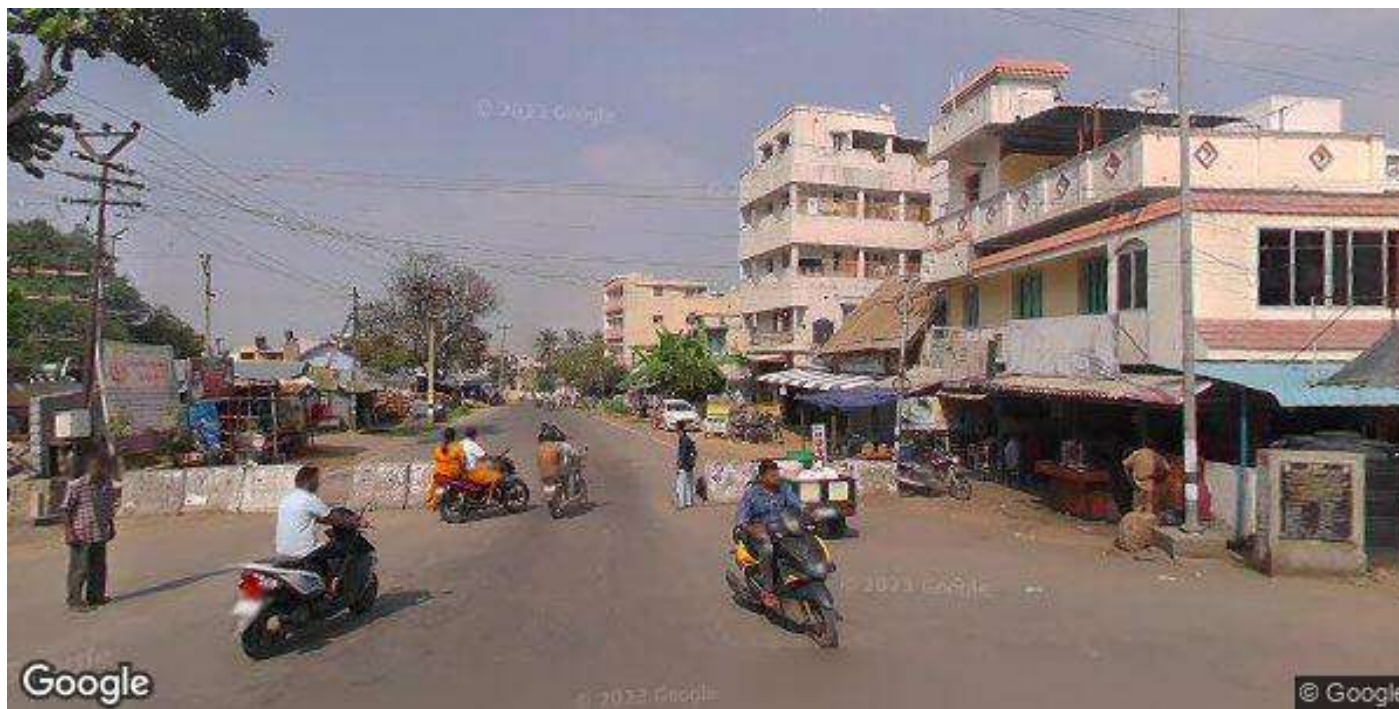
**Risk Type:** Blind Spot  
**Risk Level:** Blind Spot  
**Speed Limit:** 10 KM/Hr  
**Coordinates:** 11.37841, 77.90140

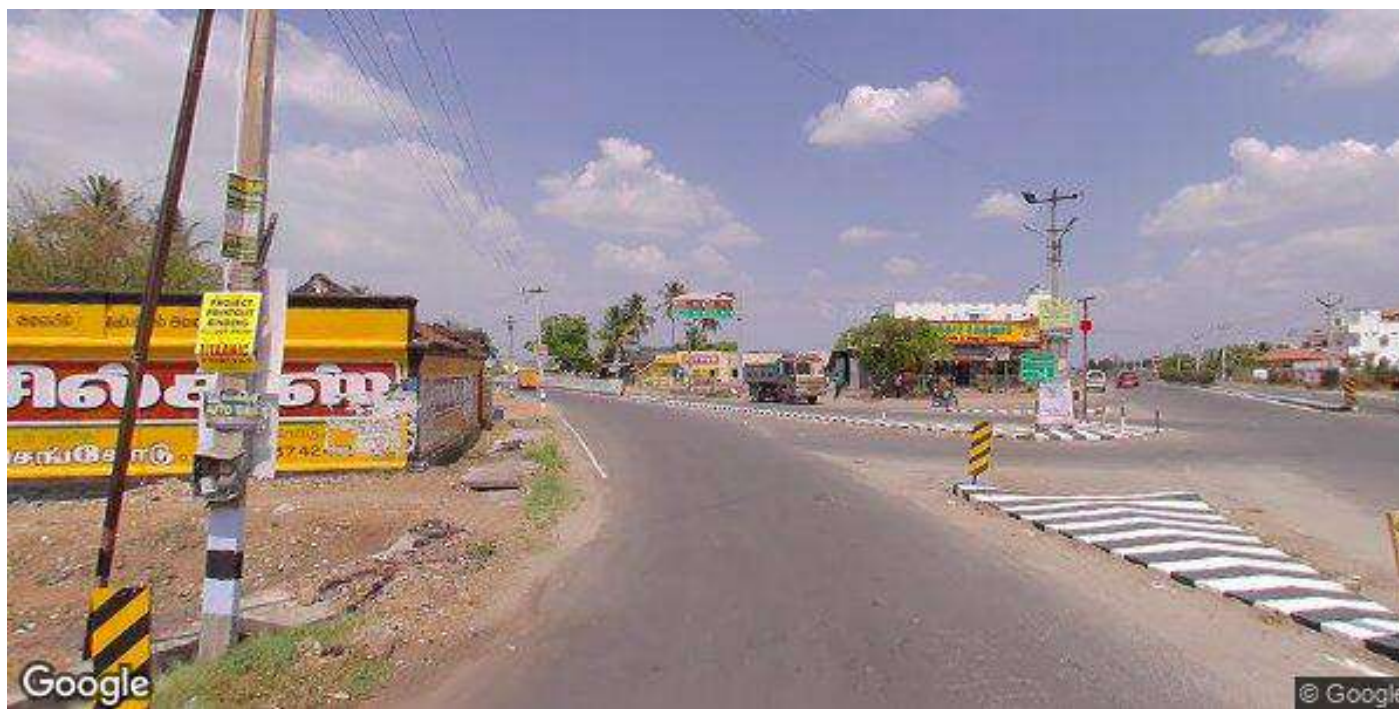
**Risk Type:** Turn  
**Risk Level:** Medium  
**Speed Limit:** 30 KM/Hr  
**Coordinates:** 11.36745, 77.93951

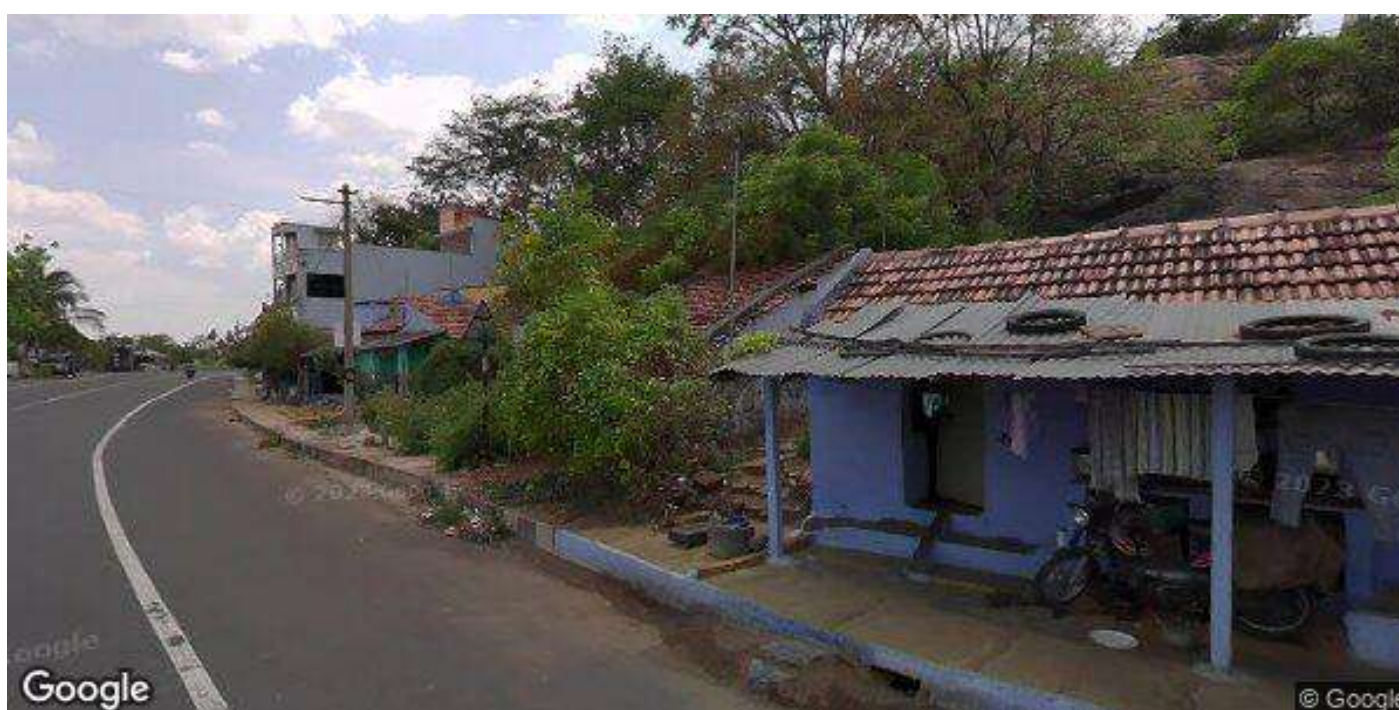
**Risk Type:** Turn  
**Risk Level:** Medium  
**Speed Limit:** 30 KM/Hr  
**Coordinates:** 11.41321, 78.08067

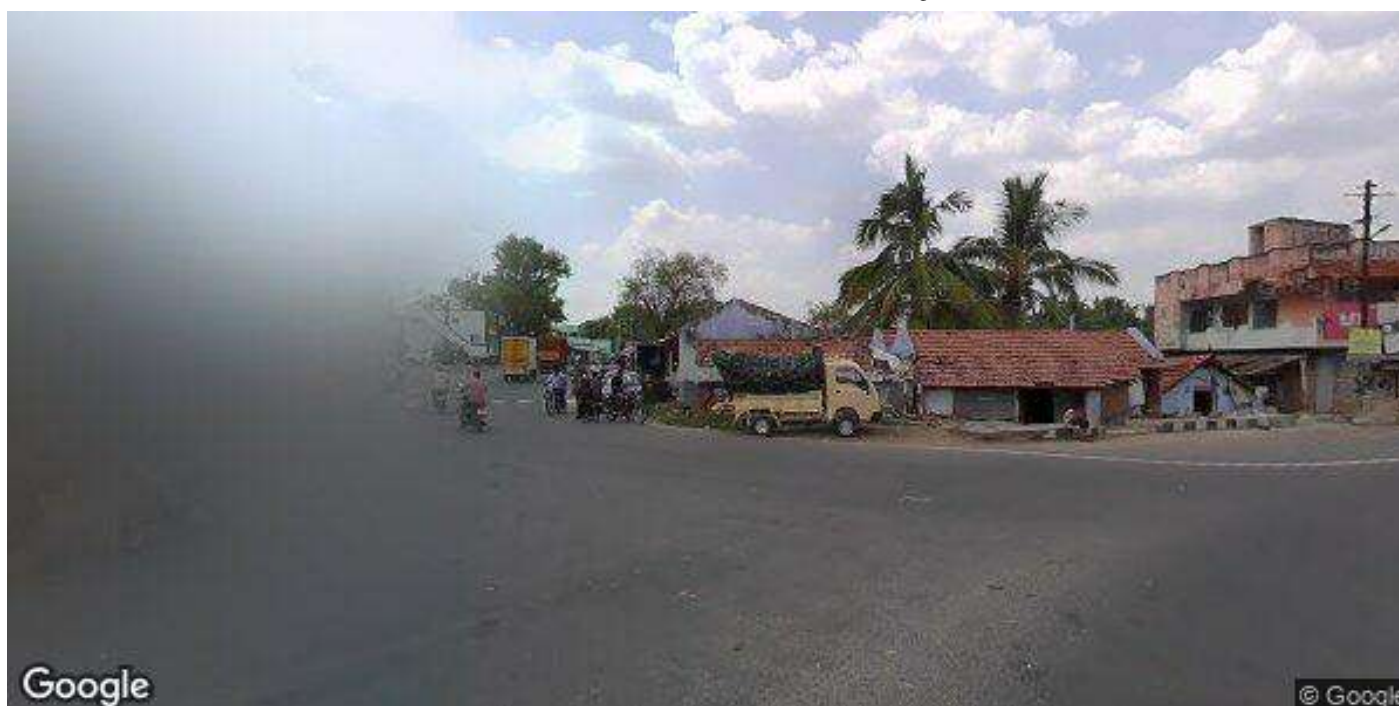
**Risk Type:** Turn  
**Risk Level:** High  
**Speed Limit:** 15 KM/Hr  
**Coordinates:** 11.41453, 78.08062

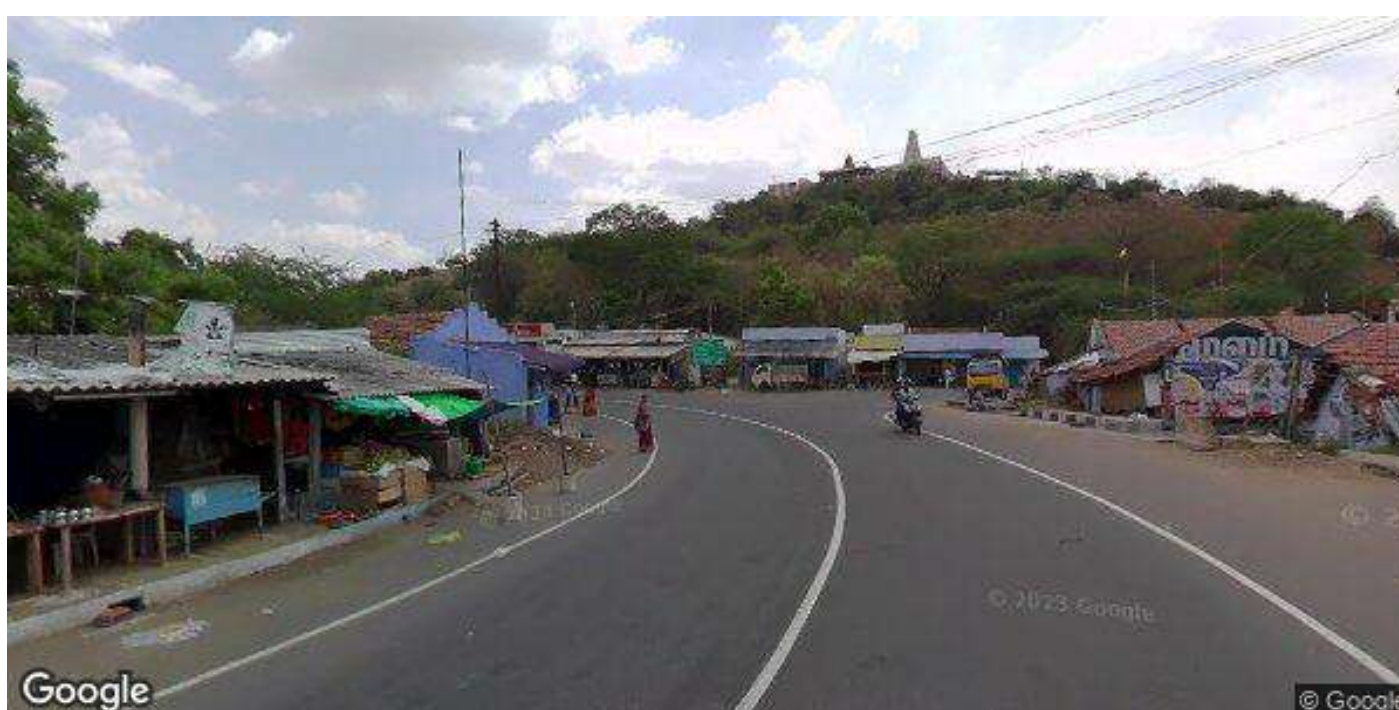
**Risk Type:** Turn  
**Risk Level:** Medium  
**Speed Limit:** 30 KM/Hr  
**Coordinates:** 11.41476, 78.08094

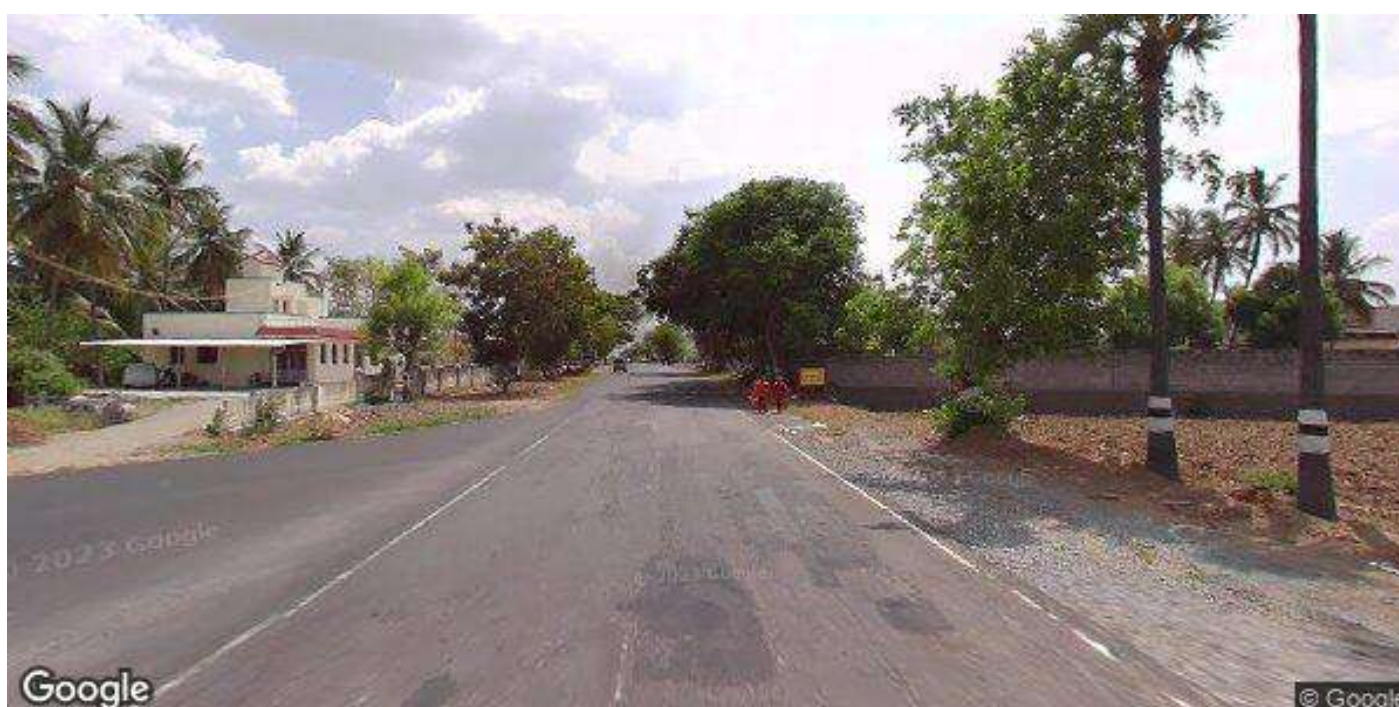
**Risk Type:** Turn  
**Risk Level:** High  
**Speed Limit:** 15 KM/Hr  
**Coordinates:** 11.42962, 78.11578

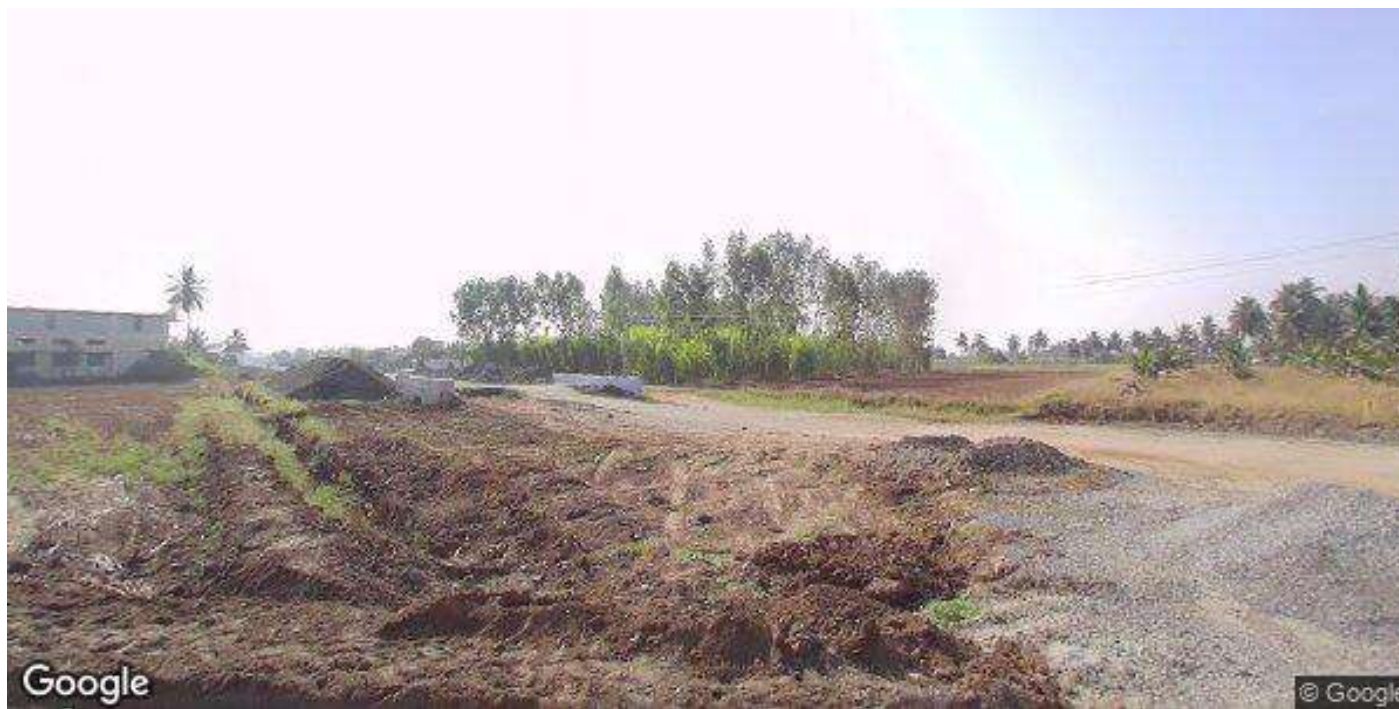
**Risk Type:** Turn  
**Risk Level:** Medium  
**Speed Limit:** 30 KM/Hr  
**Coordinates:** 11.42943, 78.11608

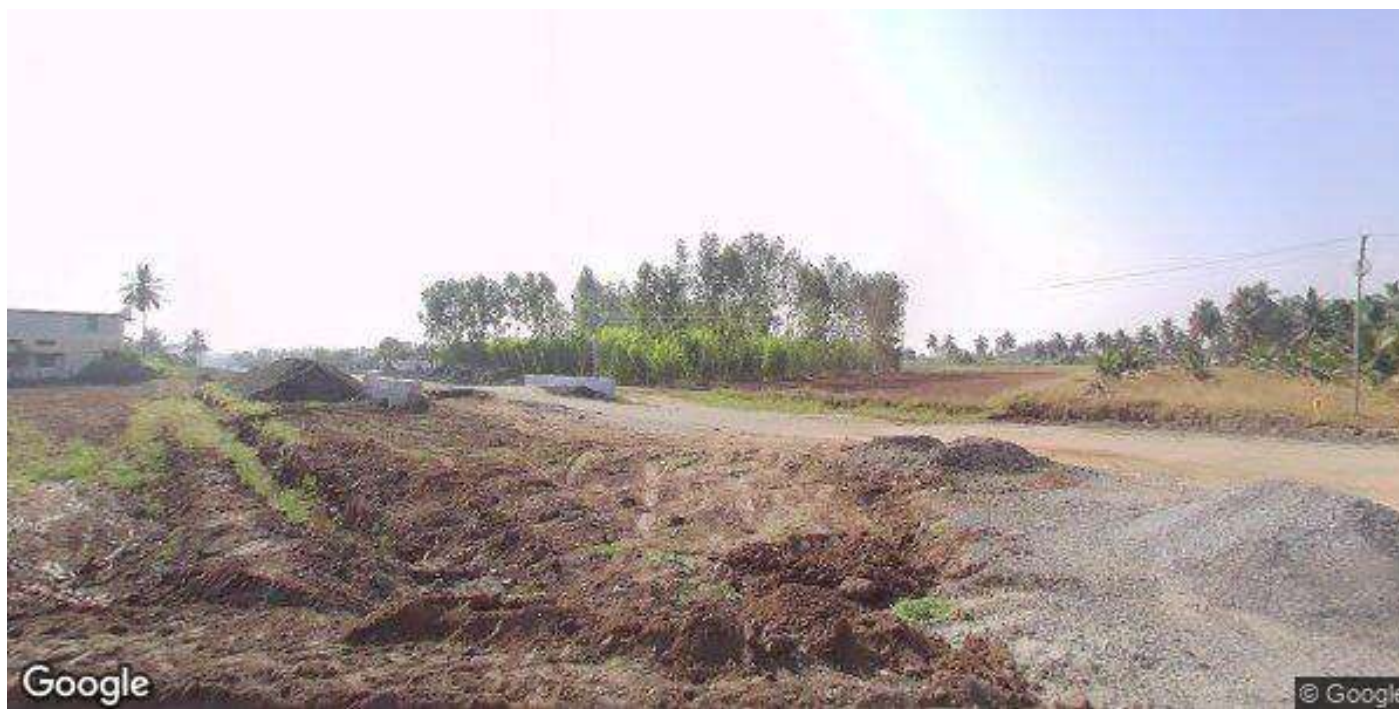
**Risk Type:** Turn  
**Risk Level:** High  
**Speed Limit:** 15 KM/Hr  
**Coordinates:** 11.42938, 78.11609

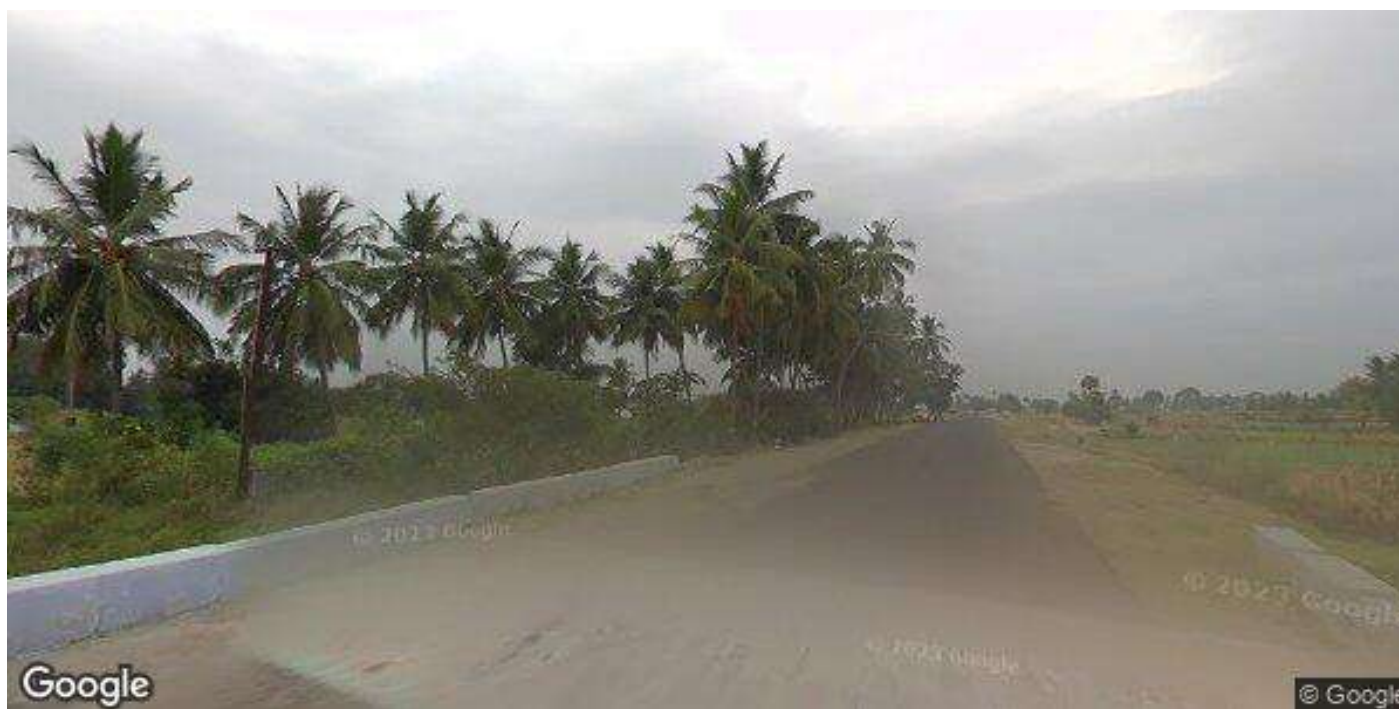
**Risk Type:** Turn  
**Risk Level:** Medium  
**Speed Limit:** 30 KM/Hr  
**Coordinates:** 11.42450, 78.15278

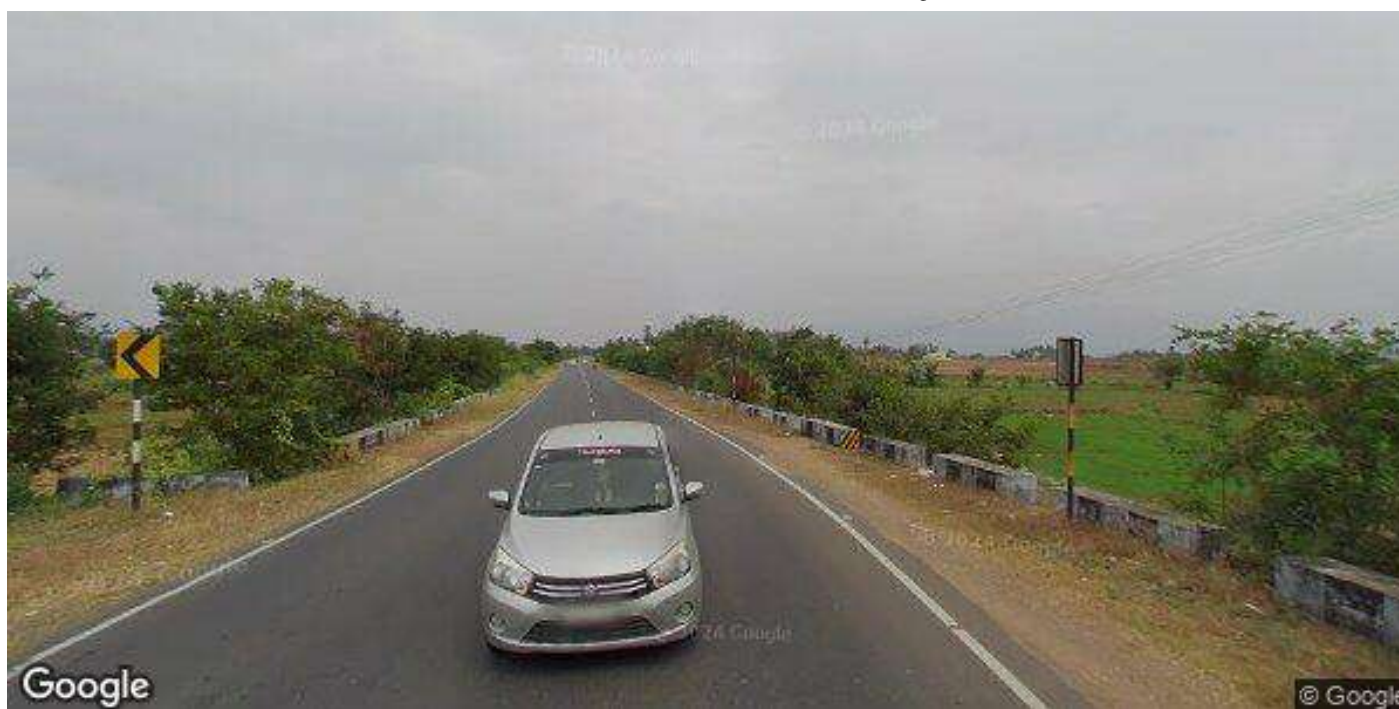
**Risk Type:** Turn  
**Risk Level:** Medium  
**Speed Limit:** 30 KM/Hr  
**Coordinates:** 11.43142, 78.18808

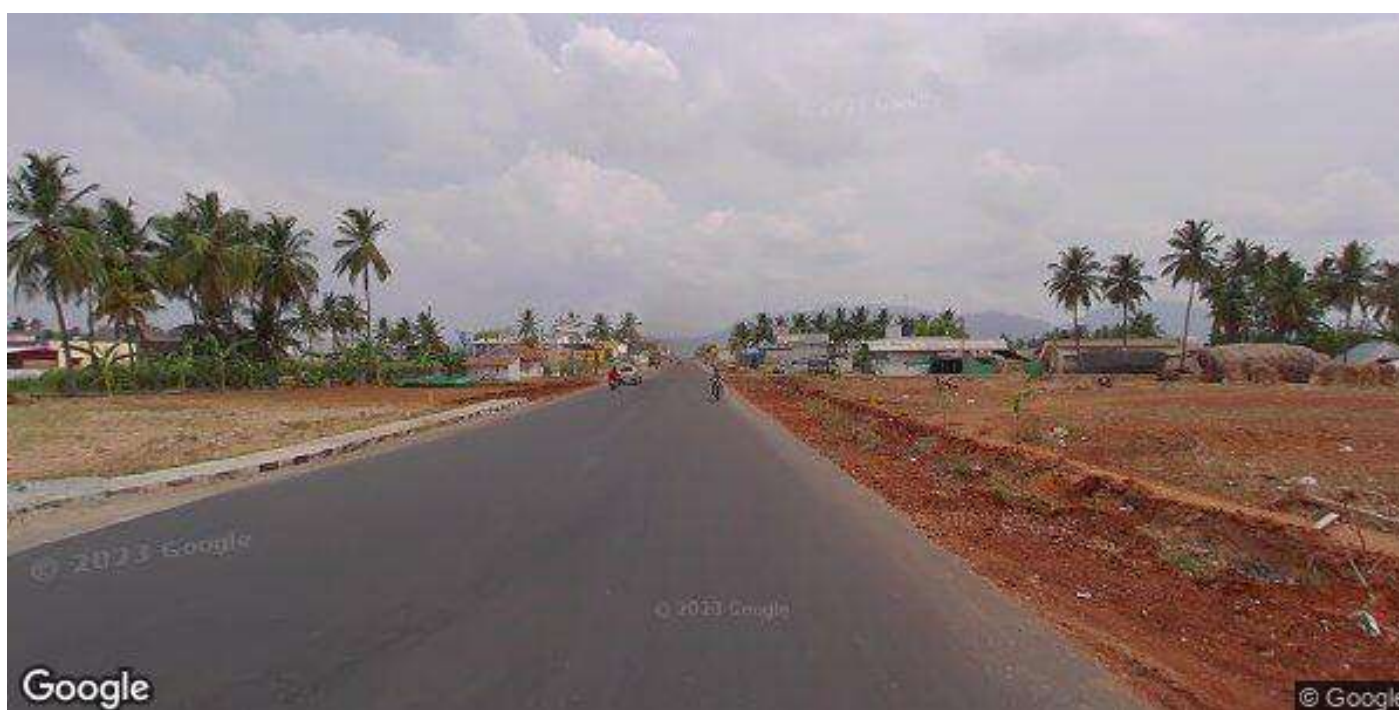
**Risk Type:** Blind Spot  
**Risk Level:** Blind Spot  
**Speed Limit:** 10 KM/Hr  
**Coordinates:** 11.43542, 78.20754

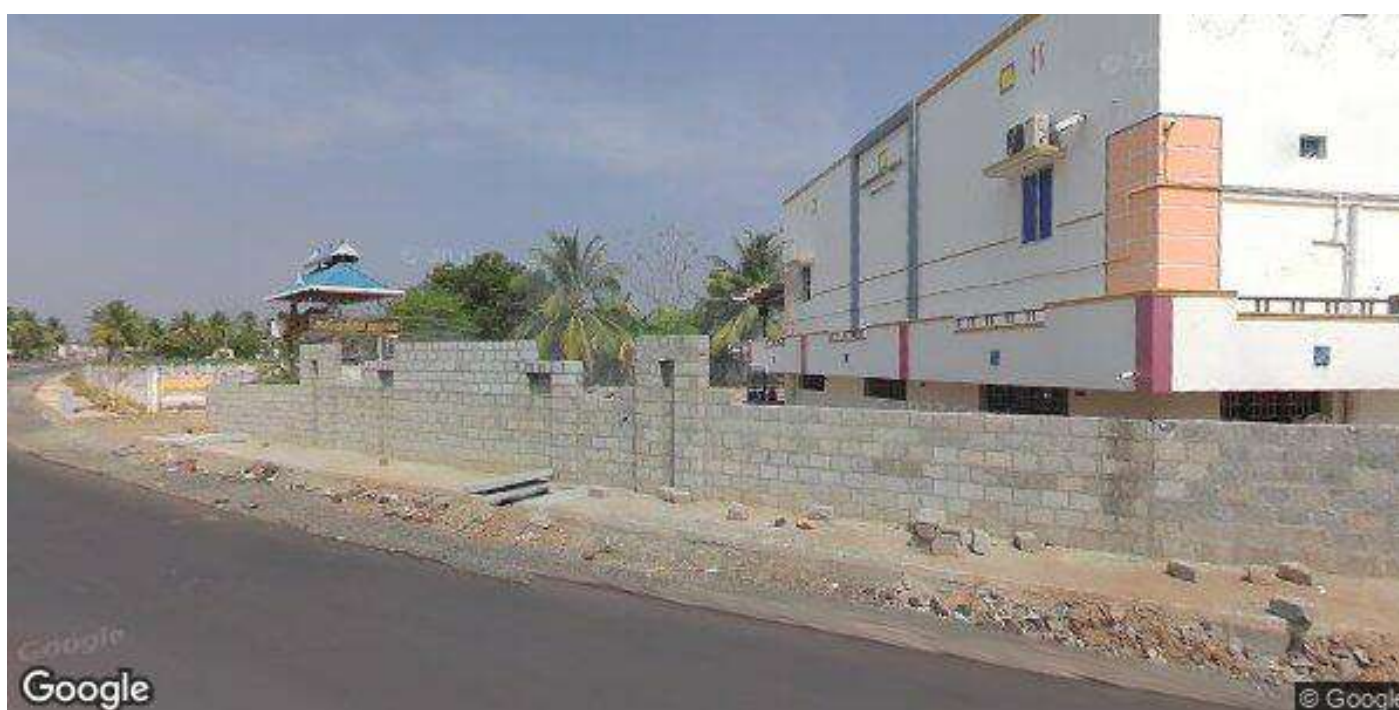
**Risk Type:** Turn  
**Risk Level:** Medium  
**Speed Limit:** 30 KM/Hr  
**Coordinates:** 11.43050, 78.20854

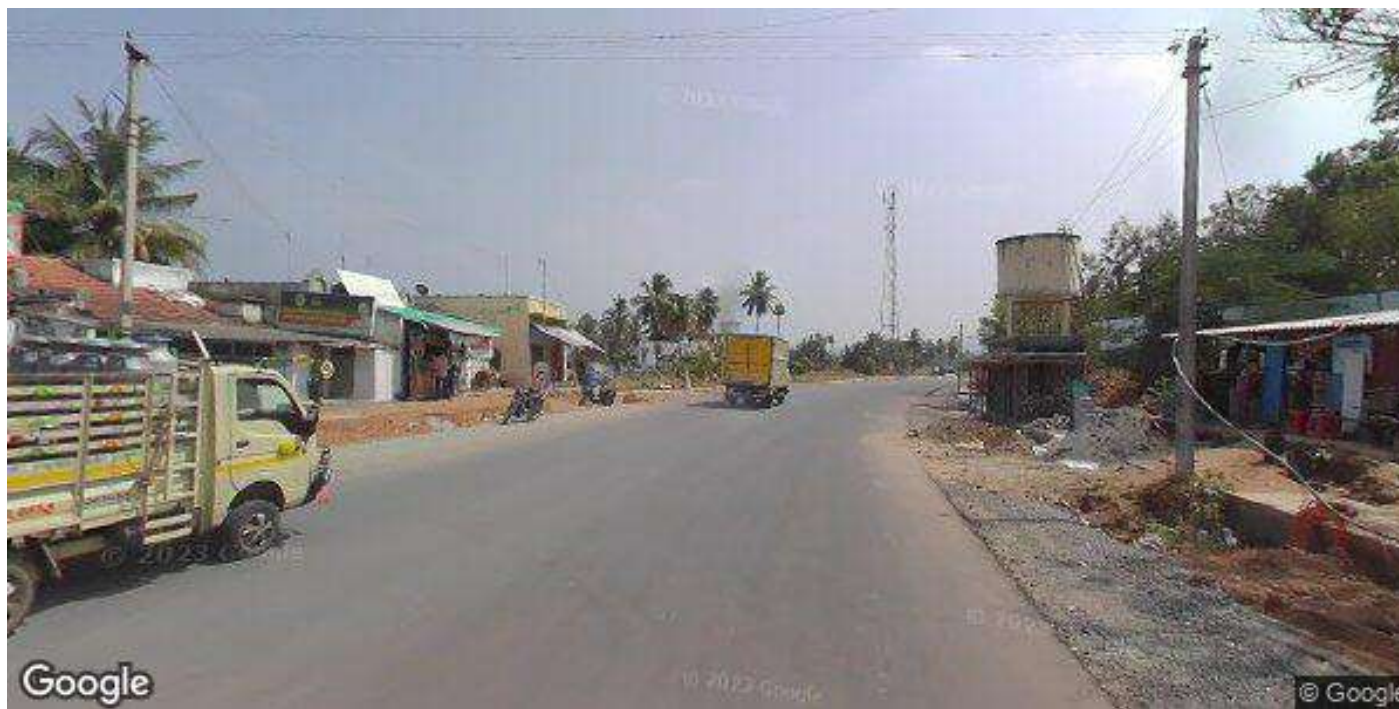
**Risk Type:** Turn  
**Risk Level:** Medium  
**Speed Limit:** 30 KM/Hr  
**Coordinates:** 11.42751, 78.21298

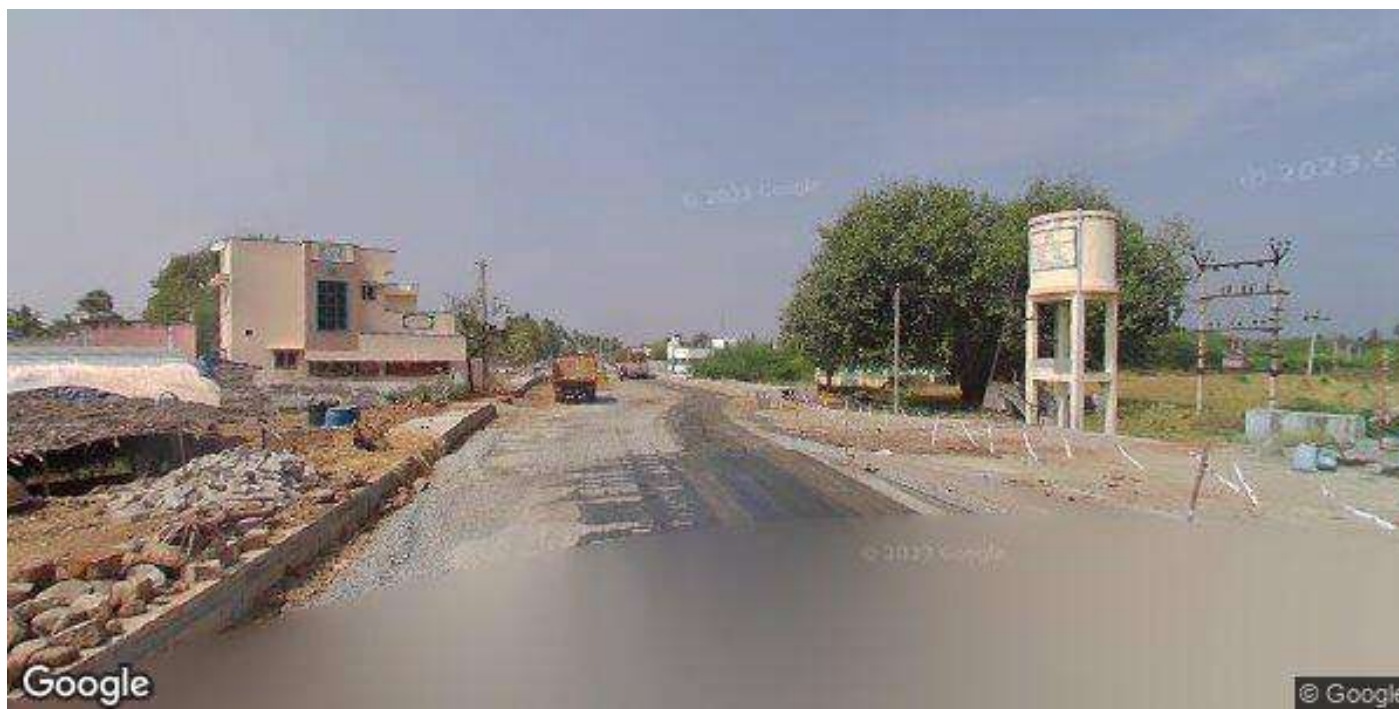
**Risk Type:** Turn  
**Risk Level:** High  
**Speed Limit:** 15 KM/Hr  
**Coordinates:** 11.42178, 78.21699

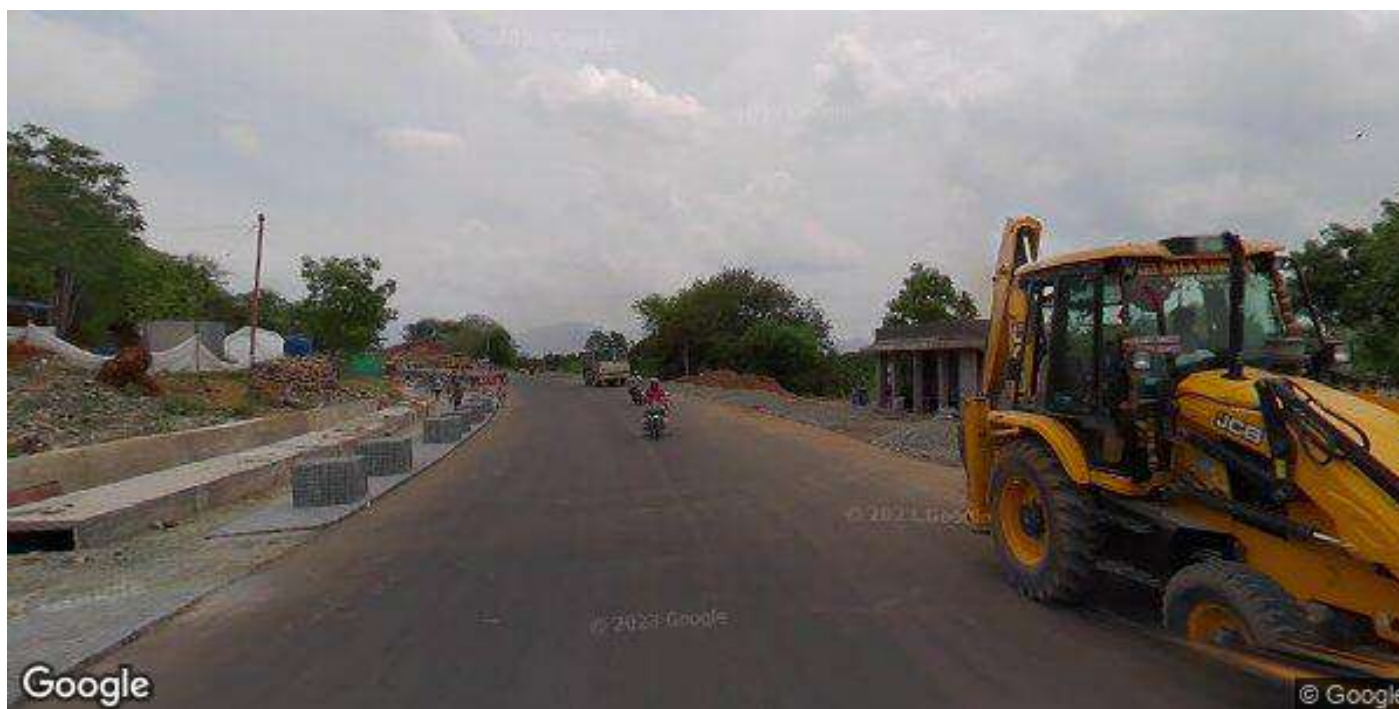
**Risk Type:** Turn  
**Risk Level:** High  
**Speed Limit:** 15 KM/Hr  
**Coordinates:** 11.39529, 78.25156

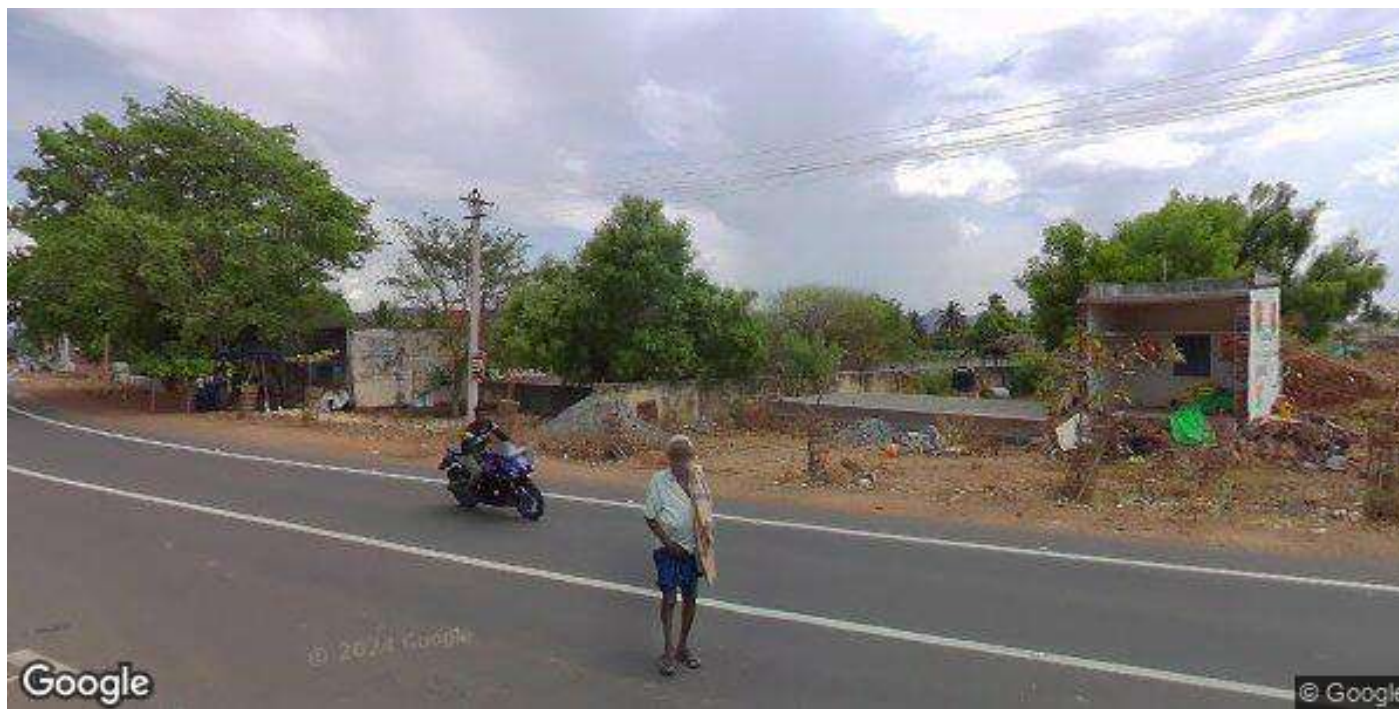
**Risk Type:** Turn  
**Risk Level:** Medium  
**Speed Limit:** 30 KM/Hr  
**Coordinates:** 11.38226, 78.25407

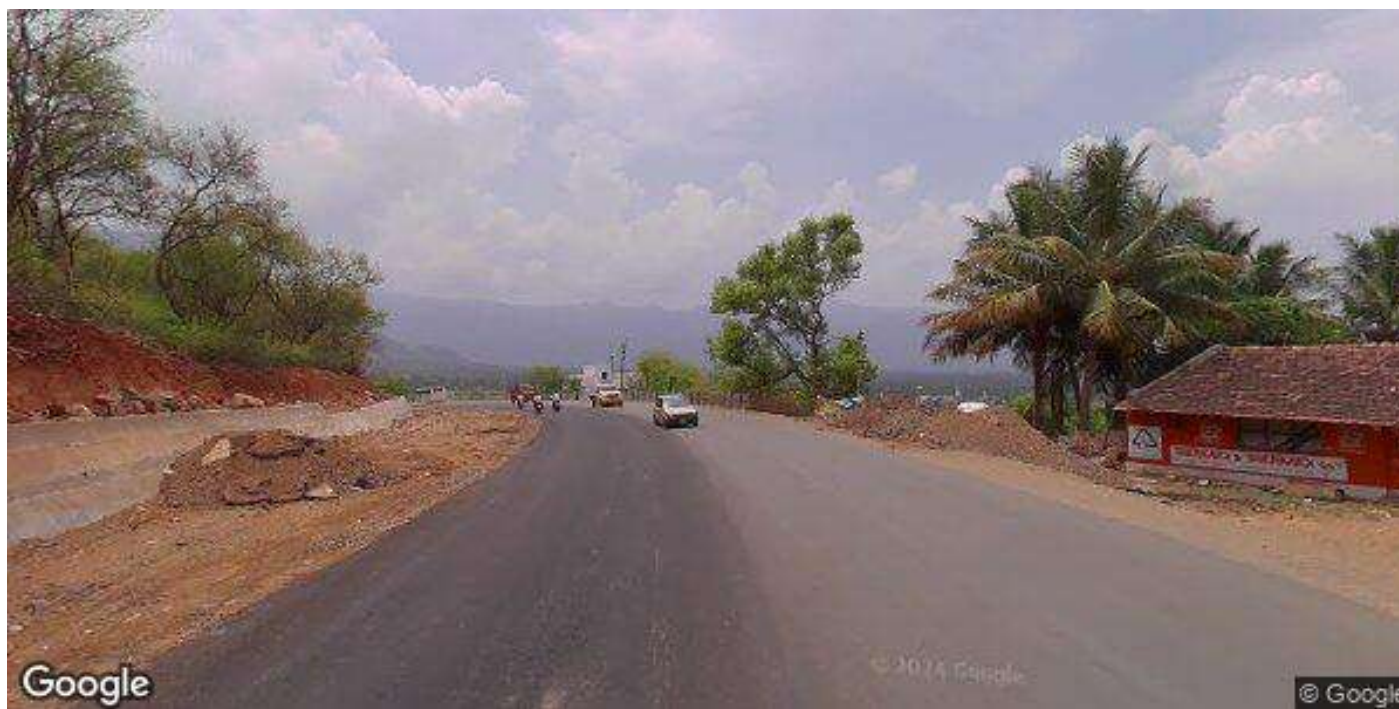
**Risk Type:** Turn  
**Risk Level:** Medium  
**Speed Limit:** 30 KM/Hr  
**Coordinates:** 11.36047, 78.25982

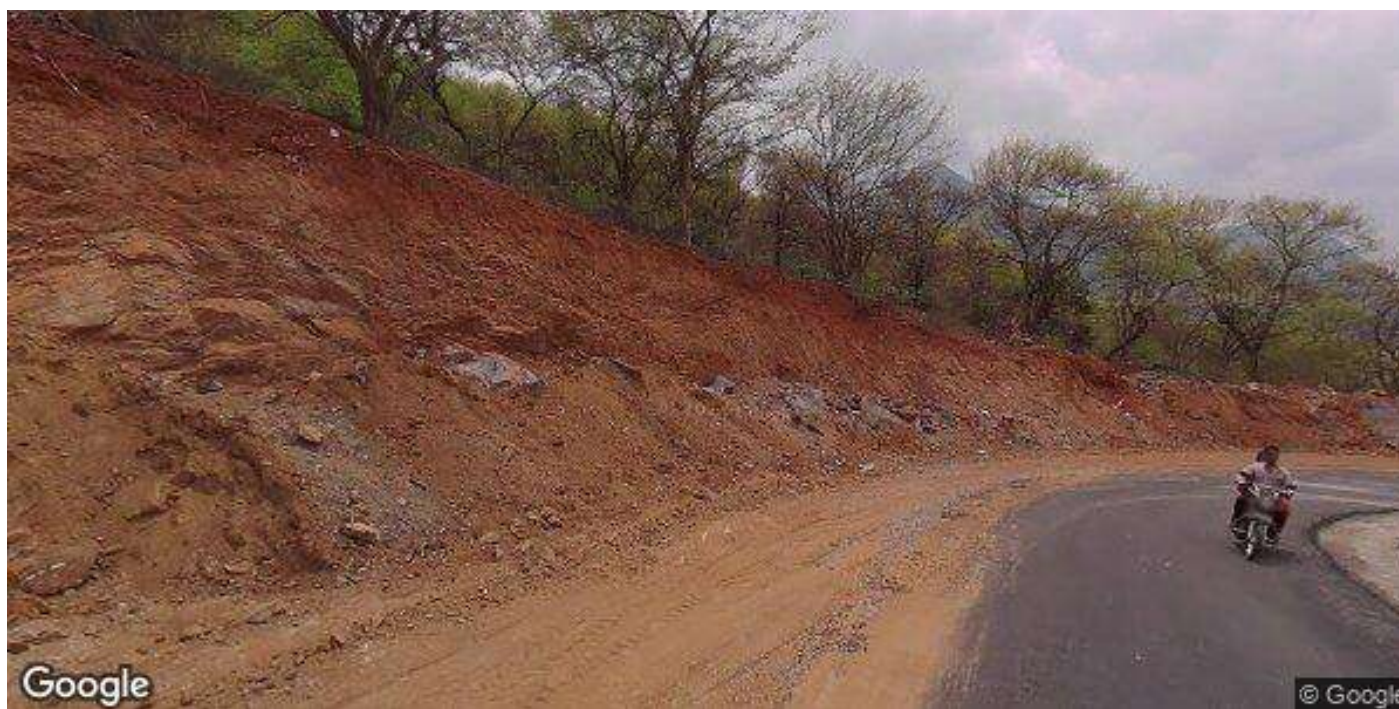
**Risk Type:** Turn  
**Risk Level:** Medium  
**Speed Limit:** 30 KM/Hr  
**Coordinates:** 11.35997, 78.26190

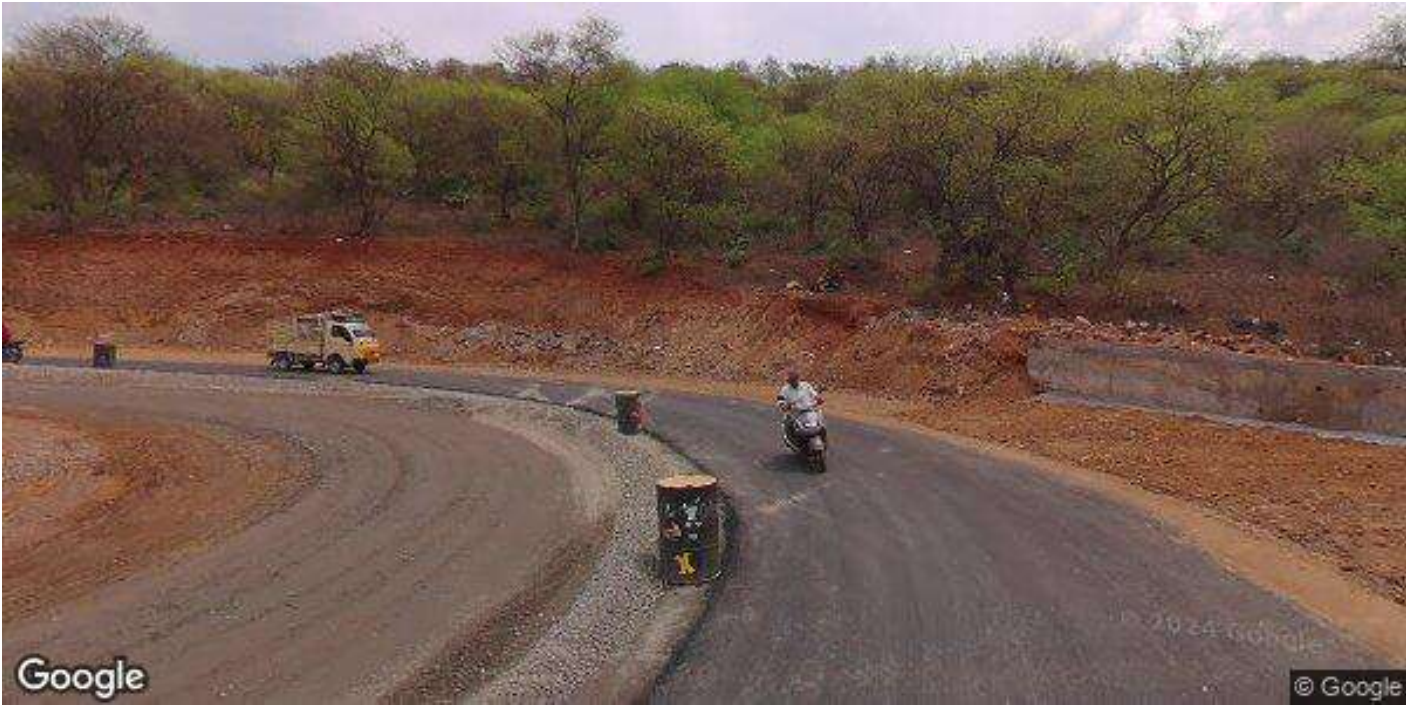
**Risk Type:** Blind Spot  
**Risk Level:** Blind Spot  
**Speed Limit:** 10 KM/Hr  
**Coordinates:** 11.35989, 78.26201
