## JOURNEY RISK MANAGEMENT (JRM) STUDY

### Salem Terminal to LAKSHMI AGENCIES

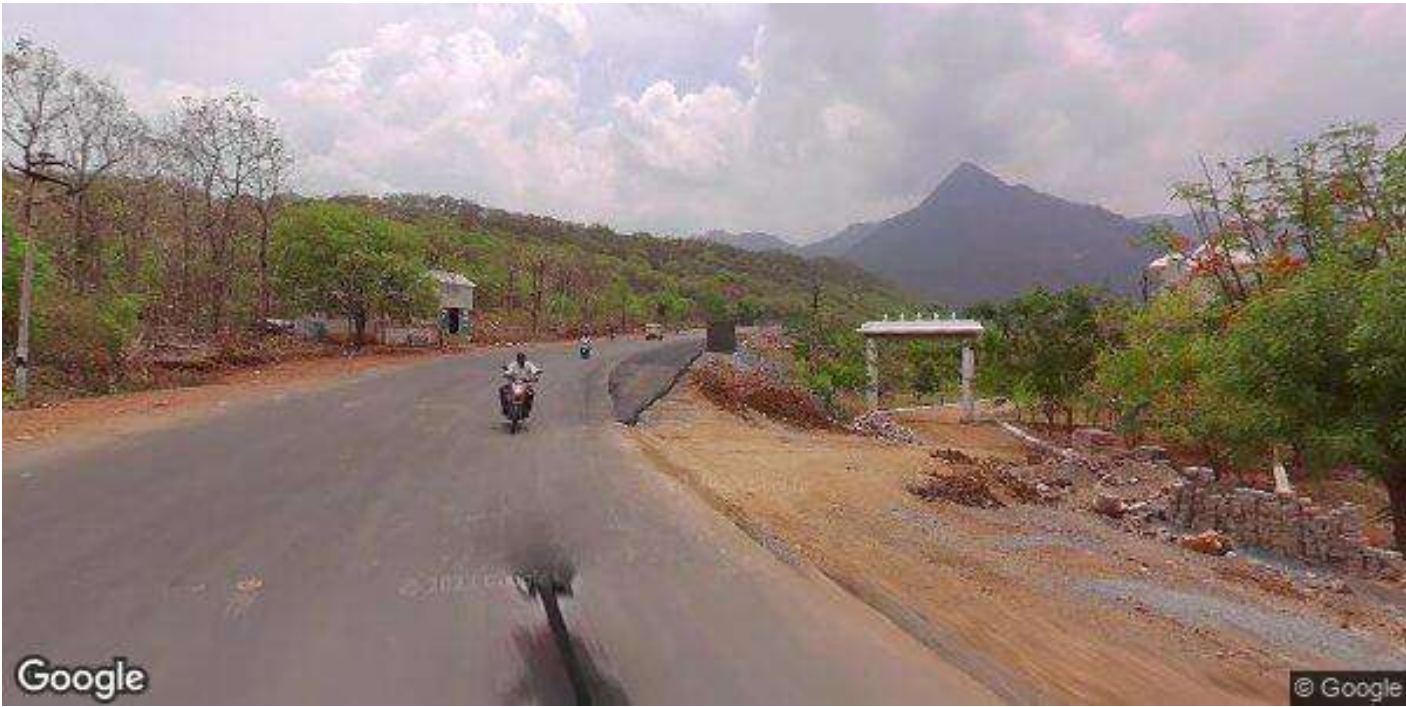
**Risk Type:** Turn  
**Risk Level:** Medium  
**Speed Limit:** 30 KM/Hr  
**Coordinates:** 11.35862, 78.25971

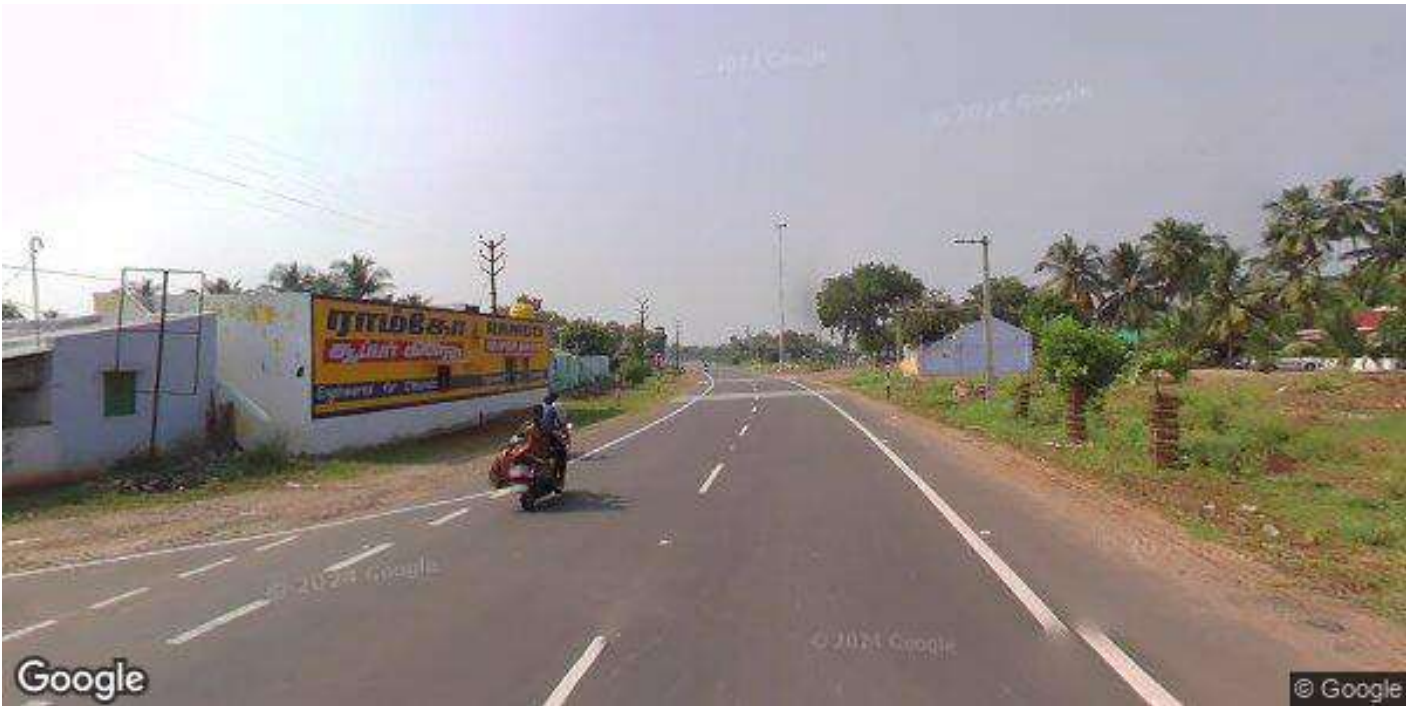
**Risk Type:** Blind Spot  
**Risk Level:** Blind Spot  
**Speed Limit:** 10 KM/Hr  
**Coordinates:** 11.33761, 78.25054

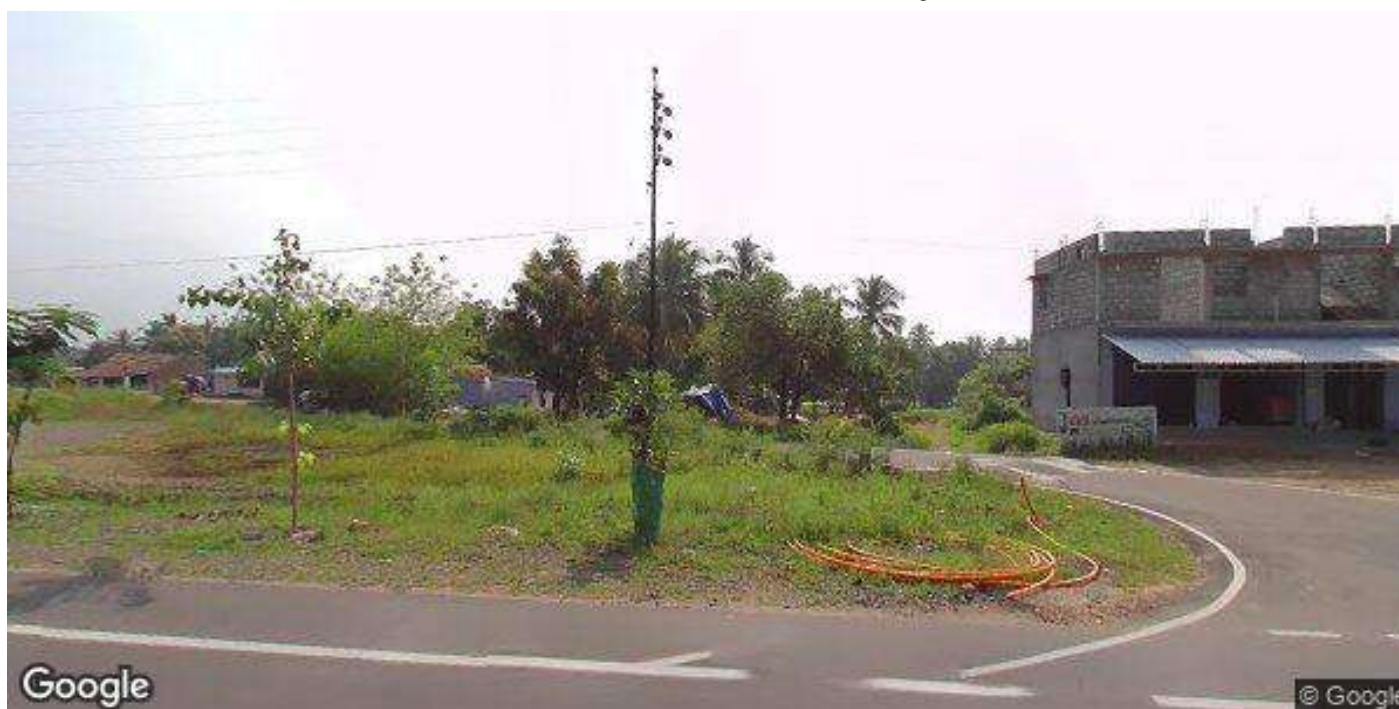
**Risk Type:** Turn  
**Risk Level:** Medium  
**Speed Limit:** 30 KM/Hr  
**Coordinates:** 11.33765, 78.25083

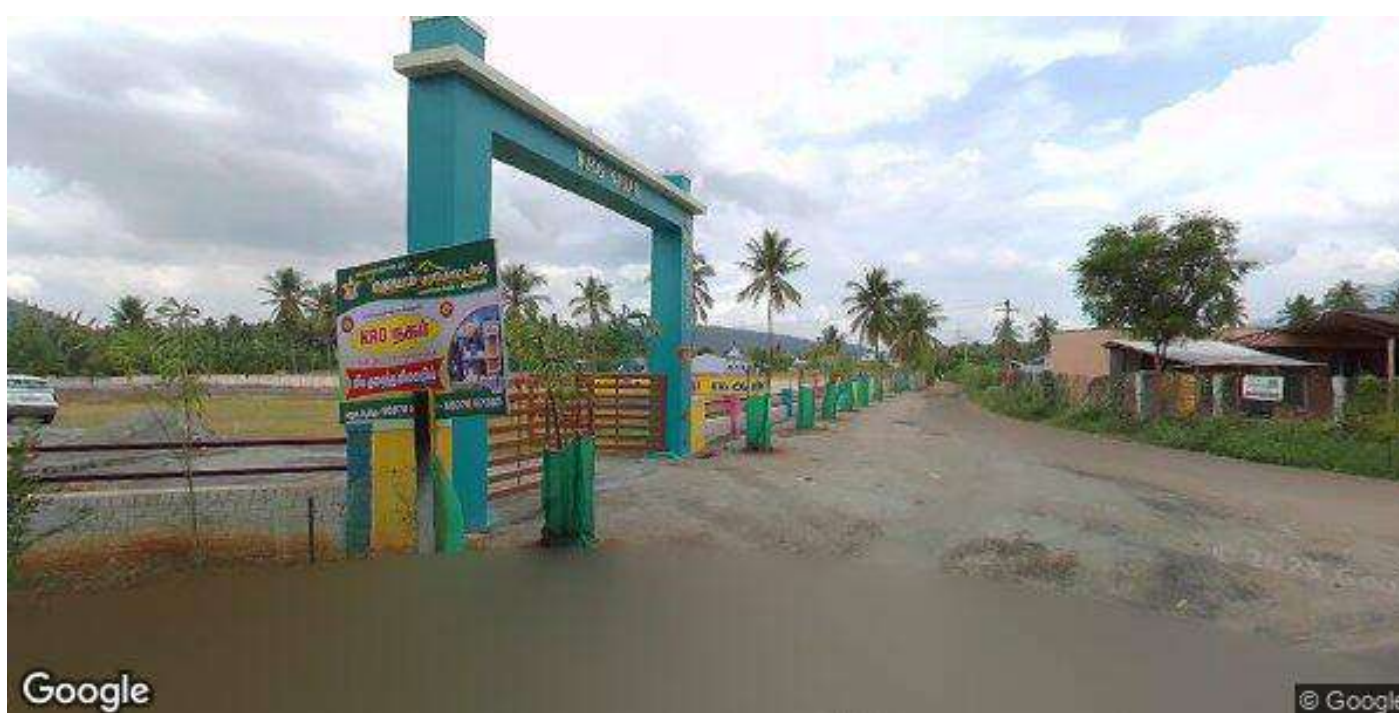
**Risk Type:** Blind Spot  
**Risk Level:** Blind Spot  
**Speed Limit:** 10 KM/Hr  
**Coordinates:** 11.33448, 78.25806

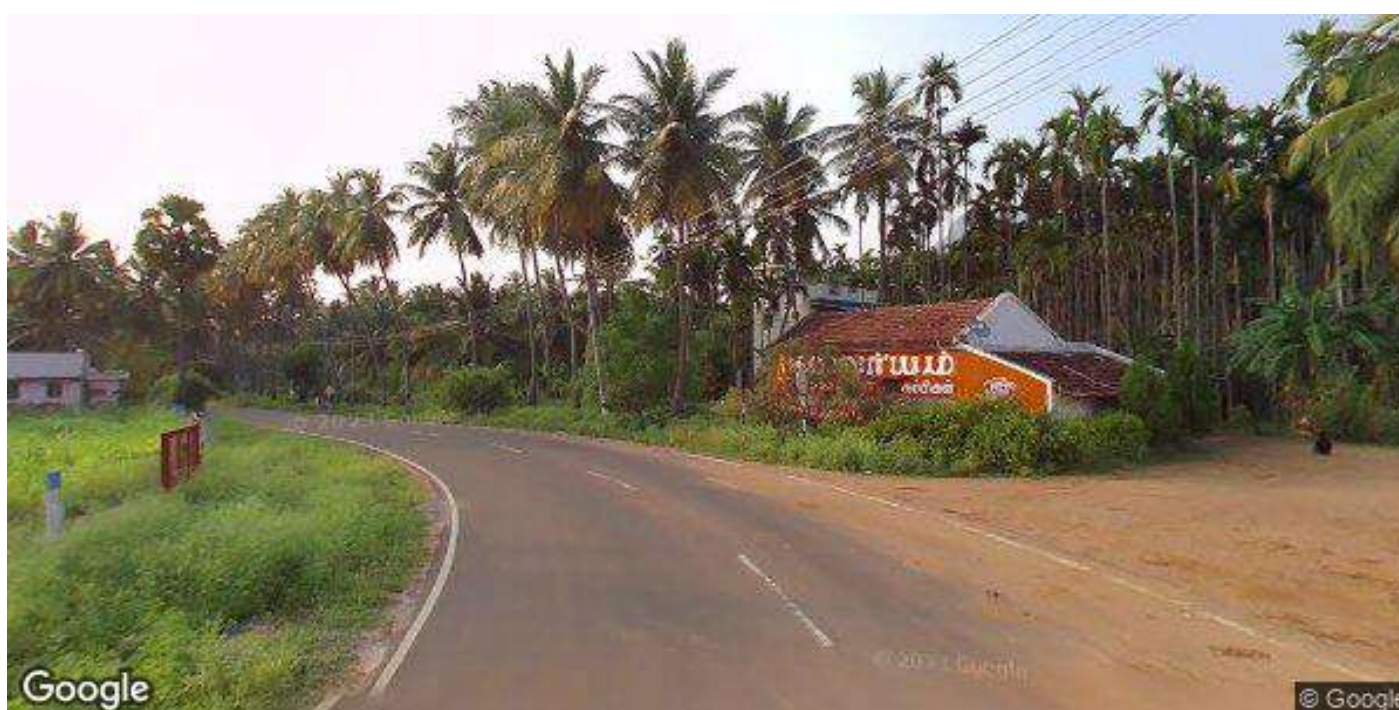
**Risk Type:** Turn  
**Risk Level:** Medium  
**Speed Limit:** 30 KM/Hr  
**Coordinates:** 11.32983, 78.29999

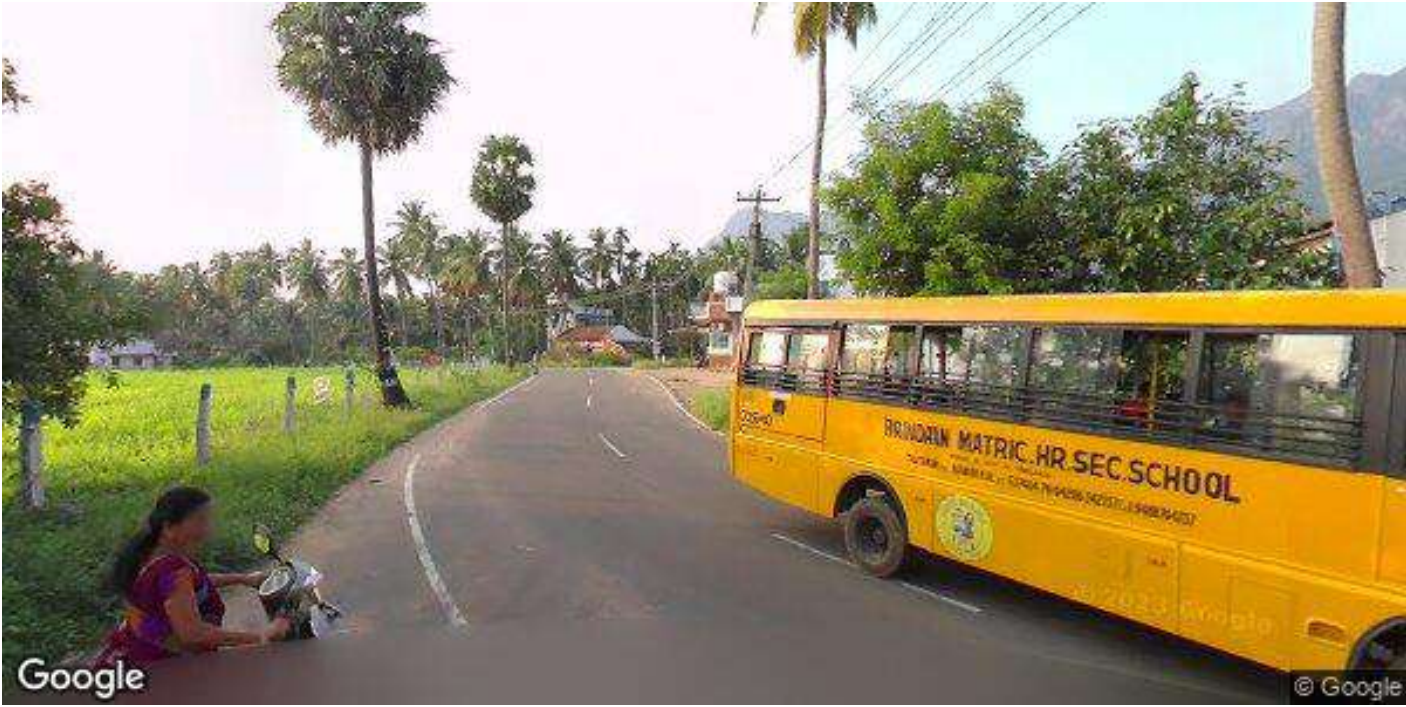
**Risk Type:** Turn  
**Risk Level:** High  
**Speed Limit:** 15 KM/Hr  
**Coordinates:** 11.32944, 78.30032
