## JOURNEY RISK MANAGEMENT (JRM) STUDY

### Salem Terminal TO HARI AGENCY

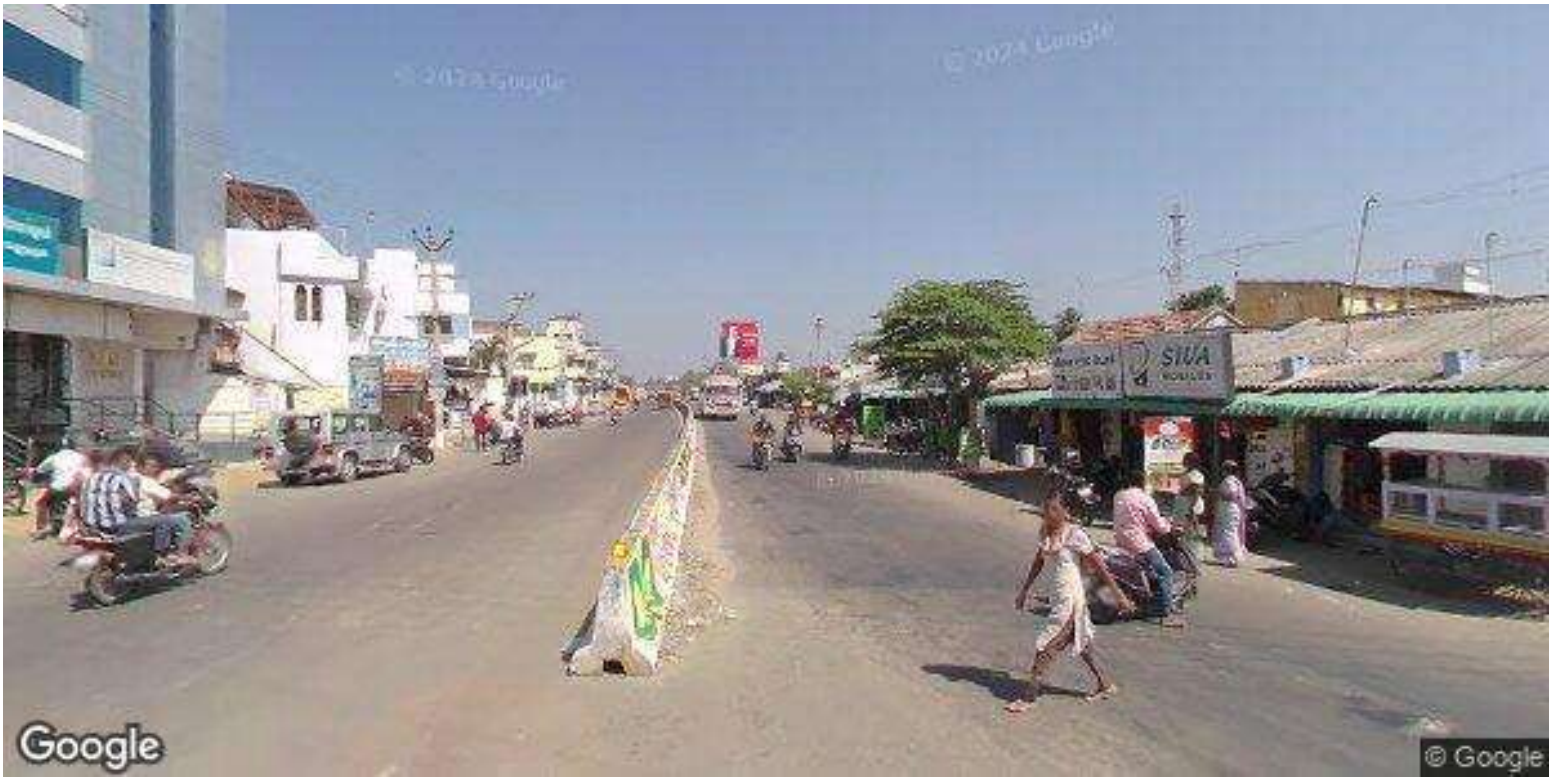
Risk Type: Roundabout  
Risk Level: High

**Speed Limit: 15 KM/Hr**  
**Coordinates: 11.37086, 77.74828**

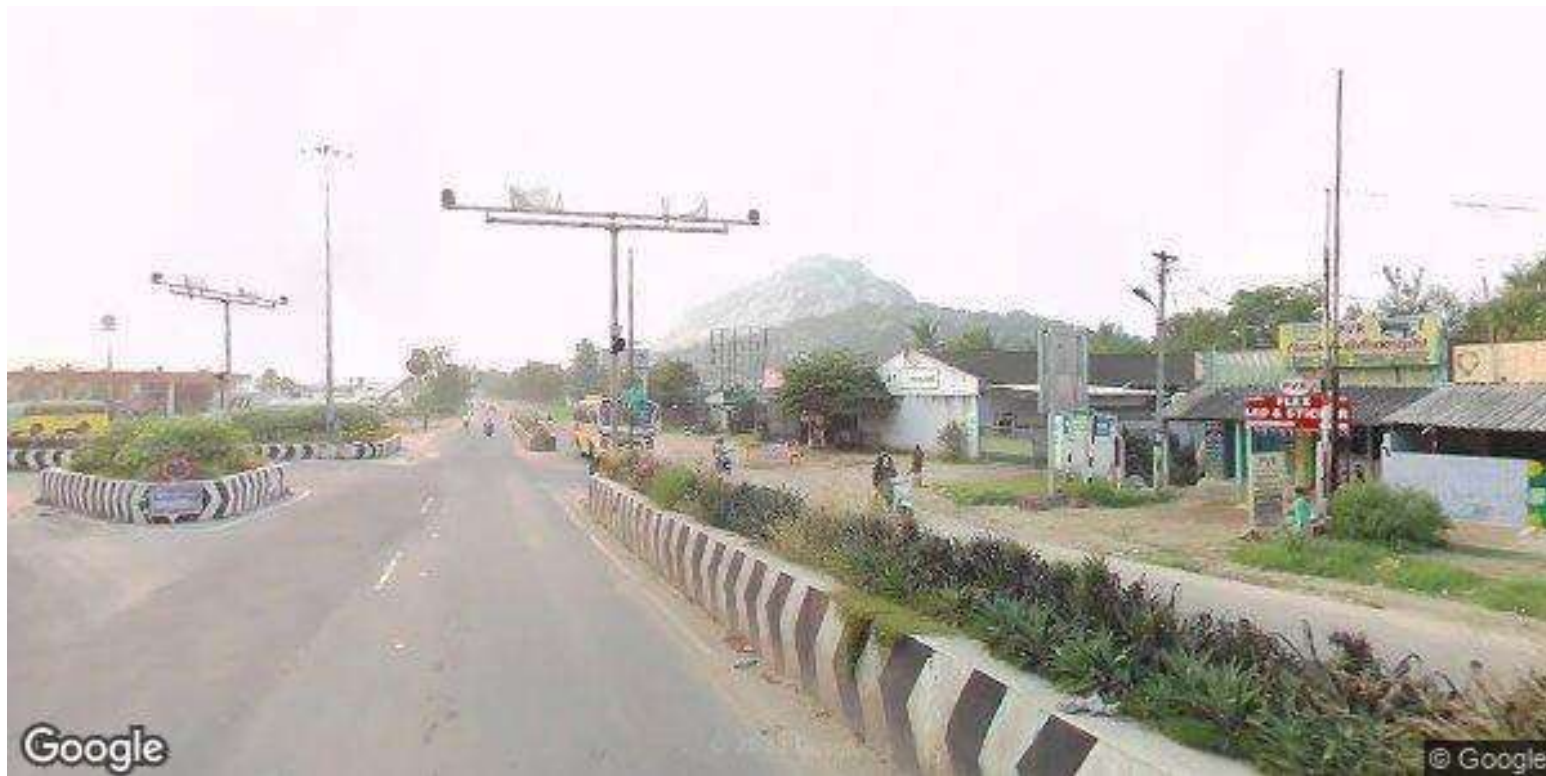
**Risk Type: Turn**

**Risk Level: Medium**

**Speed Limit: 30 KM/Hr**

**Coordinates: 11.46312, 77.84886**

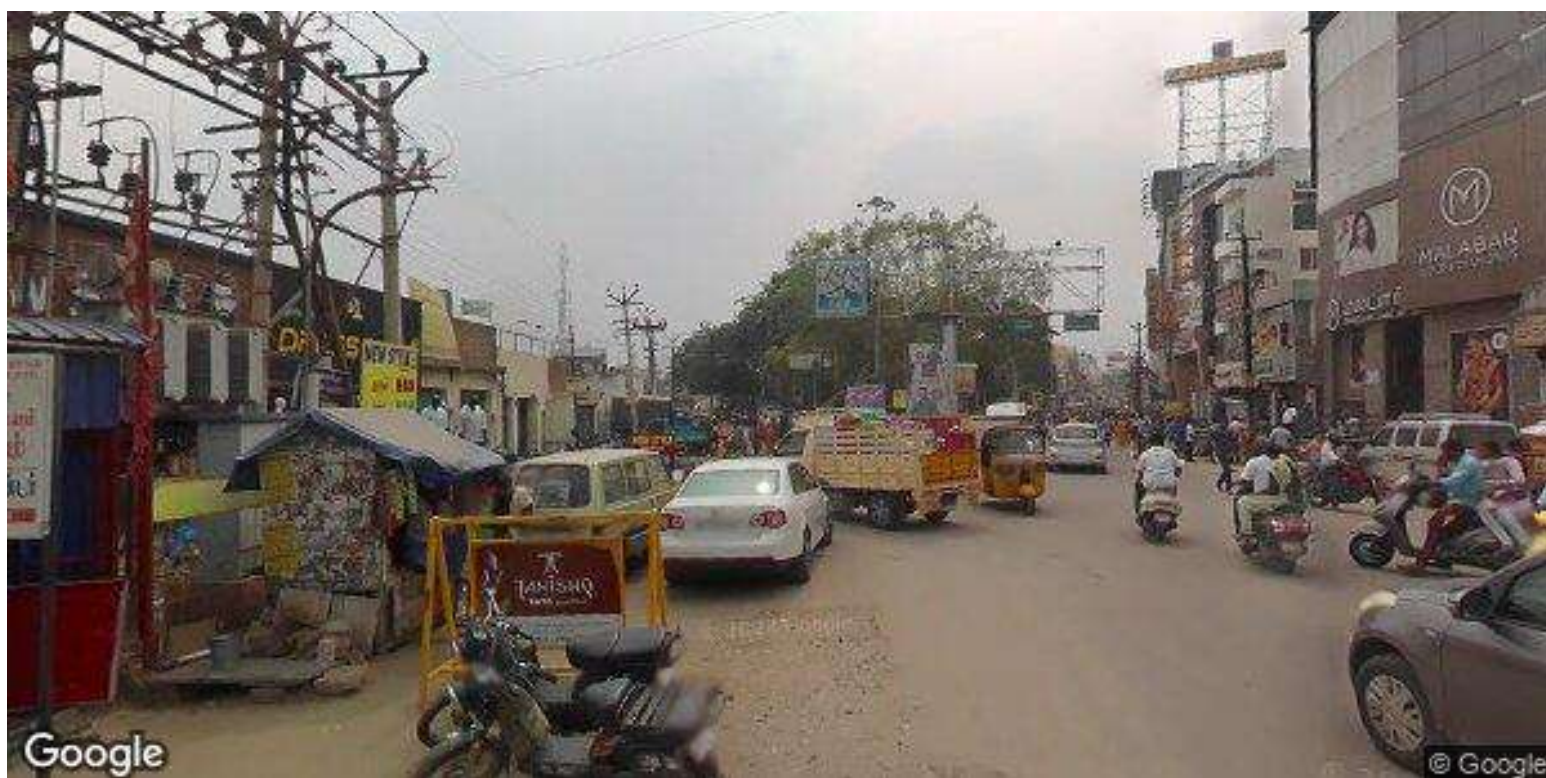
**Risk Type: Turn**

**Risk Level: Medium**

**Speed Limit: 30 KM/Hr**

**Coordinates: 11.34493, 77.73032**

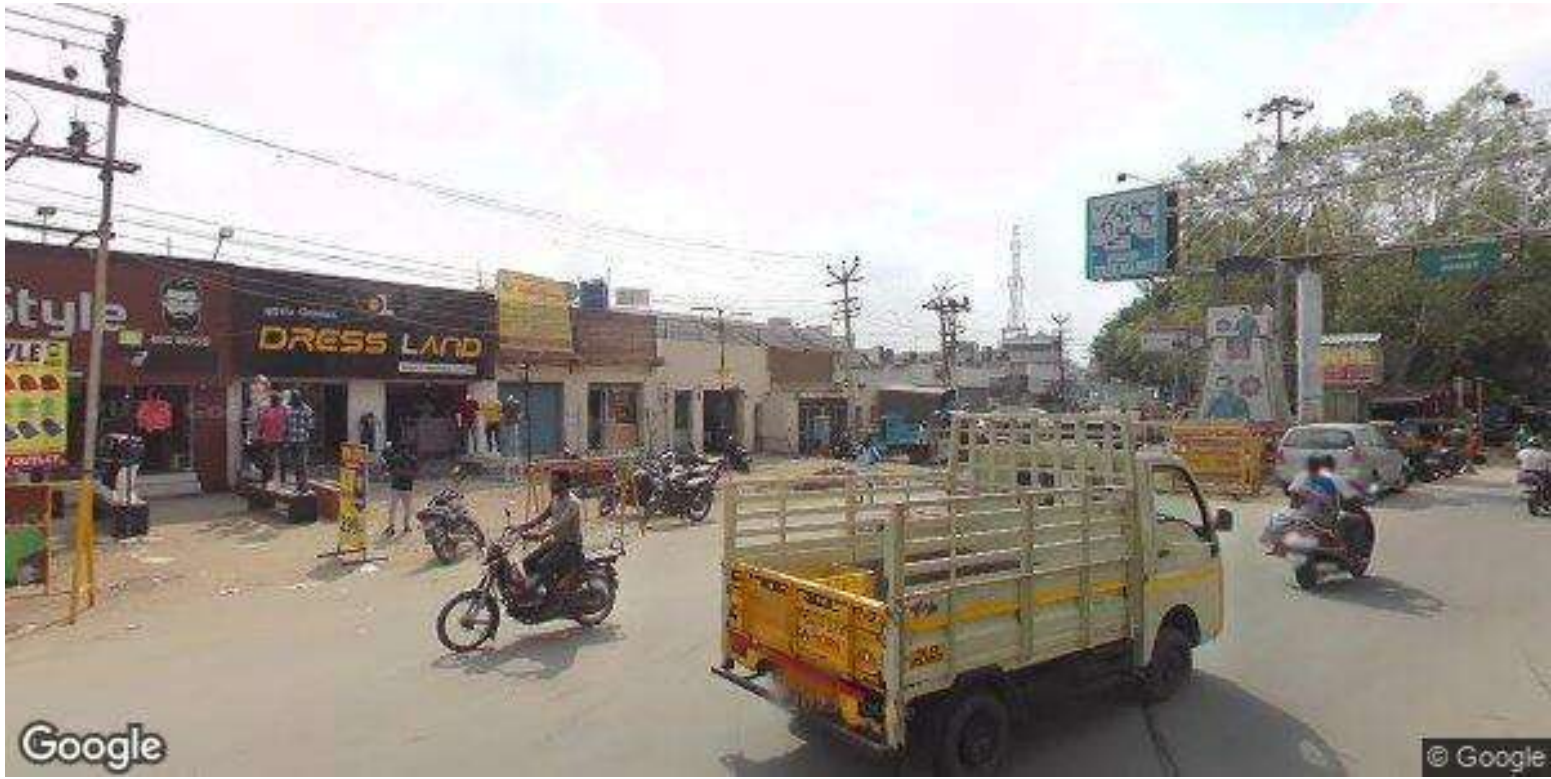
Risk Type: Turn  
Risk Level: Medium  
Speed Limit: 30 KM/Hr  
Coordinates: 11.34483, 77.73022

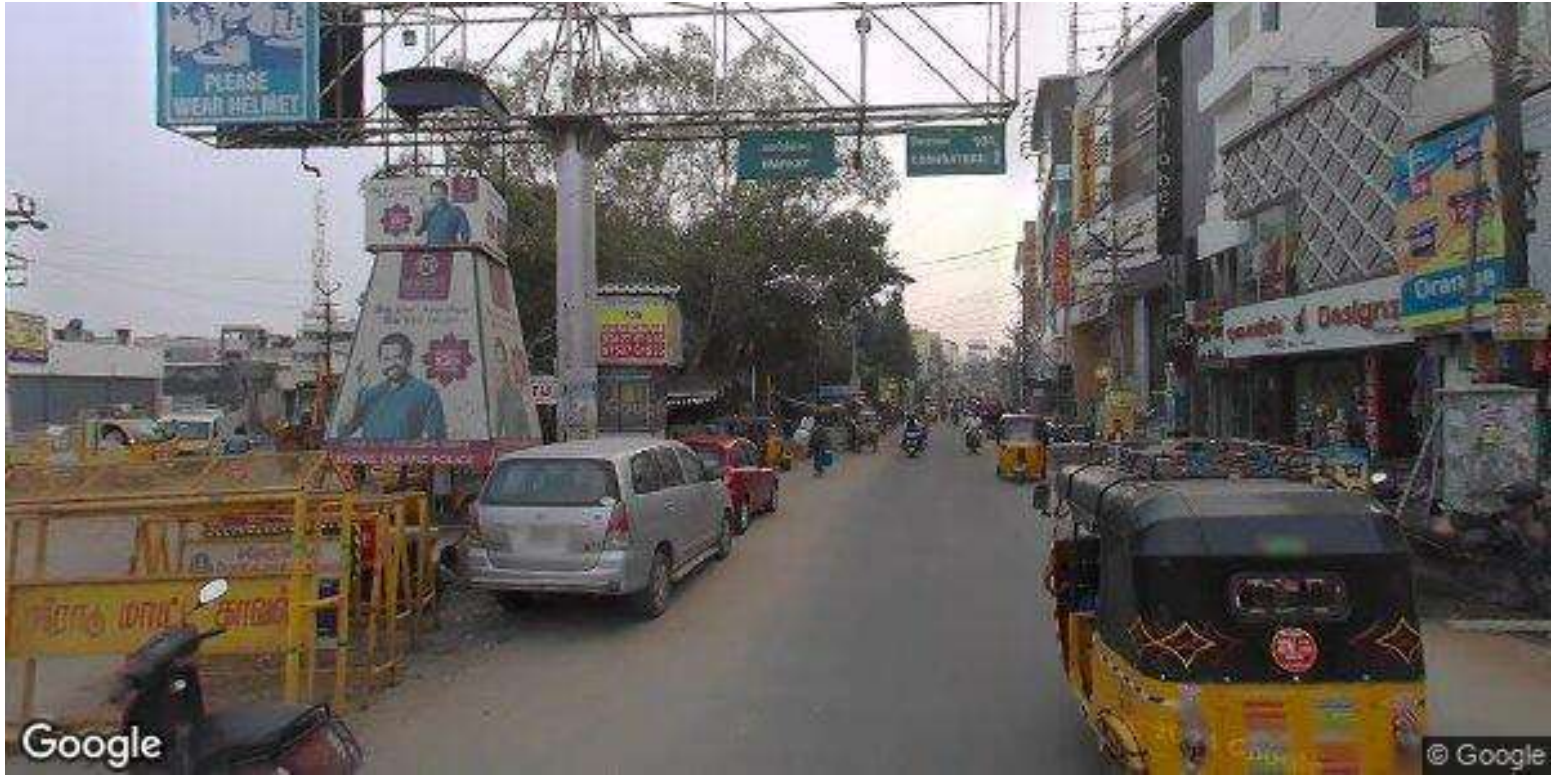
Risk Type: Turn  
Risk Level: Medium  
Speed Limit: 30 KM/Hr  
Coordinates: 11.34470, 77.73018

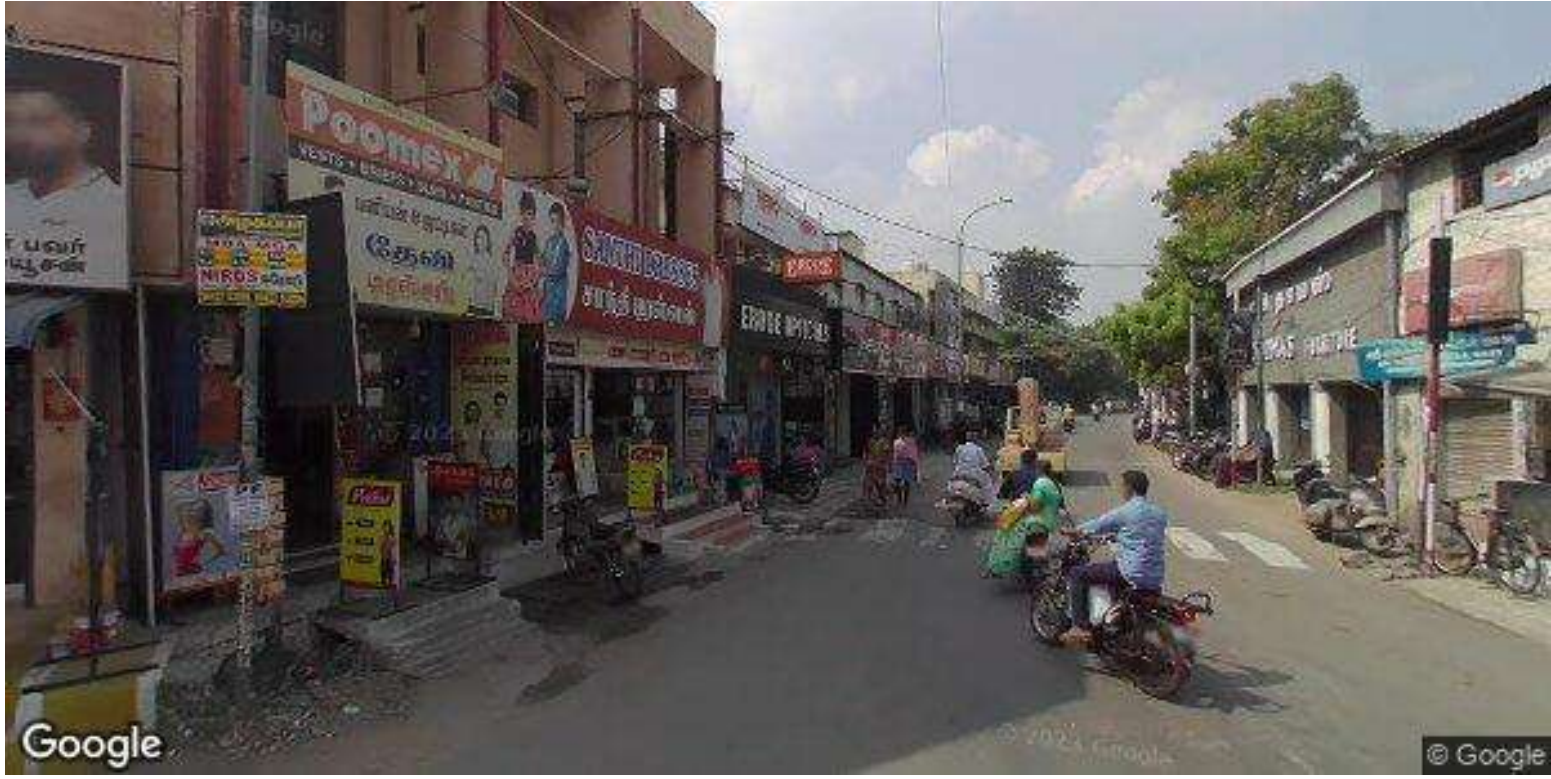
**Risk Type:** Blind Spot

**Risk Level:** Blind Spot

**Speed Limit:** 10 KM/Hr

**Coordinates:** 11.33920, 77.72902

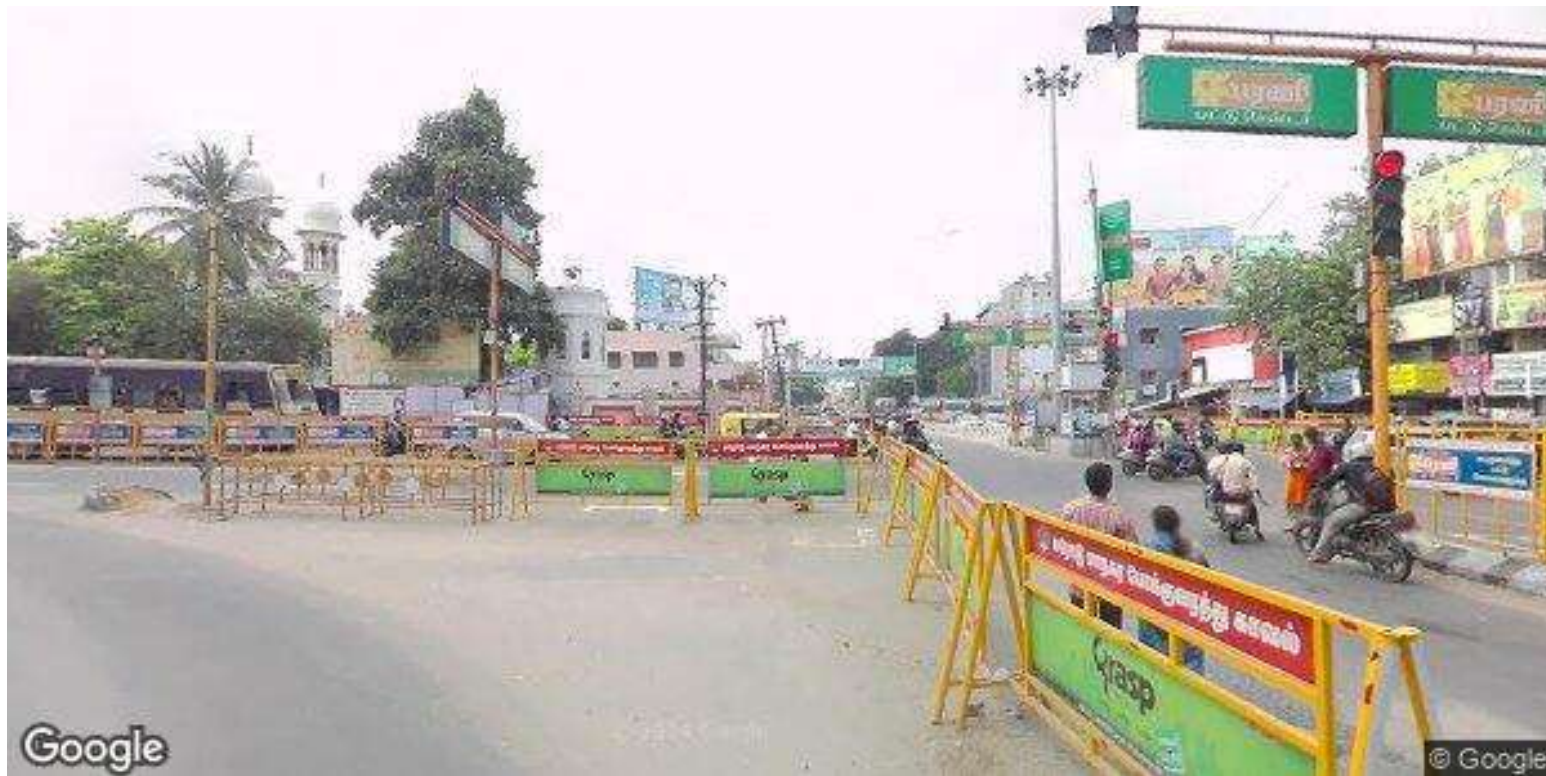
**Risk Type:** Turn

**Risk Level:** Medium

**Speed Limit:** 30 KM/Hr

**Coordinates:** 11.33914, 77.72659

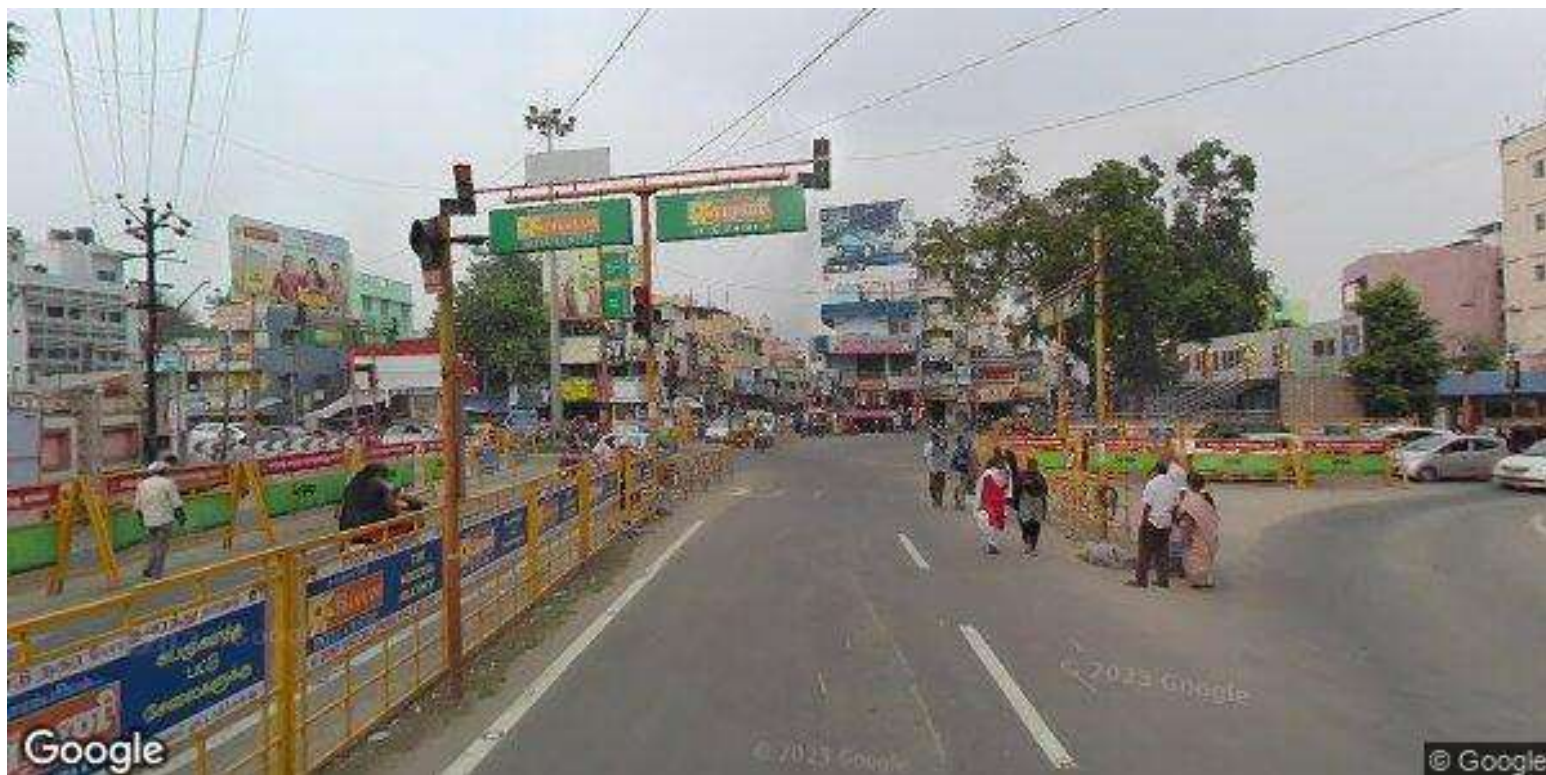
**Risk Type:** Turn

**Risk Level:** High

**Speed Limit:** 15 KM/Hr

**Coordinates:** 11.33890, 77.72637

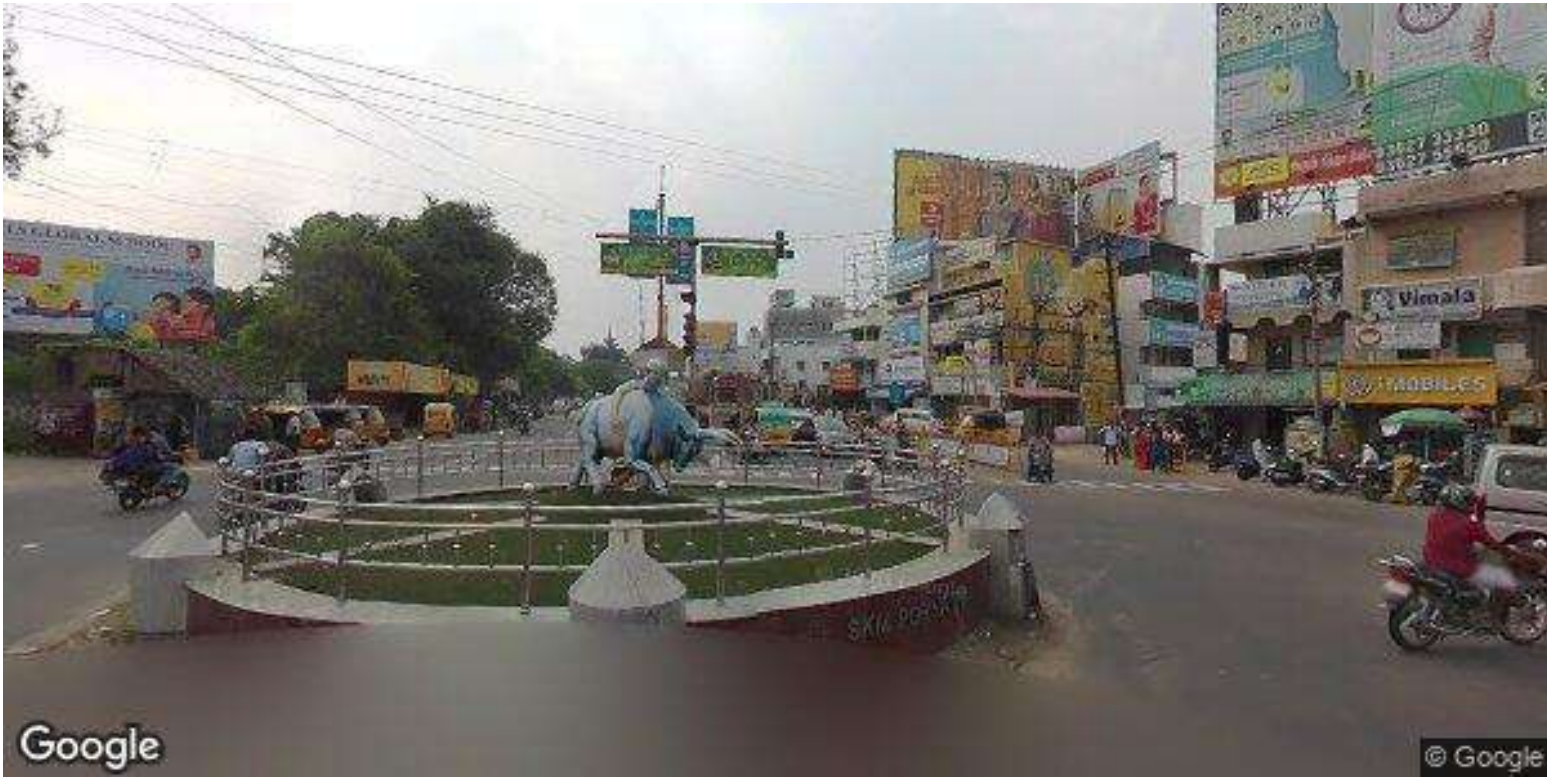
**Risk Type:** Turn  
**Risk Level:** Medium  
**Speed Limit:** 30 KM/Hr  
**Coordinates:** 11.33097, 77.72747

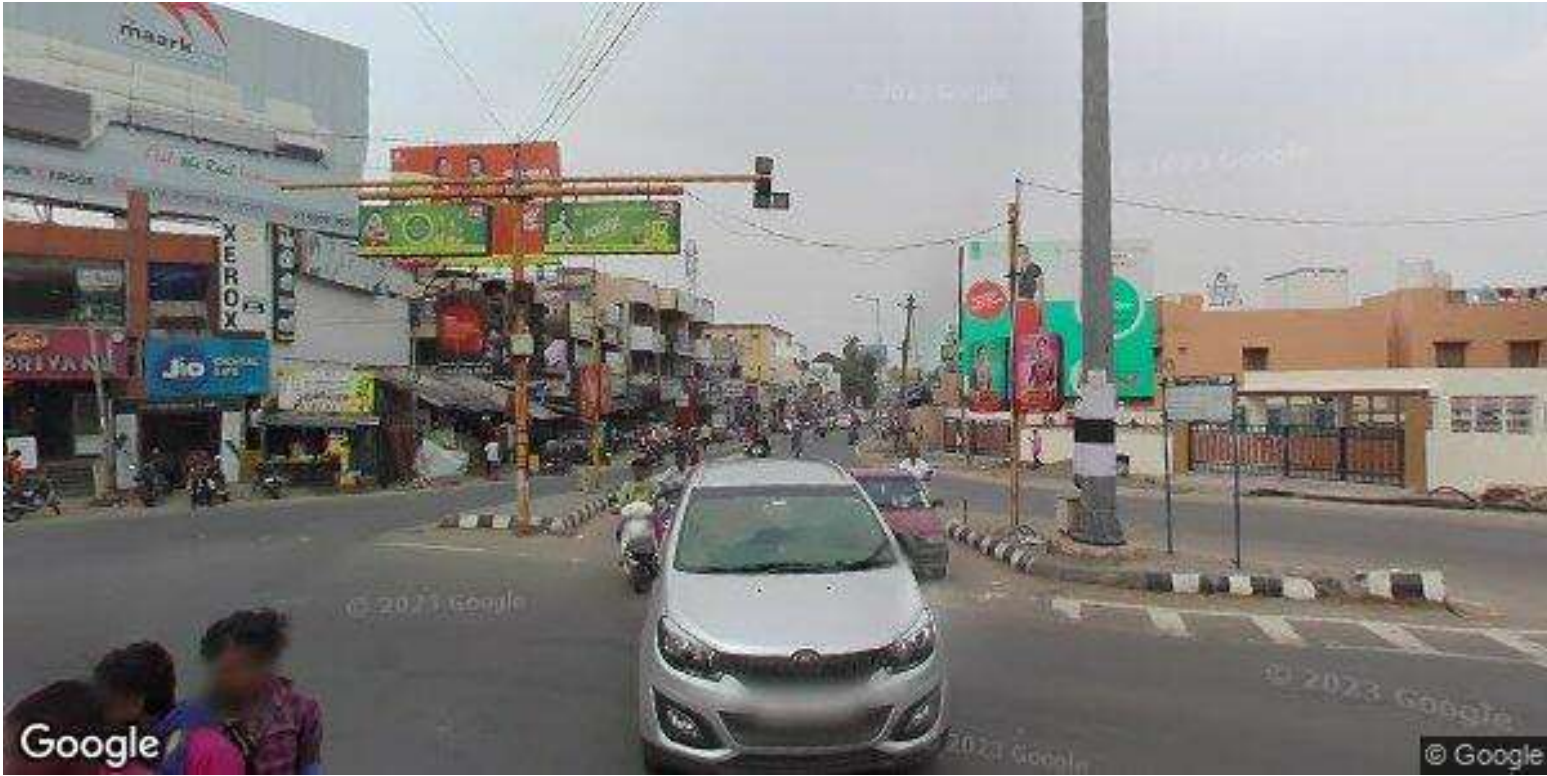
**Risk Type:** Turn  
**Risk Level:** Medium  
**Speed Limit:** 30 KM/Hr  
**Coordinates:** 11.33095, 77.72748

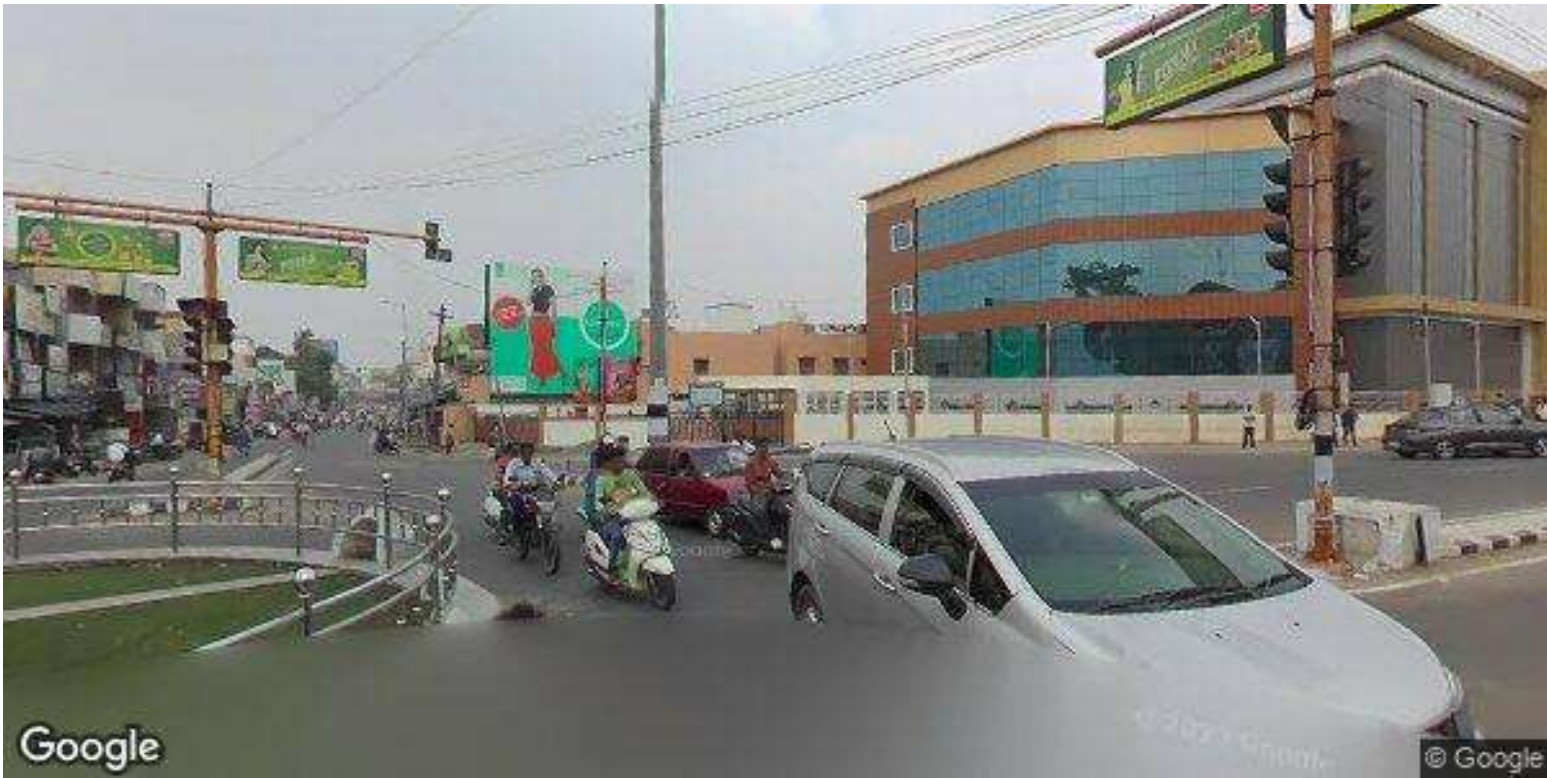
**Risk Type: Turn**

**Risk Level: High**

**Speed Limit: 15 KM/Hr**

**Coordinates: 11.33090, 77.72748**

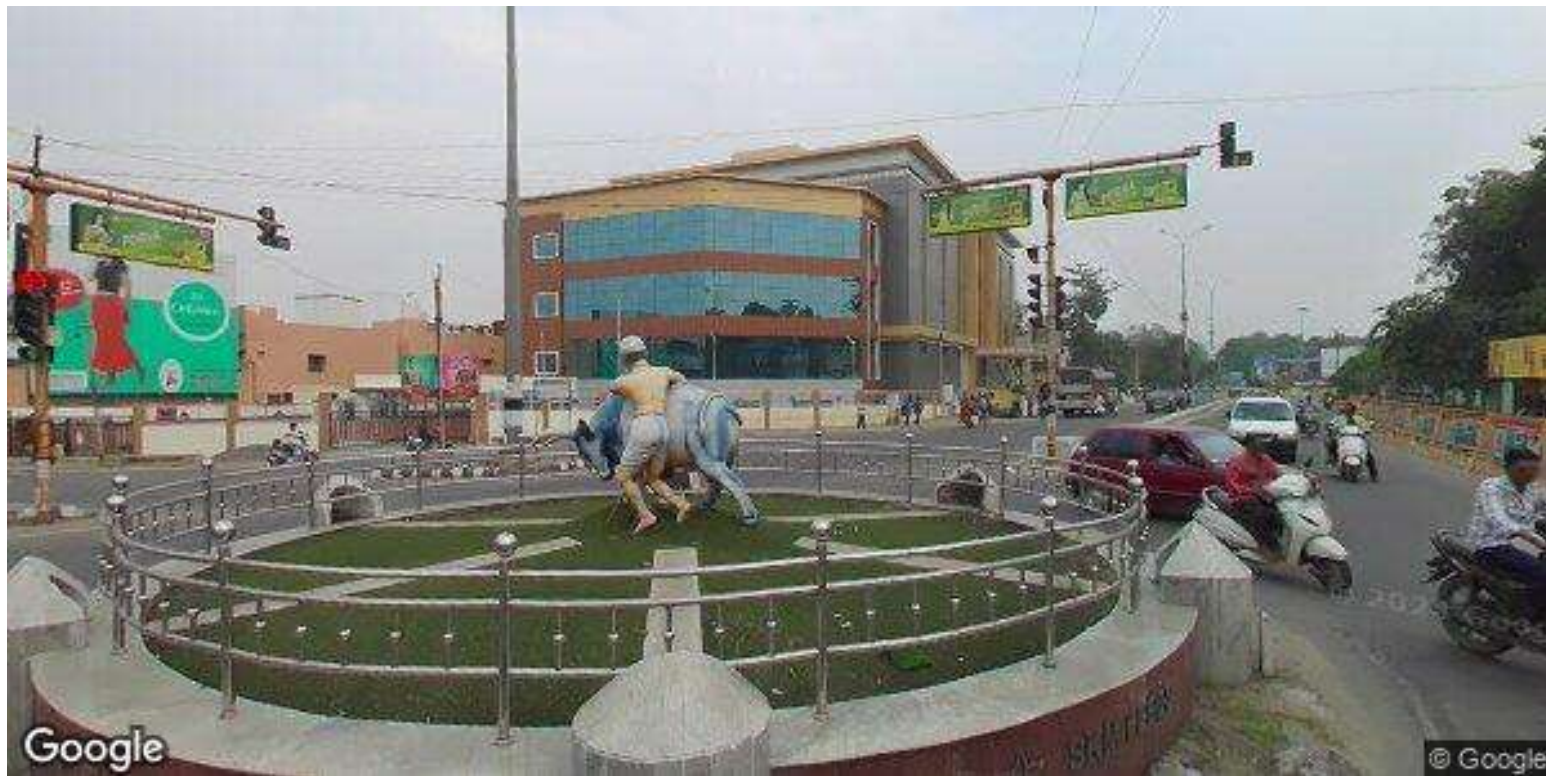
**Risk Type: Turn**

**Risk Level: Medium**

**Speed Limit: 30 KM/Hr**

**Coordinates: 11.33084, 77.72742**

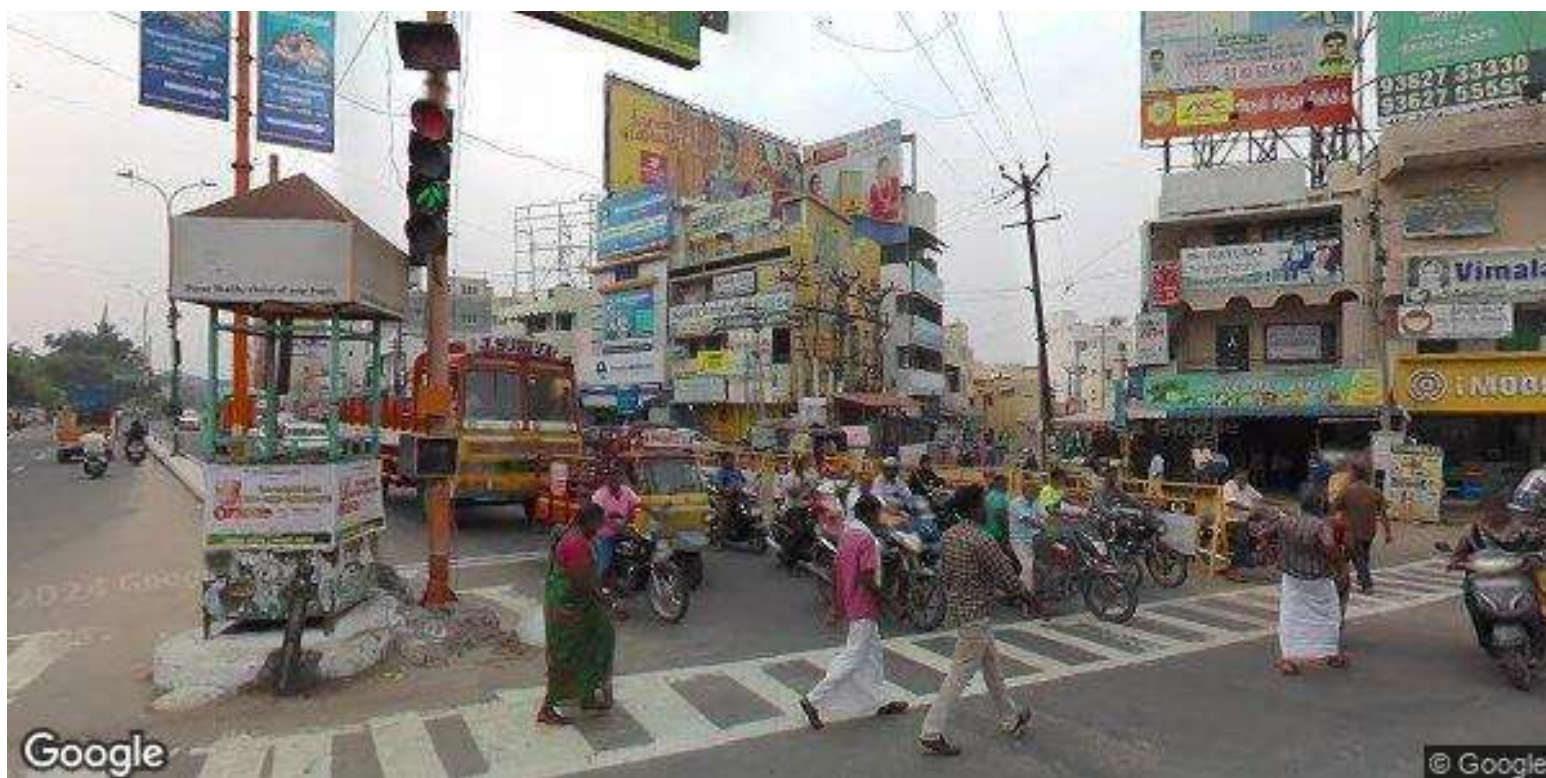
**Risk Type: Turn**

**Risk Level: Medium**

**Speed Limit: 30 KM/Hr**

**Coordinates: 11.33083, 77.72734**

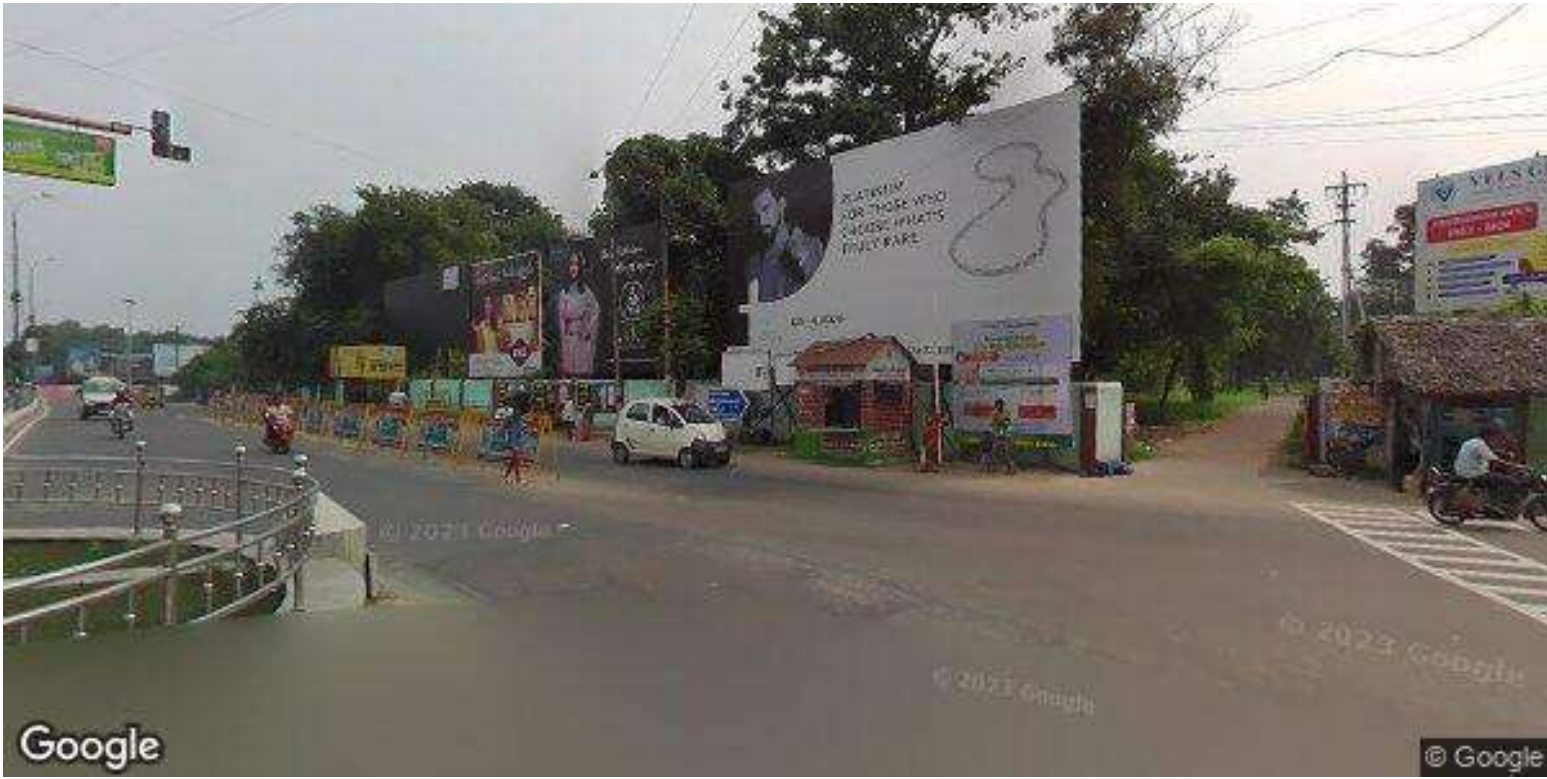
Risk Type: Turn

Risk Level: High

Speed Limit: 15 KM/Hr

Coordinates: 11.33084, 77.72731
