## **JOURNEY RISK MANAGEMENT (JRM) STUDY**

**Salem Terminal TO J.P.RAMESH AGENCIES IOC  
DEALER**

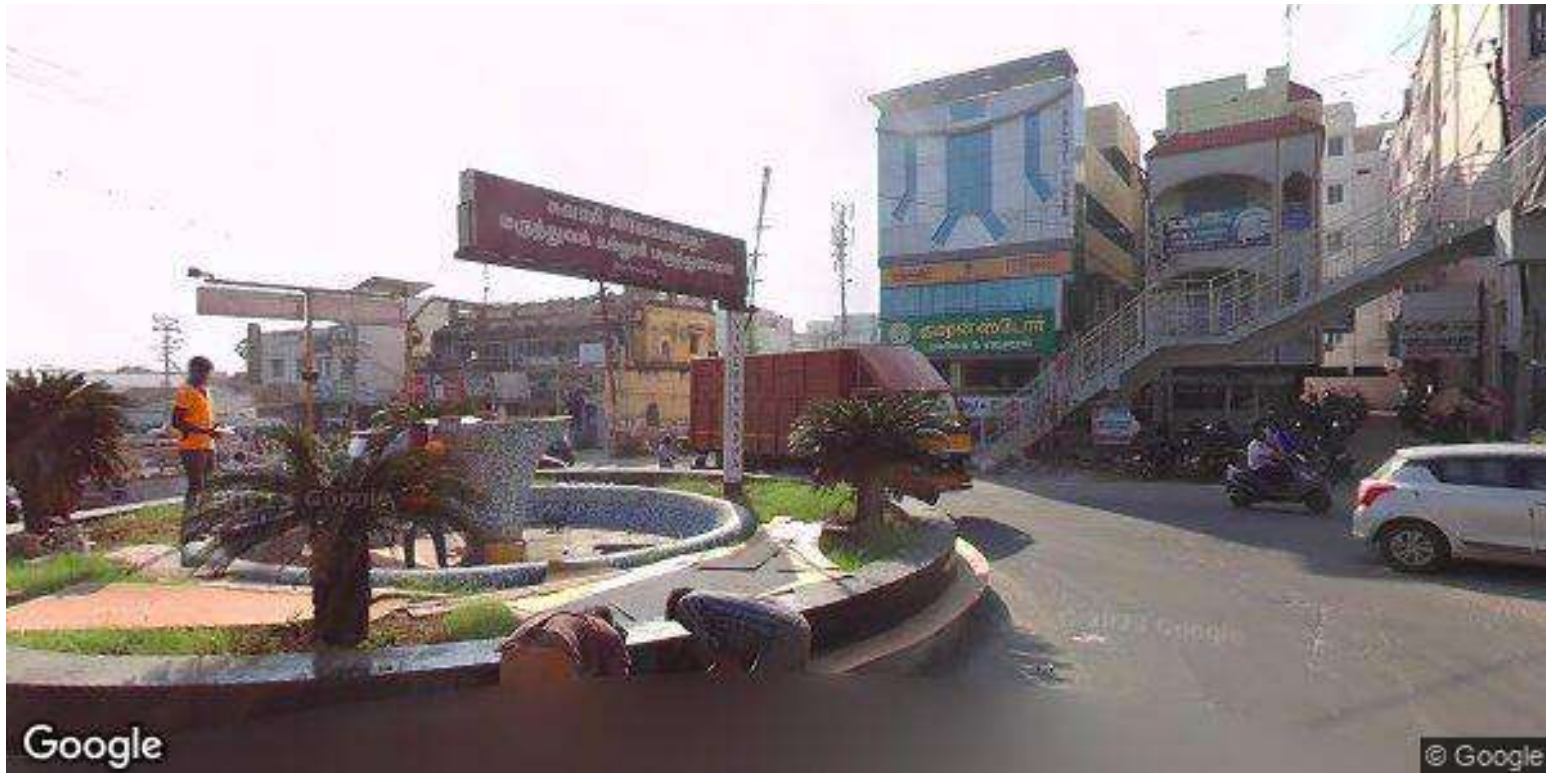
**Coordinates:** 11.38395, 77.89480

**Risk Type:** Roundabout

**Risk Level:** High

**Speed Limit:** 15 KM/Hr

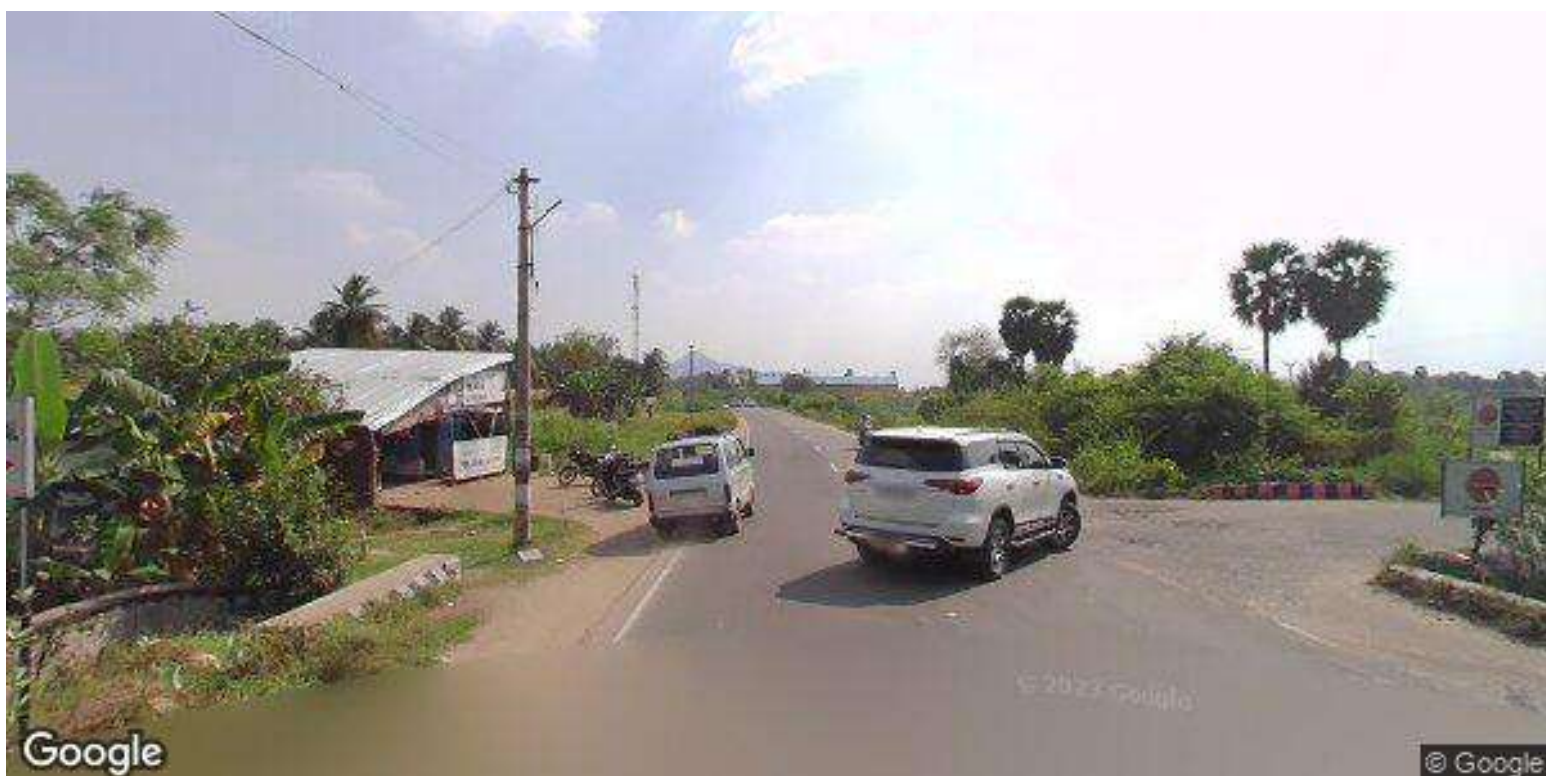
**Coordinates:** 11.44029, 77.87544

**Risk Type:** Blind Spot

**Risk Level:** Blind Spot

**Speed Limit:** 10 KM/Hr

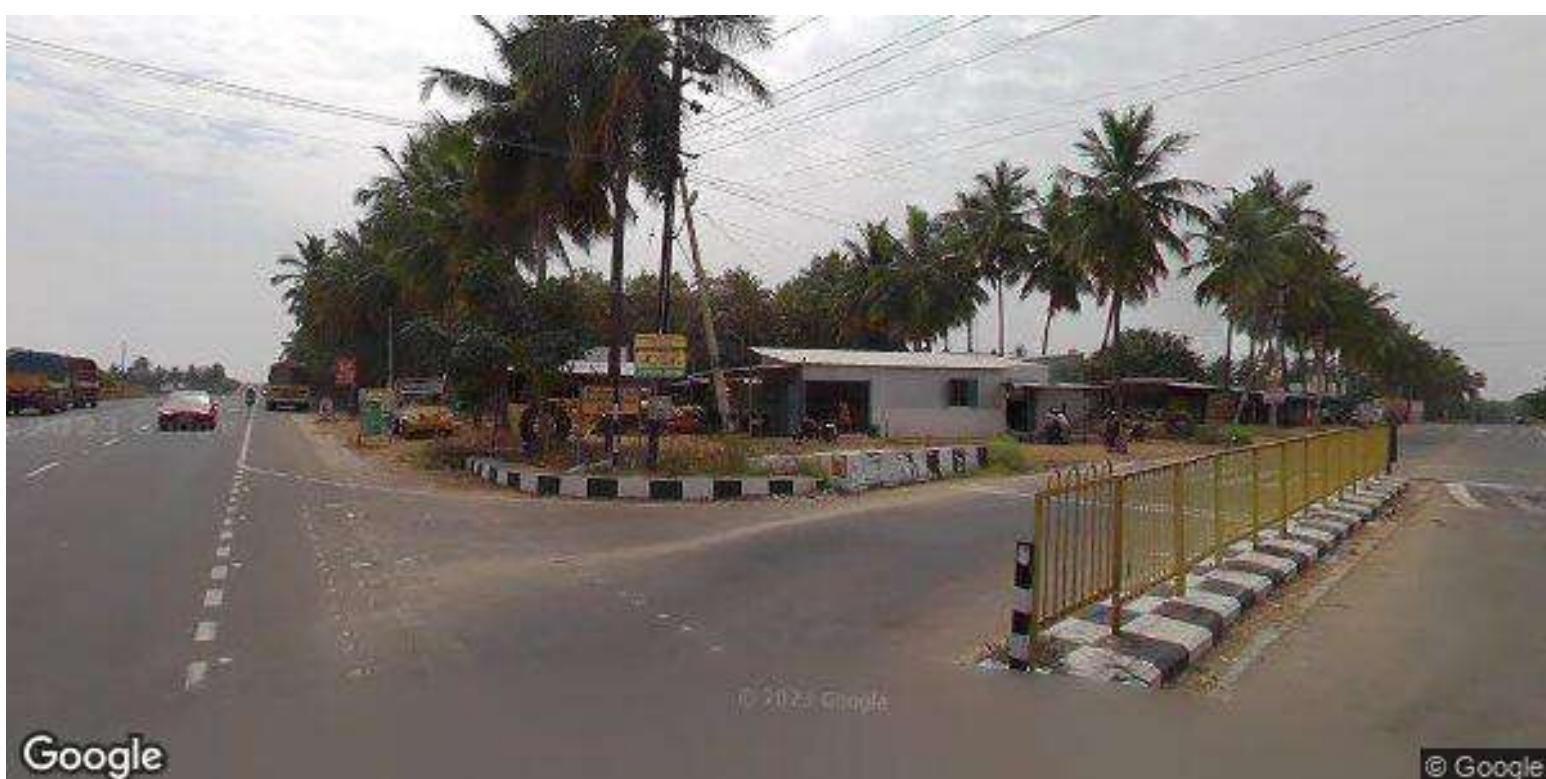
**Coordinates:** 11.30859, 77.92918

**Risk Type:** Turn

**Risk Level:** High

**Speed Limit:** 15 KM/Hr

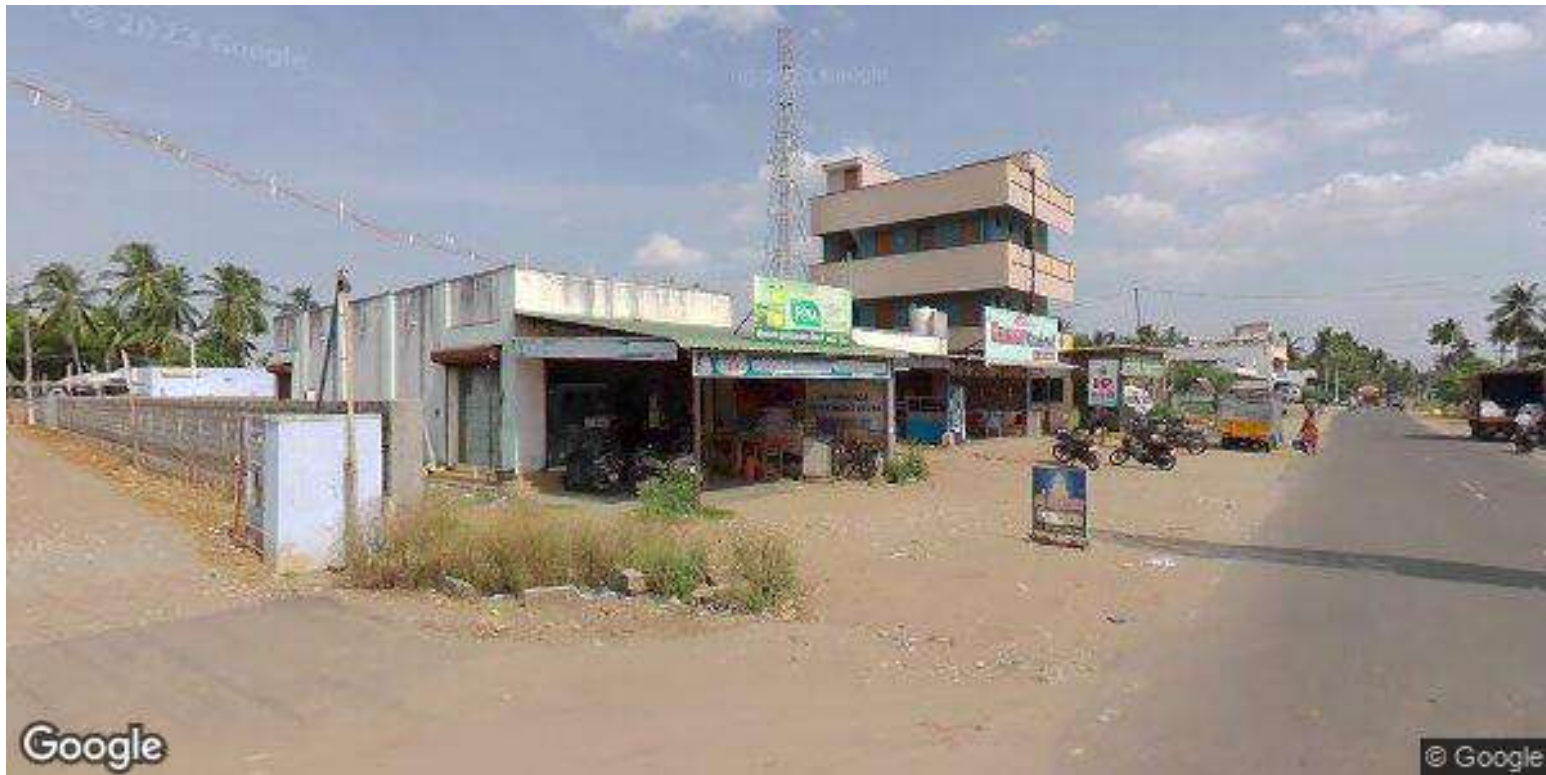
**Coordinates:** 11.23924, 77.87368

**Risk Type:** Turn

**Risk Level:** Medium

**Speed Limit:** 30 KM/Hr
