## JOURNEY RISK MANAGEMENT (JRM) STUDY

### Salem Terminal to N.N.C.FUEL STATION

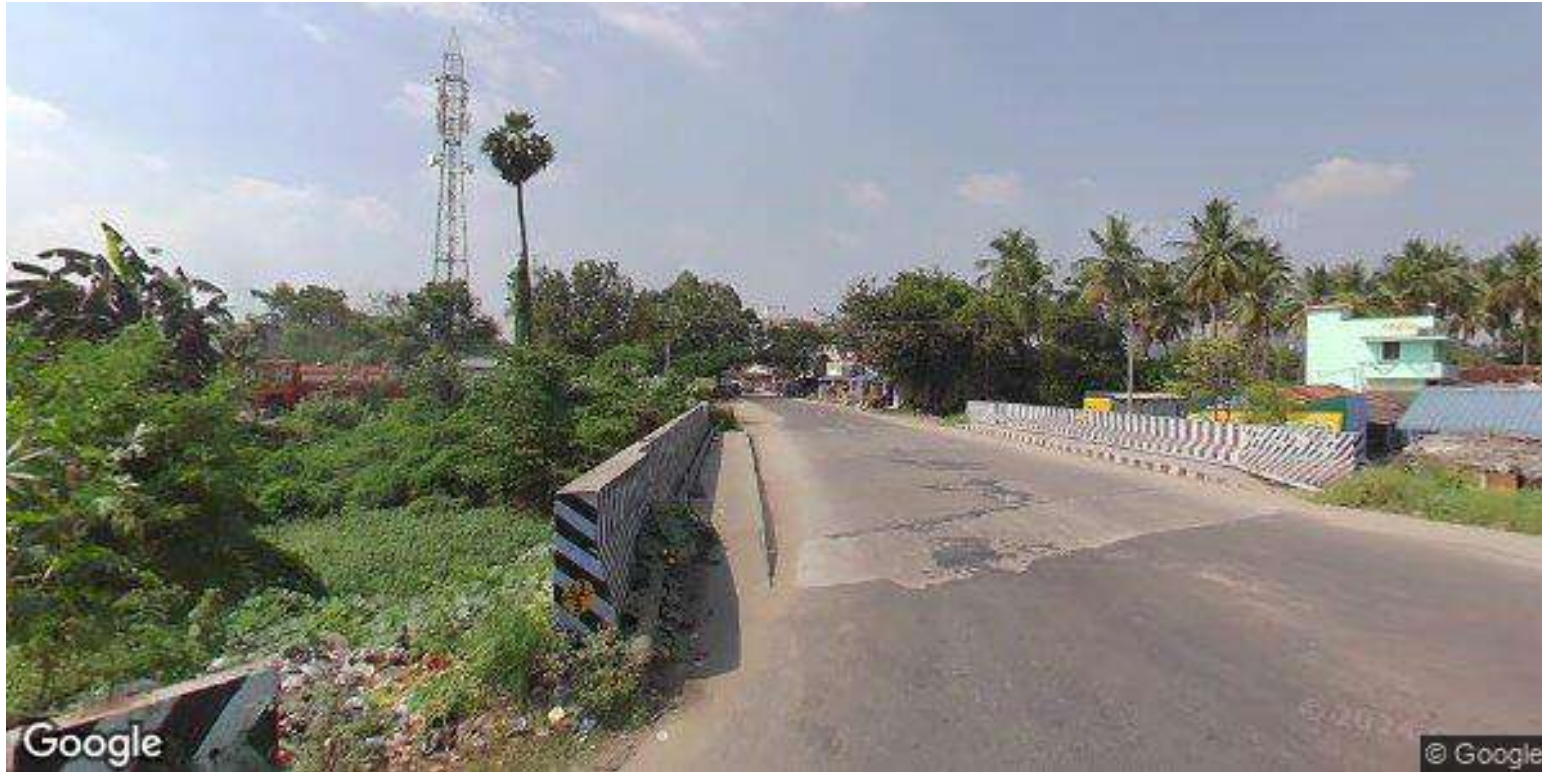
**Coordinates: 11.44900, 77.87406**

**Risk Type: Turn**

**Risk Level: High**

**Speed Limit: 15 KM/Hr**

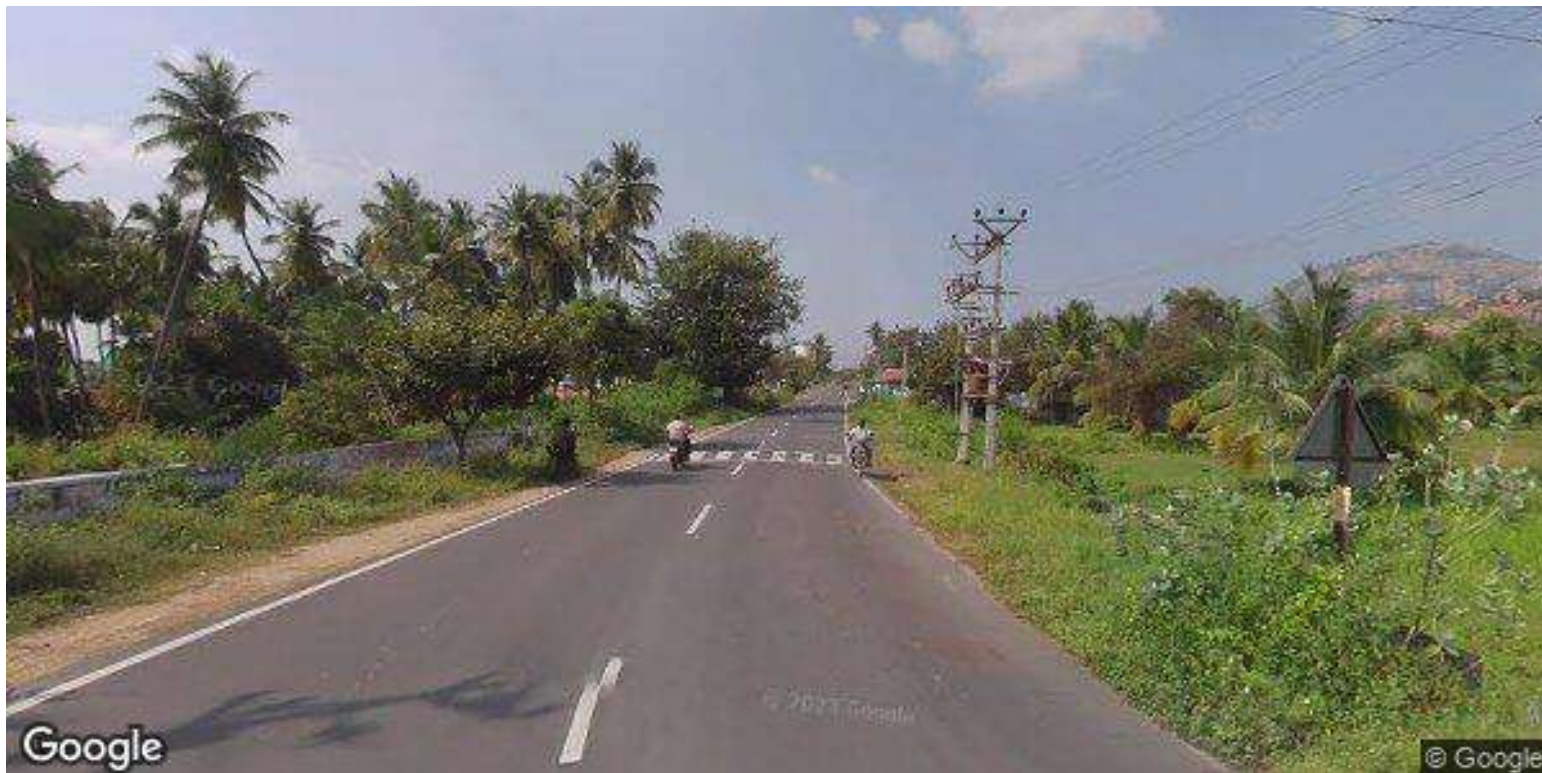
**Coordinates: 11.45352, 77.85698**

**Risk Type: Turn**

**Risk Level: High**

**Speed Limit: 15 KM/Hr**

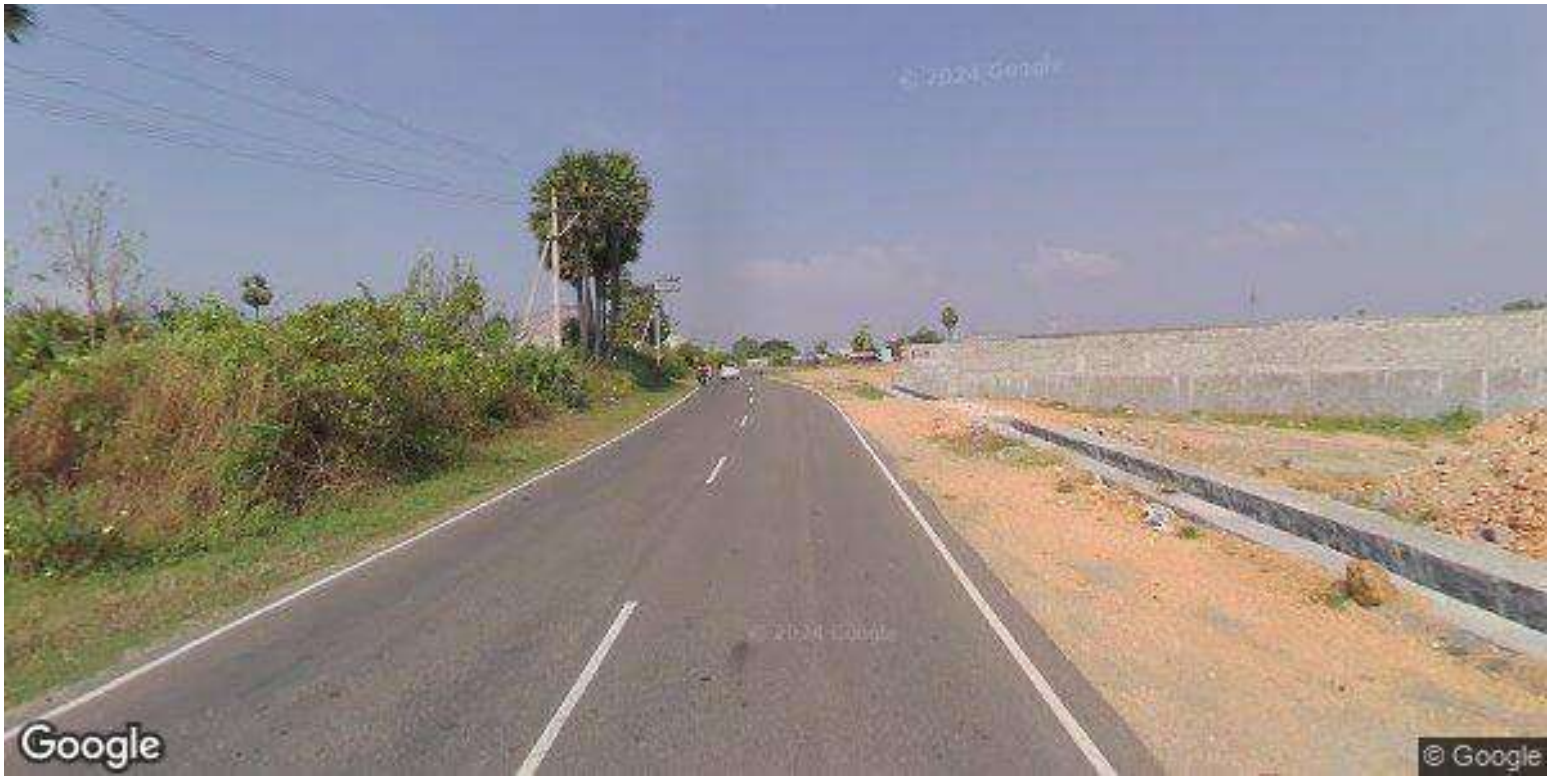
**Risk Type:** Turn  
**Risk Level:** Medium  
**Speed Limit:** 30 KM/Hr  
**Coordinates:** 11.45764, 77.85219

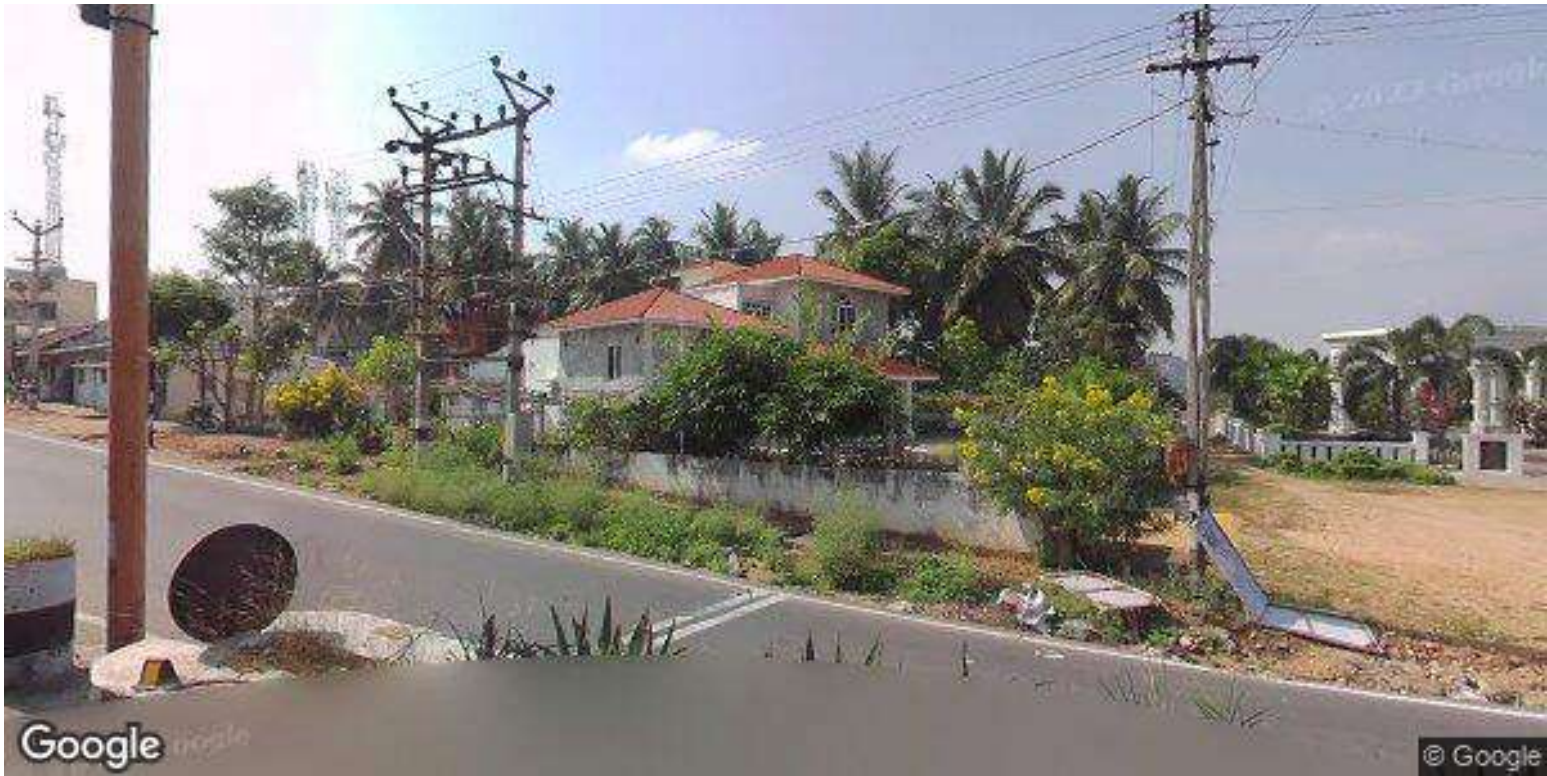
**Risk Type:** Turn  
**Risk Level:** High  
**Speed Limit:** 15 KM/Hr  
**Coordinates:** 11.46303, 77.84945

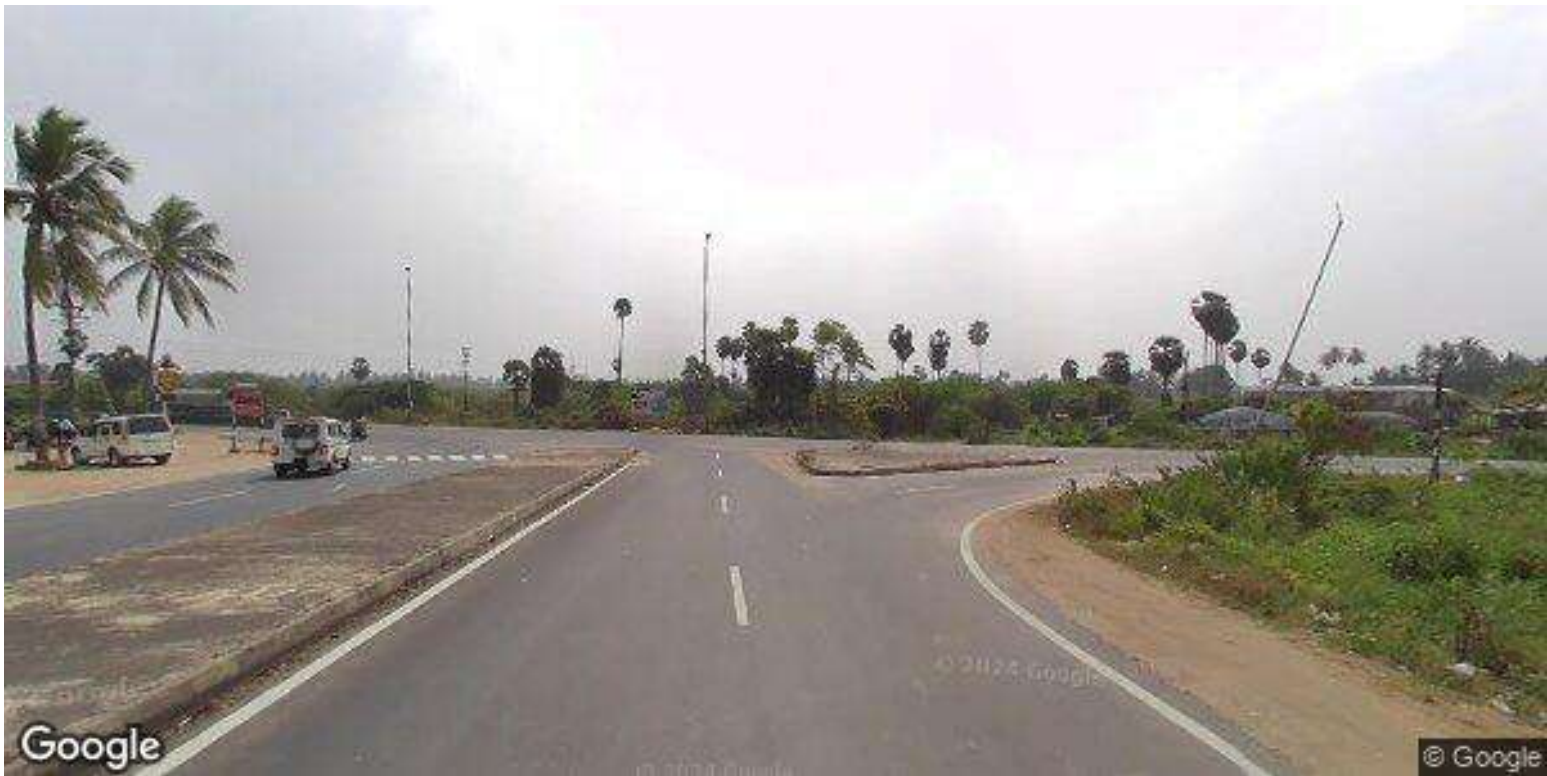
**Risk Type:** Turn  
**Risk Level:** High  
**Speed Limit:** 15 KM/Hr  
**Coordinates:** 11.45571, 77.81702

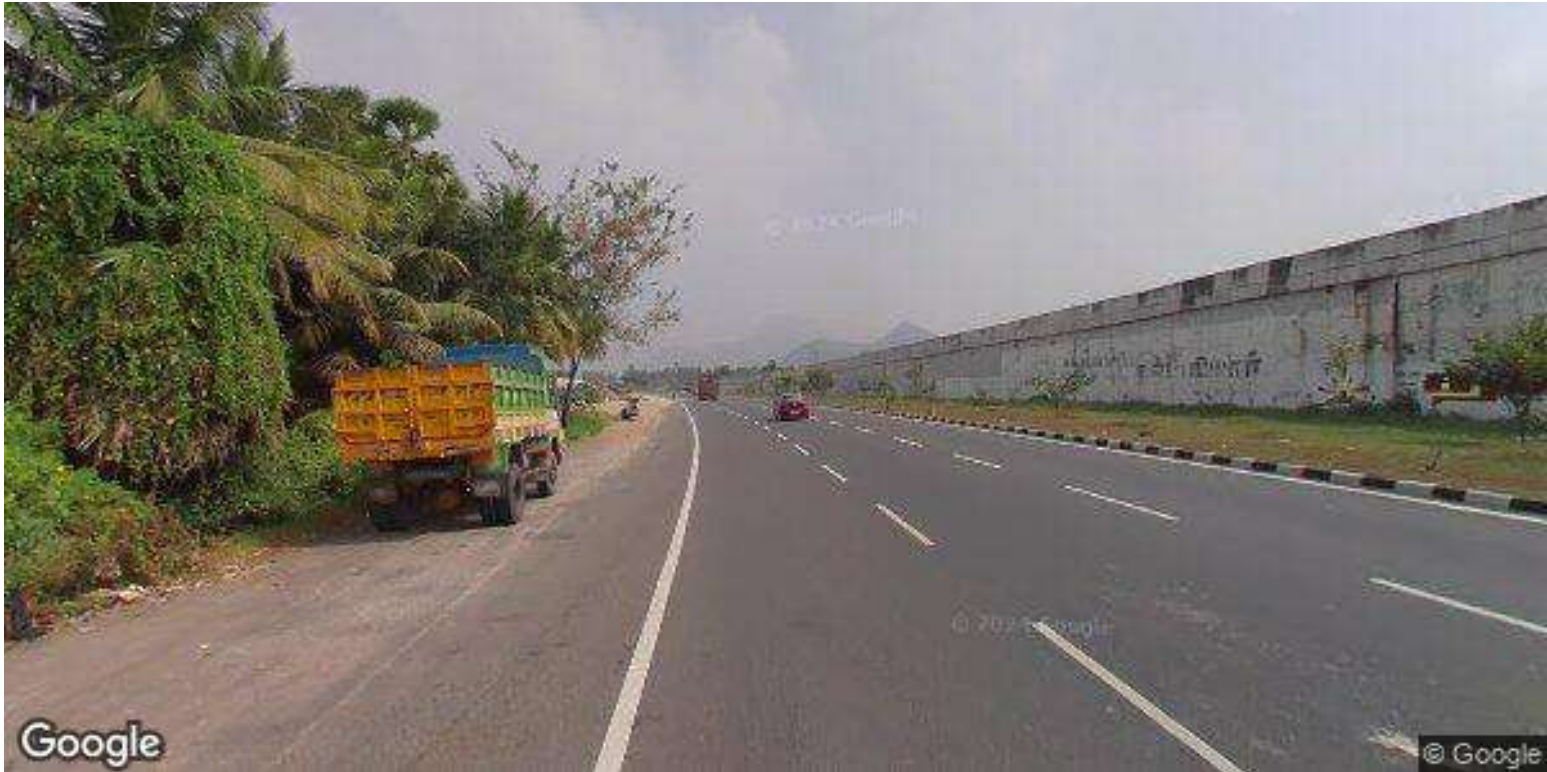
**Risk Type:** Turn  
**Risk Level:** Medium  
**Speed Limit:** 30 KM/Hr  
**Coordinates:** 11.45654, 77.81706

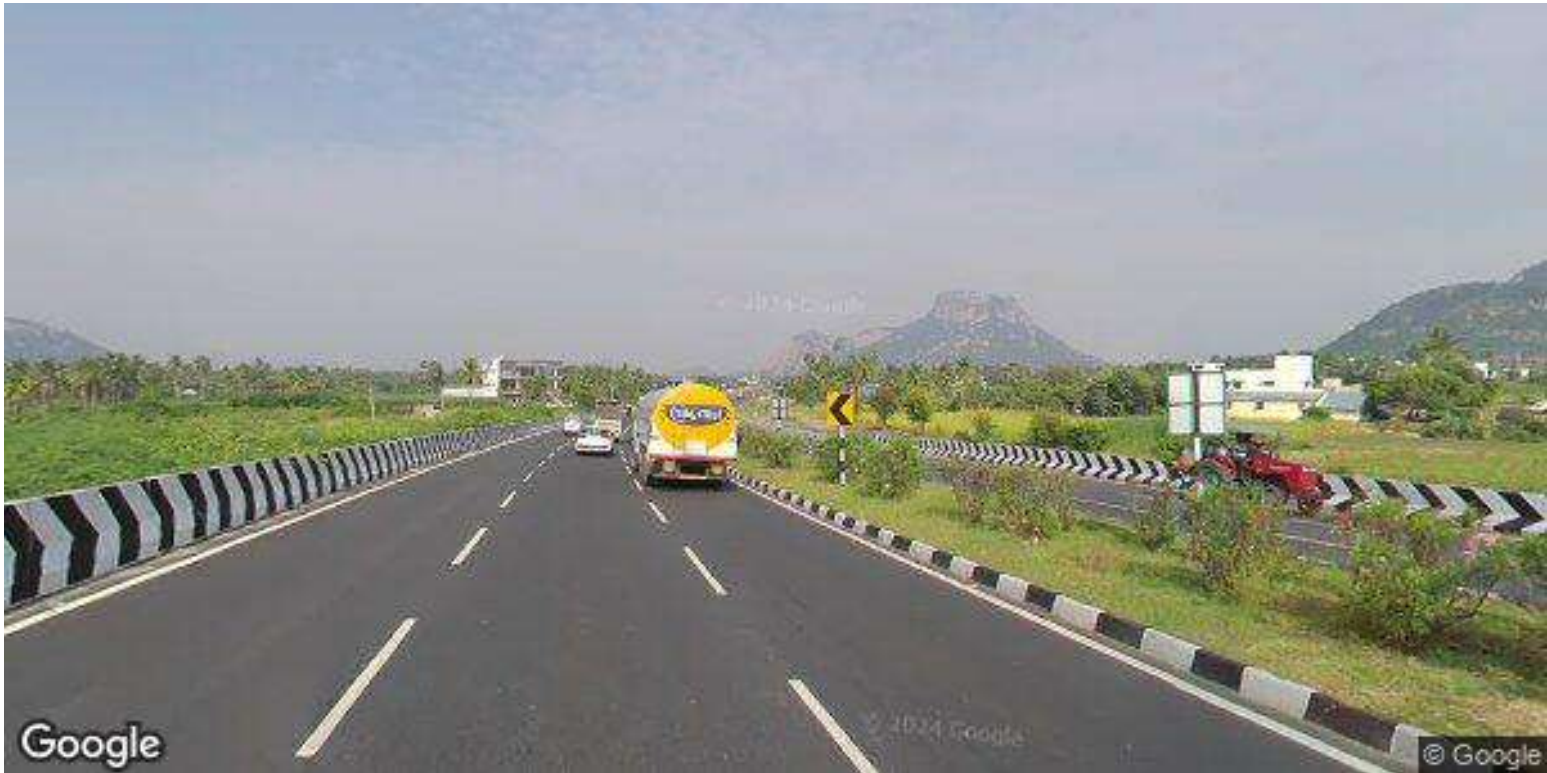
**Risk Type:** Turn  
**Risk Level:** Medium  
**Speed Limit:** 30 KM/Hr  
**Coordinates:** 11.46916, 77.82431

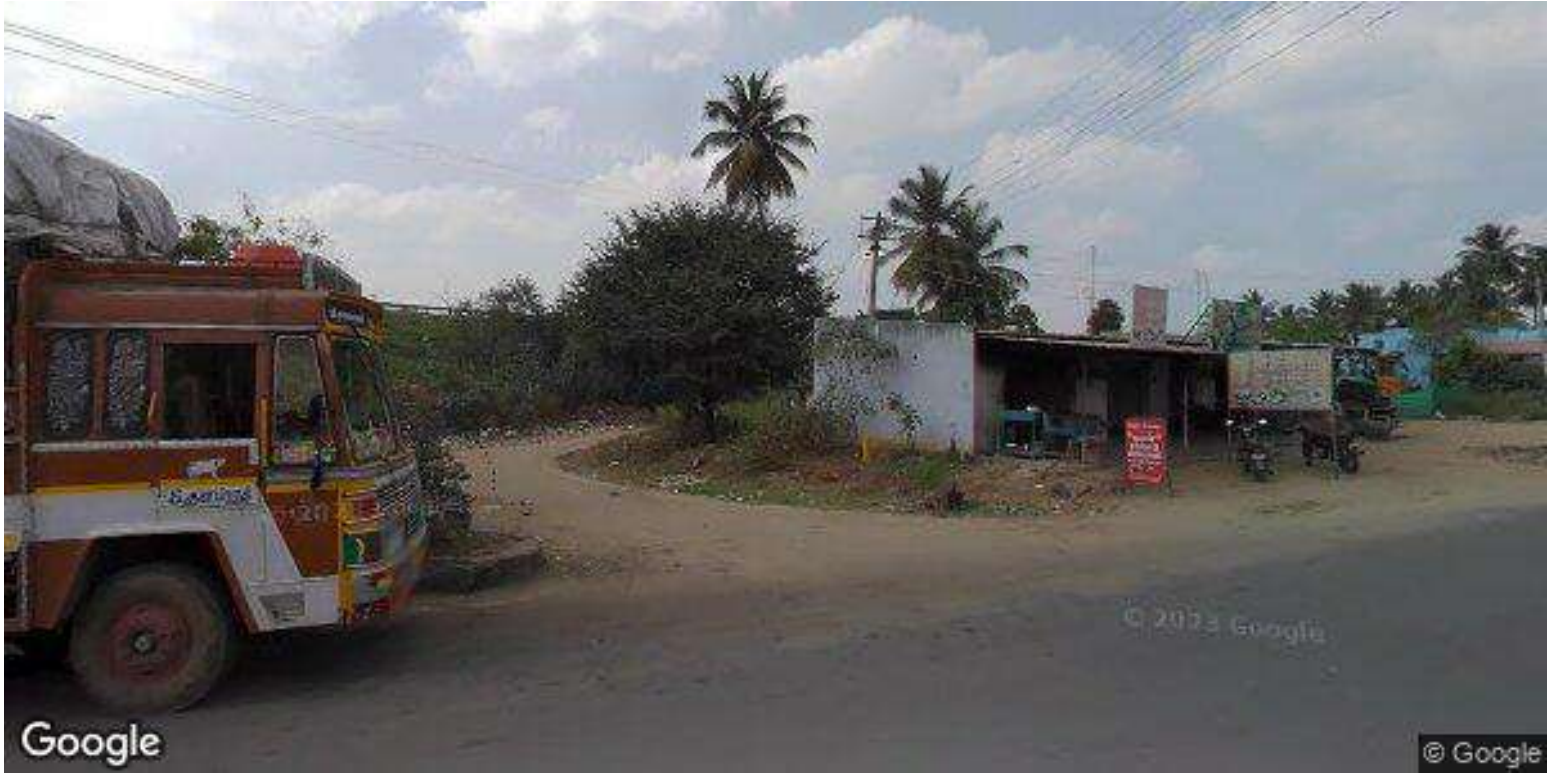
**Risk Type:** Blind Spot  
**Risk Level:** Blind Spot  
**Speed Limit:** 10 KM/Hr  
**Coordinates:** 11.49395, 77.88537

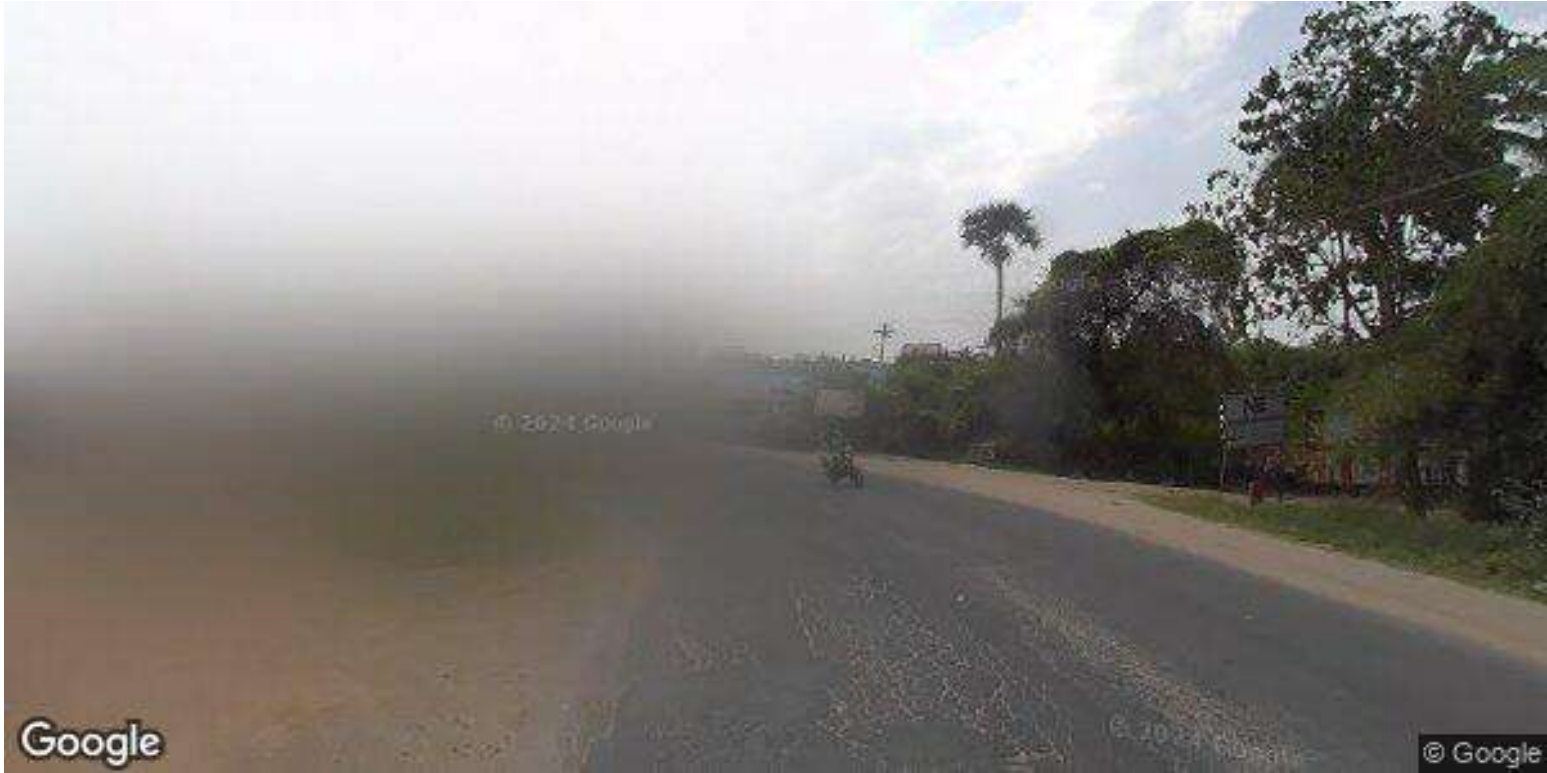
**Risk Type:** Turn  
**Risk Level:** High  
**Speed Limit:** 15 KM/Hr  
**Coordinates:** 11.49465, 77.88488

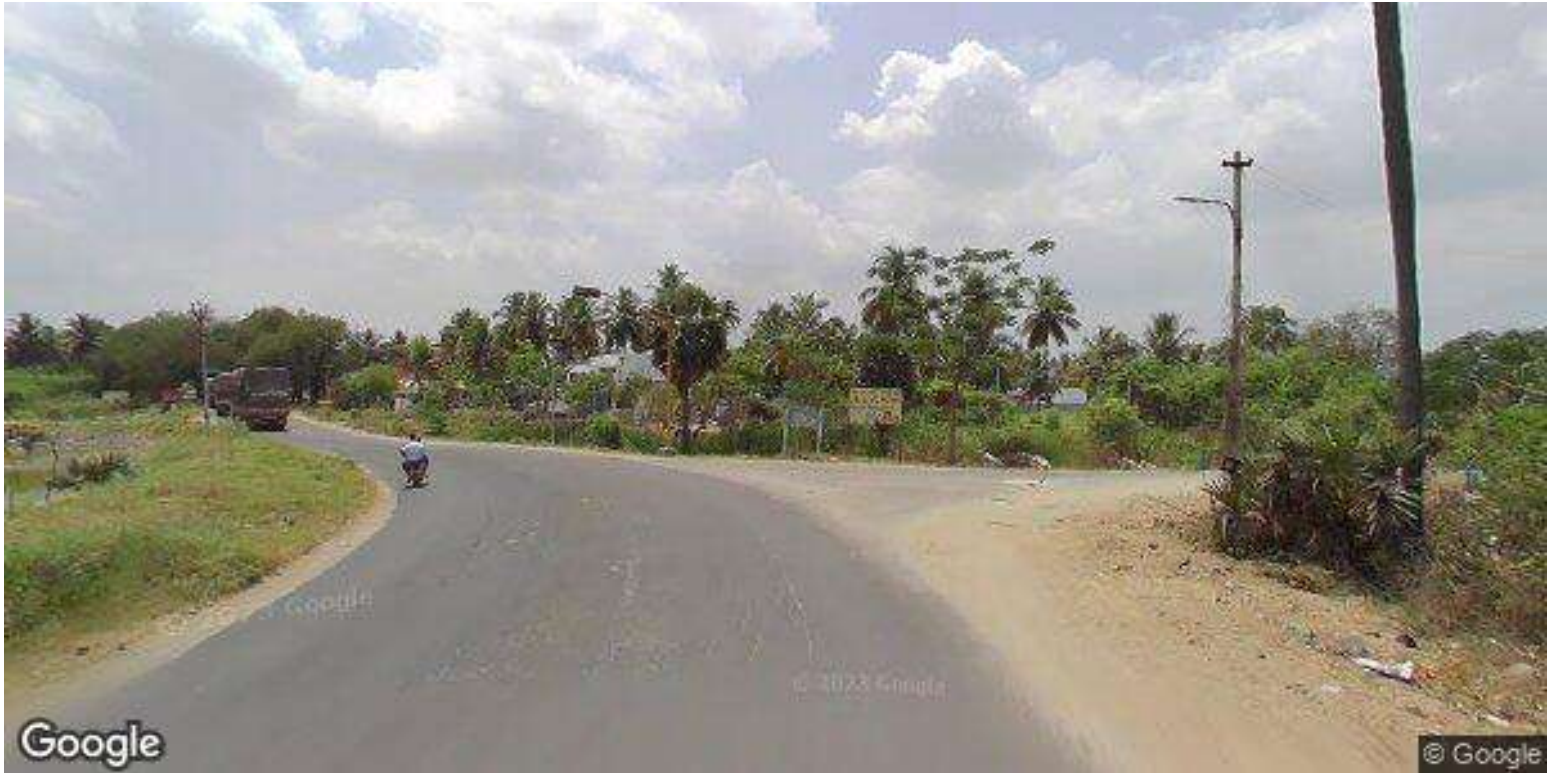
**Coordinates: 11.56096, 77.89931**

**Risk Type: Turn**

**Risk Level: Medium**

**Speed Limit: 30 KM/Hr**

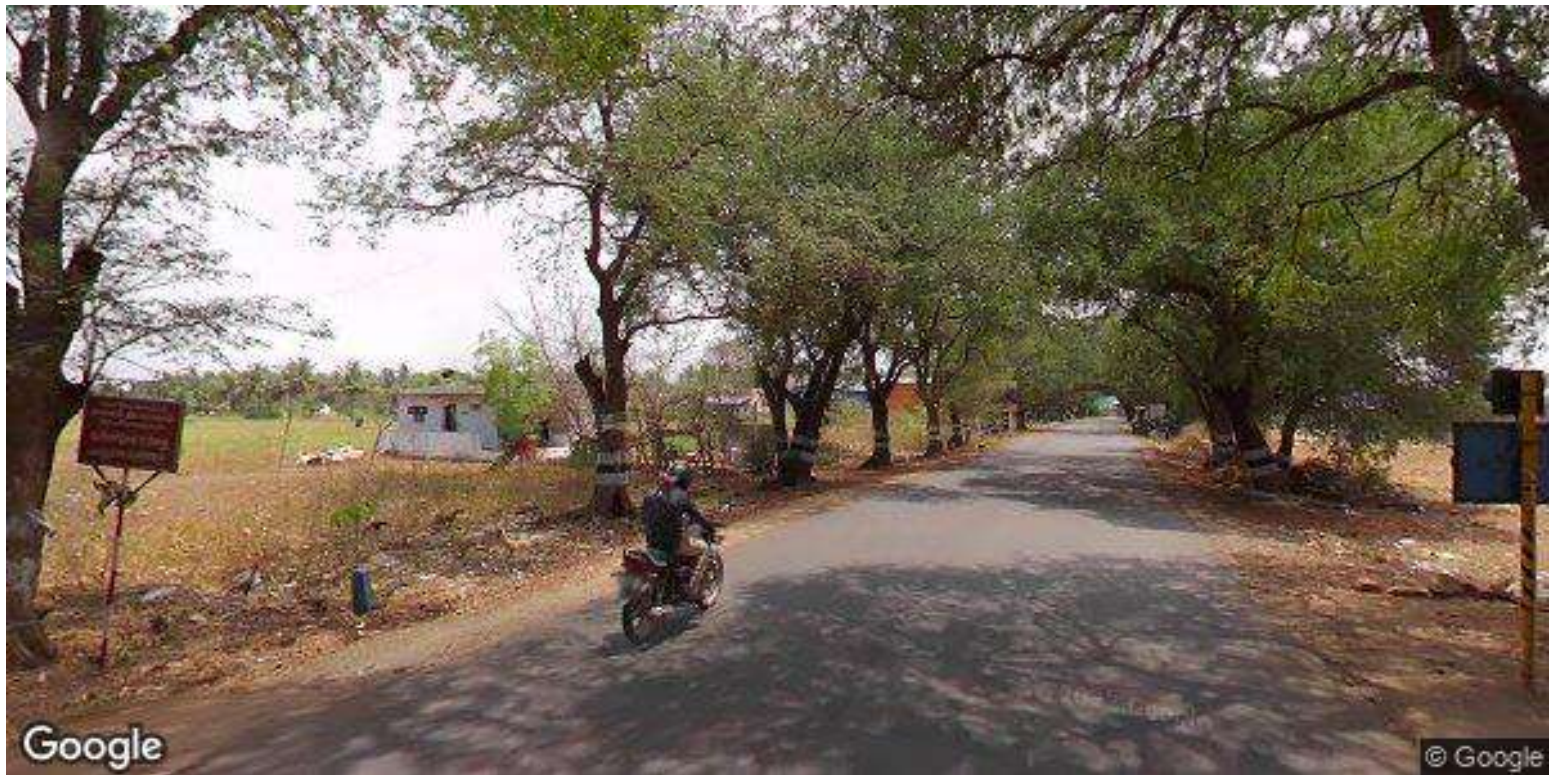
**Coordinates: 11.57649, 77.90610**

**Risk Type: Turn**

**Risk Level: Medium**

**Speed Limit: 30 KM/Hr**

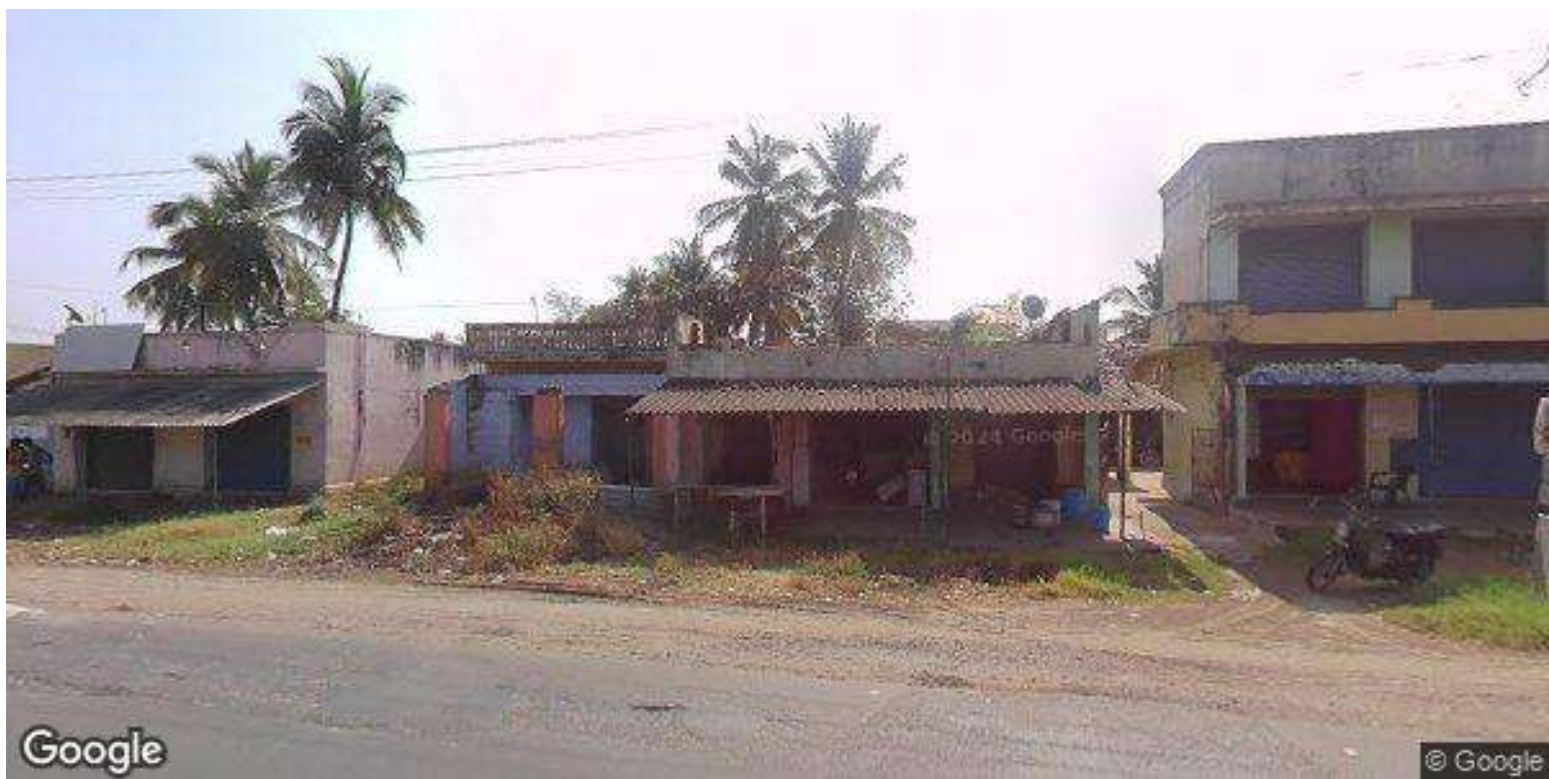
**Coordinates: 11.59214, 77.90656**

**Risk Type: Turn**

**Risk Level: Medium**

**Speed Limit: 30 KM/Hr**

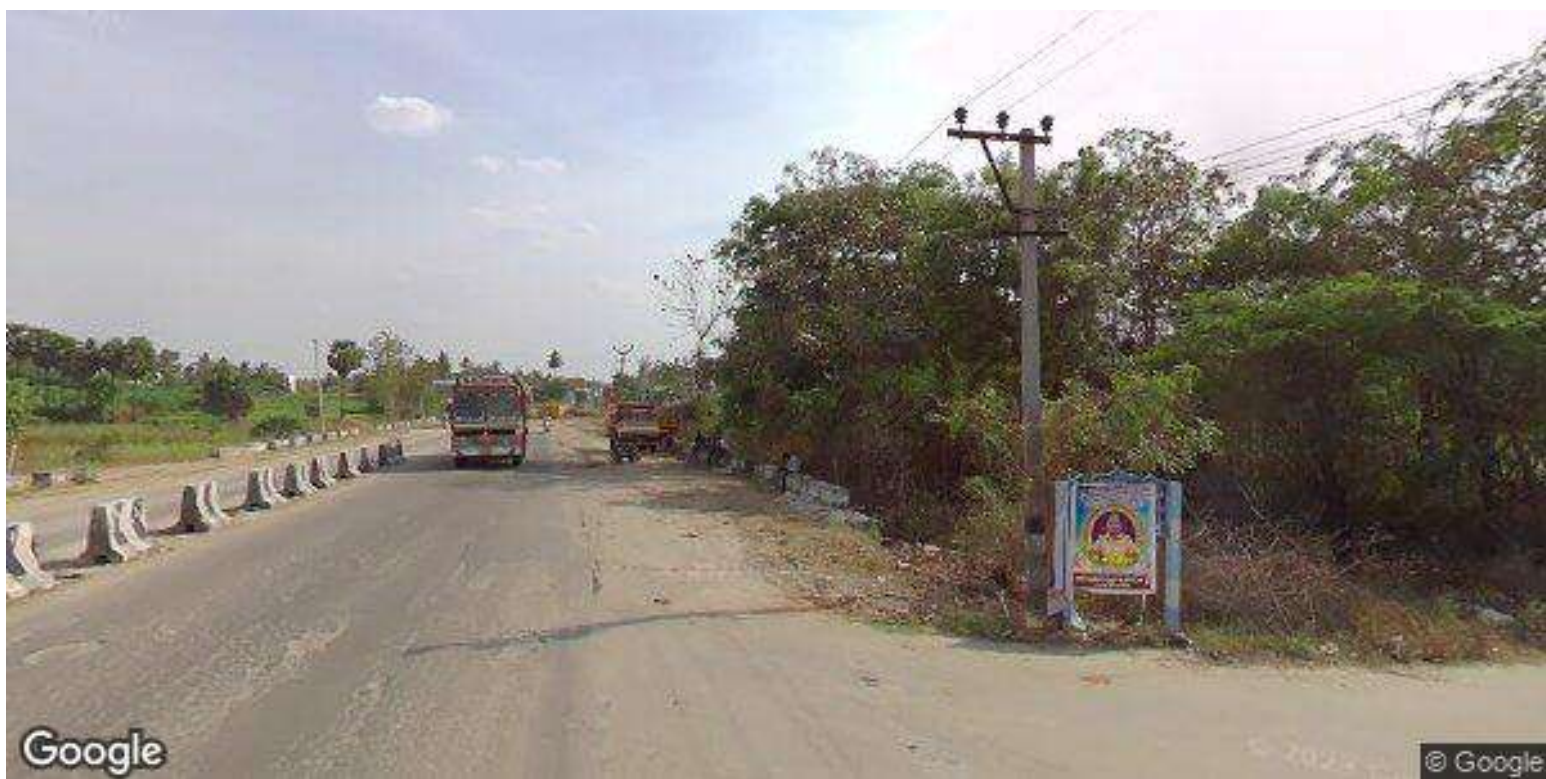
**Coordinates:** 11.63833, 77.94818

**Risk Type:** Turn

**Risk Level:** Medium

**Speed Limit:** 30 KM/Hr

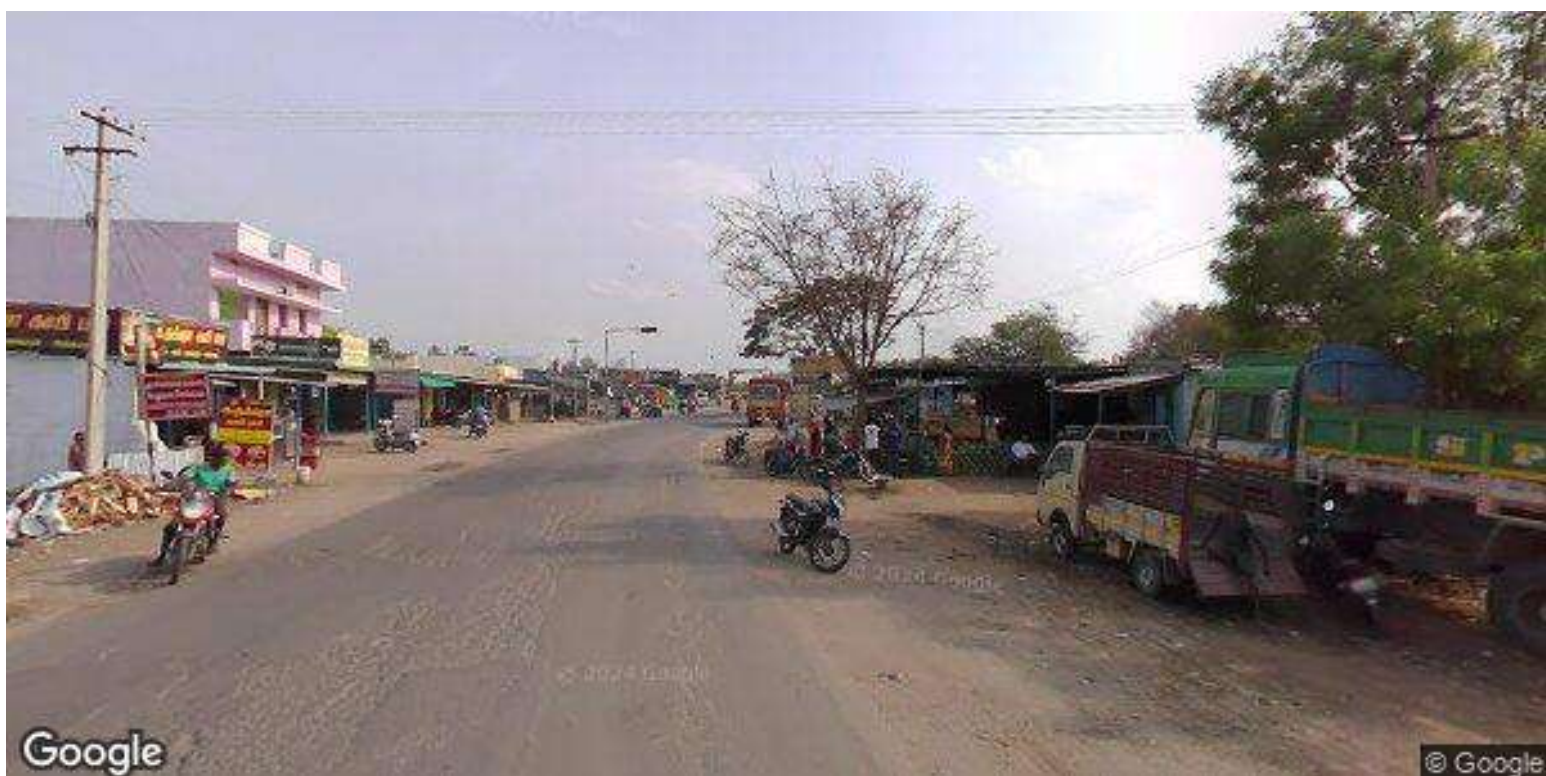
**Coordinates:** 11.64243, 77.95198

**Risk Type:** Turn

**Risk Level:** High

**Speed Limit:** 15 KM/Hr

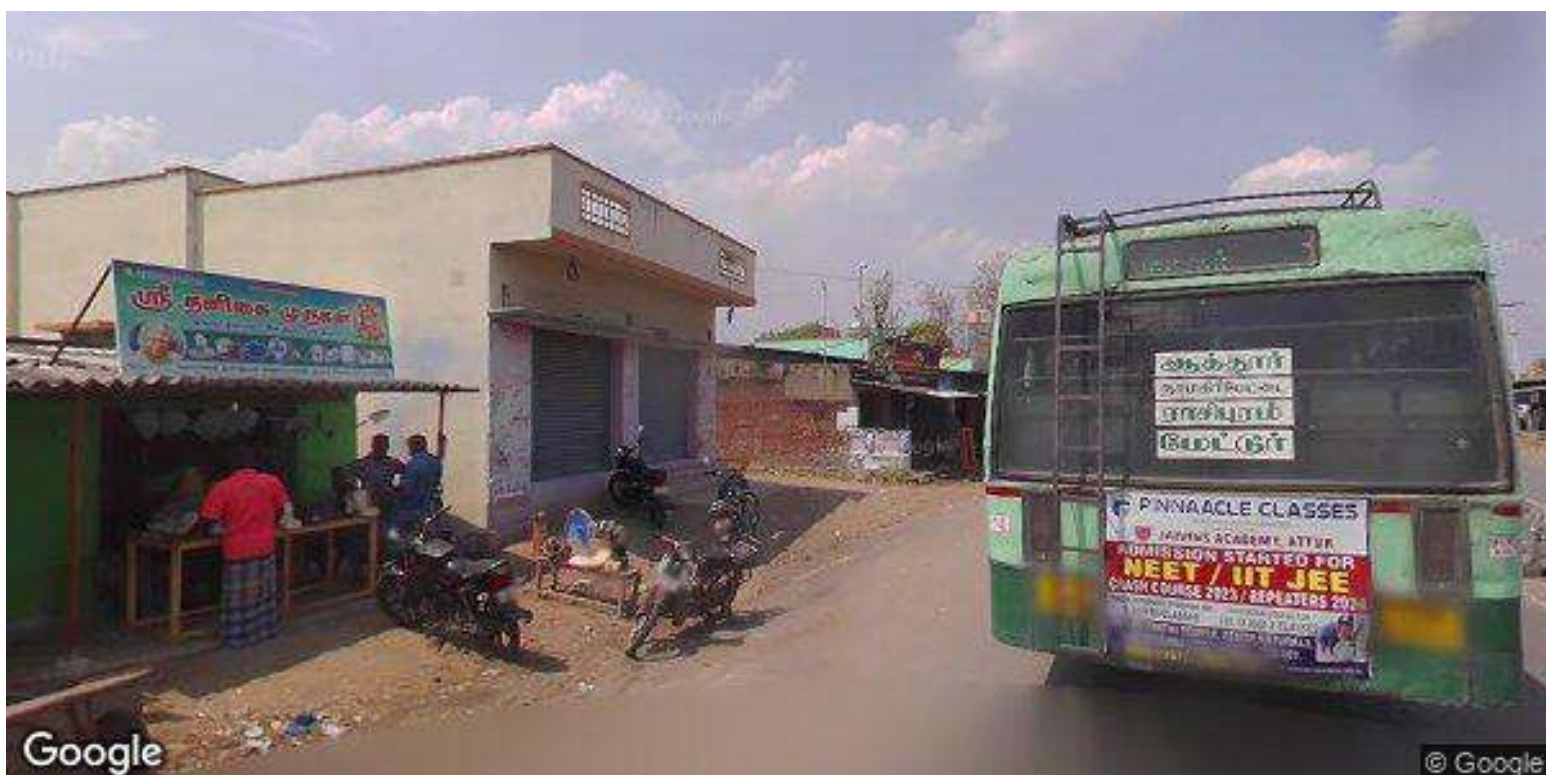
**Risk Type:** Turn  
**Risk Level:** Medium  
**Speed Limit:** 30 KM/Hr  
**Coordinates:** 11.64721, 77.95118

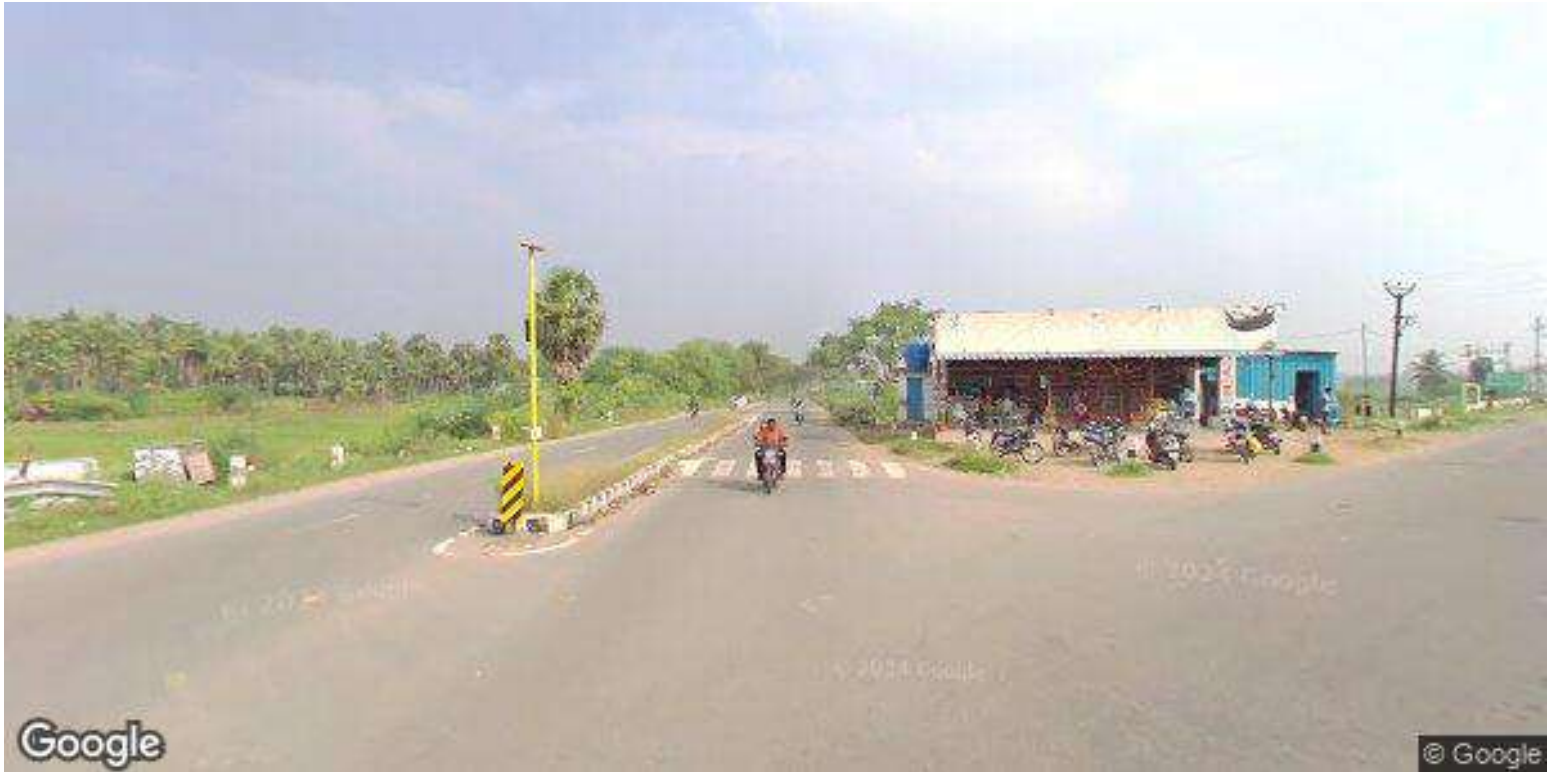
**Risk Type:** Turn  
**Risk Level:** Medium  
**Speed Limit:** 30 KM/Hr  
**Coordinates:** 11.67870, 77.96846

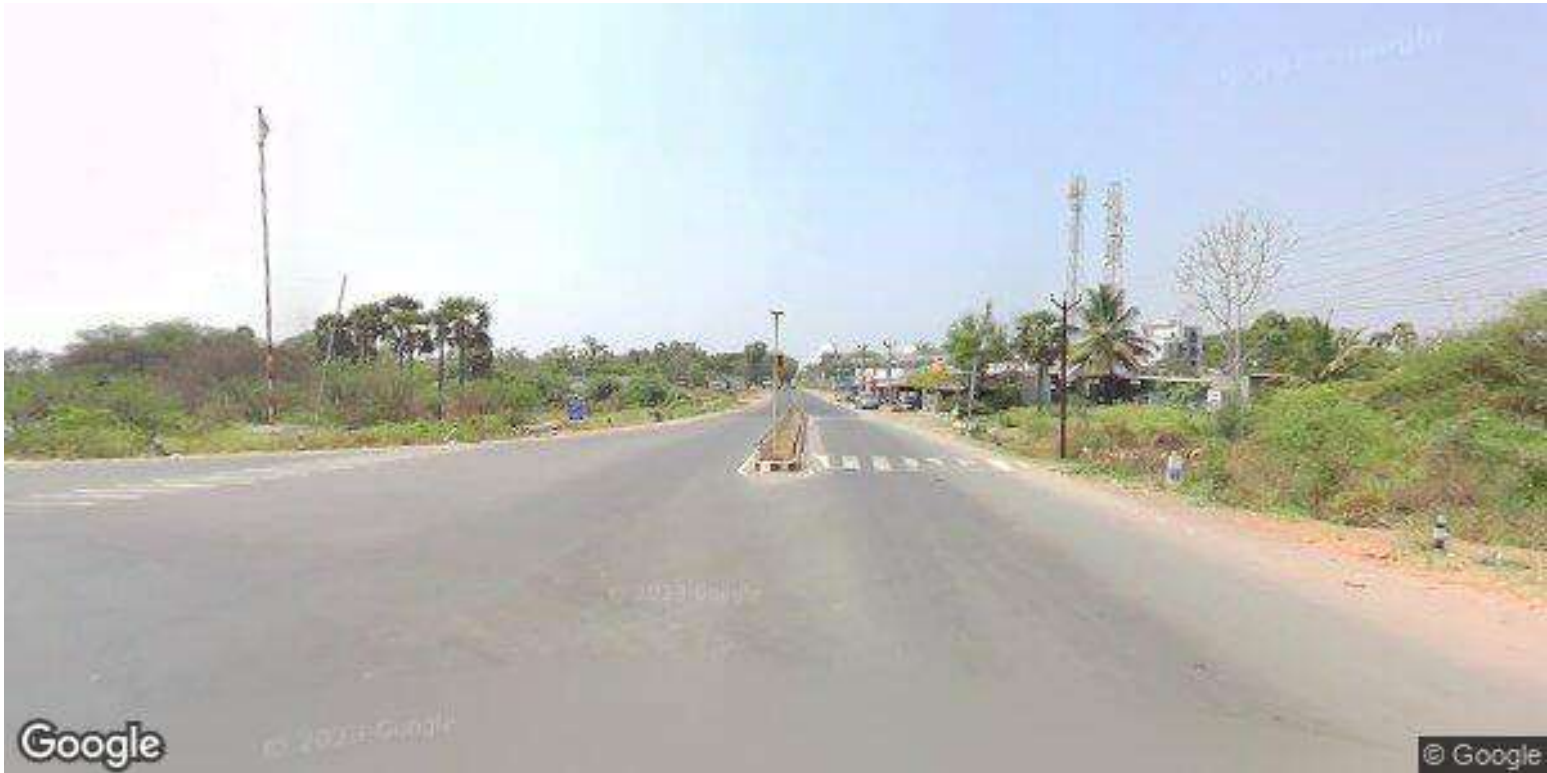
**Risk Type:** Turn  
**Risk Level:** High  
**Speed Limit:** 15 KM/Hr  
**Coordinates:** 11.70227, 77.97864

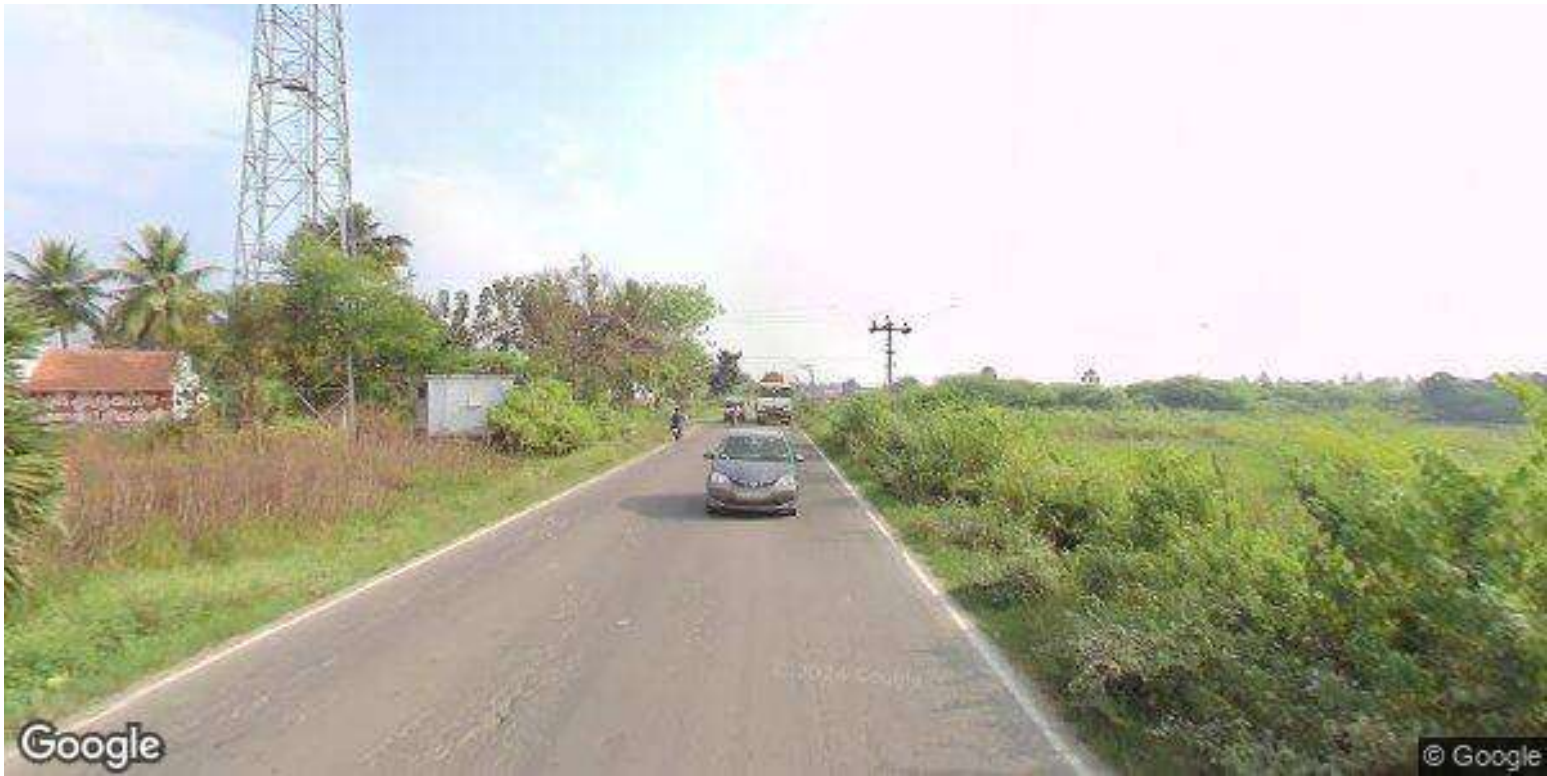
**Risk Type:** Turn  
**Risk Level:** Medium  
**Speed Limit:** 30 KM/Hr  
**Coordinates:** 11.71416, 77.99604

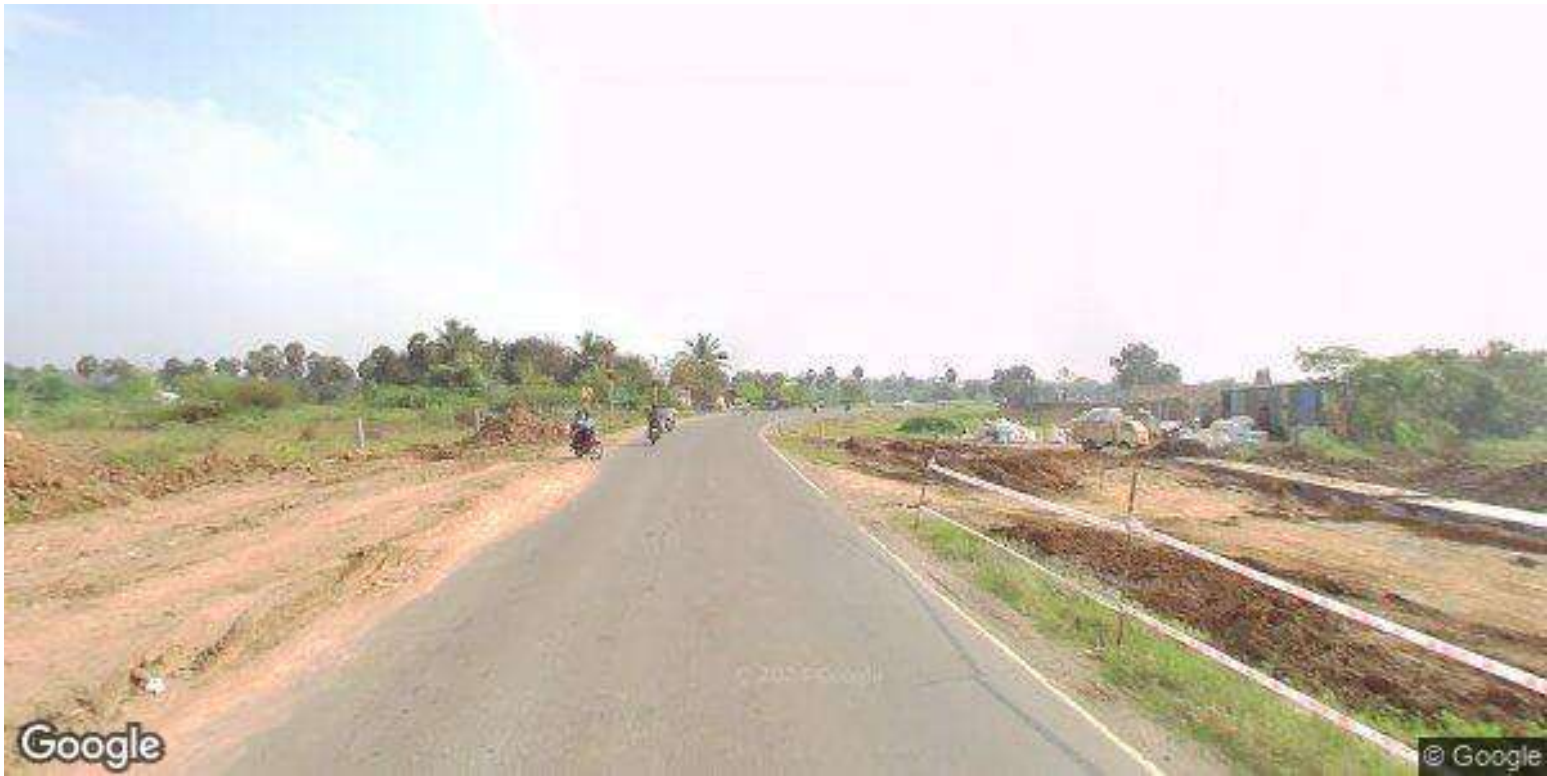
**Risk Type:** Turn  
**Risk Level:** Medium  
**Speed Limit:** 30 KM/Hr  
**Coordinates:** 11.71715, 77.99969
