## JOURNEY RISK MANAGEMENT (JRM) STUDY

### Salem Terminal to N.N.C.FUEL STATION

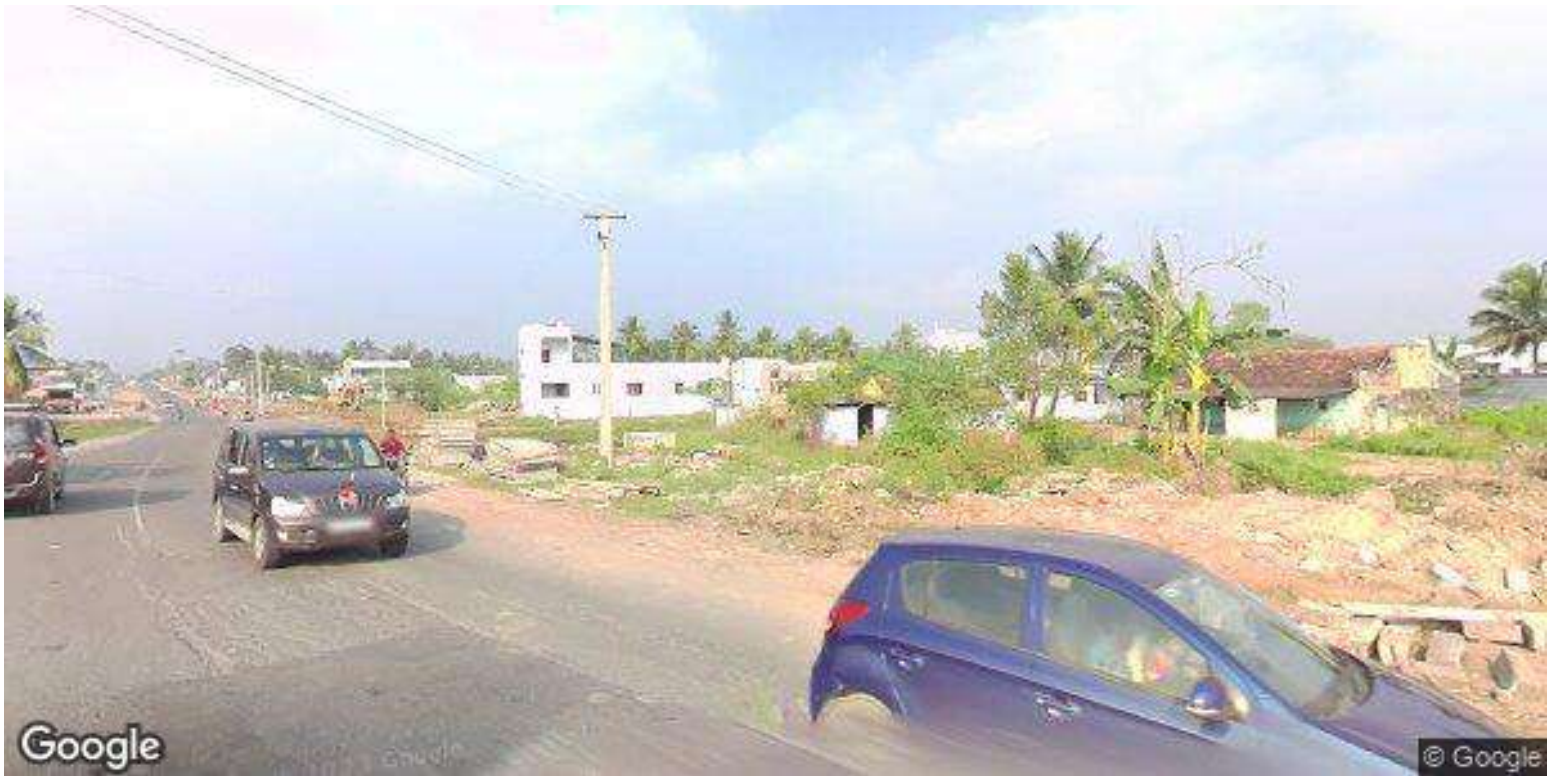
**Coordinates: 11.71921, 78.01133**

**Risk Type: Turn**

**Risk Level: Medium**

**Speed Limit: 30 KM/Hr**

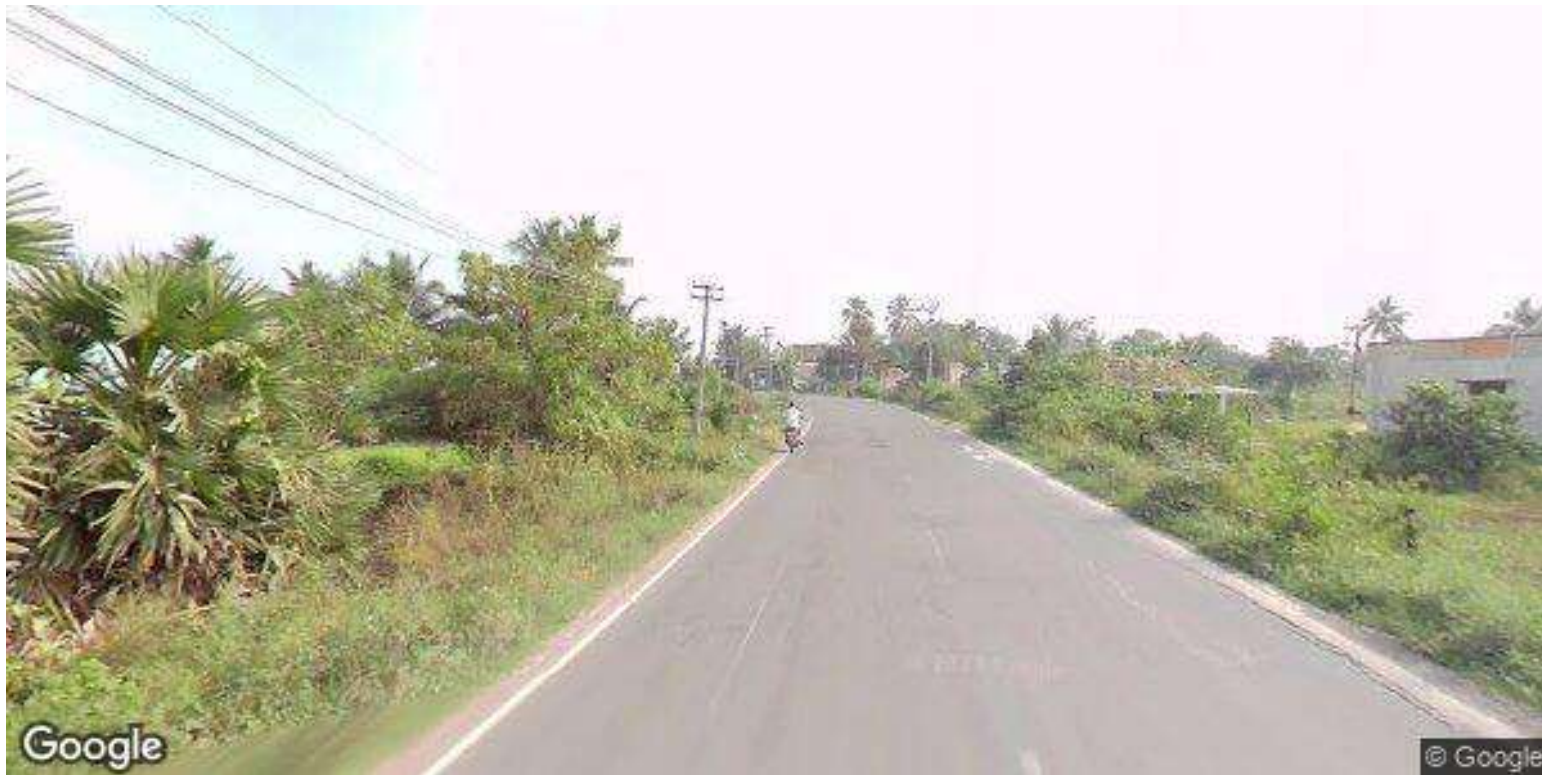
**Coordinates: 11.72737, 78.02248**

**Risk Type: Turn**

**Risk Level: Medium**

**Speed Limit: 30 KM/Hr**

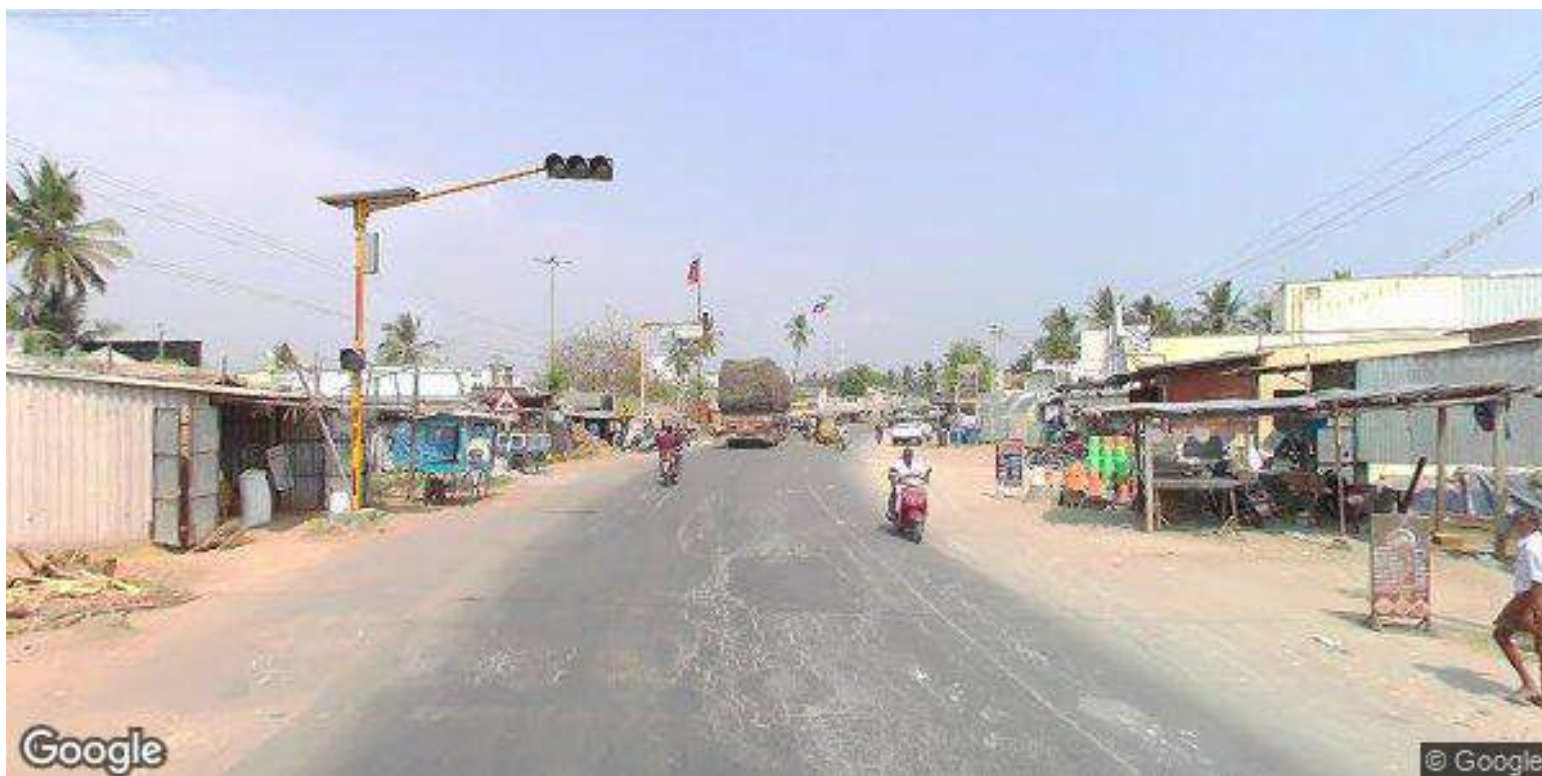
**Coordinates: 11.73775, 78.03465**

**Risk Type: Turn**

**Risk Level: High**

**Speed Limit: 15 KM/Hr**

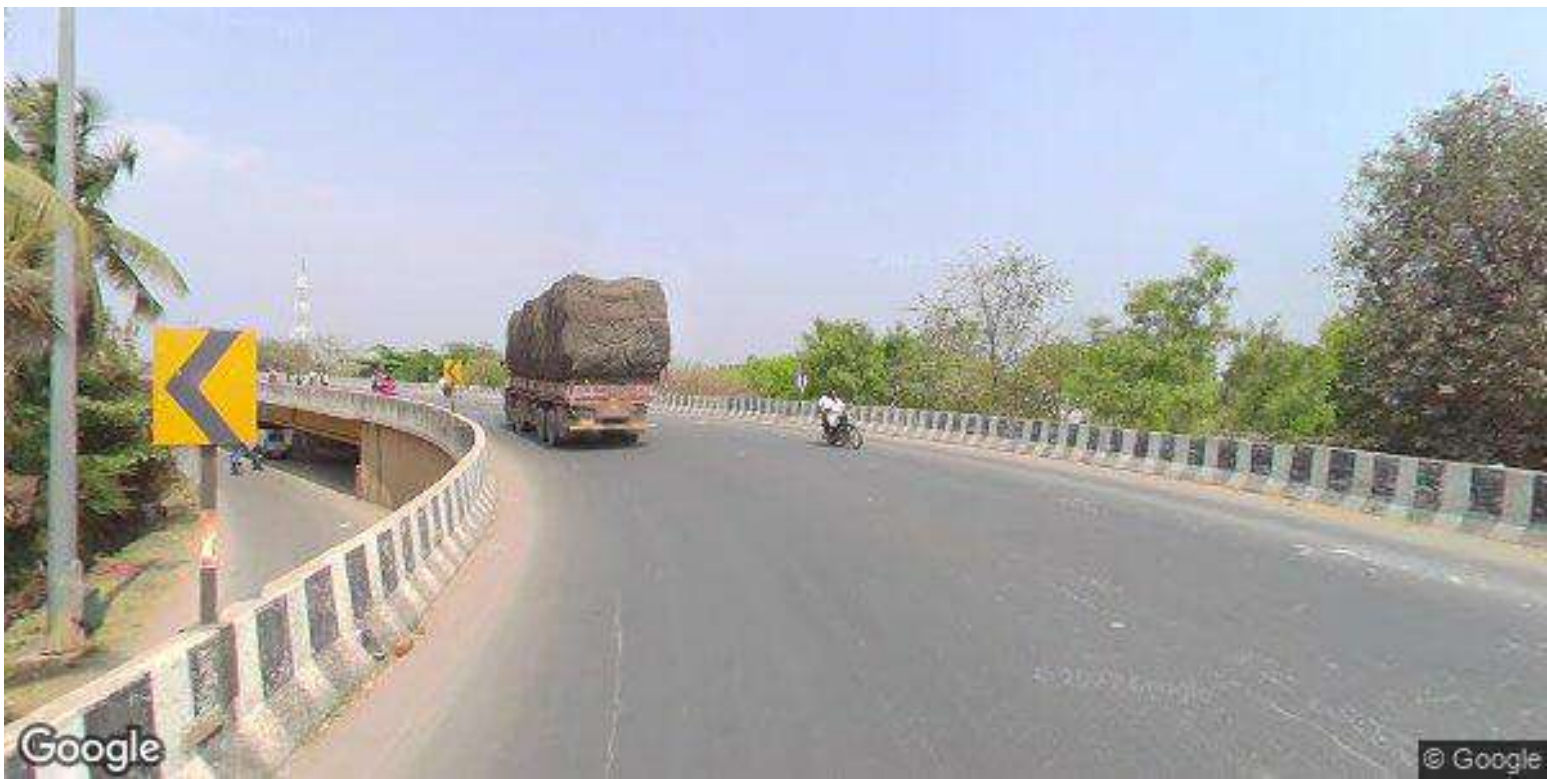
**Risk Type:** Turn  
**Risk Level:** High  
**Speed Limit:** 15 KM/Hr  
**Coordinates:** 11.73651, 78.03878

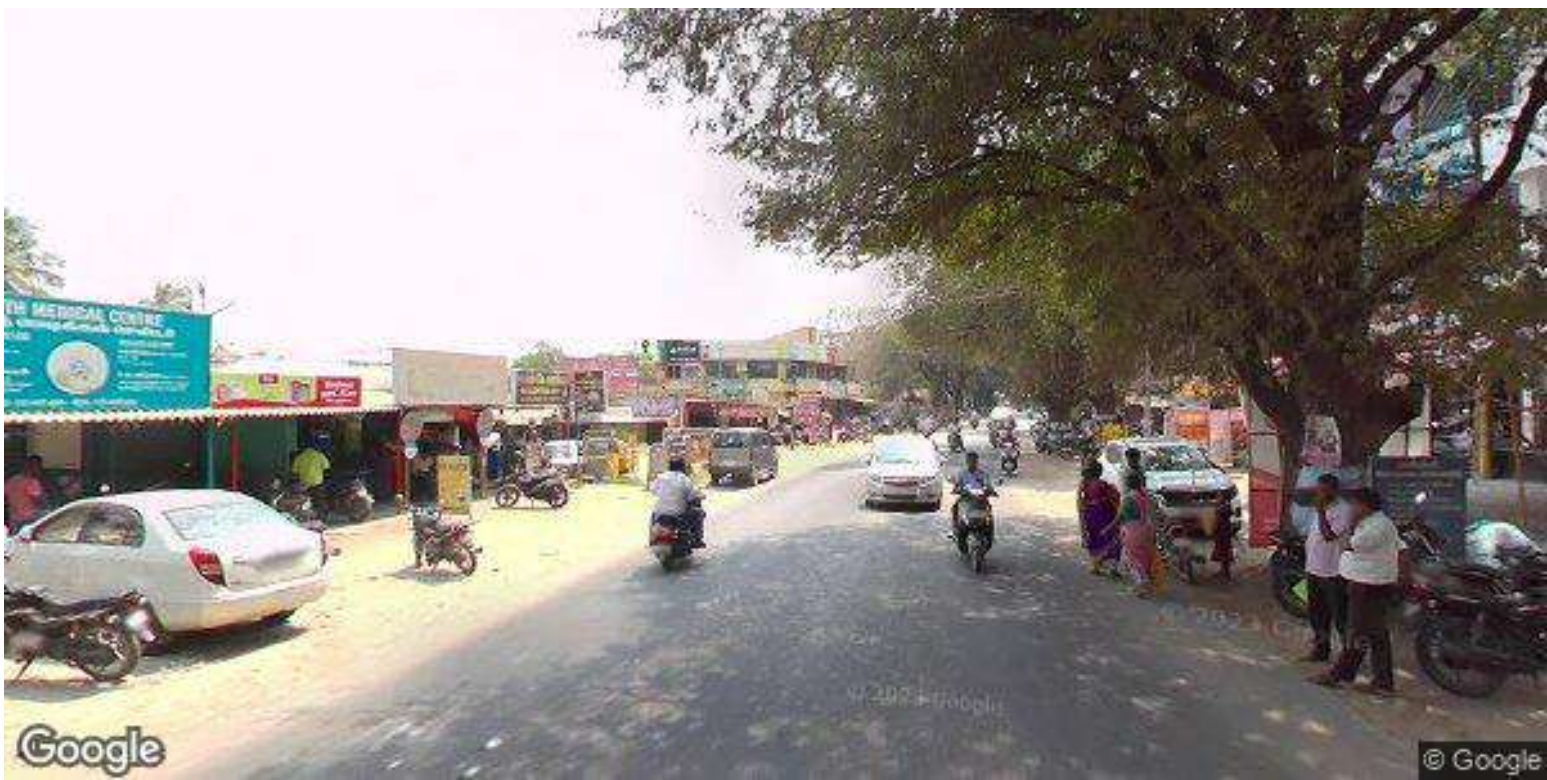
**Risk Type:** Turn  
**Risk Level:** High  
**Speed Limit:** 15 KM/Hr  
**Coordinates:** 11.74189, 78.04660

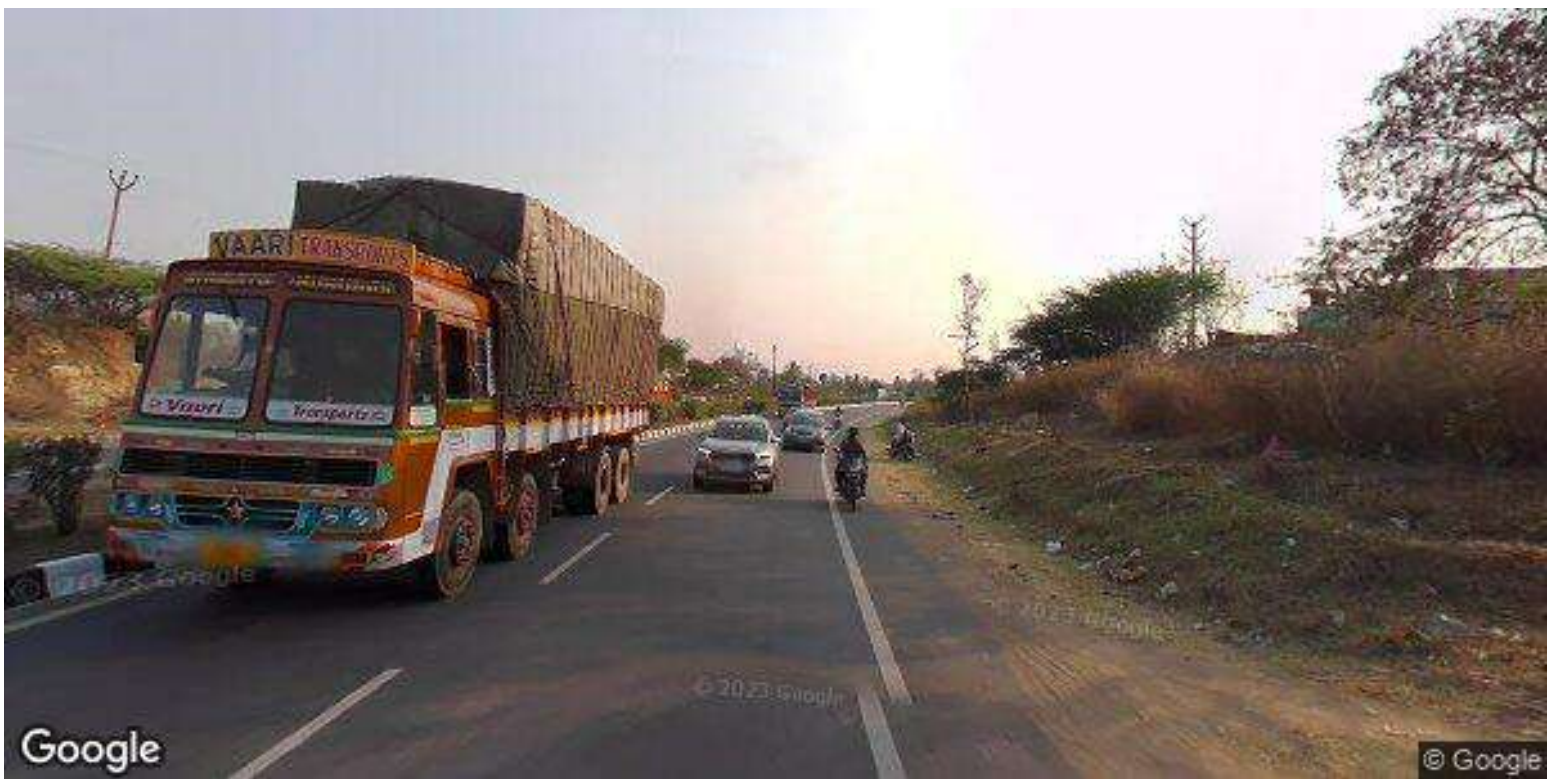
**Coordinates: 11.78039, 78.05792**

**Risk Type: Turn**

**Risk Level: Medium**

**Speed Limit: 30 KM/Hr**

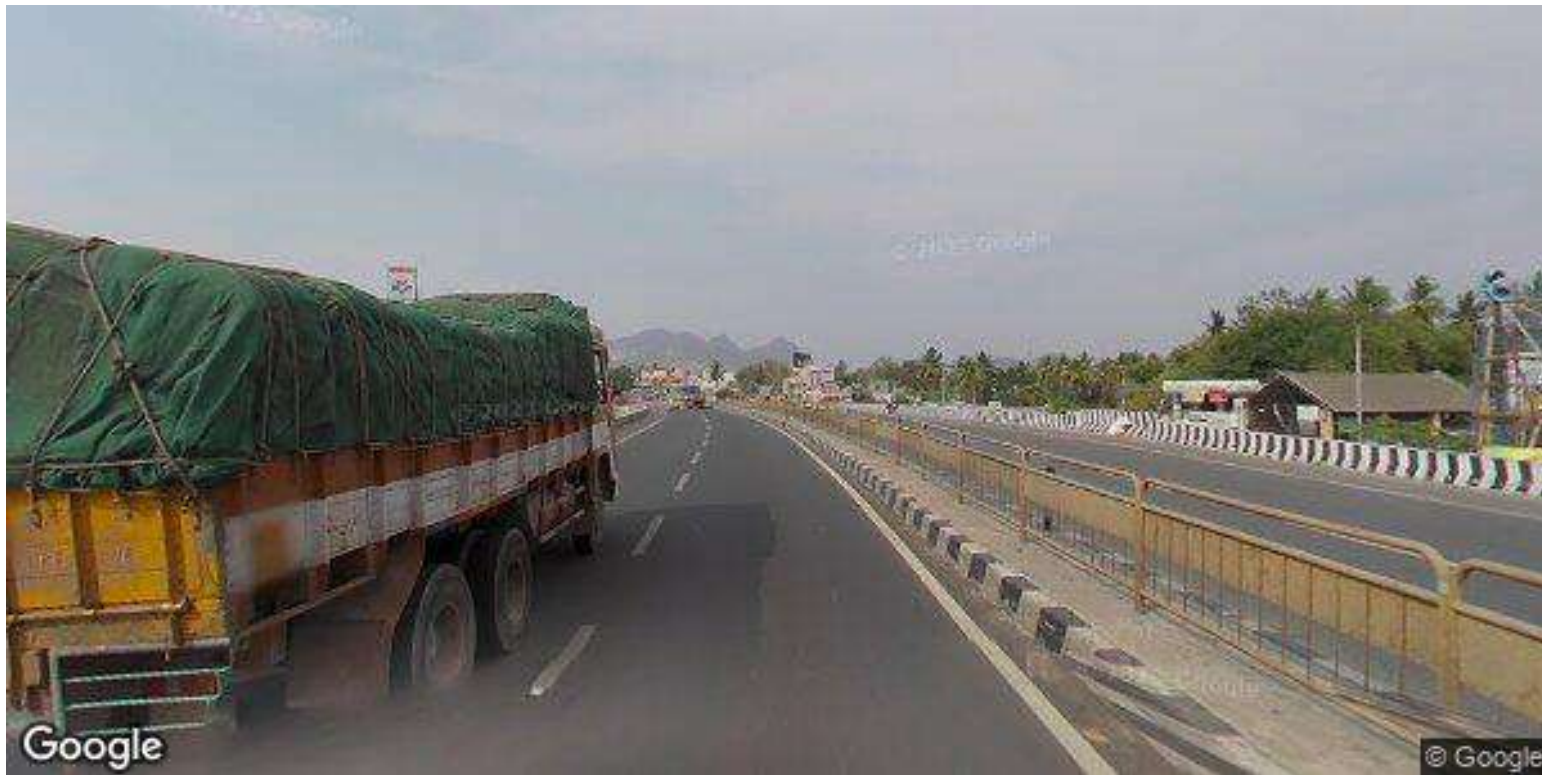
**Coordinates: 11.86753, 78.08331**

**Risk Type: Turn**

**Risk Level: Medium**

**Speed Limit: 30 KM/Hr**

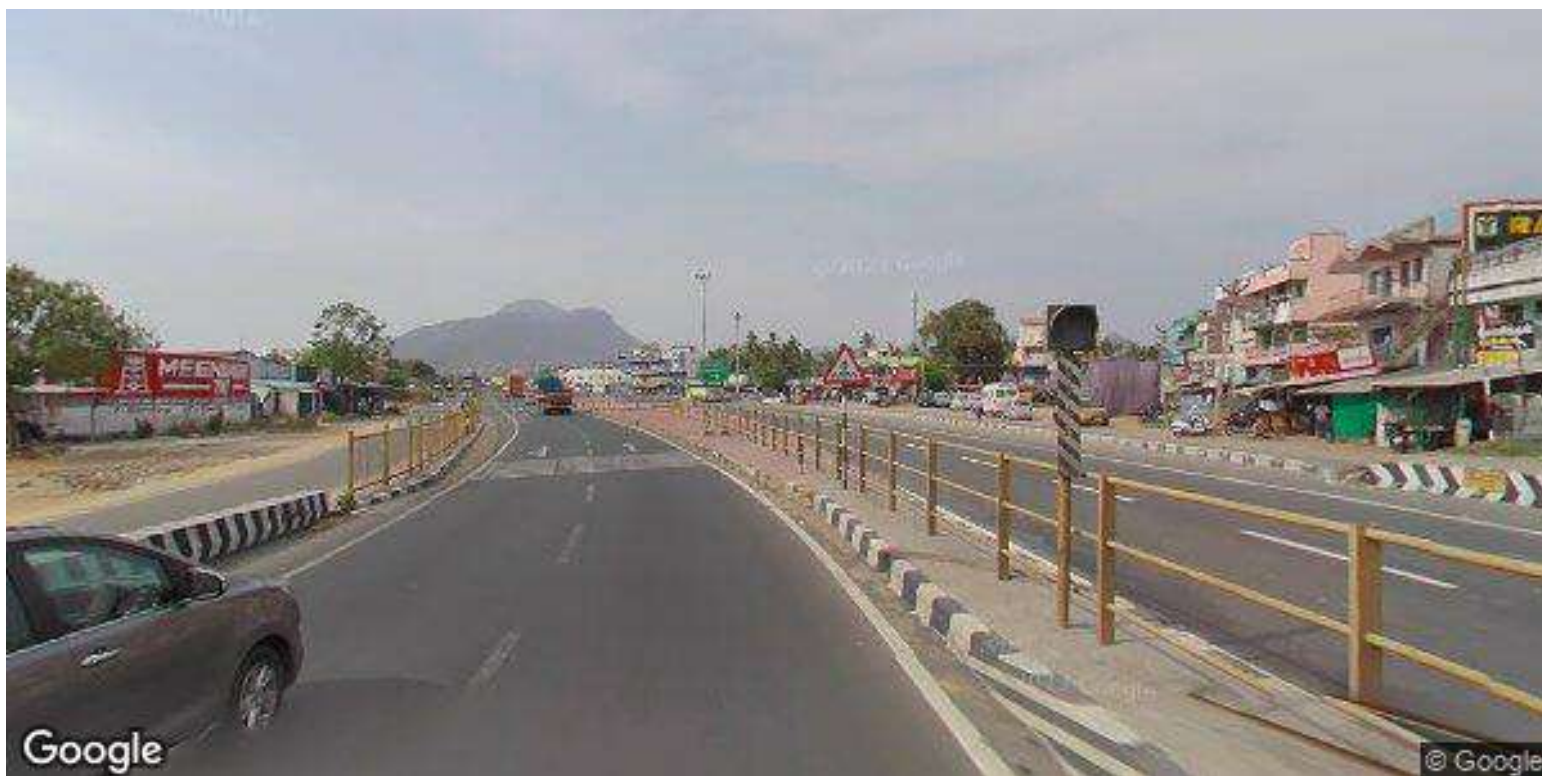
**Coordinates: 11.86981, 78.08387**

**Risk Type: Turn**

**Risk Level: Medium**

**Speed Limit: 30 KM/Hr**

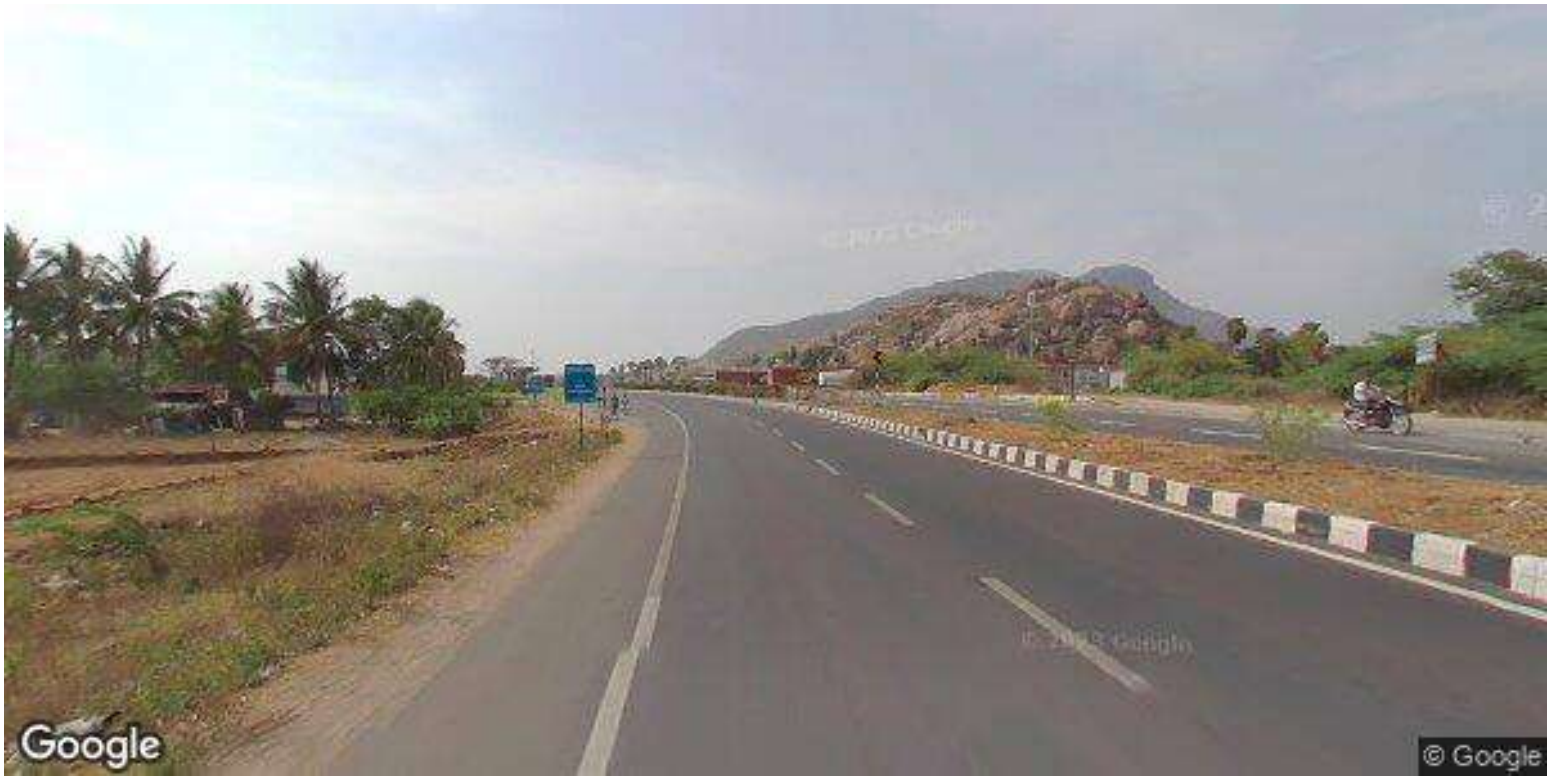
**Coordinates: 11.88041, 78.08143**

**Risk Type: Turn**

**Risk Level: Medium**

**Speed Limit: 30 KM/Hr**

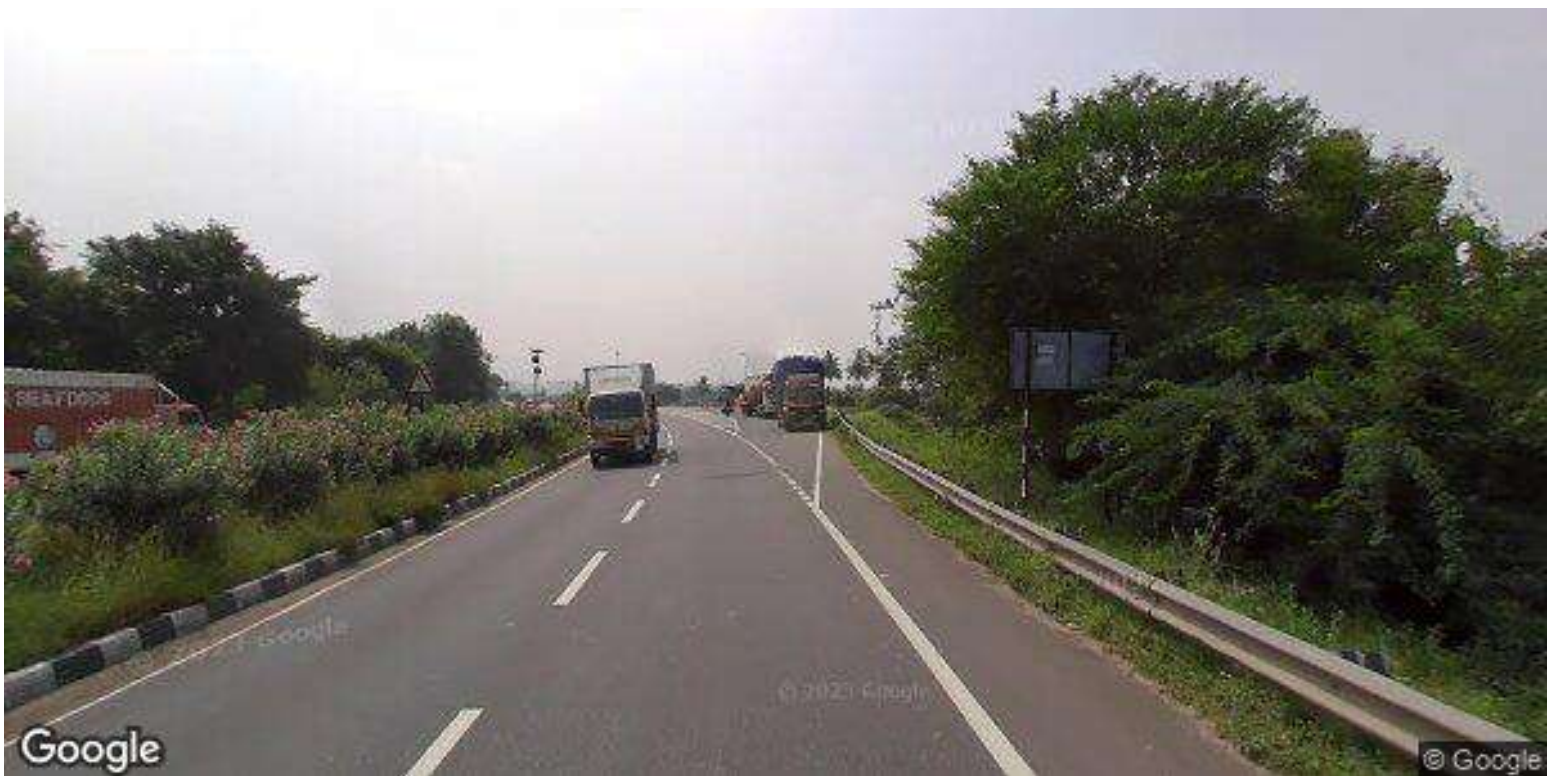
**Coordinates: 11.91302, 78.05856**

**Risk Type: Turn**

**Risk Level: Medium**

**Speed Limit: 30 KM/Hr**

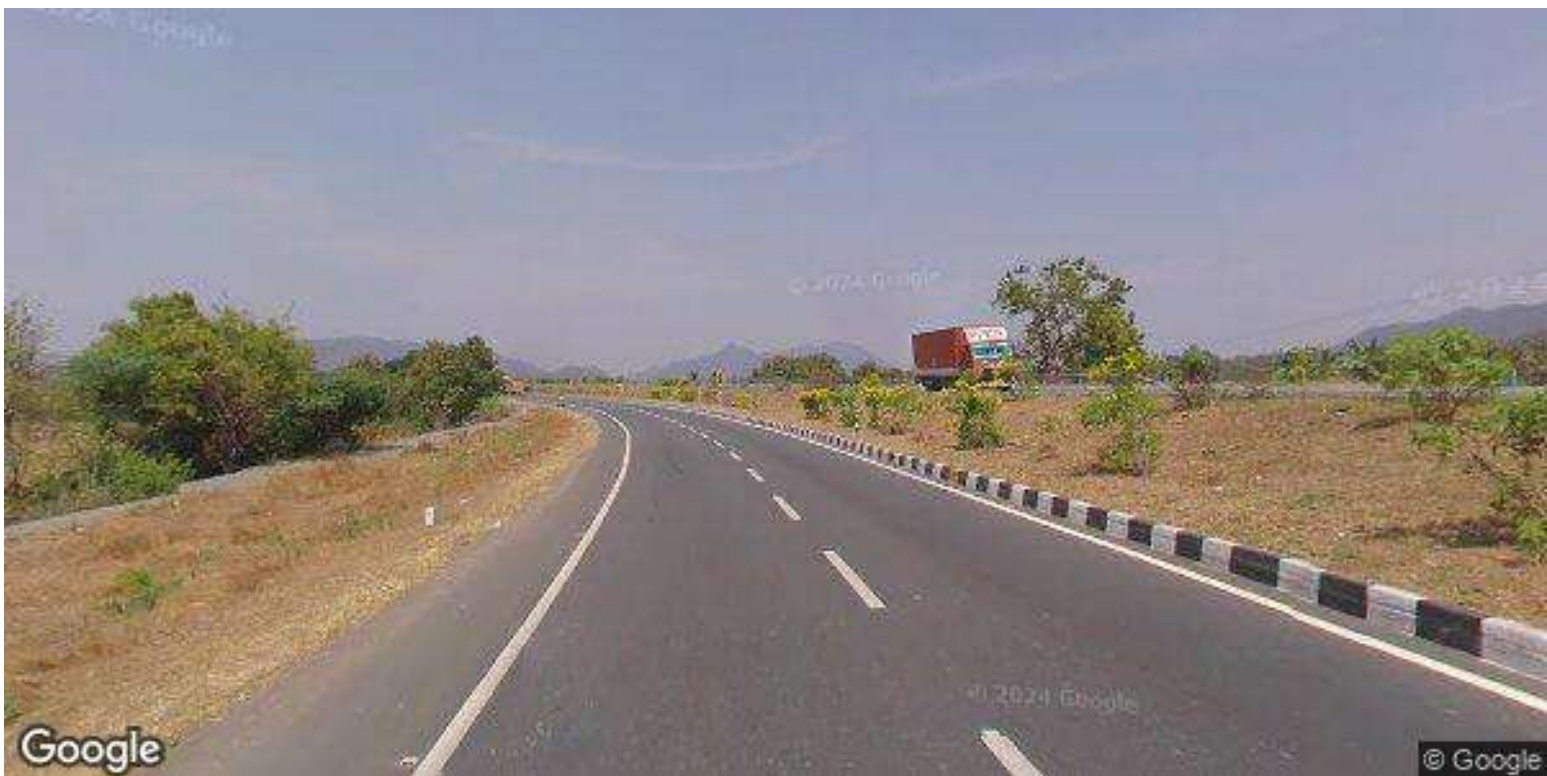
**Risk Type:** Turn  
**Risk Level:** Medium  
**Speed Limit:** 30 KM/Hr  
**Coordinates:** 11.92526, 78.06488

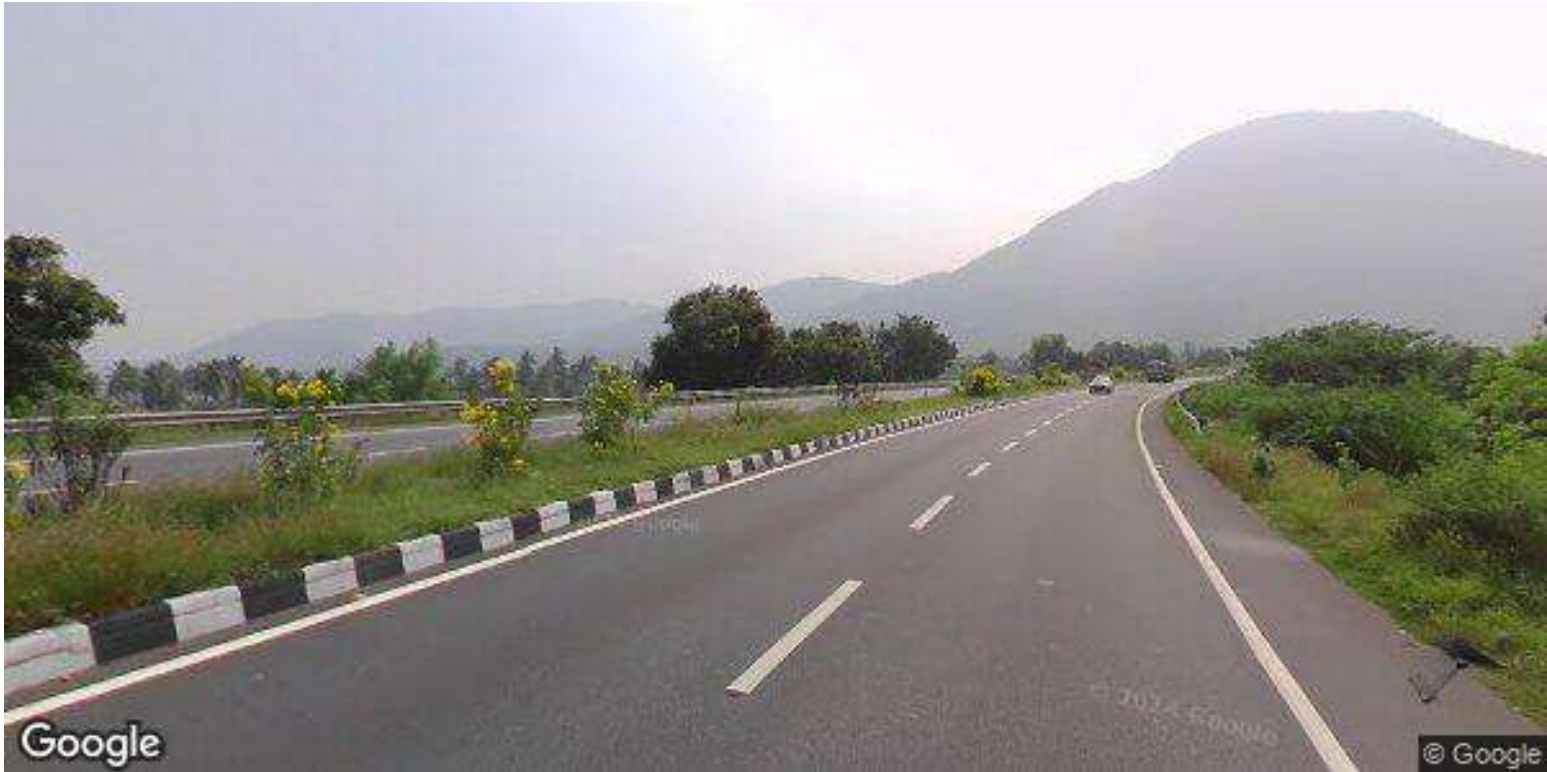
**Risk Type:** Turn  
**Risk Level:** Medium  
**Speed Limit:** 30 KM/Hr  
**Coordinates:** 11.93402, 78.06354

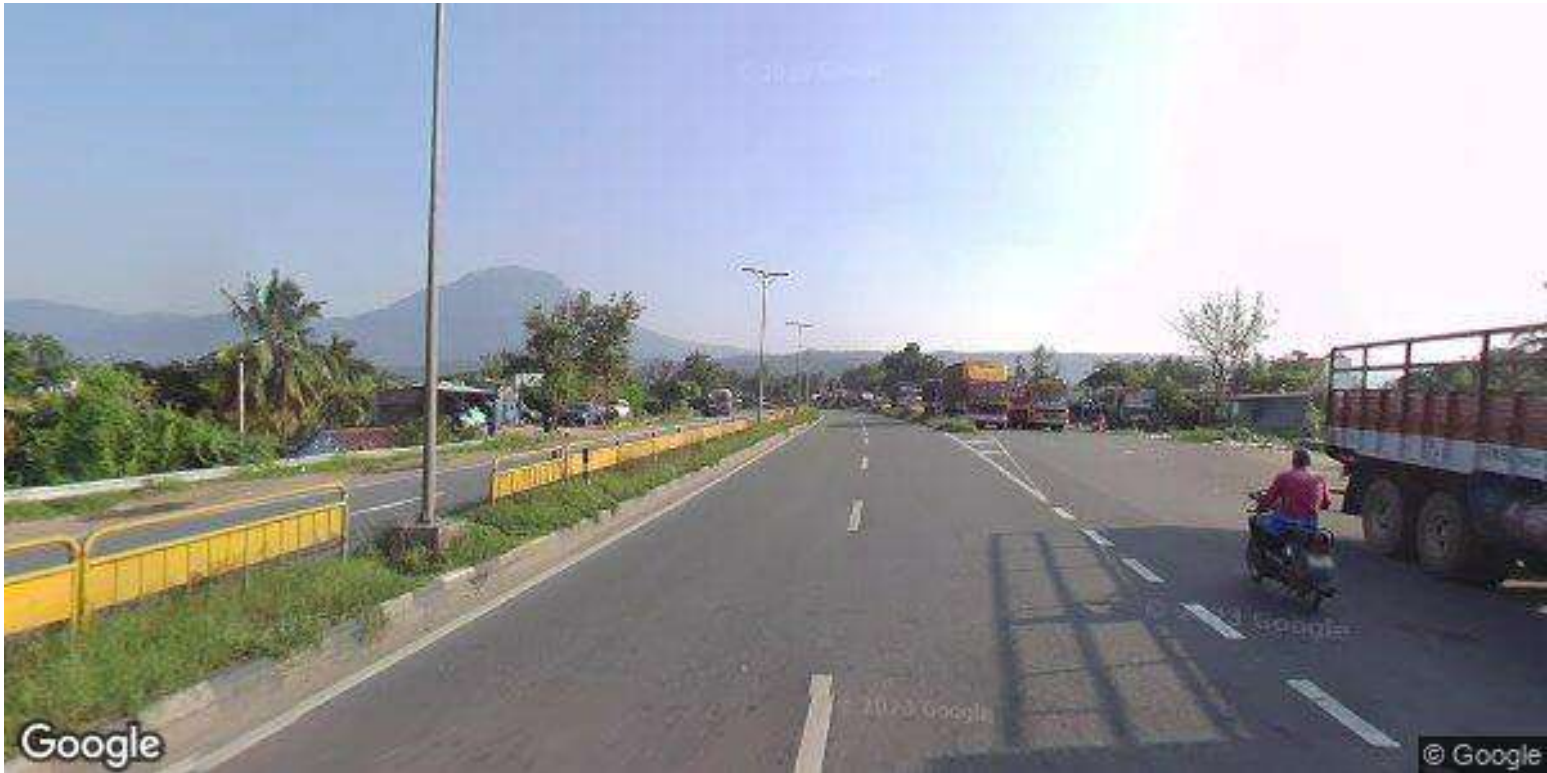
**Risk Type:** Turn  
**Risk Level:** Medium  
**Speed Limit:** 30 KM/Hr  
**Coordinates:** 11.94600, 78.04740

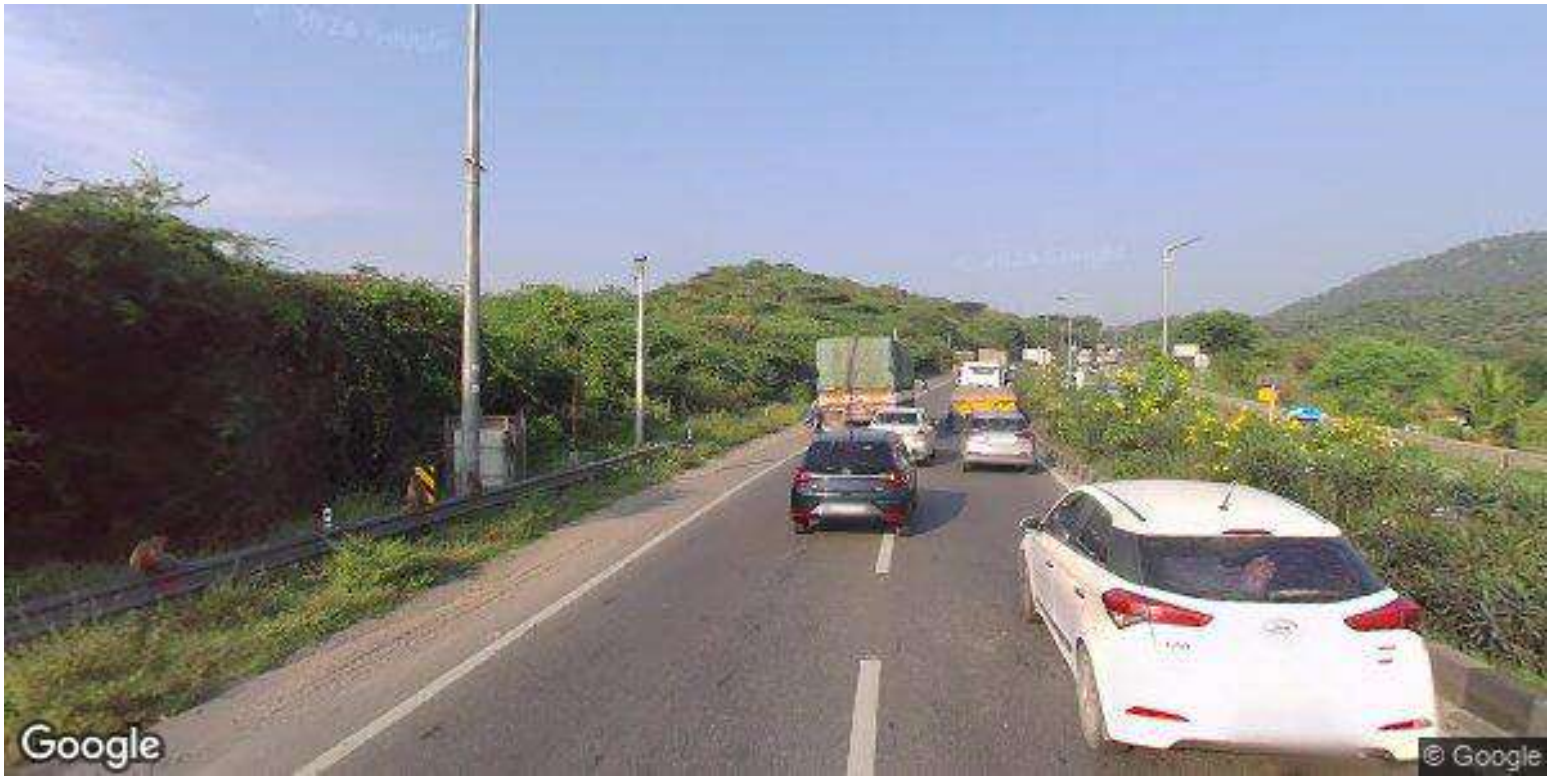
**Coordinates:** 11.95625, 78.04748

**Risk Type:** Turn

**Risk Level:** Medium

**Speed Limit:** 30 KM/Hr

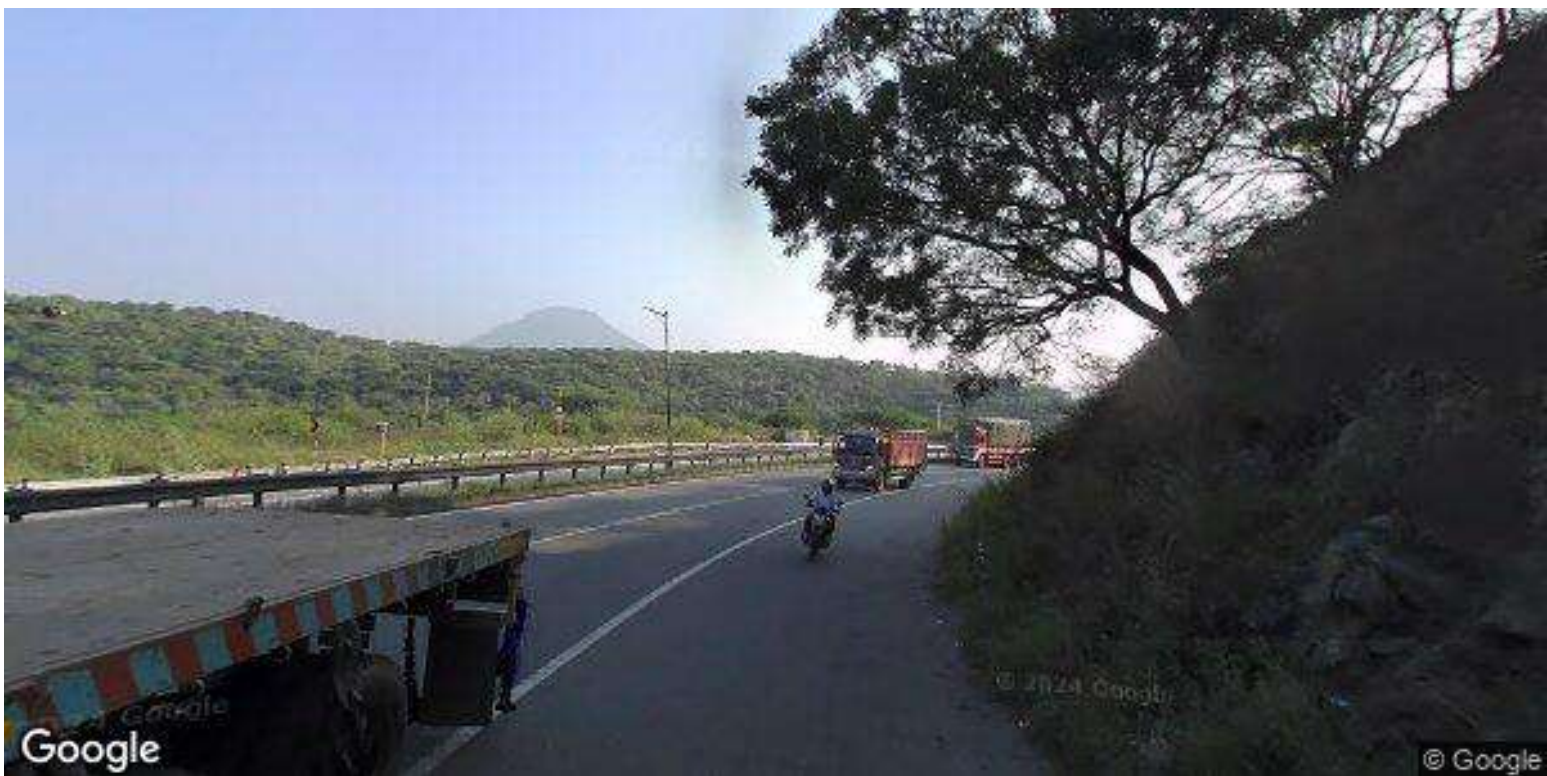
**Coordinates:** 11.95880, 78.04989

**Risk Type:** Turn

**Risk Level:** High

**Speed Limit:** 15 KM/Hr

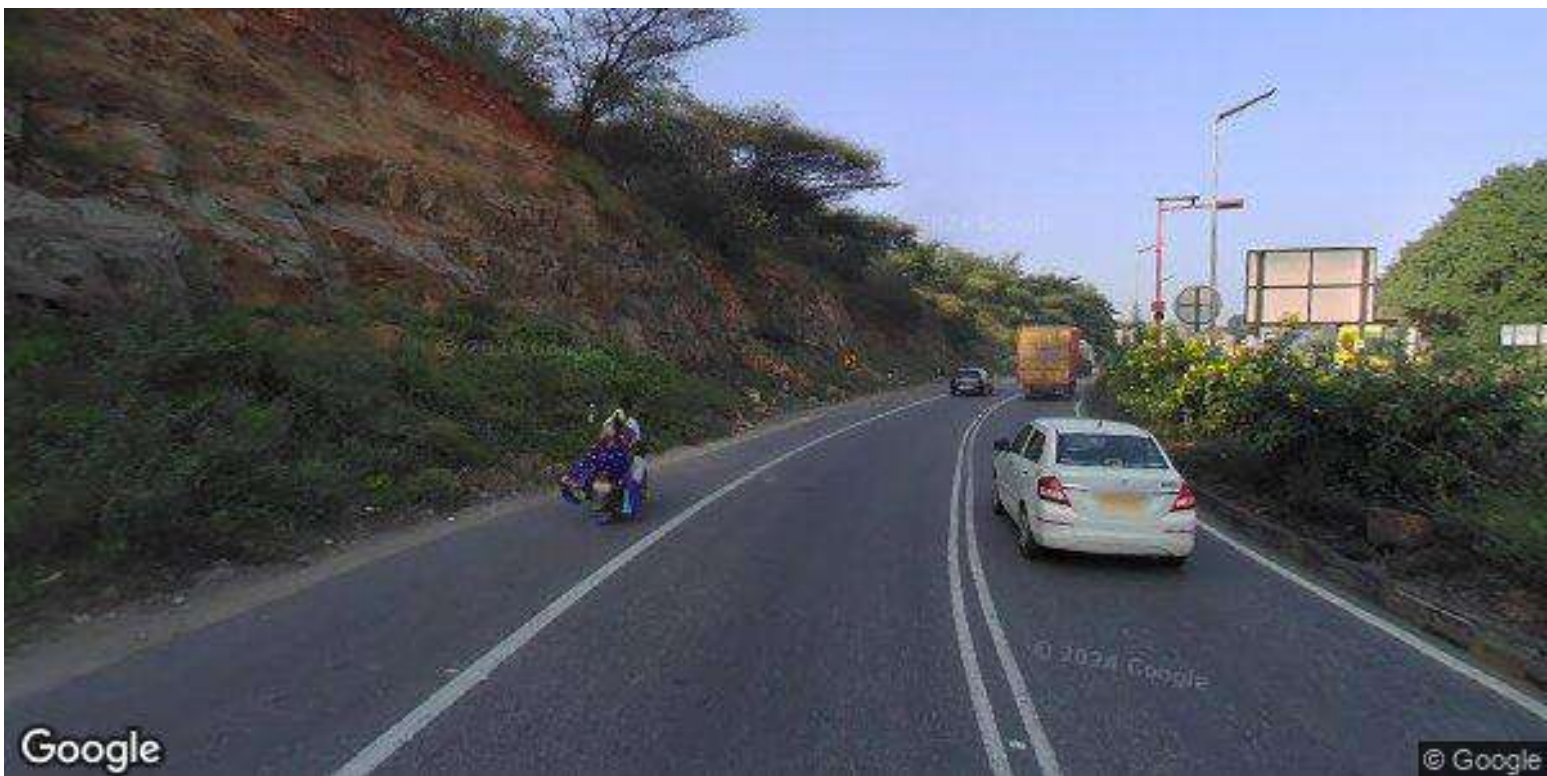
**Risk Type:** Turn  
**Risk Level:** High  
**Speed Limit:** 15 KM/Hr  
**Coordinates:** 11.96040, 78.04947

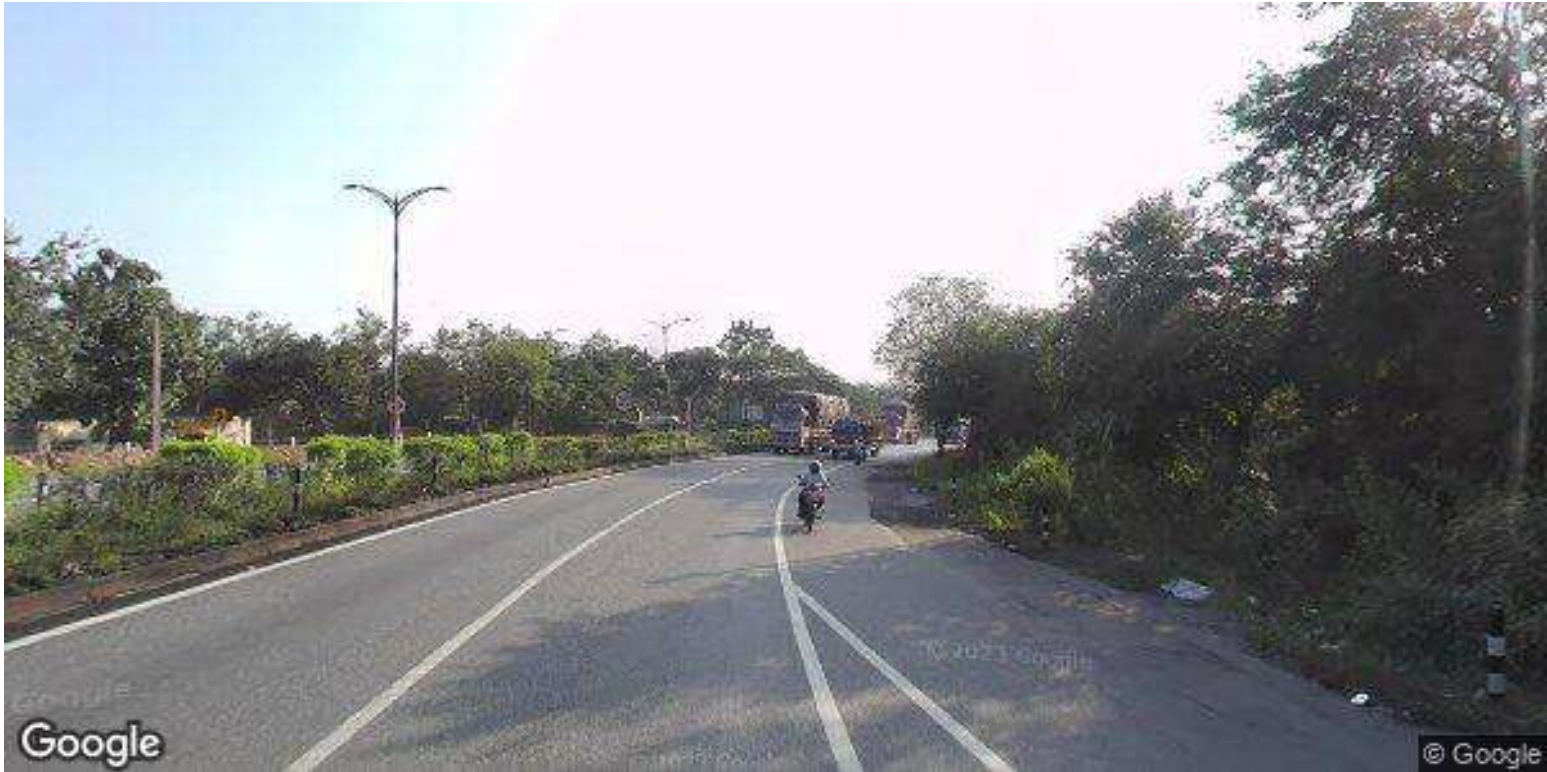
**Risk Type:** Turn  
**Risk Level:** High  
**Speed Limit:** 15 KM/Hr  
**Coordinates:** 11.96320, 78.05139

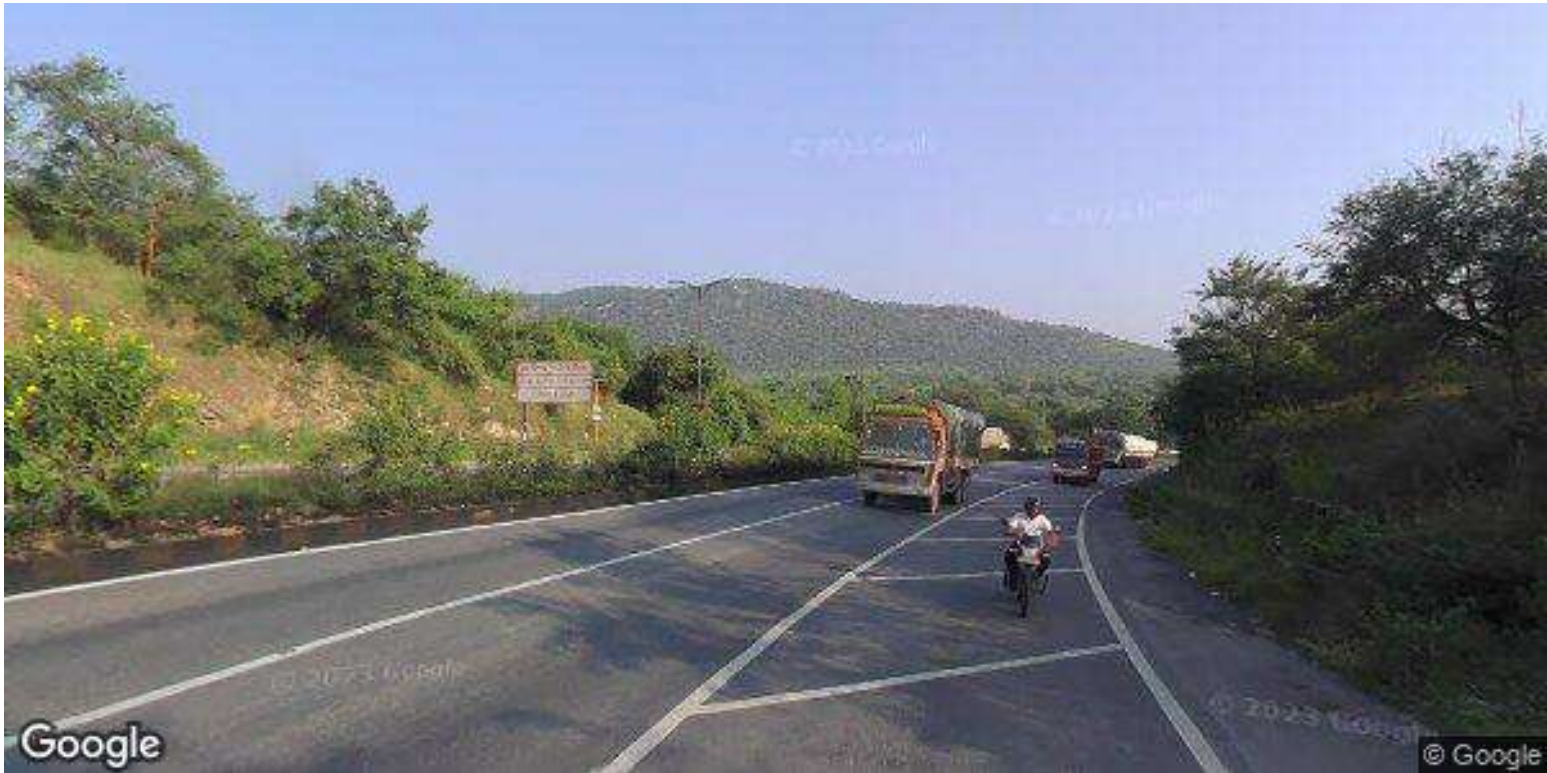
**Risk Type:** Turn  
**Risk Level:** Medium  
**Speed Limit:** 30 KM/Hr  
**Coordinates:** 11.96463, 78.05077

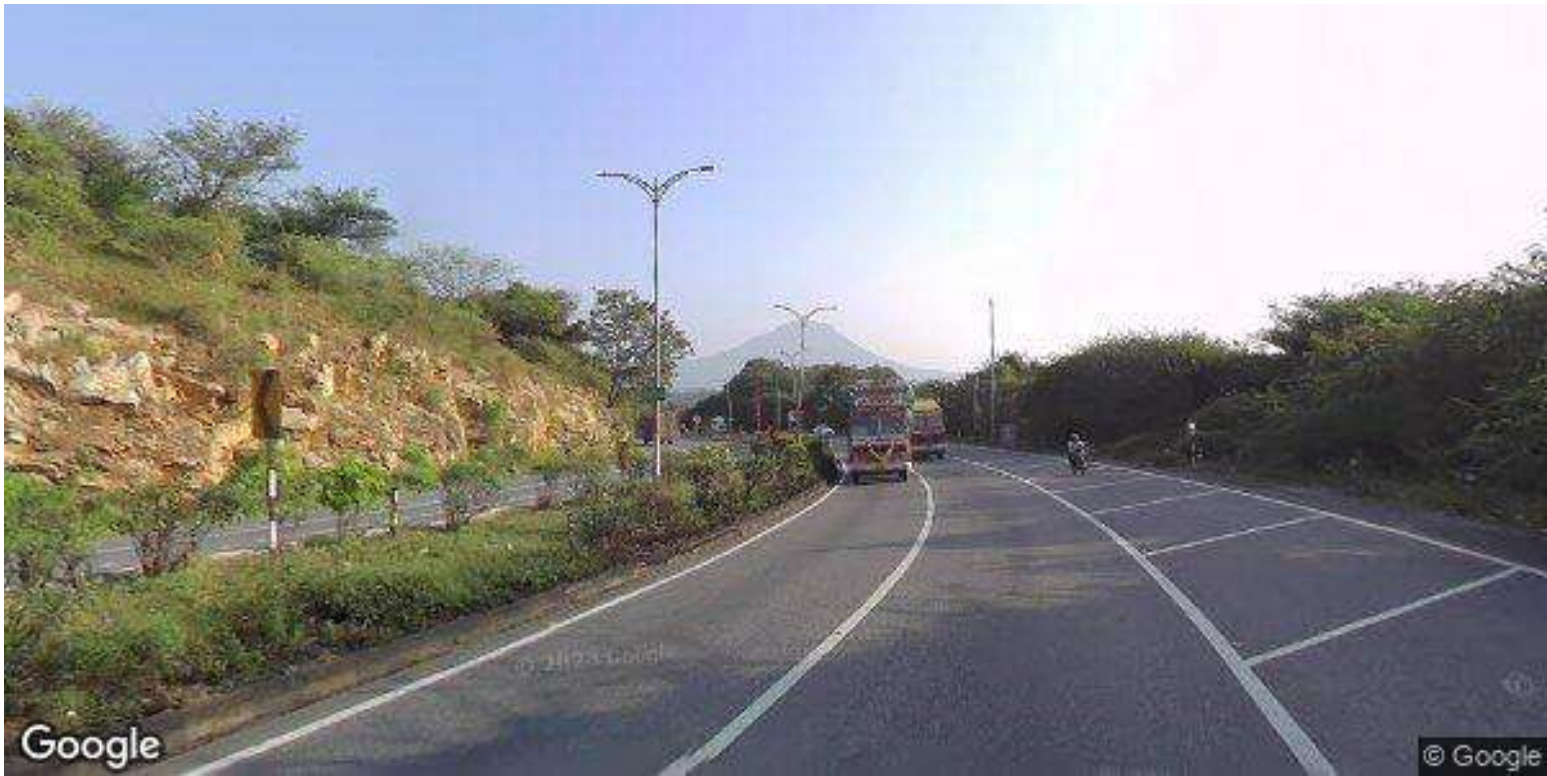
**Risk Type:** Turn  
**Risk Level:** High  
**Speed Limit:** 15 KM/Hr  
**Coordinates:** 11.96597, 78.04920
