## JOURNEY RISK MANAGEMENT (JRM) STUDY

### Salem Terminal to N.N.C.FUEL STATION

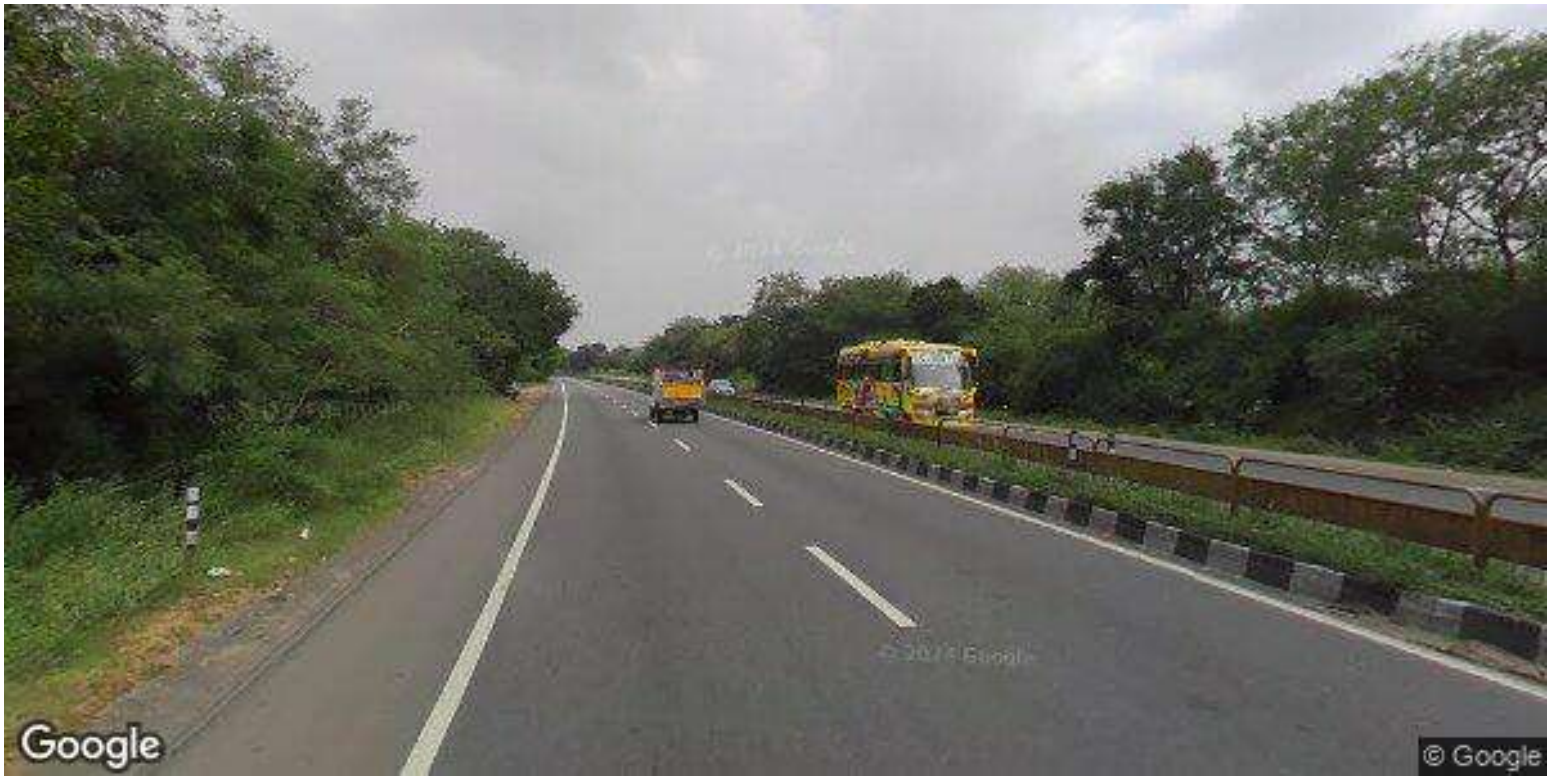
**Risk Type:** Turn  
**Risk Level:** Medium  
**Speed Limit:** 30 KM/Hr  
**Coordinates:** 11.98504, 78.06287

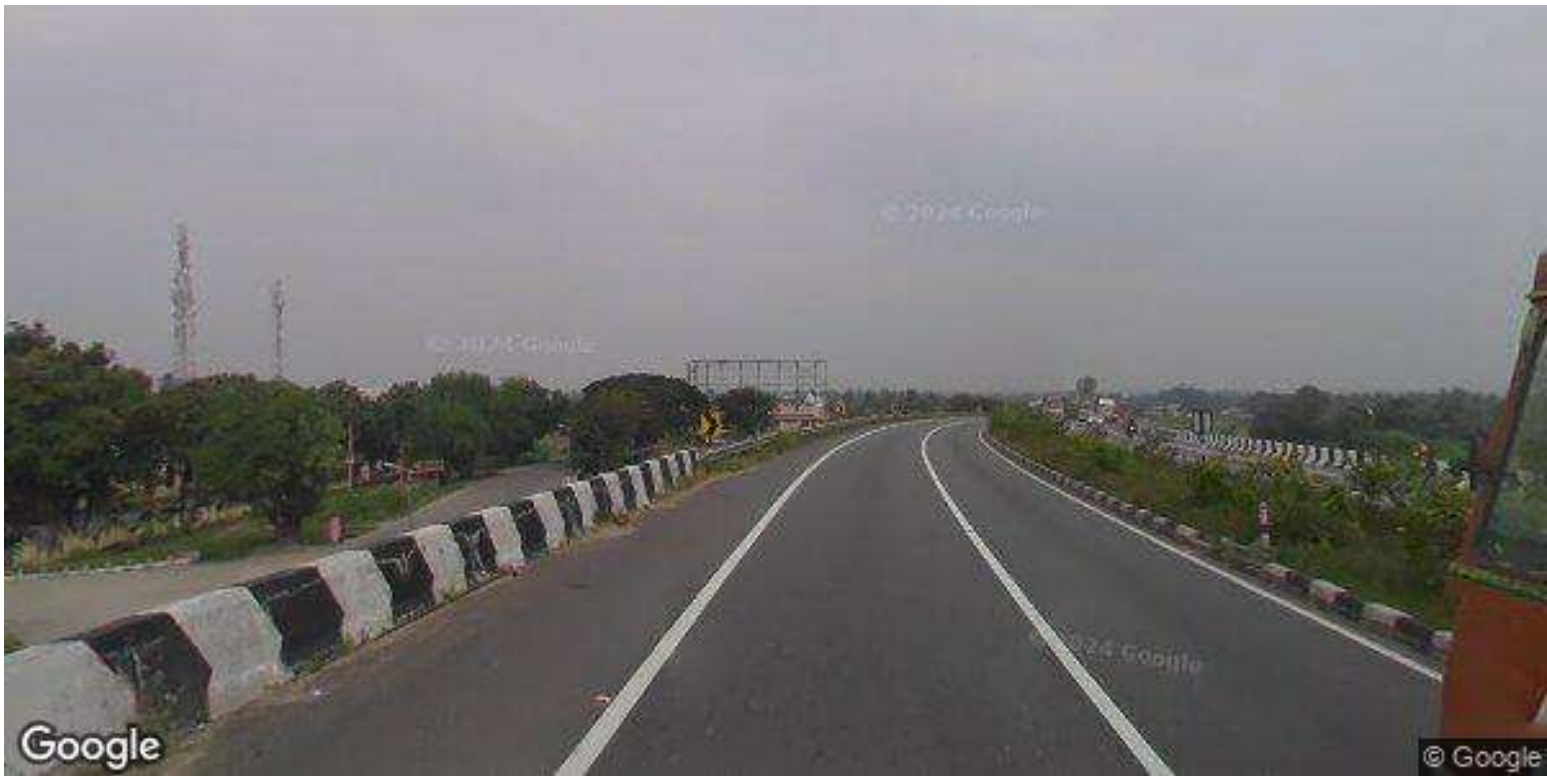
**Coordinates: 12.24611, 78.19519**

**Risk Type: Turn**

**Risk Level: High**

**Speed Limit: 15 KM/Hr**

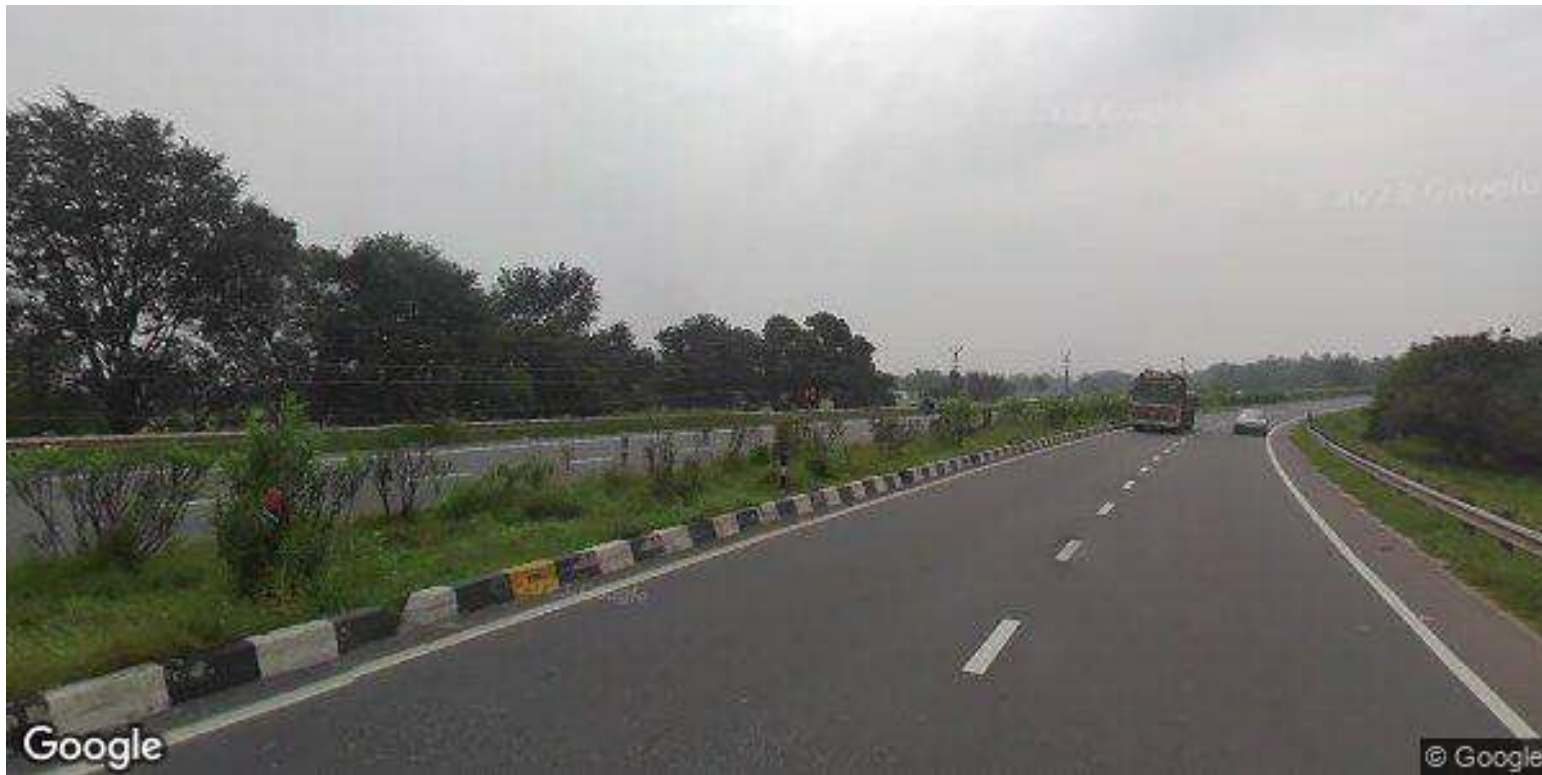
**Coordinates: 12.25200, 78.20034**

**Risk Type: Turn**

**Risk Level: Medium**

**Speed Limit: 30 KM/Hr**

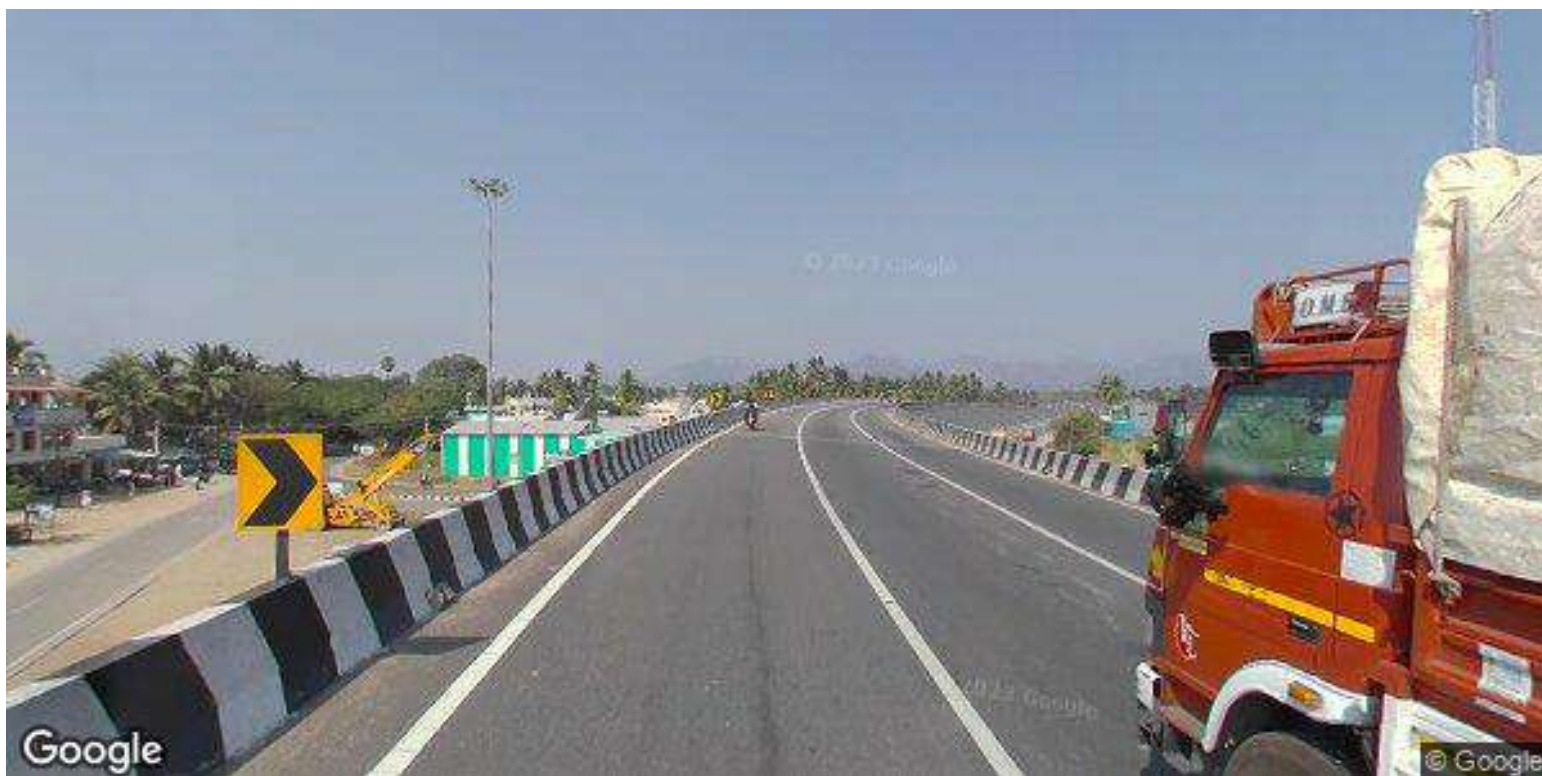
**Coordinates: 12.40026, 78.21775**

**Risk Type: Turn**

**Risk Level: High**

**Speed Limit: 15 KM/Hr**

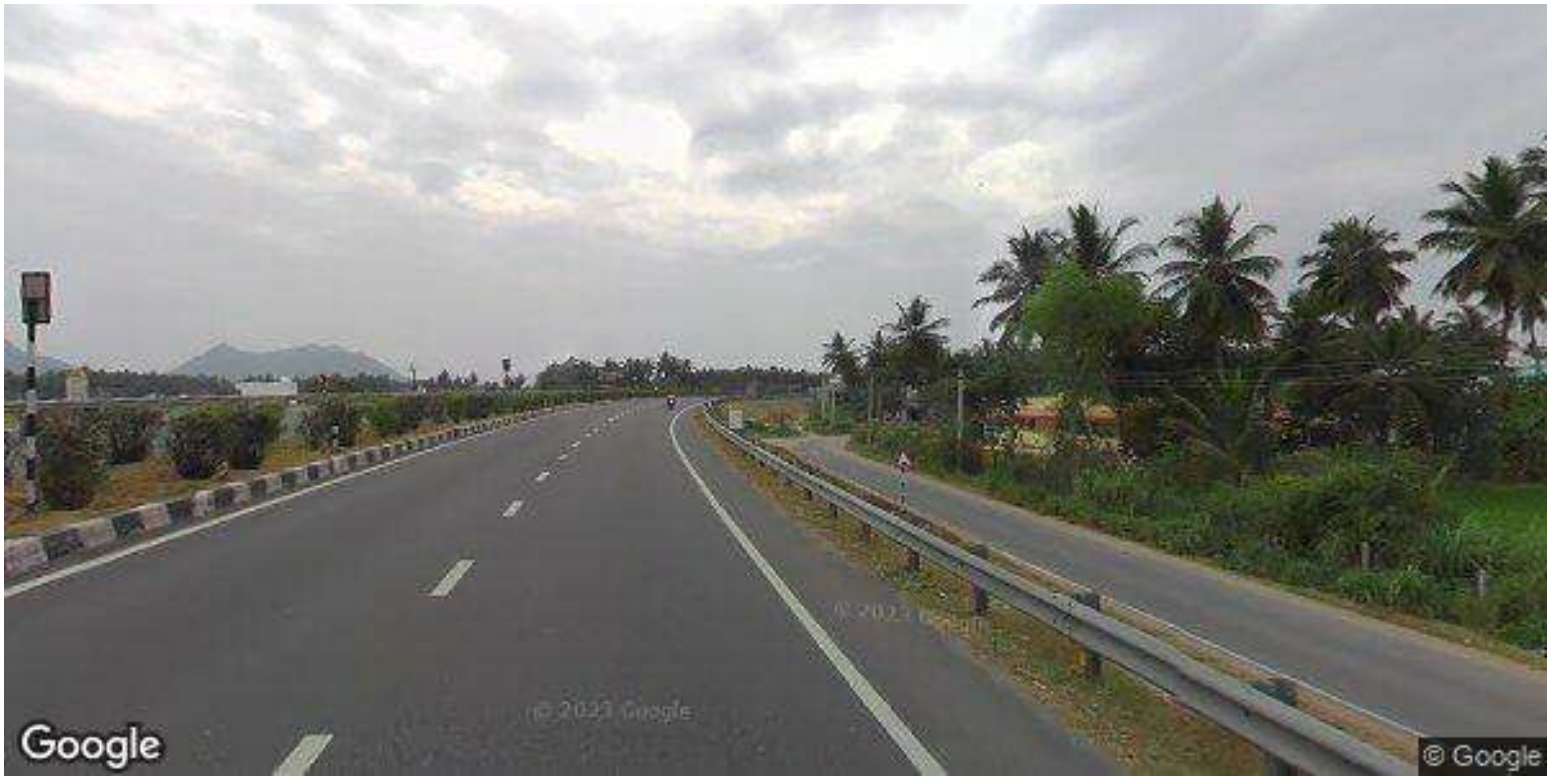
**Coordinates:** 12.40734, 78.22344

**Risk Type:** Turn

**Risk Level:** Medium

**Speed Limit:** 30 KM/Hr

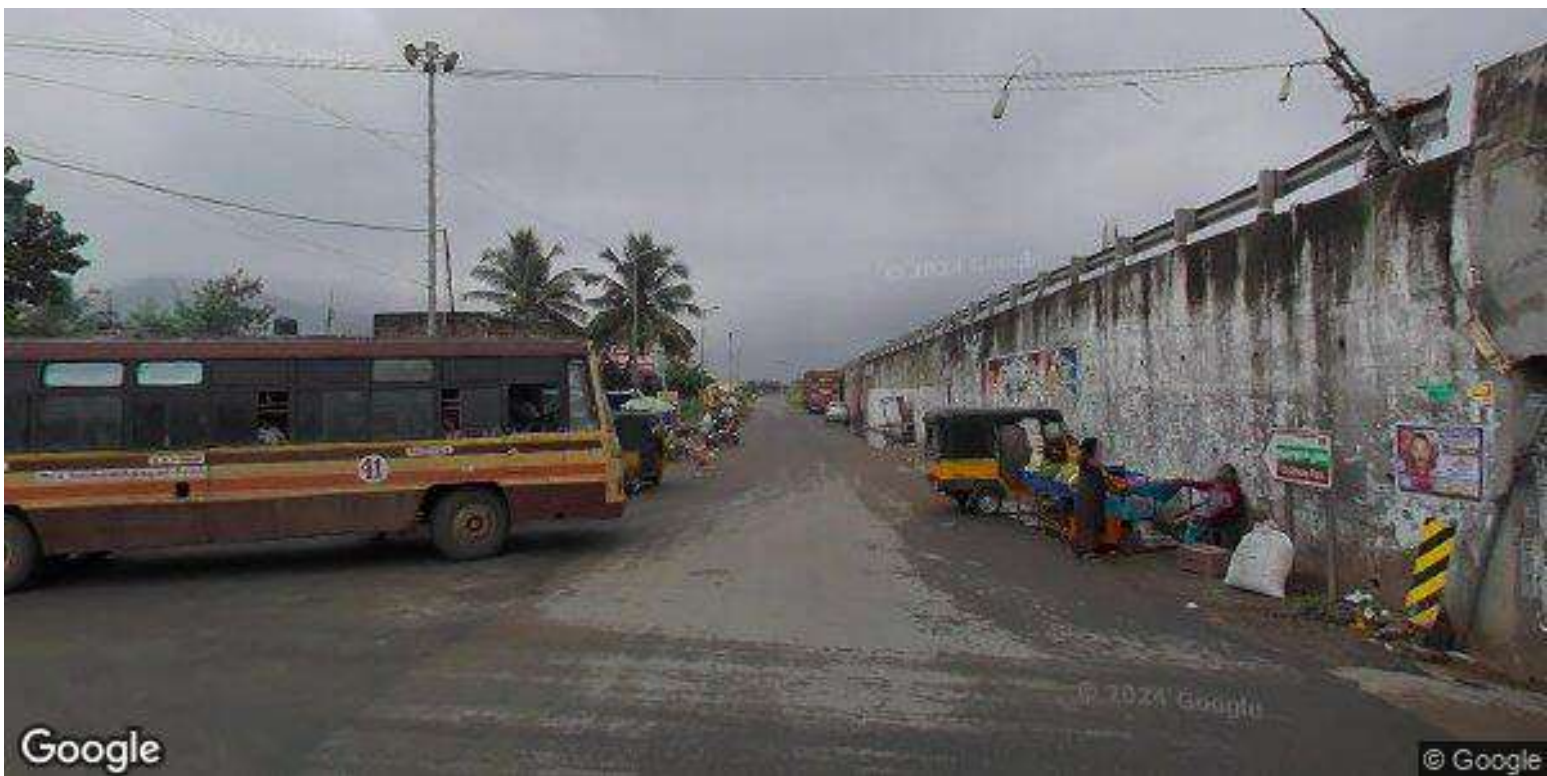
**Coordinates:** 12.46292, 78.21416

**Risk Type:** Turn

**Risk Level:** High

**Speed Limit:** 15 KM/Hr

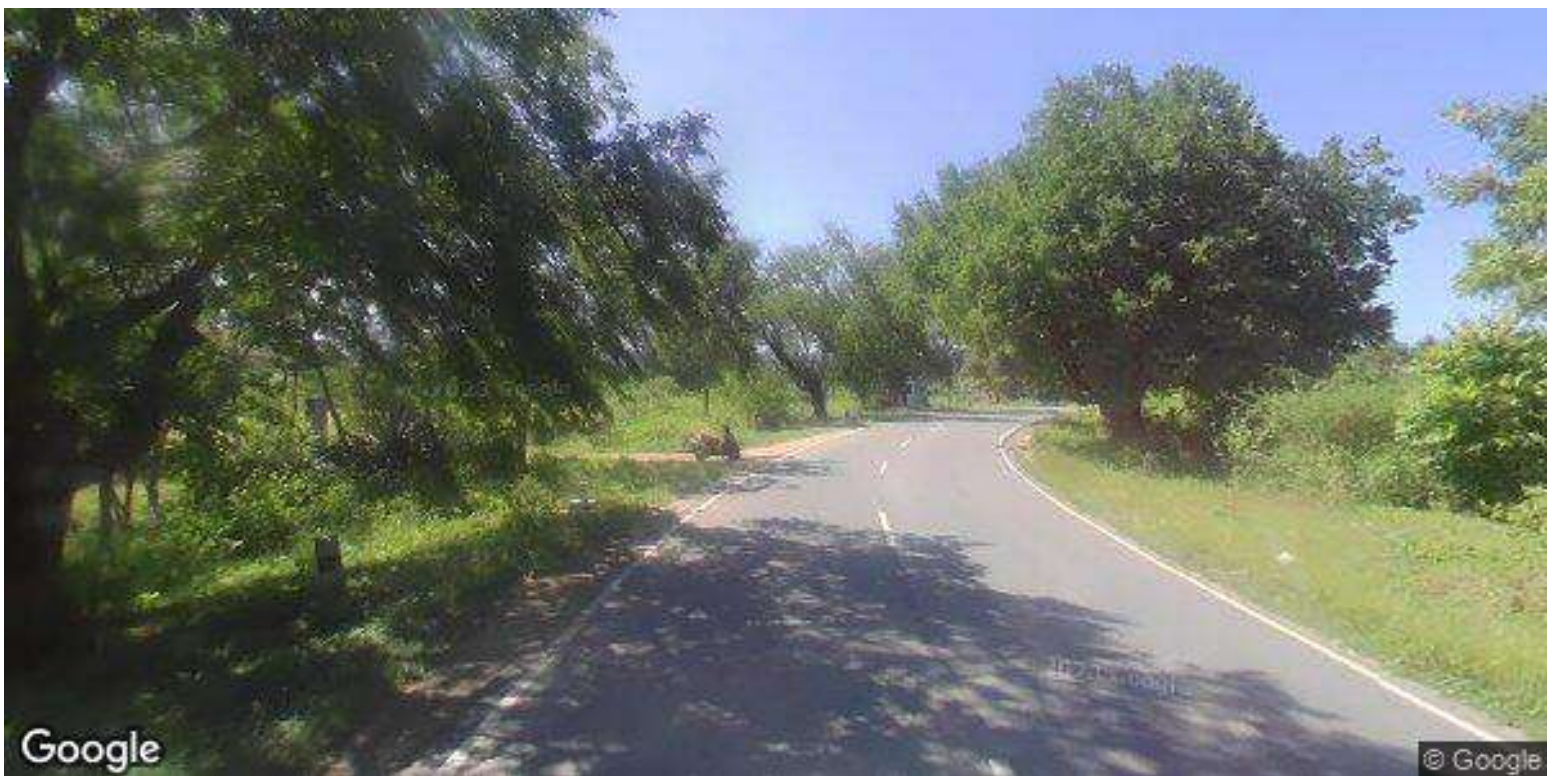
**Coordinates:** 12.49436, 78.12425

**Risk Type:** Turn

**Risk Level:** High

**Speed Limit:** 15 KM/Hr
