# IndianOil

## JOURNEY RISK MANAGEMENT (JRM) STUDY

### Salem Terminal to SREE ANNAMARR AGENCY

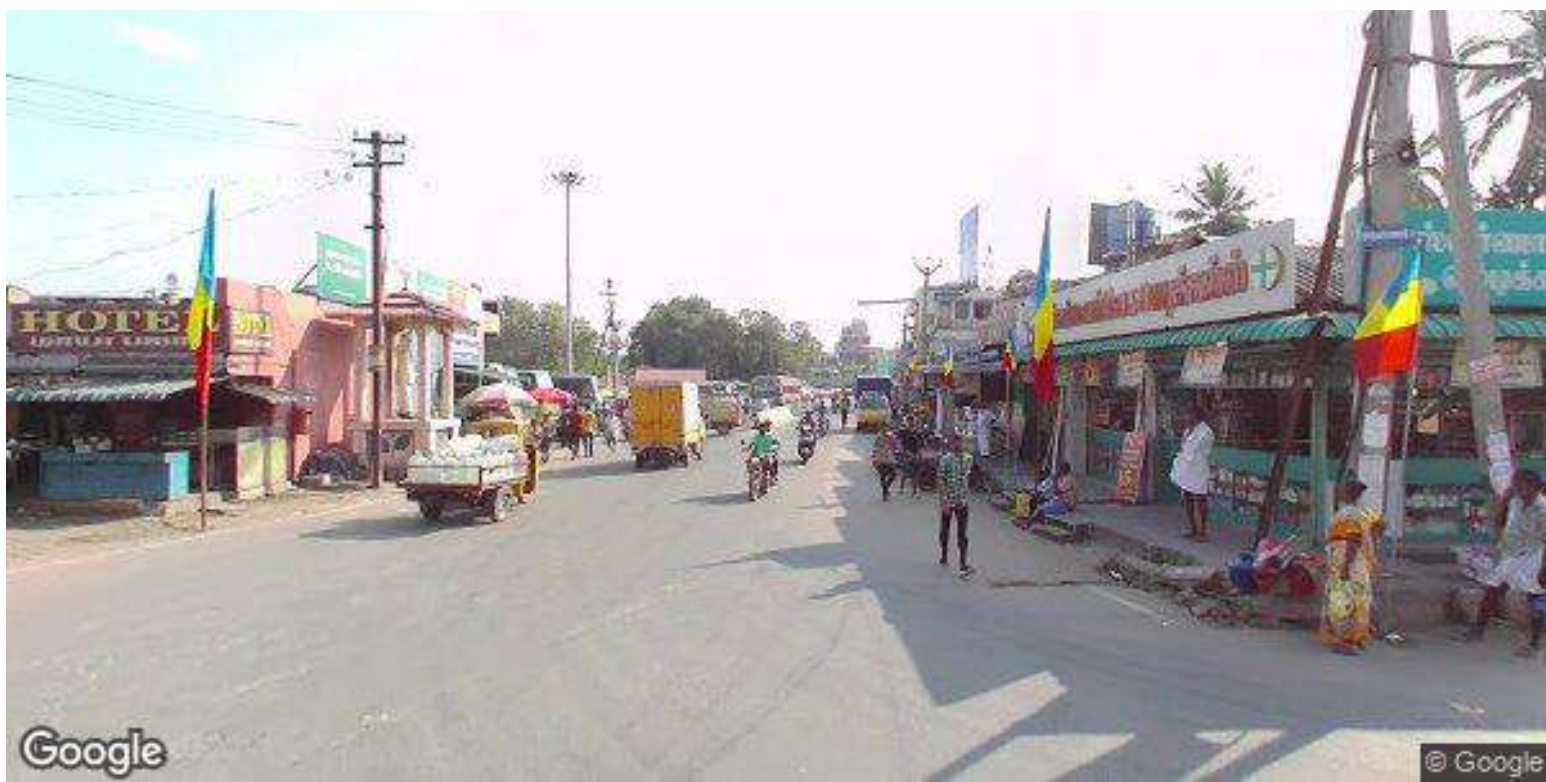
Risk Type: Blind Spot  
 Risk Level: Blind Spot  
 Speed Limit: 10 KM/Hr  
 Coordinates: 11.69590, 77.97114

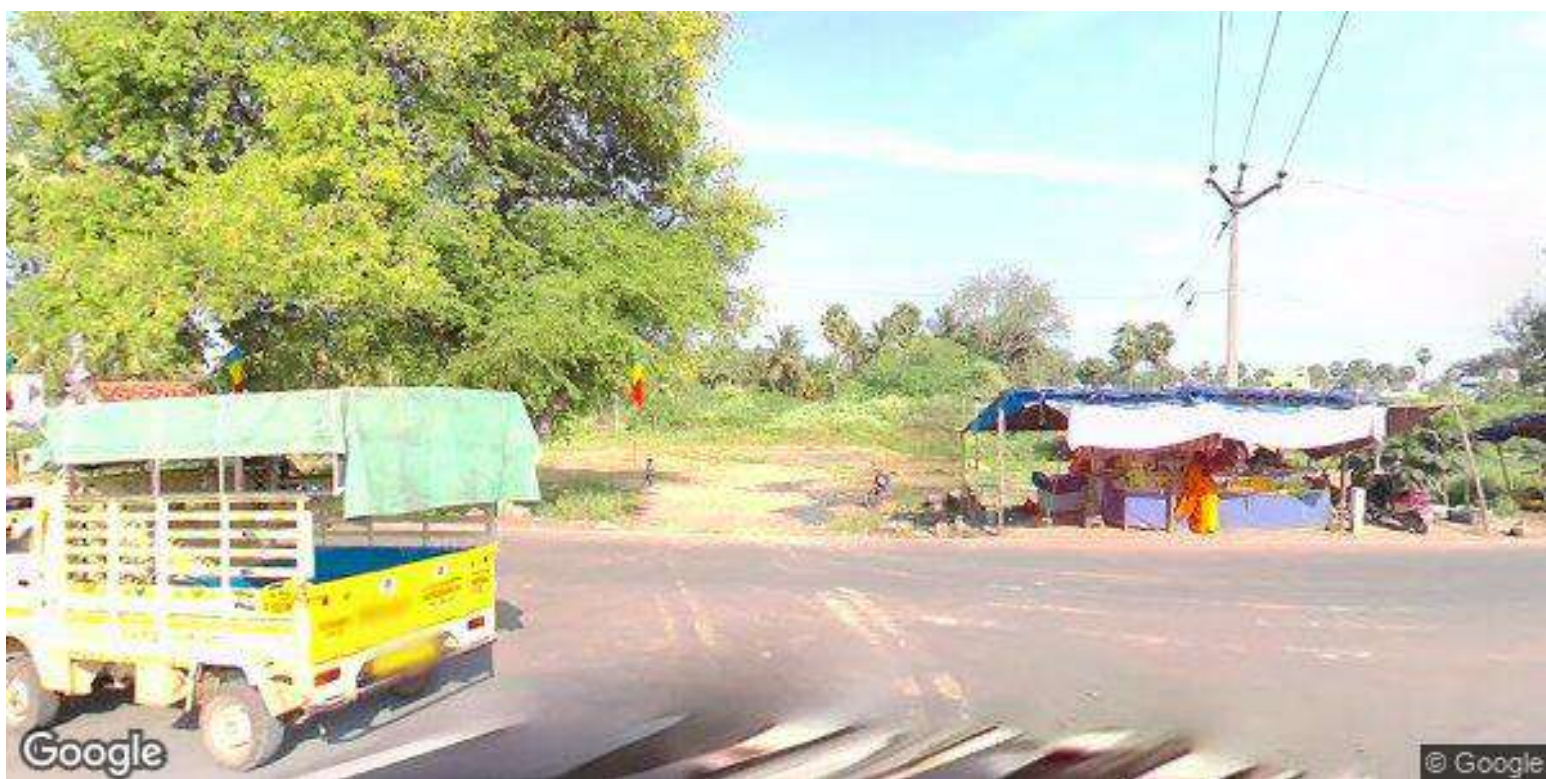
Risk Type: Turn  
 Risk Level: High  
 Speed Limit: 15 KM/Hr  
 Coordinates: 11.70133, 77.96363

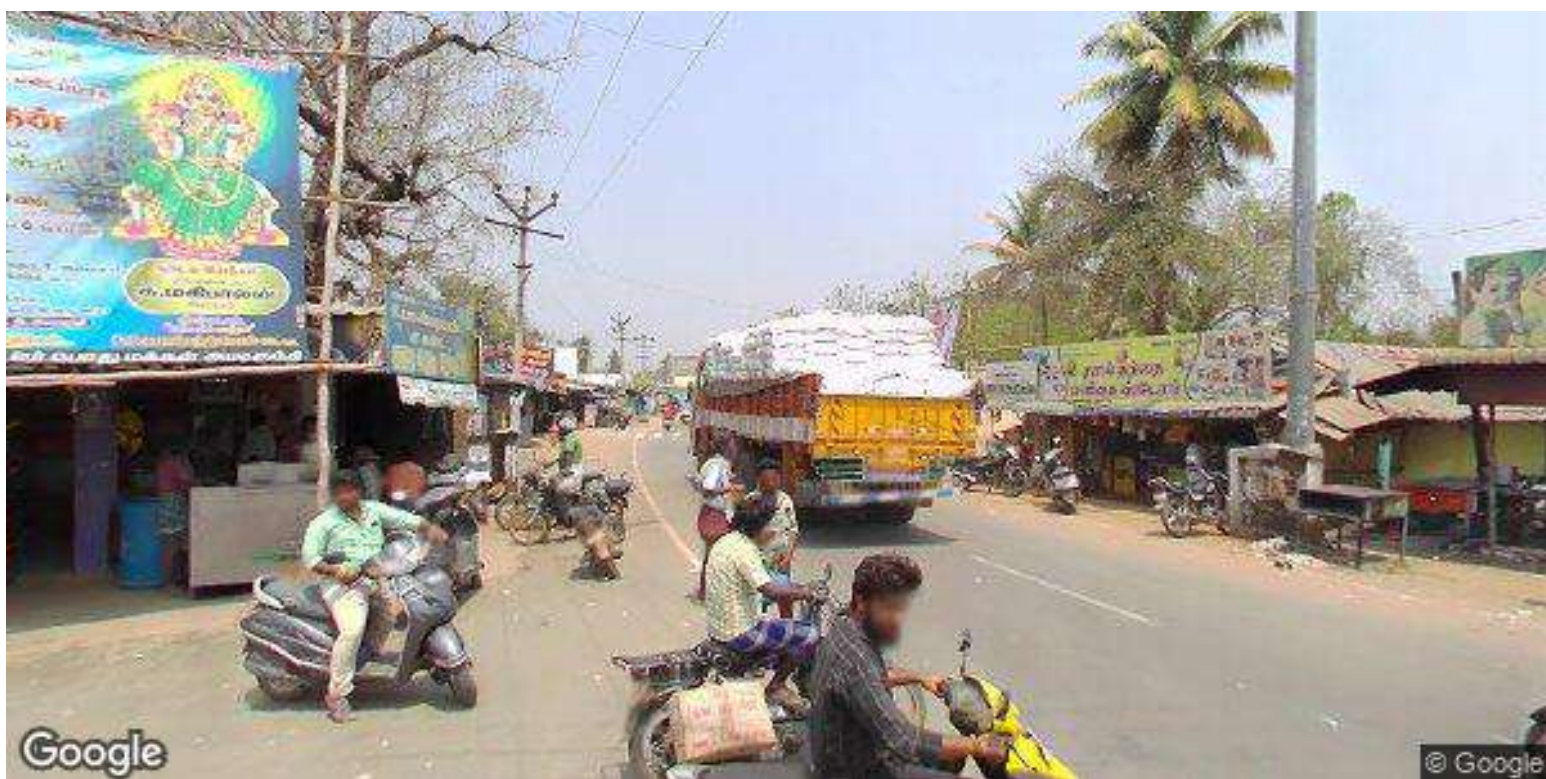
**Risk Type:** Turn  
**Risk Level:** Medium  
**Speed Limit:** 30 KM/Hr  
**Coordinates:** 11.73427, 77.96723

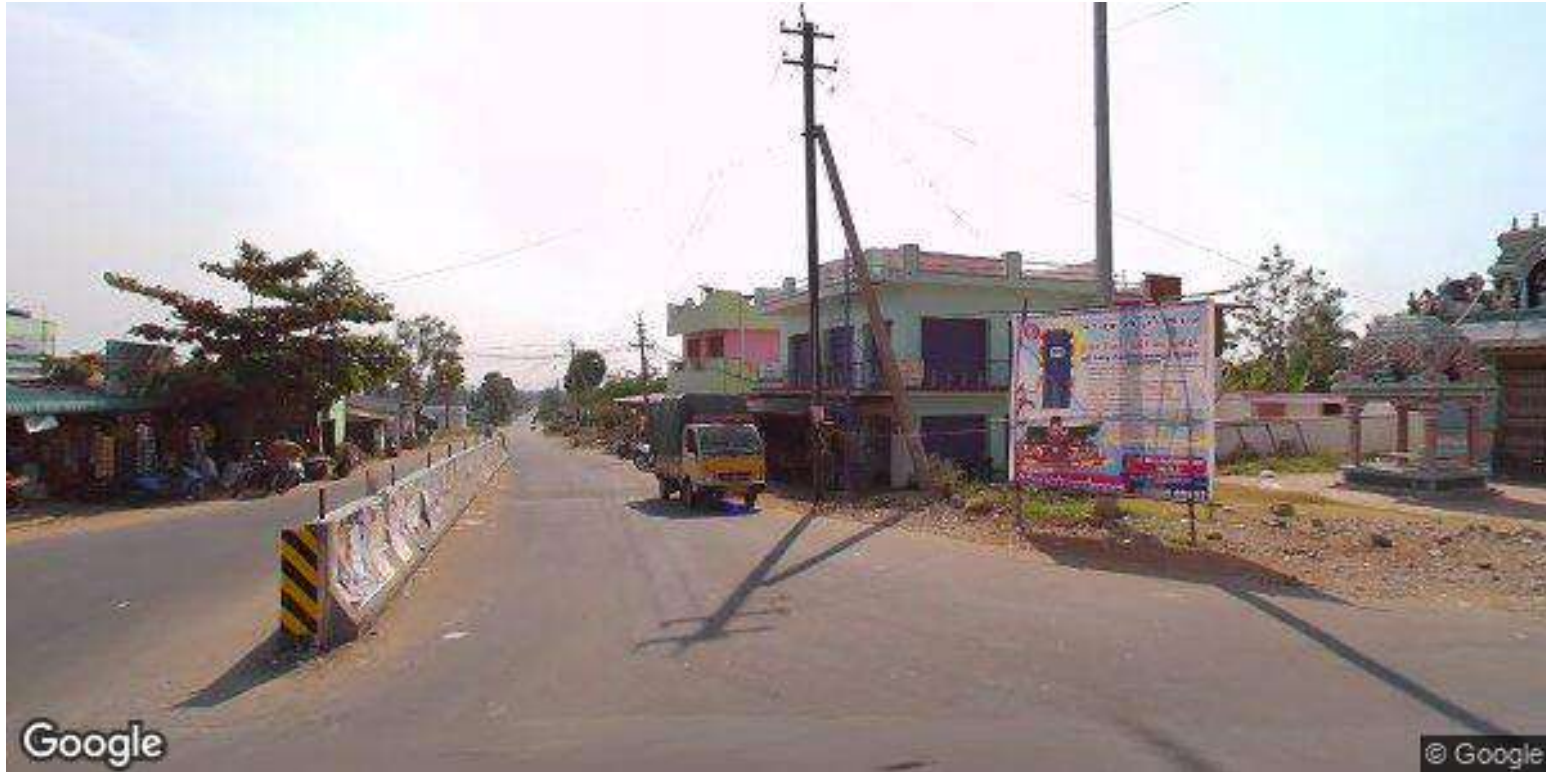
**Risk Type:** Turn  
**Risk Level:** High  
**Speed Limit:** 15 KM/Hr  
**Coordinates:** 11.77772, 77.99628

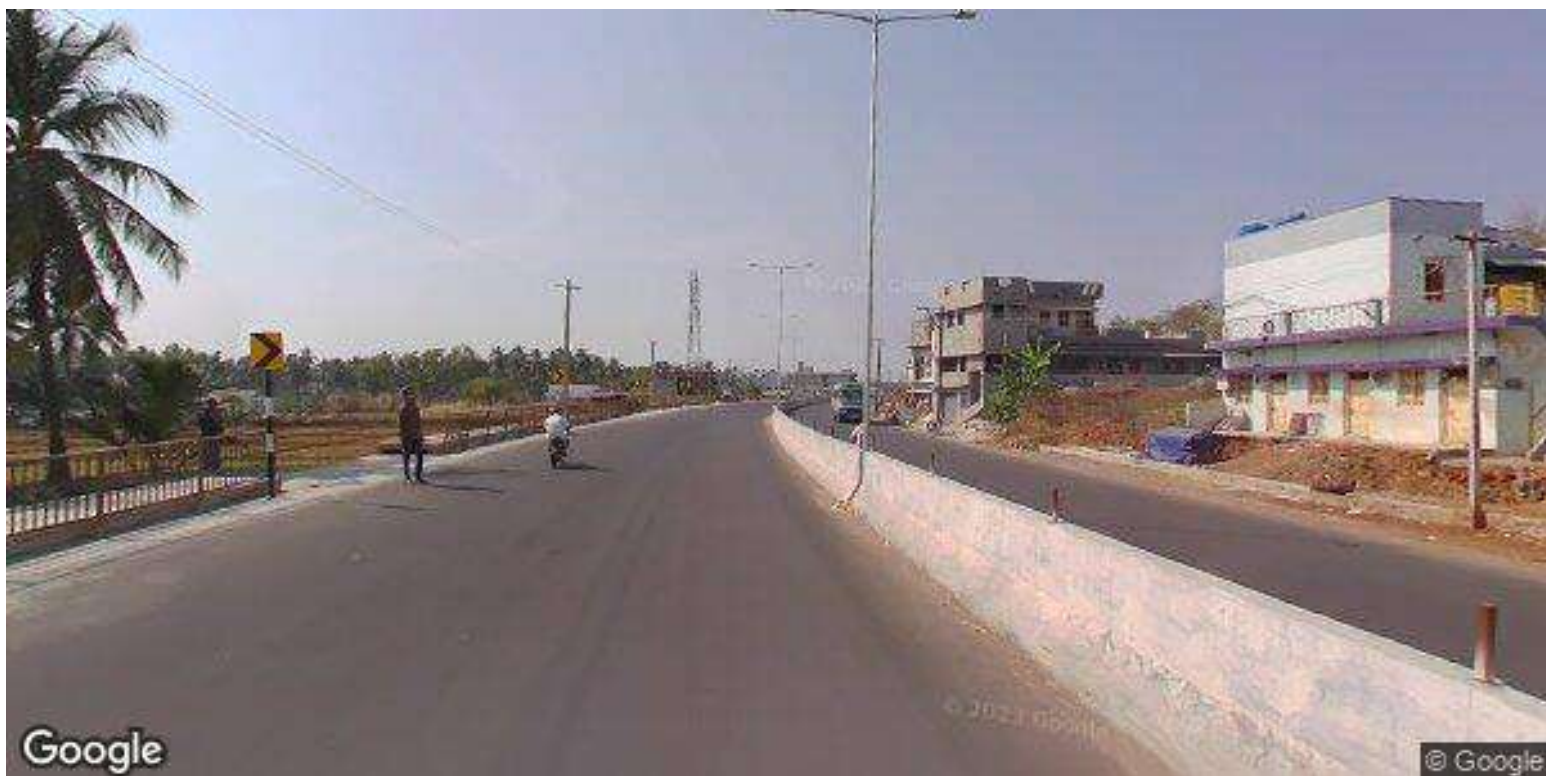
**Risk Type:** Blind Spot  
**Risk Level:** Blind Spot  
**Speed Limit:** 10 KM/Hr  
**Coordinates:** 11.78535, 77.98924
