# IndianOil

## JOURNEY RISK MANAGEMENT (JRM) STUDY

### Salem Terminal to PARAMATHY-VELUR TALUK LOA

### Route Safety Analysis Report: Sangagiri to Vasanthapuram, Tamil Nadu

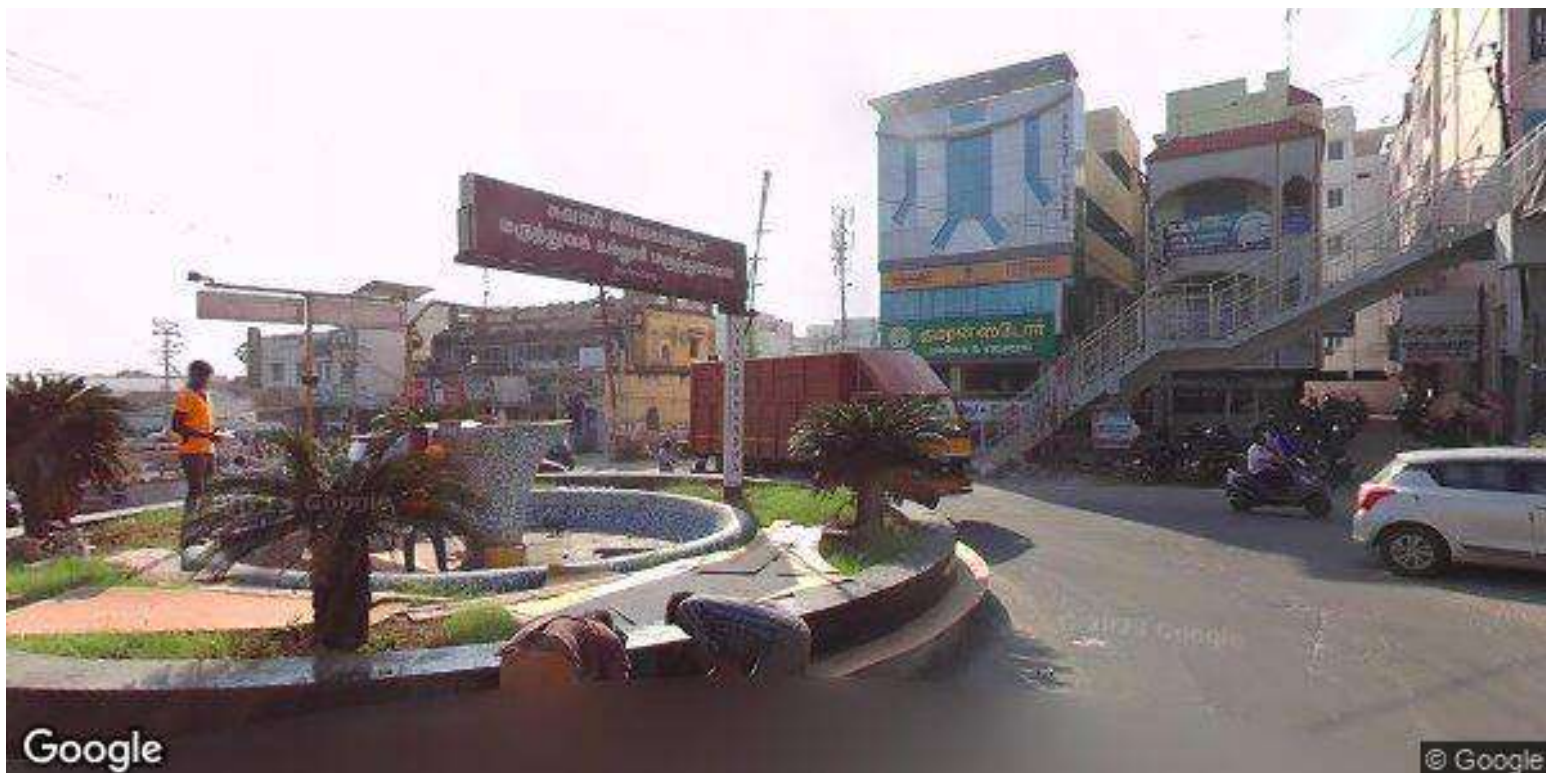
**Risk Type:** Roundabout  
**Risk Level:** High  
**Speed Limit:** 15 KM/Hr  
**Coordinates:** 11.38395, 77.89480

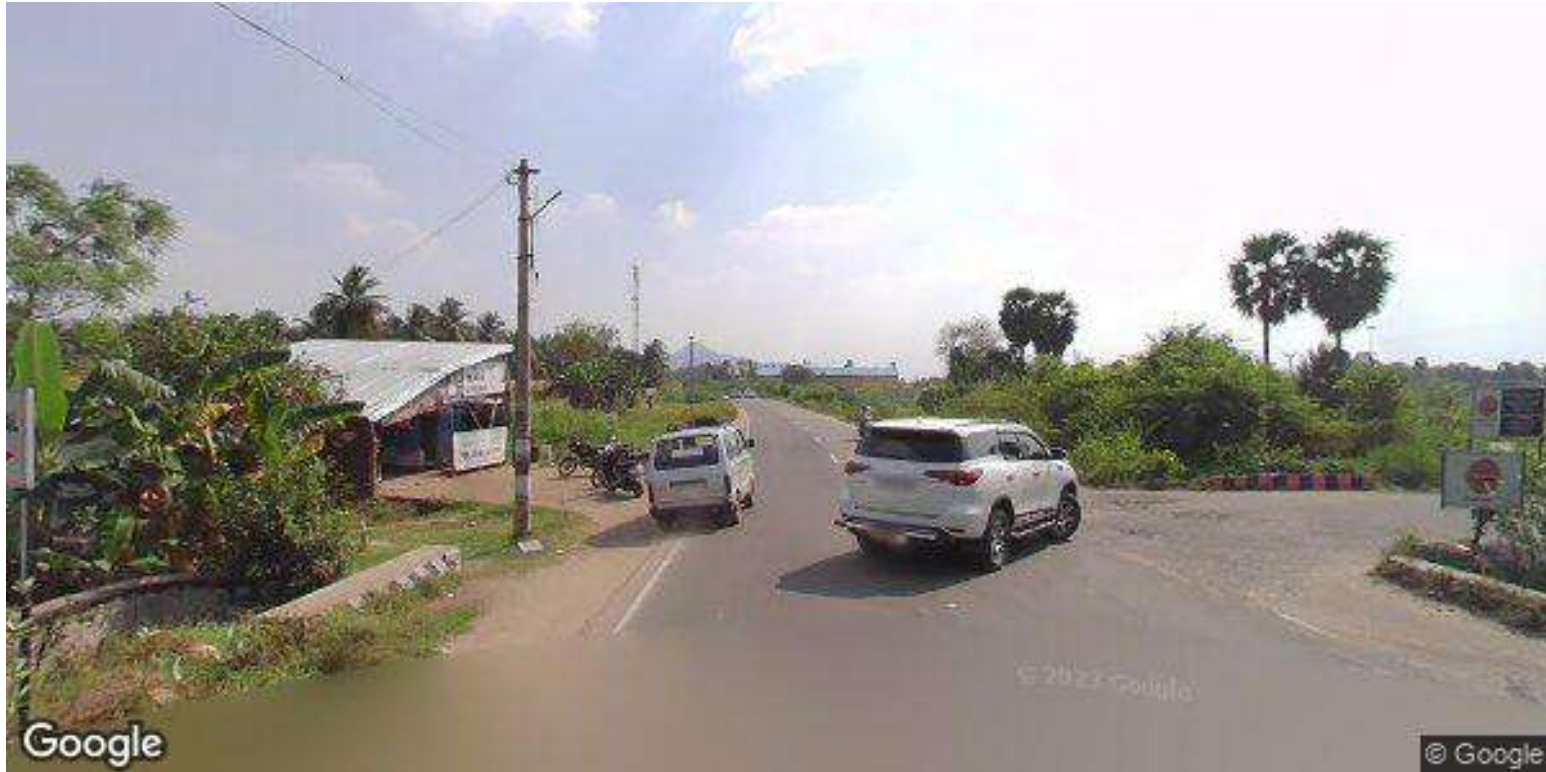
**Risk Type:** Blind Spot  
**Risk Level:** Blind Spot  
**Speed Limit:** 10 KM/Hr  
**Coordinates:** 11.44029, 77.87544

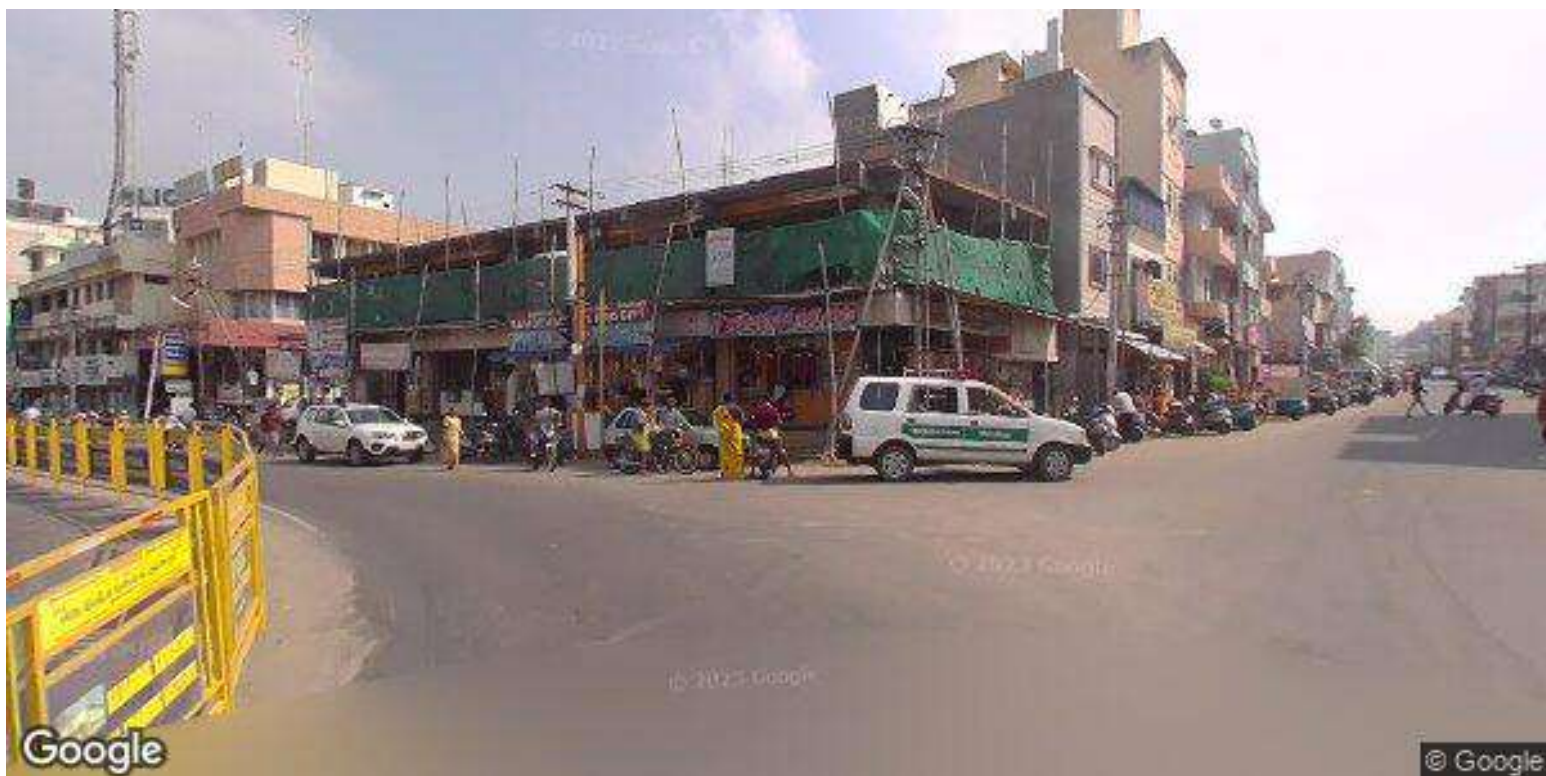
**Risk Type:** Turn  
**Risk Level:** High  
**Speed Limit:** 15 KM/Hr  
**Coordinates:** 11.37868, 77.89498

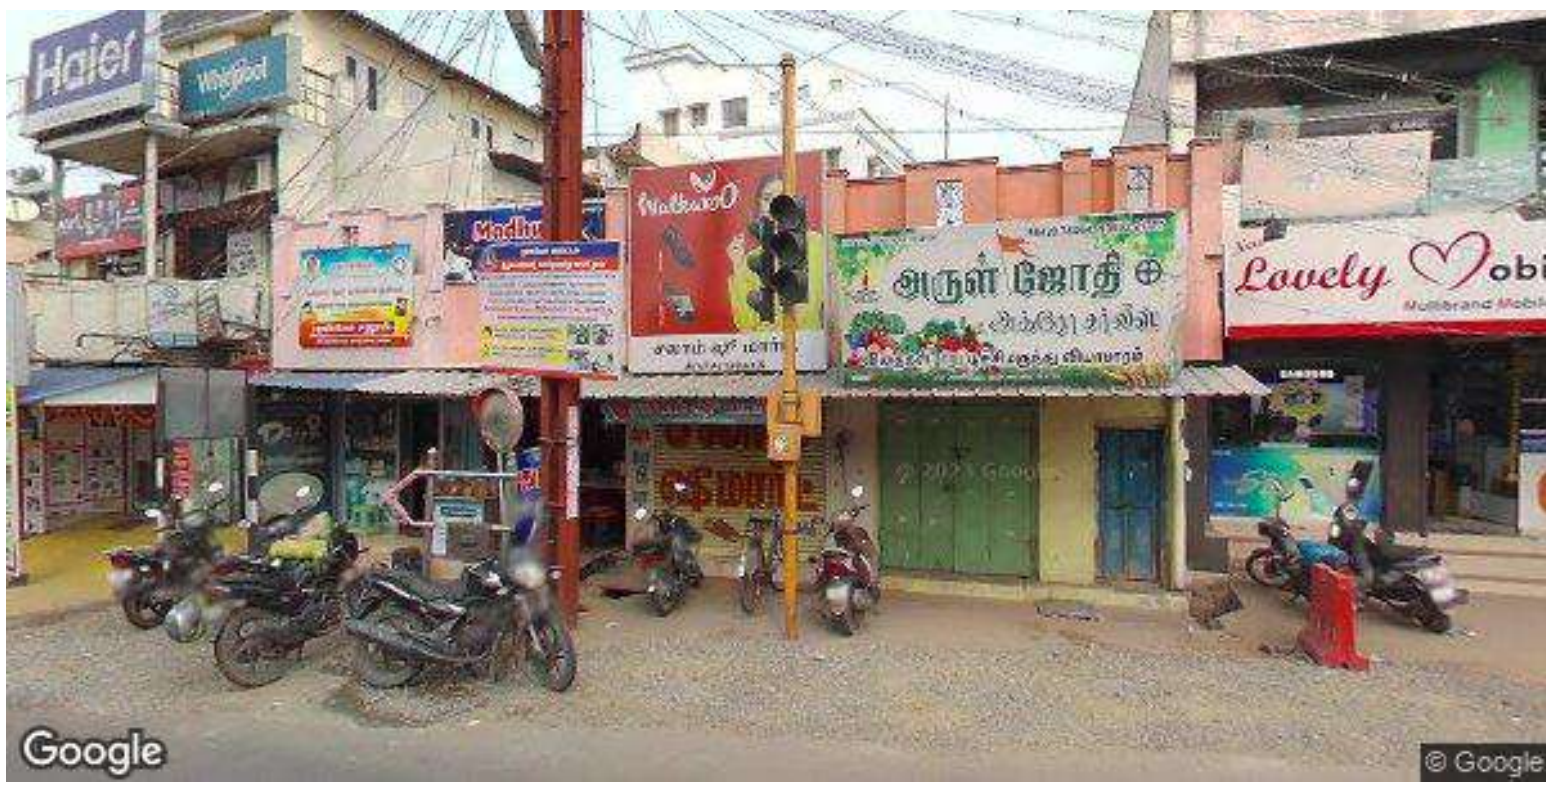
Risk Type: Turn

Risk Level: High

Speed Limit: 15 KM/Hr

Coordinates: 11.37850, 77.89453
