## JOURNEY RISK MANAGEMENT (JRM) STUDY

### Salem Terminal TO JAYAM & CO

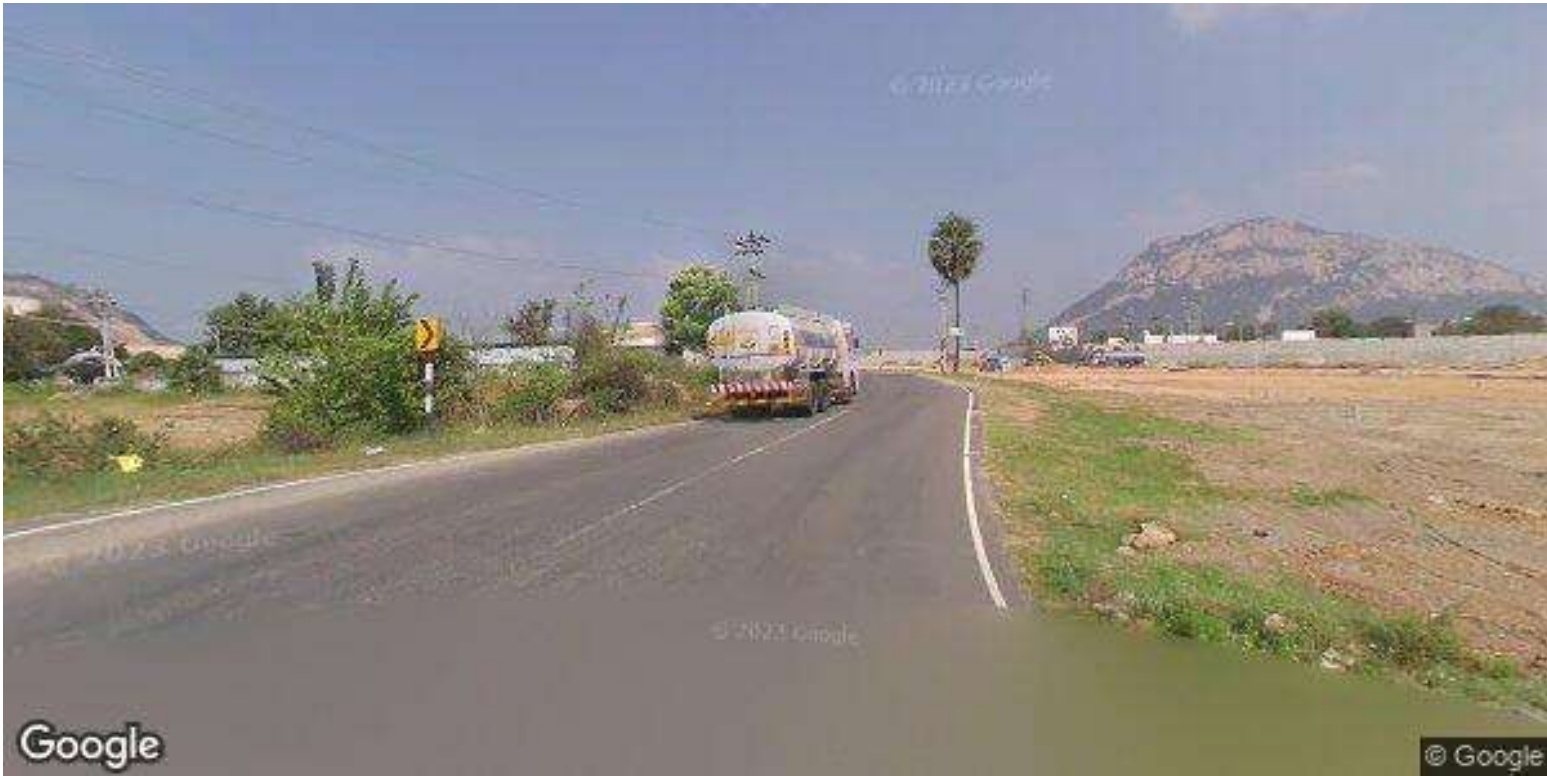
**Risk Type:** Turn  
**Risk Level:** Medium  
**Speed Limit:** 30 KM/Hr  
**Coordinates:** 11.45847, 77.85140

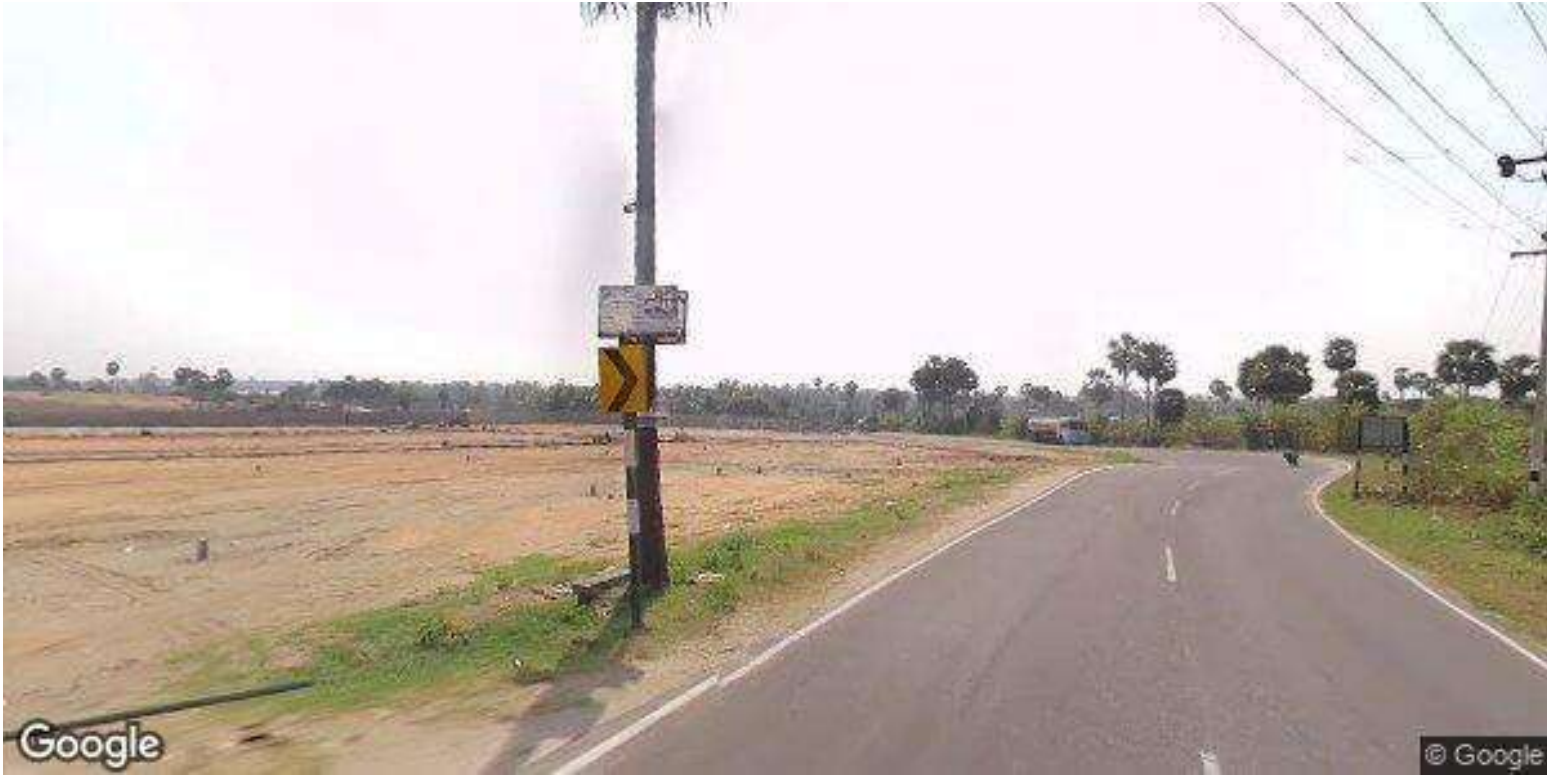
**Risk Type:** Turn  
**Risk Level:** Medium  
**Speed Limit:** 30 KM/Hr  
**Coordinates:** 11.45898, 77.85135

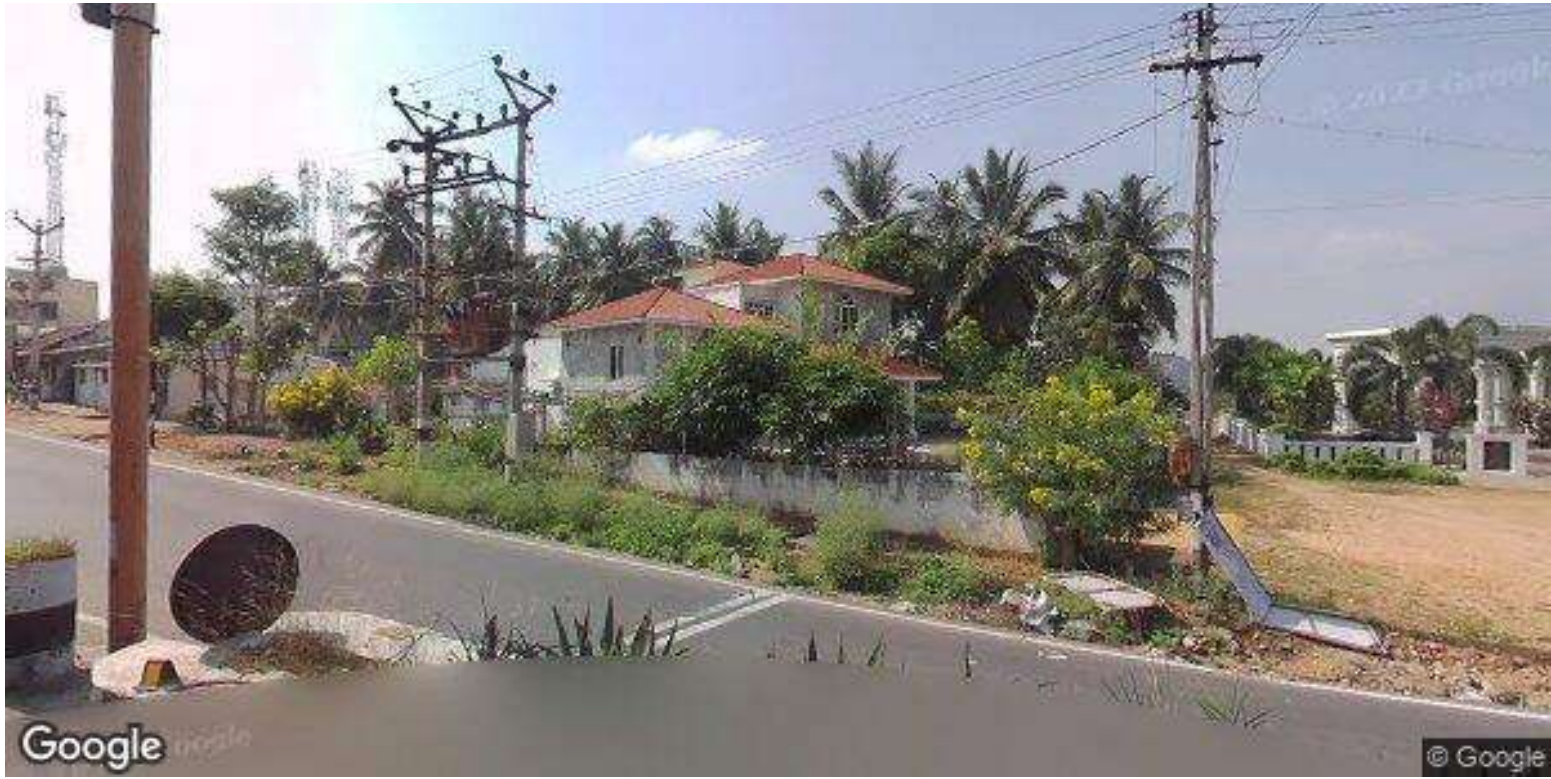
**Risk Type:** Turn  
**Risk Level:** Medium  
**Speed Limit:** 30 KM/Hr  
**Coordinates:** 11.46303, 77.84945

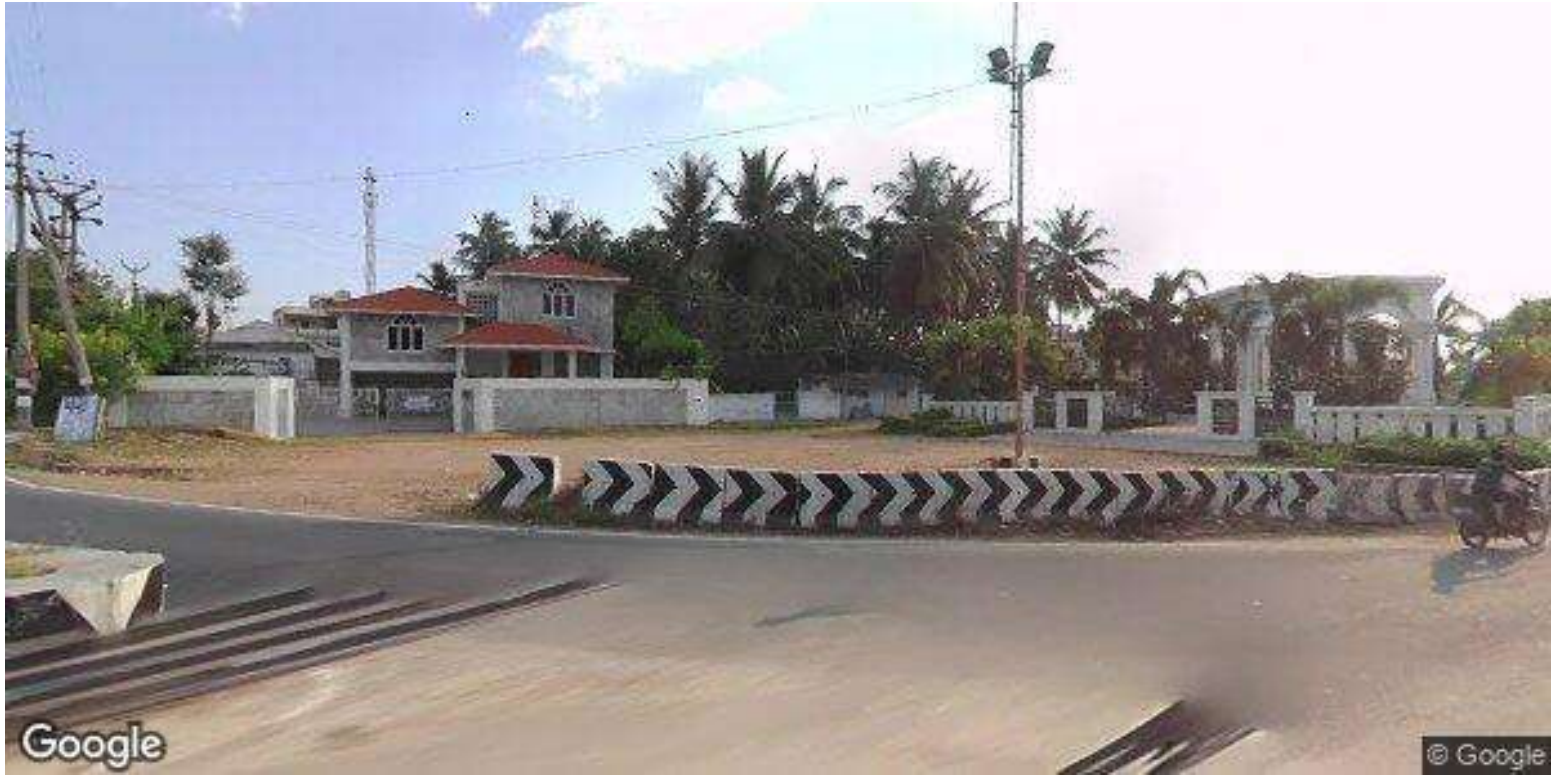
**Risk Type:** Turn  
**Risk Level:** Medium  
**Speed Limit:** 30 KM/Hr  
**Coordinates:** 11.46314, 77.84928

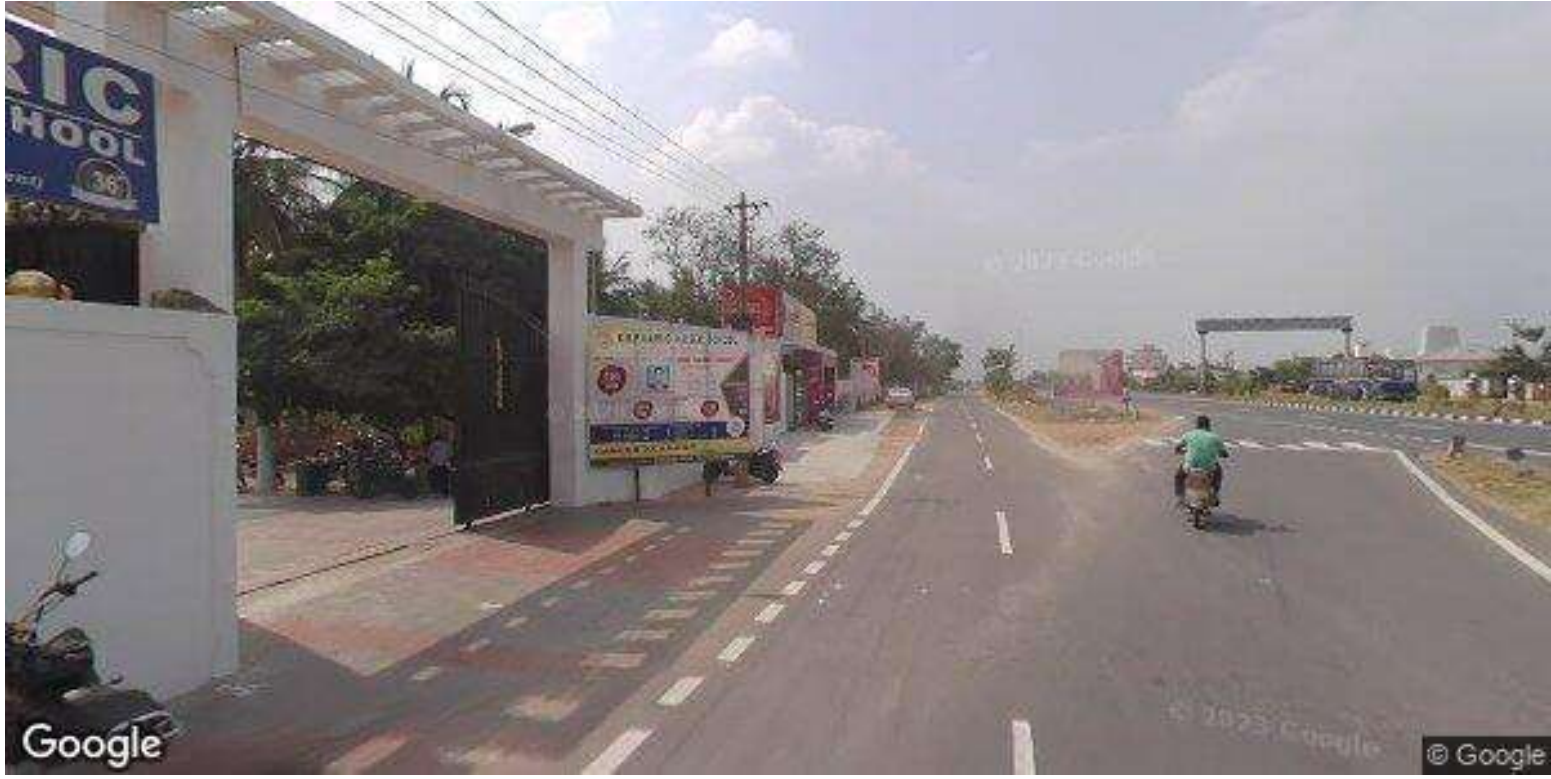
**Risk Type:** Turn  
**Risk Level:** Medium  
**Speed Limit:** 30 KM/Hr  
**Coordinates:** 11.45509, 77.81383

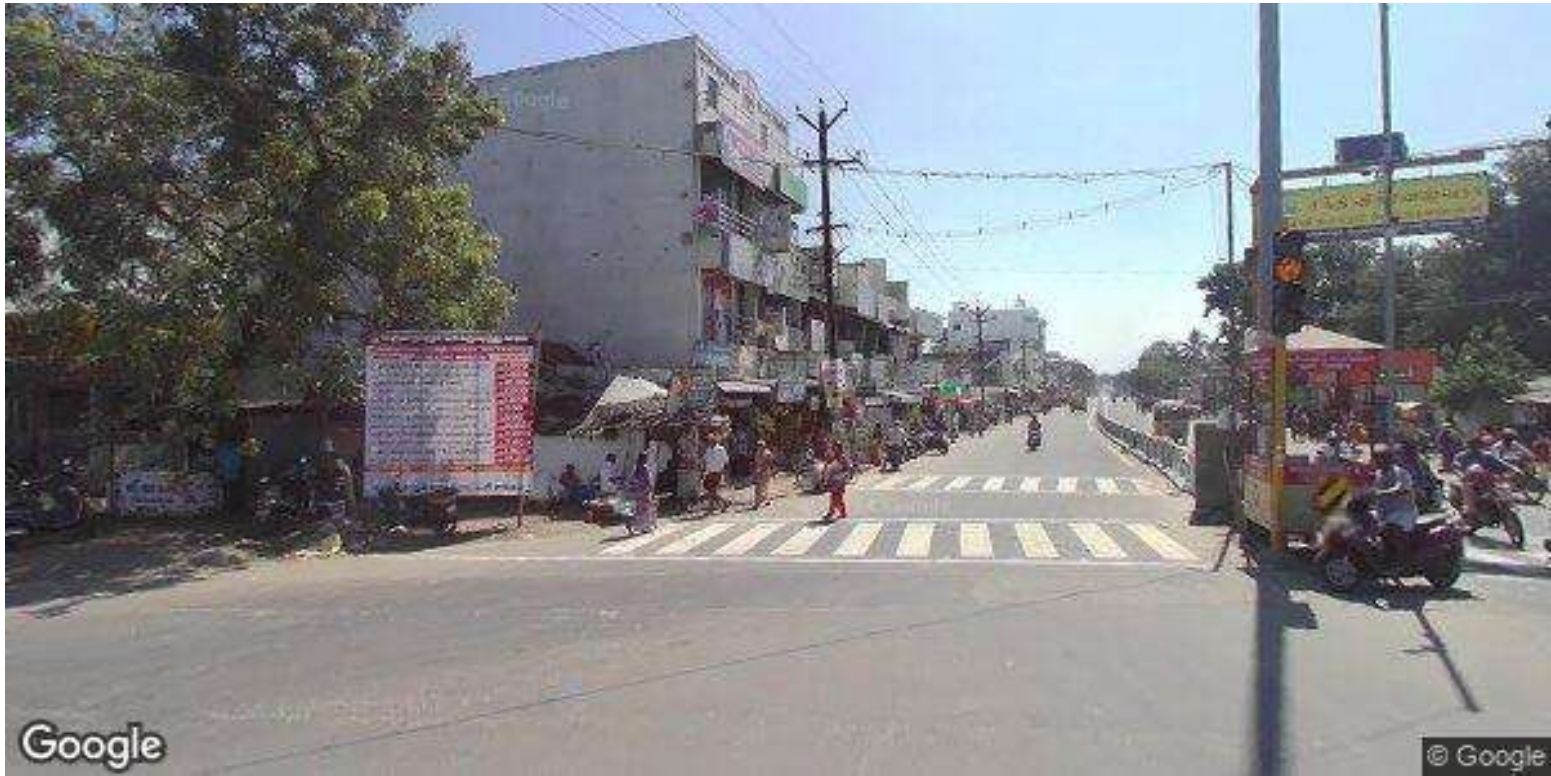
**Risk Type:** Turn  
**Risk Level:** High  
**Speed Limit:** 15 KM/Hr  
**Coordinates:** 11.20728, 77.35914

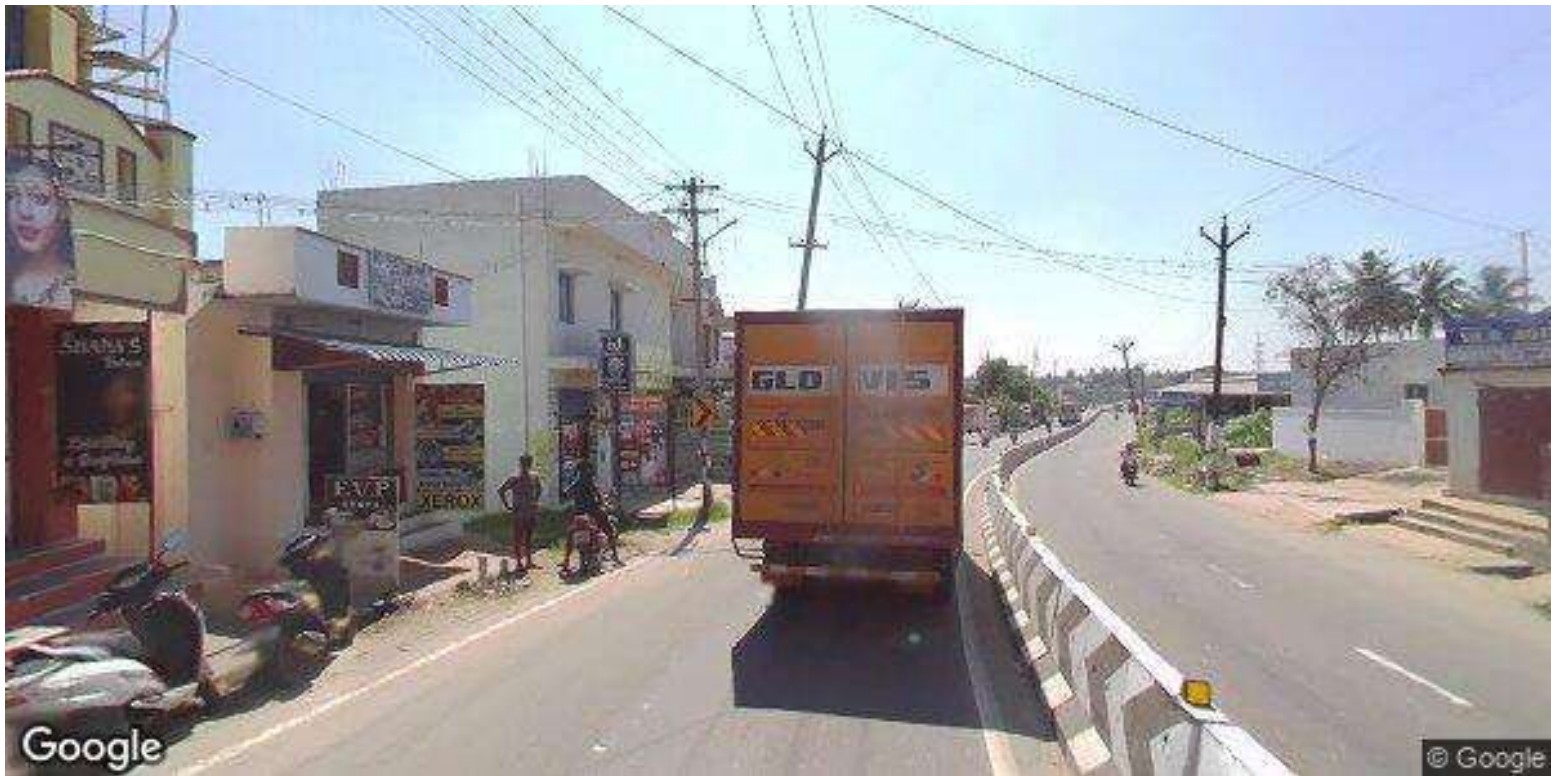
**Risk Type:** Turn  
**Risk Level:** Medium  
**Speed Limit:** 30 KM/Hr  
**Coordinates:** 11.20246, 77.35895

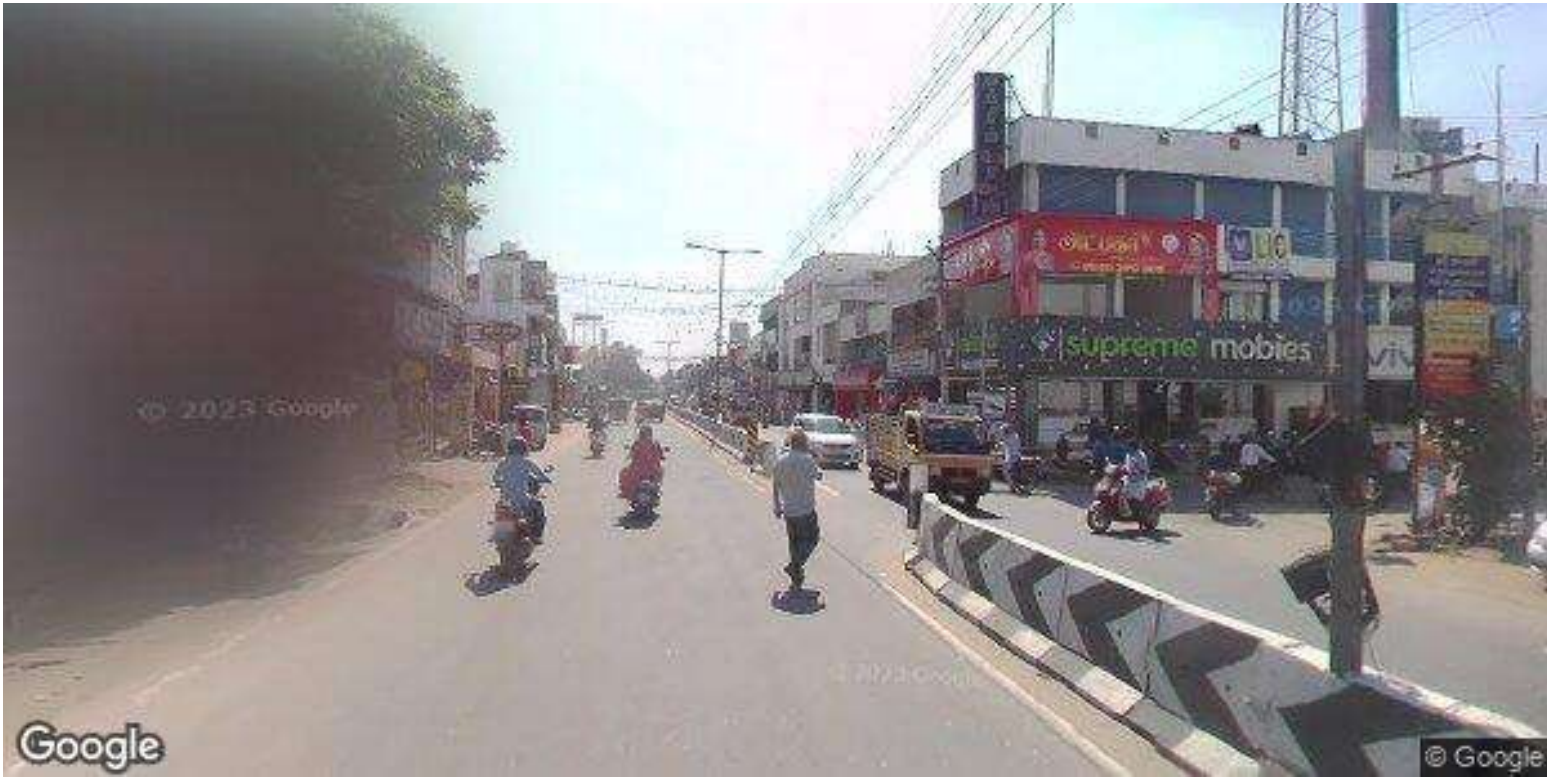
**Risk Type:** Turn  
**Risk Level:** Medium  
**Speed Limit:** 30 KM/Hr  
**Coordinates:** 11.13132, 77.34190

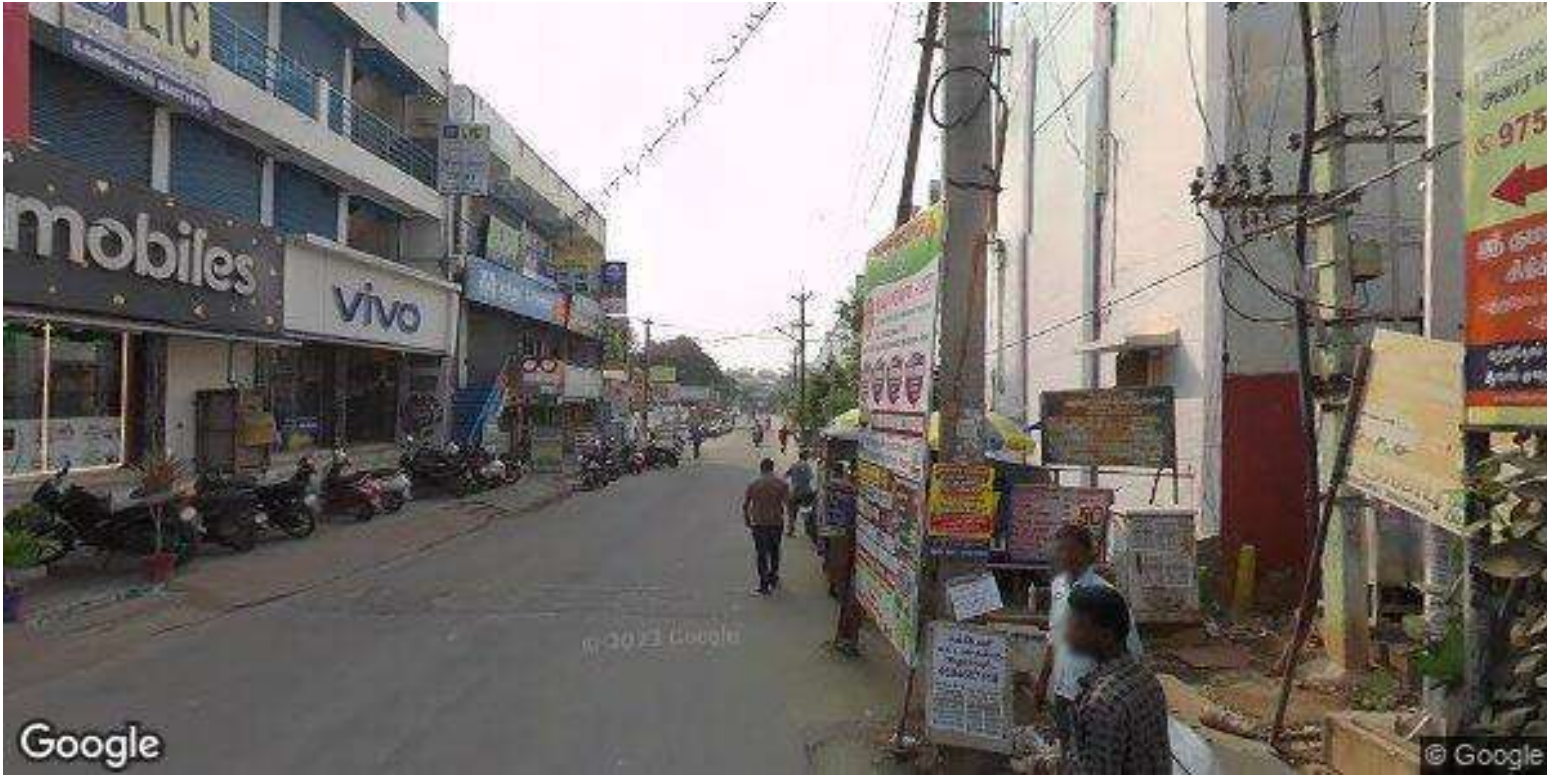
**Risk Type:** Turn  
**Risk Level:** High  
**Speed Limit:** 15 KM/Hr  
**Coordinates:** 11.13122, 77.34181

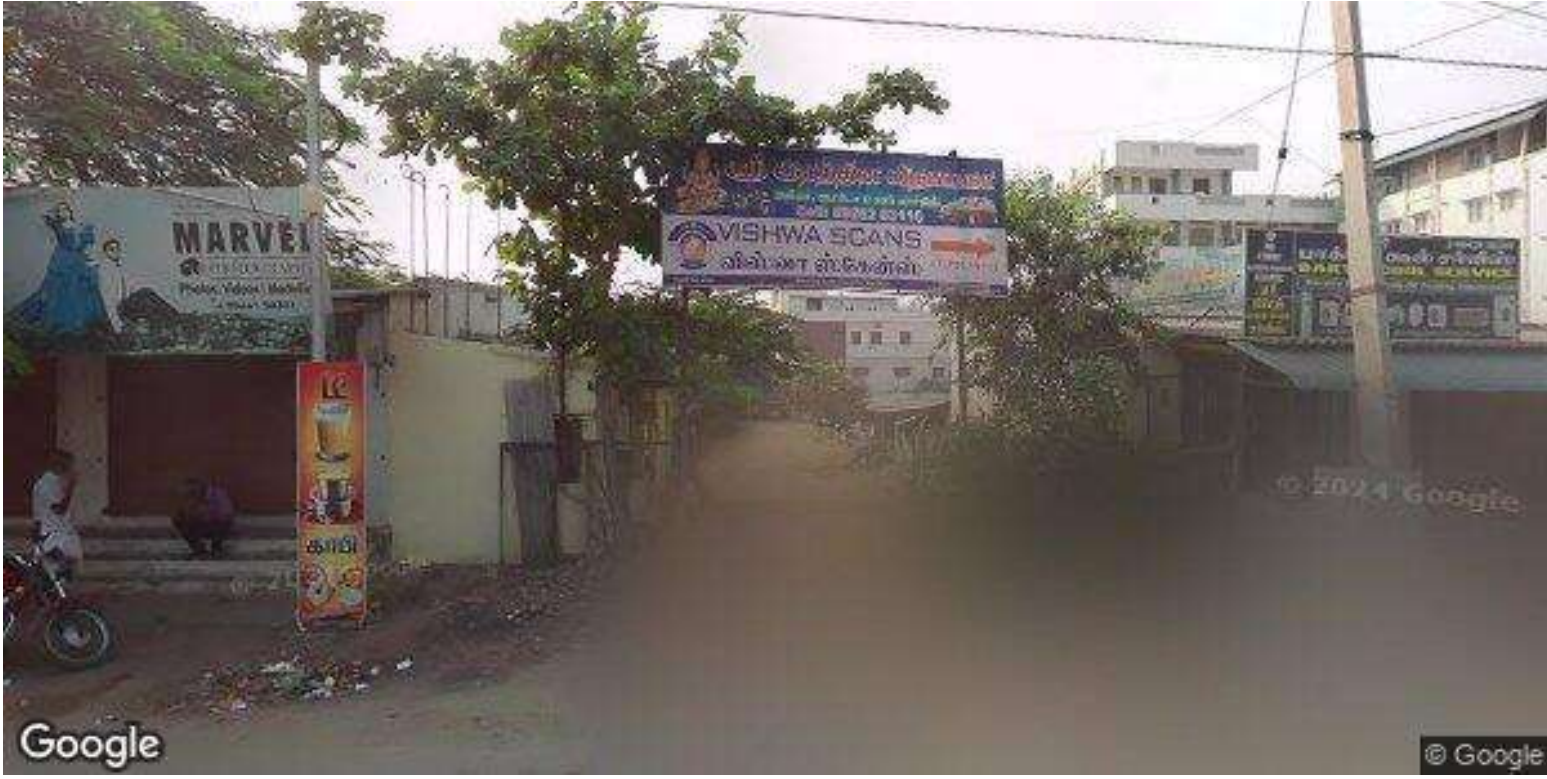
**Risk Type:** Turn  
**Risk Level:** High  
**Speed Limit:** 15 KM/Hr  
**Coordinates:** 11.13131, 77.34033

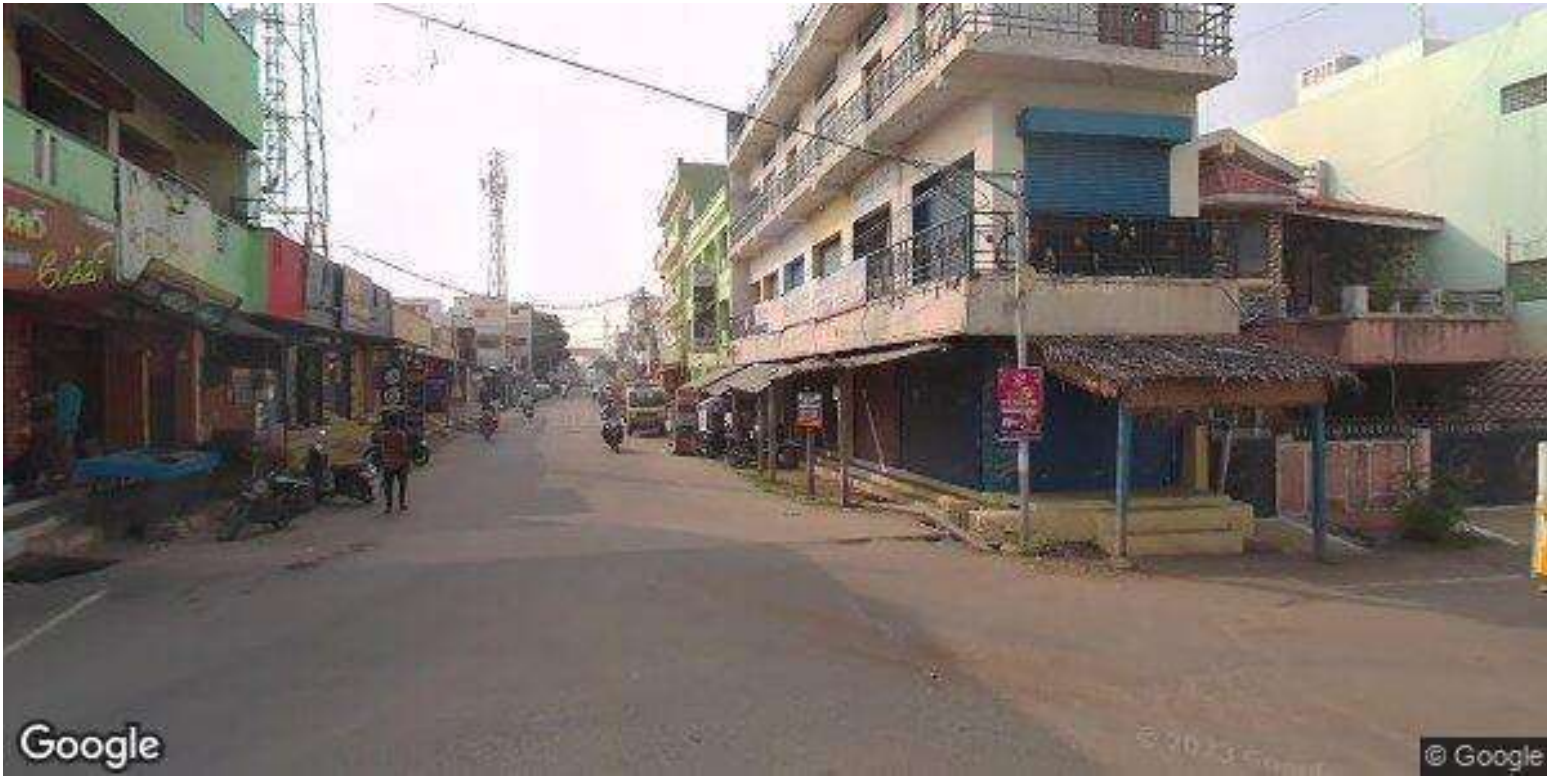
**Risk Type:** Blind Spot  
**Risk Level:** Blind Spot  
**Speed Limit:** 10 KM/Hr  
**Coordinates:** 11.12933, 77.34007

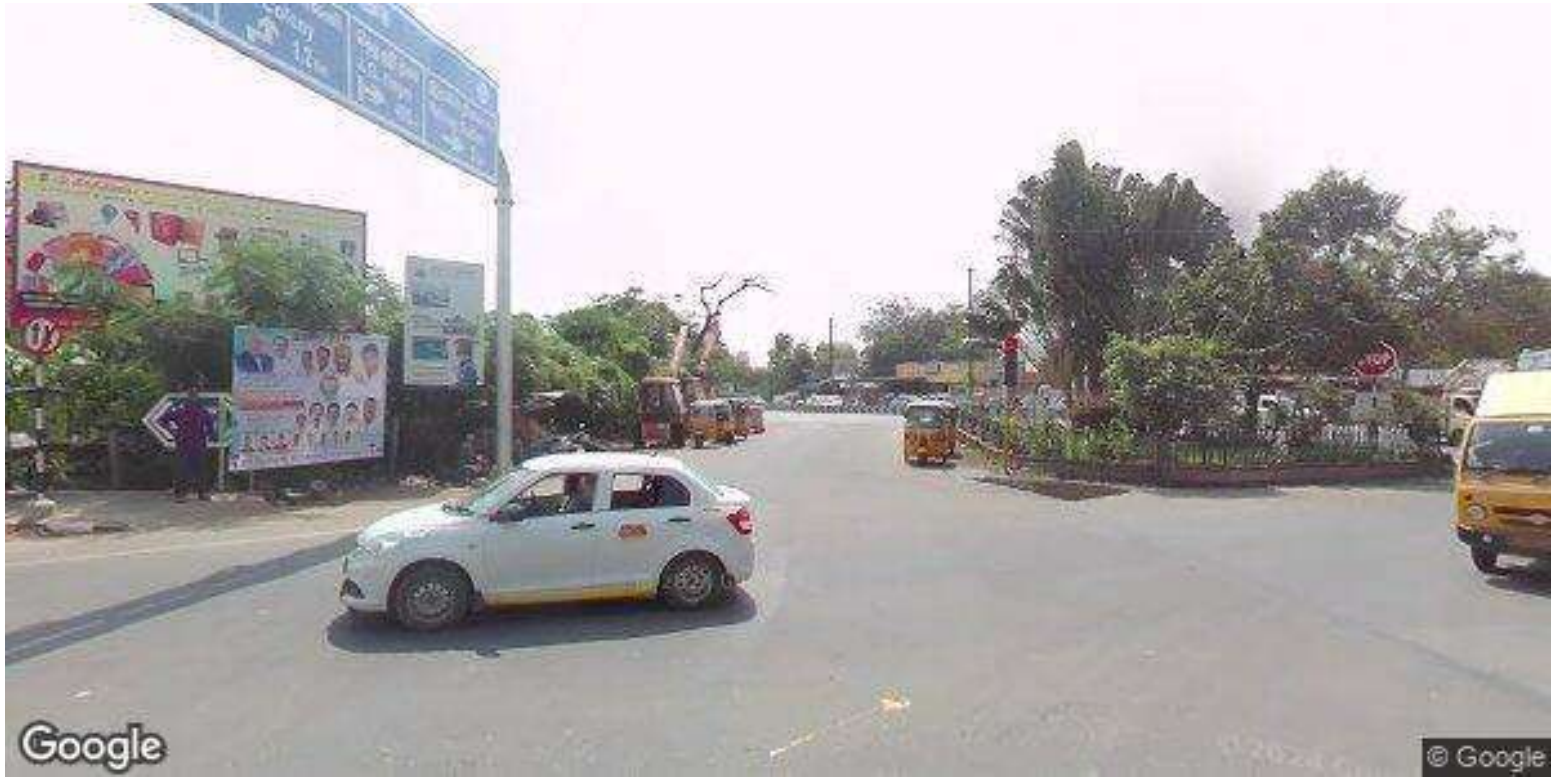
Risk Type: Turn  
Risk Level: High  
Speed Limit: 15 KM/Hr  
Coordinates: 11.12201, 77.33196

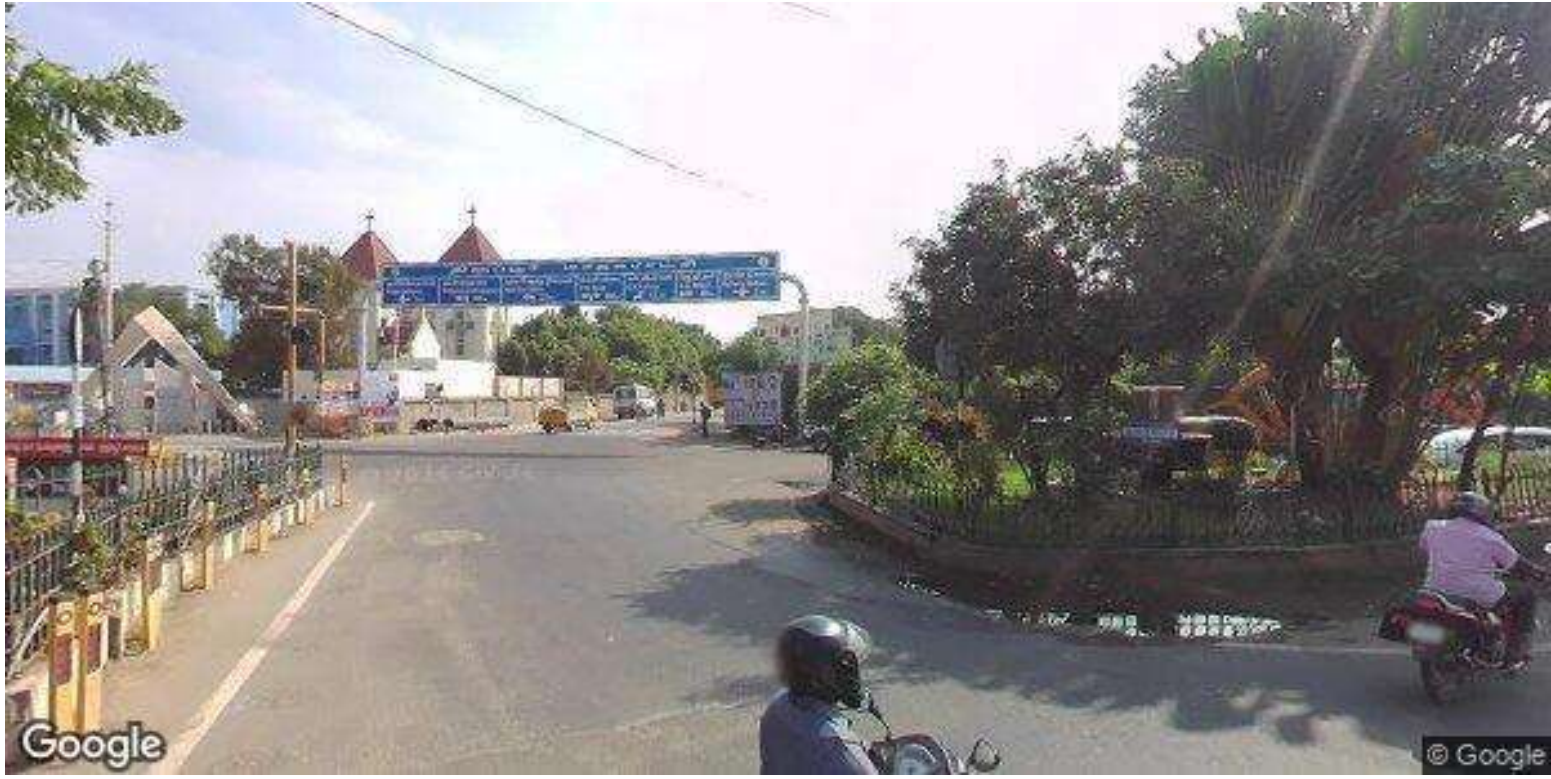
Risk Type: Turn  
Risk Level: High  
Speed Limit: 15 KM/Hr  
Coordinates: 11.12187, 77.33169
