## **JOURNEY RISK MANAGEMENT (JRM) STUDY**

**Salem Terminal TO NALLAVALLEIAMMAN  
PETROLEUM AG**

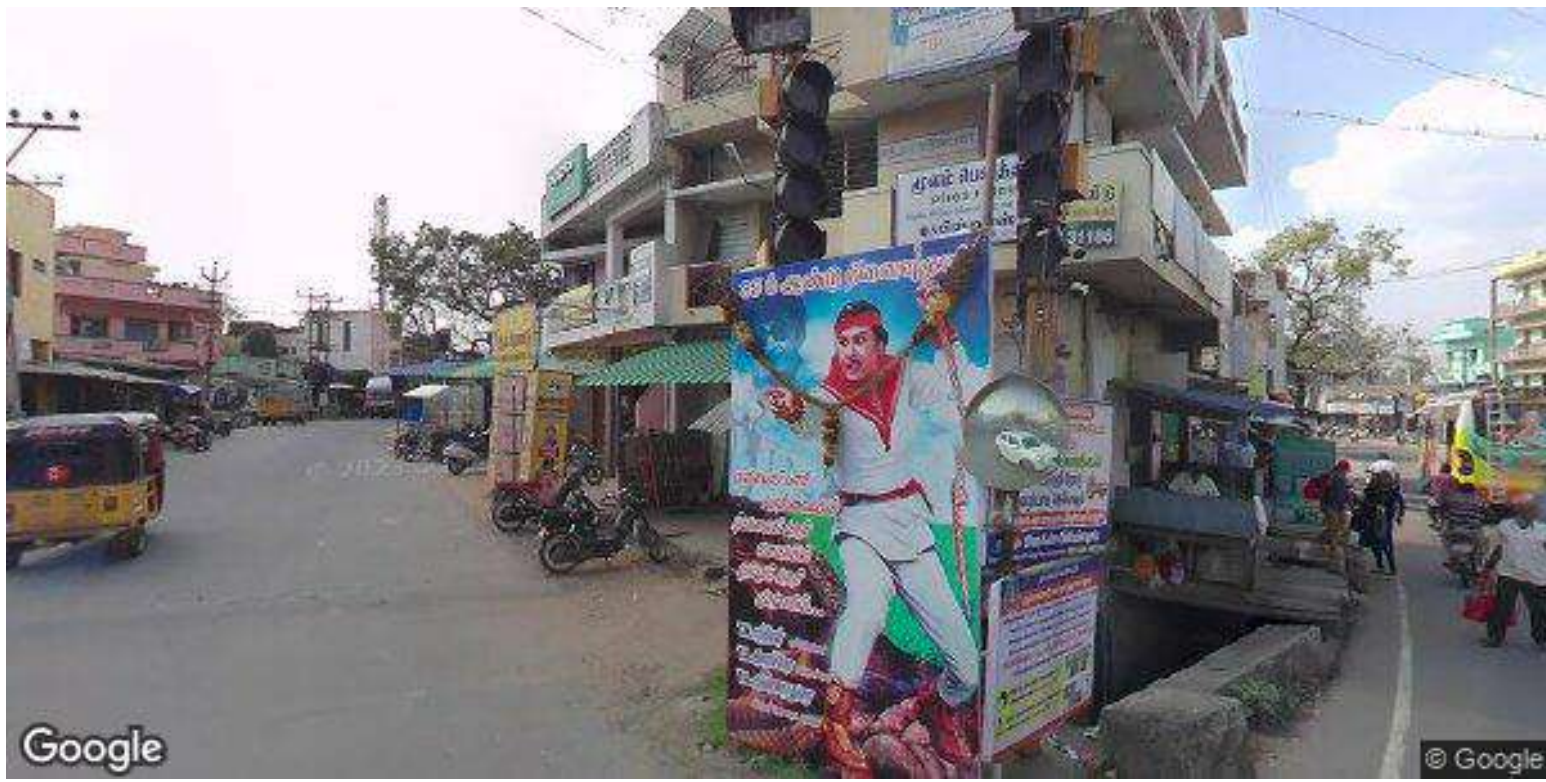
**Coordinates:** 11.38342, 77.89975

**Risk Type:** Turn

**Risk Level:** Medium

**Speed Limit:** 30 KM/Hr

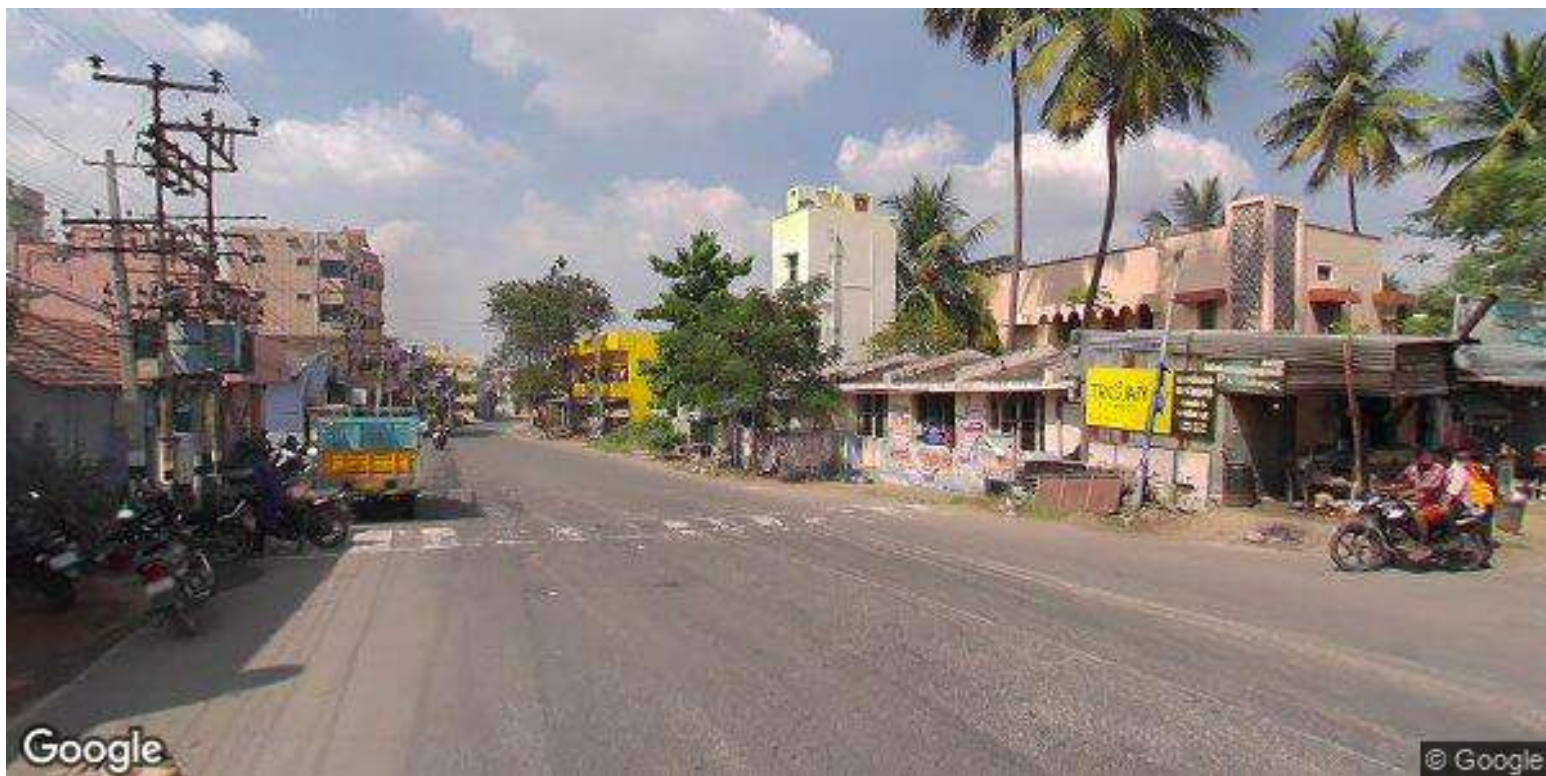
**Coordinates:** 11.38190, 77.90254

**Risk Type:** Turn

**Risk Level:** High

**Speed Limit:** 15 KM/Hr

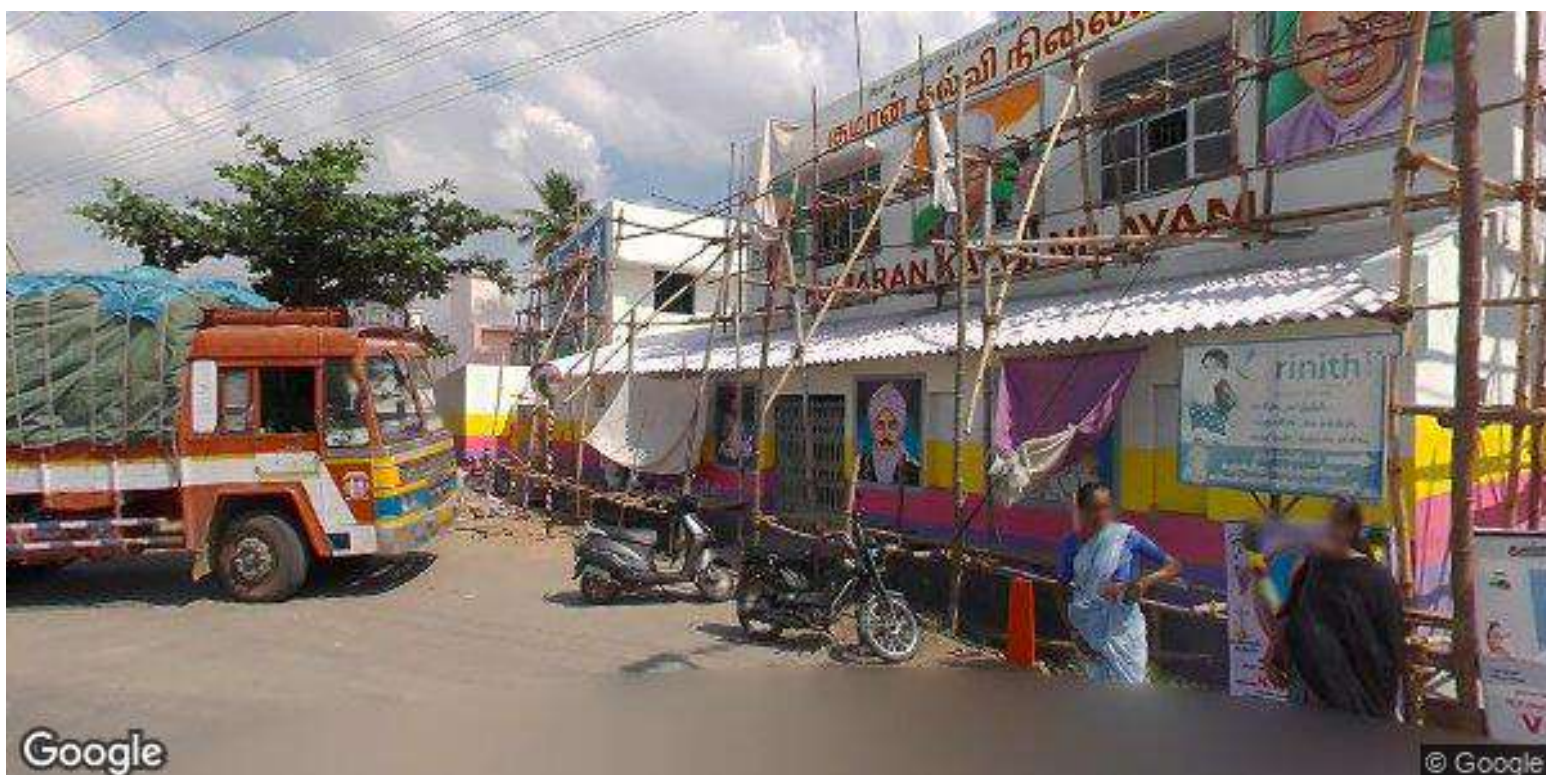
**Coordinates: 11.38182, 77.90259**

**Risk Type: Turn**

**Risk Level: Medium**

**Speed Limit: 30 KM/Hr**

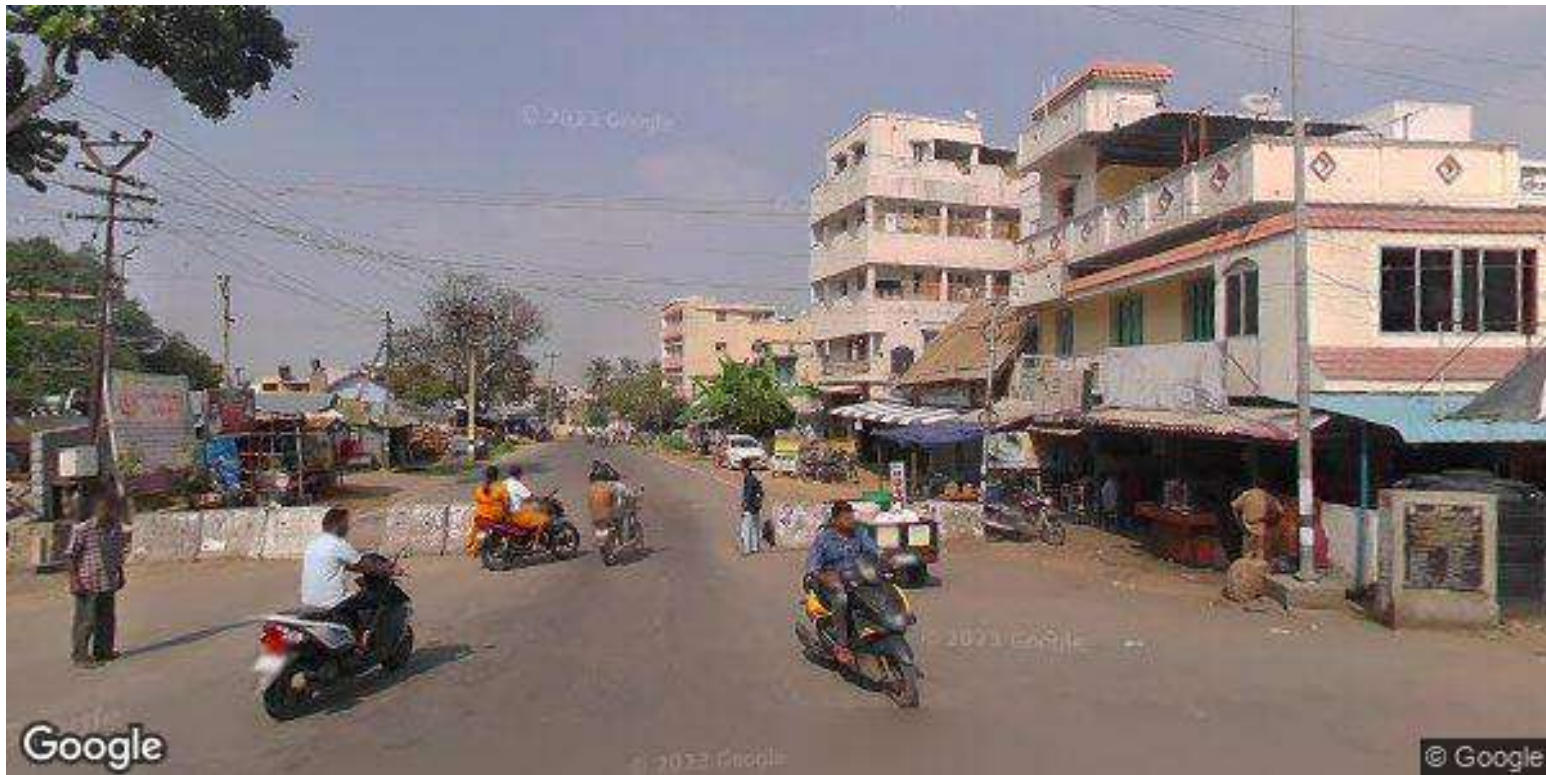
**Coordinates: 11.37841, 77.90140**

**Risk Type: Blind Spot**

**Risk Level: Blind Spot**

**Speed Limit: 10 KM/Hr**

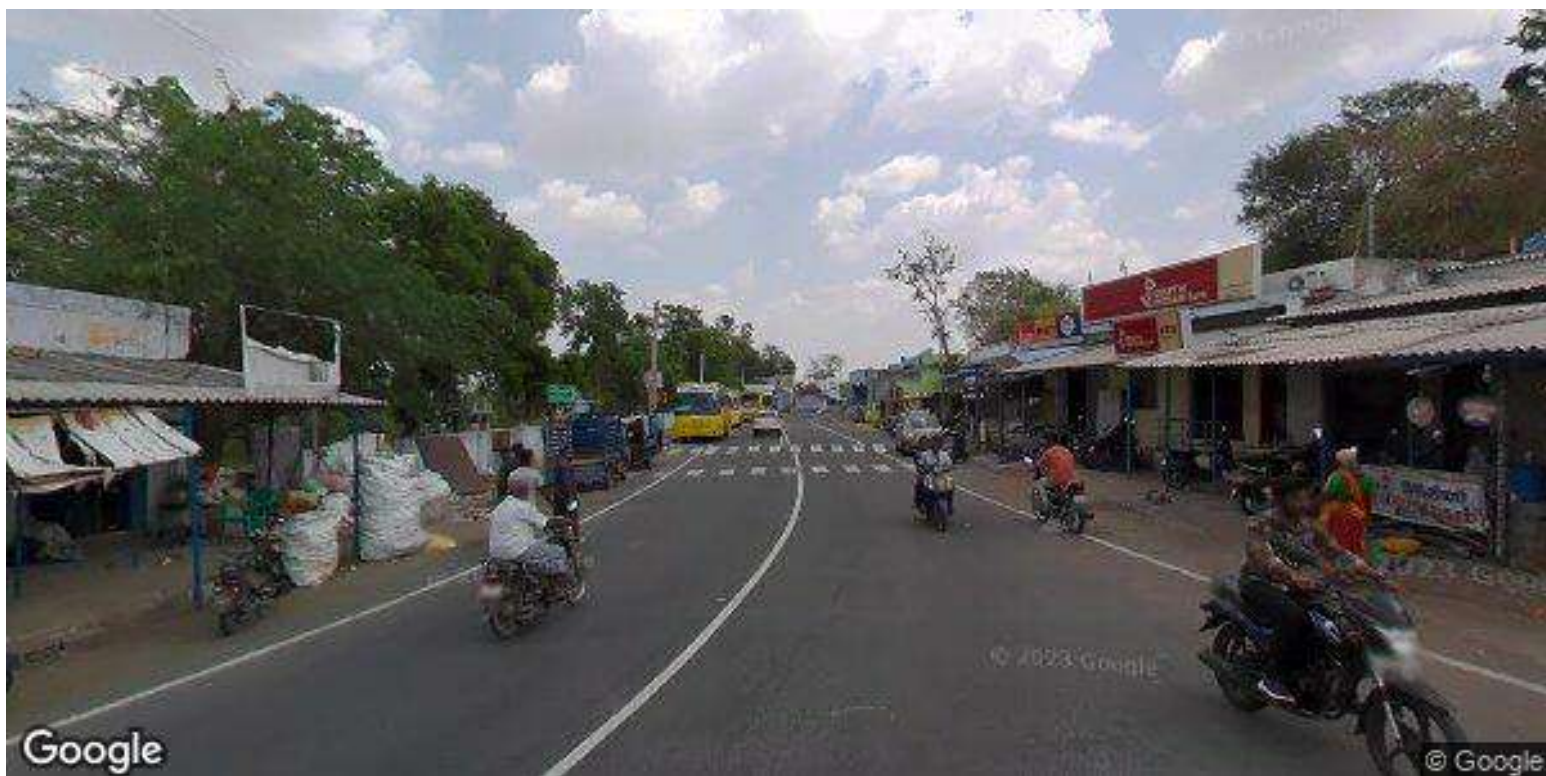
**Coordinates: 11.41447, 78.08063**

**Risk Type: Turn**

**Risk Level: Medium**

**Speed Limit: 30 KM/Hr**

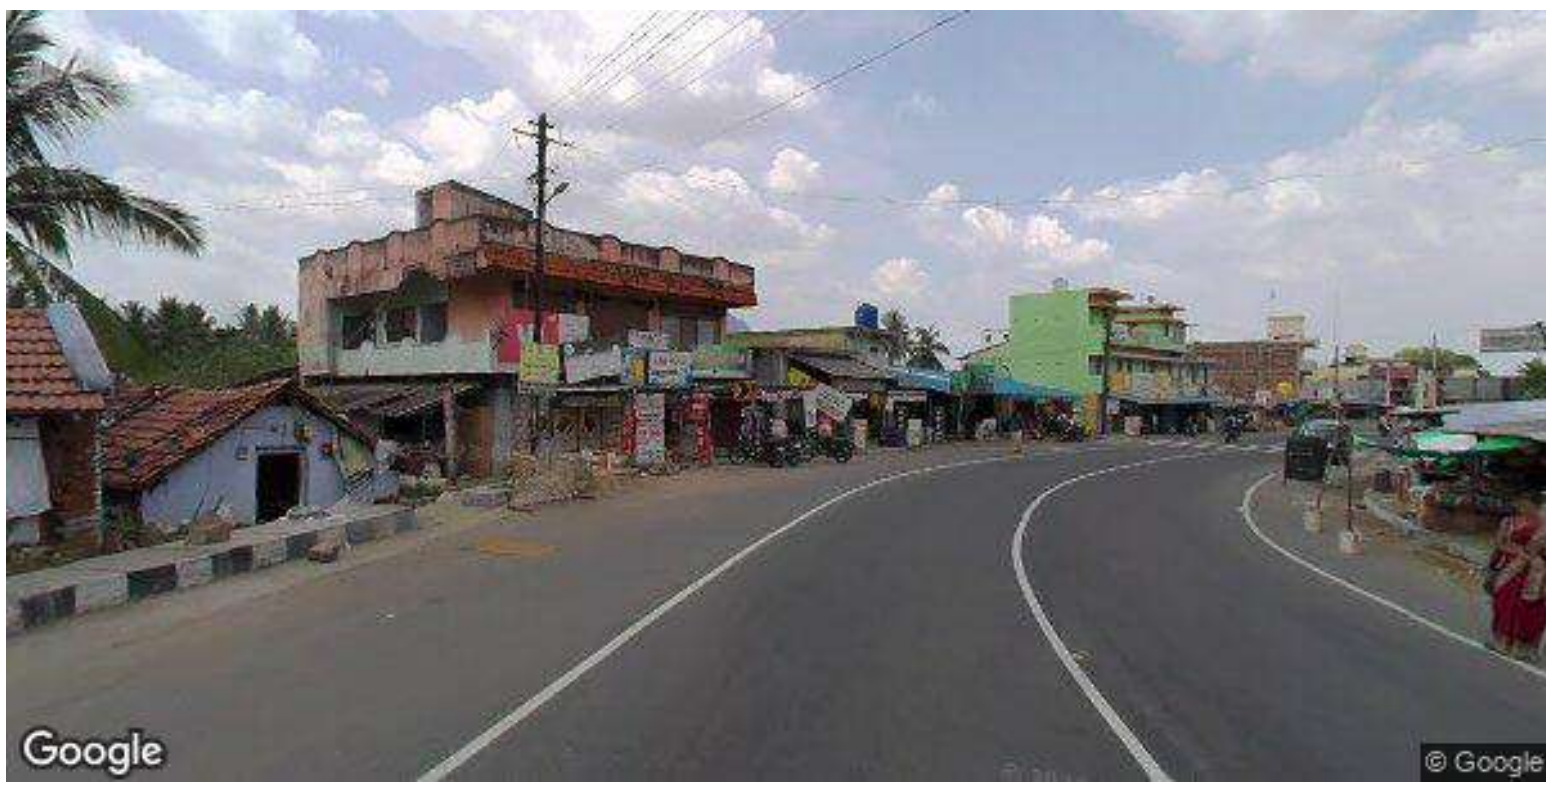
**Coordinates:** 11.41468, 78.08072

**Risk Type:** Turn

**Risk Level:** Medium

**Speed Limit:** 30 KM/Hr

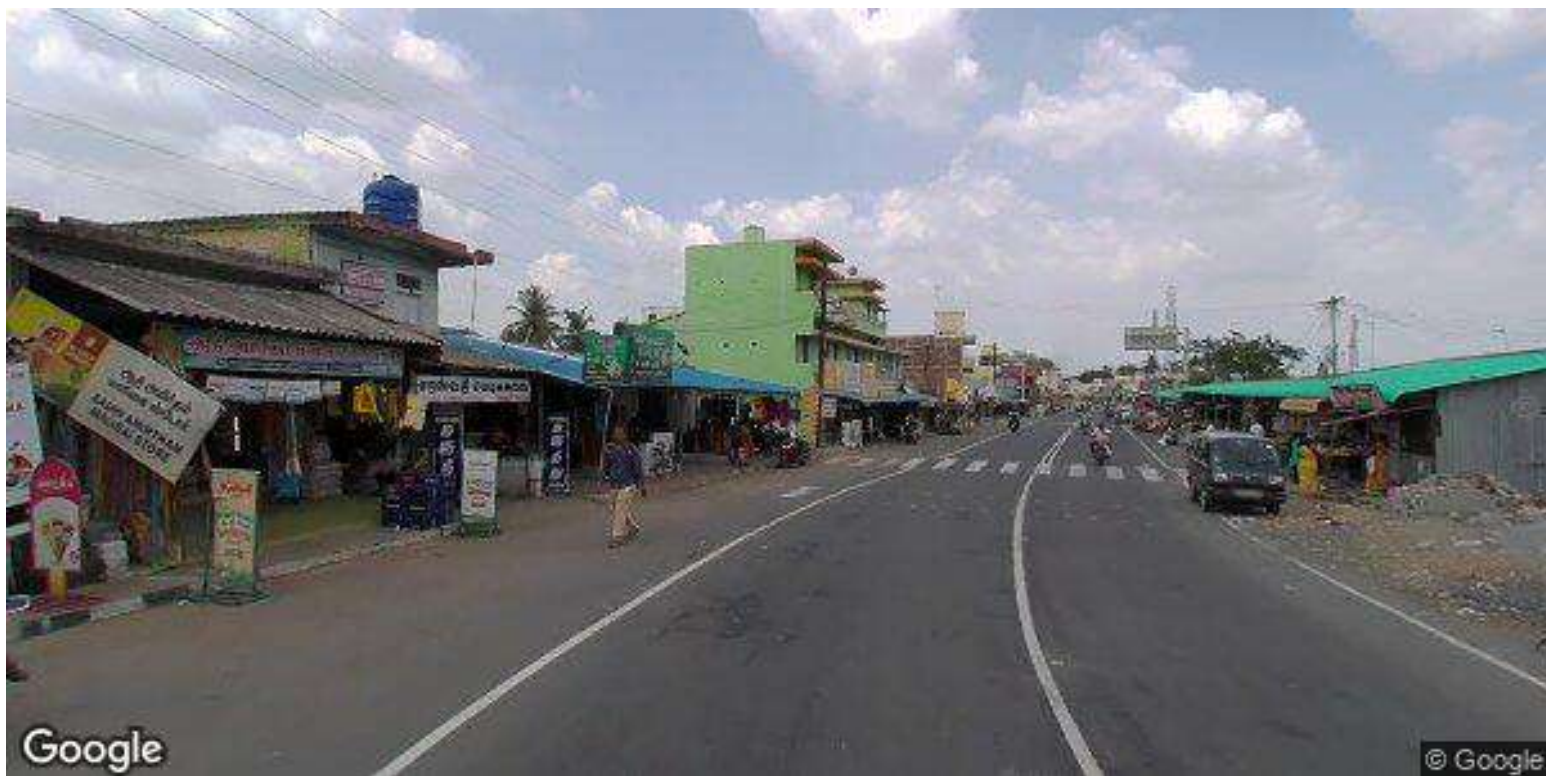
**Coordinates:** 11.41475, 78.08087

**Risk Type:** Turn

**Risk Level:** Medium

**Speed Limit:** 30 KM/Hr

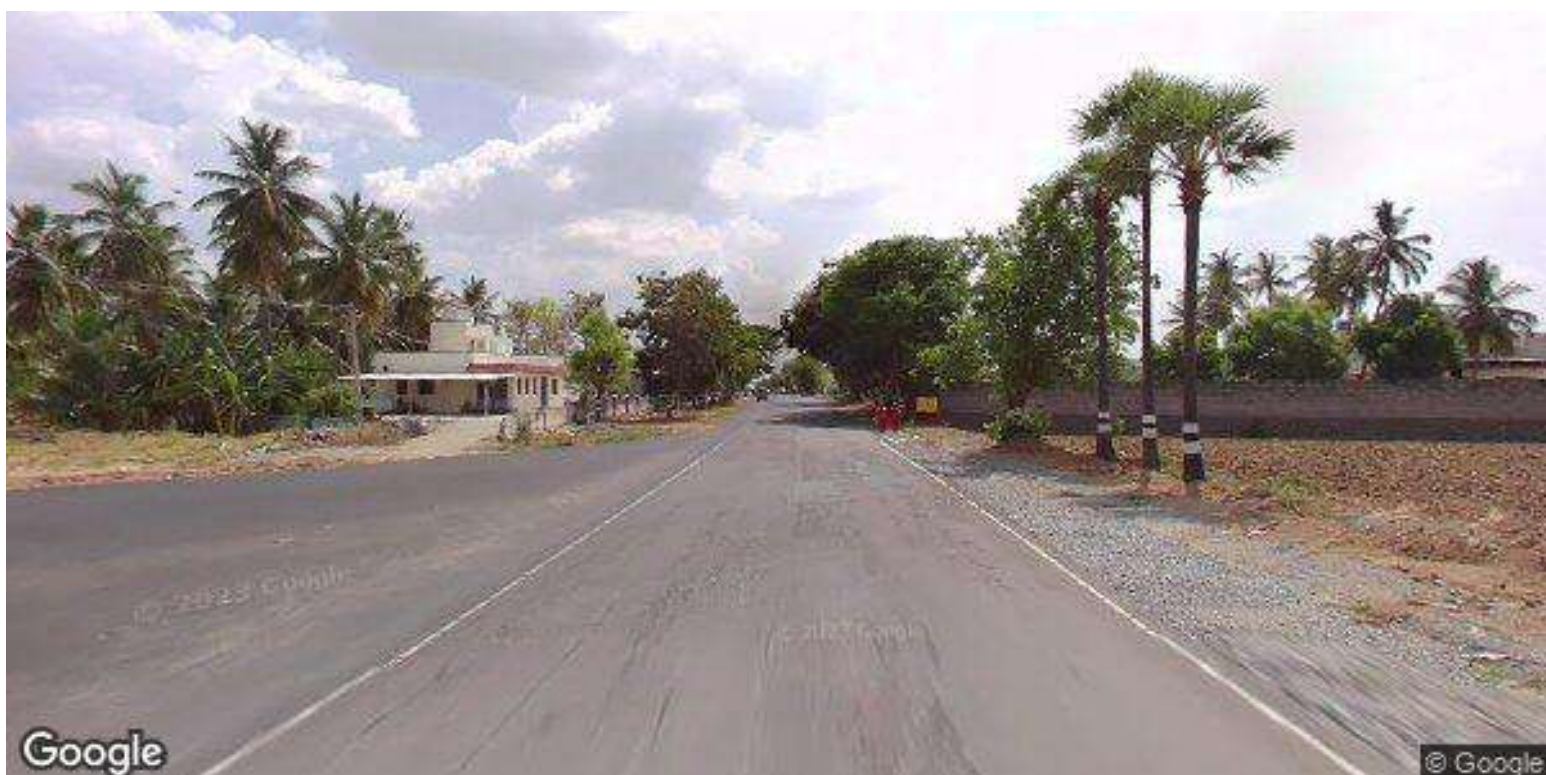
**Risk Type:** Turn  
**Risk Level:** High  
**Speed Limit:** 15 KM/Hr  
**Coordinates:** 11.42964, 78.11587

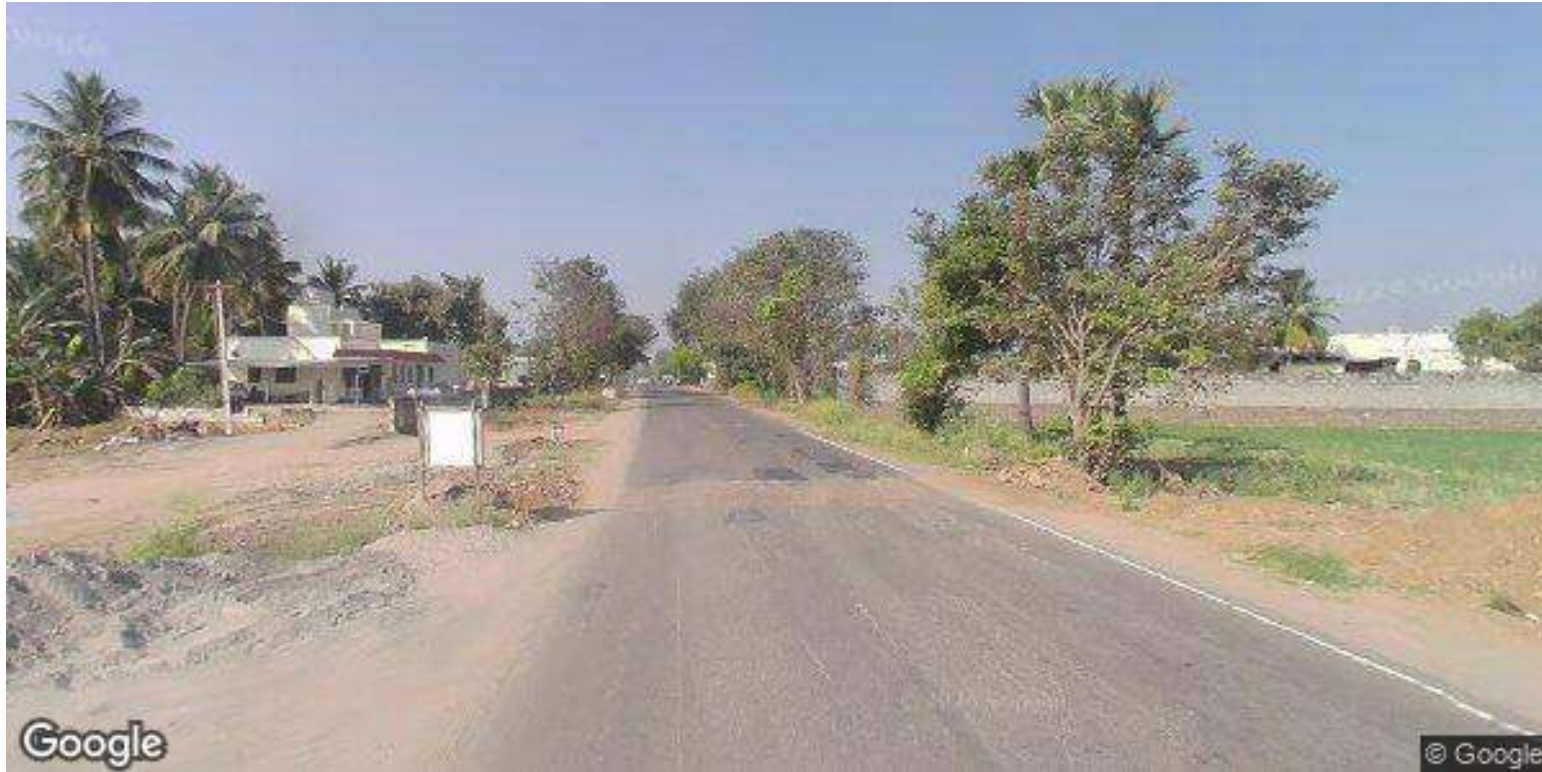
**Risk Type:** Turn  
**Risk Level:** Medium  
**Speed Limit:** 30 KM/Hr  
**Coordinates:** 11.42956, 78.11590

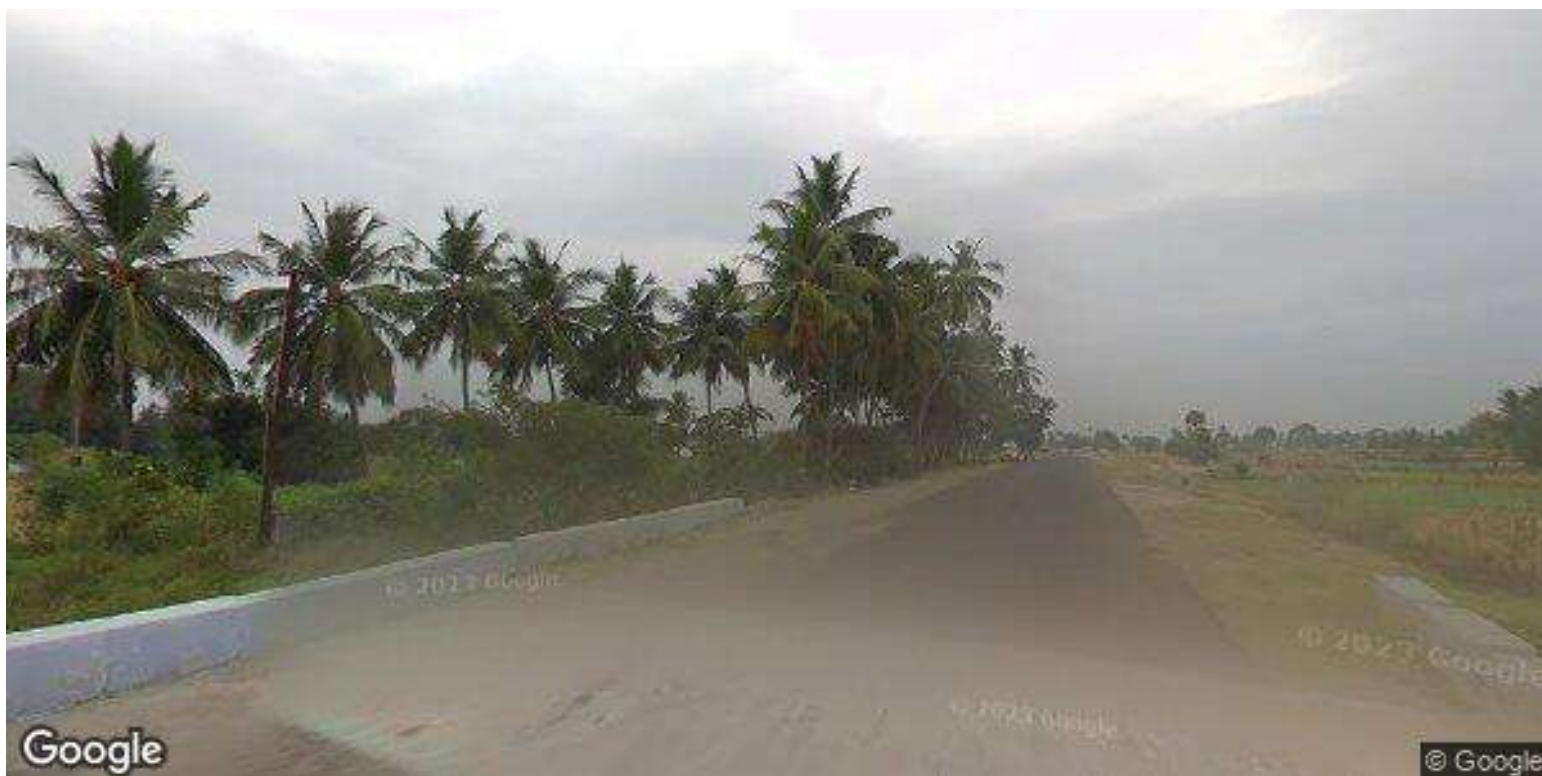
**Risk Type:** Turn  
**Risk Level:** Medium  
**Speed Limit:** 30 KM/Hr  
**Coordinates:** 11.42450, 78.15278

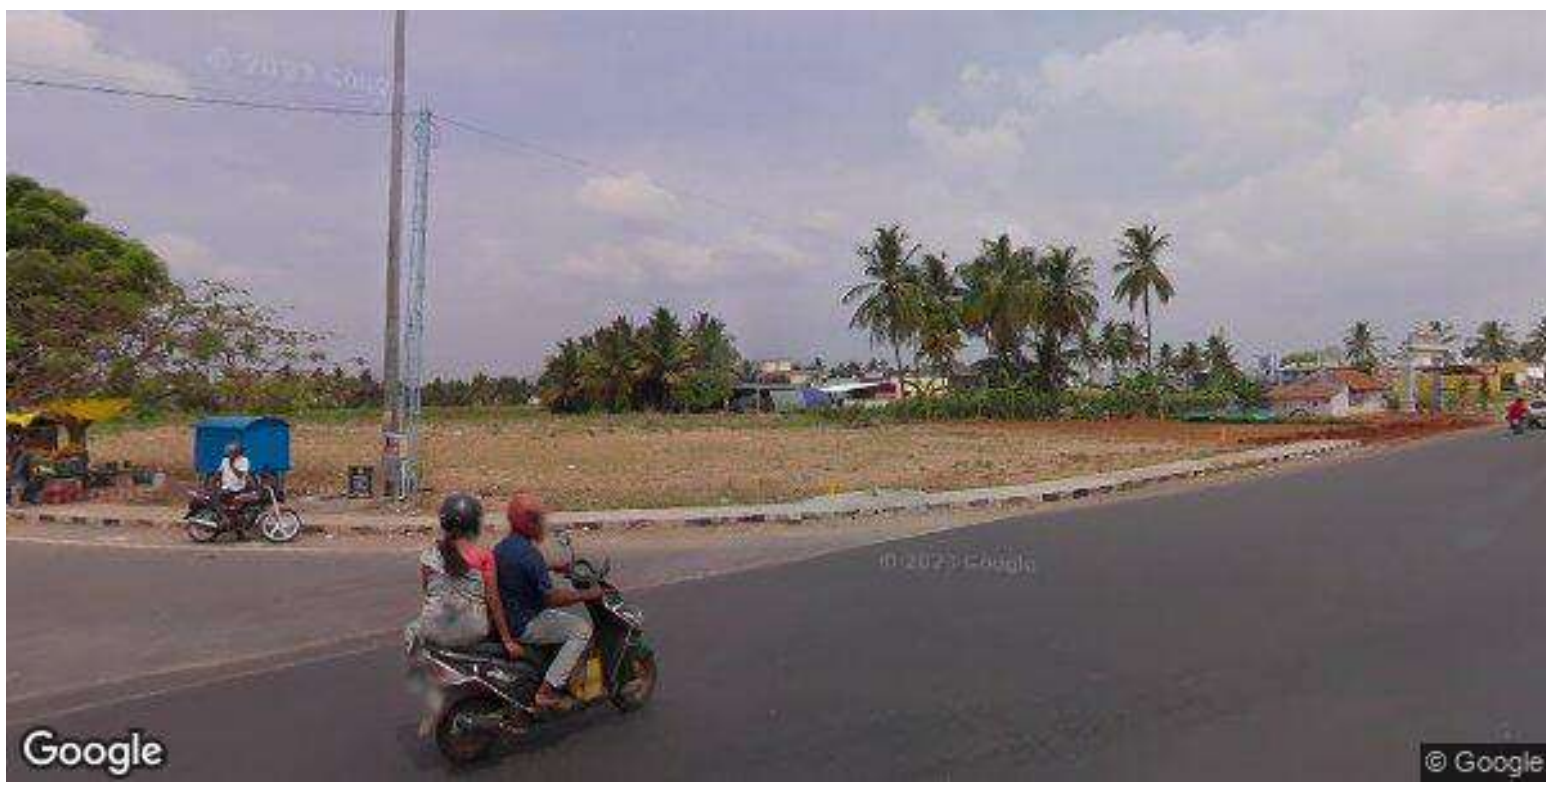
**Risk Type:** Blind Spot  
**Risk Level:** Blind Spot  
**Speed Limit:** 10 KM/Hr  
**Coordinates:** 11.43540, 78.20751

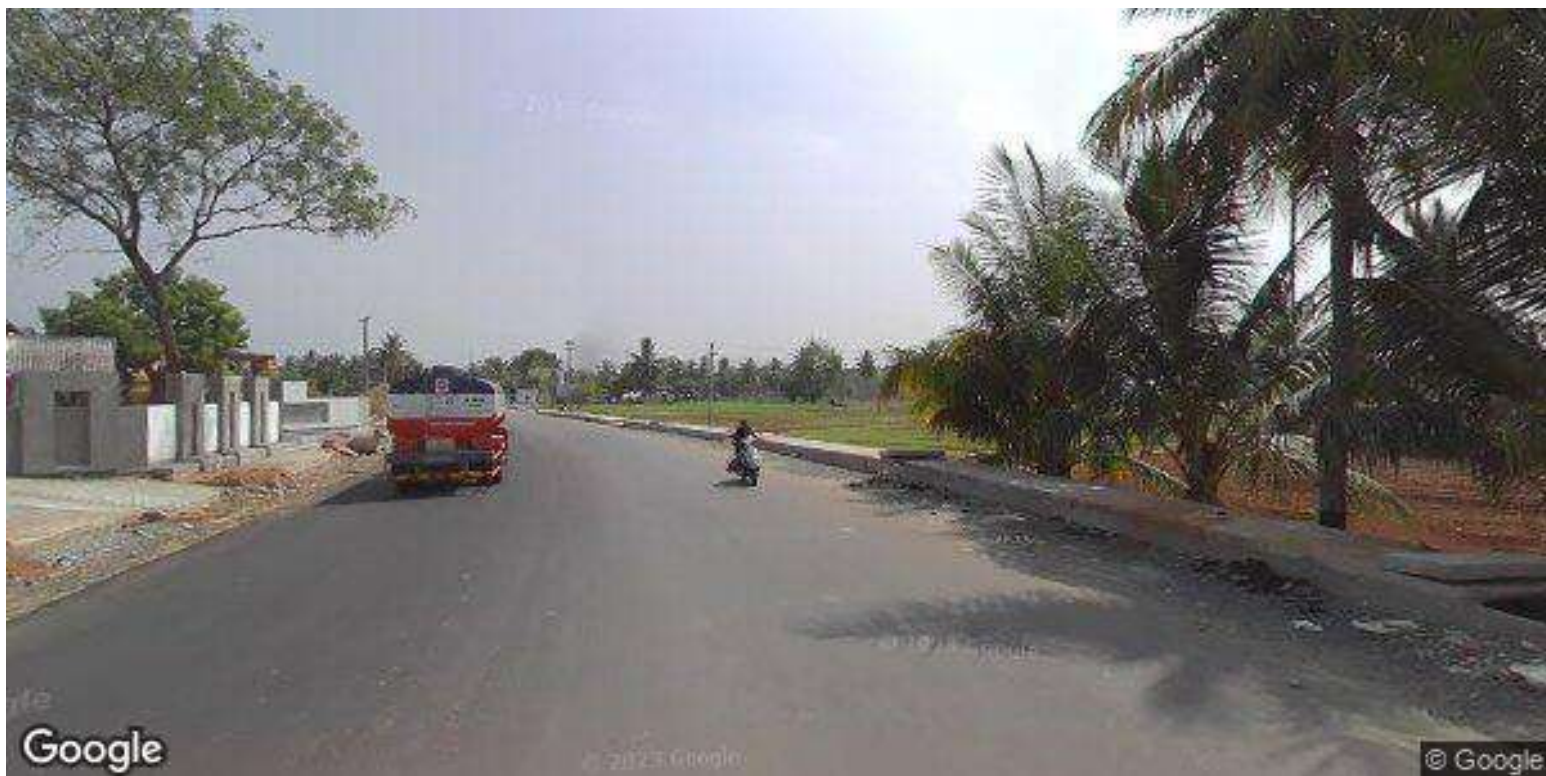
**Risk Type:** Turn  
**Risk Level:** Medium  
**Speed Limit:** 30 KM/Hr  
**Coordinates:** 11.43040, 78.20860

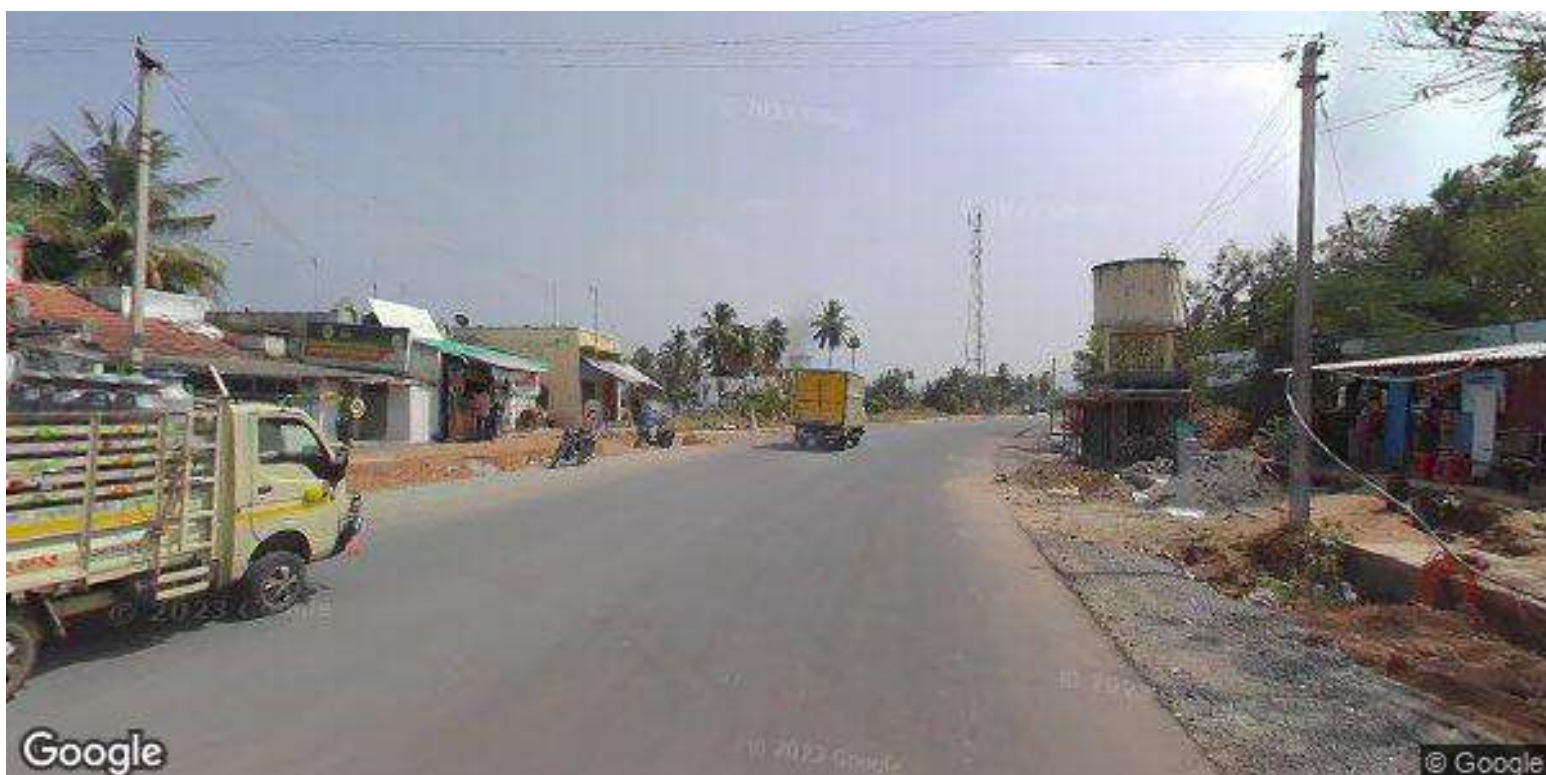
**Risk Type:** Turn  
**Risk Level:** Medium  
**Speed Limit:** 30 KM/Hr  
**Coordinates:** 11.42751, 78.21298

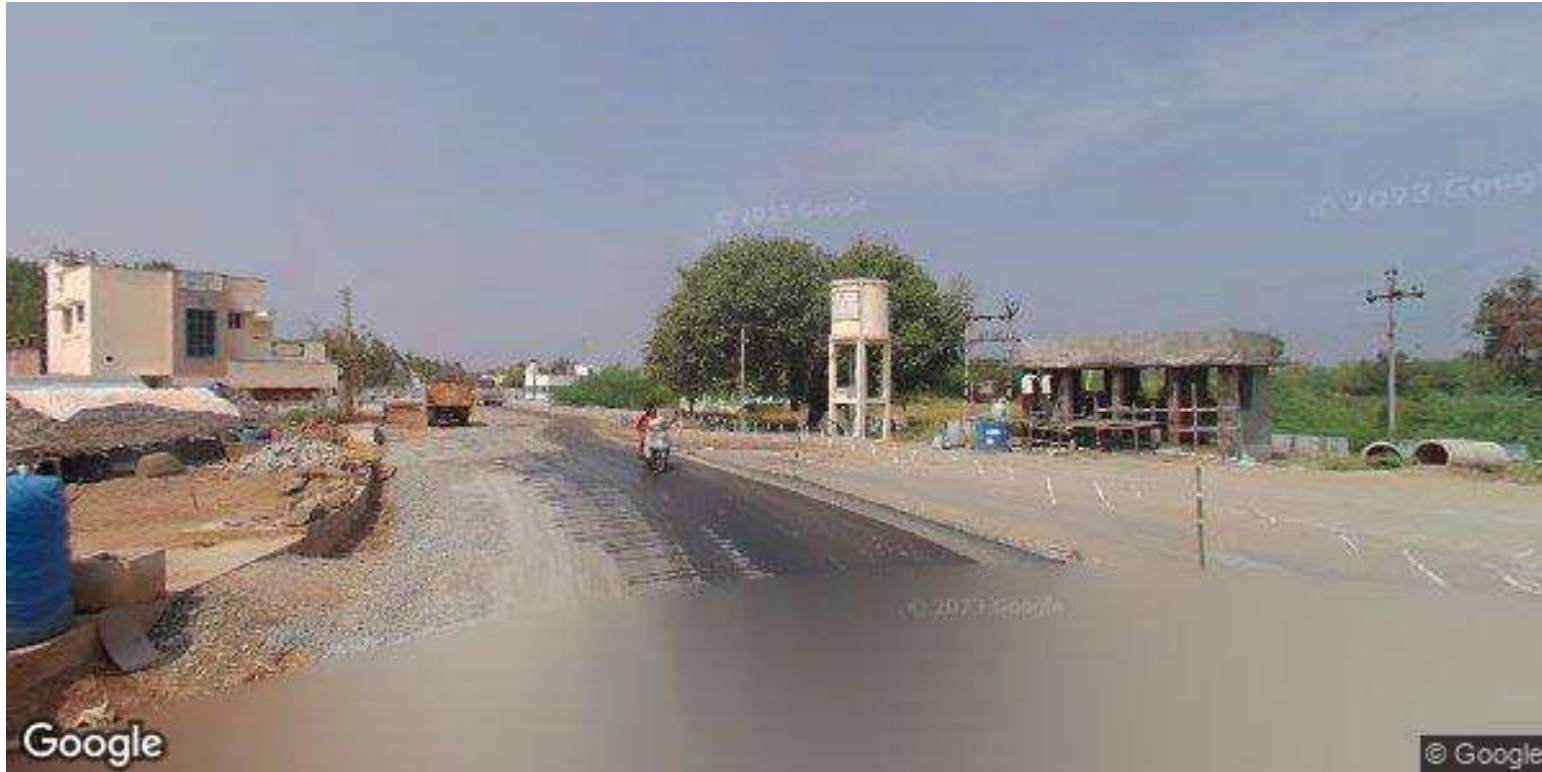
**Risk Type:** Turn  
**Risk Level:** High  
**Speed Limit:** 15 KM/Hr  
**Coordinates:** 11.42171, 78.21703

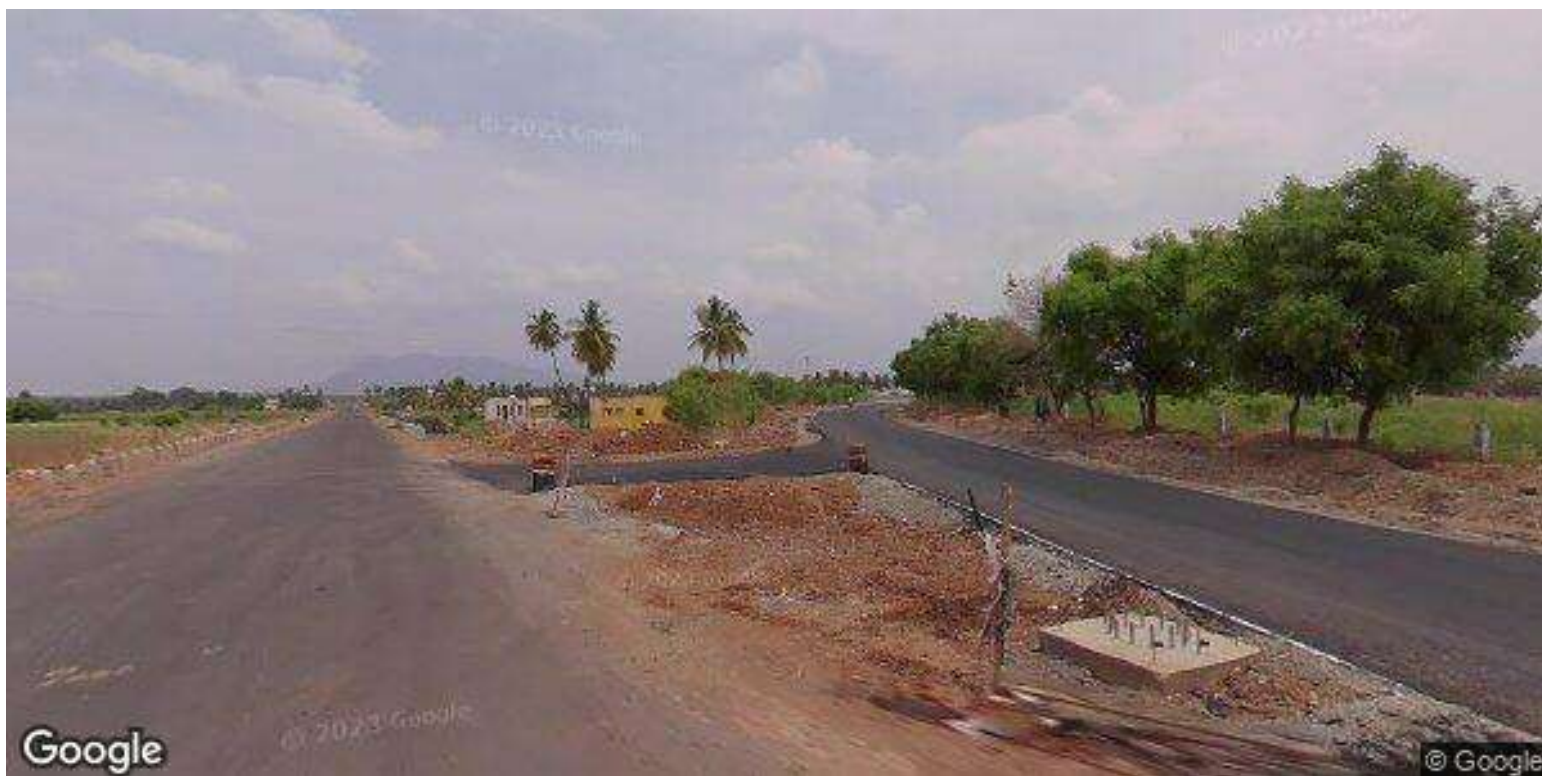
**Risk Type:** Blind Spot  
**Risk Level:** Blind Spot  
**Speed Limit:** 10 KM/Hr  
**Coordinates:** 11.41011, 78.22543

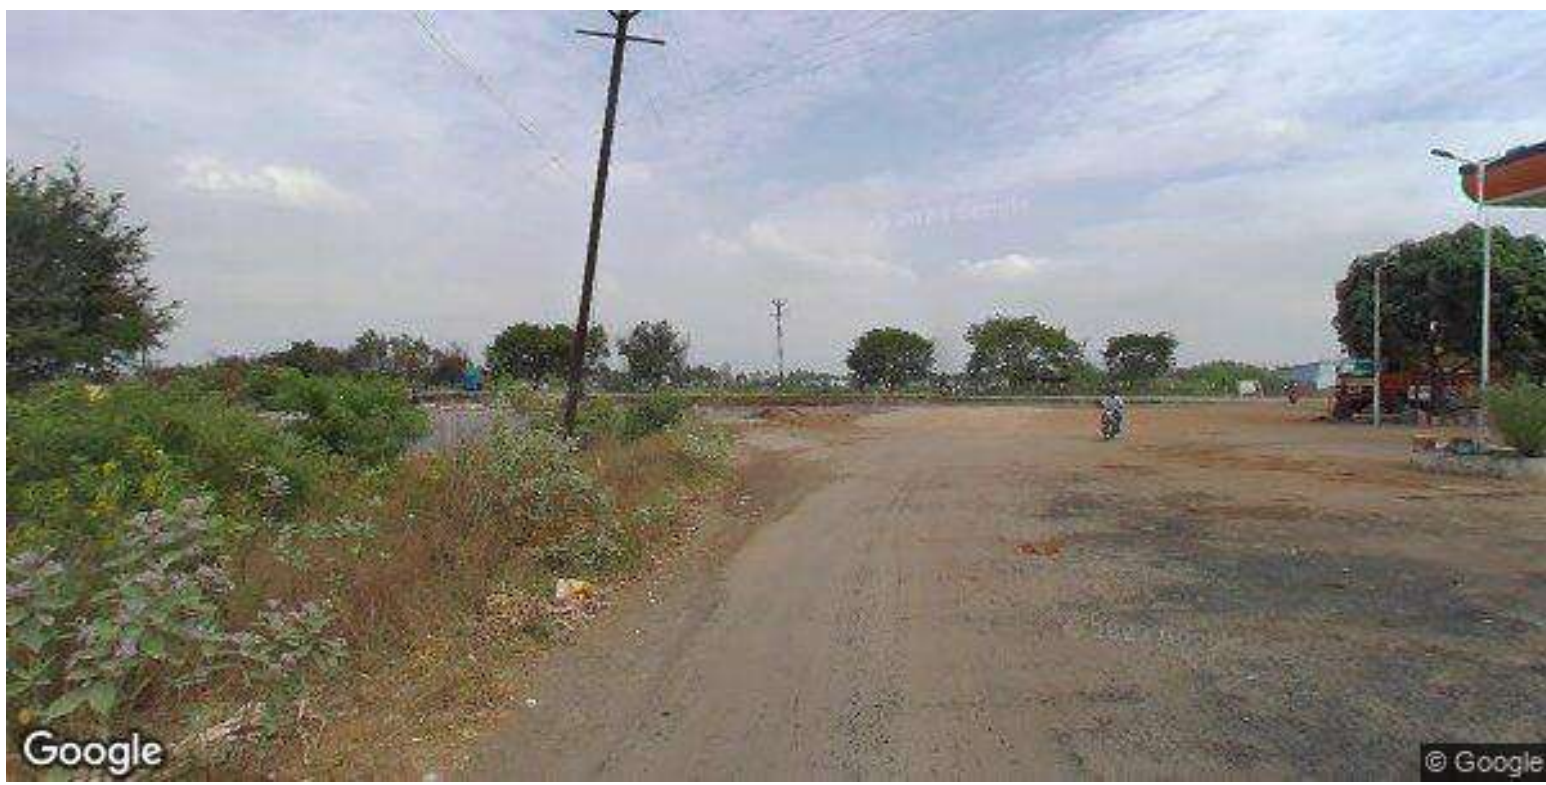
**Coordinates:** 11.40969, 78.22524

**Risk Type:** Blind Spot

**Risk Level:** Blind Spot

**Speed Limit:** 10 KM/Hr
