# IndianOil

## JOURNEY RISK MANAGEMENT (JRM) STUDY

**Salem Terminal TO GOPALAKRISHNA AGENCY**

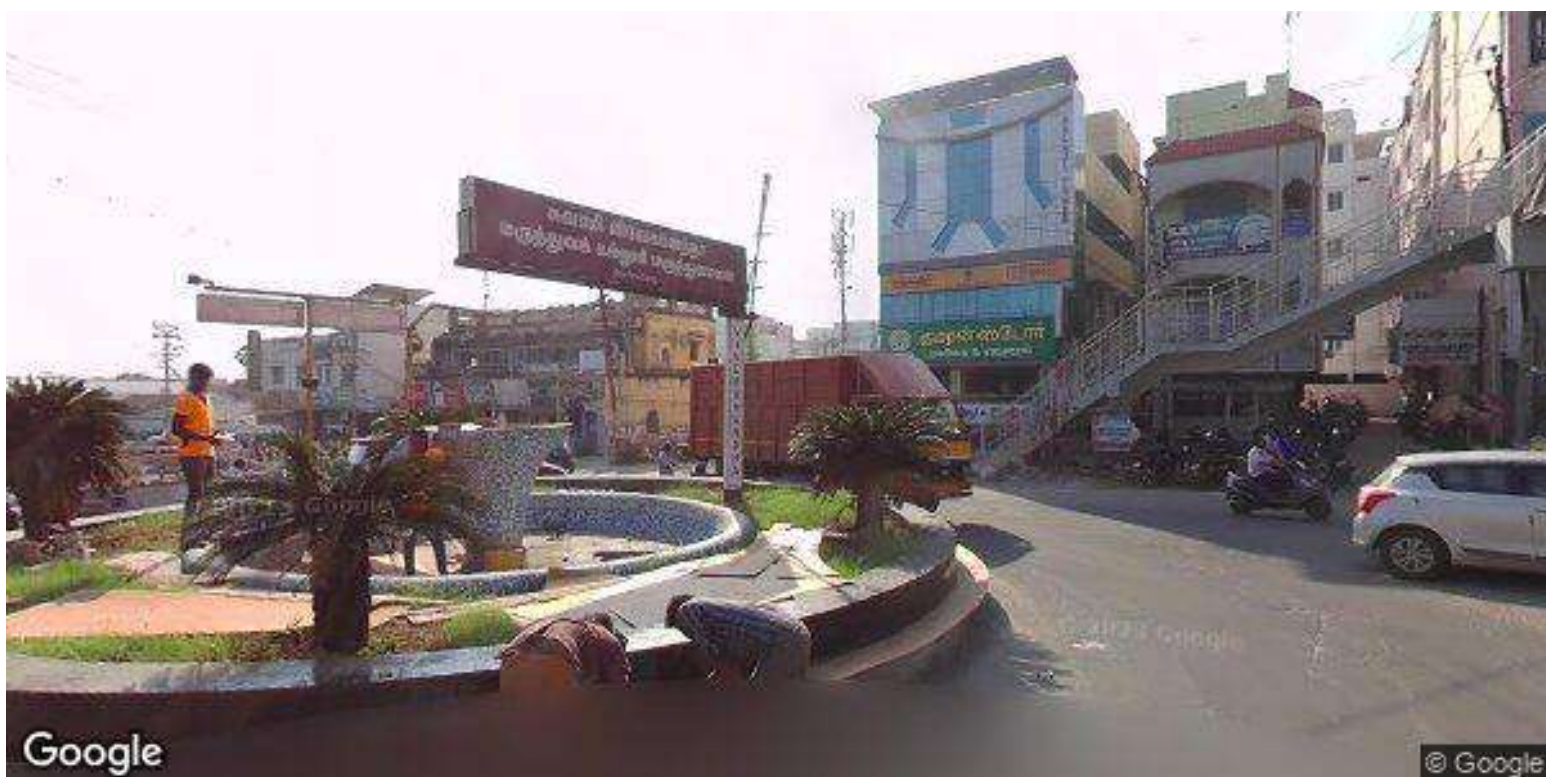
**Coordinates:** 11.38395, 77.89480

**Risk Type:** Roundabout

**Risk Level:** High

**Speed Limit:** 15 KM/Hr

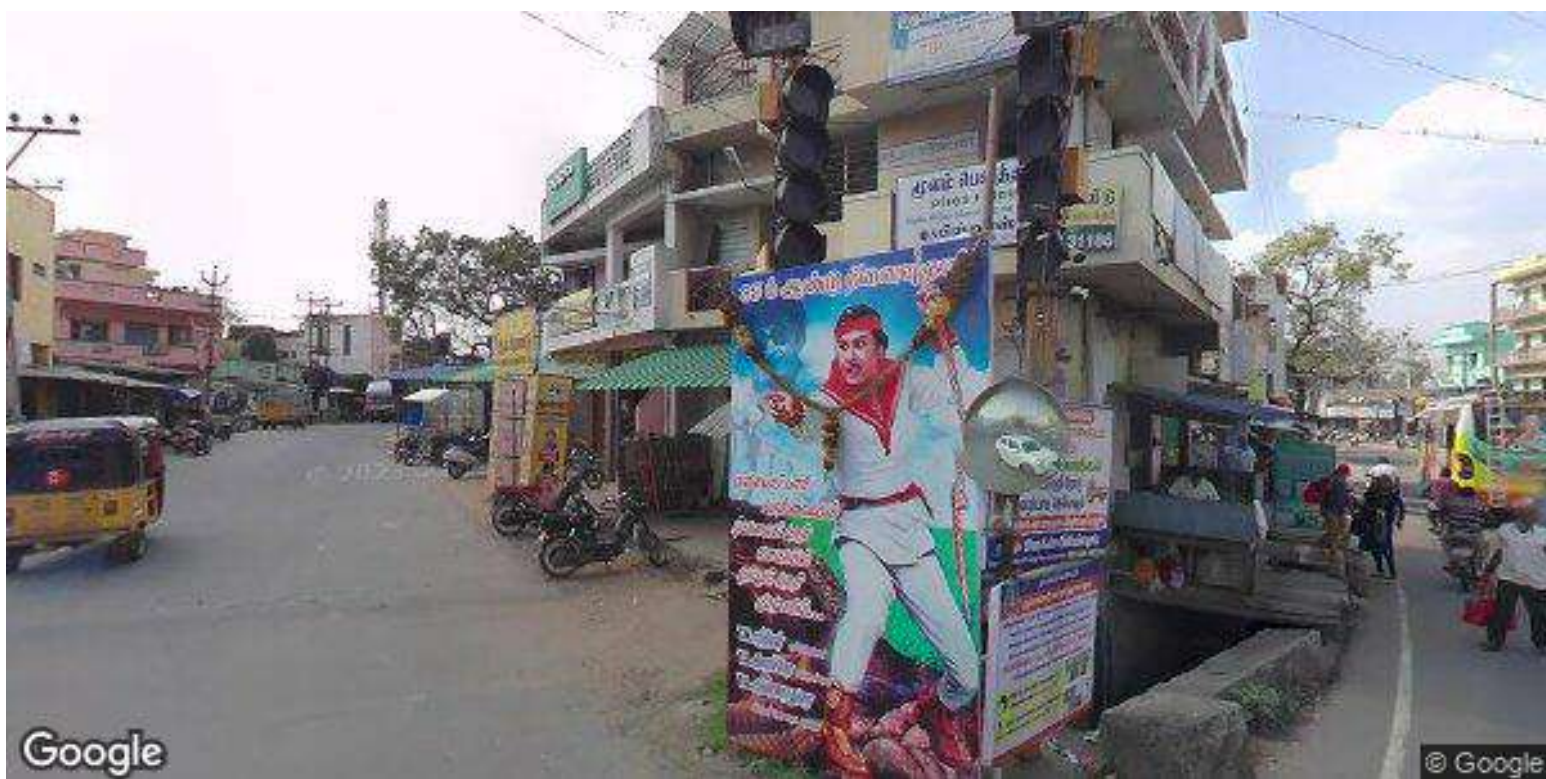
**Coordinates:** 11.38342, 77.89975

**Risk Type:** Turn

**Risk Level:** Medium

**Speed Limit:** 30 KM/Hr

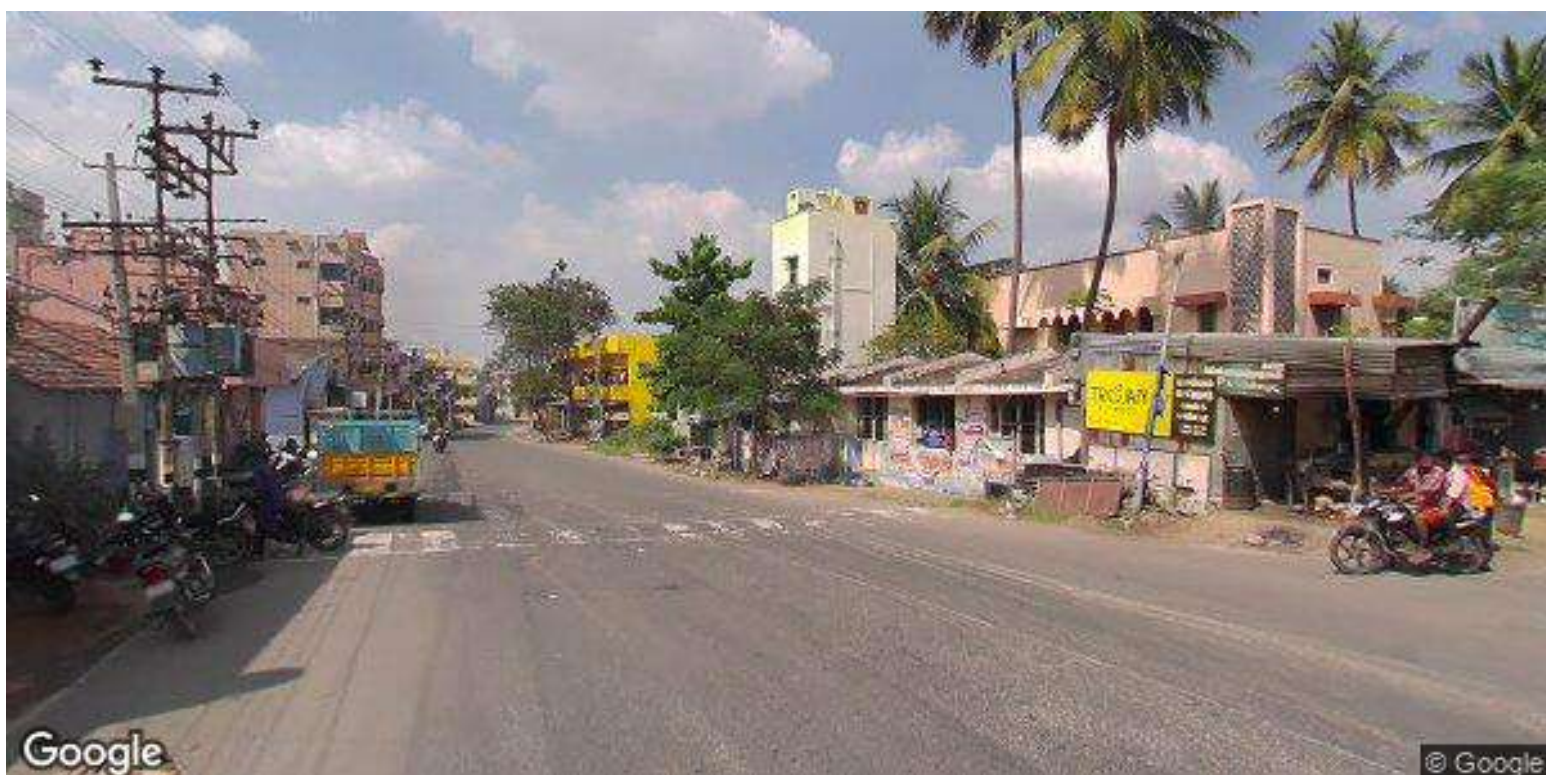
**Coordinates:** 11.38190, 77.90254

**Risk Type:** Turn

**Risk Level:** High

**Speed Limit:** 15 KM/Hr

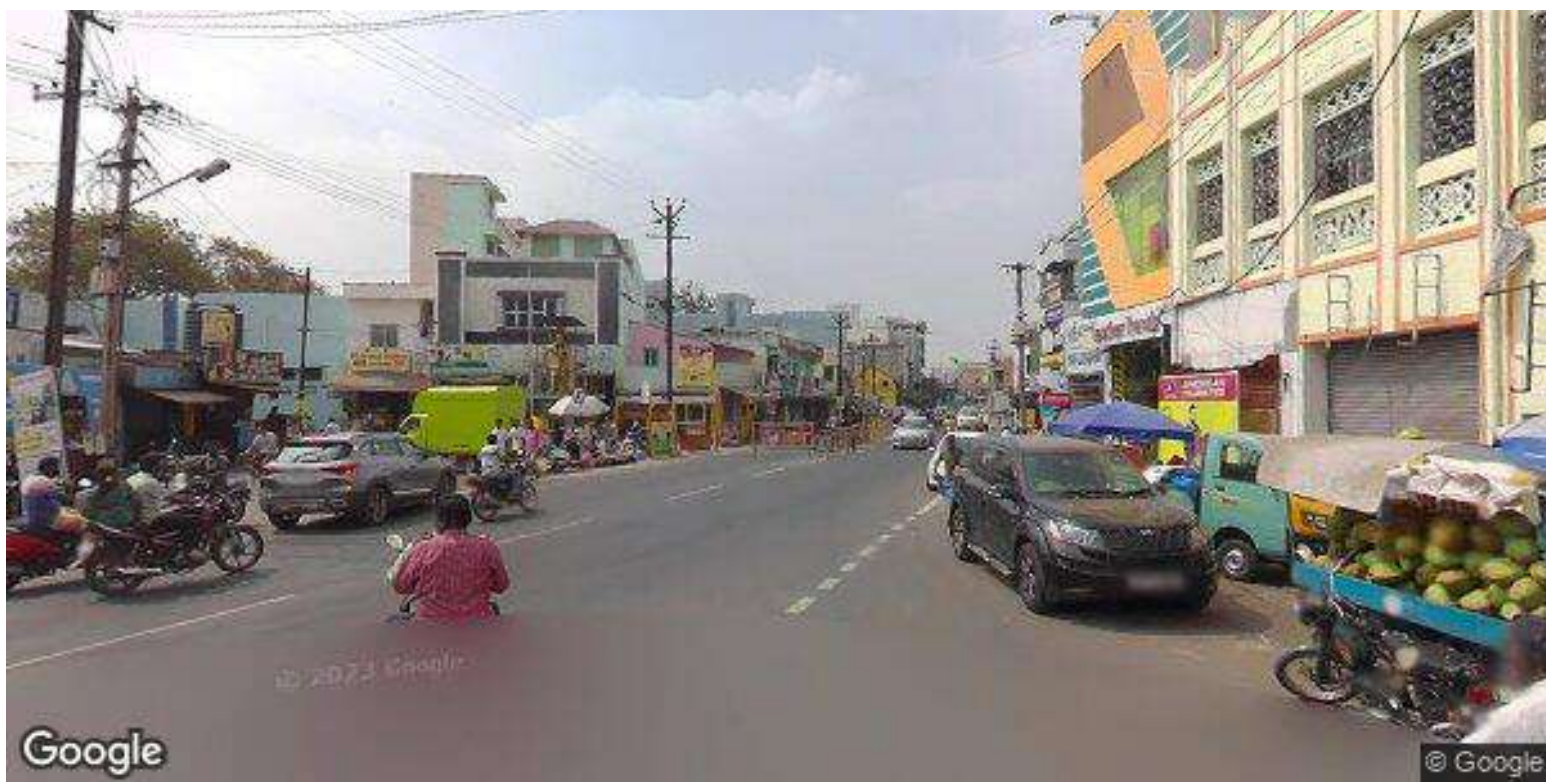
**Coordinates:** 11.22481, 78.16539

**Risk Type:** Turn

**Risk Level:** Medium

**Speed Limit:** 30 KM/Hr

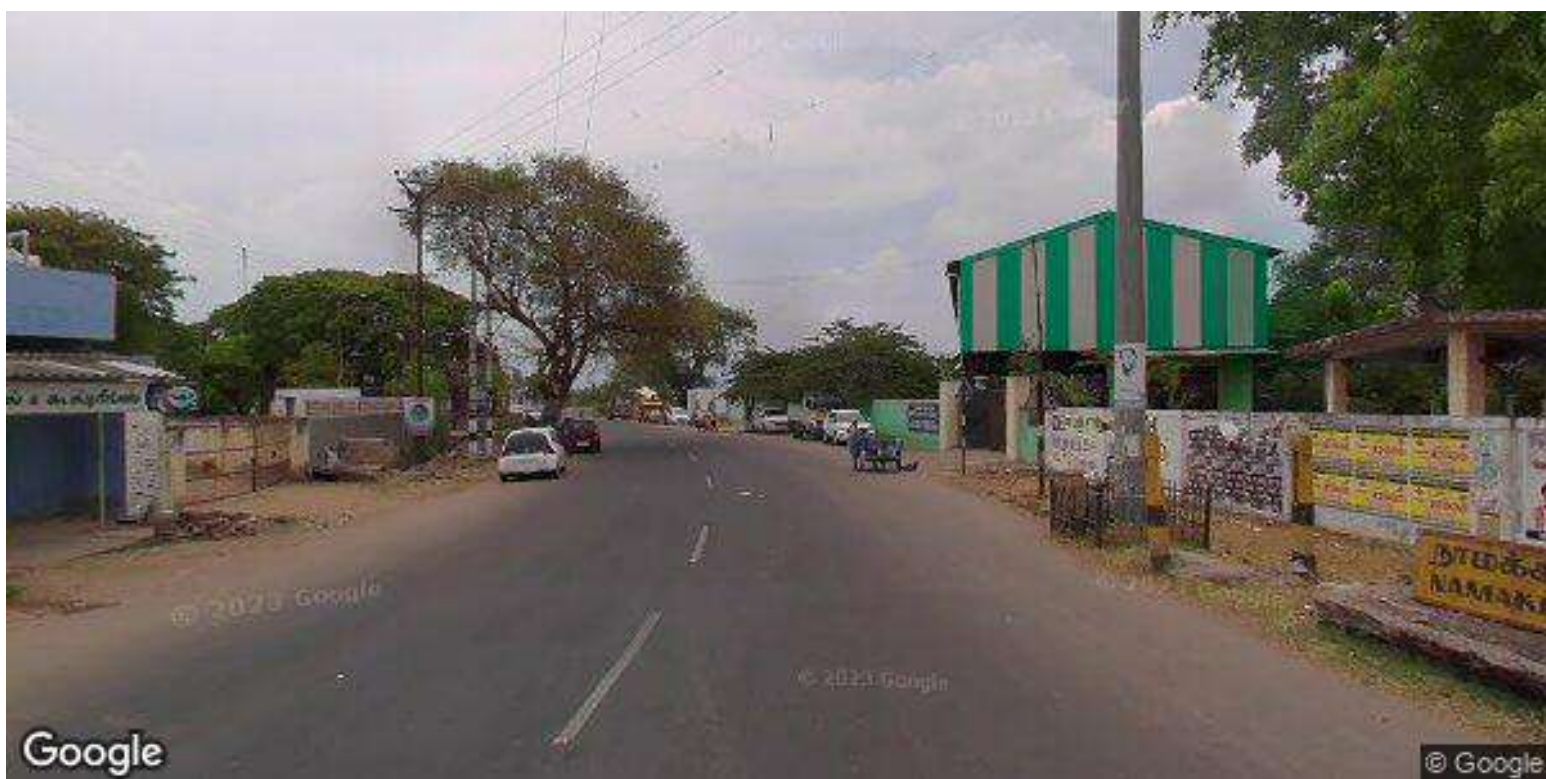
**Coordinates:** 11.22408, 78.17204

**Risk Type:** Turn

**Risk Level:** Medium

**Speed Limit:** 30 KM/Hr

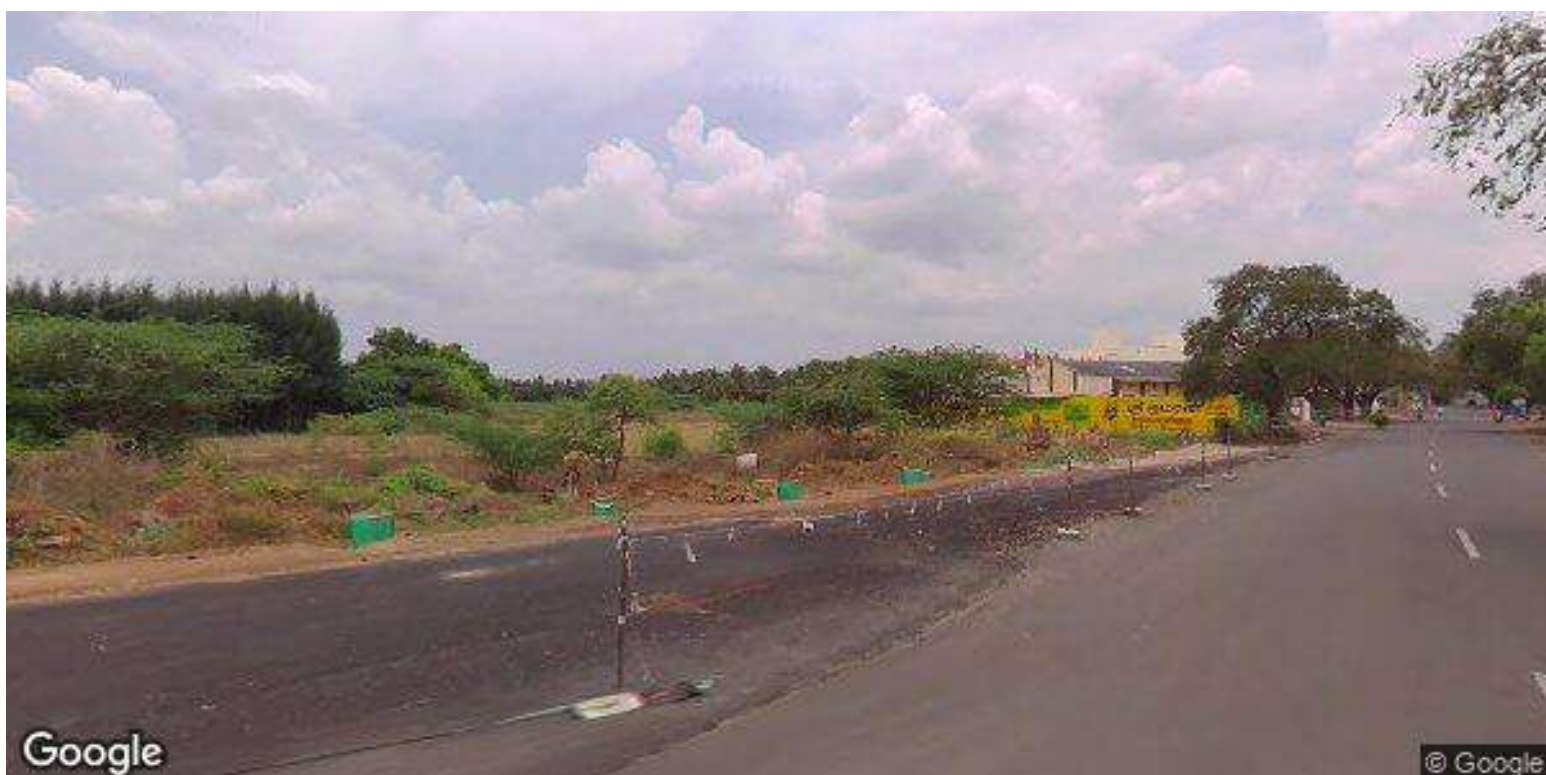
**Coordinates:** 11.23996, 78.21411

**Risk Type:** Turn

**Risk Level:** Medium

**Speed Limit:** 30 KM/Hr
