## JOURNEY RISK MANAGEMENT (JRM) STUDY

### Salem Terminal TO SHREE VIGNESHWARA FUELS

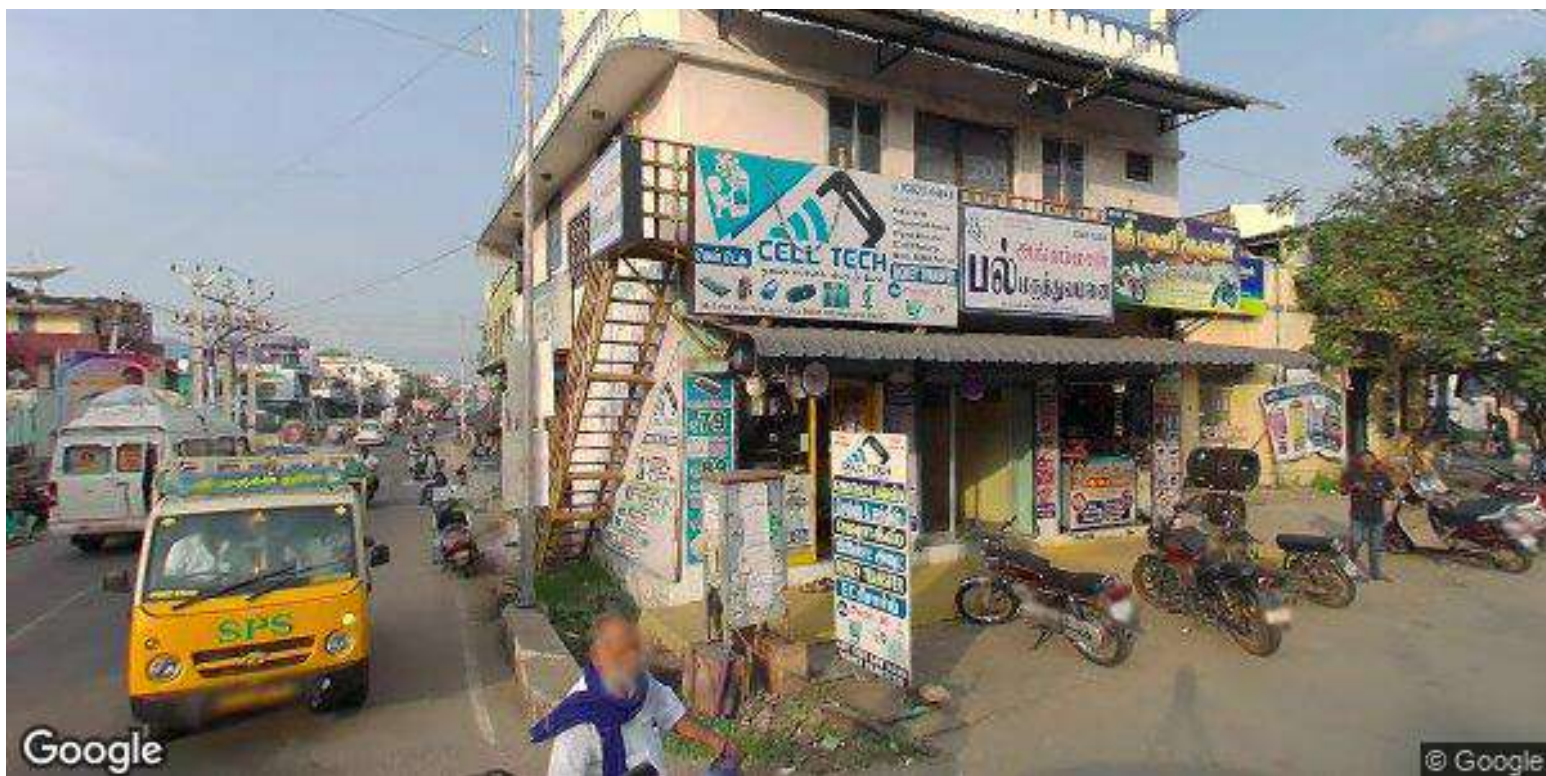
**Risk Type:** Turn  
**Risk Level:** High  
**Speed Limit:** 15 KM/Hr  
**Coordinates:** 11.44111, 77.69331

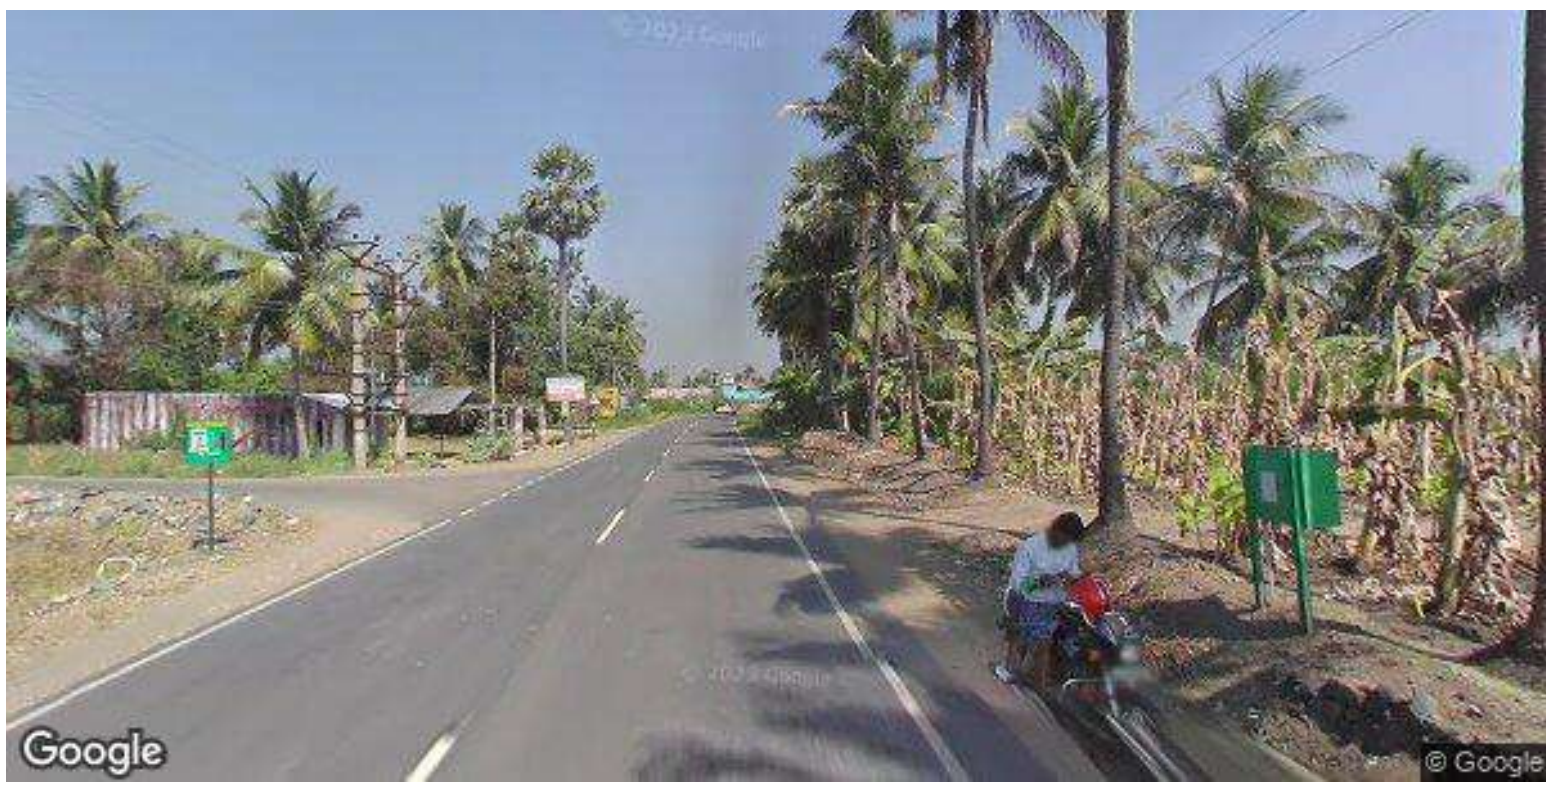
**Risk Type:** Blind Spot  
**Risk Level:** Blind Spot  
**Speed Limit:** 10 KM/Hr  
**Coordinates:** 11.48173, 77.70723

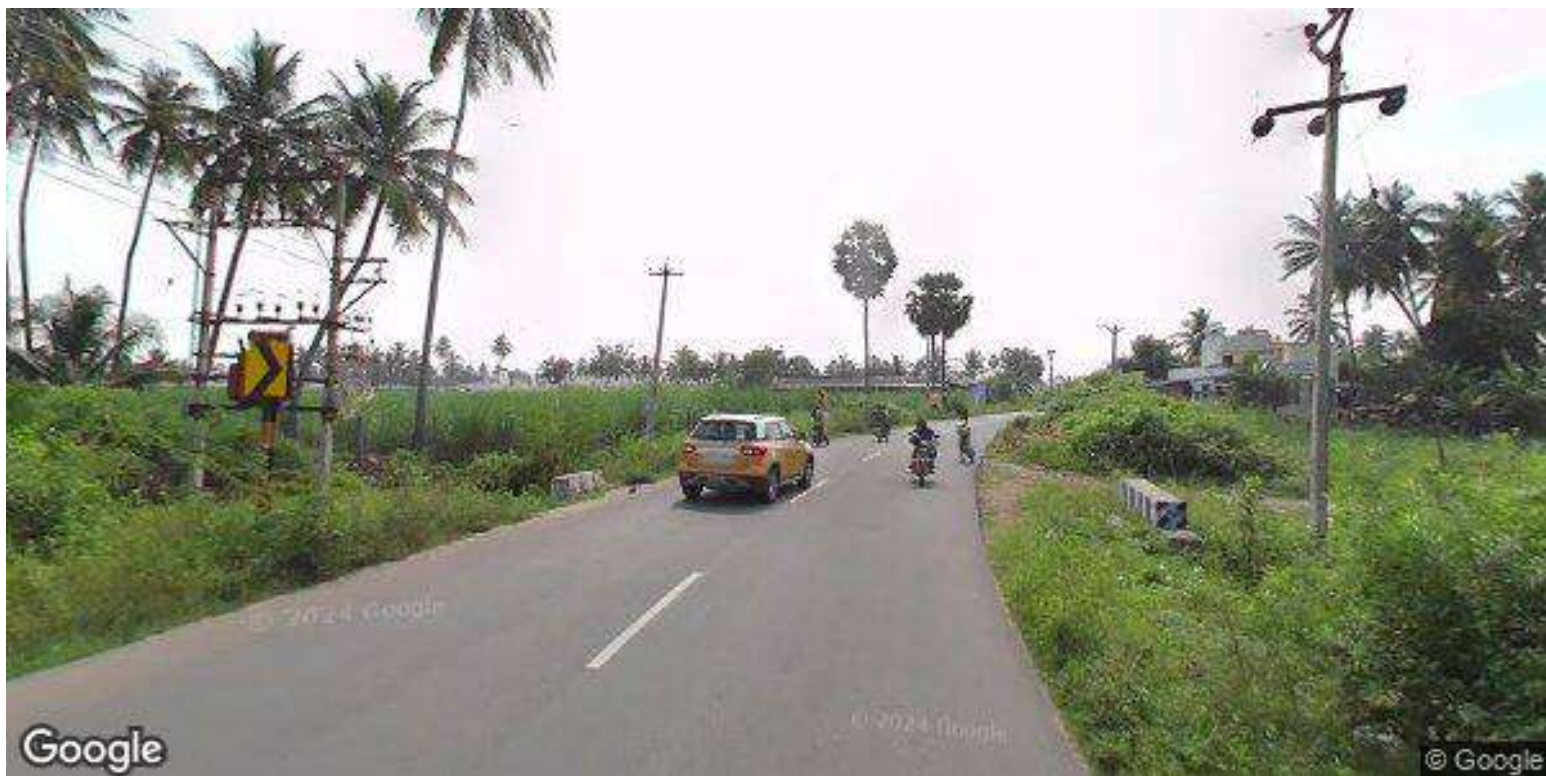
**Risk Type:** Turn  
**Risk Level:** Medium  
**Speed Limit:** 30 KM/Hr  
**Coordinates:** 11.46090, 77.69969

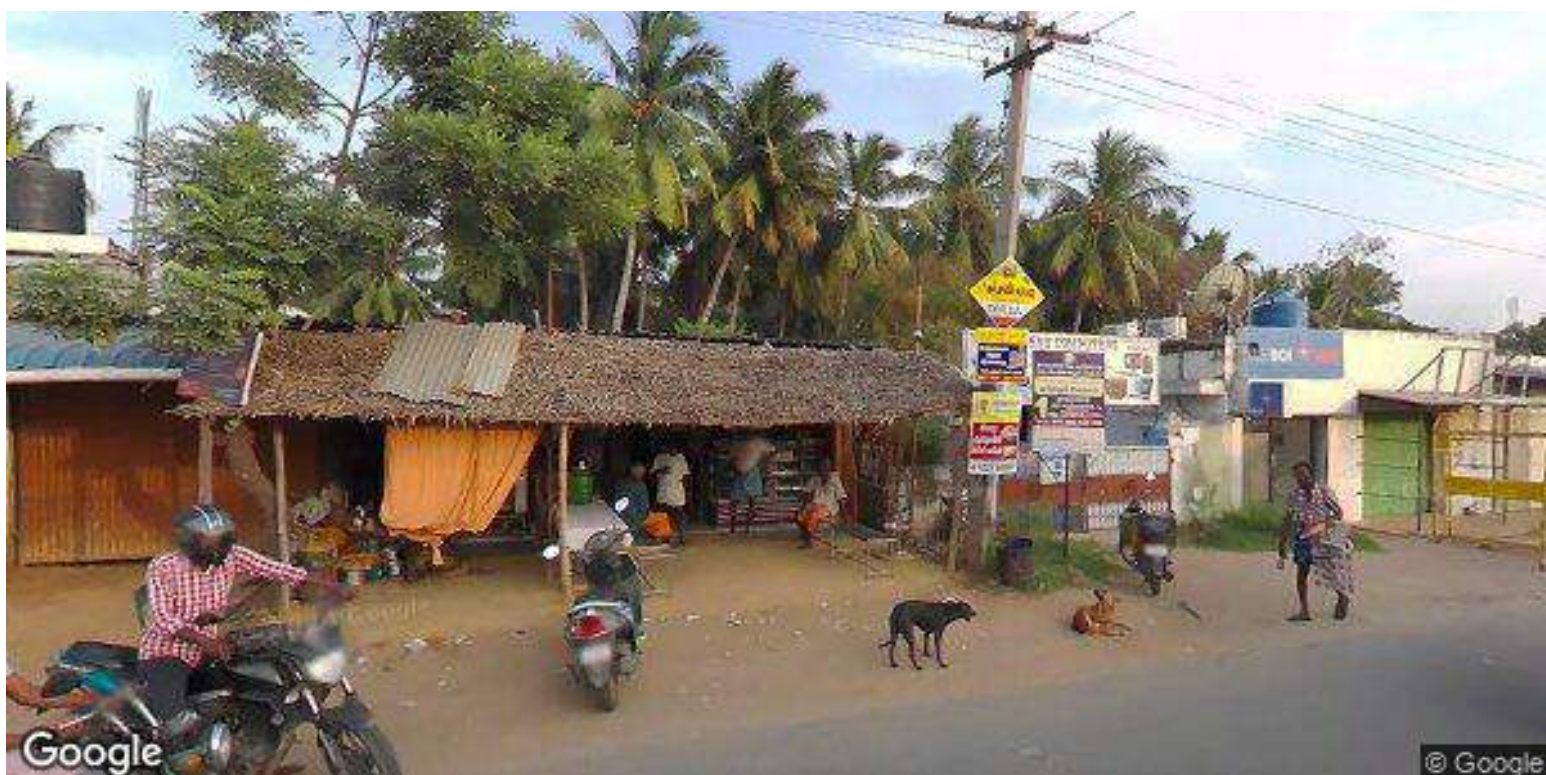
**Risk Type:** Blind Spot  
**Risk Level:** Blind Spot  
**Speed Limit:** 10 KM/Hr  
**Coordinates:** 11.44985, 77.69520

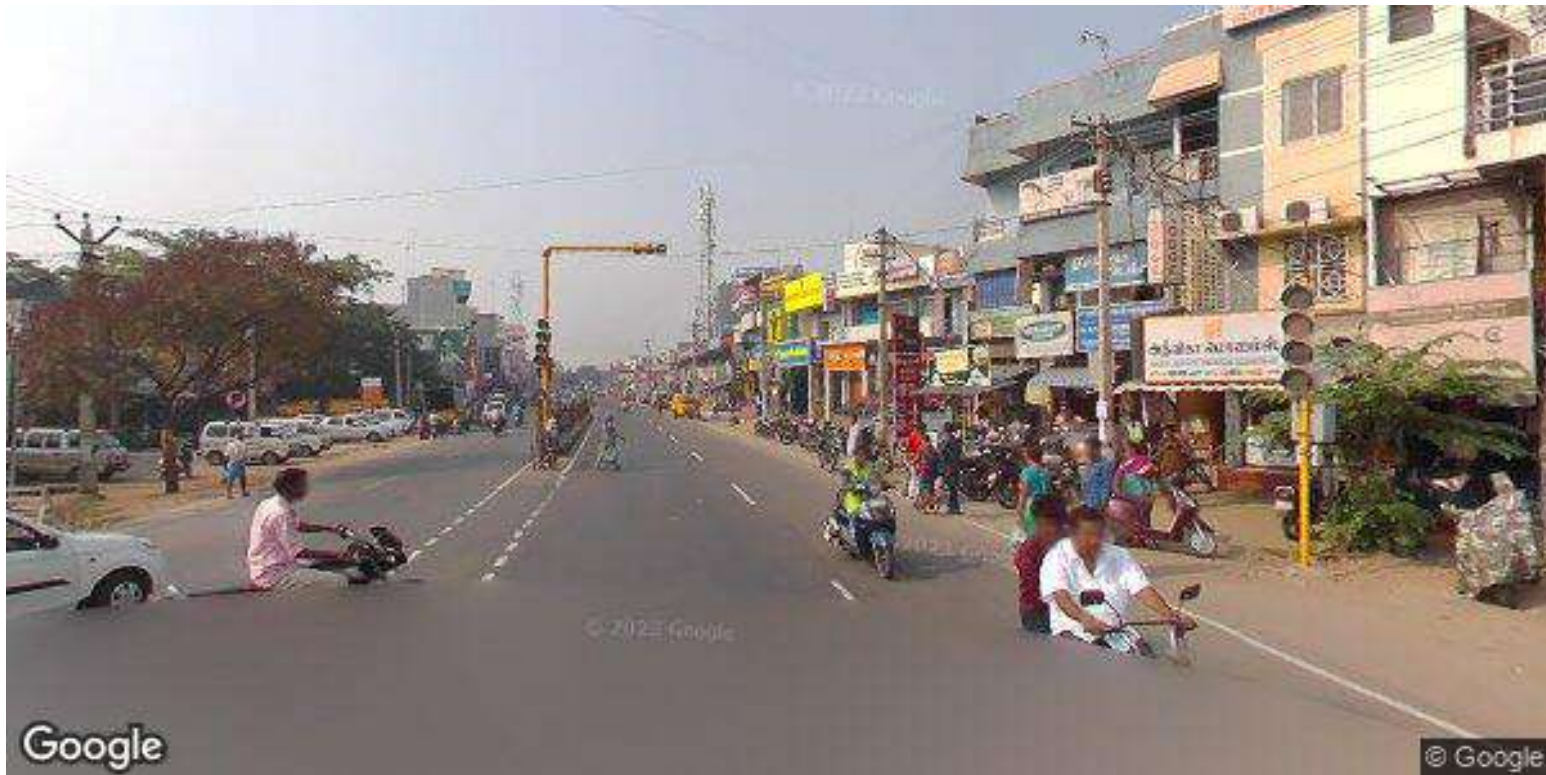
**Risk Type:** Turn  
**Risk Level:** High  
**Speed Limit:** 15 KM/Hr  
**Coordinates:** 11.45331, 77.68803

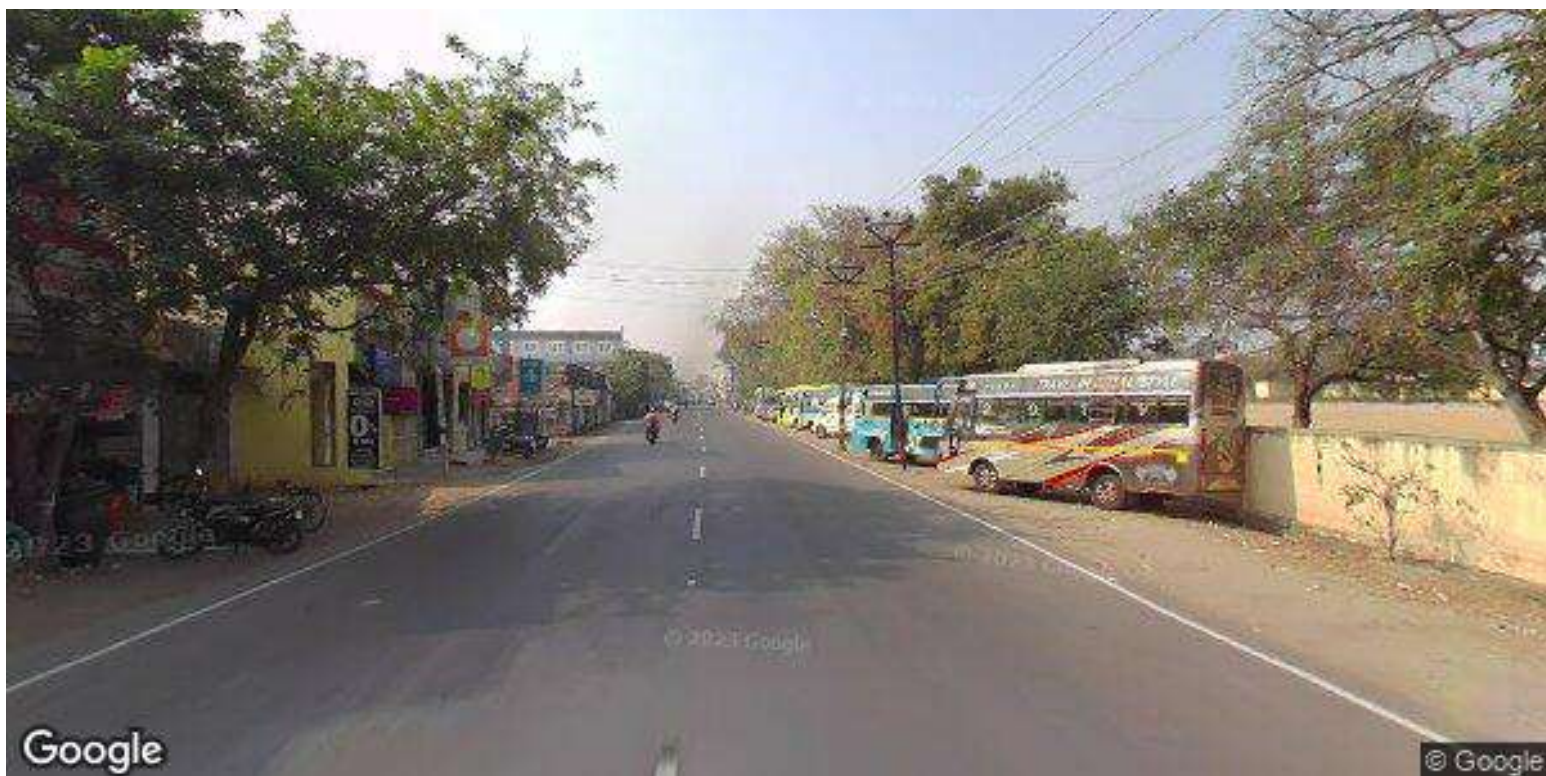
**Risk Type:** Blind Spot  
**Risk Level:** Blind Spot  
**Speed Limit:** 10 KM/Hr  
**Coordinates:** 11.44979, 77.68549

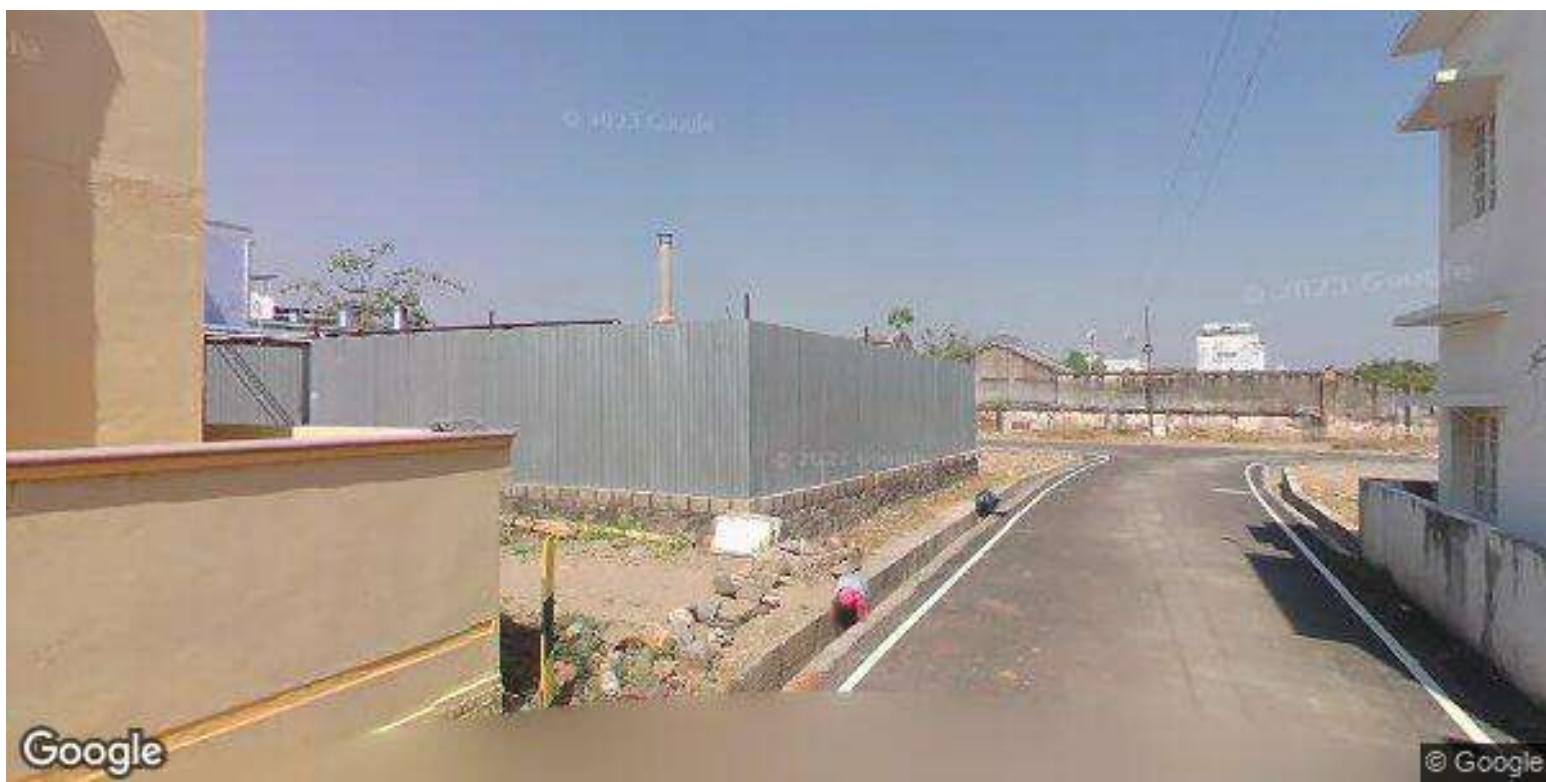
**Coordinates:** 11.44948, 77.68645

**Risk Type:** Turn

**Risk Level:** High

**Speed Limit:** 15 KM/Hr

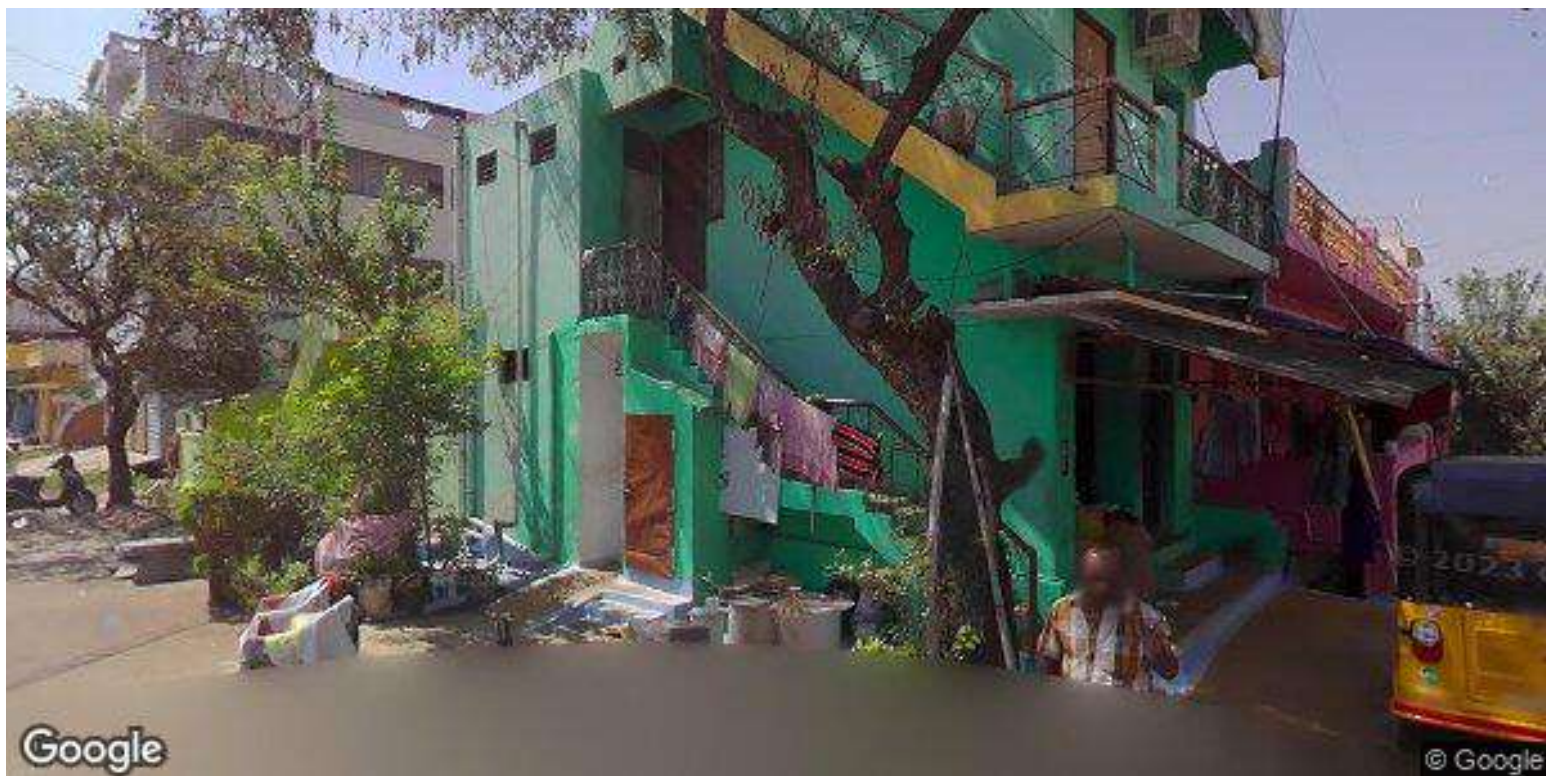
**Coordinates:** 11.44801, 77.68596

**Risk Type:** Turn

**Risk Level:** High

**Speed Limit:** 15 KM/Hr

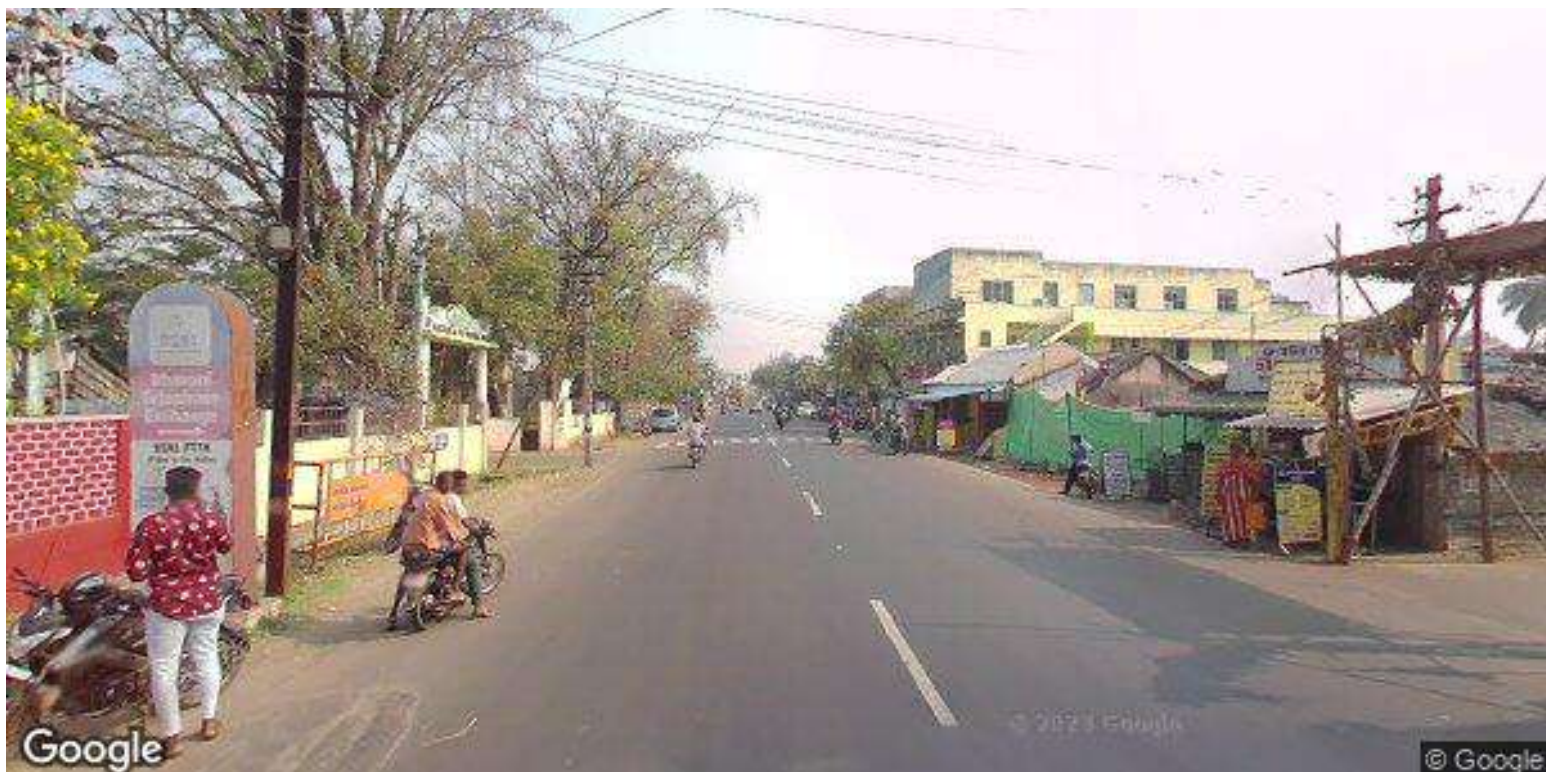
**Risk Type:** Blind Spot  
**Risk Level:** Blind Spot  
**Speed Limit:** 10 KM/Hr  
**Coordinates:** 11.44842, 77.68473

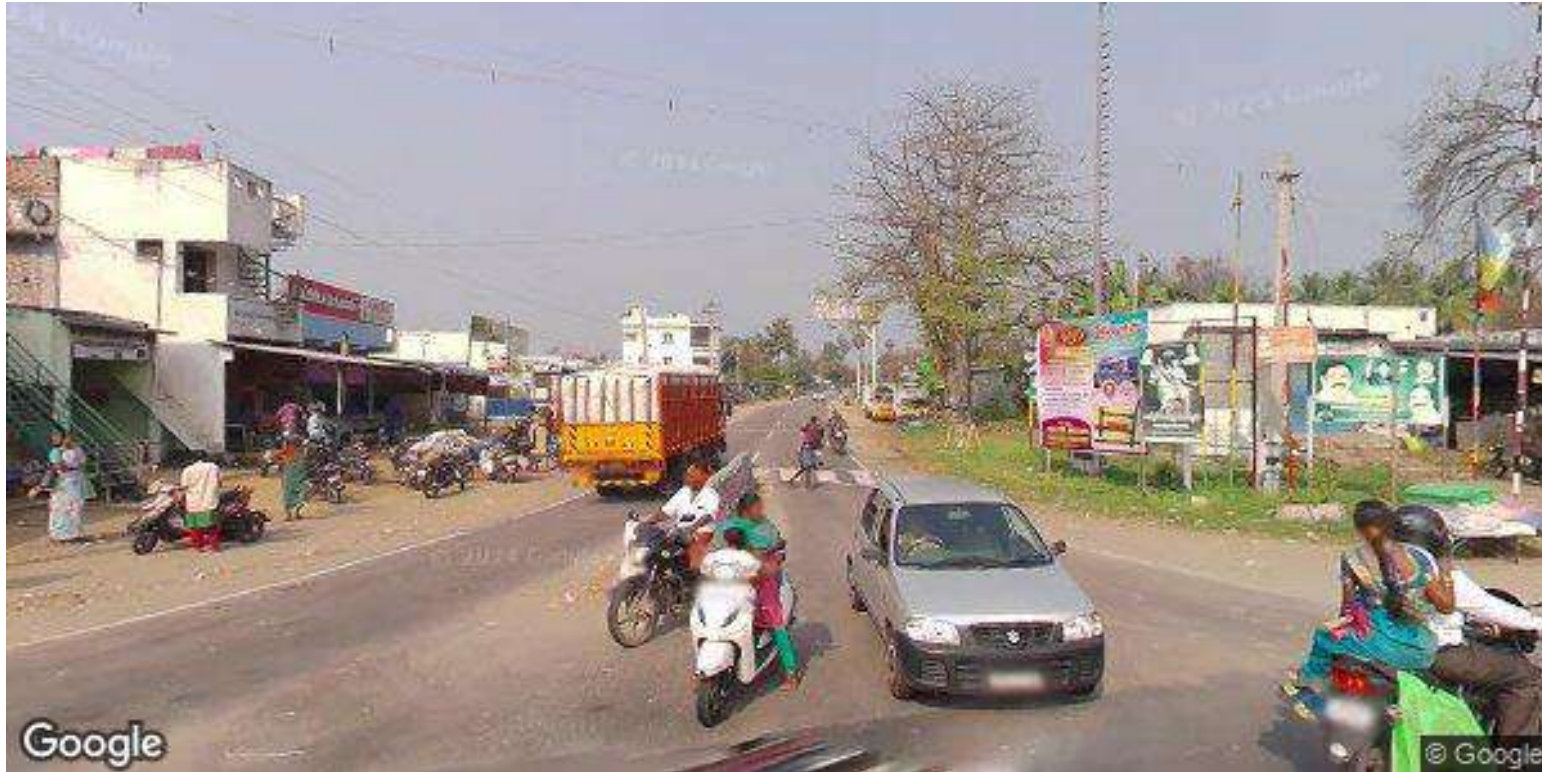
**Risk Type:** Turn  
**Risk Level:** High  
**Speed Limit:** 15 KM/Hr  
**Coordinates:** 11.49333, 77.69855

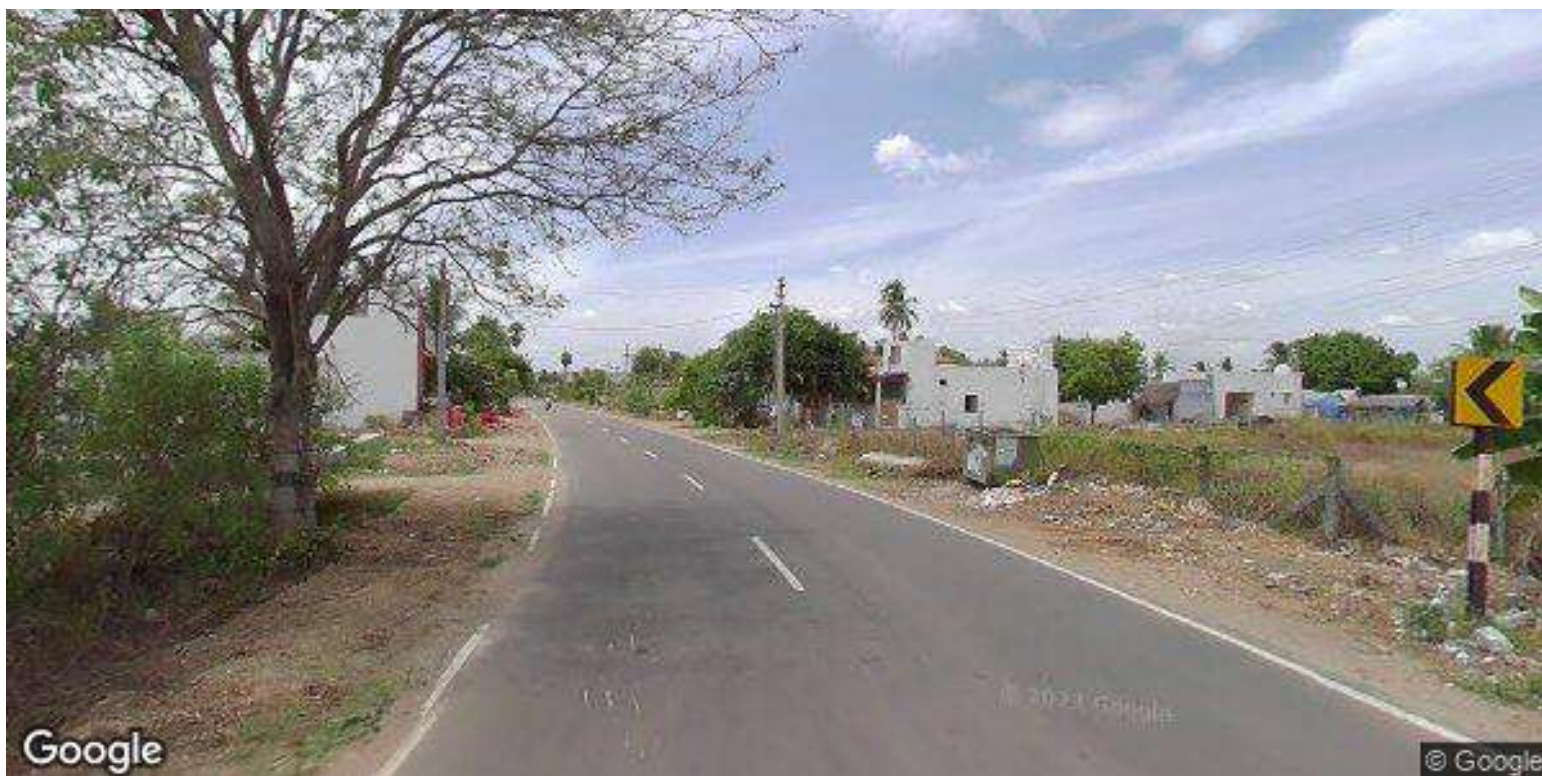
**Risk Type:** Turn  
**Risk Level:** Medium  
**Speed Limit:** 30 KM/Hr  
**Coordinates:** 11.49531, 77.69212

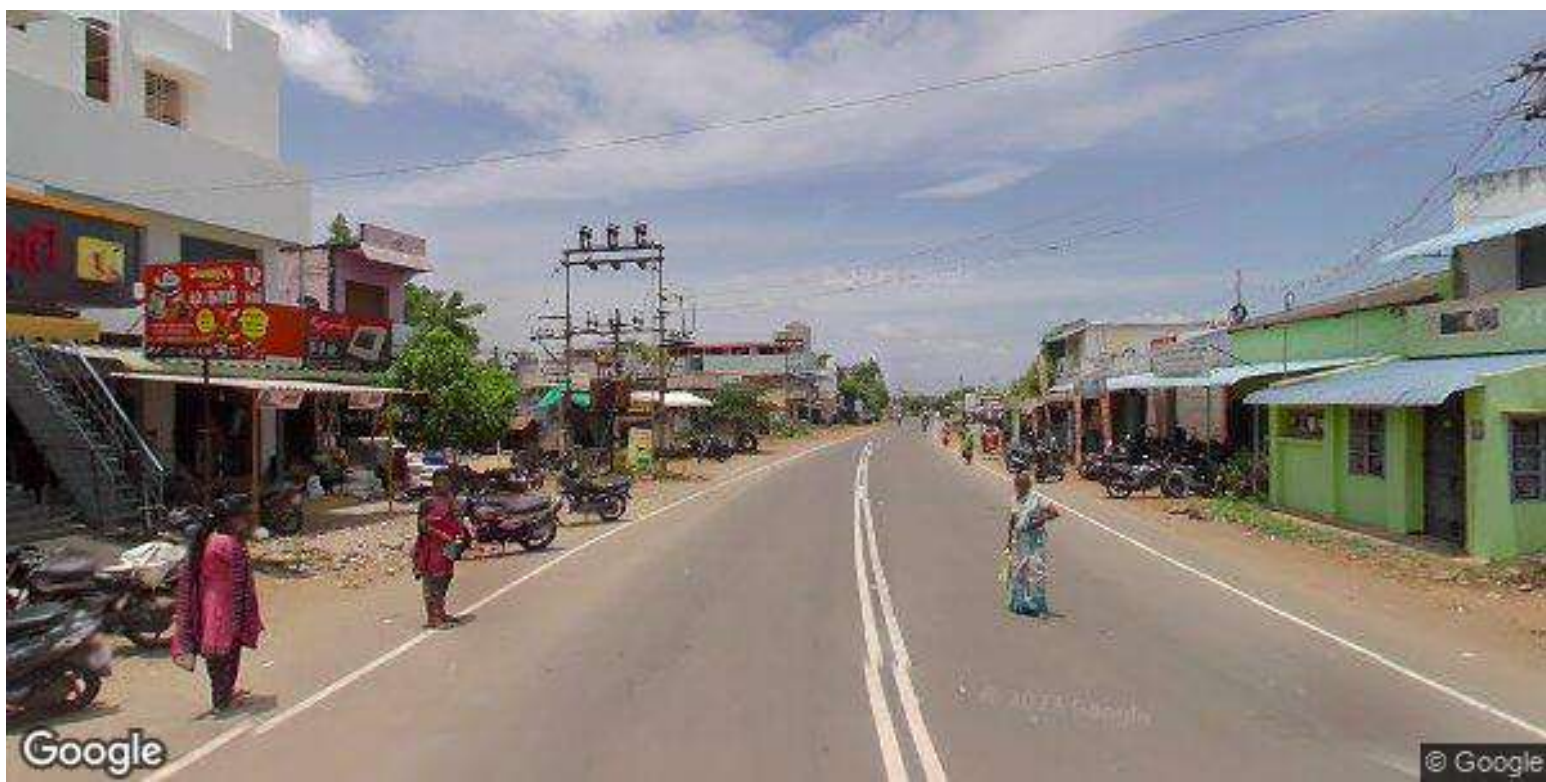
**Coordinates:** 11.52412, 77.67994

**Risk Type:** Turn

**Risk Level:** Medium

**Speed Limit:** 30 KM/Hr

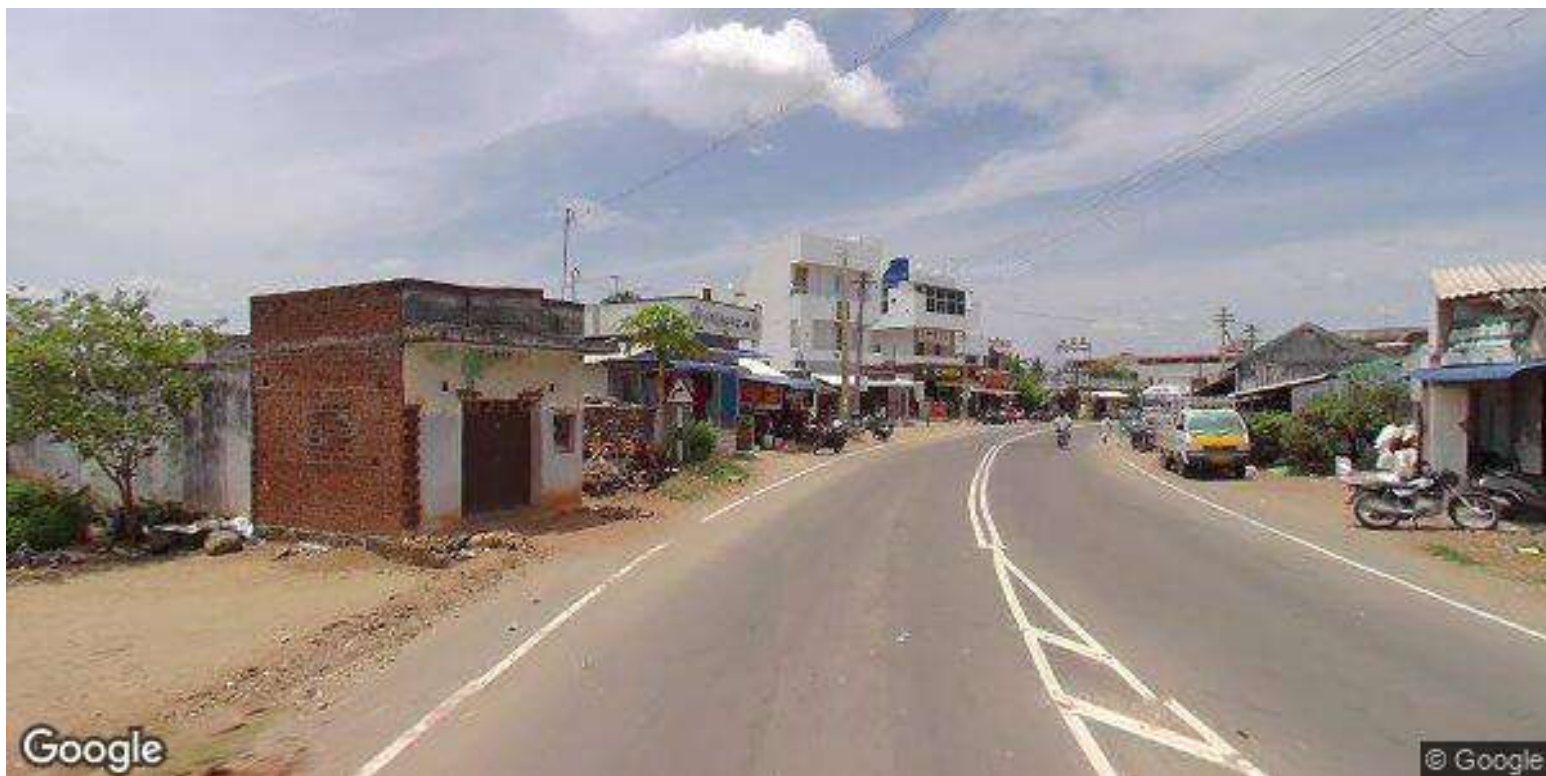
**Coordinates:** 11.52455, 77.67971

**Risk Type:** Turn

**Risk Level:** Medium

**Speed Limit:** 30 KM/Hr

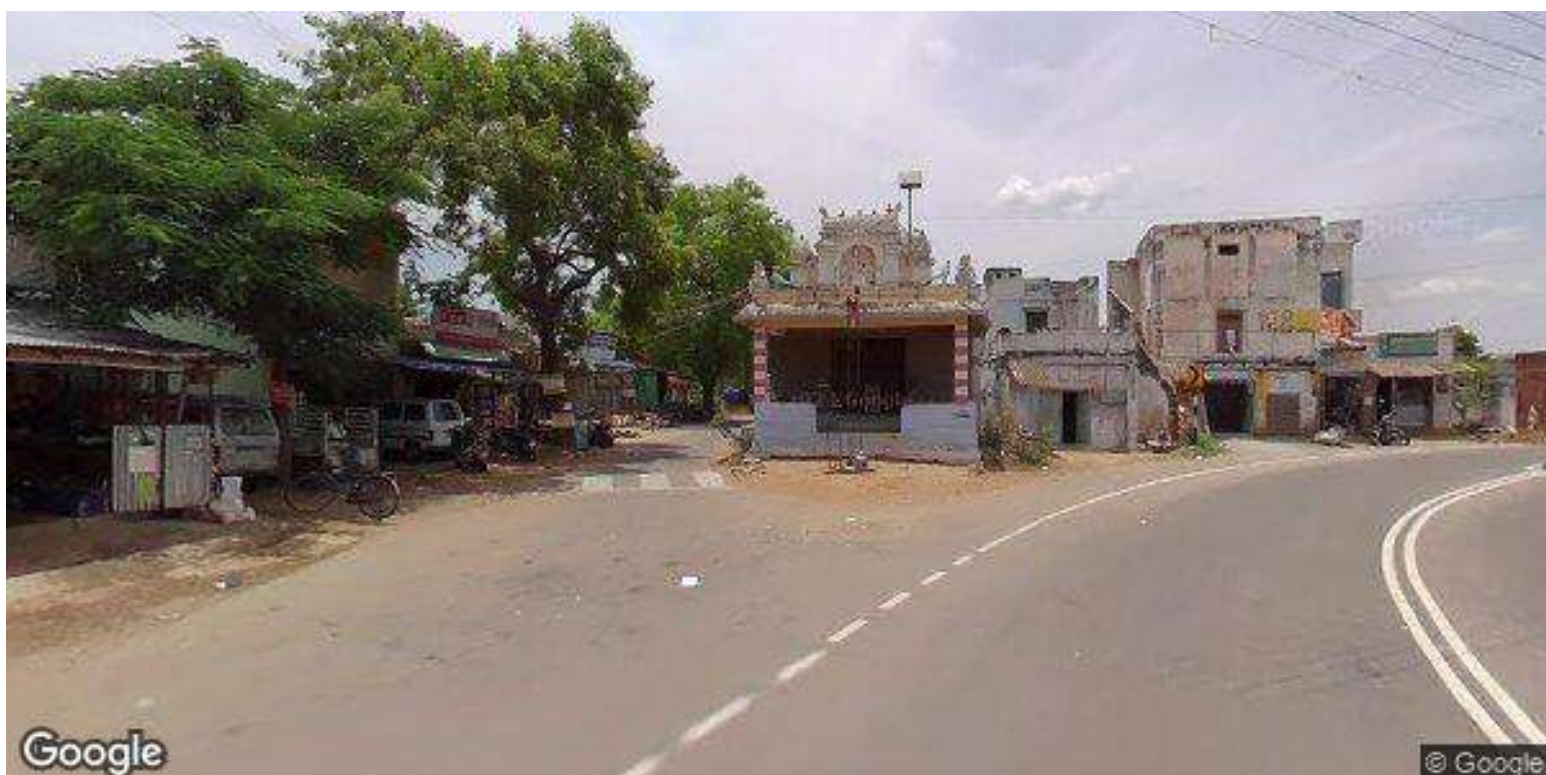
**Risk Type:** Turn  
**Risk Level:** Medium  
**Speed Limit:** 30 KM/Hr  
**Coordinates:** 11.52466, 77.67945

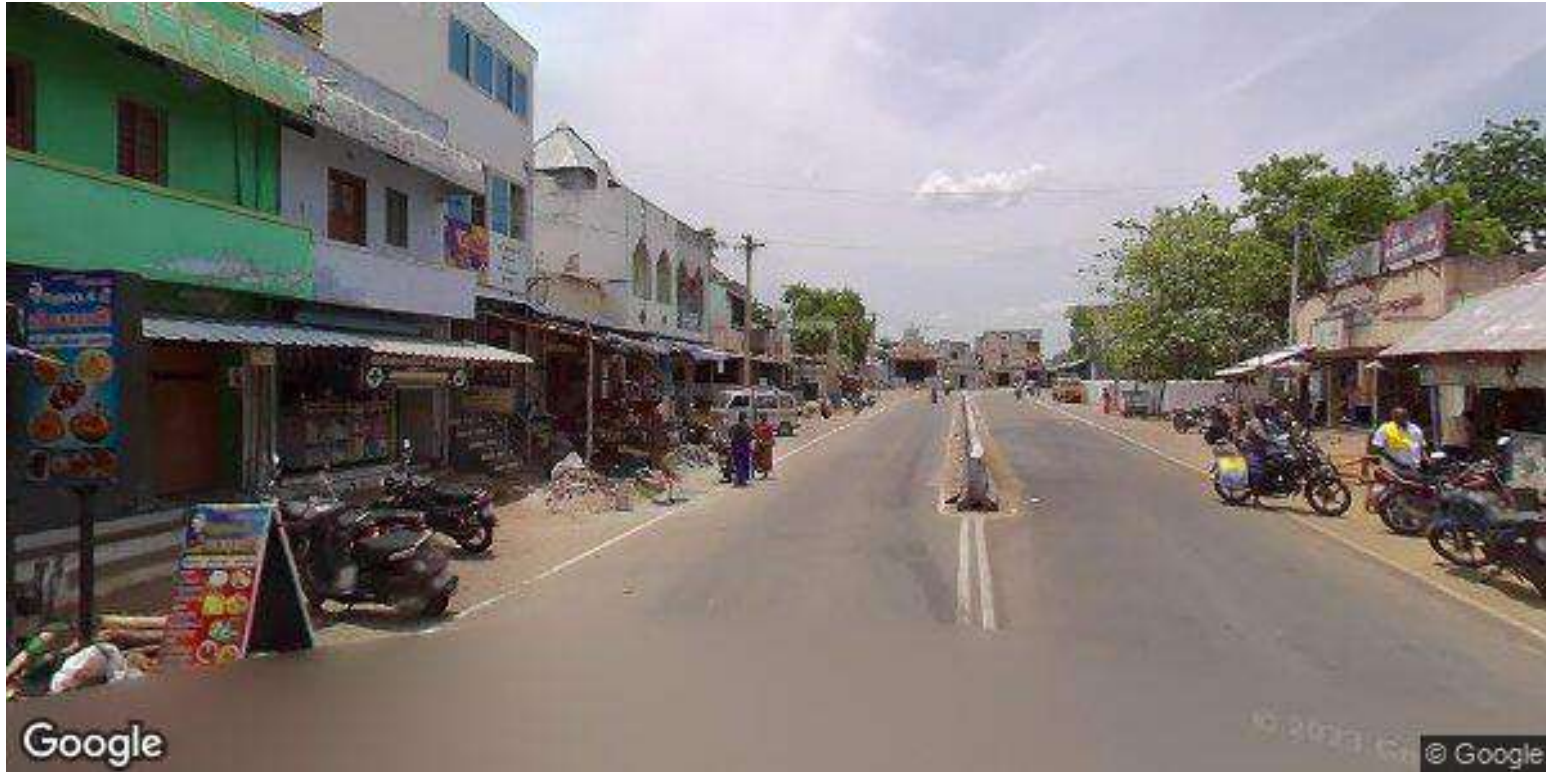
**Risk Type:** Turn  
**Risk Level:** Medium  
**Speed Limit:** 30 KM/Hr  
**Coordinates:** 11.52455, 77.67875

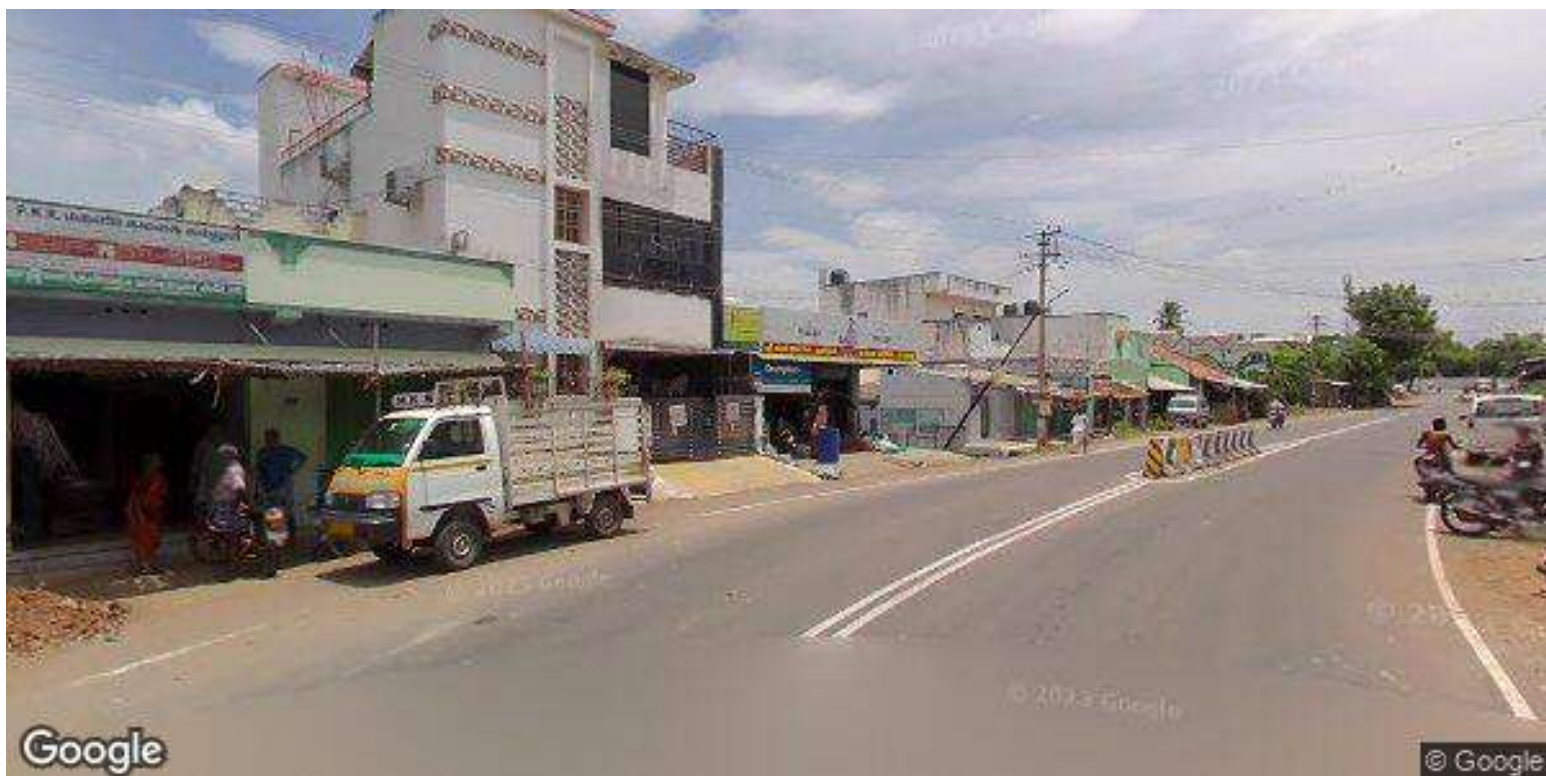
**Risk Type:** Turn  
**Risk Level:** High  
**Speed Limit:** 15 KM/Hr  
**Coordinates:** 11.52463, 77.67853

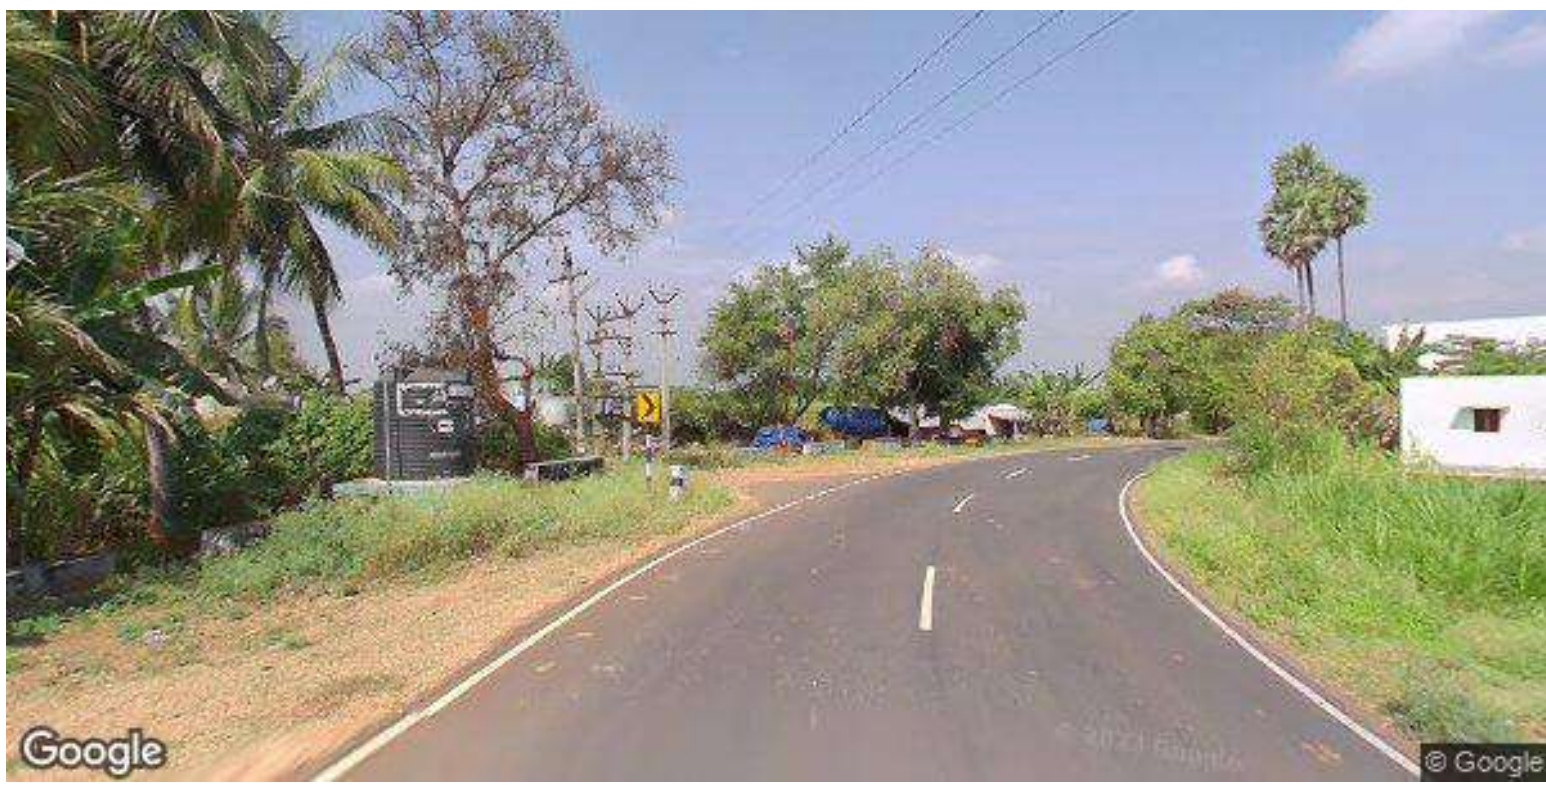
**Coordinates:** 11.55323, 77.66321

**Risk Type:** Turn

**Risk Level:** Medium

**Speed Limit:** 30 KM/Hr

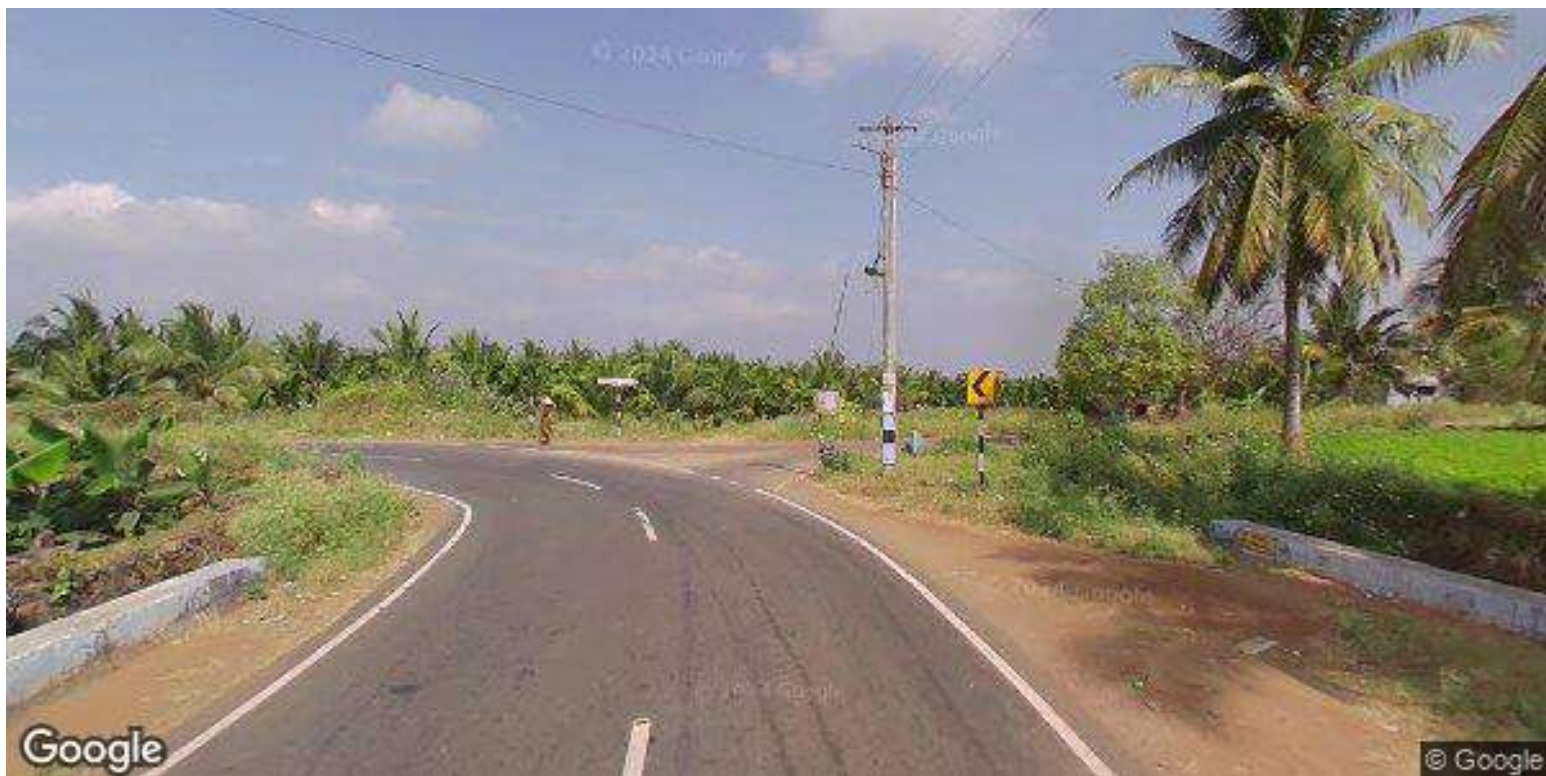
**Coordinates:** 11.56078, 77.66166

**Risk Type:** Turn

**Risk Level:** Medium

**Speed Limit:** 30 KM/Hr

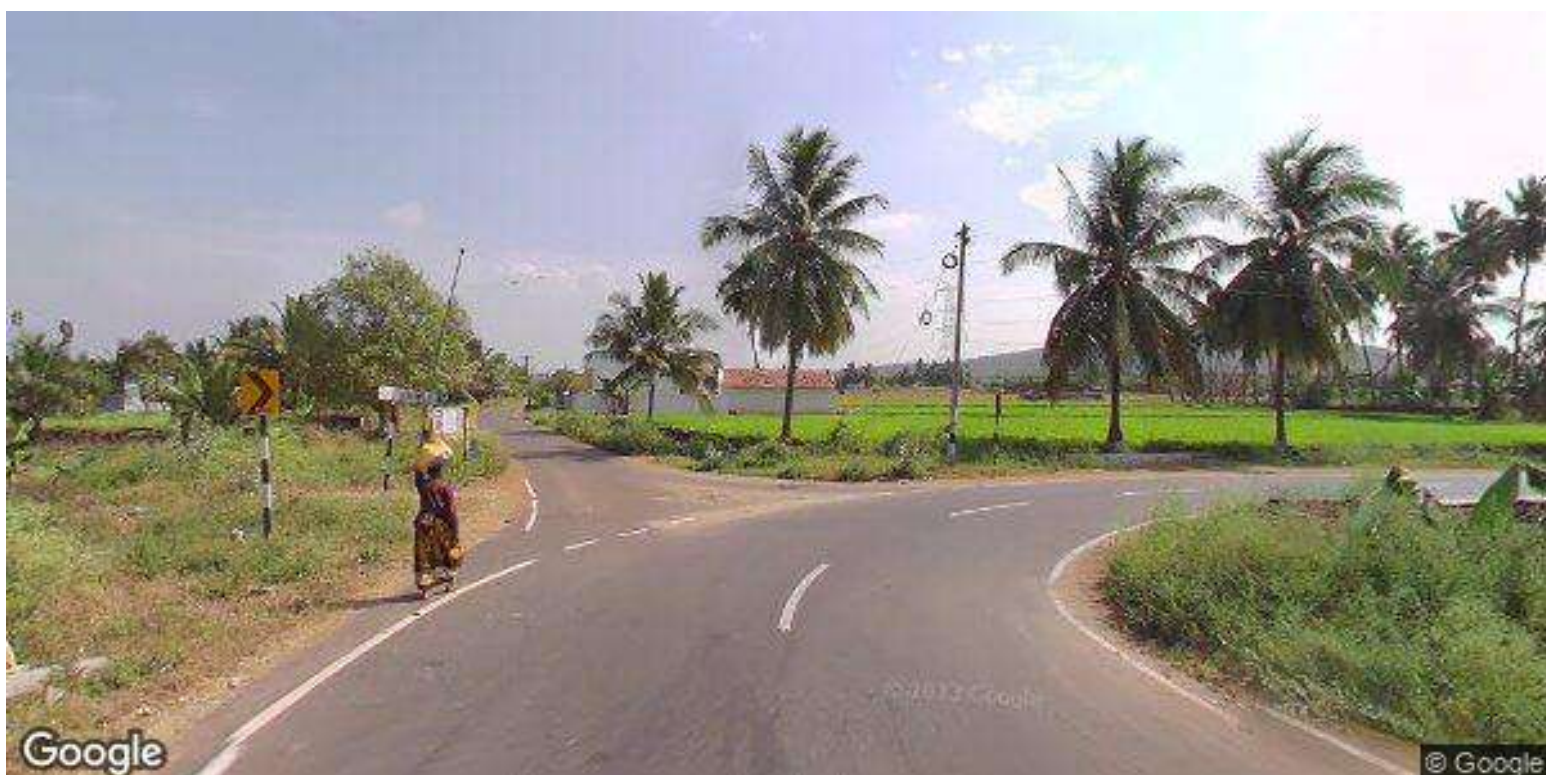
**Risk Type:** Turn  
**Risk Level:** High  
**Speed Limit:** 15 KM/Hr  
**Coordinates:** 11.56090, 77.66151
